# Confidential Inspection Report

LOCATED AT:  
7642 Hampton  
West Hollywood, California

INSPECTED ON:  
Wednesday, August 19, 2026

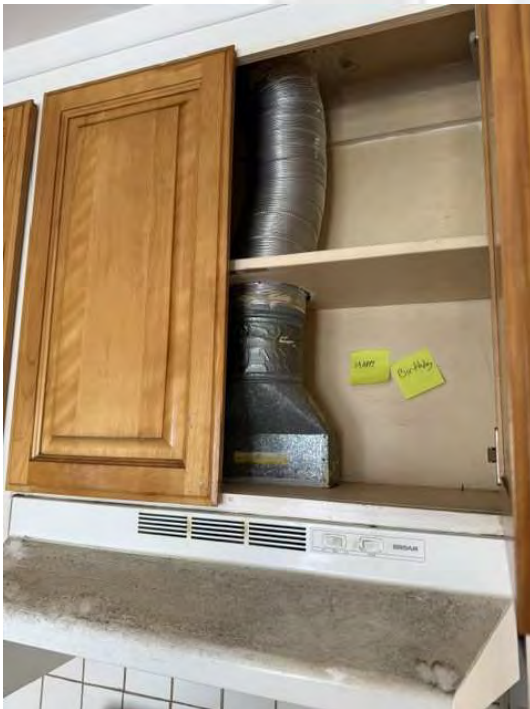
**NDSA** Non standard corrugated flexible materials are being used as the range hood exhaust vent pipe, normally rigid smooth wall material should be used to prevent grease fires.

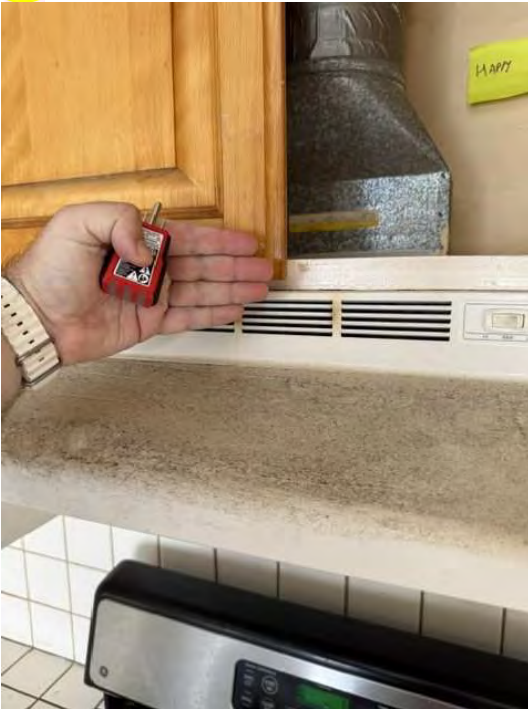
**NDSA** The unit is missing it's blocking plate to force the air out through the vent pipe

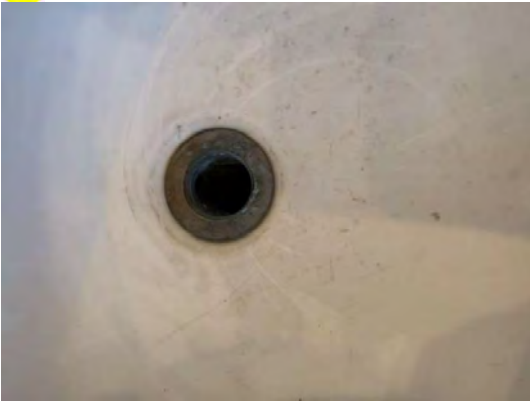
**NDSA** The bathroom sink stopper is missing.

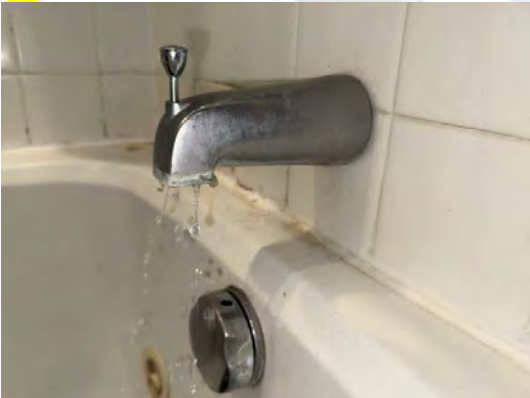
**NDSA** The diverter does not fully stop the flow of water to the spout and divert it to the shower head.

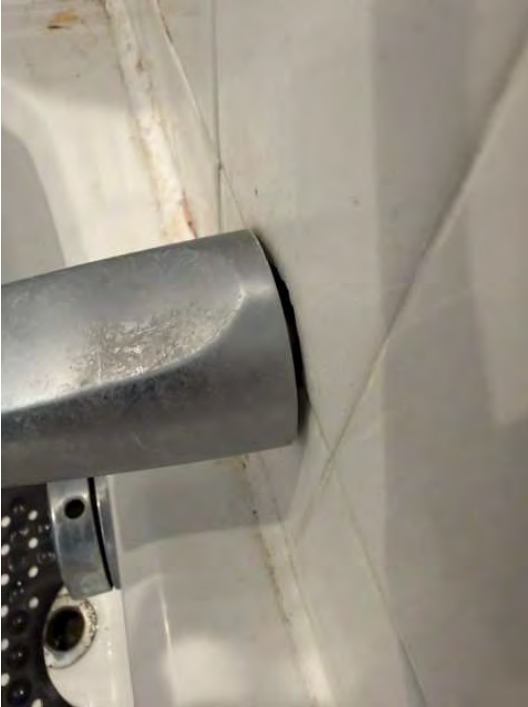
**NDSA** The tub spout is not sealed to the tile. This should be done to prevent any moisture intrusion into the wall

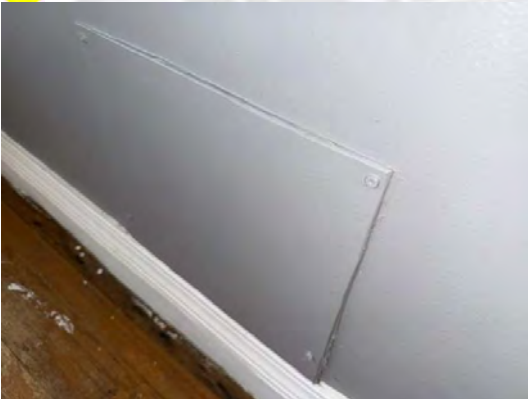
**NDSA** The jetted tub is not working when turned on. It is not known why it did not operate and needs to be checked out and repairs made to ensure it is functioning.

**NDSA** The access for the jetted tub was sealed shut . The motor, electrical items and piping could not be observed.

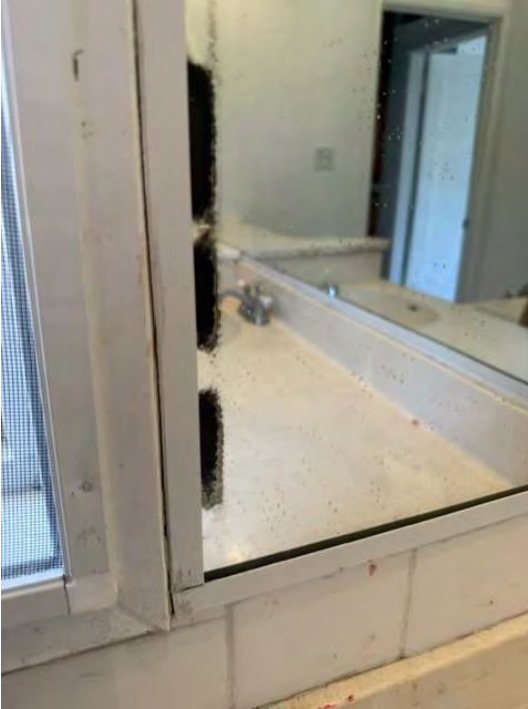
**NDSA** The mirror surfaces are deteriorated in areas.

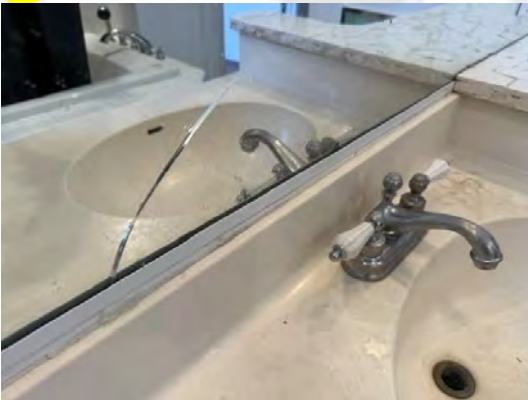
**NDSA** The mirror is cracked.

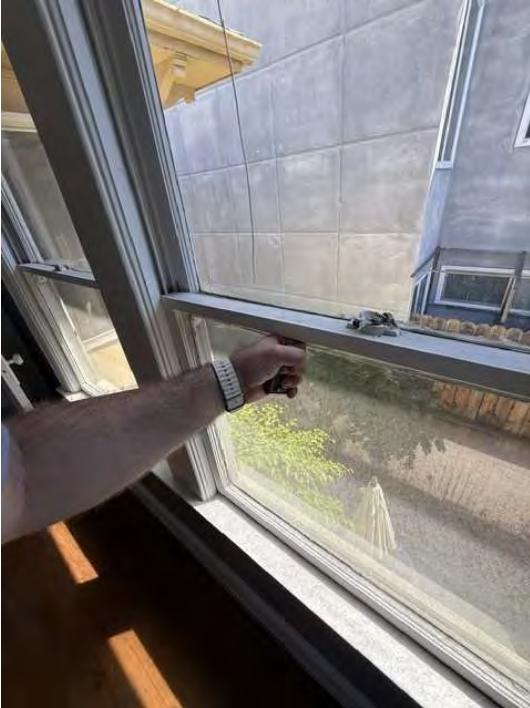
**NDSA** Some of the windows are painted shut and the paint appears to be preventing the windows from opening properly, each window will individually have to be evaluated to determine the exact cause for it not opening. This was noted in the second bedroom

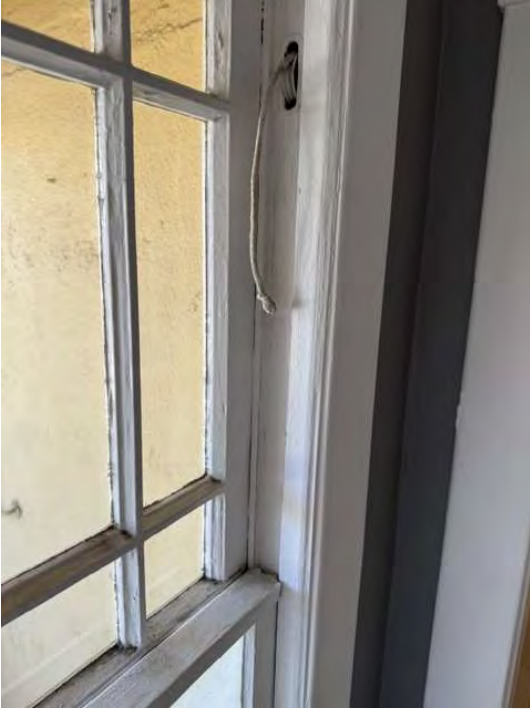
**NDSA** Some sash cords are broken and the windows will not stay open on their own. Such as in the dining area.

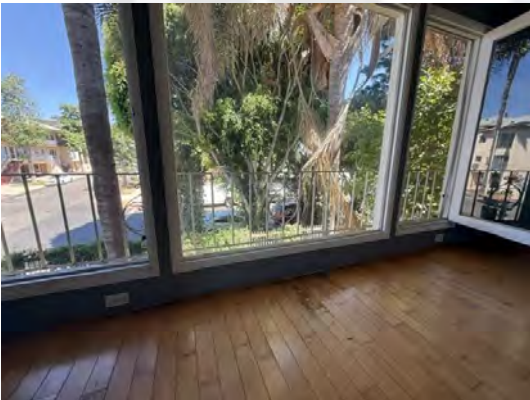
**UPG** There are panes of glass that are within 18 inches of the floor. In newer construction it is required that the glass be a tempered type of safety glass. Making this older glass into safety glass by tempering or putting a safety film on it may not be a requirement for this sale but it is recommended.

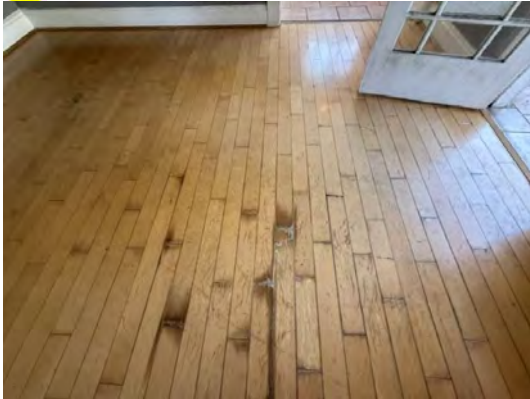
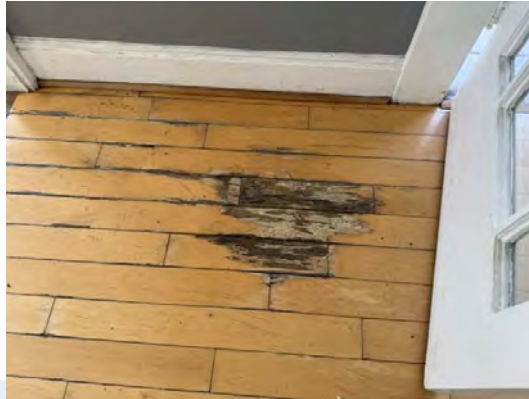
**NDSA** The hardwood flooring is damaged in areas, such as in the dining room

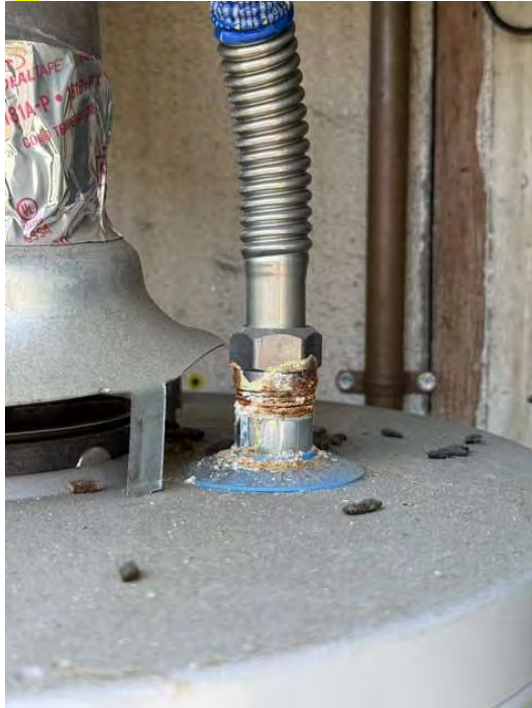
**NDSA** There is corrosion on the pipes that enter the top of the water heater and they may need to be replaced soon.

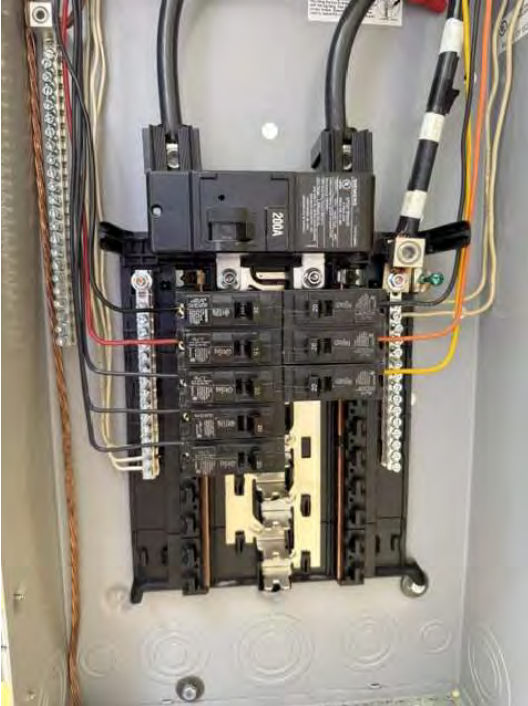
**NOTA** The left panel cover has been removed inside the electrical box and the live wiring and circuits are exposed when the outside cover is opened.

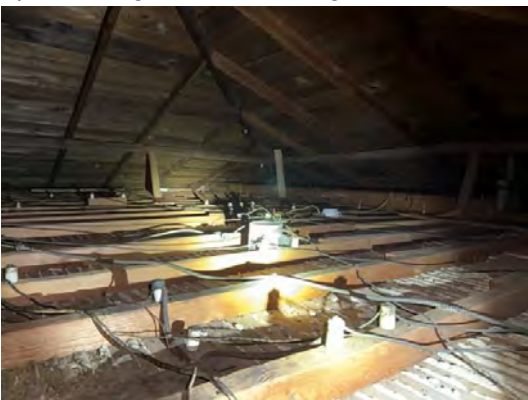
The wiring is not in conduit. It is called knob and tube wiring and the wires run parallel to each other a few inches apart throughout the building.

It is advisable to have an electrician examine the system and make all needed repairs to ensure a properly installed and correctly operating electrical system. This investigation of the system should be done prior to the expiration of the contingency period so the repair or replacement costs are known and unwanted expenses are avoided. It is expected that when the electrical specialist checks out the system they will find more problems as this is a general inspection and not designed to list every fault but to isolate areas in need of further detailed inspections by a specialists.

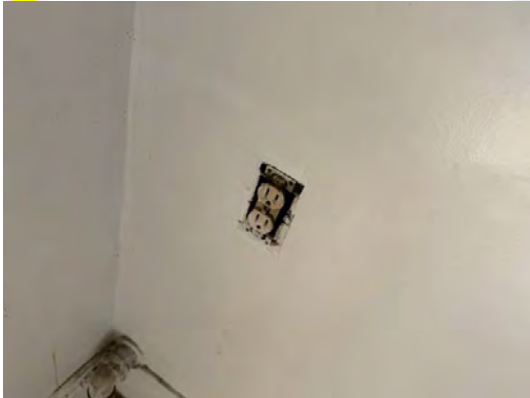
**NDSA** There are some missing cover plates, such as in the kitchen

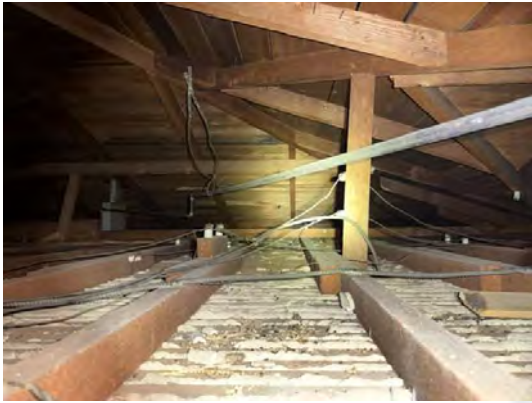
**NDSA** **UPG** No insulation is provided in the attic. Insulation was not commonly installed at the time when this building was constructed.

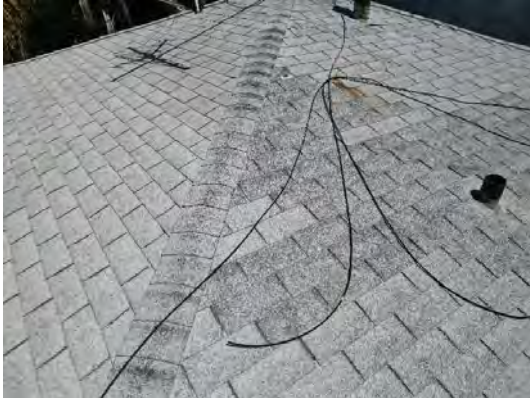
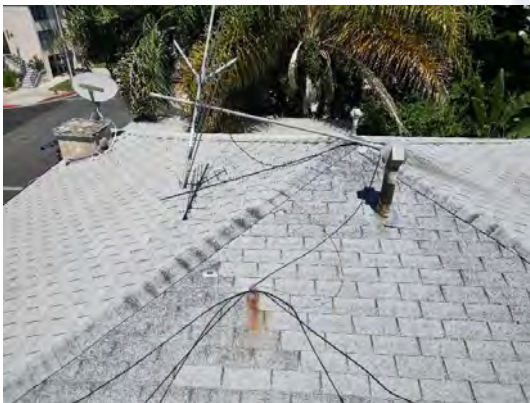
**NDSA** Needs attention, the roof is worn more in areas and sections will need to be replaced in the near future. It is recommended to consult a roofer.

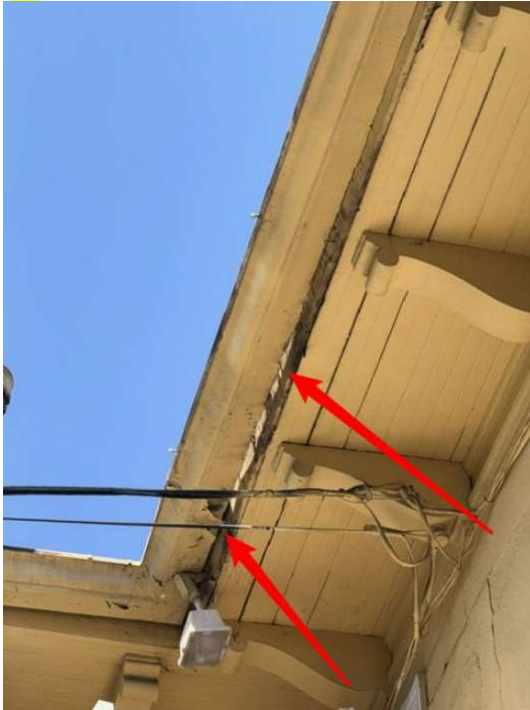
**NDSA** There are areas where the gutters are not properly connected and they may leak.

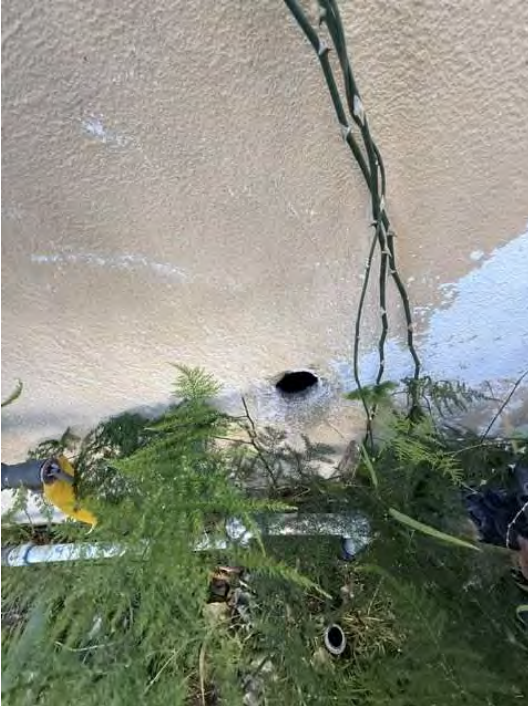
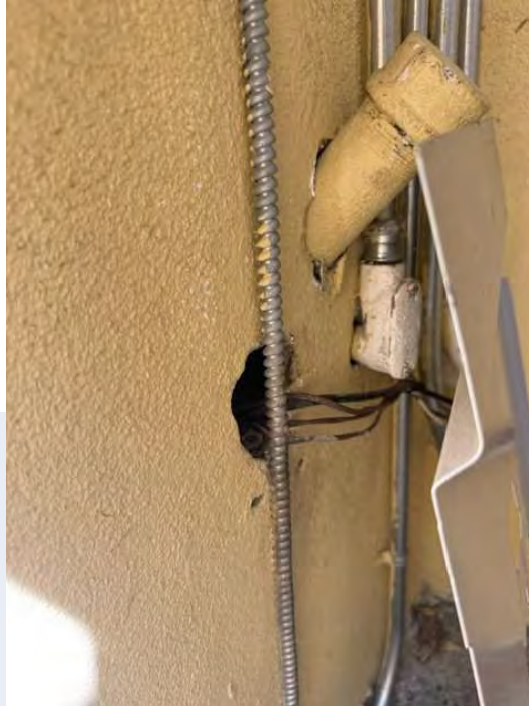
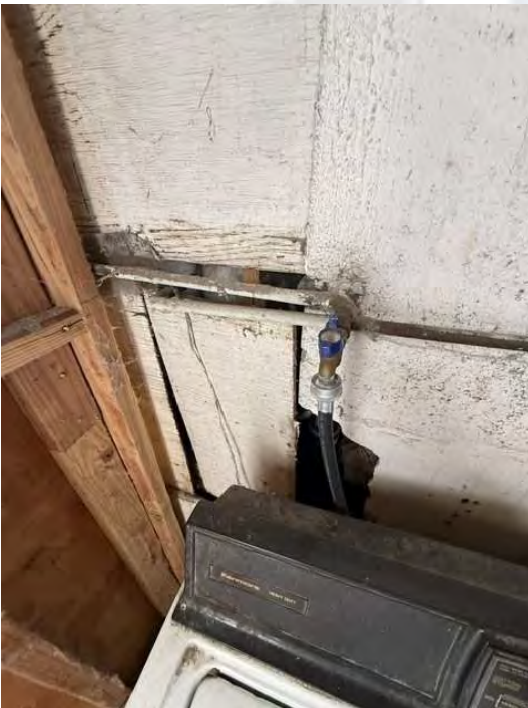
**NDSA** Needs attention, there is a hole in the wall by the main water line, by the electric panels and in the laundry area. This should be sealed to prevent moisture intrusion.

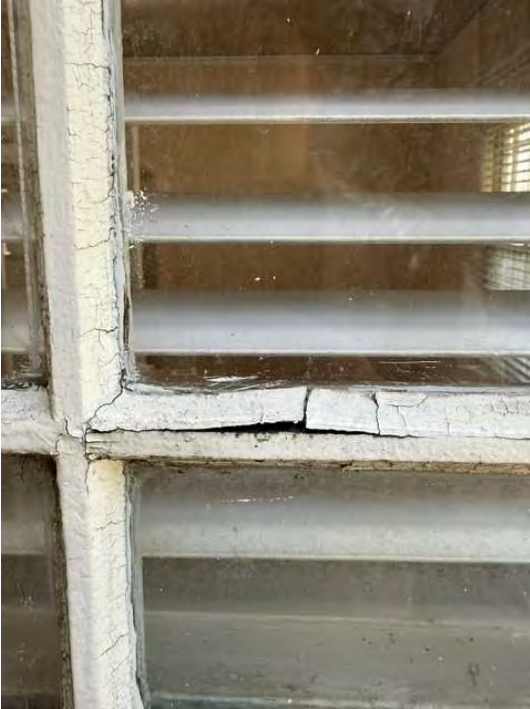
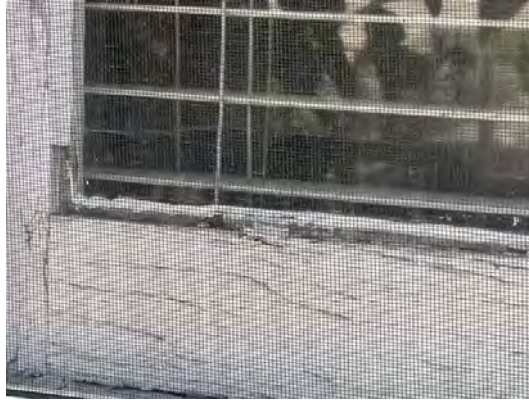
**NDSA** The glazing that holds the glass in is deteriorated in areas.

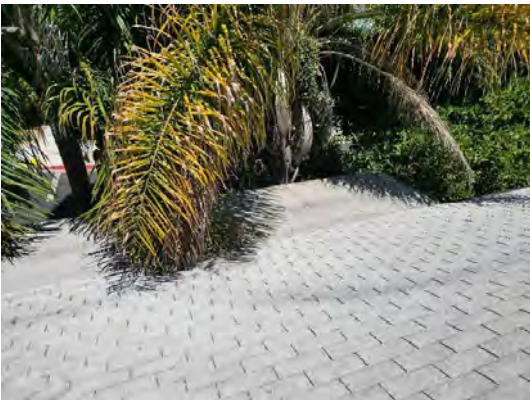
**NDSA** There are trees planted close to the structure. Tree roots systems may interfere with the foundation and plumbing systems over time as they continue to grow. Branches overhanging or in contact with the roof can also cause damage and may be a fire hazard.

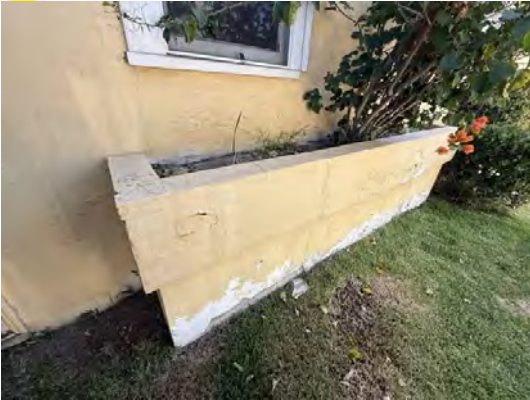
**NDSA** The site is relatively flat , it is expected that there will be some areas where water will pool during rainy periods.

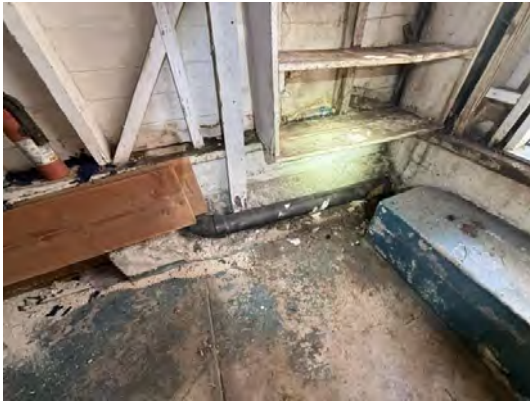
**NDSA** Needs attention, there is moisture damaged wood on the left rear corner. It appears this is from the soil level being higher than the interior.

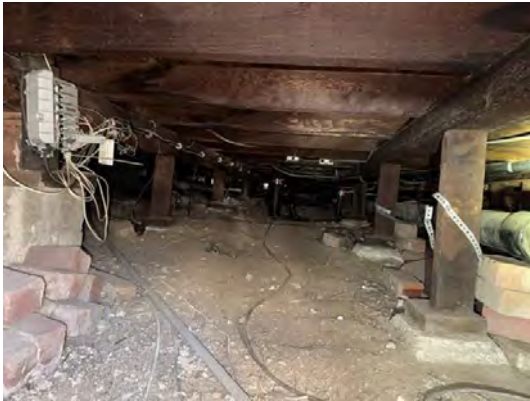
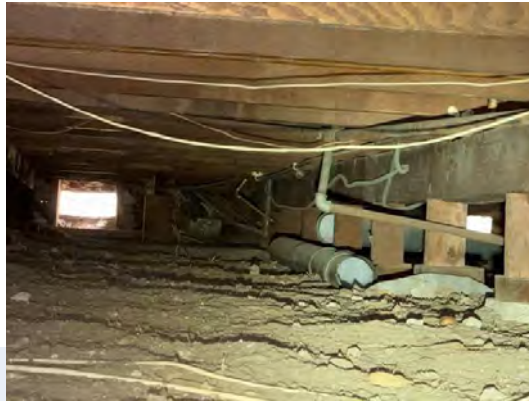
**NDSA** The crawl space has debris in it, it is advisable to have it removed and the area cleaned up. Wood especially should be removed to help prevent future infestations.

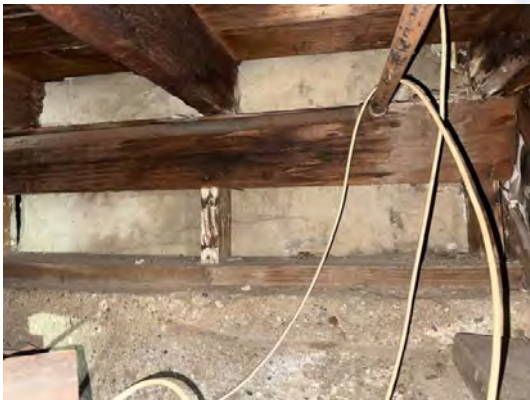
**NDSA** The concrete is deteriorated in areas. This appears to be from excessive moisture, age, or a combination of the two. It does not appear to be a major concern but if more information is desired, a foundation expert would need to be called

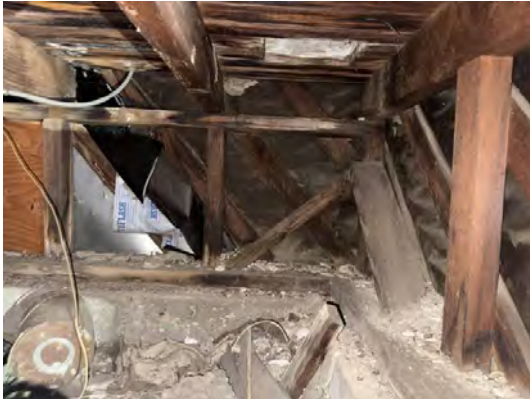
**UPG** The cripple walls have not been strengthened with shear panels. Ideally plywood shear panels would be applied to a majority of the cripple walls. These are short walls between the foundation and the under side of the house framing. Shear panels would help prevent an earthquake from shifting the structure at this junction.

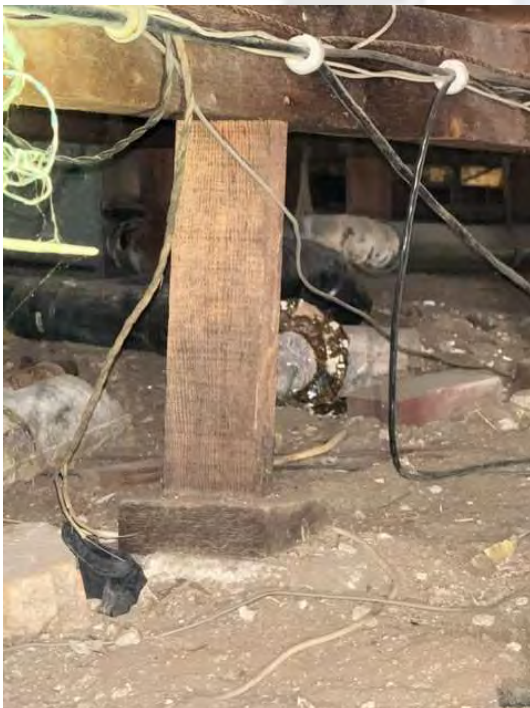
**NDSA** Needs attention, there are a few undersized posts (2x4's). The standard for many decades has been 4x4 or larger to properly support the beam above. It is recommended to increase the size for earthquake stability

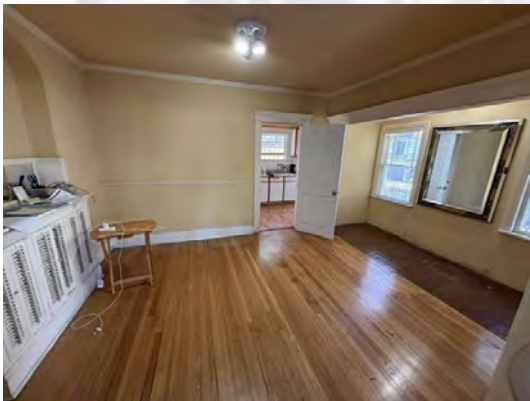
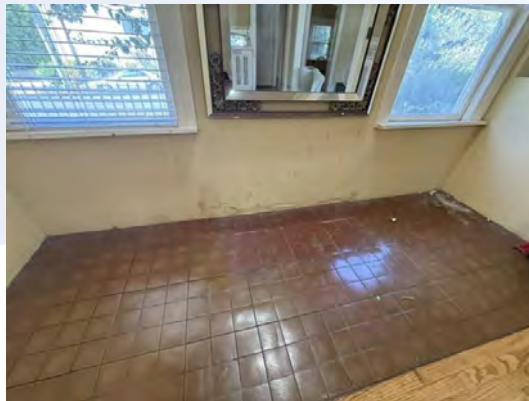
Needs Attention, there is moisture damage on the outside wall. This appears to be from the planter outside

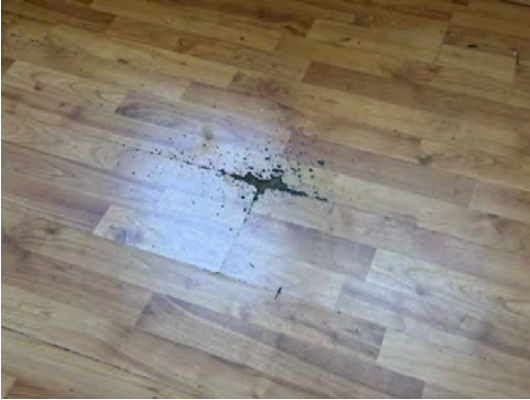
**NDSA** The kitchen linoleum flooring is worn and peeling in areas.

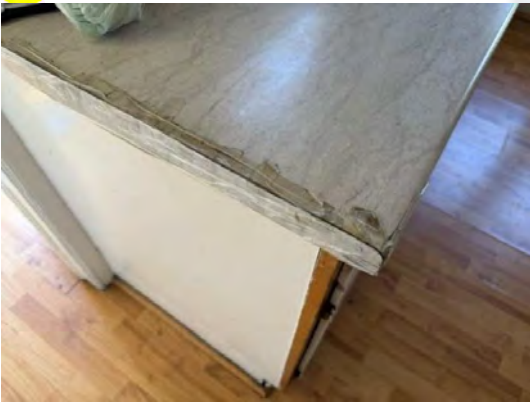
**NDSA** The counter top shows moderate to heavy wear.

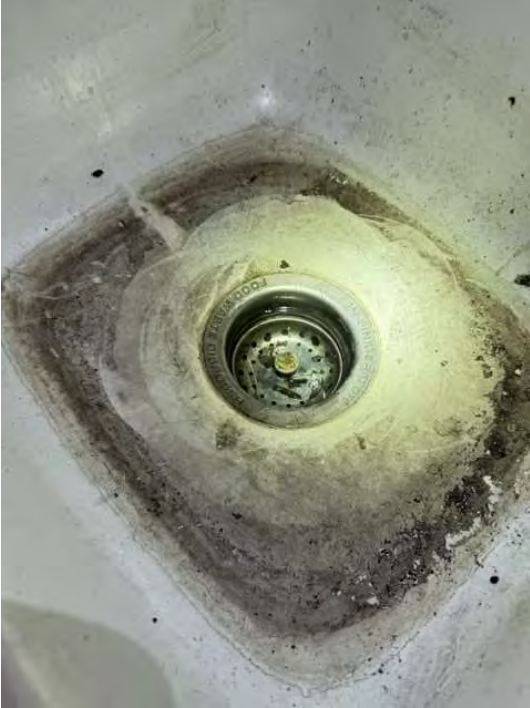
**NDSA** Needs Attention, the sink backs up and appears to be clogged

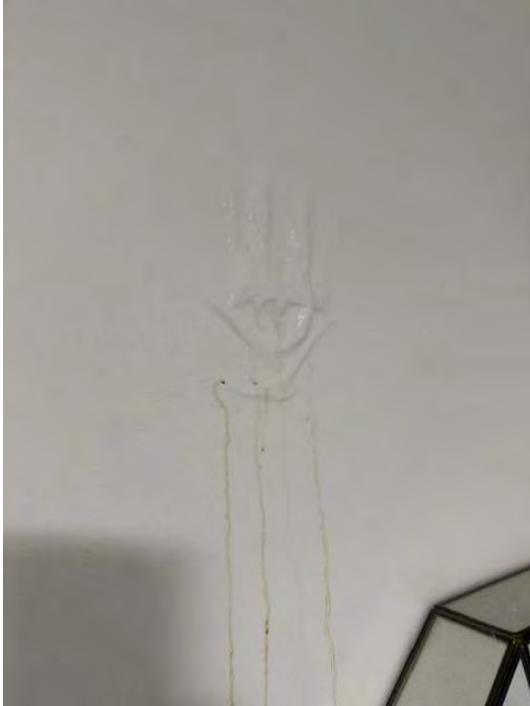
**NDSA** Needs Attention, there is moisture stains coming from a patch on the wall. This may be caused from a waste line leak in the wall from the upstairs bathroom

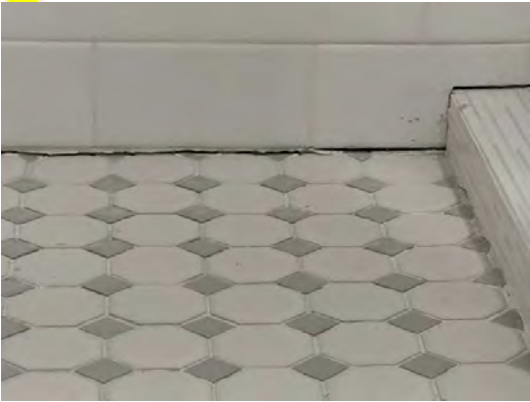
**NDSA** The base of the shower has a deteriorated seal.

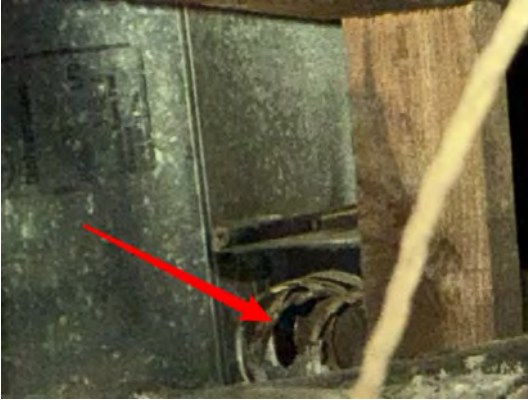
Not Acceptable, there are holes in the vent pipe under the house that will leak exhaust gases into the house

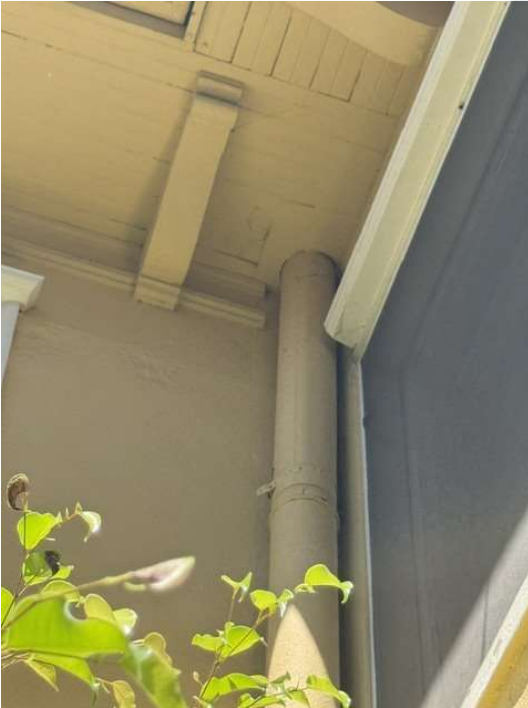
The furnace vent pipe is too close to combustibile materials. This is a hazard and the vent line needs to be repaired to have the proper clearances.
