# ***Cornerstone Inspection***

## **Property Inspection Report**

***309 Binscarth Rd, Baywood-Los Osos, CA 93402***

***Date of Inspection: 8/10/2026 Time: 9:00 AM***

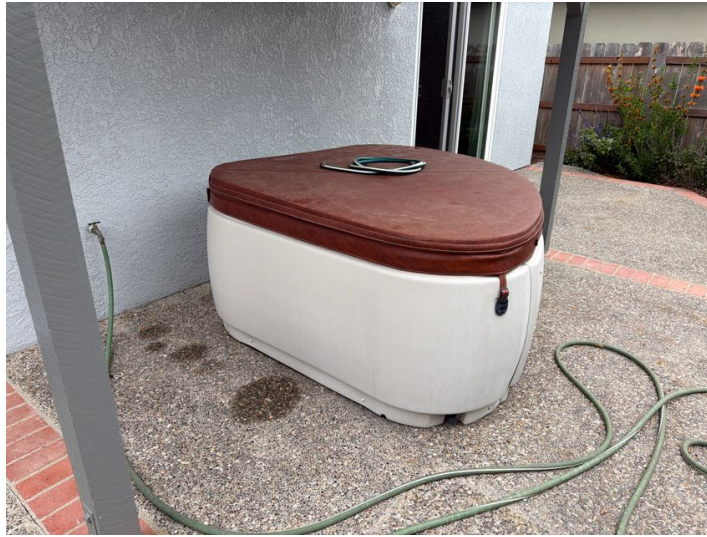
The requirements of 'two of the seven drowning safety features' as required by the Swimming Pool Safety Act as updated by SB 552, do not apply to Spas or hot tubs with locking type covers complying with ASTM International F1346 standard. We cannot confirm the hot tub cover meets this standard. We recommend further evaluation by a qualified licensed swimming pool specialist and service or correct and required to meet current safety standards.

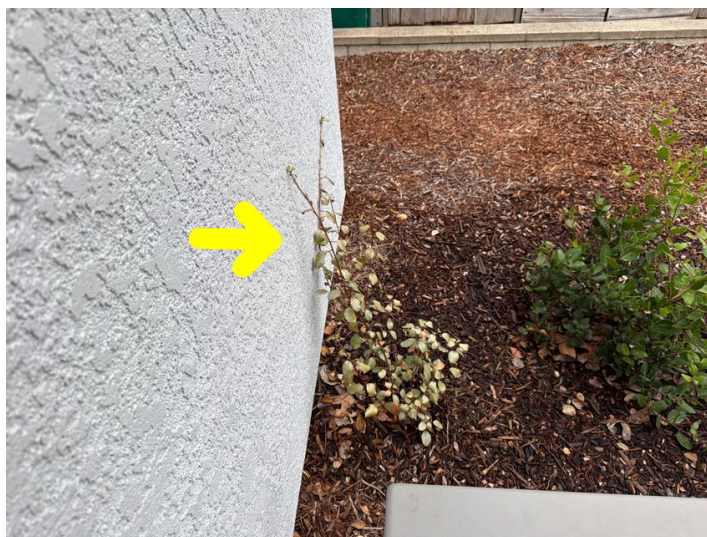
Vines, shrubs or bushes are growing on the house walls and although they are attractive they can introduce pests and rodents and accelerate deterioration. Therefore, you may wish to consider having them removed or cut back to 12 inches (30 cm) away from the home.

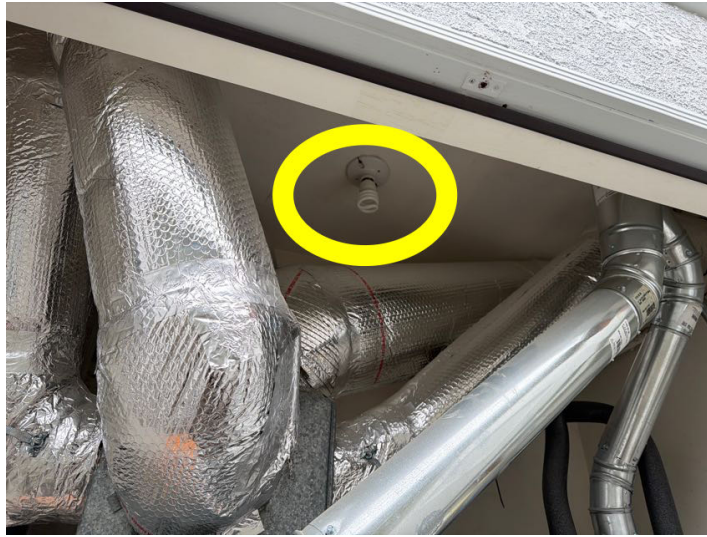
A light is missing its globe or cover and should be serviced.

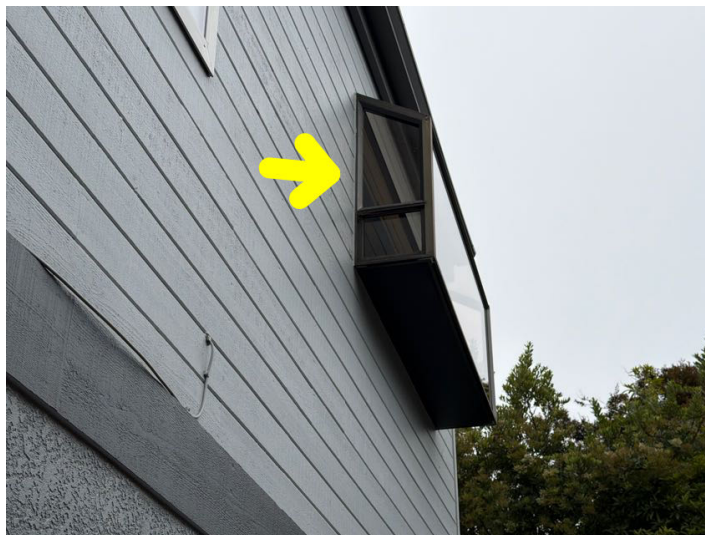
This home has one or more garden windows. These windows can be problematic if not monitored. Leaks are common due to design factors, and we advise that these type of windows be monitored regularly to prevent moisture intrusion.

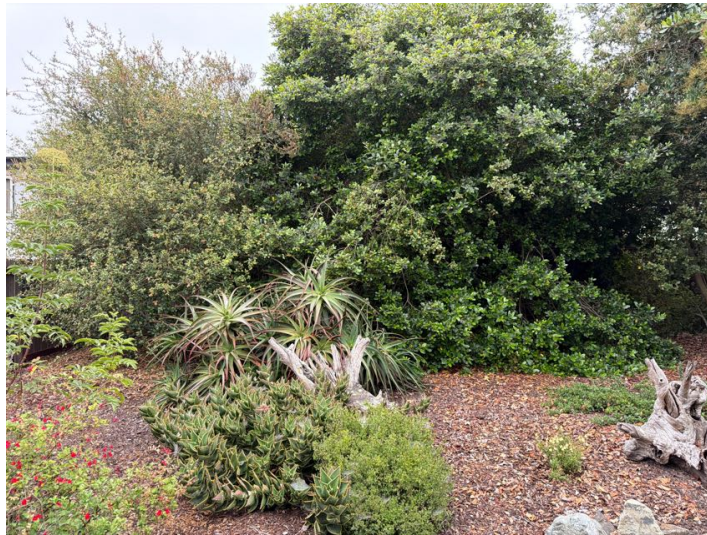
Portions of the fences are obscured by foliage or other material, which prevents a thorough inspection.

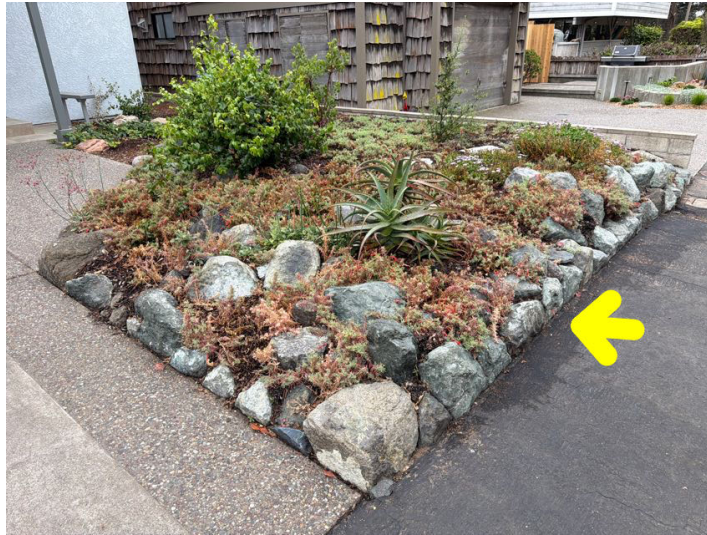
The stacked masonry or natural stone yard walls, though functional, have no value as retaining walls and will need to be periodically monitored for movement.

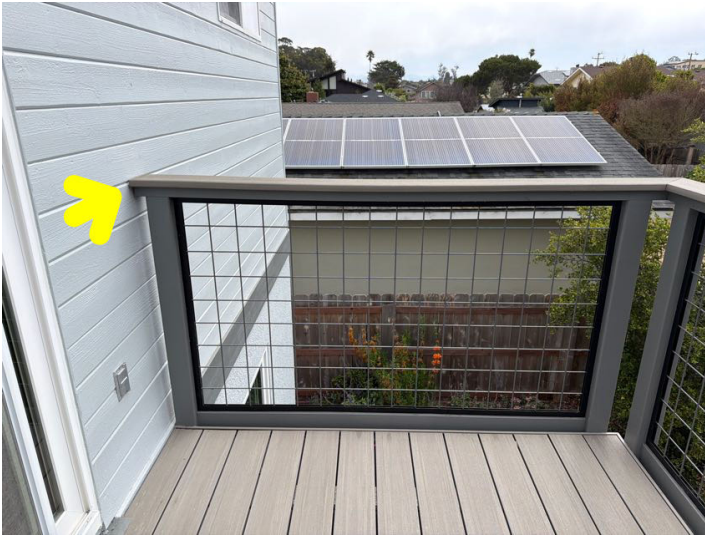
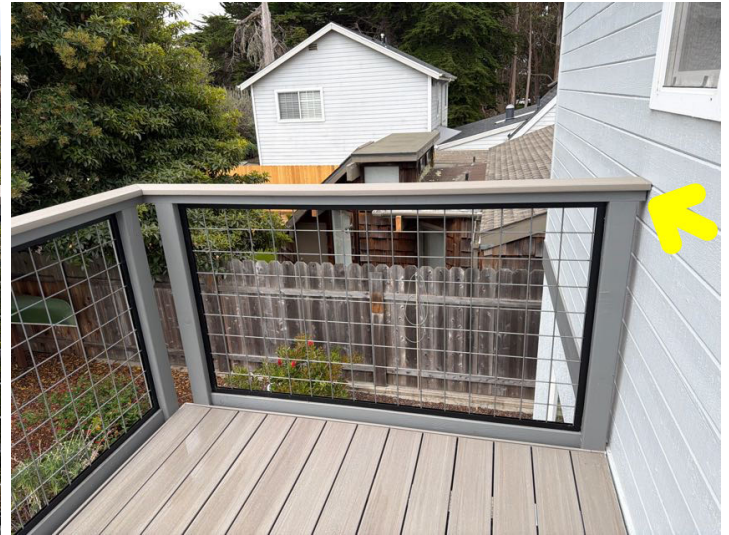
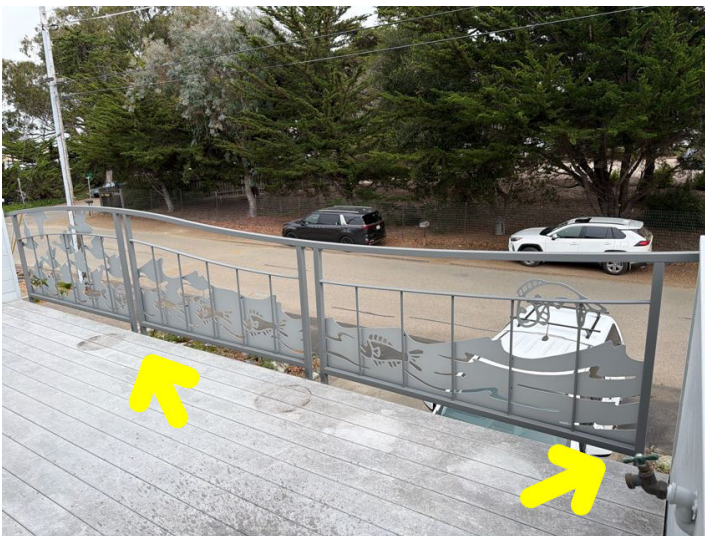
Sections of the guardrail are not secure, and should be serviced.

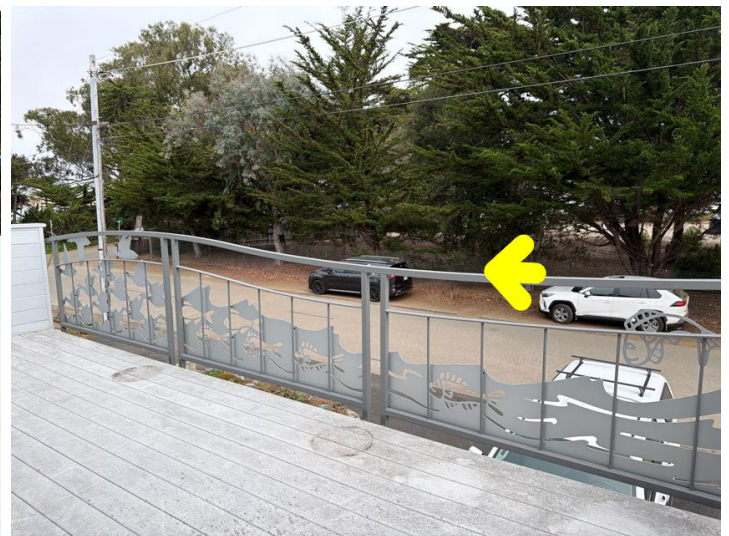
The balcony guardrail does not conform to common safety standards. Common safety standards require them to be a minimum of 42 inches high when the standing surface is thirty inches or more above grade. Also, guardrail pickets should be no more than four inches apart for child safety.

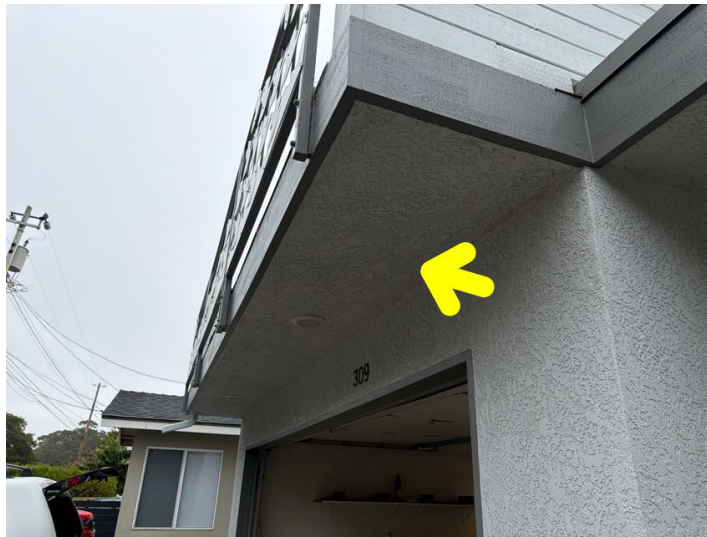
The balcony soffit is not vented, as recommended by current standards. We recommend having an evaluation by a qualified tradesperson.

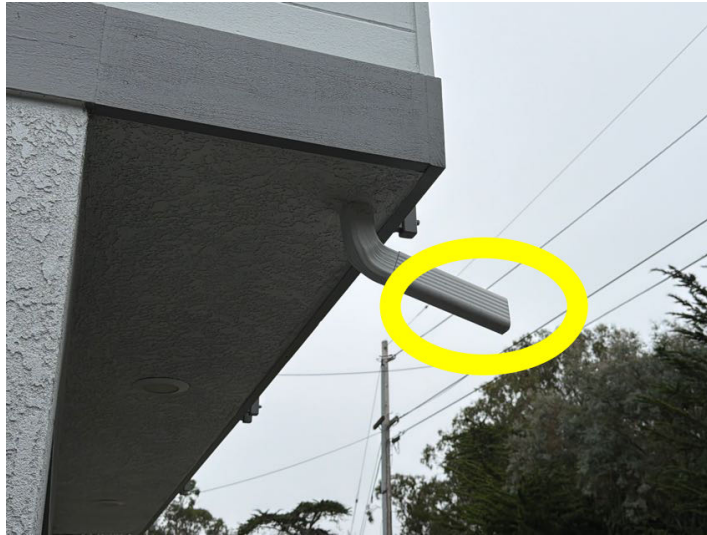
Some downspouts are missing or need to be reconnected, and should be serviced.

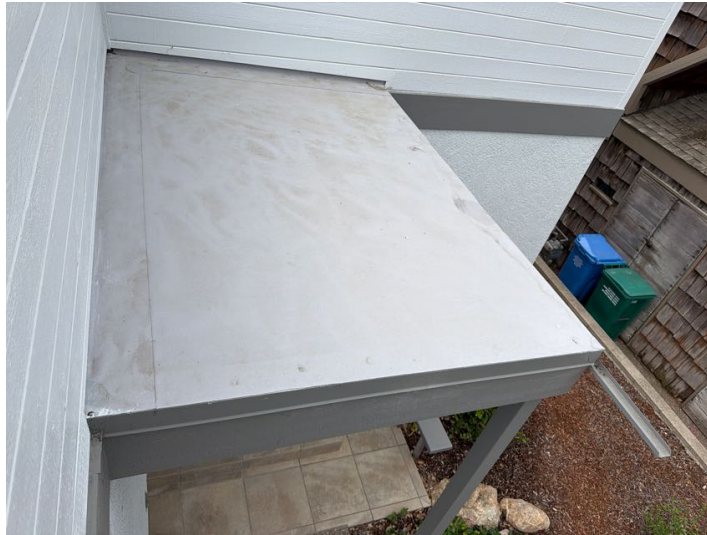
The roof includes a flat-roofed section, and flat roofs can be problematic if they are not kept clean and well maintained. Water ponds on most of them, particularly along the leading edges, and such water will generally only be dispersed by evaporation. Therefore, they must be kept clean and inspected regularly. This is important, as our service does not include any guarantee against leaks.

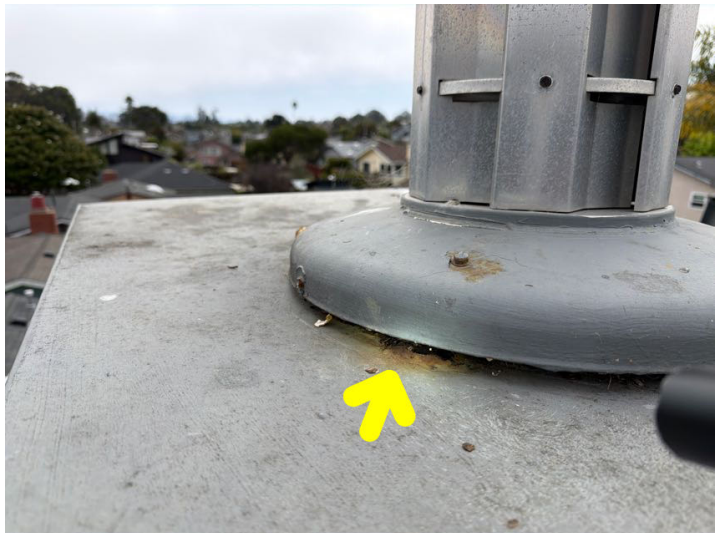
The sheet metal chase cover, which is designed to seal the chimney wall and shed rainwater, is damaged, deteriorated, or rusted and should be serviced by a certified fireplace specialist.

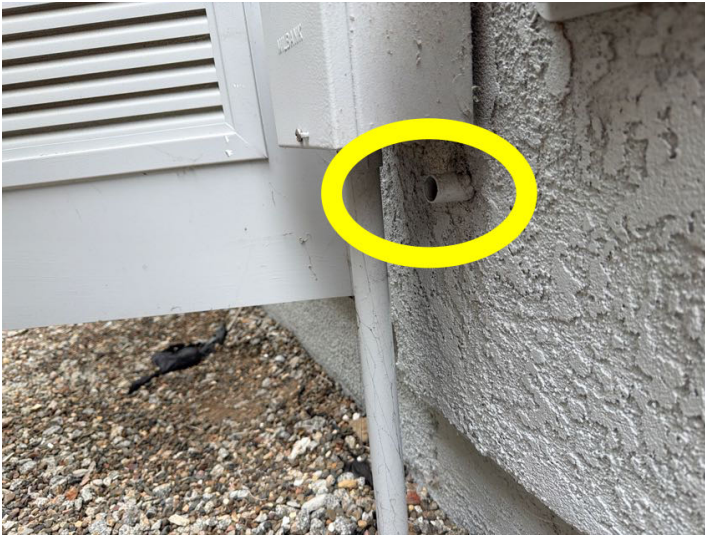
The temperature pressure relief valve discharge pipe has not been correctly installed. It must terminate no more than 24 inches above grade and no closer than 6 inches to it and be directed down towards the ground.

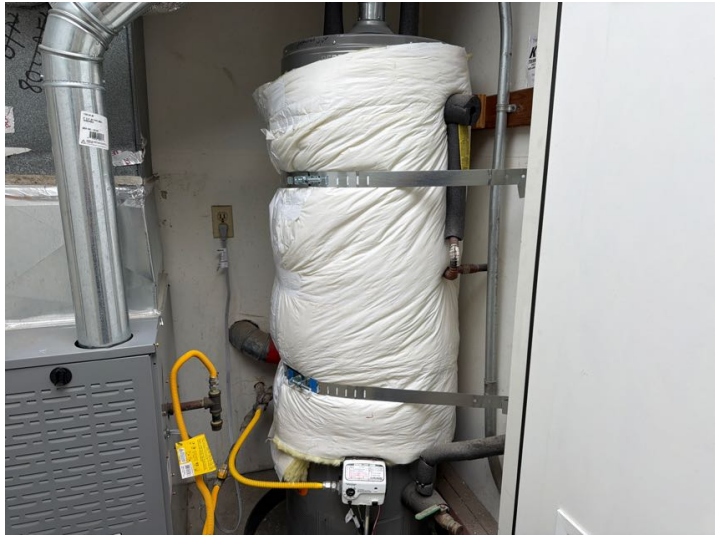
We were unable to verify the age or capacity of the water heater due to the seismic straps or the insulated blanket.

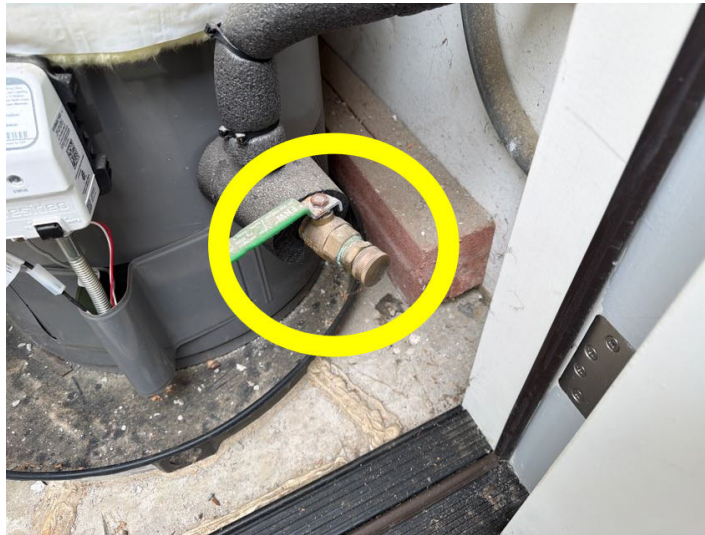
The drain valve at the gas water heater has been capped, which could imply that the valve leaks and may need to be serviced.

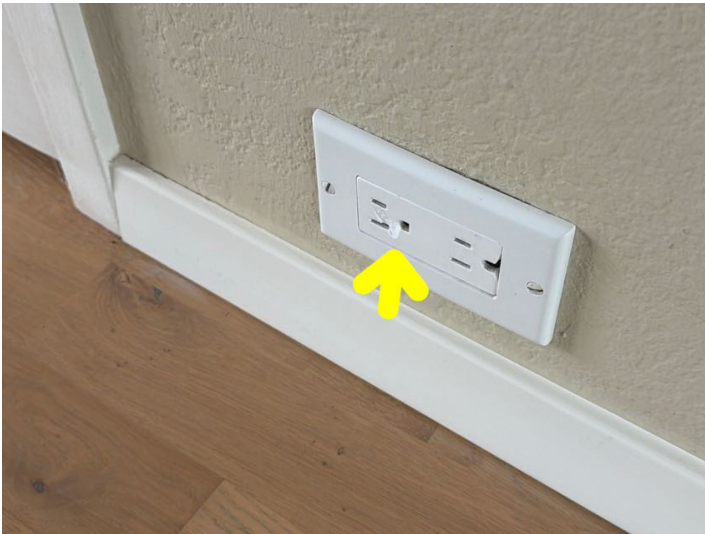
One or more outlets are damaged, and should be evaluated and serviced by a licensed electrical contractor.

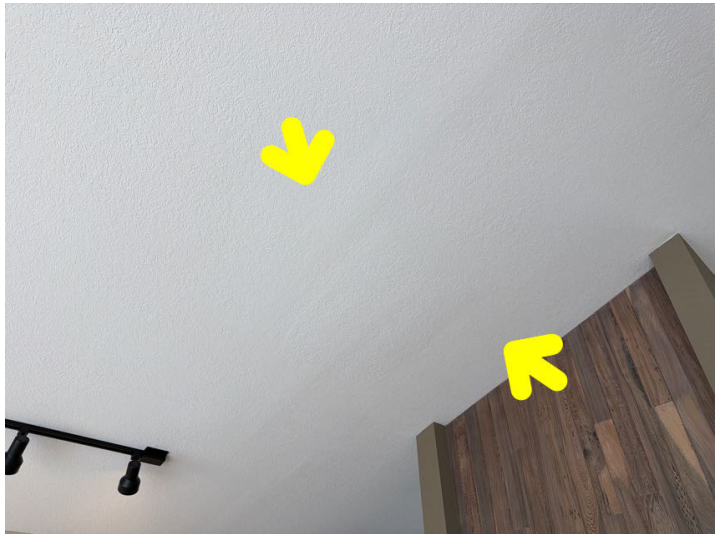
There has been a drywall/plaster repair that should be explained by the seller.

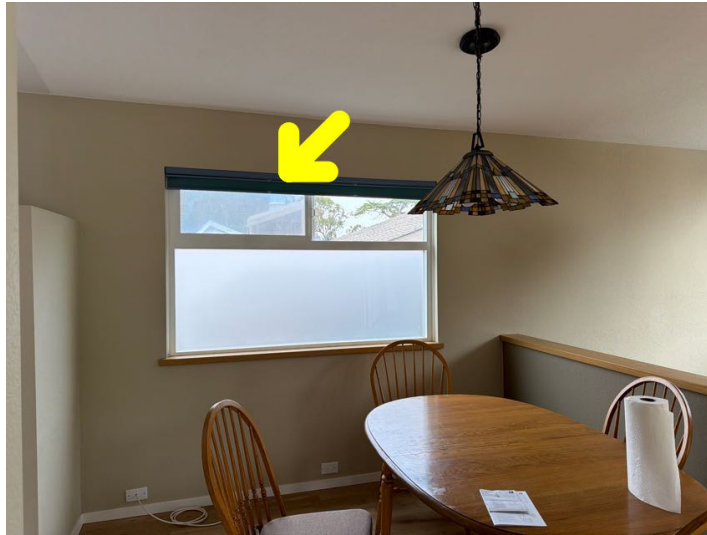
One or more windows may have a broken hermetic seal, which you may wish to have replaced. This is evident from fogging or condensation forming between the panes of glass, which implies that the seal has failed.

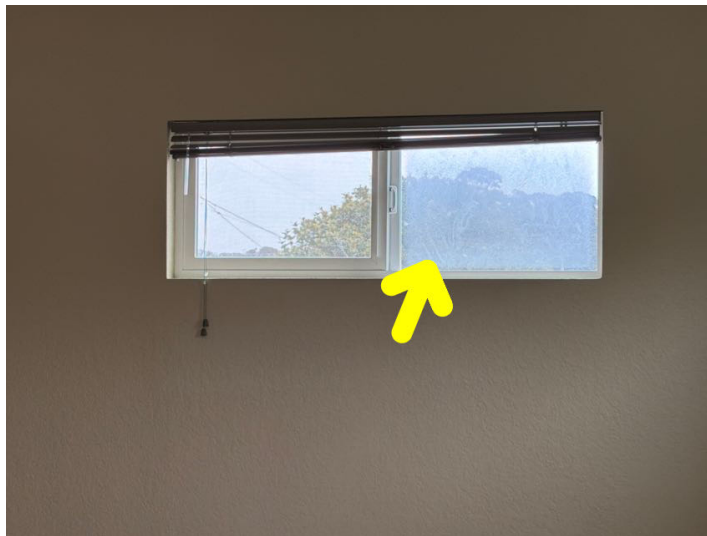
One or more windows may have a broken hermetic seal, which you may wish to have replaced. This is evident from fogging or condensation forming between the panes of glass, which implies that the seal has failed.

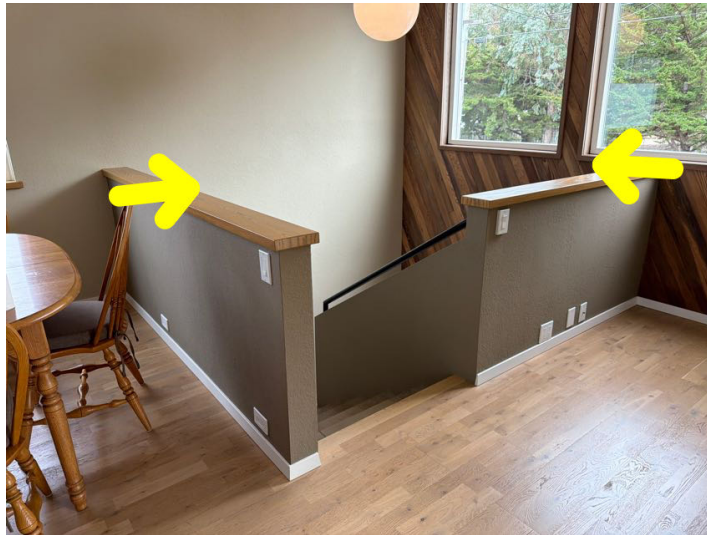
The guardrail at the top of the stairs is not the recommended 42 inches high when the standing surface is more than 30 inches below.

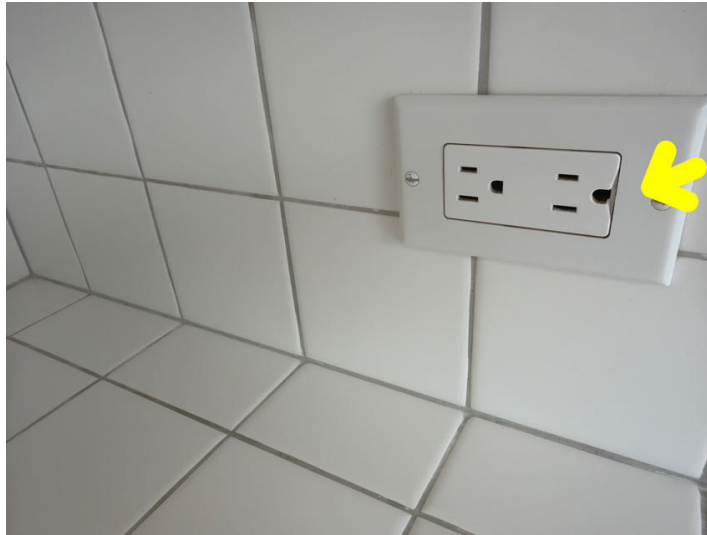
One or more outlets are damaged, and should be evaluated and serviced by a licensed electrical contractor.

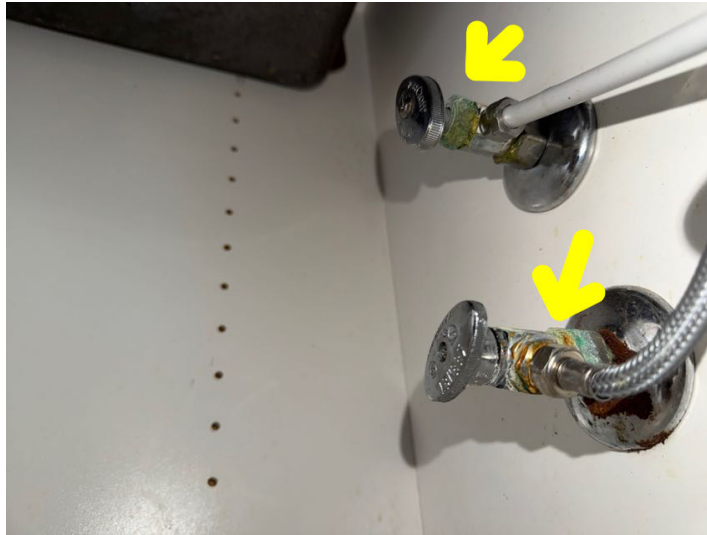
There is rust, corrosion, or mineral encrustation on the fittings of the laundry water supply, which should be evaluated and serviced by a qualified plumbing contractor.

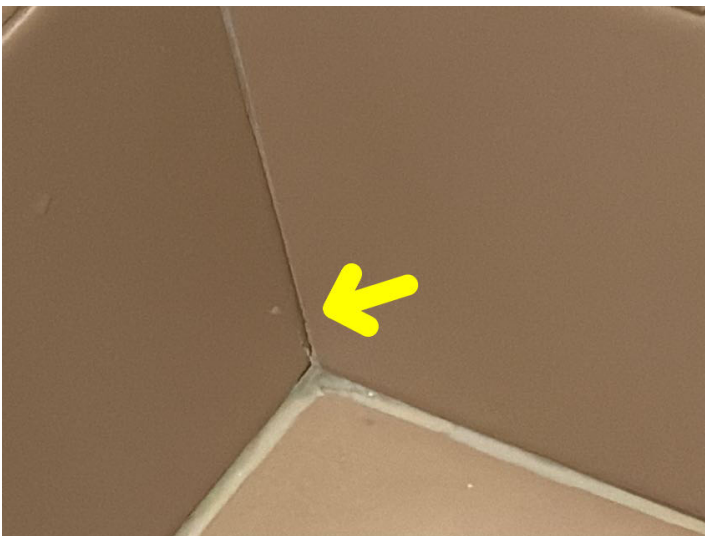
One or more open seams in the tub/shower area need to be caulked or re-grouted to forestall moisture intrusion.

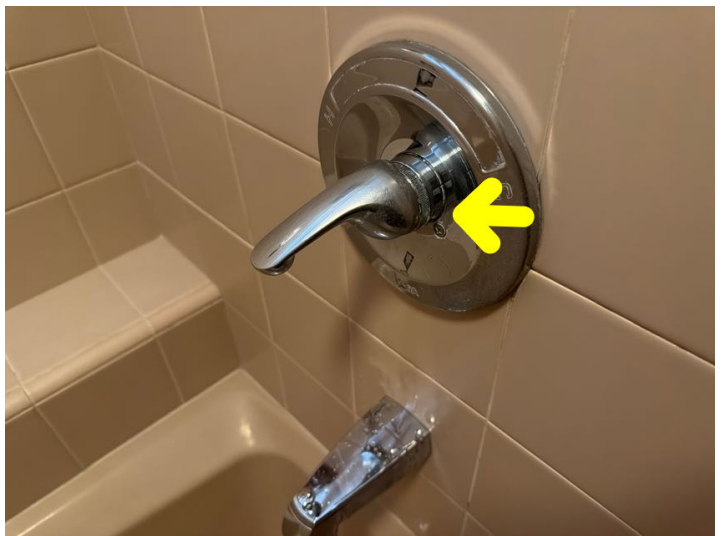
The shower faucet leaks around the stem while in use, and should be repaired by a qualified tradesperson.

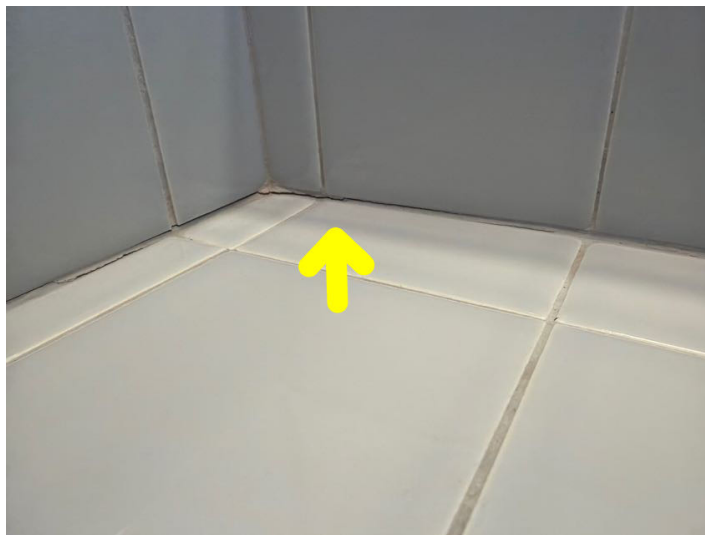
There is a separation between the sink countertop and the back-splash, which should be sealed to forestall moisture intrusion between the cabinet and the wall.

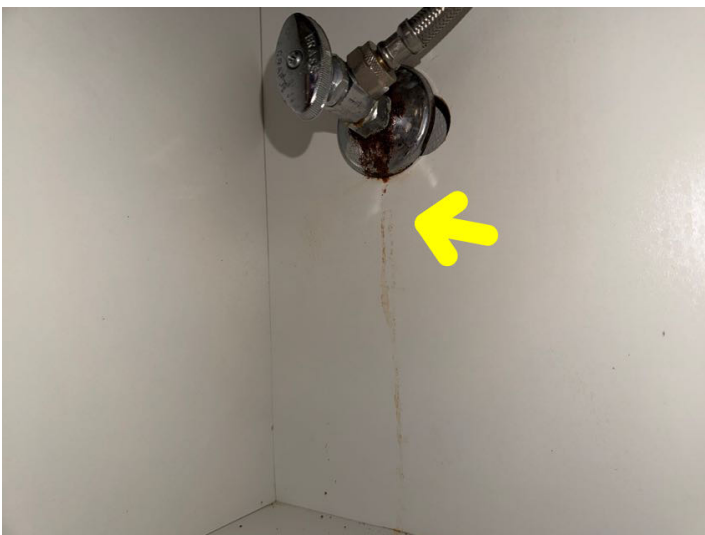
The wall of the sink cabinet below a water valve is functional but moisture damaged, which could indicate a leak, and should be evaluated by a qualified tradesperson.

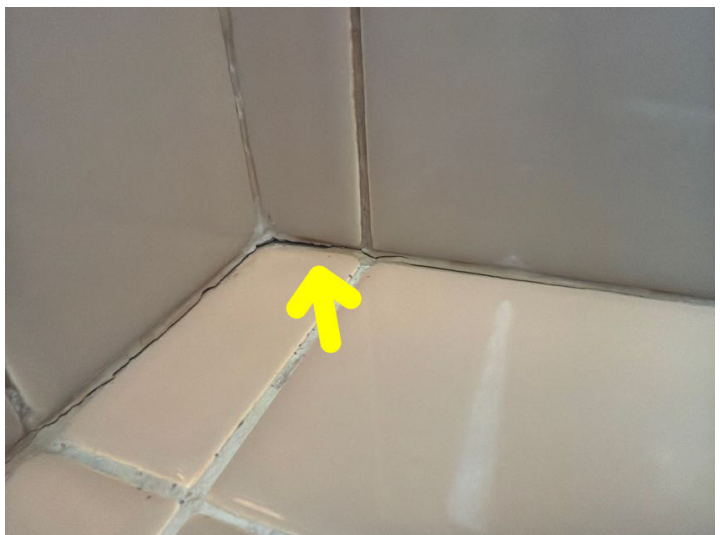
There is a separation between the sink countertop and the back-splash, which should be sealed to forestall moisture intrusion between the cabinet and the wall.

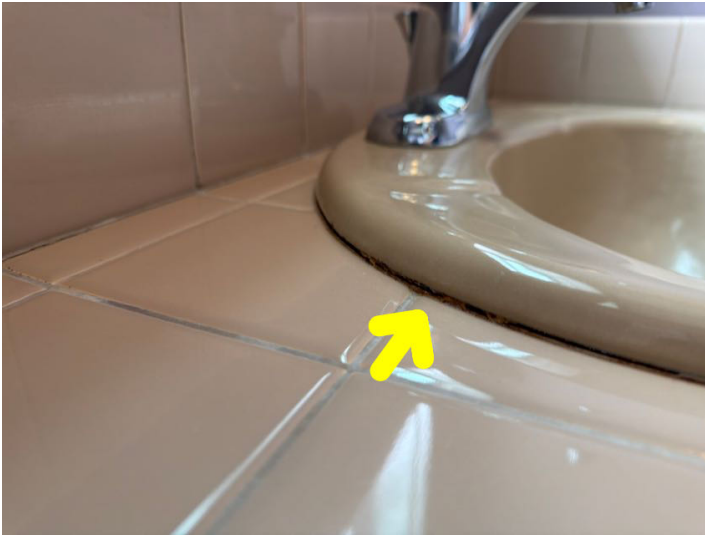
There is a separation between the sink and the countertop, which should be sealed to forestall moisture intrusion.

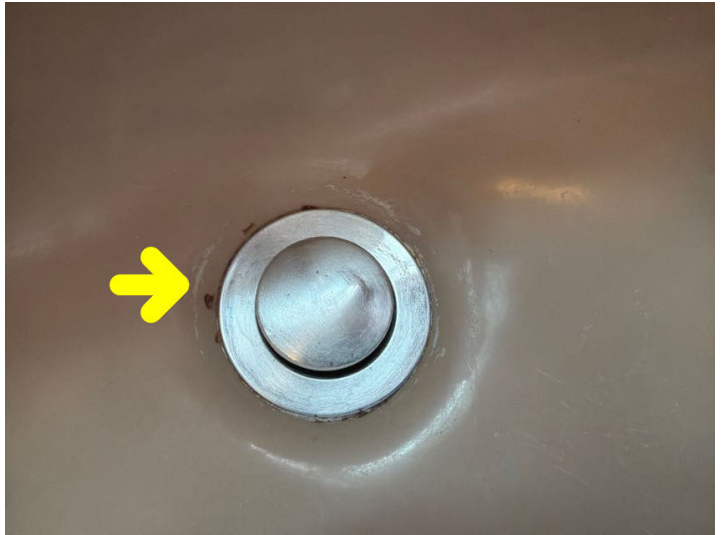
The bathroom sink has rusted at the drain or overflow inlet. It is not leaking, but will obviously be susceptible to leaks.

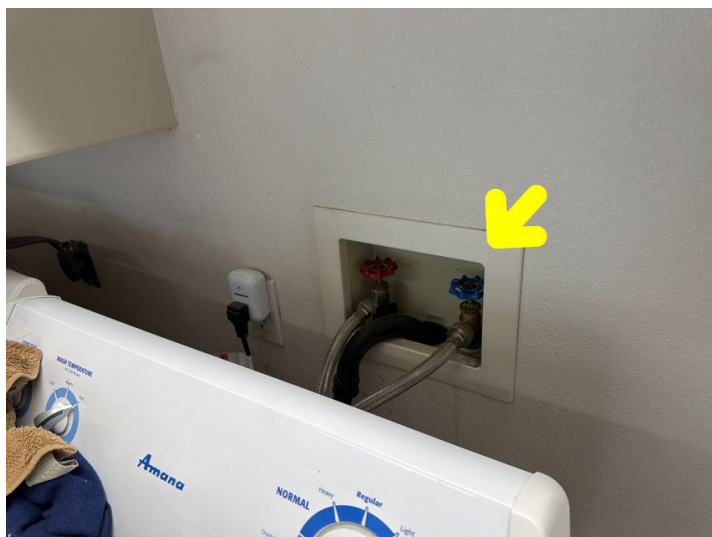
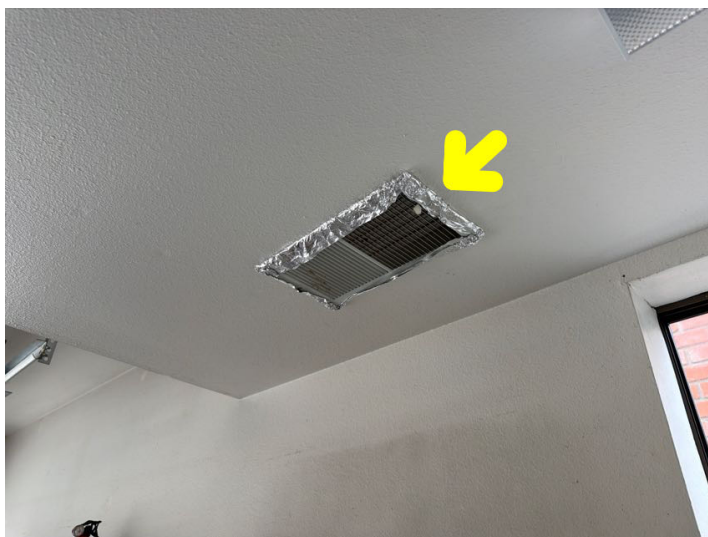
The voids in the garage firewall must be repaired, in order to maintain the necessary firewall separation between the garage and the residence. These include the plastic laundry plumbing box and the heat register.
