**ELITE GROUP**  
INSPECTION PROFESSIONALS

PROPERTY LOCATION: 207 W Buffalo Ave Santa Ana, CA 92706

# INSPECTIONREPORT

Date of Inspection: 7/31/2026 at 10:00 AM

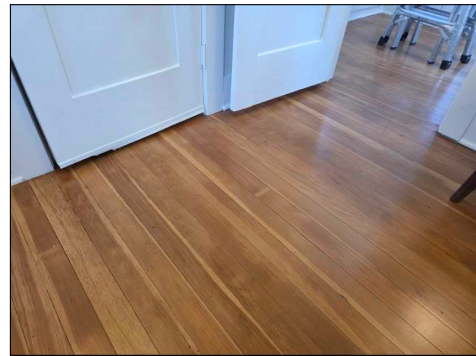
- Floors are worn with evidence of minor traffic - typical for the age
- Uneven areas throughout the structure - likely the result of foundation settling and ground soil movement - typical for older homes

Uneven areas throughout the structure

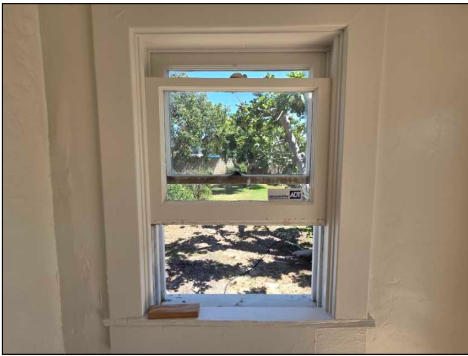
**Older/distressed window(s) - we recommend maintenance/servicing by specialist**

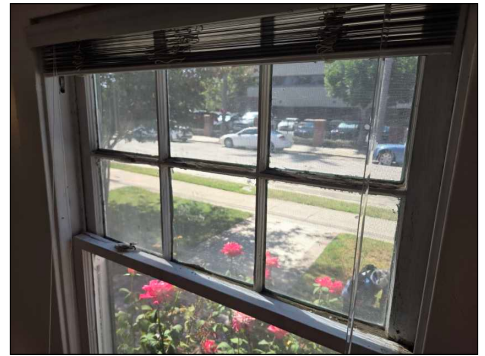
**Missing sash/cables - needs to be serviced**

**Cracked glass- needs to be serviced @ 207½**

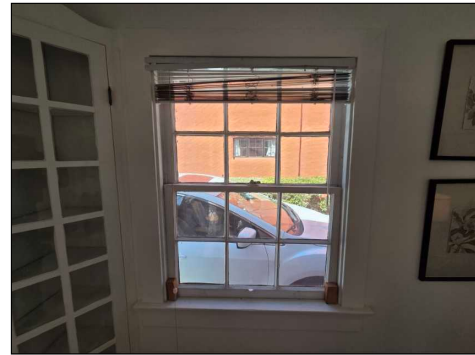
**Stuck in position - needs to be serviced**

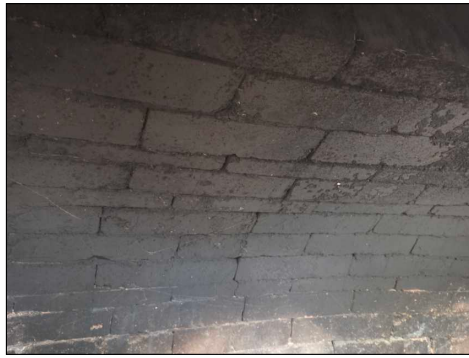
Small cracks/worn areas present at firebox - typical for age

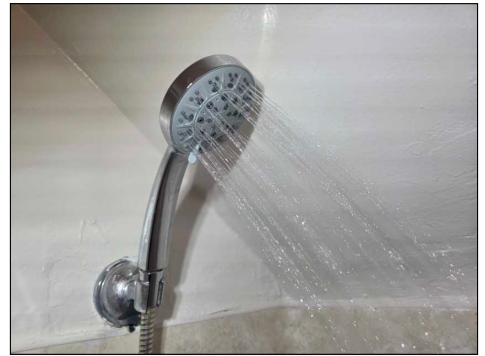
**Leak at shower line connection - needs to be serviced @ 207**

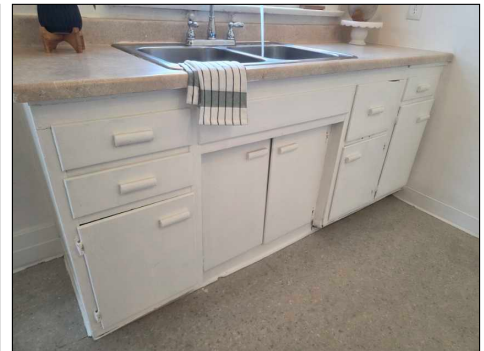
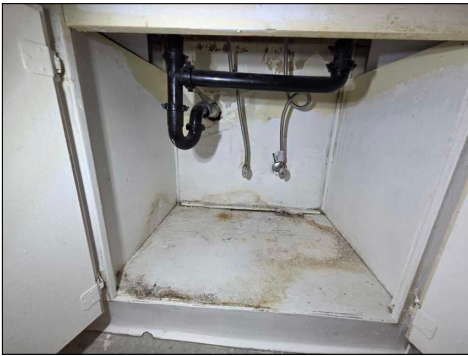
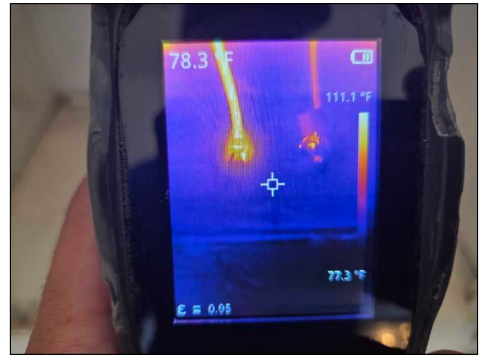
**Stained areas below sink - dry at time of inspection**

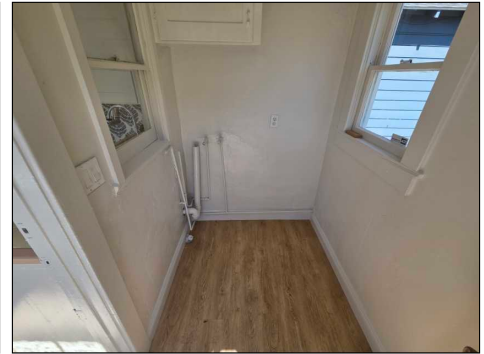
**No dryer vent installed- needs to be serviced @ 207½**

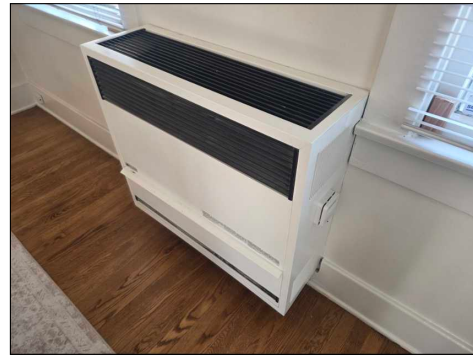
**Thermostat not operating - unit not tested - needs to be serviced @ 207½**      **Thermostat not operating - unit not tested - needs to be serviced @ 207**

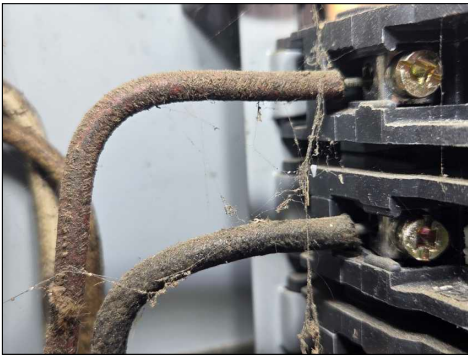
| INTERIOR | | |
|---|---|---|
| Page 29 Item: 2 | Panel Wiring | <ul style="list-style-type: none"> <li>• Wiring type: tinned/nickel clad copper - this is an older type of wiring - an upgrade is recommended</li> <li>• Wiring method: Cloth wiring observed at various locations throughout the property - we recommend a licensed electrician for upgrade of all older materials</li> <li>• Wiring method: knob and tube present in areas of the structure - considered obsolete - recommend complete inspection by electrical contractor</li> </ul> |

**Wiring type: tinned/nickel clad copper - this is an older type of wiring - an upgrade is recommended**

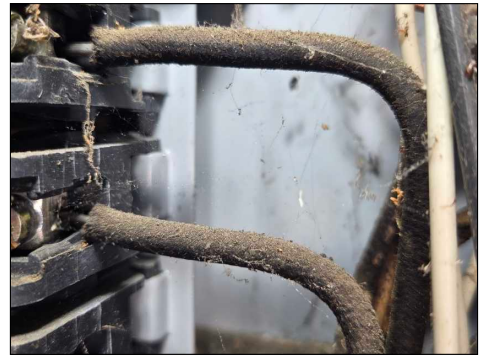
**Wiring method: Cloth wiring observed at various locations throughout the property - we recommend a licensed electrician for upgrade of all older materials**

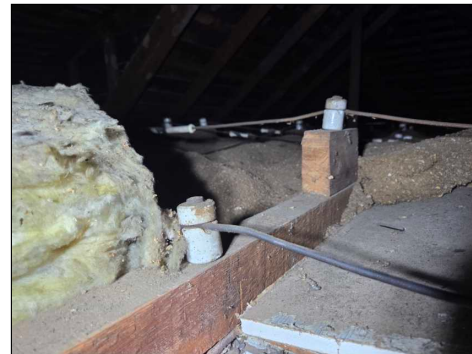
**Wiring method: knob and tube present in areas of the structure - considered obsolete - recommend complete inspection by electrical contractor @ attic**

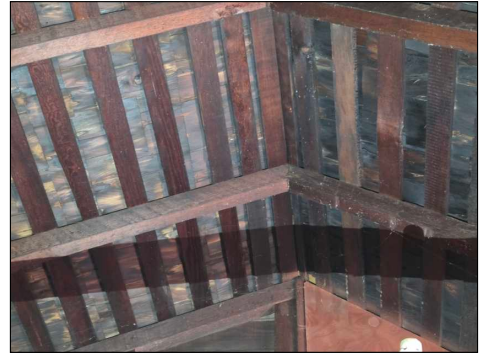
| Page 35 Item: 2 | Rafters & Ceilings | <ul style="list-style-type: none"> <li>• Deteriorated wood members - needs to be serviced</li> </ul> |

**Deteriorated wood members - needs to be serviced**

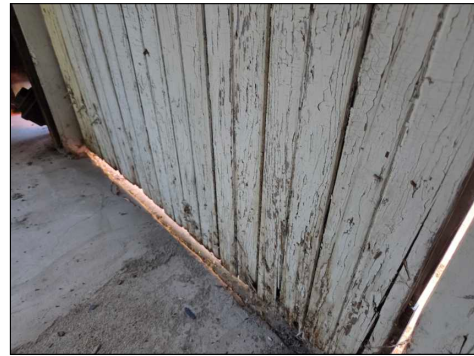
| Page 35 Item: 3 | Main Automotive Doors | <ul style="list-style-type: none"> <li>• Deteriorated wood present - needs to be serviced - <b>consult termite report</b></li> </ul> |

Deteriorated wood present - needs to be serviced

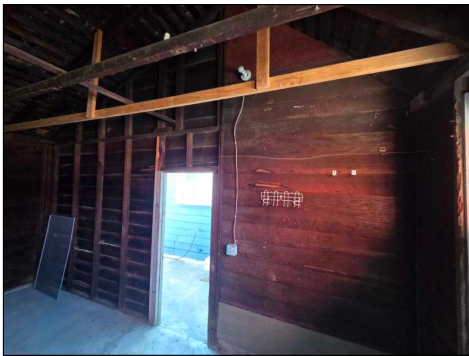
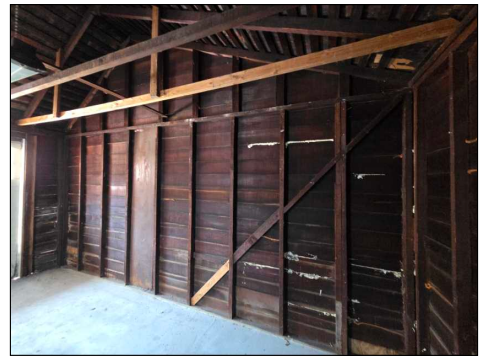
| Page 36 Item: 5 | Walls | <ul style="list-style-type: none"> <li>• Worn/stained/distressed wood members - older materials</li> </ul> |

Worn/stained/distressed wood members - older materials

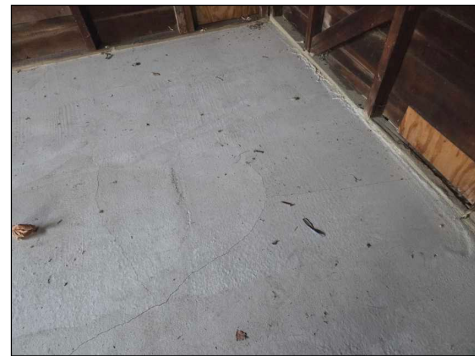
| Page 37 Item: 7 | Slab | <ul style="list-style-type: none"> <li>• Cracked/soft areas present - signs of ground movement and settling - recommend servicing</li> </ul> |

**Cracked/soft areas present - signs of ground movement and settling - recommend servicing**

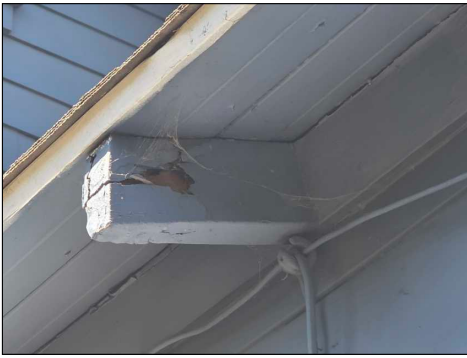
| Page 38 Item: 2 | Eaves & Fascia | <ul style="list-style-type: none"> <li>• Deteriorated wood - recommend evaluation by termite inspector</li> </ul> |

**Deteriorated wood - recommend evaluation by termite inspector**

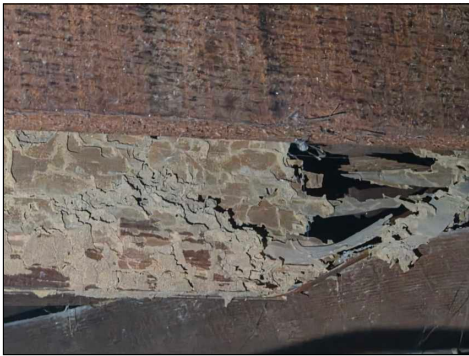
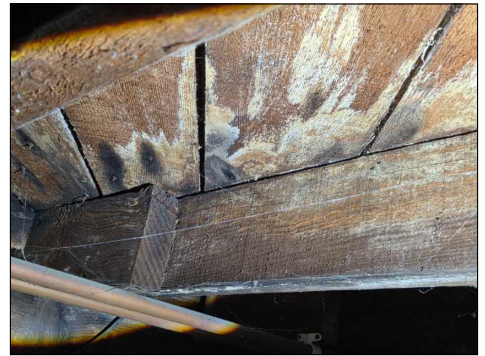
| Page 41 Item: 3 | Sub Flooring | <ul style="list-style-type: none"> <li>• Heavily deteriorated joist in areas - needs to be serviced/further evaluated by a specialist</li> </ul> |

**Heavily deteriorated joist in areas - needs to be serviced/further evaluated by a specialist**

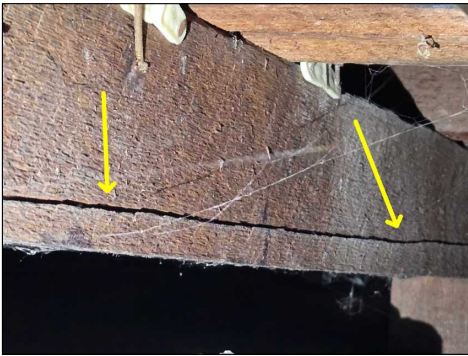
**Cracked/sagging girder - needs to be serviced**

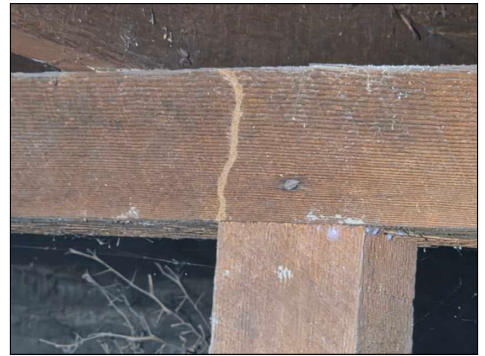
**Missing brackets at attachment points - recommend upgrade**

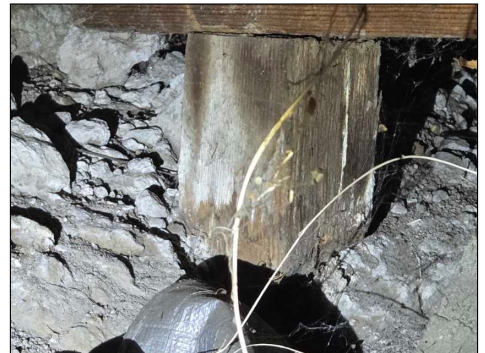
**Wood post are worn/older - recommend upgrade**
