ROB BOWLEN HOME INSPECTION INC.

## RESIDENTIAL REPORT

4537 Montara Dr  
Antioch, CA 94531

08/24/2026

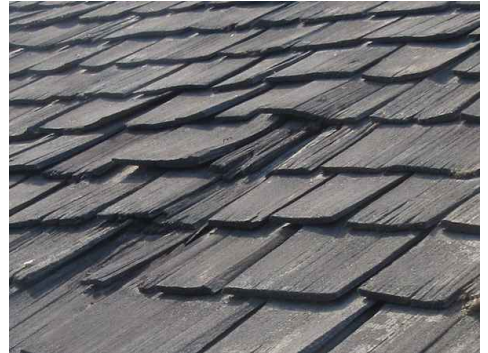
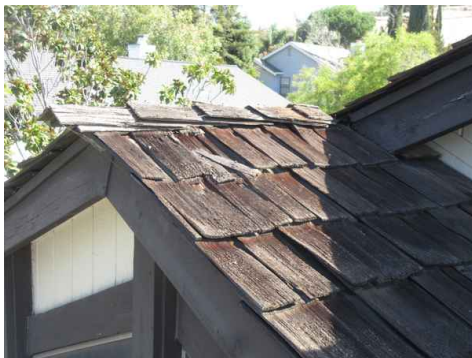
**WOOD SHAKE ROOF END OF LIFE**

The wood shake roof covering has reached the end of its serviceable life and requires replacement. Wood shake roofs typically last 20-40 years depending on climate, maintenance, and exposure. Continued use of an end-of-life roof risks water infiltration, interior damage, and potential structural compromise. A roofing professional should evaluate the roof and provide a replacement estimate and timeline.

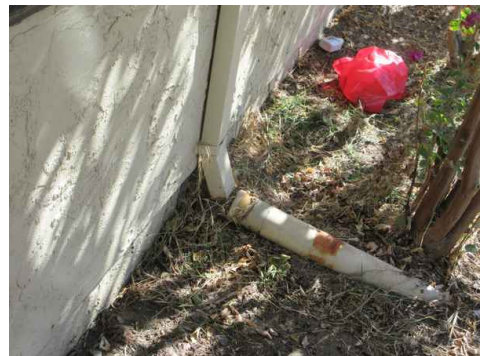
## 3.2.1 Roof Drainage Systems

One or more downspouts drain too close to the home's foundation. This can result in excessive moisture in the soil at the foundation, which can lead to foundation/structural movement. Recommend a qualified contractor adjust downspout extensions to drain at least 6 feet from the foundation. We recommend that all of the downspouts be routed away from the structure by installing splash blocks or hoses, or an underground drainage collection system to prevent pooling, saturation of the soil and/or crawl space intrusion.

[Here is a helpful DIY link](#) and video on draining water flow away from your house.

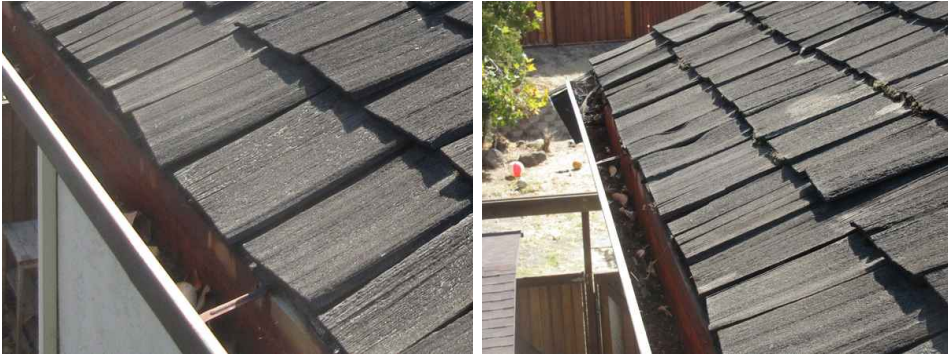
## 3.2.2 Roof Drainage Systems

**DEBRIS IN GUTTERS**

We recommend having the gutters cleaned by a qualified professional.

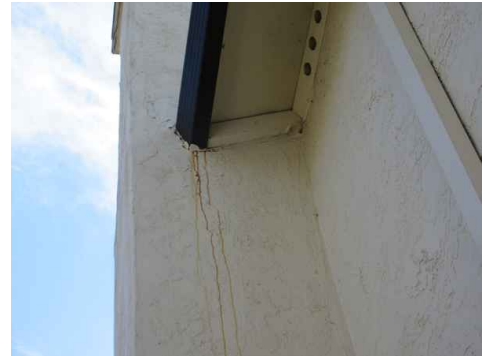
### 3.2.3 Roof Drainage Systems

#### **WATER STAINS GUTTER SEAMS**

The home was inspected on a dry day. Water stains were noted at the gutter seams. This can be an indication of gutter leaks. We recommend having the gutters water tested by a qualified roofer and repaired if/as needed. Often times gutter leaks can be easily corrected by installing a water proof caulking designed for gutters.

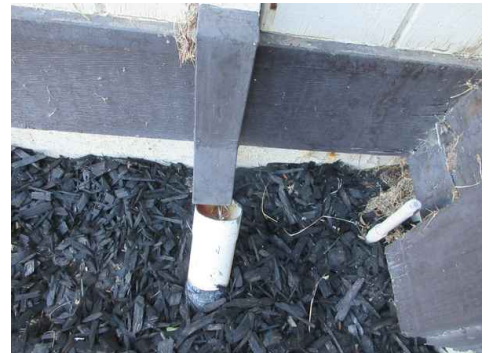
### 3.2.4 Roof Drainage Systems

#### **DISCONNECTED DOWNSPOUTS FROM UNDERGROUND DRAIN**

Portions of the downspouts are disconnected from the below-ground drain system. This prevents proper water drainage away from the foundation, allowing water to pool near the structure. Have a gutter contractor reconnect the downspouts to the underground drain system to restore proper drainage.

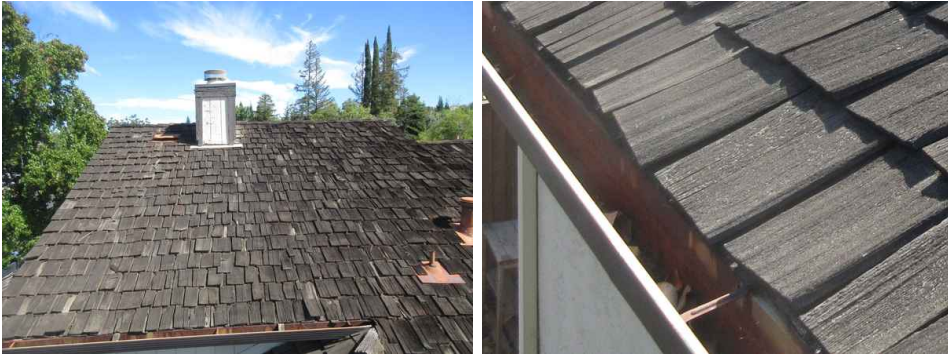
### 3.2.5 Roof Drainage Systems

#### **RUSTED GUTTERS**

Rust damage was observed on the gutters during roof drainage inspection. Rust compromises the structural integrity of the gutter system and can lead to leaks, water damage to fascia and siding, and eventual gutter failure. Have a gutter contractor evaluate the extent of rust damage and recommend repair or replacement options.

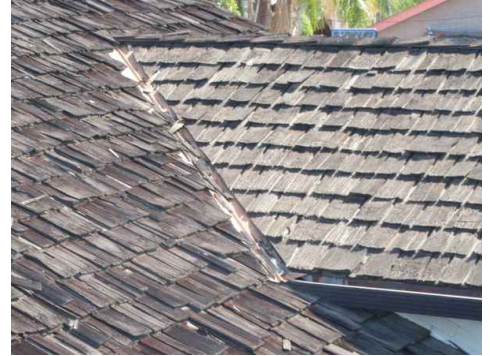
### 3.3.1 Flashings

#### **DEBRIS IN VALLEY FLASHING**

Debris should be removed from the roofing and valley flashing to reduce risk of leaks.

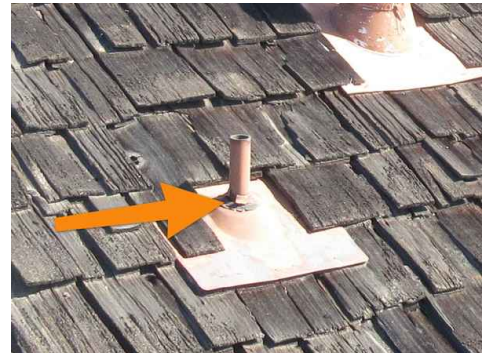
### 3.3.2 Flashings

#### **PIPE FLASHING DAMAGED**

We noted various pipe flashings with rips, tears and/or puncture holes. To ensure a water tight condition the flashings must be repaired and/or replaced.

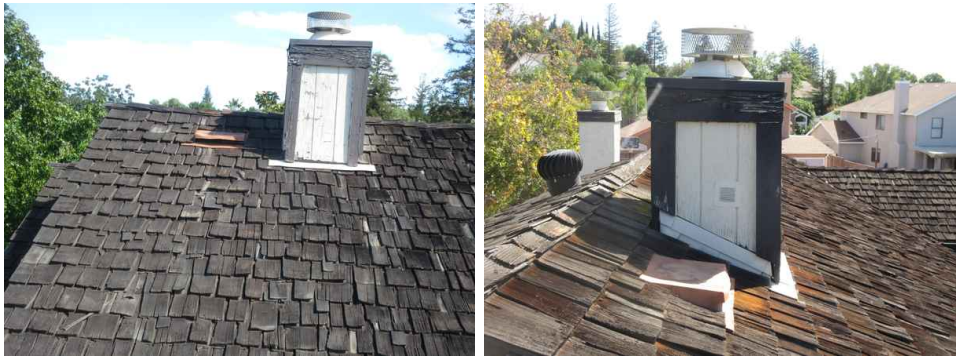
### 3.4.1 Skylights, Chimneys & Other Roof Penetrations

#### **DETERIORATED CHIMNEY SIDING AND TRIM**

Chimney siding and trim above the roof line show significant deterioration and weathering. This exposure to the elements can allow water infiltration into the chimney structure and surrounding roof areas. A chimney and siding repair contractor should evaluate the extent of damage and recommend appropriate repairs or replacement.

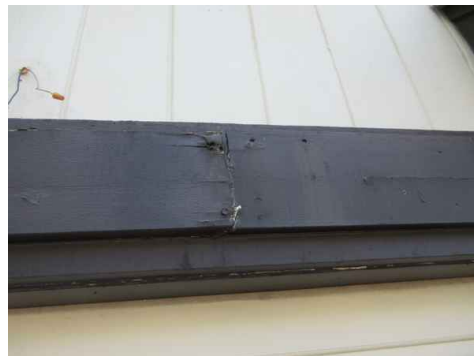
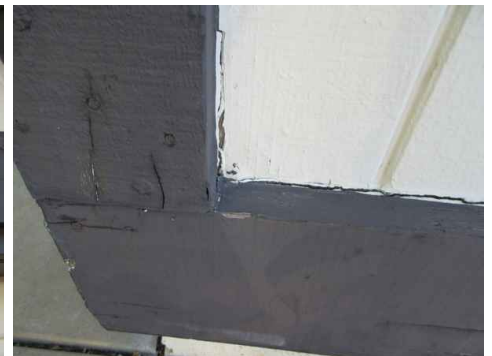
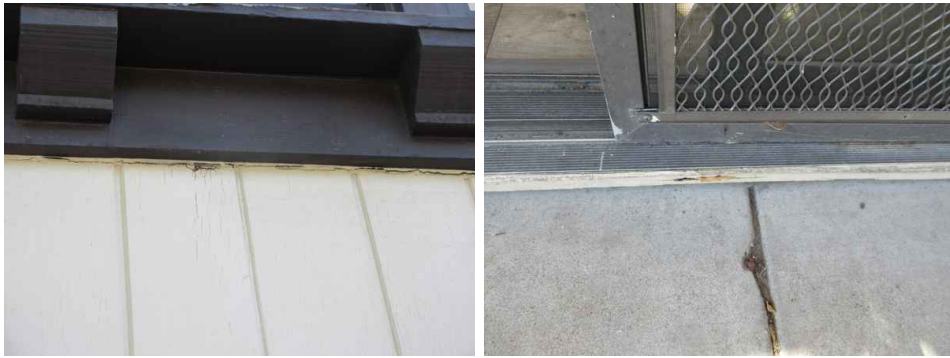
#### WATER DAMAGE TO SIDING AND TRIM

Water damage observed on the exterior siding and trim during inspection. This indicates moisture intrusion that can lead to rot, structural deterioration, and mold growth if not addressed. A qualified contractor should evaluate the extent of damage and identify the moisture source to prevent further deterioration.

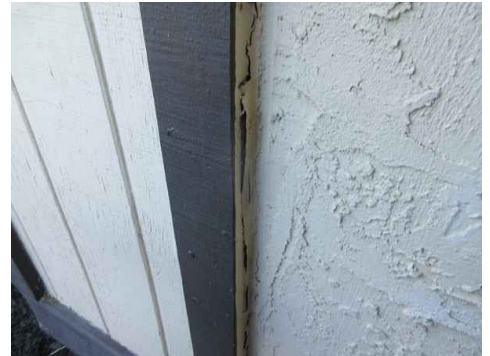
## 4.2.1 Siding, Flashing &amp; Trim

**SIDING CAULK DETERIORATED**

The exterior siding and trim caulking is deteriorated. Contact a qualified contractor to caulk and seal exterior surfaces as needed to keep any water from entering.

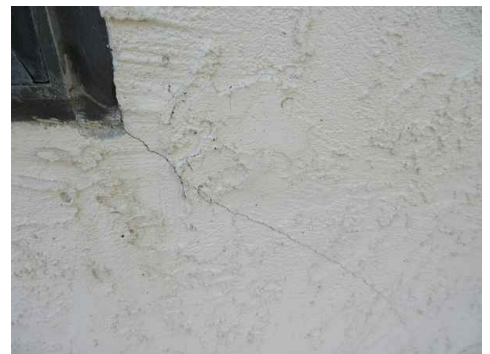
## 4.2.2 Siding, Flashing &amp; Trim

**STUCCO CRACKS TYPICAL**

Cracks were observed on the exterior stucco walls of the house. This implies that structural movement has/may have occurred. The location, size, shape of these cracks is common. The inspection did not find evidence of significant movement requiring immediate major repairs.

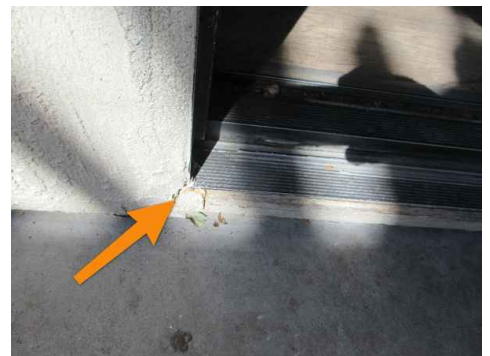
## 4.2.3 Siding, Flashing &amp; Trim

**STUCCO DAMAGE**

Localized damage of the stucco exterior walls should be repaired. There is extra risk of hidden damage in such areas caused by previous or present leaks that should be sealed.

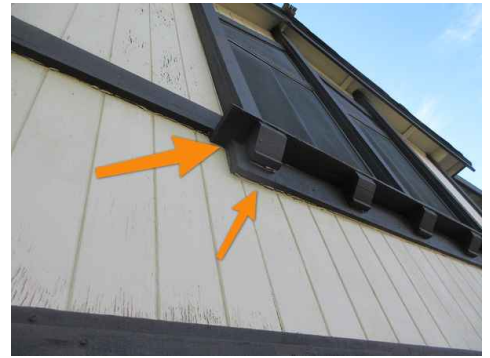
## 4.2.4 Siding, Flashing &amp; Trim

**WINDOW SHELF GAP AT SIDING**

A gap was observed between the front window shelf and siding during exterior inspection. This opening allows water infiltration and air leakage, potentially causing water damage to framing and insulation, and increased energy loss. The gap should be sealed with appropriate caulk or flashing and secured to prevent further deterioration.

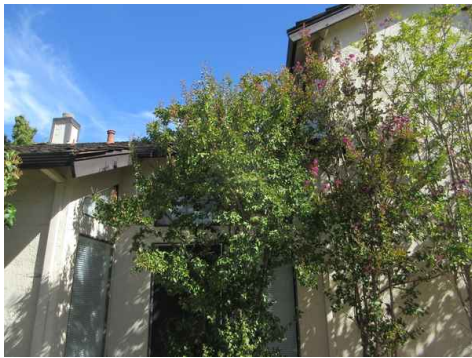
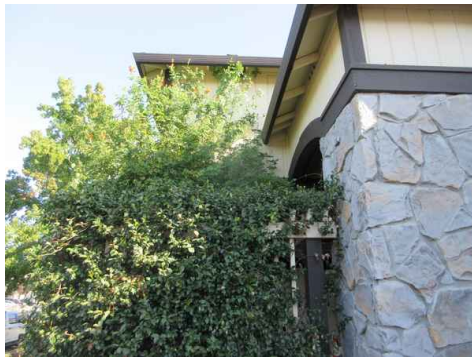
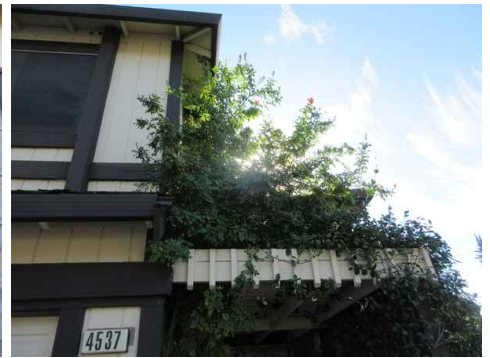
#### 4.2.5 Siding, Flashing & Trim

### VEGETATION CONTACT WITH HOUSE AND PORCH

Vegetation is in direct contact with the exterior of the house and porch structure. This contact can trap moisture against the siding, promote wood rot, and create entry points for pests and insects. Remove vegetation away from the house to maintain proper clearance and allow the exterior to dry.

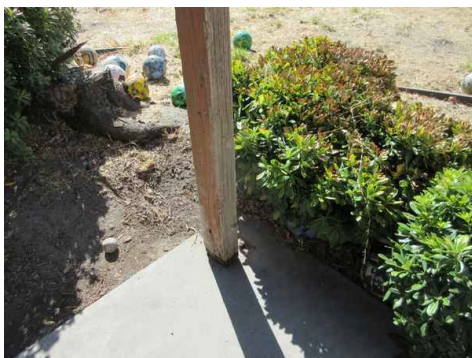
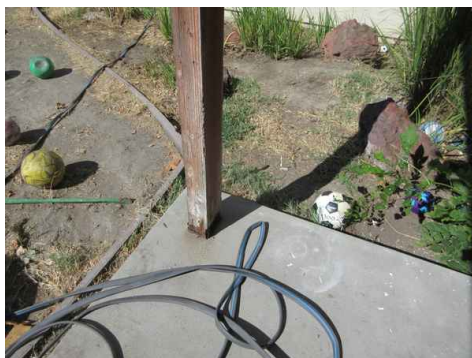
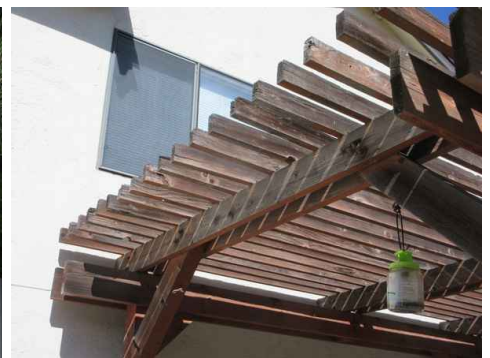
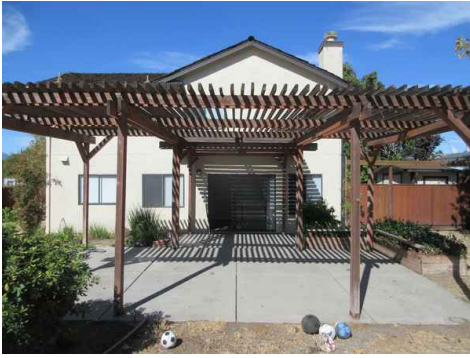
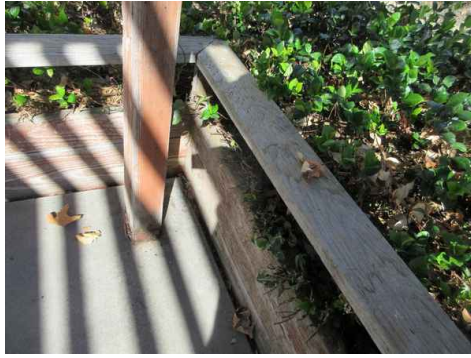
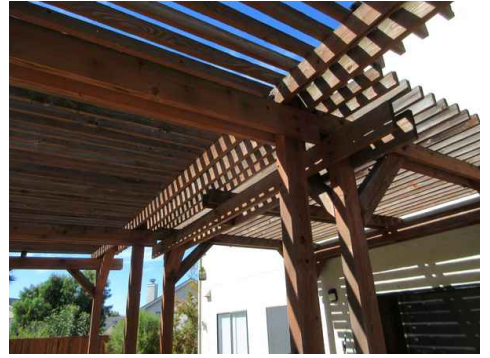
#### 4.4.1 Decks, Balconies, Porches & Steps

### DETERIORATED PATIO COVER WITH RUSTED BRACKETS

The rear patio cover exhibits significant deterioration with rusted brackets that are poorly secured to the concrete floor. This compromised structural integrity creates a potential safety hazard, as the cover could fail. A qualified contractor should evaluate the extent of rust damage, assess structural stability, and either reinforce or replace the cover and fastening system as needed.

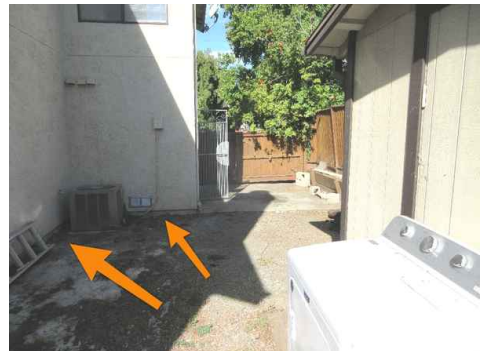
Grading is sloping towards the home in some areas. This could lead to water intrusion and foundation issues. Recommend qualified landscaper or foundation contractor regrade so water flows away from home.

[Here is a helpful article](#) discussing negative grading.

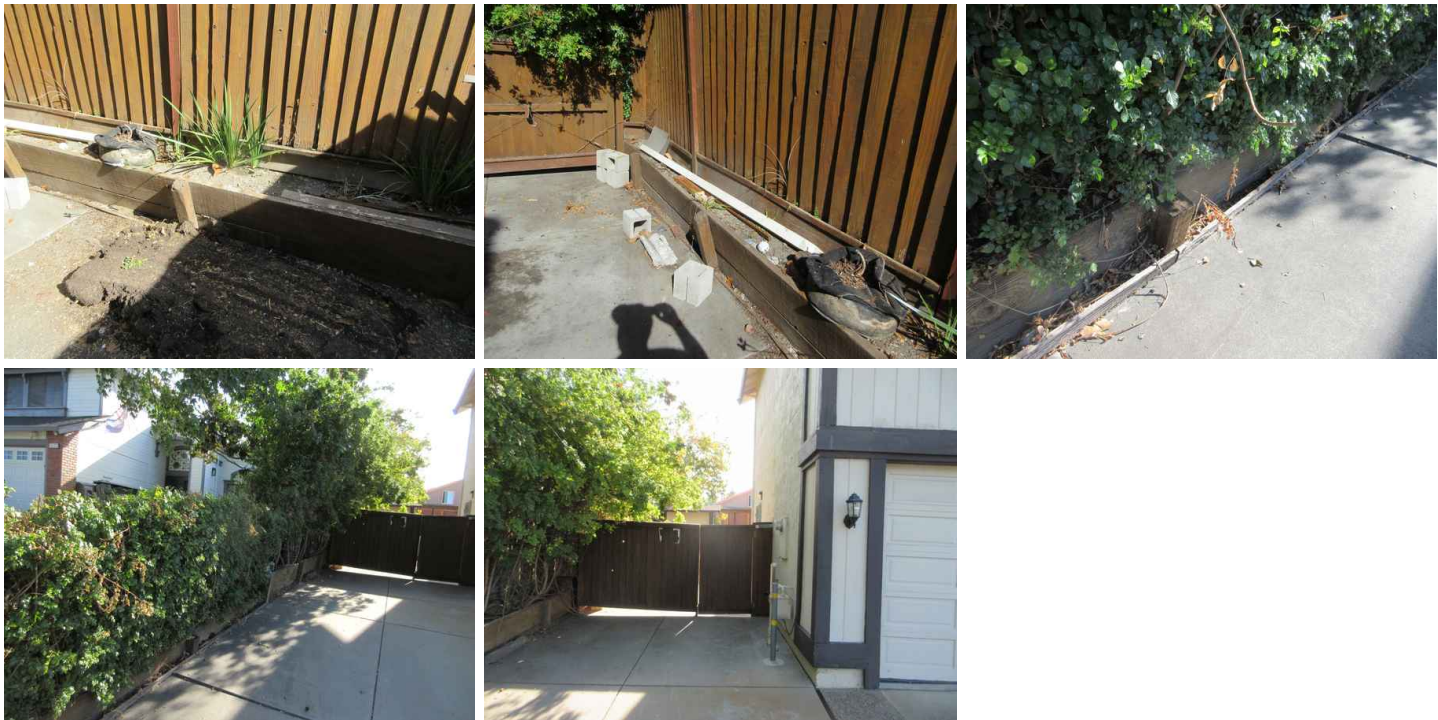
4.6.2 Vegetation, Grading, Drainage & Retaining Walls

**DAMAGED AND LEANING RETAINING WALL**

A wooden retaining wall shows visible damage and is leaning out of plumb. This indicates structural failure and potential soil pressure issues. A structural engineer or qualified contractor should evaluate the wall's stability and recommend repair or replacement to prevent collapse and property damage.

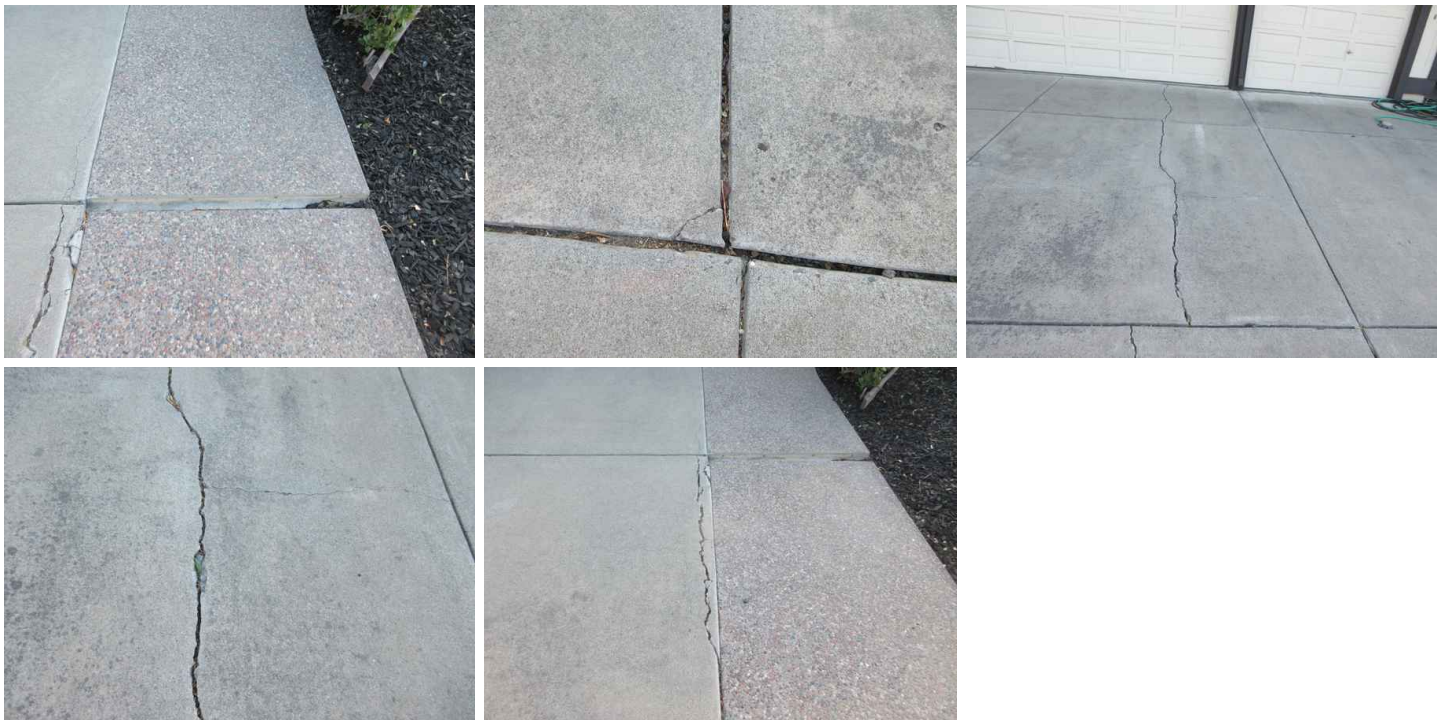
4.7.1 Walkways, Patios & Driveways

**DRIVEWAY TRIP HAZARD**

Trip hazards observed. Patch or repair recommended.

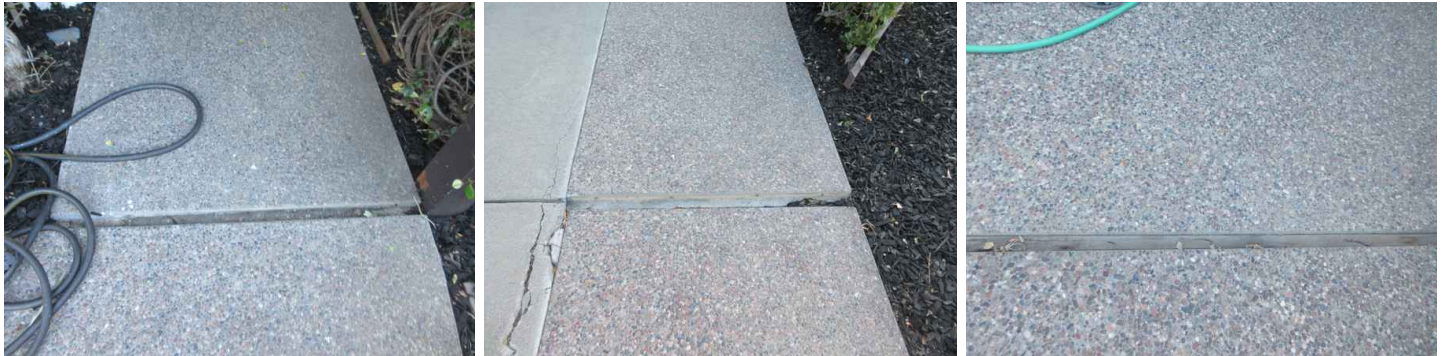
## 4.7.2 Walkways, Patios &amp; Driveways

**WALKWAYS TRIP HAZARD**

The walkways, sidewalk, patio and driveway present a trip hazard at cracked uneven surfaces and missing and damaged screed boards. These conditions should be altered for improved safety.

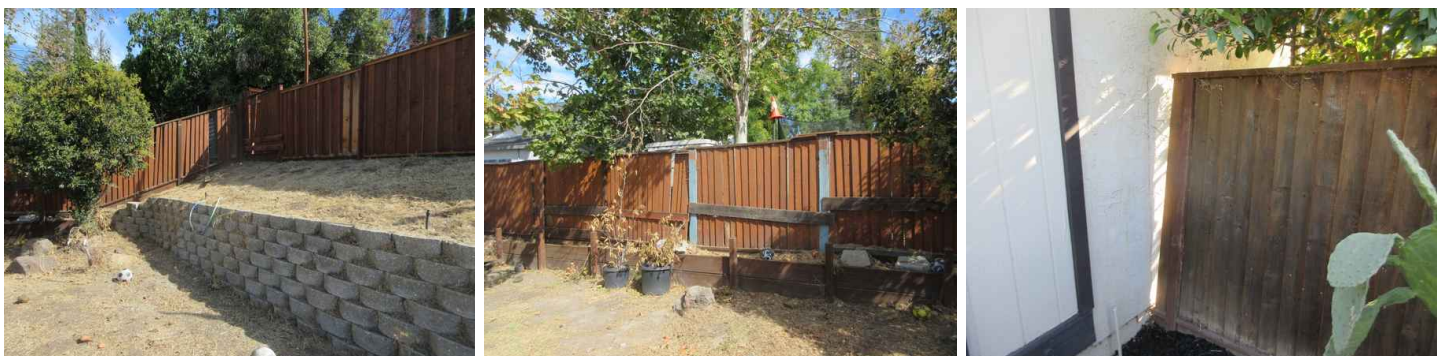
**FENCE NEEDS PORTIONS REPAIR**

Portions of the fences and gates are in need of repair. Contact a qualified fence contractor to evaluate all fences and repair as needed.

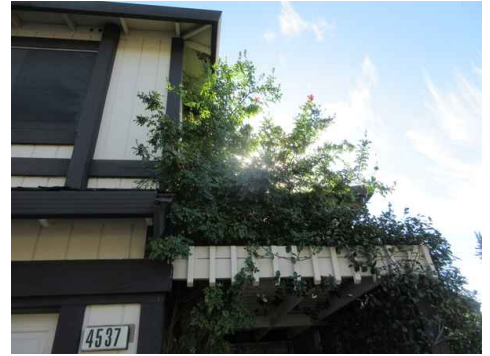
## 4.12.1 Front Porch

**VEGETATION OVERGROWTH AT ENTRY COVER**

Vegetation has grown against and is weighing on the front porch entry cover, which was not designed to support this additional load. The overgrown plants should be cut away to relieve stress on the structure and prevent potential damage or collapse of the cover.

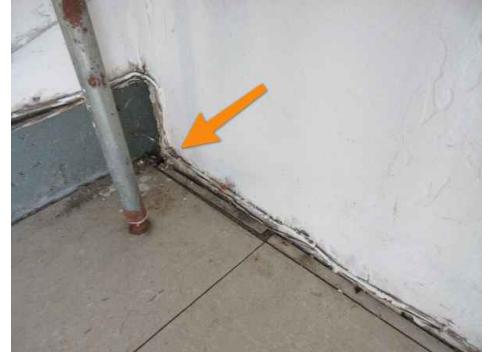
##### WALL STAINING

Staining observed at the base of the garage wall during inspection. The stain type could not be definitively determined during this visit. Further evaluation by a qualified professional may be warranted to identify the stain source and determine if any remediation is needed.

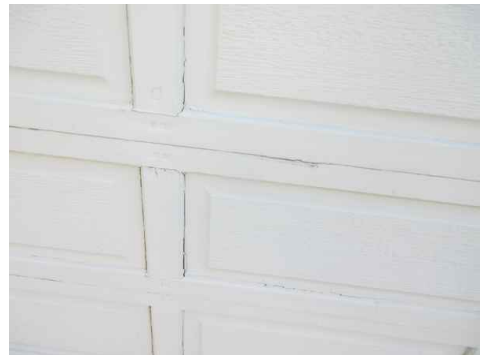
#### 5.4.1 Garage Door

##### DETERIORATED GARAGE DOOR WITH WATER DAMAGE

The garage door panels show visible deterioration with pockets of water damage observed during inspection. Water intrusion can compromise the door's structural integrity and lead to rust, rot, or mold growth. A garage door contractor should evaluate the extent of damage and recommend repair or replacement options.

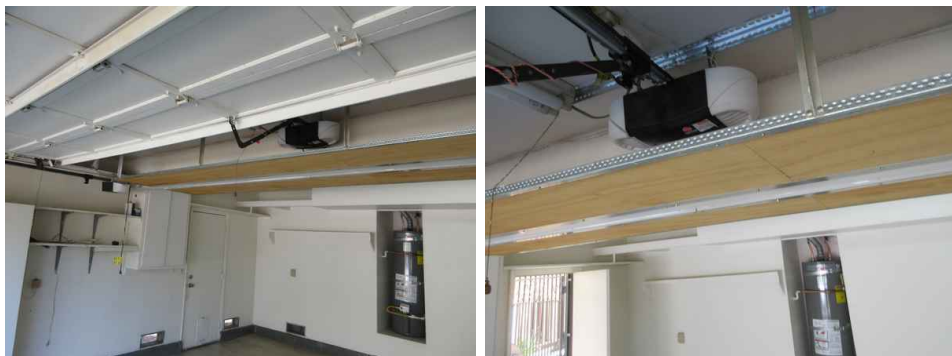
#### 5.5.1 Garage Door Opener

##### GARAGE DOOR OPENER MALFUNCTION

The single car garage door does not operate properly and fails to open the door. One of the three garage openers present is out of service. A garage door opener professional should evaluate the non-functioning opener to determine whether repair or replacement is needed.

All of the openers should be evaluated by a qualified contractor and repaired as needed to meet all current safety standards and operate properly.

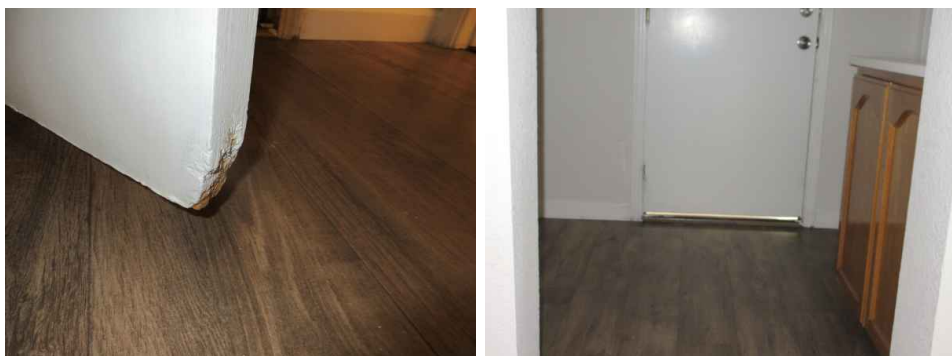
#### 5.7.1 Occupant Door (From garage to inside of home)

### DOOR DOES NOT MEET SEPARATION REQUIREMENTS

The garage door is damaged at the lower corner. There is a gap at the base of the garage door. Door separating garage and home does not meet safety standards. Doors in firewalls must be at least 1 3/8-inch thick, metal/steel, or a 20-minute fire-rated door.

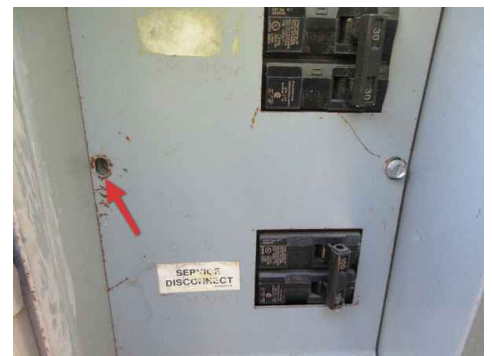
### DEAD FRONT COVER SCREWS MISSING

A dead front cover screw is missing at the main panel and needs to be added.

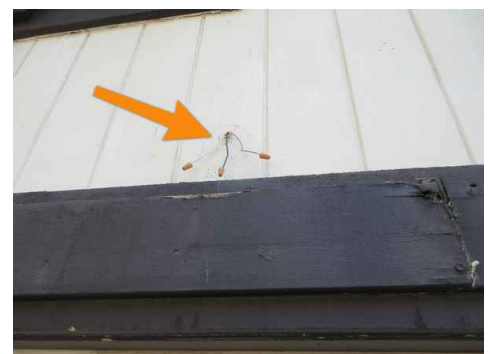
6.3.1 Branch Wiring Circuits, Breakers & Fuses

### EXPOSED WIRES REQUIRING JUNCTION BOX

Exposed wires were observed on the exterior above the front garage automatic door. These wires lack proper protection in a junction box, creating both a safety hazard and a code compliance issue. Exposed electrical connections are vulnerable to weather damage, physical contact, and potential shock hazards. An electrical contractor should install an appropriate weatherproof junction box to protect these connections and ensure safe operation.

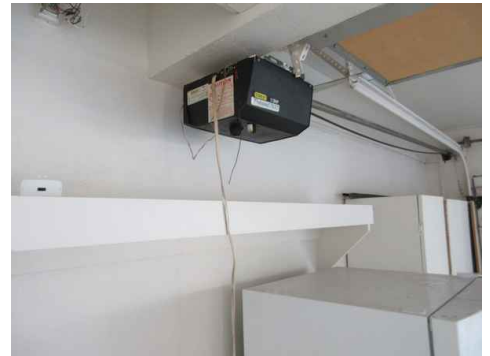
#### 6.3.2 Branch Wiring Circuits, Breakers & Fuses

An extension cord was observed being used as permanent wiring in the garage. Extension cords are designed for temporary use only and can overheat when used continuously, creating a fire hazard. The wiring should be replaced with properly installed permanent circuits and conduit by a qualified electrician to ensure safe and code-compliant electrical service.

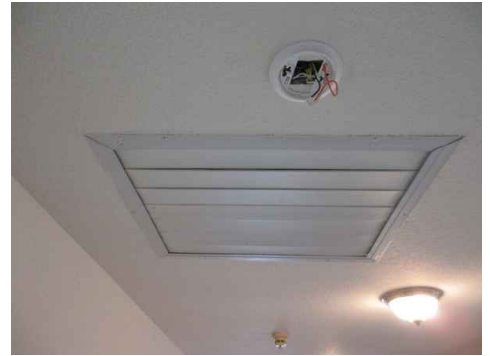
A smoke detector is missing at the second floor hallway.

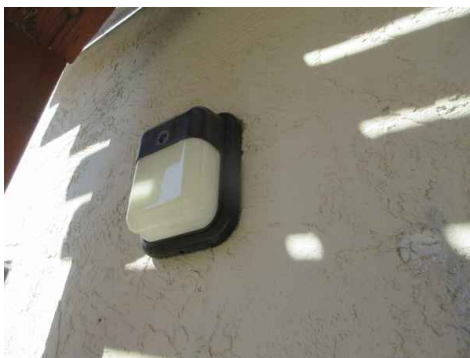
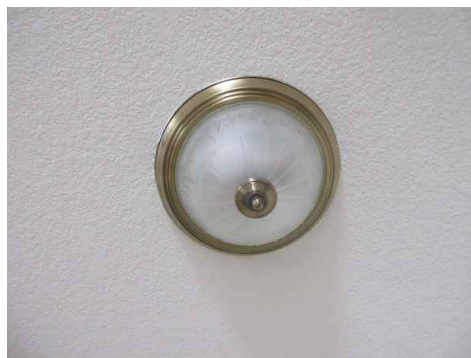
One or more of the lights are inoperative most evident at the exterior side garage door and rear exterior and interior first floor hallway. This may be due to turned off switches which were not located during our inspection. If the bulb has not failed or the lights switched off, the circuit should be investigated and repaired.

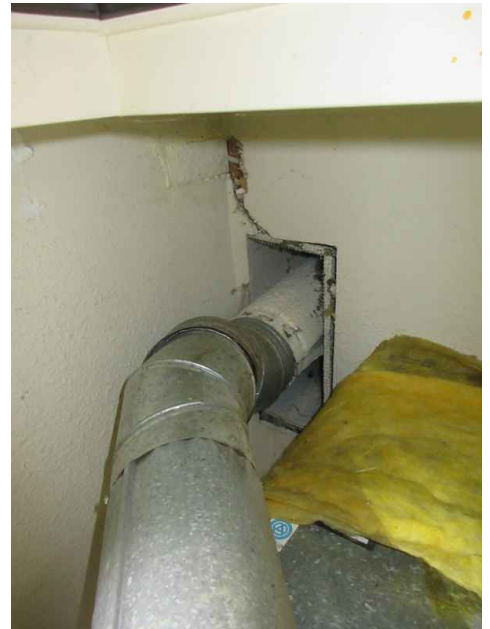
## 7.1.4 Equipment

**UNSEALED FURNACE VENT SEAMS**

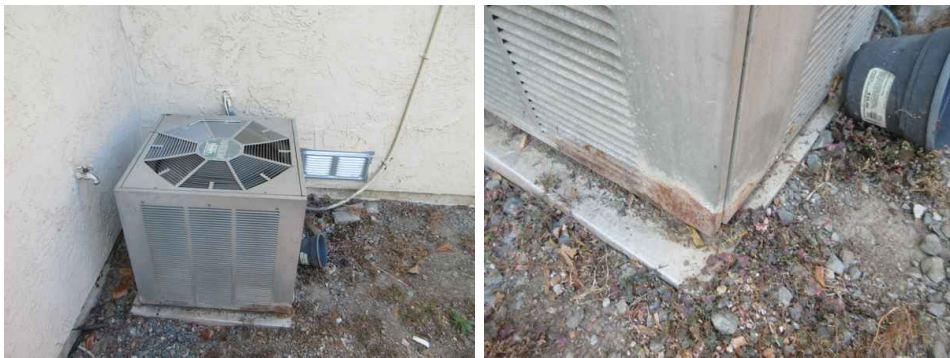
Rust was observed on the condenser housing during inspection. Corrosion can compromise the structural integrity of the unit and may lead to refrigerant leaks or reduced cooling efficiency over time. A heating and cooling contractor should evaluate the extent of rust and recommend whether cleaning, coating, or unit replacement is necessary.

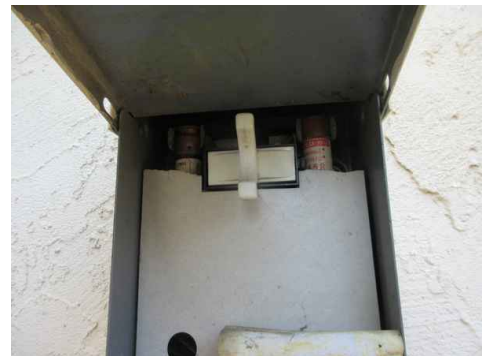
## 8.1.2 Cooling Equipment

The inner cover of the disconnect/fuse panel serving the cooling equipment is damaged. This was observed during the cooling system inspection. A damaged cover can expose electrical components to dust, debris, and accidental contact, creating potential safety hazards. The cover should be replaced by a qualified HVAC or electrical professional to restore proper protection and ensure safe operation.

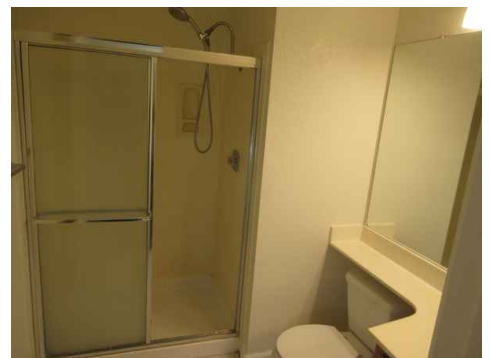
The shower doors are not sliding smoothly along their tracks. This may be caused by dirt, mineral deposits, or misalignment of the door frames. Cleaning the tracks thoroughly and lubricating with an appropriate product should restore proper operation; if problems persist, professional adjustment or replacement may be needed.

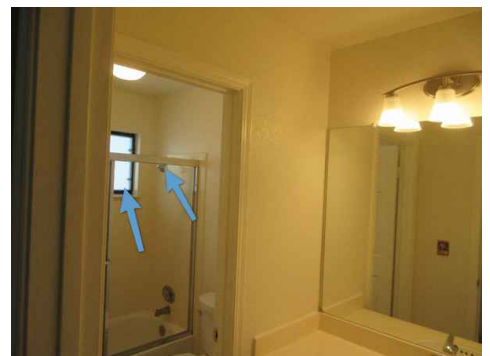
### 10.3.4 Water Supply, Distribution Systems & Fixtures

A window below the shower head in the second floor hall bathroom requires needs to be kept well sealed to prevent water entry. Water exposure from shower spray can compromise window seals, leading to water infiltration, moisture damage, and potential mold growth.

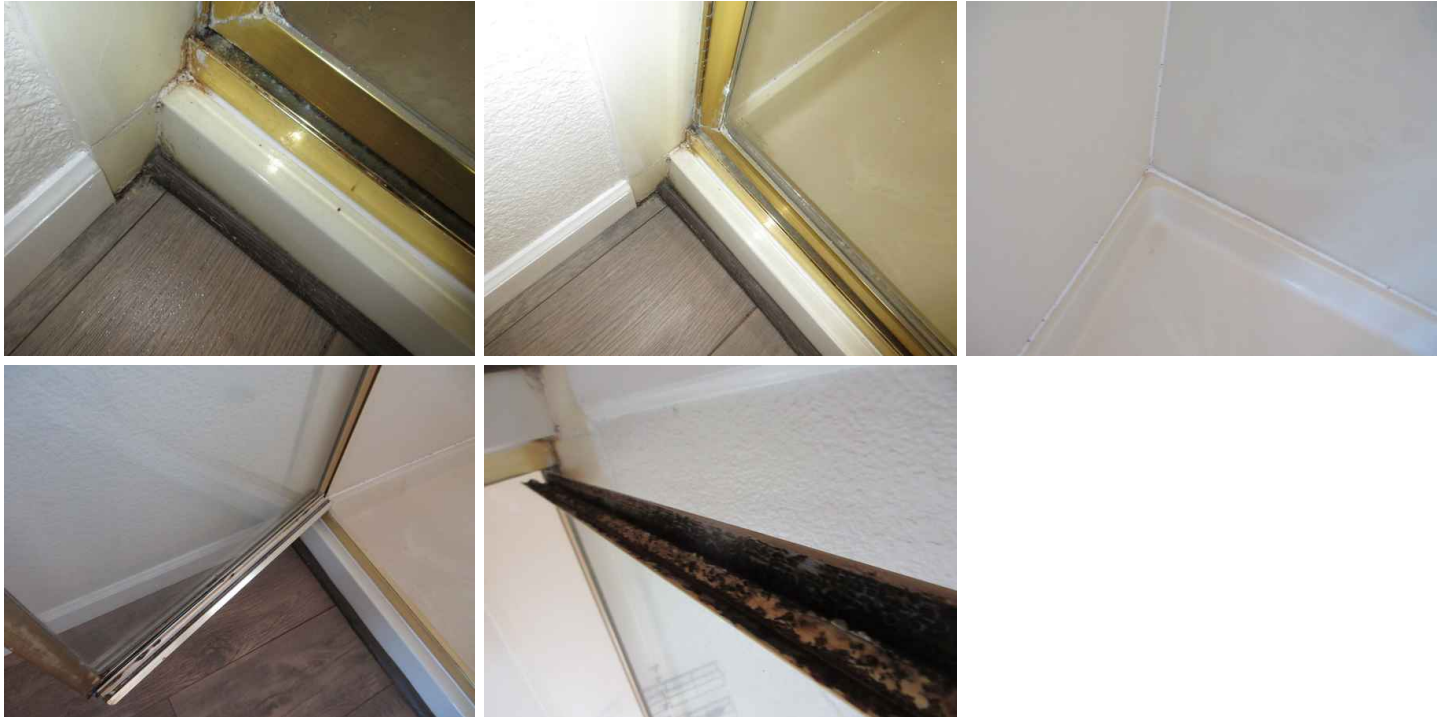
### 10.3.5 Water Supply, Distribution Systems & Fixtures

#### DETERIORATED SHOWER DOOR SEAL AND CAULK

The shower door seal needs replacement.

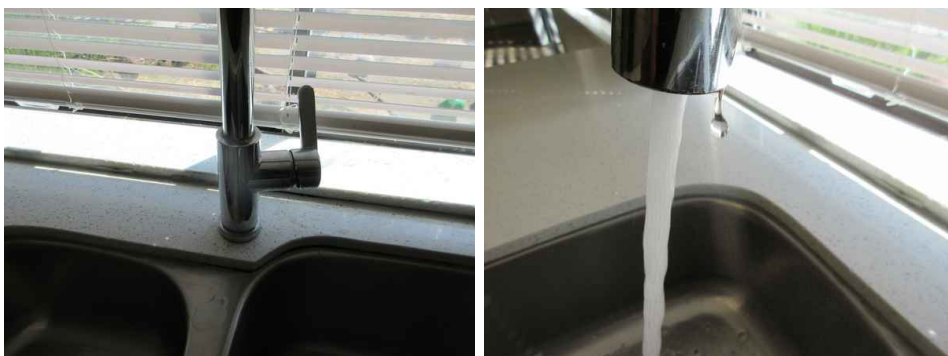
#### 10.3.6 Water Supply, Distribution Systems & Fixtures

The sink faucet is dripping and the fixture is slightly loose at the sink. A dripping faucet typically indicates worn washers or seals inside the valve, while a loose fixture suggests the mounting hardware needs tightening. If left unaddressed, this can lead to water waste, increased utility bills, and potential water damage to the cabinet or countertop below. Tighten the fixture mounting nuts and have a plumbing contractor inspect and repair the faucet valve to stop the drip.

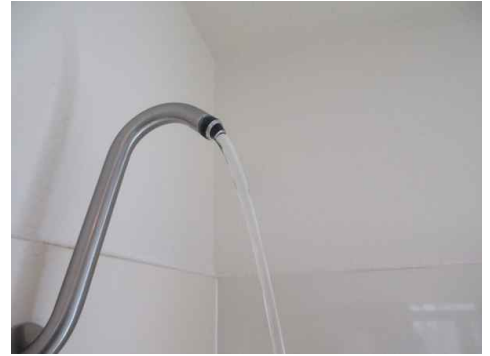
#### 10.3.7 Water Supply, Distribution Systems & Fixtures

The showerhead is missing from the shower fixture in the master bathroom. This prevents normal operation of the shower and should be replaced with a compatible unit. A plumbing contractor can install an appropriate showerhead to restore full functionality.

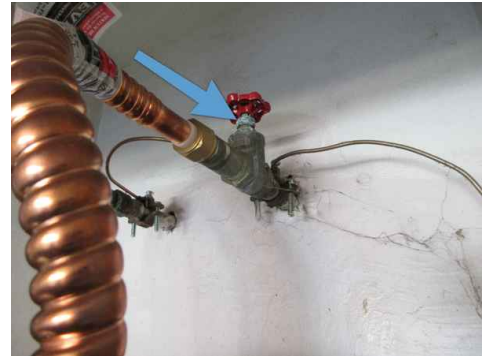
#### 10.4.1 Hot Water Systems, Controls, Flues & Vents

The supply piping and/or valve above the water heater shows evidence of a minimal amount of corrosion. Watch for leaks repair as needed.

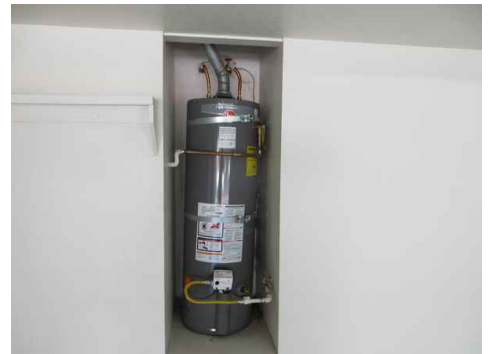
#### 10.4.2 Hot Water Systems, Controls, Flues & Vents

The water heater is leaning slightly out of vertical position. This misalignment can stress internal components and connections, potentially leading to leaks or premature failure. A qualified professional should inspect the unit's mounting and foundation to ensure proper support and stability.

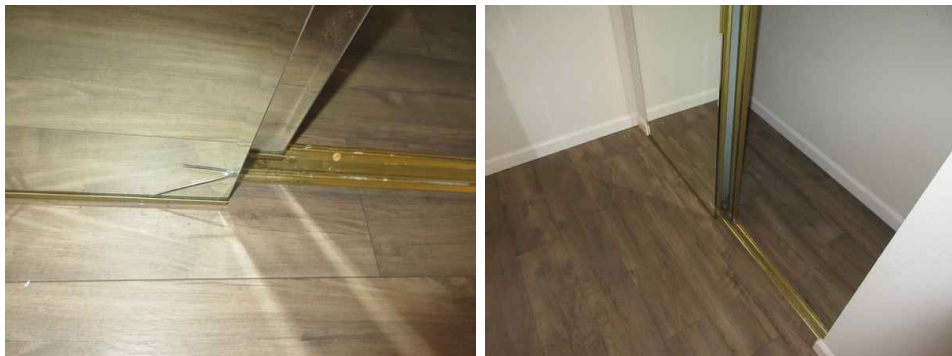
### 11.2.1 Doors

#### CLOSET DOOR MIRROR CRACKED AND OFF TRACK

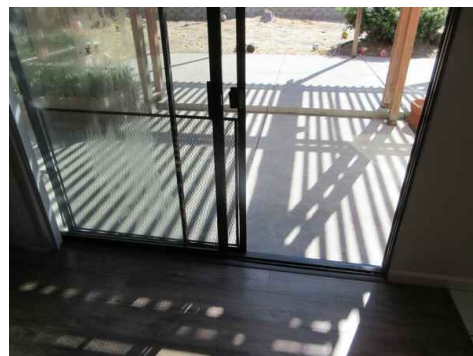
#### 11.3.1 SLIDER GLASS DOOR

##### **ROLLERS POOR**

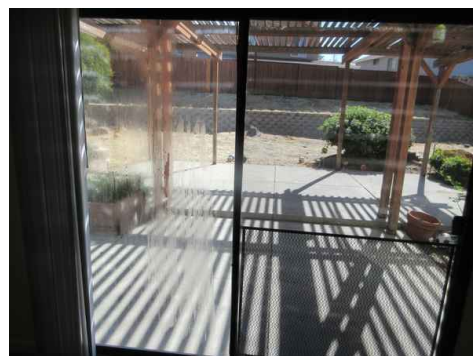
#### 11.3.2 SLIDER GLASS DOOR

##### **GLASS DOOR LOST SEAL**

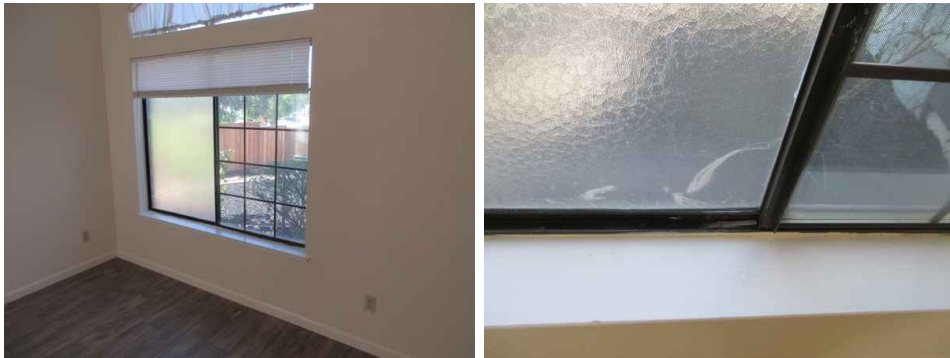
Several windows slide poorly. The dining room window does not open at all, and the front window appears to have a possible crack. Inoperable windows limit emergency egress and natural ventilation, while cracks can compromise weather sealing and allow water infiltration. A window contractor should evaluate all windows to determine if repairs or replacement is needed.

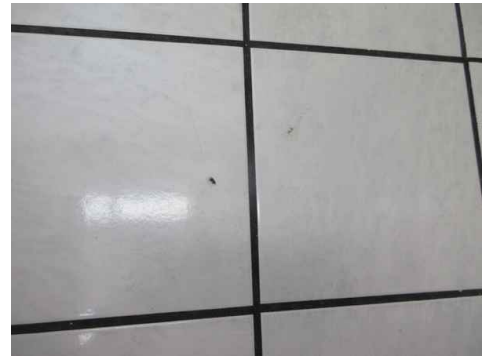
#### 11.5.1 Floors

##### **TILE FLOOR LOOSE/CRACKED/DAMAGED**

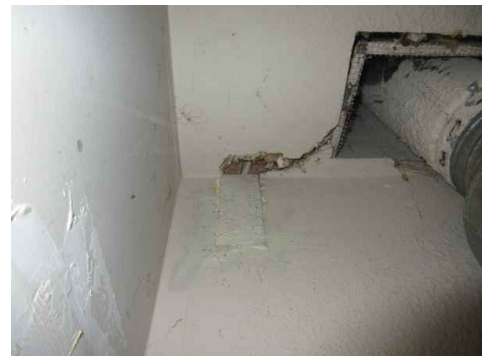
#### 11.6.1 Ceilings

##### **DAMAGED CEILING**

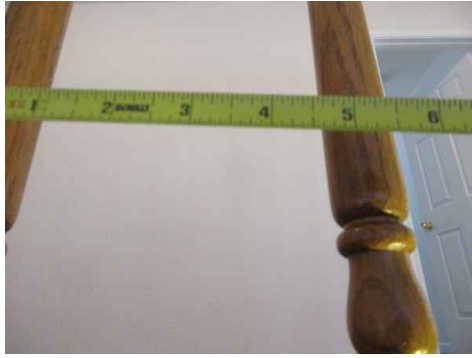
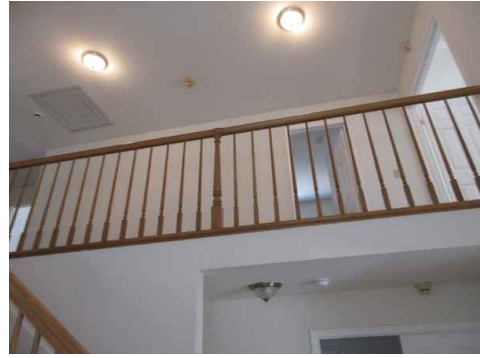
#### 11.7.1 Steps, Stairways & Railings

##### **OPENINGS STAIRWAY RAIL TO WIDE**

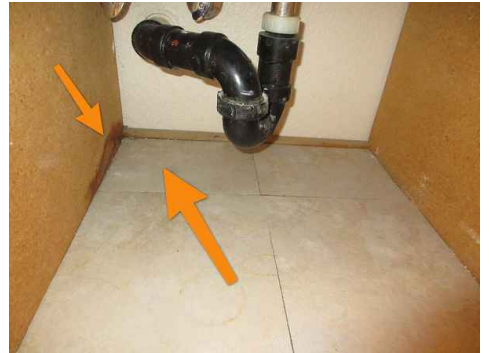
#### 11.8.1 Countertops & Cabinets

Stains and minimal water damage were observed on the cabinets during inspection. This indicates moisture exposure, which can lead to wood deterioration, mold growth, and structural compromise of the cabinet materials over time. The source of the water intrusion should be identified and corrected, and the affected cabinet areas should be evaluated by a qualified professional to determine if repairs or replacement are necessary.

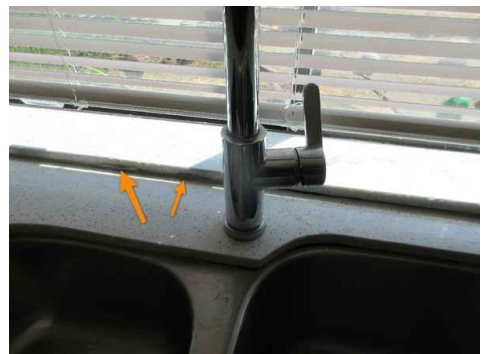
#### 11.8.2 Countertops & Cabinets

Deteriorated caulking at the countertop adjacent to the kitchen sink. This gap allows water to seep behind the countertop and into the cabinet structure below, potentially causing water damage, rot, and mold growth. The area should be cleaned and sealed with appropriate kitchen-grade caulk by a countertop contractor or handyman.

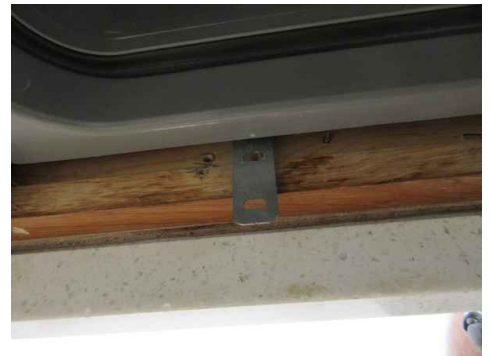
The dishwasher was not adequately secured to the underside of the countertop. We recommend the dishwasher be secured to the countertop to prevent tipping forward and possible injury.

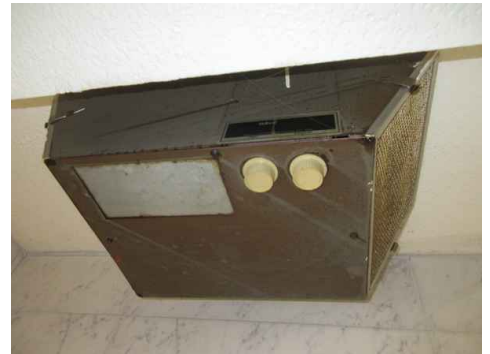
### 12.3.1 Range/Oven/Cooktop

#### **COOKTOP FAN REQUIRES CLEANING; LIGHT INOPERATIVE**

The old cooktop fan requires cleaning due to grease and debris buildup, and the associated light fixture is not functioning. A dirty fan reduces ventilation efficiency and can pose a fire hazard, while the inoperative light limits visibility during cooking. Have an appliance repair professional clean the fan thoroughly and diagnose and repair the light fixture.
