# WOOD DESTROYING PESTS AND ORGANISMS INSPECTION REPORT

| Building No.<br><b>20162</b> | Street<br><b>Pine Mountain Dr.</b> | City<br><b>Groveland</b> | Zip<br><b>95321</b> | Date of Inspection<br><b>09/17/25</b> | Number of Pages<br><b>1 of 10</b> |

**Report # 7243**

**Multi level, single family residence, wood frame construction, fiber cement siding and wood/ log timber trim, composition roof, attached decks, detached garage.**

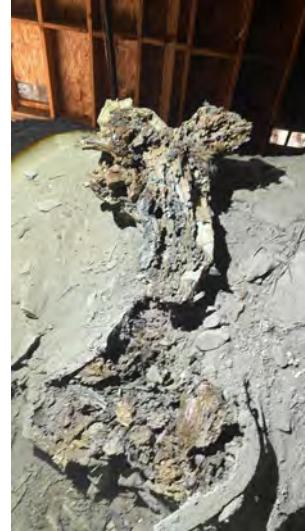
1A:

1A.  
Evidence of subterranean termites is present in the cellulose debris, formboards, and stumps in the subarea.

RECOMMENDATION: Scrape down all visible / accessible termite tubes if necessary. Treat entire subarea for the control of subterranean termites with PREMISE 75 / Termidor. All chemicals are to be applied by a state licensed applicator in accordance with manufacturer labels.

NOTE: It is recommended to maintain chemical barrier every five years to prevent future reinfestations.

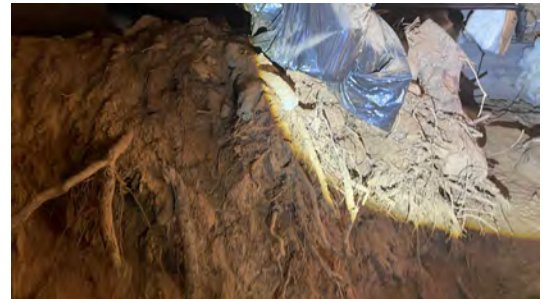
1B:

1B.  
Formboards and cellulose debris were noted in subarea. Evidence of subterranean termites is present.

RECOMMENDATION: Remove formboards and cellulose debris, as practical. (If it is found impractical to remove all formboards / stakes, treat remaining with Tim-bor- disodium octaborate tetrahydrate in accordance with manufacturer labels.) All chemicals to be applied by a state licensed applicator. Price for chemical treatment for termites is given in item # 1A.

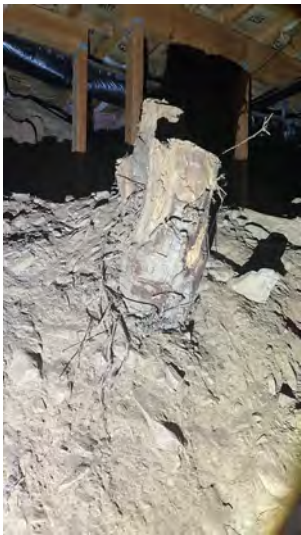
1C:

1C.  
Tree stumps were noted in the subarea. Evidence of subterranean termites is present.

RECOMMENDATION: Remove stumps as practical. Treat any remaining portions of stumps and/or root systems with CENTERFIRE 75 / Tim-bor. All chemicals are to be applied by a state licensed applicator in accordance with manufacturer labels.

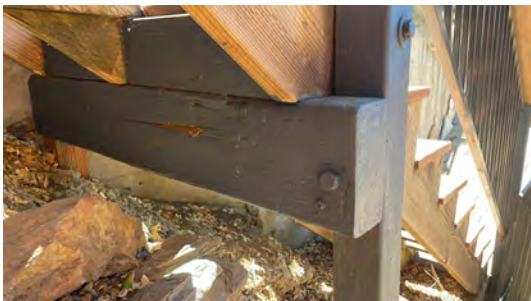
11A:

11A.  
Wood decay fungus is infecting and damaging the 4x4 support post, 4x4 handrail post, and 4x8 girder at the driveway stairs. (Stairs are not directly attached to the structure.)

**RECOMMENDATION:** Remove and replace up to 35 linear feet of damaged 4x4 support post and damaged 4x4 handrail post, and up to 4 linear feet of damaged 4x8 girder. Price for repairs does not include paint / stain. Treat all exposed wood members with (Tim-bor) disodium octaborate tetrahydrate to arrest the growth of wood decay fungi. All chemicals are to be applied by a state licensed applicator in accordance with manufacturer labels. \*Upon request, prices can be given for others to perform repairs and Streamline Inspections to chemically treat only.

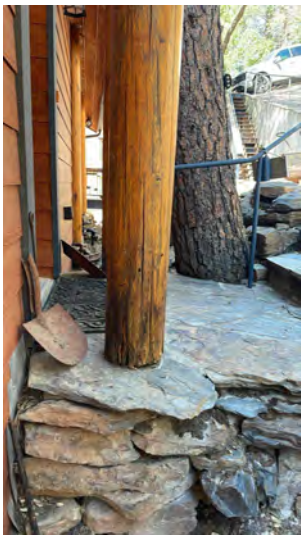
11B:

Wood decay fungus is infecting and damaging the base of the wood log timber at the front entry.

**RECOMMENDATION:** Remove and replace up to 8 linear feet of damaged material; price for repairs does not include paint / stain. Treat all exposed wood members with (Tim-bor) disodium octaborate tetrahydrate to arrest the growth of wood decay fungi. All chemicals are to be applied by a state licensed applicator in accordance with manufacturer labels. \*Upon request, prices can be given for others to perform repairs and Streamline Inspections to chemically treat only.
