# - INSPECTION REPORT -

**CHRIS RIPPY INSPECTIONS**

**3541 Goldenrod Cir Seal Beach, CA 90740**  
**Inspection prepared for: Rod & Susan Morales**  
**Real Estate Agent: Lisa Broder - Think Boutiq Real Estate**

**Date of Inspection: 8-9-2026**

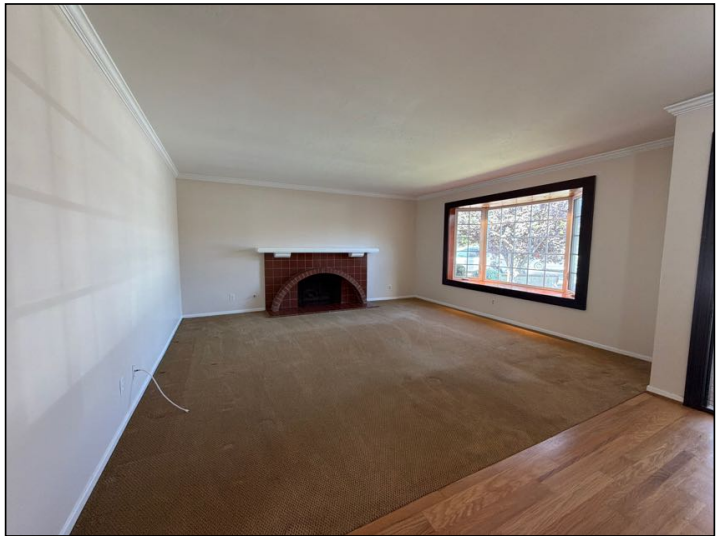
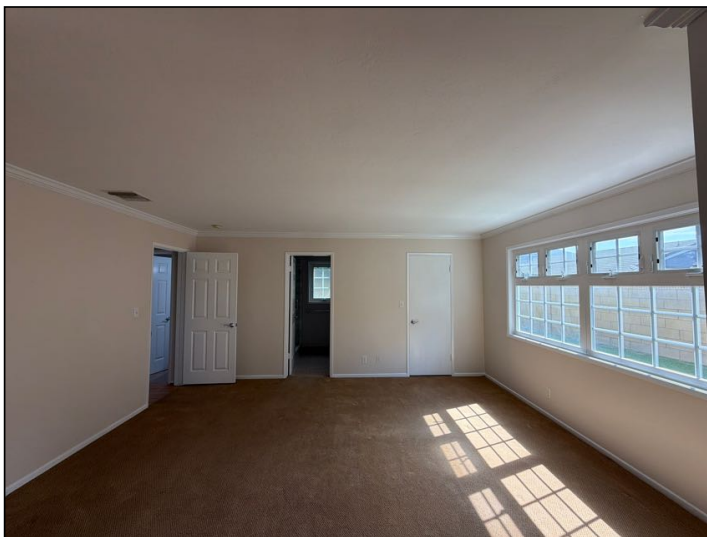
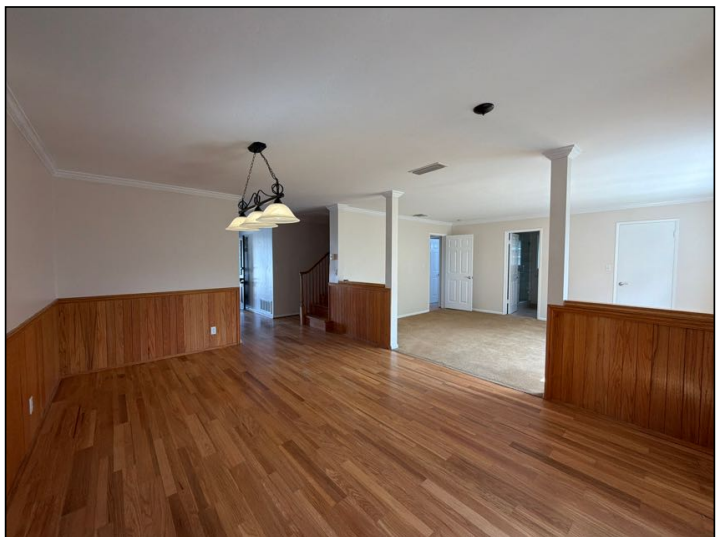
1.2. Areas appeared to have been recently painted. This may conceal underlying conditions that were not visible at the time of inspection.

1.3. Cosmetic irregularities and/or imperfections were observed. These appear to be aesthetic in nature and do not affect the functionality of the component.

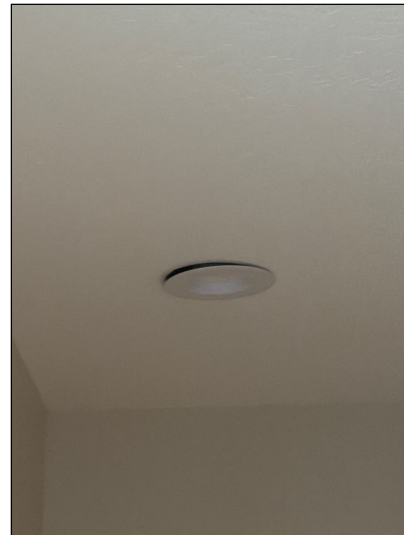
8.2. A recessed light fixture was observed to be loose at the ceiling and was not properly secured in place. Recommend securing or repairing the fixture as needed.

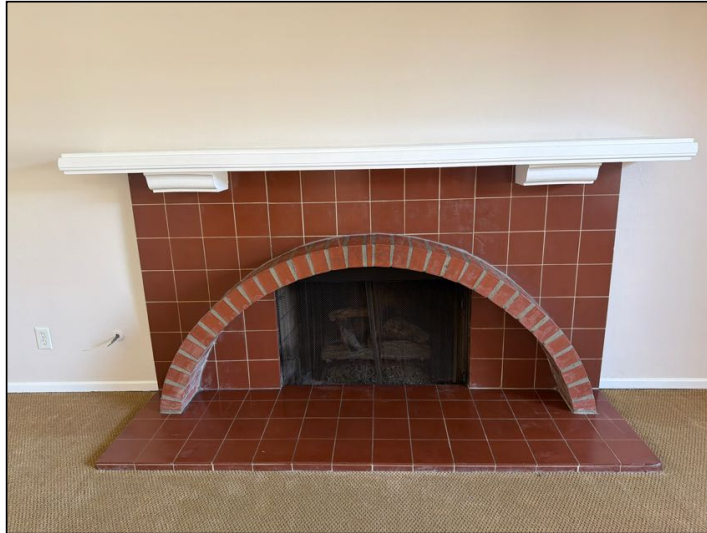
9.1. **Decorative Fireplace:** The fireplace was labeled as a decorative unit and was not inspected as part of this evaluation. No determination was made regarding its condition, safety, or functionality. If additional information regarding the fireplace or chimney system is desired, recommend consultation with a state-licensed chimney professional.

9.2. **LEVEL II INSPECTION** — *The National Fire Protection Association (NFPA) recommends that a Level II chimney inspection be performed whenever a property is transferred. This type of inspection provides a more thorough evaluation than a standard visual inspection and should be conducted by a certified chimney professional. For more information, visit [www.csia.org](http://www.csia.org) or [www.nfpa.org](http://www.nfpa.org). Recommend consulting a chimney sweep certified by the Chimney Safety Institute of America (CSIA) to perform this inspection.*

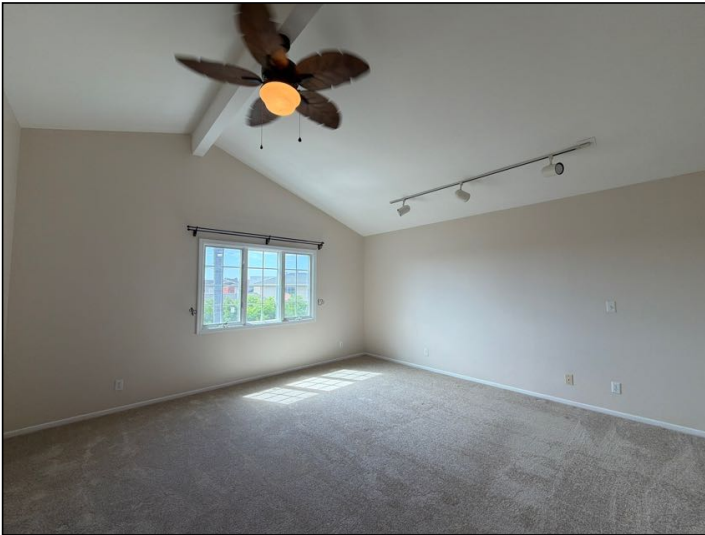
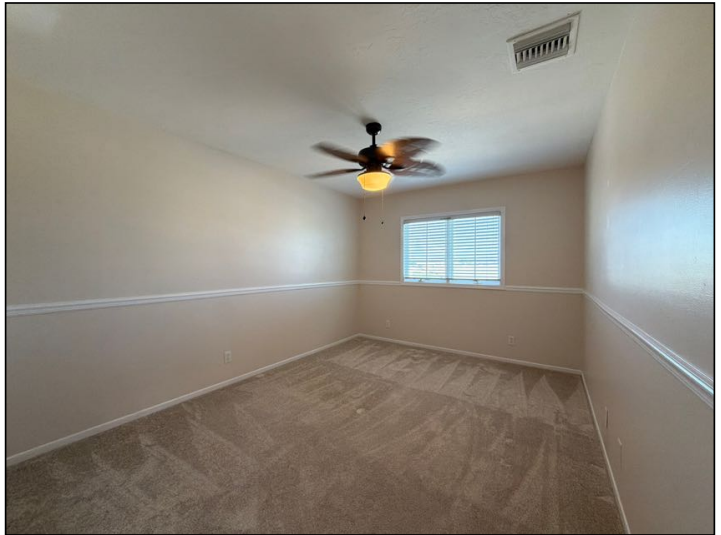
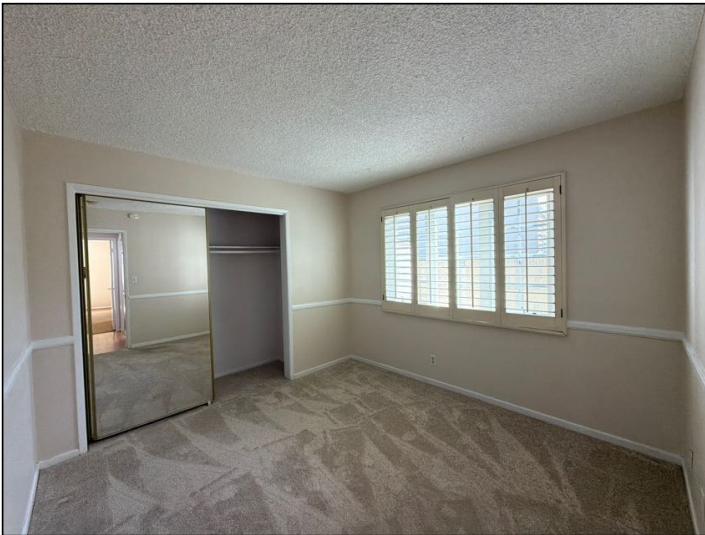
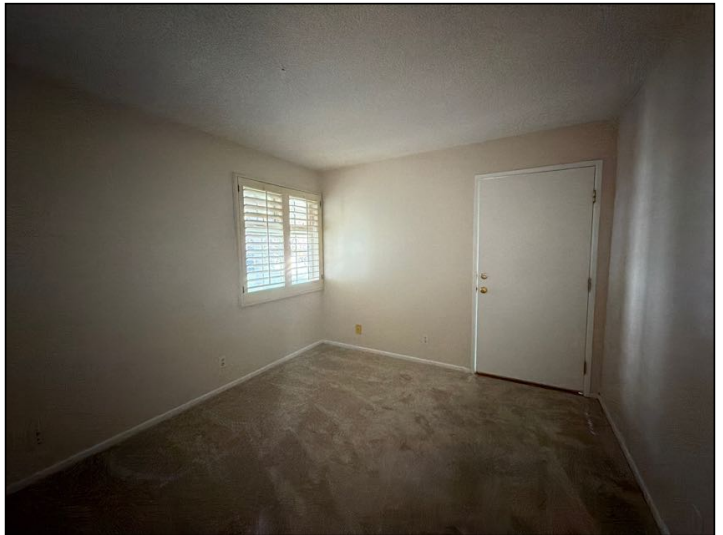
2.1. Some areas were not accessible for inspection due to the presence of stored personal items. Refer to the photos in the interior section for visual reference of all affected locations as the inspector is able.

2.2. Areas appeared to have been recently painted. This may conceal underlying conditions that were not visible at the time of inspection.

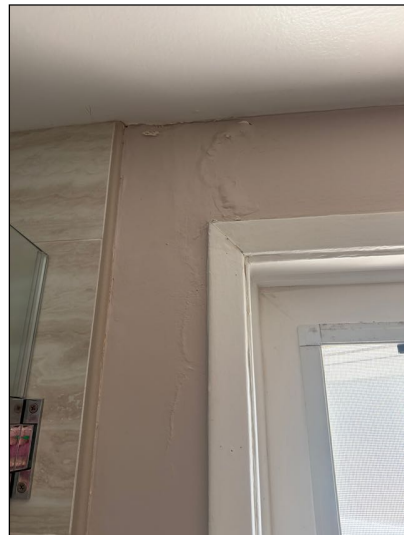
| Page 20 Item: 2 | Wall Condition | 2.2. Blistering paint observed. Unknown cause. Recommend further evaluation by a licensed professional. |

2.1. Cosmetic irregularities/imperfections noted.

2.2. Blistering paint observed. Unknown cause. Recommend further evaluation by a licensed professional.

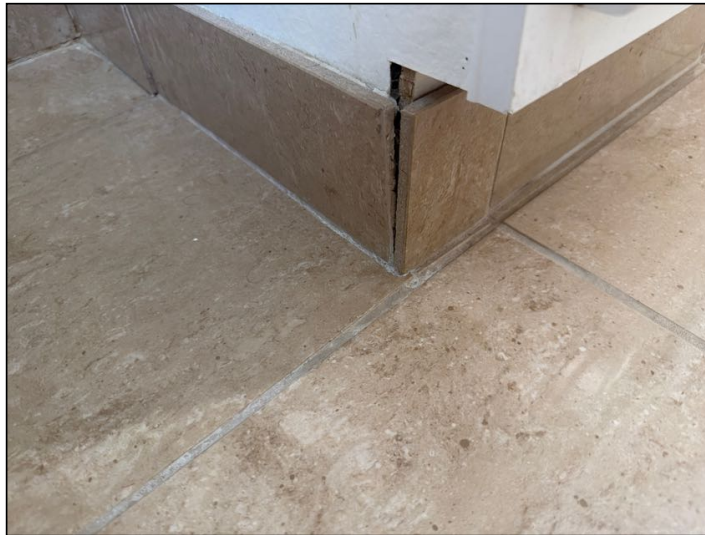
4.2. Loose tile was observed along portions of the tile baseboard trim. The condition appeared consistent with previous moisture exposure in the area; however, the exact cause could not be confirmed. Recommend securing or replacing the affected tile and evaluating the area for any underlying moisture-related damage during repairs.

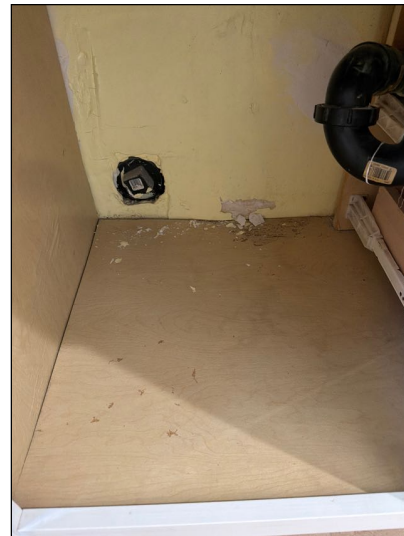
| Page 25 Item: 10 | Cabinets | <p>10.2. <b>Cabinet Water Damage:</b> Evidence of water damage was observed to the cabinet. The exact source and whether this condition is active or the result of a past event could not be determined during this visual inspection. Recommend further evaluation by a qualified, state-licensed professional to determine the source, verify whether the condition is ongoing, and perform any necessary repairs. Downstairs hallway</p> <p>10.3. <b>Moisture Damage:</b> Swelling or deterioration of the cabinet material was observed, consistent with previous moisture exposure. Recommend further evaluation and repair or replacement as appropriate. Downstairs hallway</p> |

10.2. **Cabinet Water Damage:** Evidence of water damage was observed to the cabinet. The exact source and whether this condition is active or the result of a past event could not be determined during this visual inspection. Recommend further evaluation by a qualified, state-licensed professional to determine the source, verify whether the condition is ongoing, and perform any necessary repairs. Downstairs hallway

10.3. **Moisture Damage:** Swelling or deterioration of the cabinet material was observed, consistent with previous moisture exposure. Recommend further evaluation and repair or replacement as appropriate. Downstairs hallway

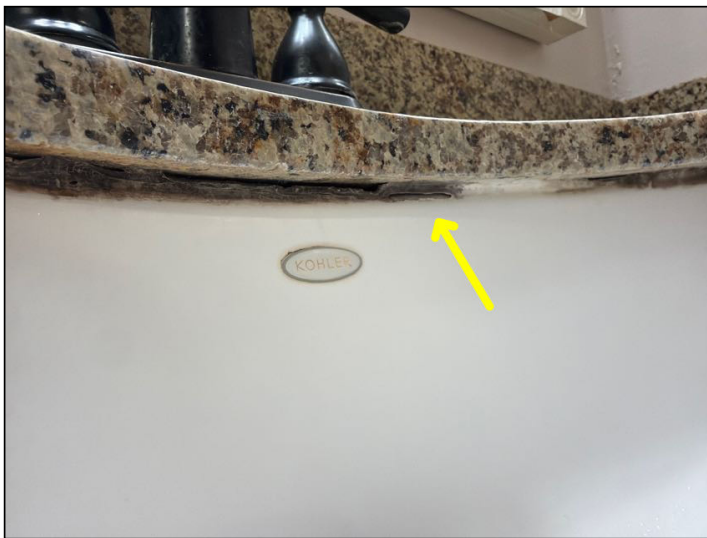
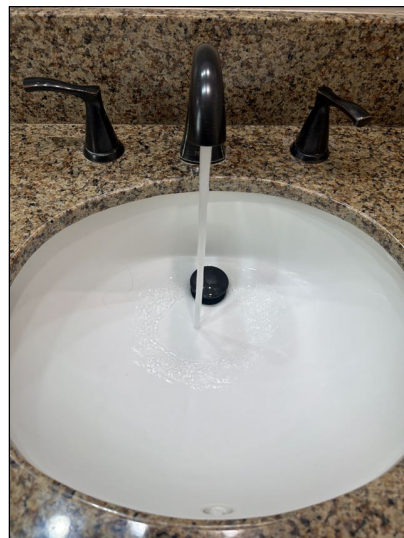
| Page 25 Item: 11 | Sinks | 11.2. Recommend re-caulking sink. Downstairs Hallway Bathroom |

11.2. Recommend re-caulking sink. Downstairs Hallway Bathroom

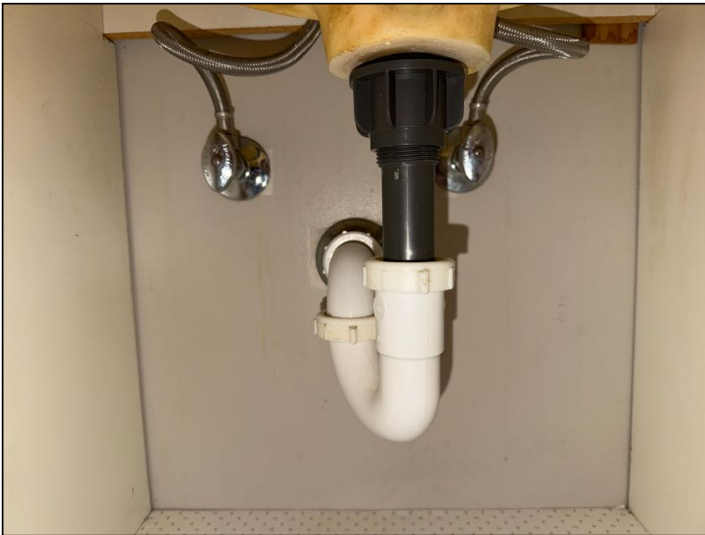
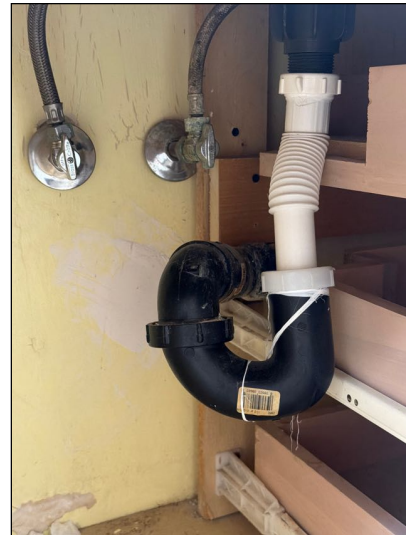
12.2. Flex drain observed, these are subject to frequent clogging.

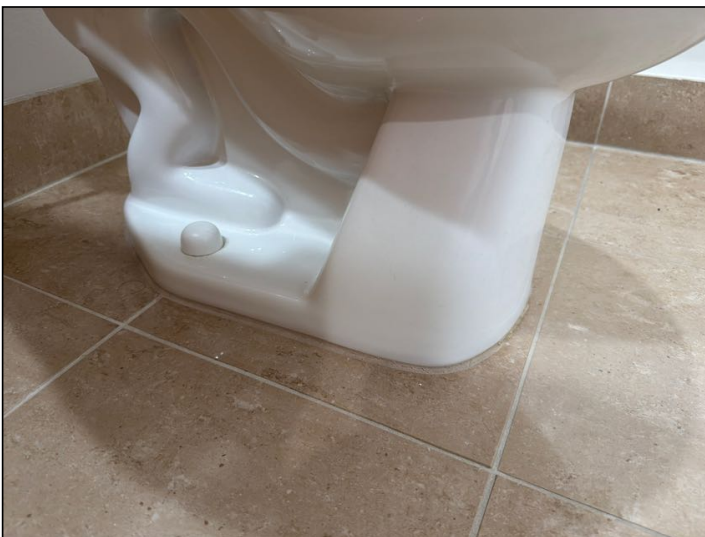
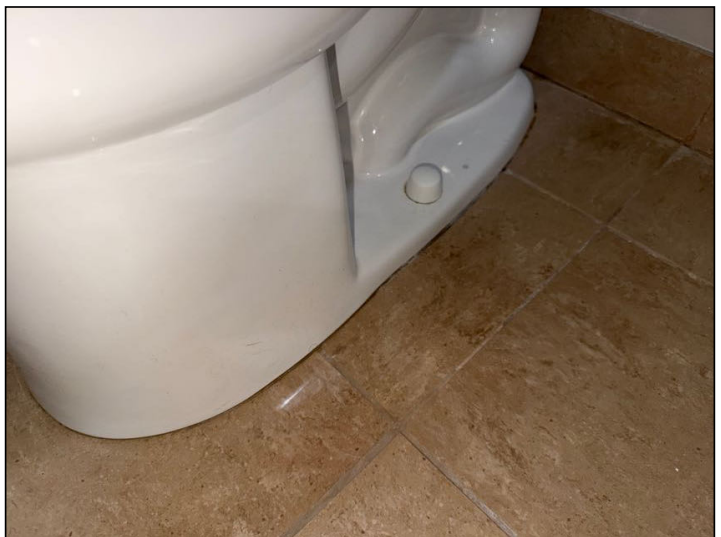
| Page 29 Item: 15 | Toilets | <p>15.3. <b>The toilet appears to be fully sealed at the base with caulking.</b> While a small bead at the front and sides is common, a full perimeter seal can restrict visibility if moisture or leaks develop beneath the fixture. Recommend having a state-licensed plumber evaluate the installation and adjust or partially remove the seal as needed to allow proper monitoring and to ensure the toilet is correctly secured.</p> <p>15.4. Evidence of past or present leak observed. Recommend further evaluation by a licensed professional. See photo for location. Downstairs Hallway Bathroom</p> |

15.3. **The toilet appears to be fully sealed at the base with caulking.** While a small bead at the front and sides is common, a full perimeter seal can restrict visibility if moisture or leaks develop beneath the fixture. Recommend having a state-licensed plumber evaluate the installation and adjust or partially remove the seal as needed to allow proper monitoring and to ensure the toilet is correctly secured.

15.4. Evidence of past or present leak observed. Recommend further evaluation by a licensed professional. See photo for location. Downstairs Hallway Bathroom

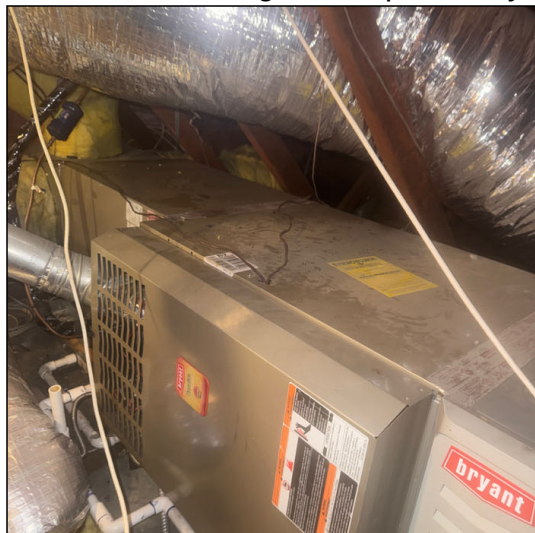
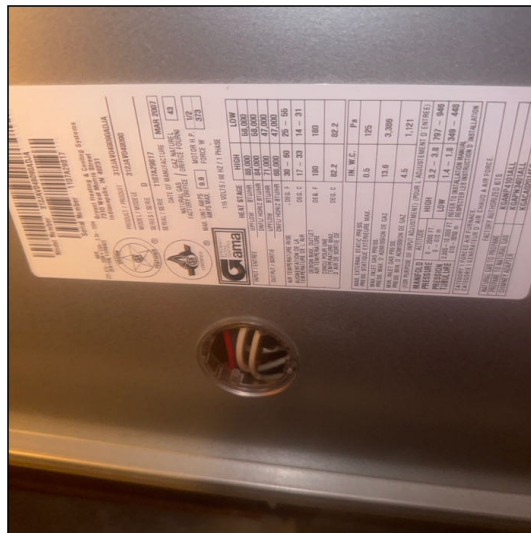
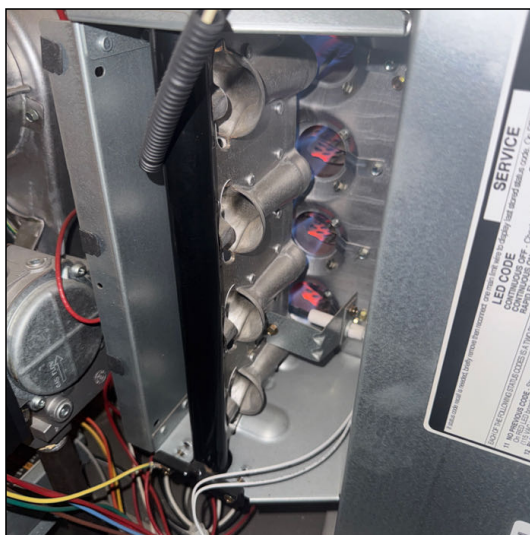
1.2. Last service date is over one year ago, or is unable to be determined, and there are areas which cannot be seen without specialized equipment and training. One such area is the combustion chamber / heat exchanger where cold air blows across the "fire box", becoming the hot air that circulates throughout your home. During the life span of any furnace, this metal wall may develop a crack or a broken weld, allowing carbon monoxide to circulate throughout the home. This is why furnace specialists recommend a complete inspection annually; consider having unit inspected by certified HVAC technician.

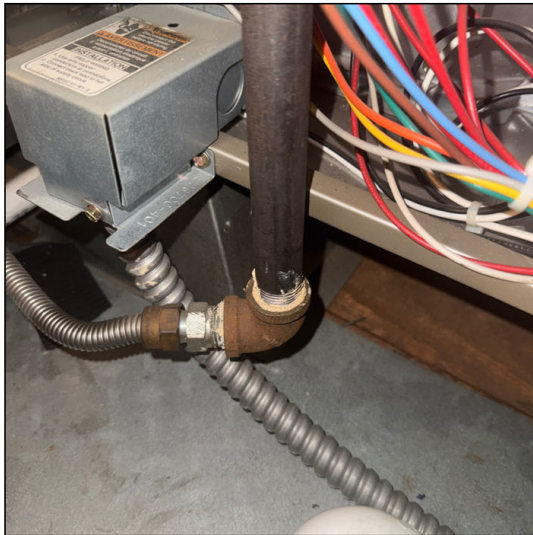
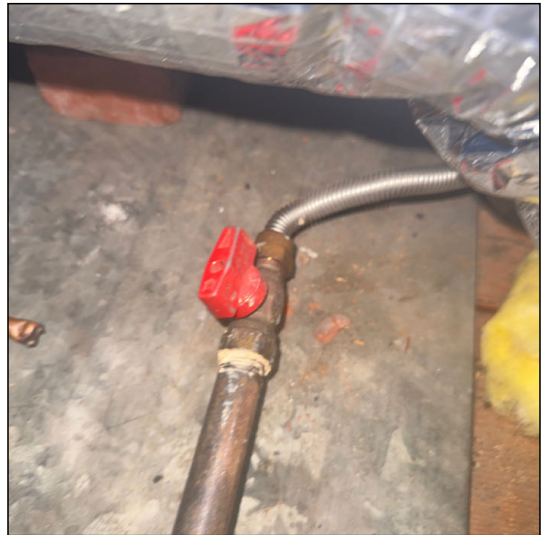
4.2. No sediment trap/drip leg was installed at the furnace. Sediment traps/drip legs are installed to keep particulates and moisture out of the furnace. Particulates or moisture in the furnace can interfere with burner operation. The Inspector recommends installation of a sediment trap/drip leg by a state licensed professional.

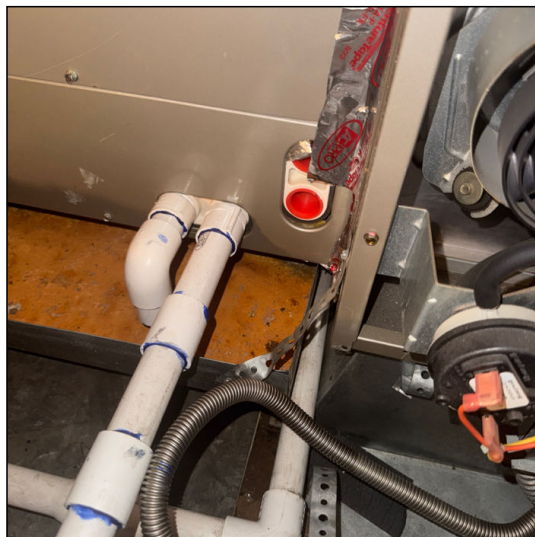
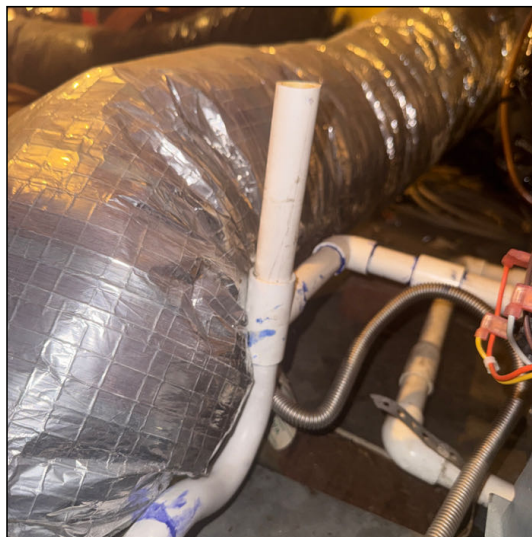
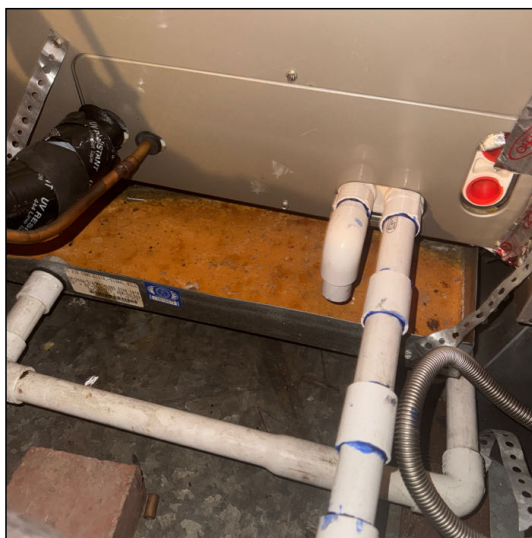
6.1. Rust/corrosion was observed inside the heater unit's catch pan. This may indicate past or ongoing moisture or condensate leakage. Recommend evaluation by a state licensed HVAC professional to determine the source and extent of the corrosion and repair as needed.

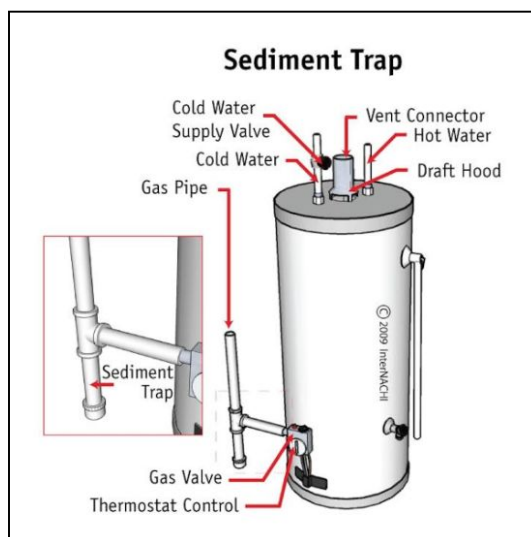
| Page 48 Item: 8 | Natural Gas Supply Valve | <b>8.1.</b> No sediment trap was observed at the time of inspection. Recommend checking local codes for requirement, and evaluation by a licensed plumber for installation as needed. |

8.1. No sediment trap was observed at the time of inspection. Recommend checking local codes for requirement, and evaluation by a licensed plumber for installation as needed.

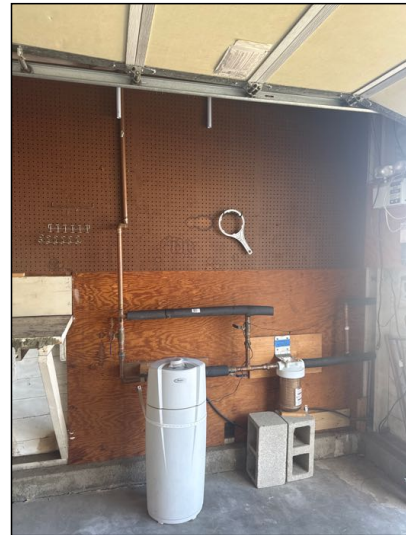
2.2. **Firewall:** Garage Firewall/Fire Separation: Plywood sheathing was installed on the garage wall where a required fire-resistive separation may be present. Type X gypsum board was visible at the lower portion of the wall; however, the extent and continuity of the fire-resistive assembly could not be determined due to the plywood covering. Because plywood is a combustible material and may not provide the required fire-resistance rating, the adequacy of the garage-to-dwelling fire separation could not be confirmed at the time of inspection. Recommend further evaluation by a state licensed professional to verify the existing assembly and make corrections as needed to meet applicable fire-separation requirements.

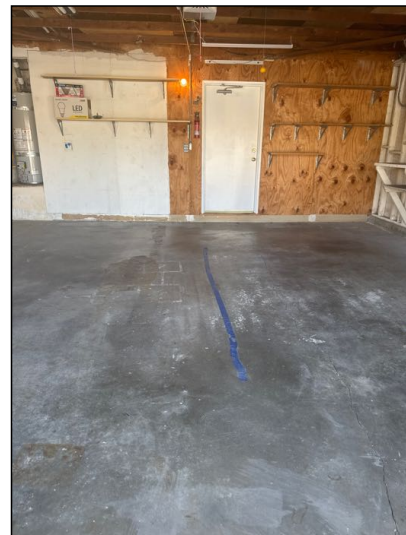
3.1. Cosmetic irregularities/imperfections noted. (Moderate)

3.2. **Garage Floor:** Common cracks were observed in the garage floor. These appear consistent with normal shrinkage or settling and do not indicate a structural concern at this time. Monitoring for expansion or movement is recommended.

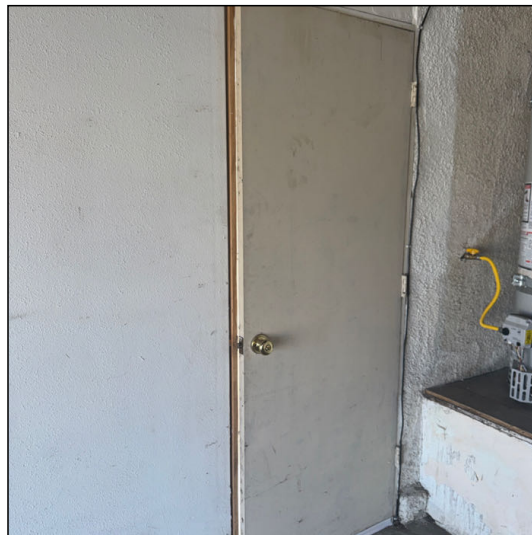
| Page 56 Item: 8 | Other Doors | <b>8.1. Improper Door Alignment:</b> The garage exterior door is misaligned or does not latch properly. Adjustment or repair is recommended to ensure smooth operation and proper sealing. |

**8.1. Improper Door Alignment:** The garage exterior door is misaligned or does not latch properly. Adjustment or repair is recommended to ensure smooth operation and proper sealing.

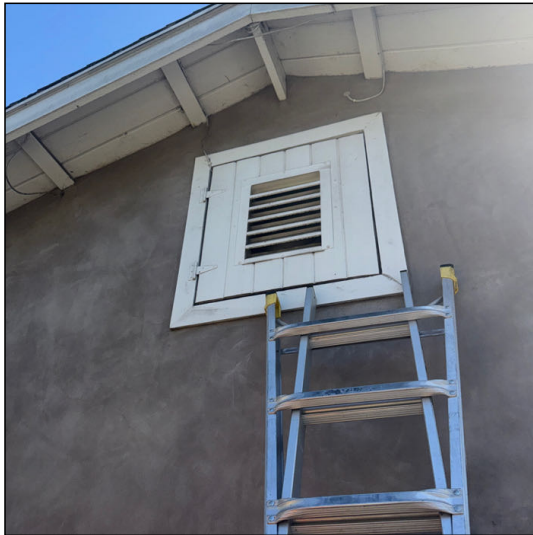
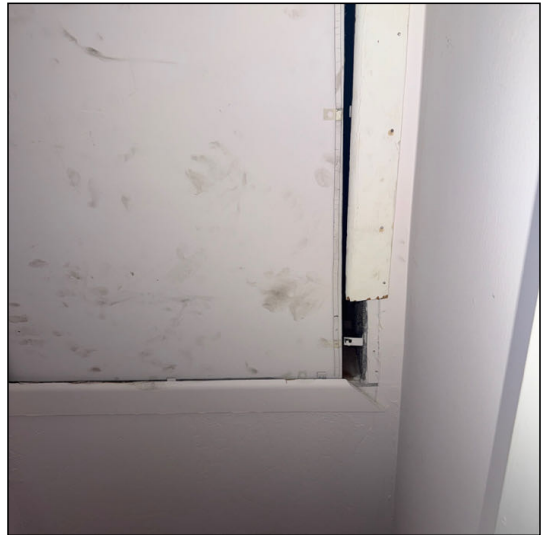
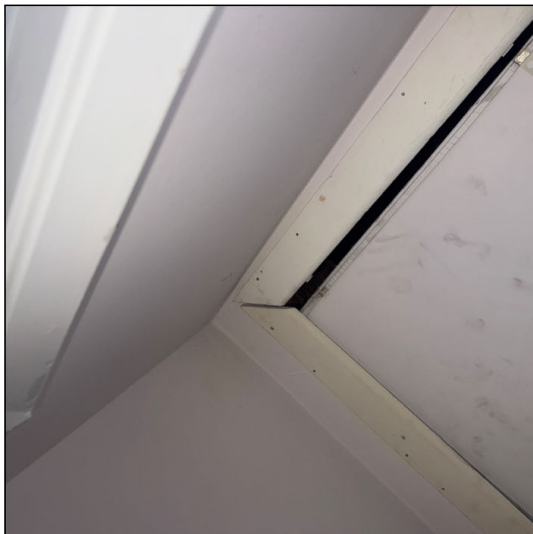
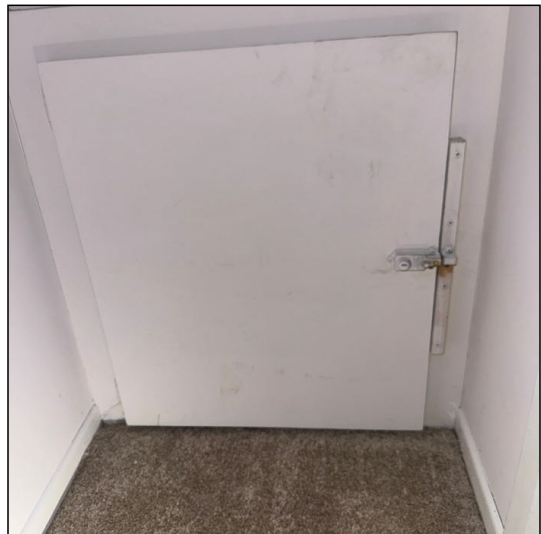
| Page 63 Item: 1 | Attic Access | <p>1.1. <b>Attic Access Hatch:</b> Damage was observed to the attic access hatch and/or surrounding components. Recommend repair or replacement as needed by a qualified, state-licensed professional. (Located at the bedroom closet ceiling hatch)</p> |

1.1. Attic Access Hatch: Damage was observed to the attic access hatch and/or surrounding components. Recommend repair or replacement as needed by a qualified, state-licensed professional.(Located at the bedroom closet ceiling hatch)

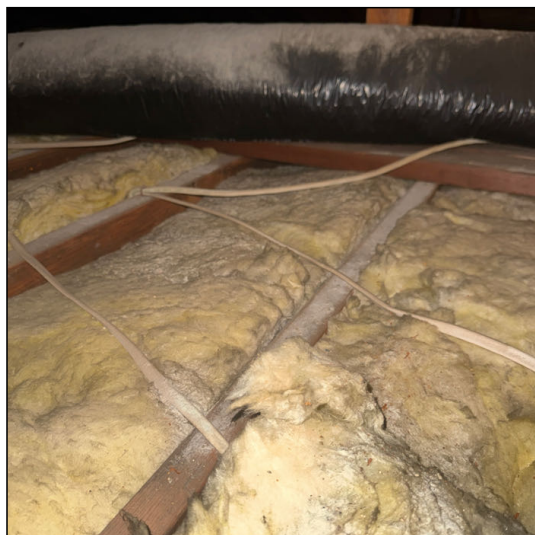
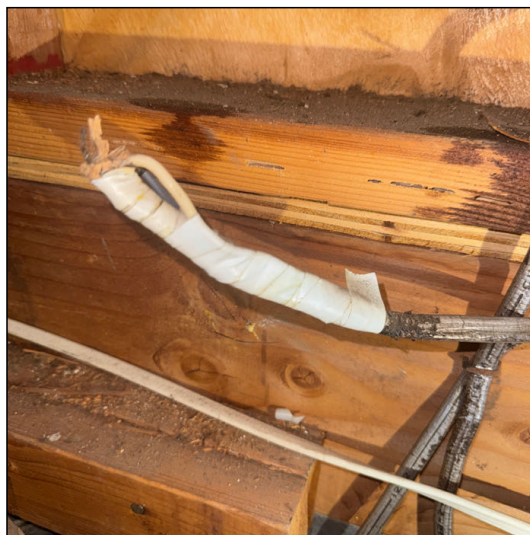
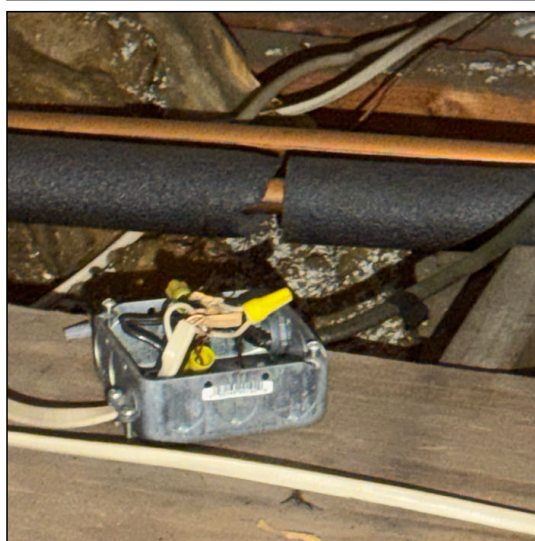
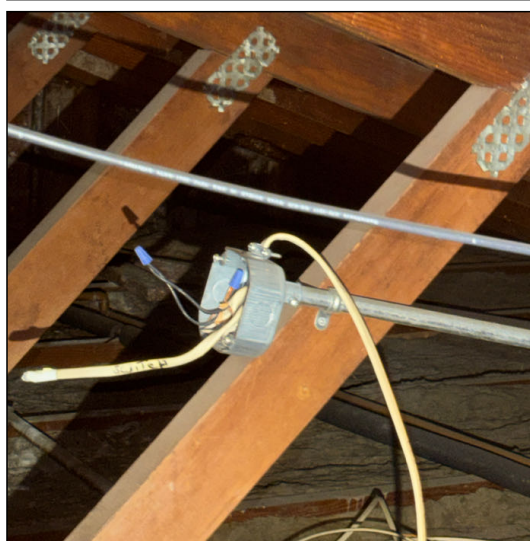
| Page 67 Item: 5 | Attic Electrical | <p>5.3. Energized electrical splices not contained within a junction box and exposed to touch were visible in the attic. Electrical splices should be contained within an approved junction box with a cover plate installed. This condition is a shock/electrocution and potential fire hazard and should be corrected by a state licensed professional.</p> <p>5.4. Open junction boxes were observed. Whenever an electric wire is cut and reconnected, the 'splice' should be encased in a covered junction box to prevent shocks and separation of the splice.</p> |

5.3. Energized electrical splices not contained within a junction box and exposed to touch were visible in the attic. Electrical splices should be contained within an approved junction box with a cover plate installed. This condition is a shock/electrocution and potential fire hazard and should be corrected by a state licensed professional.

5.4. Open junction boxes were observed. Whenever an electric wire is cut and reconnected, the 'splice' should be encased in a covered junction box to prevent shocks and separation of the splice.

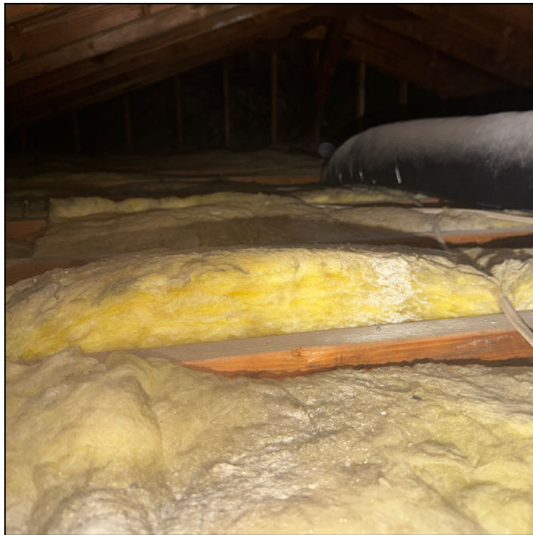
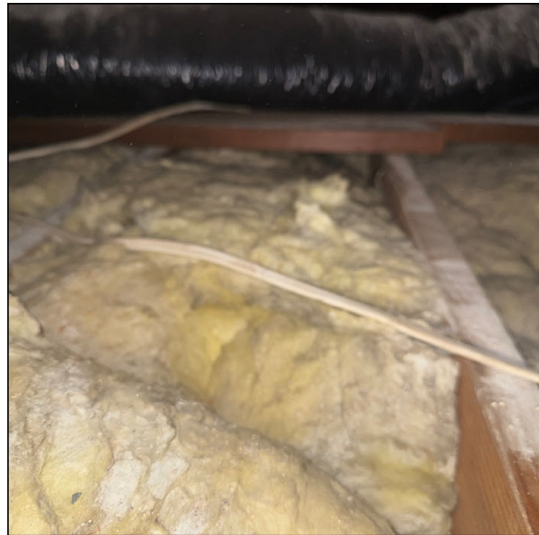
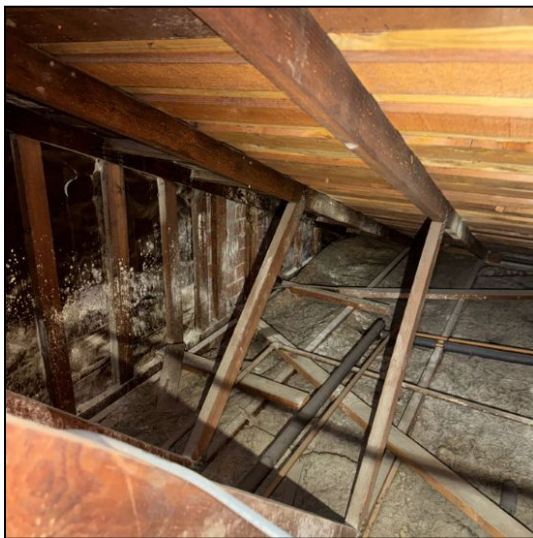
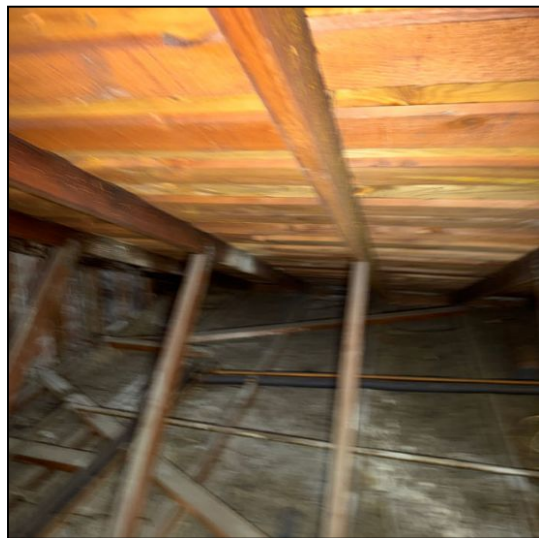
7.1. Insulation in the lower, original house section of the attic was matted and measured approximately 3 to 6 inches. Matted, thin insulation reduces thermal performance and can result in higher energy costs. Recommend further evaluation and upgrade by a state licensed professional.

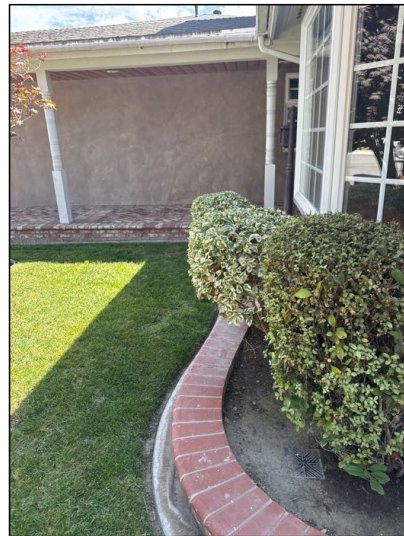
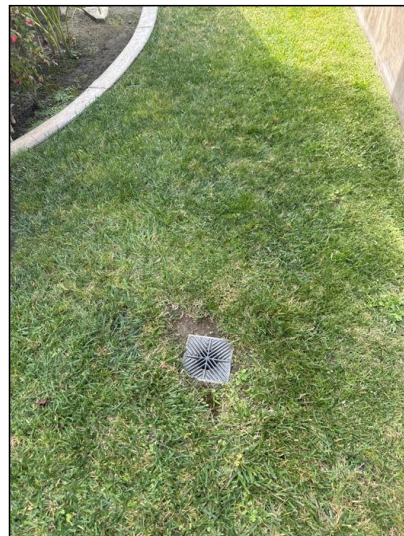
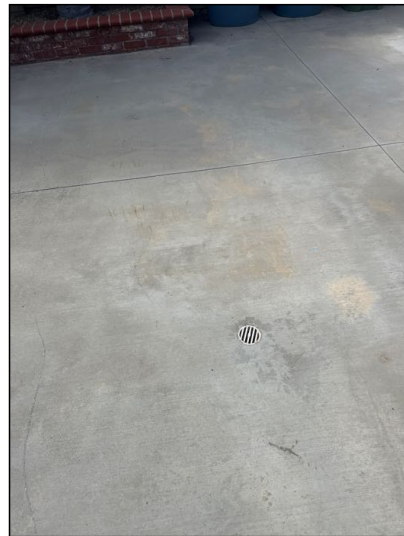
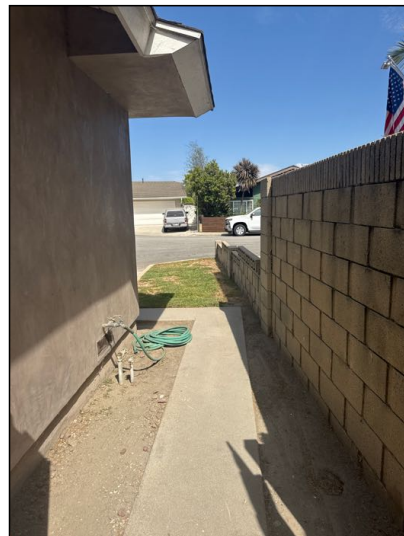
| Page 76 Item: 3 | Drainage System | 3.2. Significant debris observed. Recommend clearing. |

3.2. Significant debris observed. Recommend clearing.

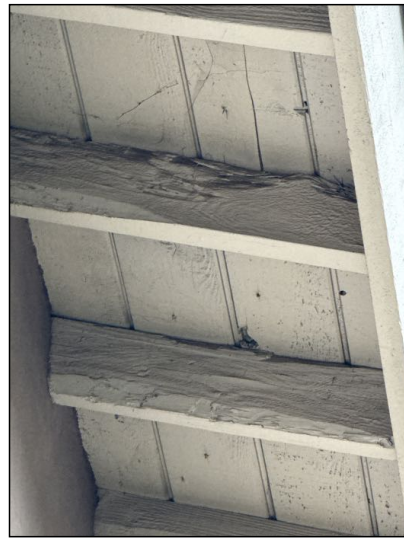
| Page 84 Item: 13 | Eaves, Soffits & Rafter Tails | <p>13.1. <b>Deteriorated or Rotted Wood:</b> Areas of rot or deterioration were observed at the eaves, soffits, or rafter tails. This condition is typically caused by prolonged moisture exposure and should be repaired or replaced as needed.</p> <p>13.2. <b>Peeling or Failing Paint:</b> Peeling or deteriorated paint was noted on the eaves or soffits. This exposes the underlying material to moisture and UV damage. Repainting is recommended to maintain protection.</p> |

**13.2. Peeling or Failing Paint:** Peeling or deteriorated paint was noted on the eaves or soffits. This exposes the underlying material to moisture and UV damage. Repainting is recommended to maintain protection.

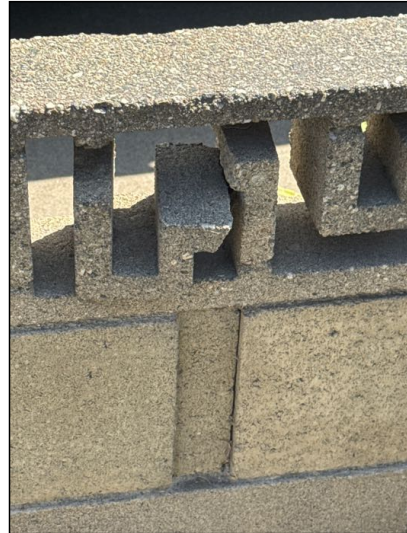
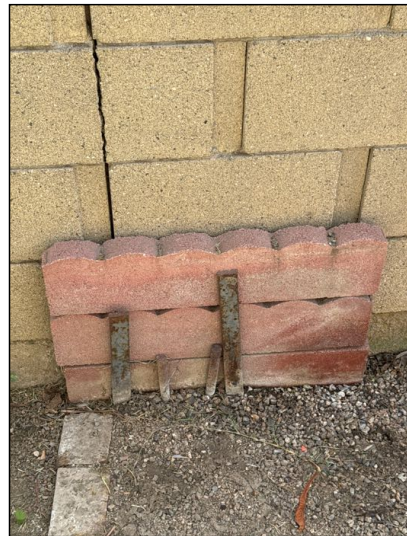
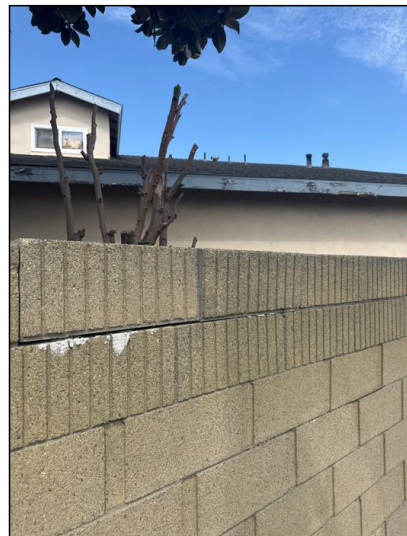
| Page 87 Item: 17 | Fence/Wall Condition | <p>17.2. Loose top blocks observed. This is a safety concern. Suggest maintenance/repairs as needed to ensure safety.(Located at the north block wall in backyard)</p> <p>17.3. The south-side block wall appeared to be leaning, with cracked mortar joints and visible separations between blocks. The wall has been reinforced in one area with stakes and brick material; however, the adequacy and effectiveness of this reinforcement could not be determined at the time of inspection. Recommend evaluation by a state licensed professional to assess the condition of the wall and recommend repairs or stabilization as needed.</p> |

17.3. The south-side block wall appeared to be leaning, with cracked mortar joints and visible separations between blocks. The wall has been reinforced in one area with stakes and brick material; however, the adequacy and effectiveness of this reinforcement could not be determined at the time of inspection. Recommend evaluation by a state licensed professional to assess the condition of the wall and recommend repairs or stabilization as needed.
