# WOOD DESTROYING PESTS AND ORGANISMS INSPECTION REPORT

| Building No.<br>122 | Street<br>Secluded Oaks Ct. | City<br>Chico | ZIP<br>95928 | Date of Inspection<br>08/04/2026 | Number of Pages<br>3 |
| | | <b>HOUSE DETECTIVE TERMITE CONTROL INC</b><br>302 Bellamy Terrace<br>CHICO CA 95973<br>(530) 591-7079<br>hdetective@att.net | | Report # : 16796<br>Registration # : PR5960<br>Escrow # :<br><input type="checkbox"/> CORRECTED REPORT | |
| GENERAL DESCRIPTION:<br>Two story wood frame single family dwelling. | | | | Inspection Tag Posted:<br>At the water heater<br>Other Tags Posted: | |

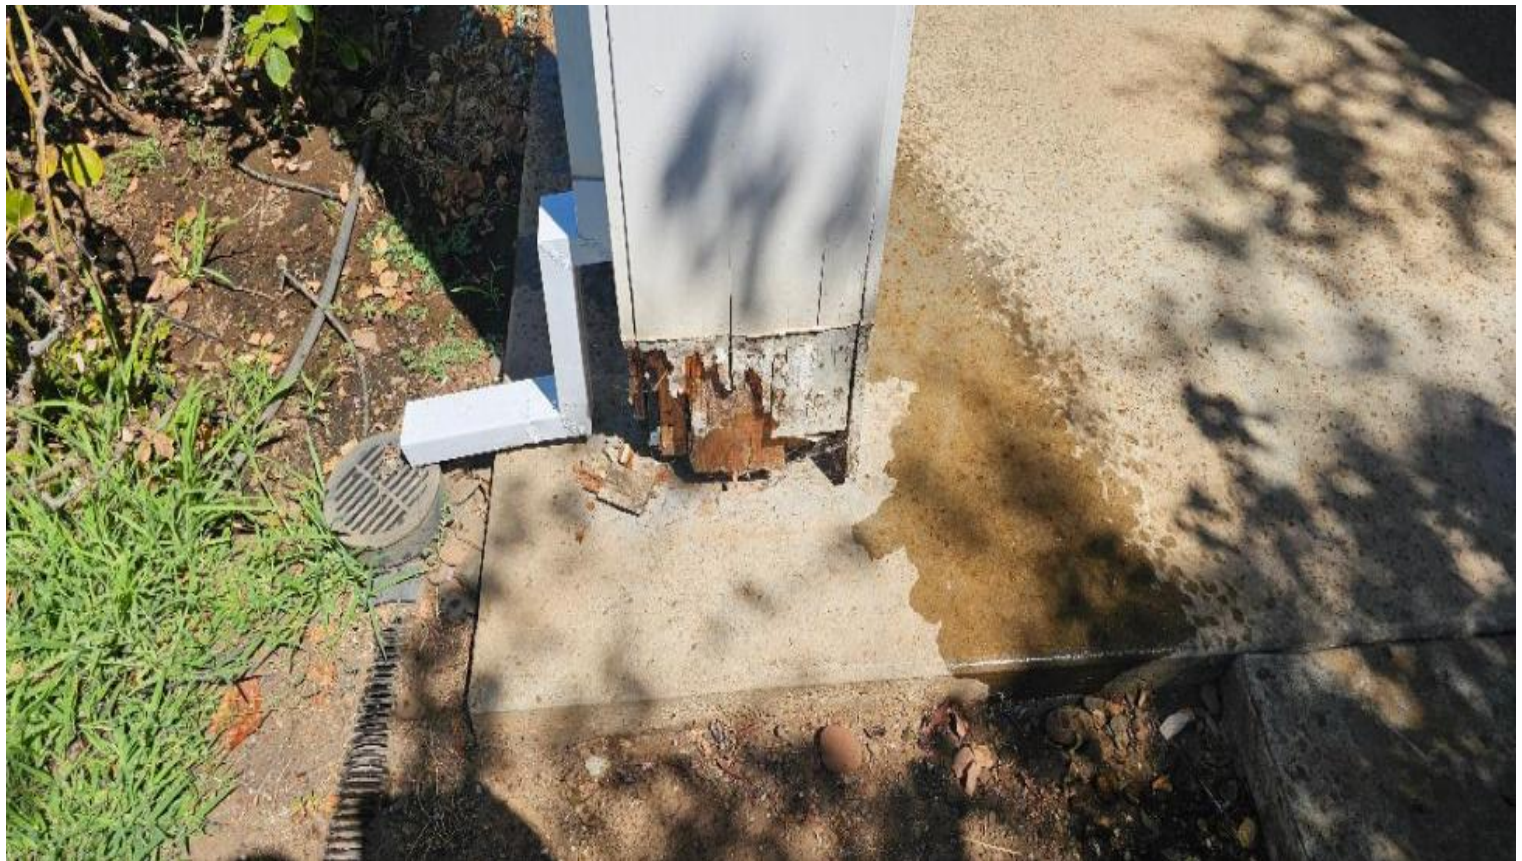
### 3A - Section I

**FINDING:** Fungus damage was found to the wood trim around the support post for the roof overhang with possible hidden damage to the post.

3A - Damaged wood trim with possible hidden damage to the support post.

**RECOMMENDATION:** We recommend the owner/agent engage the services of a licensed contractor to remove all damaged members and to replace with new appropriate material.
