# ***Cornerstone Inspection***

## **Property Inspection Report**

***1476 Vista Tesoro Place, Nipomo, CA 93444***

***Date of Inspection: 8/10/2026 Time: 9:00 AM***

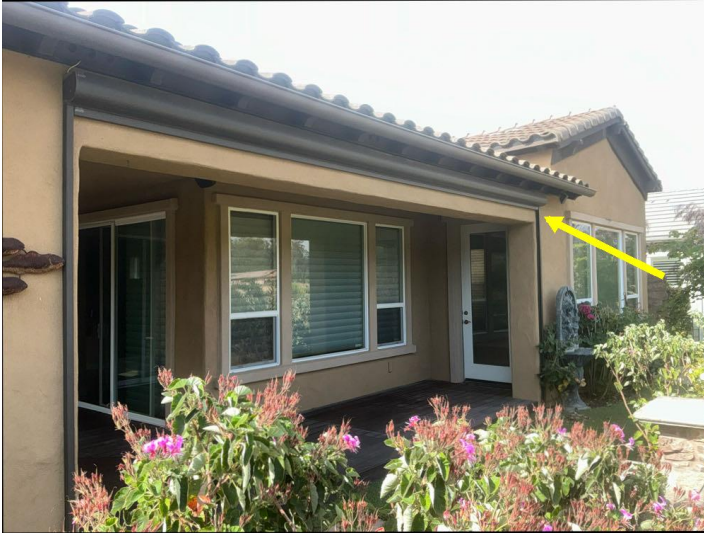
There are wind screens on the property that we do not evaluate, they should be demonstrated as functional by the sellers along with any maintenance requirements.

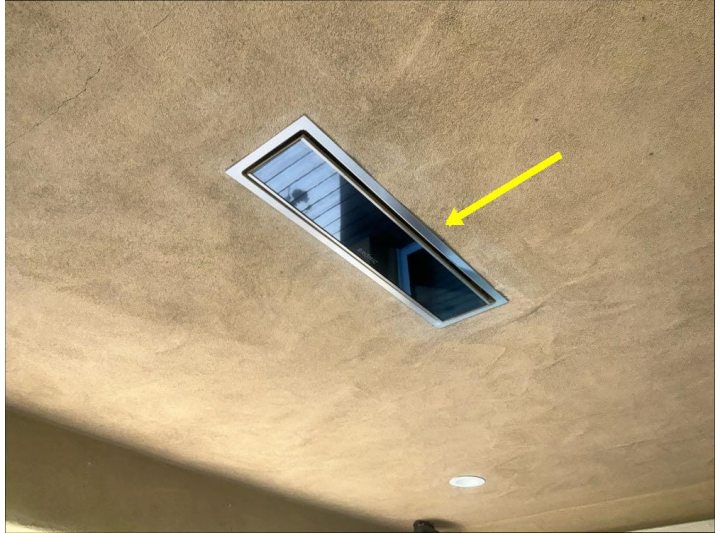
There is a patio heater that we do not have the expertise to evaluate. We recommend the seller demonstrate it as functional along with any maintenance requirements.

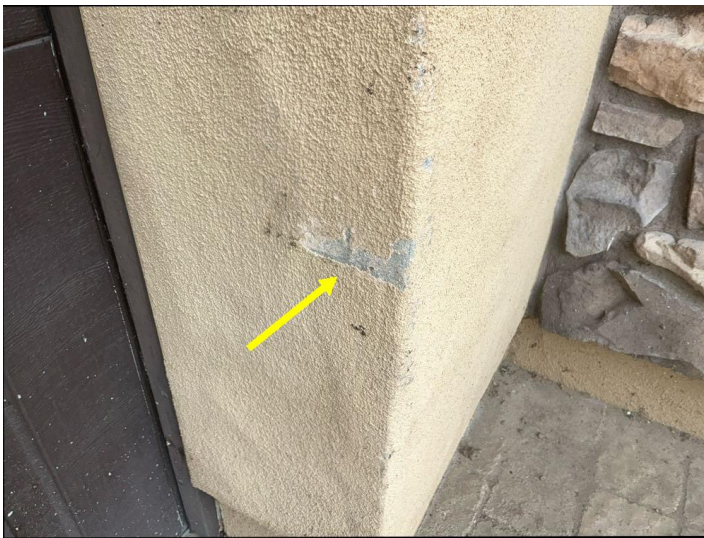
There are separations, gaps, cracks or openings on the siding that need to be serviced/sealed. This includes hose bibs, electrical or cable wires that enter the home, or cracks around the windows or doors.

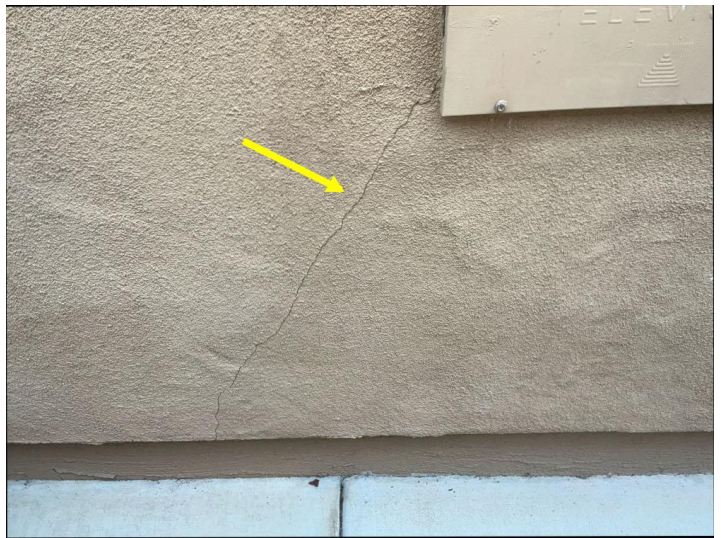
There are "expected" cracks in the stucco around some windows and doors that result from movement, and are quite common. Stress fractures can reappear after they have been repaired, and particularly if they have not been repaired correctly.

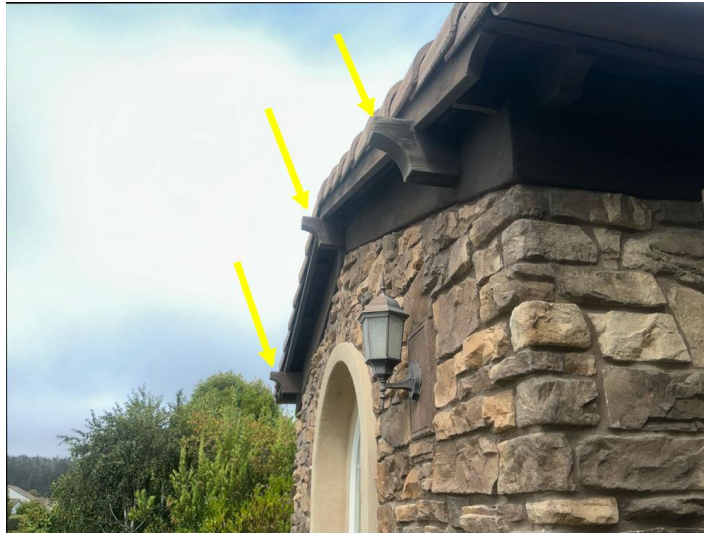
As a recommended upgrade, we recommend that the exposed wood that extends beyond the eave area, such as beams, columns or other wood members should be sealed and flashed to prevent moisture damage.

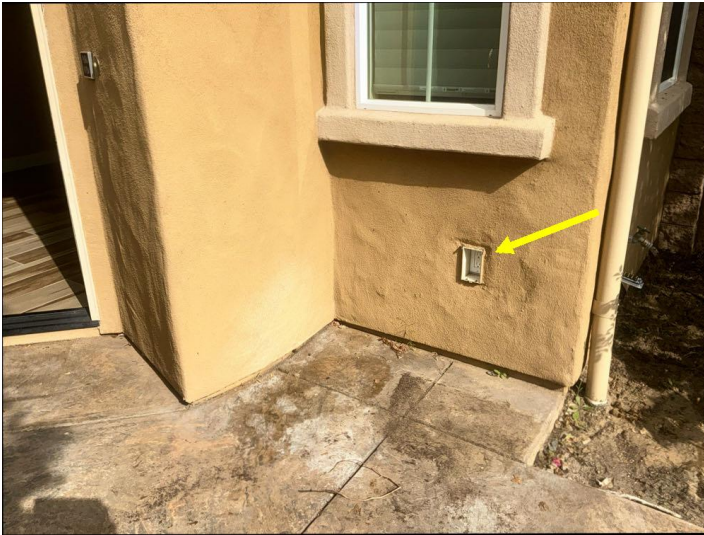
Some of the exterior electrical outlets do not have a weather rated cover or the cover is damaged and should be serviced.

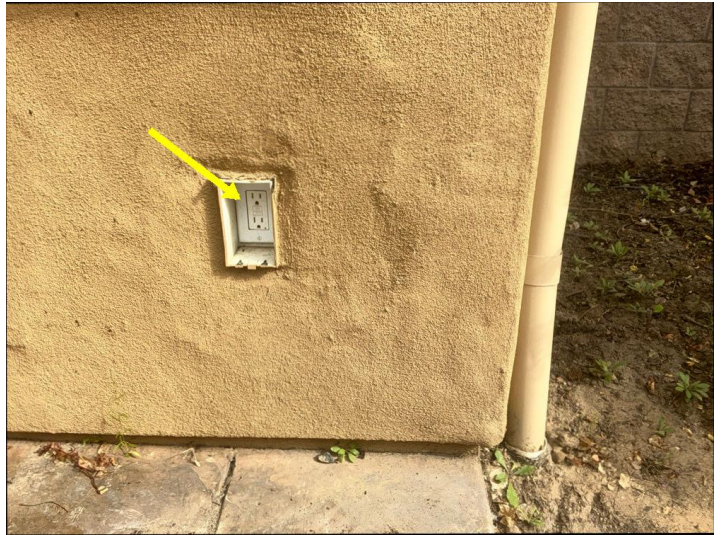
A ground-fault protected outlet on the front does not reset and should be serviced.

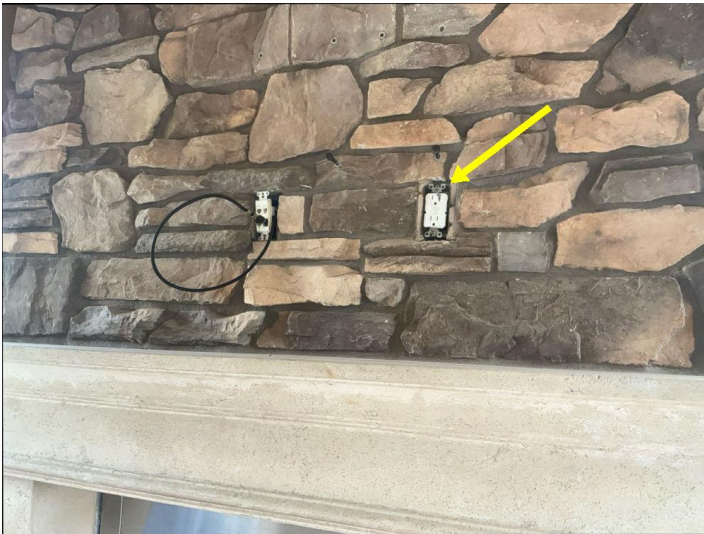
Some of the exterior electrical outlets do not have a weather rated cover or the cover is damaged and should be serviced.

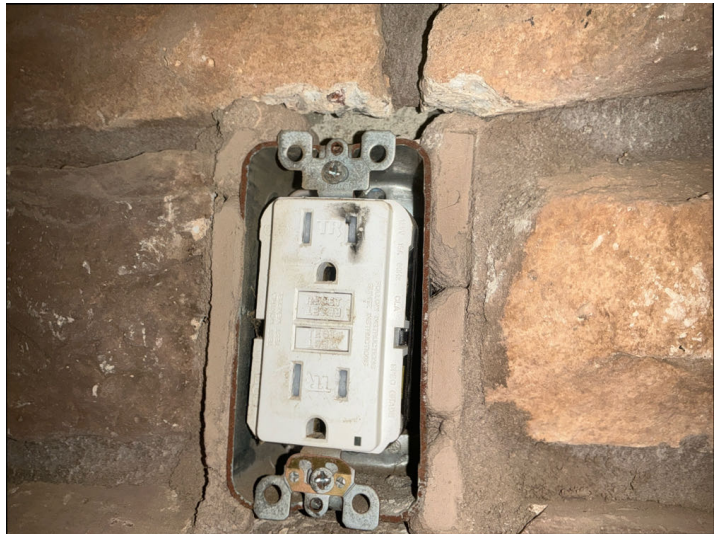
| Page 8 Item: 6 | Electrical Components | 6.7. An outlet at the rear is damaged or has a scorch mark on it and should be evaluated and serviced by a licensed electrical contractor. |

6.7. An outlet at the rear is damaged or has a scorch mark on it and should be evaluated and serviced by a licensed electrical contractor.

An outlet at the rear is damaged or has a scorch mark on it and should be evaluated and serviced by a licensed electrical contractor.

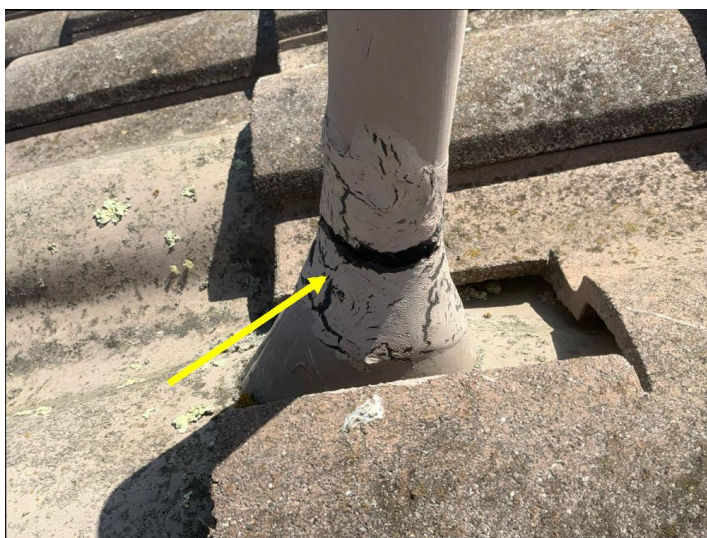
2.6. Some roof flashings need to be sealed or serviced. They are comprised of metal that seals **valley**s and vents and other roof penetrations, and are the most common point of leaks. This is particularly true of the flashing's on a layered roof, which are covered by the roofing material and which are even more susceptible to leaks.

Some roof flashings need to be sealed or serviced. They are comprised of metal that seals **valley**s and vents and other roof penetrations, and are the most common point of leaks. This is particularly true of the flashing's on a layered roof, which are covered by the roofing material and which are even more susceptible to leaks.

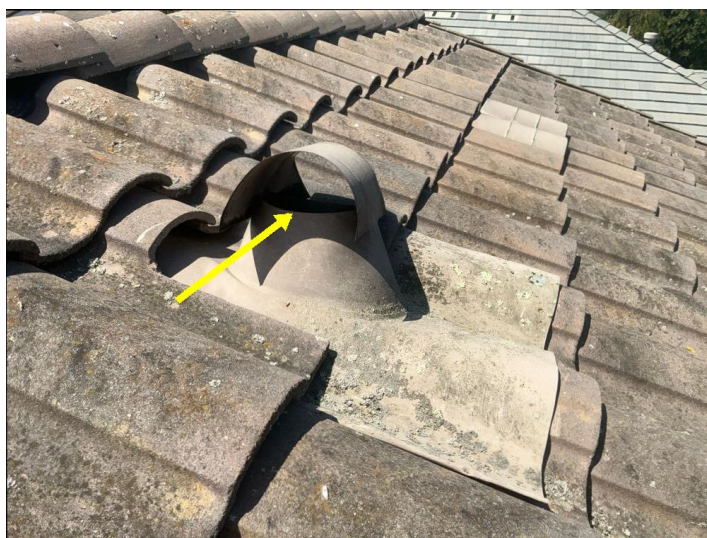
2.4. The roof tee top terminations do not include screens as required by current standards. While this wasn't required at the time of construction, we recommend screens be added to these terminations.

The roof tee top terminations do not include screens as required by current standards. While this wasn't required at the time of construction, we recommend screens be added to these terminations.

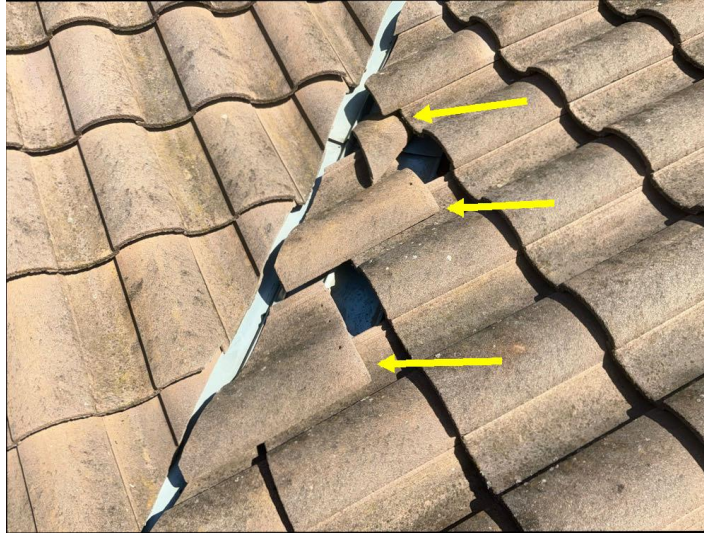
| Page 12 Item: 2 | Concrete Tile Observations | <p>2.5. There are a few loose tiles. Some of have exposed the waterproof membrane, which is subject to deterioration and will lead to leaks, if not serviced. We recommend further evaluation of the roof and serviced as required.</p> <p>2.6. Some roof flashings need to be sealed or serviced. They are comprised of metal that seals <b>valleys</b> and vents and other roof penetrations, and are the most common point of leaks. This is particularly true of the flashing's on a layered roof, which are covered by the roofing material and which are even more susceptible to leaks.</p> |

2.5. There are a few loose tiles. Some of have exposed the waterproof membrane, which is subject to deterioration and will lead to leaks, if not serviced. We recommend further evaluation of the roof and serviced as required.

There are a few loose tiles. Some of have exposed the waterproof membrane, which is subject to deterioration and will lead to leaks, if not serviced. We recommend further evaluation of the roof and serviced as required.

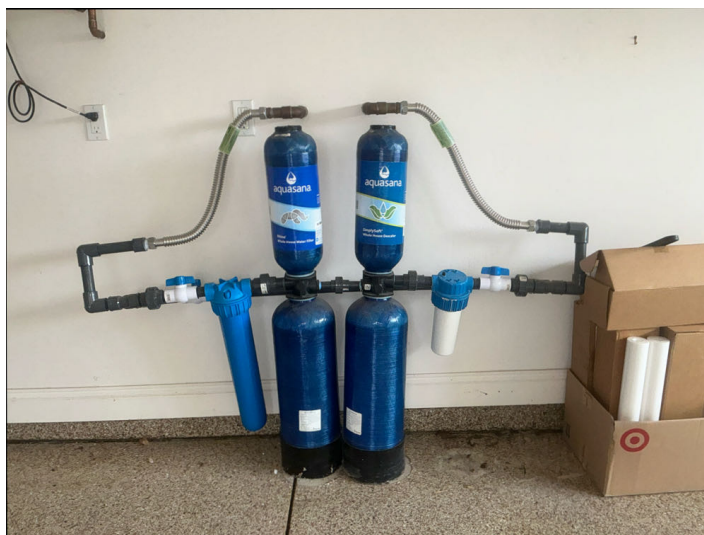
A water filtration system is present that we do not have the expertise to evaluate except for visible leaks. We recommend you ask the sellers if the unit was professionally installed and its service history.

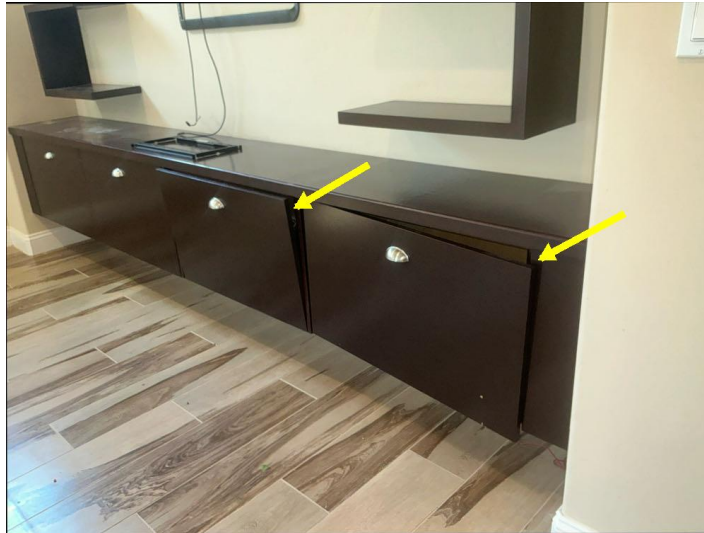
The cabinets will need service to work well, such as replacing or adjusting drawer glides, pull latches, hinges, catches, etc.

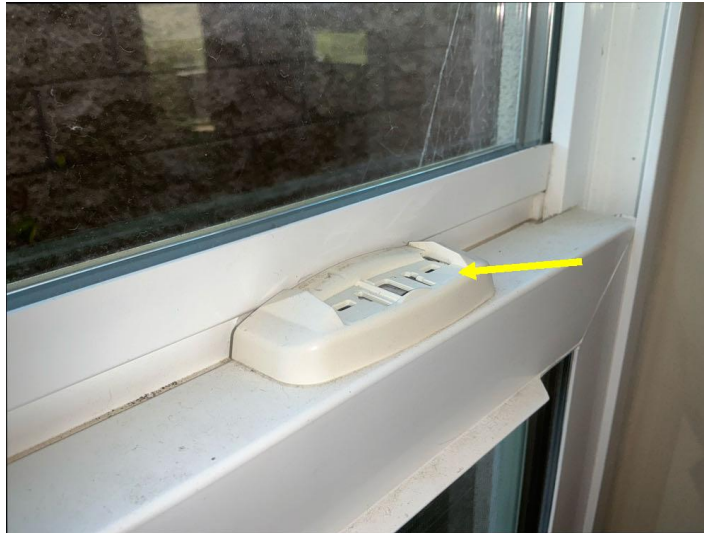
A window lock is missing or damaged and needs to be serviced to be functional.

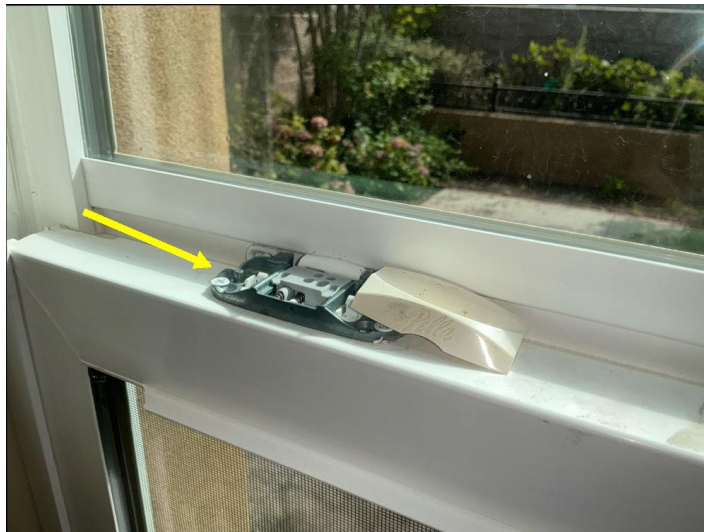
2.3. A window lock is missing or damaged and needs to be serviced to be functional.

A window lock is missing or damaged and needs to be serviced to be functional.

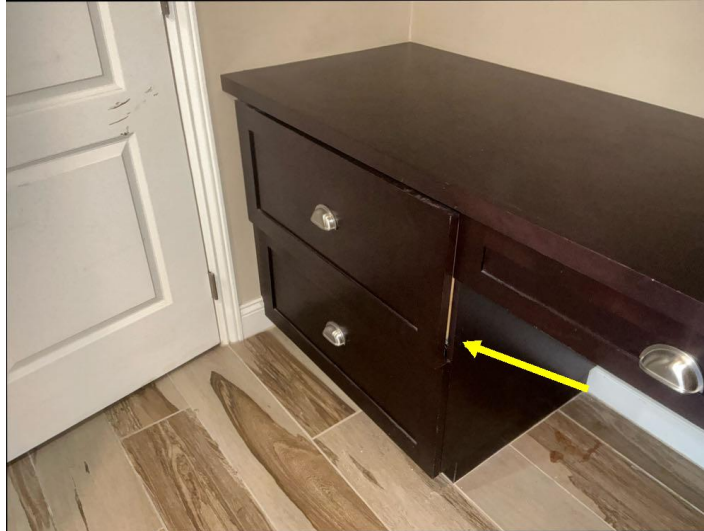
The office area cabinets will need service to work well, such as replacing or adjusting drawer glides, pull latches, hinges, catches, etc.

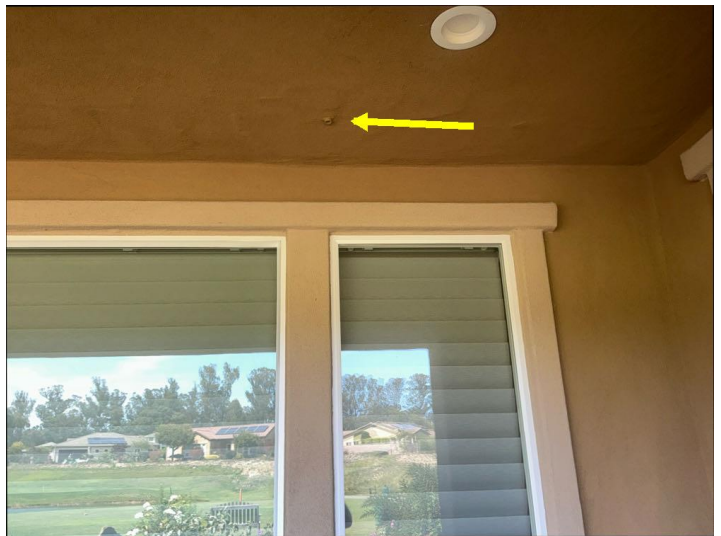
The condensate drainpipe discharges at the exterior with the secondary condensate installed to correctly drain over a window on the rear of the house. Water draining through the secondary condensate line would indicate a blockage and you should call for service by a qualified licensed HVAC contractor.

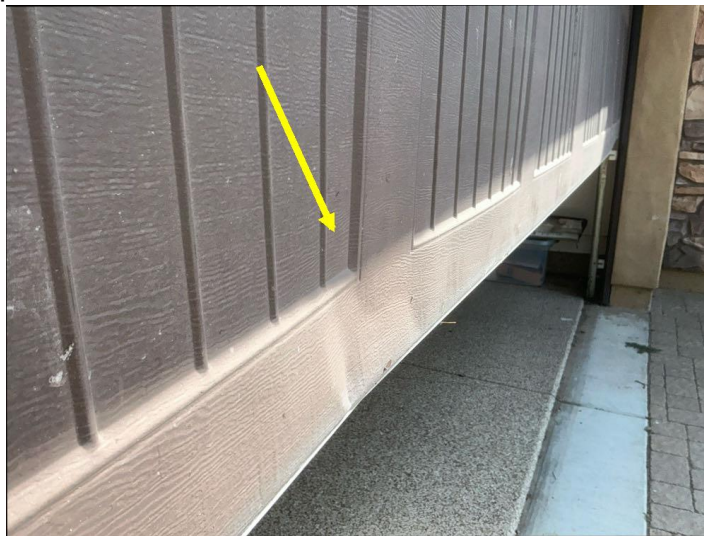
- 1.11. The garage door has damage that you should view for yourself.
- 1.12. The garage door openers are functional.

The garage door has damage that you should view for yourself.
