# WOOD DESTROYING PESTS AND ORGANISMS INSPECTION REPORT

| Building No.<br>125 | Street<br>Sterling Oaks | City<br>Chico | ZIP<br>95928 | Date of Inspection<br>07/21/2026 | Number of Pages<br>4 |
| GENERAL DESCRIPTION:<br>Single family residence; furnished, attached garage | | | | Inspection Tag Posted:<br>Garage | |

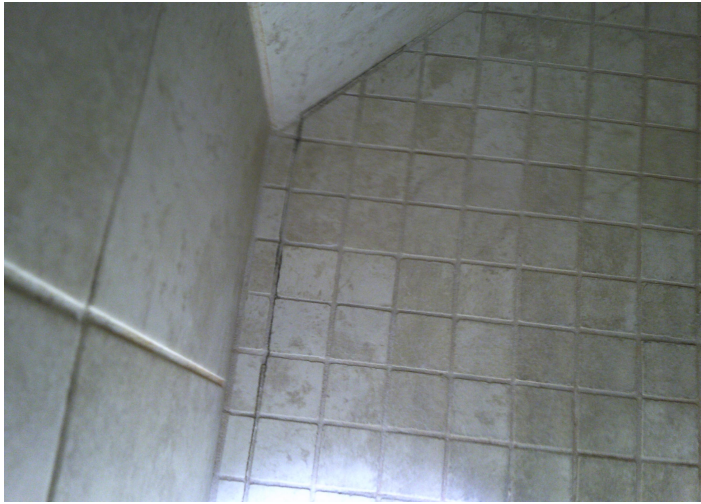
### 2A - Section II

FINDING: Cracked tile grout was noted at the bathroom stall shower enclosure.

RECOMMENDATION: Seal the stall shower tile grout as needed to help prevent moisture related problems in this area.

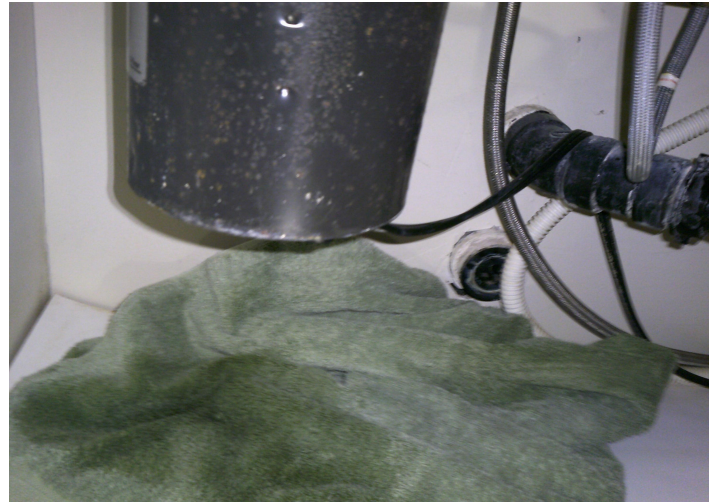
### 10A - Section II

FINDING: Active leak noted at the kitchen garbage disposal.

RECOMMENDATION: Interested parties should engage the services of a licensed plumber to make repairs as needed.

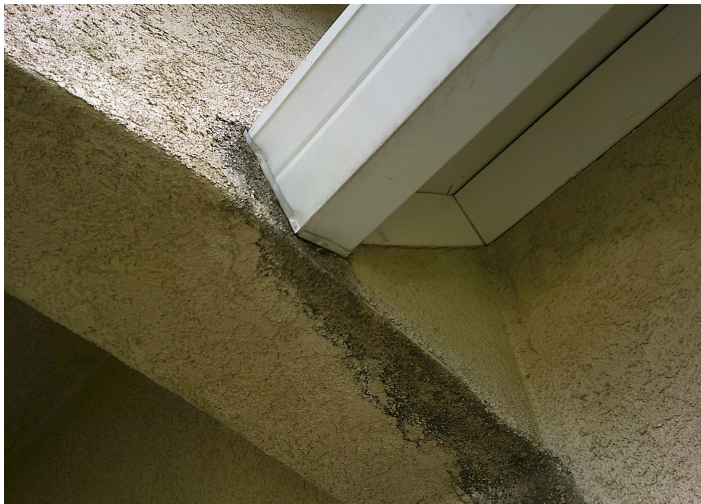
### 11A - Section II

FINDING: Stains were noted at the stucco wall beneath the gutter.

RECOMMENDATION: Interested parties should engage the services of a licensed contractor to check for leaks and to perform any corrective work needed.

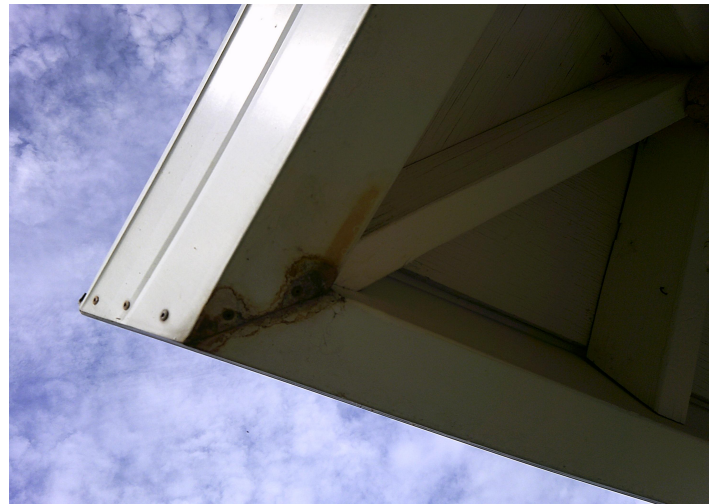
### 11B - Section II

FINDING: Leaking gutter and downspout seams were noted.

RECOMMENDATION: Seal the leaking gutter and downspout seams as needed to help prevent moisture-related problems in

this area.
