## SUMMARY

26401 Oak Crossing Rd, Santa Clarita,  
CA 91321

Ina Ray Simpson  
07/30/2026

Mike Ortiz  
CMI Certified Master Inspector, ICC  
Certified  
Home-Front Inspection Services LLC  
3103478945

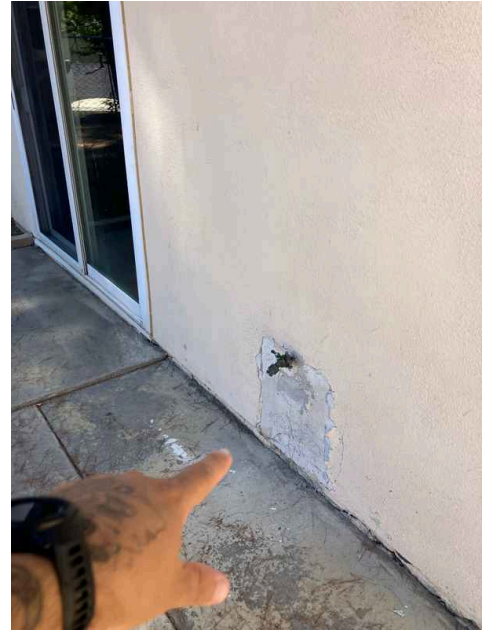
### 2.1.1 Stucco

#### CHIPPING: MODERATE

Moderate Concern

evidence of abnormal chipping in areas, recommended, stucco repair and patching as needed

Contact a qualified professional.

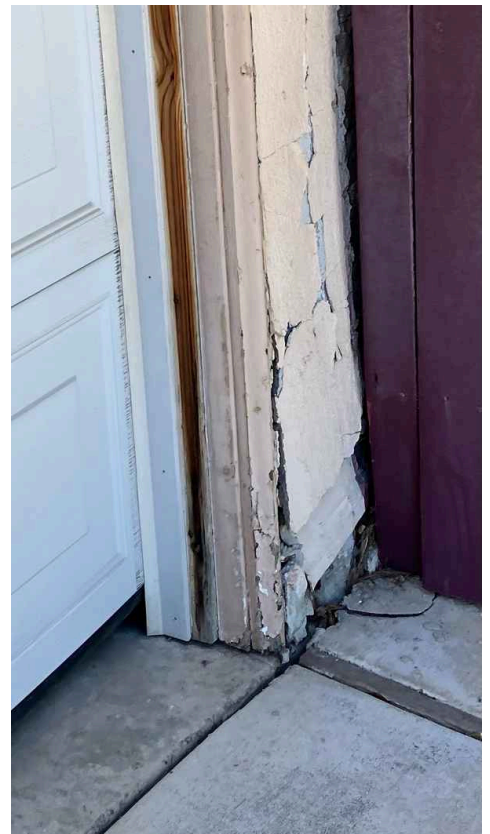
### 2.1.2 Stucco

#### HEAVY CHIPPING

Major Concern

Recommend repair by qualified professional

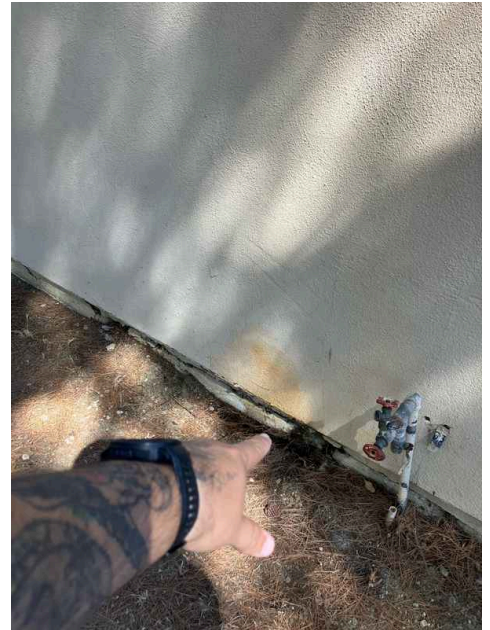
## 2.1.3 Stucco

**CONDENSATION/MOISTURE DAMAGE**

Hidden defects may exist, service recommended

**Major Concern**

Contact a qualified professional.

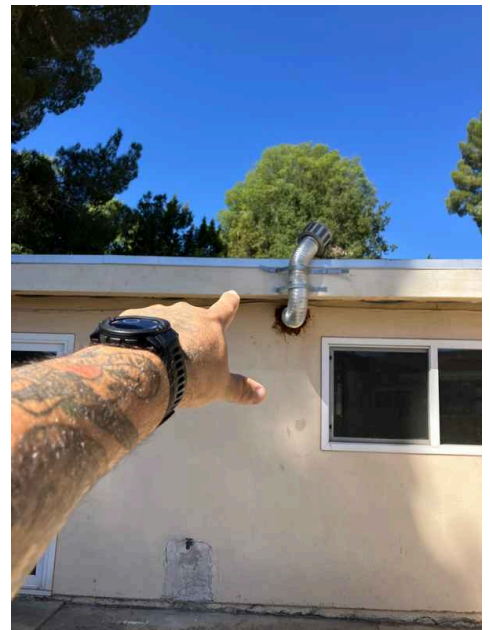
## 2.1.4 Stucco

**IMPROPERLY INSTALLED VENTILATION**

BEDROOM

Bedroom ventilation ductwork has been installed incorrectly during inspection. Improper ventilation installation can restrict airflow, reduce system efficiency, and potentially allow moisture to accumulate in wall cavities or attic spaces. A qualified HVAC professional should evaluate the installation to ensure proper venting to the exterior and correct any installation defects.

**Major Concern**

Contact a qualified professional.

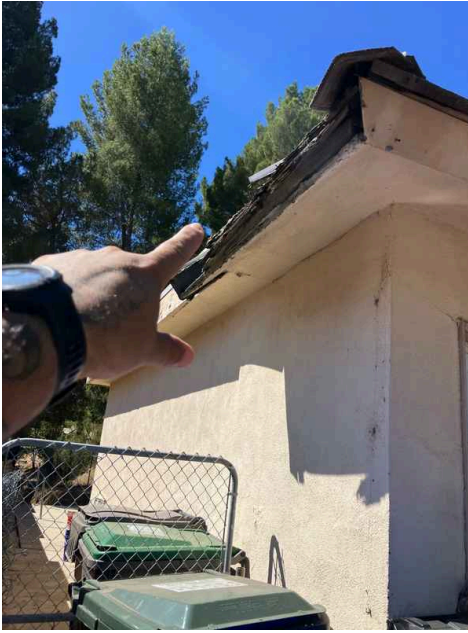
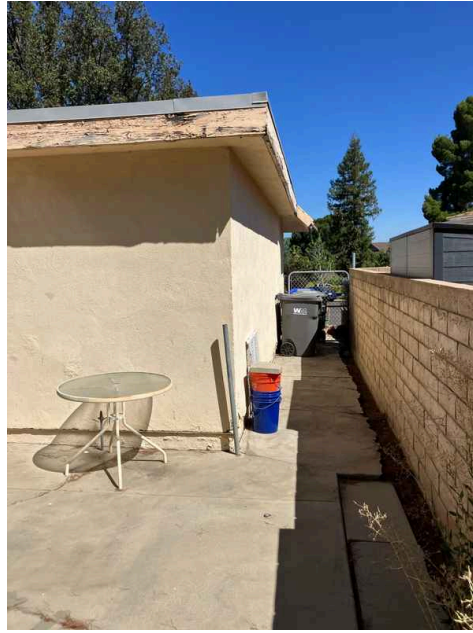
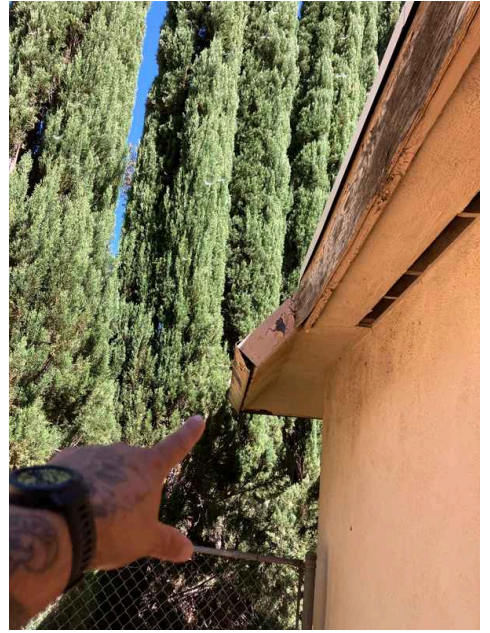
## 2.4.1 Eaves &amp; Fascia

**SIGNIFICANT DETERIORATION OBSERVED**

Significant deterioration was observed at portions of the eaves. The exact cause could not be determined during the visual inspection and may relate to age, moisture intrusion, inadequate maintenance, or other contributing factors.

**Major Concern**

A qualified contractor should evaluate the affected areas to determine the source of damage, perform necessary repairs, and verify that no concealed deterioration exists behind the exterior surfaces. Ongoing maintenance and proper sealing or painting are recommended to prevent further deterioration.

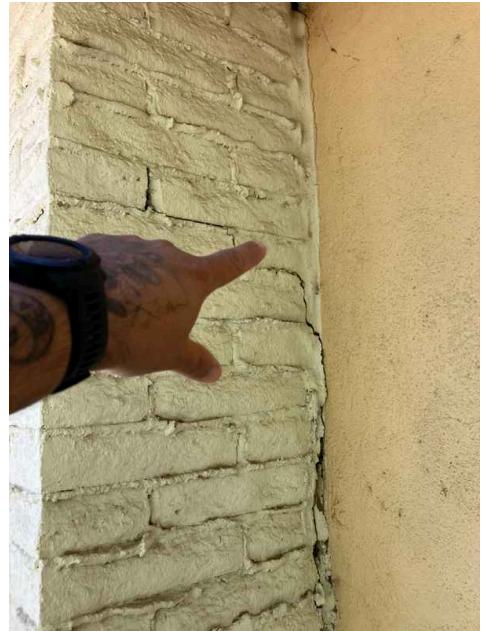
### 2.10.1 Lower Half of Chimney **LARGE CRACKING OR CHIPPING OBSERVED**

Further evaluation/ service recommended

Major Concern

Recommendation  
Contact a qualified professional.

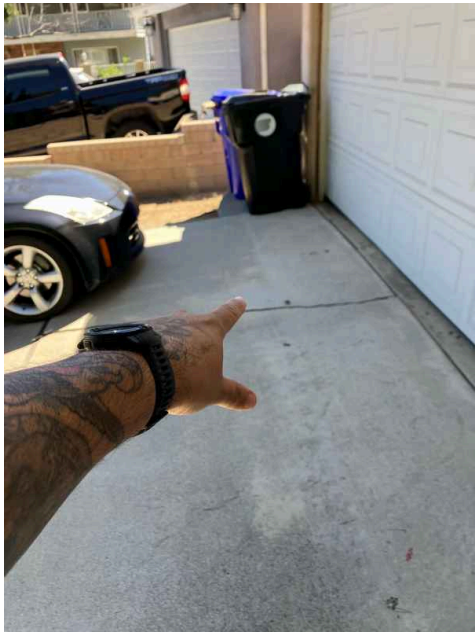
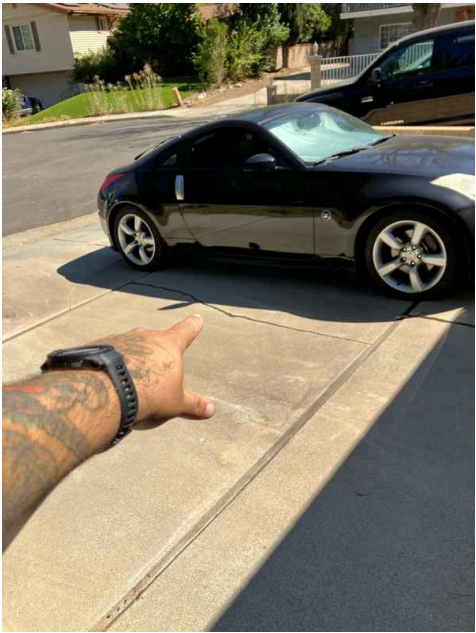
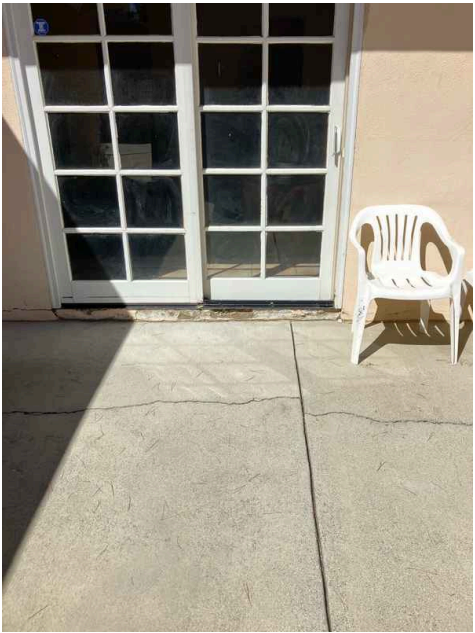
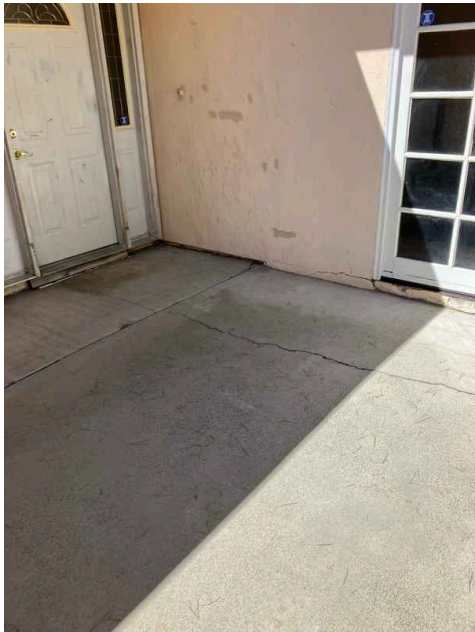
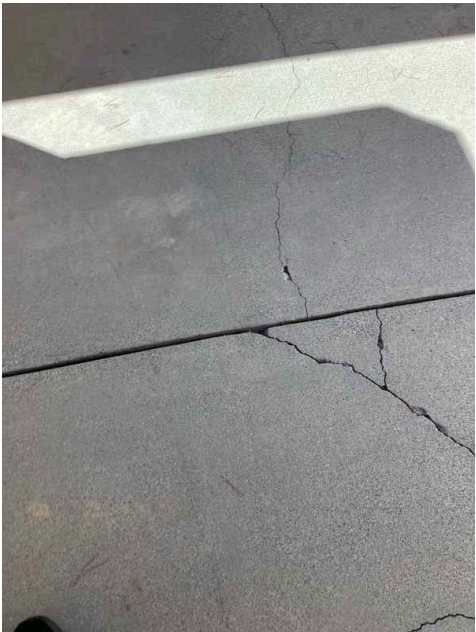
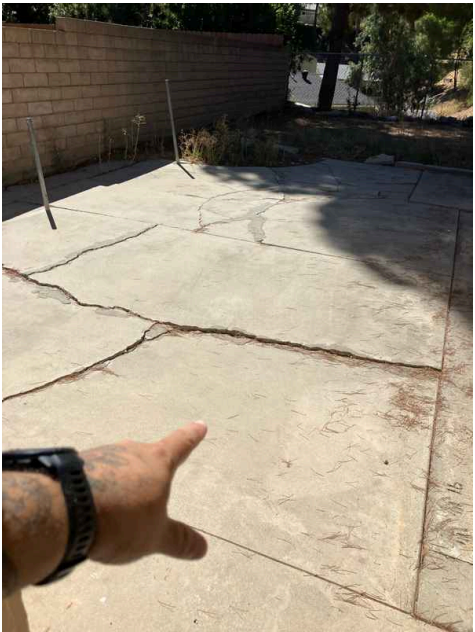
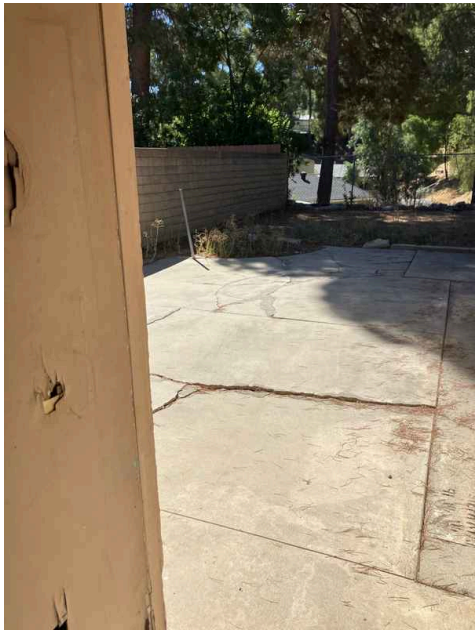
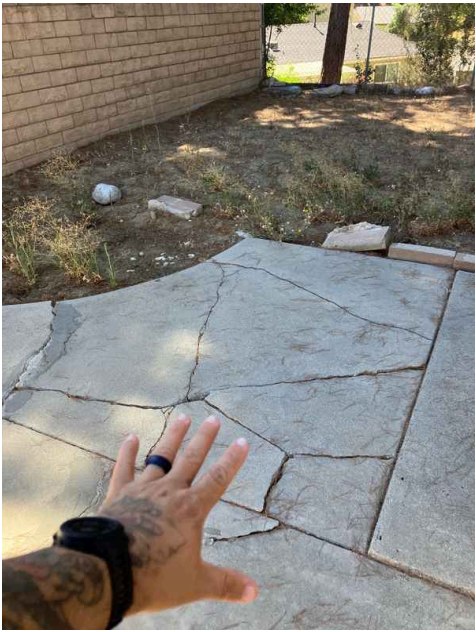
### 3.1.1 Driveways and Walkways **HEAVY CRACKING**

During the inspection, the inspector noted significant cracking on certain concrete surfaces that would benefit from repair. Addressing these cracks in a timely manner will help maintain the structural integrity and aesthetics. We recommend considering repair measures by a qualified professional to prevent any potential further issues.

Major Concern

Recommendation  
Contact a qualified concrete contractor.

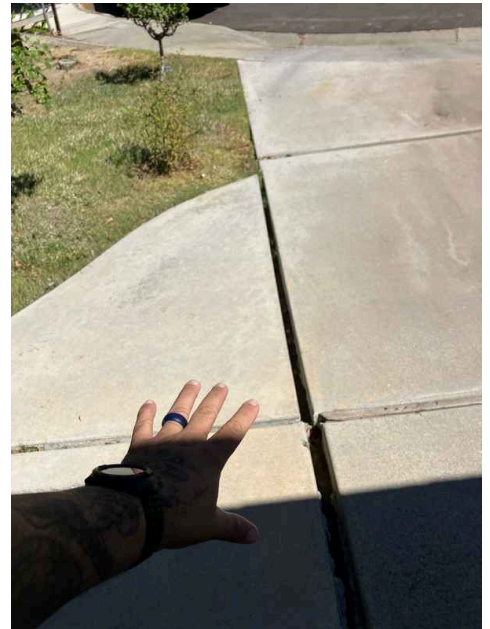
## 3.1.2 Driveways and Walkways

**WALKWAY DISPLACEMENT**

**Major Concern**

Walkway surfaces were observed to be uneven, displaced, or uplifted, presenting a potential tripping hazard. Repair is recommended to reduce the risk of injury and maintain safe walking conditions.

Contact a qualified professional.

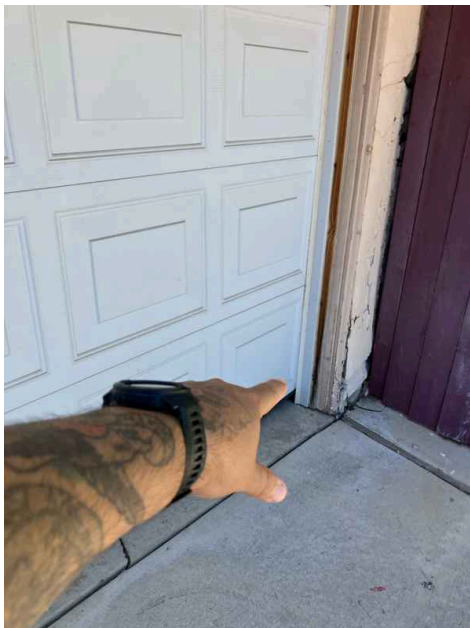
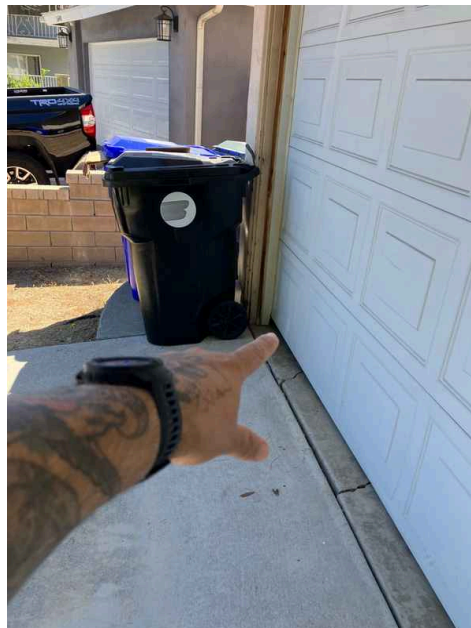
## 3.1.3 Driveways and Walkways

**DRIVEWAY DISPLACEMENT**

**Major Concern**

Driveway displacement/uplifted/uneven areas . The inspector recommends repair to prevent pedestrian hazards, vehicle damage and drainage issues.

Contact a qualified driveway contractor.

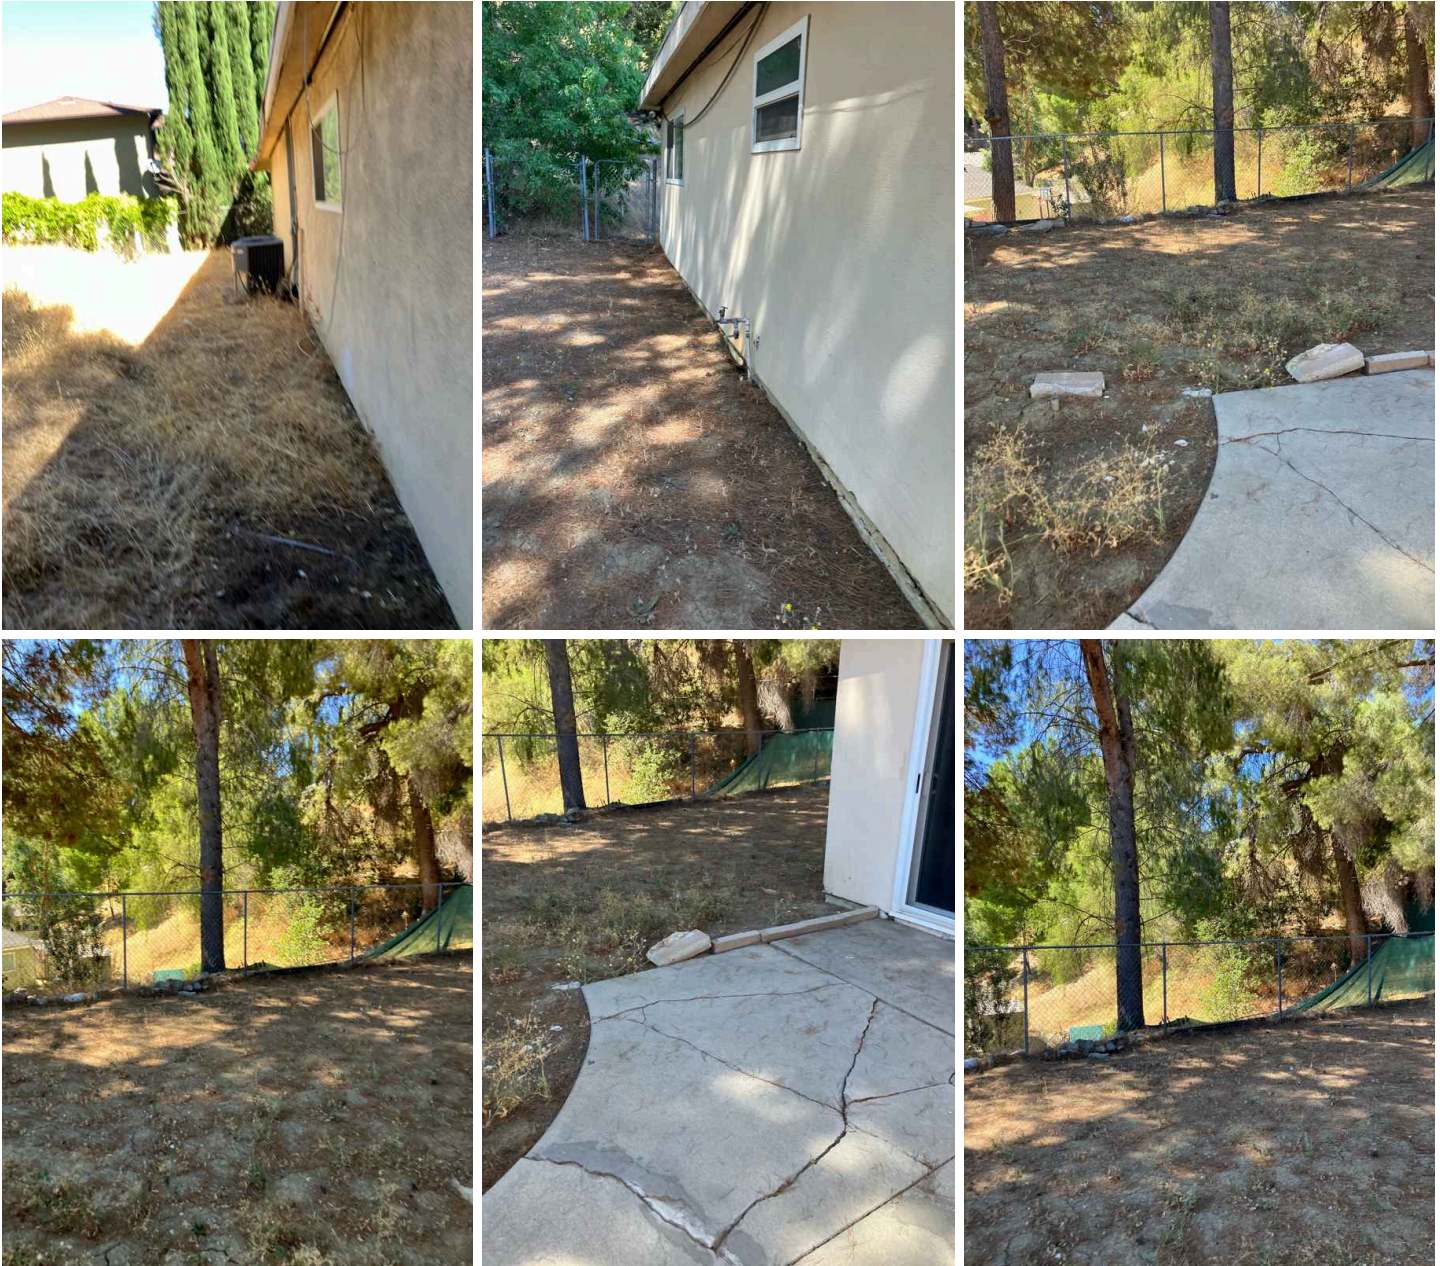
## 3.3.1 Grading

**SUBSTANDARD GRADING/DRAINAGE**

**Major Concern**

Recommend further evaluation for grading corrections and addition of drains or waterproofing as needed.

Contact a qualified professional.

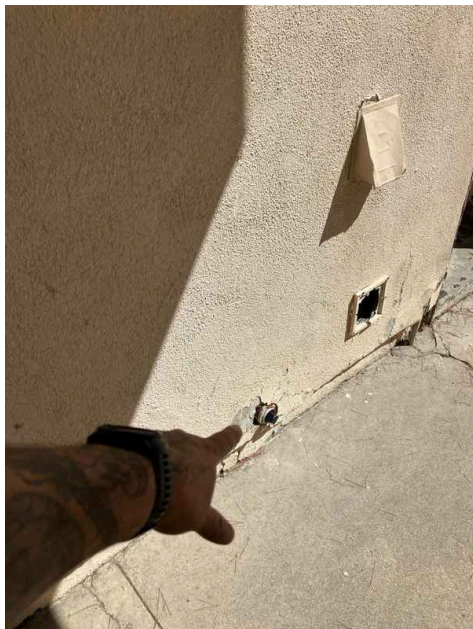
### 3.6.1 Exterior Plumbing and Faucets

## RUSTING OR RUST STAINS AT CLEAN OUT

Moderate Concern

evidence of past issues in this area – consult a plumber to further evaluate as needed

Contact a qualified professional.

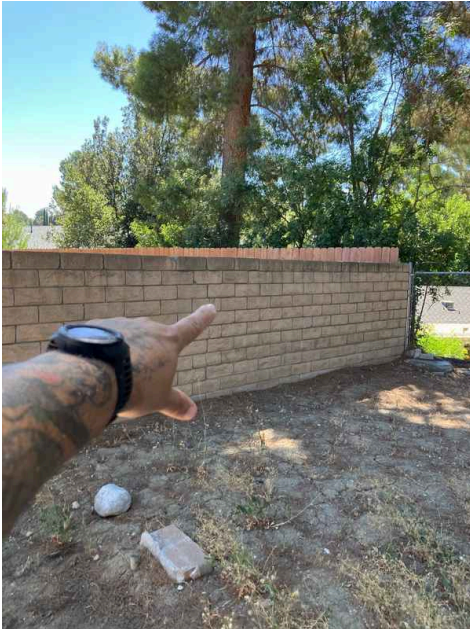
### 3.11.1 Fencing and Walls

#### **SIGNIFICANT CRACKING / CHIPPING**

Major Concern

Service/ Repair recommended

Contact a qualified professional.

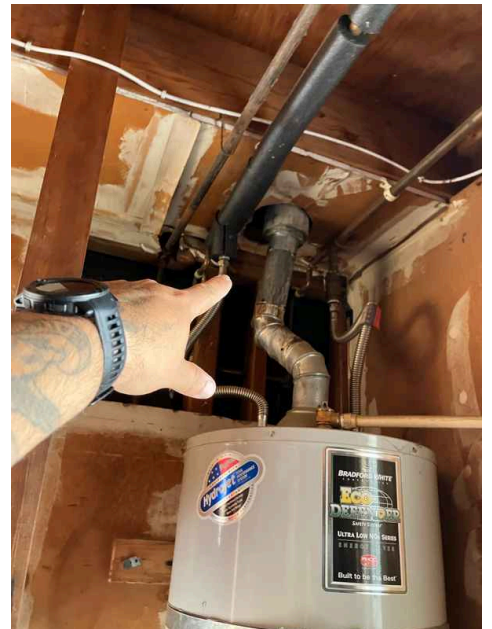
#### 4.2.1 Venting

### LOOSE CONNECTIONS

Moderate Concern

visible areas of the vent appeared to have some loose connections. It is recommended that a qualified professional properly secure all transitions and connections to ensure efficiency and safety.

Contact a qualified professional.

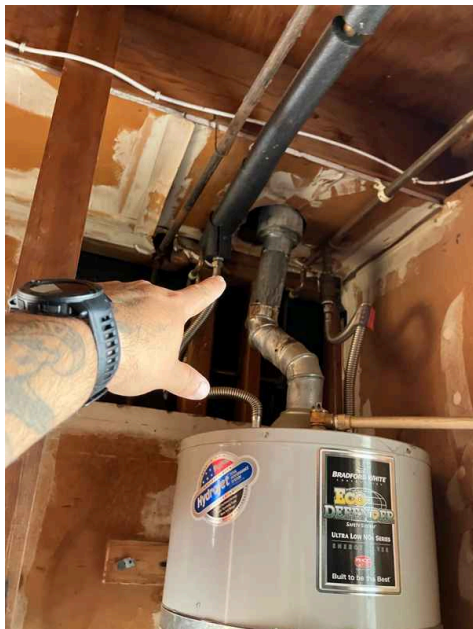
#### 4.2.2 Venting

### MASONRY/CEMENT/TRANSITE VENT

Moderate Concern

Masonry/cement/transite type chimney being used for newer water heater – service recommended and possibly upgraded

Contact a qualified professional.

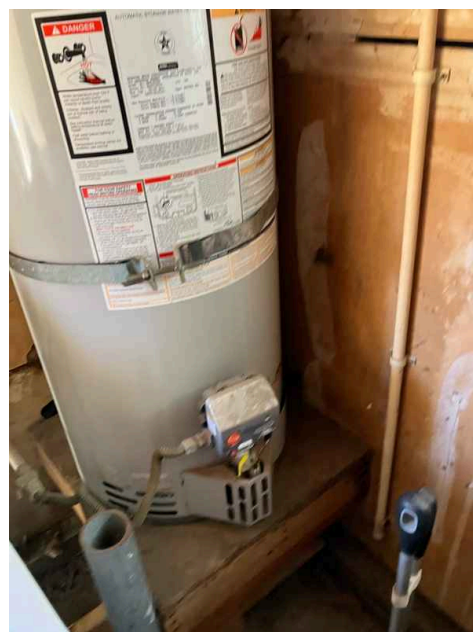
#### 4.4.1 Gas Supply Valves and Pipes

##### **NO SEDIMENT TRAP AT GAS SUPPLY**

Moderate Concern

A sediment trap was not observed at the gas appliance connection. In older homes, this may not have been required or commonly installed at the time of original installation; however, it is considered a recommended improvement by modern standards. In newer homes, installation is recommended regardless. Recommend evaluation and installation by a qualified licensed contractor

Contact a qualified professional.

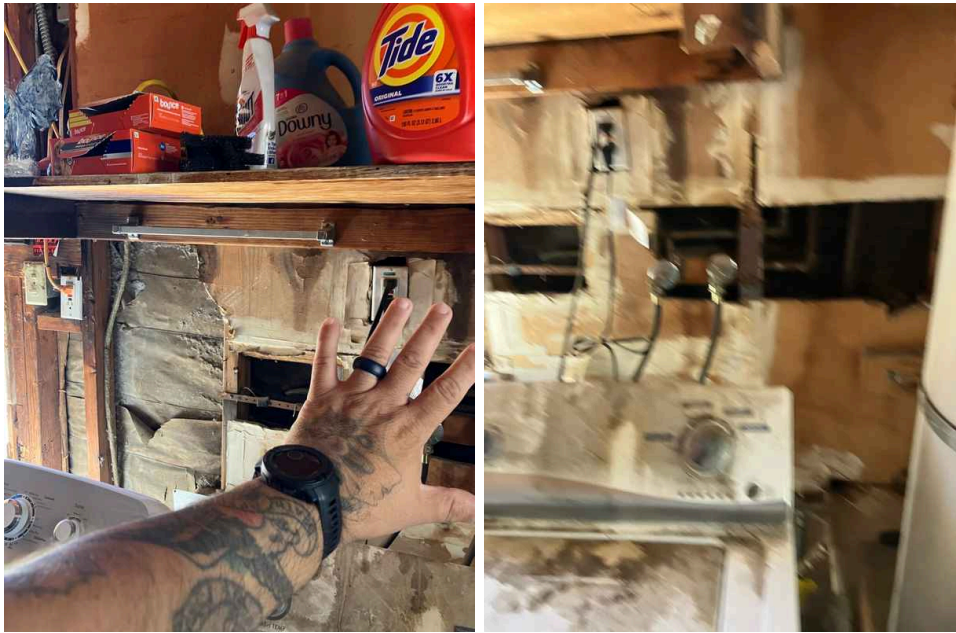
#### 5.2.1 Walls

##### **DAMAGED WALL SECTIONS WITH MOISTURE STAINING**

Major Concern

GARAGE

Heavy staining and damage observed on multiple wall sections in the garage, with evidence of moisture infiltration. Moisture damage can lead to structural deterioration, mold growth, and compromised wall integrity if not addressed. A qualified professional should evaluate the moisture source and recommend appropriate repairs or waterproofing measures.

Contact a qualified professional.

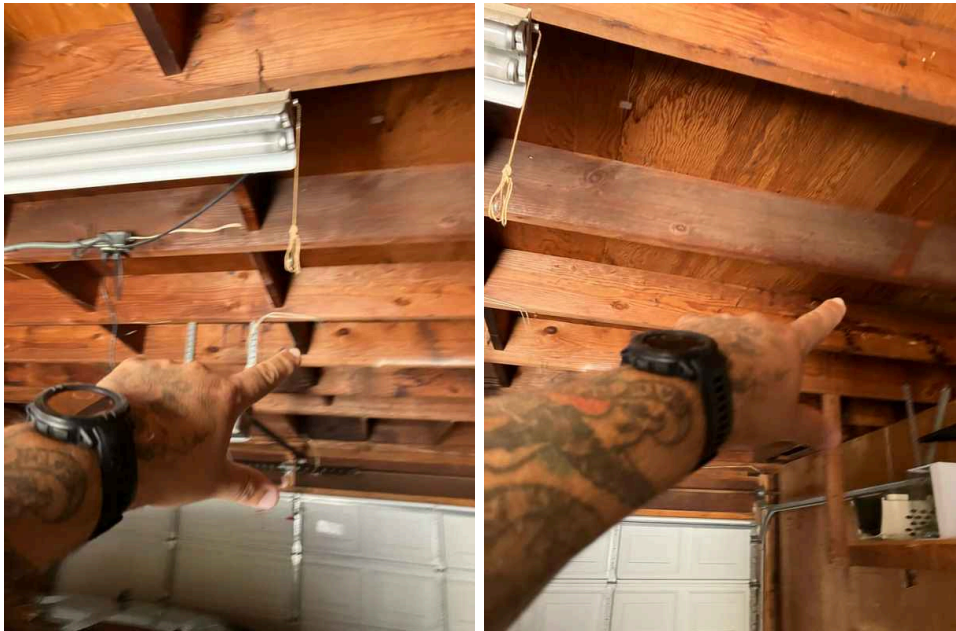
5.4.1 Rafters & Ceilings  
**MOISTURE DAMAGE/STAINS**

Moderate Concern

needs further evaluation/ repair beyond the non-invasive scope of the general inspection. Damage material in the rafters can have an overall effect on the efficiency of the roof on the structure of the roof and the overall ability to shed water and prevent moisture intrusion. Moisture damage on the drywall can cause it to sag and chip away.

Recommendation  
Contact a qualified professional.

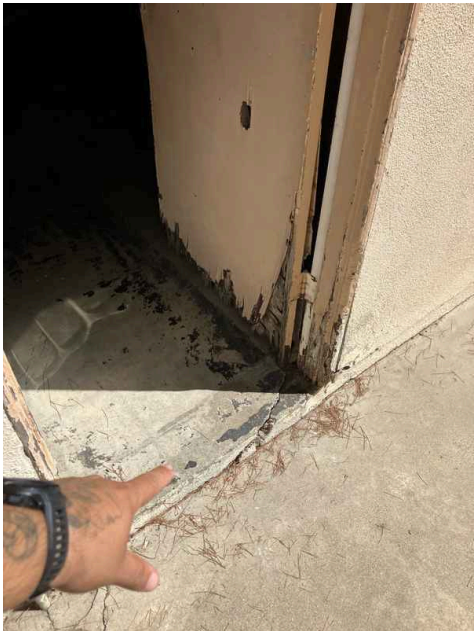
5.8.1 Exterior Doors  
**MOISTURE DAMAGE OBSERVED**

Major Concern

Service recommended

Recommendation  
Contact a qualified professional.

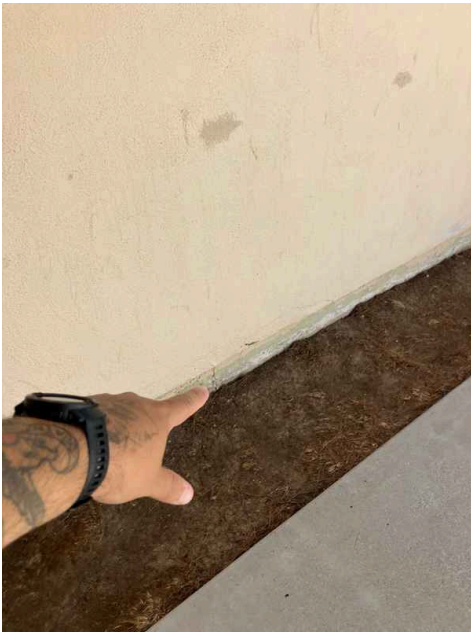
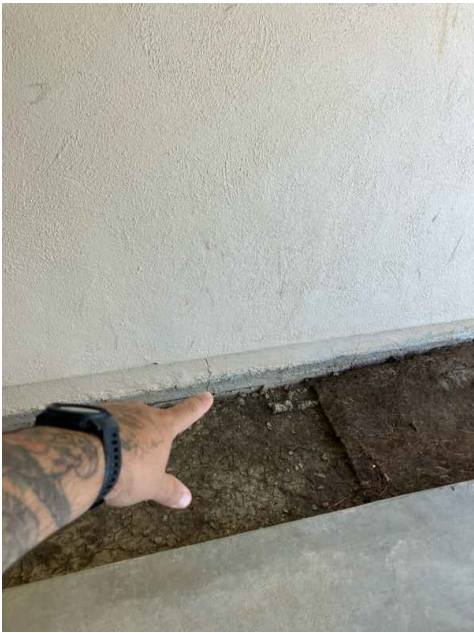
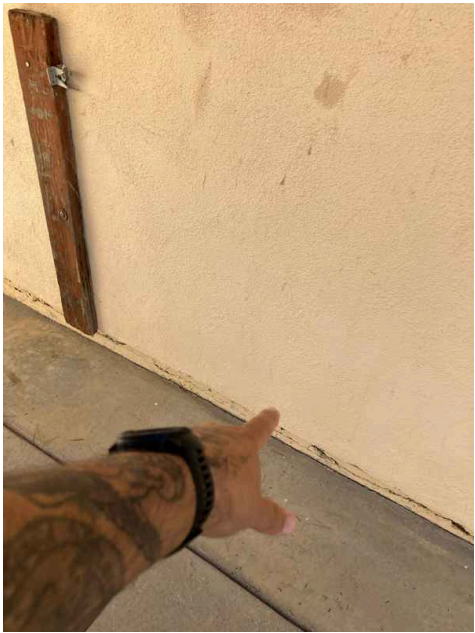
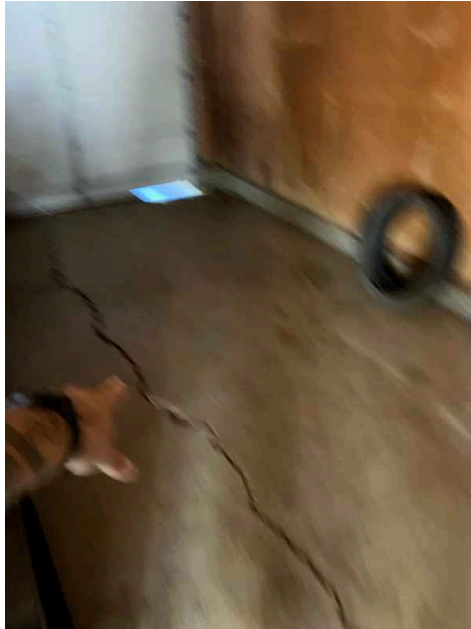
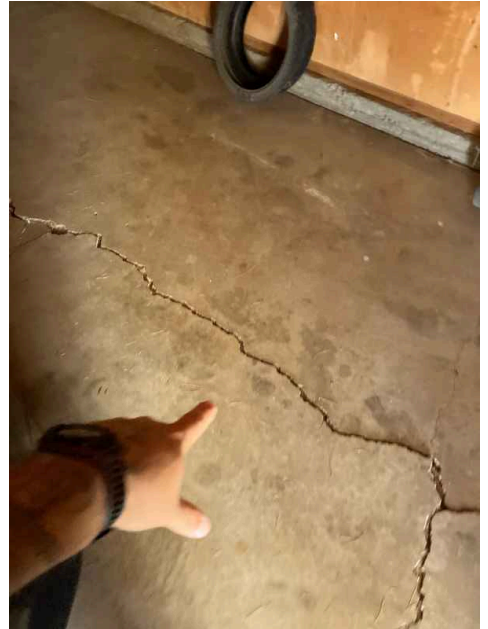
5.9.1 Slab  
**SIGNIFICANT CRACKING**  
Needs evaluation for repair and cause  
Recommendation  
Contact a qualified professional.

Major Concern

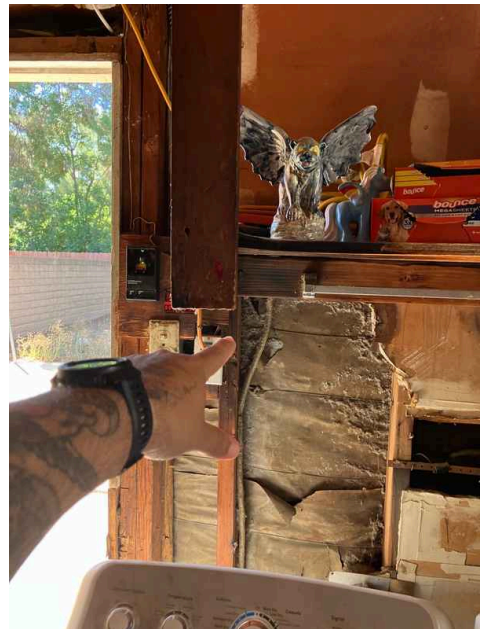
#### 5.13.1 Electrical

### UNPROTECTED NM CABLE IN GARAGE

Major Concern

Non-metallic sheathed (NM) cable was observed to be exposed and unprotected in areas of the garage where it may be subject to physical damage. This condition does not meet typical safety practices and may pose a risk of electrical shock or damage to the wiring. Evaluation and proper protection or conduit installation by a qualified electrician is recommended.

Contact a qualified professional.

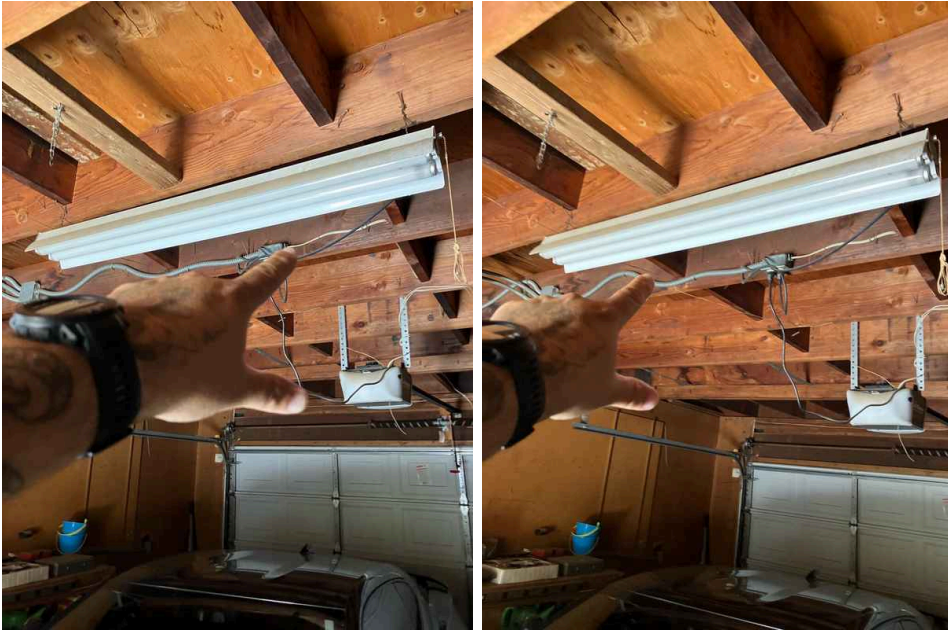
#### 5.13.2 Electrical

### UNSECURED WIRING

Moderate Concern

Wiring should be properly secured to prevent damage

Contact a qualified professional.

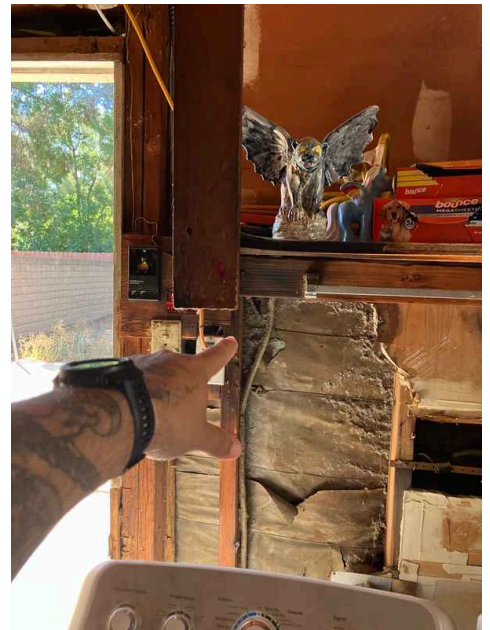
### 5.13.3 Electrical CLOTH WIRING

Moderate Concern

The inspector observed cloth wiring, and the garage areas, when cloth wiring becomes frayed. It can be an electrical safety issue, it is not possible to check all inaccessible areas that the wiring travels through, it is recommended that a qualified, professional, and licensed electrician, evaluate the longevity of the current wiring to prevent any issues in the future.

Recommendation  
Contact a qualified professional.

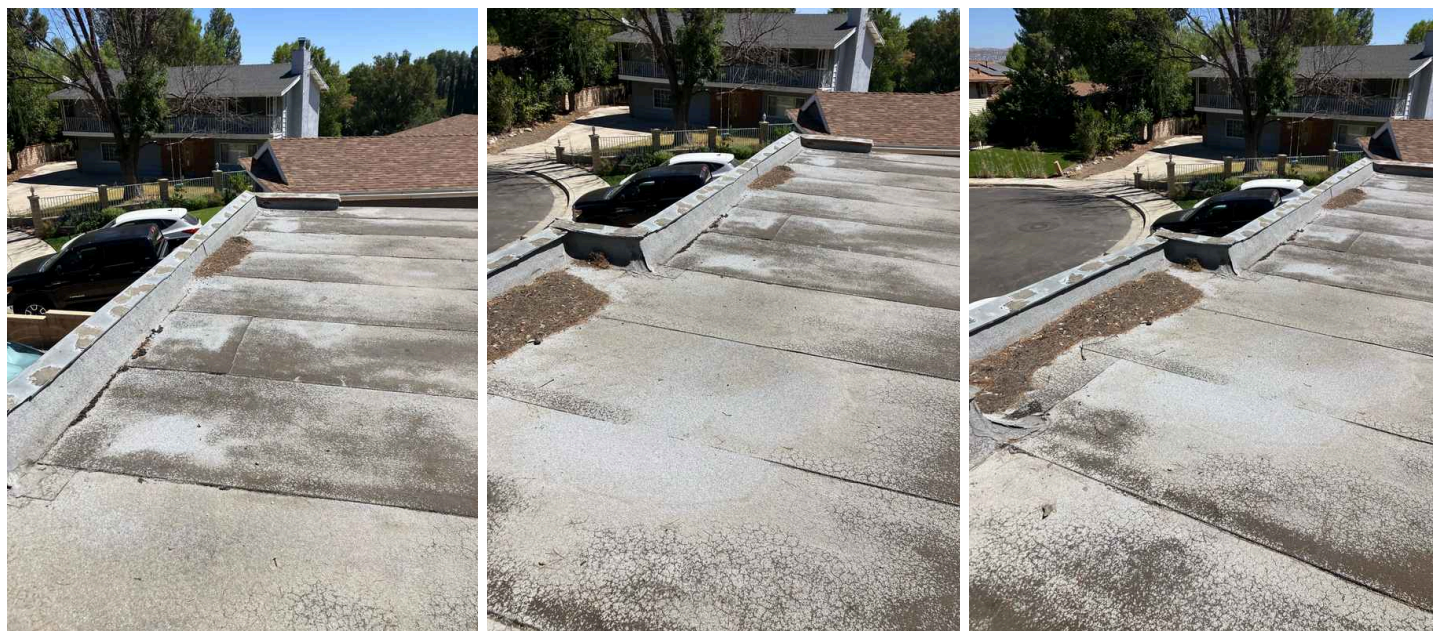
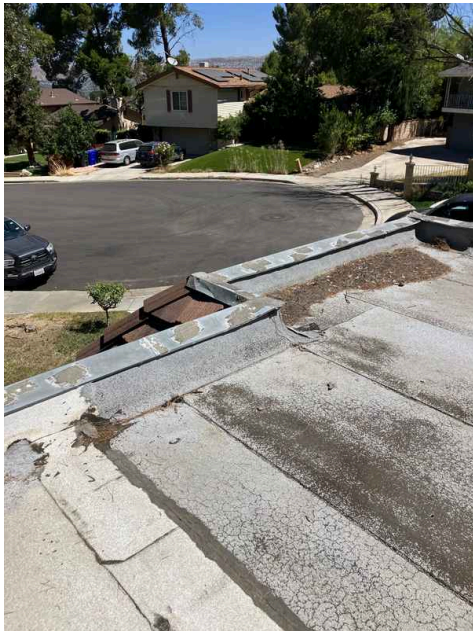
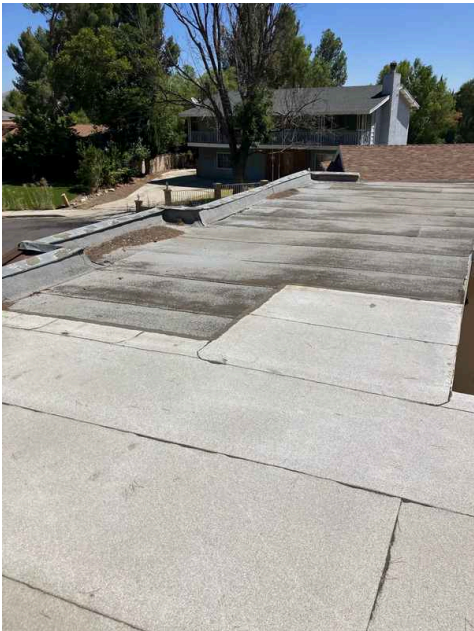
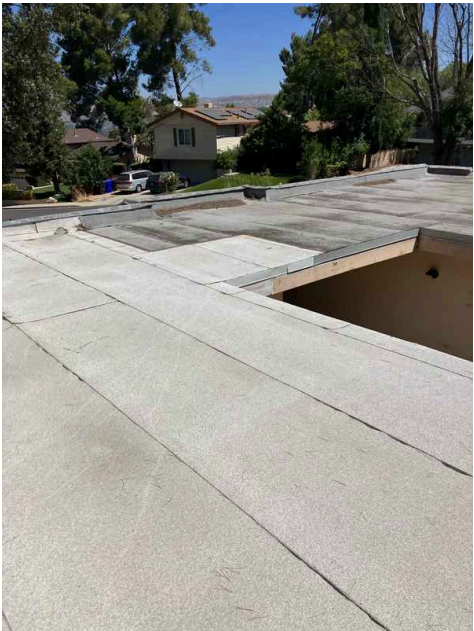
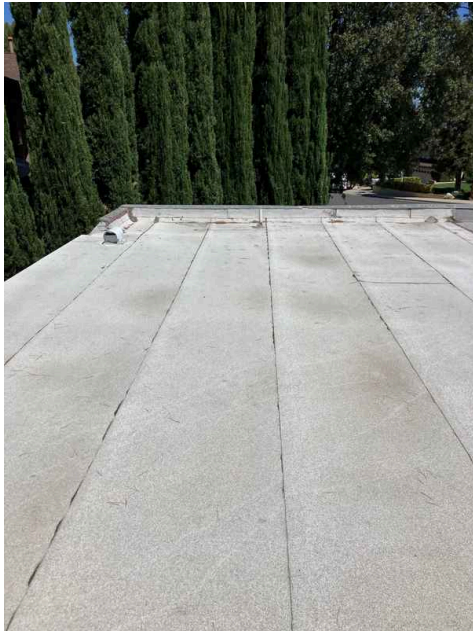
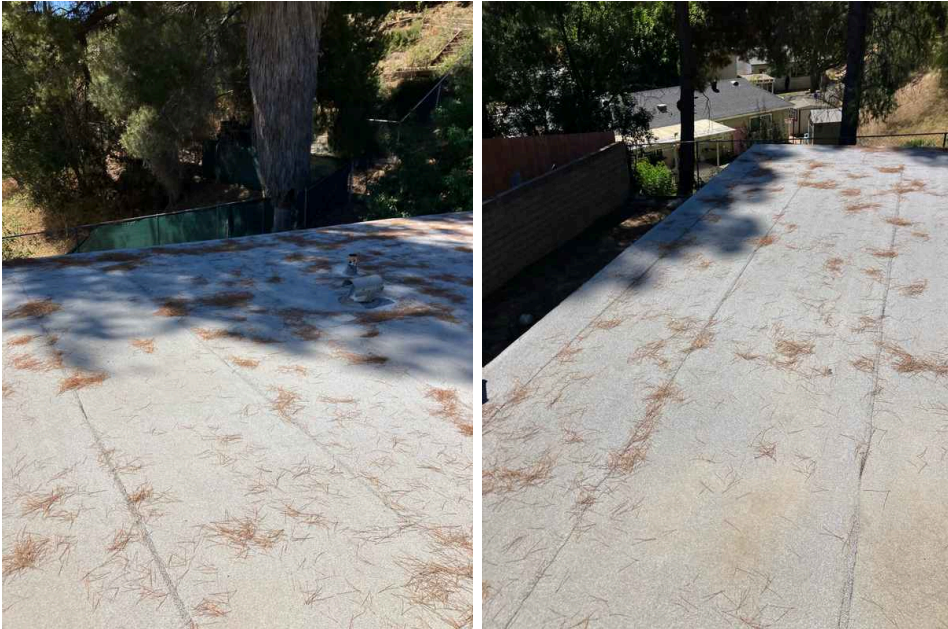
### 7.1.1 Condition DEFECTS

Major Concern

- \* **Roof Covering:** The rolled composition roofing exhibited visible wear and deterioration consistent with an aging roof covering. Overall conditions indicate that repairs and possible replacement should be anticipated.

- \* **Debris:** Moderate to heavy debris accumulation was observed across multiple roof areas. Debris can retain moisture, obstruct drainage, and accelerate deterioration of roofing materials.

- \* **Ponding Evidence:** Staining and evidence of previous ponding water were observed in multiple areas, indicating that portions of the roof may not be draining effectively.

- \* **Roof Penetrations:** Multiple vent flashings and vent boots exhibited gaps, loose components, and signs of deterioration. These conditions can allow water intrusion and should be evaluated for appropriate repair or replacement as needed.

- \* **Flashing/Drip Edge:** Sections of the perimeter flashing and drip edge appeared loose, deteriorated, or inadequately sealed in areas. Repairs are recommended to help maintain a weather-resistant roof assembly.

- \* **Areas of Greatest Concern:** The most significant deterioration was observed at the front of the property, particularly near the garage and front roof sections. These areas should receive priority during further evaluation and repairs.

- \* **Previous Repairs:** Portions of the rear roof appeared to have been repaired more recently; however, the quality and extent of those repairs could not be fully determined during this inspection.

- \* **Recommendation:** Based on the observed conditions, a qualified roofing contractor should perform a comprehensive evaluation of the entire roof system and provide recommendations for any necessary repairs or replacement.

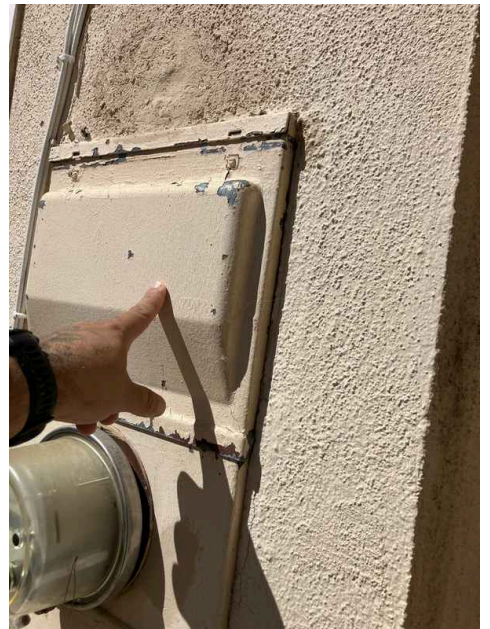
#### 8.1.1 Main Panel

### PROBLEMATIC PANEL

Major Concern

Manufacture of panel a brand (Zinsco/Sylvania/Federal Pacific/Stab-Lok) known for frequent issues, while not all panels may be defective. The inspector does recommend further evaluation by a Licensed Electrician.

Contact a qualified professional.

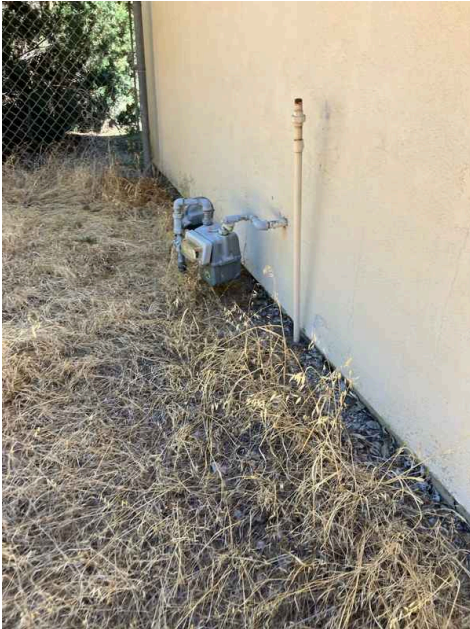
#### 8.7.1 Main Gas Valve

### NO SEISMIC SAFETY VALVE PRESENT

Major Concern

Recommend installation for increased safety

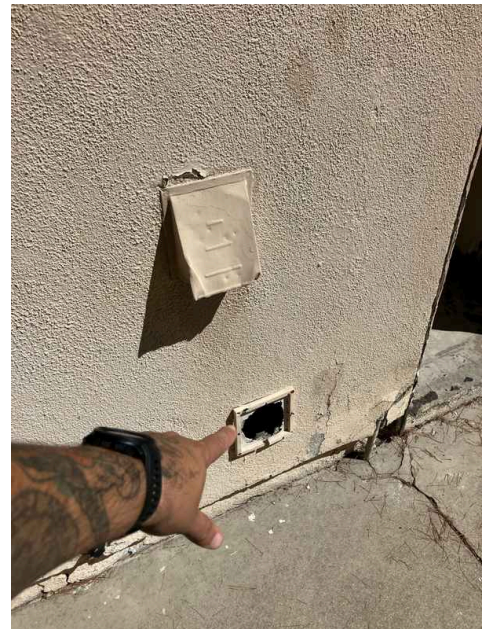
#### 10.1.1 Dryer Vent

### MISSING THE EXTERIOR COVER

Moderate Concern

The inspector recommends installing a cover to prevent any pest intrusion or issues with the dryer vent operation. Should be completed by a qualified professional.

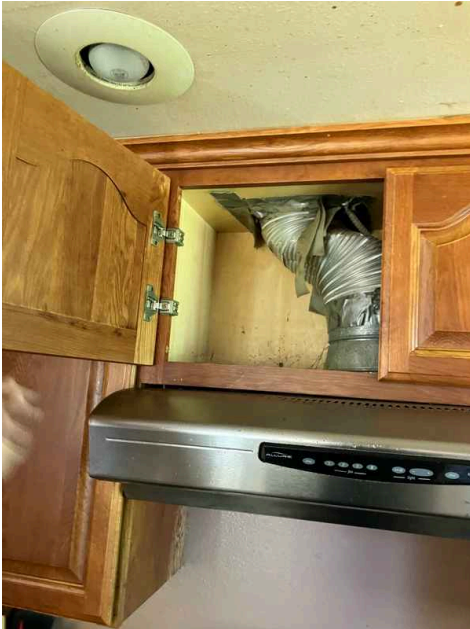
#### 11.6.1 Exhaust Vents

### FLEXIBLE VENT

Major Concern

A ribbed flexible vent pipe was observed. This type of material can allow grease and debris to accumulate within the ridges, creating a potential blockage or fire hazard over time. It is recommended that the vent be replaced with a smooth metal pipe for improved safety and performance.

Contact a qualified professional.

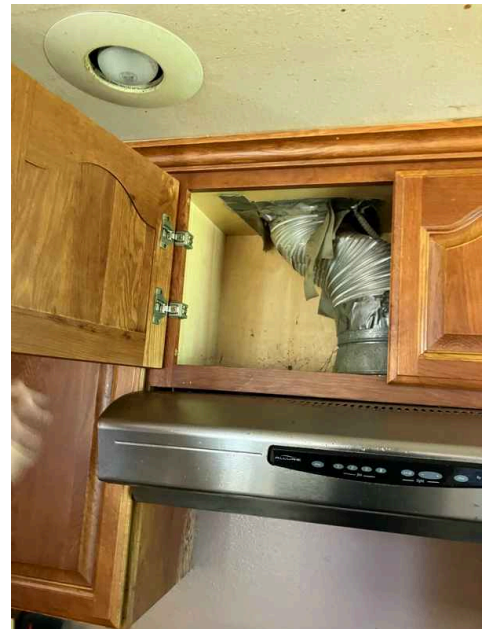
#### 11.6.2 Exhaust Vents

### LOOSE/IMPROPERLY TAPED AT VENT PIPE CONNECTIONS

Major Concern

service recommended

Contact a qualified professional.

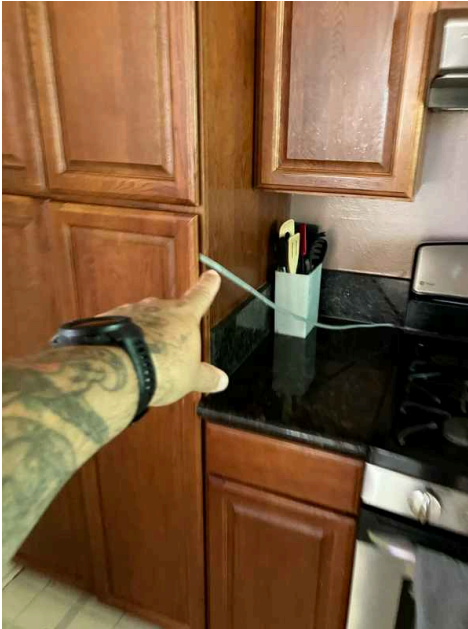
#### 11.11.1 Ovens

### IMPROPER APPLIANCE CORD INSTALLATION

Moderate Concern

#### KITCHEN

The oven's power cord is not properly installed or plugged in, with substandard connections exposed in an accessible area. This creates a risk of electrical shock, fire hazard, or cord damage. A qualified electrician should inspect the connection, ensure proper grounding, and secure the cord safely away from potential damage or contact.

Contact a qualified professional.

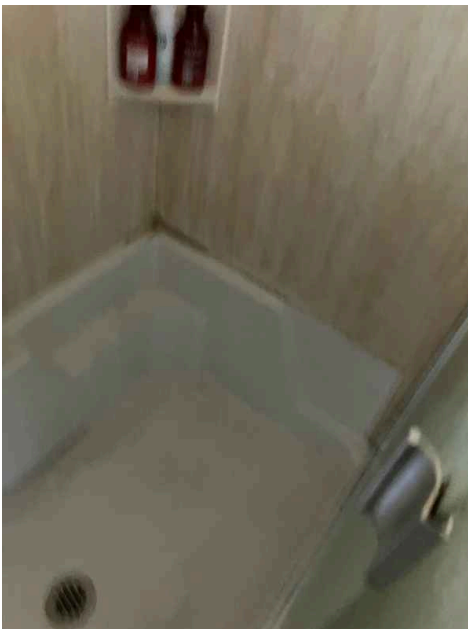
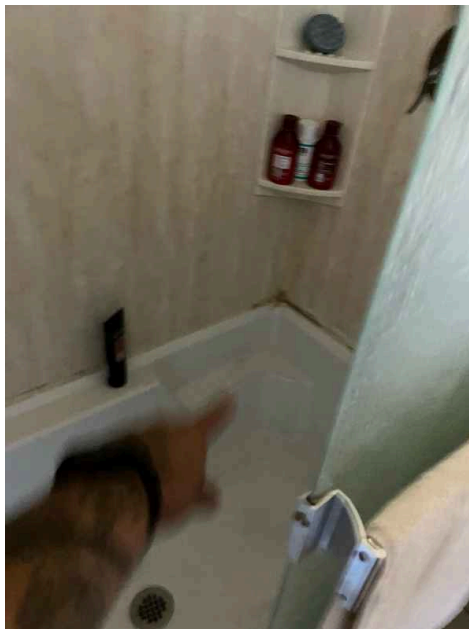
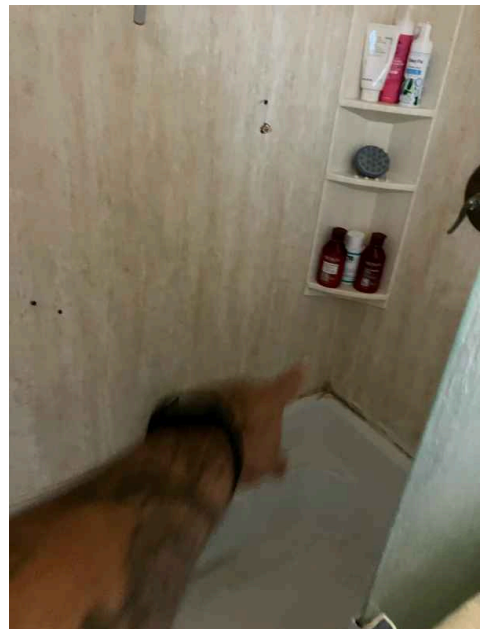
### 12.6.1 Bath Tubs

## WORN BATHTUB SURFACE AND CAULKING

Moderate Concern

### BATHROOM

The bathtub surface shows excessive wear beyond normal use, with deteriorated caulking around the tub. This wear pattern can allow water to penetrate behind the tub and into surrounding structures, potentially causing water damage, mold growth, and structural issues. The caulking should be removed and replaced, and the tub surface may require refinishing or replacement depending on the extent of damage.

Contact a qualified professional.

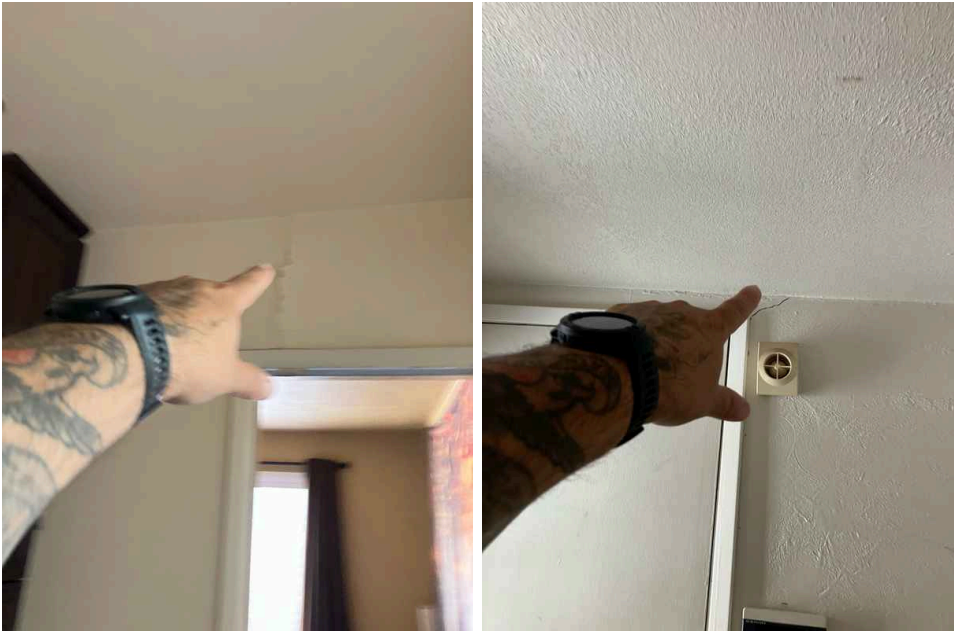
### 13.2.1 Wall Conditions

## CRACKING/ WEAR MORE THAN TYPICAL

Major Concern

Recommend service/ evaluation by licensed contractor

Recommendation  
Contact a qualified professional.
