## SUMMARY

26401 Oak Crossing Rd, Santa Clarita,  
CA 91321

Ina Ray Simpson  
07/30/2026

Mike Ortiz  
CMI Certified Master Inspector, ICC  
Certified  
Home-Front Inspection Services LLC  
3103478945

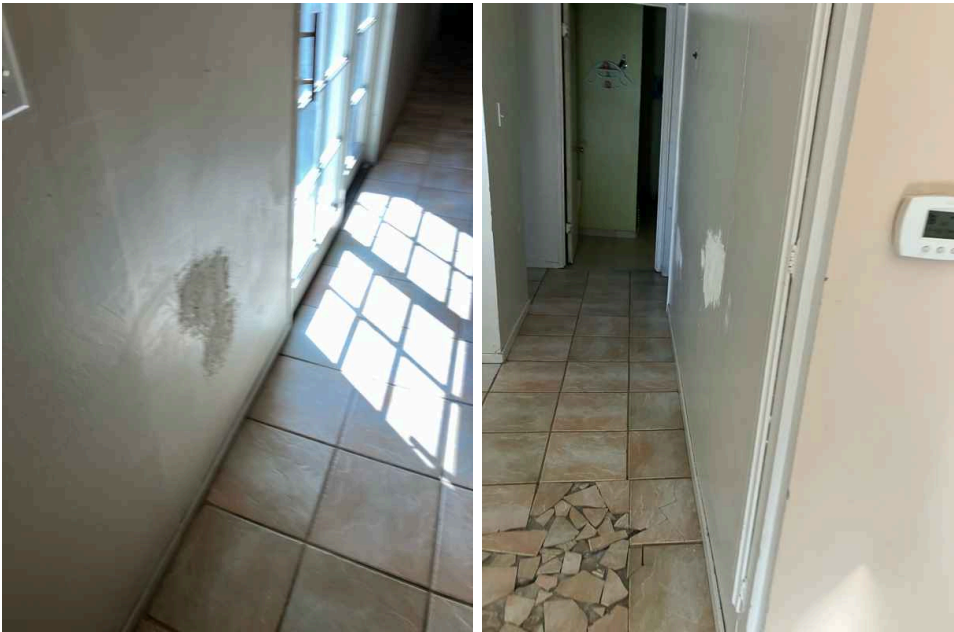
13.2.2 Wall Conditions  
**SUBSTANDARD PATCHWORK**

Moderate Concern

Recommend re-patching / re-finishing by a qualified professional

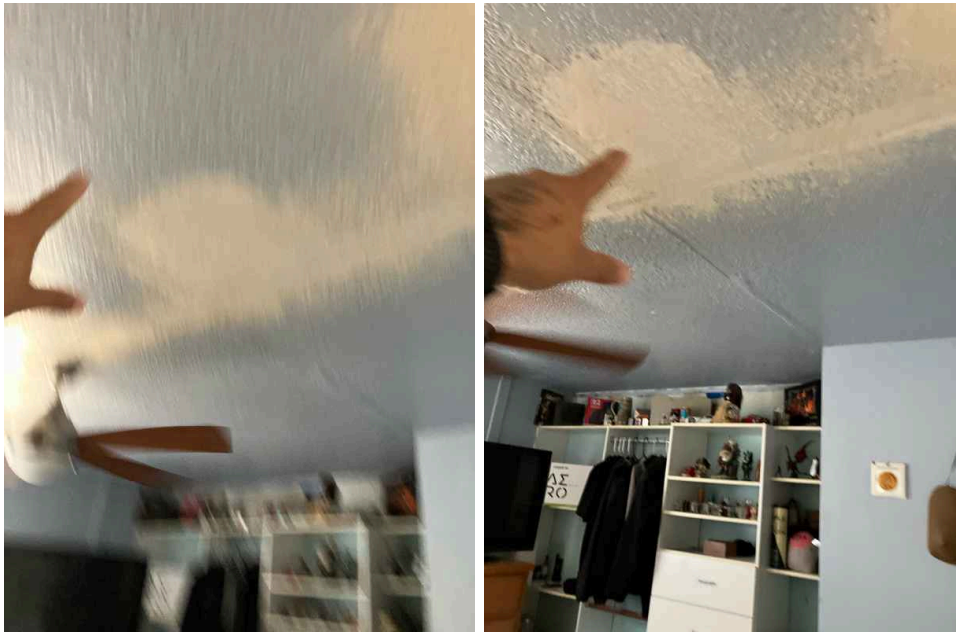
13.3.1 Ceiling Conditions  
**SUBSTANDARD PATCHING OBSERVED**

Recommend evaluation for purpose of patchwork and service to ensure

Moderate Concern

Recommendation  
Contact a qualified professional.

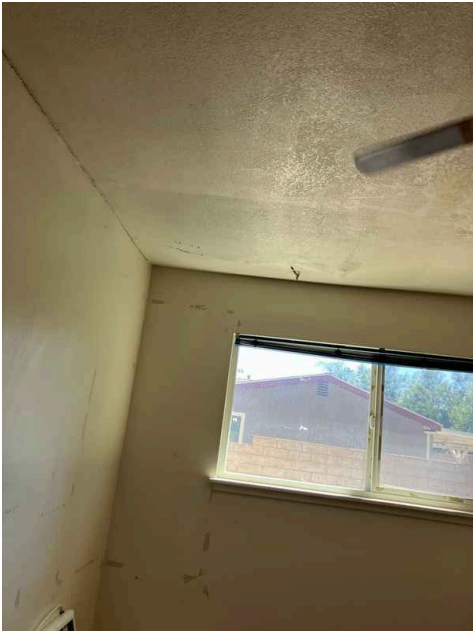
13.3.2 Ceiling Conditions

EVIDENCE OF PAST MOISTURE PROBLEMS

Major Concern

consult seller/disclosures for any past history of moisture issues

Recommendation  
Contact a qualified professional.

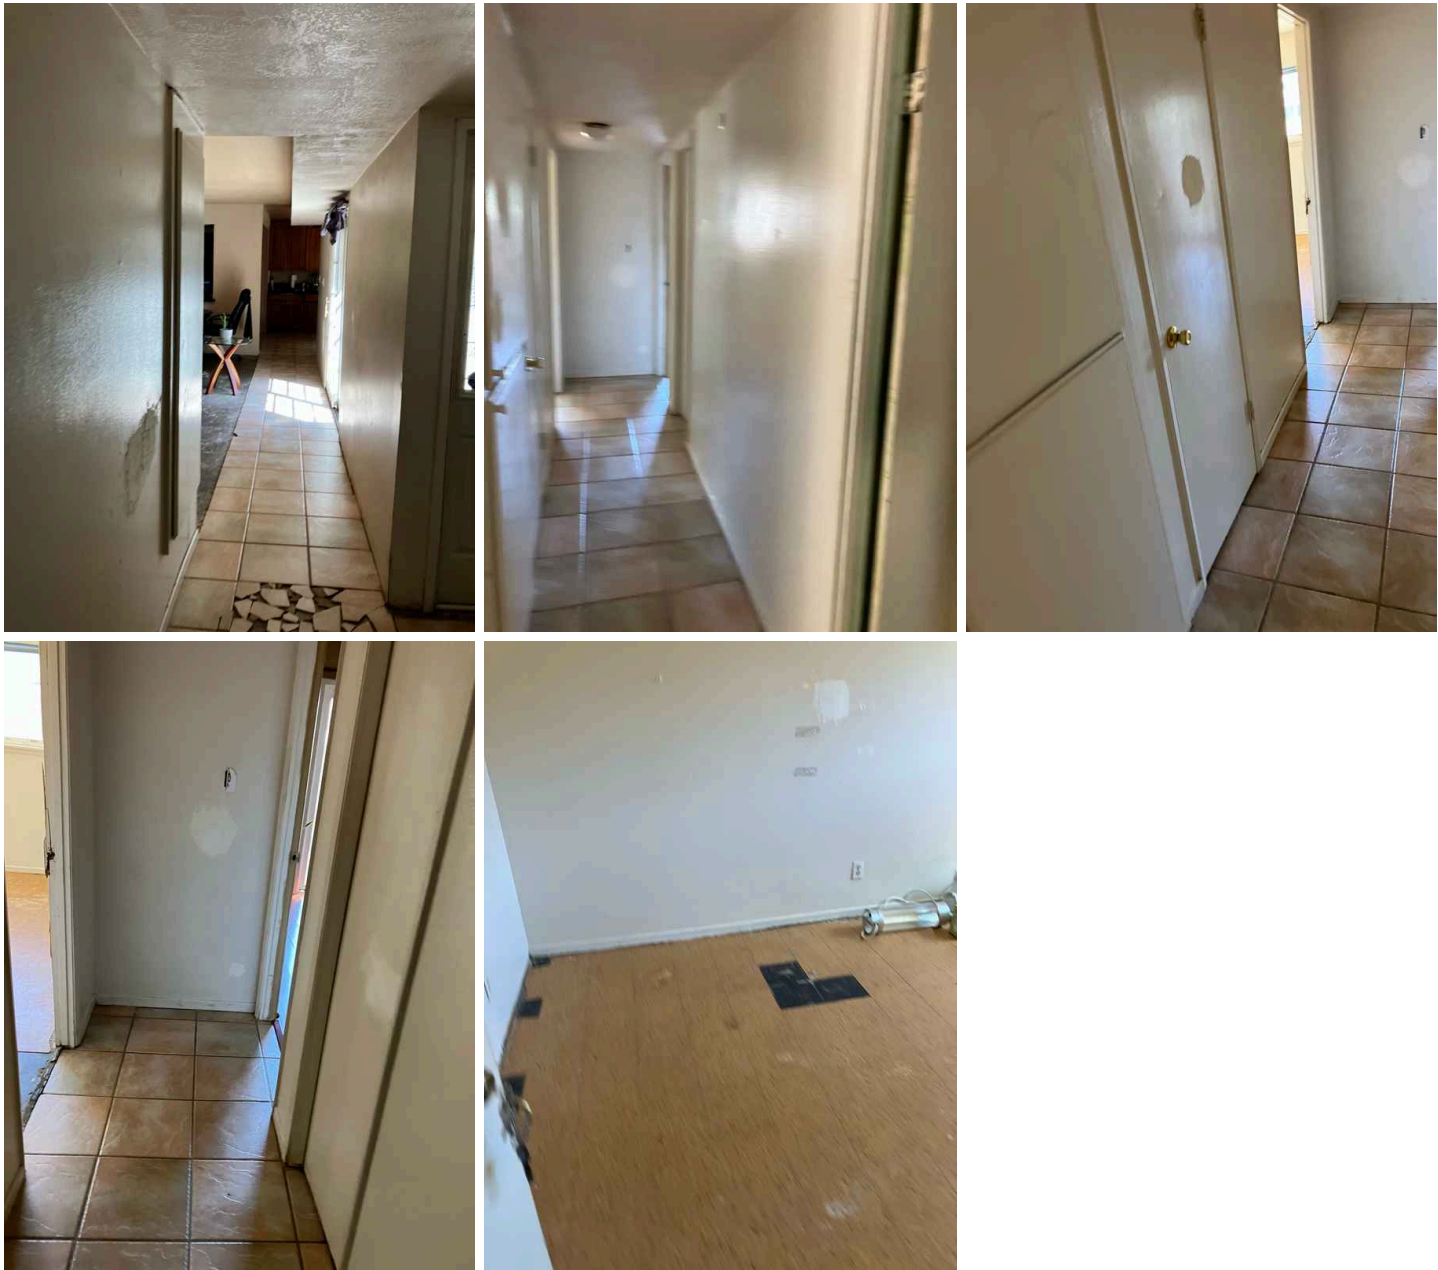
13.4.1 Floor Conditions

SUBSTANDARD FLOOR INSTALLATION

Major Concern

Improper floor installation was observed during the inspection. This may result in uneven surfaces, movement, squeaking, or accelerated wear on flooring materials. A flooring contractor should evaluate the installation quality and determine what corrective measures are necessary to ensure proper performance and longevity.

Recommendation  
Contact a qualified professional.

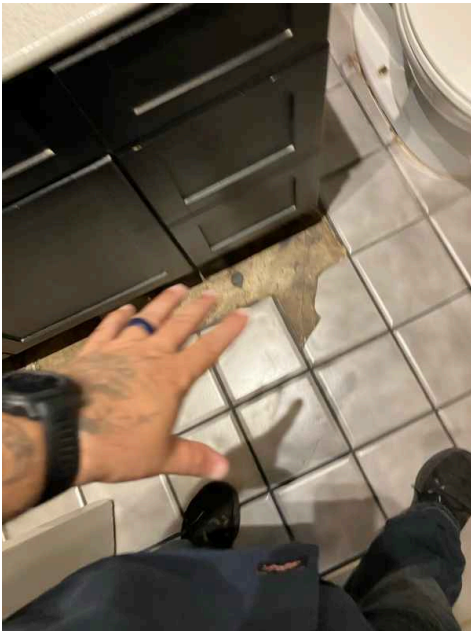
13.4.2 Floor Conditions  
**CHIPPED AREAS**

Service recommended

Major Concern

Recommendation  
Contact a qualified professional.

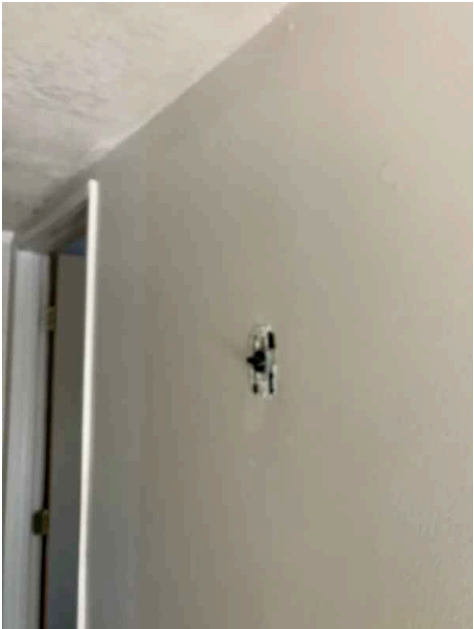
13.8.1 Electrical  
**SWITCH COVER MISSING**  
Service recommended  
Recommendation  
Contact a qualified professional.

Moderate Concern

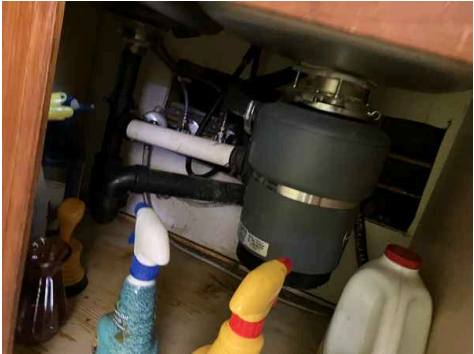
13.11.1 Cabinets  
**STAINED/BLISTERED AREA(S)**  
Needs repair / evaluation  
Recommendation  
Contact a qualified professional.

Moderate Concern

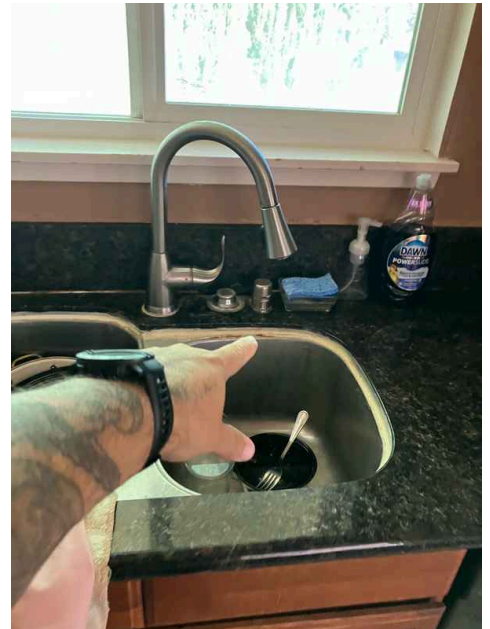
## 13.12.1 Counters

**WORN GROUT/ CAULKING**

Moderate Concern

Grout/caulking observed to be worn or deteriorated. Worn grout and caulking can allow moisture infiltration behind countertops and into underlying structures, potentially leading to water damage, mold growth, and structural deterioration. Regrouting and recaulking should be performed by a qualified professional to ensure proper water sealing and prevent further damage.

Contact a qualified professional.

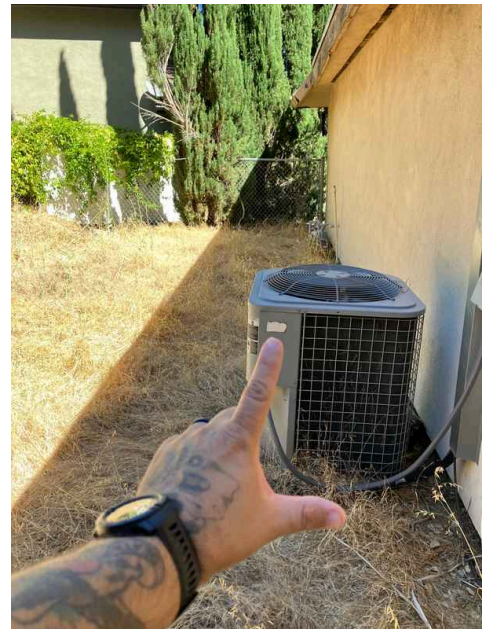
## 14.1.1 Air Conditioning Compressors

**IMPROPER COMPRESSOR BASE INSTALLATION**

Moderate Concern

The air conditioning compressor lacks a proper base and is installed unevenly. This can cause operational stress on the unit, lead to vibration and noise issues, and potentially damage internal components over time. Have an HVAC professional inspect the installation, ensure the compressor is level, and install an appropriate mounting base to provide proper support and stability.

Contact a qualified professional.

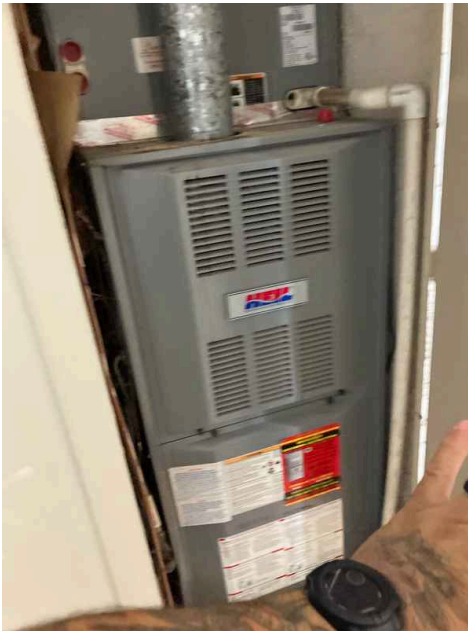
## 14.7.1 Combustion Air

**COMBUSTION AIR APPEARS TO BE INADEQUATE**

Moderate Concern

Recommend Evaluation by a qualified professional to ensure that the furnace has an adequate combustible airspace around the unit so that it can operate, efficiently. With restricted combustible airspace the unit may not operate properly, and could have possible issues in the future.

Contact a qualified professional.

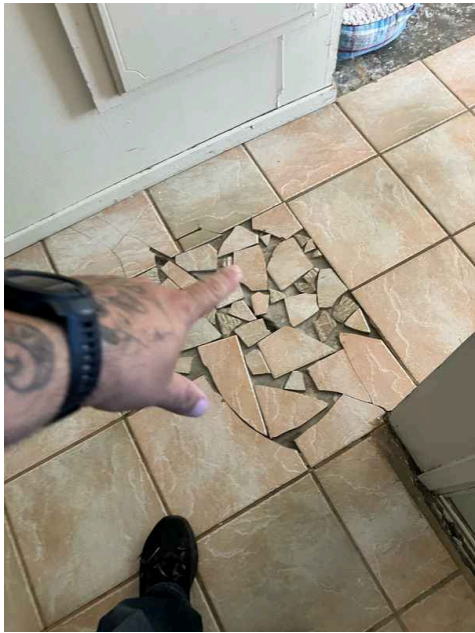
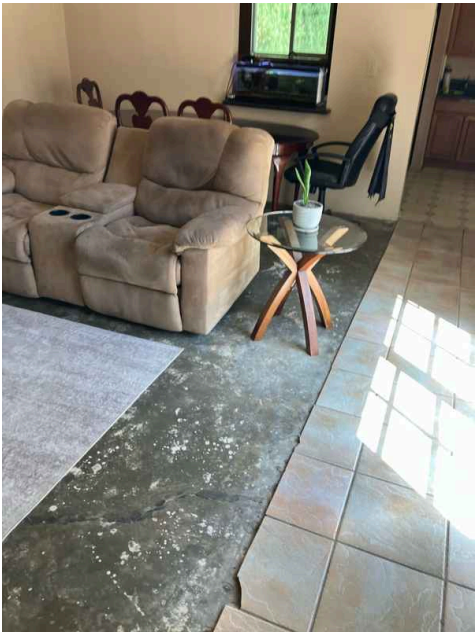
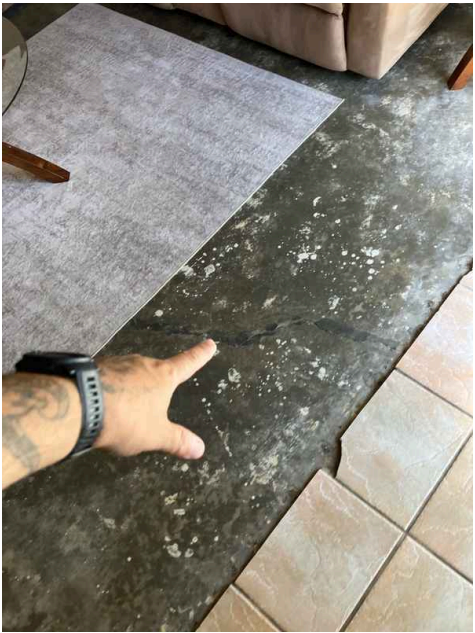
#### 15.1.1 Slab

### DAMAGED

Major Concern

Repair recommended

Contact a qualified professional.
