| CUSTOMER NAME: | Laura Pratt | | | DATE: 6.8.26 |
| LOCATION OF TEST: | 6269 Hog Canyon Road, San Miguel, CA 95667 | | | |

# WOOD DESTROYING PESTS AND ORGANISMS INSPECTION REPORT

## Inspection Report/Certification of Sewage Disposal System

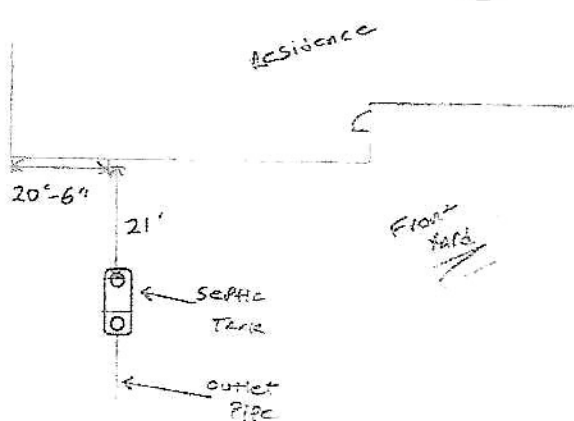
### Septic System Location Plot Plan

Septic tank is 18" underground and has light to moderate rotting on secondary chamber

Leach field passed 30-minute flood test.
