## R.B.Inspections

### Property Inspection Report

Property address: **11605 Garfield Ave, South Gate, CA 90280**

Inspection date: **Tuesday, September 22, 2026**

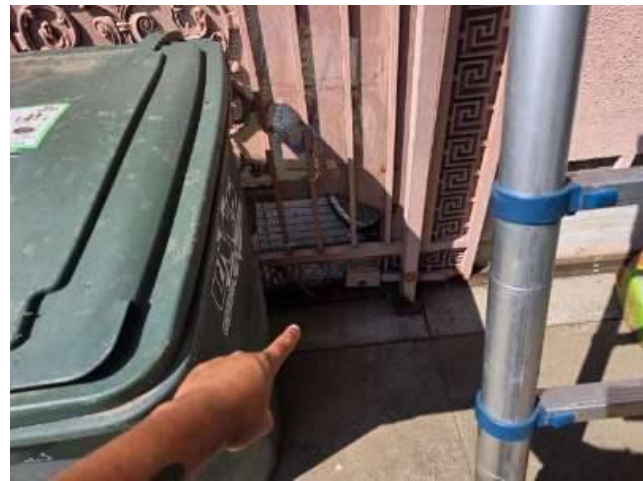
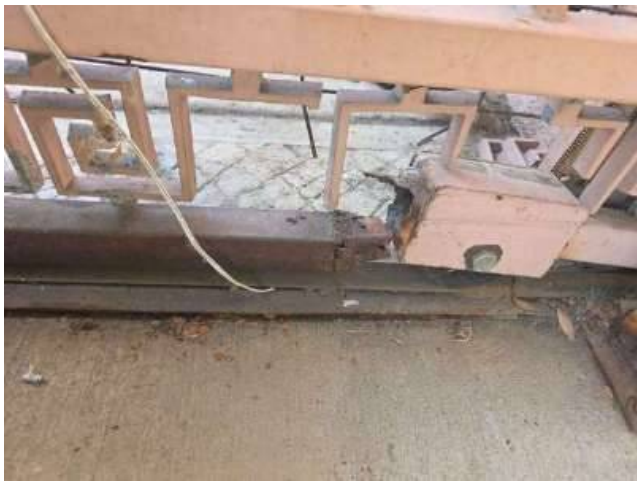
8) 🛠️ One or more gates were damaged or deteriorated and need repair.

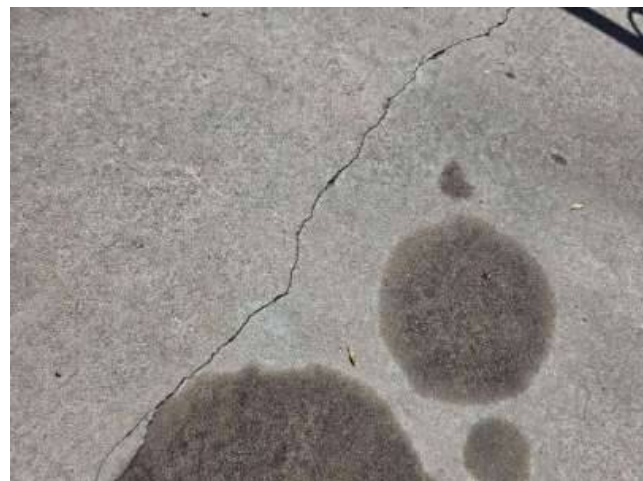
Photo 9-1

9) 🛠️ Minor deterioration (e.g. cracks, holes, settlement, heaving) was found in the driveway, but no trip hazards were found. The client may wish to have repairs made for cosmetic reasons.

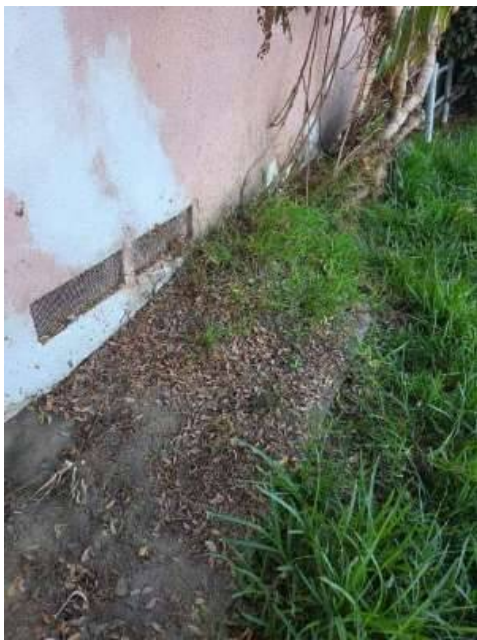
Photo 11-1

Soil was in contact with or less than 6 inches from siding or trim. Regardless of what material is used for siding, it should not be in contact with the soil. If made of wood, siding or trim will eventually rot. For other materials, ground or surface water can infiltrate siding or trim and cause damage to the wall structure. Wood-destroying insects are likely to infest and damage the wall structure. This is a conducive condition for wood-destroying organisms. Recommend grading or removing soil as necessary to maintain a 6-inch clearance. Note that damage from fungal rot and/or insects may be found when soil is removed, and repairs may be necessary.

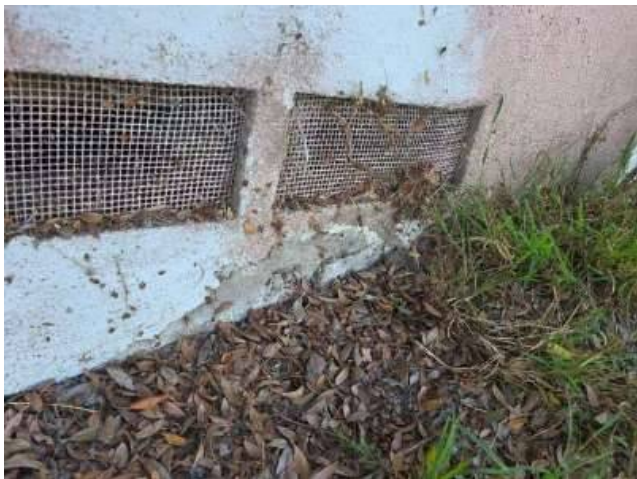
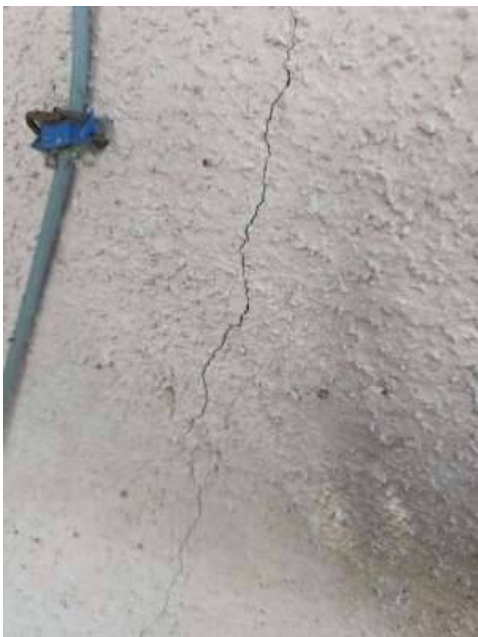
**12)** Cracks, deterioration and/or damage were found in one or more areas of the exterior stucco finish. In damp climates, moisture may enter cracks or damaged areas and further deteriorate the stucco. Also the wall behind the stucco may become damaged from moisture. Note that areas behind the stucco are inaccessible and excluded from this inspection. Recommend that a qualified contractor repair or replace stucco as necessary.

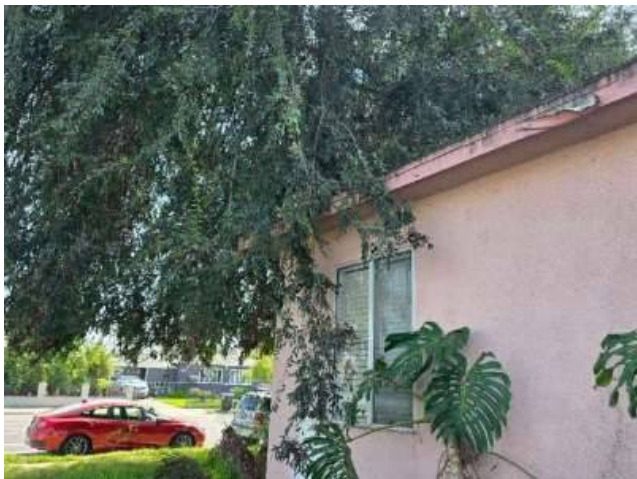
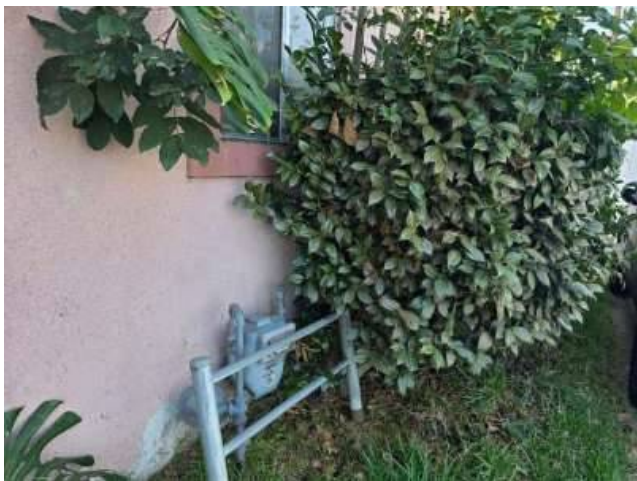
13) 🚧 Vegetation such as trees, shrubs and/or vines was in contact with or close to the building exterior. Vegetation can serve as a pathway for wood-destroying insects and can retain moisture against the exterior after it rains. This is a conducive condition for wood-destroying organisms. Recommend pruning, moving or removing vegetation as necessary to maintain at least 6 inches of space between it and the building exterior. A 1-foot clearance is better.

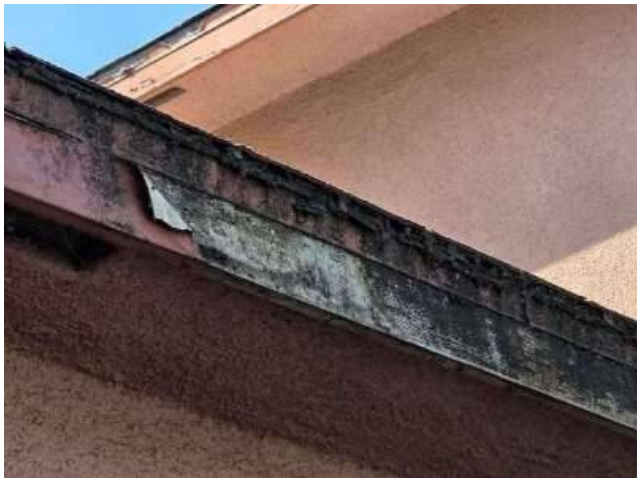
Photo 14-1

14) 🚧 The paint or stain finish in some areas was failing (e.g. peeling, faded, worn, thinning). Siding and trim with a failing finish can be damaged by moisture. Recommend that a qualified contractor prep (e.g. clean, scrape, sand, prime, caulk) and repaint or restrain the building exterior where necessary and per standard building practices. Any repairs needed to the siding or trim should be made prior to this.

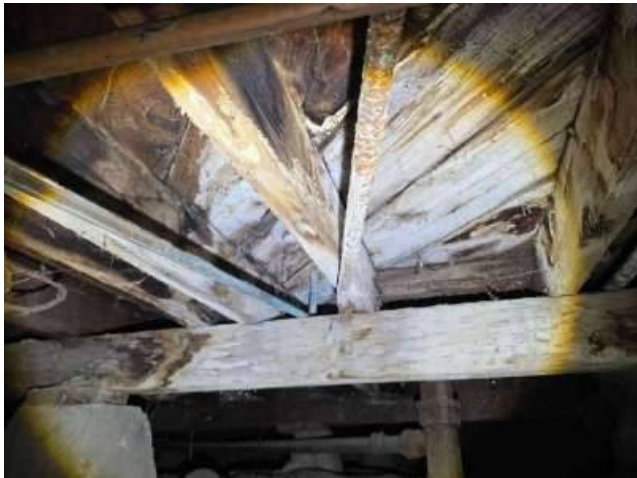
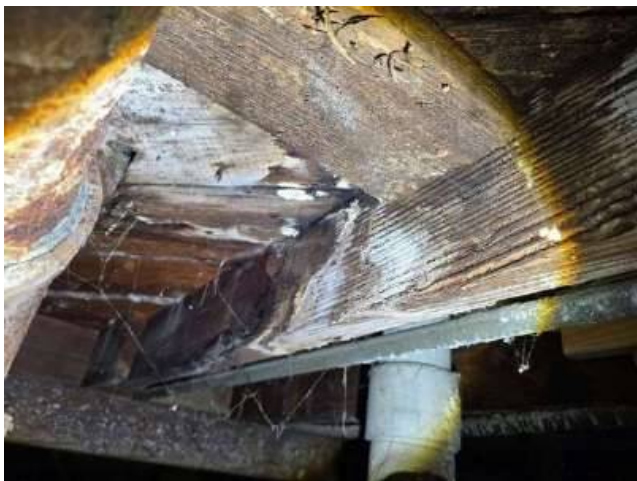
16) Fungal rot was found at one or more beams and/or sections of floor sheathing. Recommend that a qualified contractor evaluate and repair as necessary. All rotten wood should be replaced.

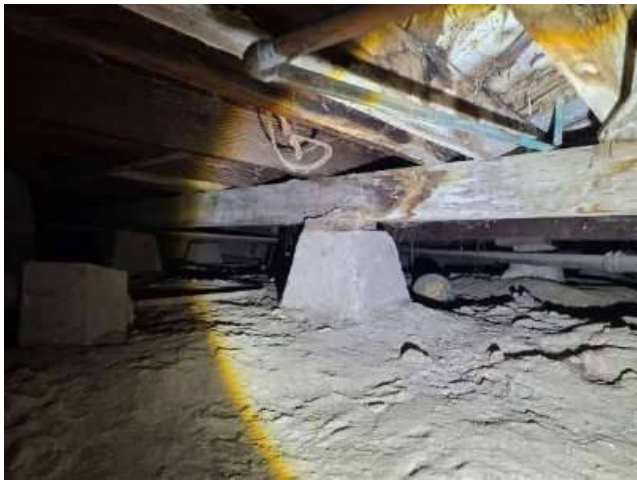
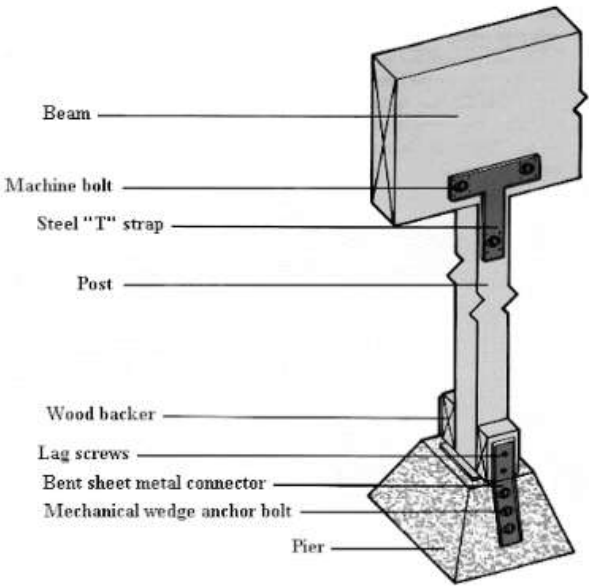
17) Many support posts were not positively secured to the beam above. While this is common in older homes, current standards require positive connections between support posts and beams above for earthquake reinforcement. Recommend that a qualified contractor repair per standard building practices. For example, by installing metal plates, plywood gussets or dimensional lumber connecting posts and beams.

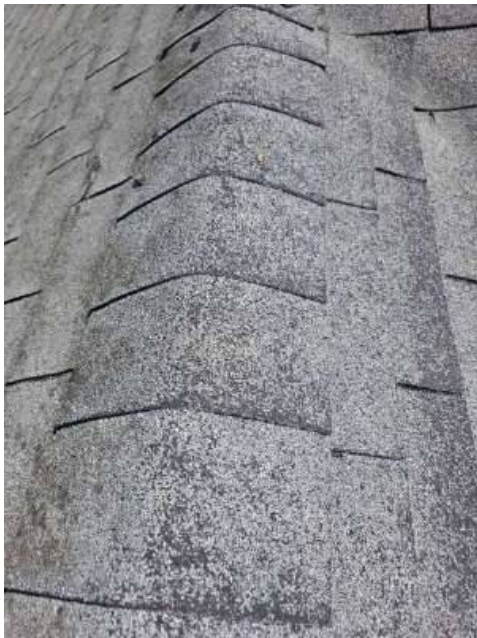
Photo 20-1

Many composition shingles were damaged and/or deteriorated. Leaks can occur as a result. This is a conducive condition for wood-destroying organisms. Recommend that a qualified contractor repair as necessary. For example, by replacing shingles.

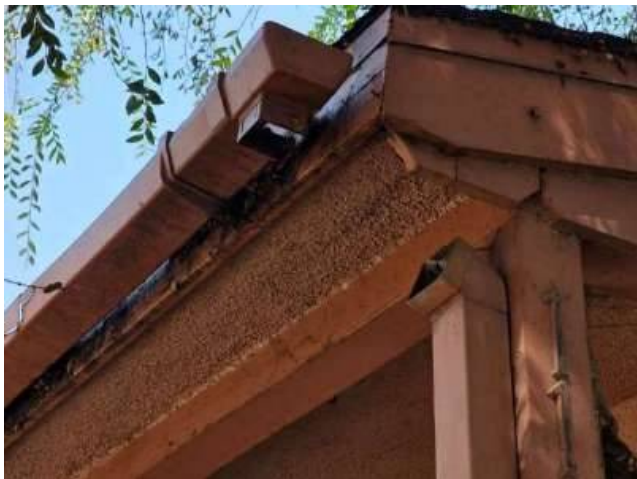
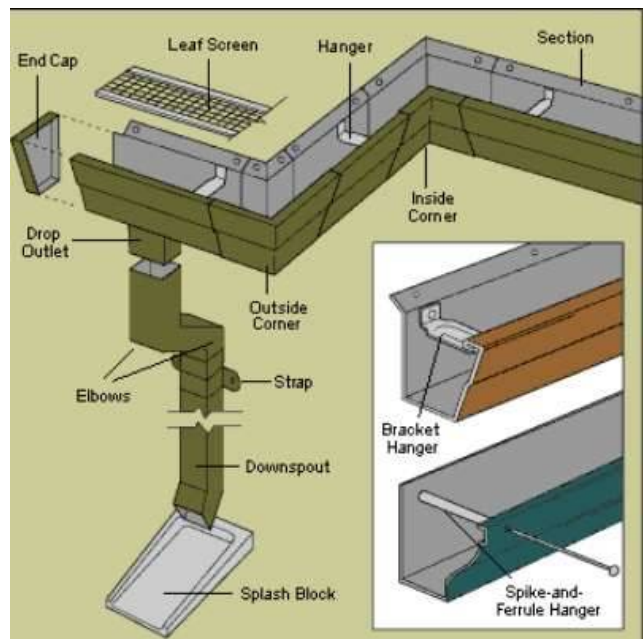
The roof drainage system was incomplete. Gutters, downspouts and extensions were missing from one or more roof sections. Rainwater may come in contact with the building exterior or accumulate around the building foundation as a result. This can be a conducive condition for wood-destroying organisms. Recommend that a qualified contractor install roof drainage components where missing per standard building practices.

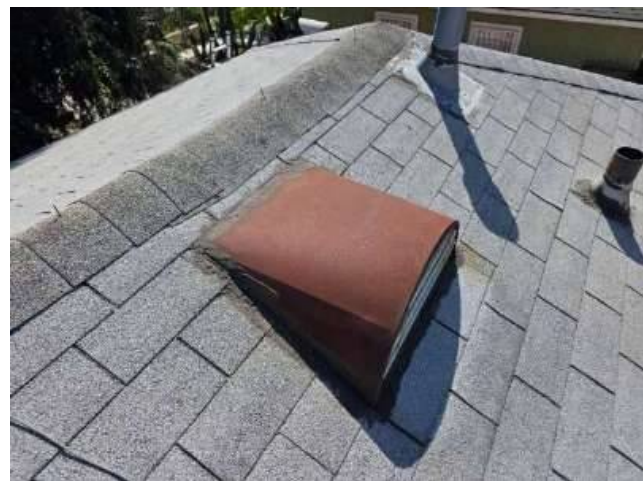
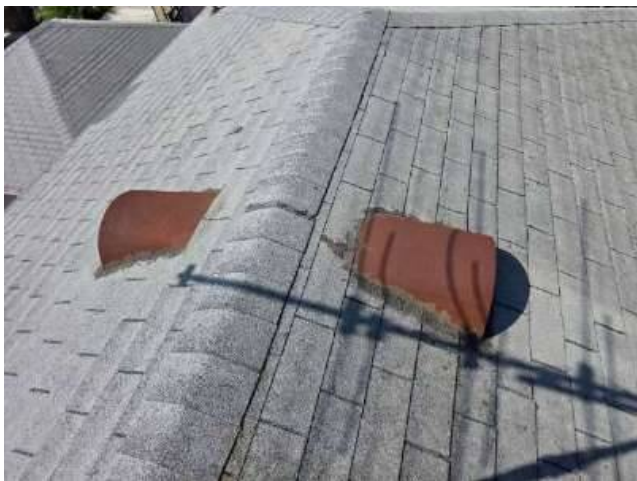
22) One or more roof-top appurtenances such as vents, sheet metal on chimney structures, masts, pipes, etc. were rusty or corroded. Metal may deteriorate to the point of needing replacement. Leaks can occur around such items if flashing or sealant doesn't form a waterproof seal with the corroded metal. This can be a conducive condition for wood-destroying organisms. Recommend that a qualified person repair as necessary. For example, by cleaning rust and repainting with a rust-inhibiting paint.

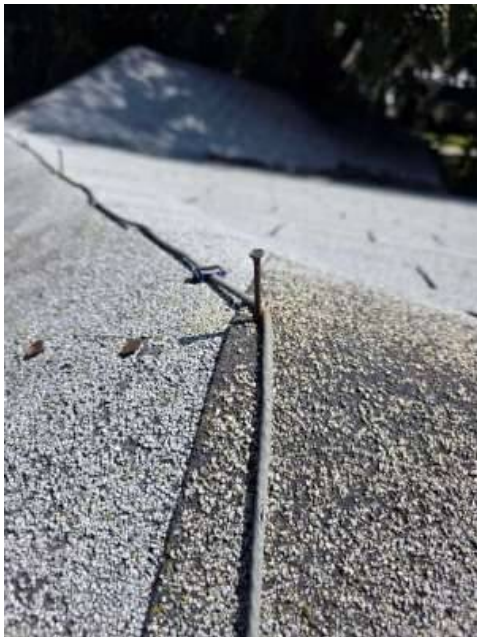
Photo 23-1

23) One or more roofing nails weren't fully seated and shingles were lifting or nail heads were protruding through shingle surfaces. The nails may have loosened, or were not pounded in fully when installed. Shingles are likely to be wind damaged, and leaks can occur as a result. This is a conducive condition for wood-destroying organisms. Recommend that a qualified contractor repair as necessary. For example, by replacing shingles.

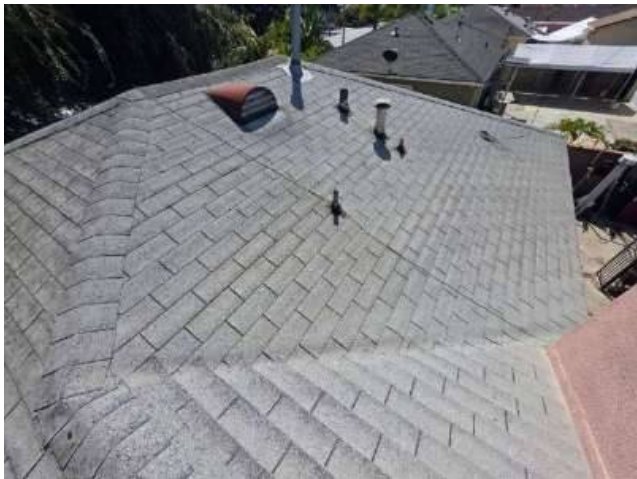
Photo 24-1

The roof surface appeared to be near the end of its service life and will likely need replacing in the near future even if repairs are made now. Recommend discussing replacement options with a qualified contractor, and budgeting for a replacement roof surface in the near future. The client may also wish to consider having a qualified contractor attempt to issue a "5 year roof certificate."

\*Roof overview.

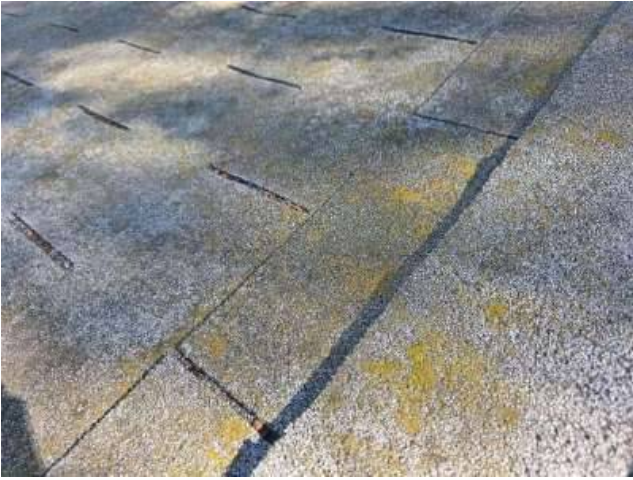
Photo 27-1

Moss was growing on the roof. As a result, shingles can lift or be damaged. Leaks can result and/or the roof surface can fail prematurely. Efforts should be made to kill the moss during its growing season (wet months). Typically, zinc or phosphate-based chemicals are used for this and must be applied periodically. For information on various moss treatment products and their pros and cons, visit:

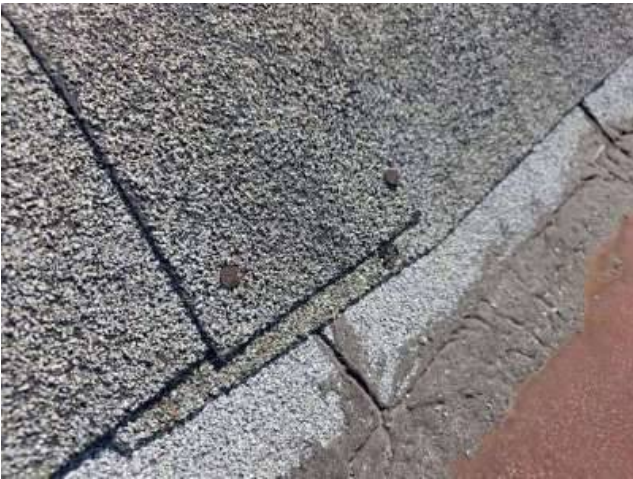
Photo 28-1

28) 🛠️ Nail heads were exposed at one or more shingles. Recommend applying an approved sealant over exposed nail heads now and as necessary in the future to prevent leaks.

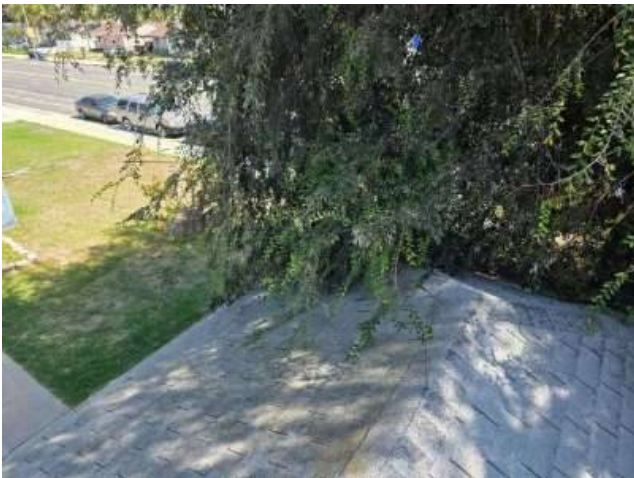
**Photo 30-1**

Vegetation such as trees, shrubs, and/or vines overhung the roof surface or were in contact with the roof edge. Organic debris such as leaves or needles are likely to accumulate in gutters and on the roof surface. Gutters can overflow and cause water to come in contact with the building exterior or water can accumulate around the foundation. This is a conducive condition for wood-destroying organisms. Vegetation in contact with the roof can damage the roof surface and/or the roof drainage system. Recommend pruning vegetation so as to not be in contact with the roof and to not overhang the roof surface. If vegetation is too tall then it should be pruned at least 10 feet above the roof surface.

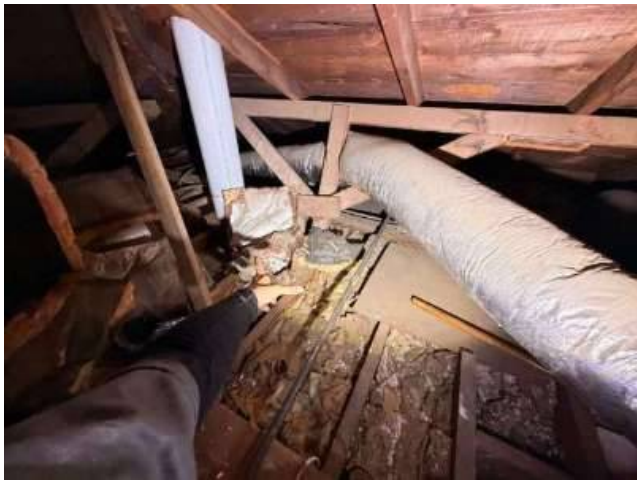
Photo 33-1

The ceiling insulation installed in the attic was substandard and appeared to have an R rating that's significantly less than current standards (R-38). Heating and cooling costs will likely be higher due to poor energy efficiency. Recommend that a qualified contractor install insulation for better energy efficiency and per standard building practices.

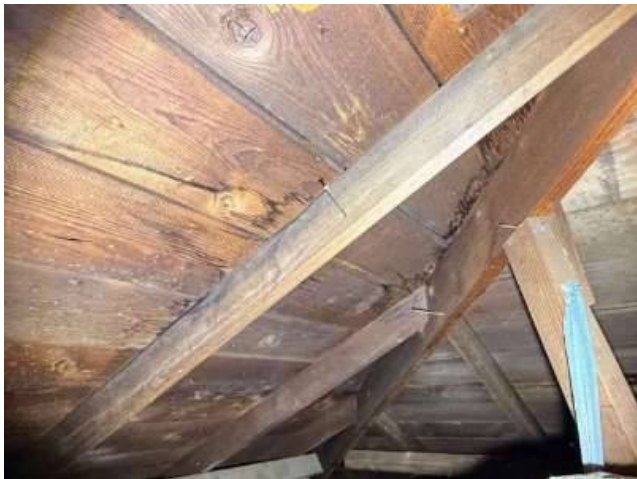
Photo 34-1

What appeared to be past water stains were visible on the roof structure at one or more locations in the attic. The stains may have been caused by a past leak. Recommend asking the property owner about past leaks. Monitor these areas in the future, especially after heavy rains to determine if active leaks exist. If leaks are found, recommend that a qualified contractor evaluate and repair as necessary.

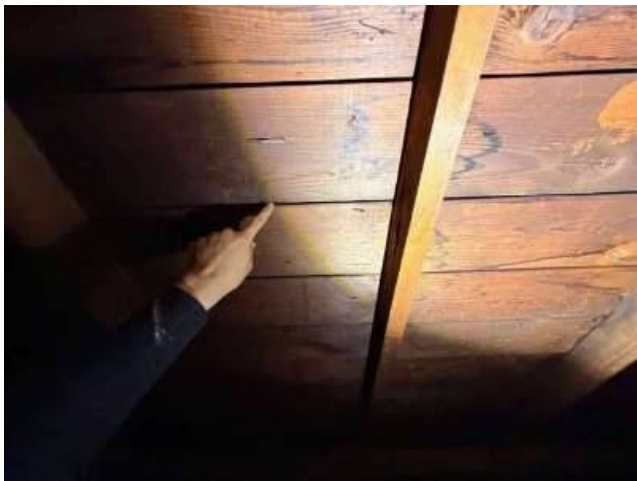
Photo 35-1

Gaps were present between one or more roof decking planks. if plank decking has more than a 1/8" gap between the planks, your roof decking must be replaced per the manufacturer's installation instructions before the roofing material can be installed. If your roofing contractor finds a gap larger than 1/8", the boards will need to be replaced after your old roof is torn off. Recommend having a qualified roofer further evaluate to determine if roof decking needs to be repaired.

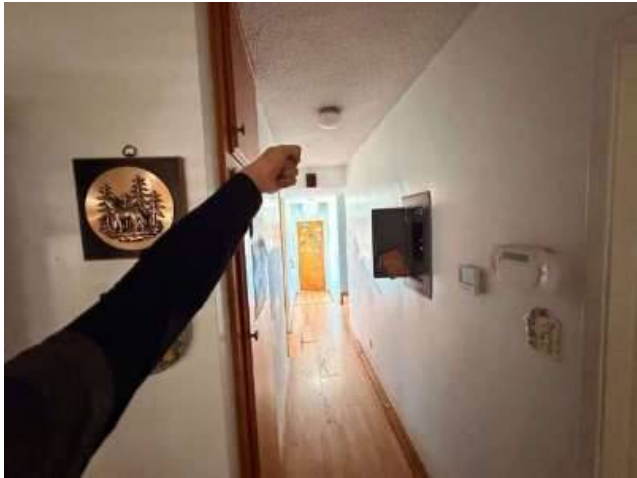
Photo 39-1

39) 🚒 No permanently installed smoke alarms were found. This is a potential safety hazard. A qualified electrician should install smoke alarms per standard building practices (e.g. in hallways leading to bedrooms, in each bedroom, on each floor and in attached garages). For more information, visit: <https://www.reporthost.com/?SMKALRM>

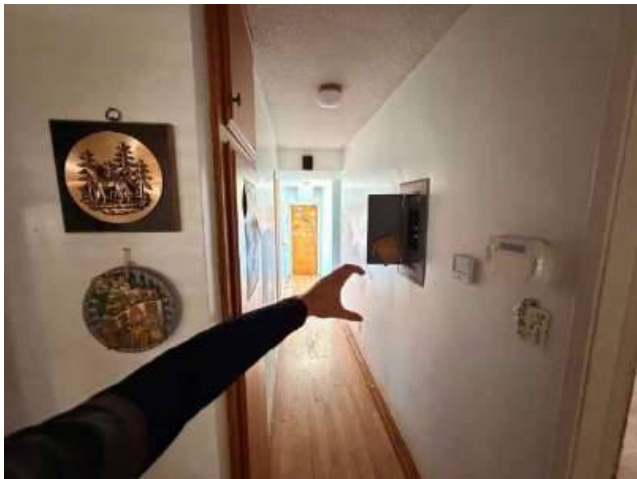
Photo 41-1

No permanently installed carbon monoxide alarms were found. This is a potential safety hazard. Some states and/or municipalities require CO alarms to be installed for new construction and/or for homes being sold. Recommend installing approved CO alarms outside of each separate sleeping area in the immediate vicinity of the bedrooms on each level and in accordance with the manufacturer's recommendations. For more information, visit: <https://www.reporthost.com/?COALRM>

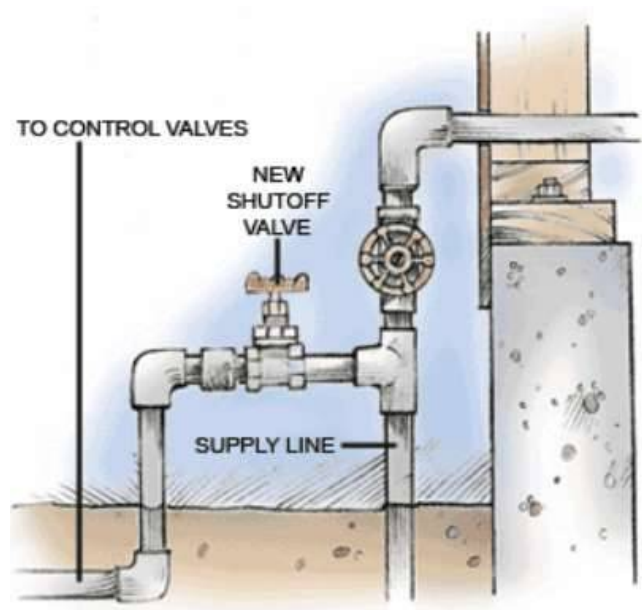
Photo 51-1

51) The inspector did not determine the location of the main water shut-off valve, or verify that a readily accessible shut-off valve in the building exists. Recommend consulting with the property owner to determine if a main shut-off valve exists, locating it yourself, or that a qualified plumber find it if necessary. If no readily accessible main shut-off valve is found in the building, then recommend that a qualified plumber install one so the water supply can be quickly turned off in the event of an emergency, such as when a supply pipe bursts.

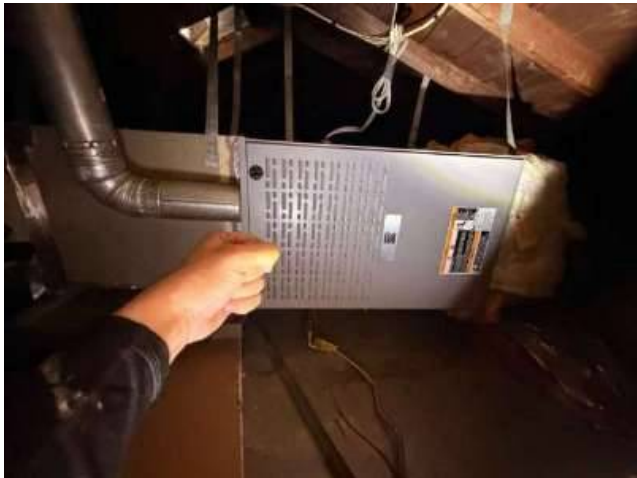
Photo 54-1

54) 🔧🔍📘 The furnace heating system was not fully evaluated because the thermostat was inoperable. Recommend that a full evaluation be made by a qualified person when conditions have been corrected so the system is operable. Note that the inspector does not operate shut-off valves, pilot lights or circuit breakers, or any controls other than normal controls (thermostat).

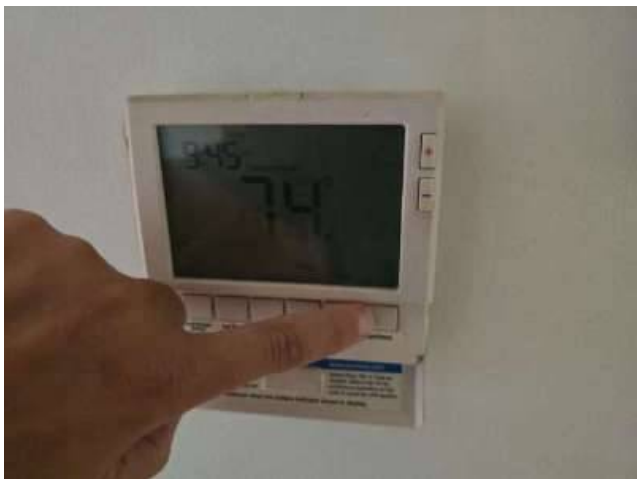
Photo 55-1

\*wouldn't allow to set to heat or cool

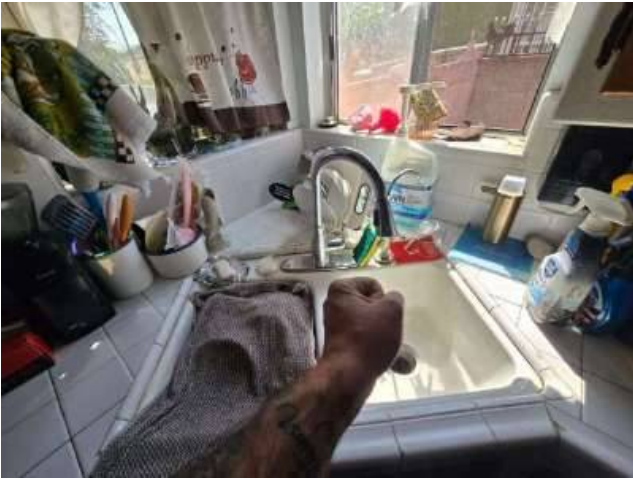
Photo 56-1

The water supply for the sink was inoperable (e.g. turned off, not plugged in, circuit breaker off) and the inspector was unable to fully evaluate. Repairs may be needed. If concerned, have a qualified person fully evaluate.

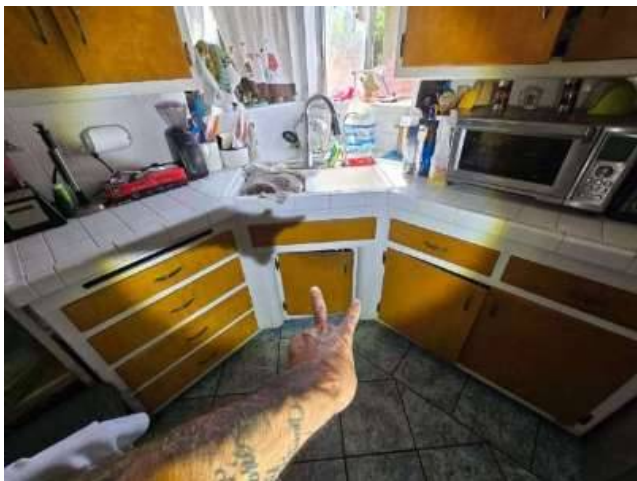
Photo 58-1

One or more cabinets, drawers and/or cabinet doors were damaged or deteriorated. Recommend that a qualified person repair or replace as necessary.

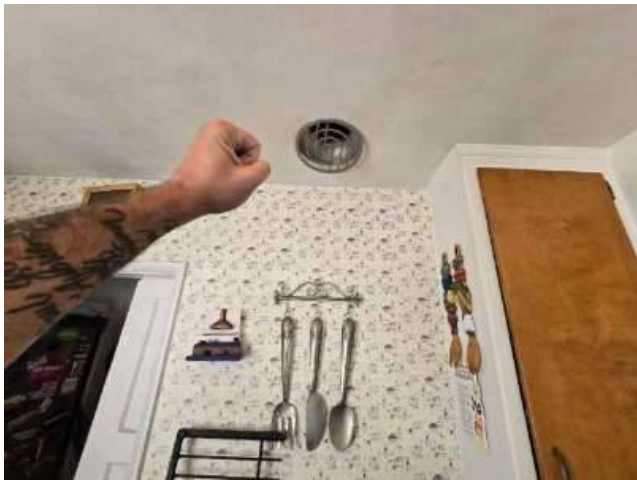
Photo 59-1

59) The cooktop exhaust fan was inoperable. Recommend that a qualified person repair or replace as necessary.

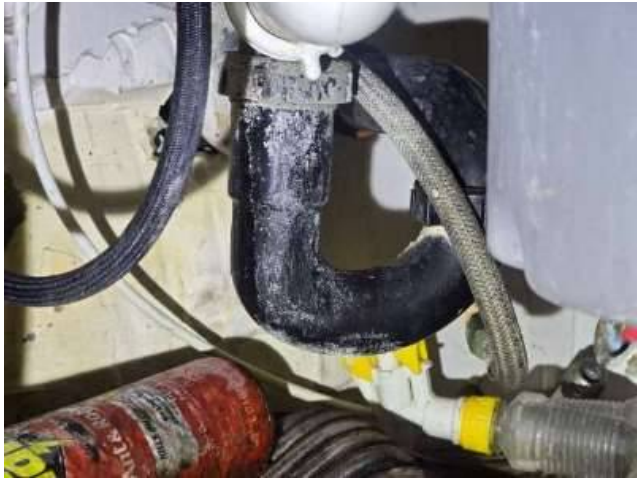
Photo 60-1

60) Rust and corrosion was found at water supply lines and drain lines under the sink. Recommend having a qualified person repair as well.

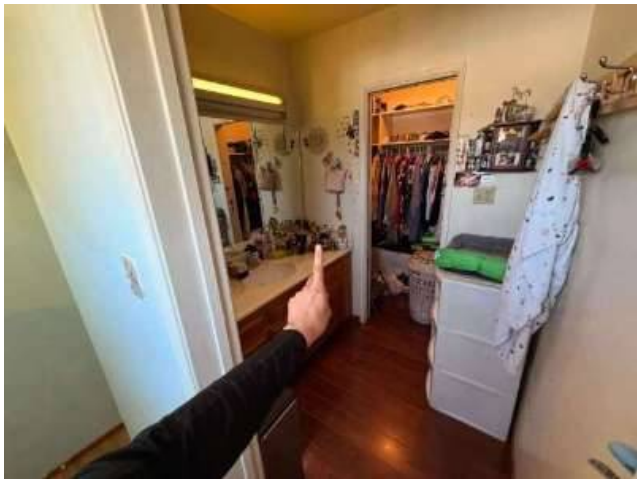
Photo 62-1

**62)** The water supply was inoperable or there was no water flow at the sink, toilet, bathtub and/or shower at location(s) #A and B. As a result the inspector was unable to fully evaluate. Shut-off valve(s) may be turned off, or repairs may be needed. Recommend asking the property owner about this if possible, and that a qualified plumber evaluate and repair if necessary.

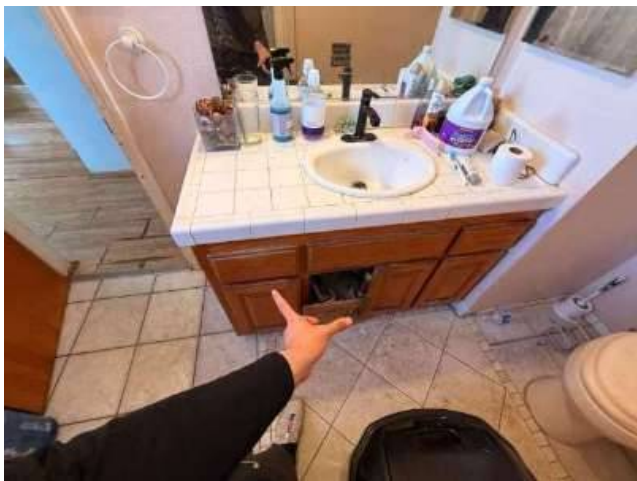
Photo 63-1

One or more cabinets, drawers and/or cabinet doors at location(s) #B were damaged or deteriorated. Recommend that a qualified person repair or replace as necessary.

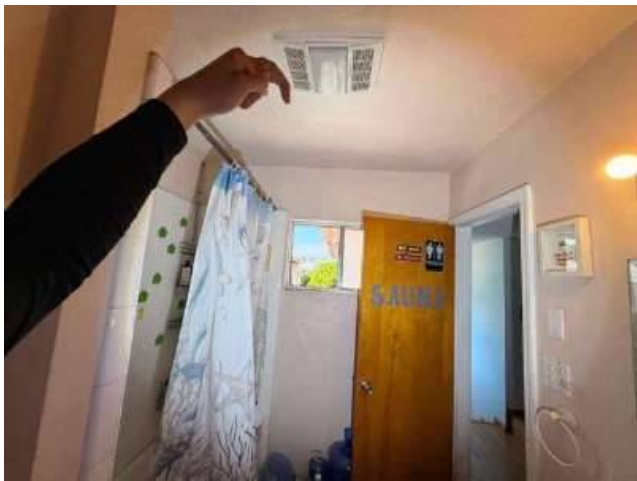
Photo 64-1

The exhaust fan at location(s) #B was noisy or vibrated excessively. Moisture may accumulate and result in mold, bacteria or fungal growth. Recommend that a qualified person clean, repair or replace fans as necessary.

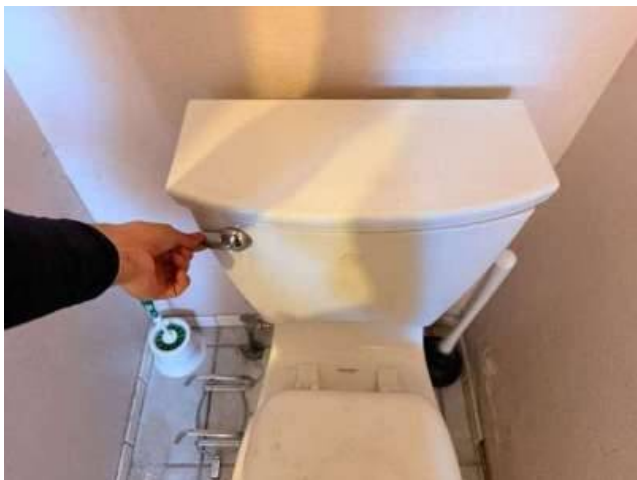
Photo 65-1

The toilet flush mechanism was loose or damaged at bathroom location(s) #B. Recommend having a qualified person repair or replace as necessary.

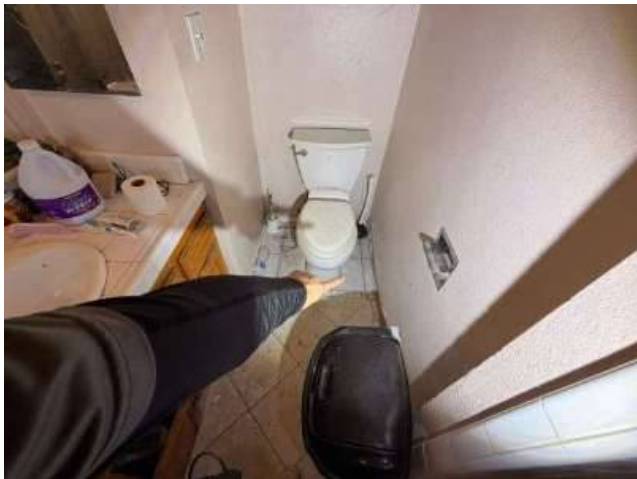
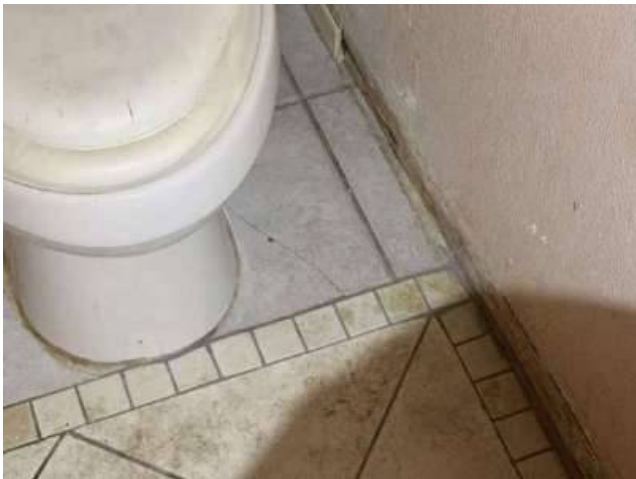
Tile, stone and/or grout in the flooring at location(s) #B was deteriorated (e.g. loose or cracked tiles, missing grout) or substandard. Water can damage the sub-floor as a result. Recommend that a qualified contractor repair as necessary.

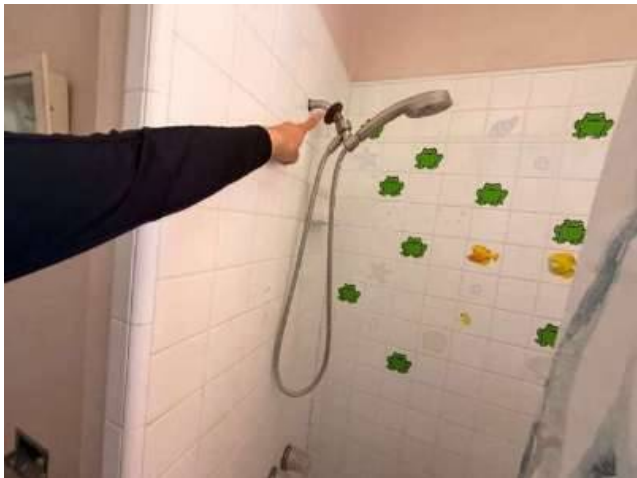
Photo 67-1

67) 🧰 The shower head wall plate at location(s) #B was loose, missing or damaged. Recommend that a qualified person repair as necessary.

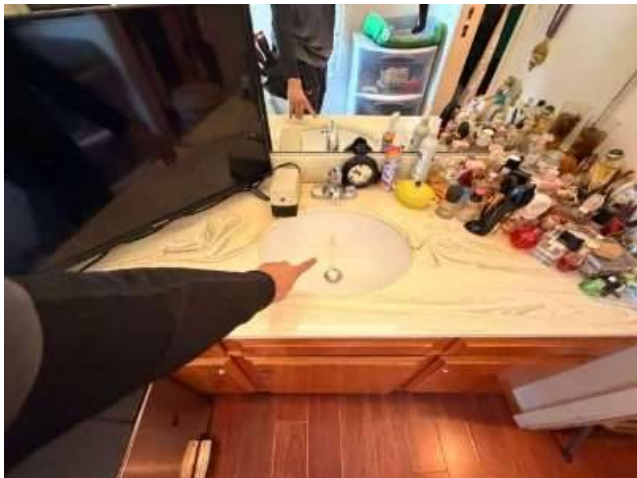
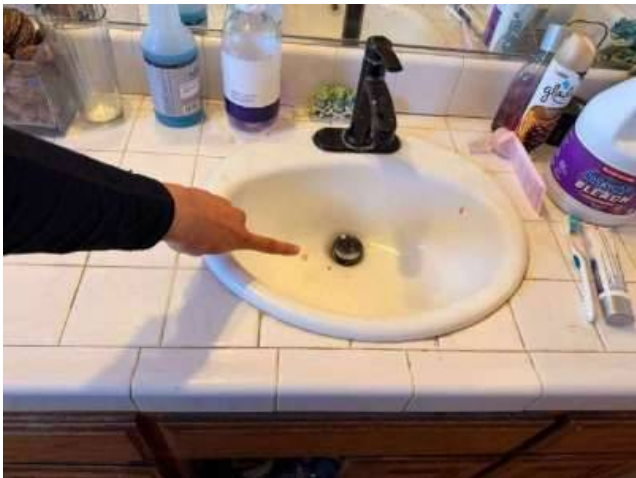
68) 🧰 ⓘ The sink at location(s) #A and B was worn, blemished or deteriorated.

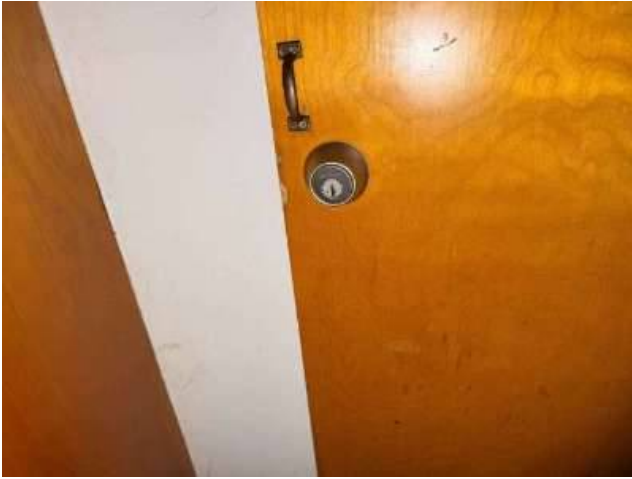
Photo 71-1

One or more interior doors had a keyed lockset or deadbolt installed. This is a safety hazard for small children in the event that they lock themselves in the room, do not know how to unlock the door, and the key is not available. Recommend that a qualified person replace keyed locksets and/or deadbolts with "privacy" locksets (no key required) as necessary.

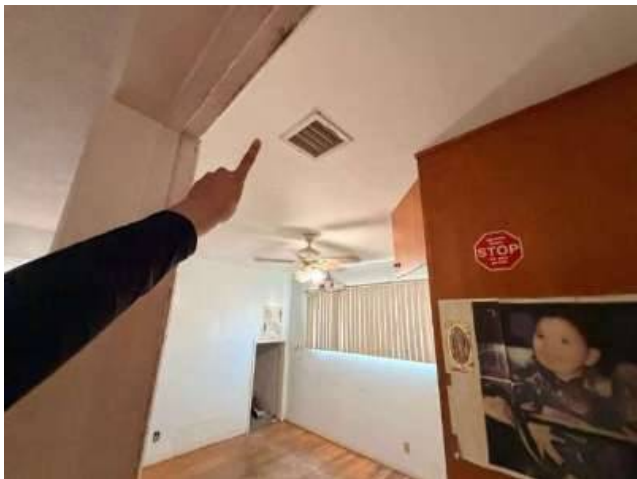
Photo 74-1

74) This structure appears to have settled, based on the presence of cracks in walls, ceilings. Recommend that a qualified contractor and/or engineer evaluate further. Significant repairs may be needed. If so, a qualified contractor should make repairs.

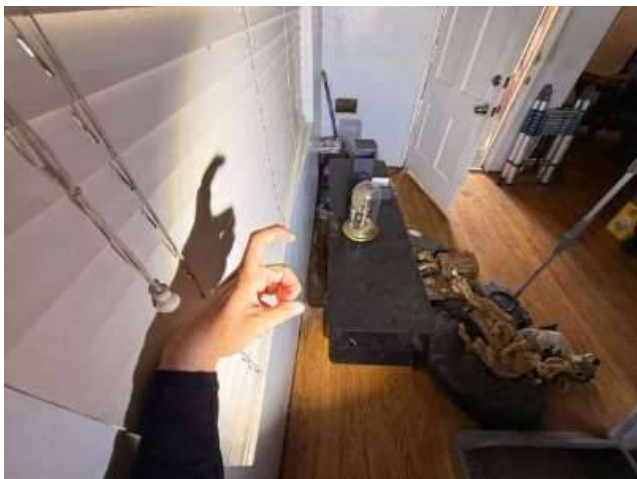
Photo 76-1

76) 🔧🔍 Fungal rot was found at one or more locations. Conductive conditions for rot should be corrected (e.g. wood-soil contact, reverse perimeter slope). Recommend that a qualified contractor repair as necessary. All rotten wood should be replaced.

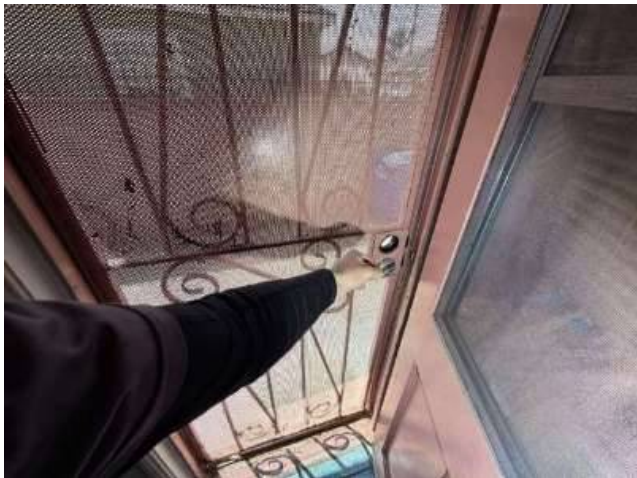
Photo 77-1

Some exterior door hardware, including locksets were missing. Recommend that a qualified person repair or replace as necessary.

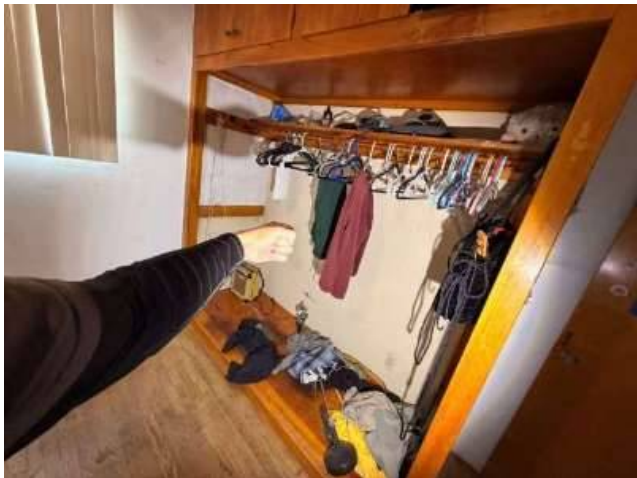
Photo 78-1

One or more interior doors were missing. Recommend that a qualified person replace or repair doors as necessary.

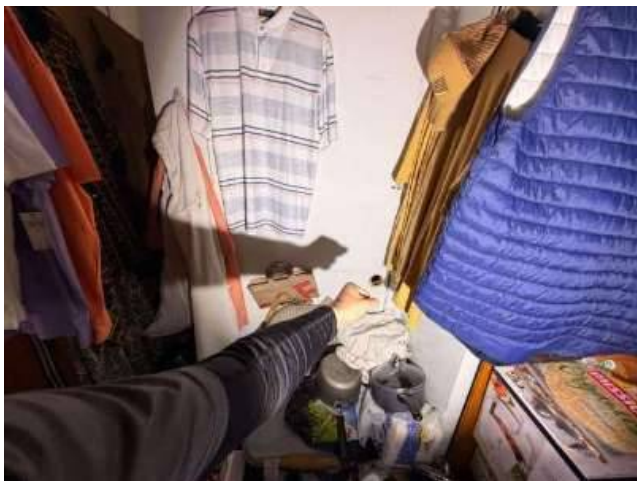
Photo 79-1

Some interior door hardware (locksets) were missing. Recommend that a qualified person repair or replace as necessary.

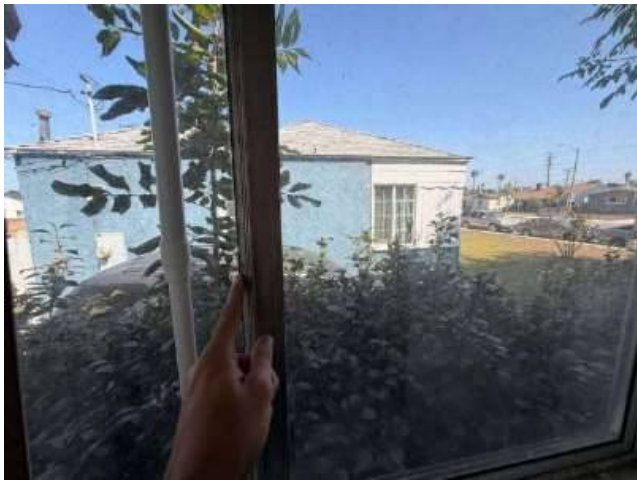
Photo 80-1

Lock mechanisms on one or more windows were missing. This can pose a security risk. Recommend that a qualified person repair as necessary.

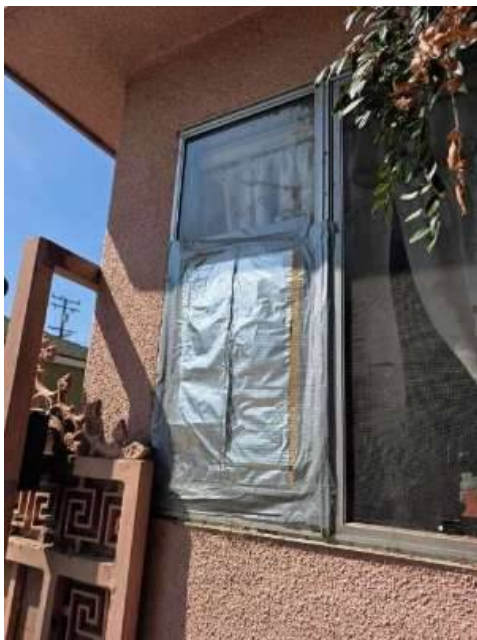
Photo 81-1

Glass in one or more windows was cracked, broken and/or missing. Recommend that a qualified contractor replace glass where necessary.

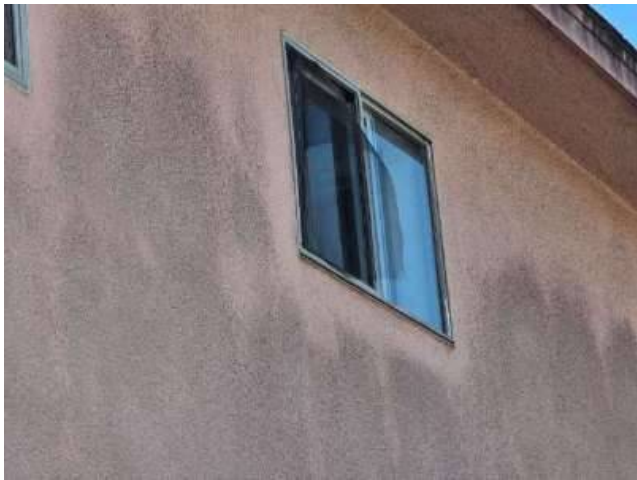
Photo 82-1

One or more window screens were damaged or deteriorated. These window(s) may not provide ventilation during months when insects are active. Recommend replacing window screens as necessary.

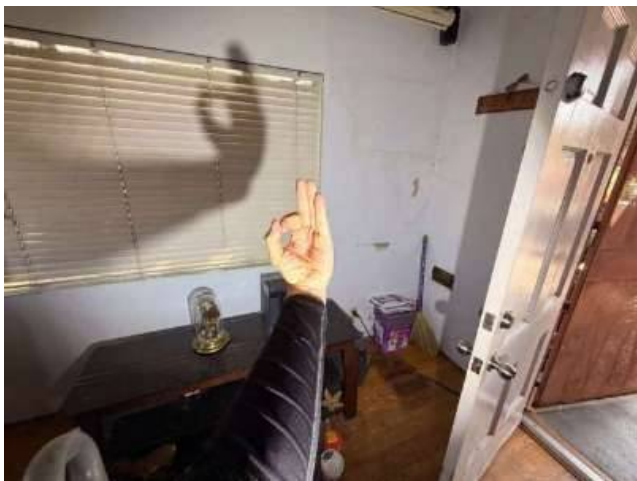
Photo 83-1

One or more walls were damaged. Recommend that a qualified person repair as necessary.

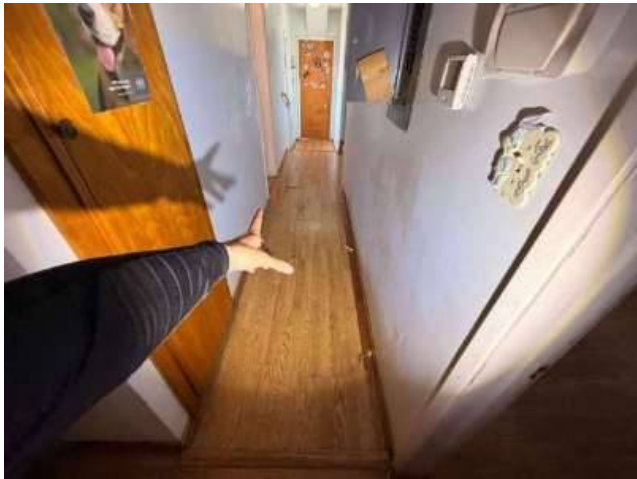
Photo 84-1

Laminate, vinyl, linoleum or marmoleum flooring in one or more areas was damaged and/or deteriorated. If in a wet area, water can damage the sub-floor as a result. Recommend that a qualified contractor replace or repair flooring as necessary.

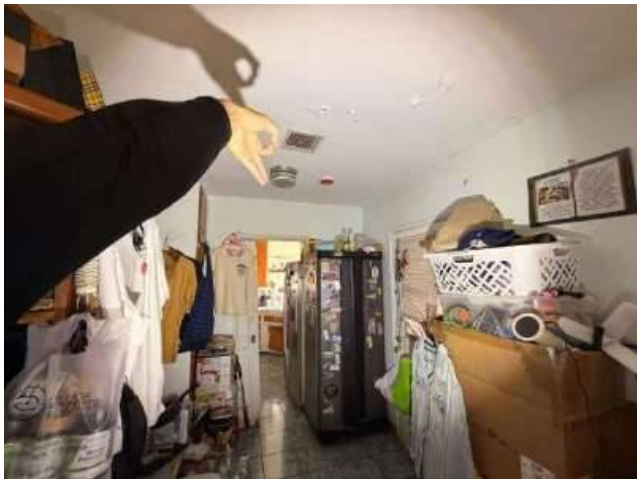
Photo 88-1

88) 🛠️ Paint was chipping, bubbling or peeling at one or more areas. Recommend having a qualified person repair as necessary.

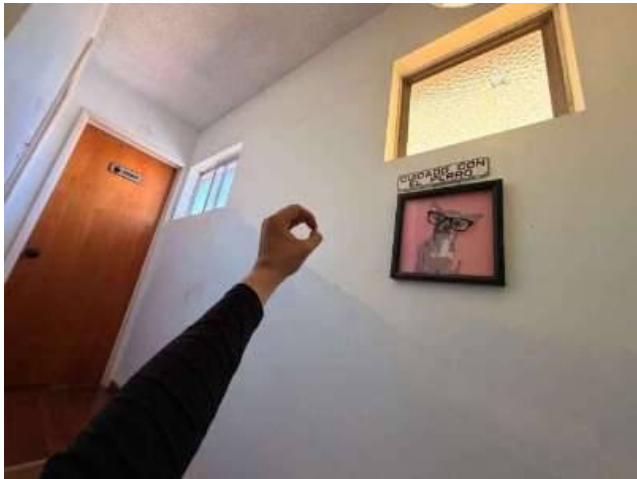
Photo 89-1

Many windows used single-pane glass. Single-pane windows are prone to sweating and are one of the largest sources of heat loss in winter and heat gain in the summer due to their low insulating ability and high air leakage rates. Consider replacing single-pane windows with multi-pane windows.
