# ***Cornerstone Inspection***

## **Property Inspection Report**

***1870 S Elm St, Oceano, CA 93445***

***Date of Inspection: 8/22/2026 Time: 9:00 AM***

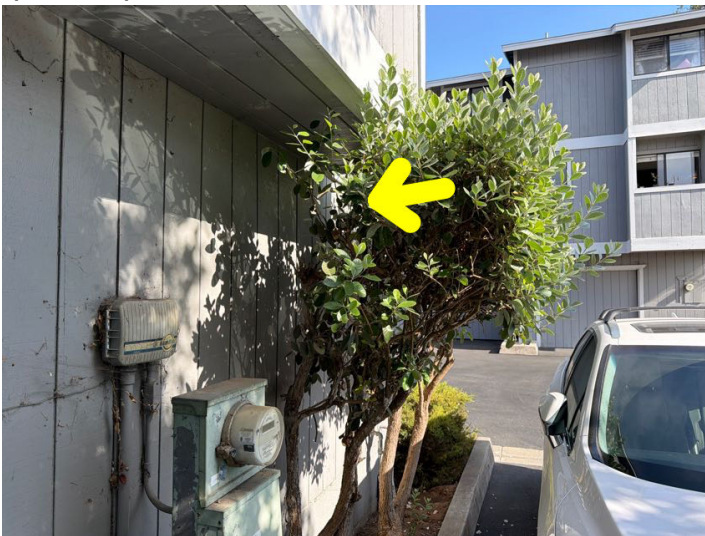
Vines, shrubs or bushes are growing on the house walls and although they are attractive they can introduce pests and rodents and accelerate deterioration. Therefore, you may wish to consider having them removed or cut back to 12 inches (30 cm) away from the home.

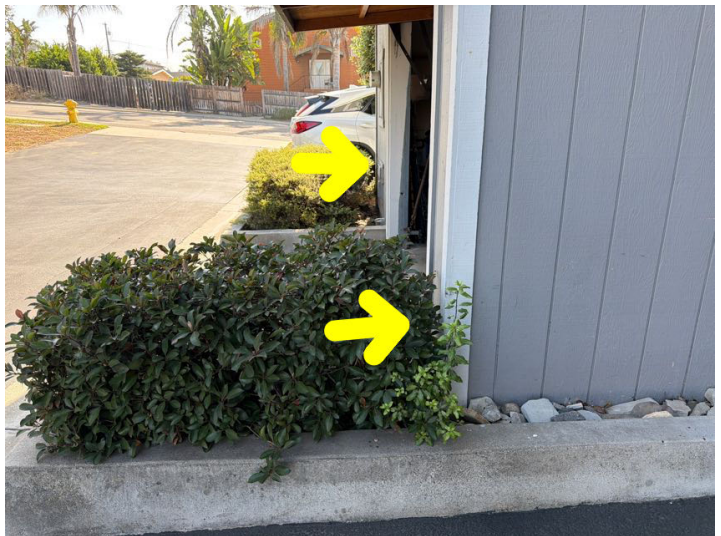
Vines, shrubs or bushes are growing on the house walls and although they are attractive they can introduce pests and rodents and accelerate deterioration. Therefore, you may wish to consider having them removed or cut back to 12 inches (30 cm) away from the home.

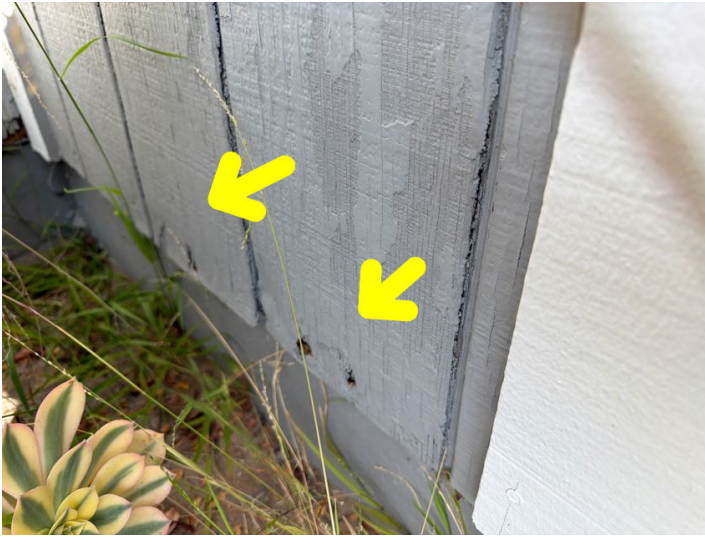
Portions of the siding have dry rot or are moisture damaged, and should be evaluated by a pest inspector.

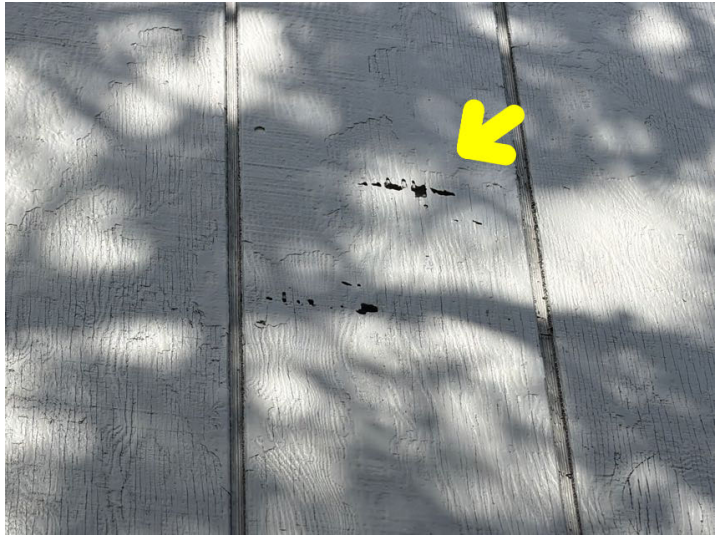
Portions of the siding have dry rot or are moisture damaged, and should be evaluated by a pest inspector.

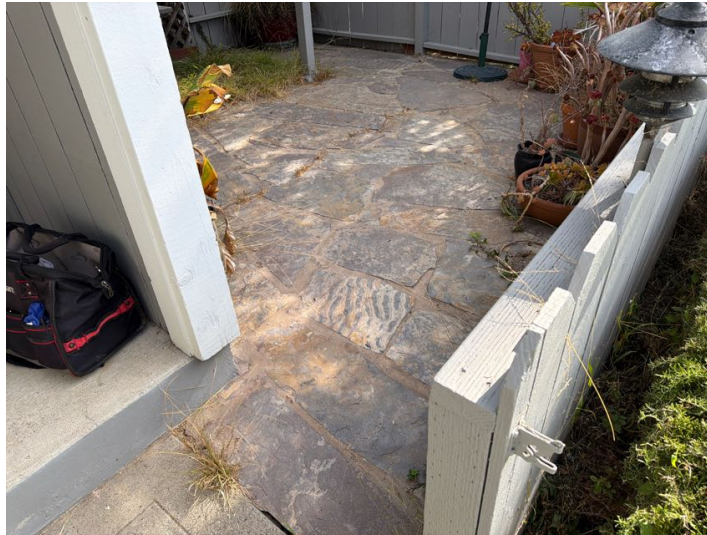
The natural stone patio or walkway has one or more offsets that may prove to be trip-hazards. This may be by design or due to unsuitable soil below the stone.

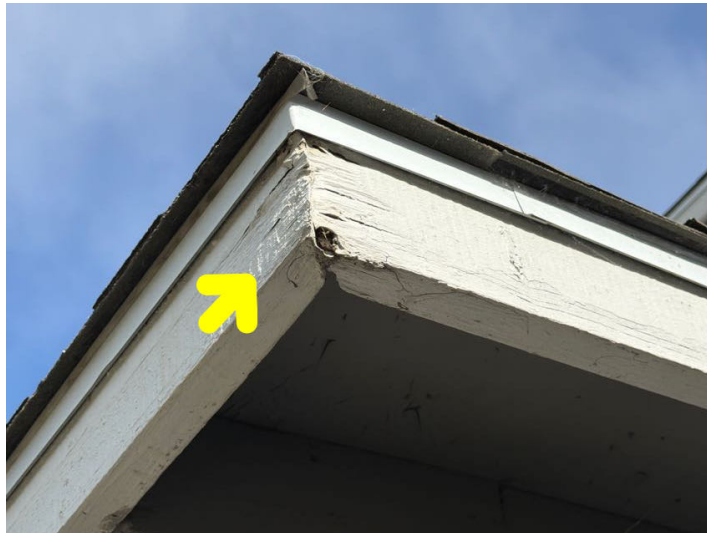
There is damage to the wood trim, fascia, and/or eaves that should be evaluated by a pest inspector.

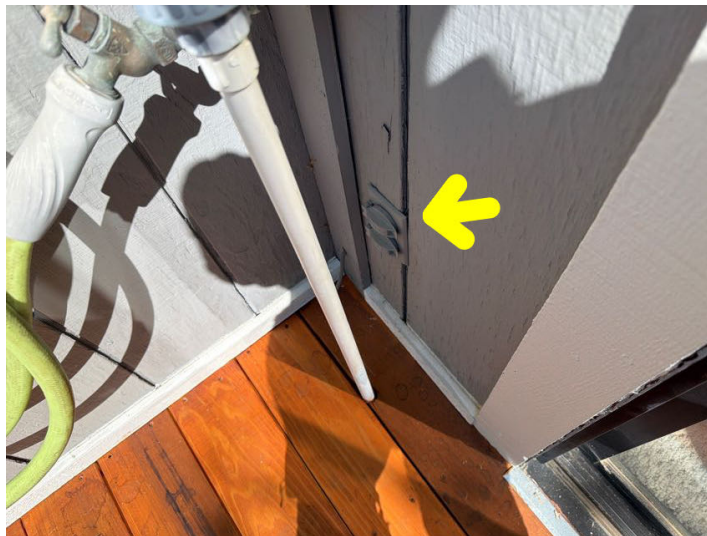
One or more outlets on the deck are not secure and should be evaluated and serviced by a licensed electrical contractor.

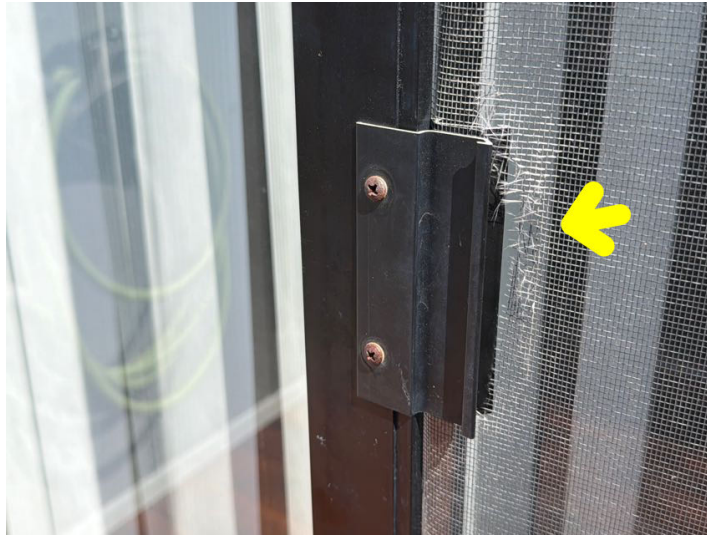
The slider screen is damaged, and you may wish to have it repaired or replaced.

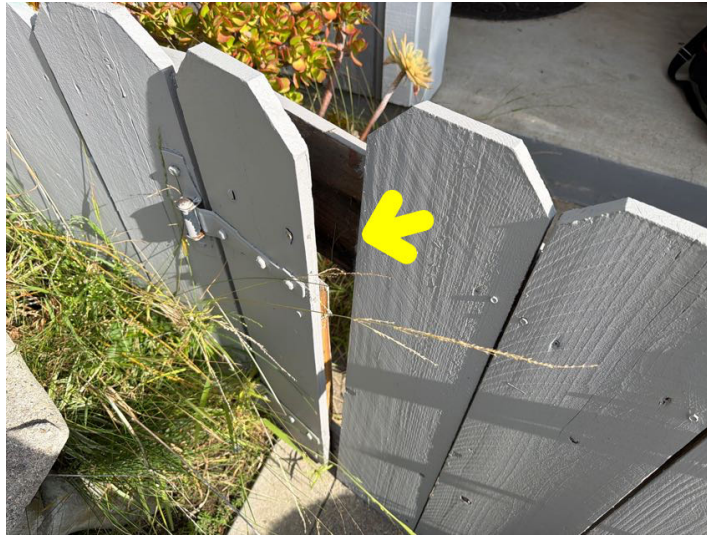
The gate at the front needs to be serviced to be functional.

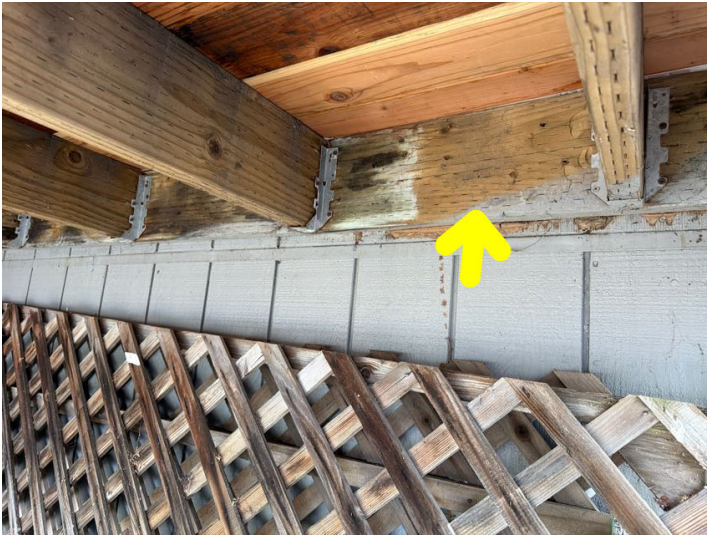
12.2. The ledger board that supports the deck has been improperly attached and should be lag-bolted, structurally screwed or attached per current standards.

The ledger board that supports the deck has been improperly attached and should be lag-bolted, structurally screwed or attached per current standards.

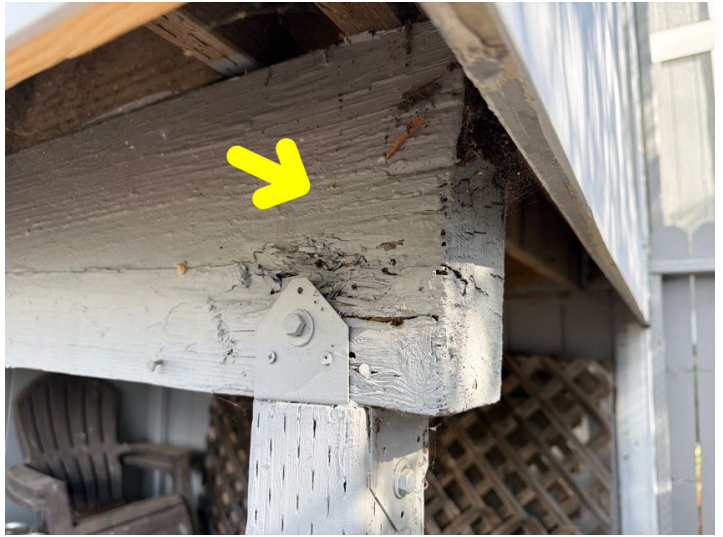
12.1. There is damage to one or more decks that should be evaluated by the pest inspector.

There is damage to one or more decks that should be evaluated by the pest inspector.

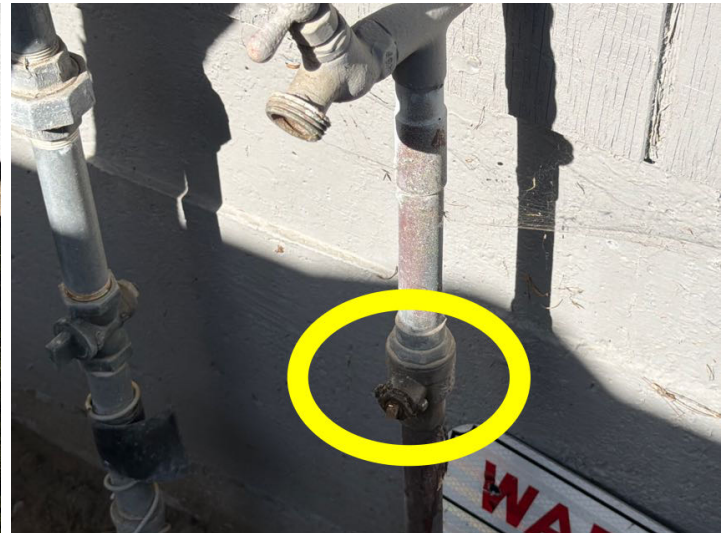
1.3. The main water shut off valve handle is missing and it should be replaced.

The main water shut off valve handle is missing and it should be replaced.

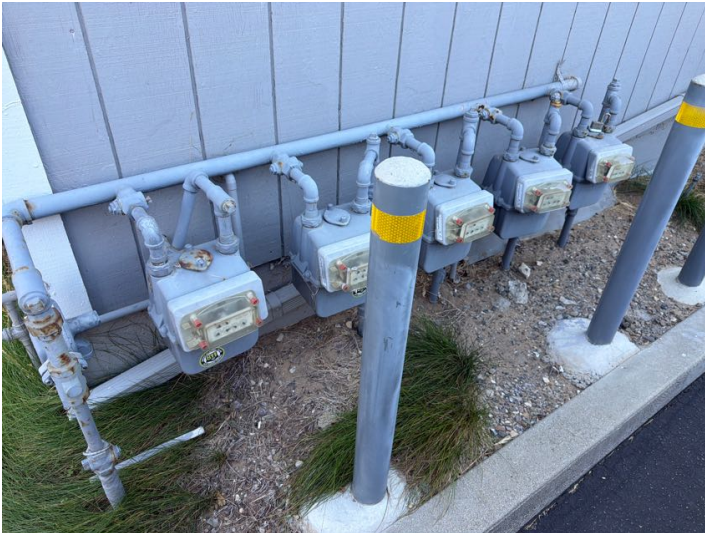
We were unable to determine which gas main shut-off valve is for your unit. It should be identified and disclosed to you, in case there's need for an emergency shut-off of the gas.

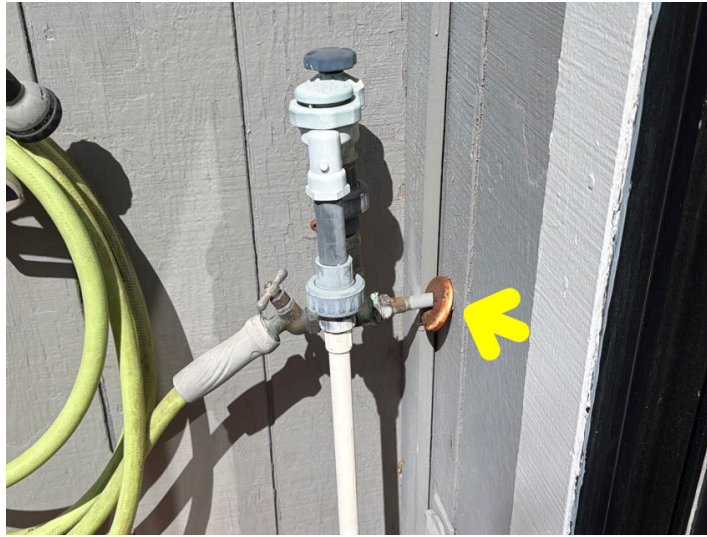
3.3. A hose bib on the deck is not fully secured and should be serviced by a qualified plumbing contractor.

A hose bib on the deck is not fully secured and should be serviced by a qualified plumbing contractor.

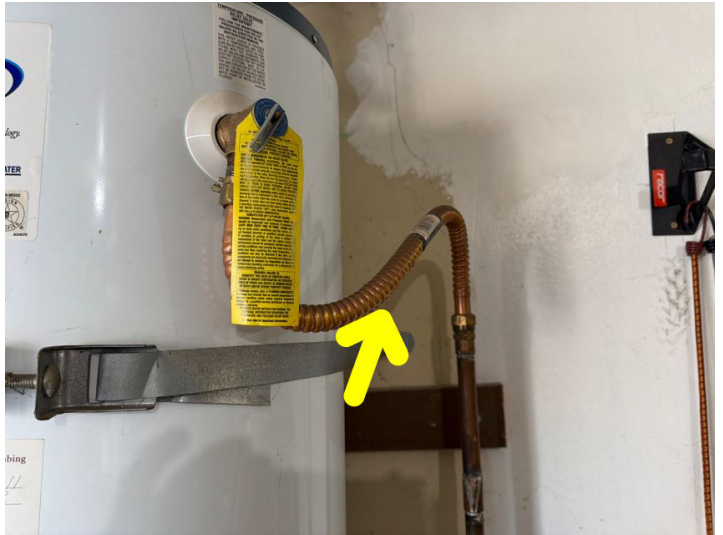
The discharge pipe from the pressure relief valve has been incorrectly plumbed uphill. We recommend an evaluation by a licensed plumber.

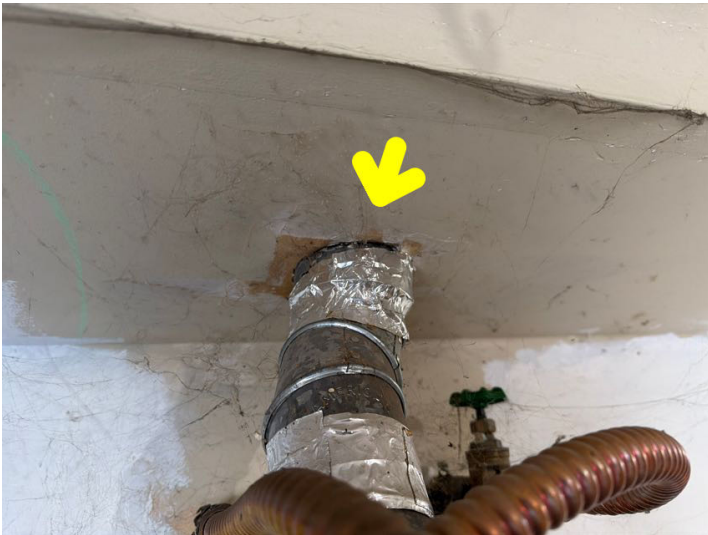
The vent pipe is too close to combustible material, and should be serviced. A single-walled vent pipe should be six inches away from any combustible material, and a double-walled vent pipe should be one inch away.

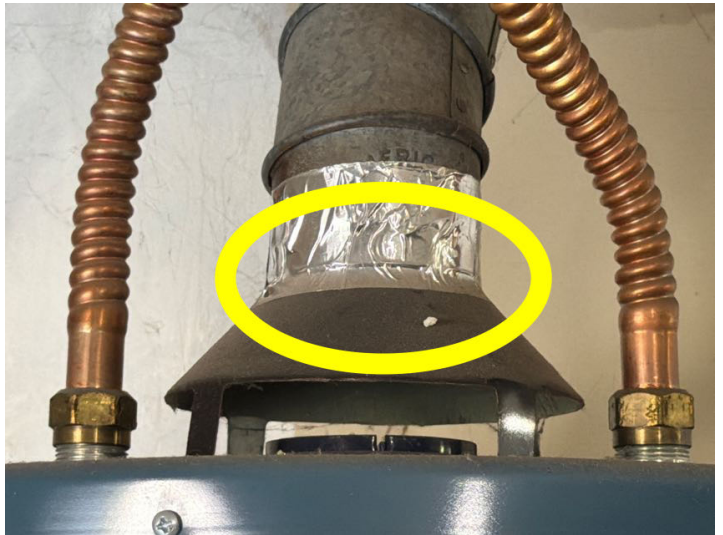
The vent pipe is not properly connected. It is required to have a minimum of 3 fasteners where the pipe connects to the draft hood or other single wall vent pipes.

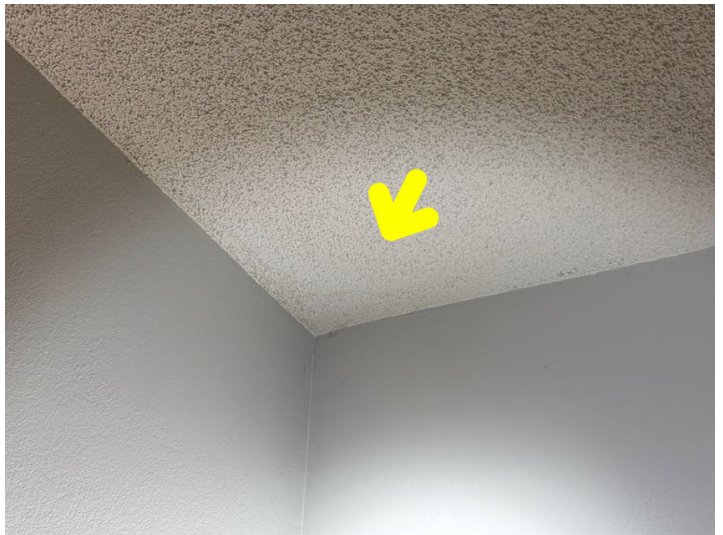
1.2. There is a moisture stain on the ceiling that should be explained or explored further.

There is a moisture stain on the ceiling that should be explained or explored further.

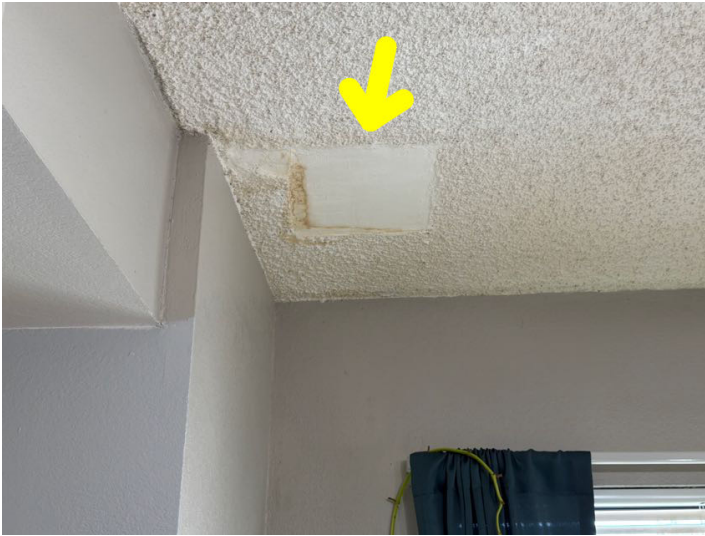
3.3. There has been a drywall/plaster repair that should be explained by the seller.

There has been a drywall/plaster repair that should be explained by the seller.

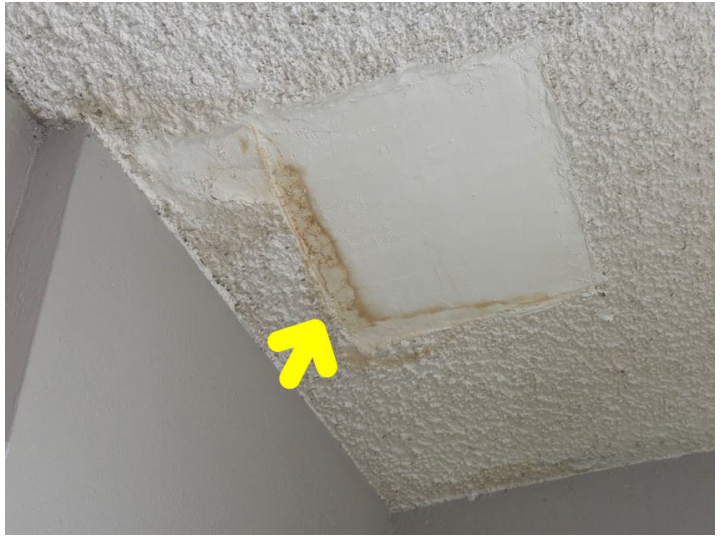
3.4. There is a moisture stain on the ceiling that should be explained or explored further.

There is a moisture stain on the ceiling that should be explained or explored further.

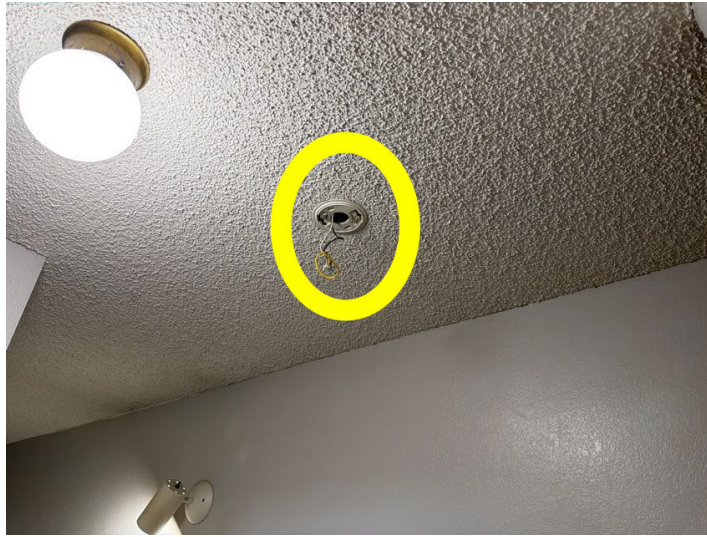
4.2. A pre-wired smoke detector is missing and should be replaced.

A pre-wired smoke detector is missing and should be replaced.

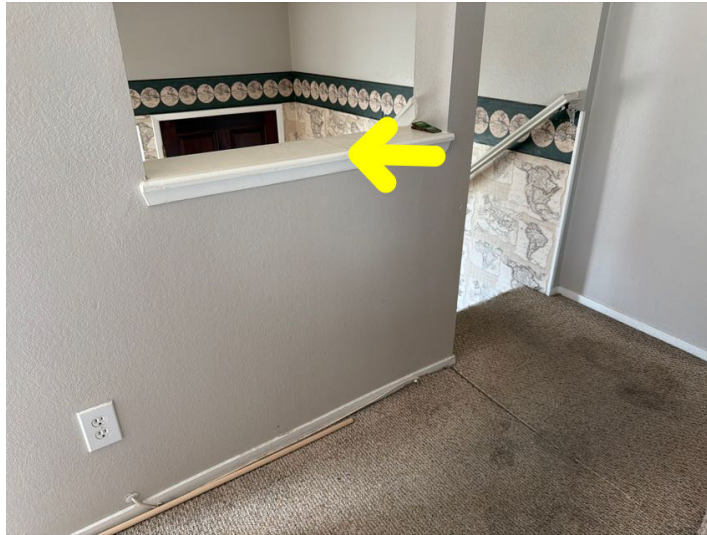
7.1. The guardrail at the top of the stairs is not the recommended 42 inches high when the standing surface is more than 30 inches below.

The guardrail at the top of the stairs is not the recommended 42 inches high when the standing surface is more than 30 inches below.

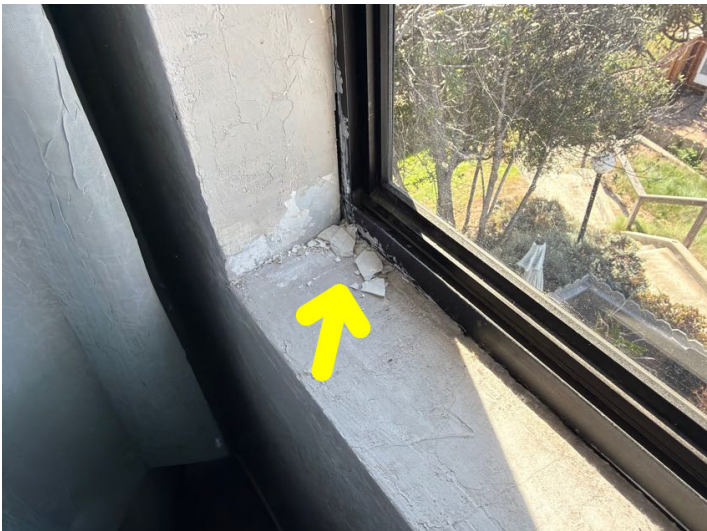
The window sills are cosmetically damaged, which you should view for yourself.

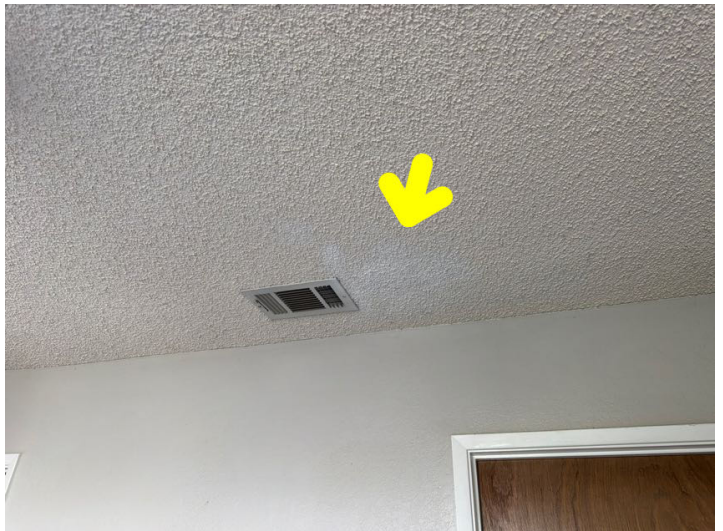
There has been a drywall/plaster repair that should be explained by the seller.

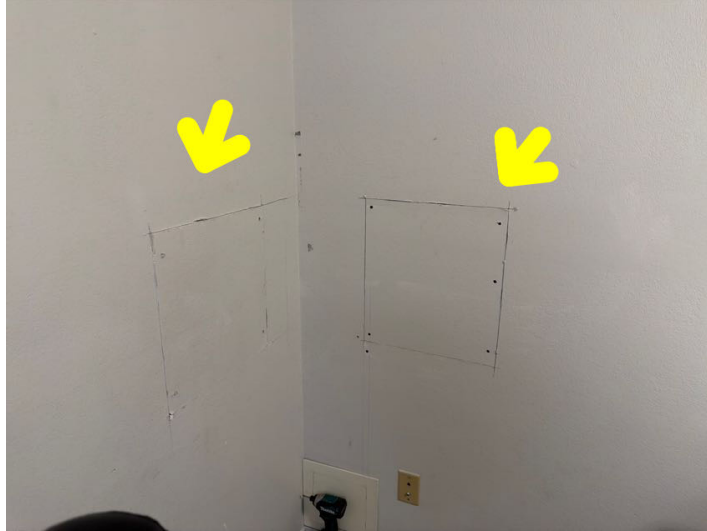
There has been a drywall/plaster repair that should be explained by the seller.

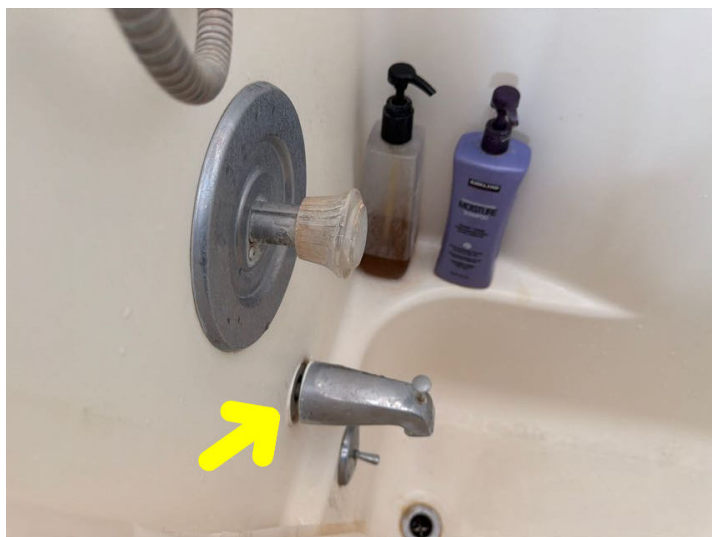
The tub spout should be sealed to the wall.

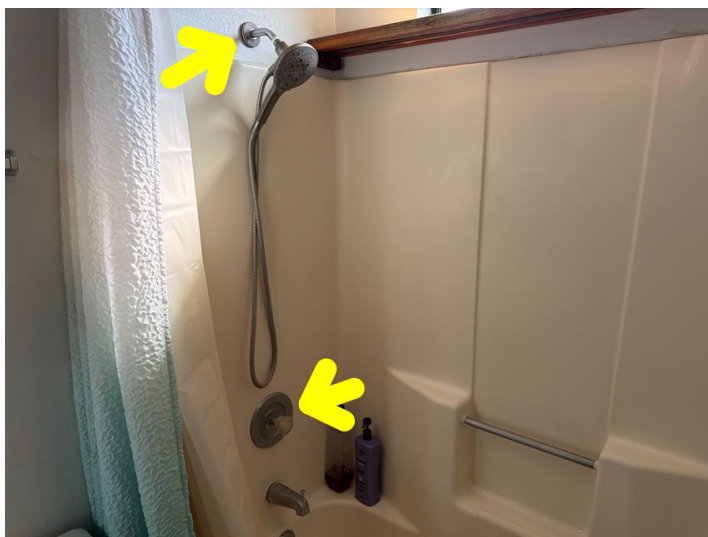
The tub/shower water supply pipe is loose and should be serviced.

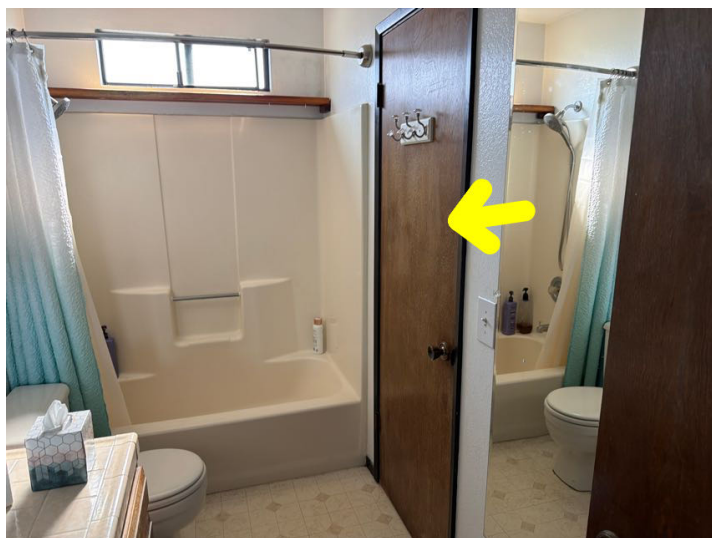
A door is blocked or locked and could not be tested, and should be demonstrated as functional.

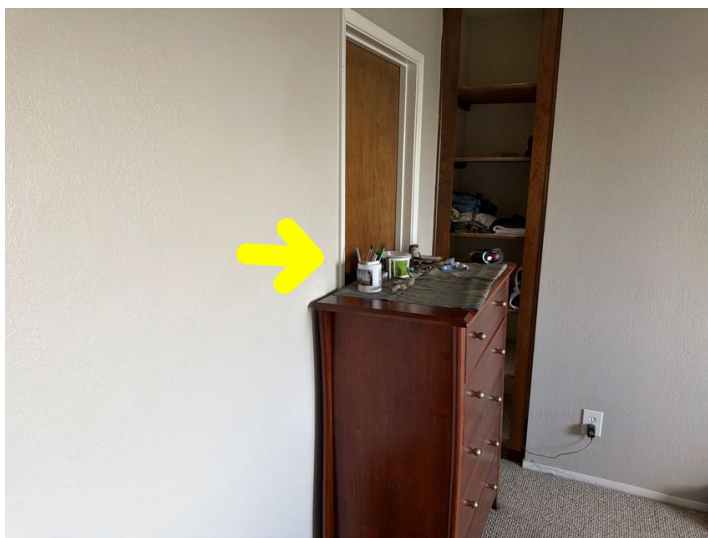
A door is blocked or locked and could not be tested, and should be demonstrated as functional.

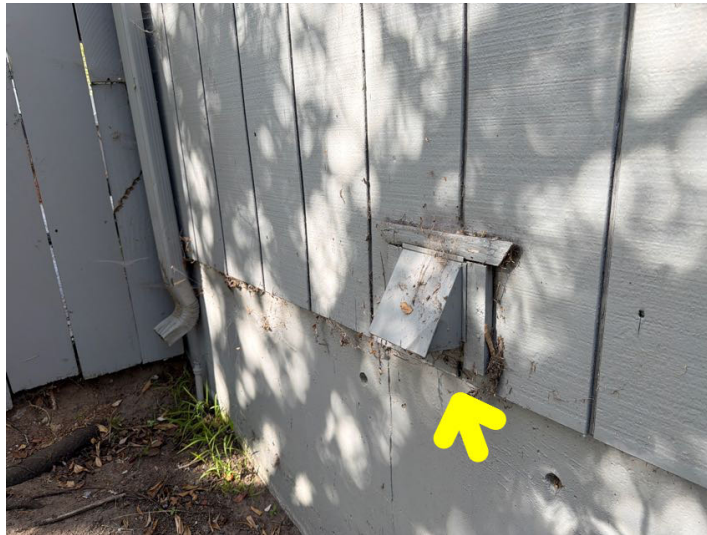
The back-draft on the exterior dryer vent cover is missing, stuck open, or incomplete and should be cleaned, repaired, or replaced.

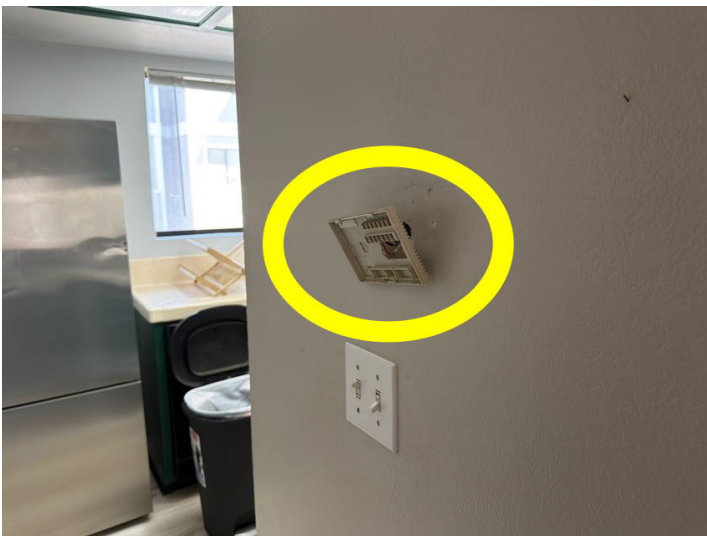
1.13. The thermostat is missing and should be replaced.

The thermostat is missing and should be replaced.

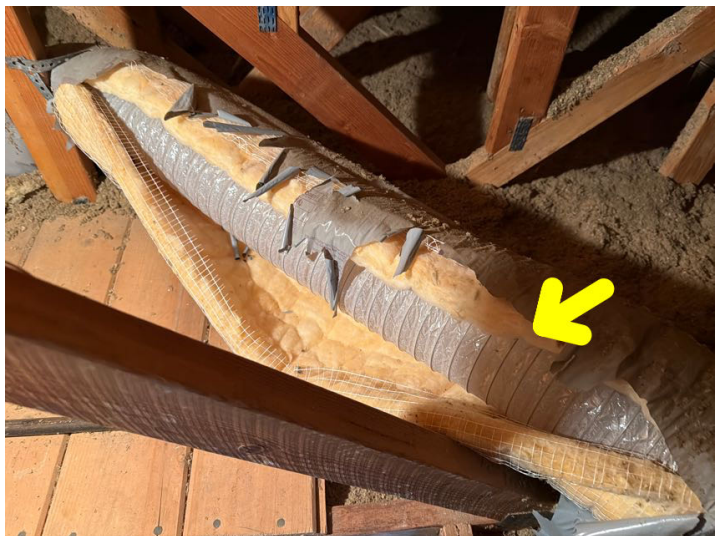
Sections of outer shell of the flexible ducting have been damaged by ultra-violet contamination, which has caused the outer shell to deteriorate, and therefore should be evaluated by a licensed HVAC contractor with a view toward replacement.

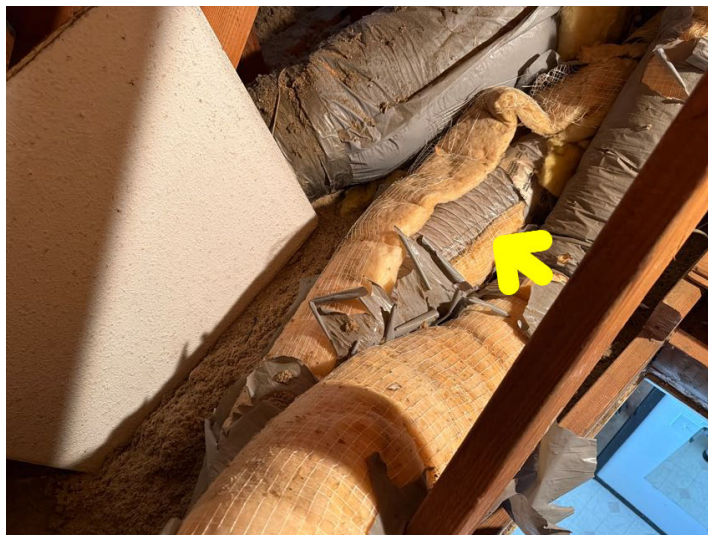
Sections of outer shell of the flexible ducting have been damaged by ultra-violet contamination, which has caused the outer shell to deteriorate, and therefore should be evaluated by a licensed HVAC contractor with a view toward replacement.

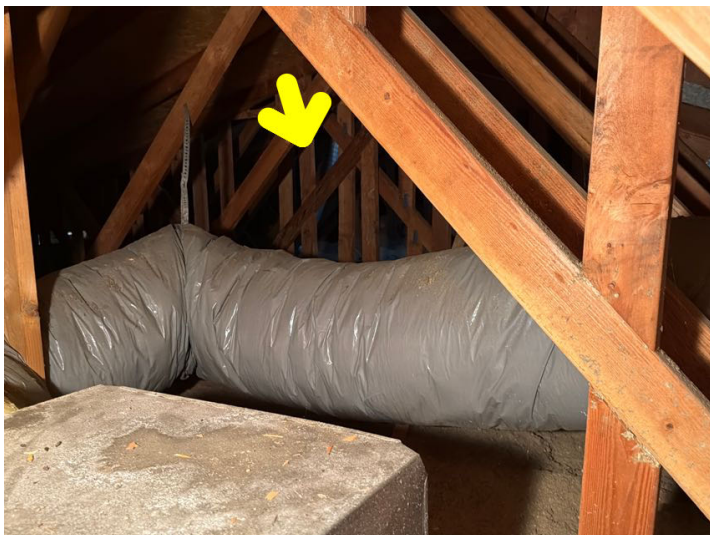
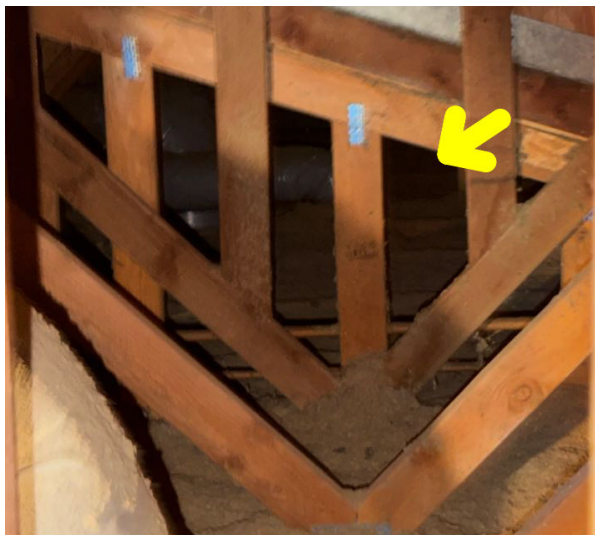
- 1.12. There is no separation between the units within the attic, which is required by current standards, and you may wish to have it added for optimal safety.

There is no separation between the units within the attic, which is required by current standards, and you may wish to have it added for optimal safety.

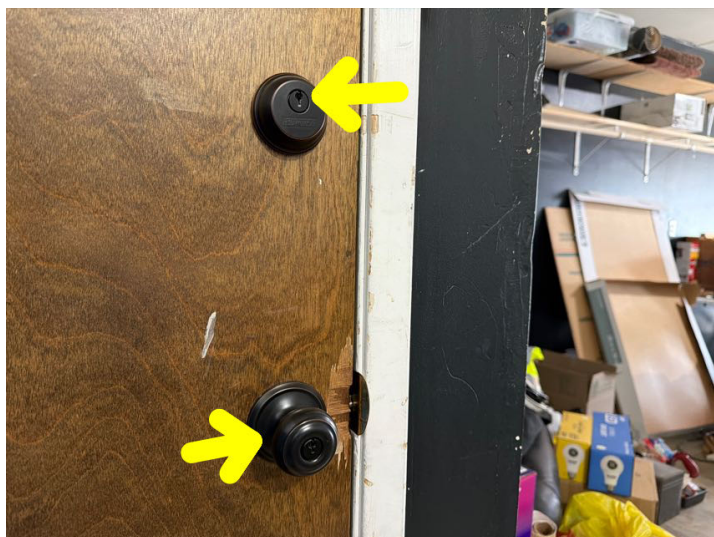
The keyed door handle or deadbolt on the house entry door could prevent or impede an emergency exit, and should be replaced with a latch type for optimal safety.

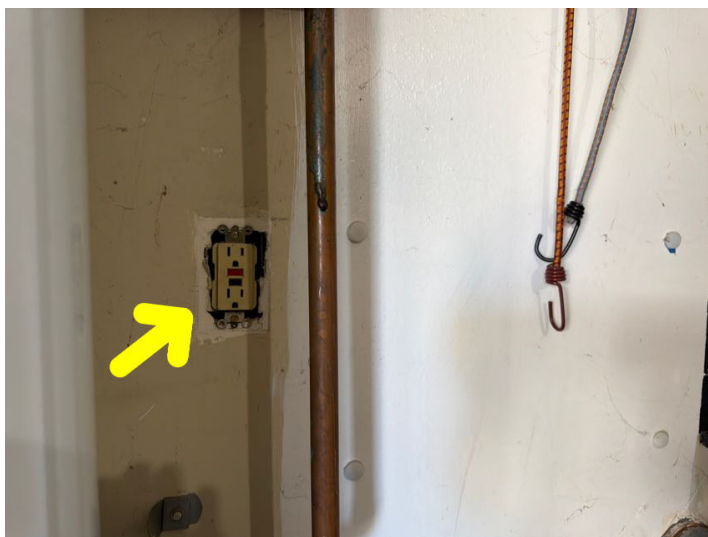
One or more outlet covers are missing and should be installed.

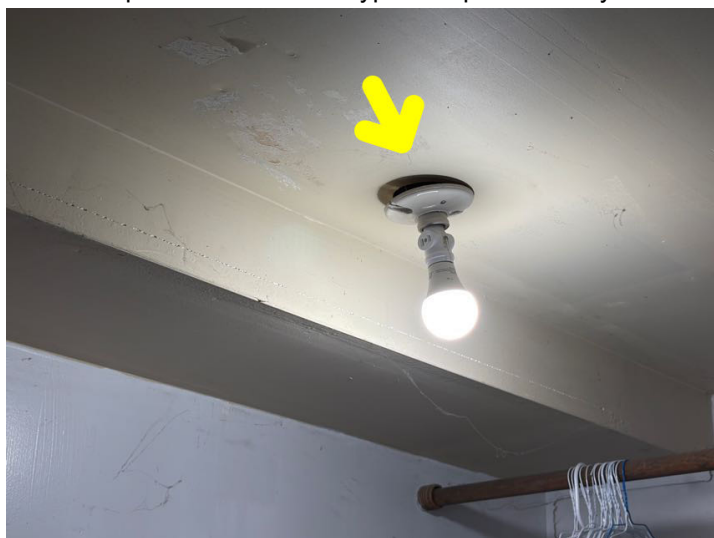
1.17. A light fixture is broken or not secure and should be serviced.

A light fixture is broken or not secure and should be serviced.

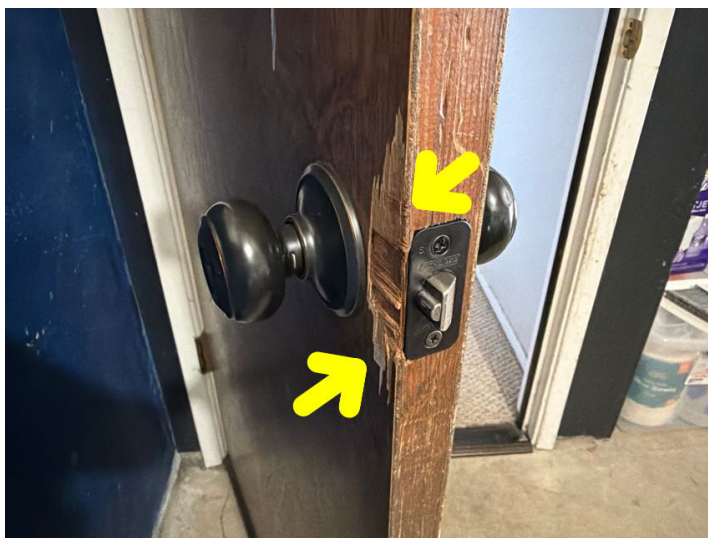
The house entry door is damaged and you may wish to have it replaced.

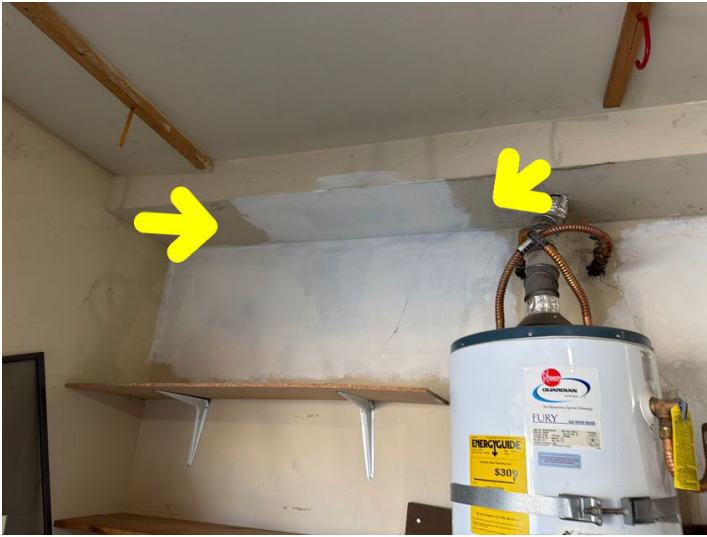
There had been a drywall/plaster repair that should be explained by the seller.

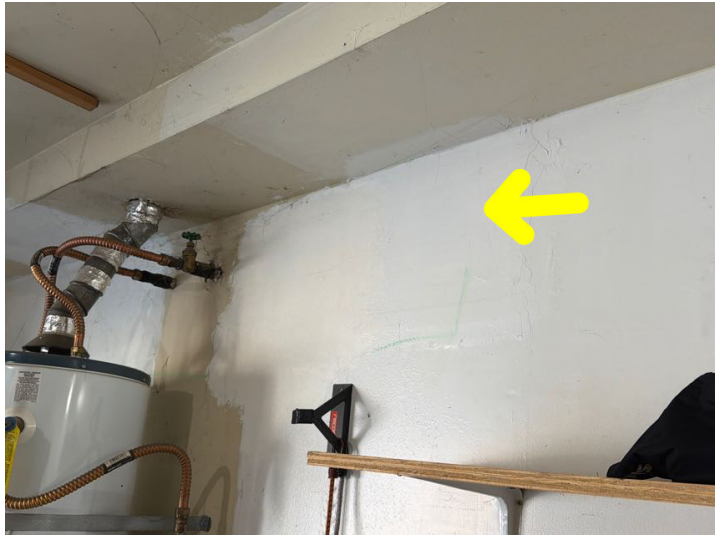
There had been a drywall/plaster repair that should be explained by the seller.
