# ***Cornerstone Inspection***

## **Property Inspection Report**

***7255 Navajoa Ave, Atascadero, CA 93422***

***Date of Inspection: 9/8/2026 Time: 1:00 PM***

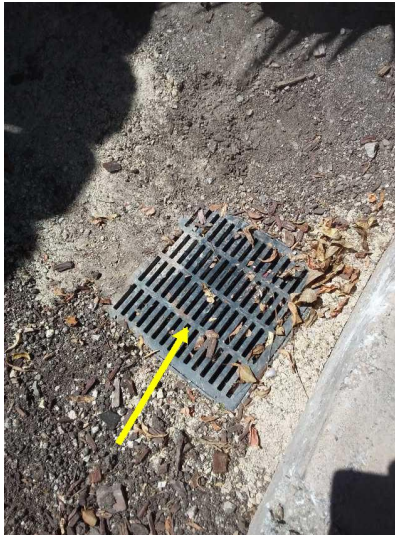
2.7. There are area drains in planter beds or yards that will be subject to contamination by dirt, which should be periodically monitored and kept free of dirt.

There are area drains in planter beds or yards that will be subject to contamination by dirt, which should be periodically monitored and kept free of dirt.

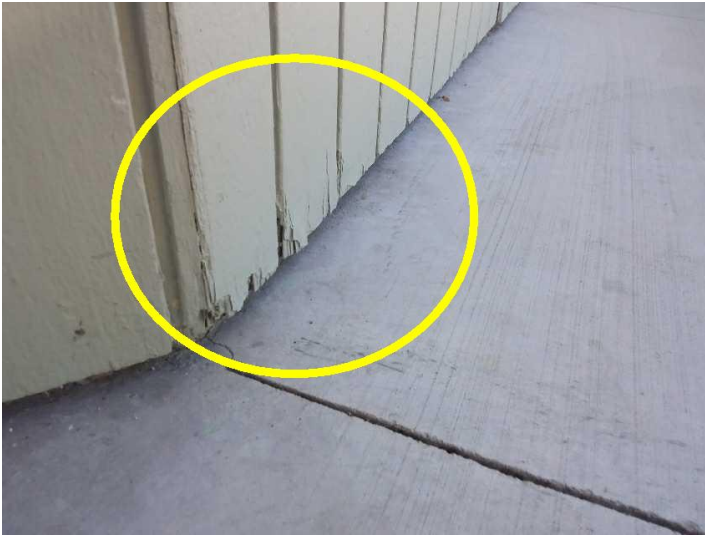
3.6. Portions of the wood siding are dry rot or moisture damaged, and should be evaluated by a termite inspector.

Portions of the wood siding are dry rot or moisture damaged, and should be evaluated by a termite inspector.

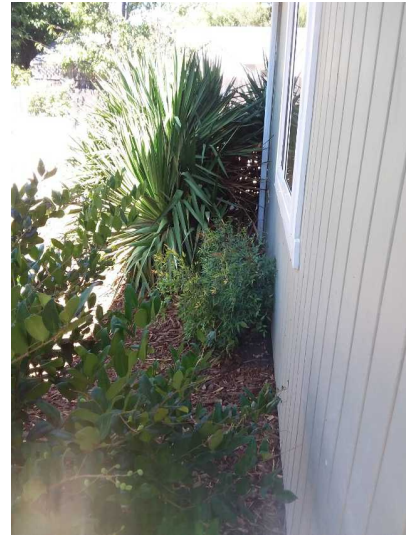
3.2. Vines, shrubs or bushes are growing on the house walls and although they are attractive they can introduce pests and rodents and accelerate deterioration. Therefore, you may wish to consider having them removed or cut back to 12 inches away from the home.

Vines, shrubs or bushes are growing on the house walls and although they are attractive they can introduce pests and rodents and accelerate deterioration. Therefore, you may wish to consider having them removed or cut back to 12 inches away from the home.

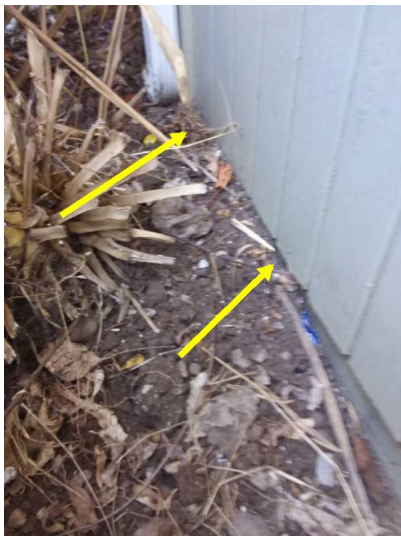
The soil is too high against the home at various areas around the home which should be serviced.

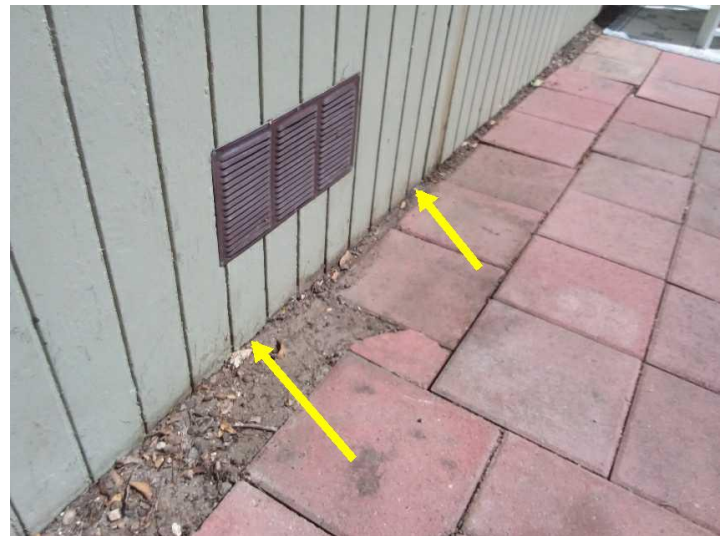
3.5. There are areas where the wooden siding is close to or touching the ground and is subject to moisture damage. These areas should be monitored closely and sealed frequently to prevent moisture damage. Wooden siding should be a minimum of 4 inches from soil and 2 inches from hard surfaces.

There are areas where the wooden siding is close to or touching the ground and is subject to moisture damage. These areas should be monitored closely and sealed frequently to prevent moisture damage. Wooden siding should be a minimum of 4 inches from soil and 2 inches from hard surfaces.

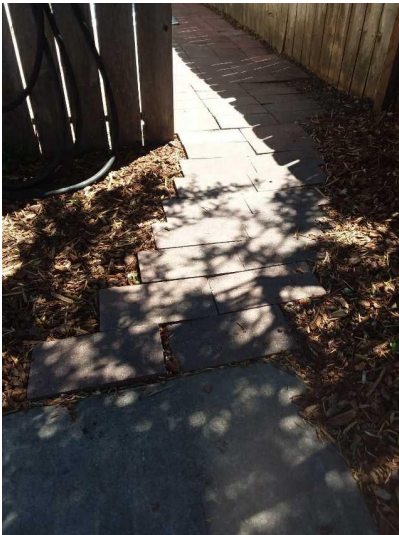
The paver patio or walkway has multiple offsets. This may be due to unsuitable soil below the pavers.

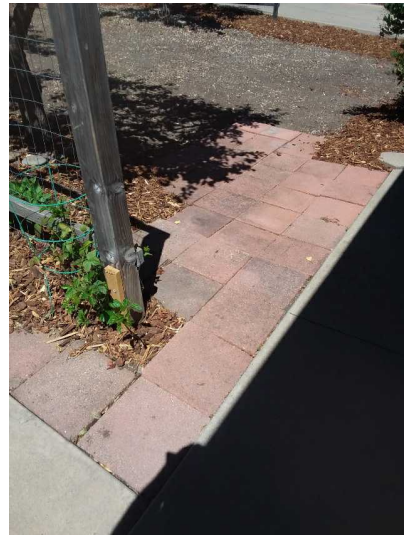
The paver patio or walkway has multiple offsets. This may be due to unsuitable soil below the pavers.

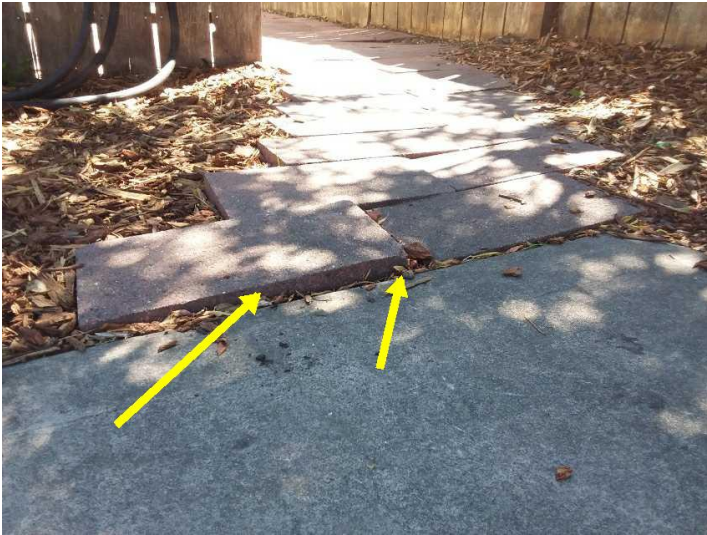
There is one or more offsets in the walkways that could prove to be trip-hazards.

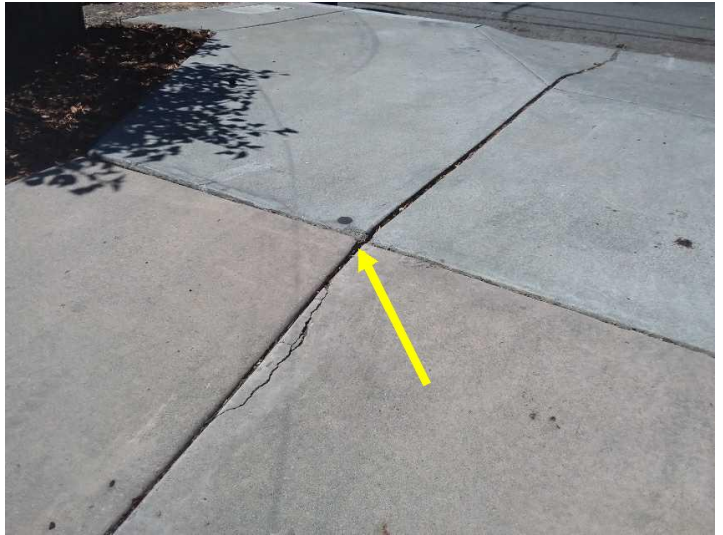
There is one or more offsets in the driveway that could prove to be trip-hazards.

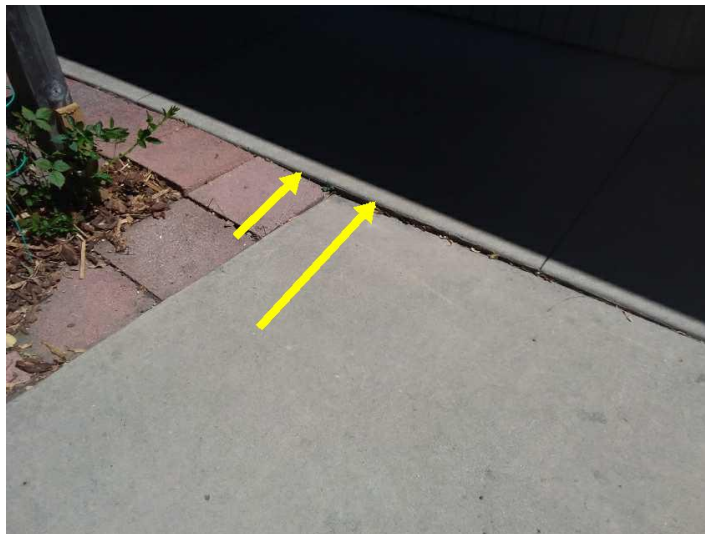
There is one or more offsets in the walkways that could prove to be trip-hazards.

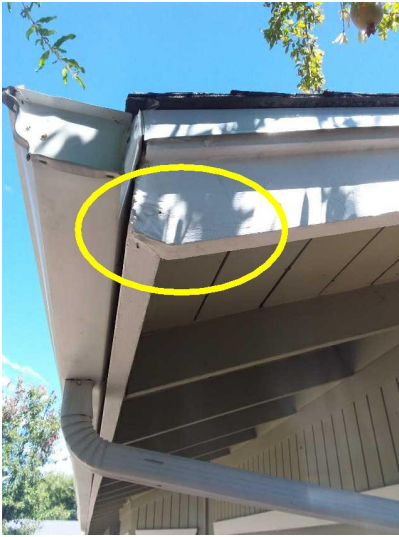
There is damage to the wood trim that should be evaluated by a termite inspector.

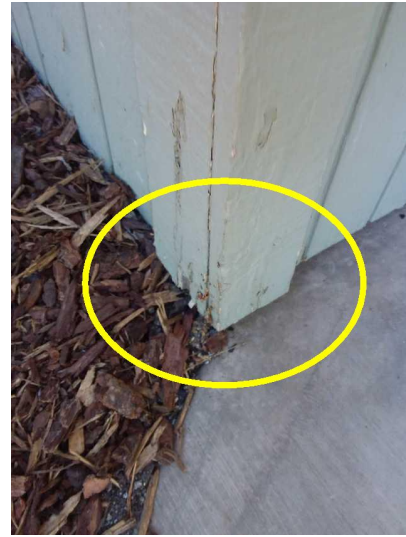
There is damage to the wood trim that should be evaluated by a termite inspector.

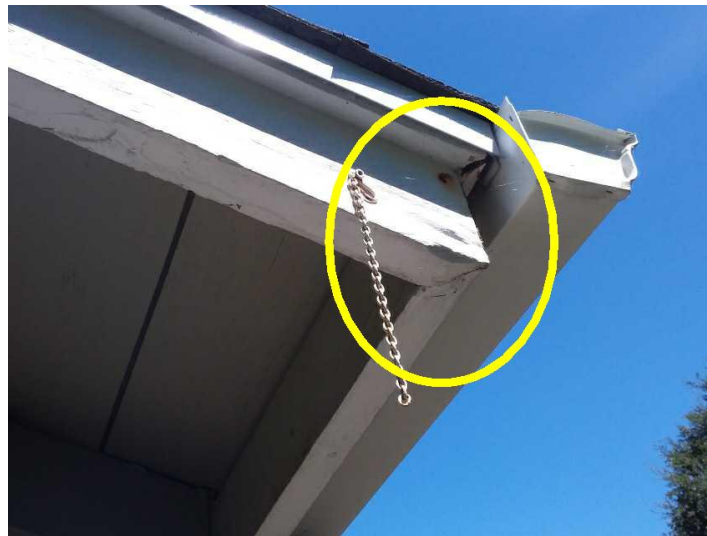
There is damage to the wood trim that should be evaluated by a termite inspector.

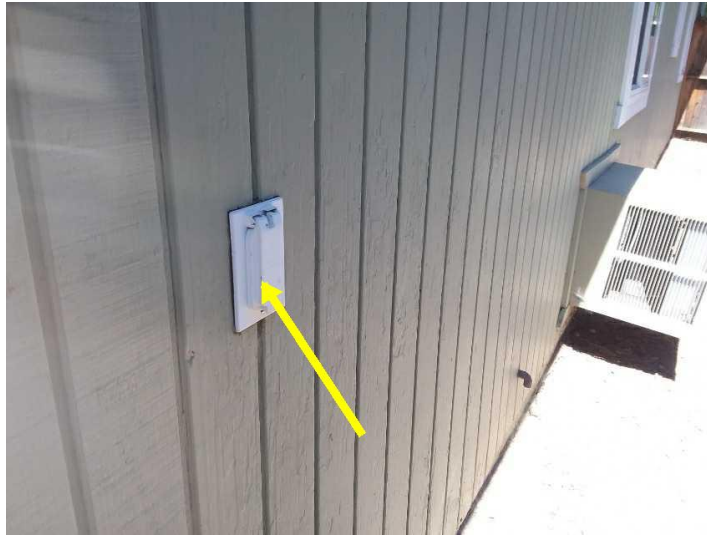
A ground-fault protected outlet on the rear does not reset when activated and should be serviced.

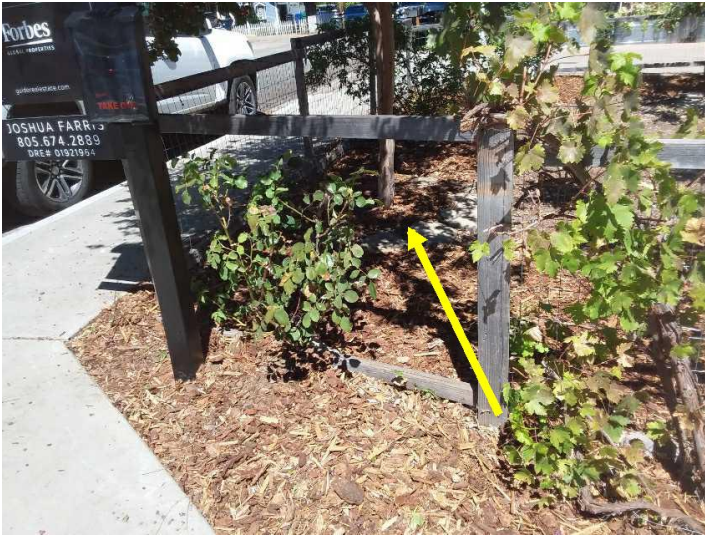
8.3. The fences have damage that you may wish to have repaired.

The fences have damage that you may wish to have repaired.

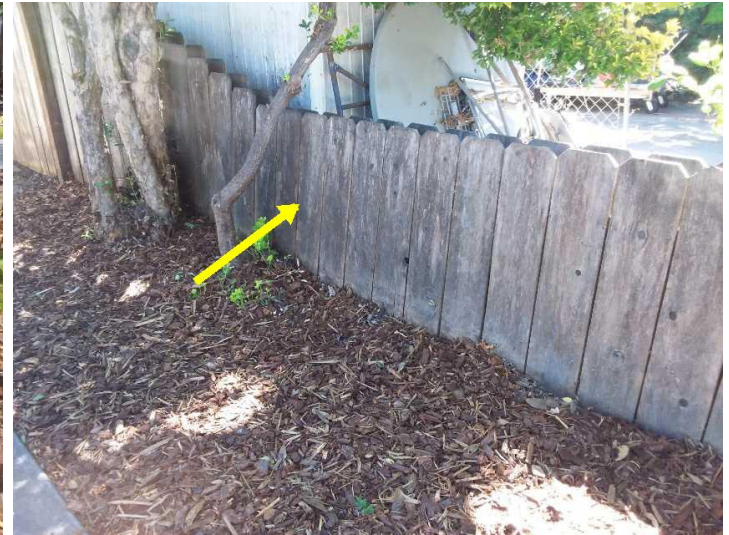
8.4. Sections of the fence are leaning or missing which you may wish to have repaired or replaced.

Sections of the fence are leaning or missing which you may wish to have repaired or replaced.

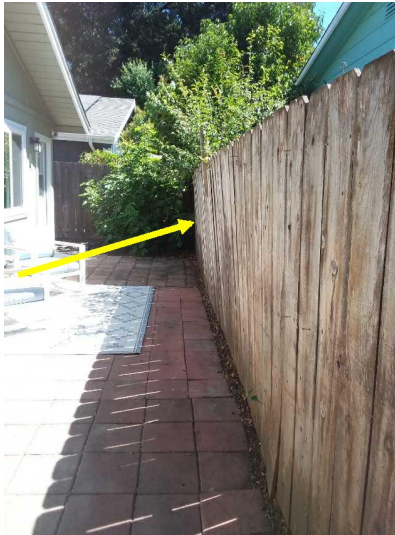
Sections of the fence are leaning or missing which you may wish to have repaired or replaced.

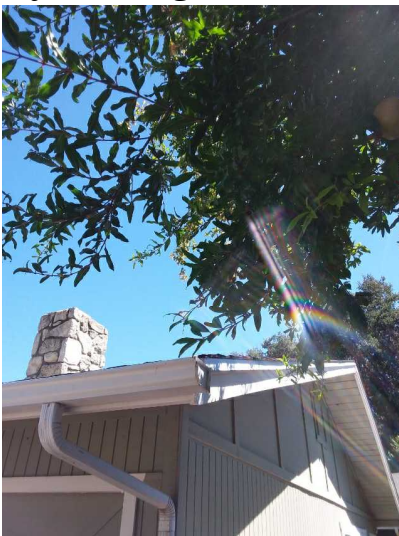
9.2. There are tree limbs over growing the residence that should be trimmed or monitored to insure that they do not impact or damage the roof or its components.

There are tree limbs over growing the residence that should be trimmed or monitored to insure that they do not impact or damage the roof or its components.

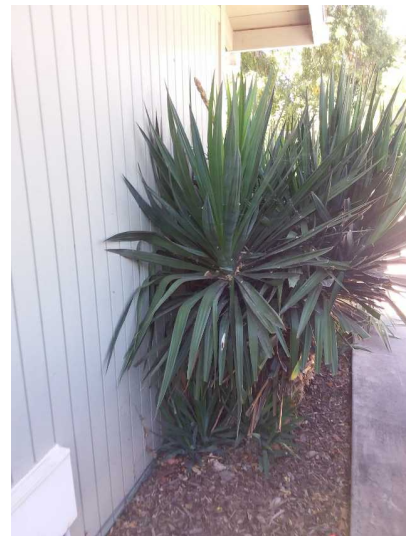
9.3. Vegetation is encroaching on the structure, and should be kept a minimum of twelve inches away for the general welfare of the walls and foundation.

Vegetation is encroaching on the structure, and should be kept a minimum of twelve inches away for the general welfare of the walls and foundation.

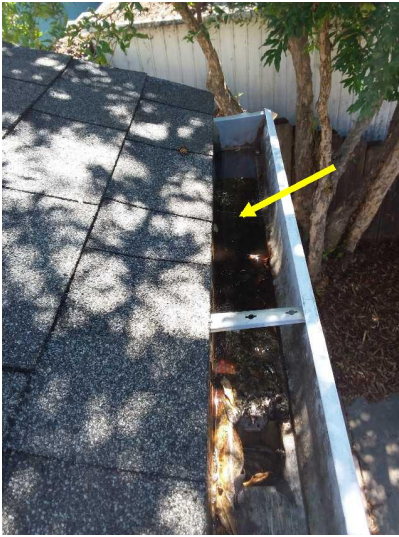
1.3. We observed standing water in some sections of the gutters which implies that it may not be properly sloped and should be evaluated and serviced.

We observed standing water in some sections of the gutters which implies that it may not be properly sloped and should be evaluated and serviced.

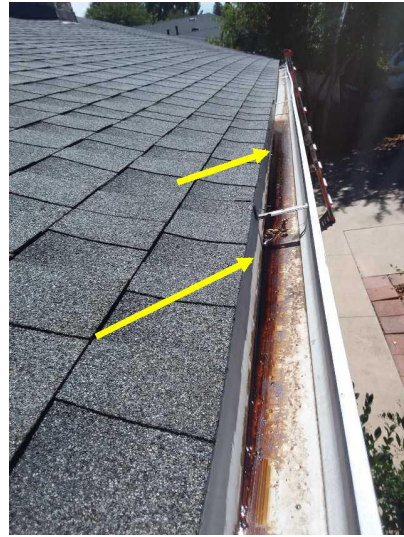
We observed standing water in some sections of the gutters which implies that it may not be properly sloped and should be evaluated and serviced.

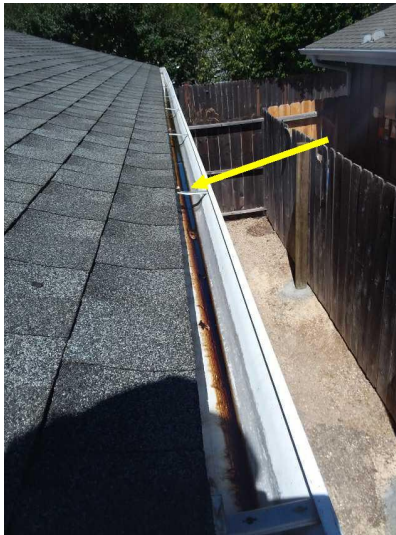
We observed standing water in some sections of the gutters which implies that it may not be properly sloped and should be evaluated and serviced.

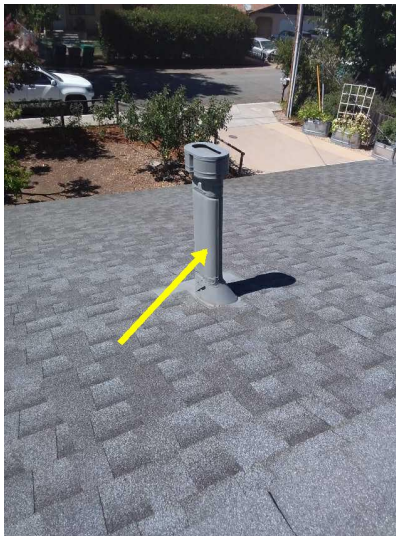
2.5. A rain collar is missing on a heat vent and should be installed.

A rain collar is missing on a heat vent and should be installed.

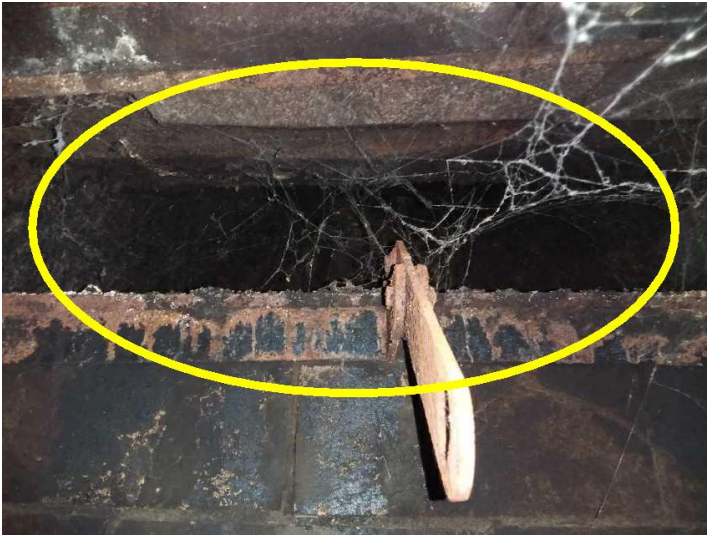
| Page 18 Item: 1 | Living Fireplace Comments | <p>1.14. The chimney flue is due for cleaning. The chimney flue need to be periodically cleaned to prevent the possibility of chimney fires. However, the complex variety of deposits that form within chimneys are not easily understood. They range from pure carbon, which does not burn, to tars that can ignite. All of these deposits are commonly described as creosote, but creosote has many forms, ranging from crusty carbon deposits that can be easily brushed away, to a tar-glazed creosote that requires chemical cleaning. These deposits should be identified and treated or cleaned by a specialist.</p> <p>1.15. There is no spark arrestor on the chimney, which is required by current standards, and should be installed.</p> |

The chimney flue is due for cleaning. The chimney flue need to be periodically cleaned to prevent the possibility of chimney fires. However, the complex variety of deposits that form within chimneys are not easily understood. They range from pure carbon, which does not burn, to tars that can ignite. All of these deposits are commonly described as creosote, but creosote has many forms, ranging from crusty carbon deposits that can be easily brushed away, to a tar-glazed creosote that requires chemical cleaning. These deposits should be identified and treated or cleaned by a specialist.

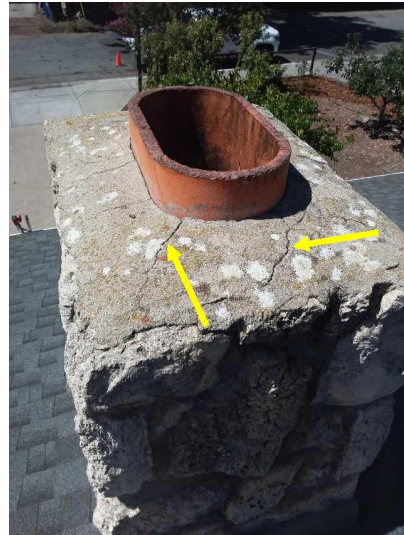
The chimney crown, which is designed to seal the chimney wall and shed rainwater, is cracked and should be sealed.

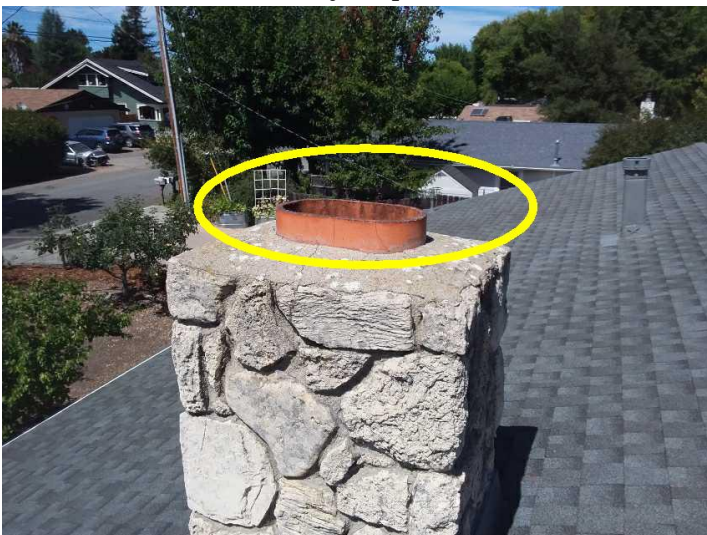
There is no weather cap on the chimney and, inasmuch as they prevent moisture intrusion and thereby extend the life of chimney, we recommend having one installed.

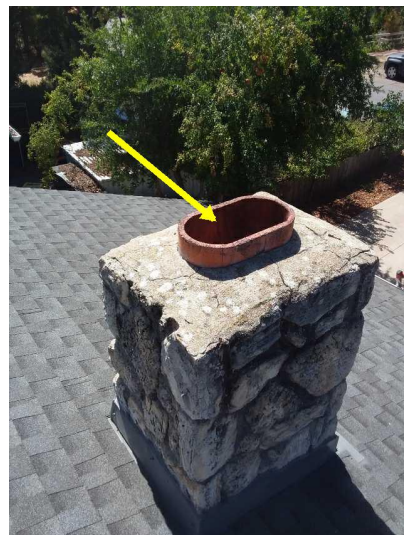
There is no spark arrestor on the chimney, which is required by current standards, and should be installed.

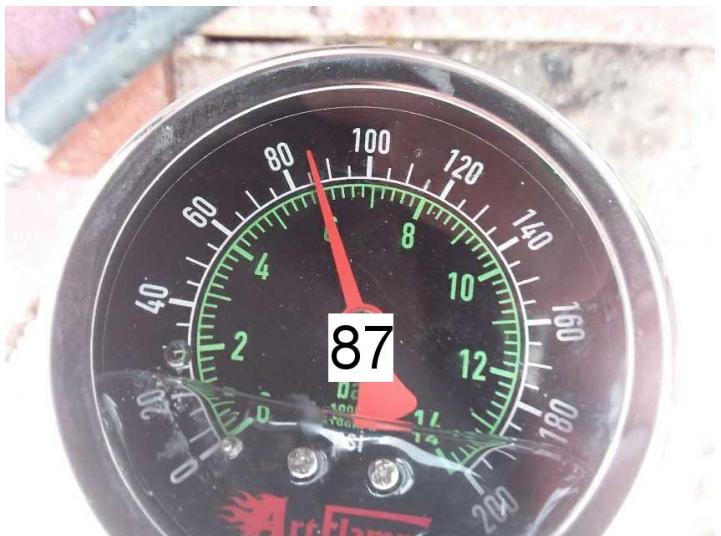
| Page 20 Item: 1 | Water Supply Comments | <p>1.4. The pressure inside the residence is above 80 PSI and will stress components of the system. A licensed plumber should reduce the pressure at the regulator to sixty pounds per square inch, which is optimum. However, the regulator may have failed and would need to be replaced.</p> |

1.4. The pressure inside the residence is above 80 PSI and will stress components of the system. A licensed plumber should reduce the pressure at the regulator to sixty pounds per square inch, which is optimum. However, the regulator may have failed and would need to be replaced.

The pressure inside the residence is above 80 PSI and will stress components of the system. A licensed plumber should reduce the pressure at the regulator to sixty pounds per square inch, which is optimum. However, the regulator may have failed and would need to be replaced.

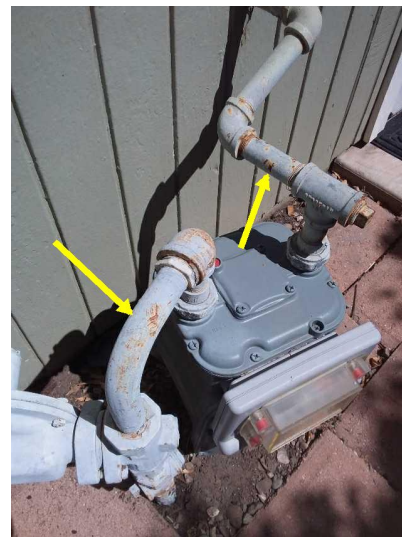
2.4. Some of the gas lines at the meter are rusted and should be painted to prevent further corrosion.

Some of the gas lines at the meter are rusted and should be painted to prevent further corrosion.

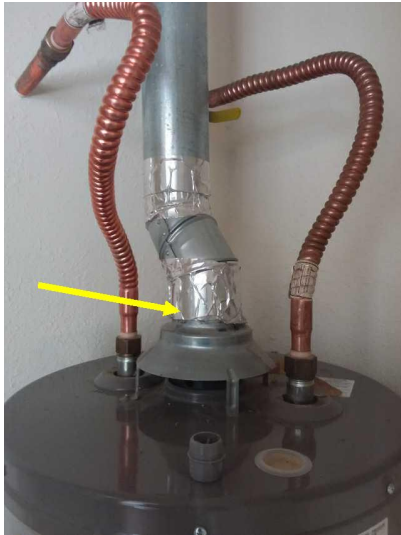
The vent pipe is not properly connected. It is required to have a minimum of 3 fasteners where the pipe connects to the draft hood or other single wall vent pipes.

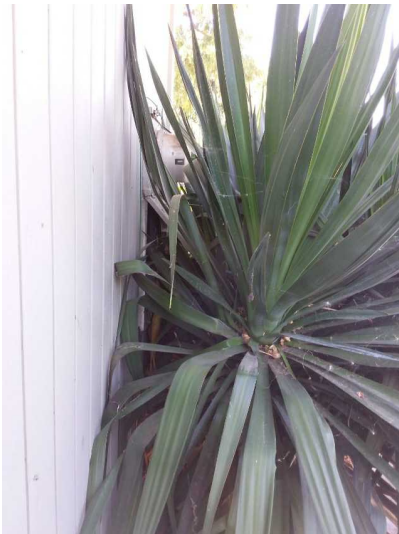
The main panel does not have thirty-six inches of clear space in front of it to facilitate an emergency disconnect, a condition which should be corrected.

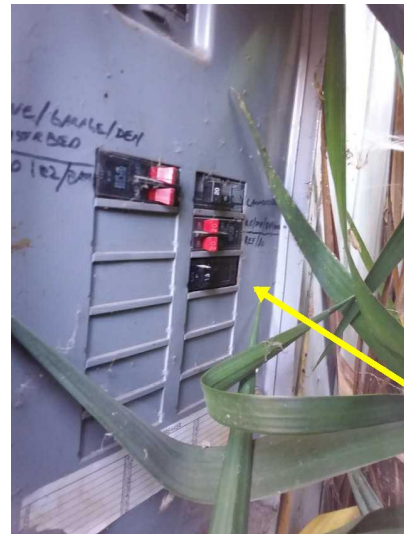
Various circuits are not labeled, which is recommended.

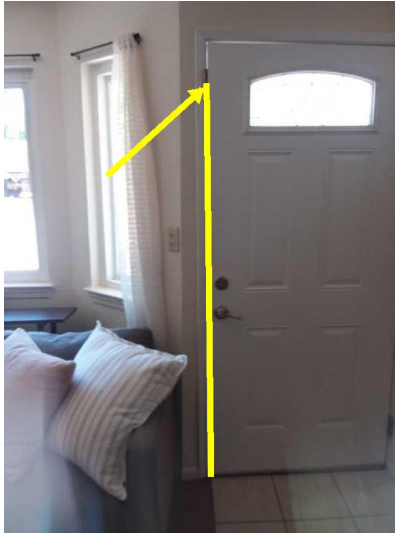
A secondary lock has been installed higher than 48 inches which could impede the exit of a child or short person.

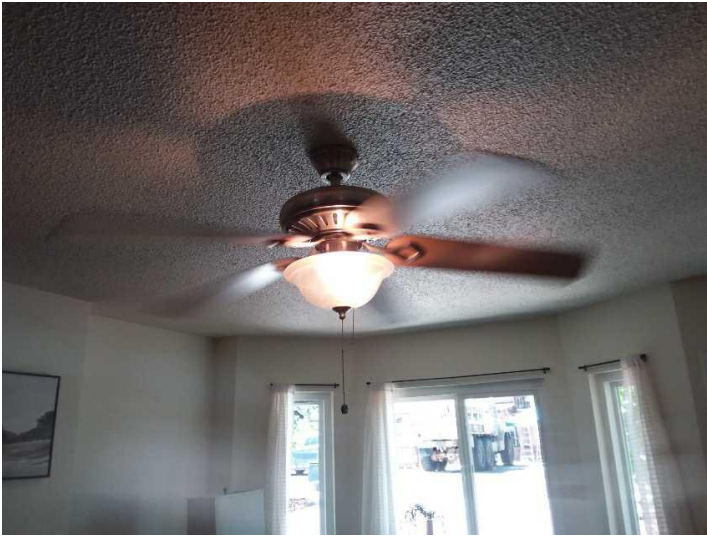
The ceiling fan is functional but out of balance and should be serviced so the fan operates smoothly.

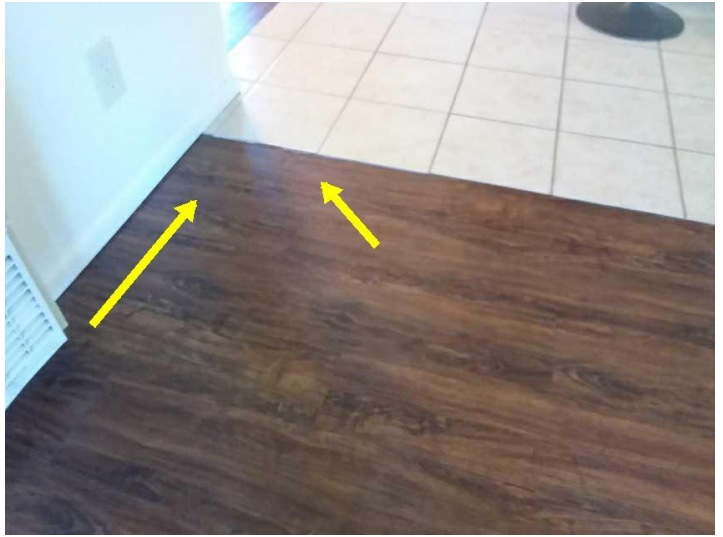
The floor is worn or cosmetically damaged, which you should view for yourself.

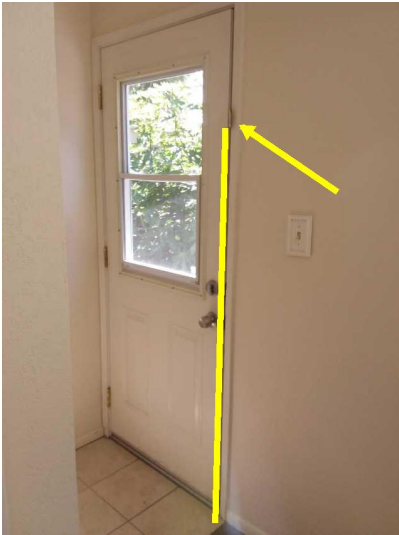
A secondary lock has been installed higher than 48 inches which could impede the exit of a child or short person.

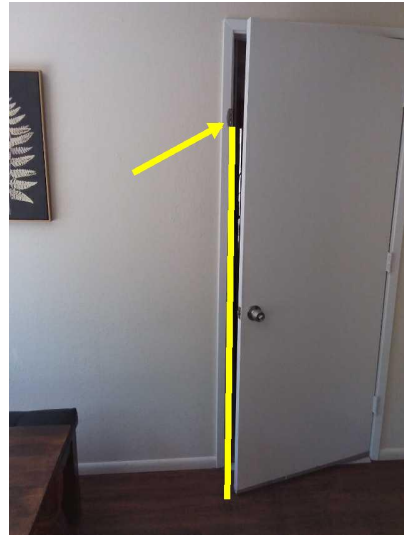
A secondary lock has been installed on both doors higher than 48 inches which could impede the exit of a child or short person.

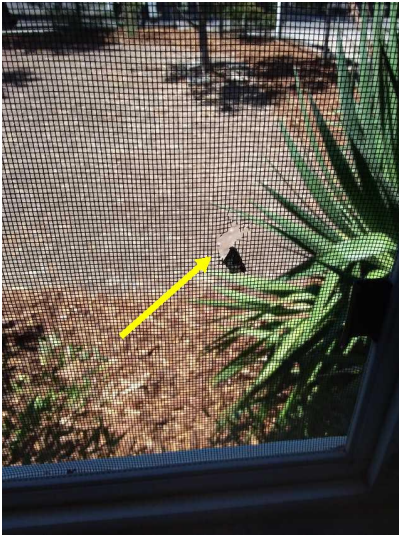
One or more window screens are damaged, which you may wish to have repaired.

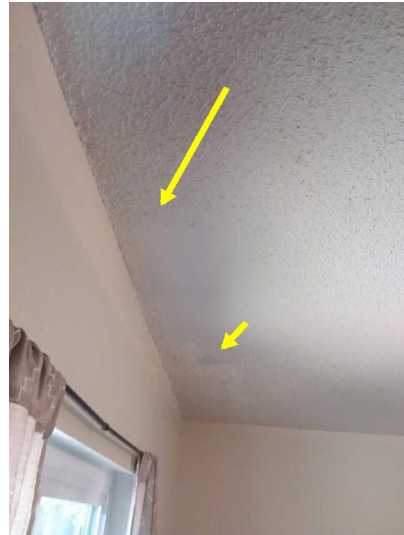
Walls/ceilings have cosmetic damage that you should view for yourself.

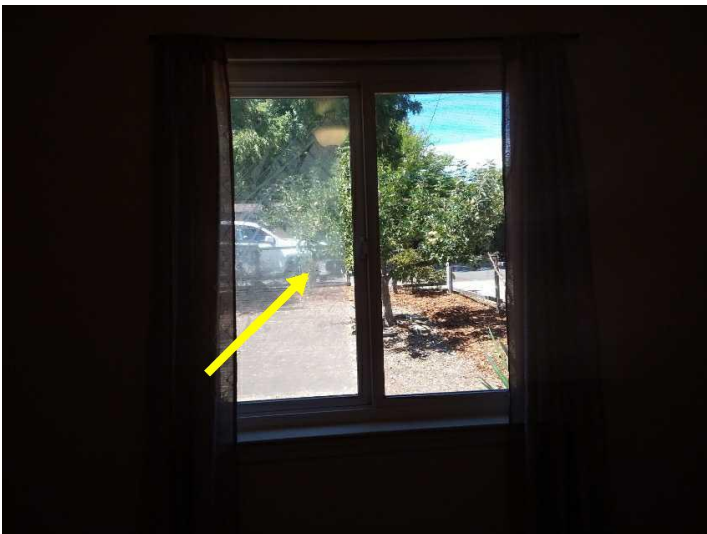
A window(s) may have a broken hermetic seal which you may wish to have replaced. This is evident from fogging, or condensation forming between the panes of glass that confirm that the seal has failed.

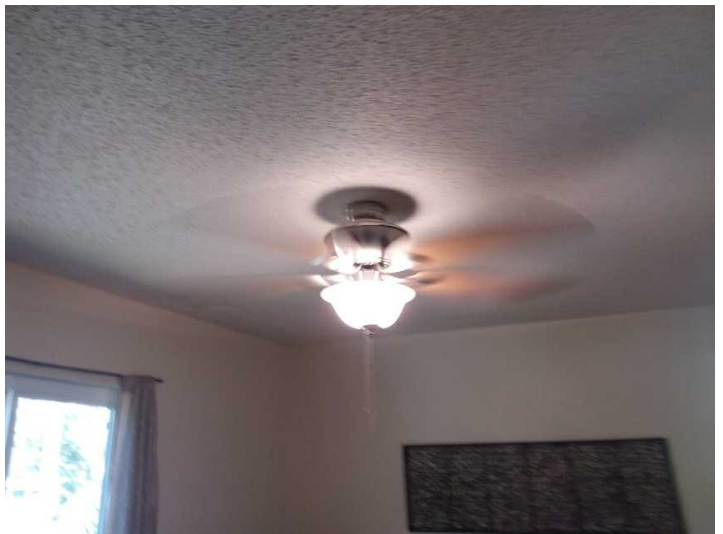
The ceiling fan is functional but rocks at high speeds and should be serviced so the fan operates smoothly.

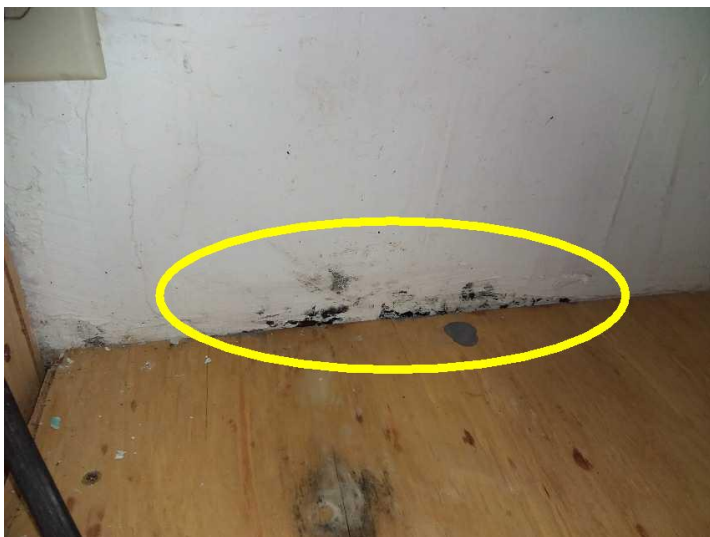
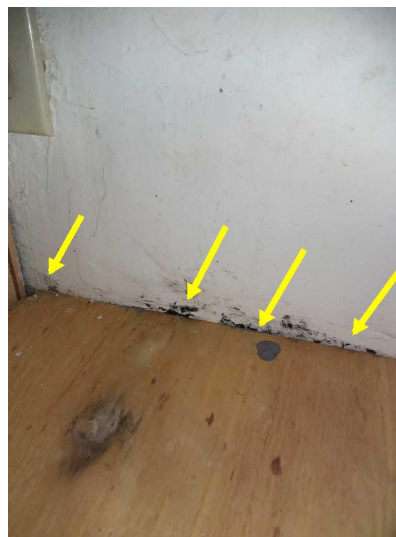
2.3. There is a mold-like substance in the sink cabinet that should be evaluated by a specialist. All molds flourish in a damp environment and many are commonplace, but some are toxic and pose a health risk.

There is a mold-like substance in the sink cabinet that should be evaluated by a specialist. All molds flourish in a damp environment and many are commonplace, but some are toxic and pose a health risk.

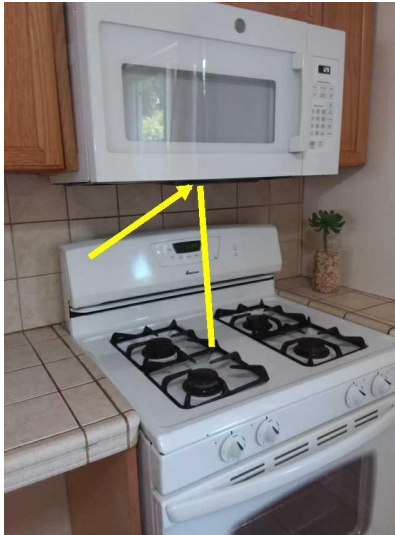
The range hood exhaust-fan is closer than the recommended 24 inches and should be used with caution.

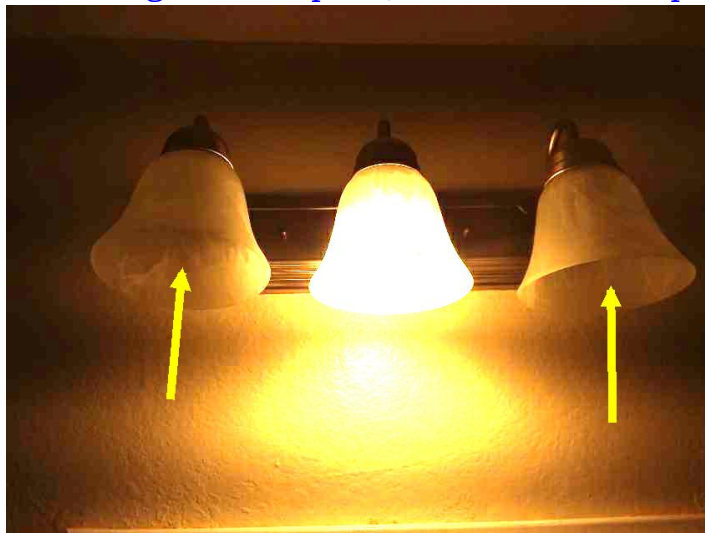
The wall light does not respond and should be serviced.

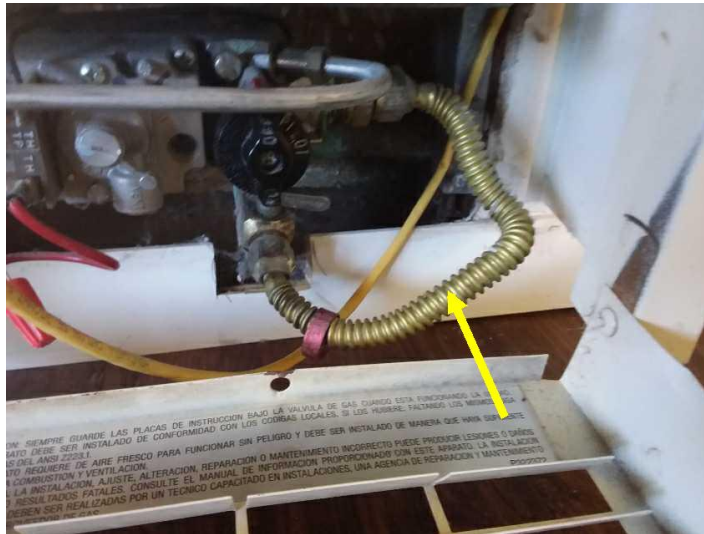
| Page 35 Item: 1 | Wall Furnace | 1.5. The wall furnace is not functional and should be evaluated and serviced or demonstrated as functional.<br><br>1.6. The flexible gas line is an uncoated brass connector, which should be replaced. |

1.6. The flexible gas line is an uncoated brass connector, which should be replaced.

The flexible gas line is an uncoated brass connector, which should be replaced.

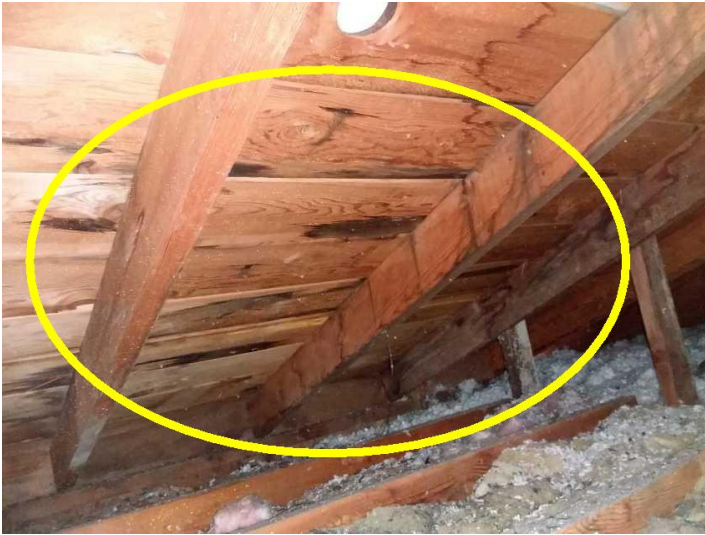
| Page 37 Item: 1 | Attic | 1.13. There are water stains on the ceiling that implies that a leak has occurred. Since it was not raining during our inspection, we were unable to determine if the leak is currently leaking, or, it is an old leak that has been repaired. You should ask the sellers for information regarding this issue.<br><br>1.14. An electrical connection at a powered attic ventilator has been made outside of a junction and is required to be made inside one in order to contain any arcing or sparking that may occur. However, see other relevant comments in this report regarding the value of powered attic ventilators.<br><br>1.15. The vent pipe of the gas water heater is too close or in contact with the roof sheathing and should be serviced. A single-walled vent pipe should be six inches away from any combustible material, and a double-walled type should be one inch away. |

There are water stains on the ceiling that implies that a leak has occurred. Since it was not raining during our inspection, we were unable to determine if the leak is currently leaking, or, it is an old leak that has been repaired. You should ask the sellers for information regarding this issue.

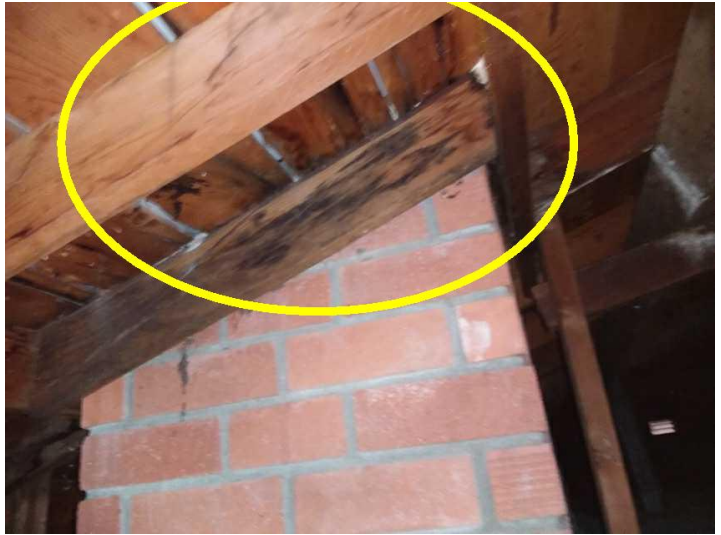
There are moisture stains on the attic ceiling at a roof penetration that indicate a past or present leak. This is a common area for leaks. We are unable to determine if the leak is current, or a past leak, in any case it should be further investigated or explained.

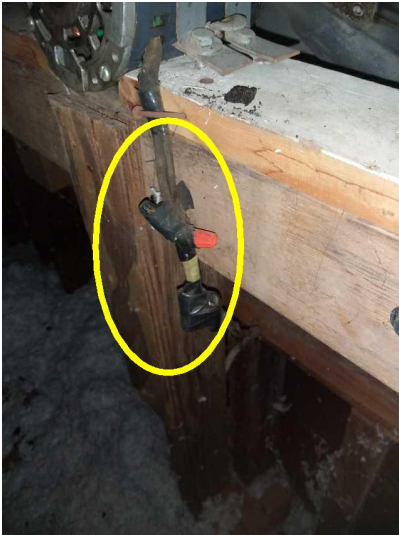
An electrical connection at a powered attic ventilator has been made outside of a junction and is required to be made inside one in order to contain any arcing or sparking that may occur. However, see other relevant comments in this report regarding to the value of powered attic ventilators.

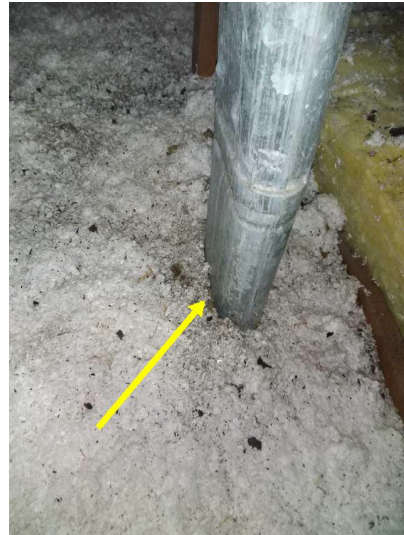
Insulation is in contact with the vent pipe and should be removed at least three inches away.

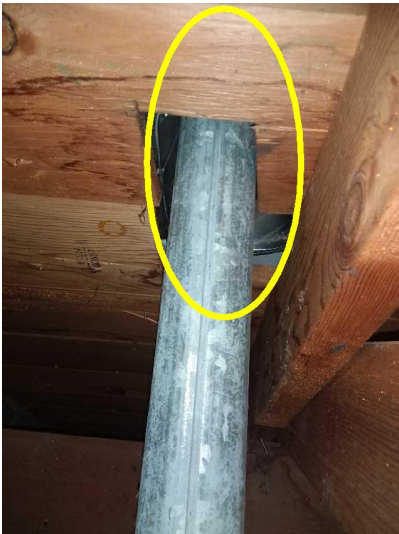
1.15. The vent pipe of the gas water heater is too close or in contact with the roof sheathing and should be serviced. A single-walled vent pipe should be six inches away from any combustible material, and a double-walled type should be one inch away.

The vent pipe of the gas water heater is too close or in contact with the roof sheathing and should be serviced. A single-walled vent pipe should be six inches away from any combustible material, and a double-walled type should be one inch away.

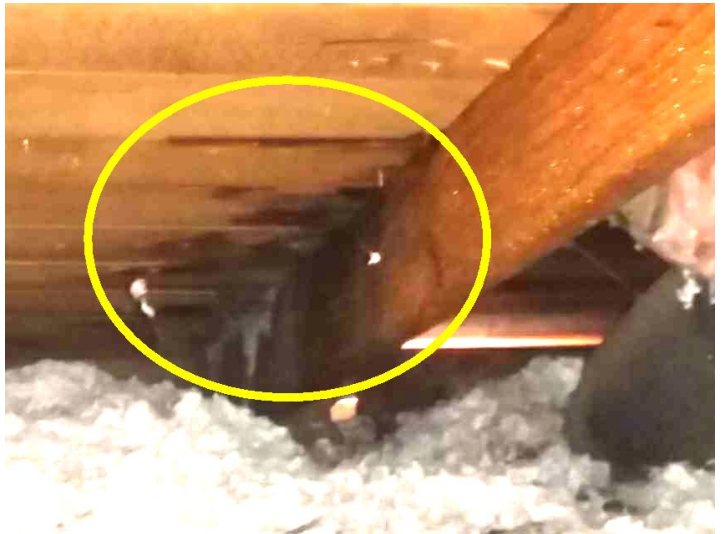
There are water stains on the ceiling that implies that a leak has occurred. Since it was not raining during our inspection, we were unable to determine if the leak is currently leaking, or, it is an old leak that has been repaired. You should ask the sellers for information regarding this issue.

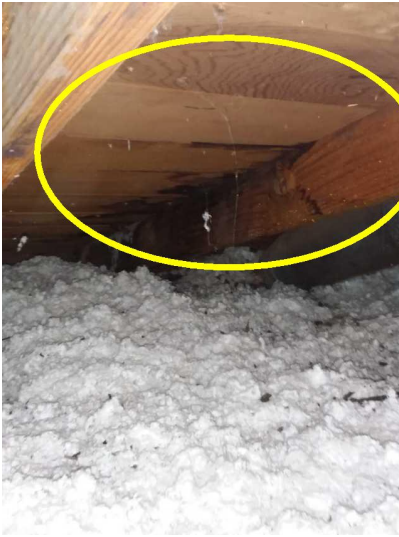
There are water stains on the ceiling that implies that a leak has occurred. Since it was not raining during our inspection, we were unable to determine if the leak is currently leaking, or, it is an old leak that has been repaired. You should ask the sellers for information regarding this issue.

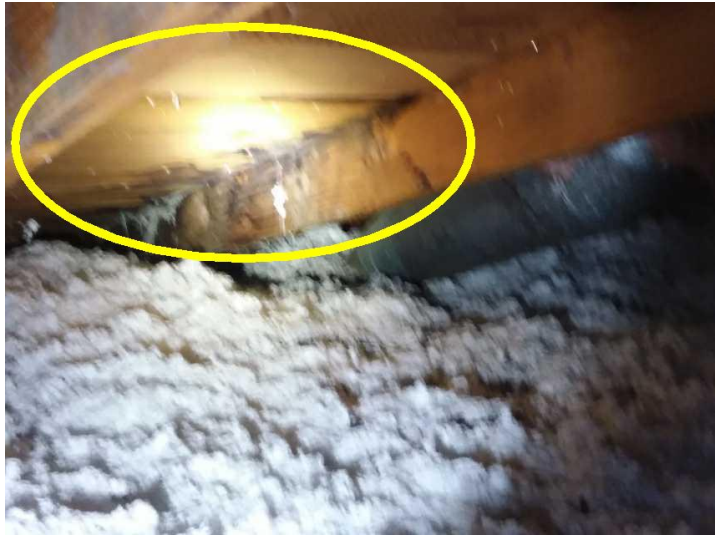
There are water stains on the ceiling that implies that a leak has occurred. Since it was not raining during our inspection, we were unable to determine if the leak is currently leaking, or, it is an old leak that has been repaired. You should ask the sellers for information regarding this issue.

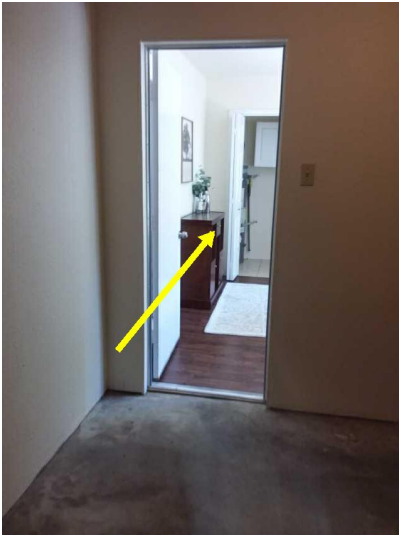
The house entry door is not a fire rated, self-closing and latching door, which should be serviced.

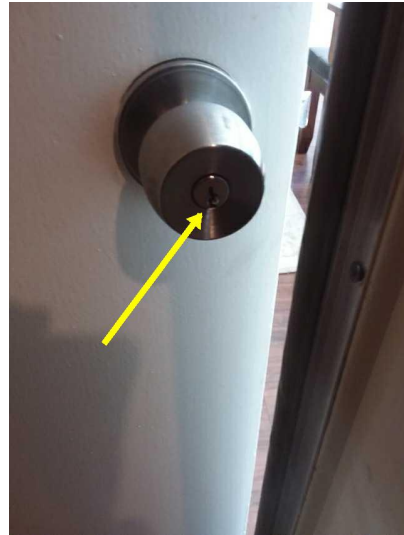
The keyed deadbolt could prevent or impede an emergency exit, and should be replaced with a safer latch type.

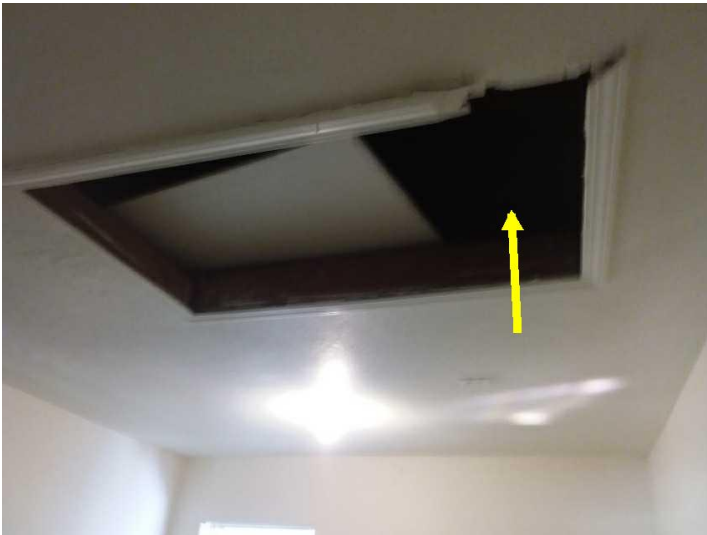
The hatch cover to the attic area should be sheathed with metal or drywall, and made to self-close and latch, in order to provide a firewall separation between the garage and the residence.

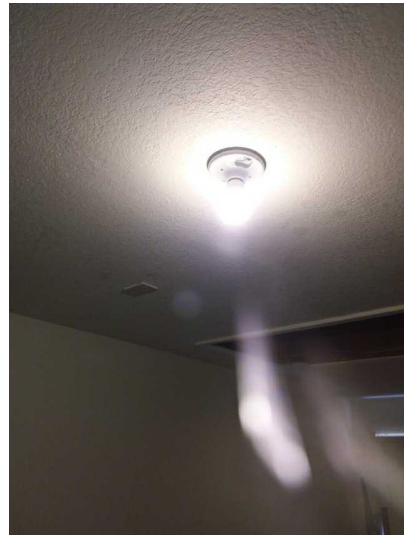
A light is missing its globe or cover and should be serviced.

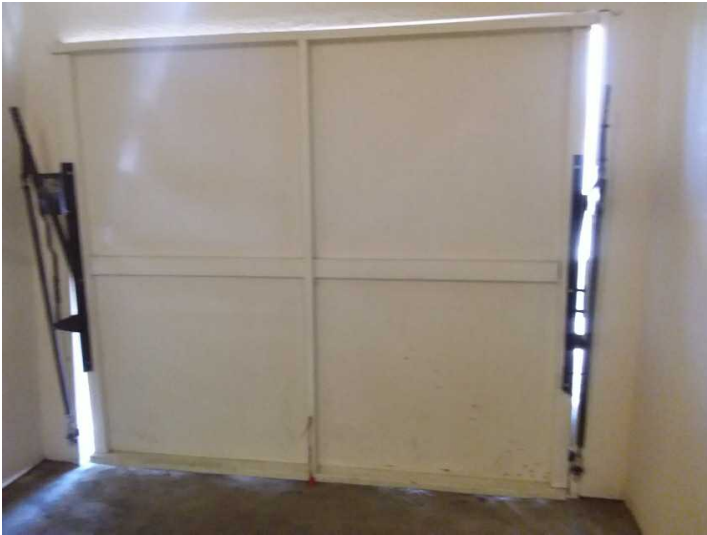
The garage door hardware needs to be adjusted, so that the door is squarely aligned in its opening.

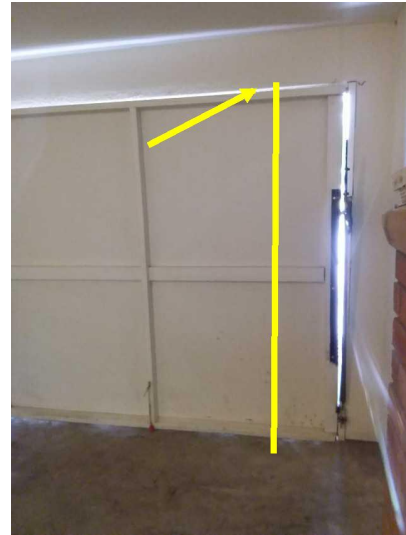
The garage door opening is less than the standard seven feet, which may prevent some vehicles from entering.

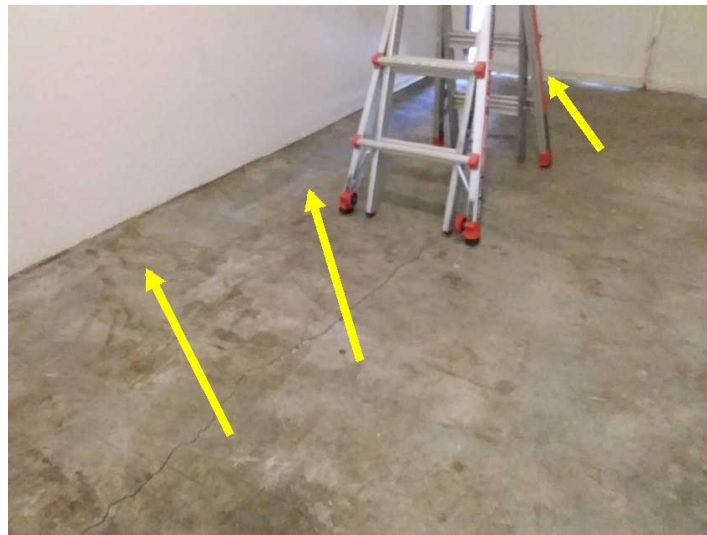
The slab floor is moderately buckled or cracked. Such cracks are common and result as a consequence of the curing process, seismic activity, ordinary settling, or the presence of expansive soils, but are usually not structurally threatening. We can elaborate, but you may wish to have a structural engineer confirm this.
