# PROPERTY INSPECTION REPORT

**FOUR POINT**  
HOME INSPECTION INC.

**5950 Forked Horn Pl**  
**Inspection Prepared For: Candy Wiedemann**  
**Agent: -**

**Date of Inspection: 9/3/2026**

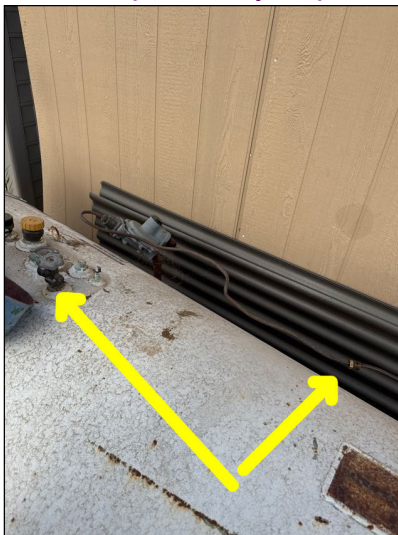
The gas was turned off at the time of the inspection. This condition will limit inspection of the plumbing and heating systems and may affect portions of other systems. Gas may be off due to leaking pipes. The inspector recommends that before the expiration of your inspection objection deadline, you have gas service returned to the home and have the gas distribution system and any gas-fired appliances inspected by a qualified contractor.

The gas was turned off at the time of the inspection.

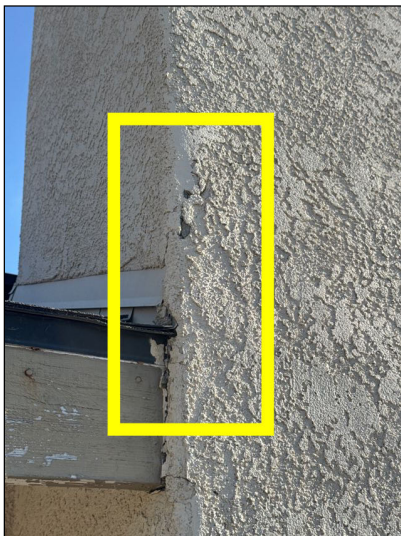
**Maintenance:** All gaps and holes in the stucco surface should be sealed to keep unwanted moisture out. Recommend having these areas sealed and painted. Continue to monitored as part of annual maintenance.

**Maintenance:** All gaps and holes in the stucco surface should be sealed to keep unwanted moisture out.

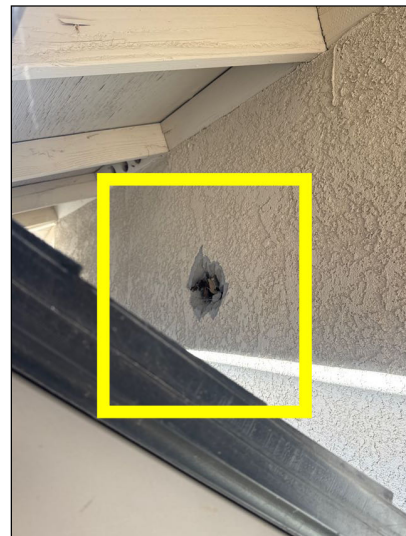
Stucco covering exterior walls of the home had moderate visible damage that should be repaired to prevent possible moisture intrusion or additional damage from exposure to moisture.

Stucco covering exterior walls of the home had moderate visible damage

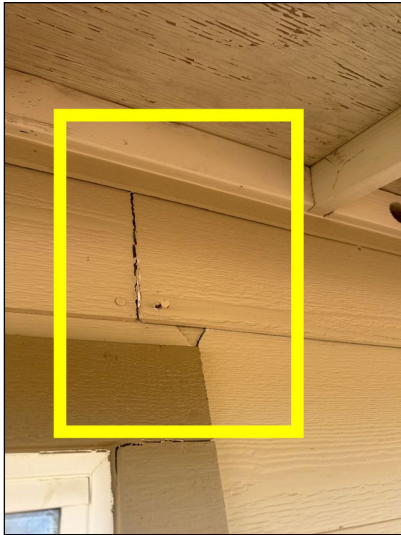
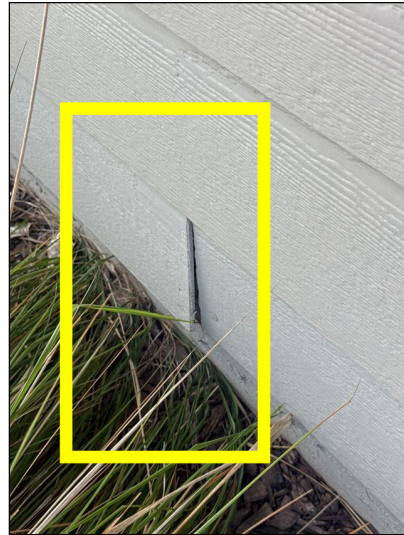
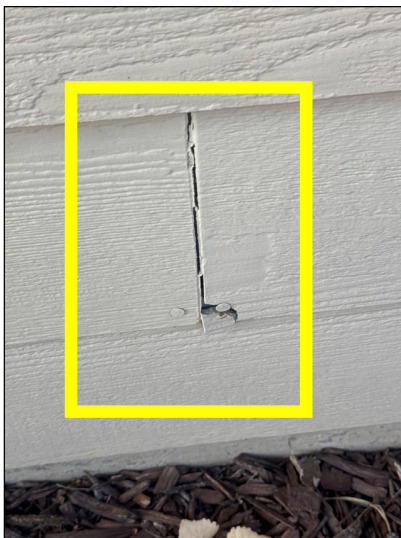
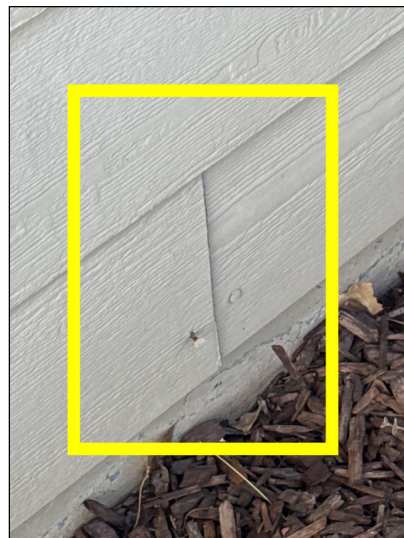
Siding was loose/detached and damaged in places and needed repair. All work should be performed by a qualified contractor.

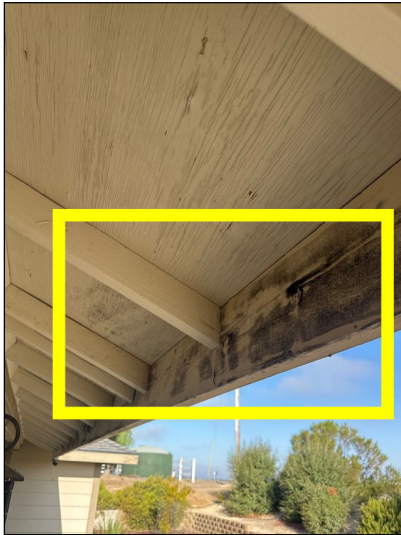
**Monitor:** Home soffits had stained areas visible at the time of the inspection indicating past roof leakage.

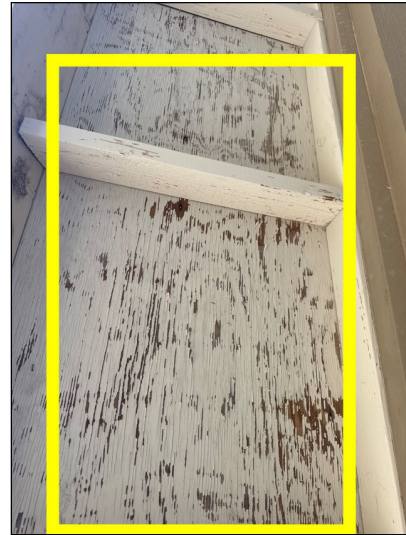
**Maintenance Needed:** Soffits had peeling paint and needed maintenance.

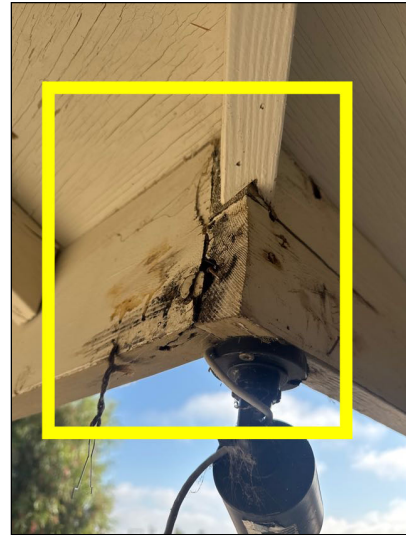
**Moisture damage, wood rot, observed. Refer to pest report for further details and repair damage as needed.**

Moisture damage, wood rot, observed.

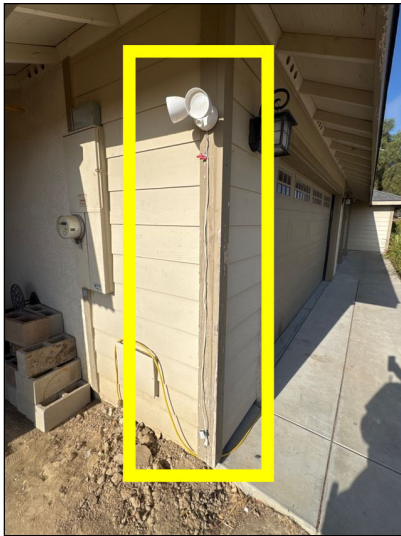
Extension cord used as permanent wiring was visible at the left corner of the garage. This condition is a potential fire hazard. The Inspector recommends that any such wiring be removed and replaced with properly-installed, approved wiring by a qualified contractor.

Extension cord used as permanent wiring was visible at the left corner of the garage.

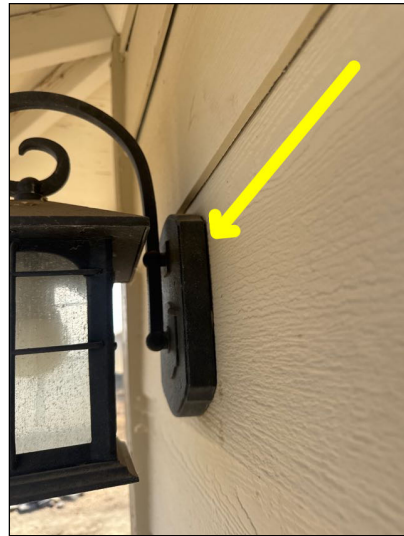
Some exterior lighting was loose to the wall and could expose electrical components to moisture intrusion. The inspector recommends all fixtures are properly fastened and sealed to the wall by a qualified electrical contractor.

Exterior lighting was loose/not flush to the wall and could expose electrical components to moisture intrusion. front of garage

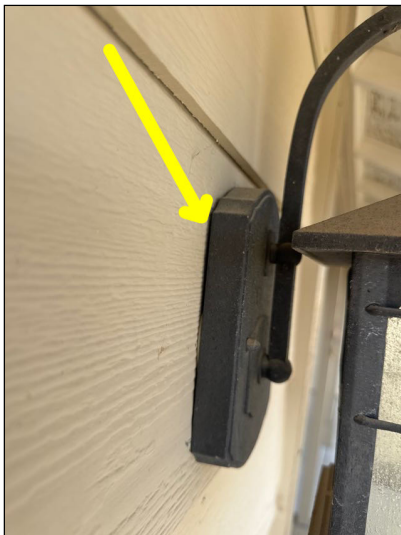
Exterior lighting was loose/not flush to the wall and could expose electrical components to moisture intrusion. front of garage

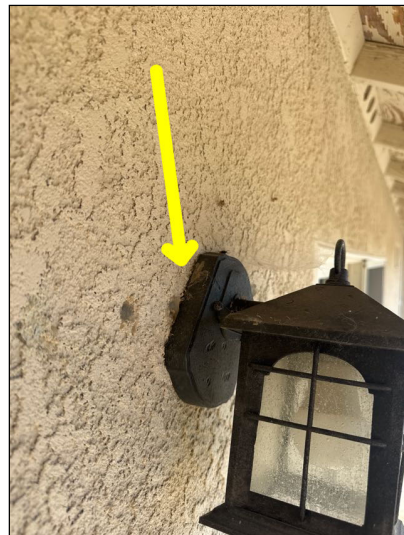
Exterior lighting was loose/not flush to the wall and could expose electrical components to moisture intrusion. rear of the home

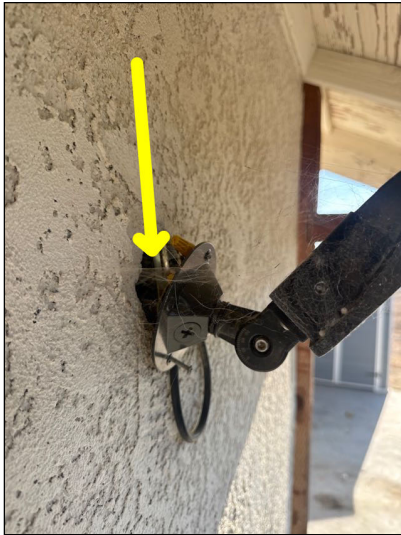
Exterior lighting was loose/not flush to the wall and could expose electrical components to moisture intrusion. rear of the home

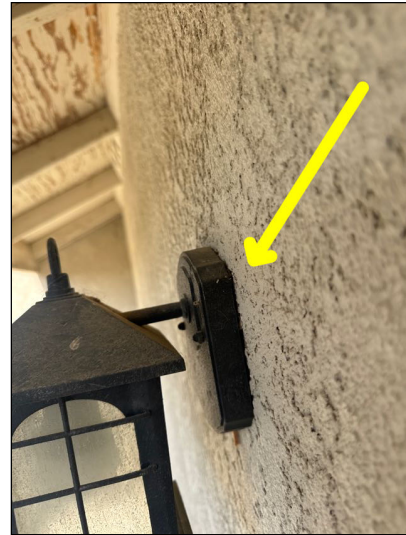
Exterior lighting was loose/not flush to the wall and could expose electrical components to moisture intrusion. rear of the home

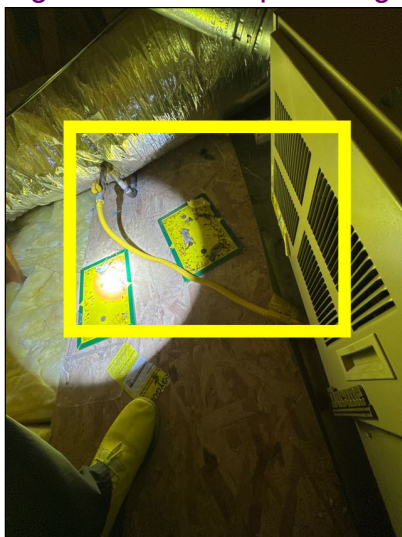
**Recommended Improvement:** The gas supply pipe contained no sediment trap. A sediment trap is generally recommended but not always required, depending on the local Authority Having Jurisdiction (AHJ). The purpose of a sediment trap is to prevent sediment or debris particulates from entering and clogging the heaters gas valve, which can cause the heater to shut down. You may wish to consult with local contractor concerning the advisability of installing a sediment trap in the gas line.

**Improvement:** The gas supply pipe contained no sediment trap.

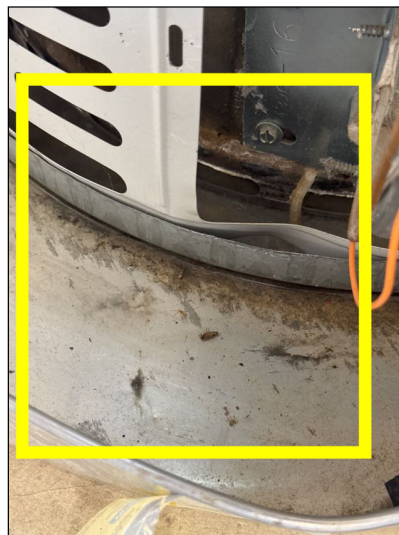
This water heater appeared to have be leaking at the time of the inspection and should be shut off, drained immediately and an an evaluation and any necessary work be performed by a qualified HVAC or plumbing contractor.

This water heater appeared to have be leaking

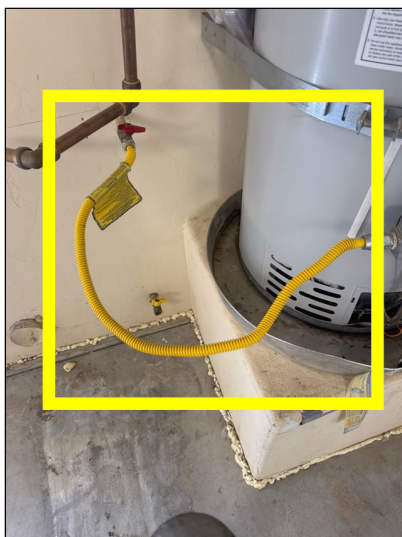
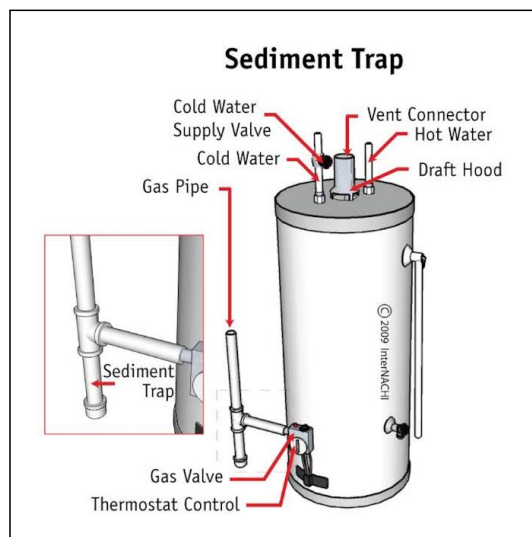
**Improvement:** The gas supply pipe contained no sediment trap.

The purpose of a sediment trap is to prevent sediment or debris particulates from entering and clogging the water heaters gas valve

**Recommended Improvement:** The gas supply pipe contained no sediment trap. The purpose of a sediment trap is to prevent sediment or debris particulates from entering and clogging the water heater gas valve, which can cause the water heater to shut down. You may wish to consult with local contractor concerning the advisability of installing a sediment trap in the gas line.

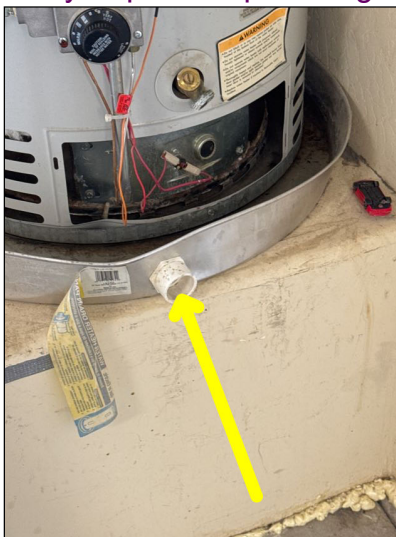
**Monitor:** The drain pipe serving this water heater drain pan had no overflow extension. To reduce the potential for damage from a leaking tank or pipe fittings, the drip pan should have an overflow pipe installed that discharges to the home exterior or just above the floor. The Inspector recommends correction by a qualified plumbing contractor.

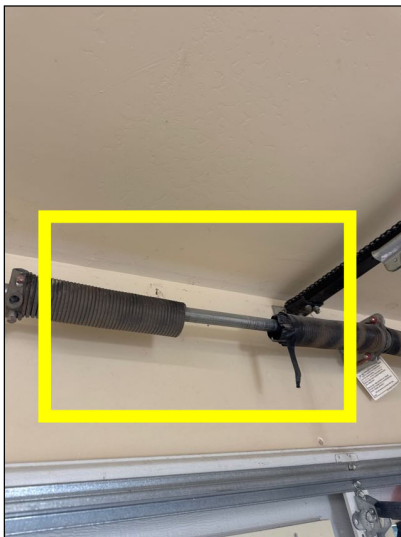
Springs supporting an overhead garage door were broken and needed replacement. This operation can be dangerous. The Inspector recommends all work be performed by a qualified contractor.

Springs supporting an overhead garage door were broken and needed replacement.

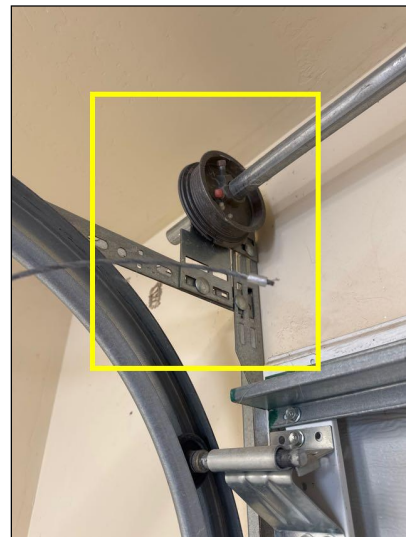
Door cabled supporting an overhead garage door were disconnected.

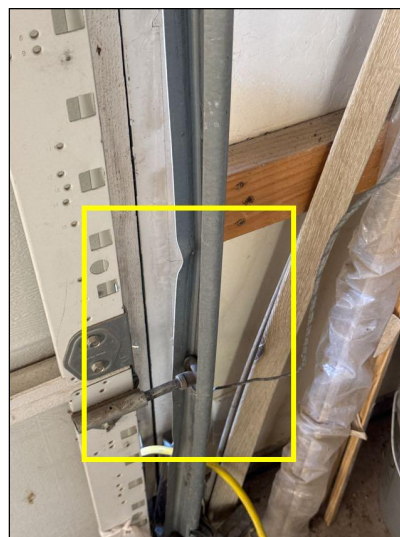
The track was damaged and needed repair.

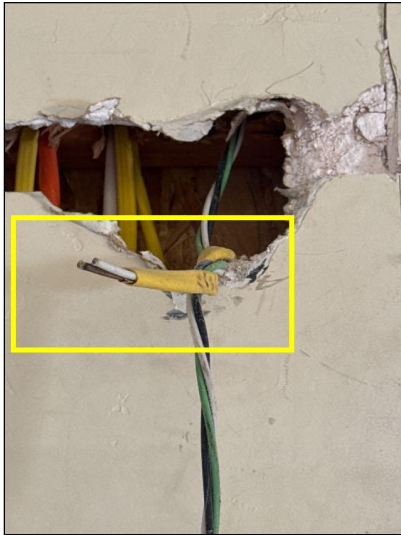
Non-energized wires were terminated outside of a proper enclosure.

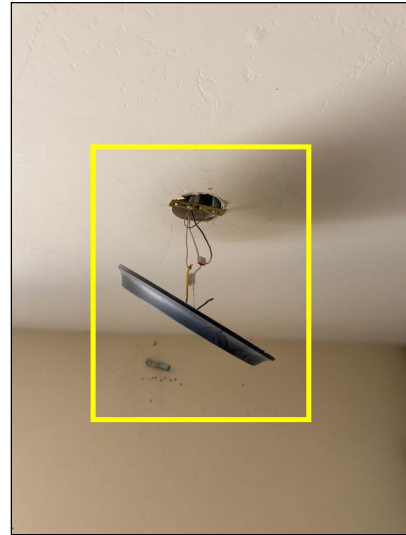
An interior light fixture in the garage was damaged at the time of the inspection.

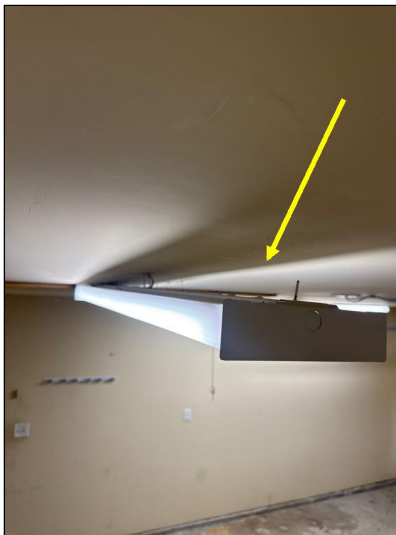
An interior light fixture in the garage was damaged at the time of the inspection.

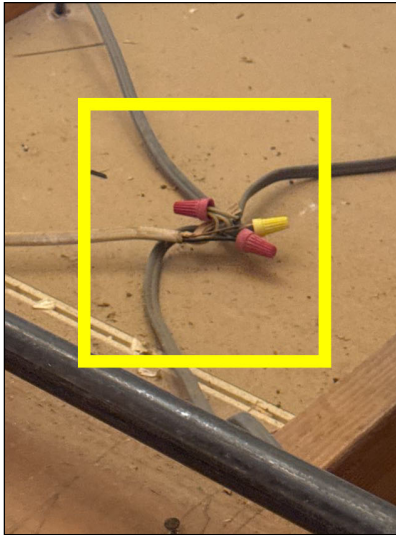
| Garage | | | |
|---|---|---|---|
| | Page 47 Item: 3 | Electrical | Energized electrical splices not contained within a junction box and exposed to touch were visible in the attic at the time of the inspection. Electrical splices should be contained within an approved junction box with a cover plate installed. This condition is a shock/electrocution and potential fire hazard and should be corrected by a qualified electrical contractor. |

Energized electrical splices not contained within a junction box and exposed to touch were visible in the attic (above the garage)

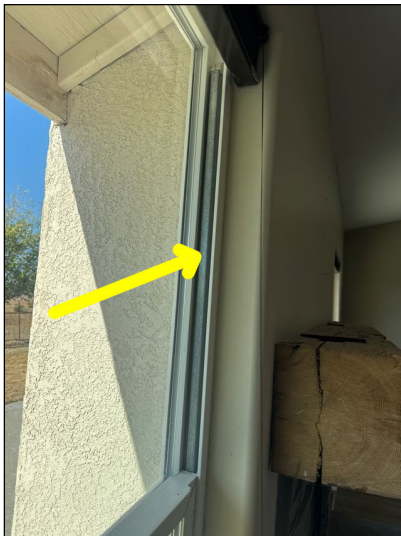
The sash bar has dropped out of place on a single-hung window in the Living Room. This could affect the ability for the window stay up when lifted and released and or make the window non-functioning. The Inspector recommends repair or replacement by a qualified contractor.

The sash bar has dropped out of place on a single-hung window

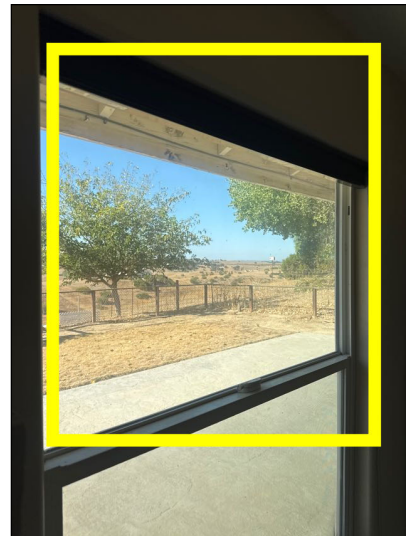
| Interior Areas | | | |
|---|---|---|---|
| | Page 52 Item: 7 | Window Condition | <p>Although no condensation was visible at the time of the inspection, staining and etching of the glass at a window in the Living Room, Front Entry indicated a loss of thermal integrity. Etching of the glass from long-term exposure to condensation constitutes permanent damage. The Inspector recommends that before the expiration of your Inspection Objection Deadline you consult with a qualified contractor to discuss options and costs for replacement.</p> <p>The sash bar has dropped out of place on a single-hung window in the Living Room. This could affect the ability for the window stay up when lifted and released and or make the window non-functioning. The Inspector recommends repair or replacement by a qualified contractor.</p> |

Staining and etching of the glass at the window indicated a loss of thermal integrity.

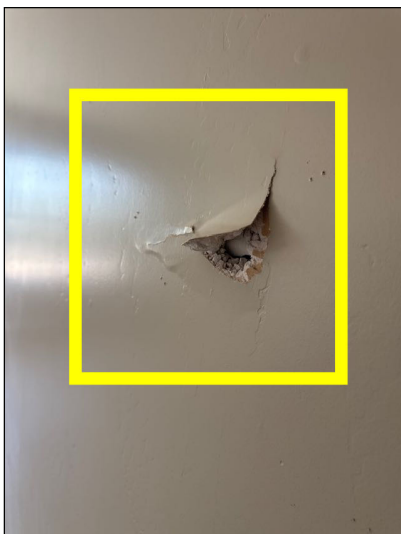
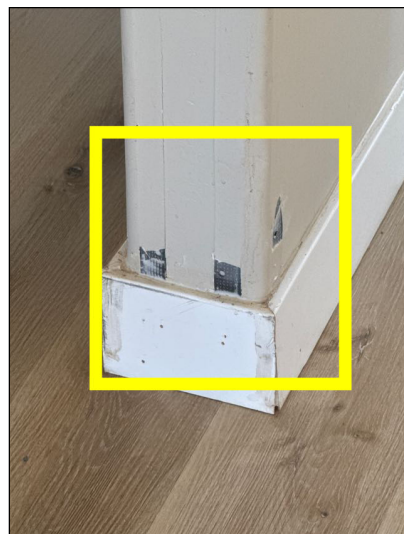
Interior walls in the home exhibited general minor damage or deterioration at the time of the inspection. The Inspector recommends that before the expiration of your Inspection Objection Deadline you consult with a qualified contractor to discuss options and costs for repair or replacement.

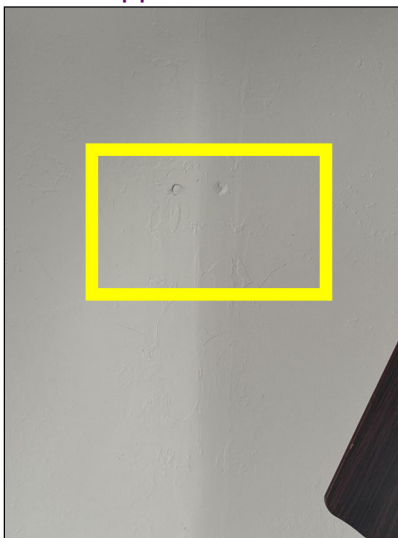
Protruding nail heads visible in ceilings in the Living Room, Kitchen appeared to be the result of framing members shrinking after original construction was complete. Framing lumber is often installed with a relatively high moisture content and typically shrinks as it dries. Once framing has reached moisture equilibrium with the homesite environment, framing will become stable and nail pops can be repaired without concern that they will reappear. The time required to reach stability depends on the moisture content of framing materials at the time of original construction and humidity levels at the homesite. The time frame may vary between one and two years in many environments. The Inspector recommends repair by a qualified drywall or painting contractor once the condition appears stable.

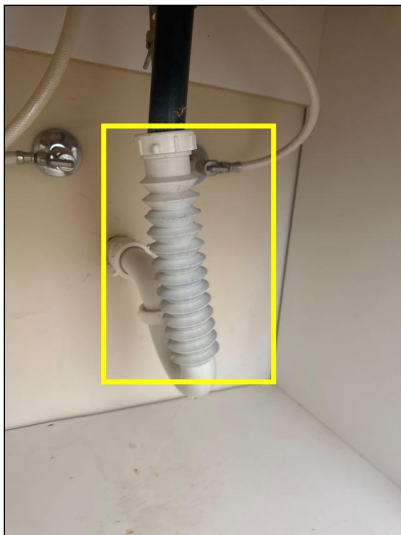
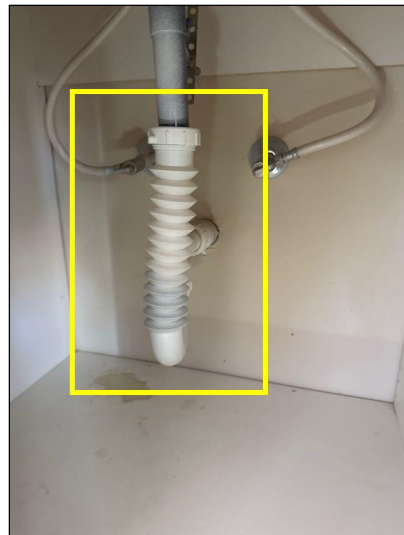
**Monitor:** Flex drain observed, these are subject to frequent clogging. **Monitor:** Flex drain observed, these are subject to frequent clogging.

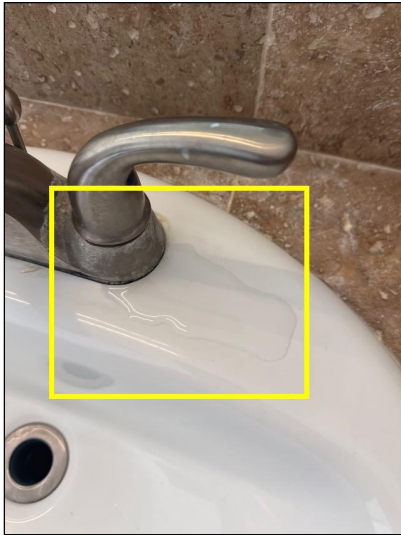
The faucet at this bathroom sink leaked when the water was turned on. This typically indicates that a valve seal needs replacement.

The faucet at this bathroom sink leaked when the water was turned on. (right side)

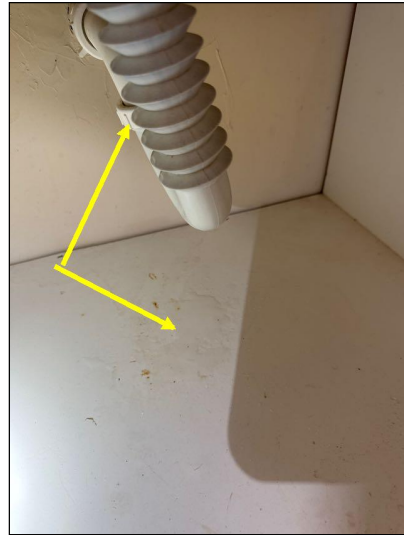
| Interior Areas | | | |
|---|---|---|---|
| | Page 60 Item: 2 | Sinks | <p>Leaking connections at the trap assembly beneath the bathroom sink should be repaired to avoid future/additional damage to the cabinet floor and possibly the wall/floor structures below. The Inspector recommends repair by a qualified plumbing contractor.</p> <p><b>-FAUCET</b></p> <p>The faucet at this bathroom sink leaked when the water was turned on. This typically indicates that a valve seal needs replacement.</p> |

Leaking connections at the trap assembly beneath the bathroom sink (right side)

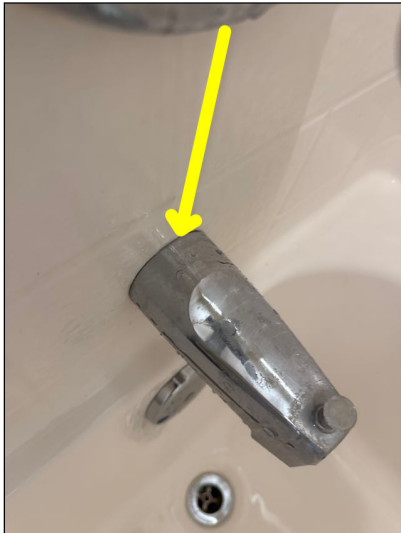
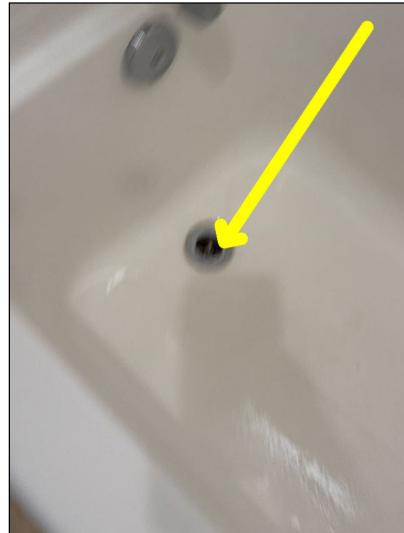
The tub in this bathroom had an inoperable stopper. The Inspector recommends service by a qualified contractor.

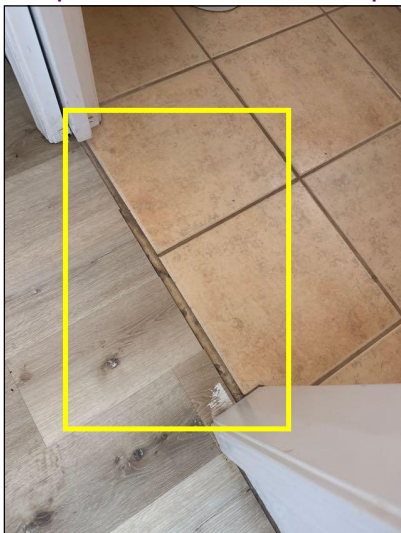
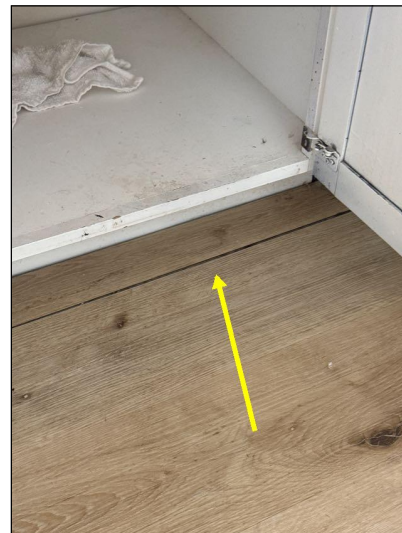
- The Inspector observed few deficiencies in the condition of floors. Notable exceptions are listed.
- Floor in this bathroom were poorly installed. The Inspector recommends that before the expiration of your Inspection Objection Deadline you consult with a qualified contractor to discuss options and costs for repair or replacement.

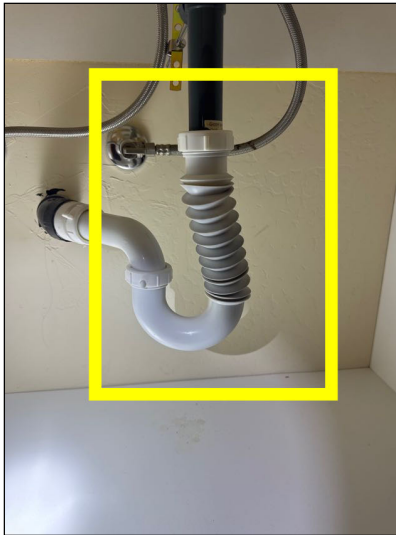
**Monitor:** Flex drain observed, these are subject to frequent clogging.

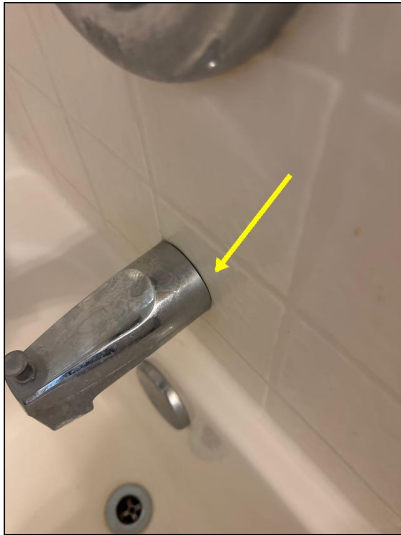
**Maintenance Needed:** The tub faucet in this bathroom not flush to wall.

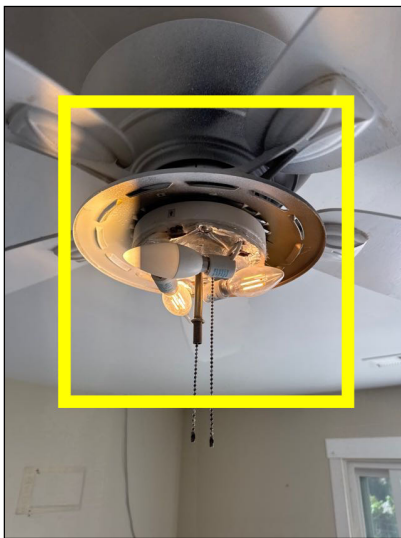
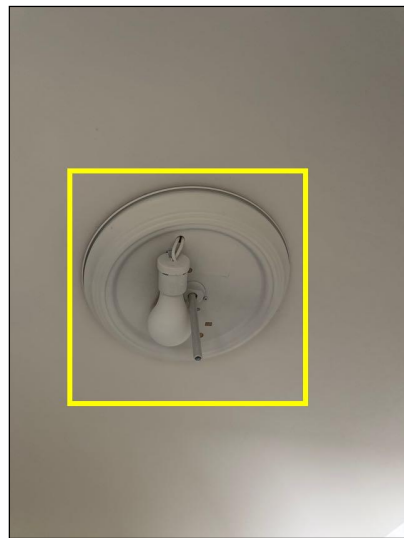
| | Page 75 Item: 8 | Light Fixture Condition | <ul style="list-style-type: none"><li>• A switch cover plate was missing in this bedroom. This condition left energized electrical components exposed to touch, a shock/electrocution hazard. The Inspector recommends that a listed cover plate be installed by a qualified electrical contractor.</li><li>• A light fixture was missing the globe cover leaving the light bulb exposed.</li></ul> |

- A switch cover plate was missing in this bedroom. This condition left energized electrical components exposed to touch, a shock/electrocution hazard. The Inspector recommends that a listed cover plate be installed by a qualified electrical contractor.
- A light fixture was missing the globe cover leaving the light bulb exposed.

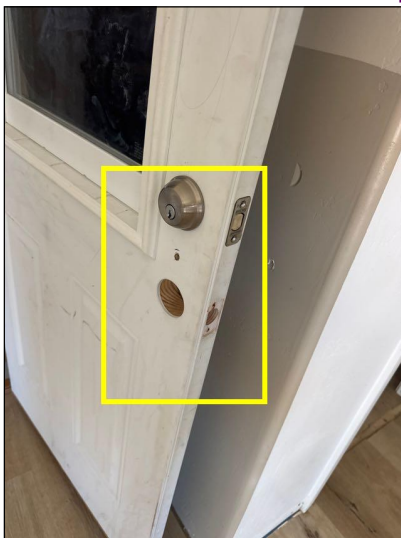
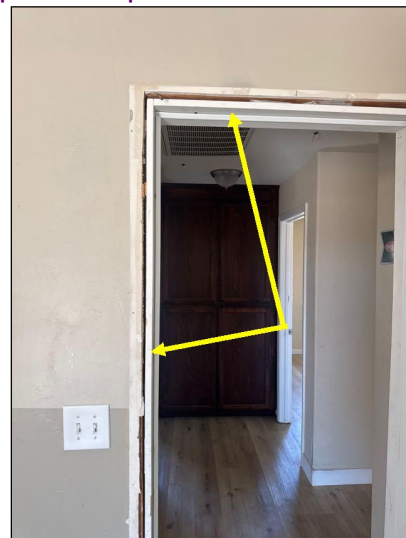
- At the time of the inspection, the Inspector observed few deficiencies in the condition of interior doors in this bedroom. Notable Exceptions are listed.
- An interior door in this bedroom was missing door hardware and trim. The Inspector recommends that before the expiration of your Inspection Objection Deadline you consult with a qualified contractor to discuss options and costs for repair or replacement.

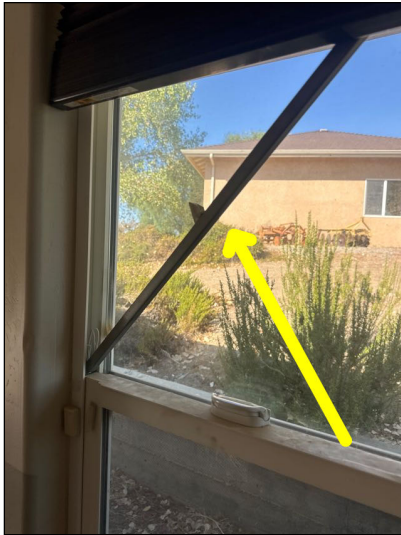
The sash bar has dropped out of place on a single-hung window

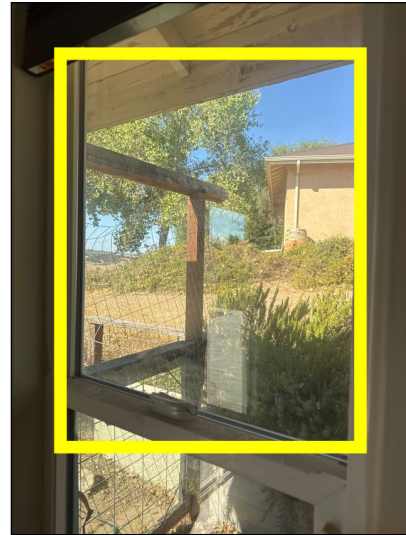
| | Page 76 Item: 11 | Window Condition | <p>Although no condensation was visible at the time of the inspection, staining and etching of the glass at a window indicated a loss of thermal integrity. Etching of the glass from long-term exposure to condensation constitutes permanent damage. The Inspector recommends that before the expiration of your Inspection Objection Deadline you consult with a qualified contractor to discuss options and costs for replacement.</p> <p>The sash bar has dropped out of place on a single-hung window. This could affect the ability for the window stay up when lifted and released and or make the window non-functioning. The Inspector recommends repair or replacement by a qualified contractor.</p> |

Staining and etching of the glass at the window indicated a loss of thermal integrity.
