### *Inspection Report*

**Address: 2630 La Mirada Los Osos, CA**

**09/08/2026**

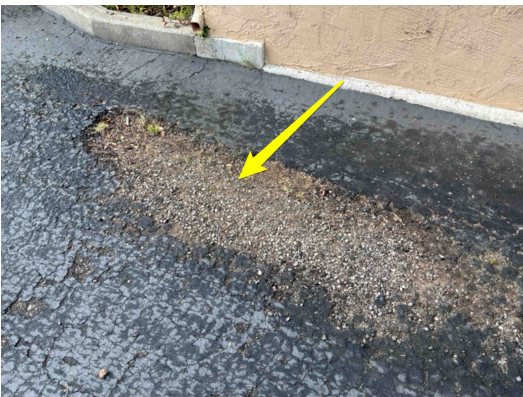
**FI** **MR** 19: Eroded or damaged asphalt found in some areas of the driveway. Maintenance or repairs are recommended.

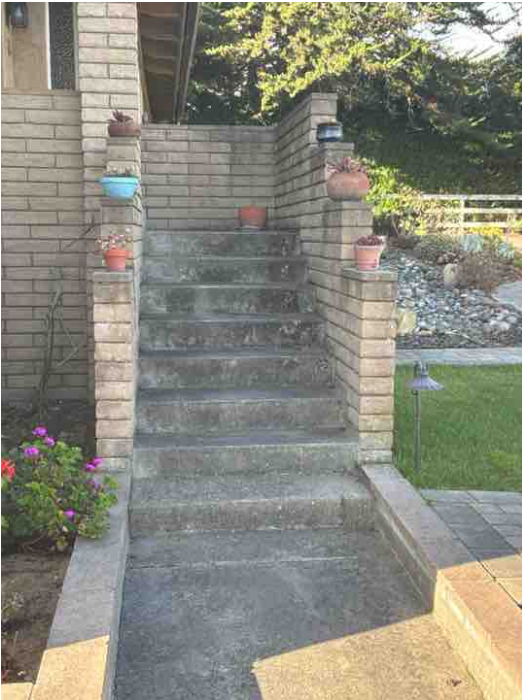
**35: Type & Location:** Concrete Exterior Stairway: OFF THE FRONT ENTRY

**36:** Exterior stairs are serviceable and in good condition.

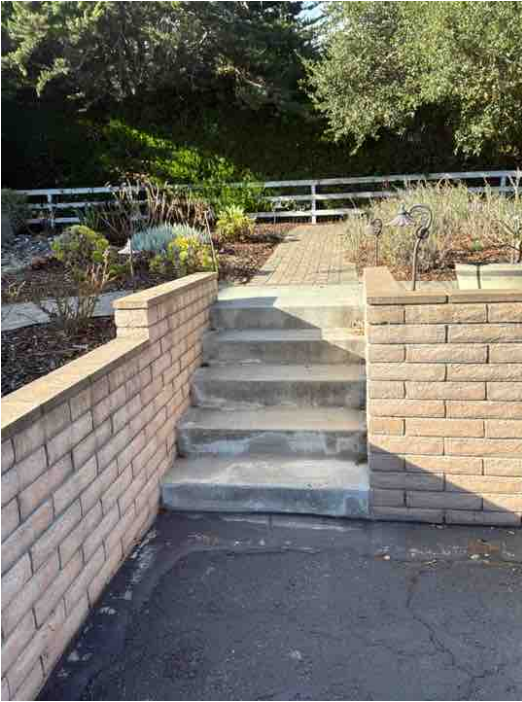
**38: Type & Location:** Concrete Exterior Stairway: OFF THE DRIVEWAY PARKING AREA

**SC 39:** Missing the proper / required graspable handrail at the exterior stairway OFF THE DRIVEWAY PARKING AREA.

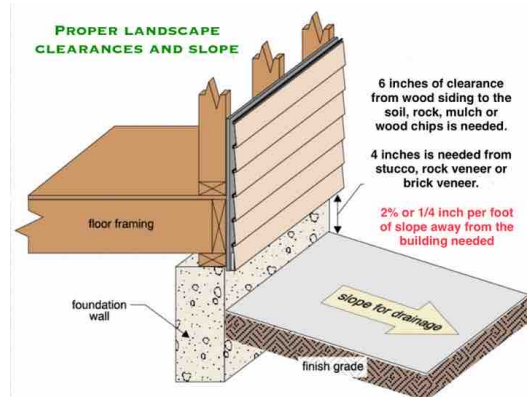
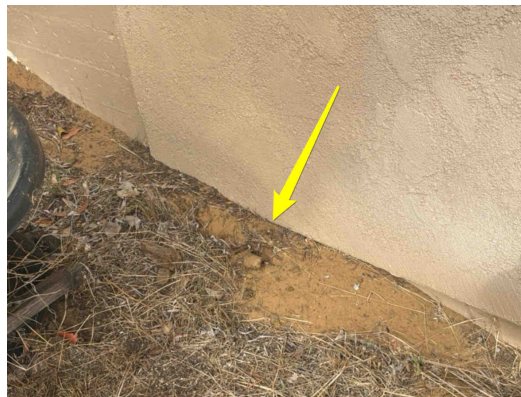
**E&C MR 43:** Soil level found high at areas of the foundation. (Recommend 4 inches from the bottom of the exterior stucco siding to dirt, rock, mulch or wood chips).

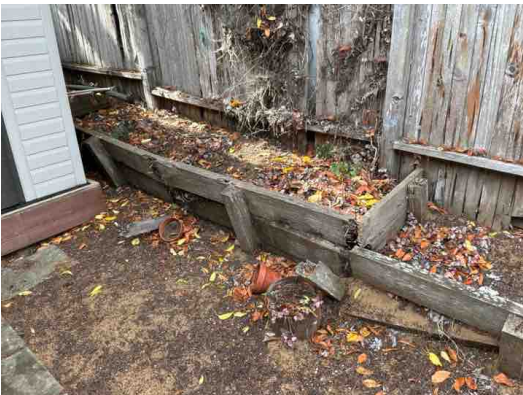
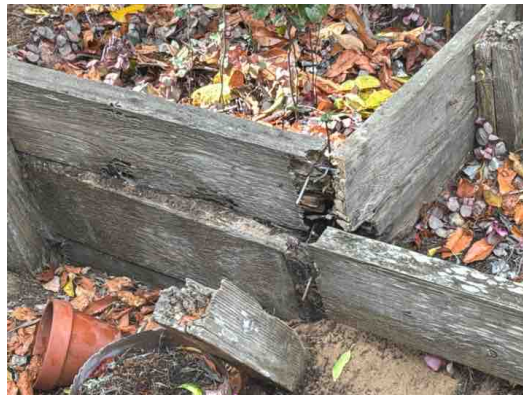
**E&C 50: Some heavy moisture damage, with leaning of the wood retaining wall(s).** Sections of the wood, retaining walls appear to be nearing the end of its structural life. *Be aware that wood retaining walls have a limited lifespan and will warrant eventual replacement. Monitor, replace or repair the wood retaining walls as needed.*

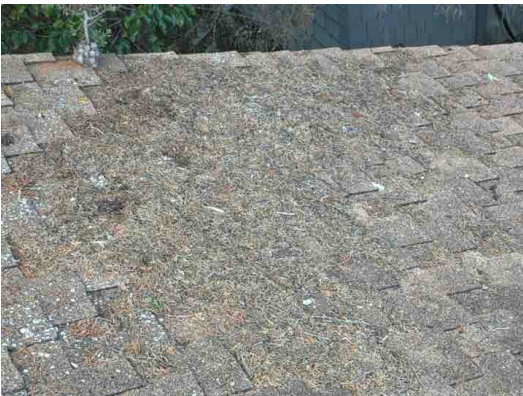
**MR 66:** Debris covers portions of the roof and/or roof flashings. This may cause deterioration and/or a roof leak. Areas of the roof are not fully visible. Clean and inspect regularly.

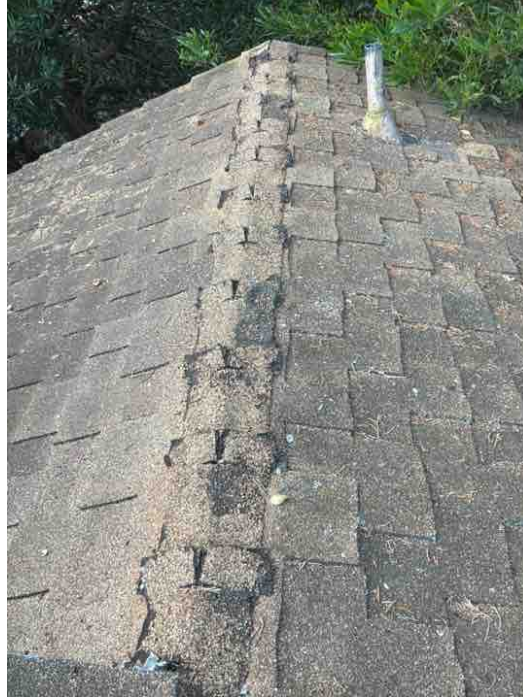
**E&C 67:** Some damaged and missing roof ridge shingles at areas of the roof. Corrections are needed. Contact a qualified roofer to evaluate the roof and make the appropriate recommendations and repairs as needed.

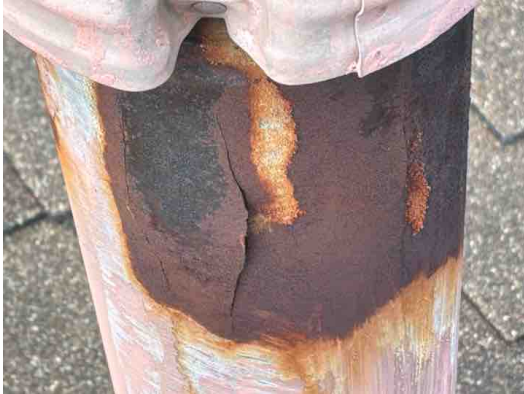
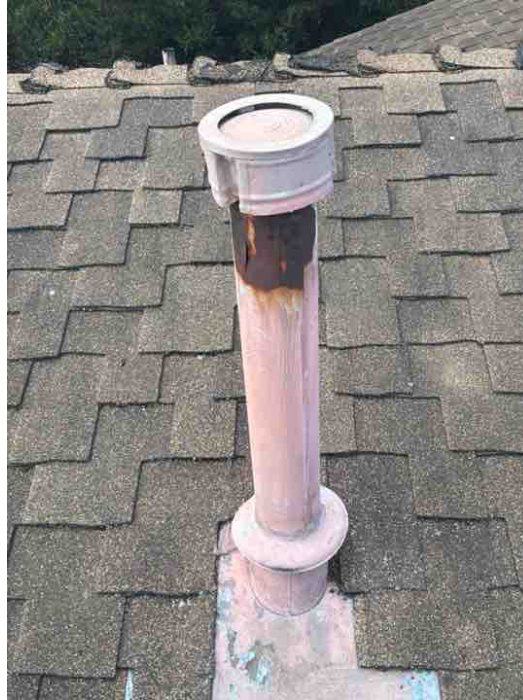
**SC 97:** Water heater vent pipe found rusted, damaged and cracked. Recommend replacement of the upper section of the vent pipe.

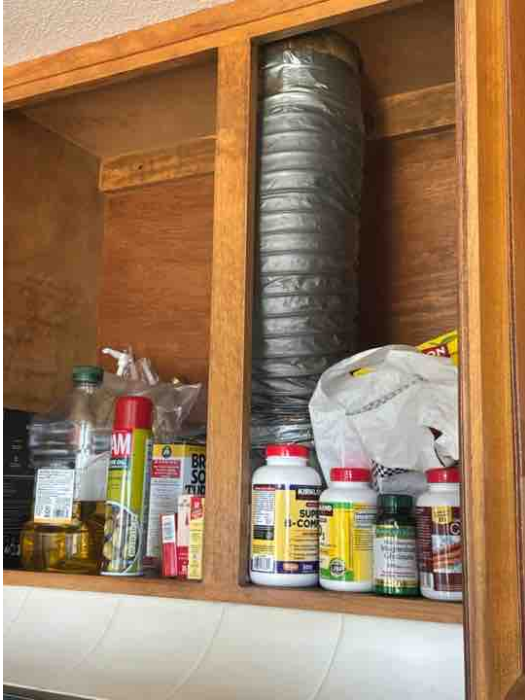
**SC 116:** Improper installation and use of a non-fire rated flexible pipe through the kitchen cabinet and/or attic above the cook top for the cook top exhaust vent pipe. A rigid fire-rated metal duct is required for fire safety. Contact a qualified HVAC professional to correct as needed.

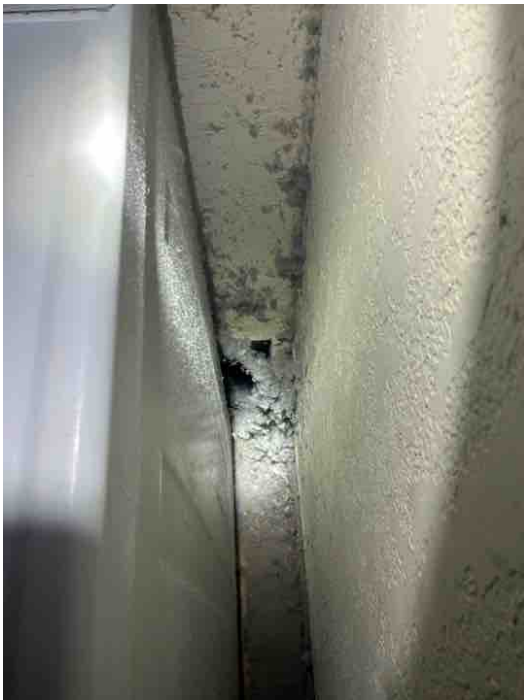
**SC 130:** The current laundry dryer vent pipe is leaking lint and exhaust air into the areas behind the laundry dryer. Additional review and correction is needed.

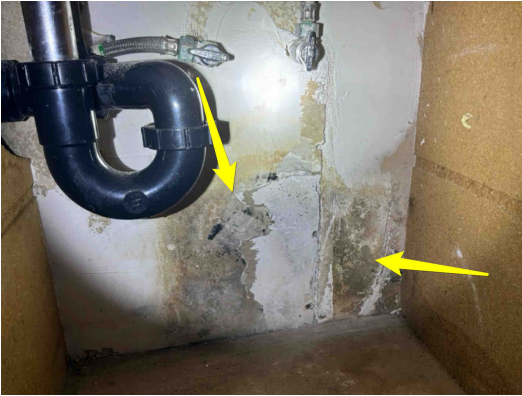
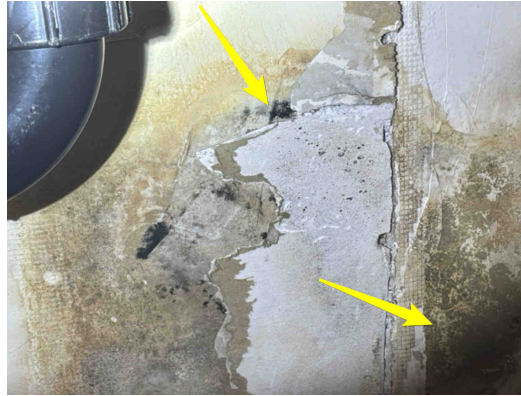
**SC FI 137:** Some moisture stains and/or damage with visible mold growth on the drywall and/or cabinetry in PRIMARY BEDROOM BATHROOM. Recommend further review and cleanup by a qualified mold remediation professional.

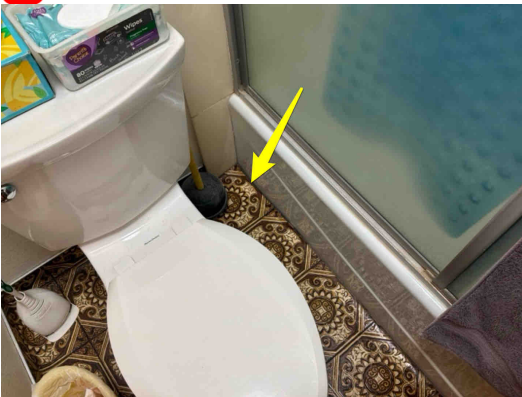
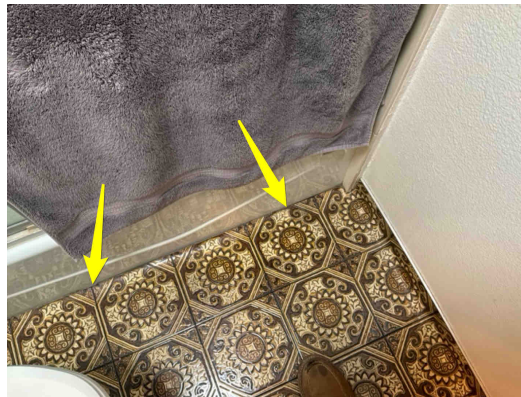
**E&C 141:** Some Moisture stains and damage to floor outside tub: HALLWAY BATHROOM.

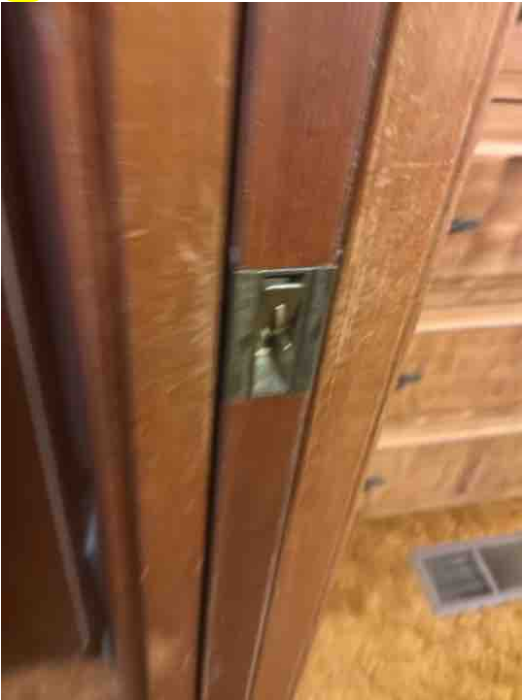
**MR 156:** Interior door knob found damaged: PRIMARY BEDROOM CLOSET POCKET DOOR

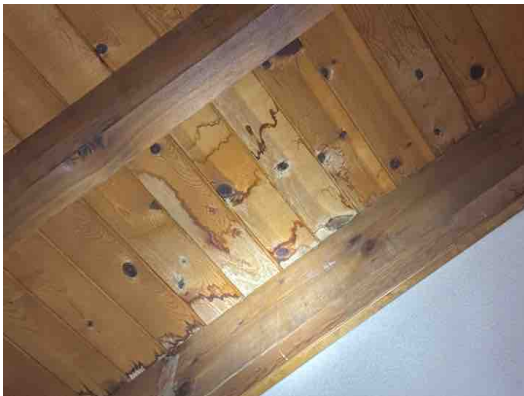
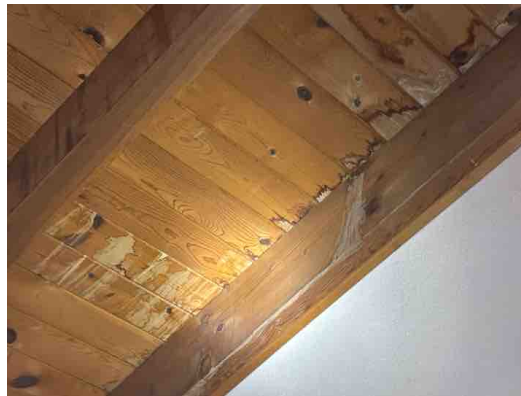
**FI 174:** Evidence of past moisture stains & damage at ceiling area in the IN THE LIVING ROOM ABOVE THE FIREPLACE CHIMNEY. Recommend further review of the water stains to determine the cause, the current condition and if repairs are needed.

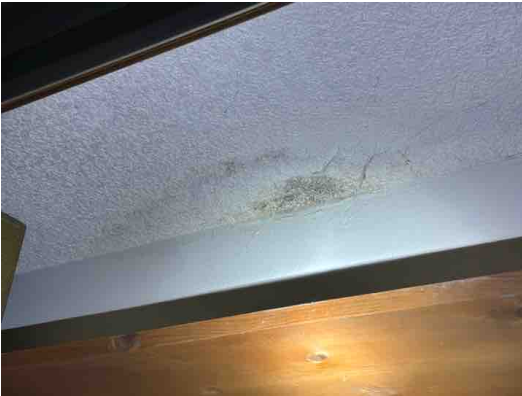
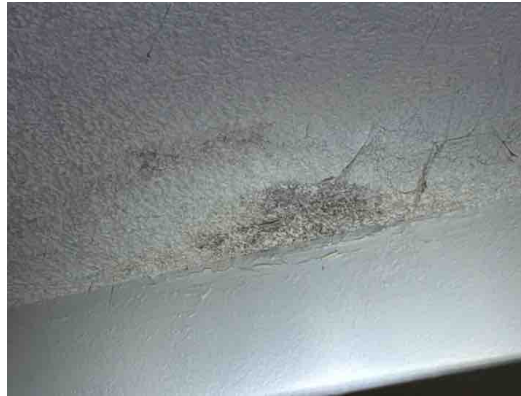
**FI 175:** Evidence of past moisture stains & damage at ceiling and walls in IN THE BEDROOM-3 CLOSET. Recommend further review of the water stains to determine the cause, the current condition and if repairs are needed.

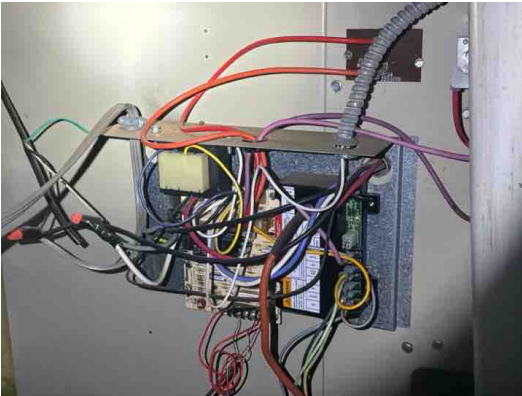
**E&C 188:** The cover is loose, not installed and missing fasteners on the electrical and wiring connections at the furnace located in the crawlspace. The cover is needing to be proper fastened to the unit for safety and help prevent critter intrusion or damage.

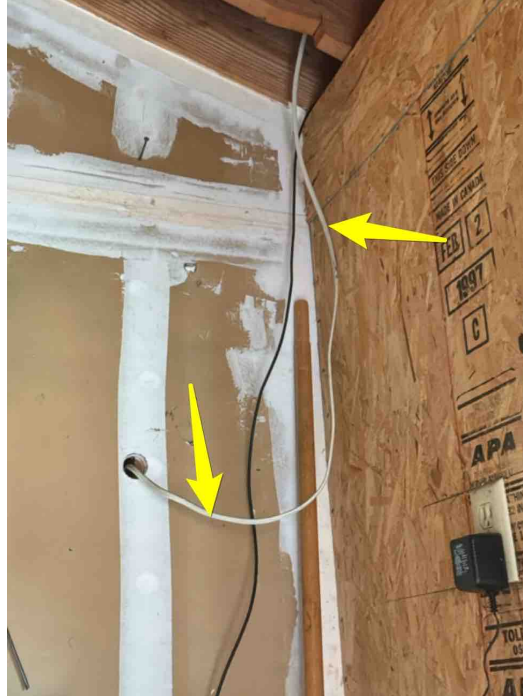
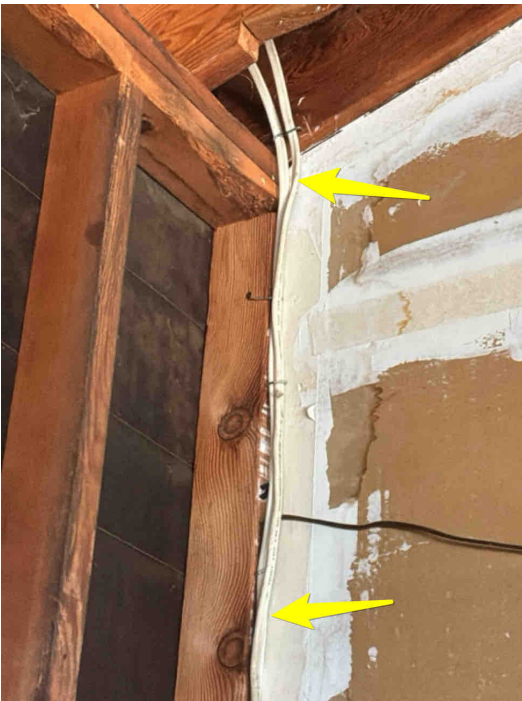
**SC 195:** Improper exposed electrical wiring, "Romex" improperly installed subject to physical damage, not in a conduit or raceway per standards: IN AREAS OF THE GARAGE

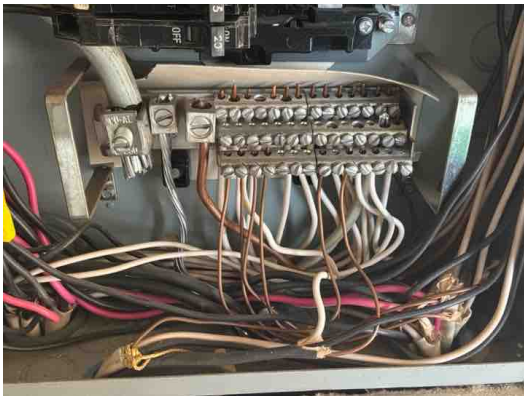
**SC 199:** Improper electrical wiring and connection of the Neutrals and Grounds in the ELECTRICAL SUB PANEL with no main disconnect. **The electrical sub panel is not bonded** due to the improper connection of the ground wires on the floating buss bar. The white or neutrals wires must be separated from the green or naked ground wires in the metal panel. The white wires must be installed on a floating buss bar and the ground wires must be installed on a separate buss bar attached directly to the metal panel box.

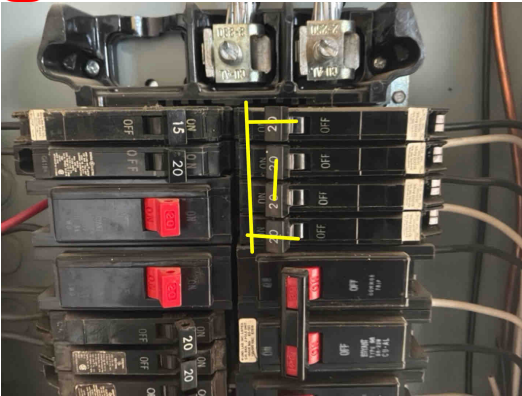
**SC 200:** Missing the required split-branch coupler at a 240-volt breaker in the: ELECTRICAL SUB PANEL.

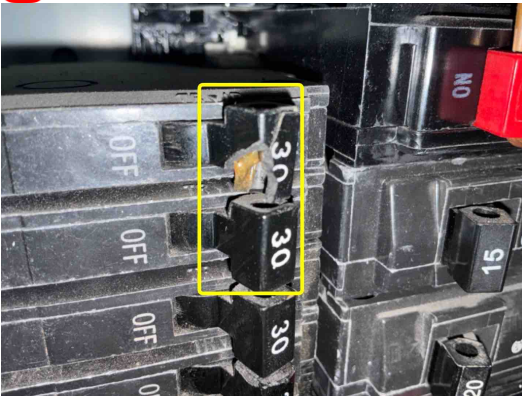
**SC 201:** Missing / BROKEN split-branch coupler at a 240-volt breaker in the: ELECTRICAL SUB PANEL.

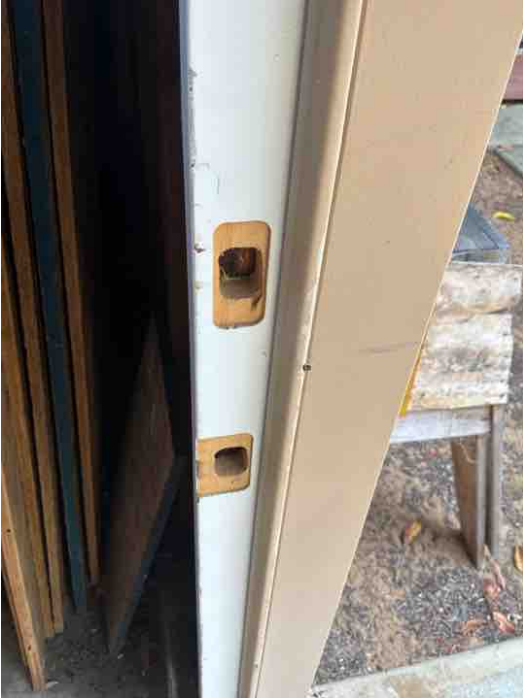
**MR 212:** Missing the metal strike plate at the doorframe at the Garage Pedestrian door.

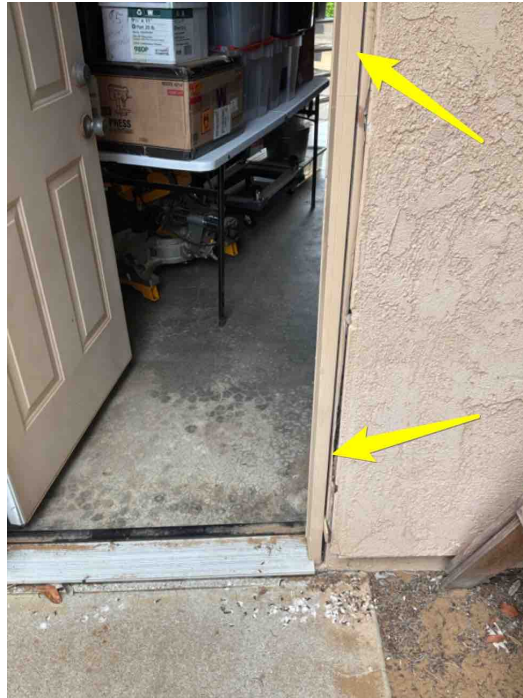
**E&C 213:** Missing the exterior trim and waterproofing around the garage exterior pedestrian door to the backyard. Contact a qualified contractor to review and correct.

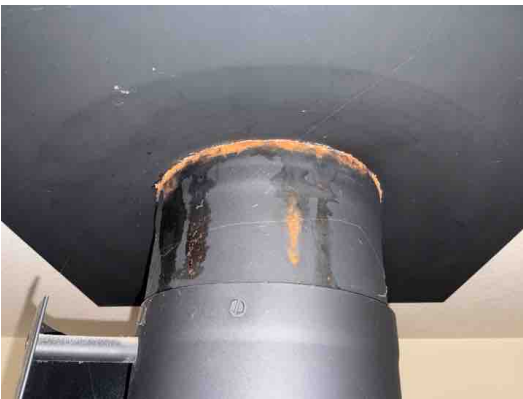
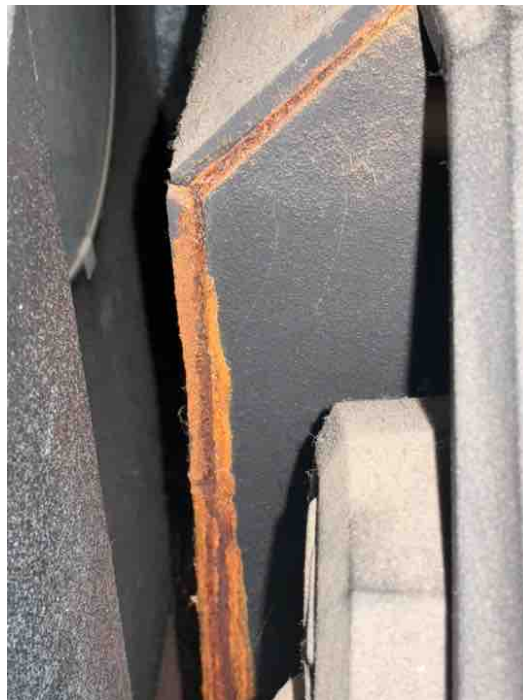
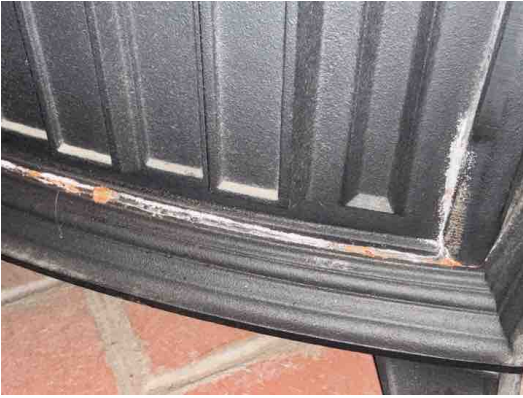
**MR UPG 225:** Evidence of water intrusion with stains and rust at and around the flue pipe and inside the freestanding fireplace. Additional review and corrections are needed by a qualified fireplace professional prior to use.

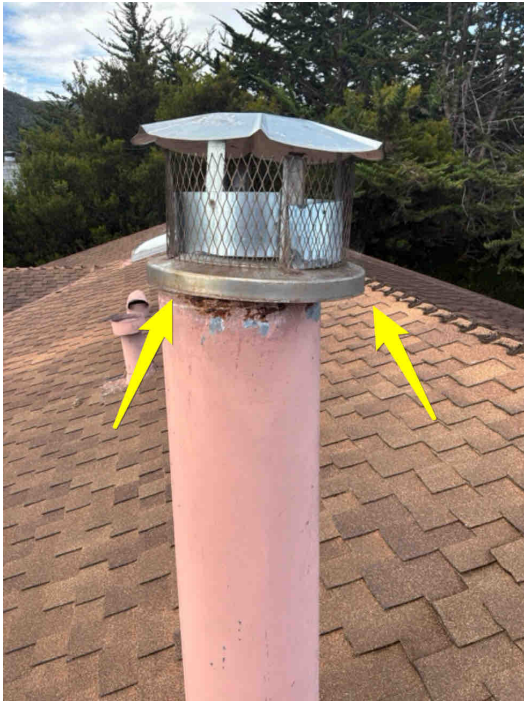
**227:** The DINING AREA Metal fireplace chimney is needing servicing or repair. The inner pipe at the metal fireplace Chimney appears to be loose, possibly disconnected and offset. Contact a qualified fireplace and chimney sweep to perform appropriate repairs, upgrades or needed maintenance.

The chimney pipe appears to be loose and or disconnected

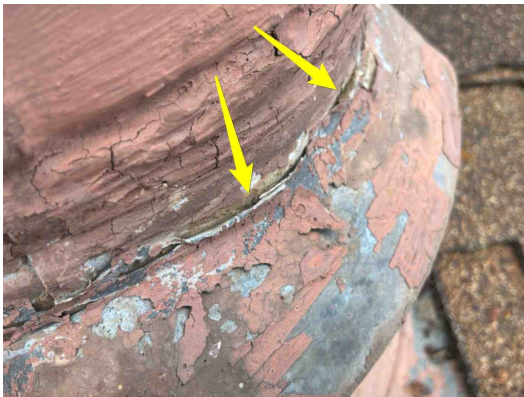
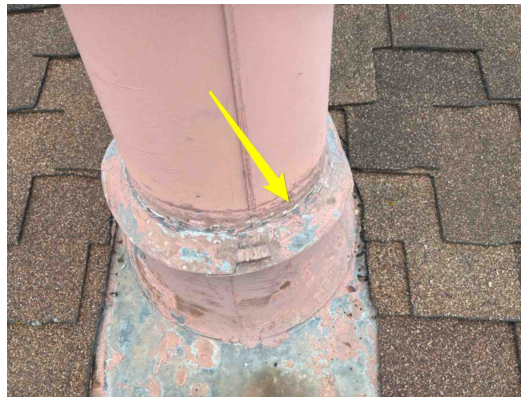
**229:** Deteriorated sealant DINING AREA FREESTANDING FIREPLACE metal Chimney pipe at the storm collar connection. Maintenance is recommended, needed to help prevent water intrusion.

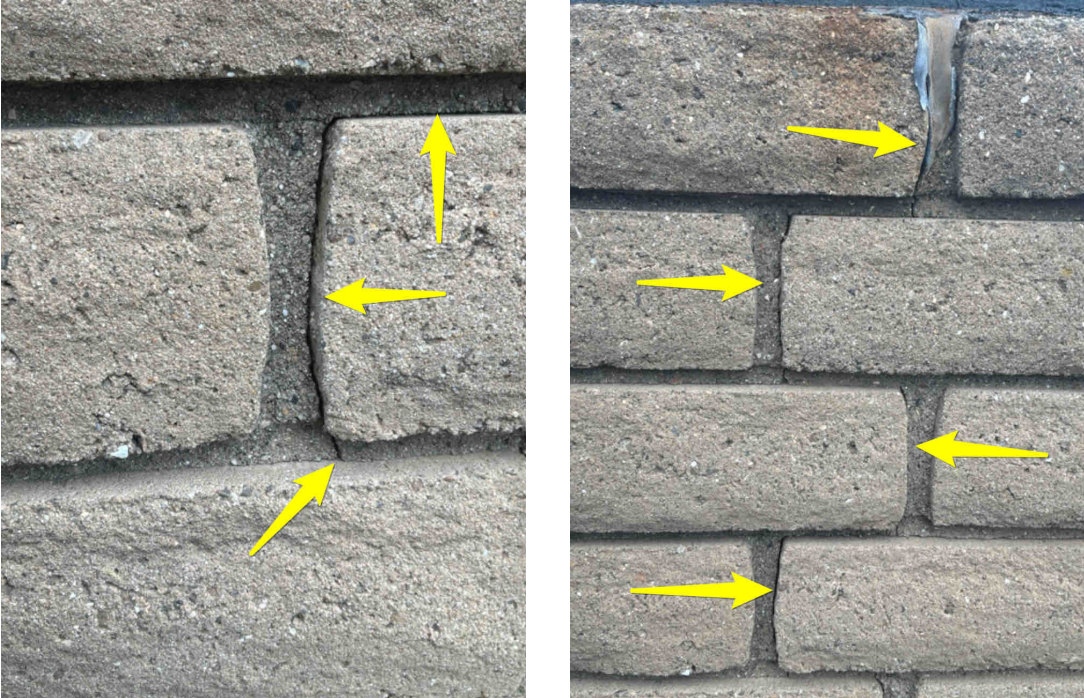
**SC FI 245:** Evidence of thermal shock cracking at the exterior of the LIVING ROOM fireplace masonry chimney. This is an indication that some damaged or excessive deterioration has occurred at the fireplace chimney flue liners, throat and/or firebox. Recommend scoping chimney with a camera to determine condition. (Fireplace should not use until proper corrections are performed).

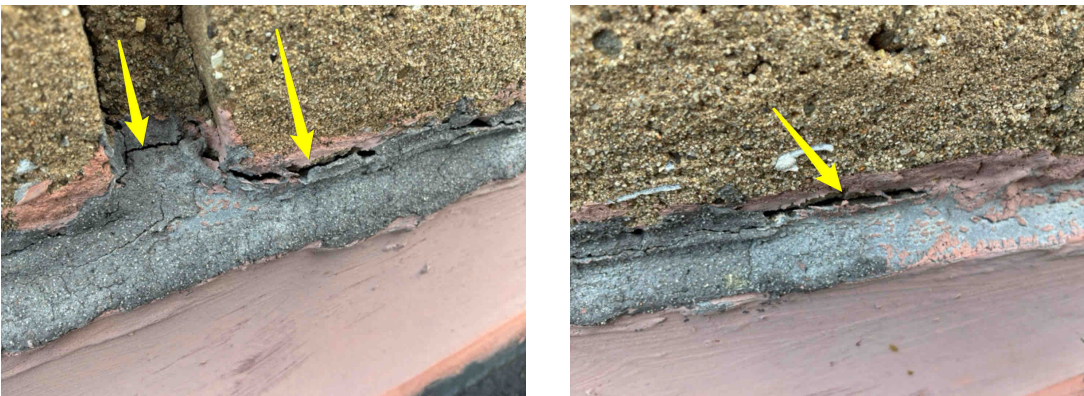
**MR 247:** Deteriorated caulking, cracks and/or separations noted at the LIVING ROOM masonry chimney at its roof flashings. General maintenance such as caulking and resealing the fireplace roof flashings is needed. Contact a qualified roofer for maintenance recommendations.
