# **Inspection Report**

**Property Address:  
11422 Edmonson Ave  
Moreno Valley CA 92555**

| <b>Date:</b> 9/18/2026 | <b>Time:</b> 11:00 AM | <b>Report ID:</b> 091826-02MC |

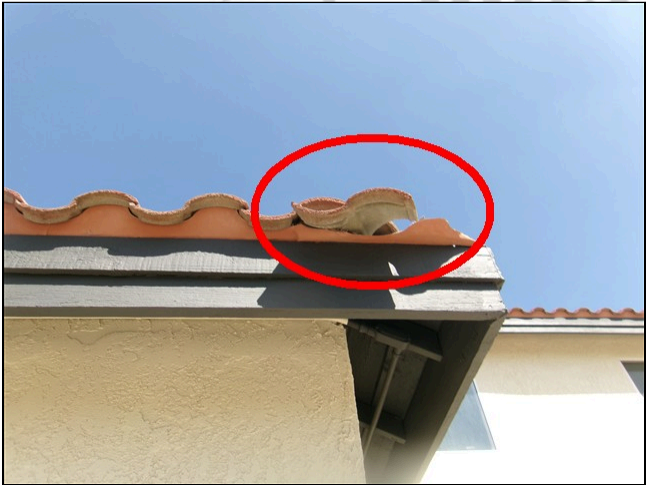
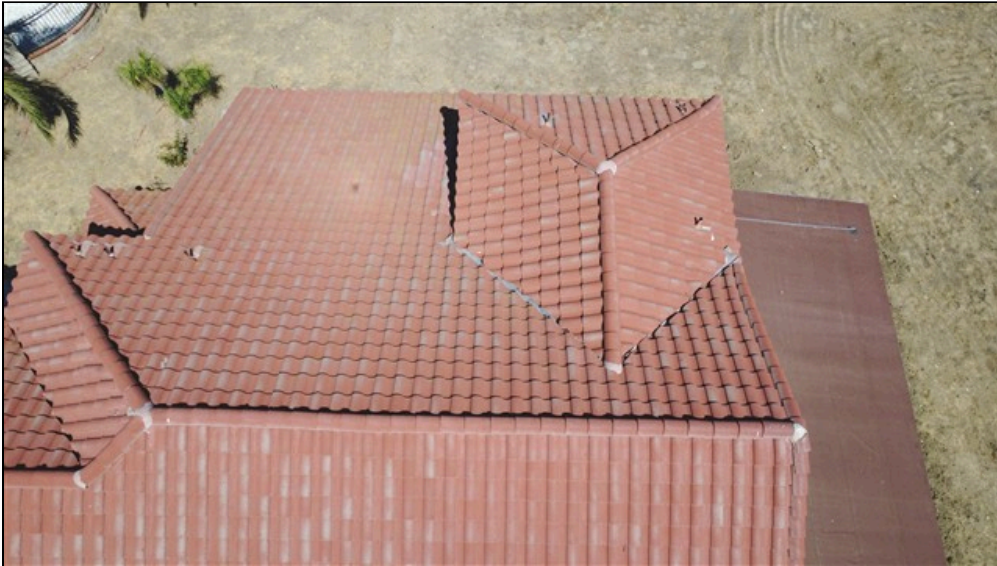
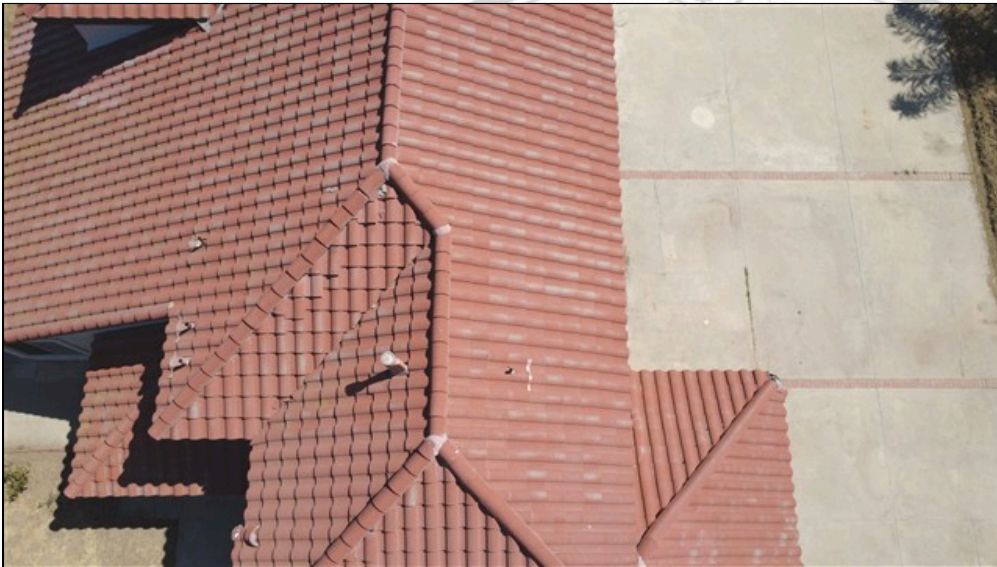
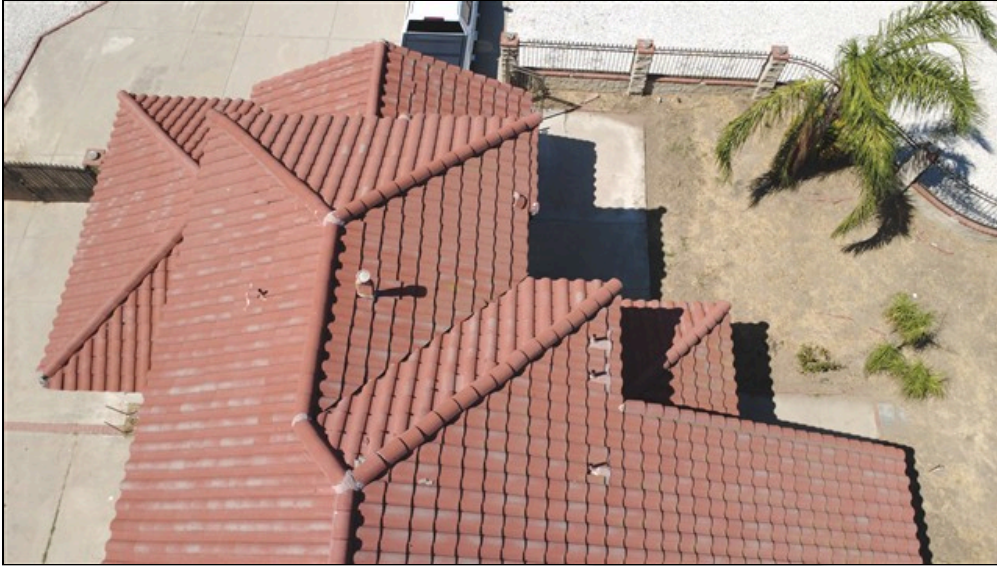
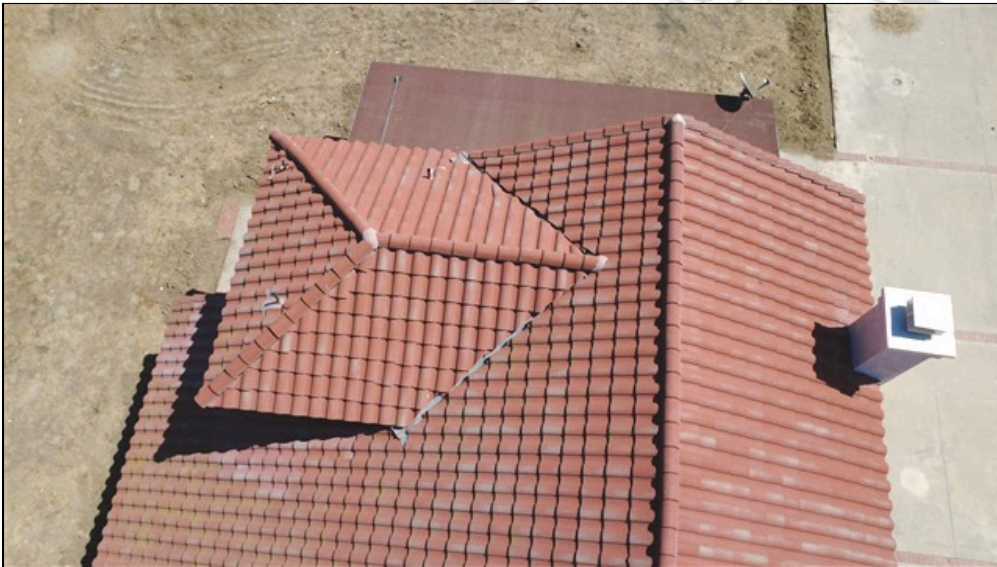
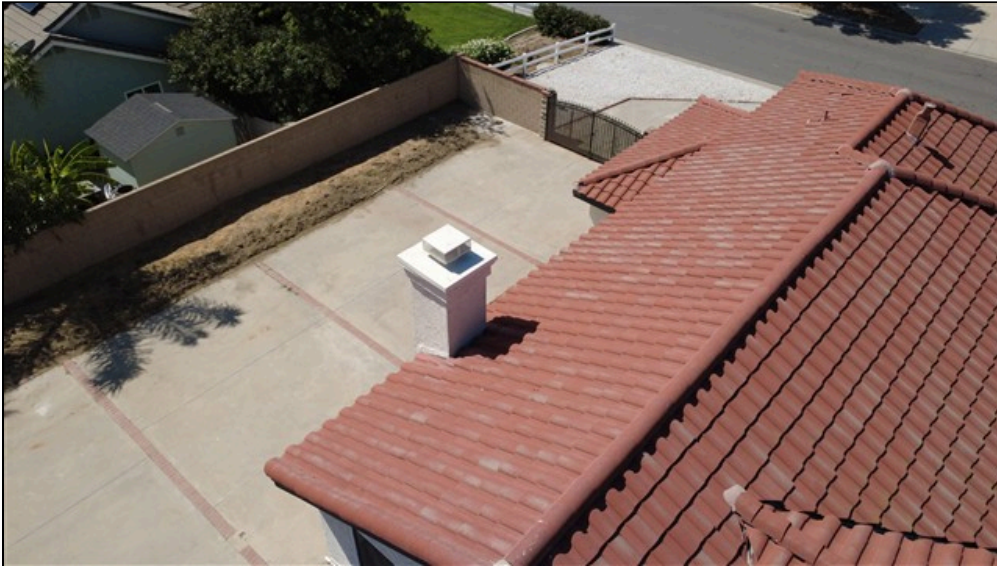
**2.0 Crack tiles were observed at roof top at time of inspection. Client must be aware roof was not walked on due to type of material and height in result viewing was limited. Recommend replacement of crack tiles were needed by a qualified or licensed roofing contractor. Note: Underlayment was not viewed, Any other issues the roofer may discover while evaluation should be repaired.**

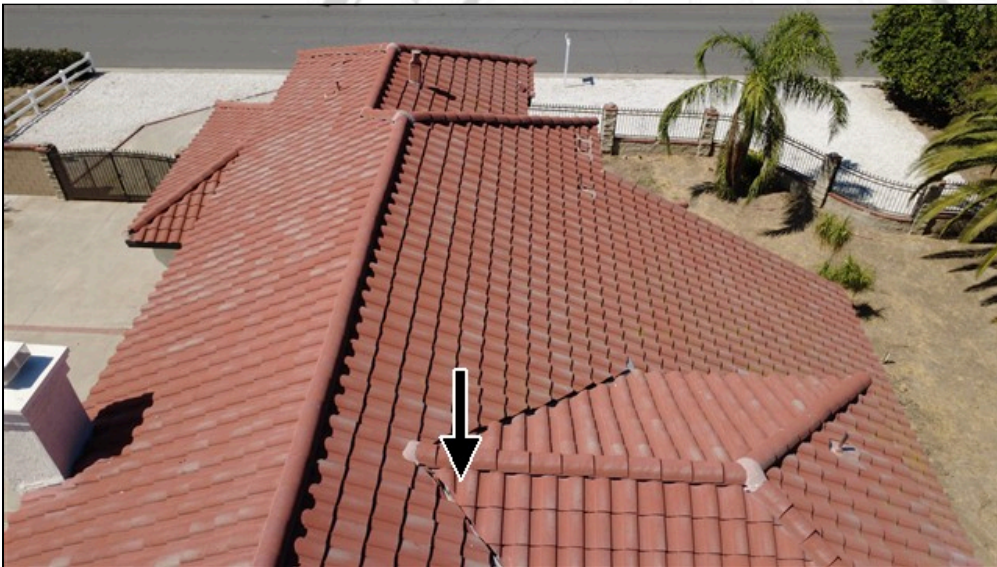
2.1 Item 1(Picture) General View

**2.1 An open gap on a tile roof valley is intentional and necessary, typically measuring between 3 to 6 inches (Centered on the metal flashing) to allow high volumes of water leaves, and debris to flow freely. Work can be done by a qualified or licensed contractor.**

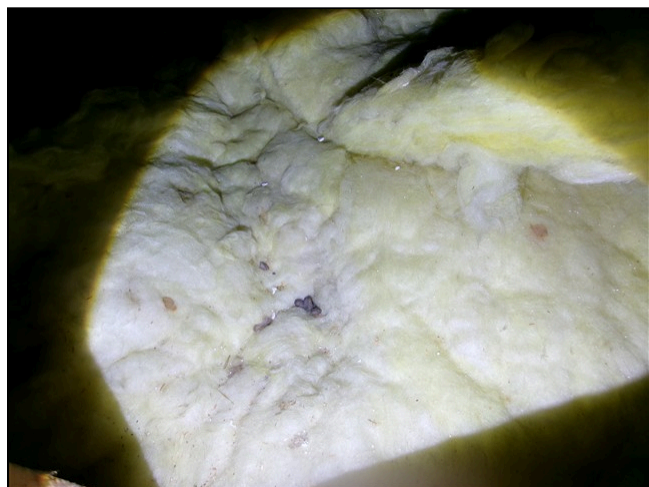
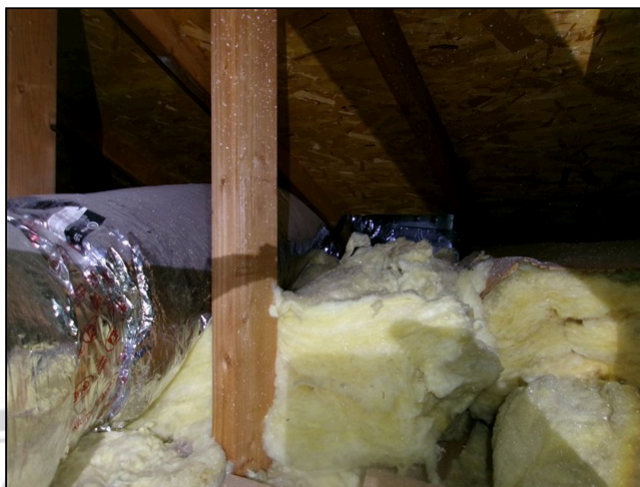
**2.3 Client must beware rodent droppings were present throughout interior attic. Inspector can not determine infestation. Recommend a more thorough evaluation and discuss treatment with pest control prior to your contingency removal. Note: Rodent within attic can cause severe structural, electrical and thermal damage.**

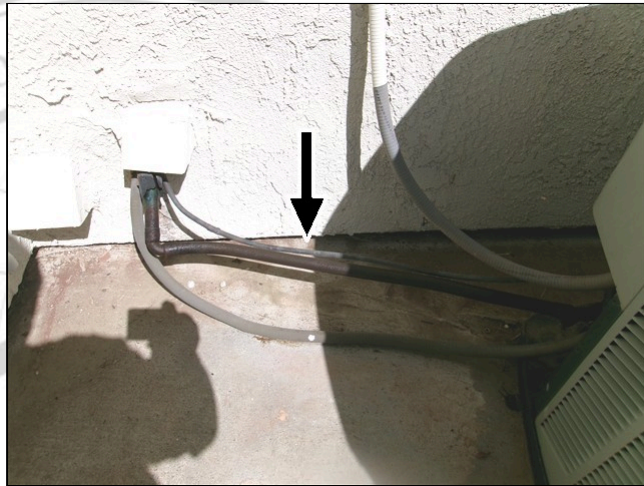
3.3 Item 6(Picture) General View

**3.3 (2) Recommend removing existing foam cover and installing new at A/C unit. Complete foam cover helps out with more energy-efficient on home cooling. Work can be done by a qualified or licensed HVAC technician.**

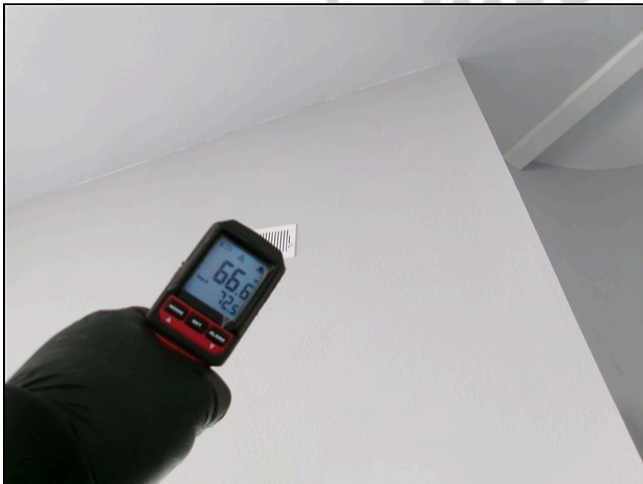
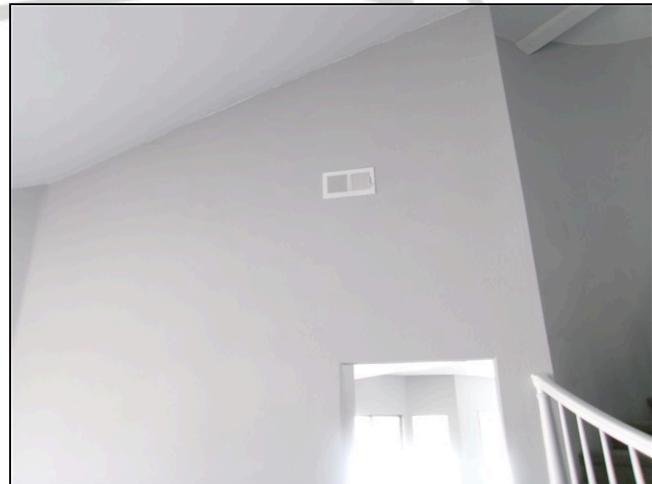
**3.5 Minor or no air degree flow was present when tested at wall vent, Vent can be clogged, disconnected, torn at ductwork system within your attic. Recommend further evaluation and repair by a qualified or licensed HVAC Technician.**

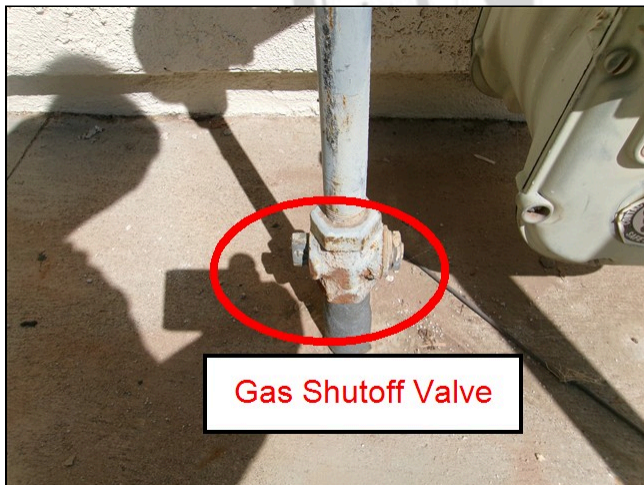
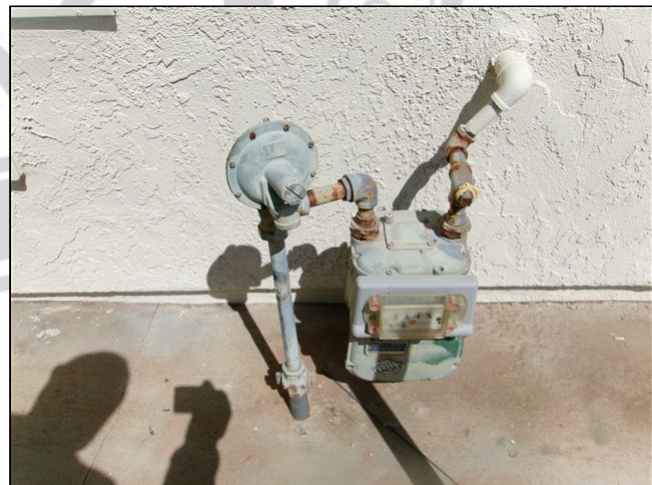
**4.0 The Main fuel shut off is at gas meter outside located at the South walkway. Client should be aware surface rust was present on fuel Meter and lines, condition is typical but knowing Meter has not been serviced. Recommend your local Gas Company to perform a full safety check inspection prior to occupancy. Note: Maintenance with a rust prohibiting paint on Meter should be followed with Gas Company slip of inspection.**

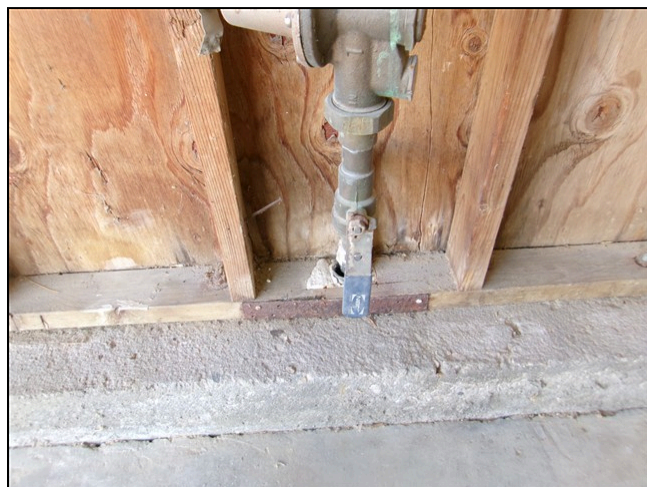
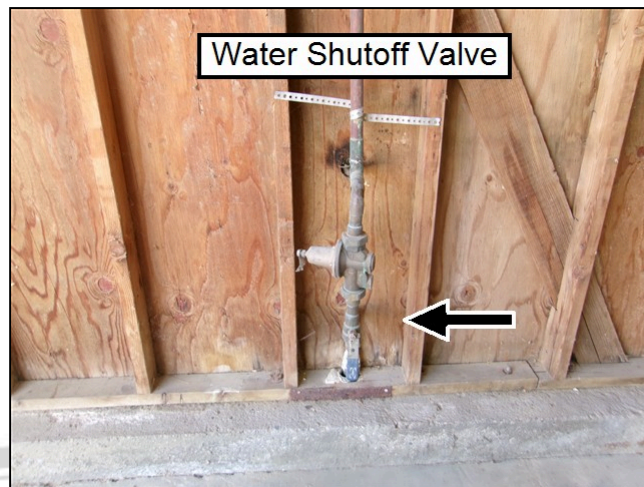
**4.2 (1) Home water shutoff valve design Lever was operational, free flowing with no signs of water leaks at time of inspection. Note: Water cutoff was not tested when water was on within home by your inspector.**

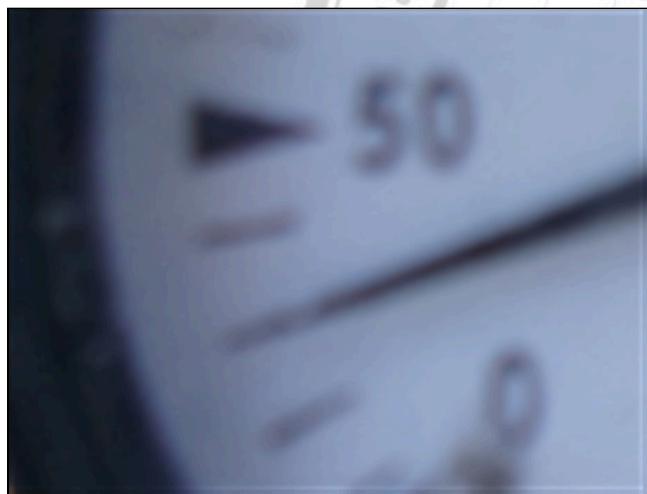
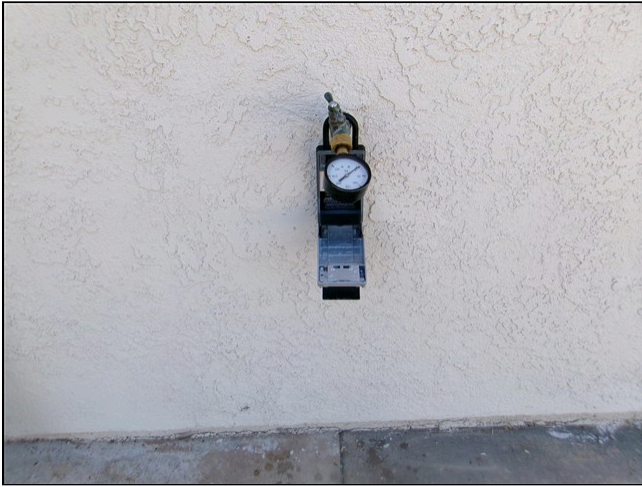
**4.2 (2) The client should be aware that the water supply pressure was less than 50 pounds per square inch (PSI) at time of inspection. 40-80 PSI is considered the normal range for water pressure in a home and most plumbers recommend 50-60 PSI. Recommend re-evaluation by a qualified or licensed plumber. Note: Pressure regulator was present.**

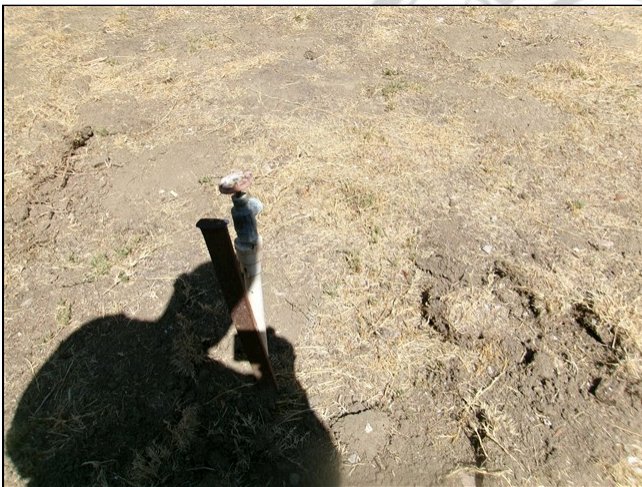
4.2 Item 6(Picture) General View

**4.2 (3) Water supply has been discontinued, not in working order at exterior walkways. Recommend discussing reevaluation and repair back to it's original design. Work can be done by a qualified or licensed plumber.**

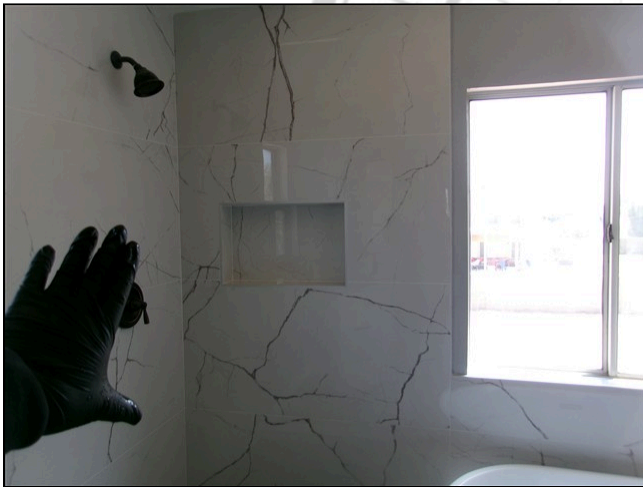
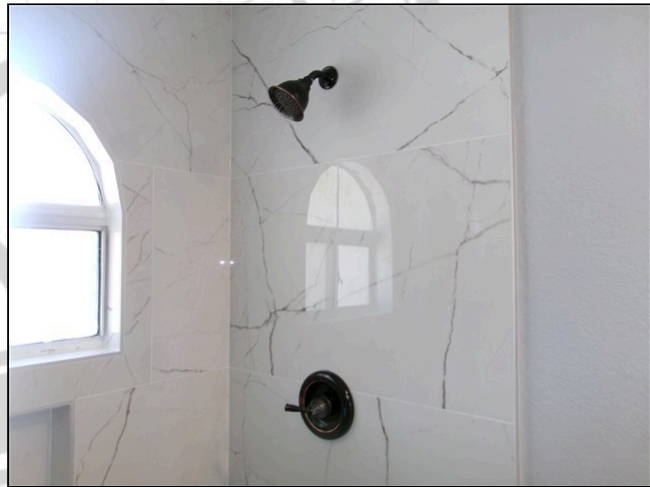
**4.10 Client should beware air in plumbing line was present at time of water testing. Temporary loss of water pressure can be caused by recent plumbing repairs, pressure regulator, water leaks. Recommend further evaluation and repair by a qualified or licensed plumber.**

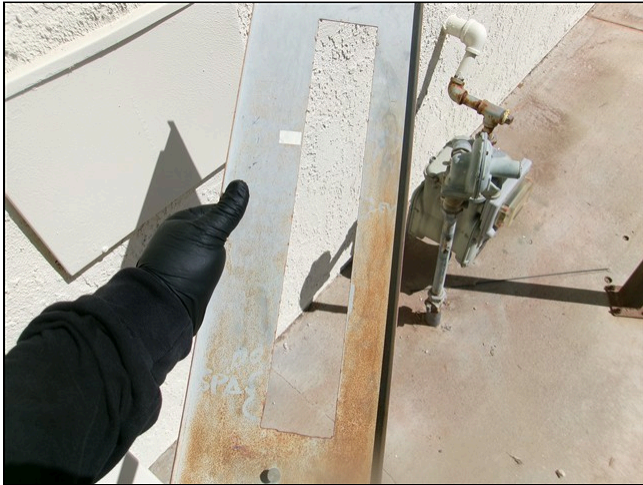
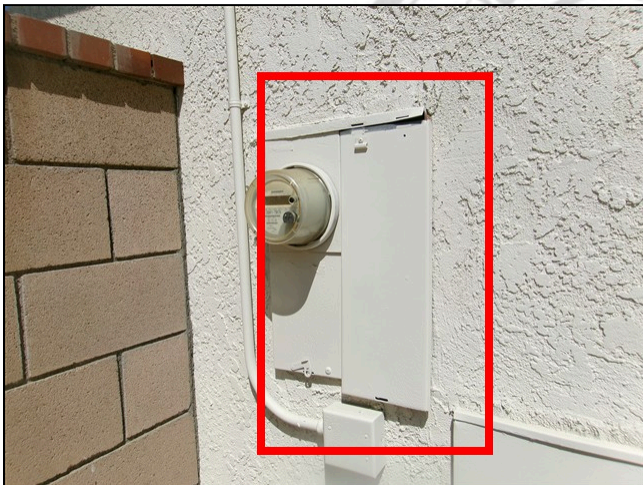
**5.0 Main distribution panel was in working order at time of inspection. Recommend installing adequate legends at dead front cover for improved ease of station location. Work should be done by a qualified or licensed electrician.**

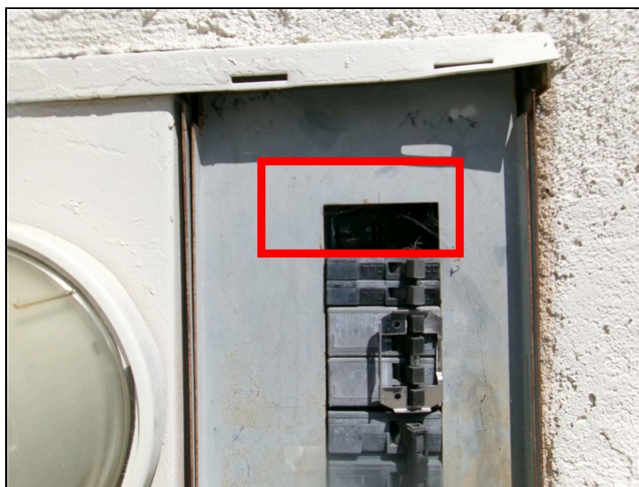
5.1 Item 1(Picture) General View

**5.1 (1) Problem discovered with Main panel circuit breakers such as knock-outs missing on panel cover at time of inspection Any other problems that an electrician may discover while performing repairs should be corrected prior to your contingency period. I recommend a licensed or qualified electrician inspect further and correct as needed. Note: Inspector can not determine wiring condition within walls.**

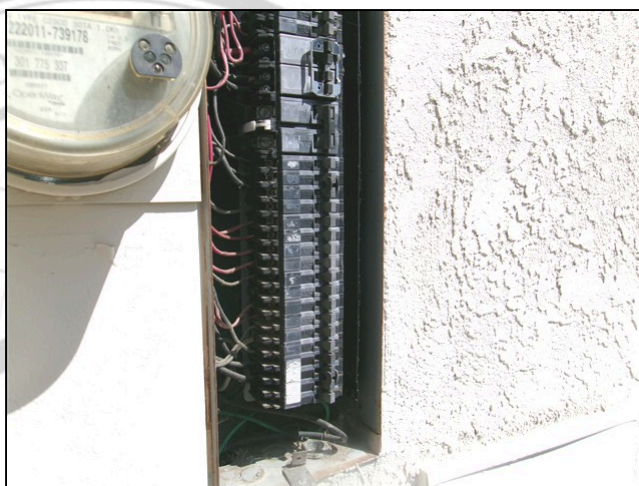
5.1 Item 2(Picture) General View

**5.1 (2) Circuit breakers were secured within panel and in working order at time of inspection. Inspector observed a 120 / 240 volt test. In result range was satisfactory. Note: Installed circuit breaker panel within panel were full (Overload). Additional circuit breakers can be added by adding a Sub Panel. Options can be discussed with a qualified or licensed electrician.**

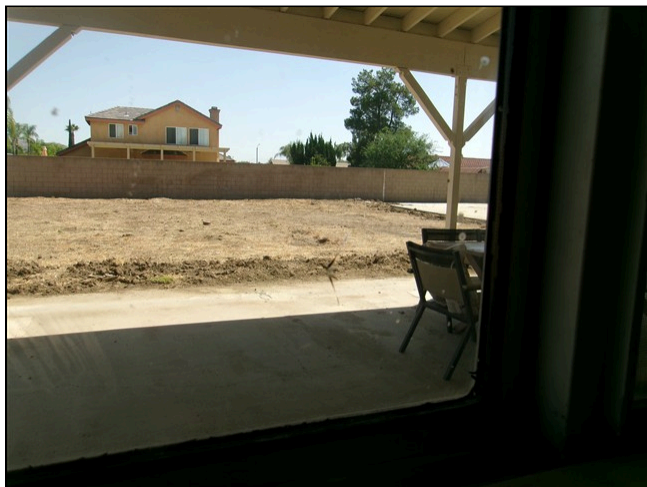
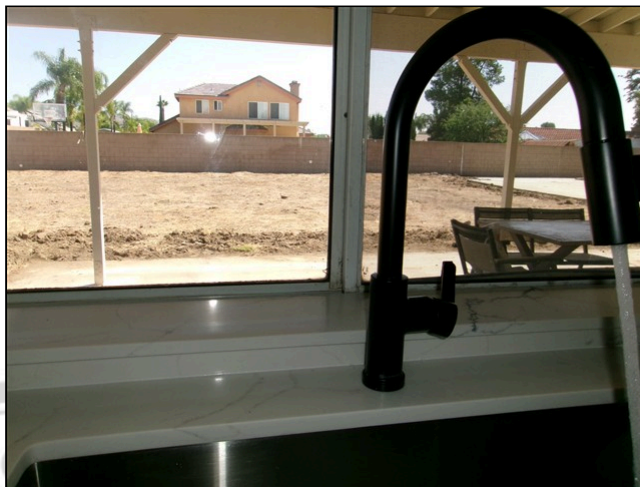
**6.0 Cracked window pane were observed at kitchen at time of inspection. This poses a safety hazard as crack may worsen, recommend a qualified or licensed contractor evaluate and replace window pane as necessary.**

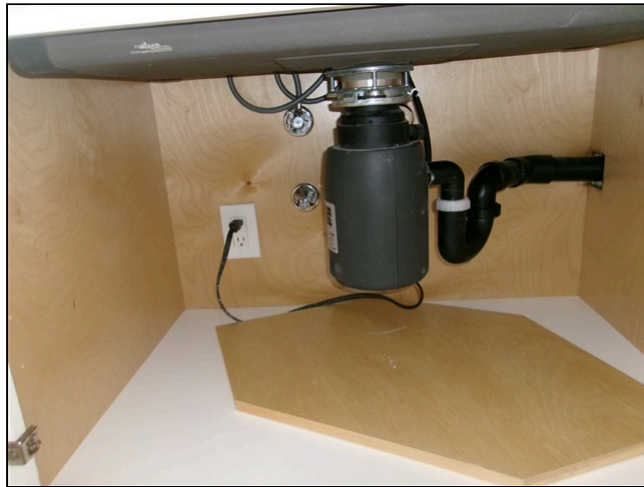
7.1 Item 1(Picture) General View

**7.1 Under sink plumbing  
observed no leaks/ clogging  
during water testing at time of  
inspection.**

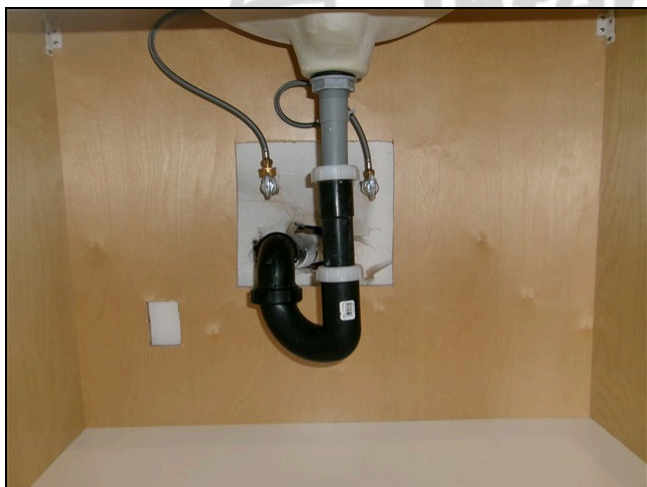
8.2 Item 1(Picture) General View

**8.2 Under sink plumbing observed satisfactory and no leaks/ clogging at time of inspection. Angle stops were movable and in working order.**

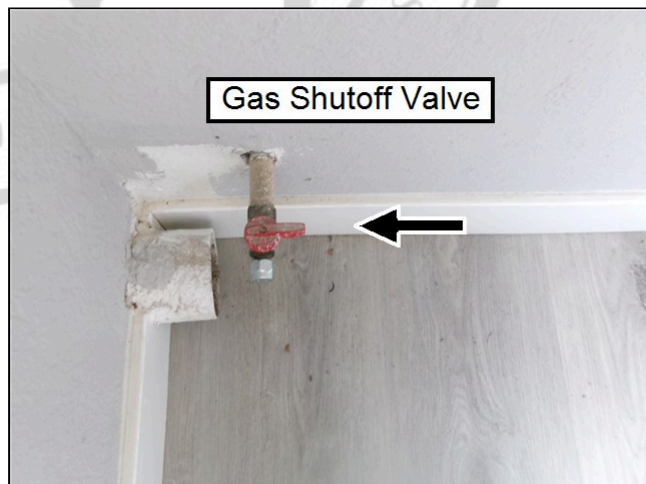
8.6 Item 1(Picture) General View

**8.6 Gas Shutoff Valve and supply line were present. Gas flow was not turned on to test.**

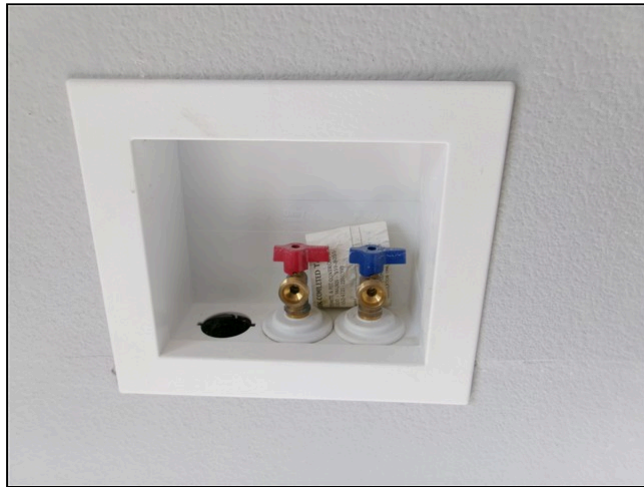
8.7 Item 1(Picture) General View

**8.7 Washer water source water fixtures were present at time of inspection. Client should beware no hose connecting was performed. Recommend reevaluation on hose connecting prior to taking occupancy. Note: Unable determine washer stand pipe/ return line overall function and supply hot and cold fixtures. Reevaluation should be considered. Mote: Washer Hammer was not installed. Hammers purpose is to stop loud pipe from banging.**

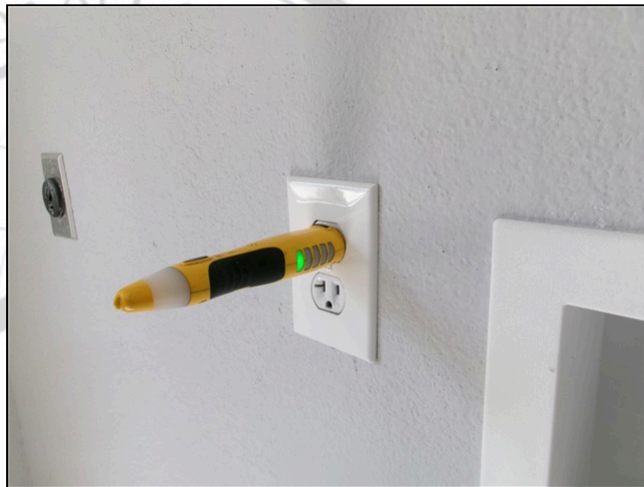
8.8 Item 1(Picture) General View

**8.8 (1) Utility laundry 120V Plug In outlet was tested and in working order at time of inspection.**

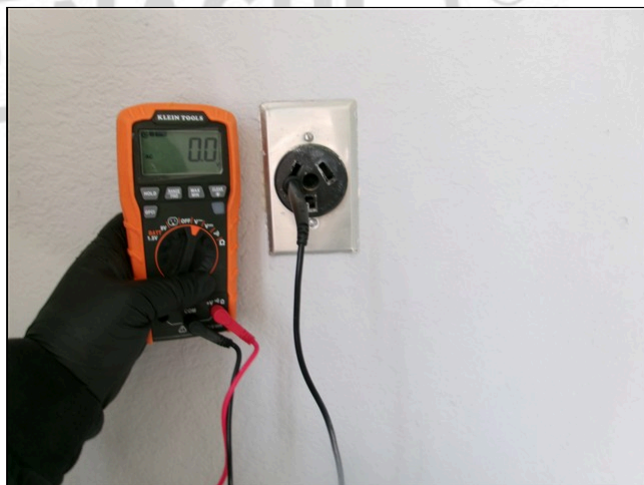
8.8 Item 2(Picture) General View

**8.8 (2) 240V/ 250V plug in outlet at laundry room was inoperable. This is for your information. A qualified or licensed electrician should evaluate and repair. Note: Plug in tester prongs may have not made contact.**

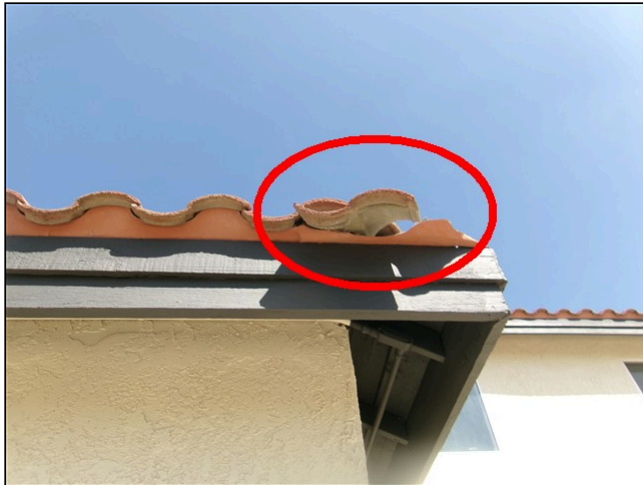
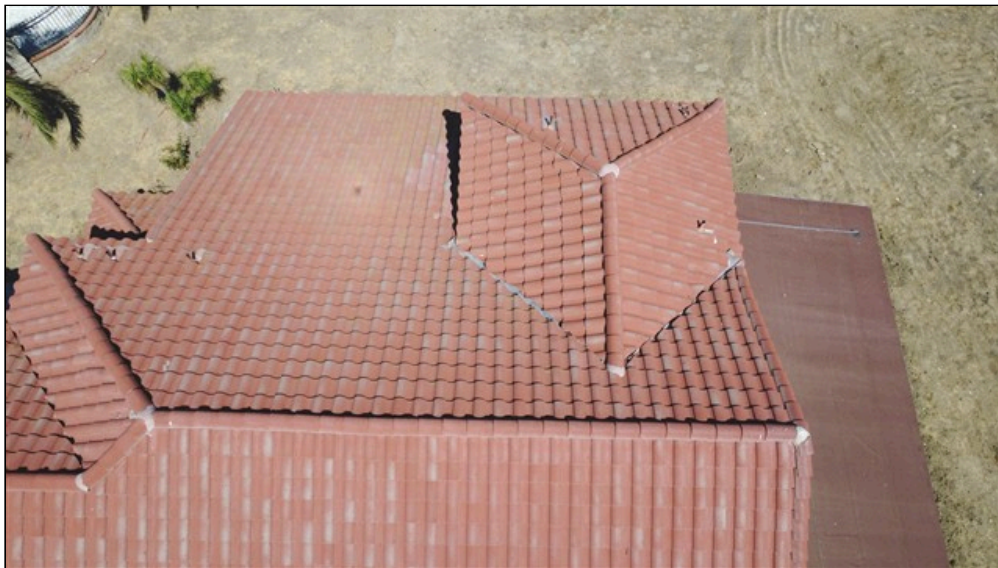
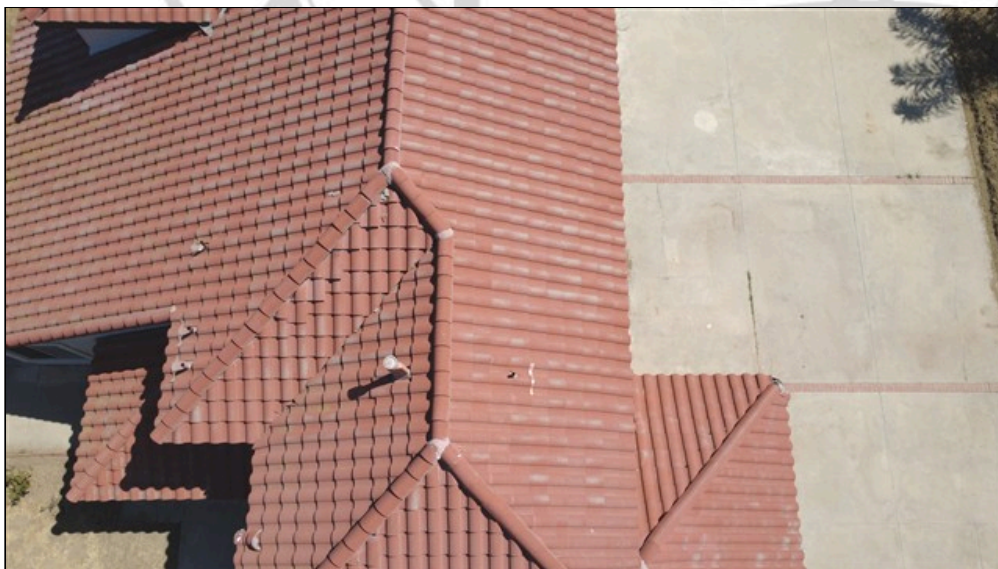
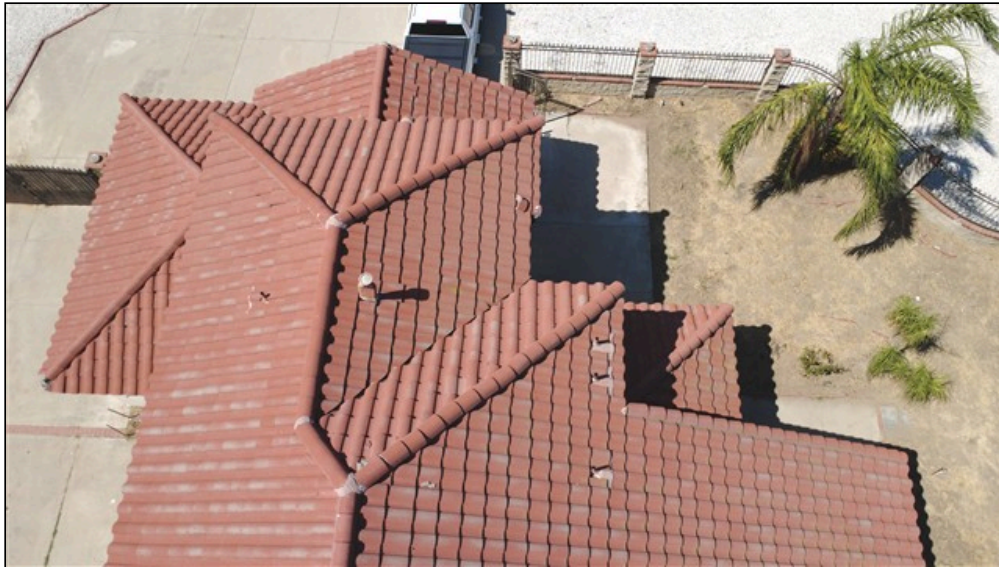
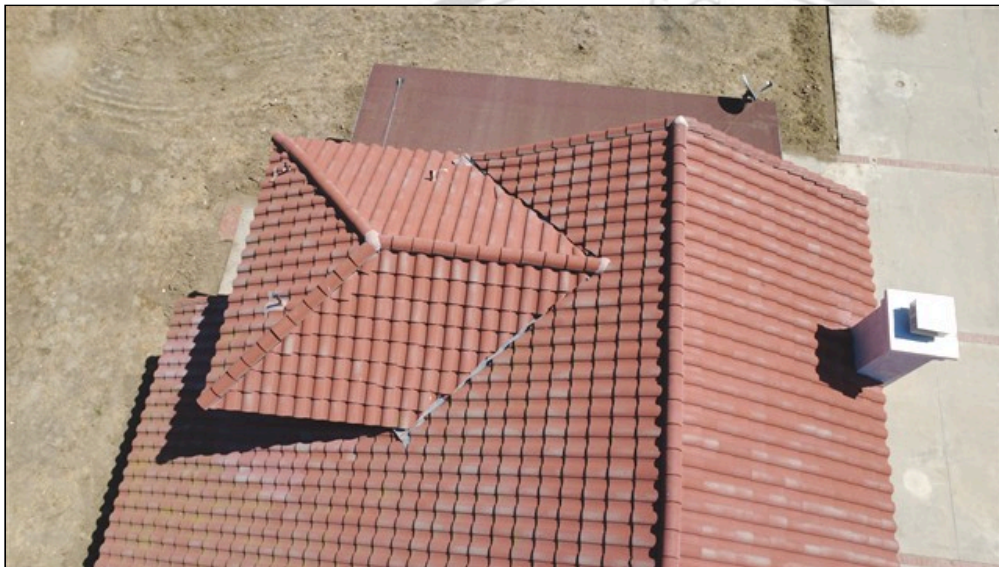
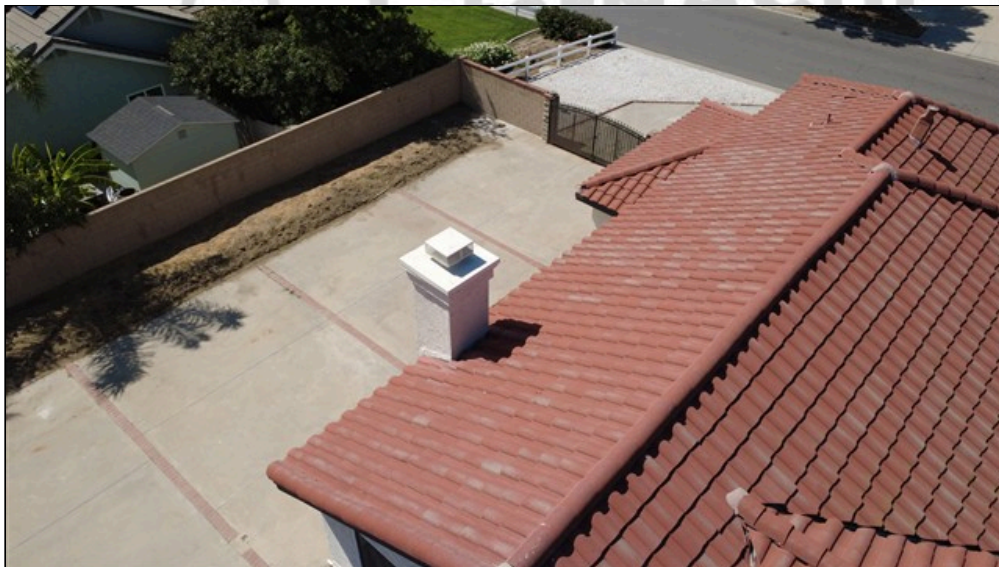
**Crack tiles were observed at roof top at time of inspection. Client must be aware roof was not walked on due to type of material and height in result viewing was limited.**

**Recommend replacement of crack tiles were needed by a qualified or licensed roofing contractor. Note: Underlayment was not viewed, Any other issues the roofer may discover while evaluation should be repaired.**

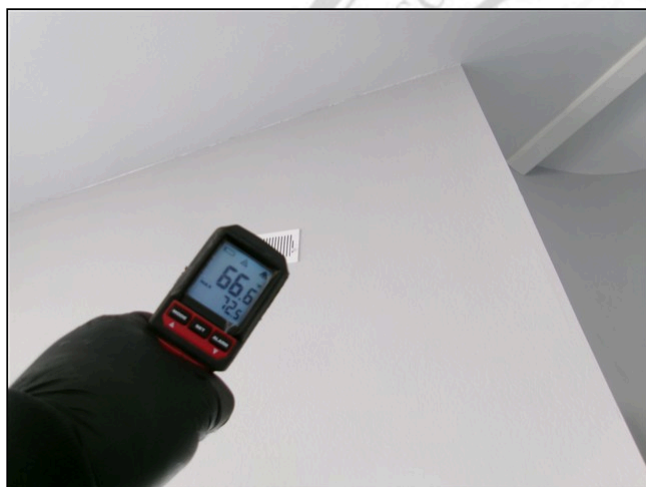
3.5 Item 1(Picture) General View

Minor or no air degree flow was present when tested at wall vent, Vent can be clogged, disconnected. torn at ductwork system within your attic. Recommend further evaluation and repair by a qualified or licensed HVAC Technician.

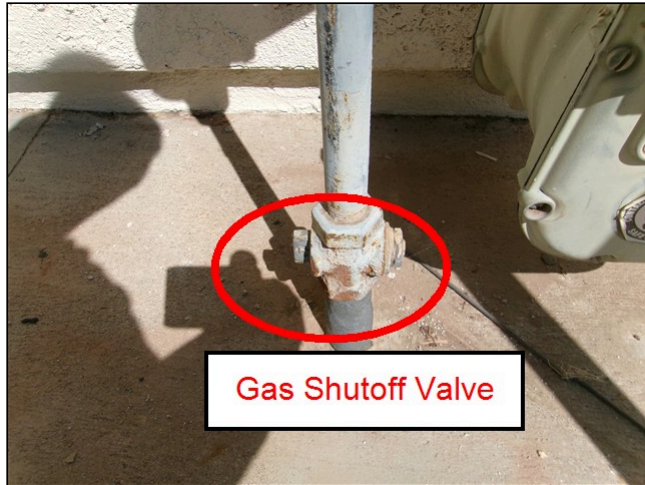
4.0 Item 1(Picture) General View

The Main fuel shut off is at gas meter outside located at the South walkway. Client should be aware surface rust was present on fuel Meter and lines, condition is typical but knowing Meter has not been serviced. Recommend your local Gas Company to perform a full safety check inspection prior to occupancy. Note: Maintenance with a rust prohibiting paint on Meter should be followed with Gas Company slip of inspection.

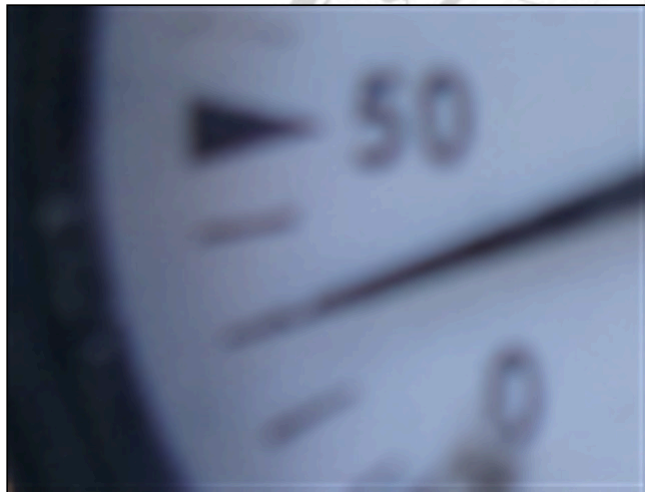
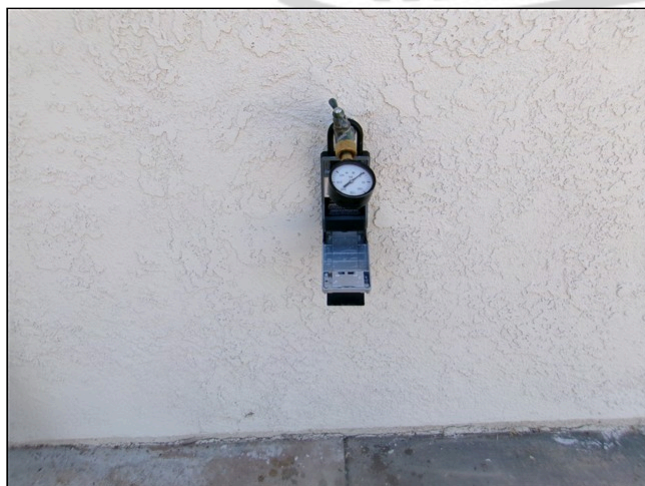
(2) **The client should be aware that the water supply pressure was less than 50 pounds per square inch (PSI) at time of inspection. 40-80 PSI is considered the normal range for water pressure in a home and most plumbers recommend 50-60 PSI. Recommend re-evaluation by a qualified or licensed plumber. Note: Pressure regulator was present.**

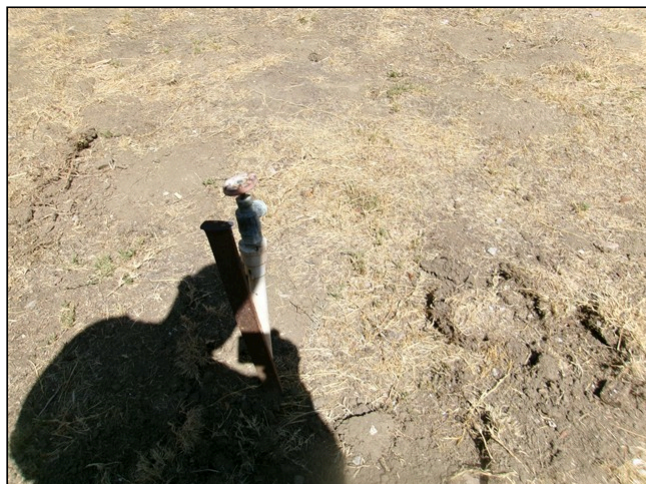
4.2 Item 6(Picture) General View

(3) **Water supply has been discontinued, not in working order at exterior walkways. Recommend discussing reevaluation and repair back to it's original design. Work can be done by a qualified or licensed plumber.**

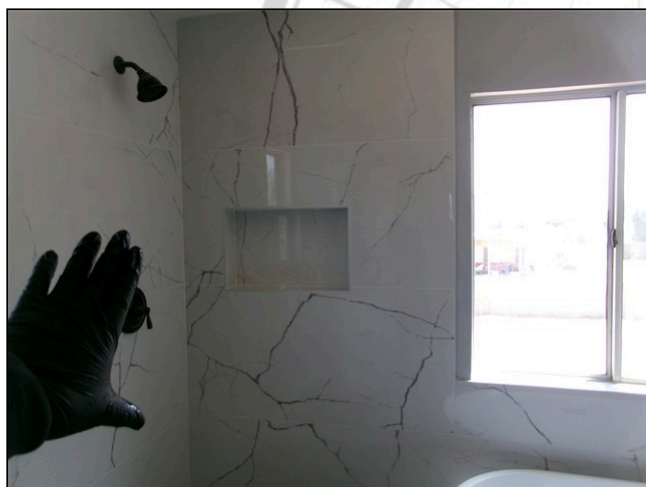
4.10 Item 1(Picture) General View

**Client should beware air in plumbing line was present at time of water testing. Temporary loss of water pressure can be caused by recent plumbing repairs, pressure regulator, water leaks. Recommend further evaluation and repair by a qualified or licensed plumber.**

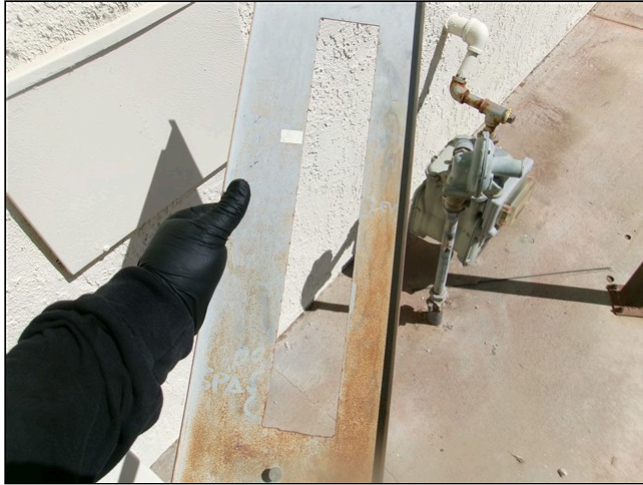
5.0 Item 1(Picture) General View

**Main distribution panel was in working order at time of inspection. Recommend installing adequate legends at dead front cover for improved ease of station location. Work should be done by a qualified or licensed electrician.**

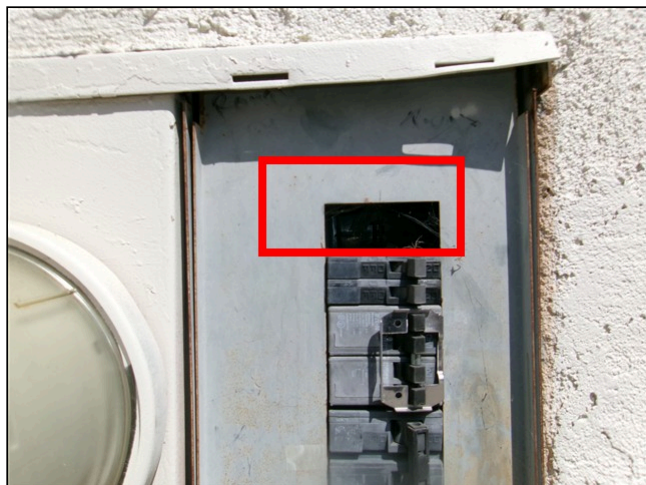
5.1 Item 1(Picture) General View

(1) **Problem discovered with Main panel circuit breakers such as knock-outs missing on panel cover at time of inspection Any other problems that an electrician may discover while performing repairs should be corrected prior to your contingency period. I recommend a licensed or qualified electrician inspect further and correct as needed. Note: Inspector can not determine wiring condition within walls.**

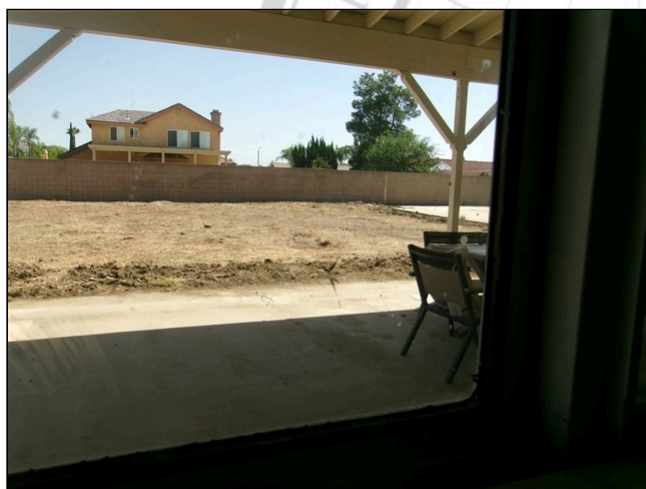
6.0 Item 1(Picture) General View

**Cracked window pane were observed at kitchen at time of inspection. This poses a safety hazard as crack may worsen, recommend a qualified or licensed contractor evaluate and replace window pane as necessary.**

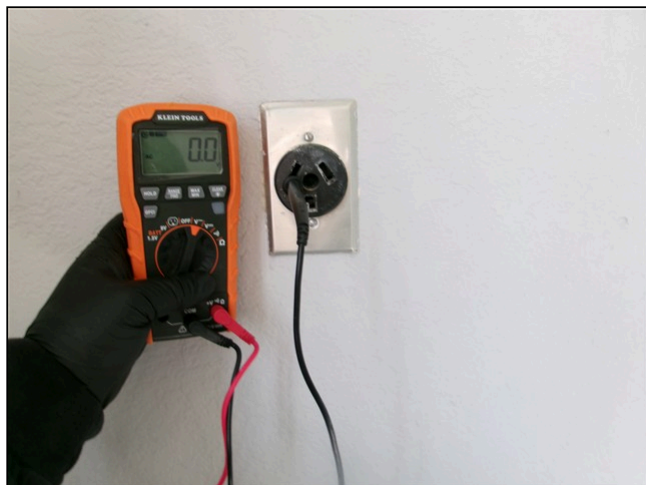
8.8 Item 2(Picture) General View

**(2) 240V/ 250V plug in outlet at laundry room was inoperable. This is for your information. A qualified or licensed electrician should evaluate and repair. Note: Plug in tester prongs may have not made contact.**
