File Number: **0926-204-650**  
Address of Inspection: **3018 Jolley Drive**  
Date of Inspection: **9/10/26**

## **HOME VIEW INSPECTION SERVICE**

### **REAL ESTATE INSPECTION REPORT**

3018 JOLLEY DRIVE  
BURBANK, CA 91504

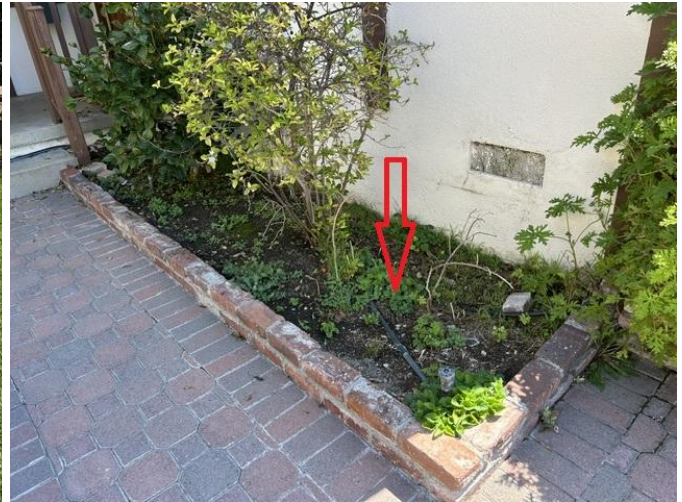
1. Home View recommends that all exterior surfaces be monitored during heavy rains to verify proper drainage.
2. Exterior planter boxes should be monitored to ensure that they do not allow rainwater to penetrate the crawl space.

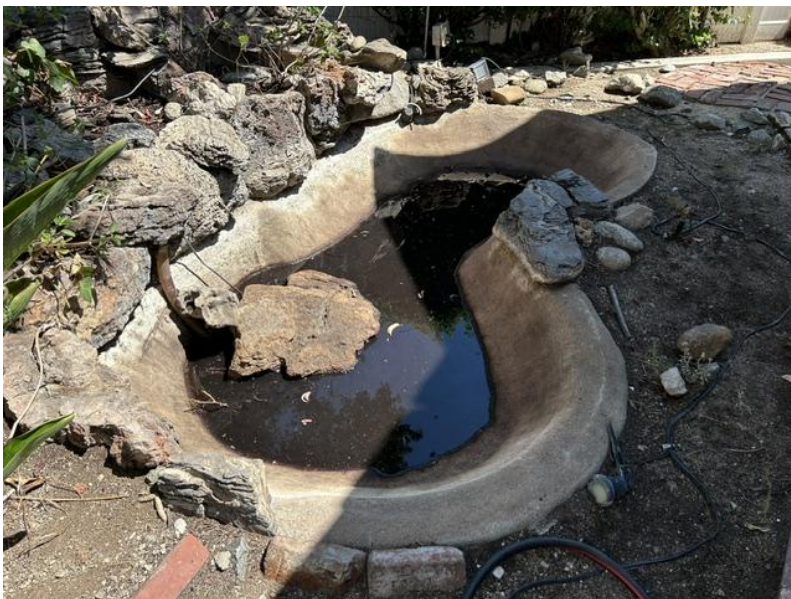
3. Stagnant and contaminated water was found in the rear pond. Stagnant water is a health hazard, providing breeding environment for harmful insects.

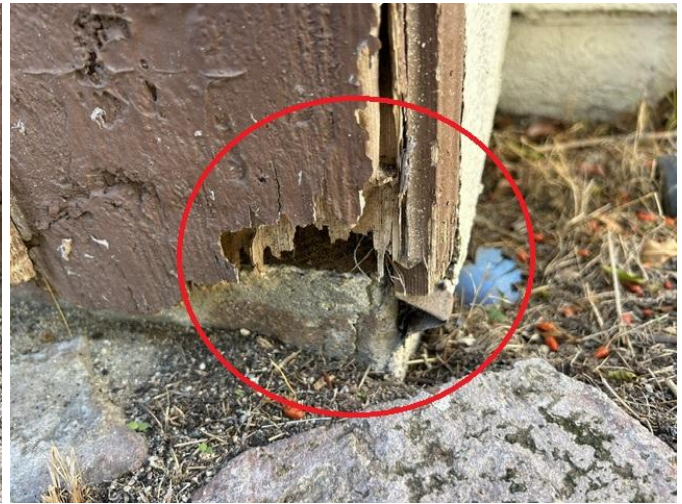
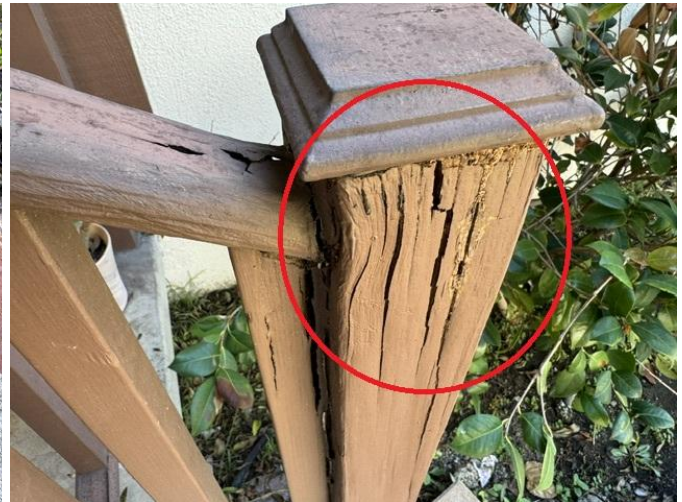
4. Rot and damages were visible on sections of the exterior wood surfaces. All wood surfaces should receive periodic water proofing and paint in order to avoid wood deterioration and rot. For further information regarding the condition of the wood materials, please refer to the termite inspection report.

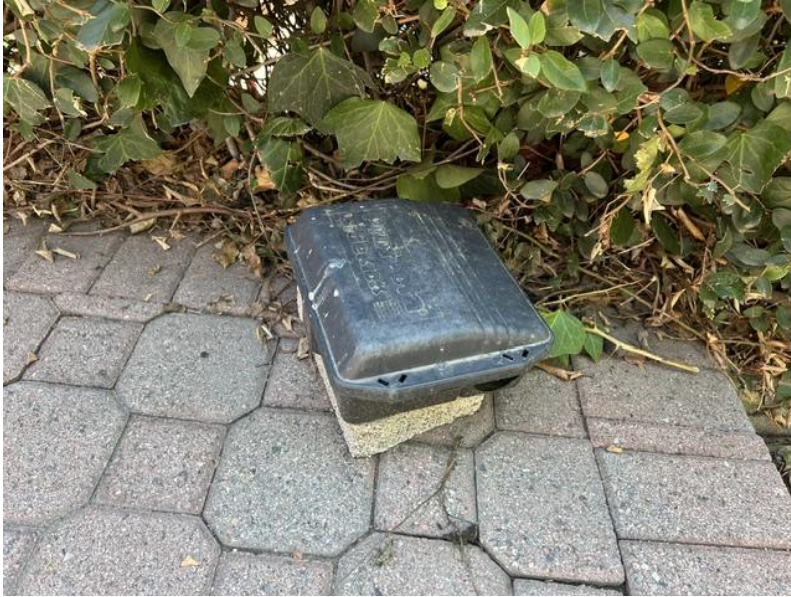
5. Cracks were visible on the exterior stucco siding of the home. These cracks should be monitored and patched as required to prevent water penetration.
6. The street number was not properly displayed on the exterior of the home.
7. Rodent trap was found on the exterior.

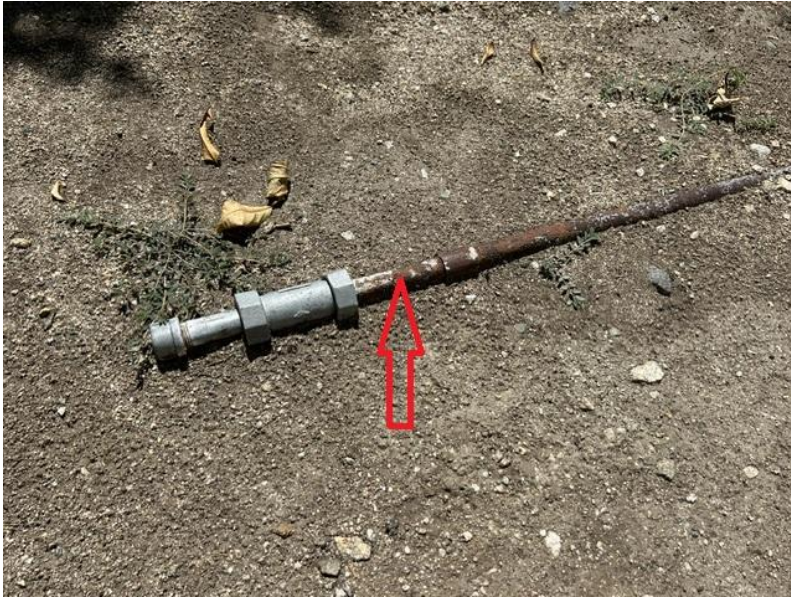
1. Home View recommends that all appliances and fixtures relying on natural gas service be inspected by a gas company technician prior to use.
2. Partially exposed, capped and rusted gas pipe was found on the right side of the property.

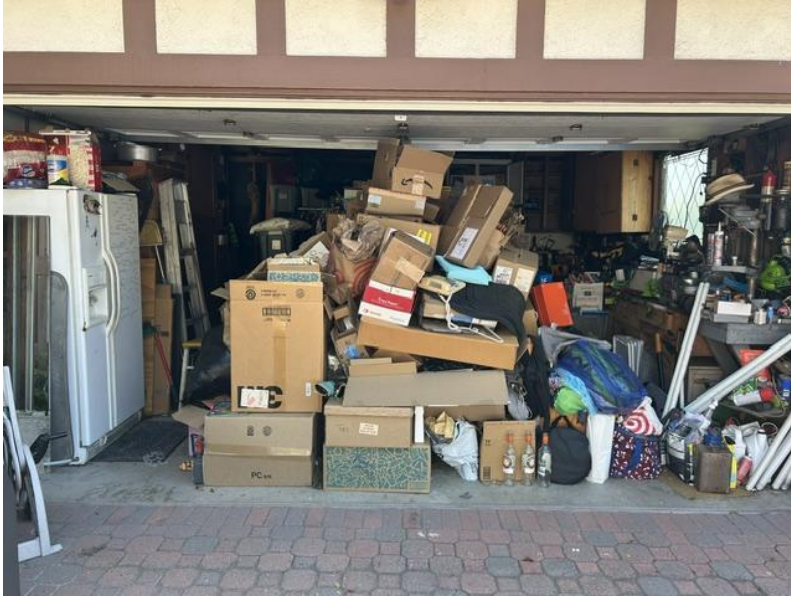
1. Due to the quantity and location of the homeowner's belongings, the garage could not be entered, and the floors, walls and wall fixtures could not be thoroughly inspected.

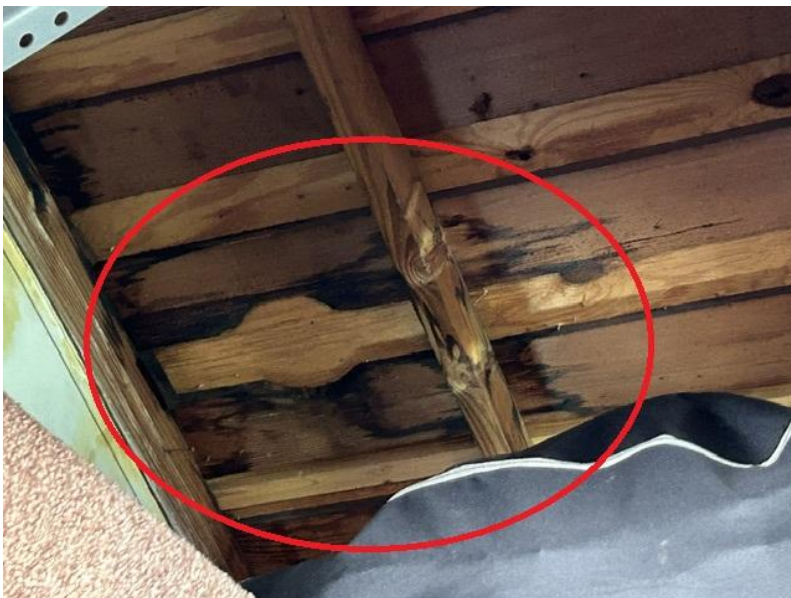
2. Water stains were visible on the roof structure, as viewed from the garage. This indicates water penetration.

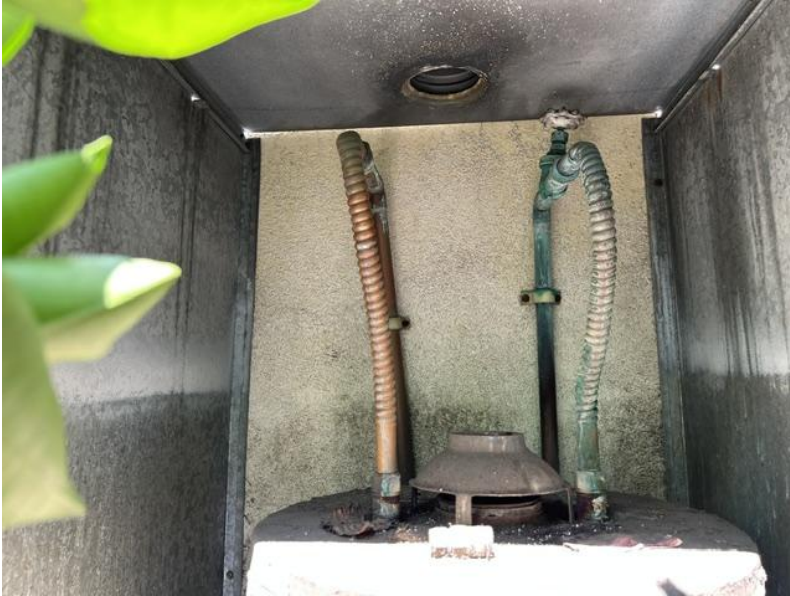
1. Lower portion of the exhaust pipe was missing. This was allowing harmful exhaust fumes to discharge in the enclose.

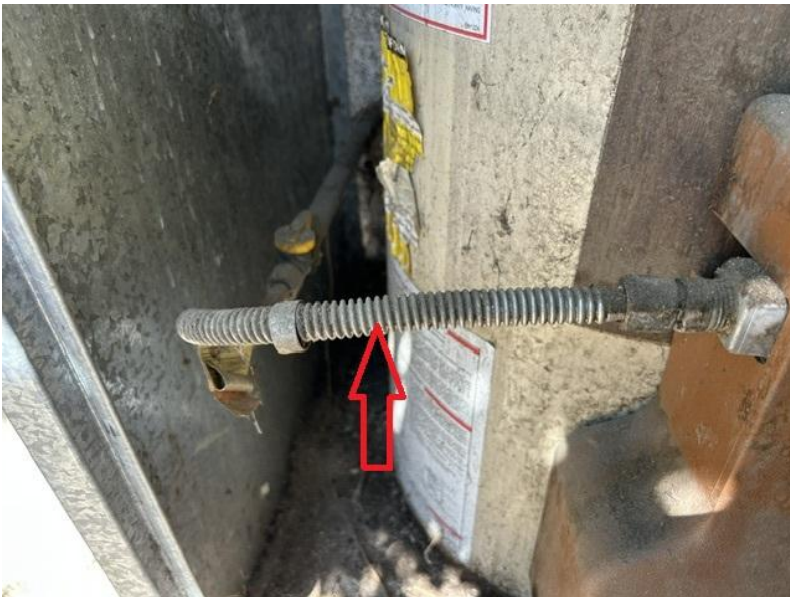
2. Gas supply pipe was missing sediment trap.

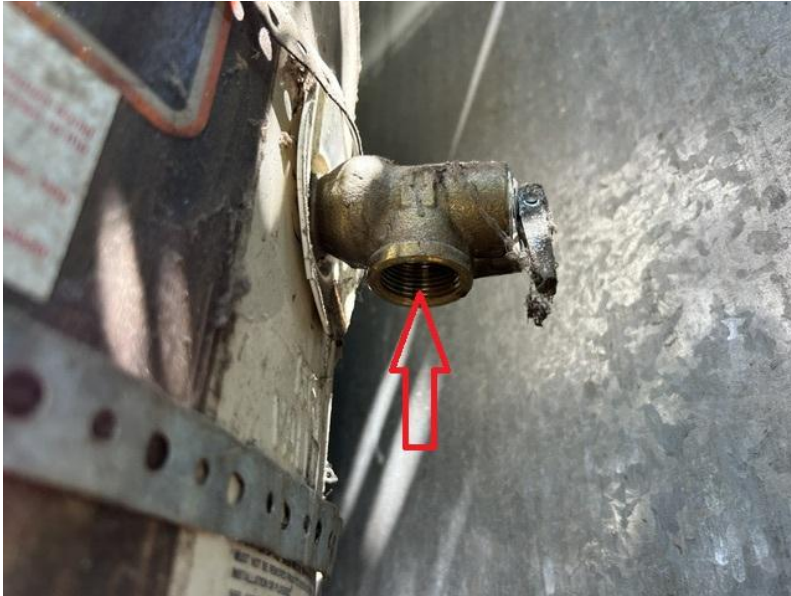
3. Water and gas lines connected to the water heater were not bonded.
4. Water heater was missing the required expansion tank.
5. The required overflow pipe was missing.

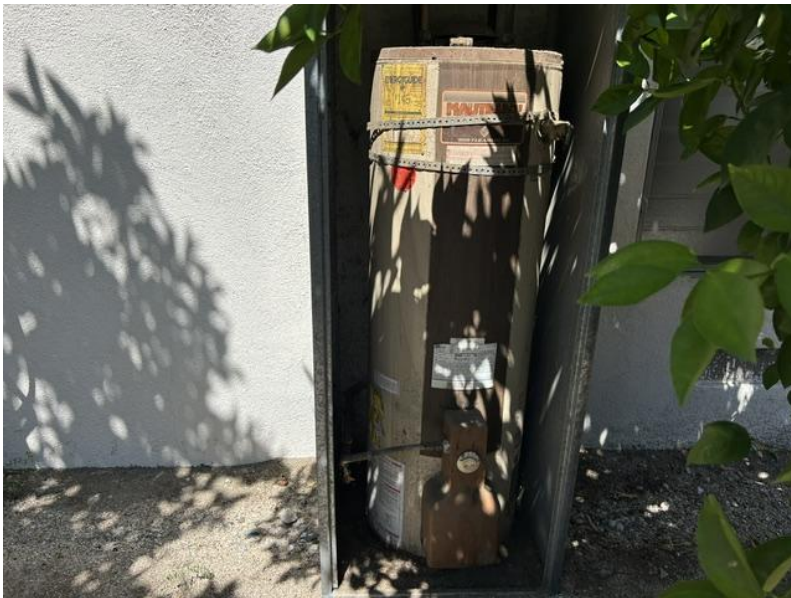
6. Water heater was missing the required seismic restraints. The upper strap is not considered seismic restraint. Water heater of this size requires a proper seismic restraints one on the upper one-third of the tank and the other on the lower one-third.

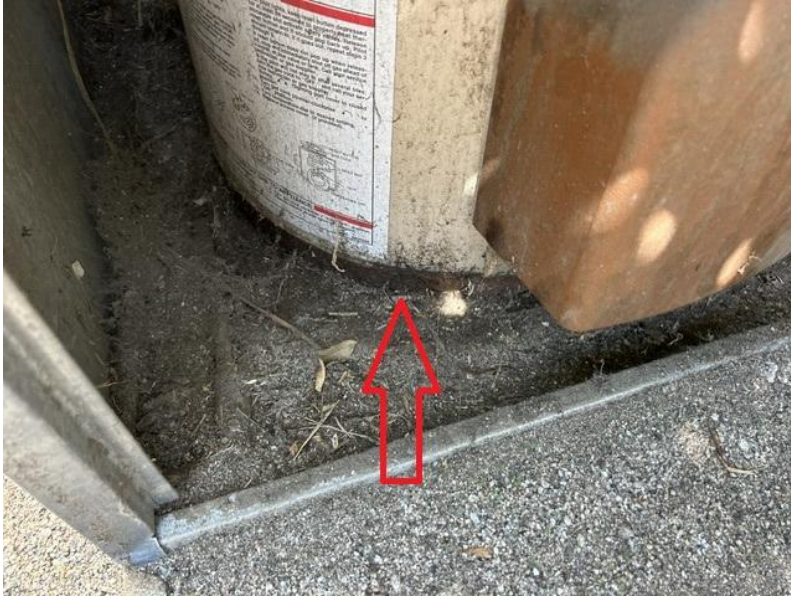
7. Water heater was not placed on a platform.

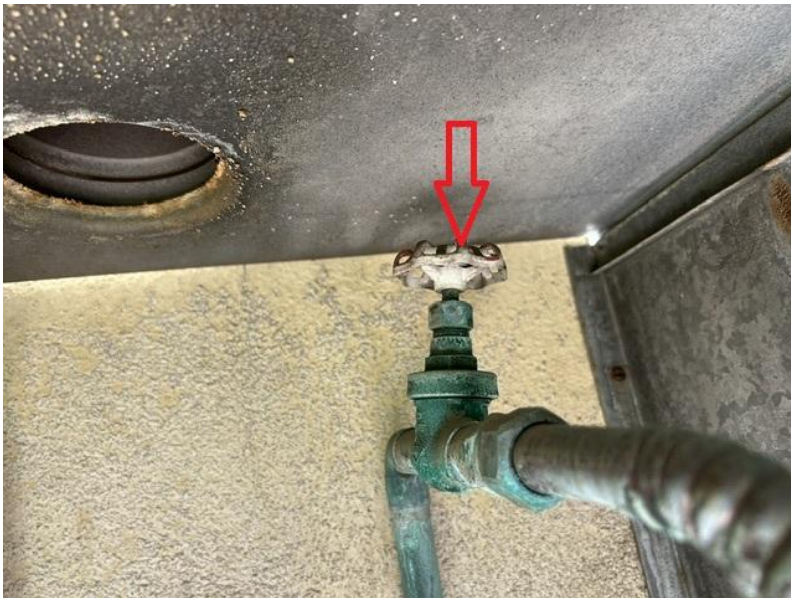
8. The shutoff valve handle on the water heater cold water supply pipe was a full turn type valve. This type of valve is considered less reliable and may fail during operation due to internal wear or corrosion. It is recommended that the valve be replaced with a quarter-turn type shutoff valve, which is generally more dependable and easier to operate. Home View does not operate or test full-turn type valves.

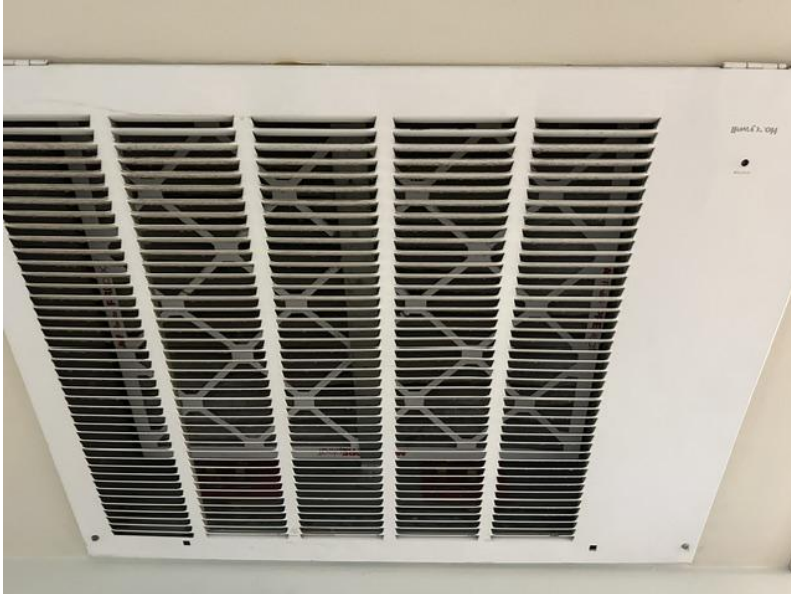
1. Filter in the air return register was soiled and needed to be replaced. The air return register was modified to properly hold the filter.

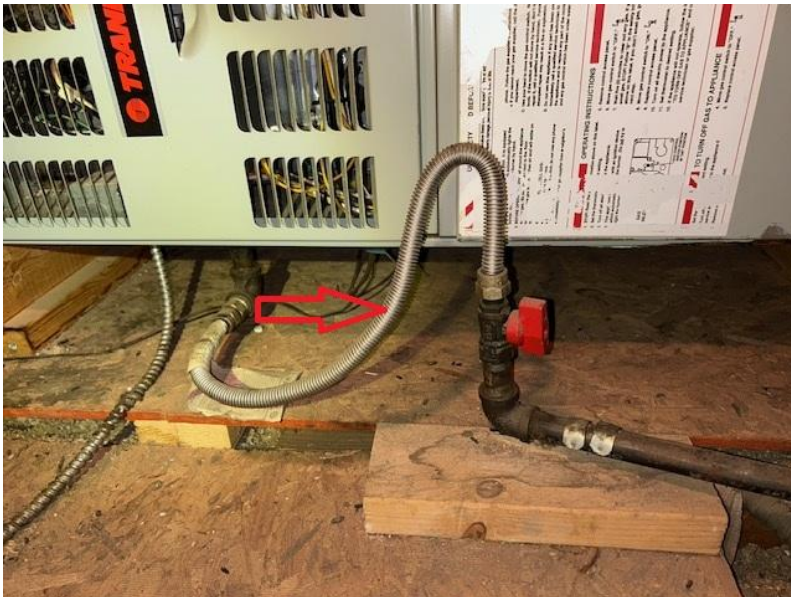
2. Furnace gas supply pipe was missing sediment trap.

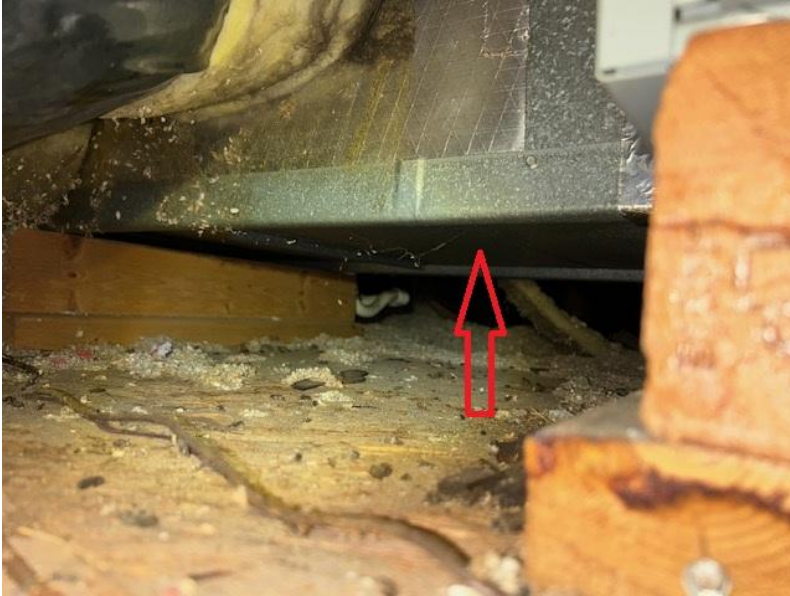
3. Furnace was missing the required drip pan.

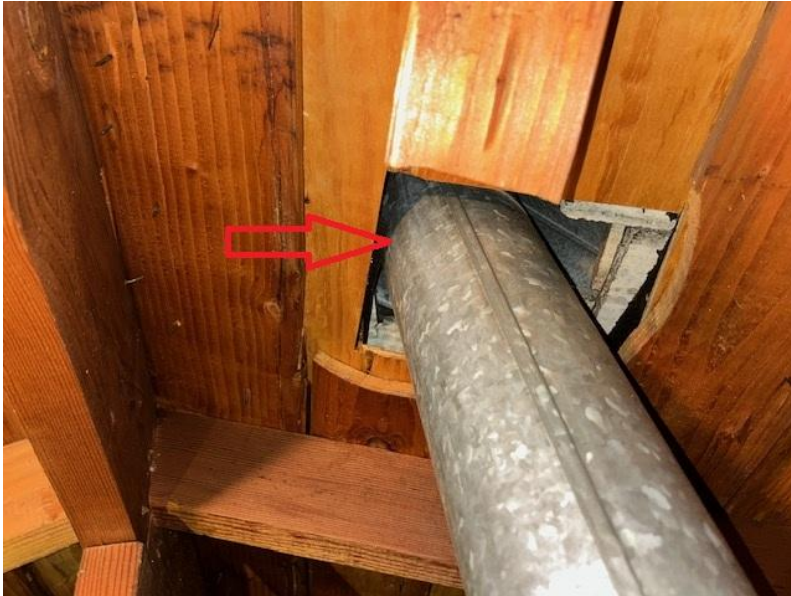
5. The furnace exhaust pipe was too close to combustible (wood) material. Single wall exhaust pipes must have 6-inch clearance from combustible material and double wall exhaust pipes, 1-inch.

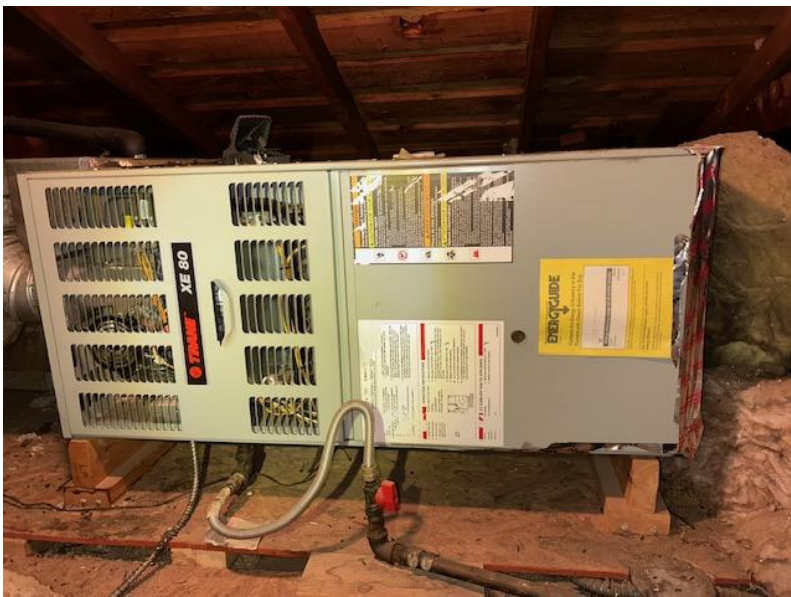
6. The furnace was manufactured approximately 30 years ago and was at the end of its useful life. It was tested and found to be non-functional.

The heating system was found to be non-functional.

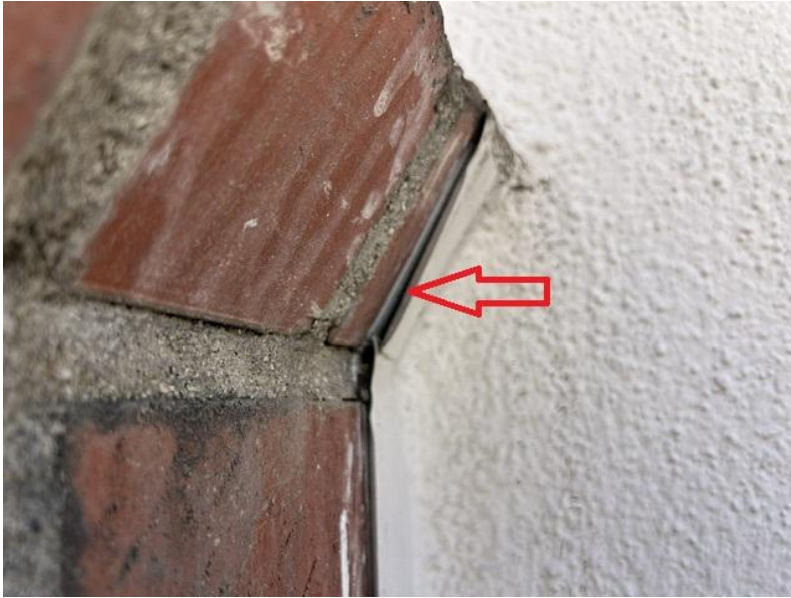
1. Joints between the chimney and flashing needed to be sealed.

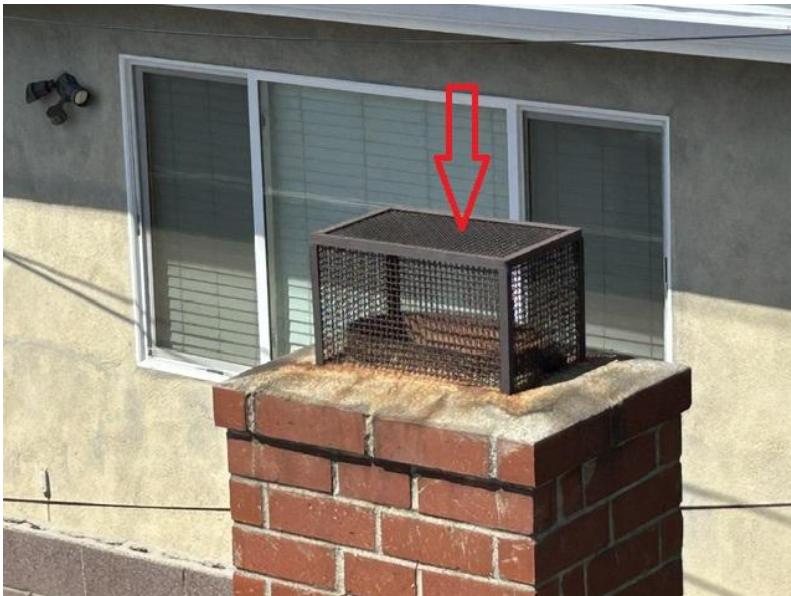
2. Chimney was missing rain cap.

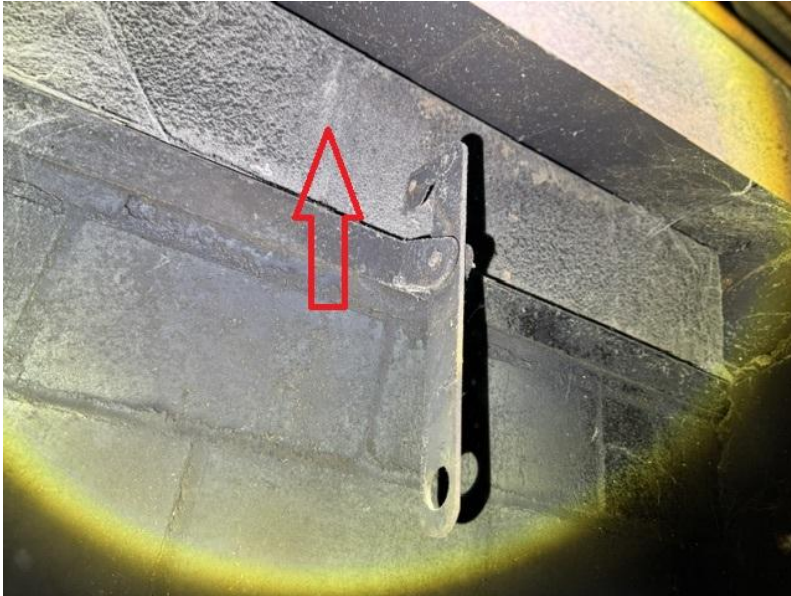
3. The fireplace damper was operational. Dampers in a gas-burning fireplace should be permanently locked in the “open” position to prevent the possible buildup of natural gas fumes.

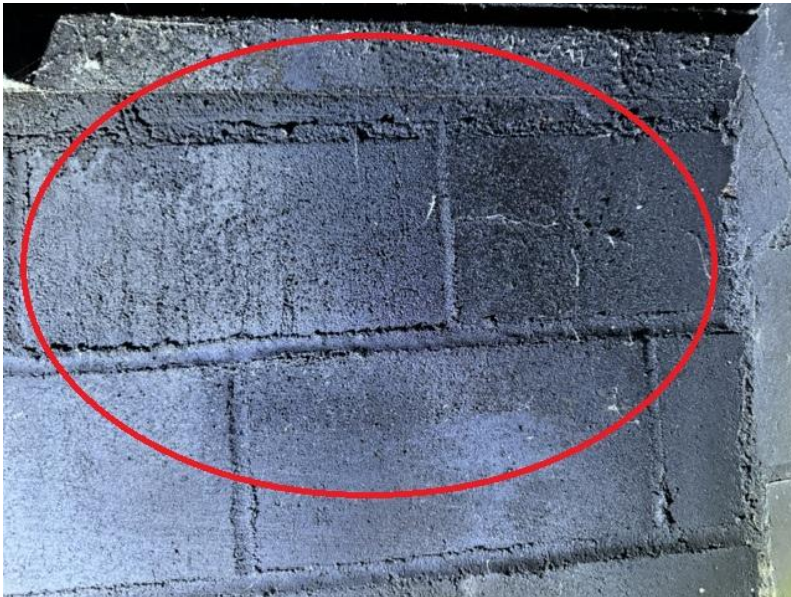
4. Creosote buildup was visible in the firebox.

A gas-log fireplace was located in the family room. The damper was functional. There was visual evidence of creosote buildup in the firebox. There were no cracks observed in the firebox or visible portions of the chimney.

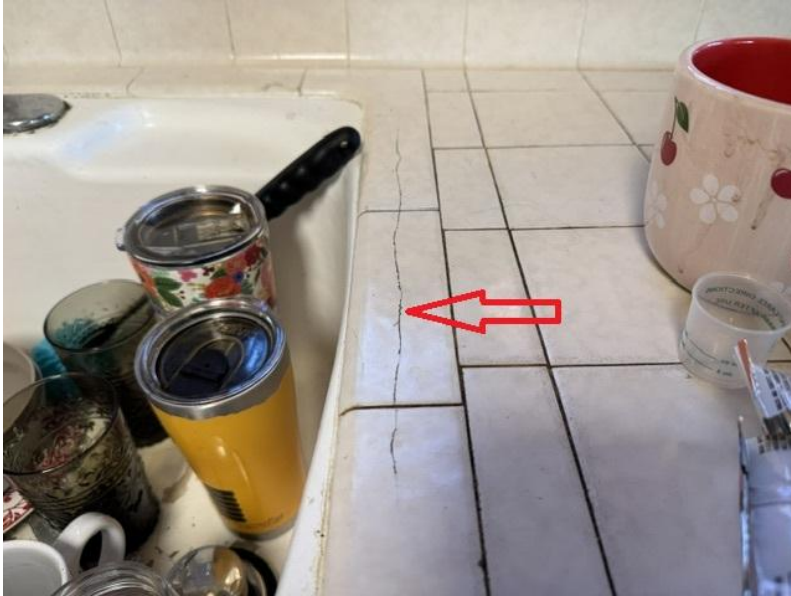
3. Crack was visible on the surface of the kitchen countertop to the right of the sink.

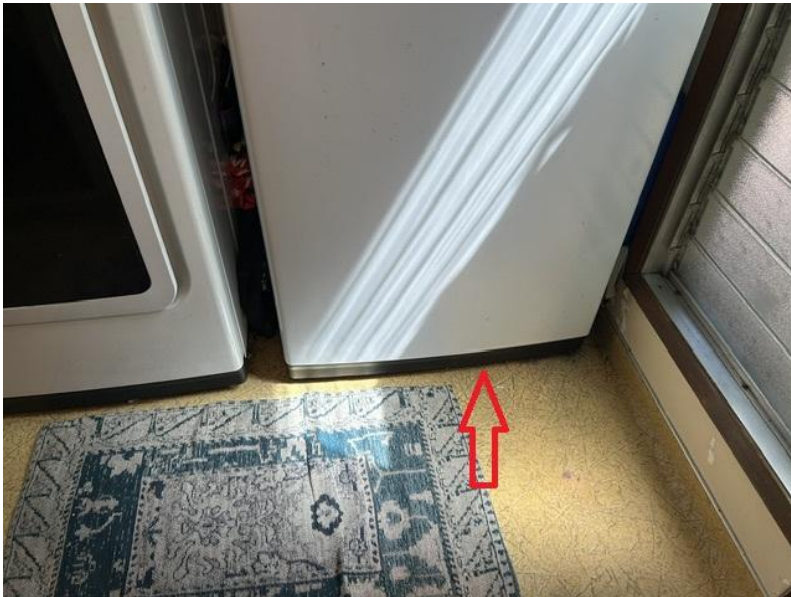
4. The washing machine was not equipped with a drip pan or dedicated drain system. Drip pan with a dedicated drain system is highly recommended to avoid damage in the event of water leak.

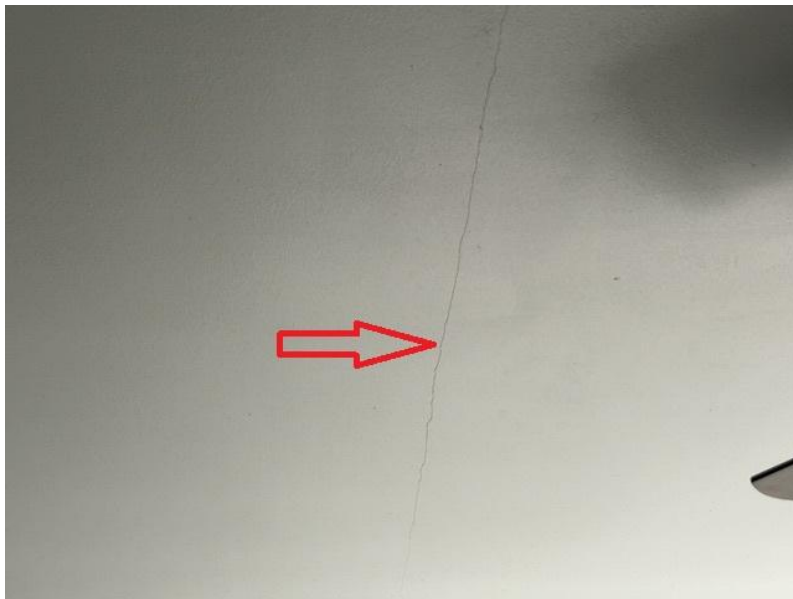
5. Crack was observed on the ceiling of the right front bedroom.

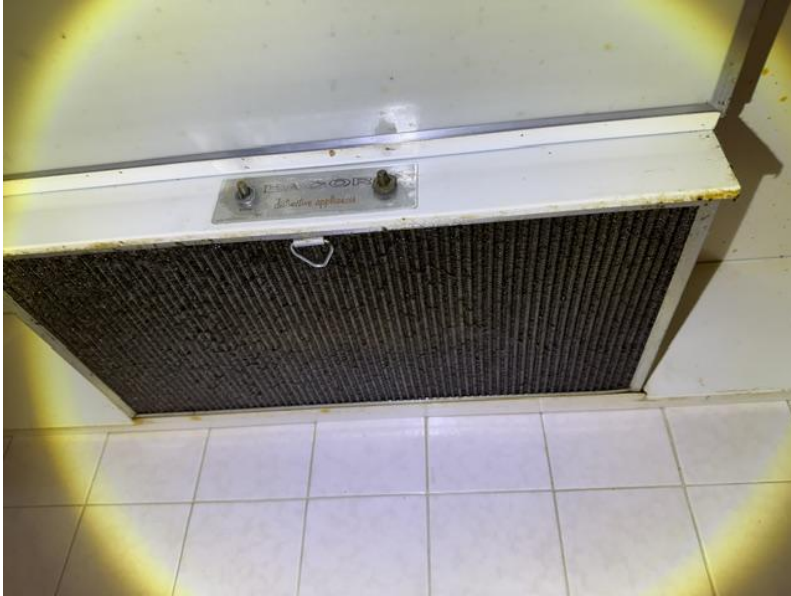
1. Right-rear burner of the cooktop was not functional.
2. Range hood filter was soiled.

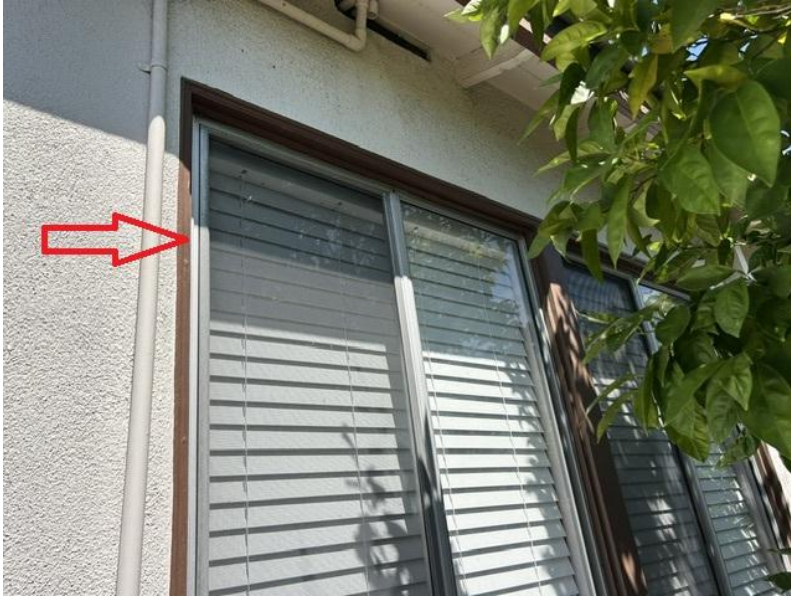
1. Perimeter of the windows and exterior doors must be monitored and resealed as needed in order to prevent rainwater penetration.

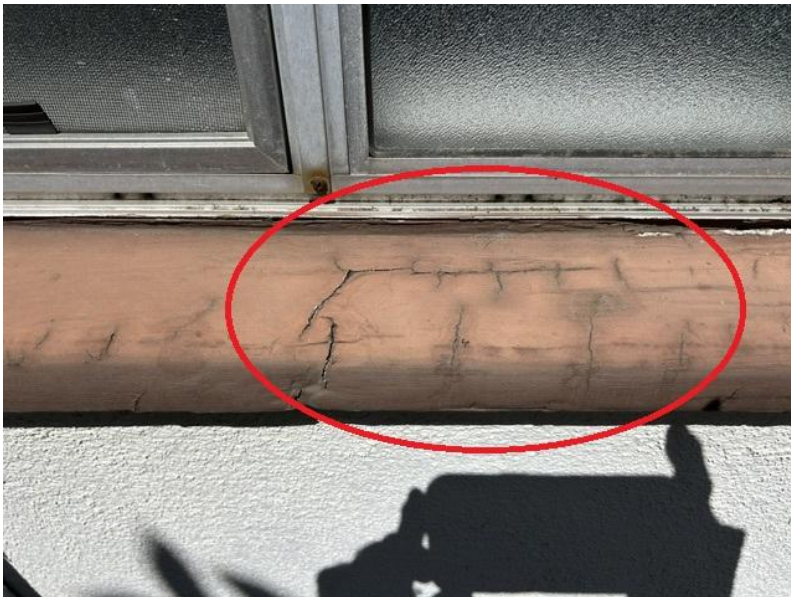
2. Sections of the window sills were cracked.

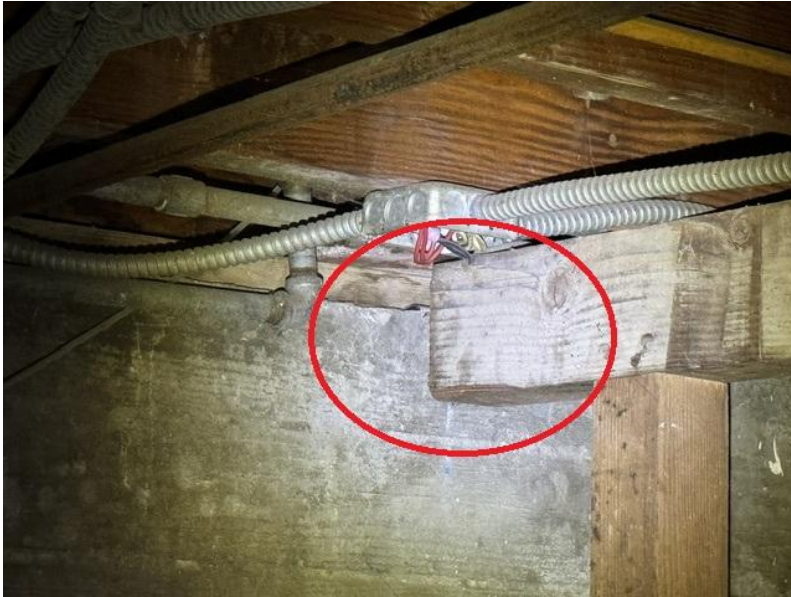
1. Discoloration was visible on portions of the floor structure as viewed from the crawl space. For further information regarding the condition of the wood materials, please refer to the termite inspection report.
2. One of the structural beams was not inserted inside the foundation wall.

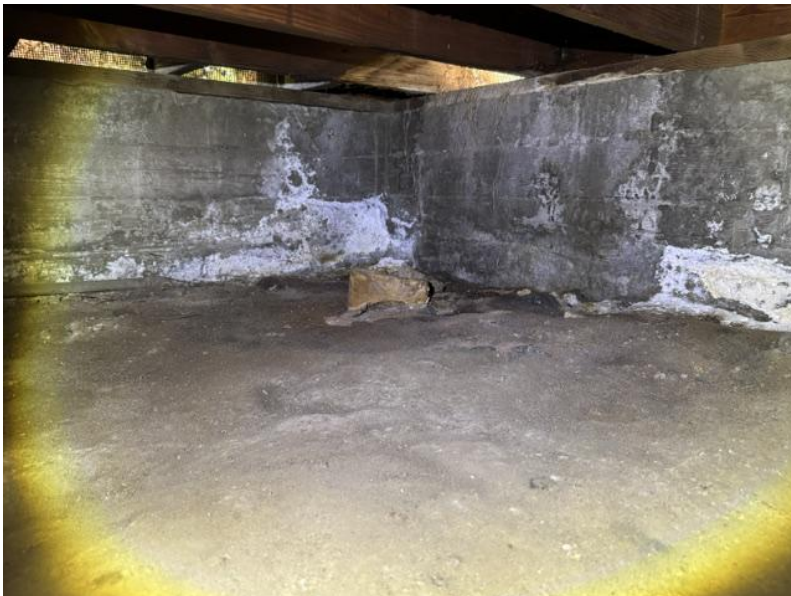
3. Water stains were visible on sections of the soil.

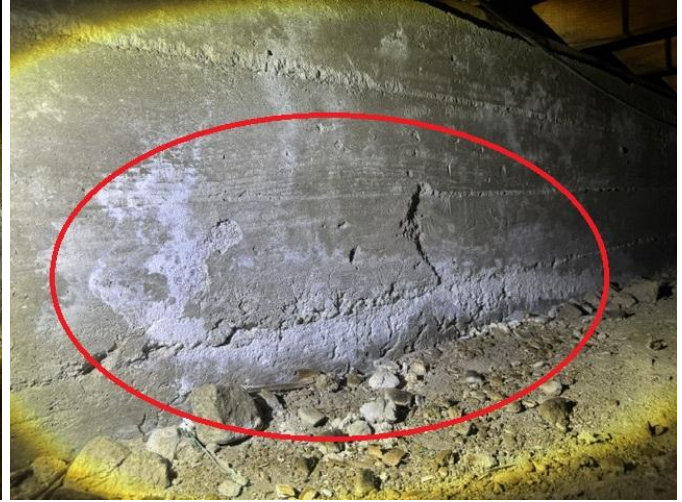
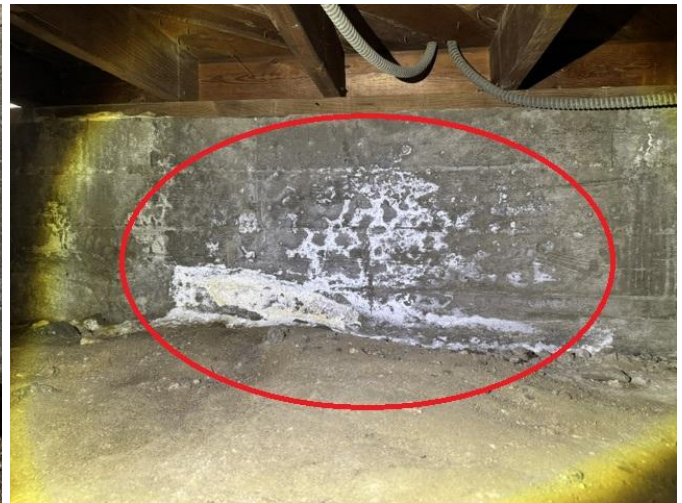
4. Efflorescence buildup and spalling was visible on portions of the foundation walls, indicating water penetration.

Spalling was visible on sections of the foundation walls.

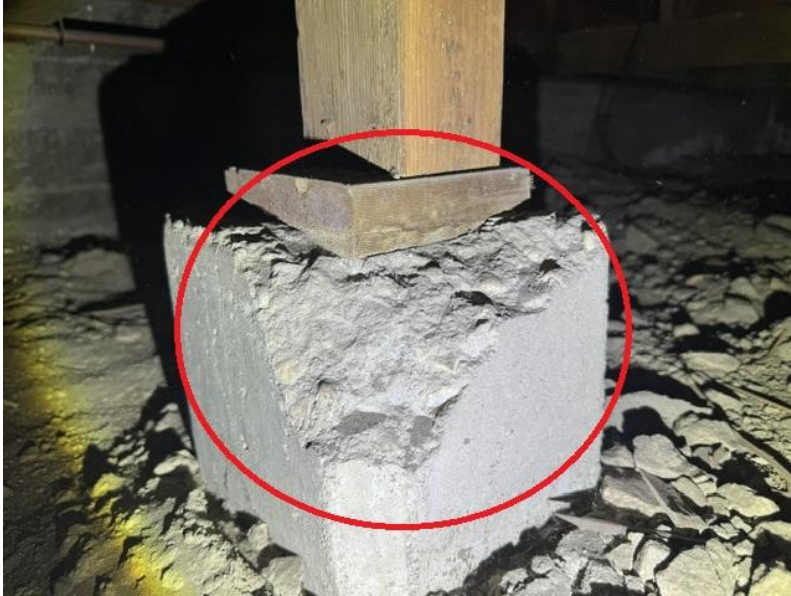
5. Damaged concrete pier was found in the crawl space.

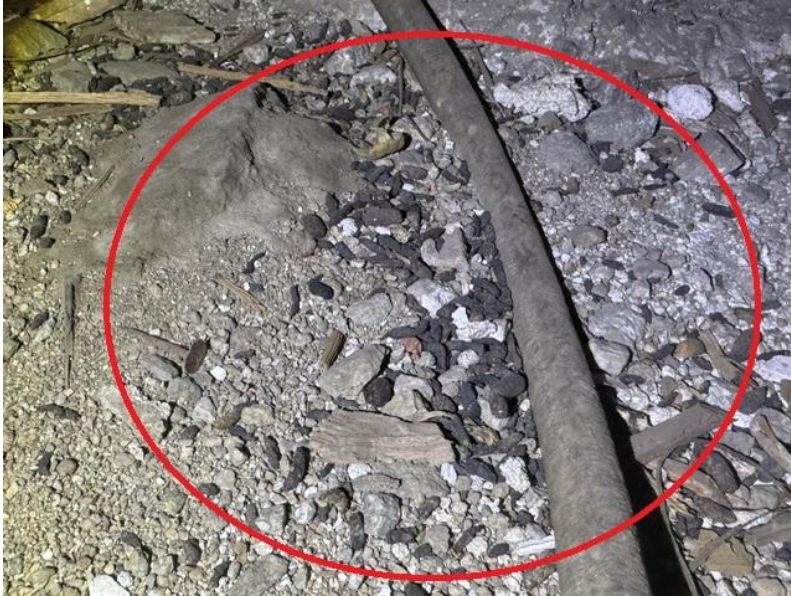
7. Rodent droppings were visible in the crawl space.

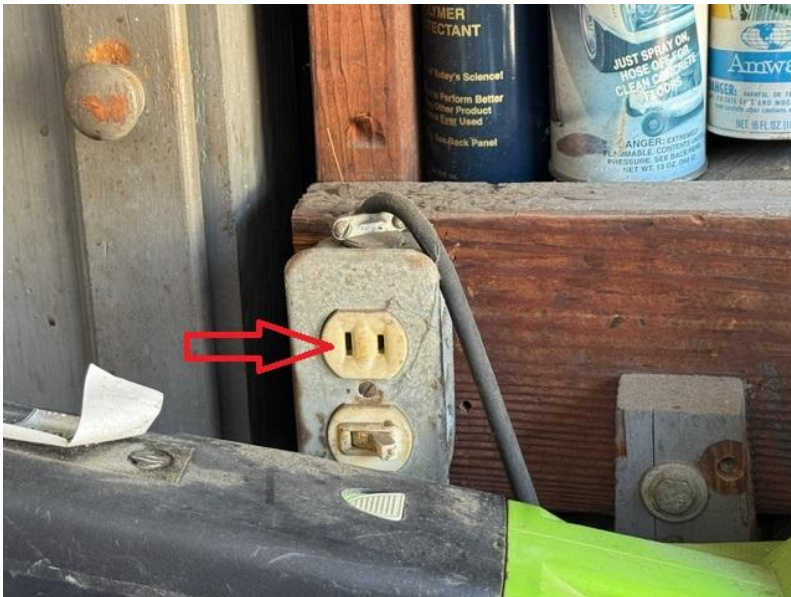
2. Visible garage wall receptacle was not GFCI type and was obsolete two prong type.

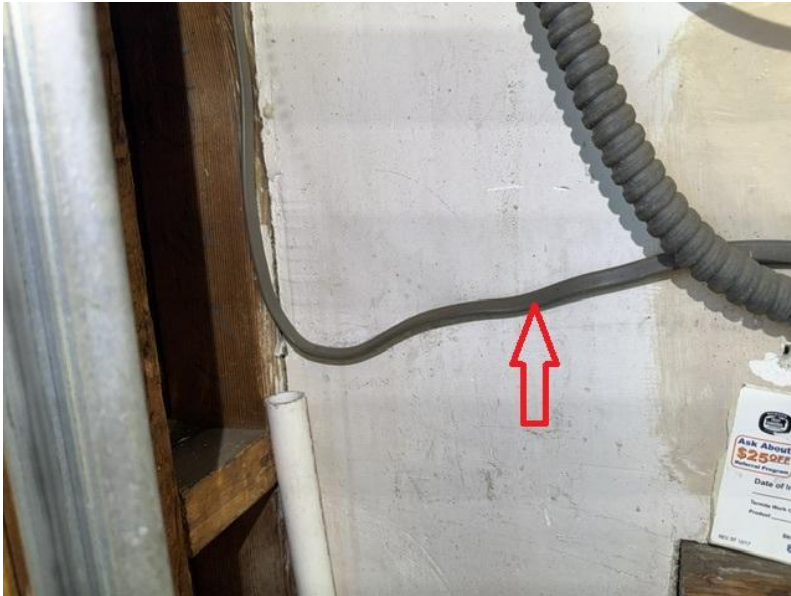
3. Exposed electrical wires were observed in the garage. All exposed electrical wires must be inserted in proper type conduits.

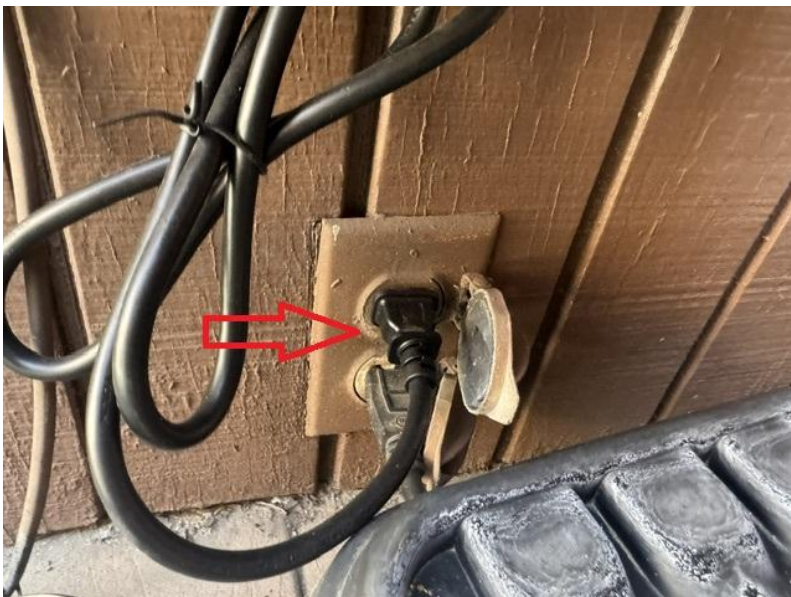
4. Receptacle on the deck wall was not GFCI type. In addition, the receptacle was in continuous use and contained standard type protective cover. Continuously, used exterior wall receptacles require bubble type protective covers.

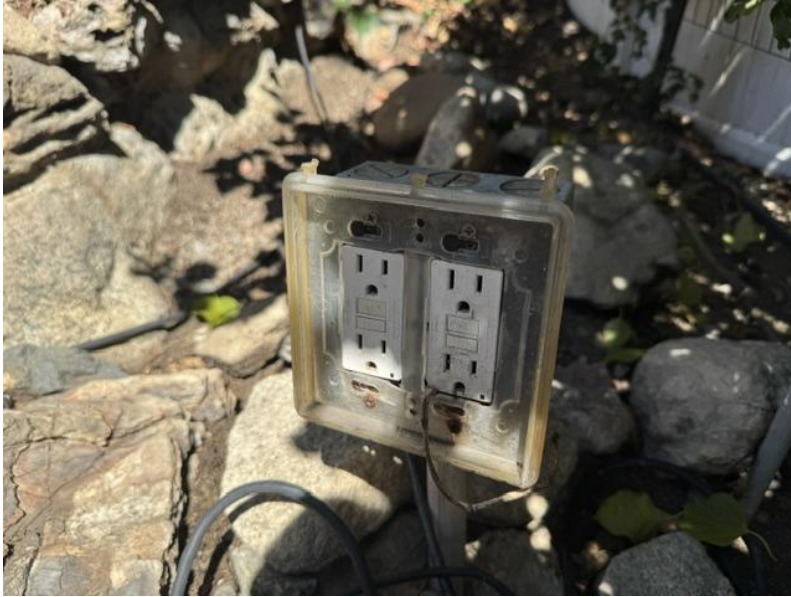
5. One of the GFCI receptacles adjacent to the pond was open ground, and the other had hot and neutral wires reversed. These receptacles would not trip under load. In addition, the receptacles were missing bubble type protective cover, and were exposed to the elements.

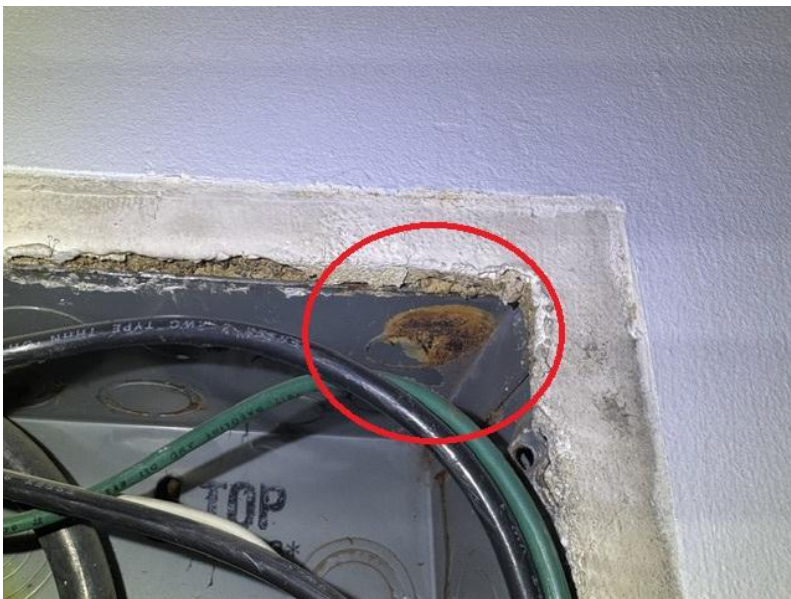
6. Rust was found in the interior of the electrical service panel.

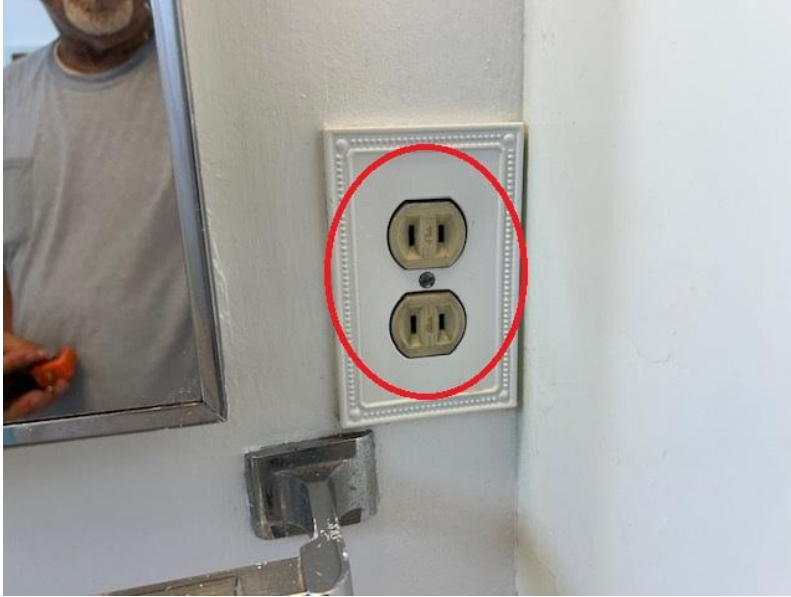
10. Significant portion of the interior wall receptacles were obsolete two prong type. This also indicates presence of aged and obsolete branch circuit wires.

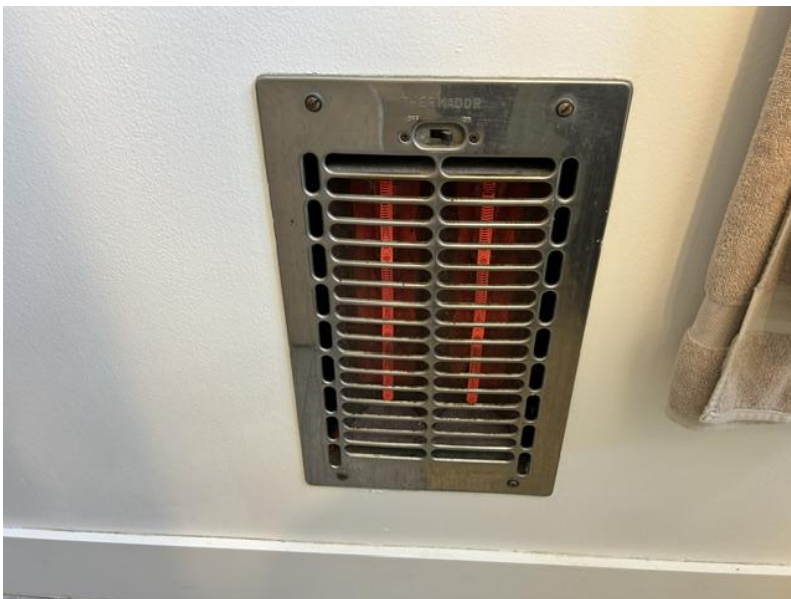
11. Receptacles in the bathrooms were not GFCI type. The three-quarter bathroom receptacle had hot and neutral wires reversed.
12. A functional electric wall heater was found in the full bathroom. Because of its age, this unit should be removed or rendered permanently non-functional, as it represents a safety hazard.

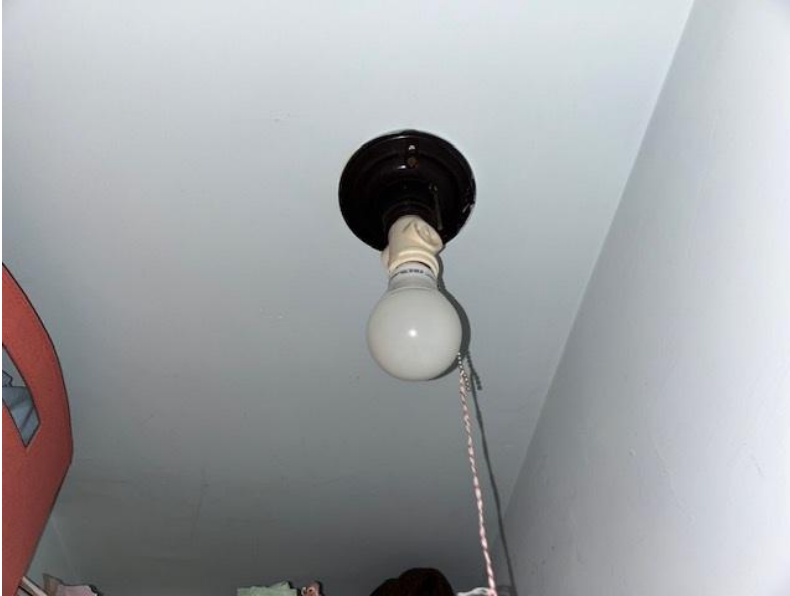
13. Closet lighting fixtures require outer protective covers.

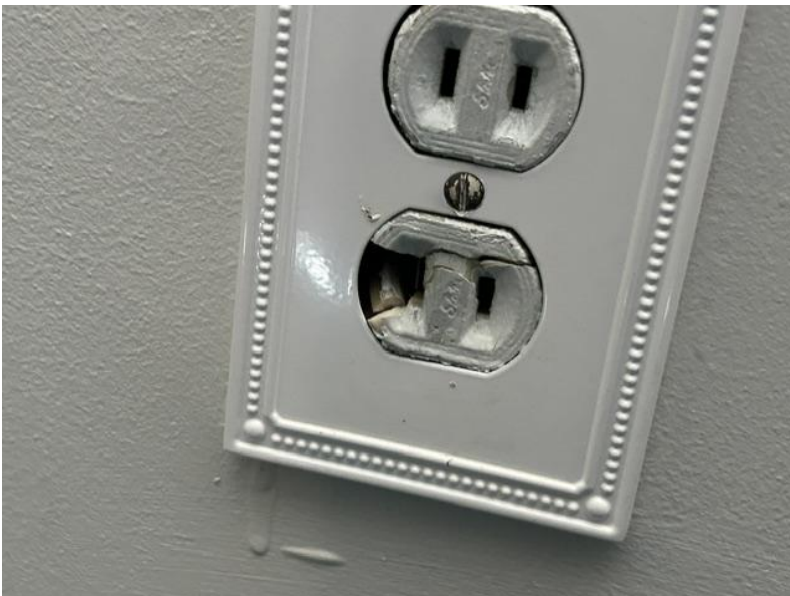
14. The accessible receptacle in the right front bedroom was damaged.

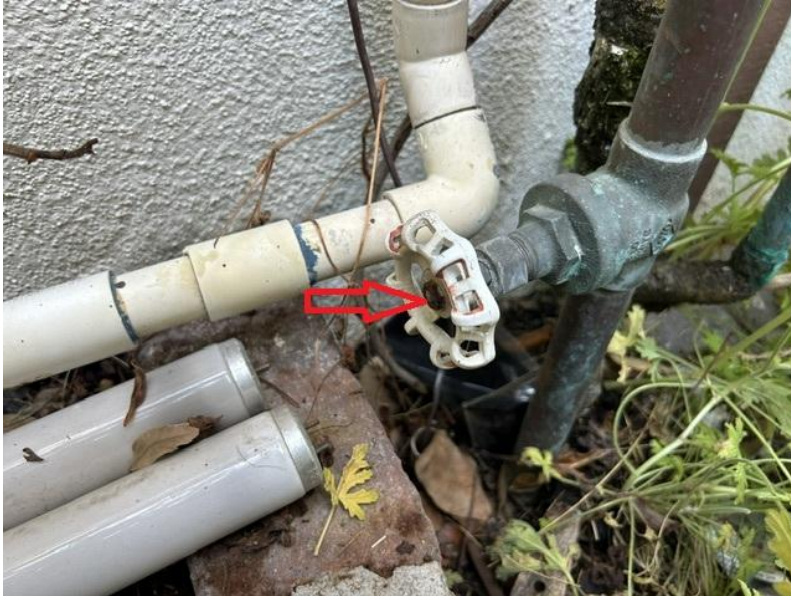
1. The main water shutoff valve handle was a full turn type valve. This type of valve is considered less reliable and may fail during operation due to internal wear or corrosion. It is recommended that the valve be replaced with a quarter-turn type shutoff valve, which is generally more dependable and easier to operate. Home View does not operate or test full-turn type valves.

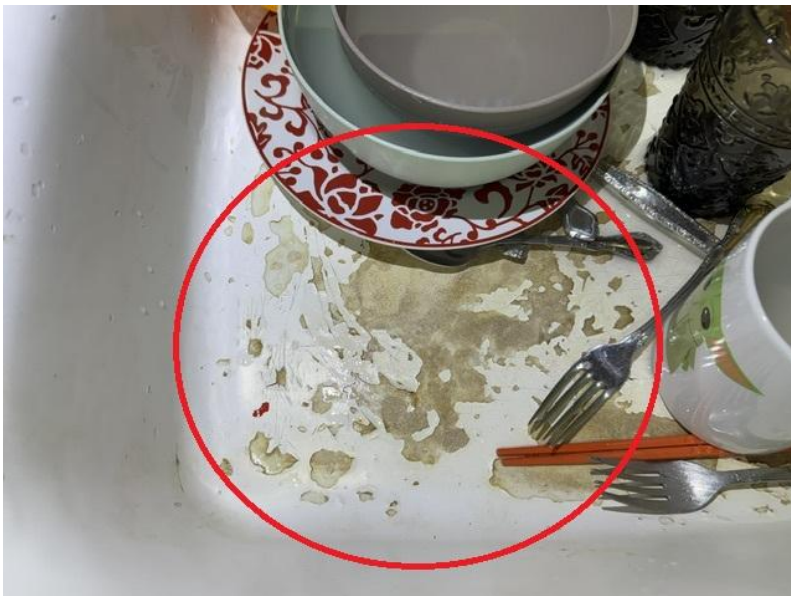
2. Counterweight for the kitchen faucet needed to be adjusted.
3. Chips were visible on the surface of the kitchen sink.
