File Number: **0926-204-650**  
Address of Inspection: **3018 Jolley Drive**  
Date of Inspection: **9/10/26**

## **HOME VIEW INSPECTION SERVICE**

### **REAL ESTATE INSPECTION REPORT**

3018 JOLLEY DRIVE  
BURBANK, CA 91504

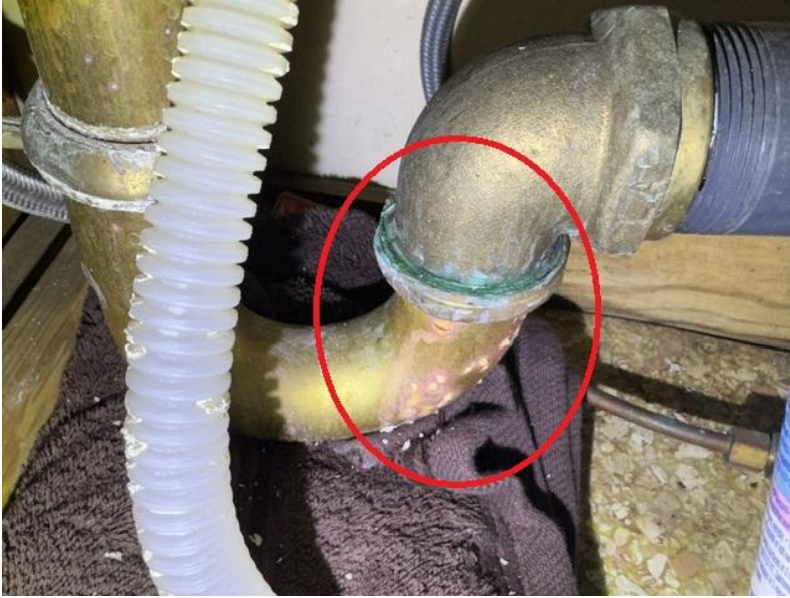
4. Corrosion was visible on the drainpipe beneath the kitchen sink.

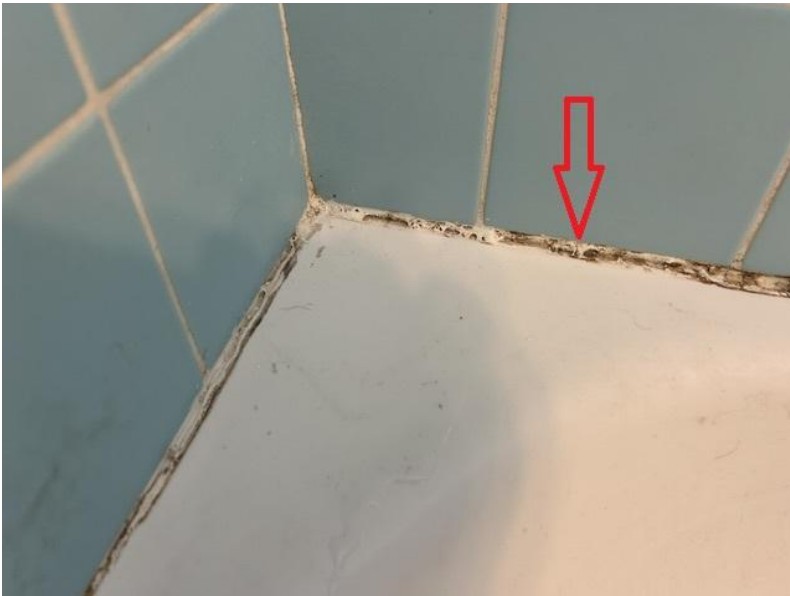
5. Perimeter of the full bathroom tub needed to be resealed properly.

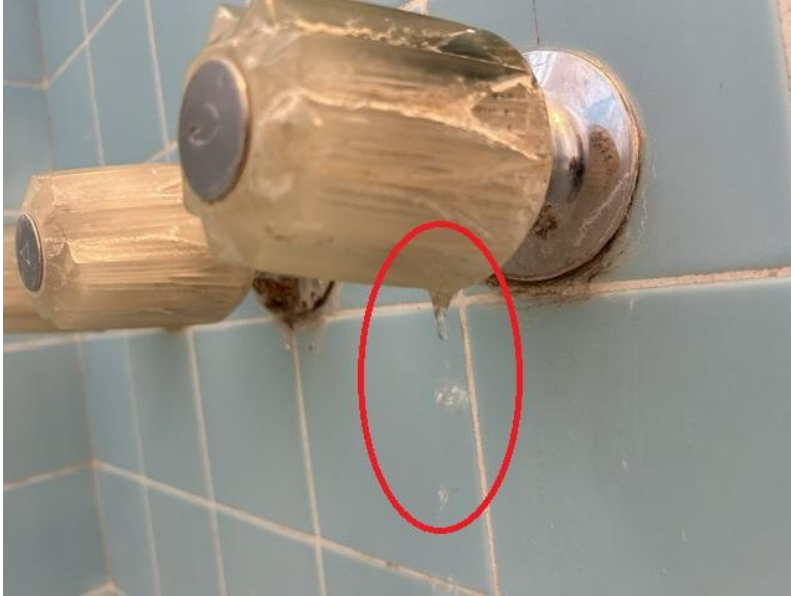
6. Water leak was visible from the cold water handle of the full bathroom tub.

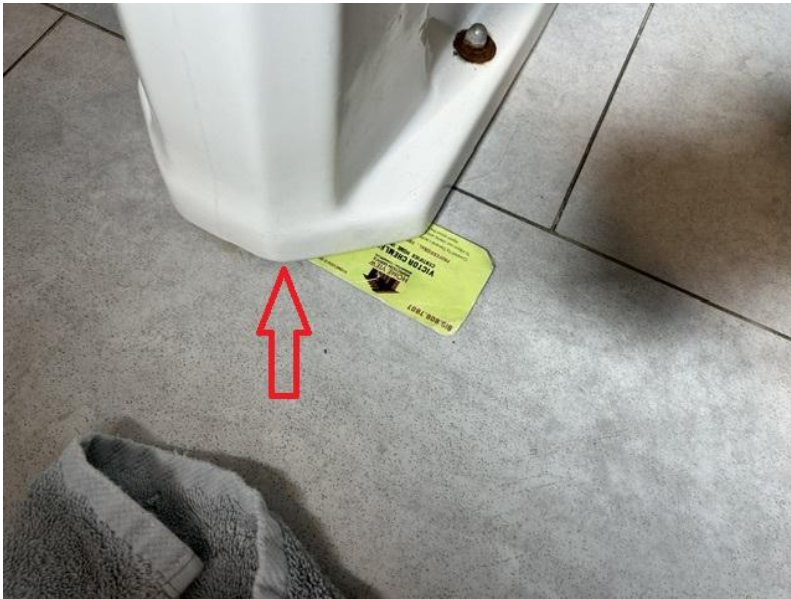
10. Bases of both toilets needed to be sealed.

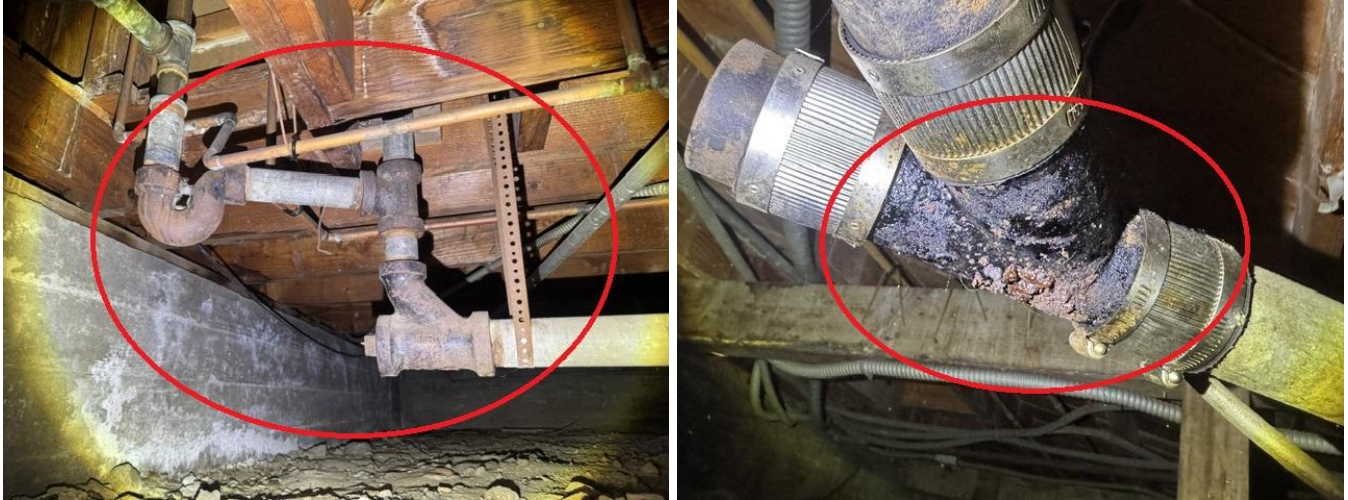
12. Drainpipes consisted of aged/rusted cast-iron and galvanized type, as viewed from the crawl space. These pipes were at the end of their useful lives.

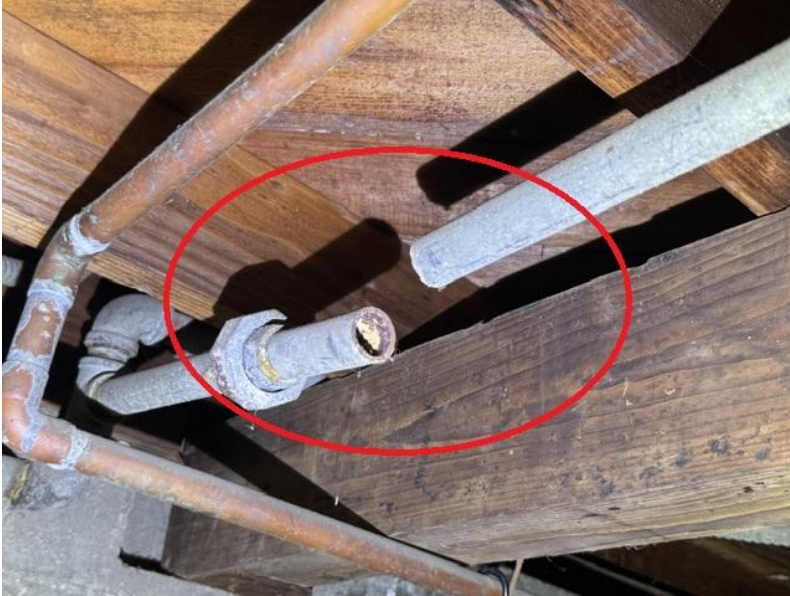
14. Abandoned galvanized water supply pipes in the crawl space should be removed.

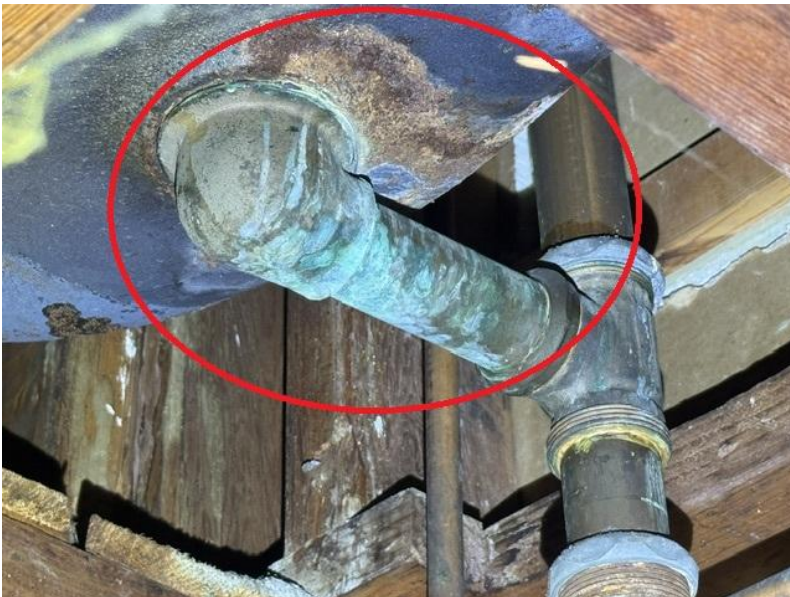
15. Rust was visible on the underside of the tub, as viewed from the crawl space, and corrosion on the drainpipe.

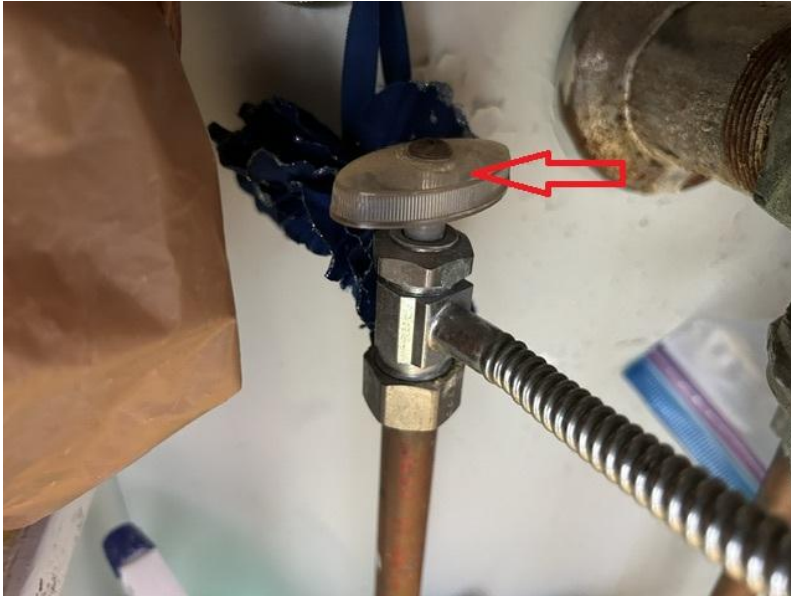
Note: The full turn shutoff valves/angle stops beneath sinks and behind toilets were not handled/tested. Due to prolonged non-operation, these valves can potentially leak or break when doing so. Home View recommends these be replaced with quarter turn type.
