# Professional

### *Inspection Report*

Address: 345 N 4th St Grover Beach, CA 93433

08/20/2026

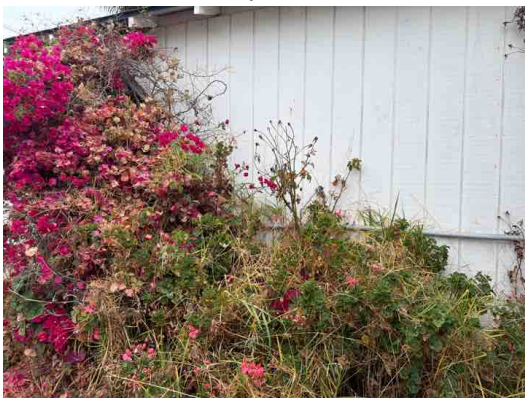
**MR** 24: Areas of the exterior are not fully visible and not inspectable due to overgrown foliage and occupant's belongings. Conditions are behind the blockage are unknown. Client is advised to have the obstructions moved to have the areas reinspected.

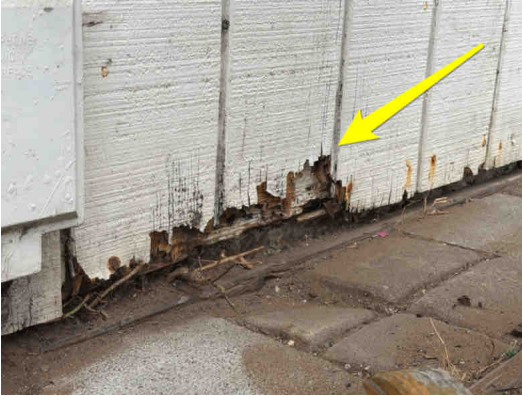
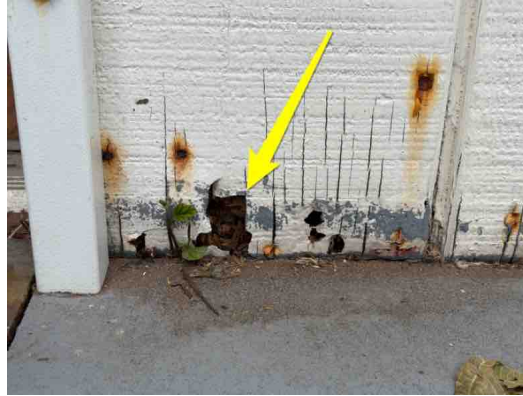
**E&C 25:** Some moisture and/or bug-type damage and deterioration found at areas of the exterior wood siding and/or trim. Refer to the termite report for additional comments, recommendations, locations and extent.

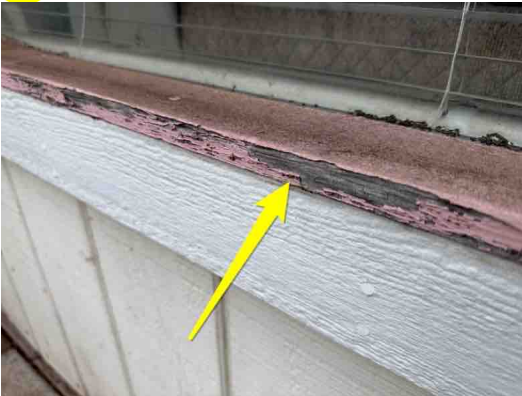
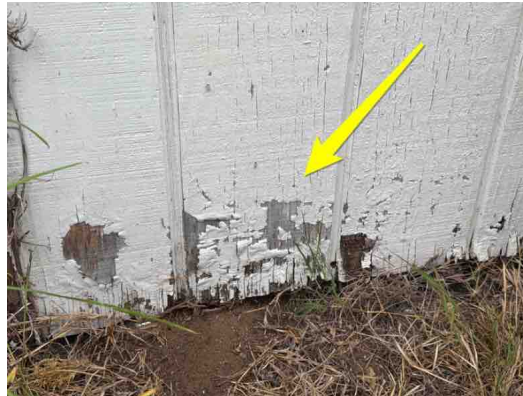
**MR 26:** Deteriorated paint at areas of the exterior.

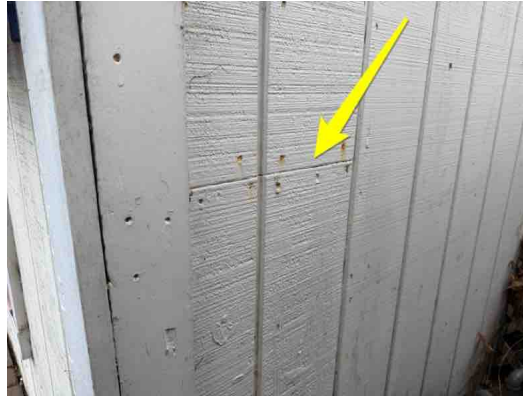
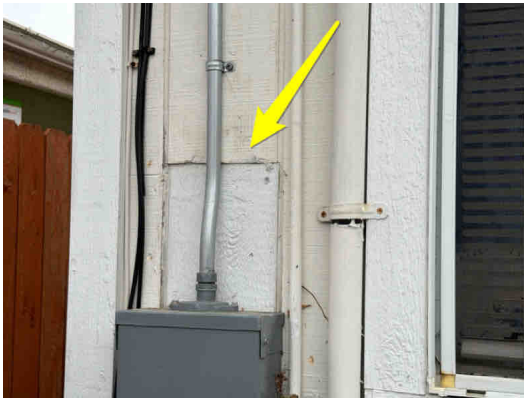
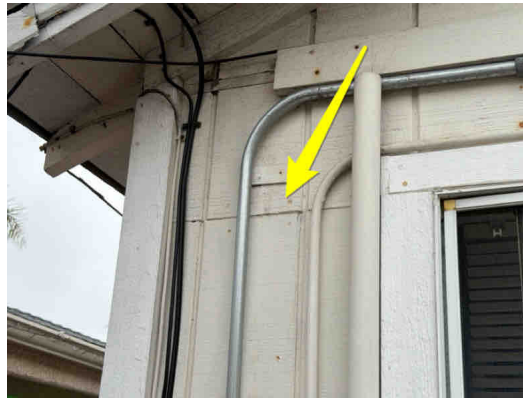
'Z' Weather Strip Flashing

**FI 27: Disclosure:** No visible water shed / "Z" bar flashing at areas of some past exterior plywood wood siding repairs. Areas will need to be sealed and maintained regularly or removed and replaced with appropriate Z-bar flashing to help ensure water tightness.

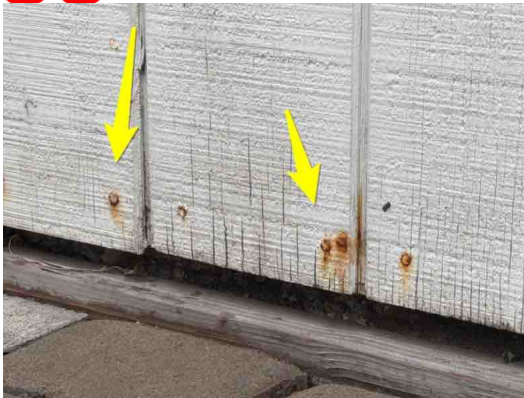
**E&C FI 28:** Several exterior fasteners found rusted and deteriorated.

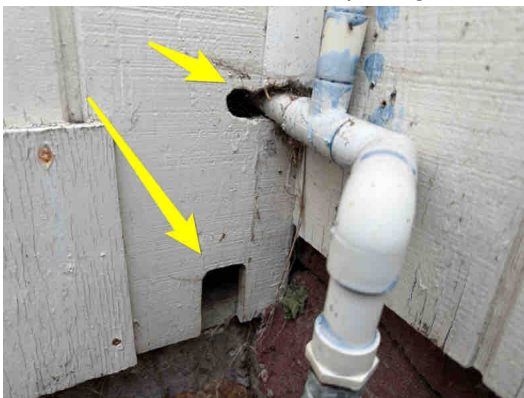
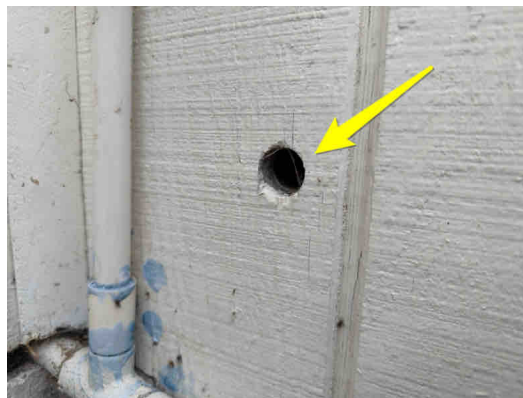
**MR 30:** Recommend sealing holes in exterior walls to prevent water intrusion around areas such as unused open holes in the exterior siding and trim, exterior light fixtures, around exterior electrical boxes and covers, and where utility pipes and/or wires pass through the exterior walls. Have a qualified painter or licensed professional evaluate the entire exterior and seal openings where needed.

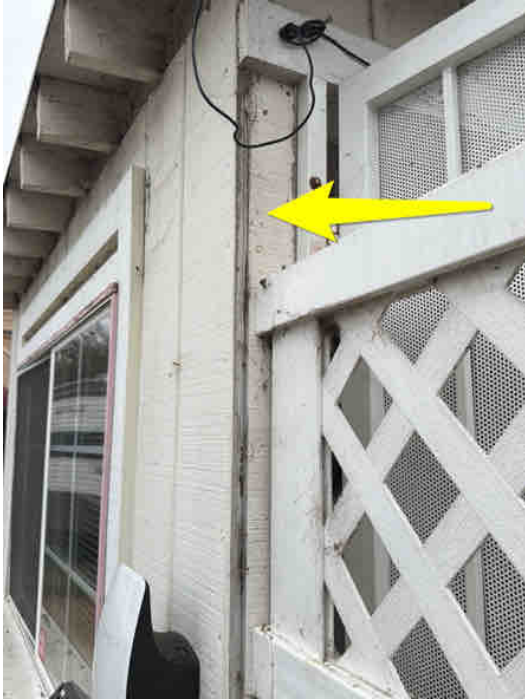
**E&C FI 35:** Some loose, damaged or missing trim noted at some areas of the exterior. Contact an appropriate professional to correct all areas of the exterior as needed.

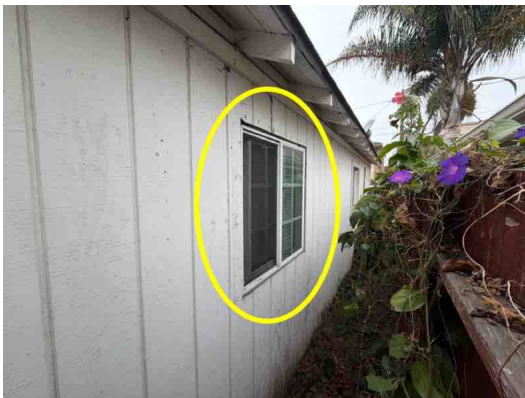
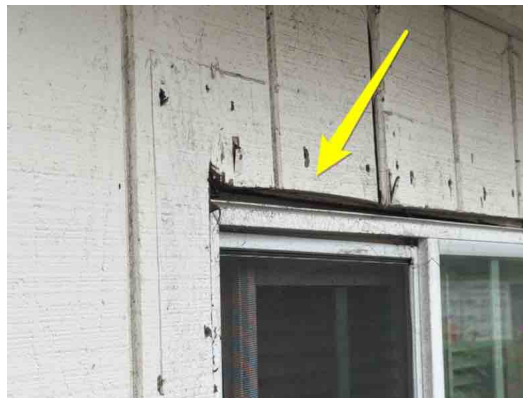
**36:** The North window in the bedroom is missing required exterior trim. Further evaluation and repairs warranted. Condition of waterproofing and wood framing around the window is Unknown.

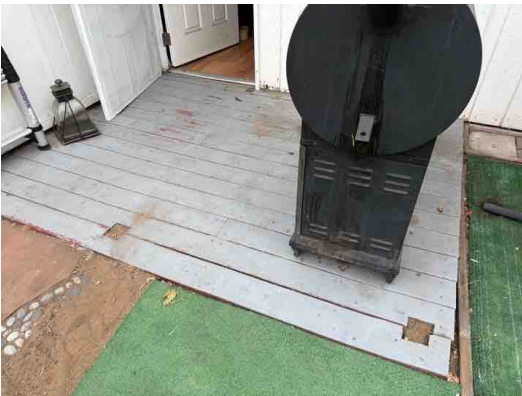
**E&C 39:** The FRONT ENTRY DECK does not meet minimum construction standards, has moderate moisture damage, and appears to be at the end of serviceable life. Contact a qualified contractor for evaluation and repairs or replacement.

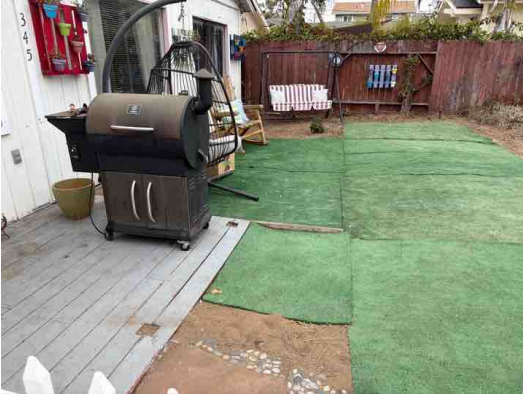
**MR** **42:** Areas of insufficient slope of the soil away from the building along some areas of the perimeter foundation. A proper slope of the soil, patios and walkways should allow for water to flow freely away from the building, not allow water to flow against areas the foundation edges and water should not allow for ponding of water in areas near or at the foundation as this can cause erosion and/or settling of the foundation system.

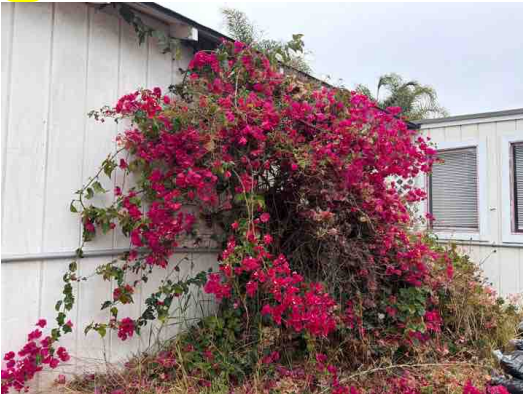
**MR** **44:** Plants and/or Trees touch the buildings exterior and/or the roof. Proper landscape maintenance needed.

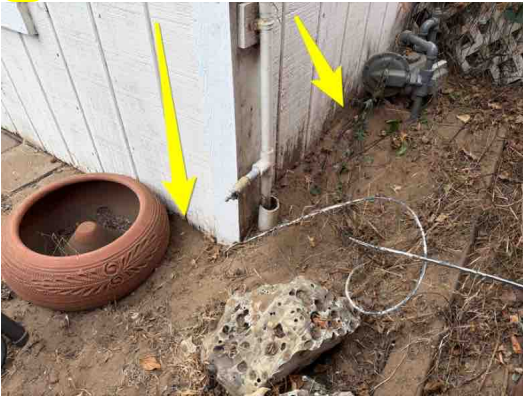
**MR 45:** Earth-to-wood contact noted at areas of the exterior siding or trim. Proper landscape grading warranted.

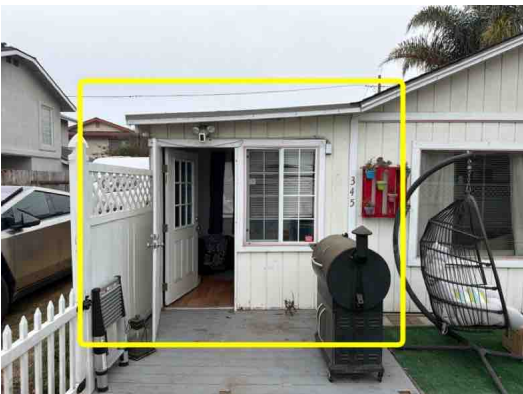
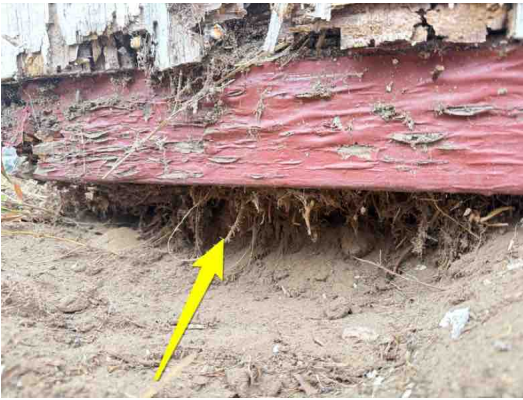
**49:** The entry area lean-to structure appears to have no foundation and may consist of direct wood framing-on-dirt style construction. Moderate leaning and settlement of the small addition is visible and warrants further evaluation by a qualified foundation professional or engineer.

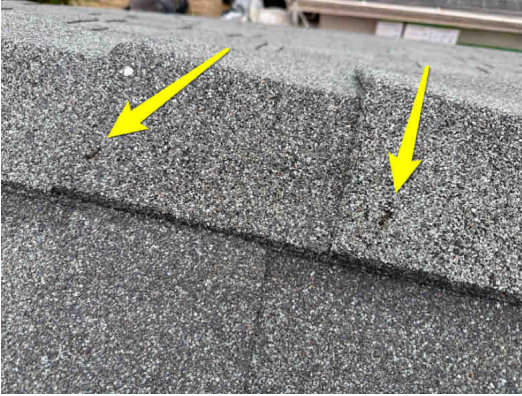
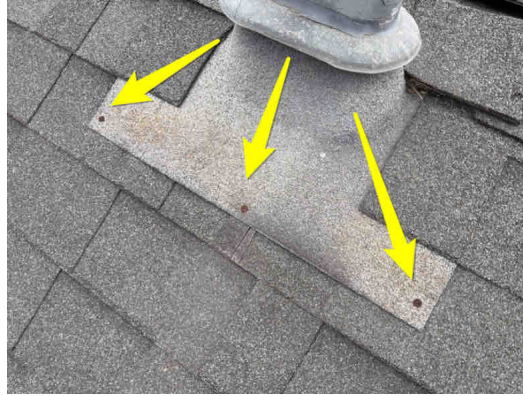
**DS 55: Disclosure:** Exposed fasteners noted at areas of the roof and/ or roof flashings.

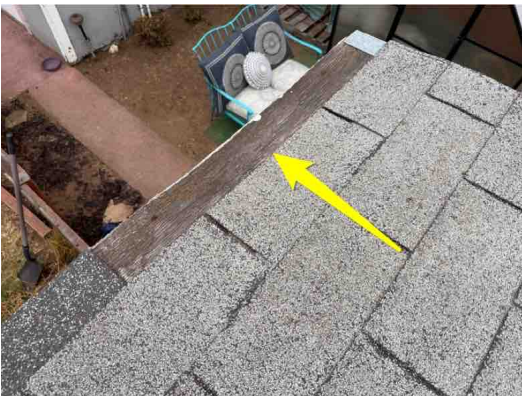
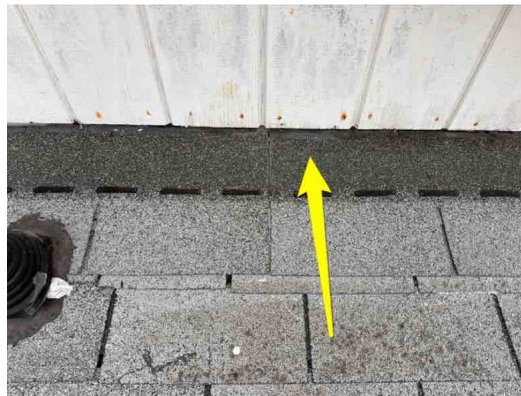
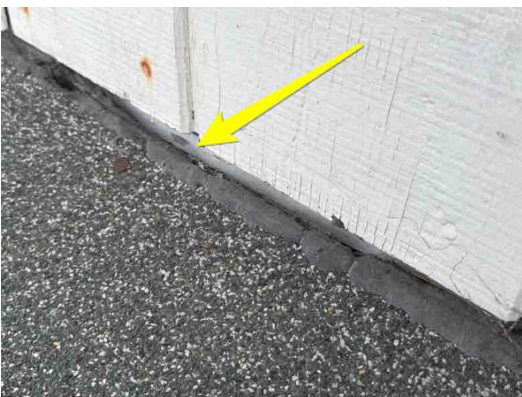
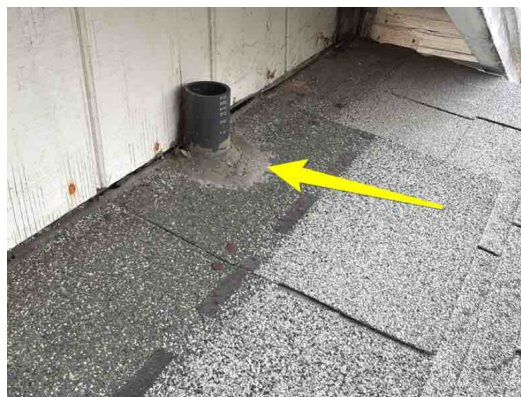
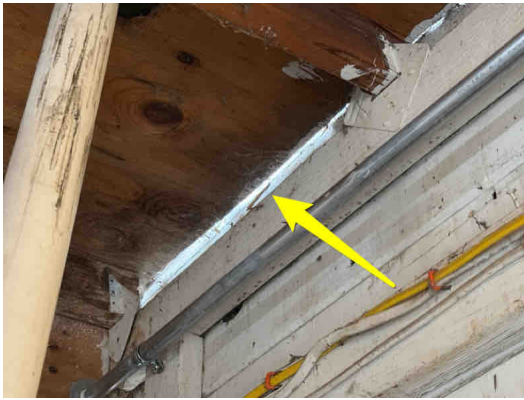
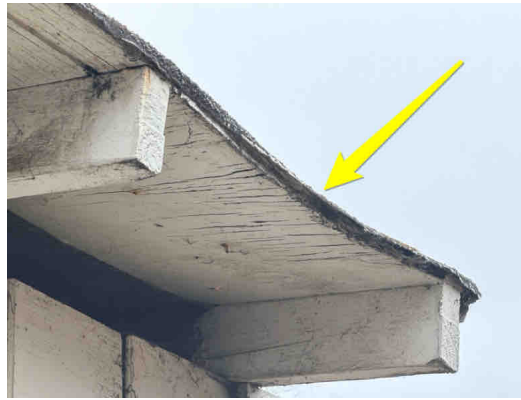
**E&C 64:** The single slope composition roof over the laundry room, found improperly installed, heavily damaged, and is missing required metal roof flashings. Too many individual defects and locations to list. Recommend further evaluation and re-roofing by licensed roofing professional familiar with minimum codes and waterproofing standards.

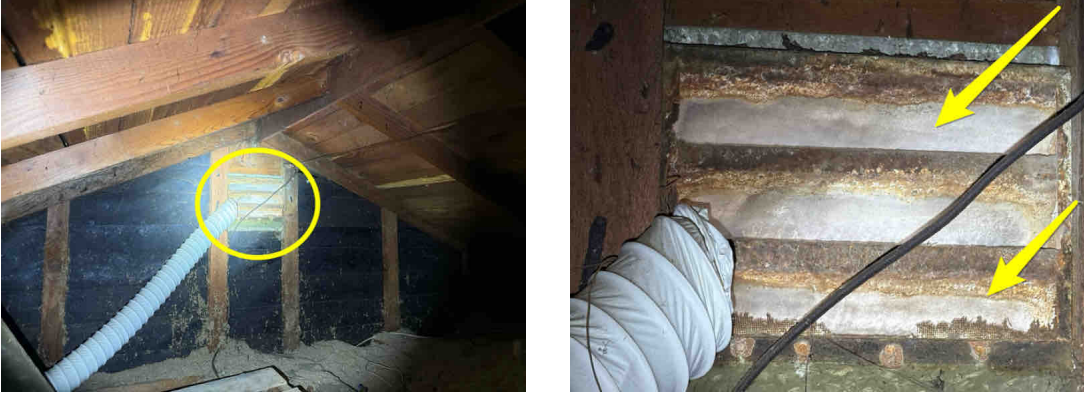
**E&C MR 75:** Some damaged attic gable vent screens found on areas of the exterior. Repair or replacement recommended to help prevent critter intrusion into attic areas.

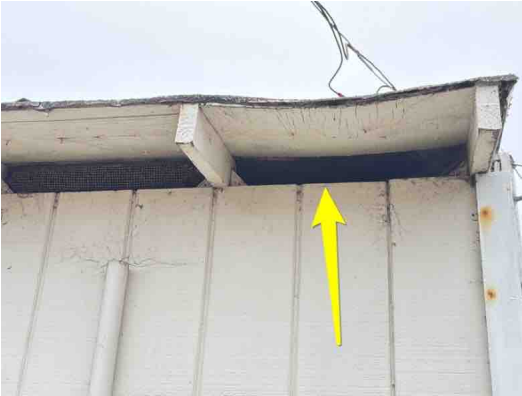
**E&C 76:** Unprotected openings into the attic or confined spaces from the exterior should be sealed or screened per standards to help keep rodents out of the attic.

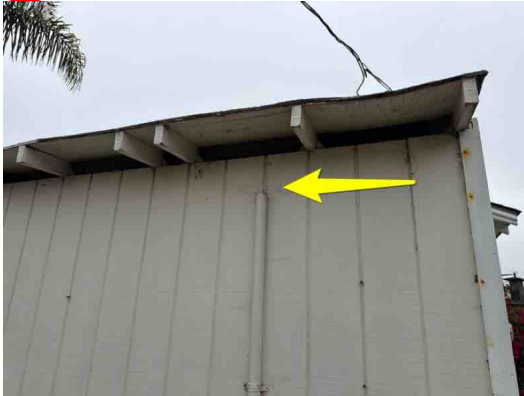
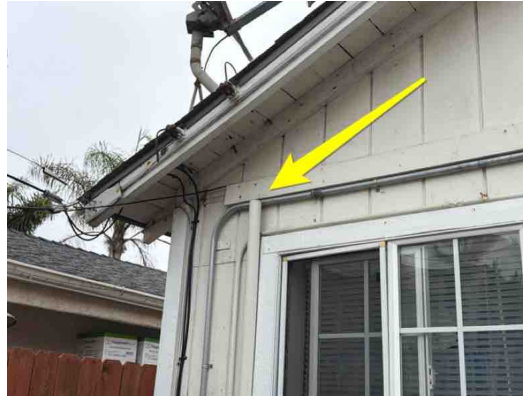
**E&C** 95: Improper plumbing waste vent pipe termination: WEST SIDE LAUNDRY AREA AND KITCHEN

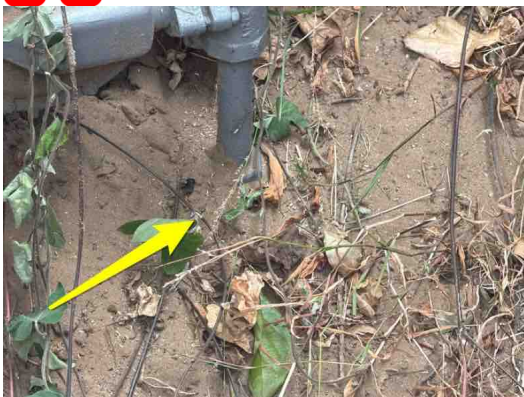
**E&C SC** 97: Gas meter main shut off found buried or partially buried in the soil. Corrections warranted.

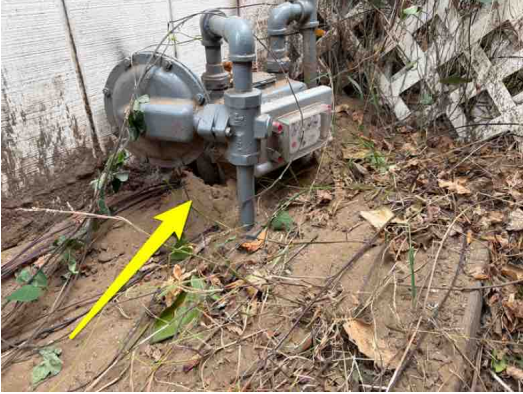
**MR** **UPG** **98:** The Gas meter and/or shutoff valve found to be improperly in contact with ground or soil. Deterioration has or may occur. Maintenance or upgrades are needed to help prevent deterioration or damage.

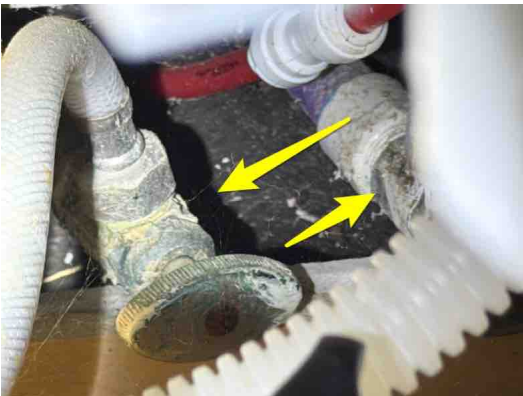
**FI 117:** Some corrosion found at the water supply shutoff valves under the Kitchen sink / evidence of past leaking. Client should investigate further until satisfied as to the cause, condition and potential future issues. Correction Recommended.

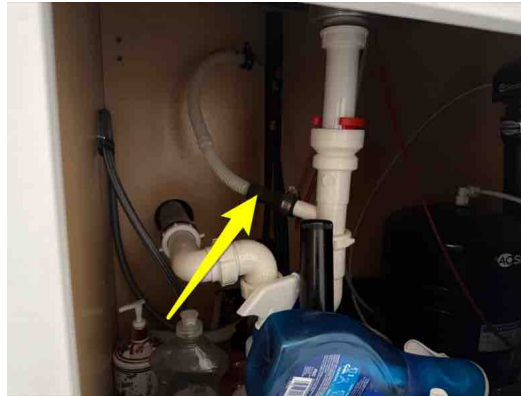
**SU 121:** Improper installation of the dishwasher drain hose. Missing the Air Gap Device at the dishwasher drain per minimum codes and standards (California does not allow for high-loop methods or direct waste connections). {CPC 801.2}

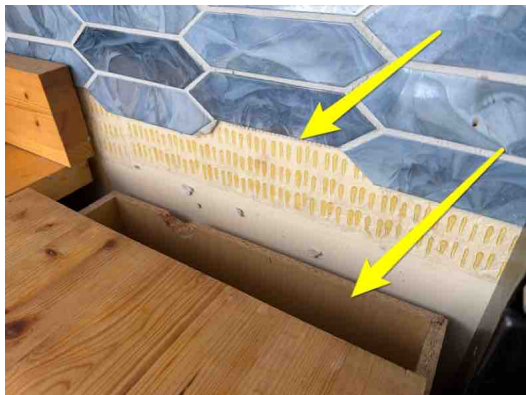
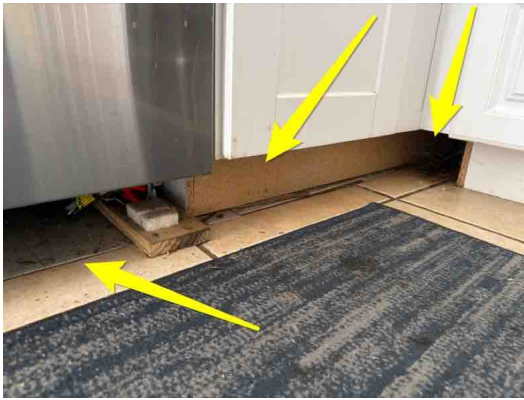
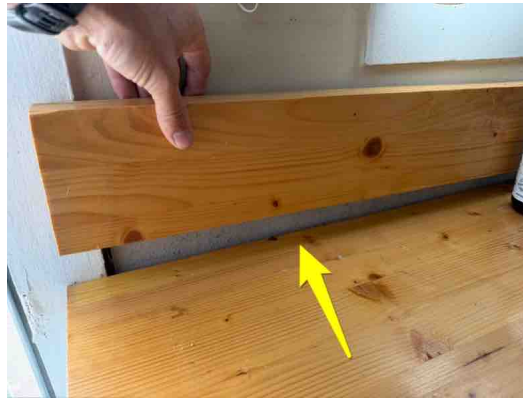
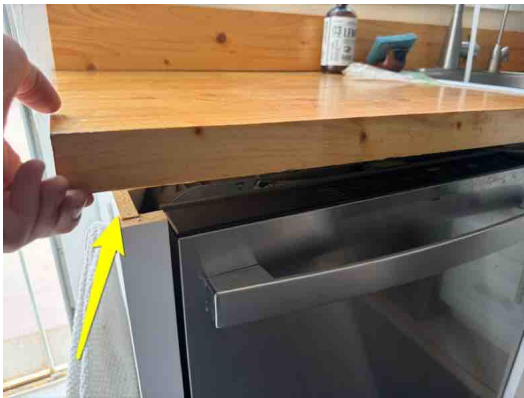
**126:** The kitchen appears to have incomplete finish work, including areas of missing backsplash tile, missing kick-plates, and unfinished countertop/backsplash components, Etc. Recommend buyer awareness that additional work and repairs will be needed to complete the kitchen finishes.

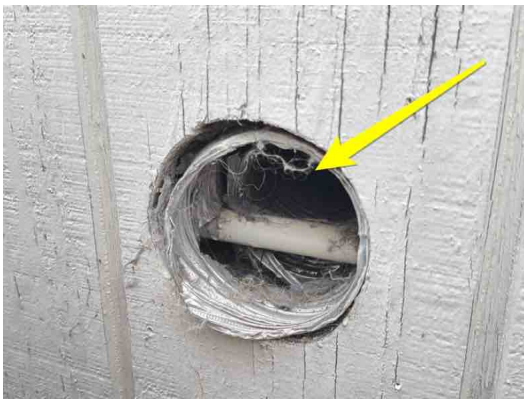
**E&C 136:** The laundry dryer vent system found damaged and improperly installed. Too many individual defects to list. Contact a licensed plumbing professional for evaluation and reinstallation of a properly installed dryer venting system.

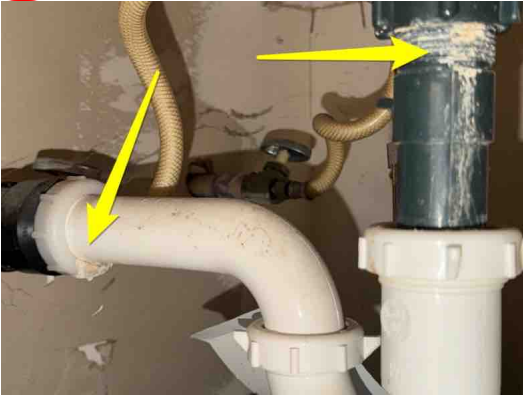
**FI 141:** Some corrosion found at waste pipe connections under the bathroom sink / evidence of past leaking.

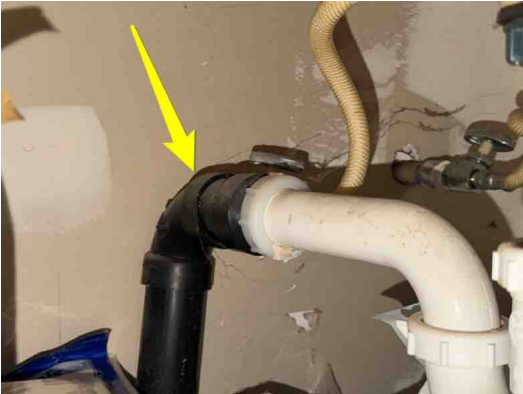
**E&C 142:** Improper waste piping found under the bathroom sink where waste piping is improperly vented allowing for vapor lock or through siphoning. Corrections or installation of an air admittance valve is recommended.

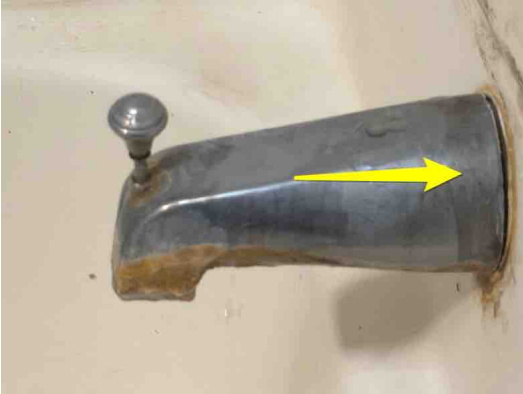
**MR 146:** Tub spout found loose and not sealed well at the shower wall connection.

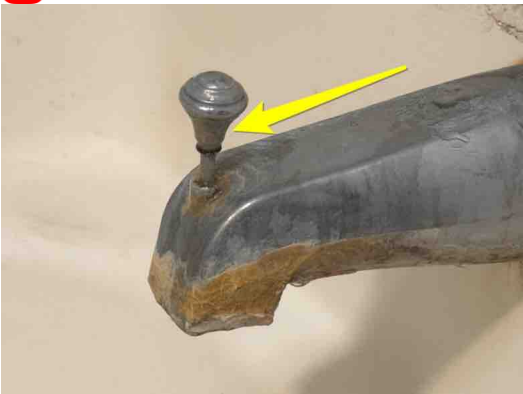
**E&C 148:** Shower diverter found non-operational at tub spout.

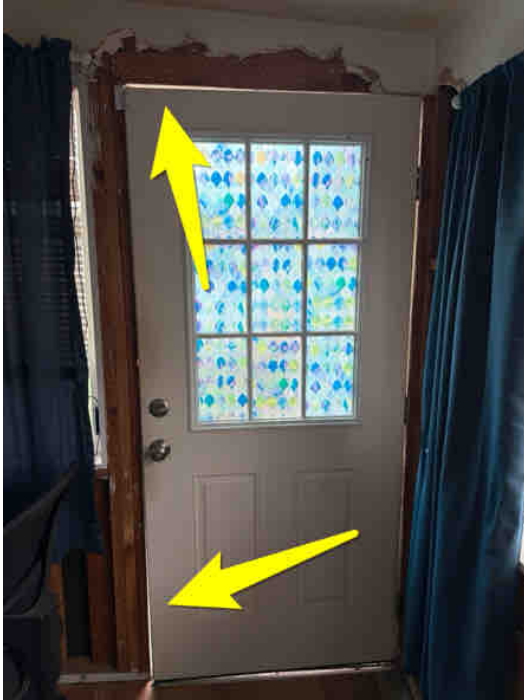
**FI DS 149:** The front entry door appears to be out of alignment and not sitting properly in the frame. Further evaluation/corrections recommended.

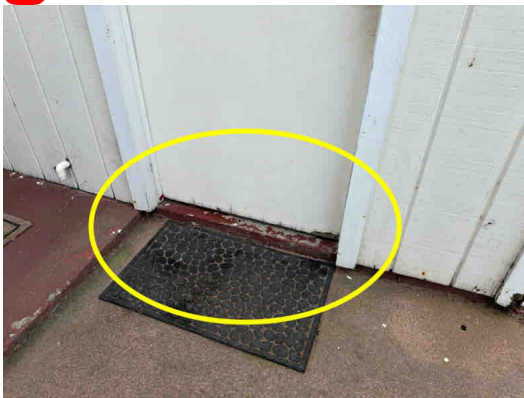
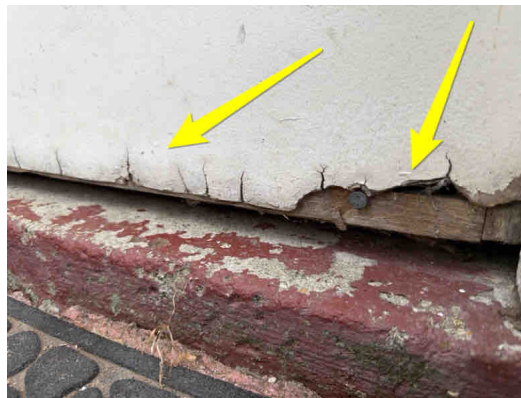
**E&C 150:** Moisture damage noted at the LAUNDRY ROOM exterior door. Refer to termite report.

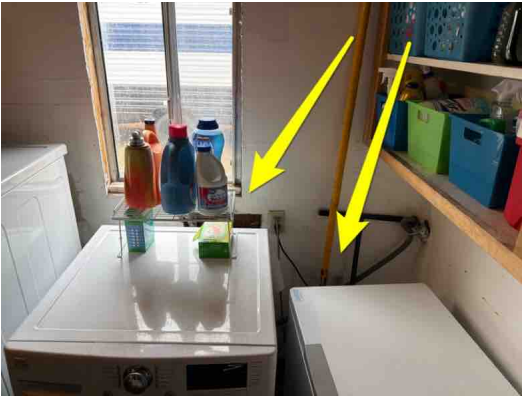
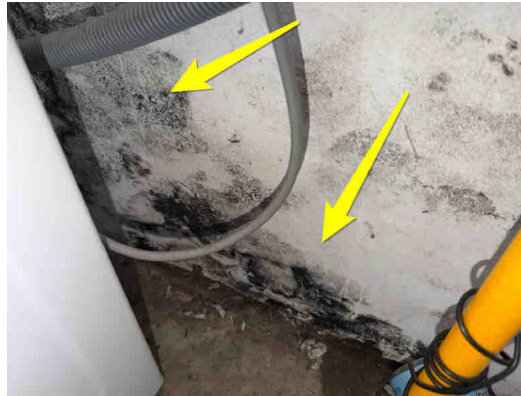
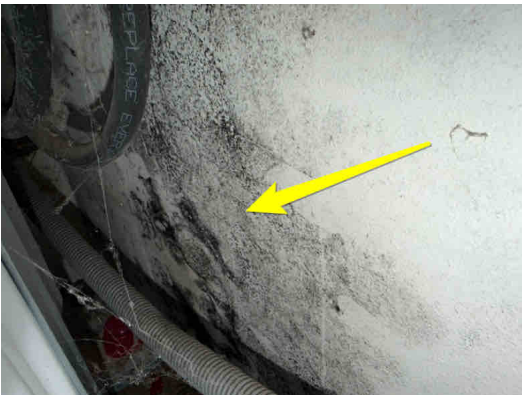
**SC FI 167:** Evidence of past moisture stains & damage with some visible mold growth on areas of the drywall: LAUNDRY ROOM. Recommend additional review by a qualified remediation professional. Recommend further review to determine if stains are current or old and if repairs are needed.

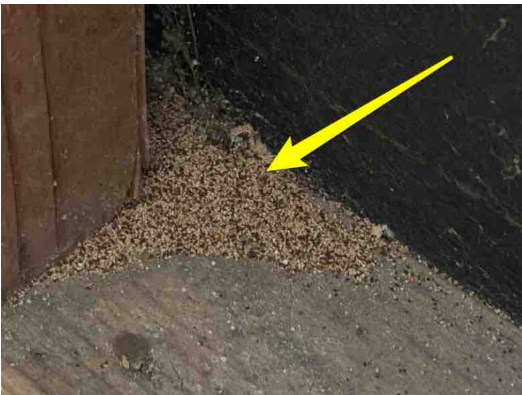
**168:** Evidence of termites in the areas of the building. Contact a qualified termite professional for additional comments and recommendations. Determining if condition are old or active is outside the scope of this inspection. Recommend proper clean up and prevention for sanitary purposes.

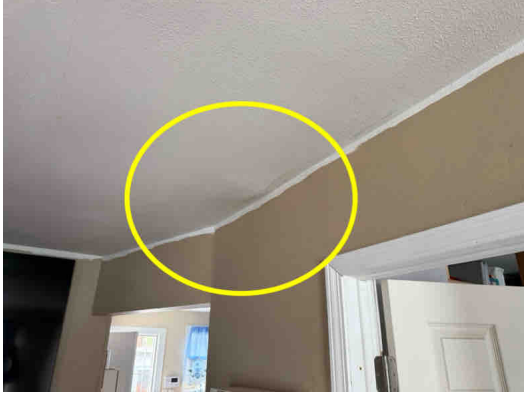
**FI 169:** The ceiling in the LIVING ROOM NEAR THE HEATER found sagging. Cause and condition is unknown. Client may wish to investigate further until satisfied as to cause and current condition.

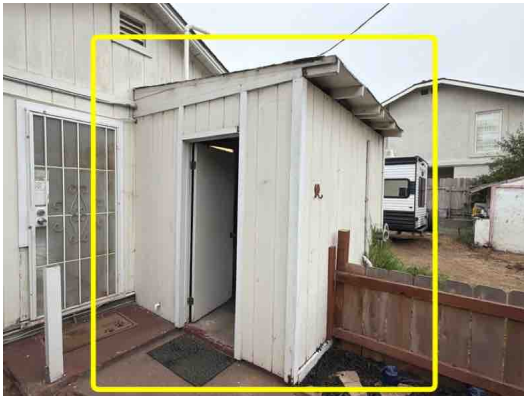
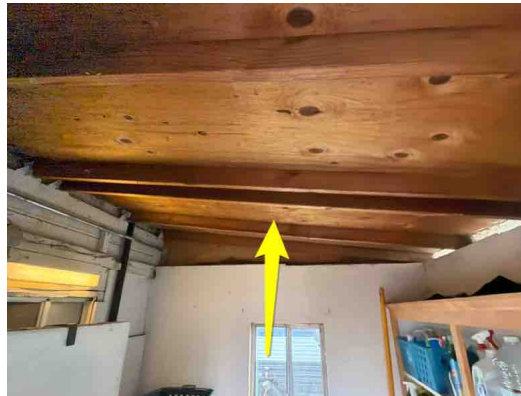
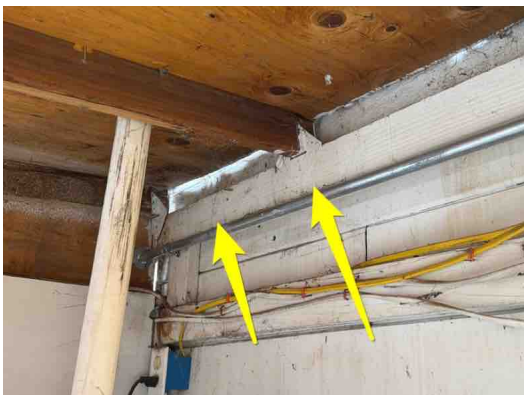
**E&C FI 170:** The wood framing at the added laundry room structure does not meet minimum construction standards and show signs of sagging and separation/pulling away from the building. Too many individual defects to list. Contact a licensed contractor for evaluation and repairs.

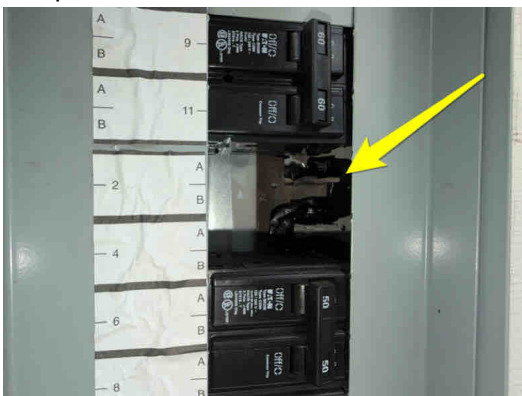
**179:** Openings in the electrical panel dead front cover were not properly sealed with approved filler plates. Unprotected openings are considered a safety hazard and may allow accidental contact with energized components

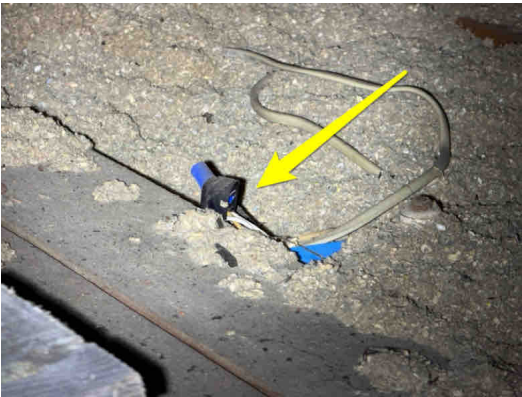
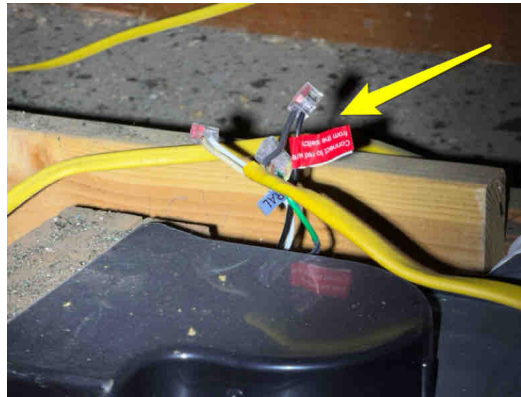
**SC 184:** Improper electrical wiring. Exposed electrical wires and/or splices not protected in a box with a cover:  
MULTIPLE THROUGHOUT THE ATTIC
