## **Property Inspection Report**

***412 Penelope Ln, Santa Maria, CA 93455***

***Date of Inspection: 8/12/2026 Time: 1:30 PM***

***Inspector: Peter Ruiz***

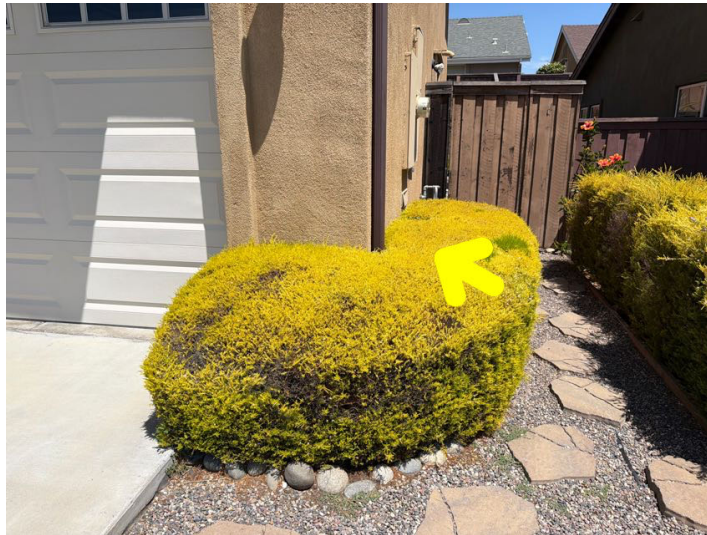
3.2. Vines, shrubs or bushes are growing on the house walls and although they are attractive they can introduce pests and rodents and accelerate deterioration. Therefore, you may wish to consider having them removed or cut back to 12 inches (30 cm) away from the home.

Vines, shrubs or bushes are growing on the house walls and although they are attractive they can introduce pests and rodents and accelerate deterioration. Therefore, you may wish to consider having them removed or cut back to 12 inches (30 cm) away from the home.

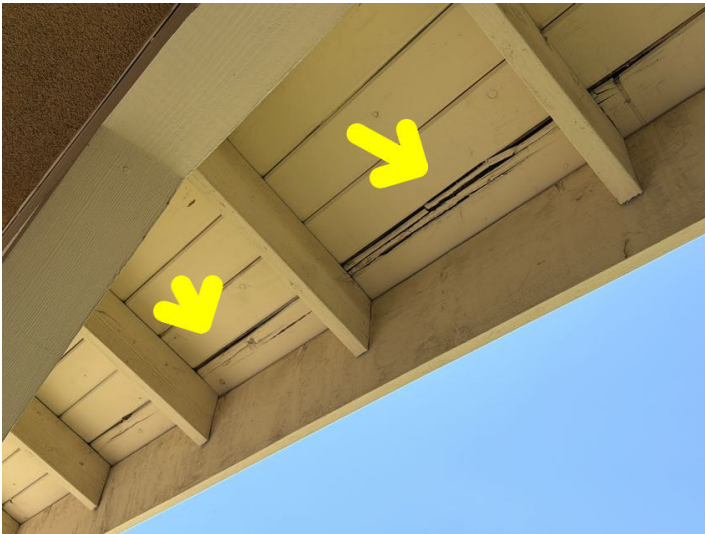
There is damage to the wood trim, fascia, and/or eaves that should be evaluated by a pest inspector.

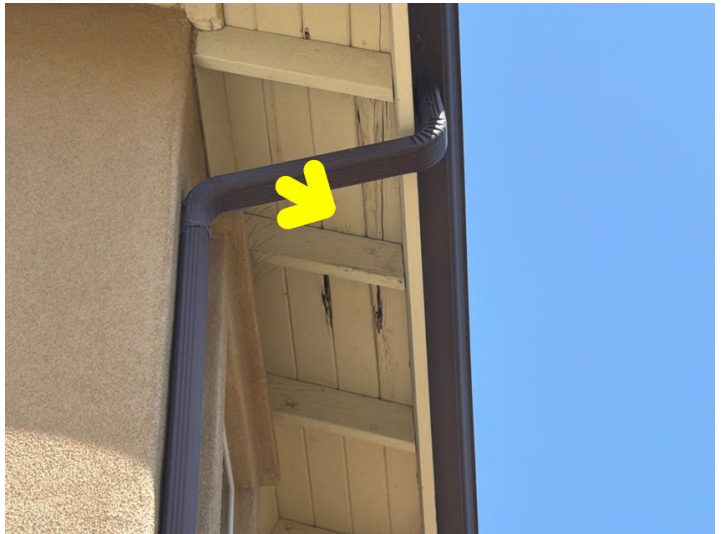
There is damage to the wood trim, fascia, and/or eaves that should be evaluated by a pest inspector.

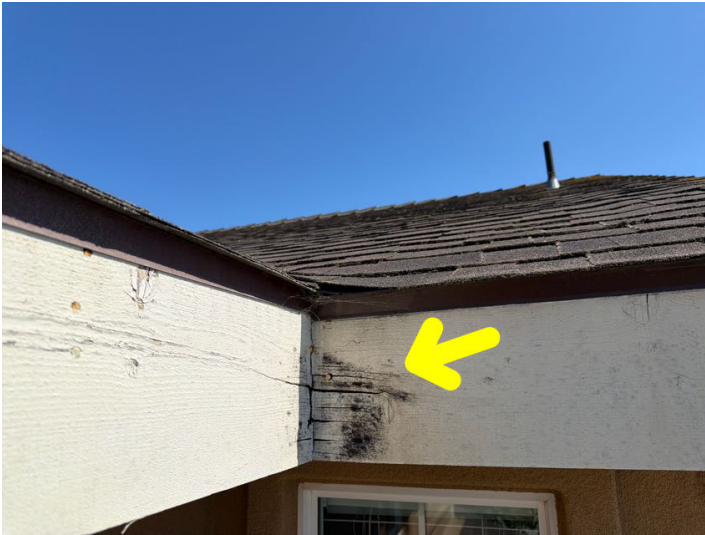
5.3. There is moisture damage or dry rot to the wood trim and or fascia on the upper roof area, which is typically not inspected by the pest inspector. The pest control company should be alerted to inspect and include these repairs in their estimate.

There is moisture damage or dry rot to the wood trim and or fascia on the upper roof area, which is typically not inspected by the pest inspector. The pest control company should be alerted to inspect and include these repairs in their estimate.

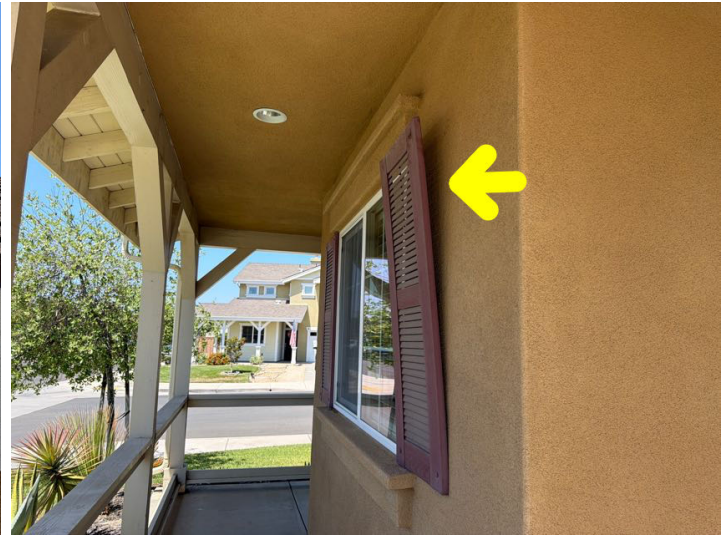
5.4. The decorative wood trim has separated from the house walls, and should be serviced to forestall further deterioration.

The decorative wood trim has separated from the house walls, and should be serviced to forestall further deterioration.

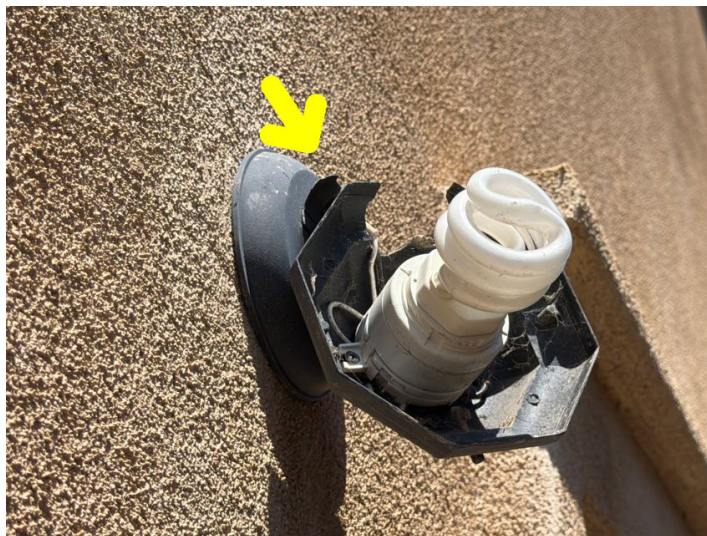
| Page 9 Item: 6 | Electrical Components | 6.4. An exterior light fixture is damaged or broken and should be serviced. |

**6.4. An exterior light fixture is damaged or broken and should be serviced.**

An exterior light fixture is damaged or broken and should be serviced.

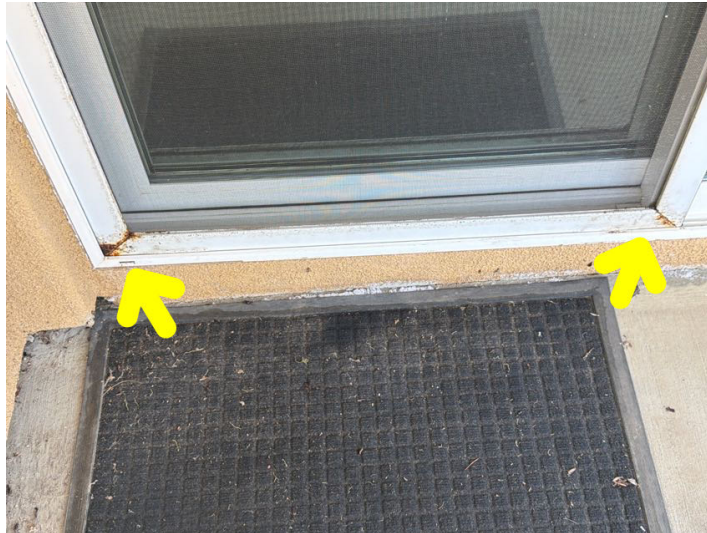
7.2. A slider screen is damaged, and you may wish to have it repaired or replaced.

A slider screen is damaged, and you may wish to have it repaired or replaced.

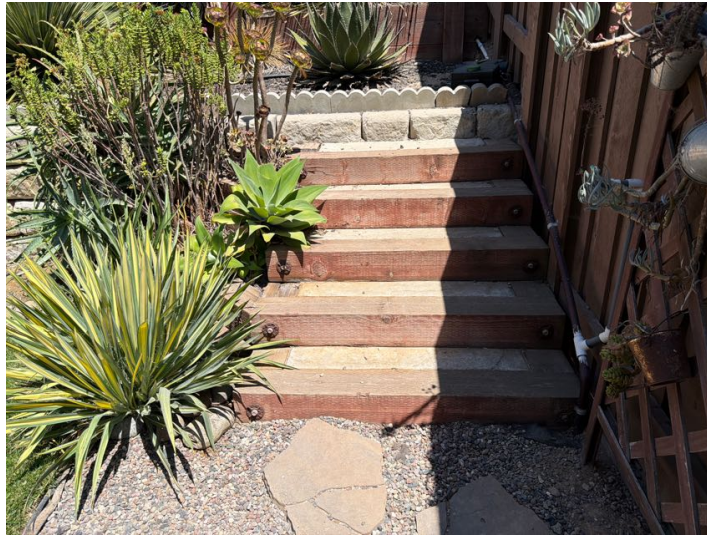
The railroad tie, wooden post, or natural stone steps are landscape components and would not conform to common standards requiring certain dimensions, handrails, guardrails, etcetera.

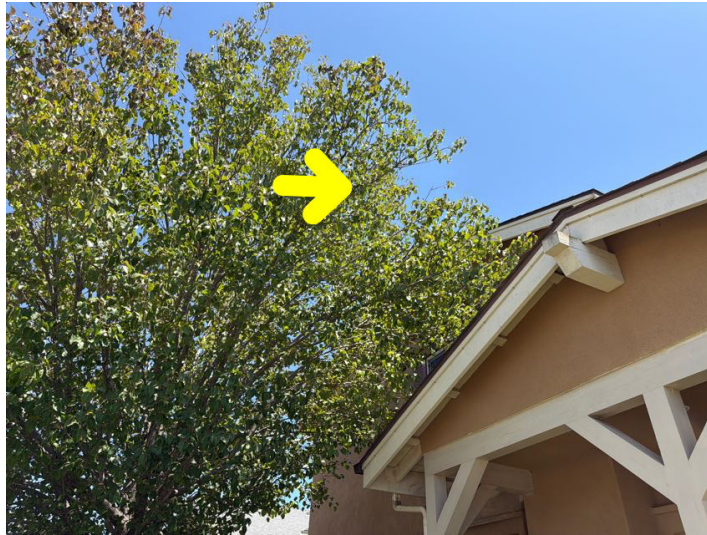
12.2. There are tree limbs over growing the residence that should be trimmed or monitored to ensure that they do not impact or damage the roof or its components.

There are tree limbs over growing the residence that should be trimmed or monitored to ensure that they do not impact or damage the roof or its components.

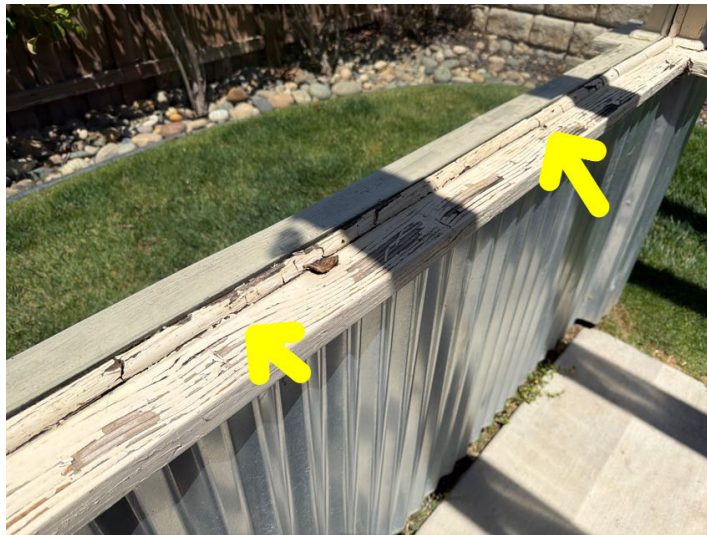
13.2. There is damage to the patio cover that should be evaluated by the termite inspector.

There is damage to the patio cover that should be evaluated by the termite inspector.

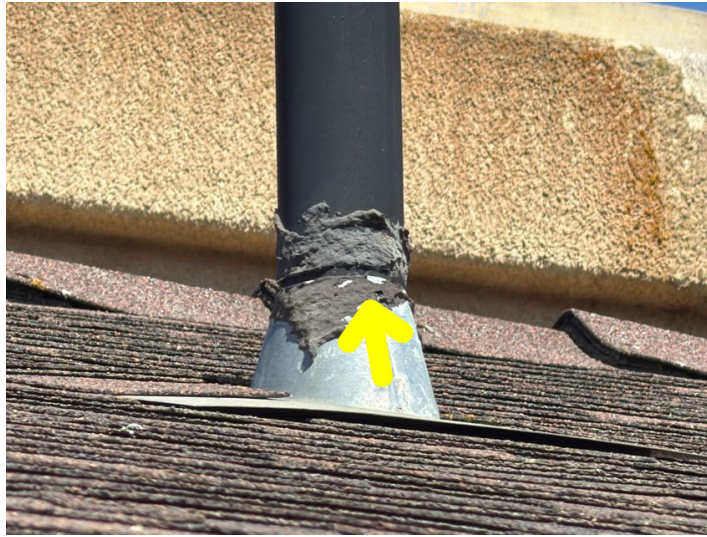
One or more of the roof flashings need to be sealed or serviced. They are comprised of metal that seals valleys, vents, and other roof penetrations, and are the most common point of leaks. This is particularly true of the flashings on a layered roof, which are covered by the roofing material and are even more susceptible to leaks.

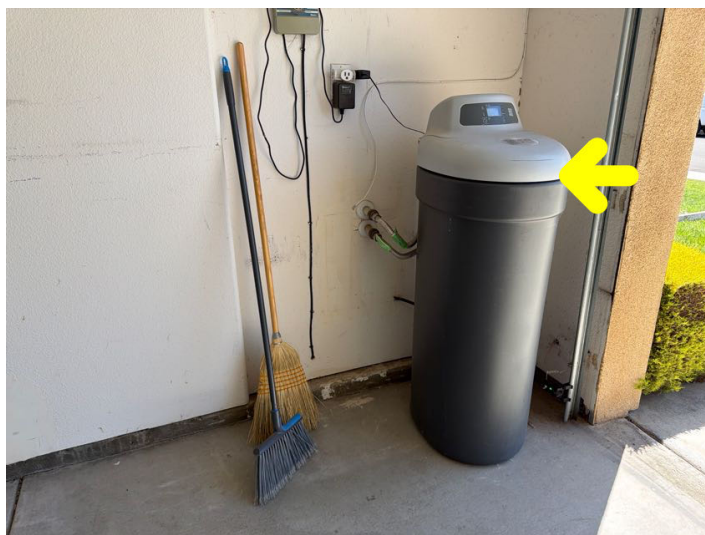
A water softener is present that we do not have the expertise to evaluate except for visible leaks. We recommend having the seller disclose its operation, maintenance history, and relevant documentation.

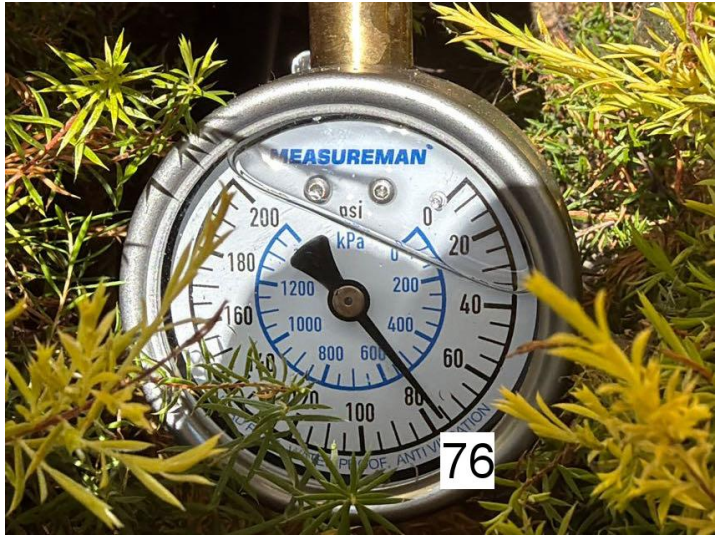
| Page 17 Item: 2 | Water Supply Comments | 2.4. The pressure inside the residence is nearing 80 PSI and will stress components of the system. A qualified tradesperson should reduce the pressure at the regulator to sixty pounds per square inch. However, the regulator may have failed and would need to be replaced. |

The pressure inside the residence is nearing 80 PSI and will stress components of the system. A qualified tradesperson should reduce the pressure at the regulator to sixty pounds per square inch. However, the regulator may have failed and would need to be replaced.

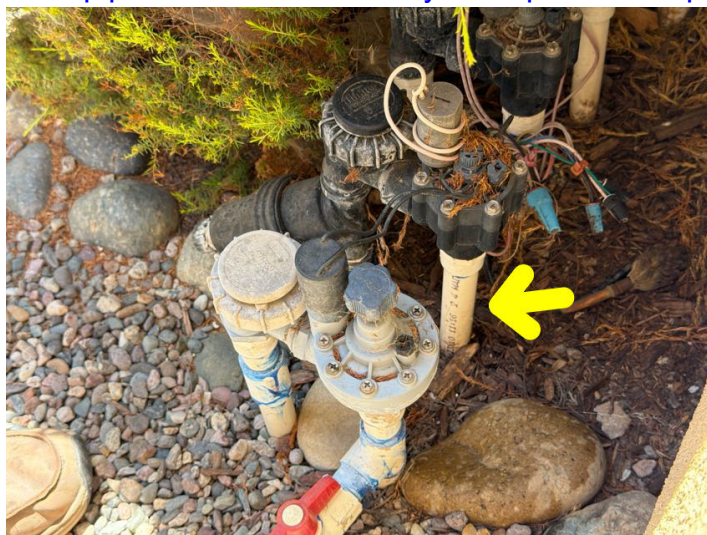
4.3. We have observed exposed PVC pipes on the exterior, which may become brittle when exposed to the sun's ultraviolet light. These pipes can become subject to breaking or leaking. We recommend painting the PVC pipes to block the UV rays and protect the pipe.

We have observed exposed PVC pipes on the exterior, which may become brittle when exposed to the sun's ultraviolet light. These pipes can become subject to breaking or leaking. We recommend painting the PVC pipes to block the UV rays and protect the pipe.

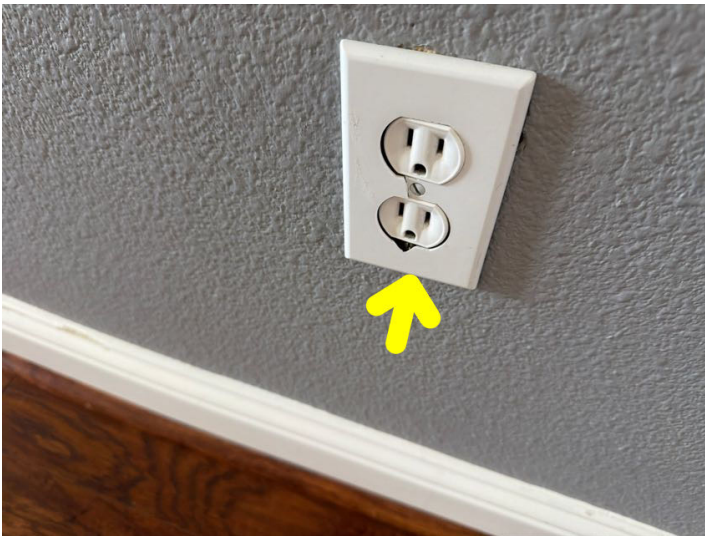
| Page 23 Item: 2 | Living Room | 2.4. One or more outlet covers are cracked or broken and should be serviced. |

2.4. One or more outlet covers are cracked or broken and should be serviced.

One or more outlet covers are cracked or broken and should be serviced.

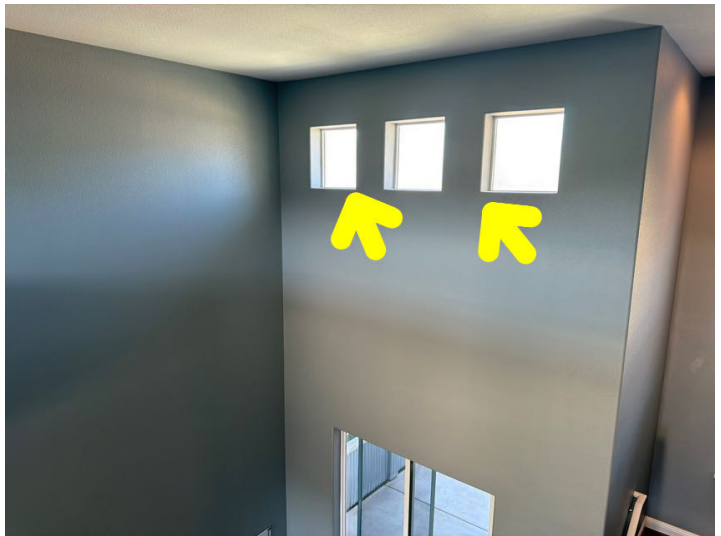
One or more windows may have a broken hermetic seal, which you may wish to have replaced. This is evident from fogging or condensation forming between the panes of glass, which implies that the seal has failed.

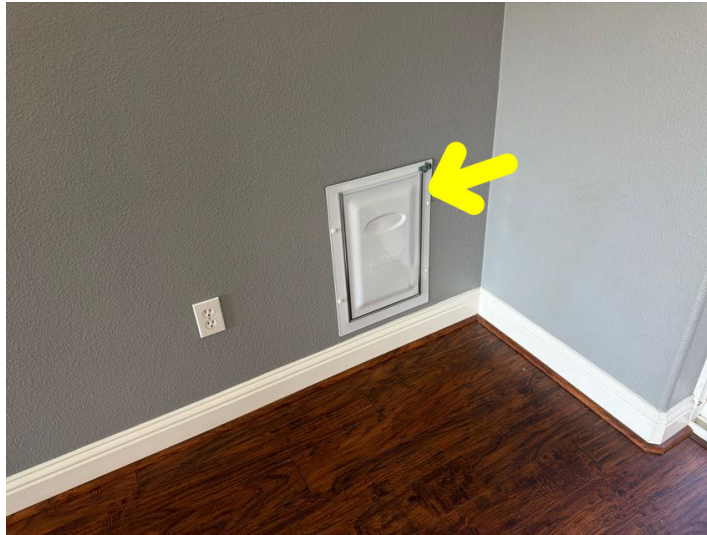
The wall has been modified to include a pet door that we do not evaluate and may not be weathertight.

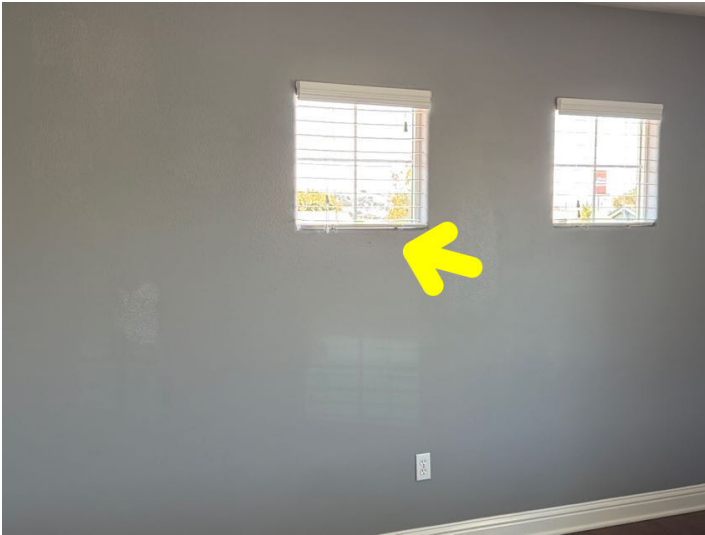
One or more windows may have a broken hermetic seal, which you may wish to have replaced. This is evident from fogging or condensation forming between the panes of glass, which implies that the seal has failed.

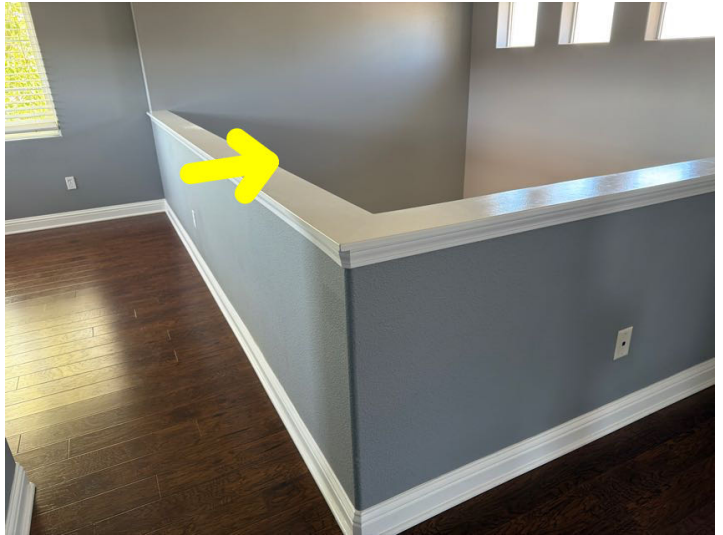
The guardrail is not the recommended 42 inches high when the standing surface is more than 30 inches below.

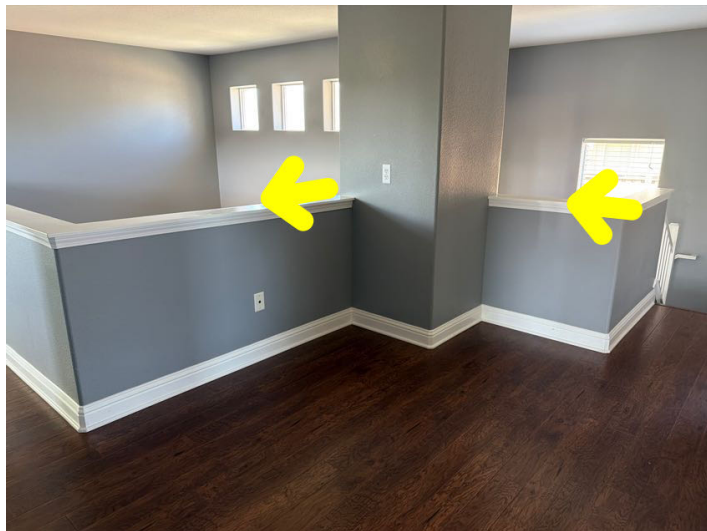
5.5. The guardrail is not the recommended 42 inches high when the standing surface is more than 30 inches below.

The guardrail is not the recommended 42 inches high when the standing surface is more than 30 inches below.

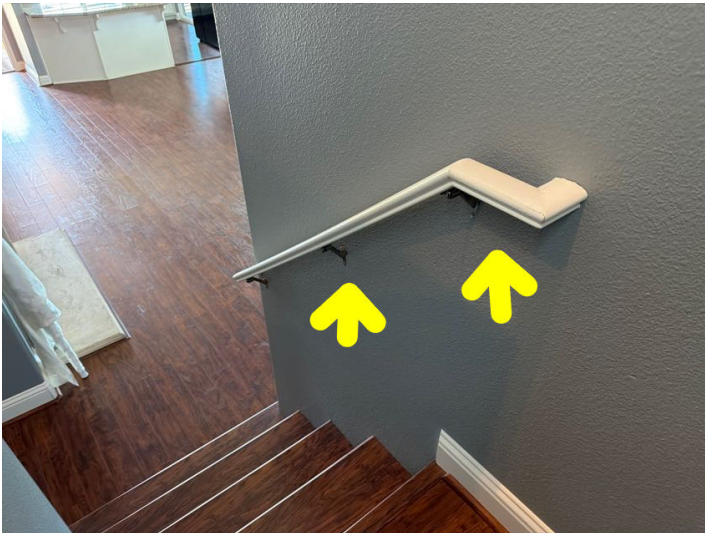
A handrail is loose and should be secured for optimal safety.

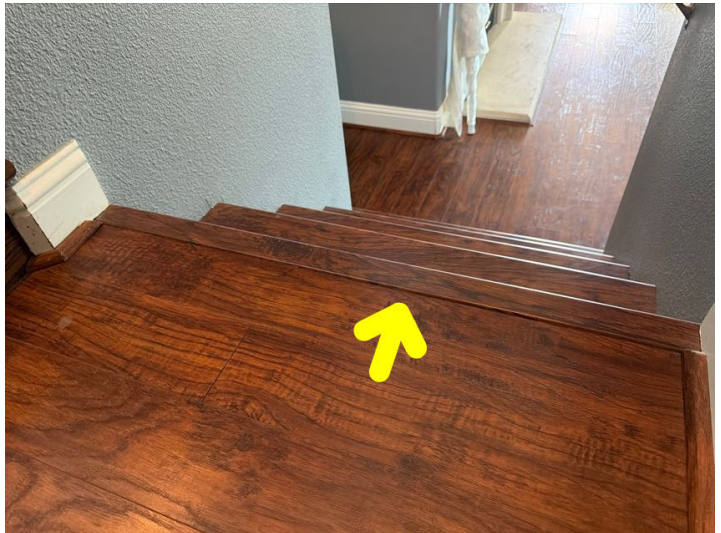
7.3. There is an offset in the floor that could prove to be a trip hazard.

There is an offset in the floor that could prove to be a trip hazard.

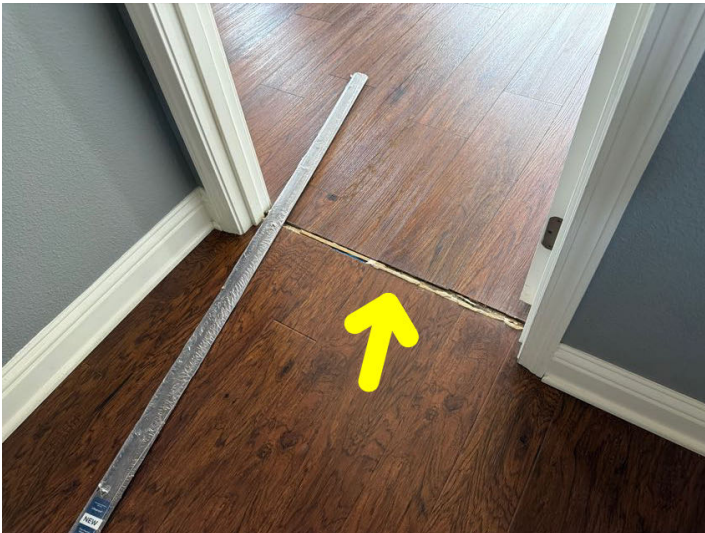
The entry door floor trim is missing or damaged and should be replaced.

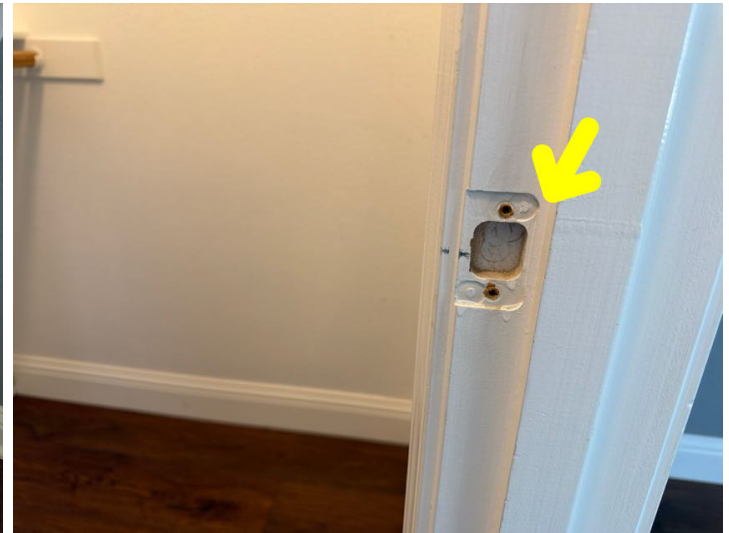
The closet door striker plate is missing and should be adjusted for the striker pin to engage.

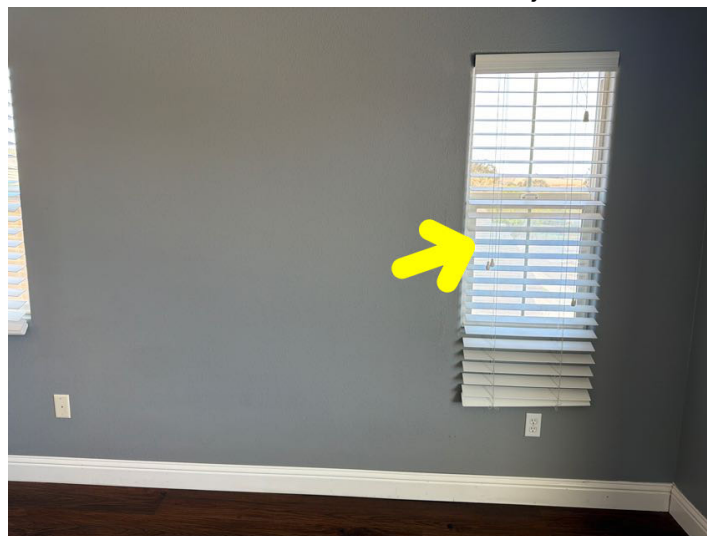
One or more windows may have a broken hermetic seal, which you may wish to have replaced. This is evident from fogging or condensation forming between the panes of glass, which implies that the seal has failed.

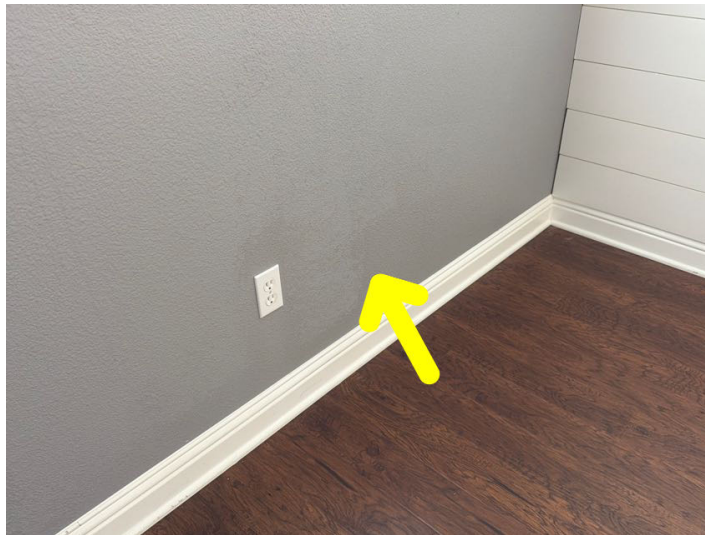
There has been a drywall/plaster repair that should be explained by the seller.

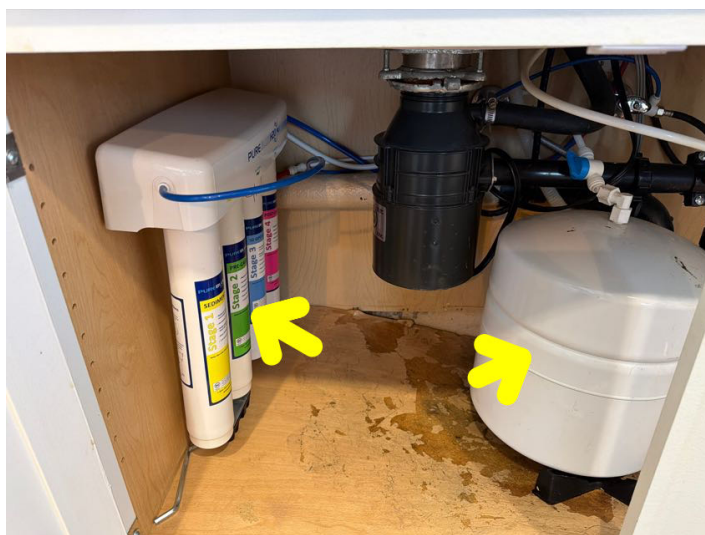
The kitchen includes a reverse osmosis or water filtration system that we do not have the expertise to evaluate. We recommend the seller demonstrate its operation and maintenance history and procedures.

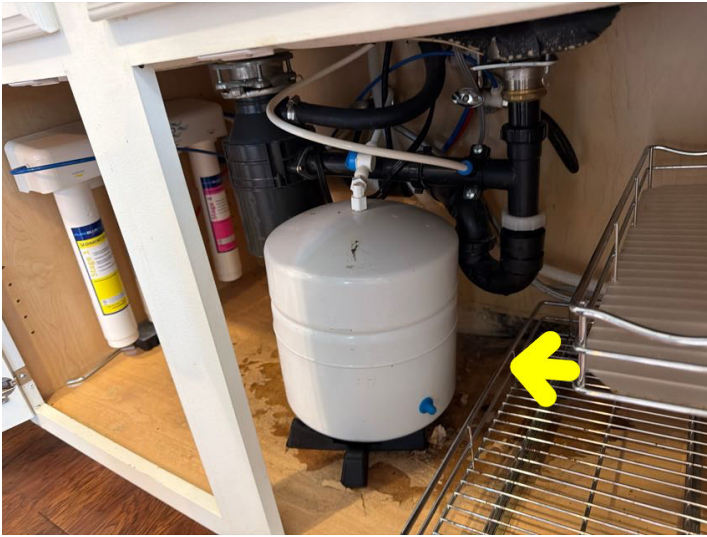
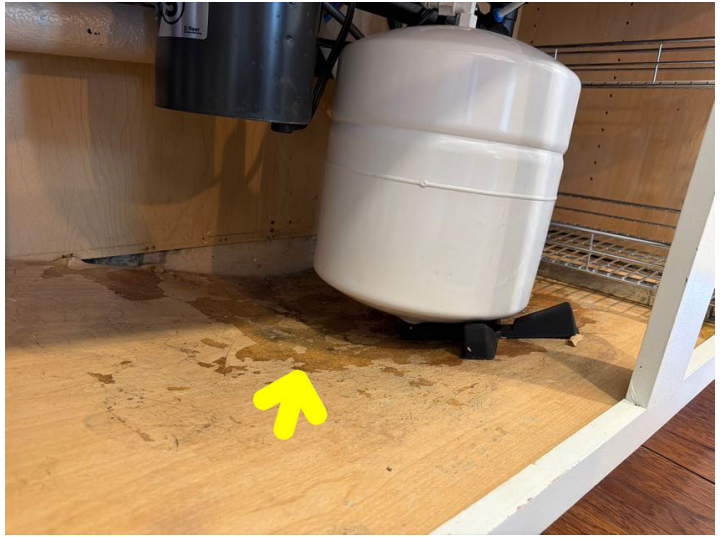
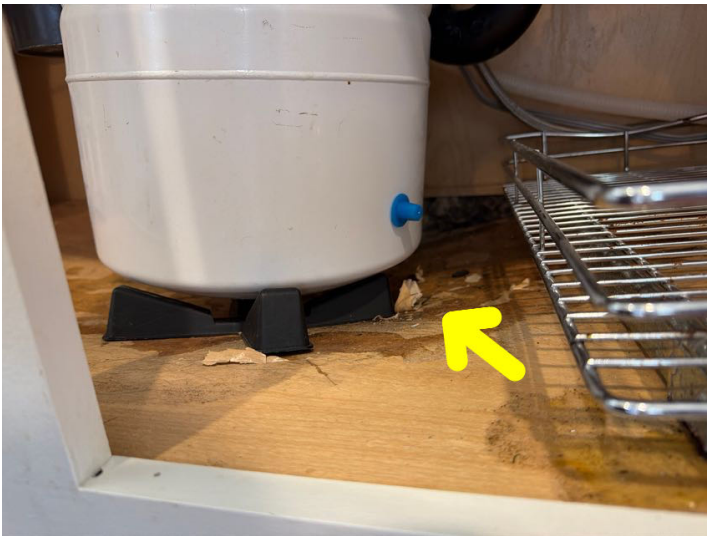
The floor of the kitchen sink cabinet is damaged, and should be replaced.

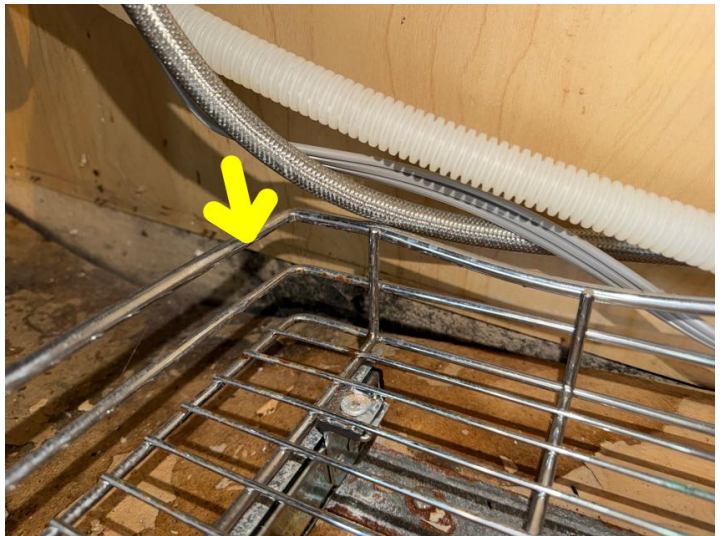
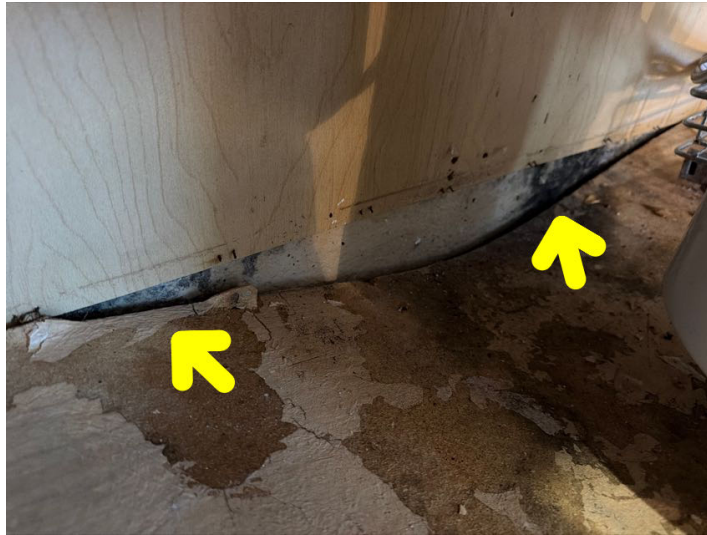
There is a mold-like substance present in the sink cabinet, which should be evaluated by a specialist and serviced as necessary. All molds flourish in a damp environment and many are commonplace, but some are toxic and may represent a health threat.

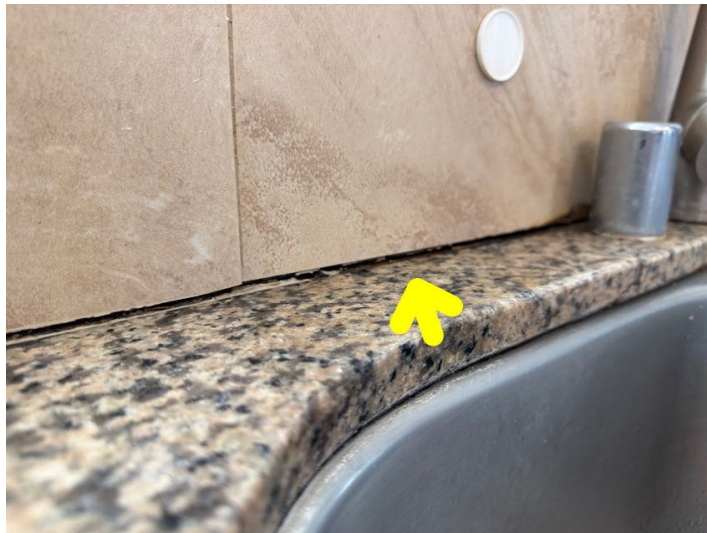
3.1. A typical separation between the kitchen counter top and the backsplash should be grouted or caulked to forestall moisture intrusion.

A typical separation between the kitchen counter top and the backsplash should be grouted or caulked to forestall moisture intrusion.

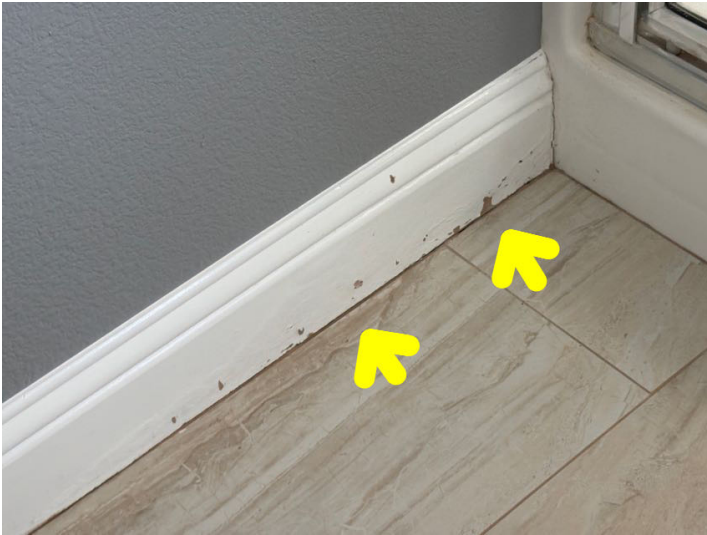
There is moisture damaged drywall/baseboard adjacent to the tub or shower, which is not uncommon but should be repaired.

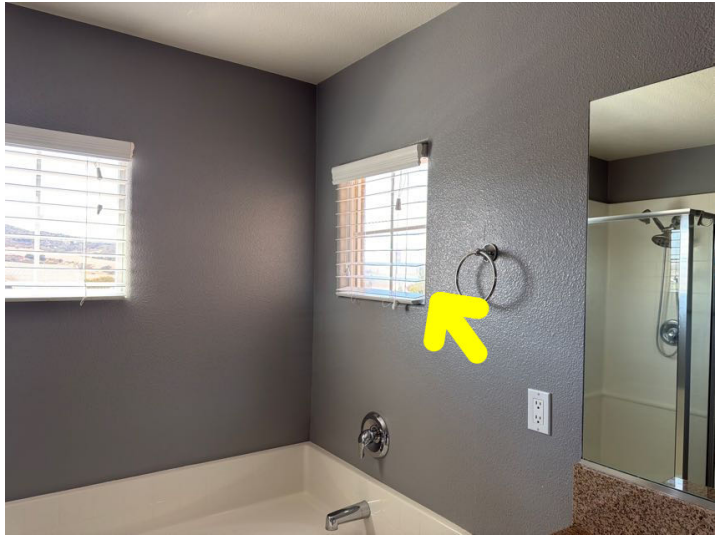
One or more windows may have a broken hermetic seal, which you may wish to have replaced. This is evident from fogging or condensation forming between the panes of glass, which implies that the seal has failed.

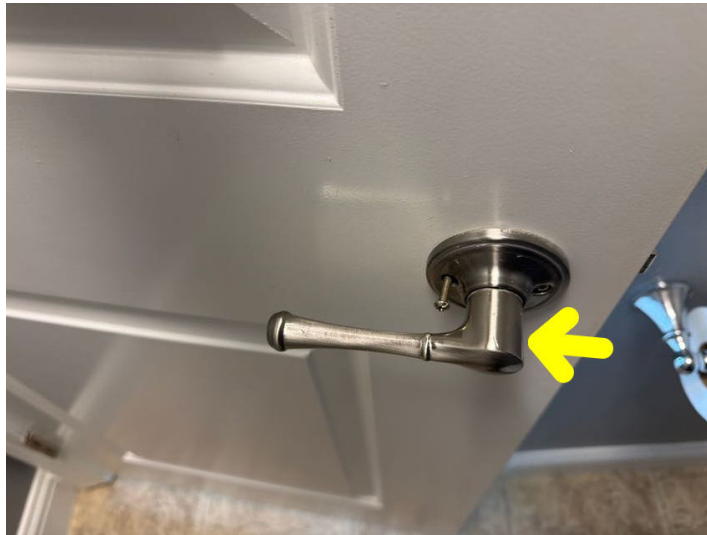
The door handle has loose or missing screws and should be serviced.

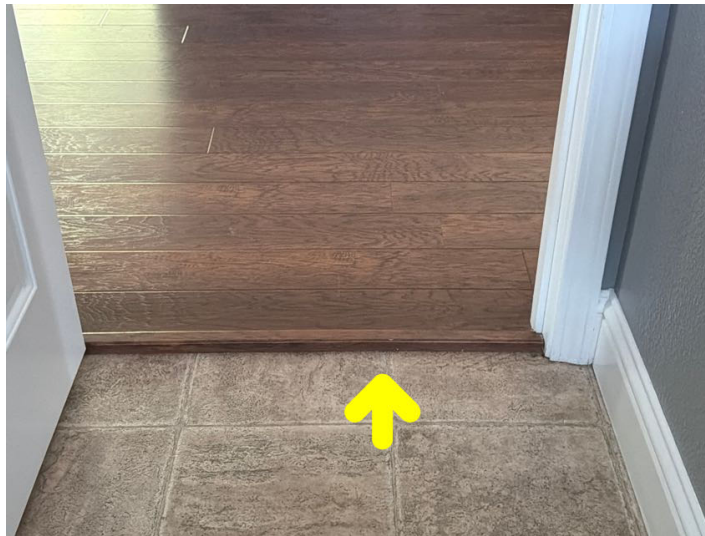
There is an offset in the floor that could prove to be a trip hazard.

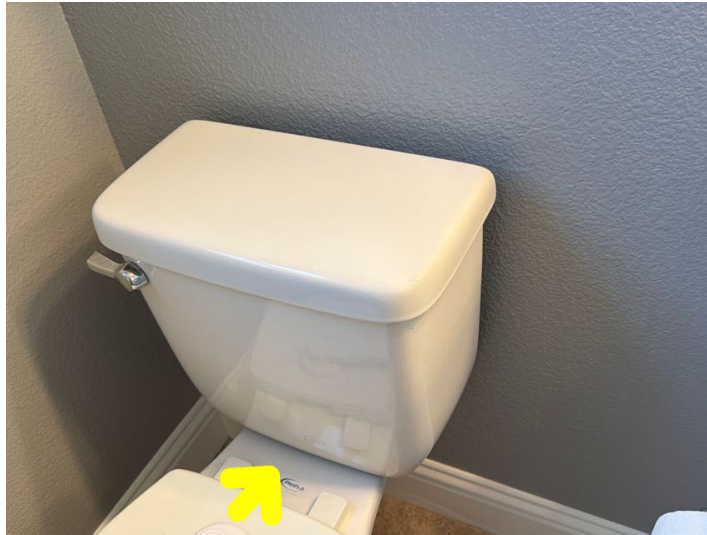
| Page 36 Item: 3 | Downstairs<br>Hallway Bathroom | 3.15. The toilet tank is loose, and should be secured, as this could be a safety hazard. |

The toilet tank is loose, and should be secured, as this could be a safety hazard.

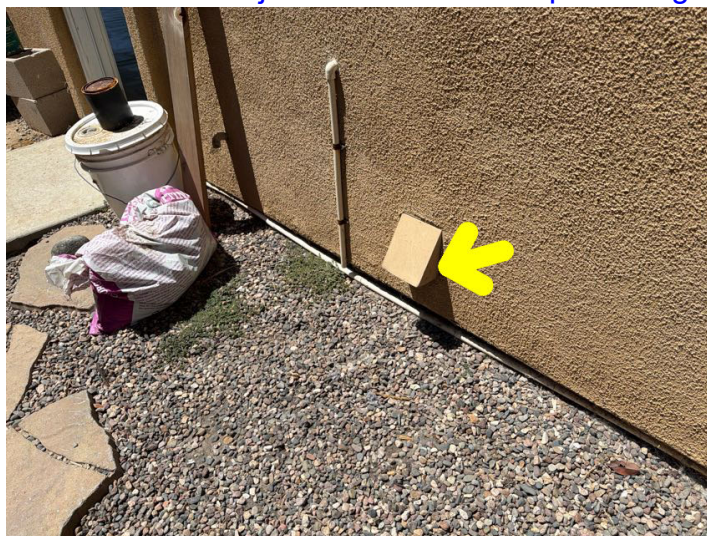
The back-draft on the exterior dryer vent cover is missing, stuck open, or incomplete and should be cleaned, repaired, or replaced.

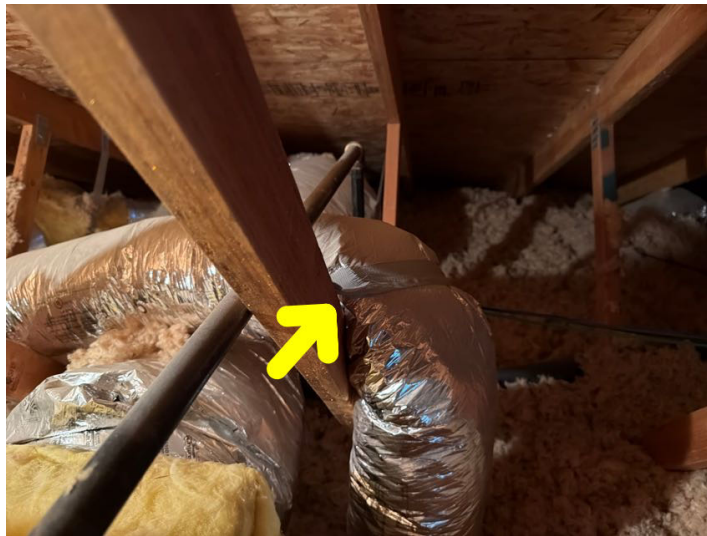
One or more of the flexible ducts are crushed and should be serviced by a licensed HVAC contractor.

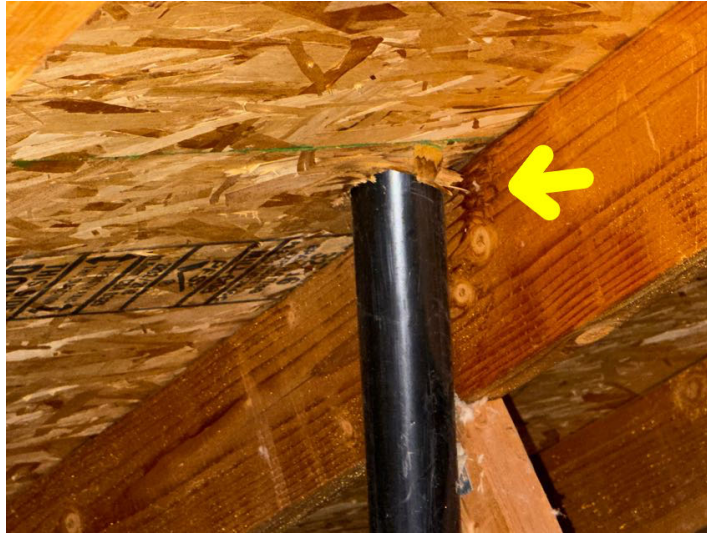
There are moisture stains on the attic ceiling at a roof penetration, which indicates a past or present leak. This is a common area for leaks. We are unable to determine if the leak is current or occurred in the past. In any case, we recommend that it be further investigated or explained by the seller.

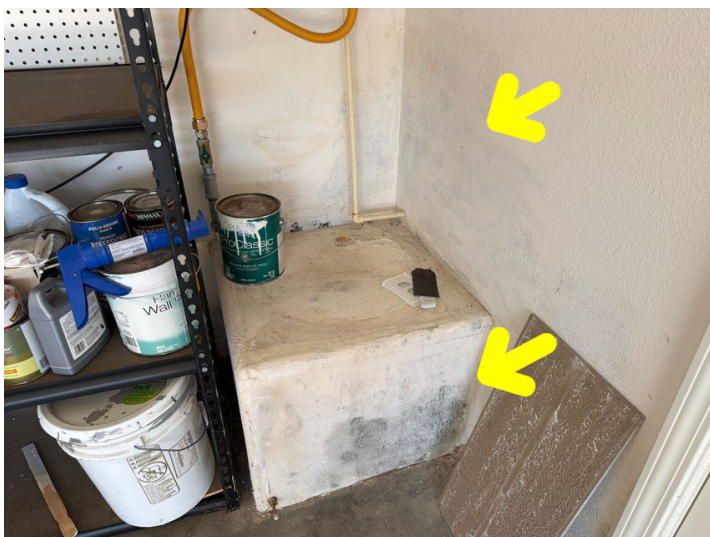
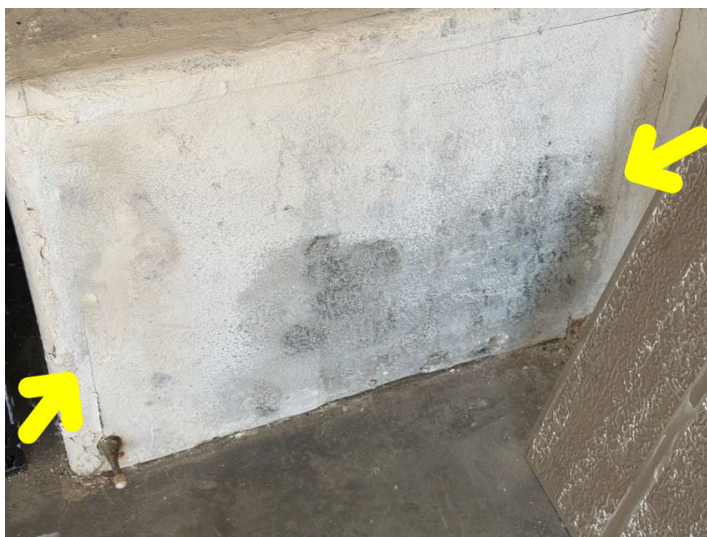
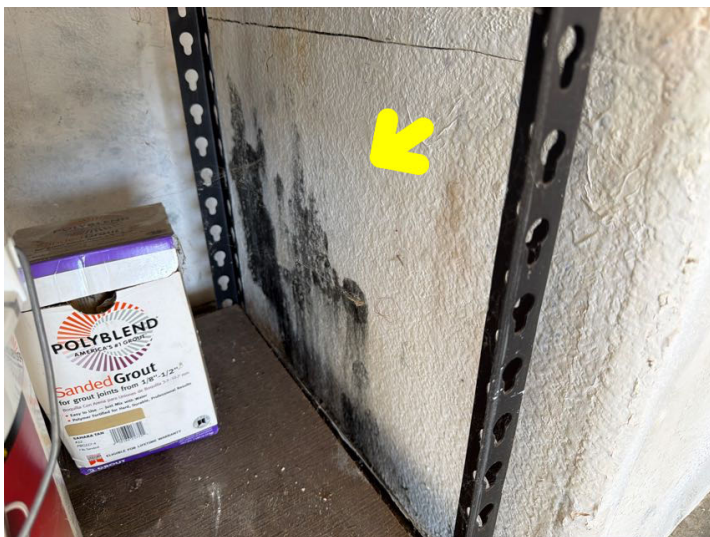
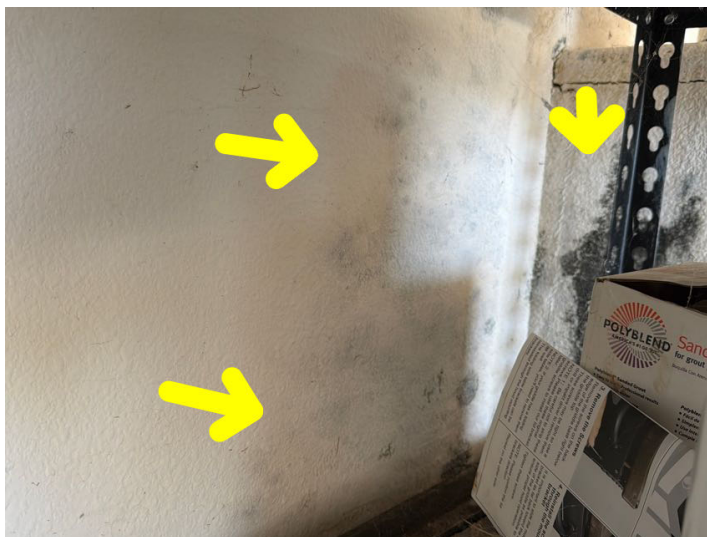
There is a mold-like substance present, which should be evaluated by a specialist and serviced as necessary. All molds flourish in a damp environment and many are commonplace, but some are toxic and may represent a health threat.

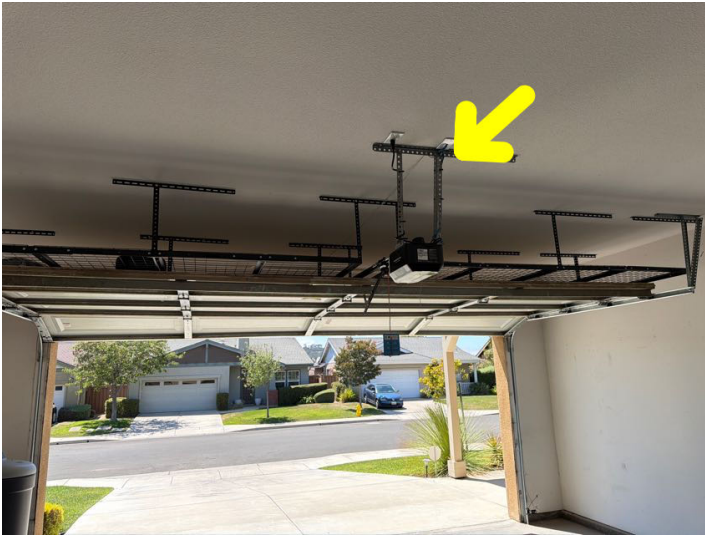
The storage space may have been added without the benefit of a permit, which could stress the roof framing. You may wish to verify this with the sellers. Regardless, you should limit the storage to lightweight items.

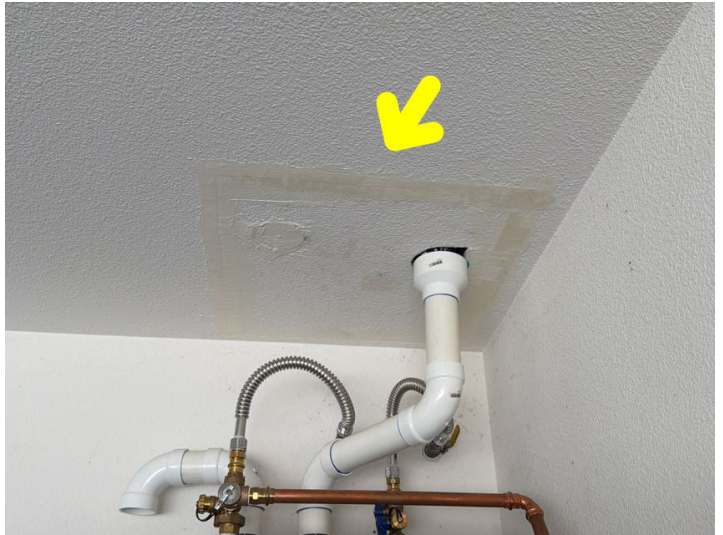
There has been a drywall/plaster repair that should be explained by the seller.

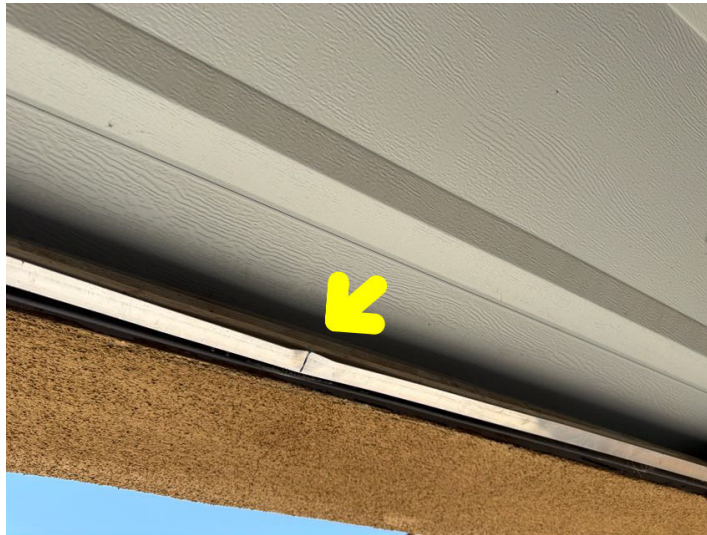
The garage door has cosmetic damage that you should view for yourself.
