### *Inspection Report*

Address: 920 Walnut Dr Paso Robles, CA 93446

07/18/2026

Inspector: Keith Vreeken, MCI, FCI  
P.O. Box 415 Templeton, CA 93465 O: 805.462.1978 C: 805.440.5050

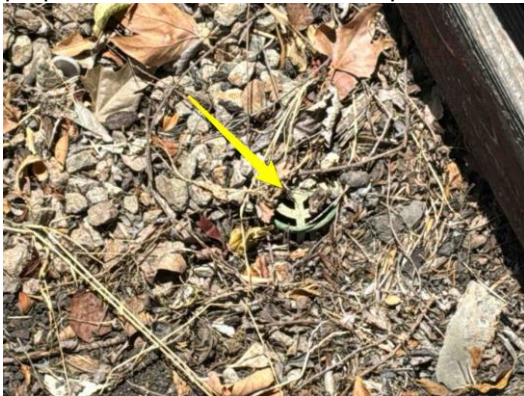
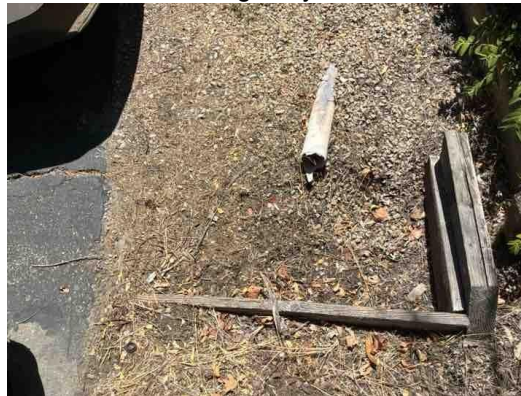
**MR DS** 15: Surface drains and boxes noted in areas of the driveway. Drains are not tested, conditions of the underground piping and terminations are unknown. Recommend having drains cleaned and tested to determine proper flow and termination. Keep drains clean and free of debris regularly.

Surface drain warrants attention to Repair And maybe too small

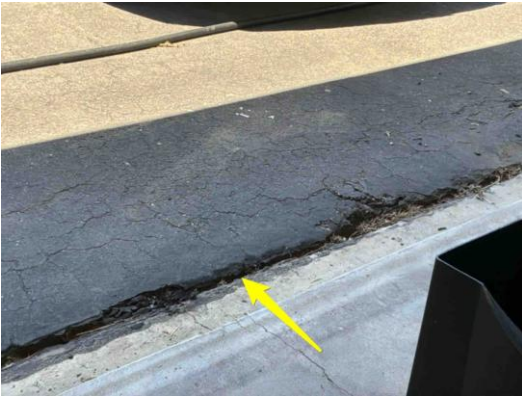
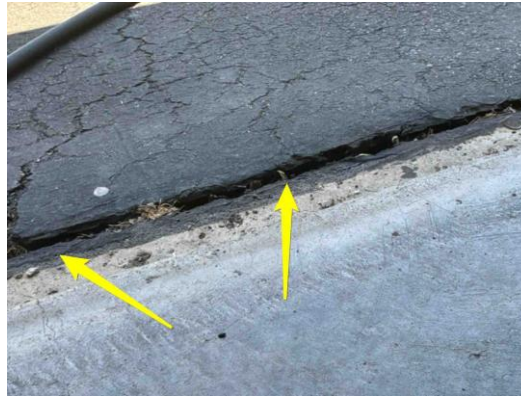
Example location

**FI DS** 16: The asphalt driveway appears to be lifted slightly at the garage connection. This may allow water to collect against the garage vehicle door and considered a potential trip hazard.

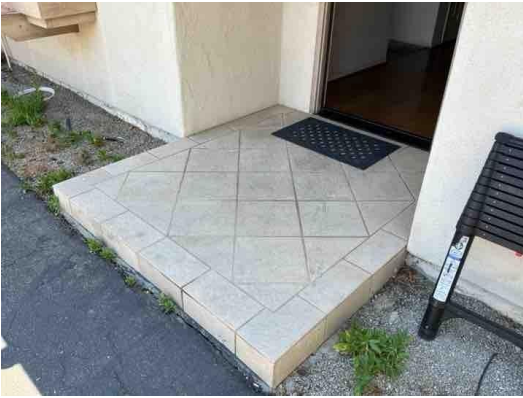
**DS 18:** Tiled Concrete Walkways  
*Some tiles when used at exterior walkways can be slippery when wet. Use caution.*

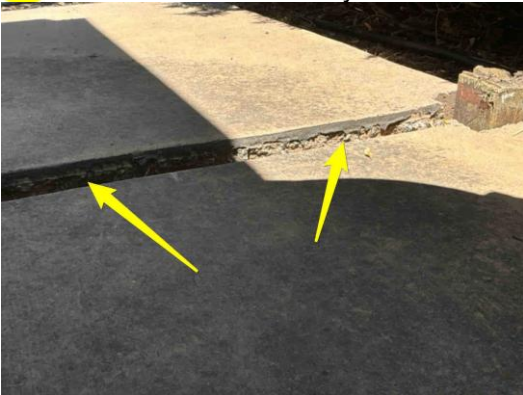
Example

**SU 20:** Areas of the walkways are uneven with potential trip hazards.

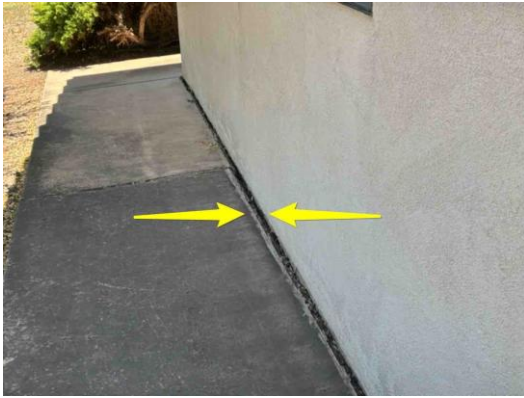
Example location

**FI 22:** Areas of the sidewalks appear to be settling and pulling away from the building. Client should investigate further until satisfied as to the cause, condition and potential future issues.

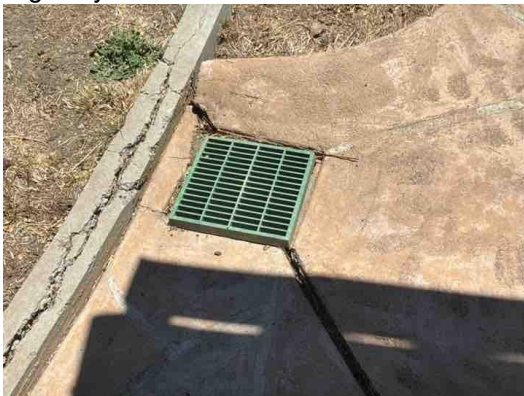
**MR UPG DS** 25: Disclosure: Some surface drains noted in areas of the patio. Drains not tested. The condition of the underground piping and terminations are unknown. Recommend having drains and terminations cleaned, tested and inspected by a qualified landscape contractor to determine the proper flow. Keep drains clean and free of debris regularly.

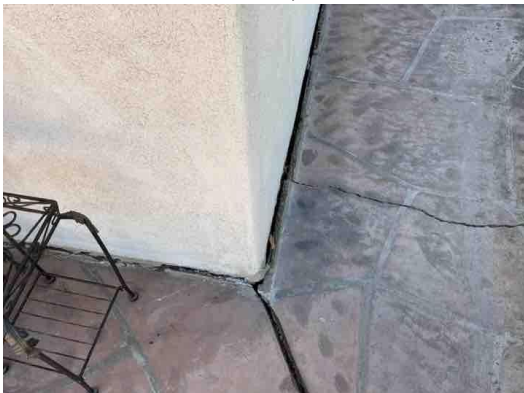
**FI** 26: Areas of the patios are pulling away from the building. Client should have a civil engineer investigate until satisfied as to the cause, current condition and determine potential future issues.

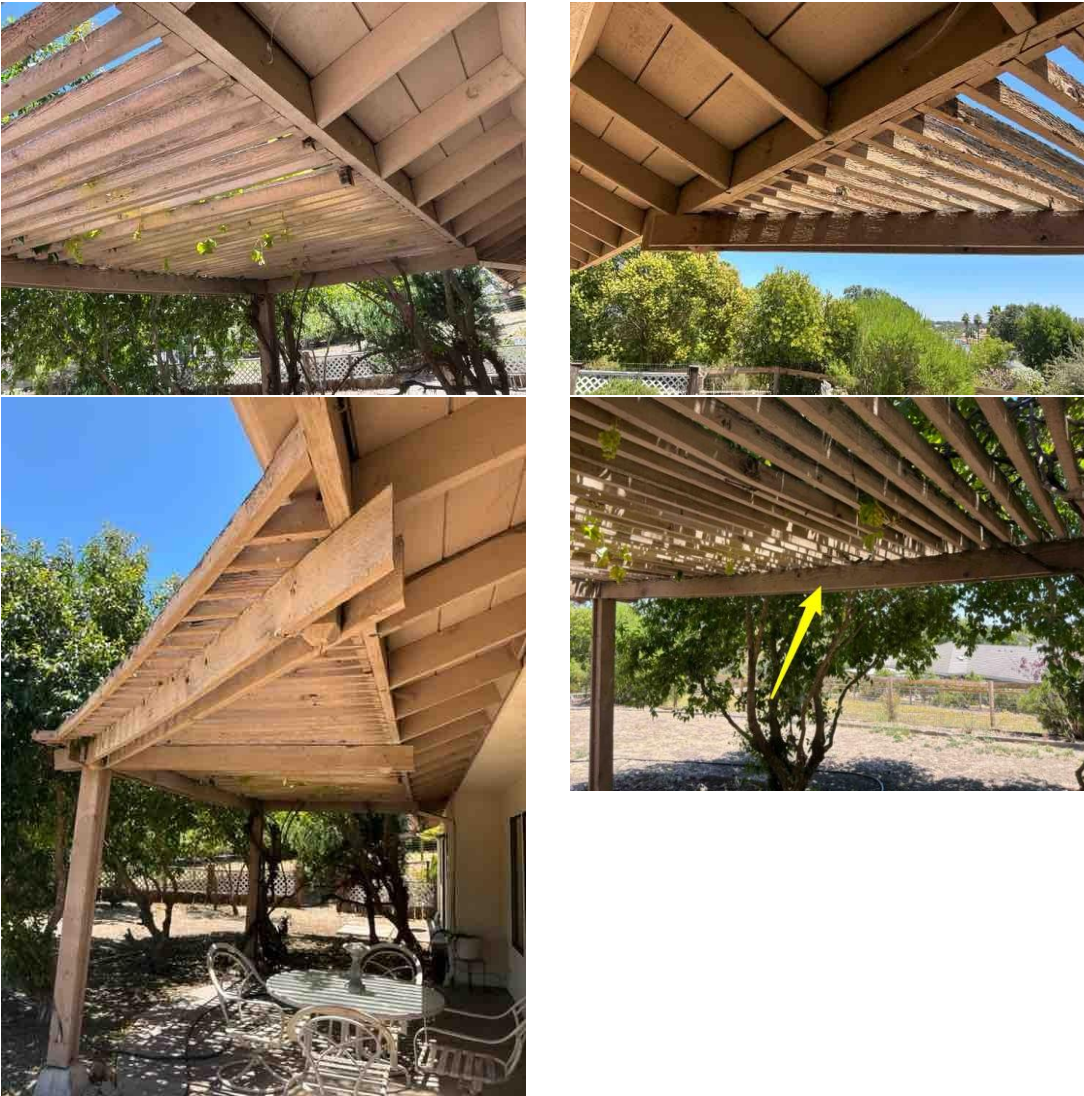
**SC 27:** Some moisture damage found at the backyard patio cover. Refer to the Termite report for additional comments and recommendations.

1. Improper installation of the heavy wood framed patio cover attached directly to the existing house roof overhang fascia board without appropriate connections and fasteners other required upgrades,
2. Improper beam size for the roof framing support.

Further evaluation by a licensed contractor familiar with minimum construction and engineering standards is recommended.

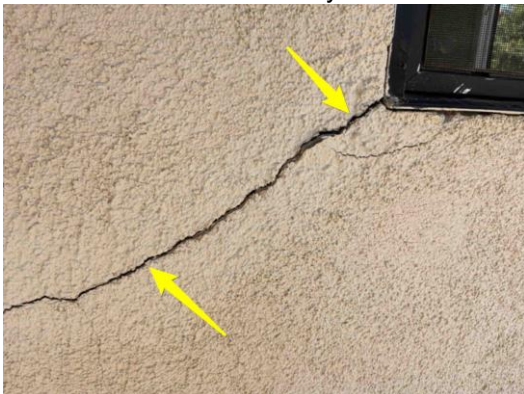
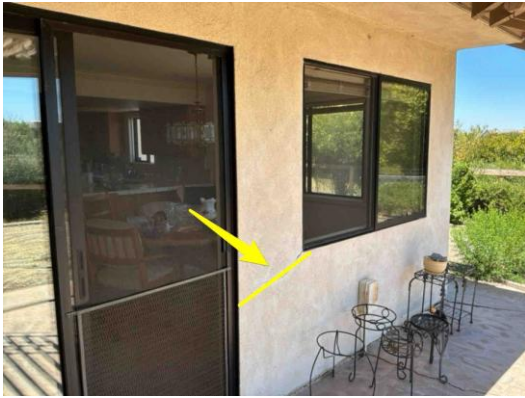
Example location

**FI** 36: Some unusual visible cracks found in the exterior stucco siding along areas OUTSIDE THE DINING AREA WINDOWS which are open greater than 3/32", (thickness of a nickel). These cracks are open / separated more than normal indicate some unusual settlement or movement of the foundation or wall. framing.

Separations in the exterior stucco that are open / separated, (greater than 3/32"), are a potential concern for water intrusion as the underlayment, Tar Paper or Tyvek, can tear allowing moisture or water intrusion into the wall cavities. Buyer or seller should consult an appropriate Civil engineer to evaluate the cause, the current conditions, and the potential future issues that may arise if not addressed. Afterwards, they also should contact a stucco professional to evaluate and to address any concerns as to potential of water intrusion, and correct as needed.

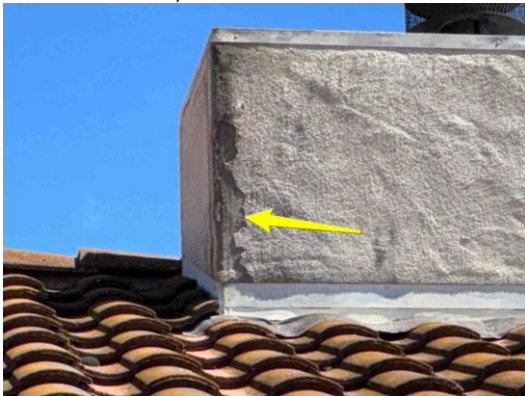
**MR 37:** Some peeling of stucco color coat found at the fireplace stuccoed chimney chase. (Ongoing maintenance recommended).

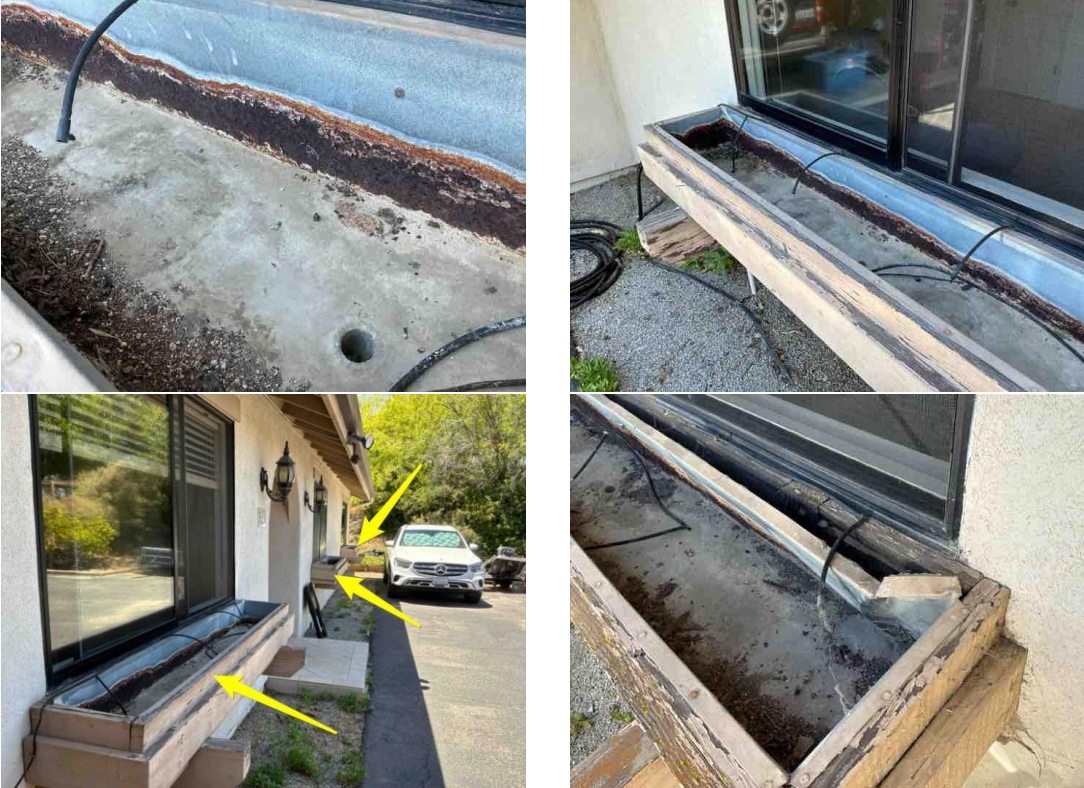
**FI 43:** Some moderate to heavy rust deterioration and damage found at the exterior window flower boxes.

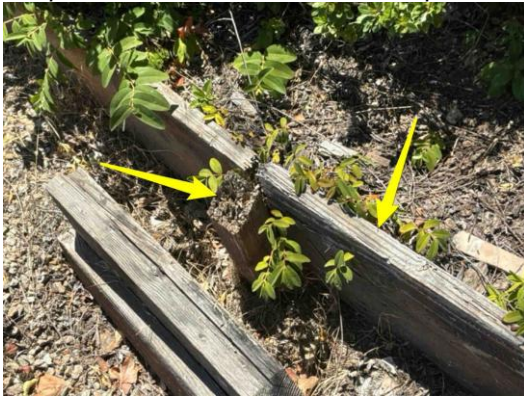
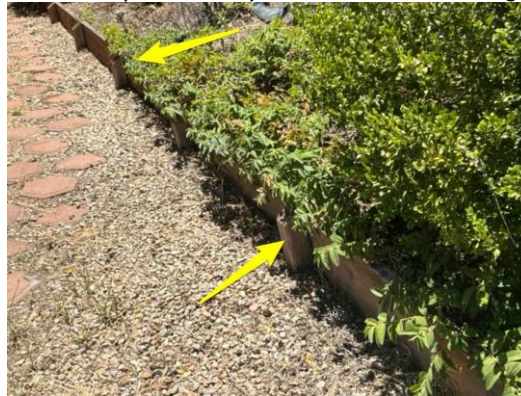
**E&C 50:** Some moisture damage, deterioration, with some leaning of the wood retaining wall(s). Sections of the wood retaining walls appear to be nearing the end of its structural life. *Be aware that wood retaining walls have a limited lifespan and will warrant eventual replacement. Monitor, replace or repair the wood retaining walls as needed.*

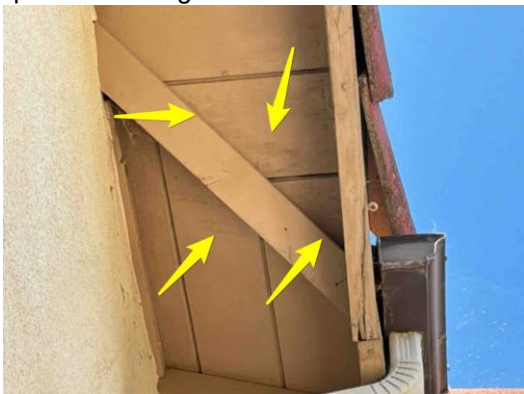
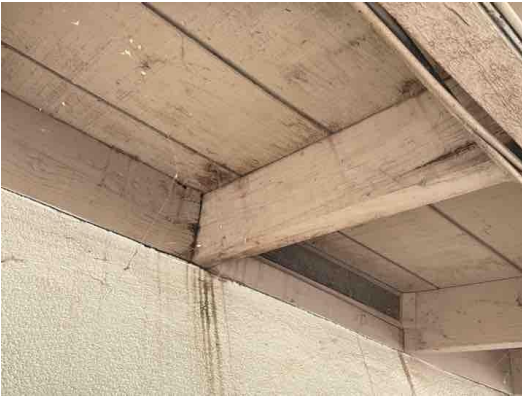
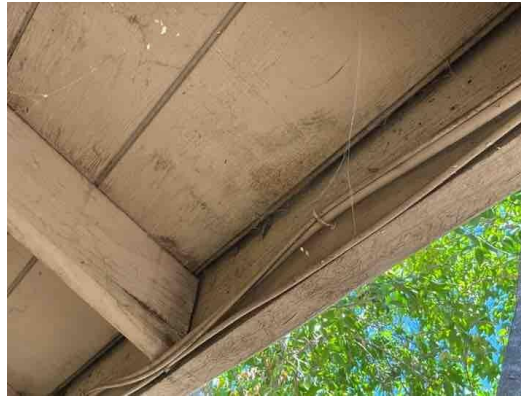
**58:** Evidence of past roof leakage was observed at the roof overhang area, including visible moisture staining and/or damage: **Example - at the Roof valley termination off the back of the laundry room .** These conditions indicate a failure of roofing components and possible concealed damage. Recommend further evaluation by a qualified roofing contractor to determine the source, full extent of damage, and to perform necessary repairs.

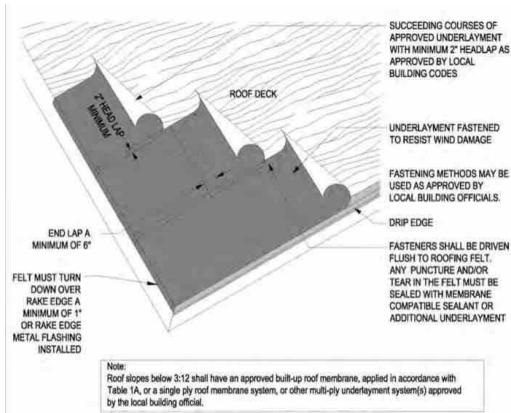
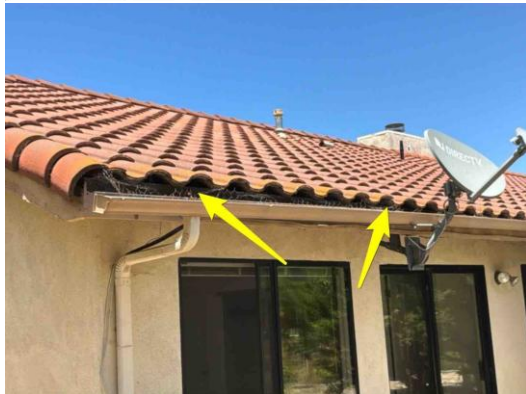
Example

**E&C MR 61:** Improper or poor installation of the tar paper along the roof lower edges. Some deteriorated and damage tar paper. Recommend the installation of a proper metal roof drip edge flashings, a proper tile lifter, chamfer strip and the proper extension of the tar paper. See installation requirements in the photos below. Current condition can/is causing puddling of water on the back side of the fascia board and does not allow the roof to properly drain.

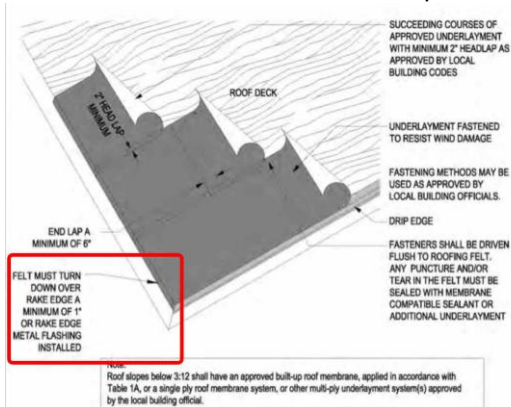
**E&C 62:** Areas found where the roof tar paper was not properly folded over the rake edges along the fascia. Contact a licensed roofer to evaluate and repair as needed. Refer to the manufacturer's requirements.

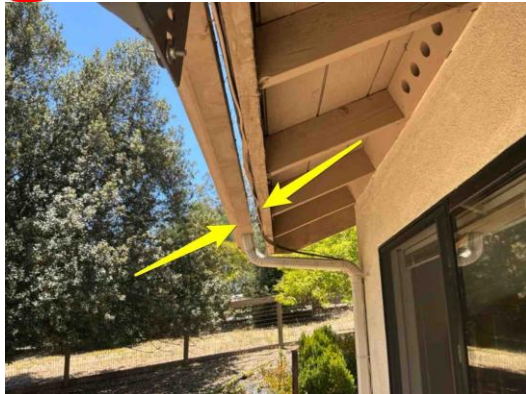
**66:** Loose, hanging and separated roof rain gutters needing maintenance or repairs.

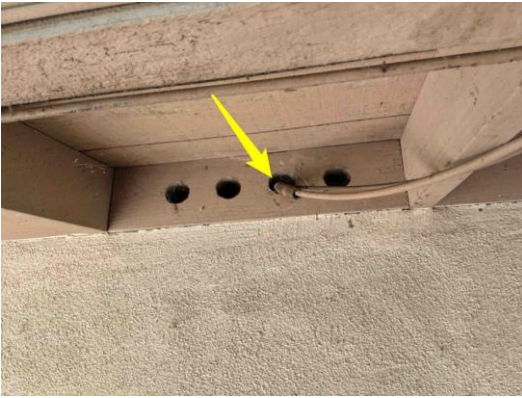
**E&C** **MR** 73: Some damaged or missing attic eave vent screens on areas of the exterior at the roof overhangs. Repair or replacement of the damaged or missing vent screens is recommended to help prevent critter intrusion into attic areas.

Unprotected openings can lead to bird or bat intrusion

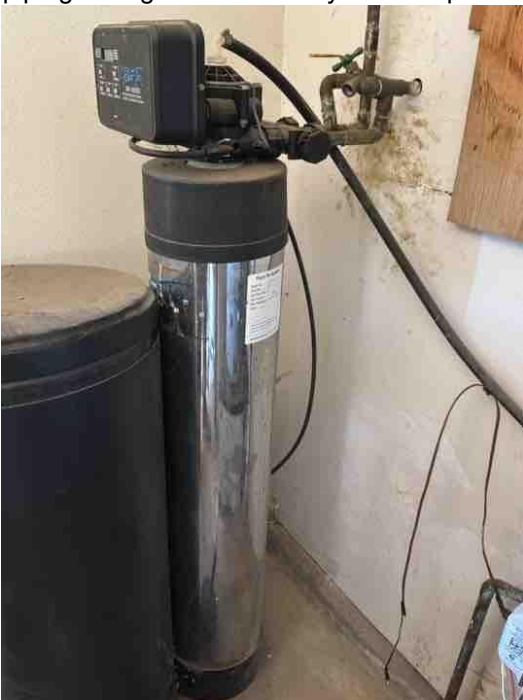
**MR** **UPG** **82:** Recommend servicing water softener. Water softener found out of salt and dirty.

**UPG** **83:** The Water softener system should be strapped and braced to prevent falling, causing breakage of the water piping during seismic activity or other potential physical contact. Upgrade recommended.

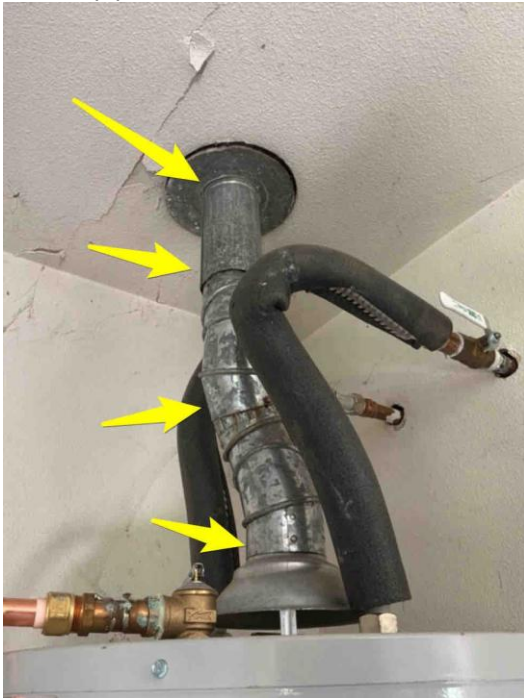
Missing the required three fasteners

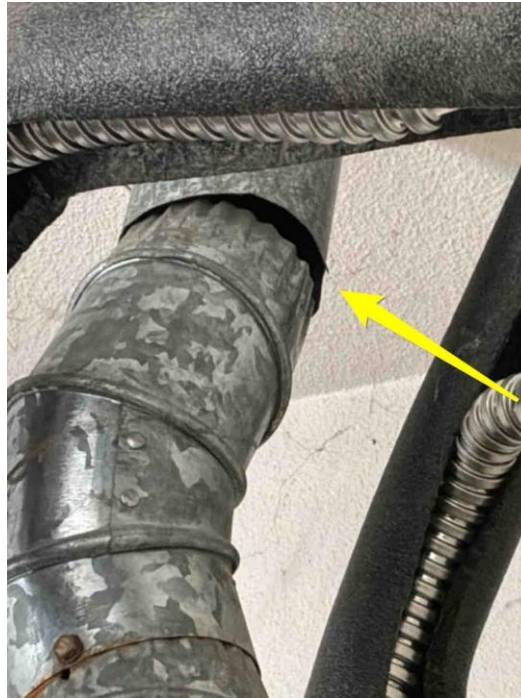
Connector pipe found disconnected

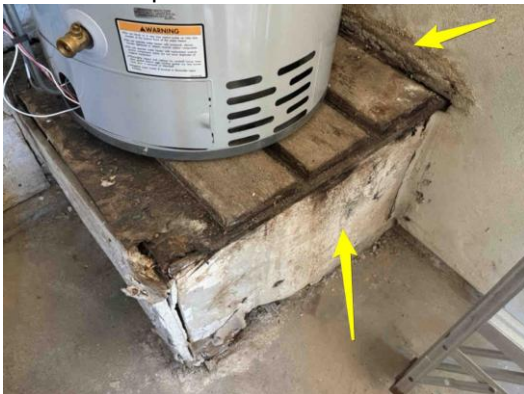
**SC FI** 98: Moisture stains and damage at the drywall areas of the water heater platform and/or enclosure. Some visible mold growth noted on areas of the drywall. Recommend additional review and clean up by a qualified mold remediation professional. Refer to Termite report for additional comments and recommendations.

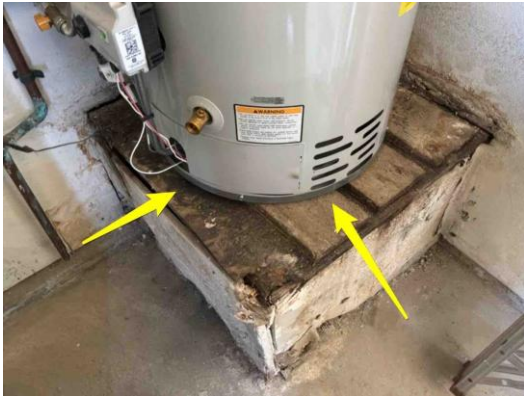
**E&C** 102: Missing / recommend a drip pan under the water heater. A drip pan is needed to help prevent damage if a leak were to occur per California plumbing codes and standards. [CPC 507.5]

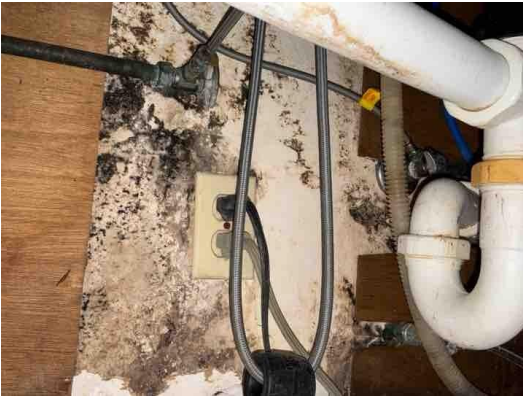
**SC FI 104:** Moisture stains and damage in the cabinets below and/or next to the kitchen sink. Some visible mold growth noted on areas of the drywall and/or cabinetry. Recommend additional review by a qualified remediation professional.

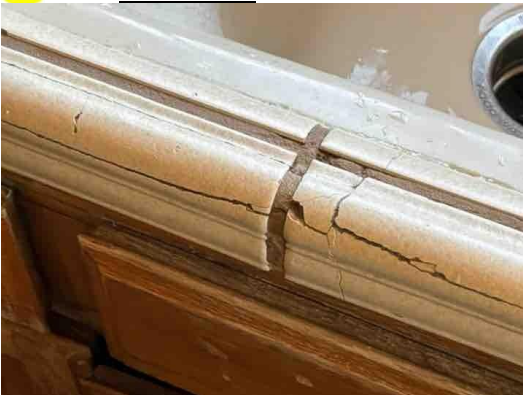
**MR 110: Disclosure:** Some cracked tiles noted at the kitchen counter.

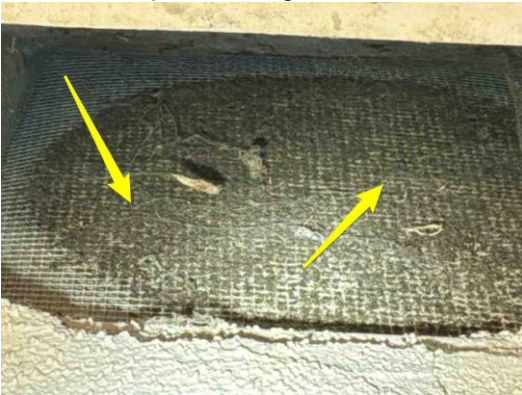
**SC 113:** The kitchen cooktop hood exhaust vent pipe termination found to have its screen clogged or partially blocked. Proper cleaning, maintenance is needed.

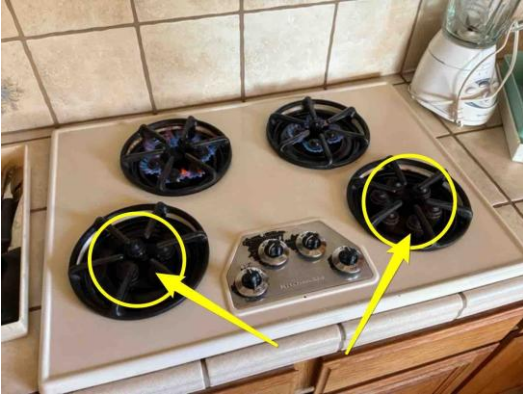
**E&C 116:** The TWO FRONT Cook top burners did not operate or ignite properly when tested. Recommend cleaning / servicing.

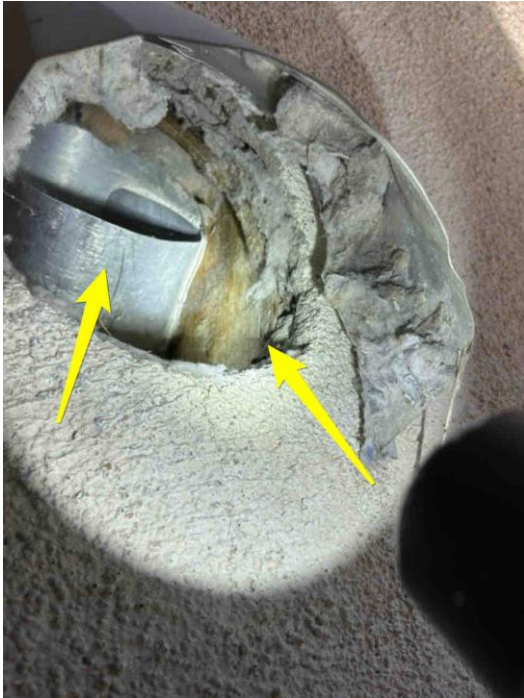
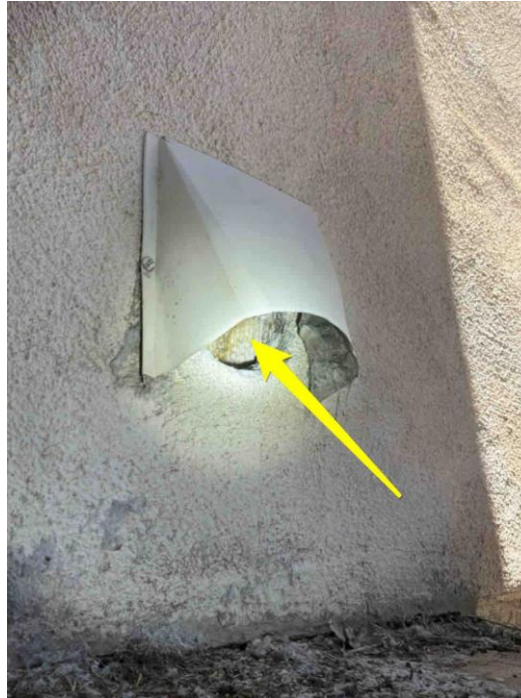
**SC** **127:** Damaged and unsafe laundry dryer vent termination. The dryer vent cap sleeve found damaged or disconnected inside the wall cavity and dryer vent cap missing flapper. Recommend replacement or repairs.

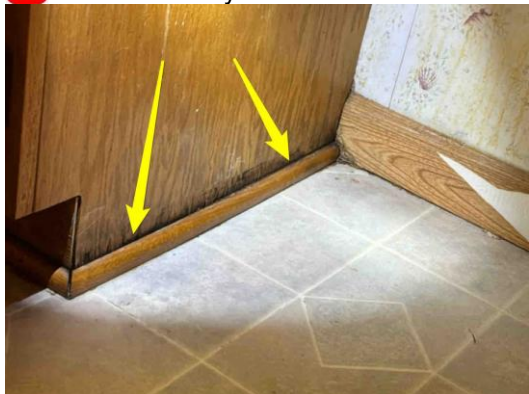
**FI** 133: Some dry moisture stains and damage found at the bathroom cabinet in the: HALLWAY BATHROOM

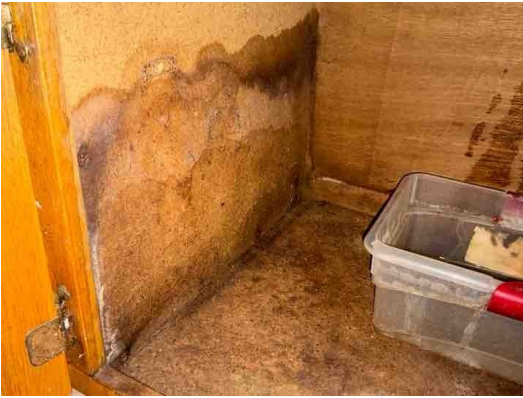
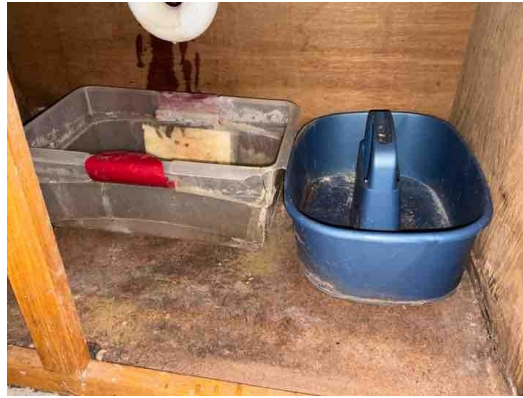
**SC** **FI** 134: Some moisture stains and/or damage with visible mold growth on the drywall and/or cabinetry in HALLWAY BATHROOM. Recommend further review and cleanup by a qualified mold remediation professional.

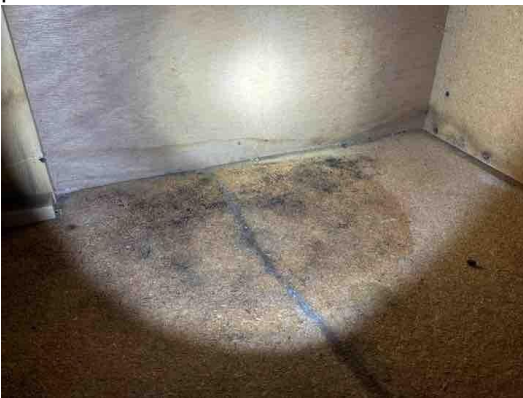
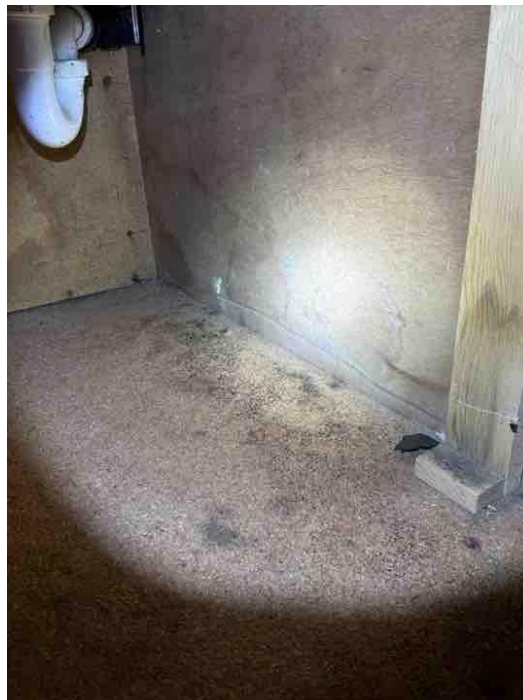
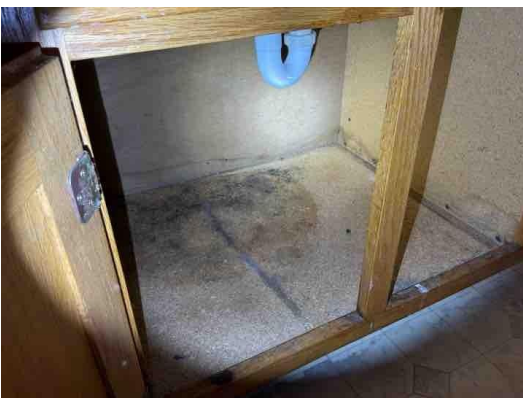
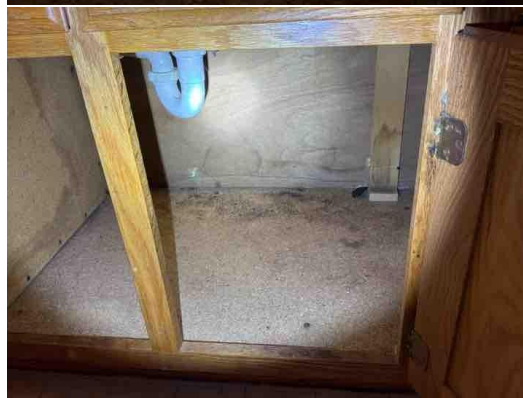
**SC FI** 135: Some moisture stains and/or damage with visible mold growth on the drywall and/or cabinetry in PRIMARY BEDROOM BATHROOM. Recommend further review and cleanup by a qualified mold remediation professional.

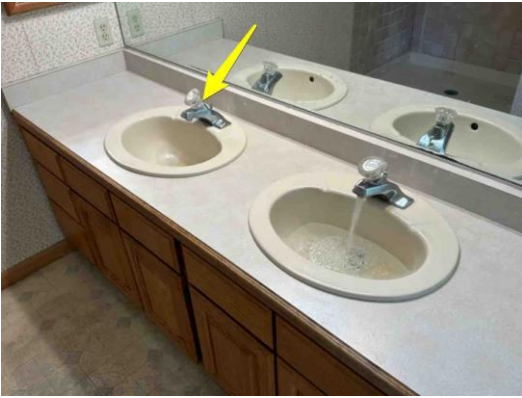
**FI** 137: The HOT and COLD water found non-operational at the LEFT SIDE bathroom sink faucet: PRIMARY BEDROOM BATHROOM

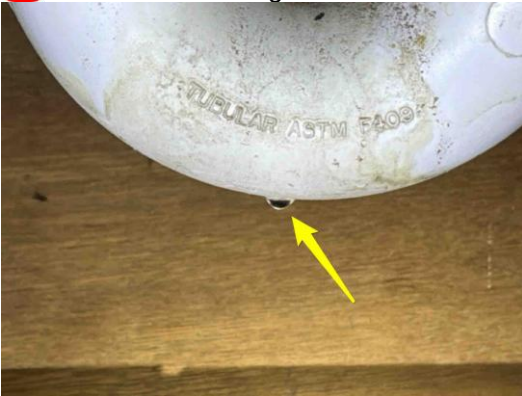
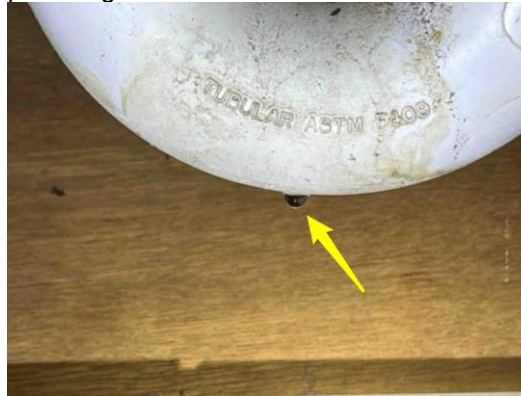
**E&C** 138: Active leaking from the bathroom sink plumbing: HALLWAY BATHROOM

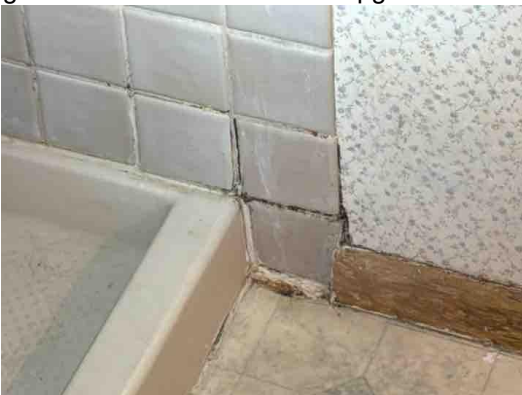
**UPG** 142: Deteriorated and or moldy grout found in the PRIMARY BEDROOM BATHROOM shower enclosure. Some general maintenance and/or upgrades are recommended.

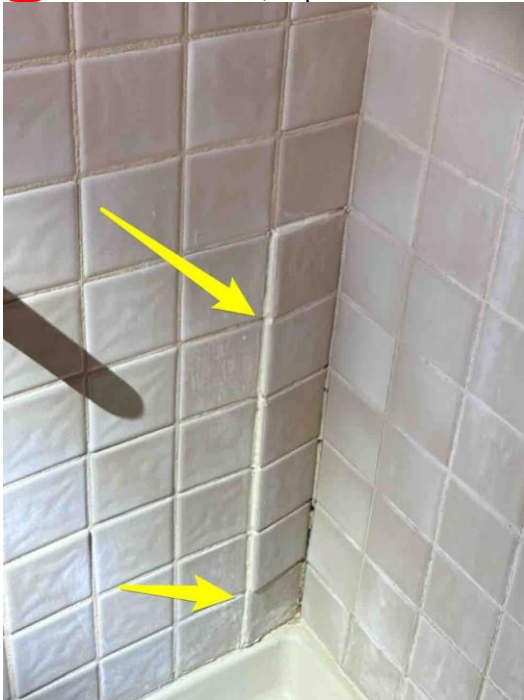
**FI 144:** Some loose, separated and uneven tiles found PRIMARY BEDROOM BATHROOM SHOWER.

Damaged grout

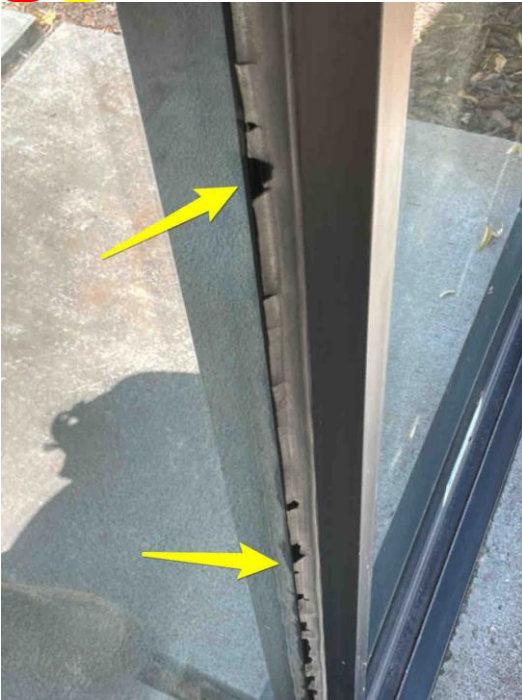
**152:** Damaged weatherstripping at the exterior sliding glass doors.

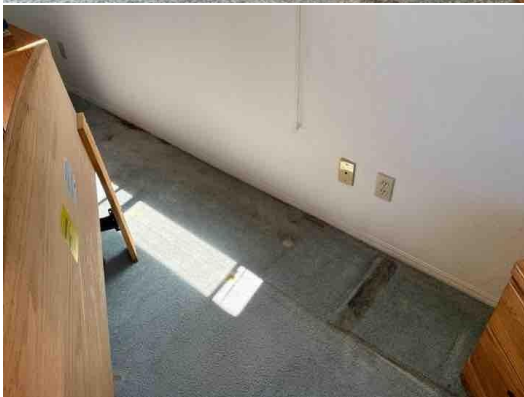
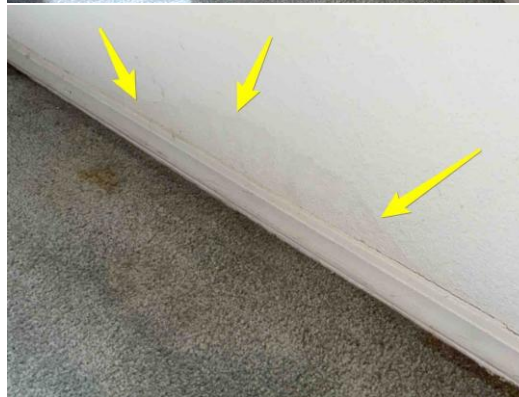
**167:** Some significant water stains and damage to the flooring and wall found in areas of BEDROOM-2 along the exterior walls. Client is advised to have a licensed contractor removed the baseboards, flooring and drywall to determine the cause and conditions inside the wall cavity. **Suspected mold growth** in confined areas of the wall.

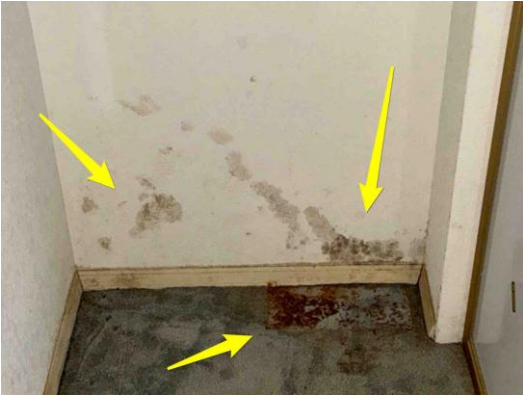
**FI 175:** Evidence of past moisture stains & damage at wall area in the PRIMARY BEDROOM CLOSET. Recommend further review of the water stains to determine the cause, the current condition and if repairs are needed.

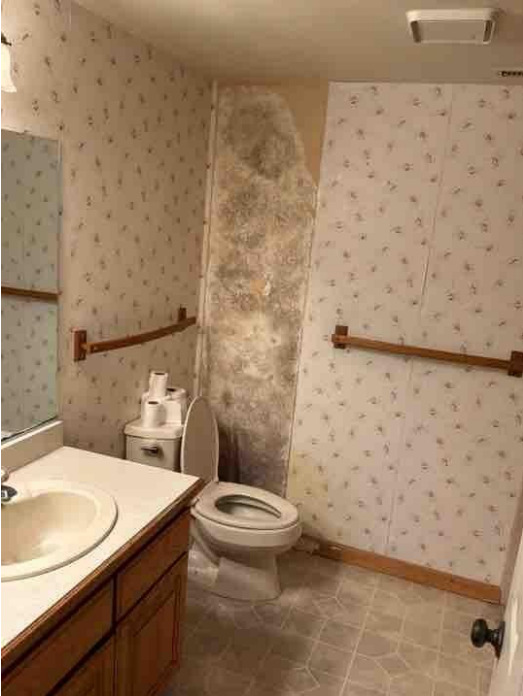
**SC FI 176:** Evidence of past moisture stains & damage with some visible mold growth on areas of the drywall: HALL BATHROOM. Recommend additional review by a qualified remediation professional. Recommend further review to determine if stains are current or old and if repairs are needed.

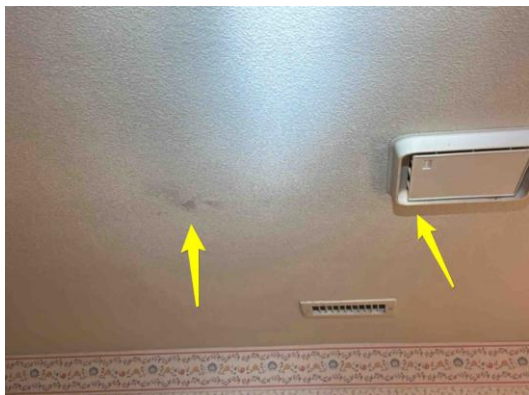
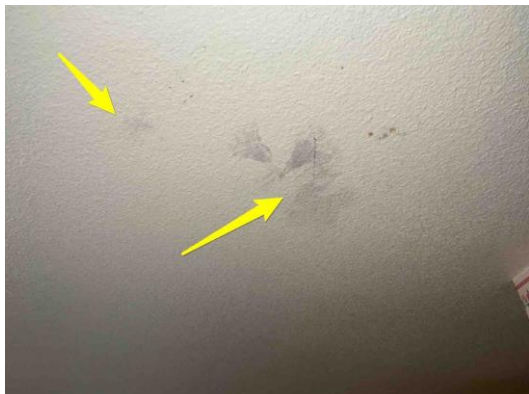
**SC 177:** Evidence of past moisture stains & damage with some visible mold growth on areas of the drywall: PRIMARY BEDROOM BATHROOM. Recommend additional review by a qualified remediation professional. Recommend further review to determine if stains are current or old and if repairs are needed.

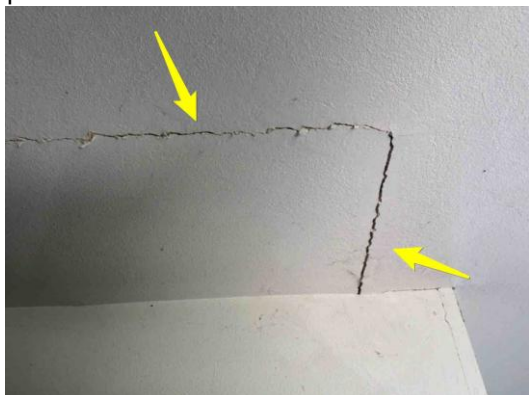
Example. In the garage over the water heater

**FI 178:** Evidence of some unusual cracks and/or tearing of the drywall. The visible movement appears more than normal: IN AREAS OF THE GARAGE. This appears to be from some type of movement or settlement of the framing and/or foundation system. It is advised to have a licensed engineer evaluate the cause, current condition and potential future issues.

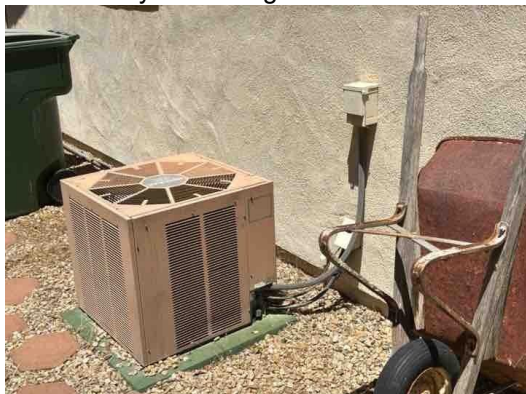
The average life of this type of air conditioner condenser is +/- 20-25 years. This air conditioner condenser appears old and maybe nearing or at the end of a useful life.

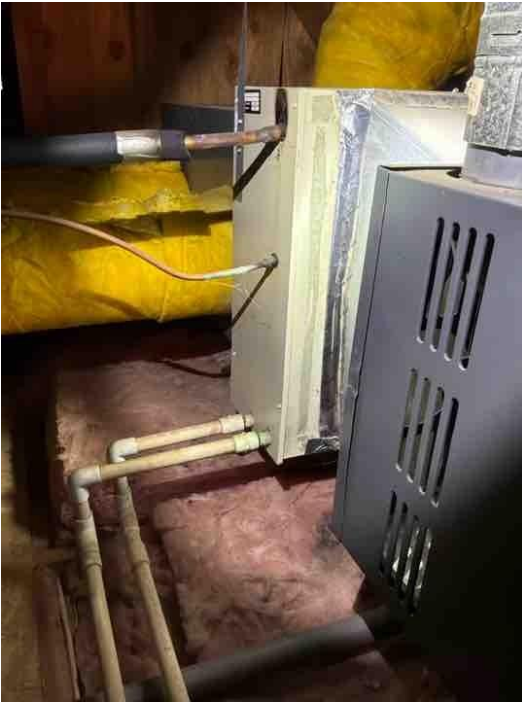
**E&C 192:** Missing a secondary safety overflow catch pan under the Air Conditioner coil in the attic to help prevent water damage to the ceiling below if a leak were to occur per standards. Recommended repairs by a certified or licensed HVAC professional familiar with the minimum installation requirements.

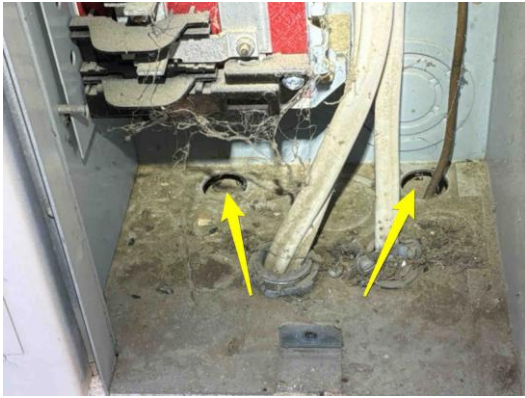
**SU 195:** Unprotected / unused opening(s) through the BOTTOM of the MAIN ELECTRICAL PANEL needing to be sealed for safety per standards. This will help prevent critter intrusion into the electrical panel.

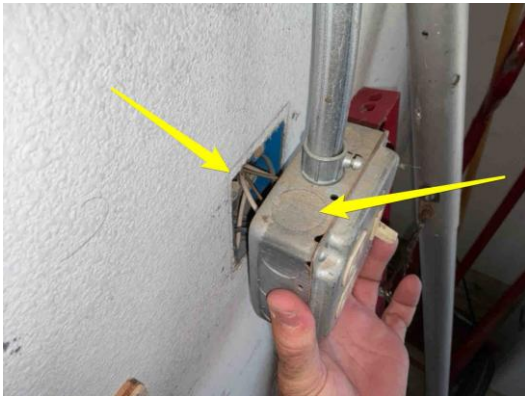
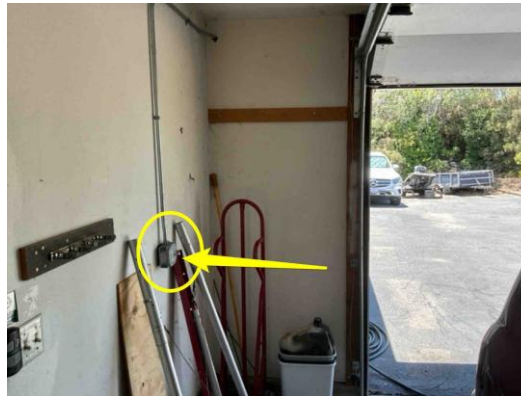
**SC 196:** Improper and unsafe electrical wiring AT THE ADDED ELECTRICAL OUTLET AND LIGHT SWITCH IN THE GARAGE.

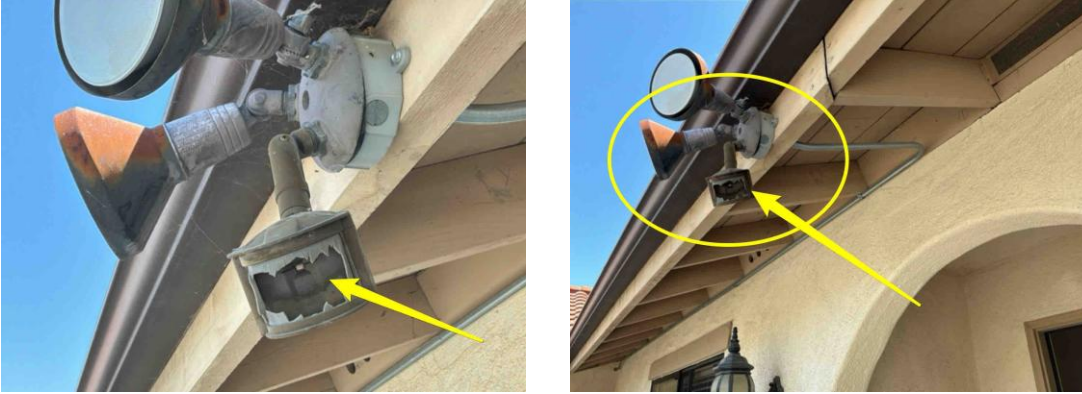
**E&C 202:** Light fixture is damaged: EXTERIOR FRONT ENTRY LIGHT
