### *Inspection Report*

Address: 1345 Cecelia Ct San Luis Obispo, CA 93401

06/05/2026

Inspector: Taylor Vreeken, CCI

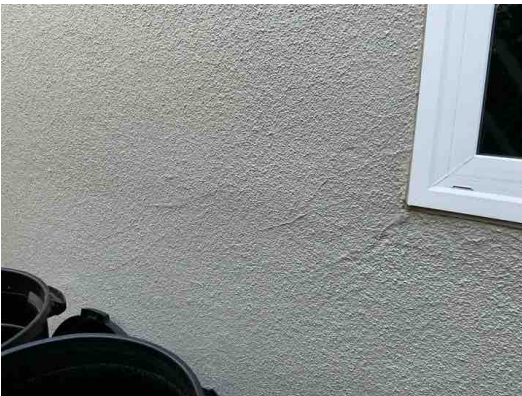
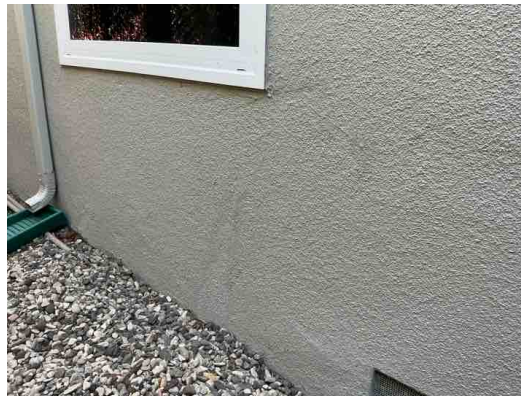
**FI DS 39:** Multiple past stucco crack repairs noted throughout. Ask seller for details.

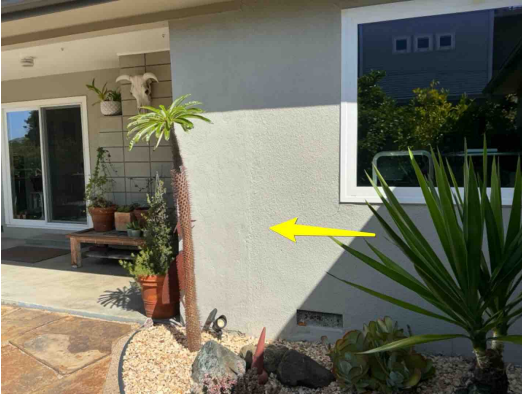
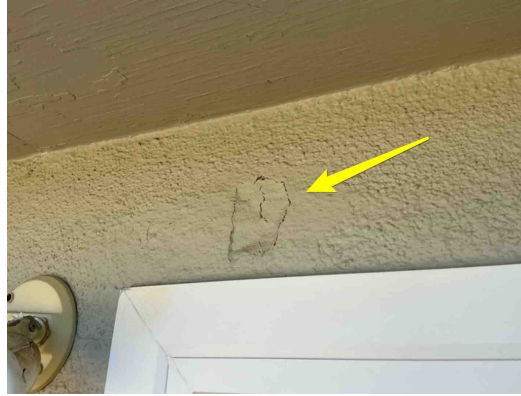
**FI DS 40:** Multiple past stucco repairs noted throughout. Ask seller for details.

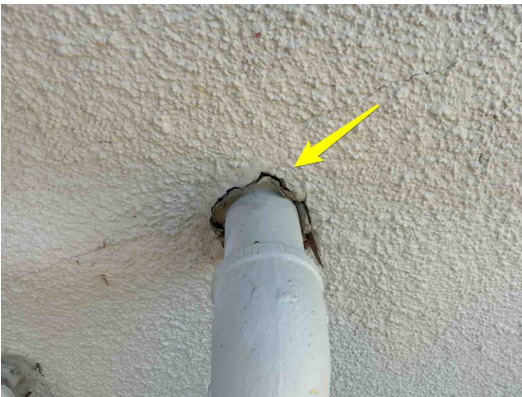
**MR 42:** Recommend sealing holes in exterior walls to prevent water intrusion around areas such as unused open holes in the exterior siding and trim, exterior light fixtures, around exterior electrical boxes and covers, and where utility pipes and/or wires pass through the exterior walls. Have a qualified painter or licensed professional evaluate the entire exterior and seal where needed.

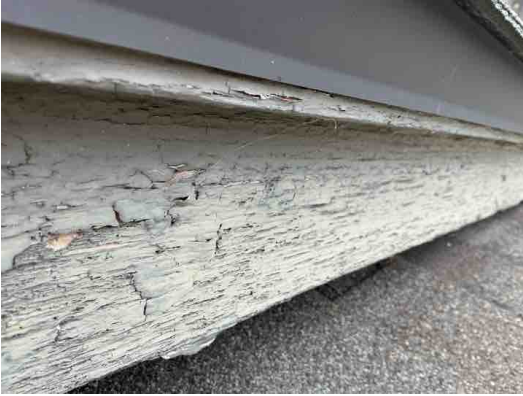
**MR 46:** Deteriorated paint or finish at areas of the exterior.

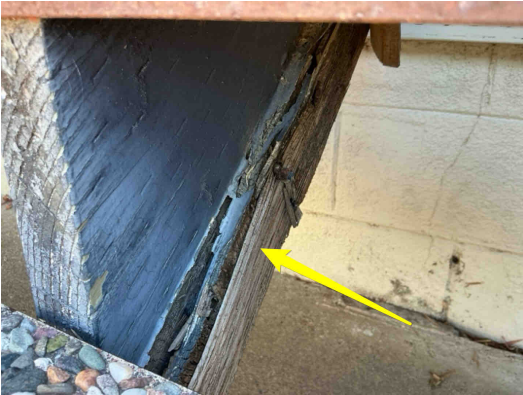
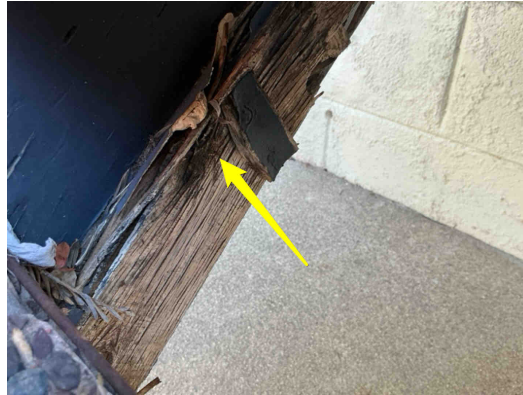
**E&C 52:** Moisture and/or bug type damage & deterioration found at exterior wood stairs, steps and/or landings: OFF THE BACKYARD PATIO. Refer to the Termite report for additional details and recommendations.

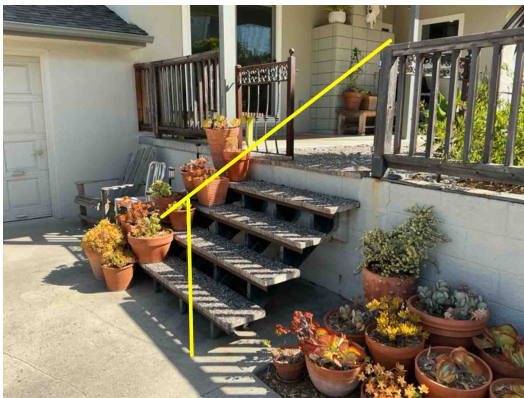
**SC 53:** Missing the proper guardrails and graspable handrail at the exterior stairway: OFF THE BACKYARD PATIO. A proper guardrail and graspable handrail is required on all exterior stairs where the potential fall from the stairway is greater than 30 inches.

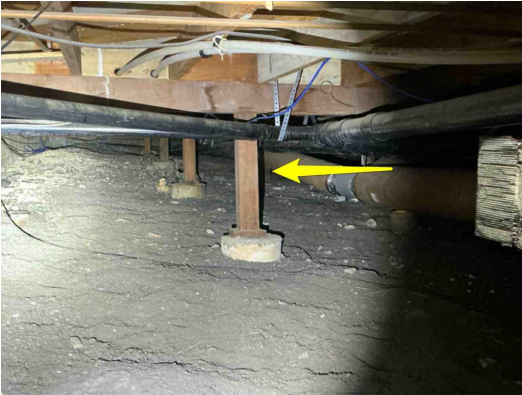
**E&C 72:** Some support posts in the crawlspace show signs of minor settlement with uneven framing and interior floors. Recommend further review and repairs by qualified foundation professional.

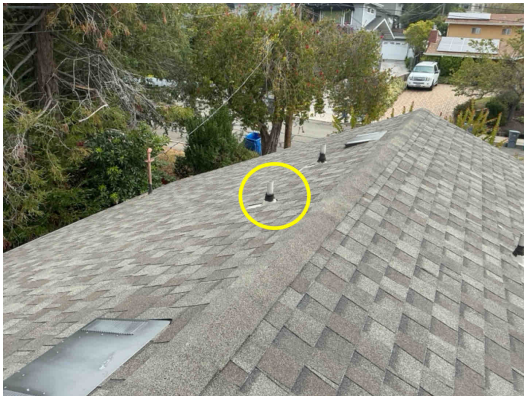
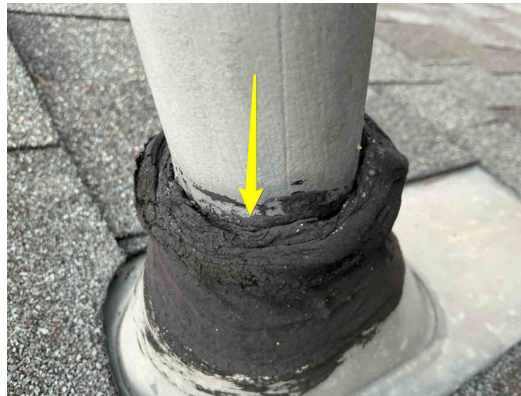
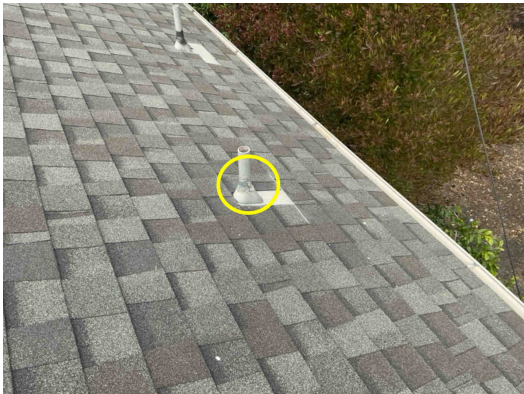
**MR 82:** Deteriorated sealant at some roof flashings, around the roof penetrations. Maintenance recommended to help prevent water intrusion into areas of the attic. Have roofer evaluate the roof flashings and correct as needed.

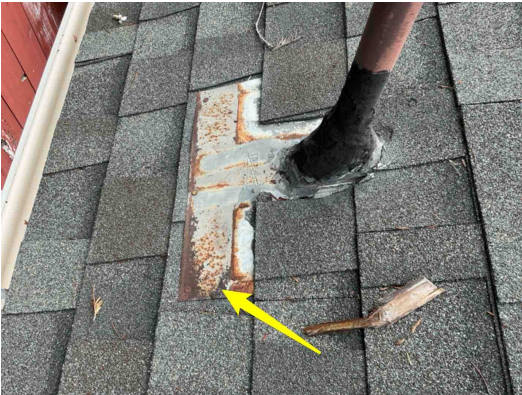
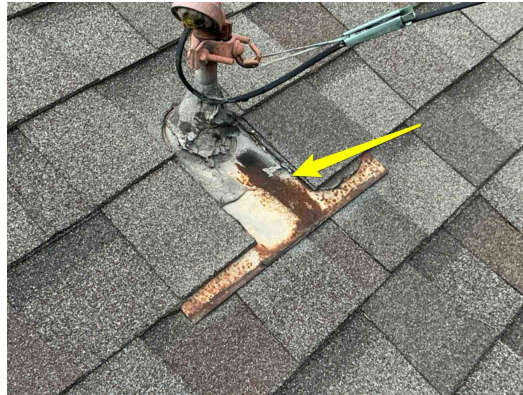
**FI** **84:** Some roof flashings found rusted and deteriorated. Maintenance or replacement of deteriorated and damaged roof flashings are recommended.

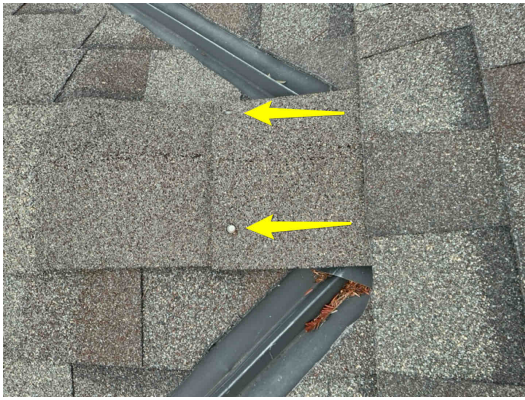
**MR** **85:** Recommending resealing fasteners at the roof flashing as part of typical maintenance.

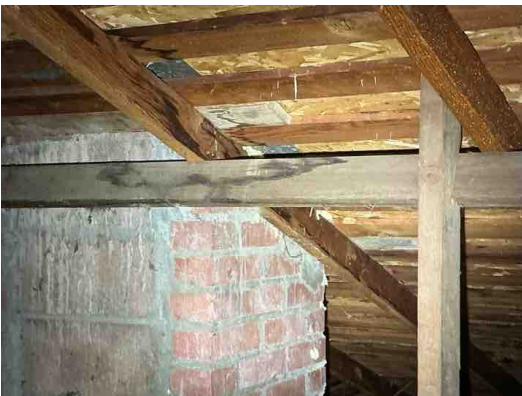
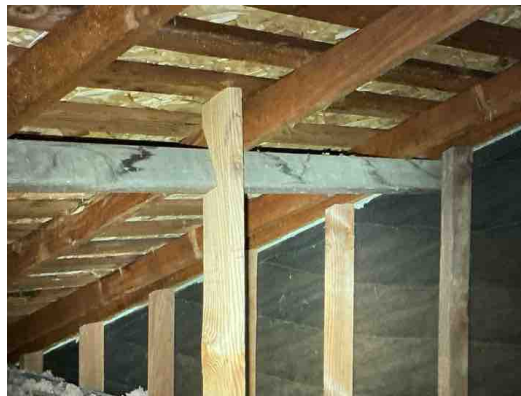
**FI DS 95:** Some minor and moderate moisture stains noted in areas throughout the attic. All water stains should be investigated by a licensed roofer. Refer to termite report for additional comments and/or recommendations.

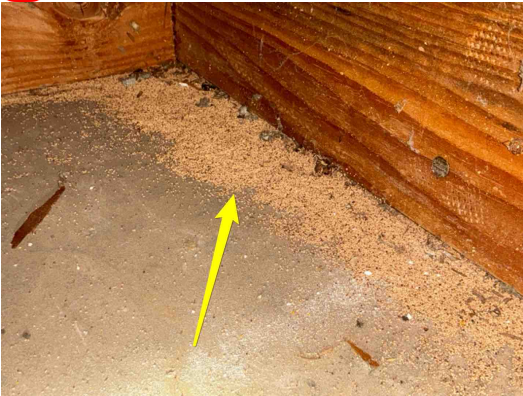
**E&C 96:** Evidence of bug type droppings in areas of the attic. Refer to termite report for extent and location.

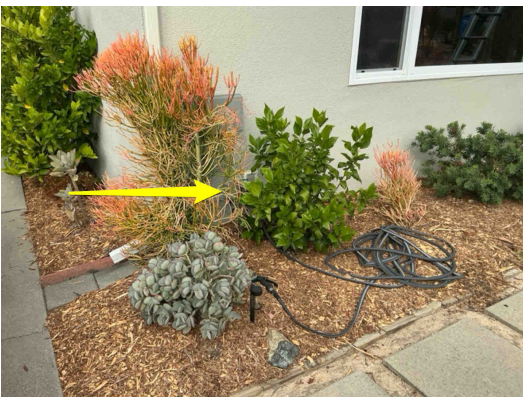
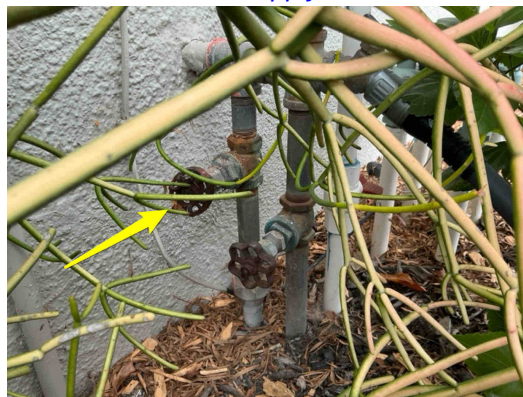
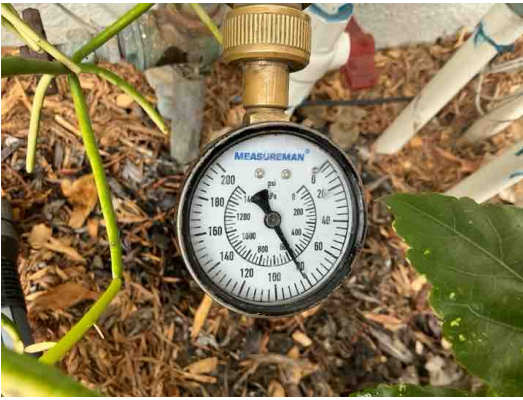
1. **Pressure Regulator Installed: NO**
2. **An Automatic Leak Detection Device installed on the main water supply: NO.**

**E&C 98: Excessive water pressure** (above the maximum of 80-psi, **currently at: 81-psi** ). Recommend the installation of a pressure regulator.

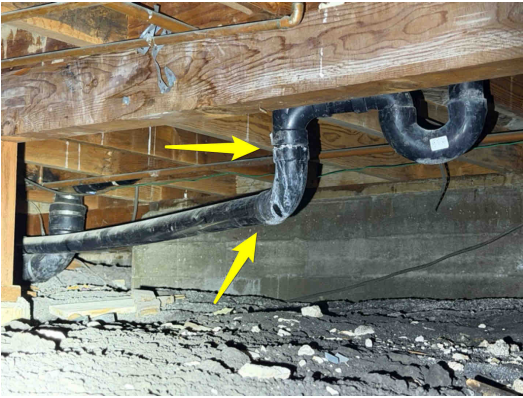
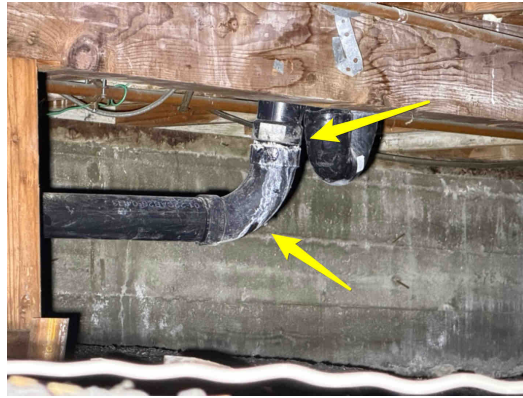
**FI 114:** Active water leak(s) found in the waste pipe in the crawlspace: HALLWAY BATHROOM TUB. Have plumber check all waste piping throughout the crawlspace for any additional leakage.

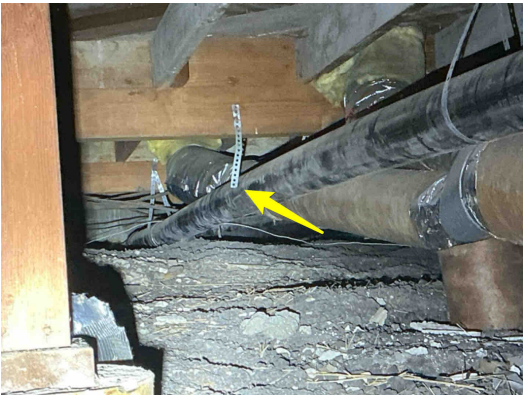
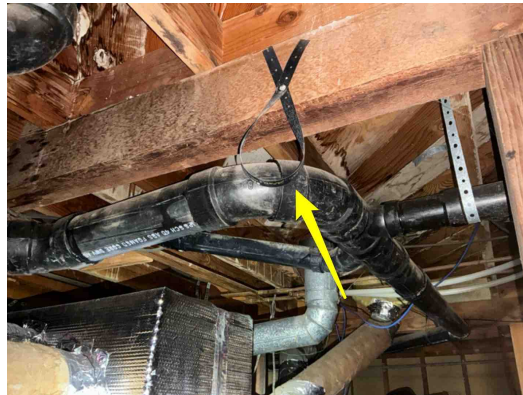
**E&C 115:** Some sewer pipe support straps found damaged in areas of the crawlspace. Contact a plumber to evaluate and correct as needed.

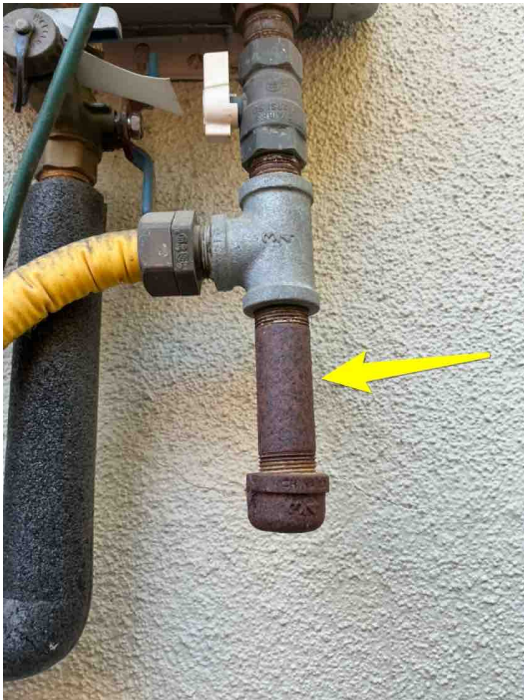
**E&C 120:** Exterior gas piping is improperly installed without adequate corrosion protection and is exhibiting rusting. Metallic gas piping installed outdoors is required to be protected from corrosion. The current condition may result in continued deterioration and increased risk of gas leakage. Recommend repair or replacement and proper corrosion protection by a qualified professional. (CPC §1211.1.2 / §1211.1.5).

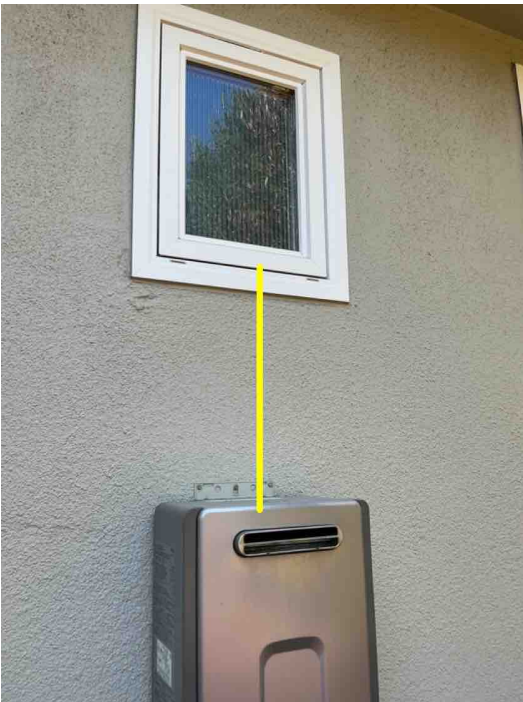
**126:** The tankless water heater vent termination is located below an operable window. Manufacturer installation instructions for this appliance require a minimum clearance of 48 inches below or beside an operable opening. The observed clearance is insufficient at 24". Improper vent termination clearances may allow combustion products to enter the structure through nearby openings. Recommend evaluation and correction by a qualified plumbing contractor in accordance with the manufacturer's installation instructions.

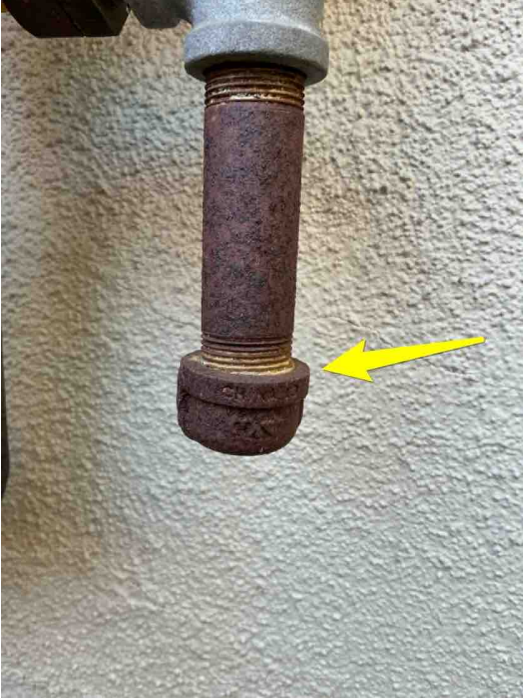
**E&C 128:** The tankless water heater sediment trap cap found cross threaded. No gas leak detected during inspection.

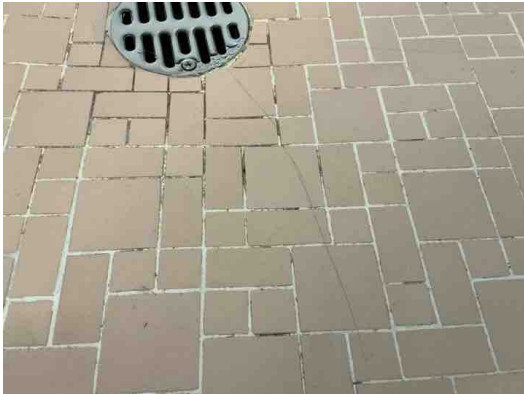
**FI 167:** Some cracked tiles in the LAUNDRY BATHROOM shower enclosure. Recommend contacting a tile professional to evaluate and determine cause, condition and if repairs are warranted.

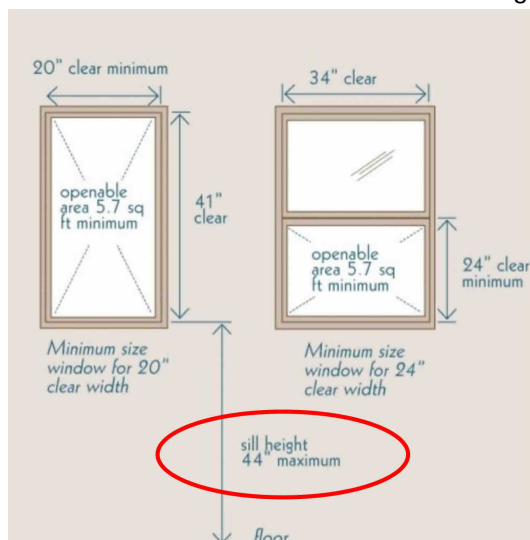
**SU 179:** Windows in bedroom-2 are a too high off the floor and do not meet the current minimum fire egress standards. The current standards for fire egress windows are no more than 44 inches off the floor.

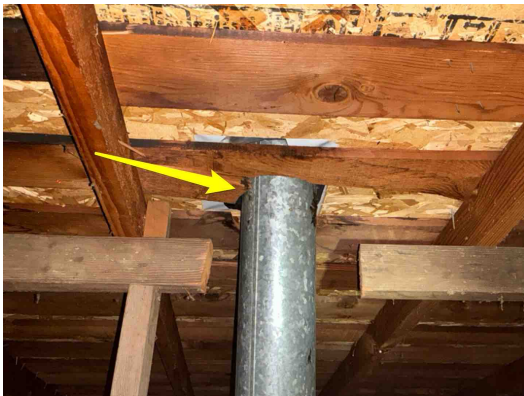
**E&C 202:** Furnace vent pipe lacks proper clearance to combustible material through roof plywood. A minimum of 1 inch of space between the vent pipe and combustibles is needed per minimum standards.

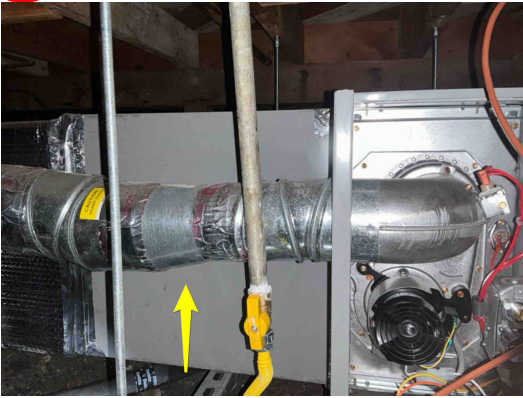
**E&C** **203:** Improper horizontal rise of the furnace vent pipe through the crawlspace.

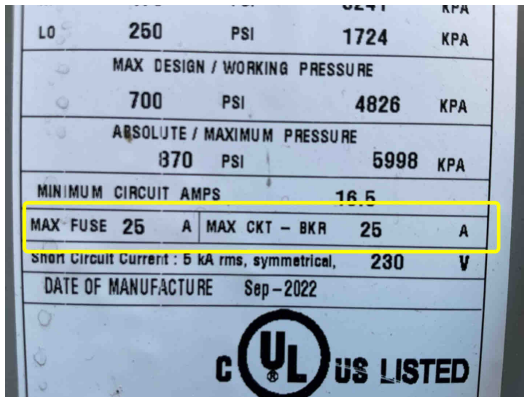
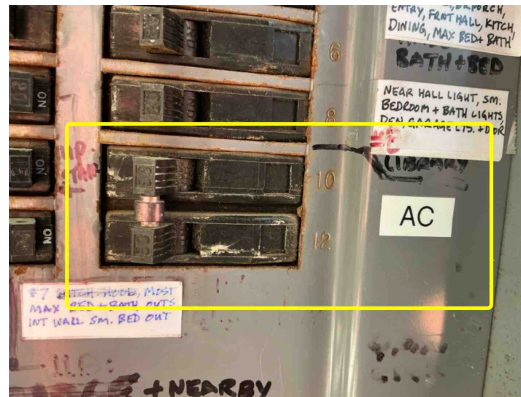
**E&C 213:** Improper circuit breaker size installed for the air conditioner condenser in electrical panel per the manufacturer's placard: Currently at 30-amps, which is more than the maximum allowed of 25-amps. Recommend replacement of the current breaker to a new proper 20 or 25-amp per requirements and warranty retention.

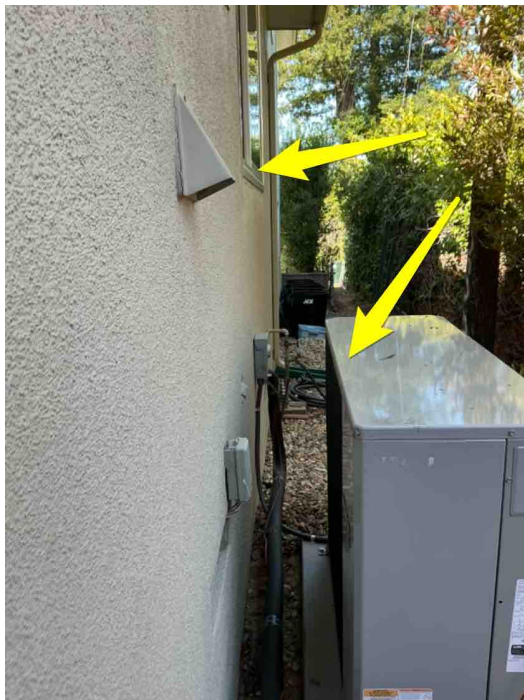
**SU 214:** The LAUNDRY dryer vent terminates too close to the exterior air conditioner compressor per standards. This can clog or build-up dryer lint on the compressor grill. Upgrades are recommended. Laundry dryer vent should terminate a minimum of 5 feet away from the air conditioner compressor for California energy code [150.h.3.a]

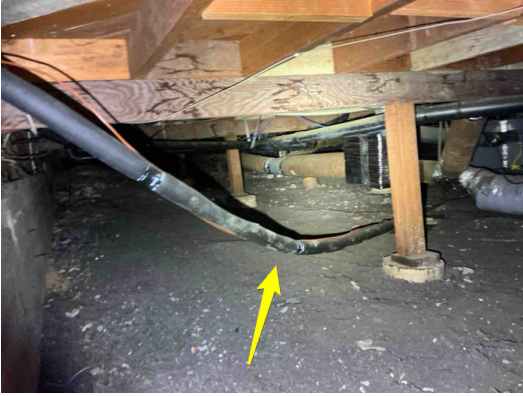
**E&C 215:** The refrigerant line set serving the air conditioning system was inadequately supported in the crawlspace and was observed sagging between support points. California Mechanical Code (CMC §304.1) requires mechanical equipment and associated piping to be installed in accordance with the manufacturer's installation instructions and supported to maintain the structural integrity of the system. Improperly supported refrigerant piping may be subject to physical damage, insulation deterioration, excessive vibration, and premature failure. Recommend evaluation and installation of proper supports/hangers by a qualified HVAC contractor.

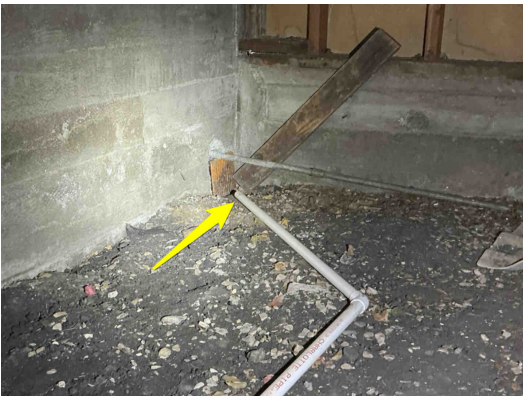
**E&C 217:** The A/c condensate drip pipe is currently terminating in the CRAWLSPACE. Exterior termination recommended.

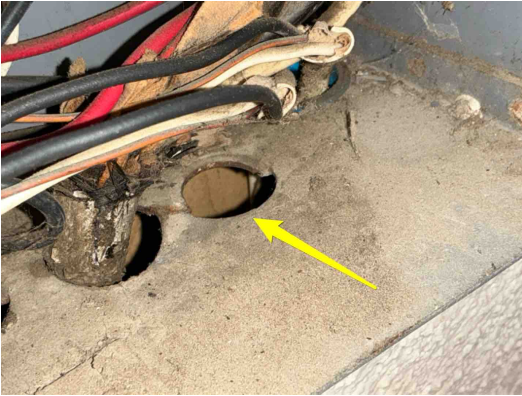
**SU 221:** Unprotected / unused opening(s) through the BOTTOM of the MAIN ELECTRICAL PANEL needing to be sealed for safety per standards. This will help prevent critter intrusion into the electrical panel.

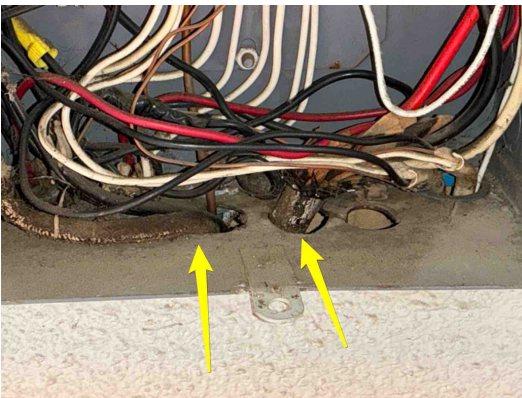
**SU 223:** Missing a bushing clamp as wires are passing into the metal MAIN ELECTRICAL PANEL. Wires are improperly rubbing on the sharp metal edge of the electrical panel as they pass through.

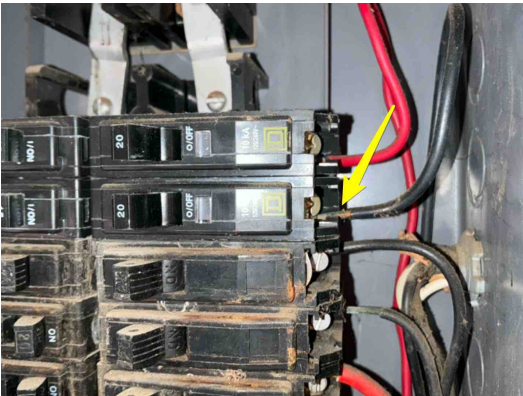
**SC 225:** Some of the protective coating around the outside of the electrical wire found to be over-stripped exposing the energized portion of the wire at some circuit breakers connections inside the MAIN ELECTRICAL PANEL. Exposed electrical wires should be protected to help prevent accidental contact.

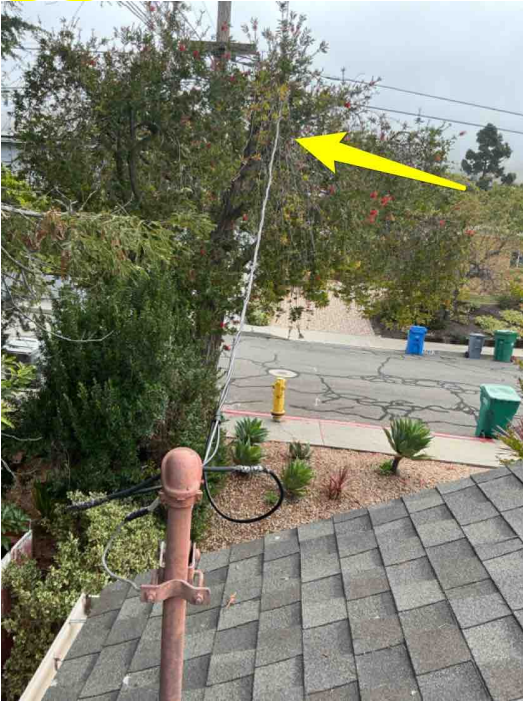
**MR SU** 226: Overhead main electrical service wires touch trees. Potential hazard. Contact utility company.

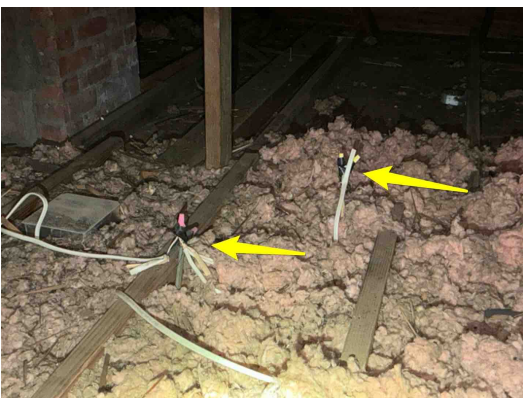
**SC** 229: Improper electrical wiring. Exposed electrical wires and/or splices not protected in a box with a cover:  
MULTIPLE IN THE ATTIC

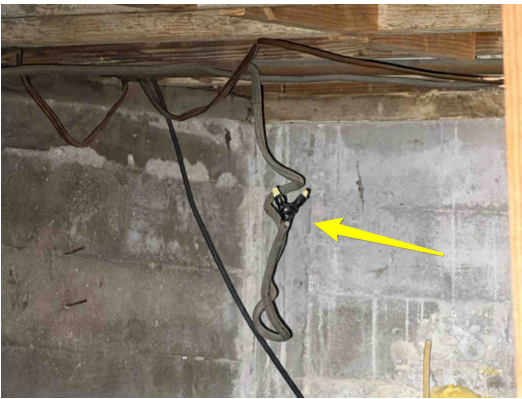
**SC 230:** Improper electrical wiring. Exposed electrical splices / wires not protected in a box with a cover:  
MULTIPLE IN THE CRAWLSPACE

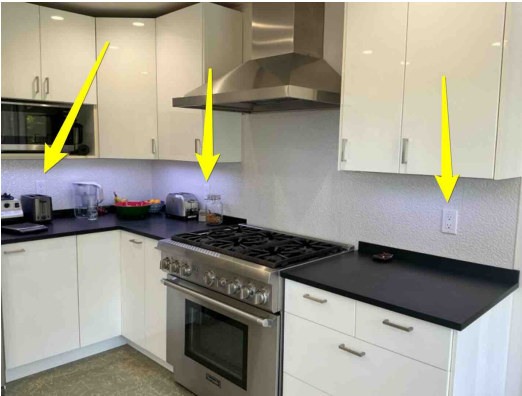
**SC 235:** Missing GFCI protected outlets in some required locations. Recommend repairs and upgrades by a qualified and licensed electrical professional familiar with the minimum GFCI protection requirements: **THREE OUTLETS IN THE KITCHEN (REQUIRED AT KITCHEN REMODELS POST 1987)**

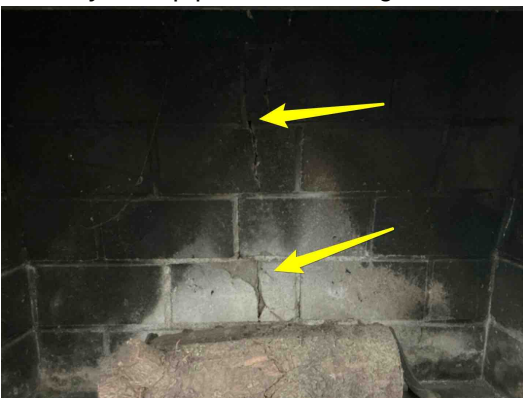
**E&C 267:** Cracked and damaged bricks and/or mortar found at the back wall inside the DINING AREA fireplace firebox. General maintenance and/or repairs are warranted as cracks and separations can allow superheated gases to escape through the back wall and collect in the confined spaces of the chimney. Contact a qualified chimney sweep/professional to grind out and re-mortar cracked and separated areas for safety.

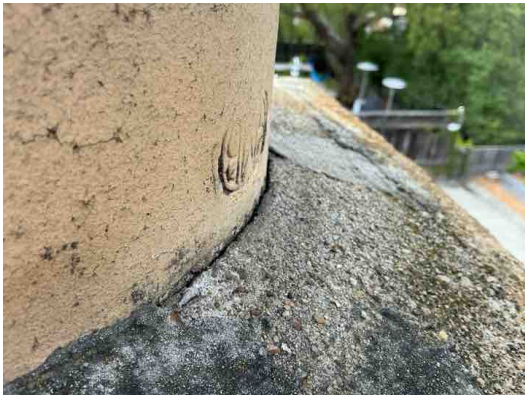
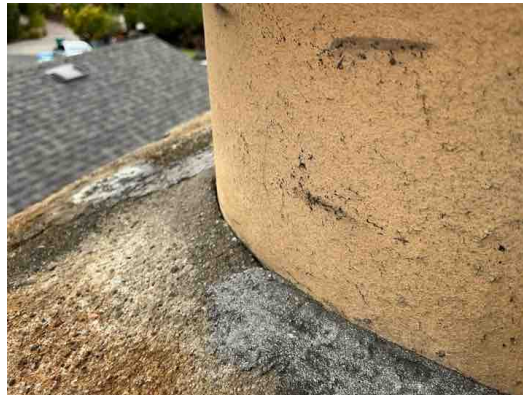
**MR 269:** Deteriorated sealant found at the mortar crown to flue connection located at the top of the DINING AREA fireplace chimney. Maintenance / caulking or sealing is recommended to help prevent water intrusion into the confined spaces within the masonry chimney.

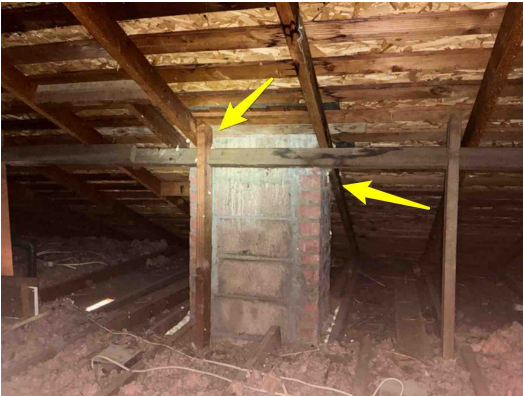
**E&C 270:** Some of the wood framing in the attic and/ or eaves around the masonry fireplace chimney is too close and or touching the brick. A minimum of one inch of air space is required. Monitor for heat deterioration. No visible heat deterioration noted today.
