### *Inspection Report*

Address: 2925 Warm Springs Ln Templeton, CA 93465

04/05/2025

Inspector: Keith Vreeken, MCI, FCI  
P.O. Box 415 Templeton, CA 93465 O: 805.462.1978 C: 805.440.5050

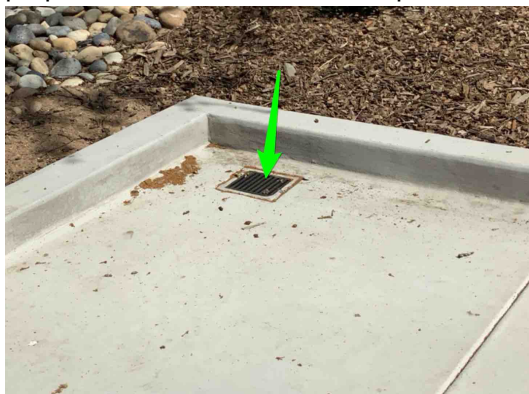
**MR DS 19:** Surface drains and boxes noted in areas of the driveway. Drains are not tested, conditions of the underground piping and terminations are unknown. Recommend having drains cleaned and tested to determine proper flow and termination. Keep drains clean and free of debris regularly.

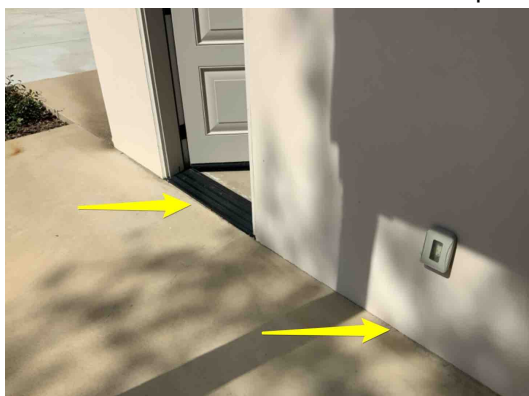
**DS 25:** Areas of the exterior walkways and/or patios found to be installed high at or above exterior stucco siding and the door threshold at the GARAGE. This can allow for moisture which can collect behind the exterior siding or trim to properly drain and build up moisture inside the wall cavity. This can also allow water to intrude through the door threshold. Refer to the Termite Report for additional comments and recommendations.

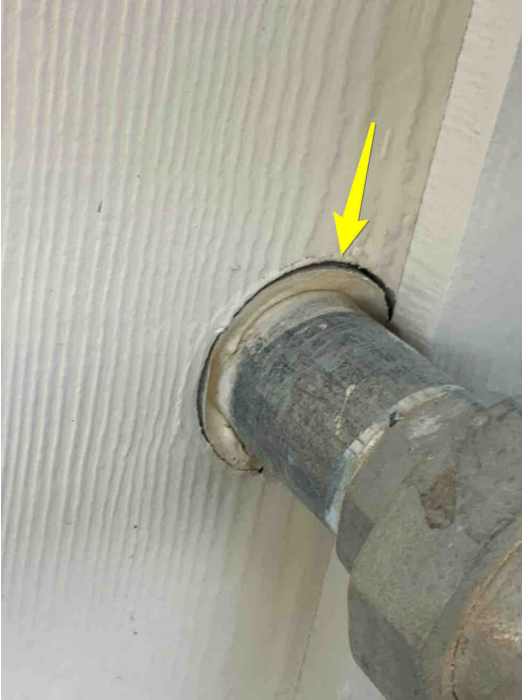
**MR 35:** Recommend sealing holes in exterior walls to prevent water intrusion around areas such as unused open holes, exterior light fixtures, around exterior electrical boxes, and where utility pipes and/or wires pass through the exterior walls. Have a qualified painter or licensed professional evaluate the entire exterior and seal where needed.

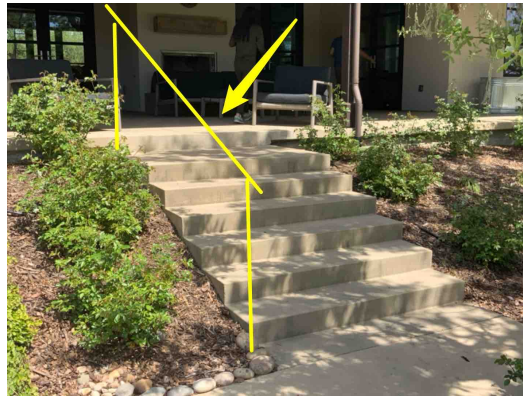
**SU 41:** Recommend a proper graspable handrail at the exterior stairway OFF THE BACKYARD PATIO for safety.

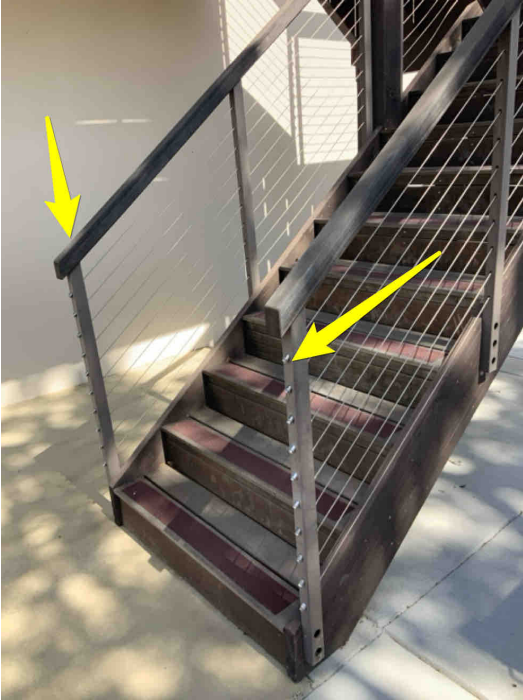
**SC 44:** Loose stairway railings at the exterior stairway TO THE UPSTAIRS UNIT OVER THE GARAGE. Safety upgrades recommended.

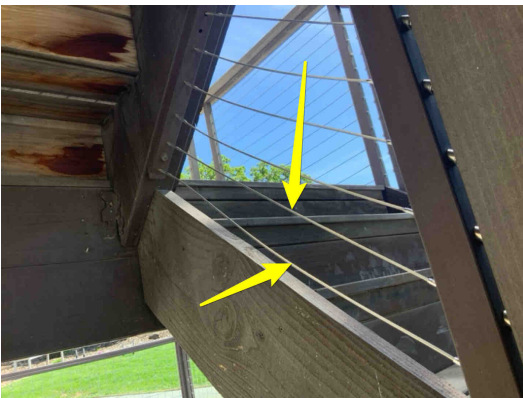
**SC 45:** Some loose cable found at the guardrails at the exterior stairway TO THE UPSTAIRS UNIT OVER THE GARAGE

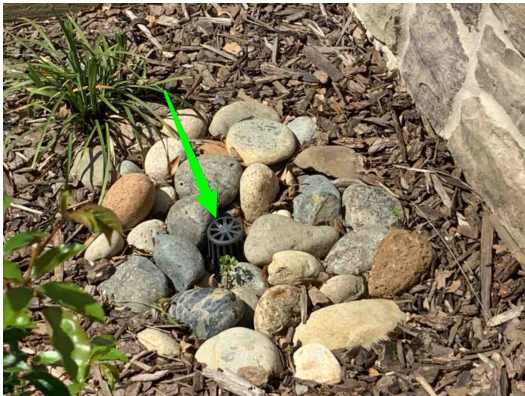
**MR DS 54:** Surface and/or yard drain boxes noted but not tested. The condition of the underground piping and terminations are unknown. Recommend having drains and terminations cleaned, tested and inspected by a qualified landscape contractor to determine the proper flow. Keep drains clean and free of debris regularly.

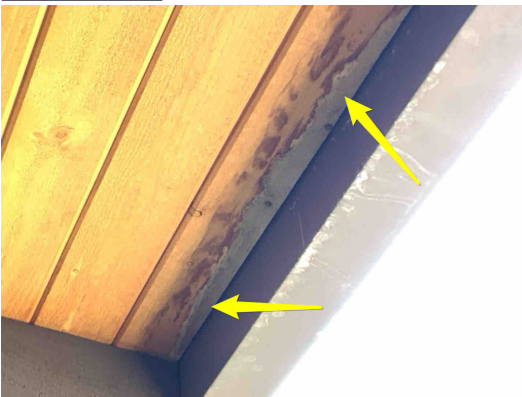
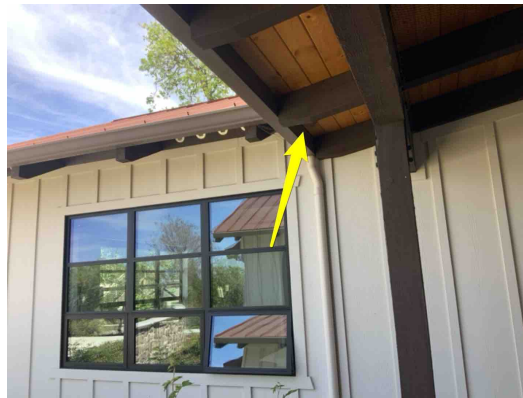
**E&C** 64: Suspected roof leaks. Evidence of moisture stains and/or damage at areas of the roof overhangs: **Front Porch Cover**

Example - at the front porch cover

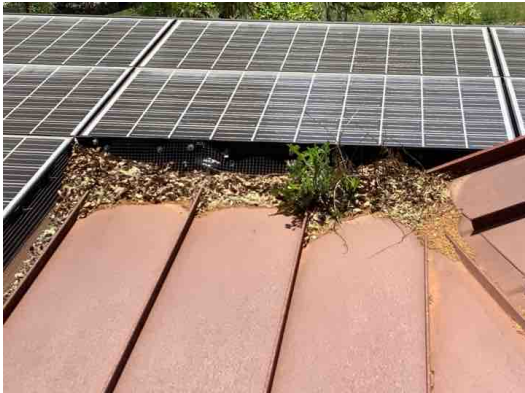
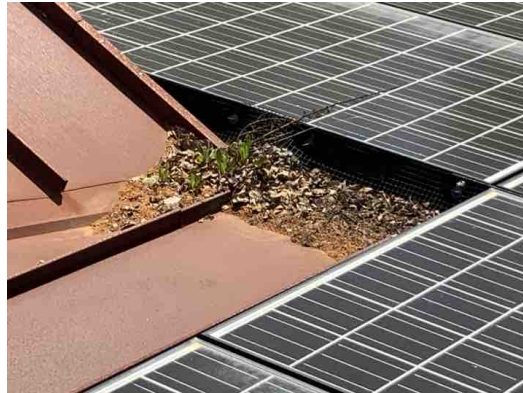
**MR DS 65:** Heavy debris buildup on areas of the roof and/or roof valley flashings. Areas not fully visible. Recommend removal of the debris and inspect areas to help determine current conditions. Continuous cleaning and inspections is warranted to help prevent roof leakage.

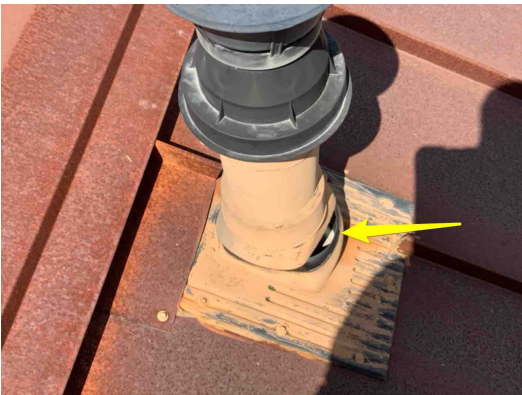
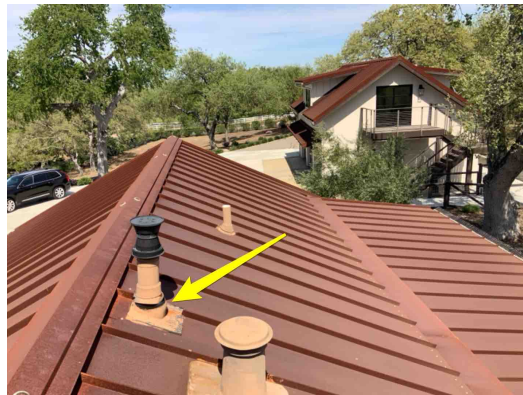
**E&C 67:** A damaged and open roof flashing found at the water heater vent termination cap located on the southeast corner of the home. This would be considered an active roof leak.

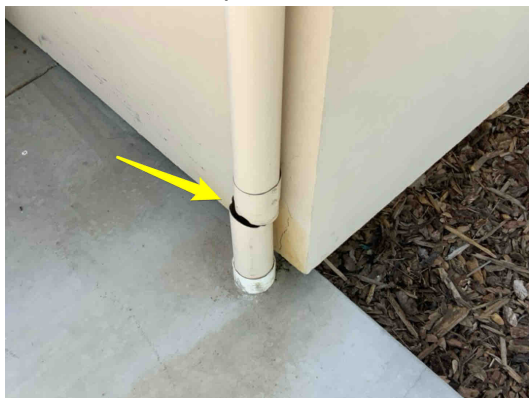
**E&C 71:** Loose rain gutter downspout at the underground drain connection on the garage at the southeast corner. Maintenance or repair needed.

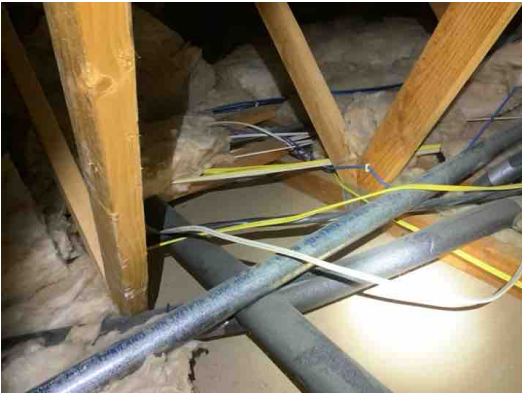
**E&C MR 78:** Insulation in areas of the attic have been moved or displaced for reasons unknown and were not reinstalled in its appropriate location. Corrections recommended.

In the laundry room attic next to the attic access opening

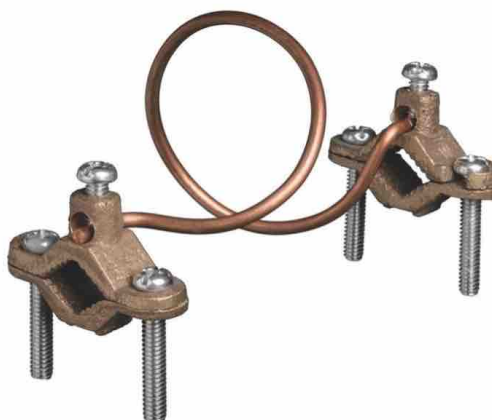
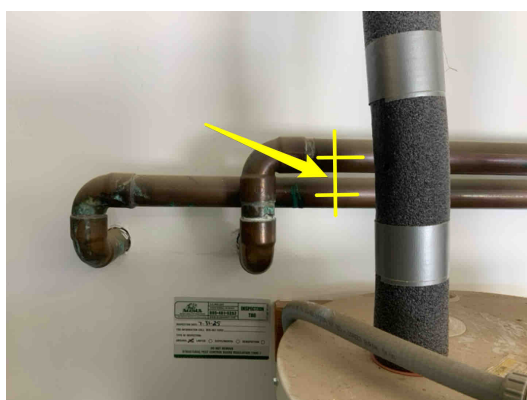
**SC 91:** Missing a proper bond jumper (ground connection) across the water softener pipes due to the plastic water valve assembly.

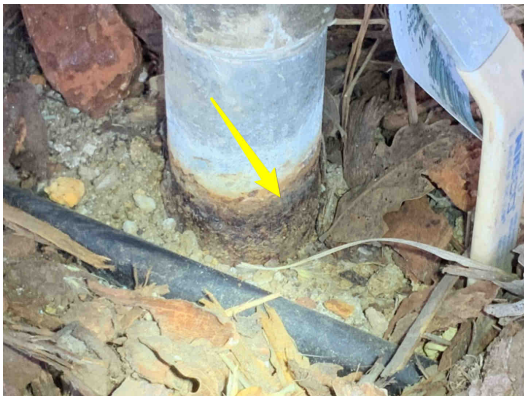
**SC 97:** An improper use and installation of unprotected / unwrapped metal Gas pipe through the soil. All gas piping which runs under ground or in contact with the soil must be protected from rust and corrosion to help prevent a leak. Contact a qualified plumber to evaluate the current condition and replace the unprotected gas piping if/as needed.

Some rust and deterioration noted at areas of the unprotected gas pipe at dirt level

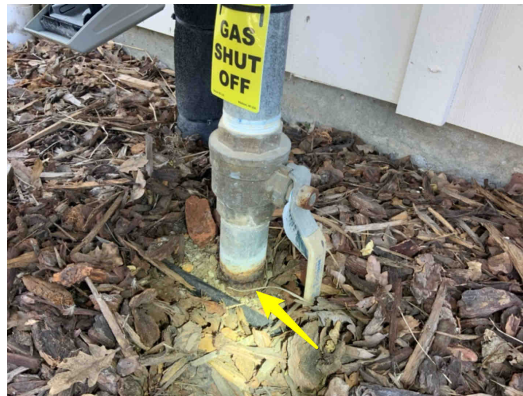
Some rust and deterioration noted at areas of the unprotected gas pipe at dirt level

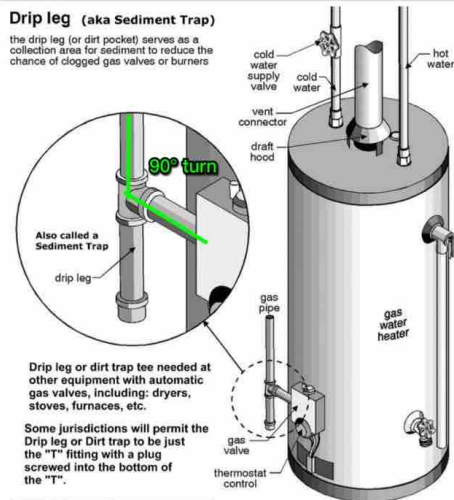
**UPG 105:** Recommend the installation of a sediment trap / drip leg at the WATER HEATER gas piping at flex connection by a certified or licensed plumbing professional familiar with minimum requirements.

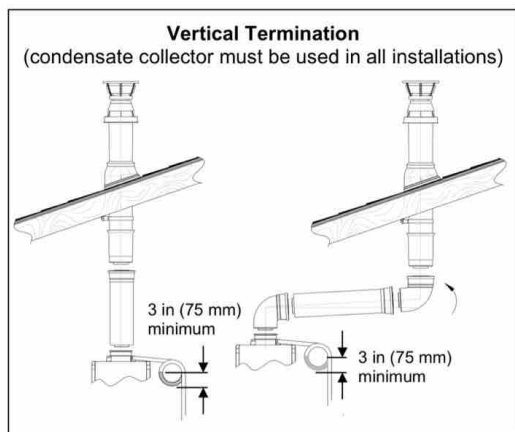
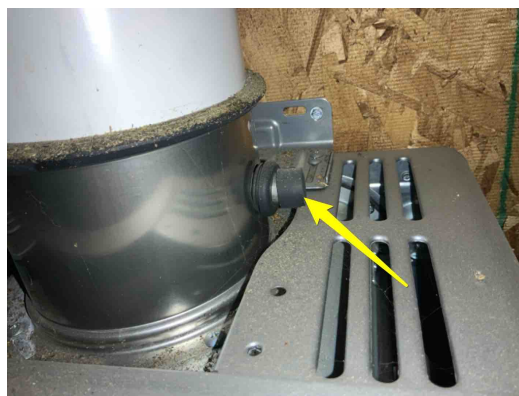
**E&C 108:** Missing the required condensate tube, loop, trap at the Rinnai tankless water heater per the minimum installation requirements.

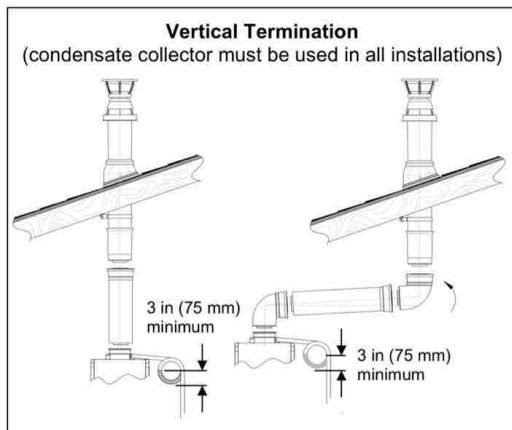
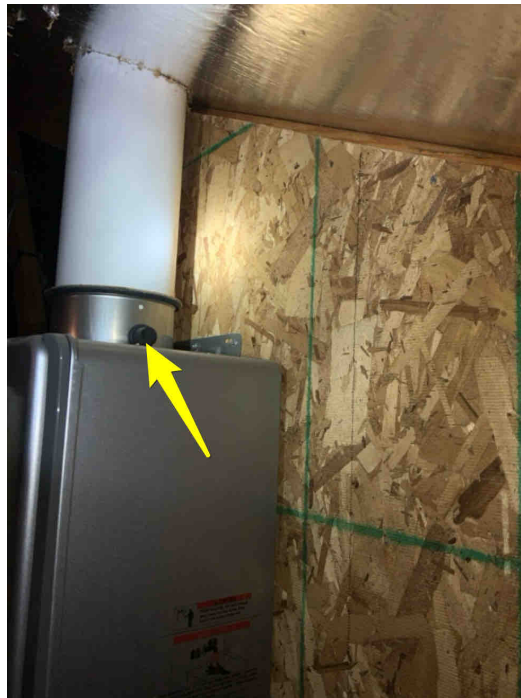
**E&C 127:** Missing the required condensate tube, loop, trap at the Rinnai tankless water heater per the minimum installation requirements.

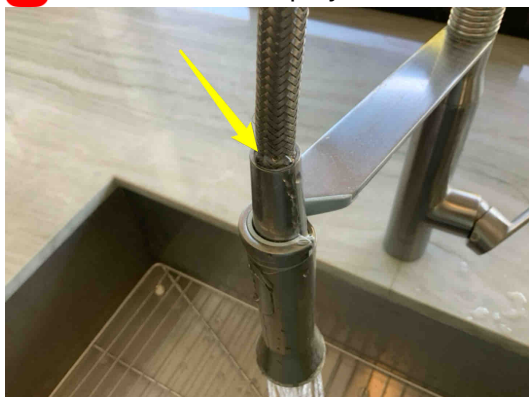
**E&C 131:** Kitchen sink spray wand found defective / leaks at the spray head to hose connection. Servicing needed.

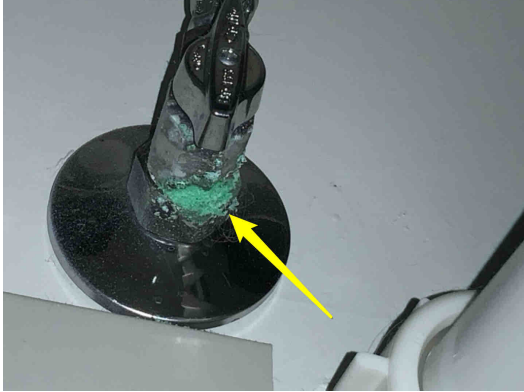
**FI 162:** Corrosion on supply lines below the bathroom sink / evidence of a past leak: GUEST BEDROOM BATHROOM. Have plumber review incorrect all hot and cold water shut off as needed under bathroom sink.

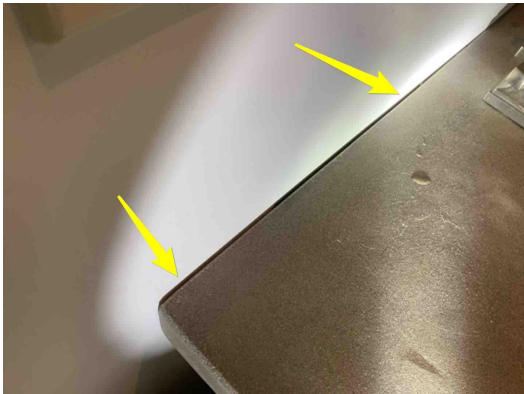
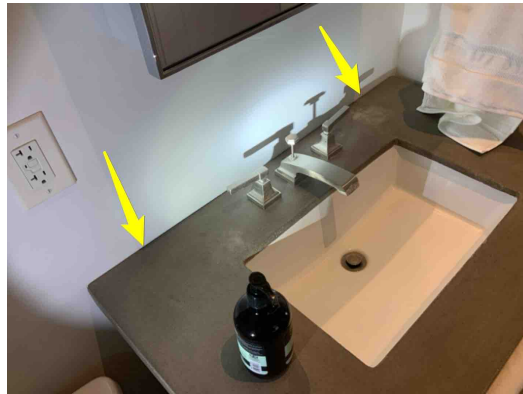
**UPG 163:** Caulking is missing, needed at countertop to back wall as part of proper installation at the LAUNDRY ROOM 1/2 BATHROOM sink countertop.

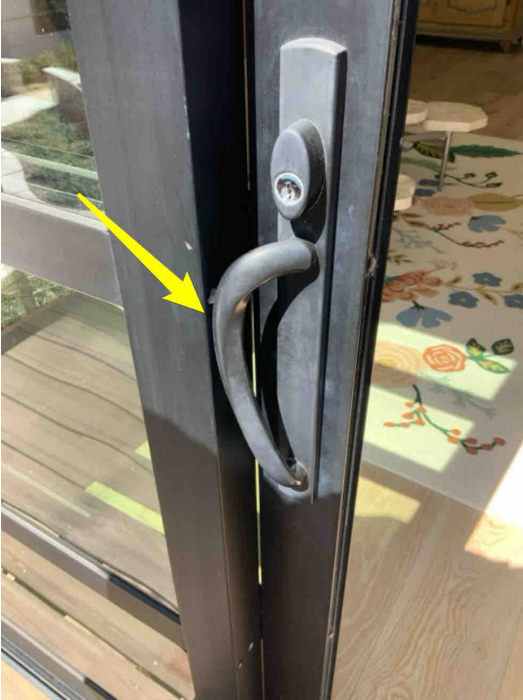
**MR SU 174:** Missing door stops at the UPSTAIRS CASITA exterior sliding glass door over the garage. Corrections are recommended to help prevent damage to the door handle and occupant's fingers.

Door handle improperly hits the door frame

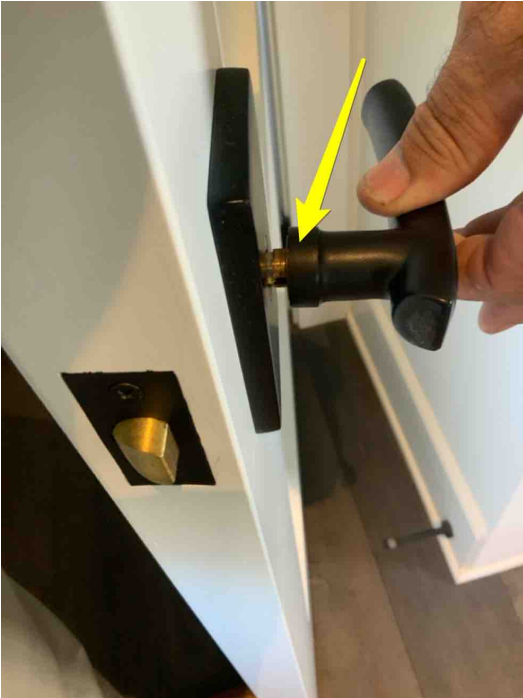
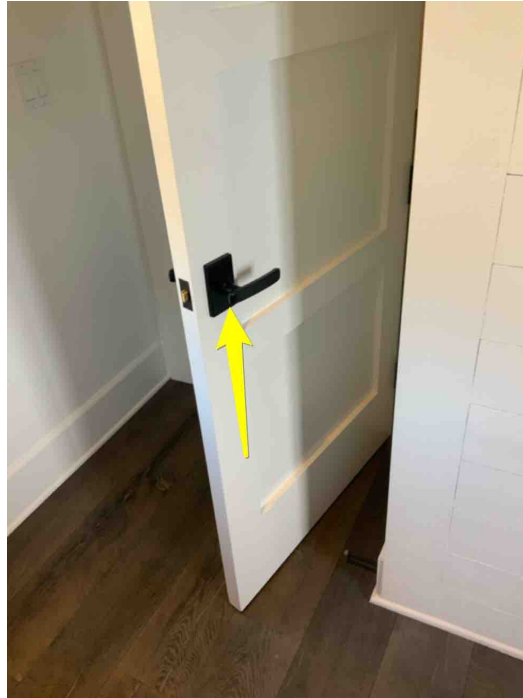
**176:** Door knob handle found loose need maintenance upgraded repairs in the north side office

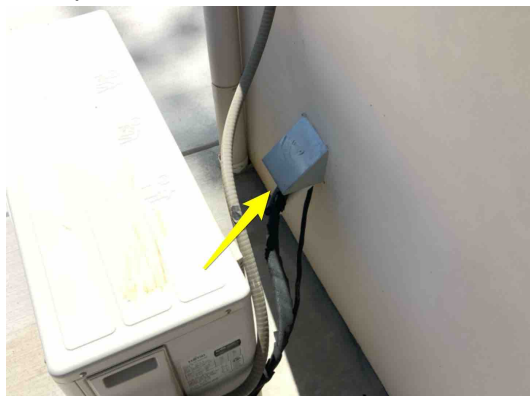
**E&C 190:** Recommend sealing the hole or opening through the exterior wall where the Air Conditioner's refrigeration pipes enter the building. This will help prevent rodent, bug and /or water intrusion through this area as need per standards.

Opening sealed for critter protection

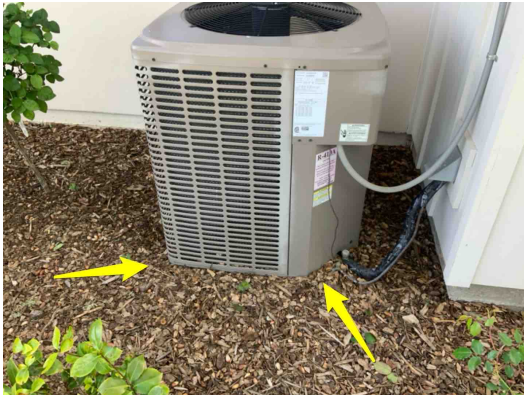
**MR** **UPG** **206:** Some Soil or leaf debris build up around the base of UNIT-A, Northeast Corner air conditioner condenser. The condenser should be a minimum of 2-4 inches above the surrounding soil to help prevent deterioration and damage.

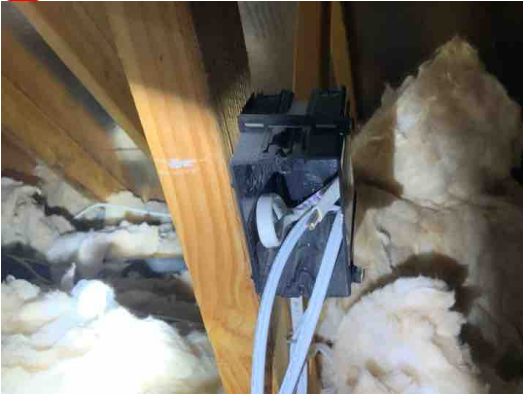
**SC 211:** Improper and unsafe electrical wiring in the laundry room attic.

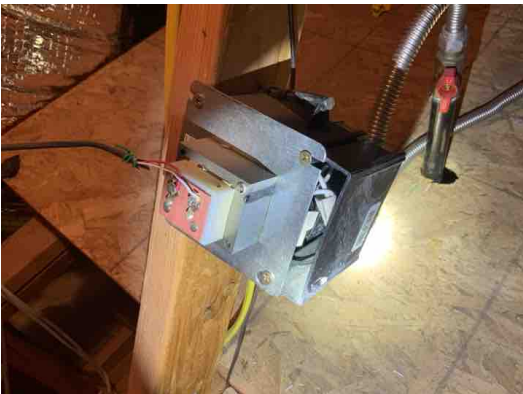
**SC 214:** Improper, and unsafe electrical junction box cover plate: IN THE PRIMARY BEDROOM ATTIC AT THE LOW VOLTAGE TRANSFORMER. Exposed electrical wires.

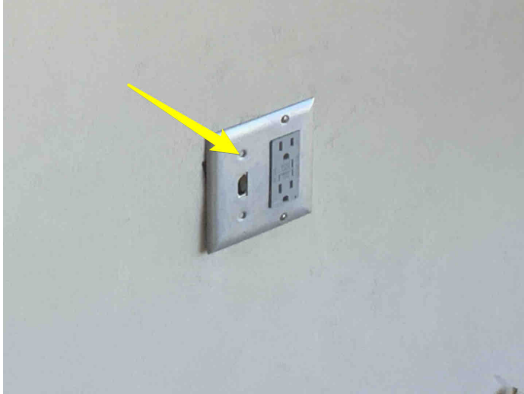
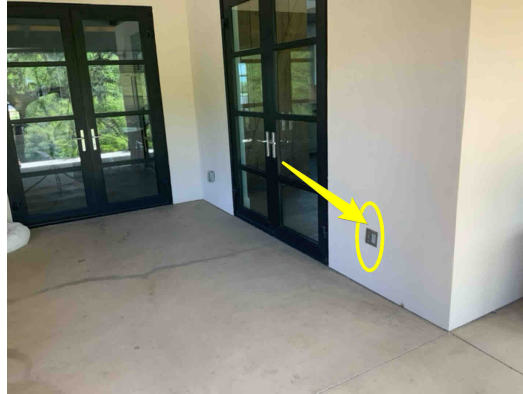
**SC 215:** Exterior electrical outlet found without a proper weather tight cover: EXTERIOR OUTLET ON THE BACK OF THE HOUSE

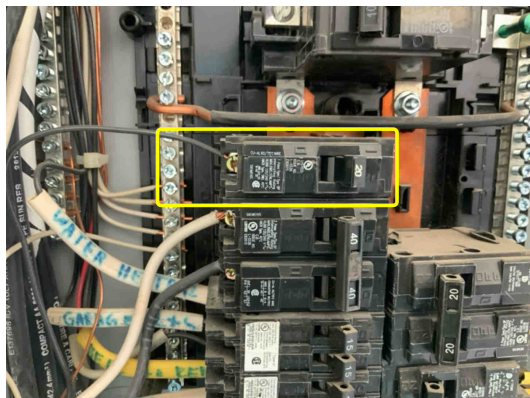
**SC 217:** Electrical panel defect / Over-fusing (breaker found too large for wire), 15-amp wire on a 20-amp breaker in the GARAGE ELECTRICAL SUB PANEL.

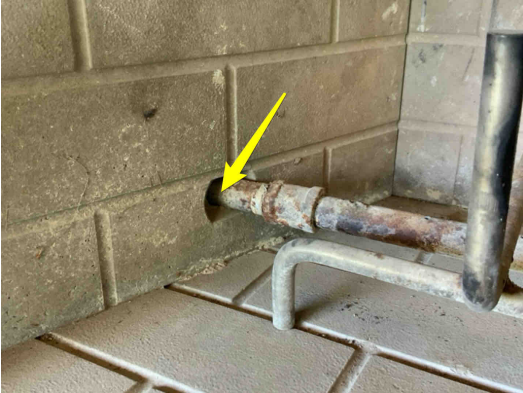
**SC 240:** Recommend sealing the opening around the gas pipe through the sidewall inside the EXTERIOR BACKYARD PATIO fireplace for safety per standards.

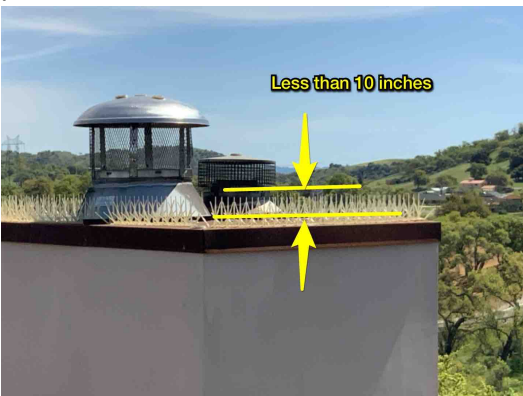
**E&C 242:** The metal prefabricated fireplace chimney pipe and cap improperly terminates to low at the roof at the EXTERIOR BACKYARD PATIO. The pipe and cap should terminate a minimum of 10-12 inches above the chase per standards.
