## Inspection Services

### *Inspection Report*

Address: 2945 Hemlock Ave Morro Bay, CA 93442

08/29/2026

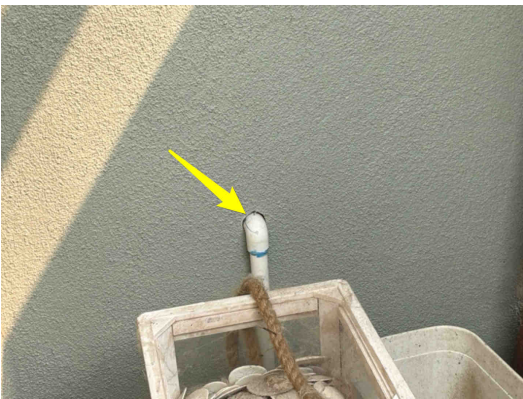
Example

**MR** 25: Recommend sealing holes in exterior walls to prevent water intrusion around areas such as unused open holes in the exterior siding and trim, exterior light fixtures, around exterior electrical boxes and covers, and where utility pipes and/or wires pass through the exterior walls. Have a qualified painter or licensed professional evaluate the entire exterior and seal openings where needed.

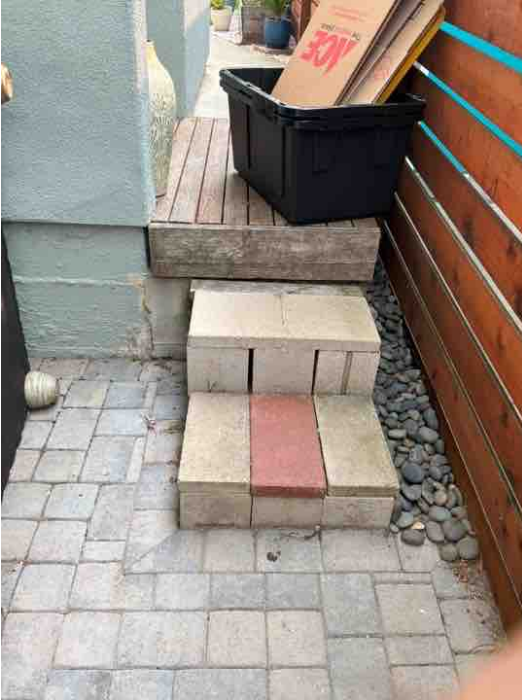
1. Tread height exceeds maximum of 7-3/4 inches,
2. Uneven tread rise some treads are taller than others
3. Uneven tread length some treads are longer than others.

Recommend further review, upgrades and/or repairs by a qualified licensed contractor familiar with minimum standards to help ensure the overall safety of the exterior steps.

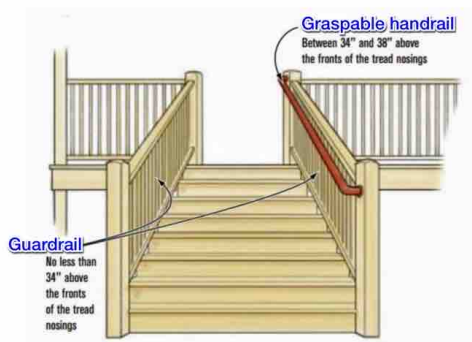
**SU 29:** Recommend a graspable handrails at all exterior steps where not installed as a safety upgrade. Not necessarily required.

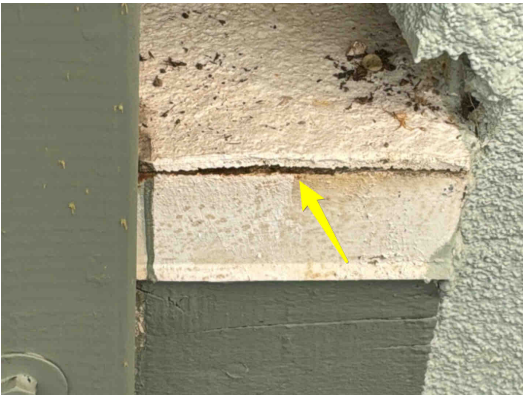
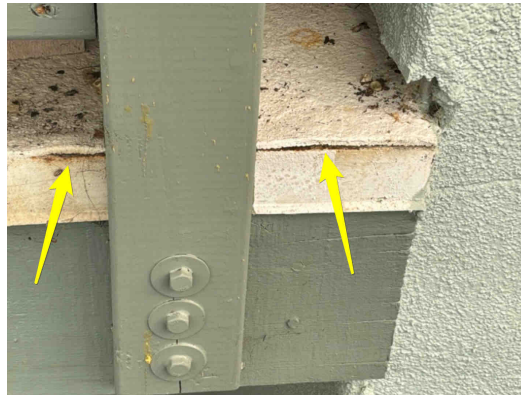
**E&C 31:** Areas of deterioration, cracking and separations of the waterproof deck coating noted at areas of the **UPSTAIRS WATERPROOF DECK OFF THE KITCHEN**. Maintenance or repairs needed. Recommend further review and/or repairs by a certified or licensed waterproof deck coating professional familiar with minimum requirements.

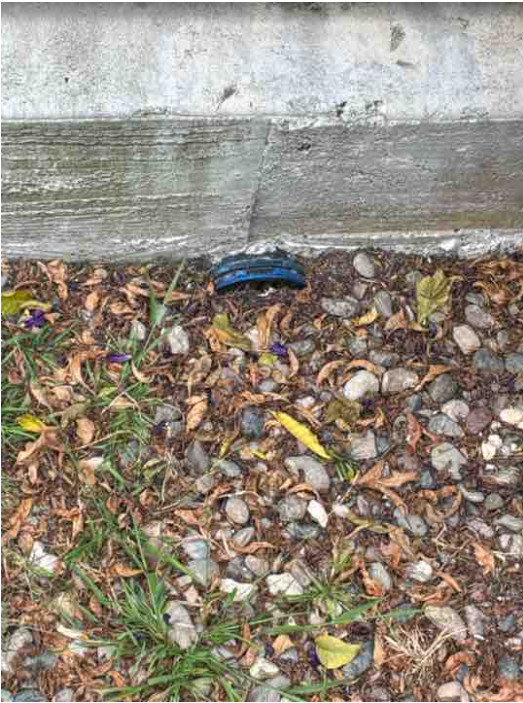
**MR DS 38:** Surface and/or yard drain boxes noted but not tested. The condition of the underground piping and terminations are unknown. Recommend having drains and terminations cleaned, tested and inspected by a qualified landscape contractor to determine the proper flow. Keep drains clean and free of debris regularly.

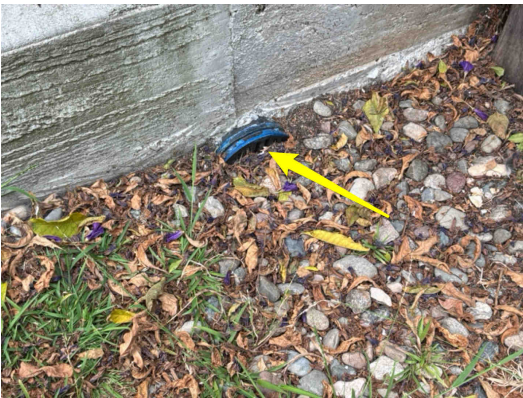
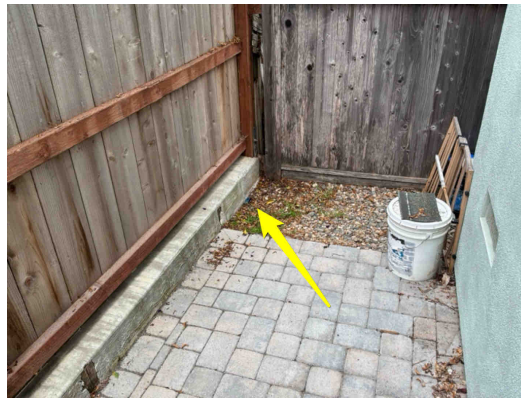
**E&C MR 39:** Surface and/or yard drain boxes or inlets found full of debris. Recommend having drains and terminations cleaned and tested to determine proper flow.

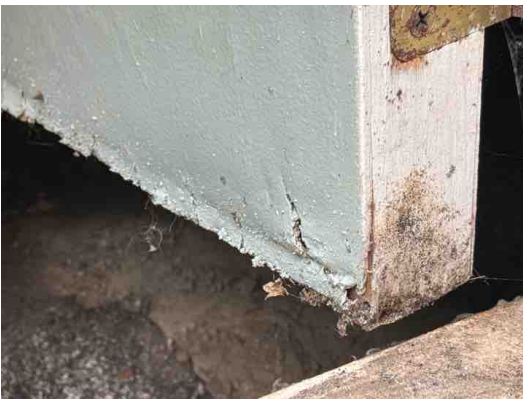
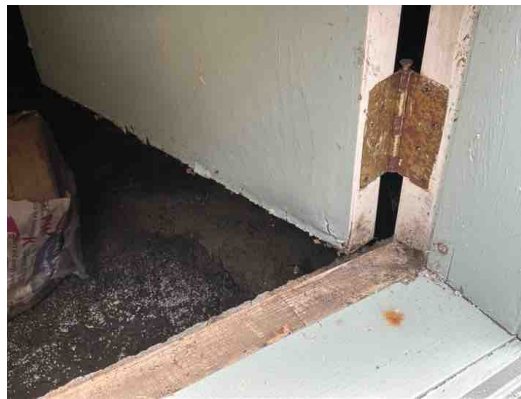
**E&C 46:** Some moisture damaged found at the crawlspace door. Refer to the Termite report for additional information.

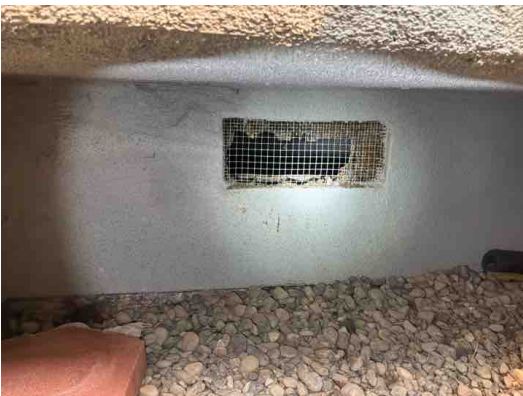
**UPG 47:** Some Ventilation screens for the crawlspace / sub-area are found to be oversized. 1/4 inch screen recommended to avoid rodent intrusion.

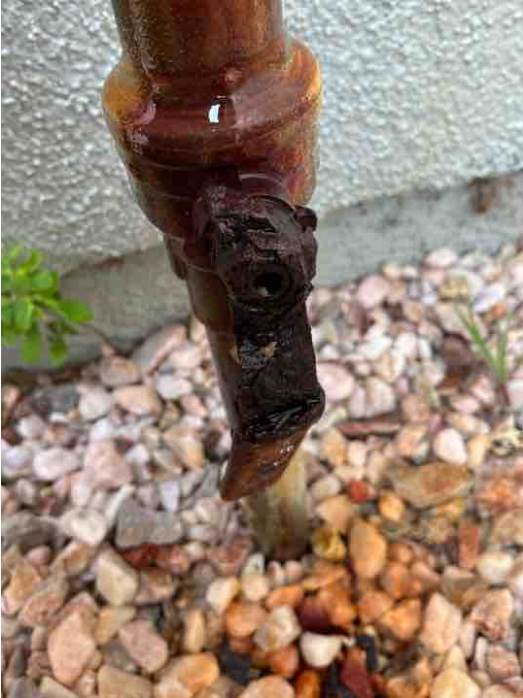
**E&C 65: The Handle rusted and damaged** at the main water supply shut-off valve. Recommend replacement.

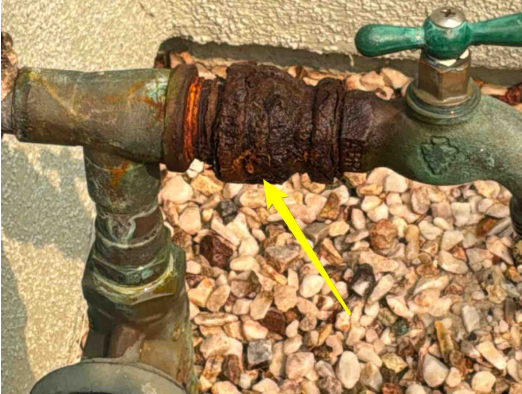
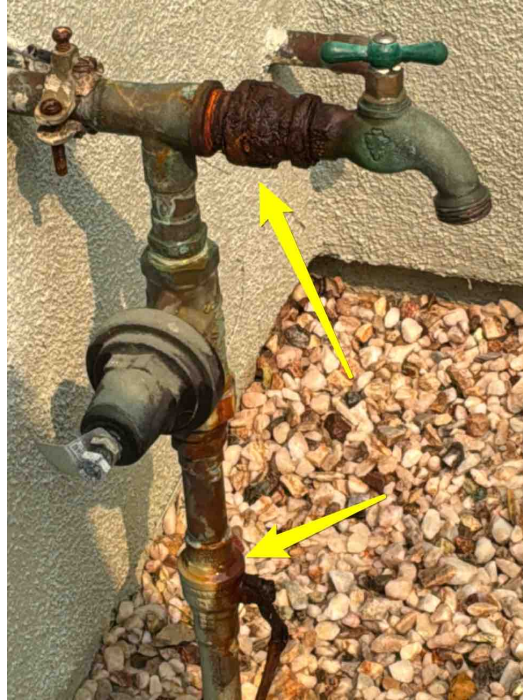
**UPG 70:** Evidence of past leaking with heavy rust and deterioration at a main water supply hose faucet metal fittings.

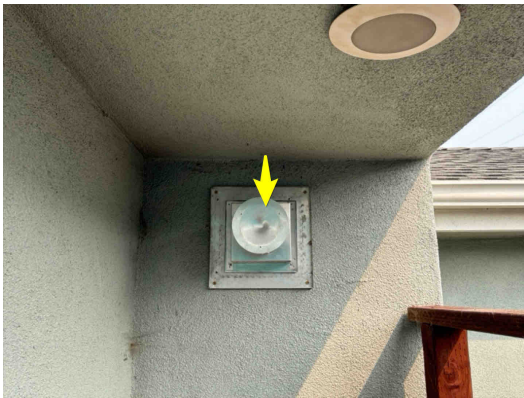
Improper clearance at the direct-vent water heater termination. The Bradford White RG2DV40S6N vent termination was observed approximately 8 inches or less below the horizontal ceiling/soffit above. Bradford White specifies a minimum 12-inch vertical clearance to a ventilated or unventilated soffit at this location. Recommend correction by a qualified plumbing contractor in accordance with the manufacturer's installation requirements.

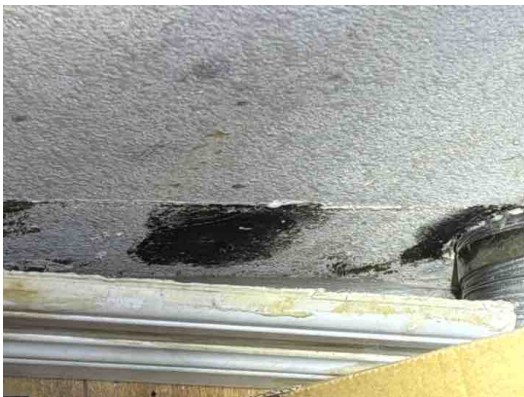
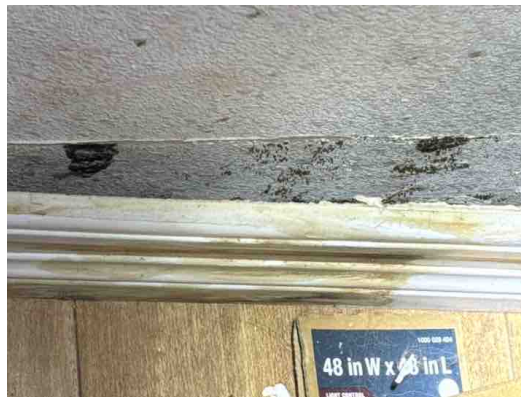
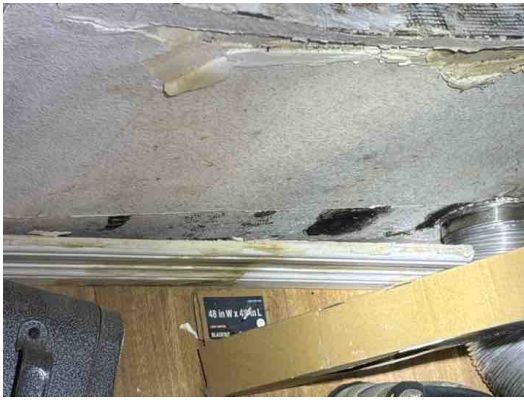
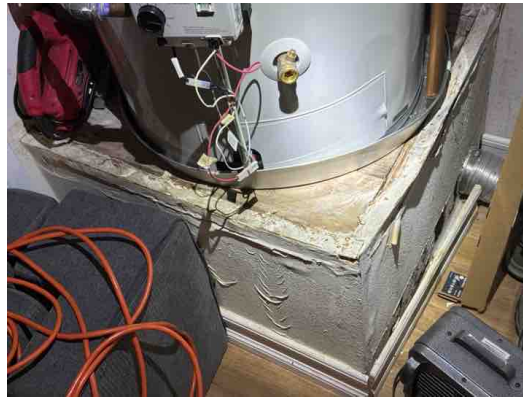
**SC FI 86: Moisture stains and damage at the drywall areas of the water heater platform and/or enclosure. Some visible mold growth noted on areas of the drywall.** Recommend additional review and clean up by a qualified mold remediation professional. Refer to Termite report for additional comments and recommendations.

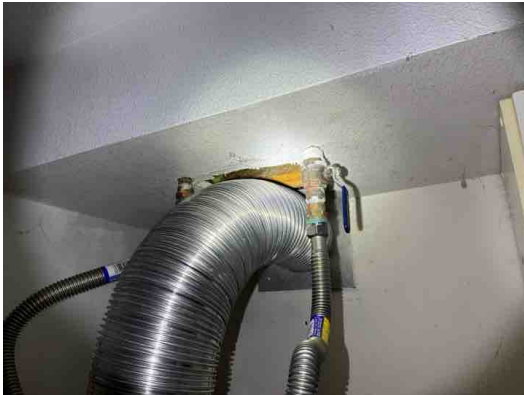
**SC 87:** Some holes found in the water heater enclosure at the ceiling which is part of the garage firewall and needing to be properly sealed for fire safety.

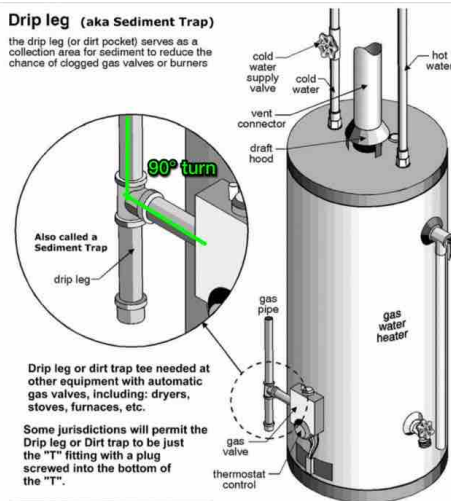
**SU 88:** Recommend the installation of the missing sediment trap / drip leg at the WATER HEATER gas piping at flex connection by a certified or licensed plumbing professional familiar with minimum requirements. [CPC 1212.8]

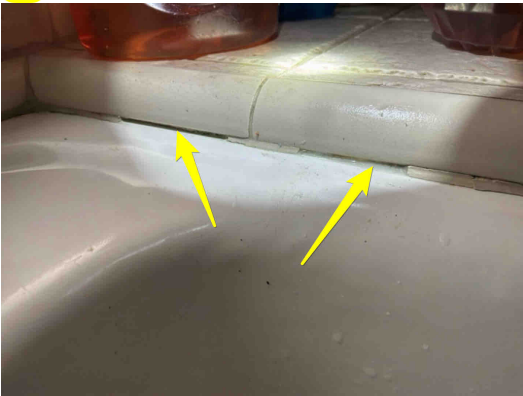
Example

**MR 96:** Recommend sealing the kitchen sink at counter connection.

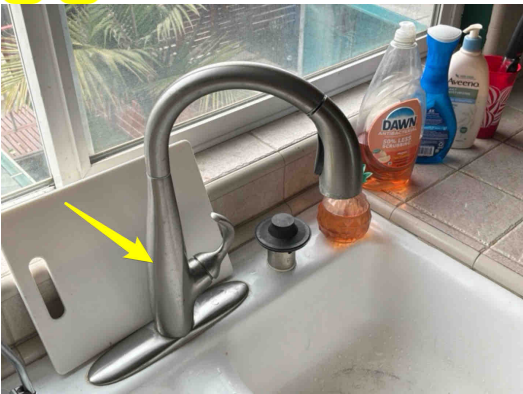
**MR UPG 98:** Kitchen sink faucet found loose at sink or counter connection. Maintenance or repairs Recommended.

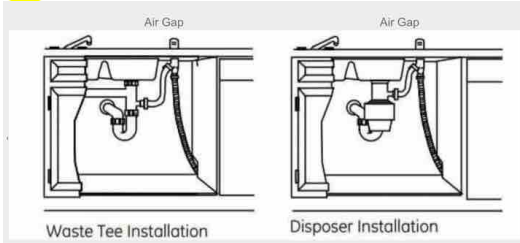
**SU 101:** Recommend an Air Gap Device at the dishwasher drain.

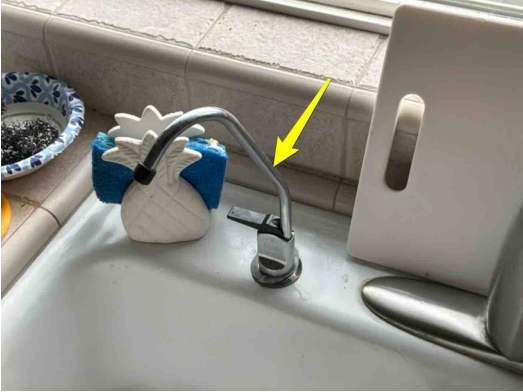
**MR 111:** The faucet at the filtered drinking water system at the Kitchen sink found loose and in need of maintenance or repair.

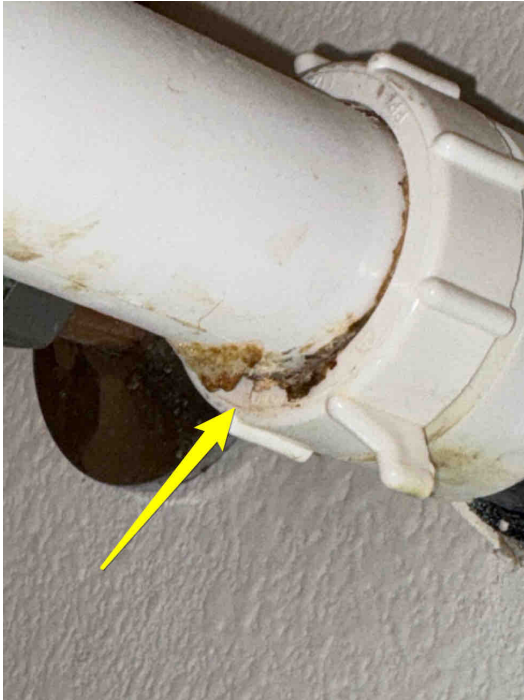
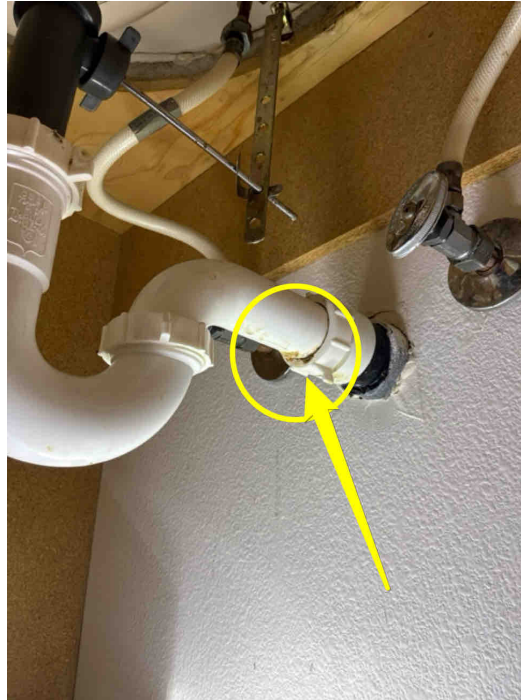
**FI 129:** Some corrosion found at waste pipe connections under the bathroom sink / evidence of past leaking:  
UPSTAIRS 1/2 BATHROOM

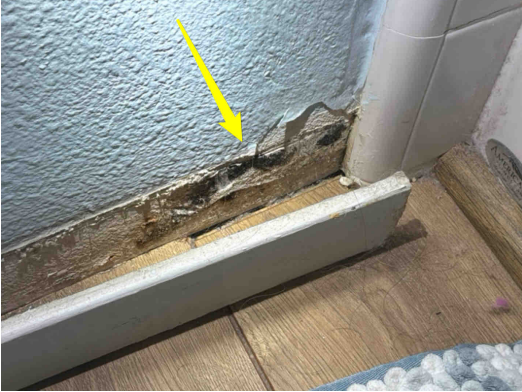
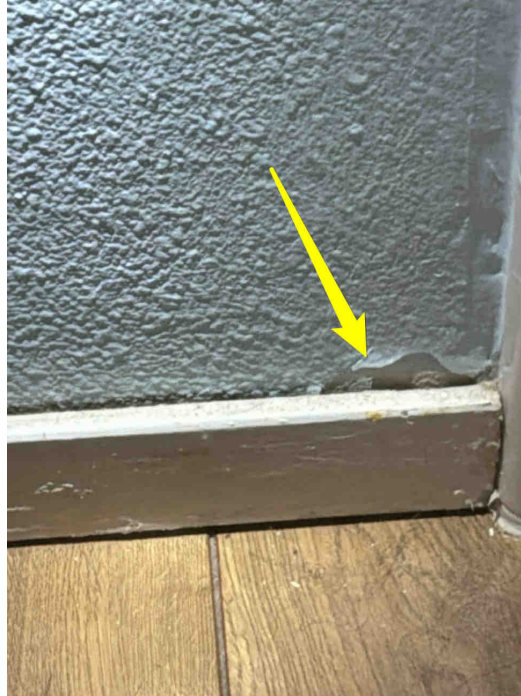
**E&C 133: Moisture stains and damage to wall and baseboards outside tub: PRIMARY BEDROOM BATHROOM.**

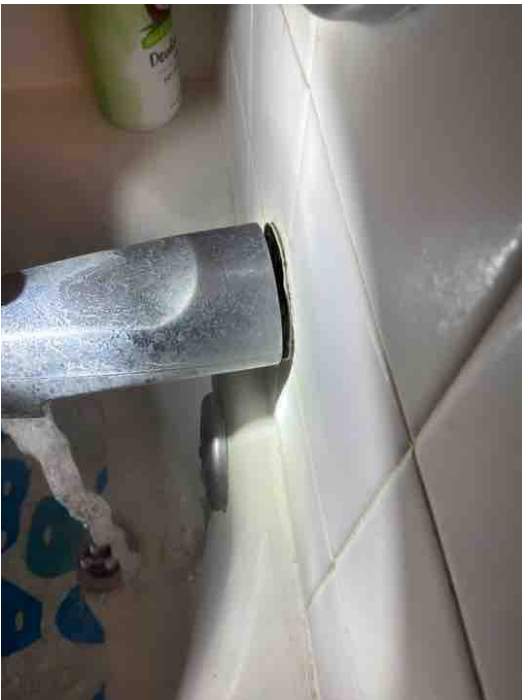
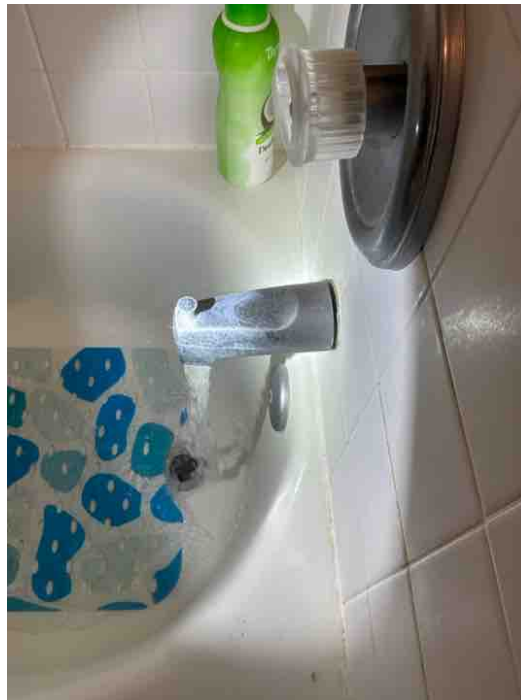
**MR 134: Tub spout found loose and not sealed well at the shower wall connection in the: PRIMARY BEDROOM BATHROOM**

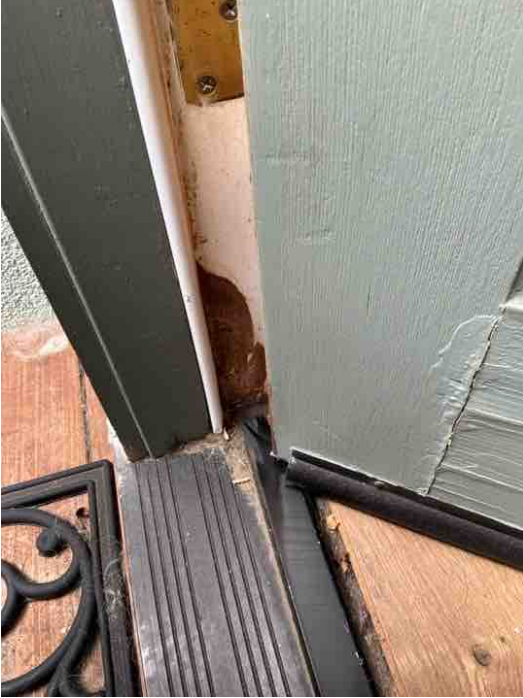
**E&C 142:** Some moisture damage noted at the FRONT ENTRY DOOR and FRAME. Refer to the terminal report for additional comments and recommendations. Corrections and/or upgrades recommended.

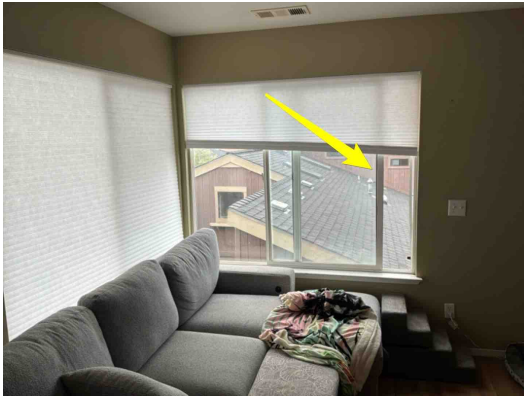
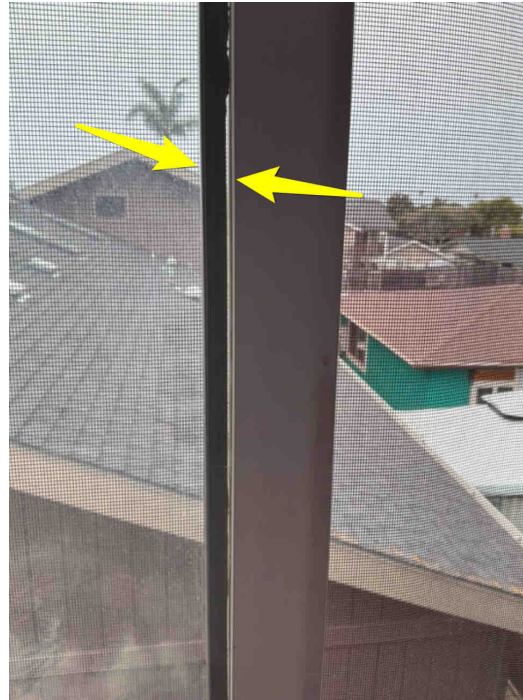
**SC 157:** Some window glass found loose in its frame. Correction Recommended: AT THE UPSTAIRS FAMILY ROOM WEST WALL WINDOW. Recommend contacting a qualified window installation contractor to evaluate all windows and correct as needed.

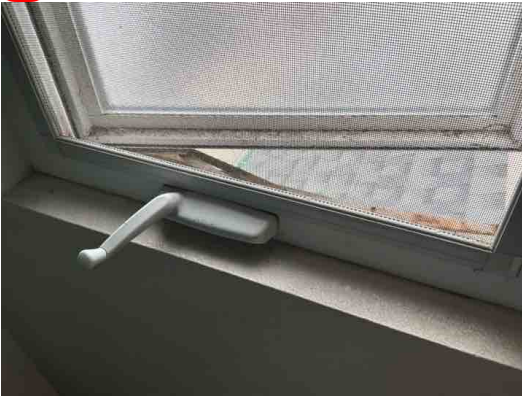
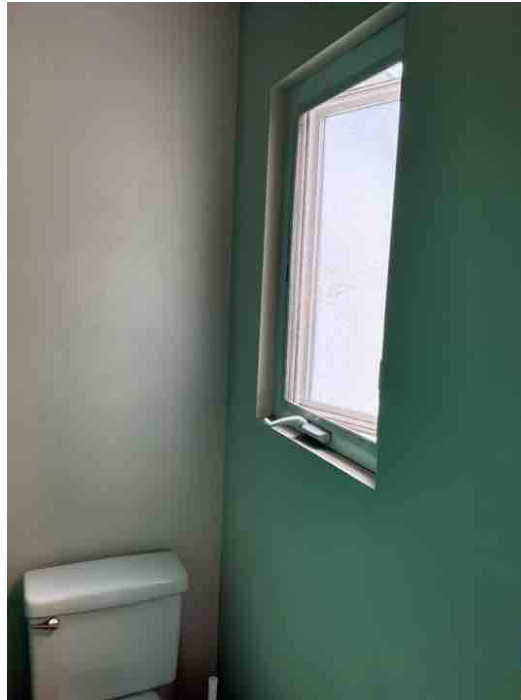
**E&C 158:** Casement crank window in the UPSTAIRS 1/2 BATHROOM found broken and not operational.

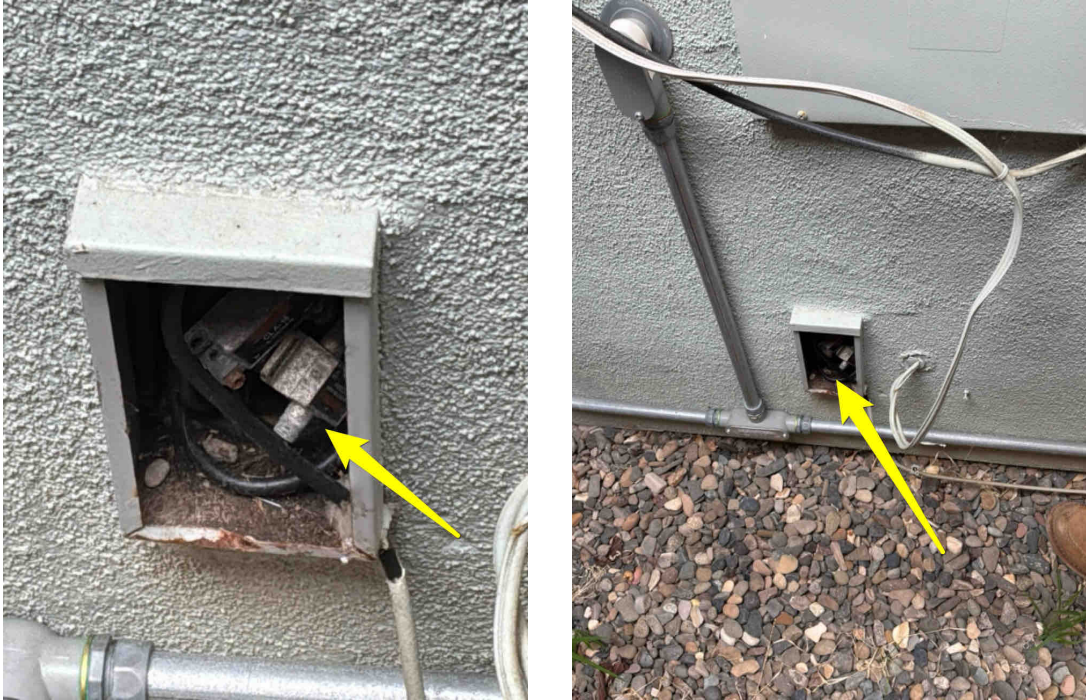
**E&C MR 181:** Missing the cover on the exterior cable TV main junction box located on the: Exterior - Northeast Corner. The cover is needed to help prevent critter and/or water intrusion into the exterior walls. Correction needed.

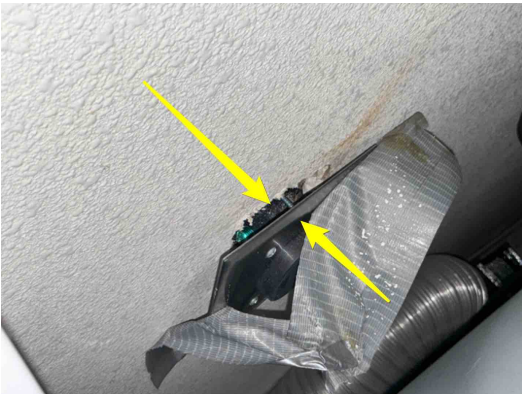
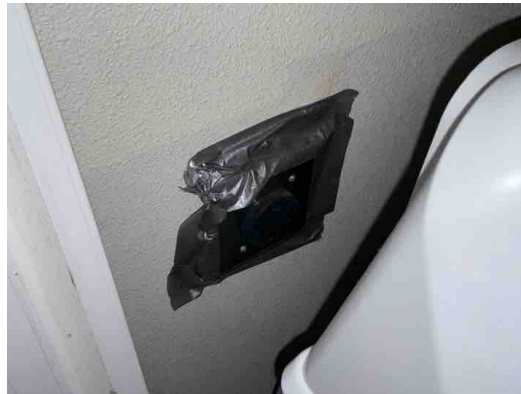
**SC 185:** Laundry room 240 volt here went the first time outlet found not properly install installed flush into the wall behind the laundry dryer.

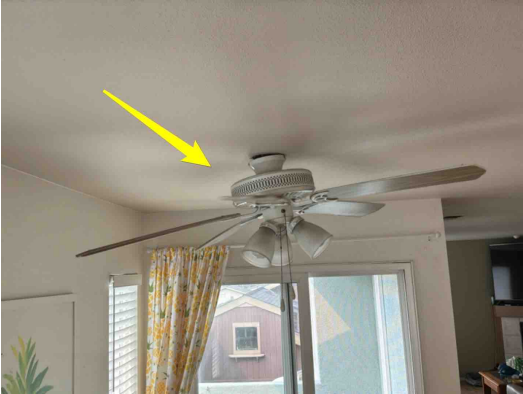
**SC 187:** The ceiling fan hangs crooked in the kitchen area. Contacted qualified Professional to re-hang the ceiling fan.
