Inspector: Blas Calvillo

130 Island View Drive, Lakeport, CA 95453

Inspection prepared for: Schad Schweitzer

Date of Inspection: 9/4/2026 Time: 09:00 AM

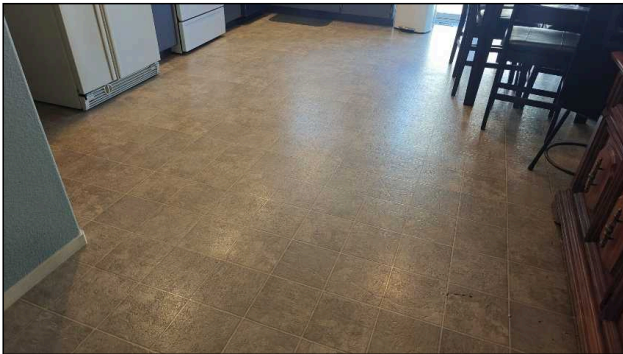
## 1. Floor Condition

The vinyl kitchen flooring is torn, exposing the underlying subfloor or underlayment. A torn floor covering allows spilled liquids to penetrate beneath the vinyl, which can cause water damage or rot to the subfloor over time.

Recommendation: A qualified flooring contractor should repair or replace the damaged vinyl flooring to restore a smooth, continuous surface and protect the subfloor from moisture.

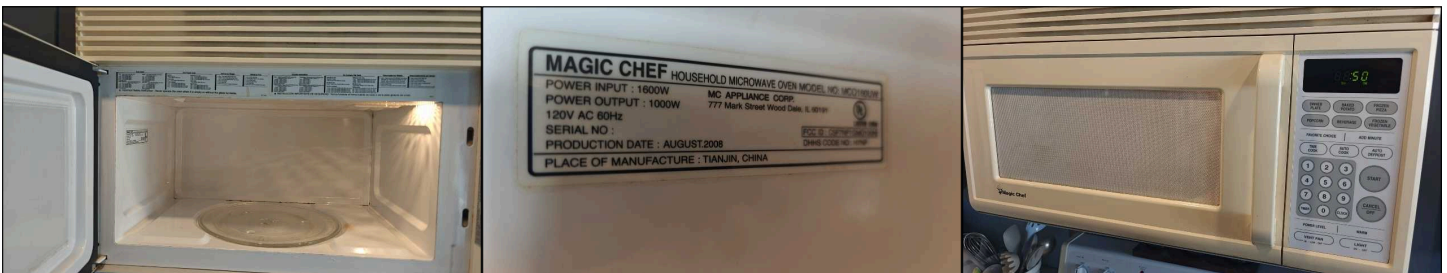
The microwave oven operated when turned on, but it makes an unusual buzzing sound during operation. An abnormal buzzing or humming noise typically indicates a failing internal component, such as the magnetron, high-voltage transformer, or cooling fan. Note that the unit was not fully tested for microwave energy leakage or heating efficiency.

**Recommendation:** A qualified technician should evaluate the appliance to determine the source of the noise, or the client should budget for a future appliance replacement.

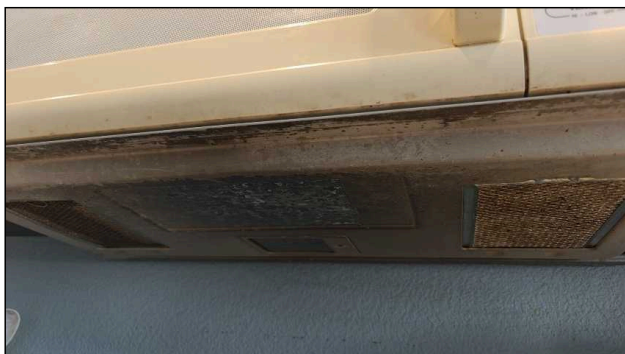
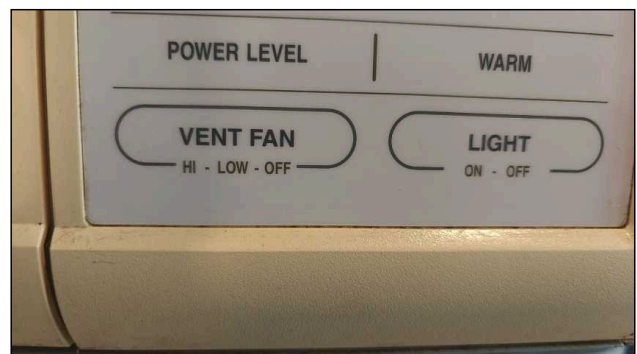
### 9. Vent Condition

The vent hood light did not operate when tested using normal operating controls. This may simply be due to a burned-out bulb, or it could indicate a faulty light switch, socket, or internal wiring issue.

**Recommendation:** Replace the bulb to verify operation. If replacing the bulb does not resolve the issue, a qualified person should evaluate and repair the light fixture or switch mechanism as needed.

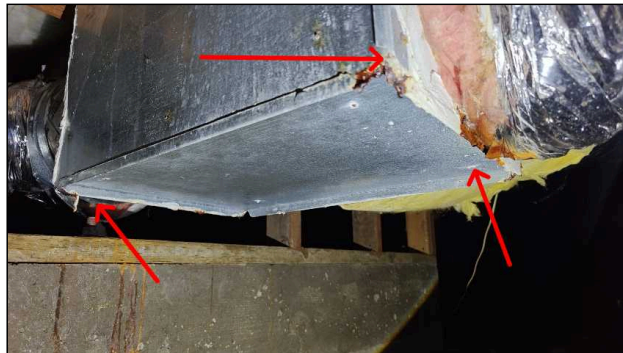
## 2. AC Compress Condition

The air conditioner unit was manufactured in 2001, appeared to be in good condition, and operated normally when tested using normal operating controls. However, the system is 25 years old and has exceeded its typical design life expectancy of 15 to 20 years.

The air conditioning condensate drain line is improperly terminated in the crawlspace below the air handler, discharging water directly onto the crawlspace floor.

Additionally, condensate appears to be leaking directly out of the supply ducting plenum. Discharging and leaking water under the home creates excessive moisture levels, which can lead to foundation wood rot, structural framing decay, and accelerated mold growth.

Recommendation: Due to its advanced age, budget for future replacement and have the system serviced annually by a licensed HVAC technician to maximize its remaining operational life.

Recommendation: A licensed HVAC technician should be contacted to evaluate the system. They should properly route the condensate drain pipe to the exterior of the home (or to an approved drainage location) and seal the leaking ducting plenum to ensure all moisture is safely contained and discharged.

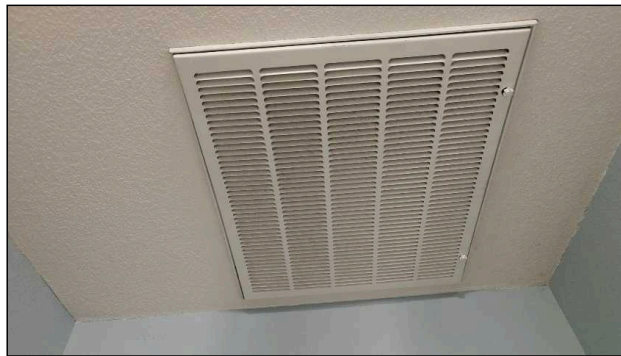
## 3. Filters

The air filter located in the hallway ceiling return grille is dirty and restricted with dust and debris. A clogged air filter restricts airflow, which reduces the efficiency of the HVAC system, increases utility costs, and can cause the 2002 furnace to overheat and short-cycle, leading to premature component failure.

Recommendation: The air filter should be replaced immediately. Establish a routine maintenance schedule to inspect and replace the filter every 30 to 90 days to ensure optimal system performance and indoor air quality.

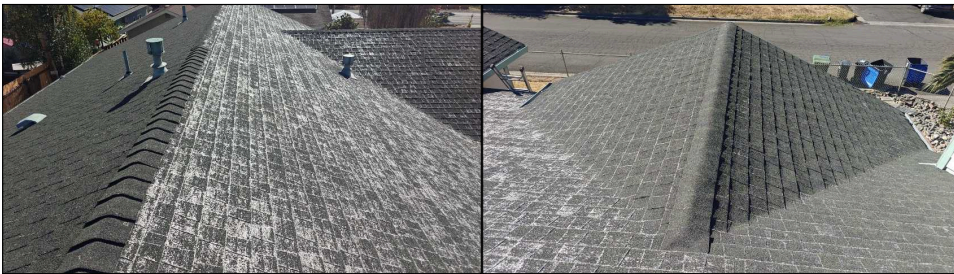
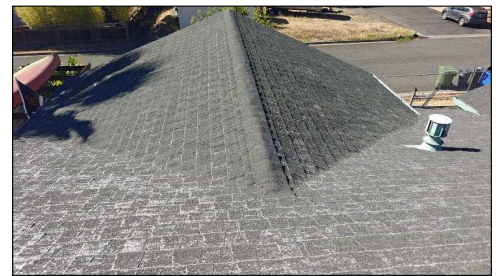
## 1. Roof Condition

Excessive granule loss was observed on the roof shingles, and the plumbing vent boots are torn. The loss of protective granules accelerates asphalt shingle deterioration from UV exposure, while the torn rubber boots create an active path for rainwater to leak directly into the roof framing and attic space.

**Recommendation:** A licensed roofing contractor should be contacted to evaluate the roof, replace the torn plumbing vent boots, and determine the remaining serviceable life of the shingles.

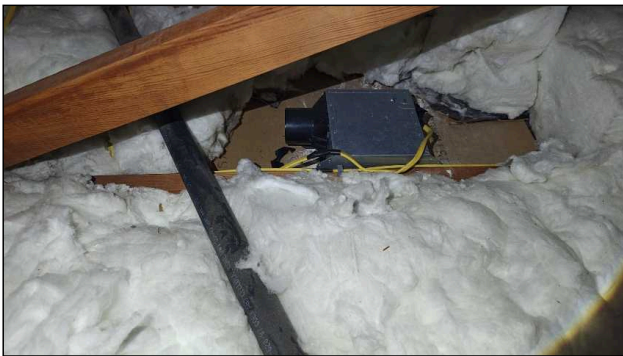
### 4. Exhaust Vent

The bathroom exhaust fan is installed without any ducting, causing it to discharge warm, moist air directly into the attic space rather than to the exterior of the home. Venting moist air into an enclosed space can trap humidity, leading to condensed water accumulation, wood rot of structural framing, and accelerated mold growth.

Recommendation: A qualified contractor or HVAC specialist should install a dedicated, insulated duct line that vents the exhaust fan directly to the exterior of the home through a proper roof or wall cap equipped with a backdraft damper.
