# WOOD DESTROYING PESTS AND ORGANISMS INSPECTION REPORT

| BUILDING NO.<br><b>5471</b> | STREET, CITY, STATE, ZIP<br><b>Belgrave Avenue, Garden Grove CA 92845</b> | Date of Inspection<br><b>9/2/2026</b> | No. of Pages<br><b>6</b> |
| General Description:<br>One story stucco home with a composition roof and an attached two car garage (occupied). | | Inspection Tag Posted:<br>Attic<br><br>Other Tags Posted:<br>None | |

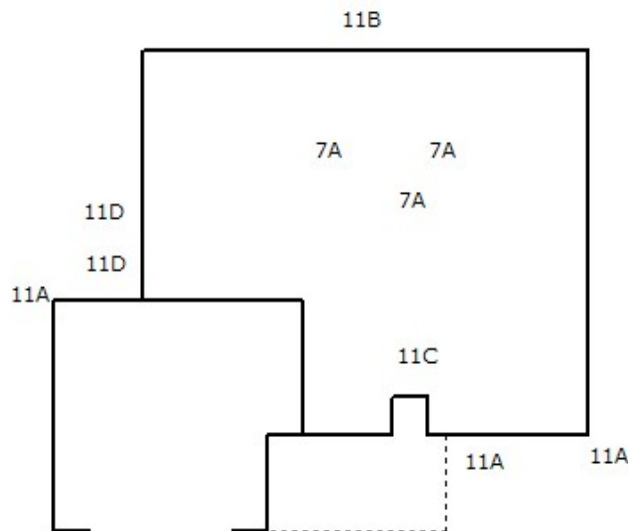
ITEM 7A Evidence of drywood termites noted in the attic.

ITEM 11A Dry rot noted at the fascia.

ITEM 11B Dry rot noted at the sheathing.

ITEM 11C Evidence of drywood termite damage noted at the rafter.

Rec: Manually treat with a toxic chemical, cover or remove the evidence.

Rec: Remove the damaged wood. If no further damage is exposed, install new lumber. NOTE: If further inspection reveals an infestation/infection in the wood, a supplemental report will be issued and an additional cost may apply.

Rec: Remove the damaged wood. If no further damage is exposed, fill or replace the damaged wood. NOTE: If further inspection reveals an infestation/infection in the wood, a supplemental report will be issued and an additional cost may apply.
