# ***Cornerstone Inspection***

## **Property Inspection Report**

***512 S Elm St, Arroyo Grande, CA 93420***

***Date of Inspection: 9/11/2026 Time: 9:00 AM***

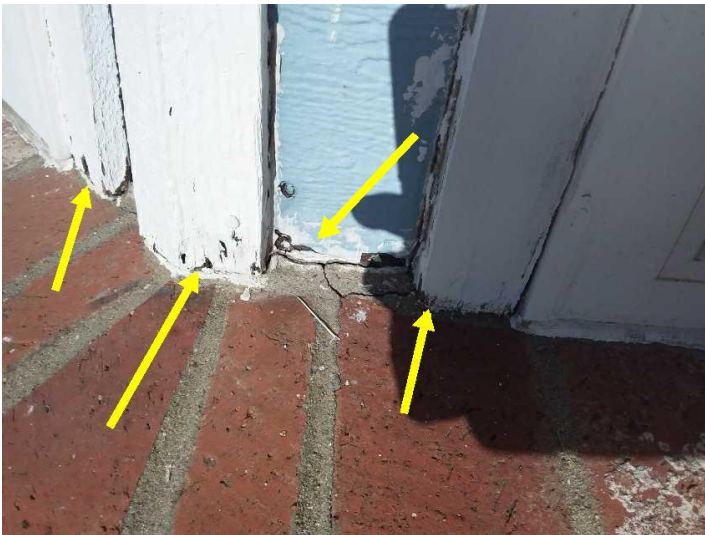
Portions of the wood siding are dry rot or moisture damaged, and should be evaluated by a termite inspector.

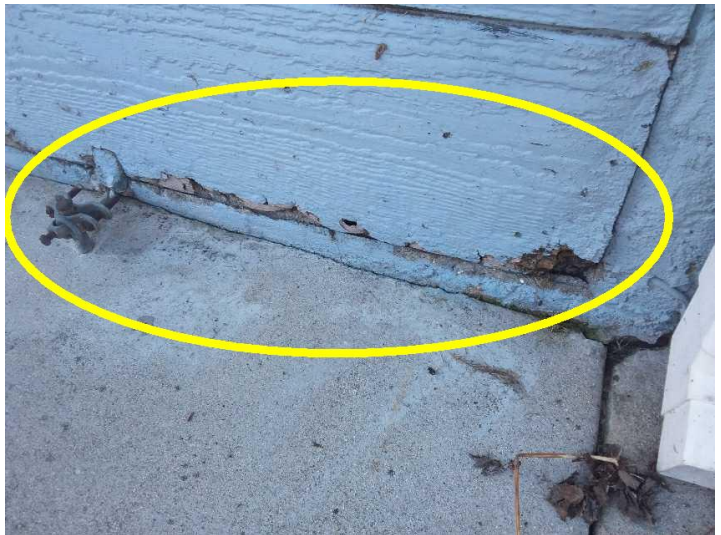
Portions of the wood siding are dry rot or moisture damaged, and should be evaluated by a termite inspector.

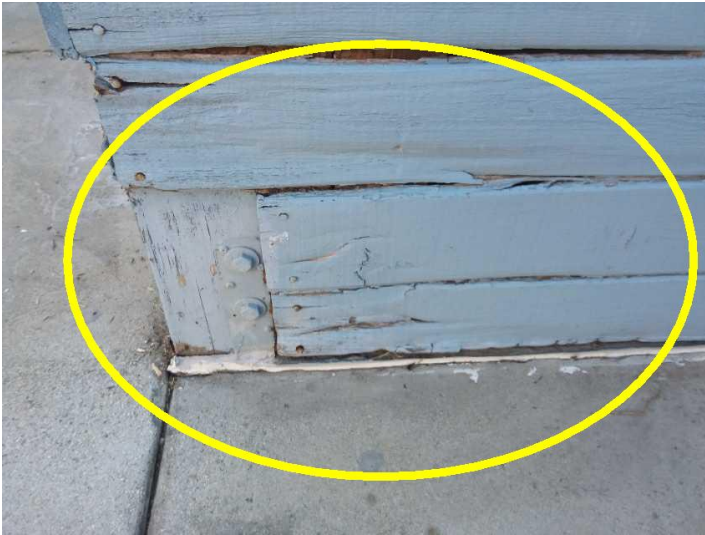
Portions of the wood siding are dry rot or moisture damaged, and should be evaluated by a termite inspector.

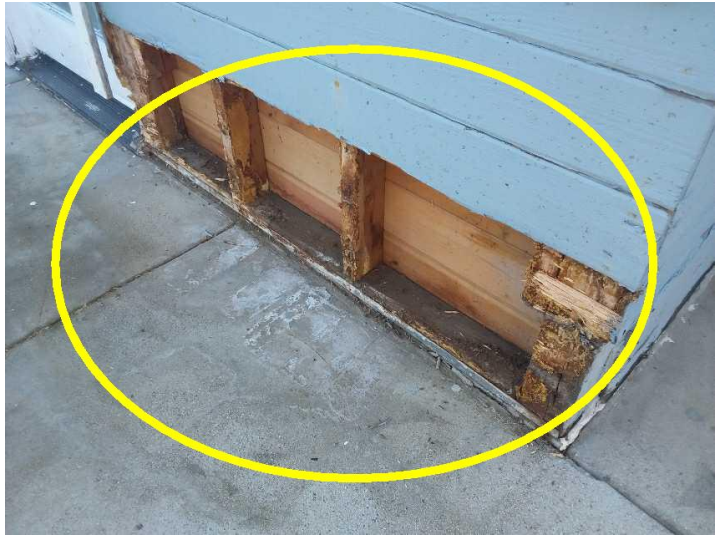
The siding needs typical maintenance such as sealing and painting.

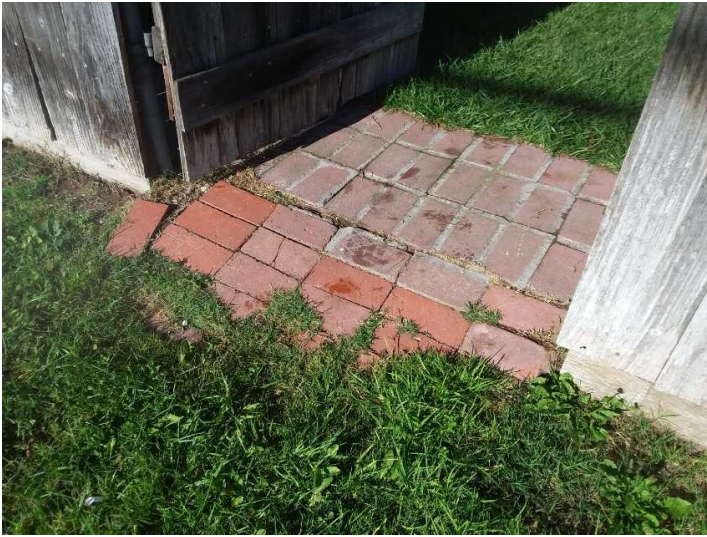
The paver patio or walkway has multiple offsets. This may be due to unsuitable soil below the pavers.

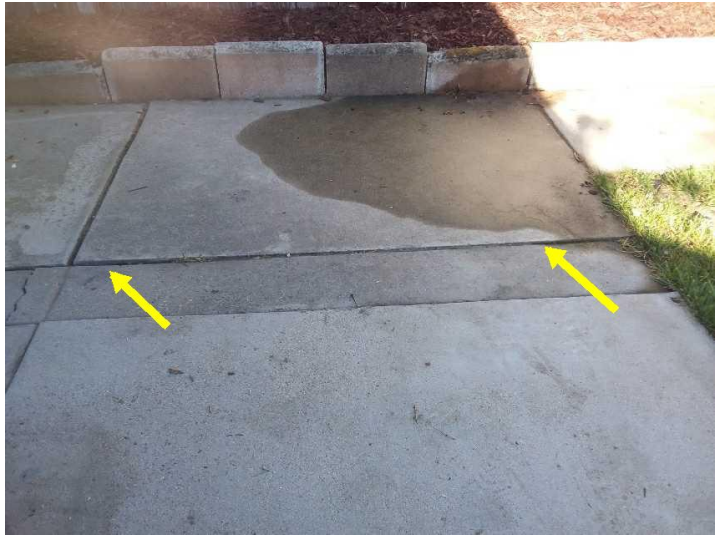
There is one or more offsets in the walkways that could prove to be trip-hazards.

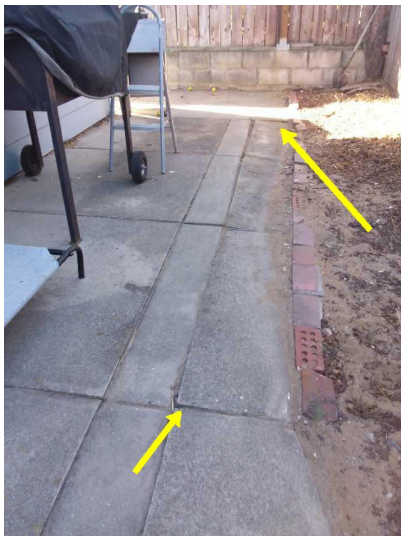
There is one or more offsets in the walkways that could prove to be trip-hazards.

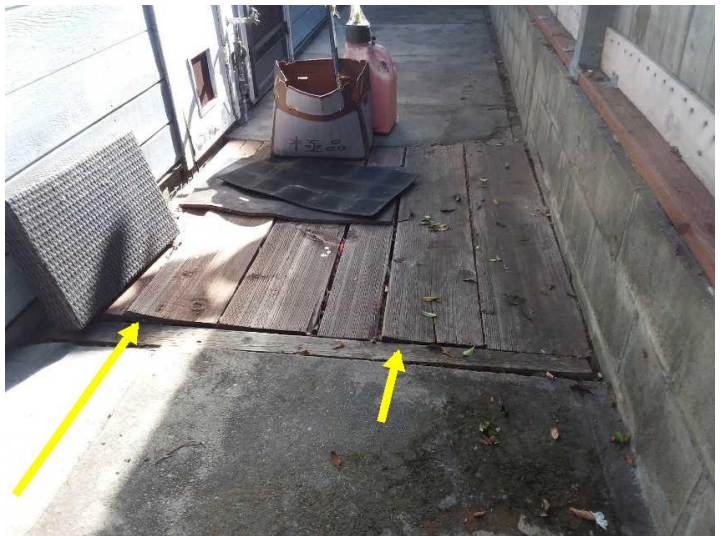
There is one or more offsets in the walkways that could prove to be trip-hazards.

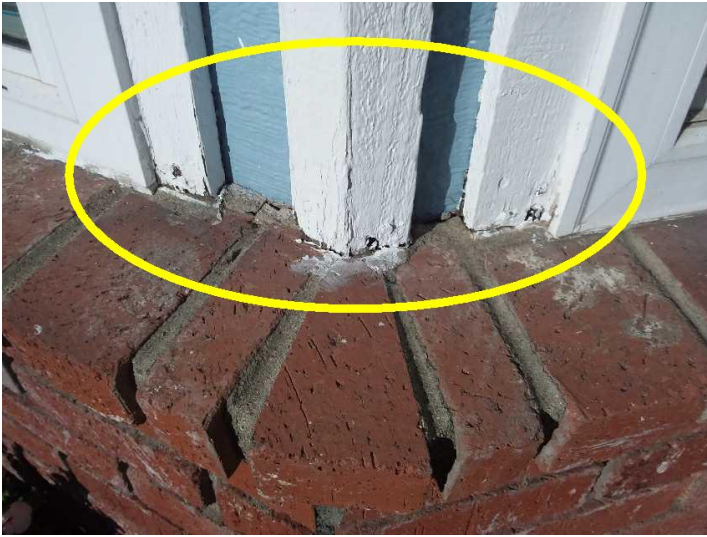
There is damage to the wood trim that should be evaluated by a termite inspector.

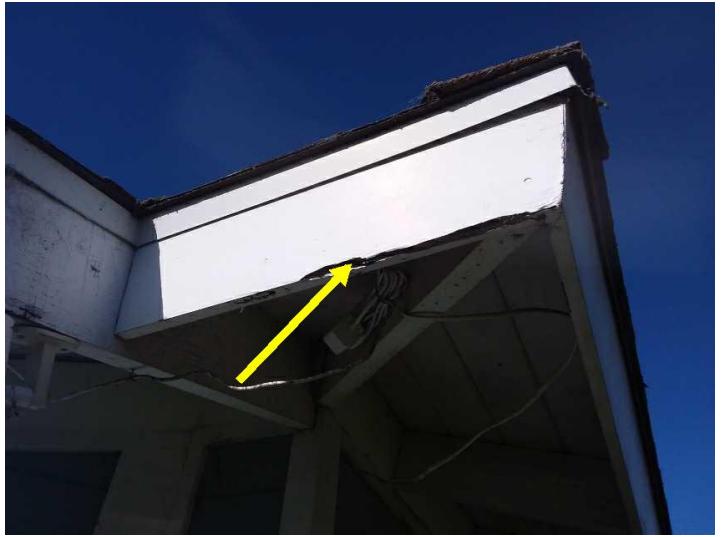
There is damage to the wood trim that should be evaluated by a termite inspector.

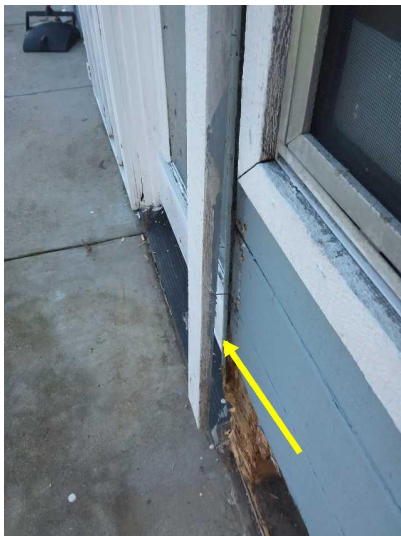
Sections of the fascia board or wood trim are weathered and have separated slightly, and should be serviced to prevent further deterioration.

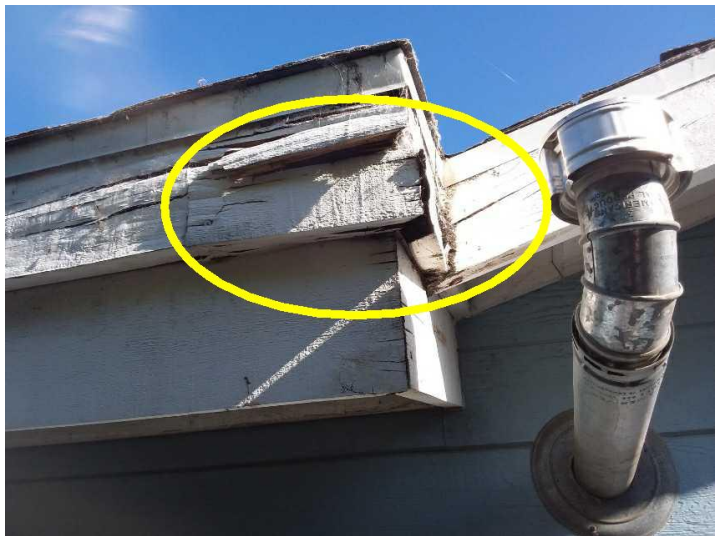
There is damage to the wood trim that should be evaluated by a termite inspector.

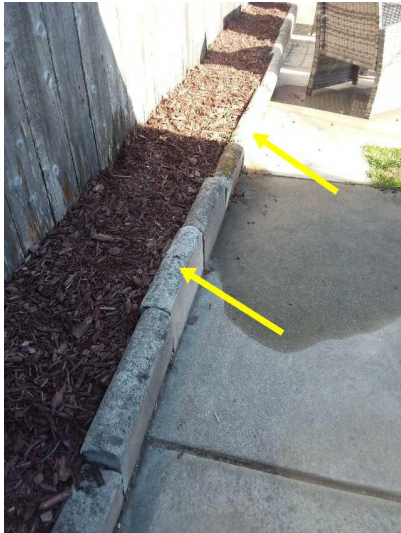
Some of the planter block-caps are loose or missing and should be serviced.

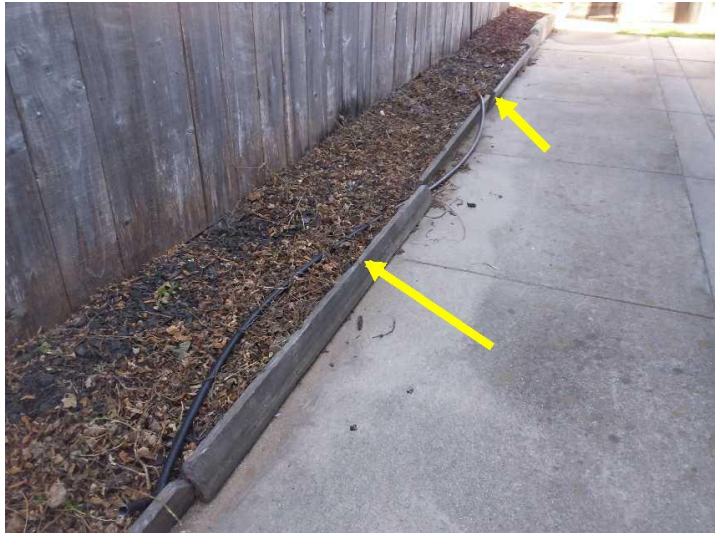
The wooden planks at the rear of the property have no structural value, and are intended to inhibit surface soil movement, and should be periodically monitored for damage or stability.

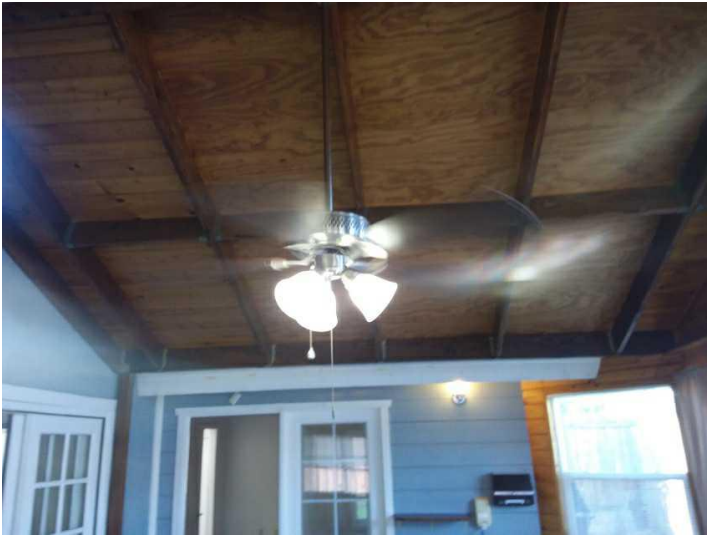
The ceiling fan is functional but out of balance and should be serviced so the fan operates smoothly.

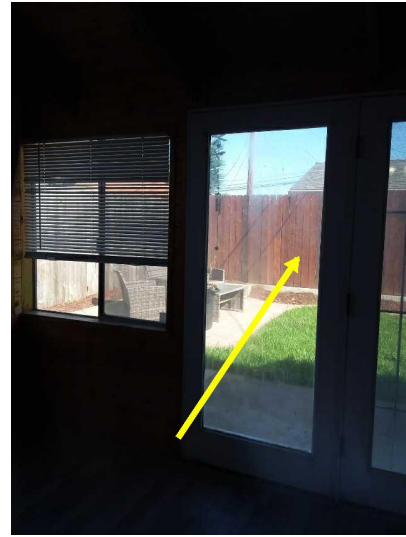
One or more windows may have a broken hermetic seal, and should be replaced. This is evident from fogging, or condensation forming between the panes of glass, that confirm that the seal has failed.

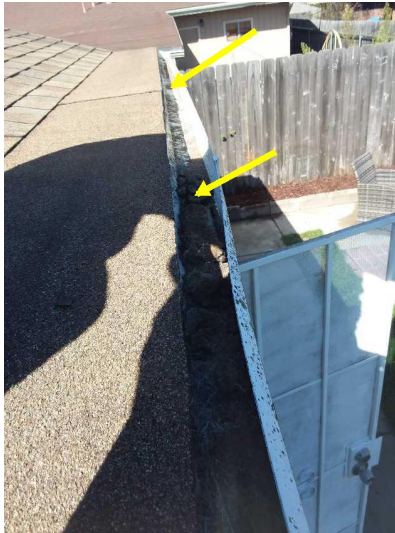
Some of the gutters need to be cleaned to drain properly.

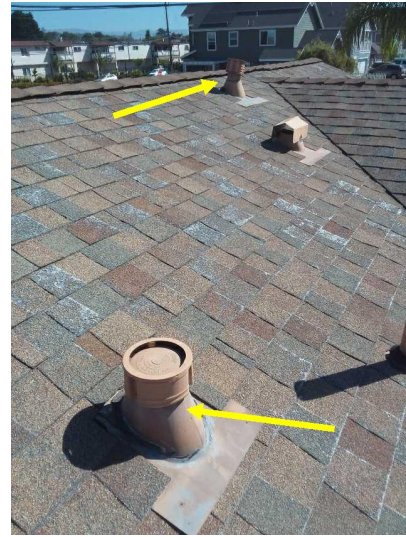
A rain collar is missing on a heat vent and should be installed.

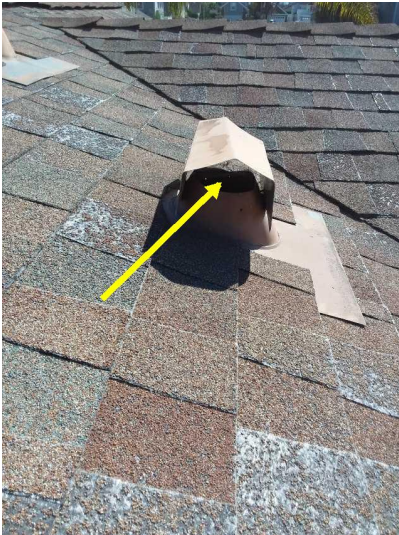
Some of the roof flashing need to be sealed or serviced. They are comprised of metal that seals valleys and vents and other roof penetrations, and are the most common point of leaks. This is particularly true of the flashing on a layered roof, which are covered by the roofing material and which are even more susceptible to leaks.

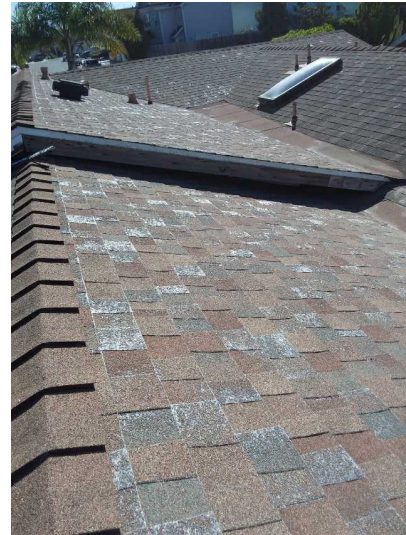
| Page 17 Item: 2 | Composition Shingle Observations | 2.7. The southside roof is at the end of its serviceable life, and should be evaluated by a licensed roofing contractor, because it could leak and the cost of replacing it could affect you evaluation of the property. |

The southside roof is at the end of its serviceable life, and should be evaluated by a licensed roofing contractor, because it could leak and the cost of replacing it could affect your evaluation of the property.

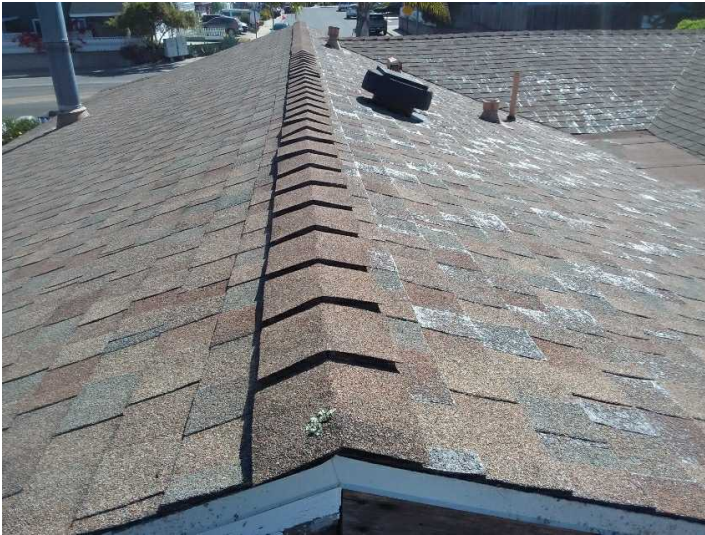
The southside roof is at the end of its serviceable life, and should be evaluated by a licensed roofing contractor, because it could leak and the cost of replacing it could affect you evaluation of the property.

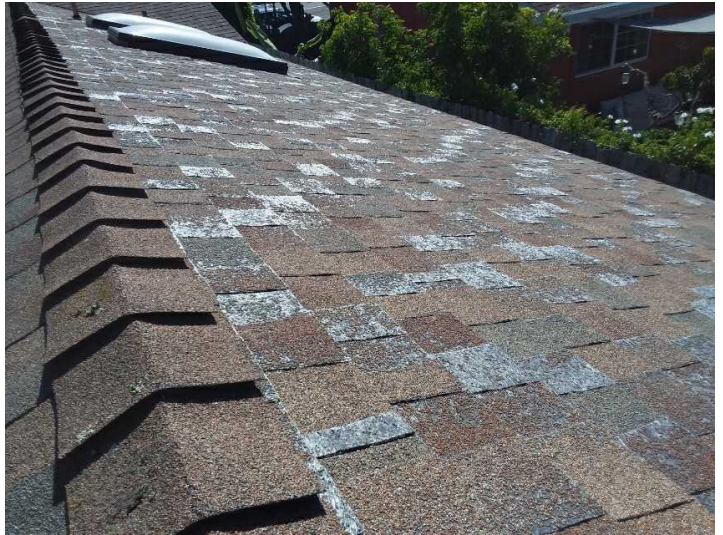
The southside roof is at the end of its serviceable life, and should be evaluated by a licensed roofing contractor, because it could leak and the cost of replacing it could affect you evaluation of the property.

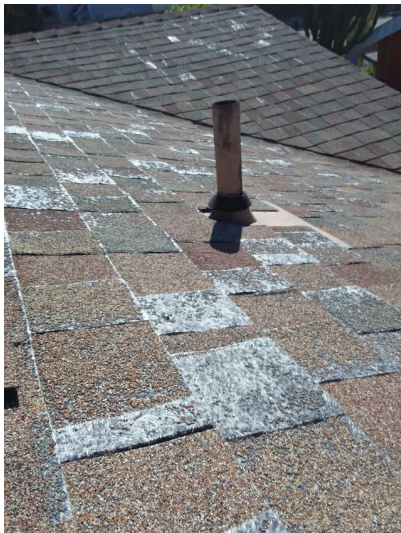
The southside roof is at the end of its serviceable life, and should be evaluated by a licensed roofing contractor, because it could leak and the cost of replacing it could affect you evaluation of the property.

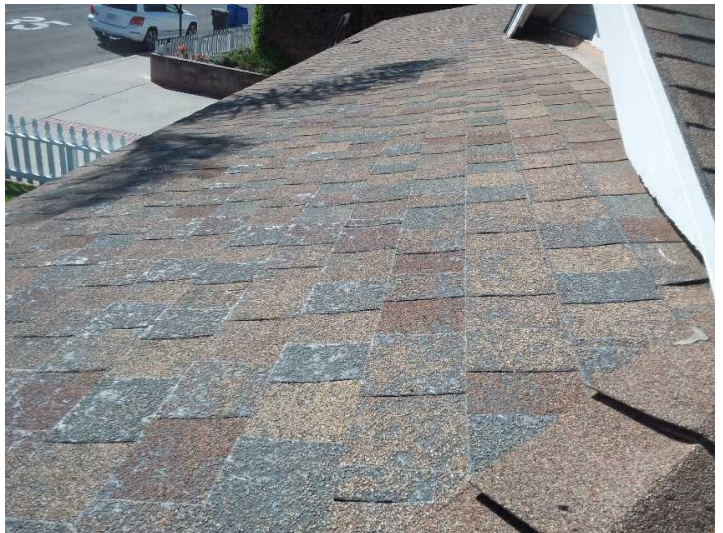
The southside roof is at the end of its serviceable life, and should be evaluated by a licensed roofing contractor, because it could leak and the cost of replacing it could affect you evaluation of the property.

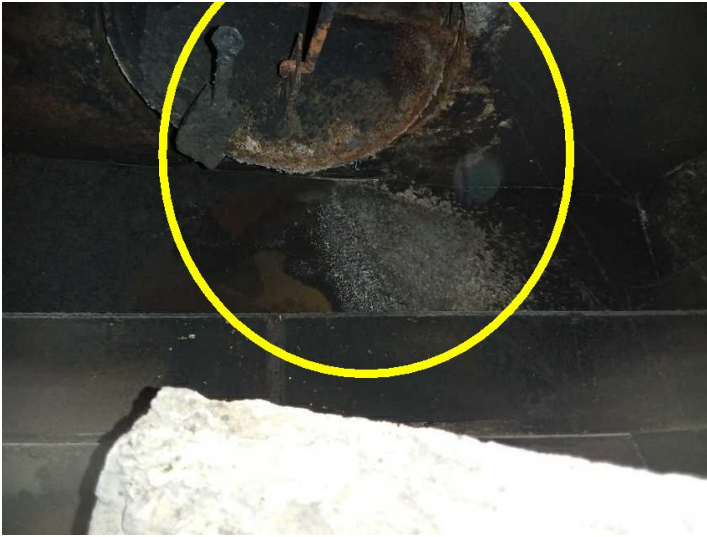
There is evidence that implies the flue may be leaking which should be evaluated to determine if the flue is leaking, or the roof flashing is defective.

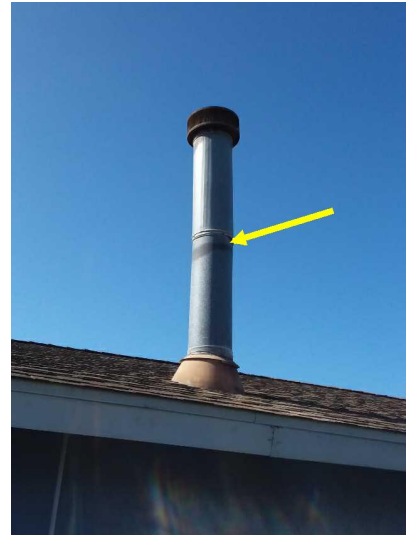
This chimney extends more than six feet above the roofline and is not braced, and you may wish to consider having it braced, or have a specialist evaluate.

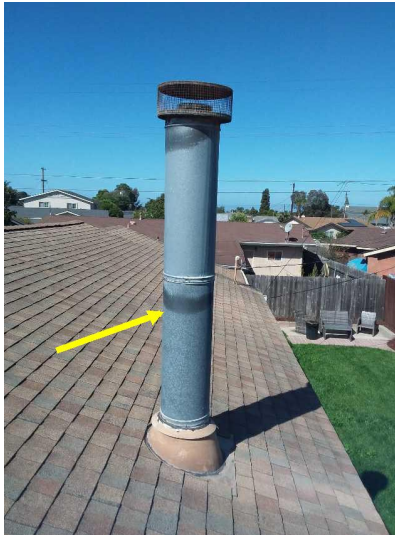
This chimney extends more than six feet above the roofline and is not braced, and you may wish to consider having it braced, or have a specialist evaluate.

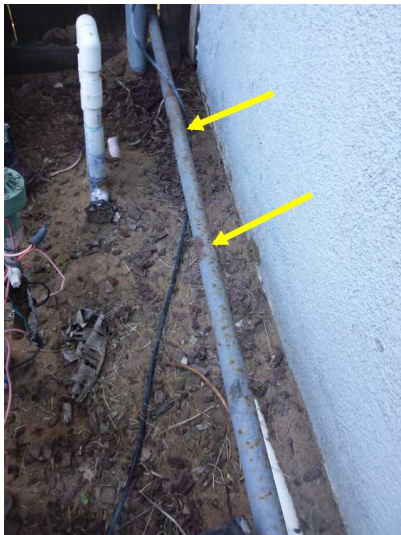
A gas pipe on the exterior of the home is rusted and should be painted to prevent further corrosion.

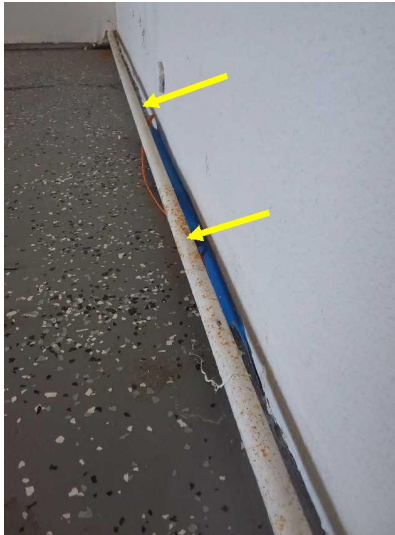
2.4. A gas pipe on the exterior and in garage of the home is rusted and should be painted to prevent further corrosion.

A gas pipe on the exterior and in garage of the home is rusted and should be painted to prevent further corrosion.

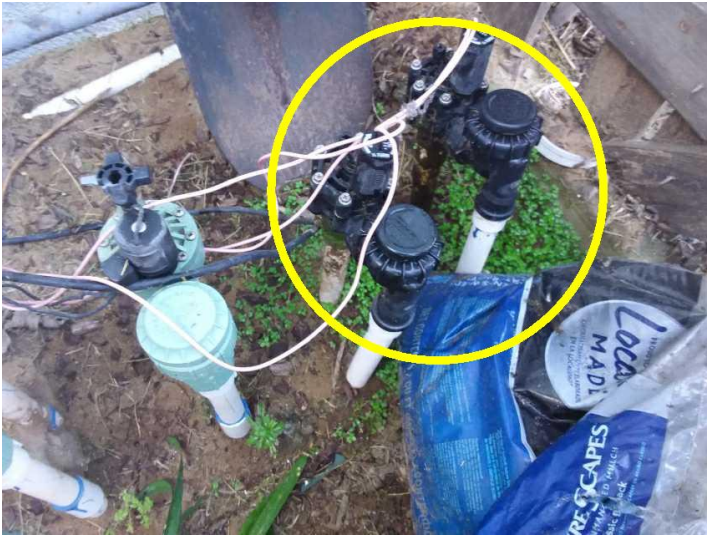
A sprinkler valve located at the right side is leaking and should be repaired.

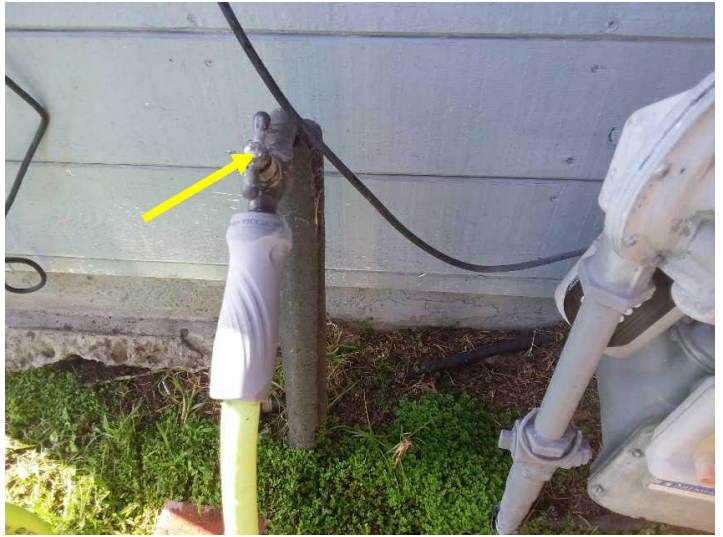
3.5. A hose bib at the right side leaks when activated and should be serviced.

A hose bib at the right side leaks when activated and should be serviced.

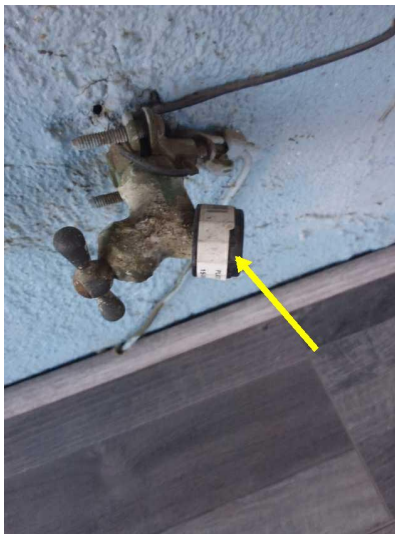
A hose bib has been capped which implies it might be dripping, which you may want to have evaluated.

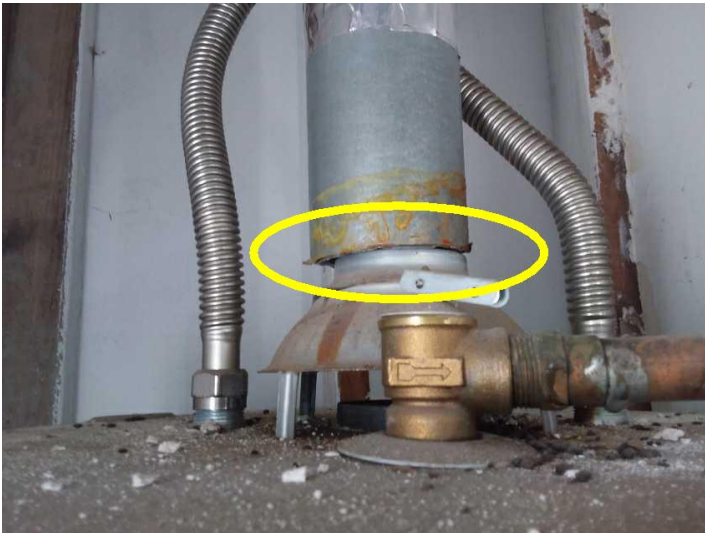
The vent pipe is disconnected and will not effectively draft the bi-products of combustion beyond the residence, and should be serviced.

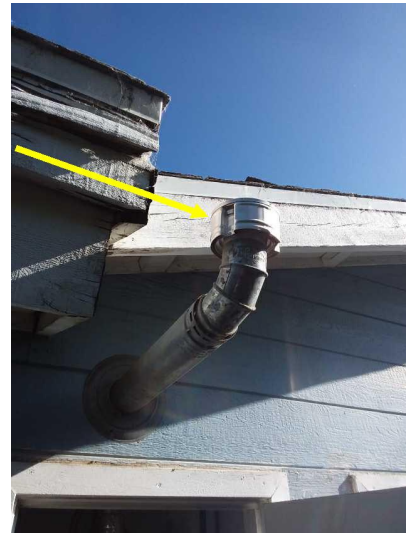
The vent pipe should extend above the roofline, to safely discharge the bi-products of combustion beyond the residence, and should be serviced.

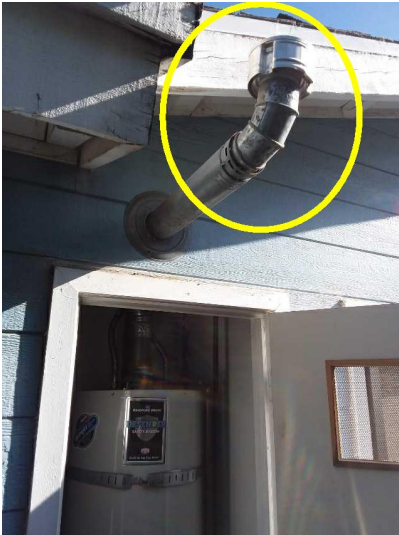
The vent pipe should extend a minimum 5 feet above the flue collar, to safely discharge the bi-products of combustion beyond the residence, and should be serviced.

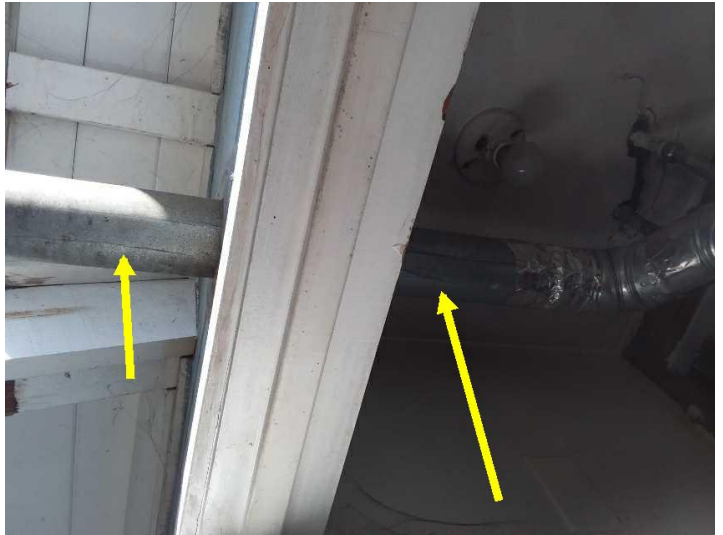
The vent pipe is negatively pitched. To ensure a positive draft, it should rise at one-quarter inch per foot, and should be serviced.

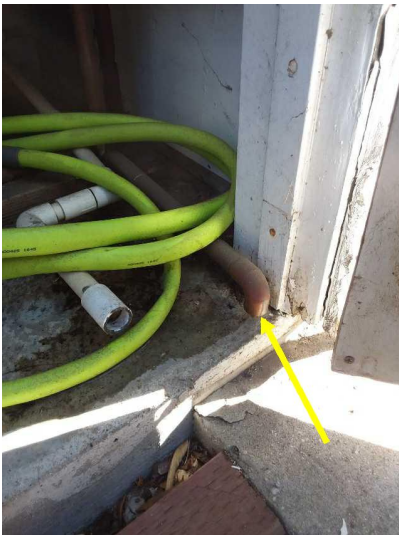
The discharge pipe from the relief valve should be extended beyond the exterior closet, so that if it activates water will not contaminate the closet walls.

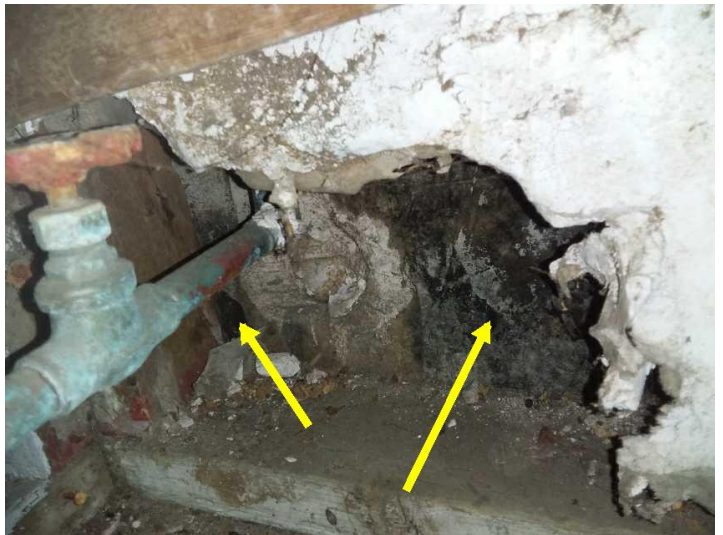
4.23. We have observed a mold like staining within the water heater closet that should be evaluated by a specialist.

We have observed a mold like staining within the water heater closet that should be evaluated by a specialist.

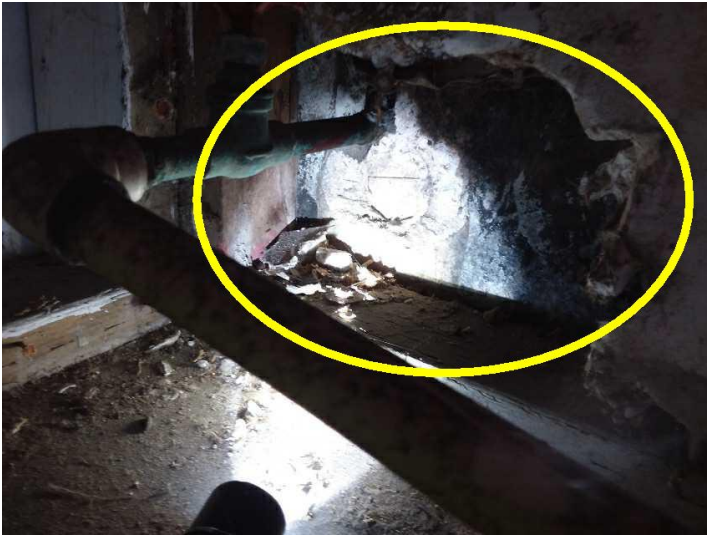
We have observed a mold like staining within the water heater closet that should be evaluated by a specialist.

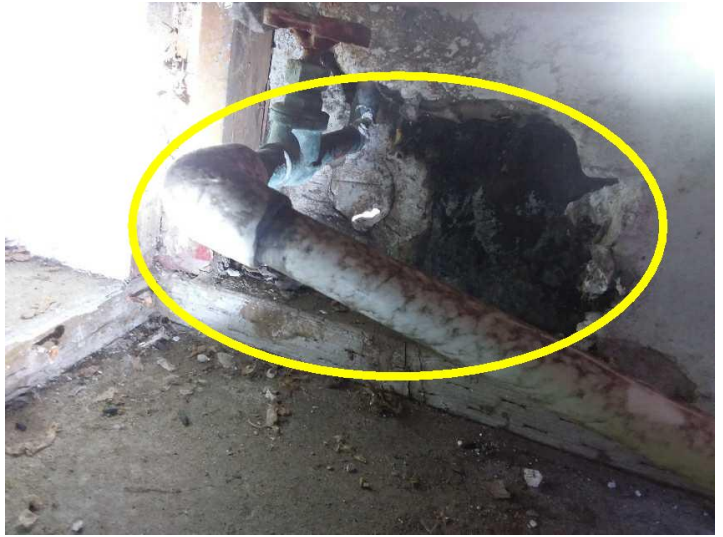
We have observed a mold like staining within the water heater closet that should be evaluated by a specialist.

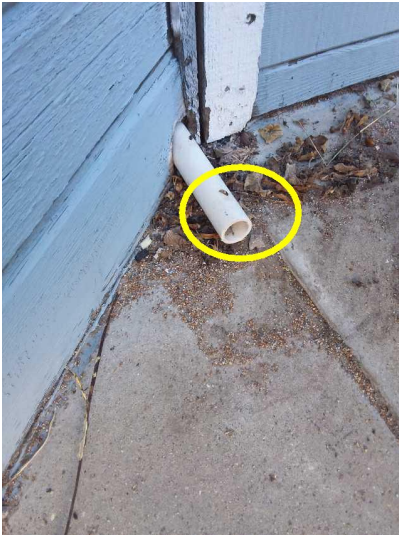
The discharge pipe is plumbed incorrectly to discharge into a drain pan. It or the drain pan should be plumbed to discharge at the exterior and terminate at a point no more than twenty-four inches above grade and no less than six inches to it.

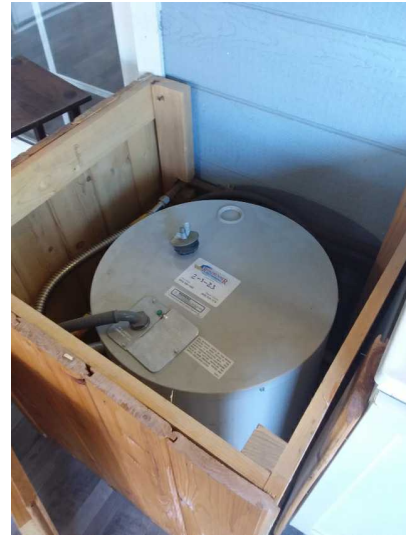
The water heater is not correctly secured, and needs to be seismically strapped and braced in accordance with local standards.

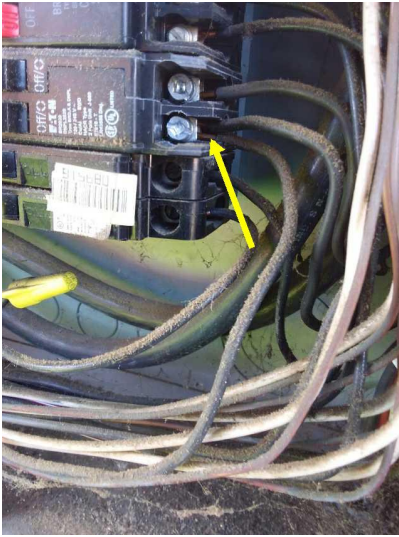
| Page 32 Item: 1 | Main Electrical Panel | 1.11. Breakers in the main panel are serving two circuits, which could overload the circuits, and there is no room within the panel to add additional breakers. This condition should be evaluated by an electrician as soon as possible, or before the close of escrow. |

Breakers in the main panel are serving two circuits, which could overload the circuits, and there is no room within the panel to add additional breakers. This condition should be evaluated by an electrician as soon as possible, or before the close of escrow.

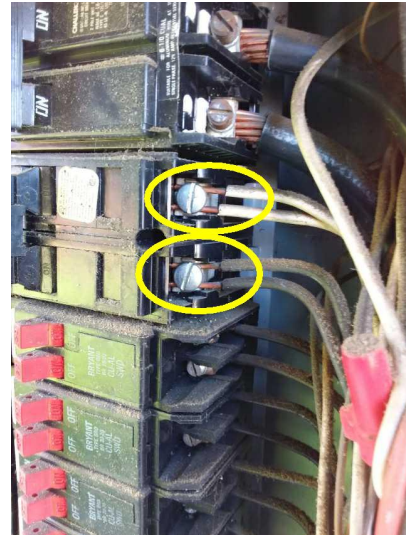
Breakers in the main panel are serving two circuits, which could overload the circuits, and there is no room within the panel to add additional breakers. This condition should be evaluated by an electrician as soon as possible, or before the close of escrow.

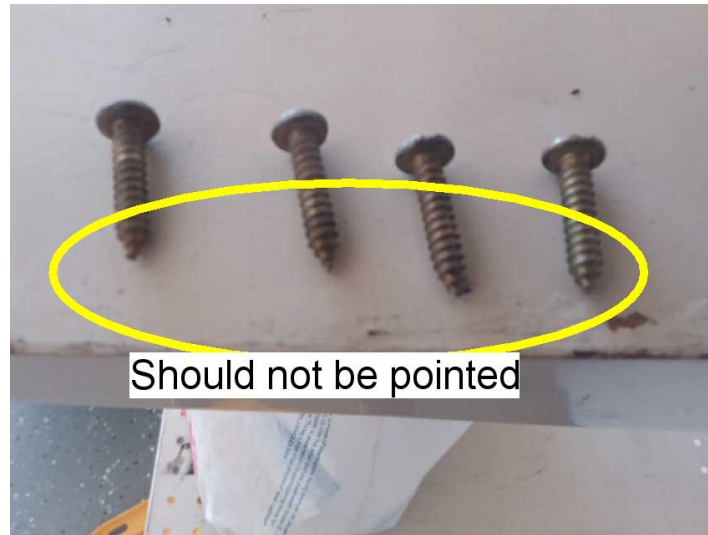
| Page 33 Item: 2 | Sub Panel Observations | 2.8. The interior panel cover has one or more improper fasteners or screws and should be replaced. |

The interior panel cover has one or more improper fasteners or screws and should be replaced.

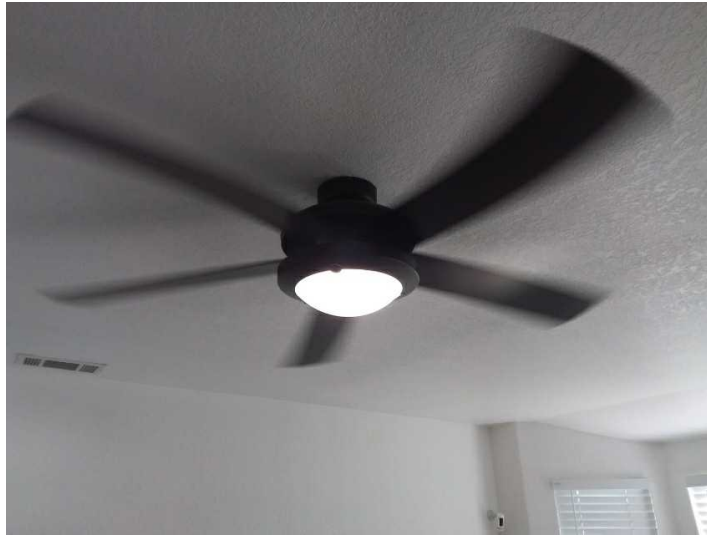
The ceiling fan is functional but out of balance and should be serviced so the fan operates smoothly.

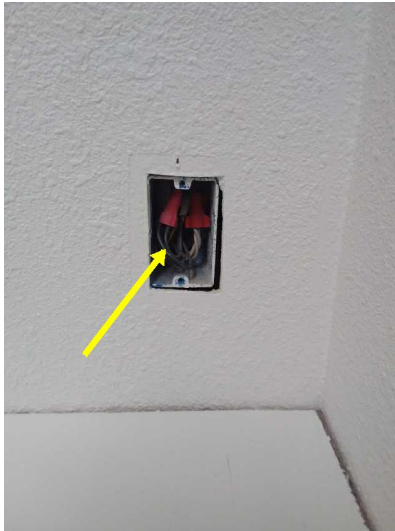
There is an open electrical junction box in the bedroom closet that should be sealed.

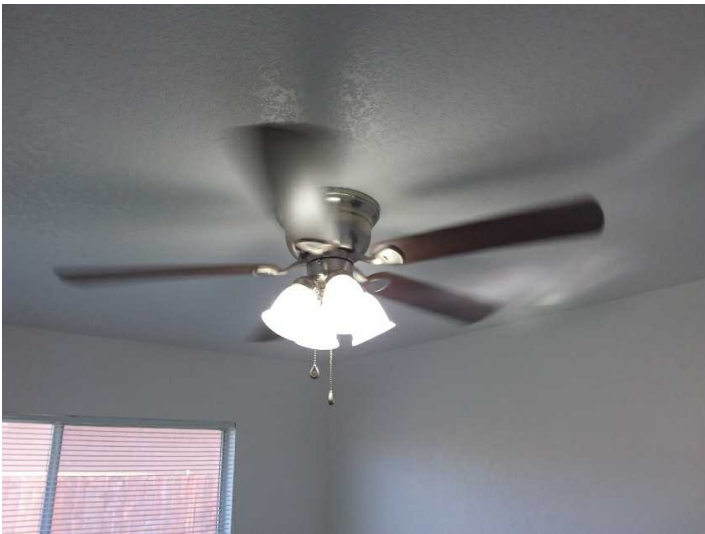
The ceiling fan is functional but rocks at high speeds and should be serviced so the fan operates smoothly.

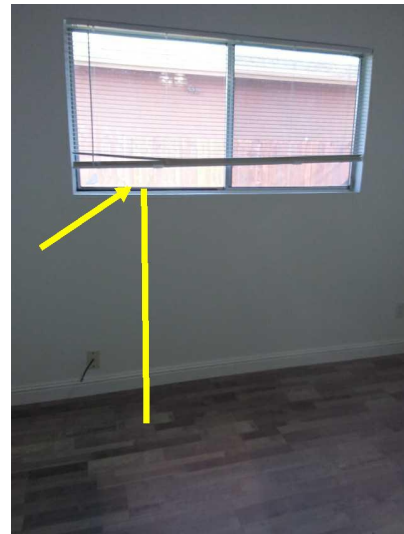
A window is too high or too small to facilitate an emergency exit or egress. Bedroom windows should measure 24" high by 20" wide, with an optimum sill height of 44", to facilitate an emergency exit by the occupant and an emergency egress for a fire person wearing breathing apparatus.

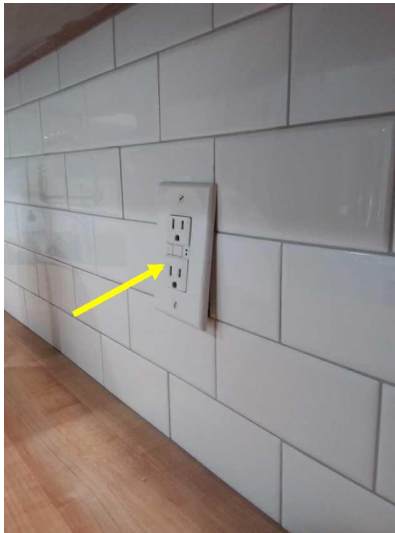
One or more outlets is not secure, and should be evaluated and serviced by a licensed electrical contractor.

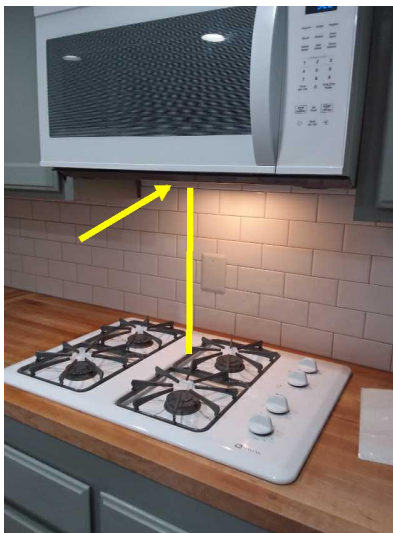
9.2. The range hood exhaust-fan is closer than the recommended 24 inches and should be used with caution.

The range hood exhaust-fan is closer than the recommended 24 inches and should be used with caution.

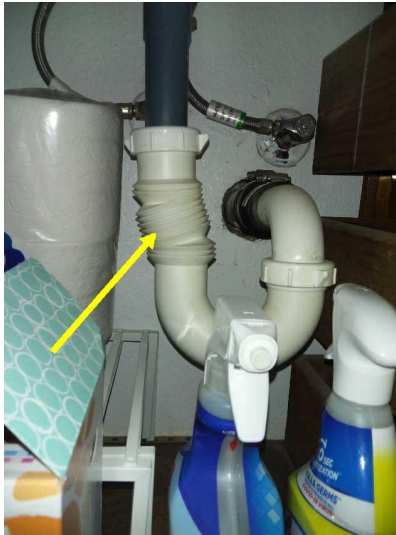
The sink employs an unconventional flexible drainpipe that could contribute to blockages.

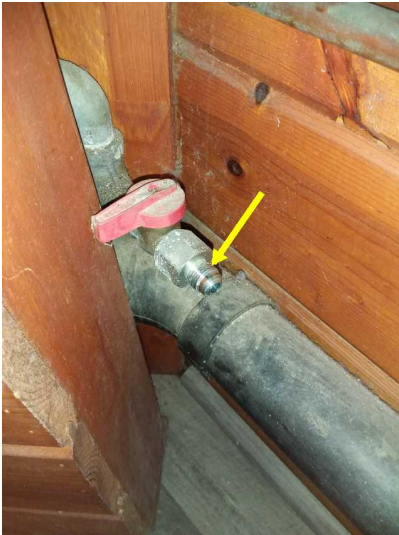
There is no cap on the gas valve. The gas valve should be capped when not in use.

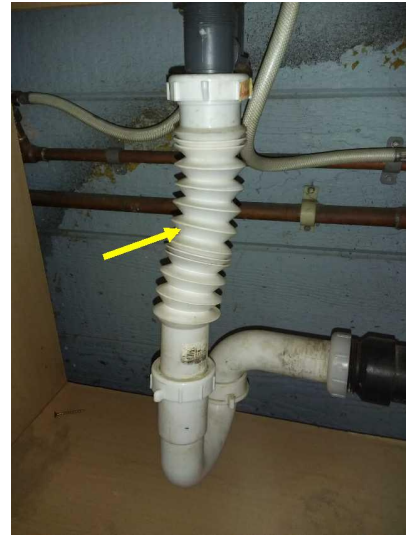
The sink employs an unconventional flexible drainpipe that could contribute to blockages.

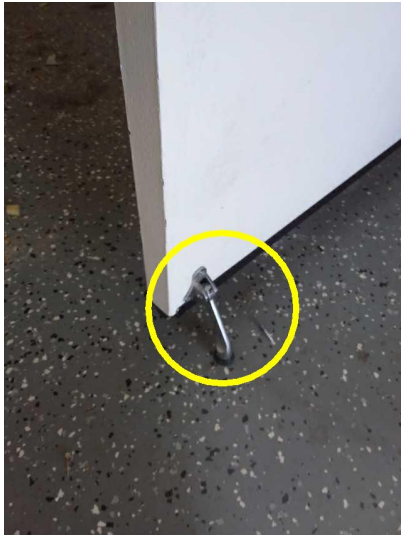
The fire rating of the house entry door has been nullified by the addition of a foot operated door stop.

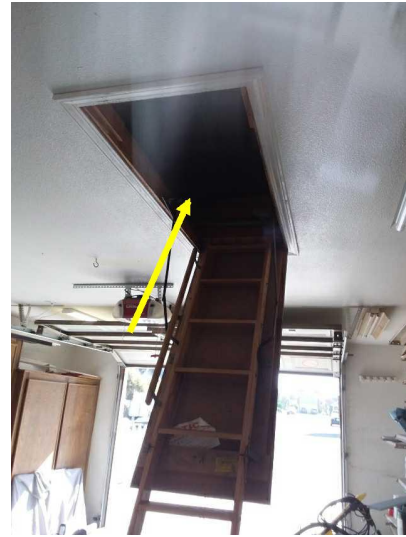
The hatch cover to the attic area should be sheathed with metal or drywall, and made to self-close and latch, in order to provide a firewall separation between the garage and the residence.

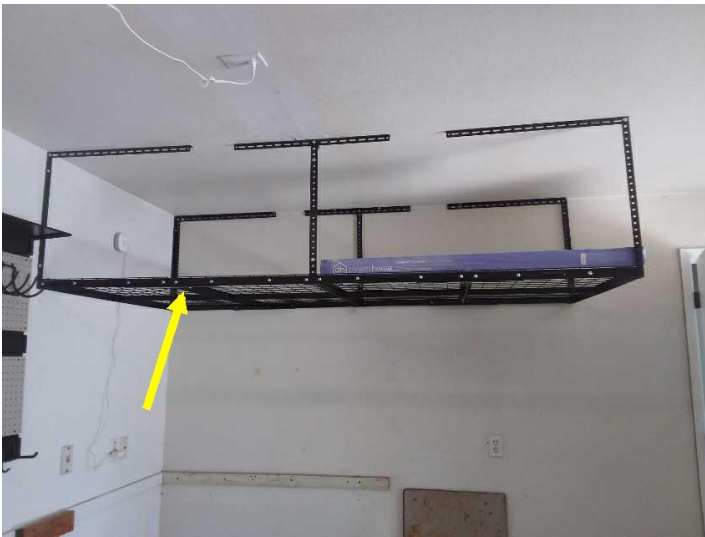
The storage space may have been added without the benefit of a permit, which could stress the roof framing. You may wish to verify this with the sellers. Regardless, you should limit the storage to lightweight items.

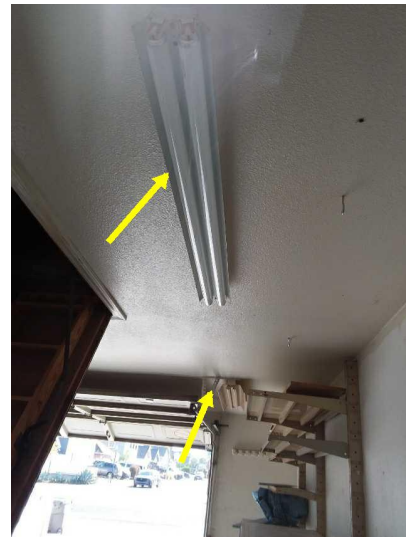
A ceiling light does not respond, and should be serviced.

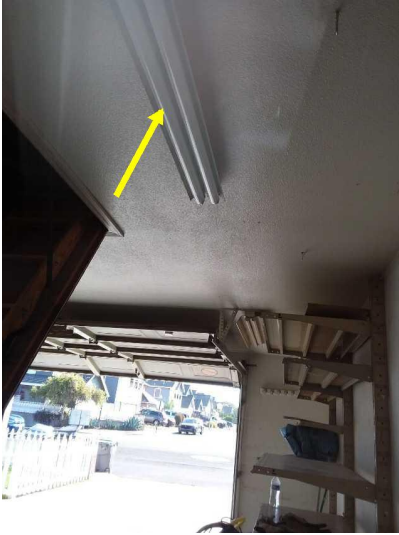
A light is missing its globe or cover and should be serviced.

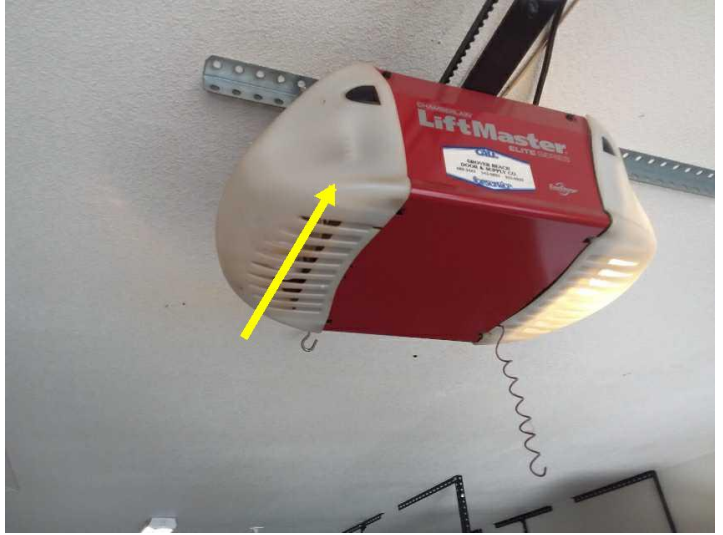
The garage door opener left light did not respond when the auto-reverse mechanism when activated which should be serviced. This is important because it typically is the only light on when pulling into the garage at night.
