# ***Cornerstone Inspection***

## **Property Inspection Report**

***9040 Caleta Ln, 93422, Atascadero, CA 93422***  
***Inspection prepared for: Chris Cucchiara***  
***Real Estate Agent: Chris Cucchiara - Keller Williams***

***Date of Inspection: 8/26/2026 Time: 9:00 AM***

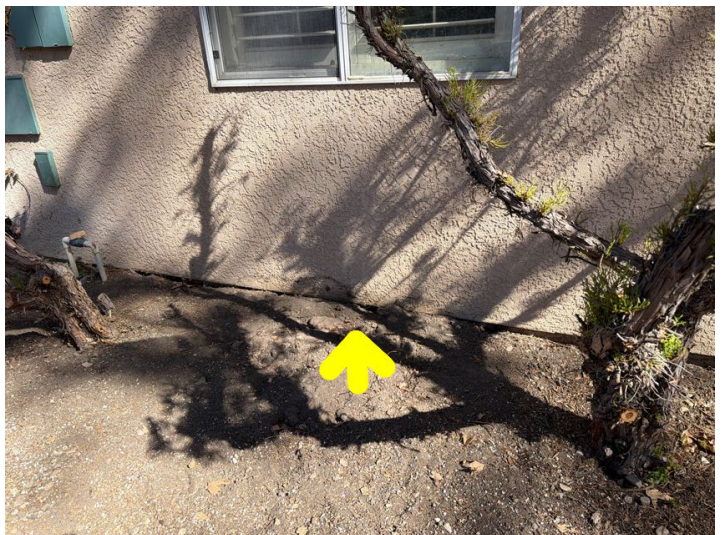
The soil is too high against the home at various areas around the residence, which should be serviced.

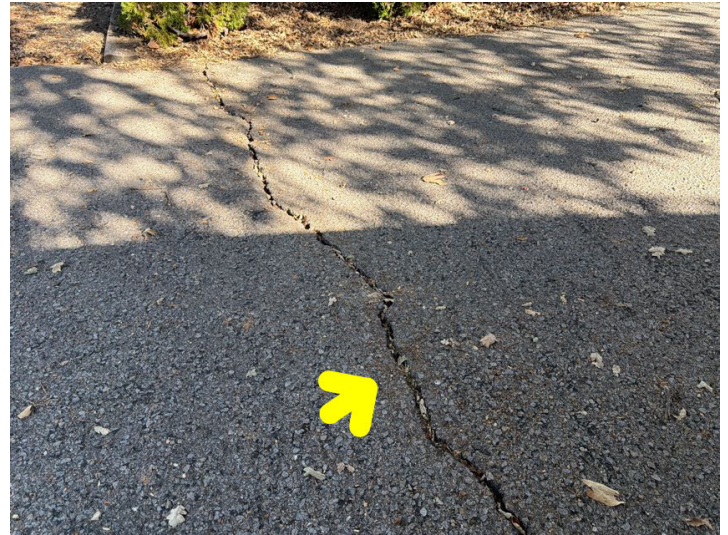
The driveway is damaged or has deteriorated and should be repaired.

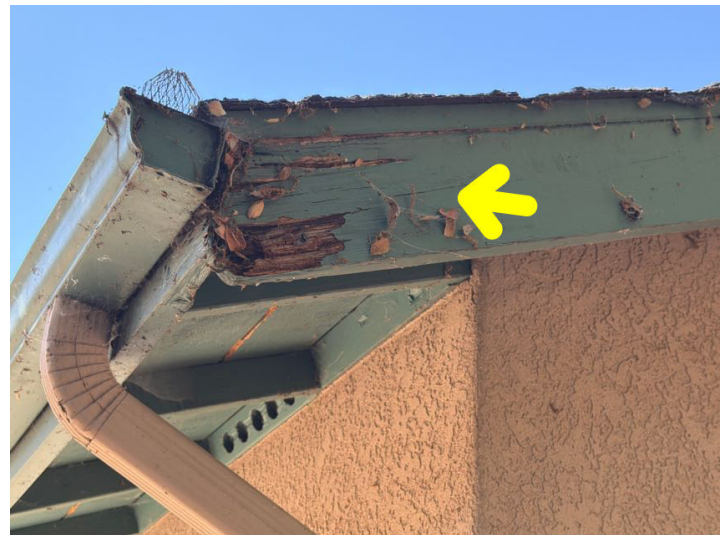
There is damage to the wood trim, fascia, and/or eaves that should be evaluated by a pest inspector.

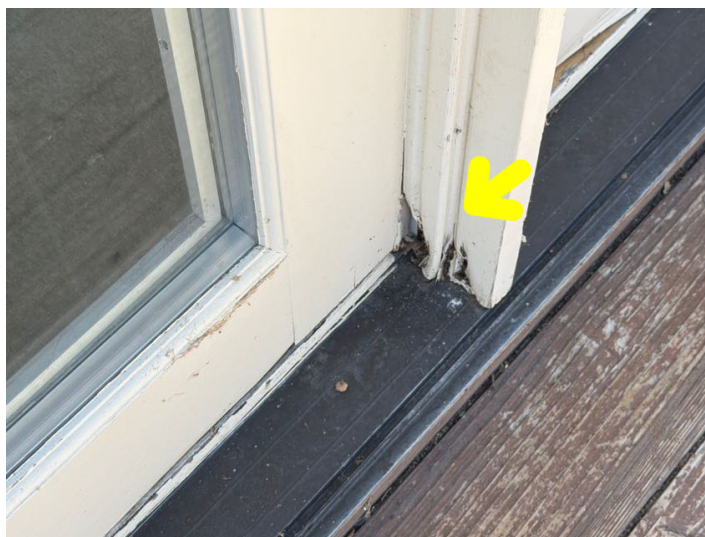
There is damage to the wood trim, fascia, and/or eaves that should be evaluated by a pest inspector.

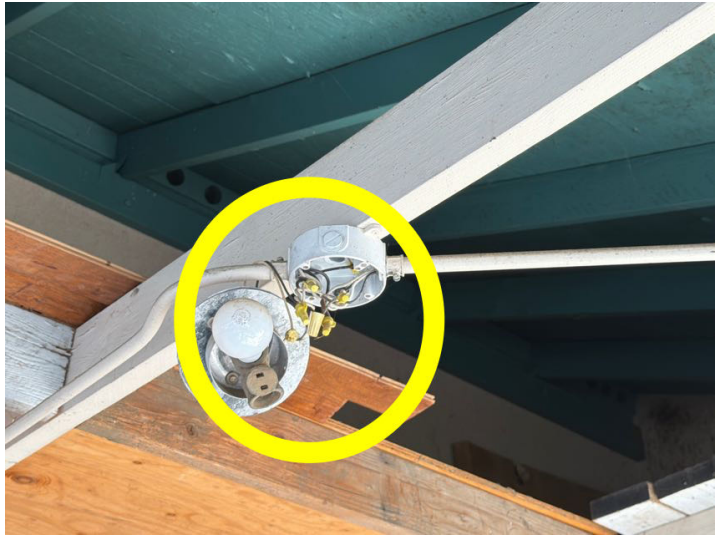
An exterior light is not properly secured or is loosely installed and should be serviced.

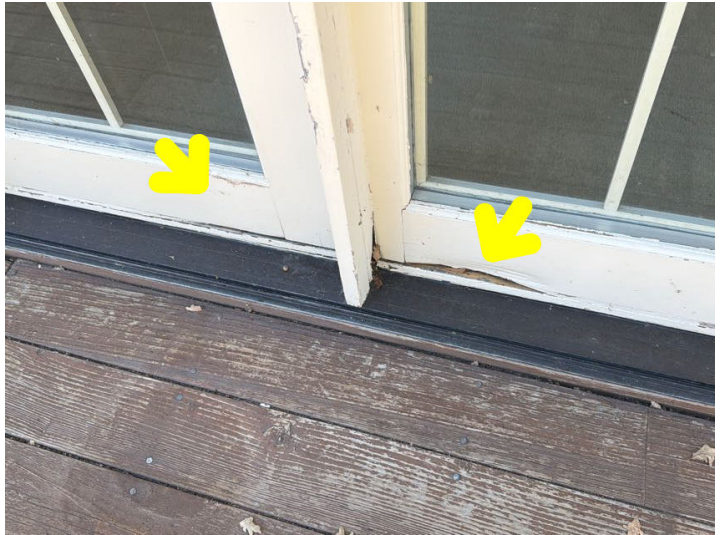
Damage was noted to an exterior door. There are many sizes and styles of exterior doors, many are no longer available and an exact match may not be possible. Refer to the pest report for further clarification.

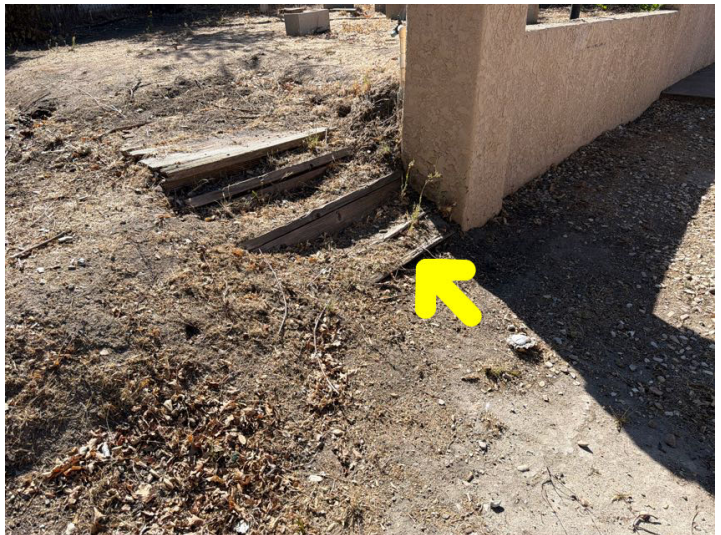
The railroad tie, wooden post, or natural stone steps are landscape components and would not conform to common standards requiring certain dimensions, handrails, guardrails, etcetera.

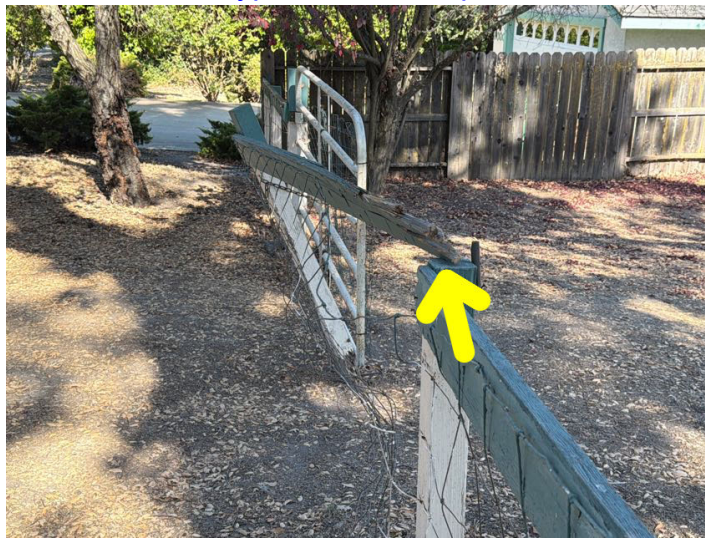
The fences have damage that you may wish to have repaired.

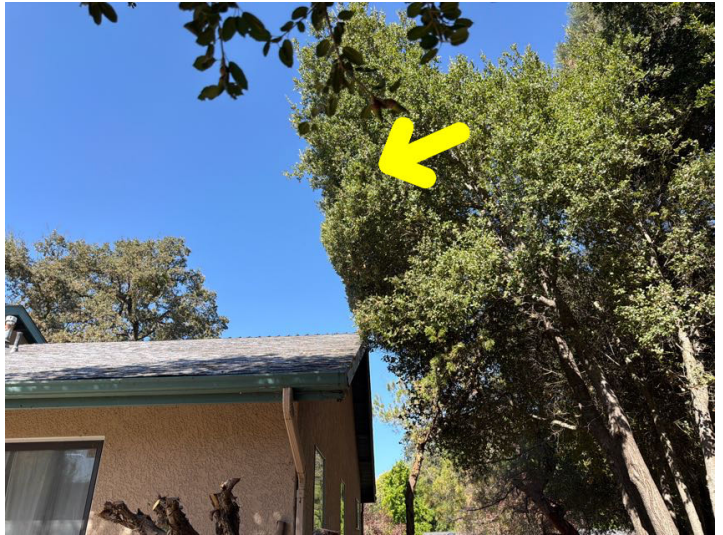
There are tree limbs over growing the residence that should be trimmed or monitored to ensure that they do not impact or damage the roof or its components.

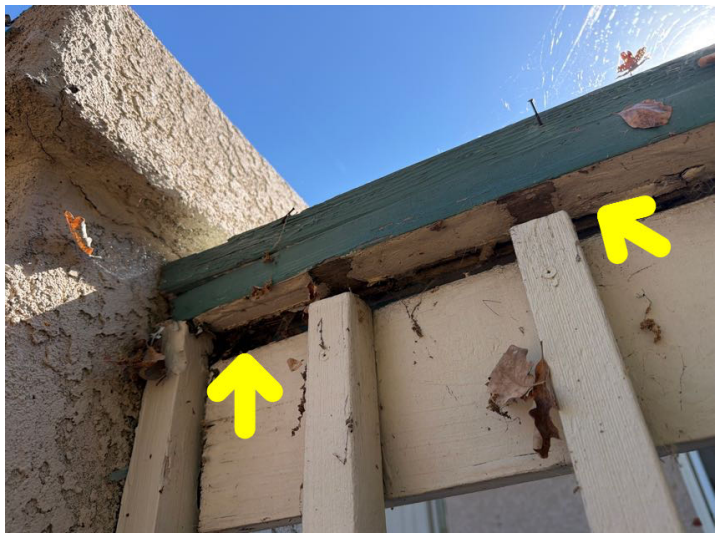
There is damage to one or more guardrails that should be evaluated by a pest inspector.

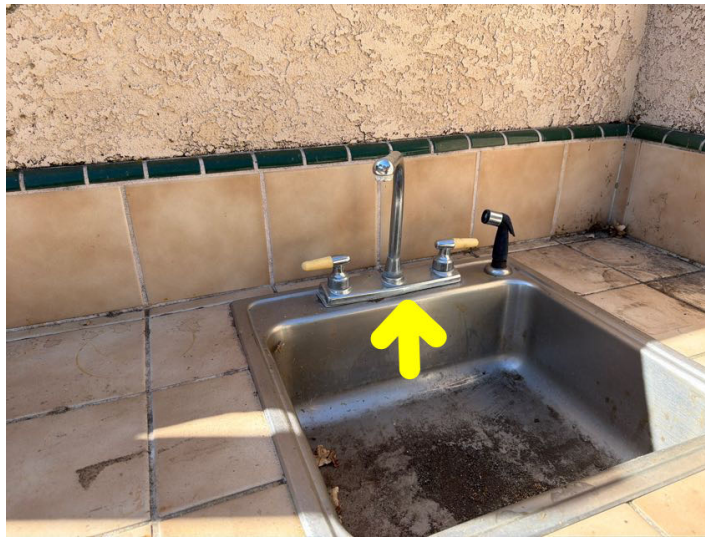
The faucet is loose or does not fully swivel and should be secured.

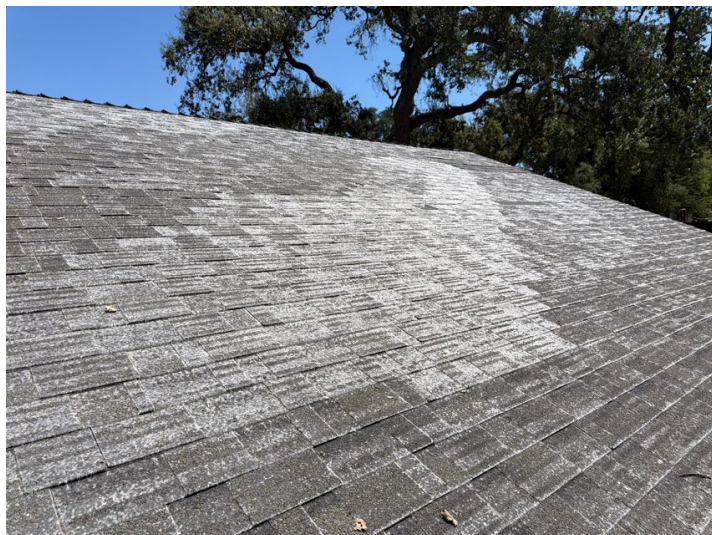
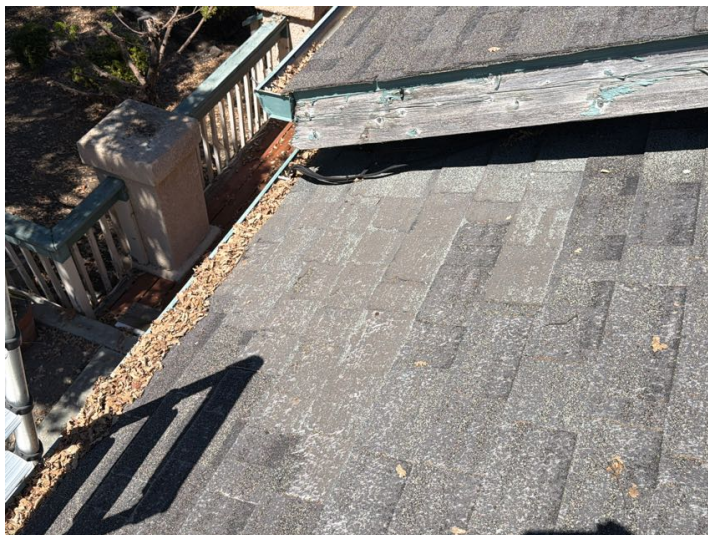
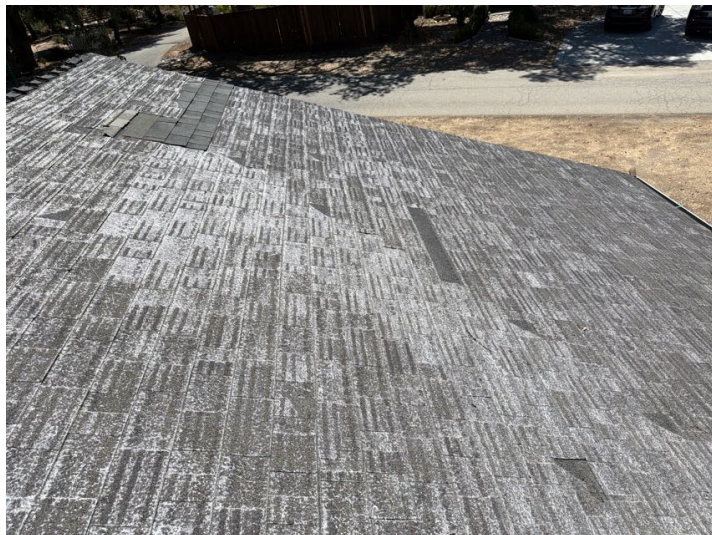
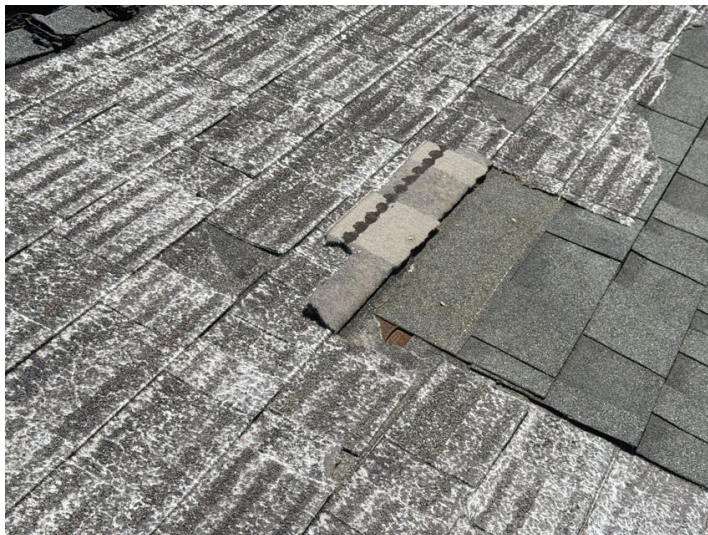
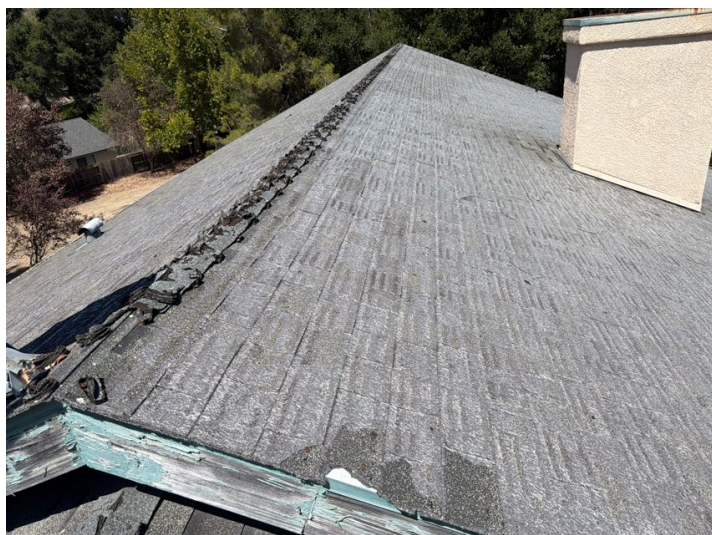
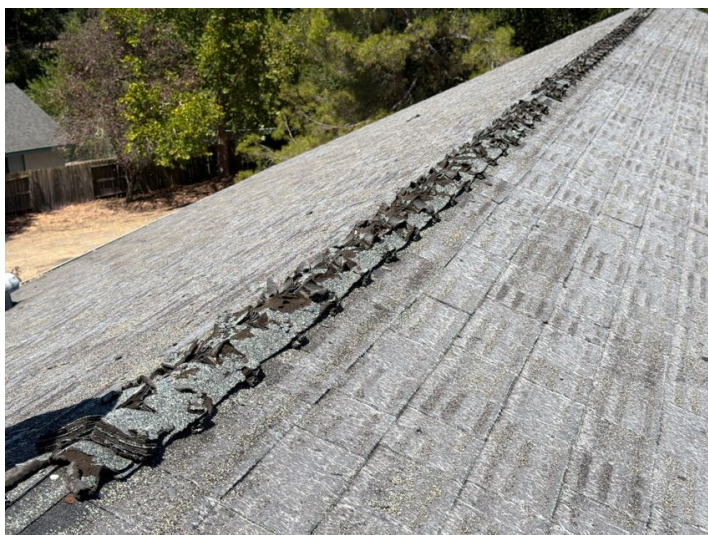
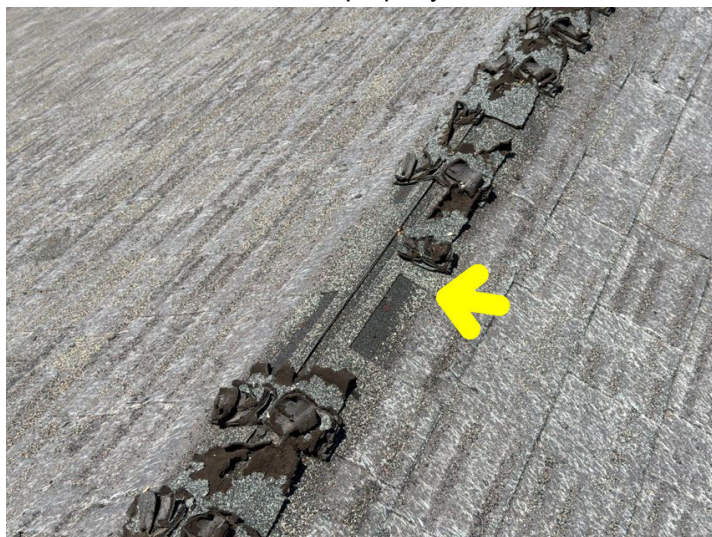
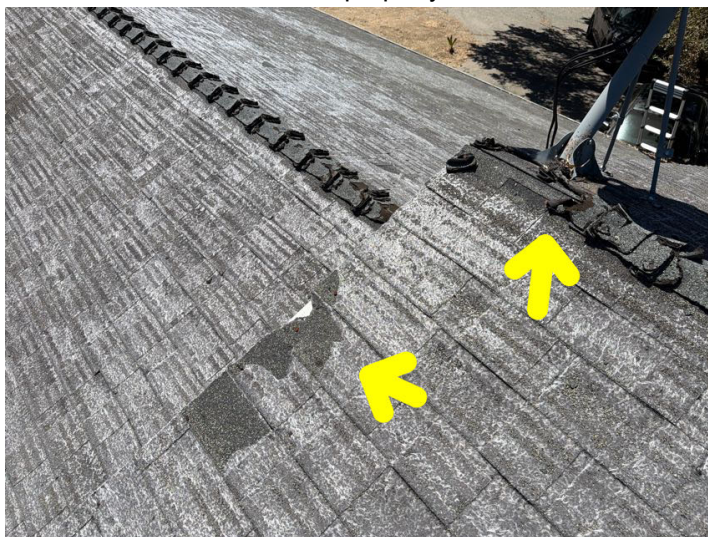
| Page 26 Item: 2 | Composition Shingle Observations | 2.6. The roof is at the end of its serviceable life, and should be evaluated by a licensed roofing contractor, because it could leak and the cost of replacing it could affect your evaluation of the property. |

The roof is at the end of its serviceable life, and should be evaluated by a licensed roofing contractor, because it could leak and the cost of replacing it could affect your evaluation of the property.

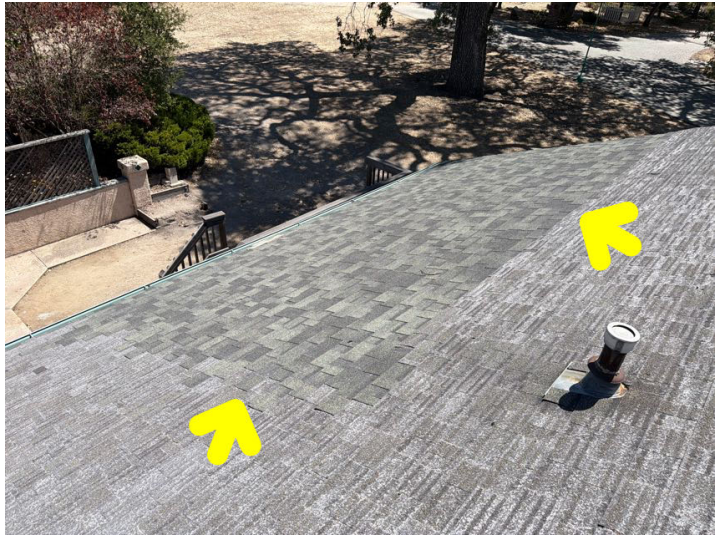
We observed repairs done to the roof. You should have the sellers disclose the reason that the repairs were completed, as well as any documentation of any warranty or guarantee from the roofer.

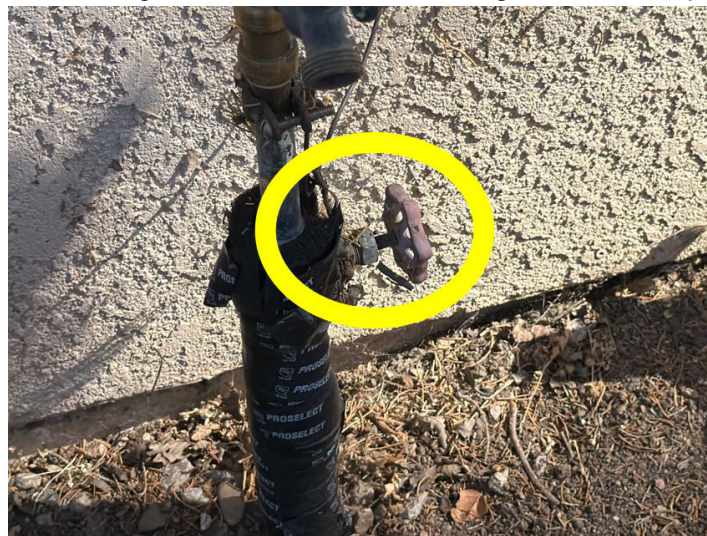
The main water shutoff valve is an older 'Gate' style valve. This older valve may no longer properly function. We recommend it be upgraded to a newer 'Ball' valve.

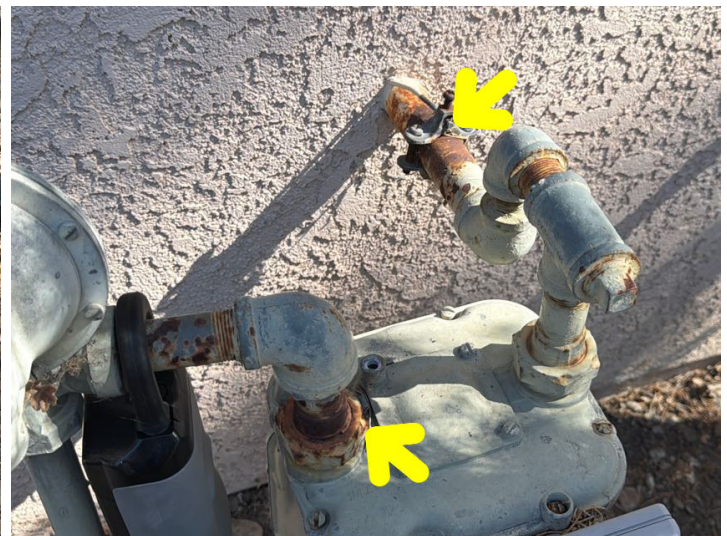
One or more of the gas pipes at the meter are rusted and should be painted to prevent further corrosion.

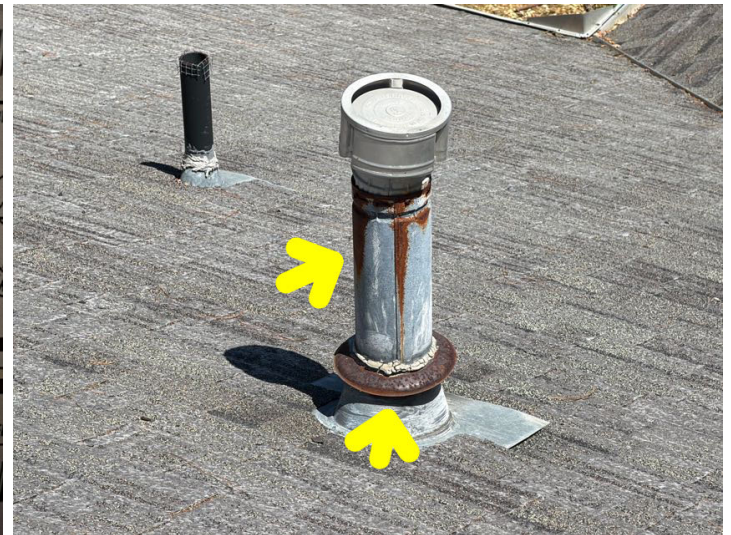
The vent pipe on the roof is rusted or deteriorated, and should be serviced by a qualified tradesperson.

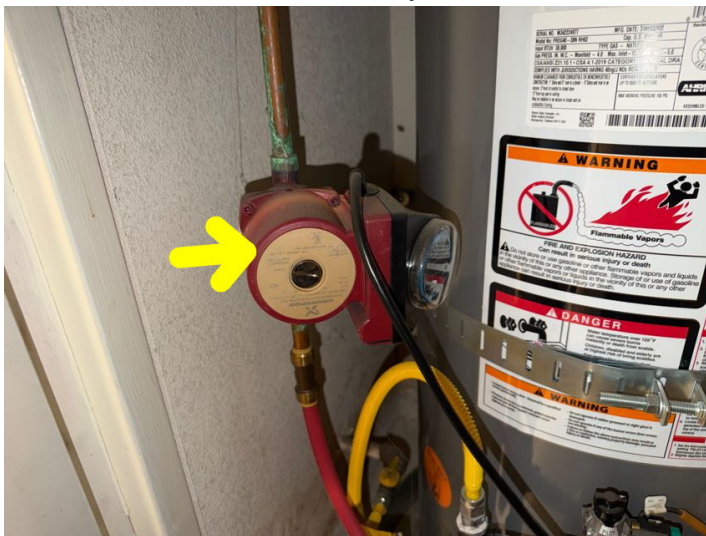
The water heater system includes a recirculating pump that we do not have the expertise to evaluate. We recommend having the seller disclose its operation, maintenance history, and relevant documentation.

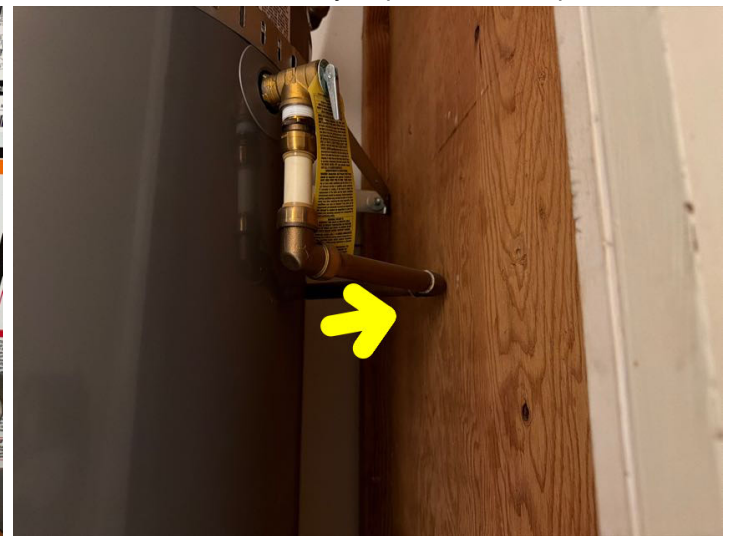
The discharge pipe from the pressure relief valve has been incorrectly plumbed uphill. We recommend an evaluation by a licensed plumber.

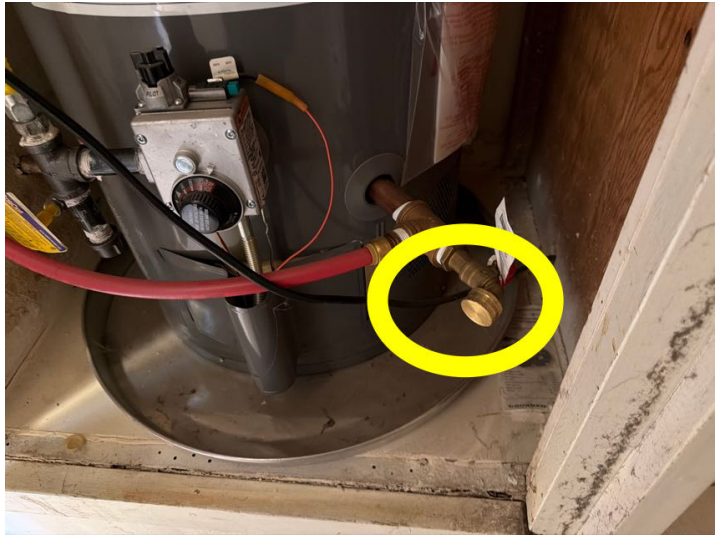
The drain valve at the gas water heater has been capped, which could imply that the valve leaks and may need to be serviced.

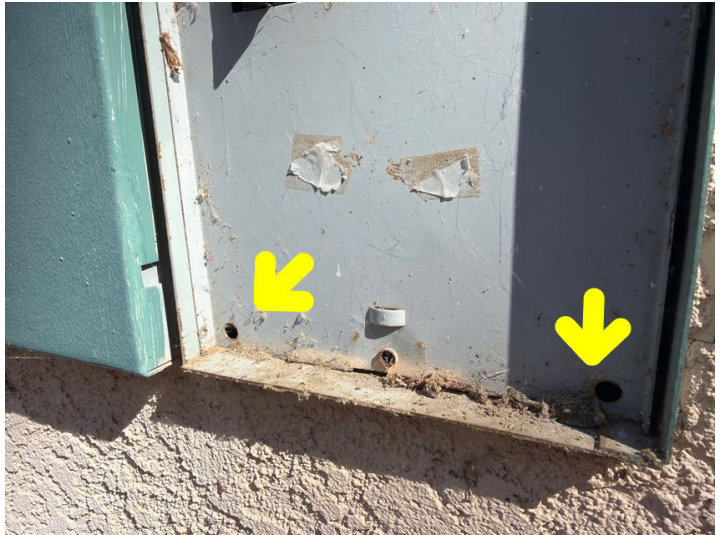
The interior panel cover is missing one or more of its fasteners or screws and should be serviced.

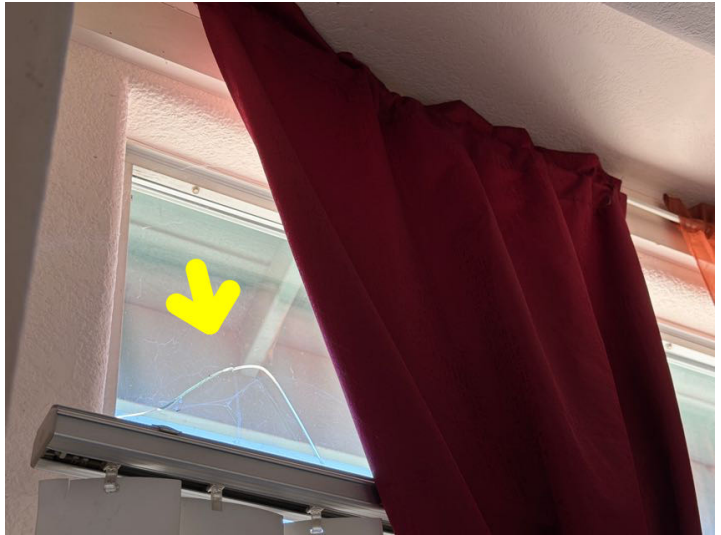
A window pane is cracked or broken and should be replaced.

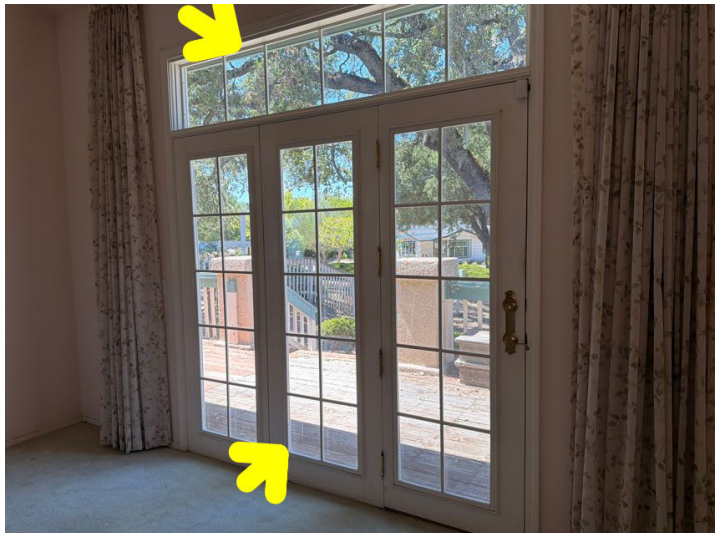
One or more windows may have a broken hermetic seal, which you may wish to have replaced. This is evident from fogging or condensation forming between the panes of glass, which implies that the seal has failed.

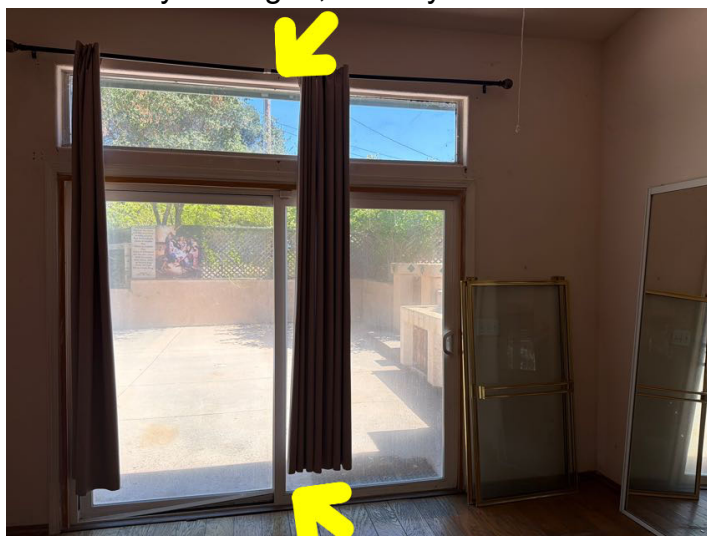
One or more windows may have a broken hermetic seal, which you may wish to have replaced. This is evident from fogging or condensation forming between the panes of glass, which implies that the seal has failed.

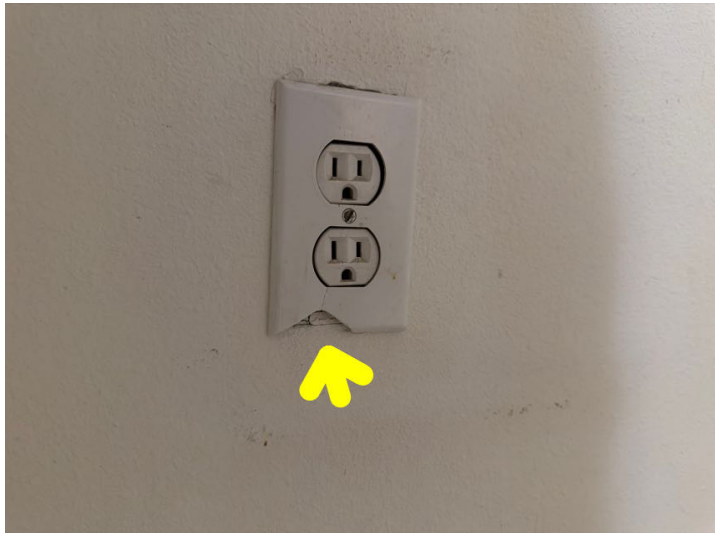
One or more outlet covers are cracked or broken and should be replaced.

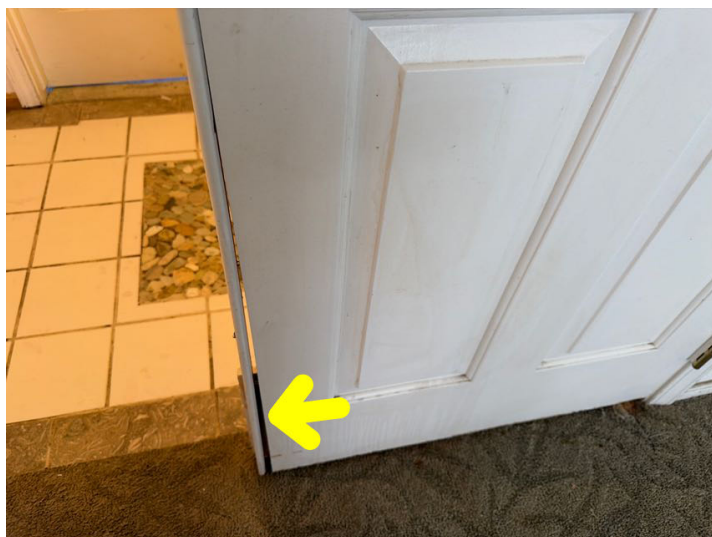
The entry door is damaged and should be serviced.

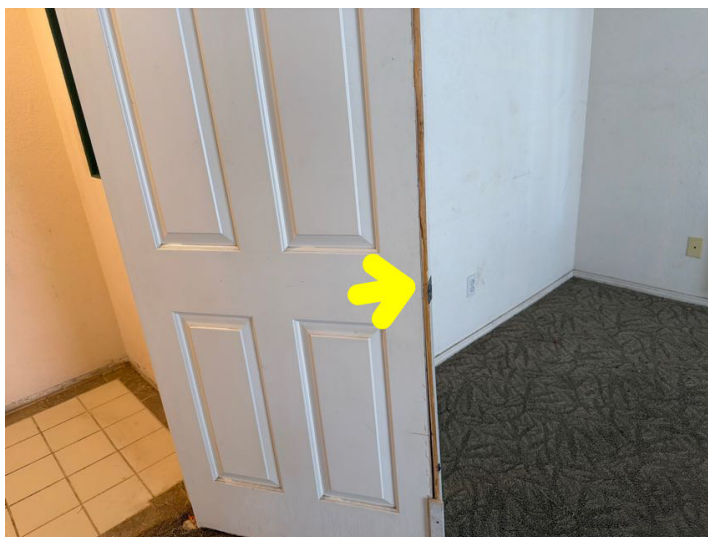
The entry door is damaged and should be serviced.

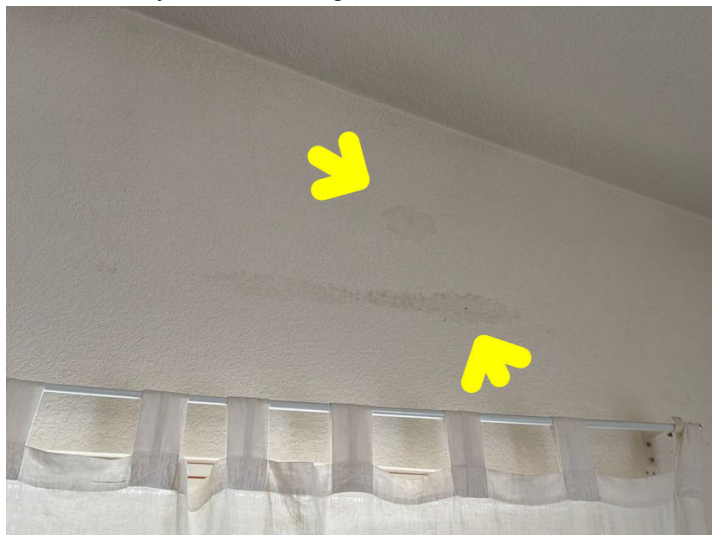
There is a moisture stain on the wall or ceiling that should be explained or explored further.

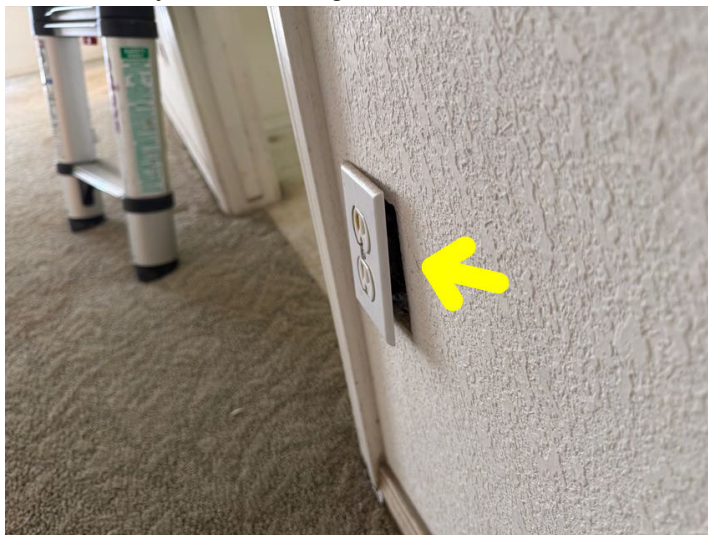
One or more outlets are not secure, and should be evaluated and serviced by a licensed electrical contractor.

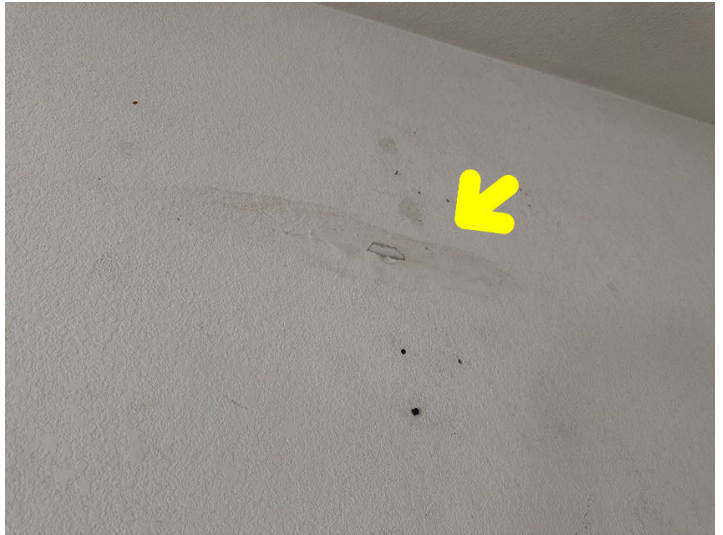
There is a moisture stain on the wall or ceiling that should be explained or explored further.

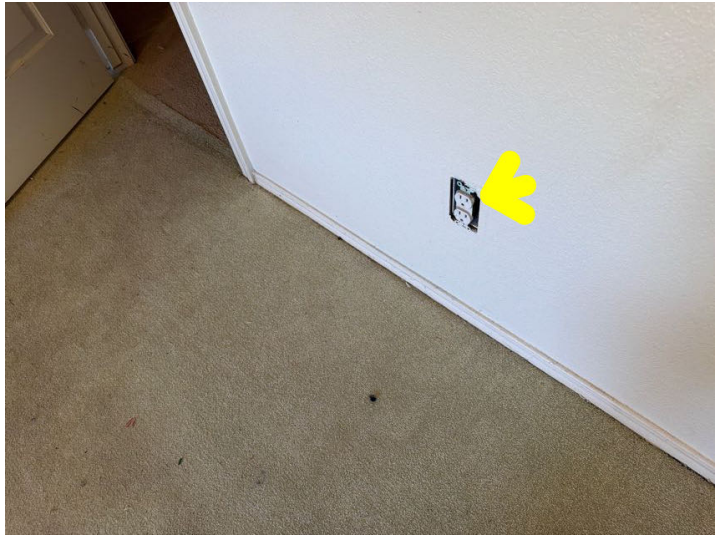
One or more outlet covers are missing and should be installed.

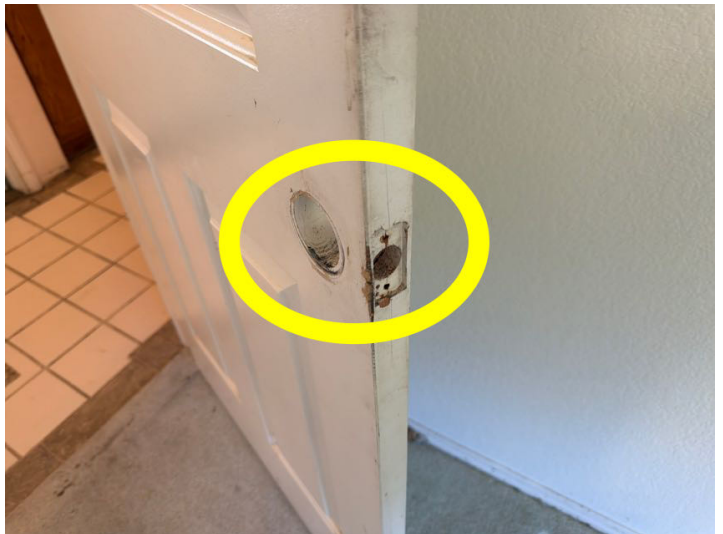
The entry door handle and hardware are missing and should be serviced.

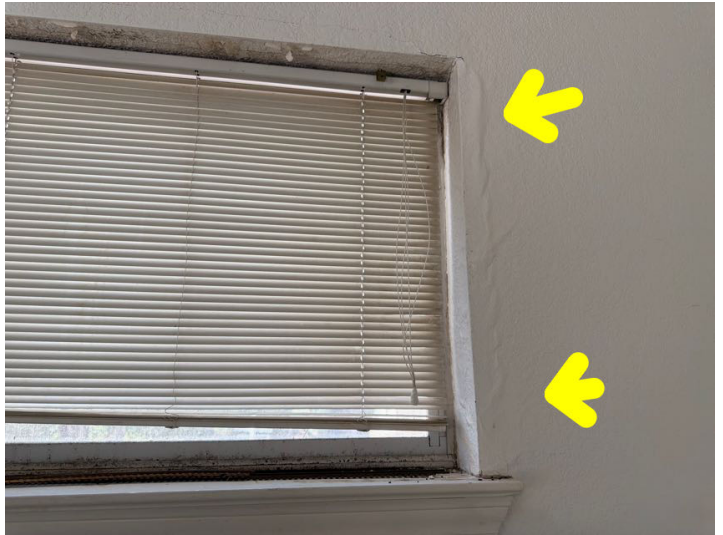
There is a moisture stain on the wall or ceiling that should be explained or explored further.

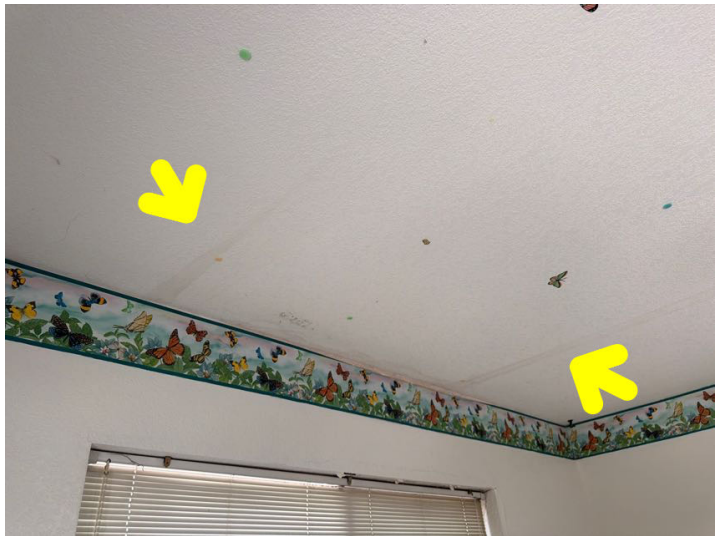
There is a moisture stain on the wall or ceiling that should be explained or explored further.

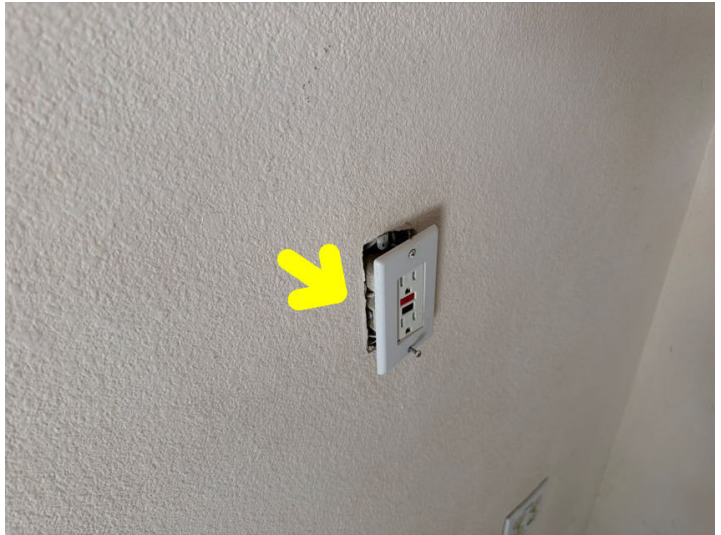
One or more outlets are not secure, and should be evaluated and serviced by a licensed electrical contractor.

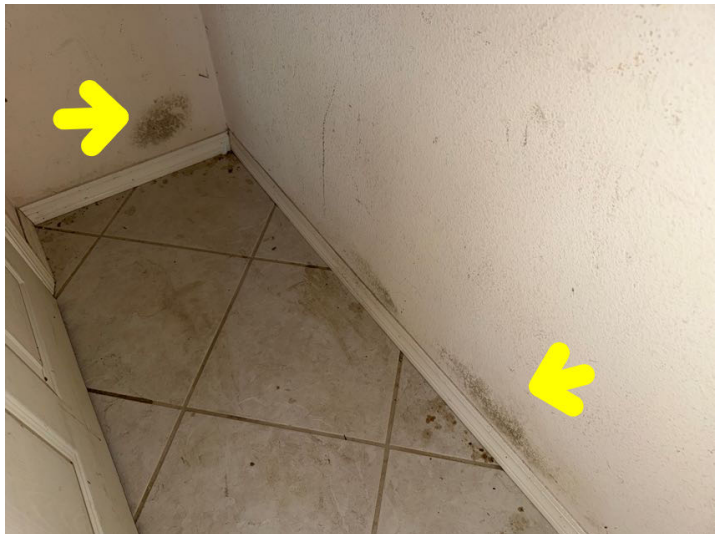
There is a mold-like substance present, which should be evaluated by a specialist and serviced as necessary. All molds flourish in a damp environment and many are commonplace, but some are toxic and may represent a health threat.

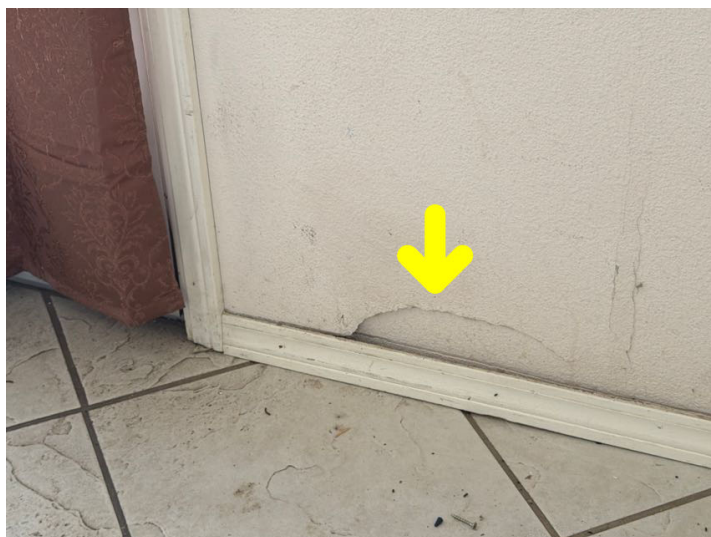
The walls or ceiling have cosmetic damage, which you may wish to view for yourself.

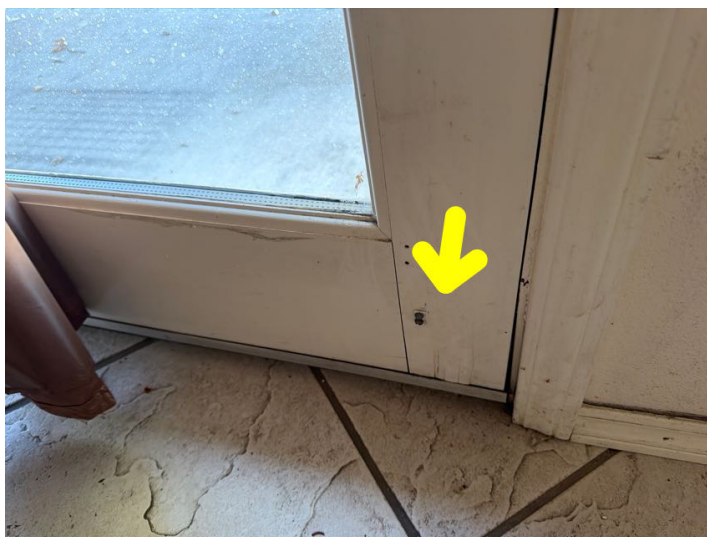
An exterior door has moisture damage, and should be evaluated by a pest inspector.

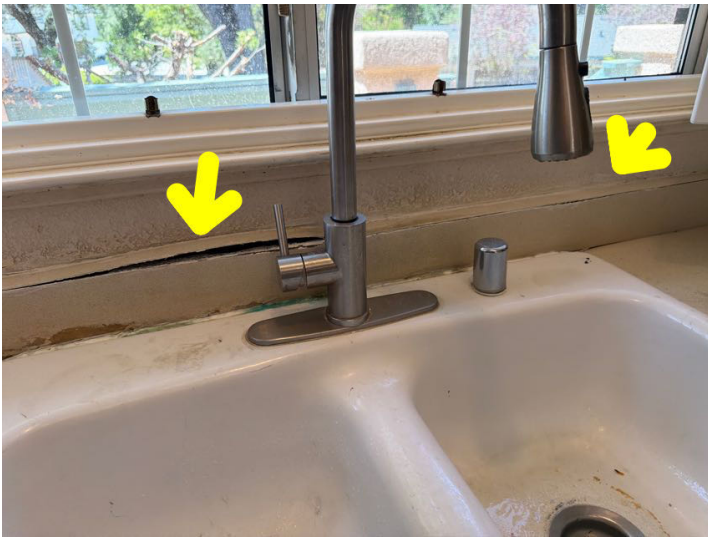
The counter top has damage such as small cracks or scuffs which you should view for yourself.

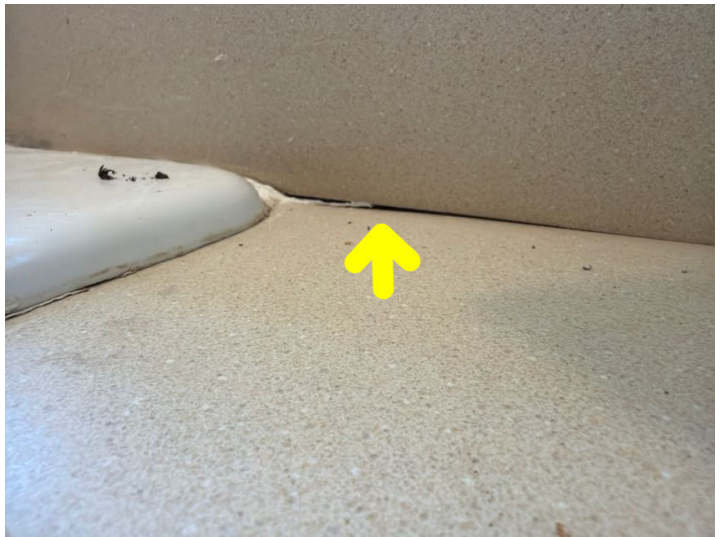
A typical separation between the kitchen counter top and the backsplash should be grouted or caulked to forestall moisture intrusion.

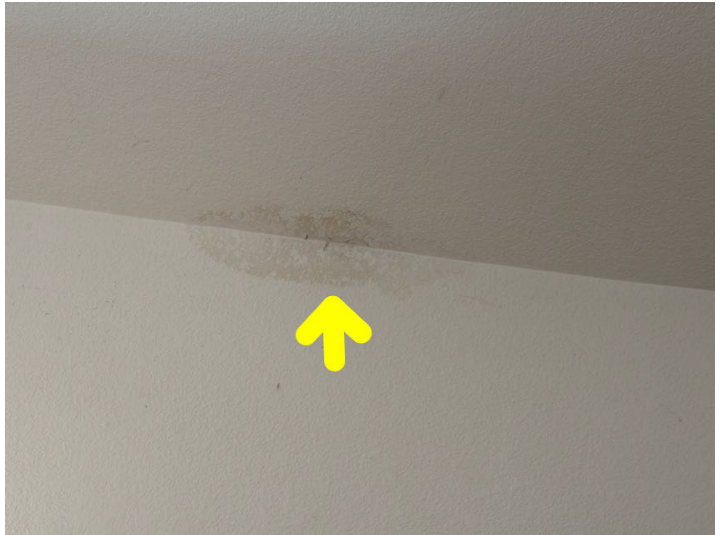
There is a moisture stain on the ceiling that should be explained or explored further.

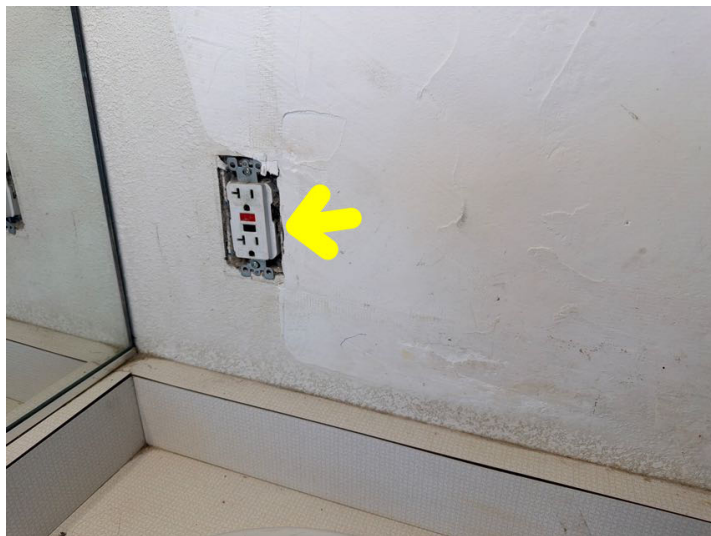
One or more outlet covers are missing and should be installed.

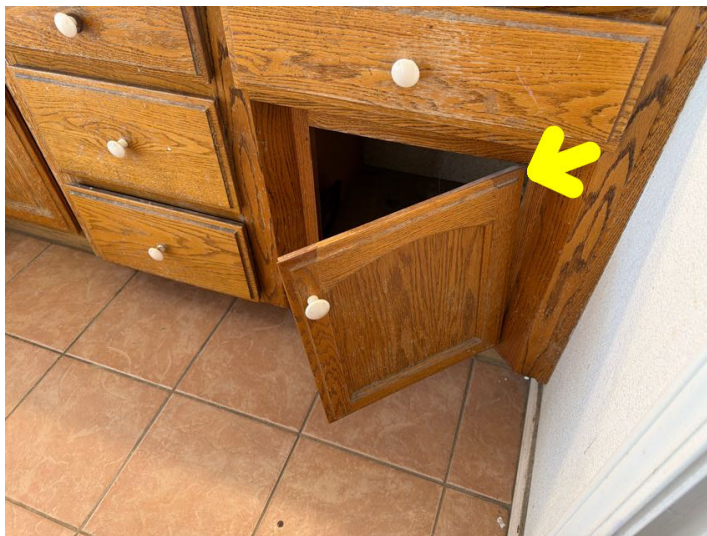
The cabinet hardware needs maintenance-type service, such as that to latches, knobs, catches, hinges, or drawer glides.

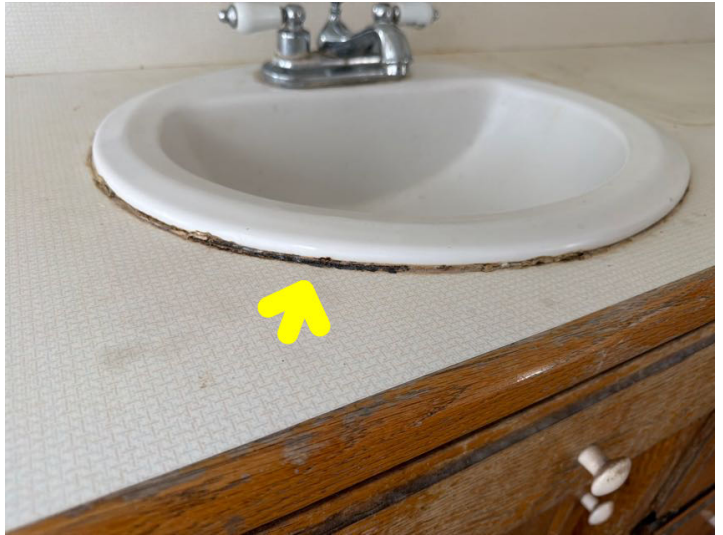
There is a separation between the sink and the countertop, which should be sealed to forestall moisture intrusion.

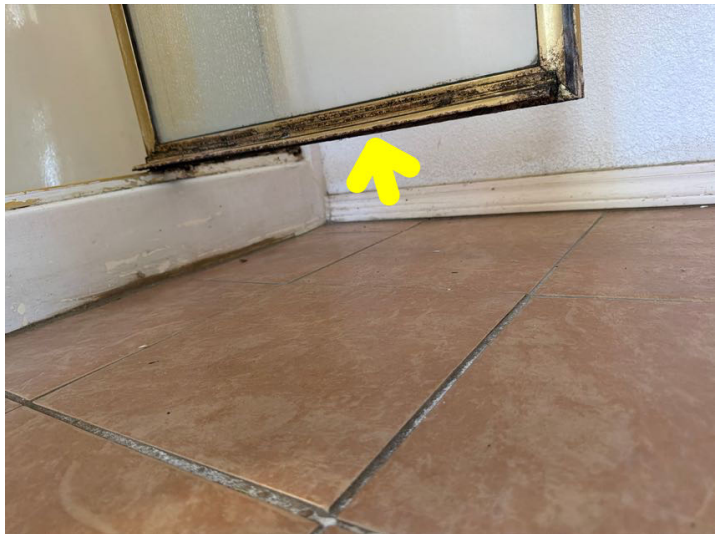
The shower door seal is missing or damaged, and should be serviced.

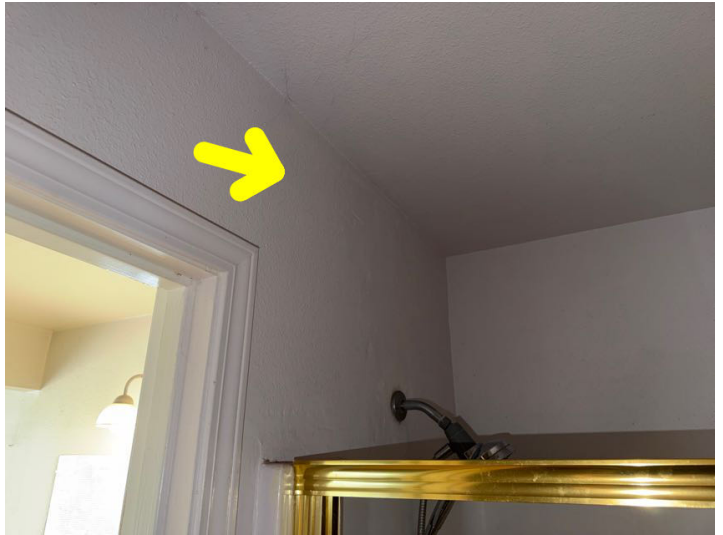
There has been a drywall repair that should be explained by the seller.

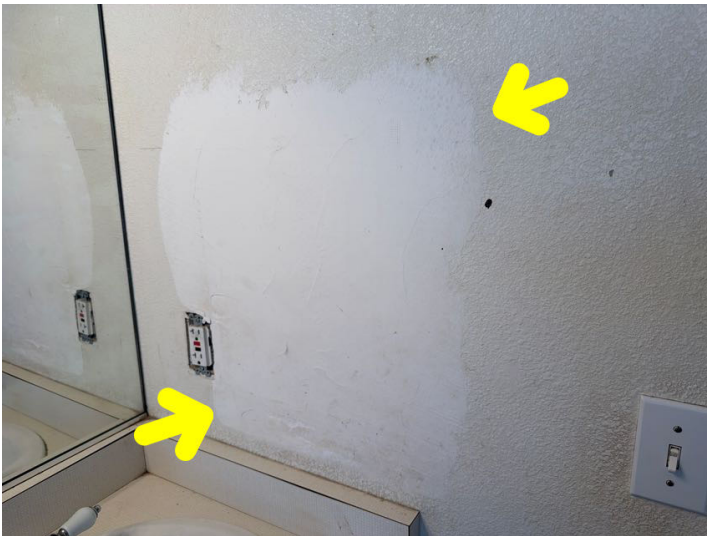
There has been a drywall repair that should be explained by the seller.

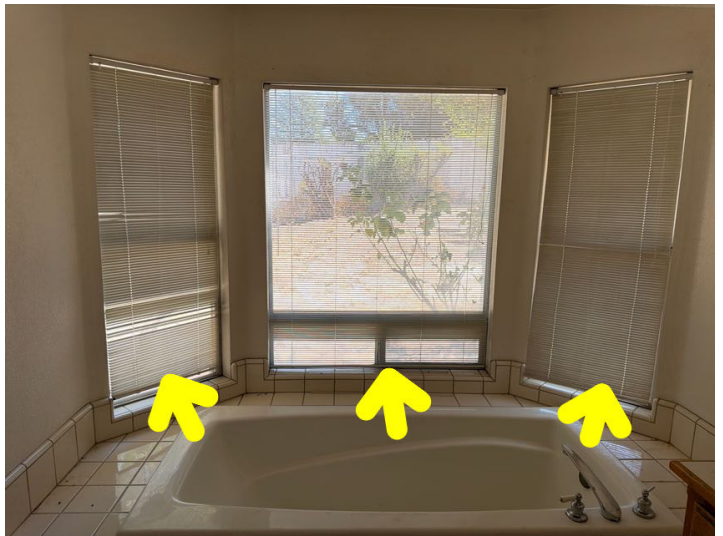
One or more windows may have a broken hermetic seal, which you may wish to have replaced. This is evident from fogging or condensation forming between the panes of glass, which implies that the seal has failed.

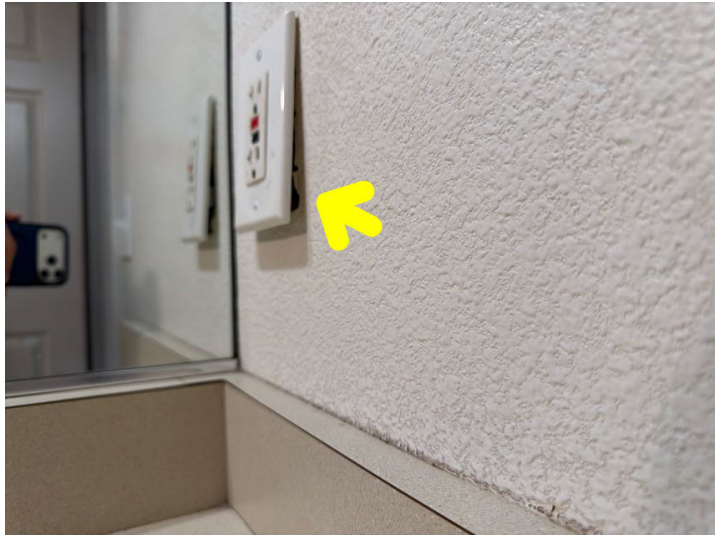
One or more bathroom sink outlets are not secure, and should be evaluated and serviced by a licensed electrical contractor.

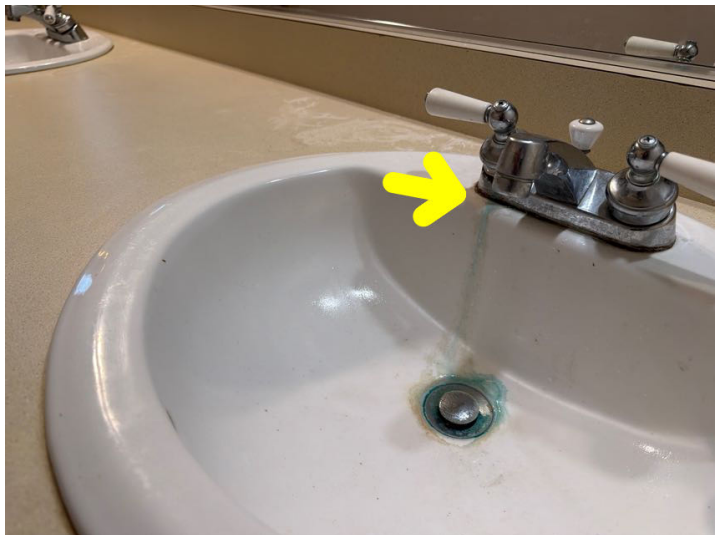
The sink faucets leak around the stem while in use, and should be repaired.
