# ***Cornerstone Inspection***

## **Property Inspection Report**

***9040 Caleta Ln, 93422, Atascadero, CA 93422***  
***Inspection prepared for: Chris Cucchiara***  
***Real Estate Agent: Chris Cucchiara - Keller Williams***

***Date of Inspection: 8/26/2026 Time: 9:00 AM***

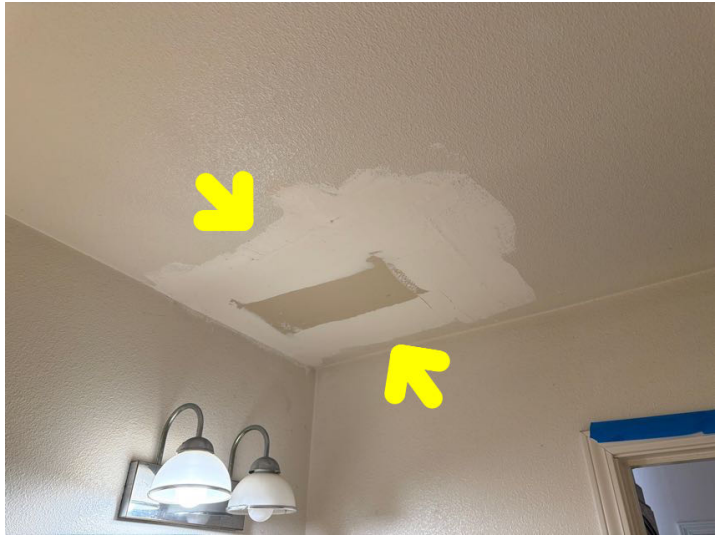
There has been a drywall repair that should be explained by the seller.

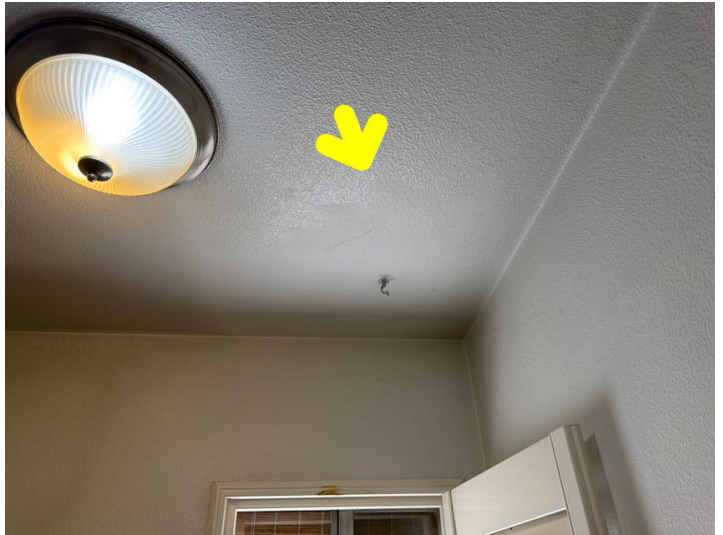
There has been a drywall repair that should be explained by the seller.

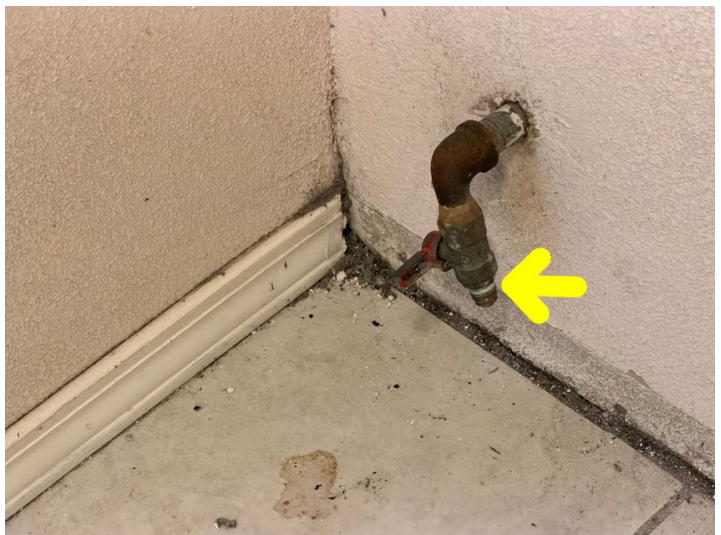
There is no cap on the gas valve. The gas valve should be capped when not in use.

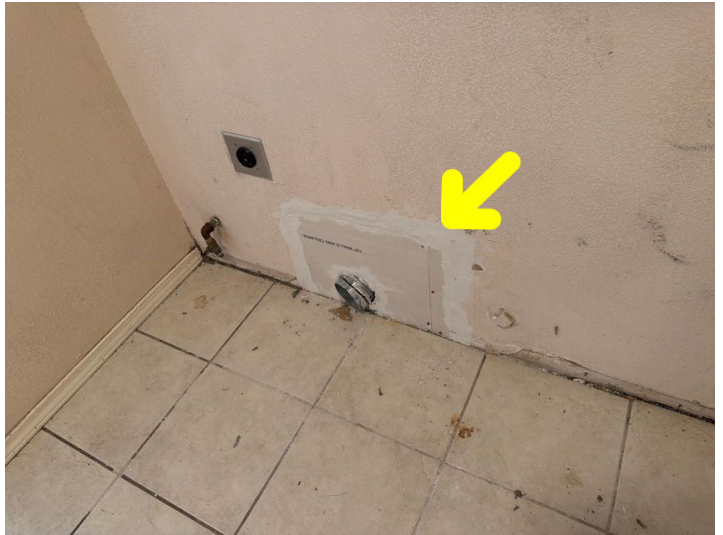
There has been a drywall/plaster repair that should be explained by the seller.

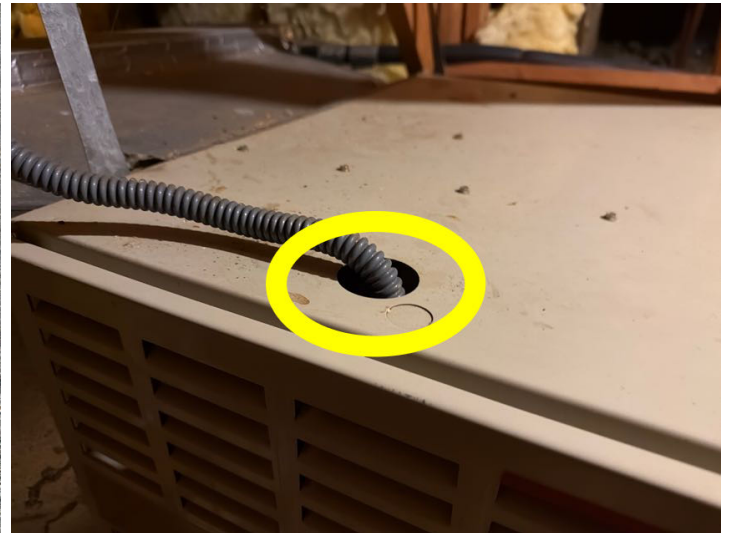
The flexible gas connector passes through the furnace cabinet sidewall. Current standards require the gas supply to be rigid pipe until it passes beyond the furnace cabinet, so it is not damaged by the metal cabinet sidewall. The gas supply should then have an approved flexible connector to the gas shutoff valve. The local utility gas company will likely repair this issue for free.

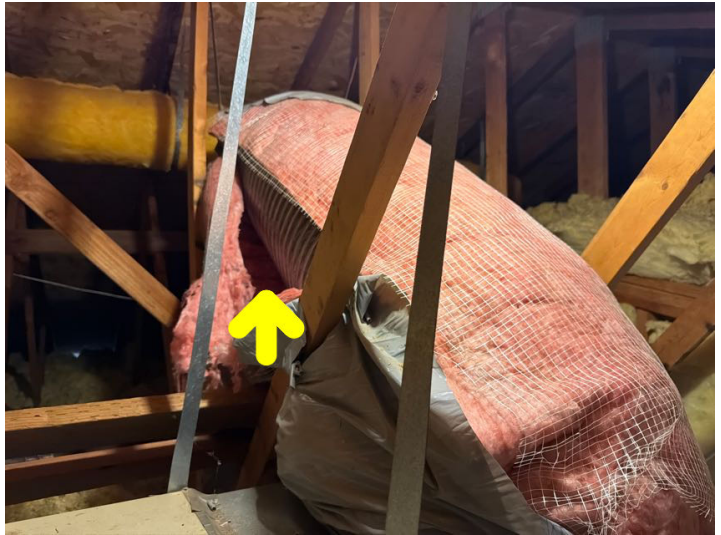
Sections of outer shell of the flexible ducting have been damaged by ultra-violet contamination, which has caused the outer shell to deteriorate, and therefore should be evaluated by a licensed HVAC contractor with a view toward replacement.

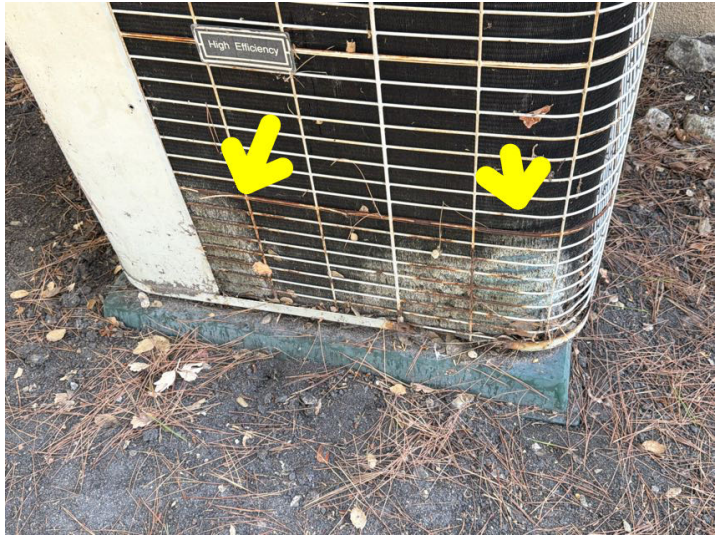
The fins of the condensing coil have been eroded by animal urine. We recommend an evaluation by a qualified tradesperson and service as necessary.

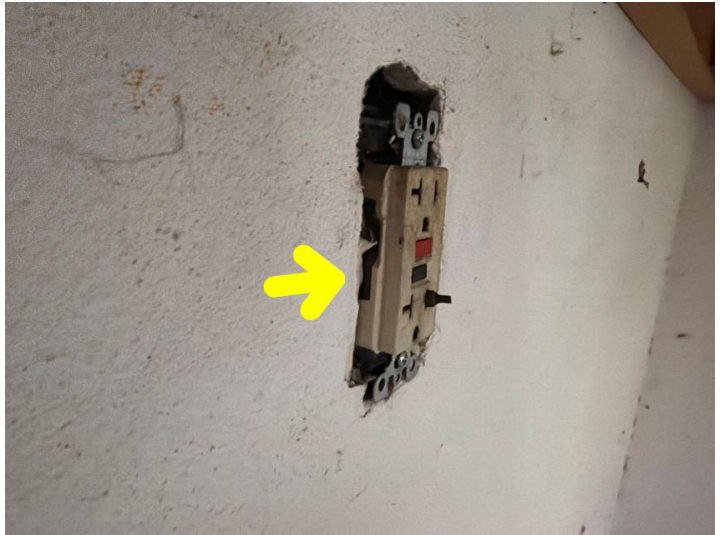
One or more outlets have an obstruction within, and should be evaluated and serviced by a licensed electrical contractor.

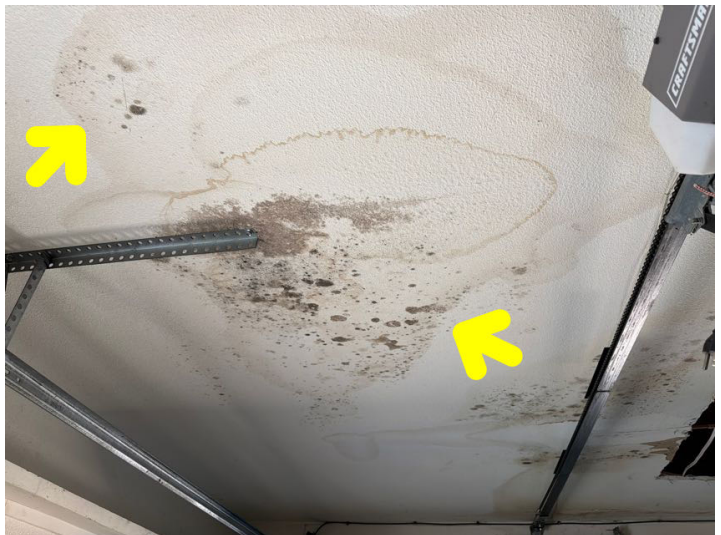
There is a mold-like substance present, which should be evaluated by a specialist and serviced as necessary. All molds flourish in a damp environment and many are commonplace, but some are toxic and may represent a health threat.

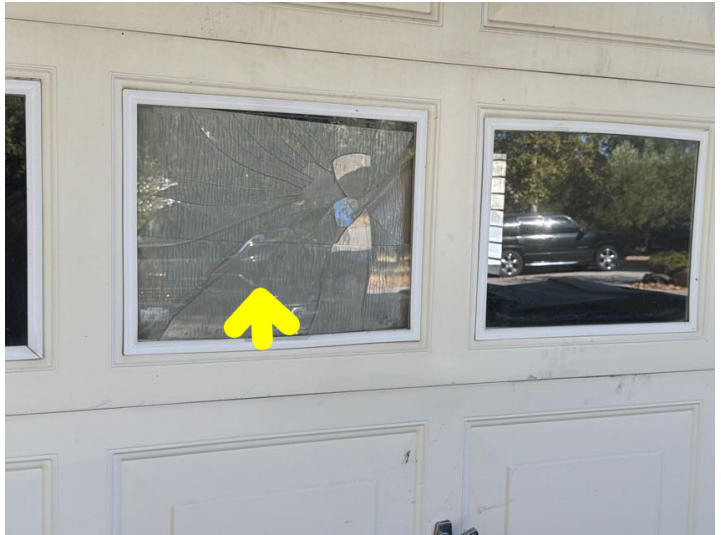
A window pane is cracked or broken and should be replaced.

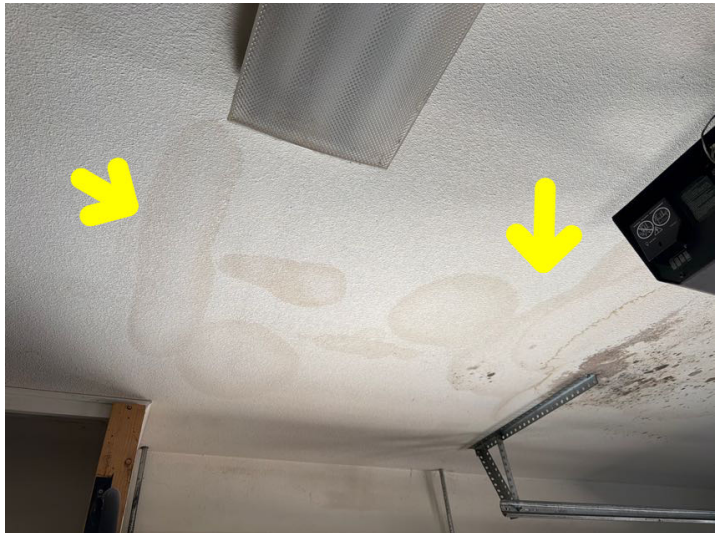
There is a moisture stain on the garage ceiling, the cause of which should be explained or explored further. However, we not unable to confirm that is being caused by an active leak.

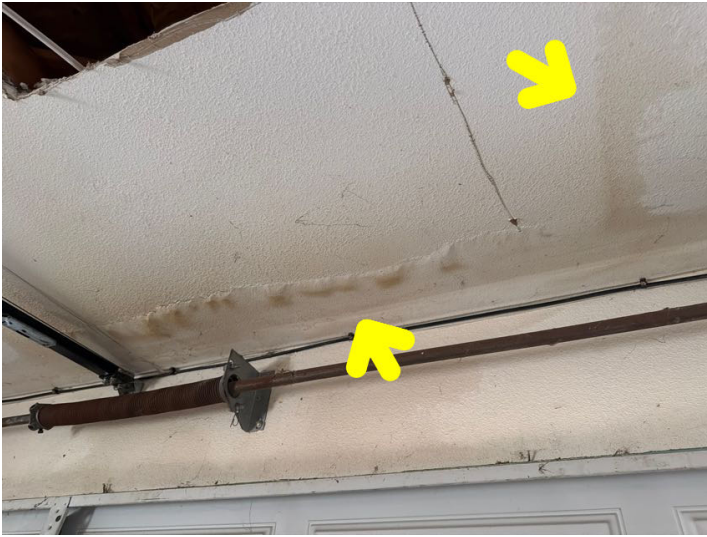
There is a moisture stain on the garage ceiling, the cause of which should be explained or explored further. However, we not unable to confirm that is being caused by an active leak.

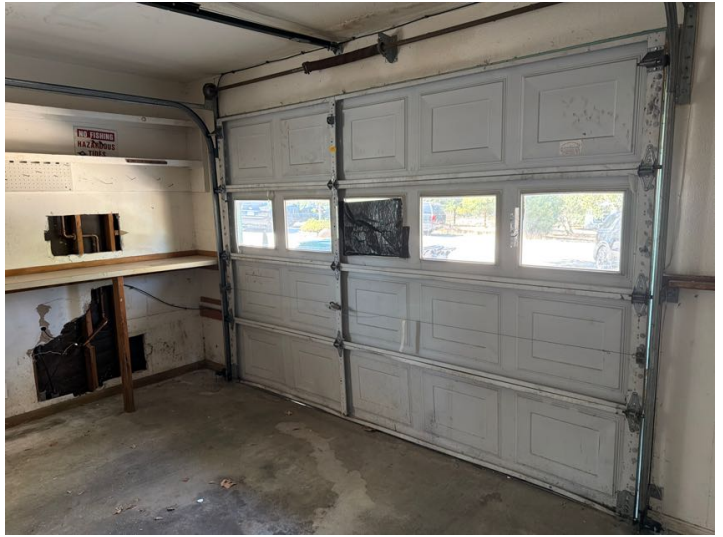
The garage door and its hardware could not be tested because it was damaged and off the tracks, and should be demonstrated as functional by the sellers or serviced as necessary.
