## WOOD DESTROYING PESTS AND ORGANISMS INSPECTION REPORT

| Building Address:<br><b>4430 E. Silverleaf Av., Orange, CA 92869</b> | | Date of Inspection<br><b>09/14/2026</b> | Number of Pages<br><b>6</b> |
| | | Report #<br><b>W56816</b> | |

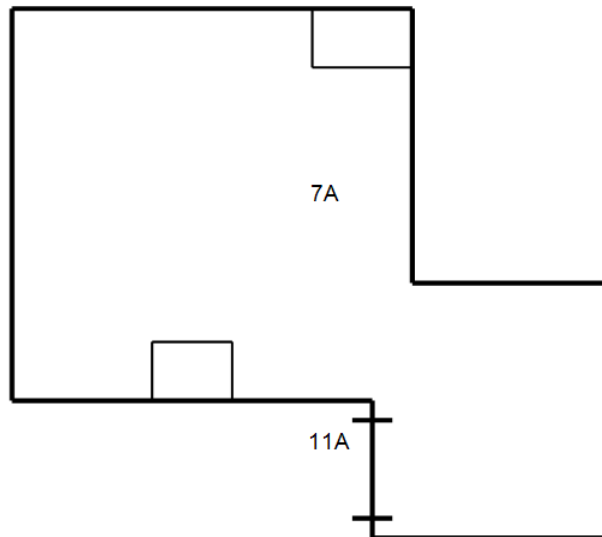
This Diagram is not to scale

7A PRICE: \$387.00 (Section I)  
FINDINGS: Evidence of drywood termite infestation noted at time of inspection.  
RECOMMENDATION: Chemically treat visible and accessible infestations. Remove or cover accessible pellets.

11A PRICE: See 7A (Section I)  
FINDINGS: Wood Fungus condition visible noted at time of inspection.

RECOMMENDATION: Scrape and remove fungus condition, chemically treat with wood preservative, and fill with a hard wood filler
