The Inspectors Company Inc  
4538 Cass Street  
San Diego, CA 92109  
(858) 866-6431

1616 Glenwood Drive  
San Diego, CA 92103

#### SUMMARY:

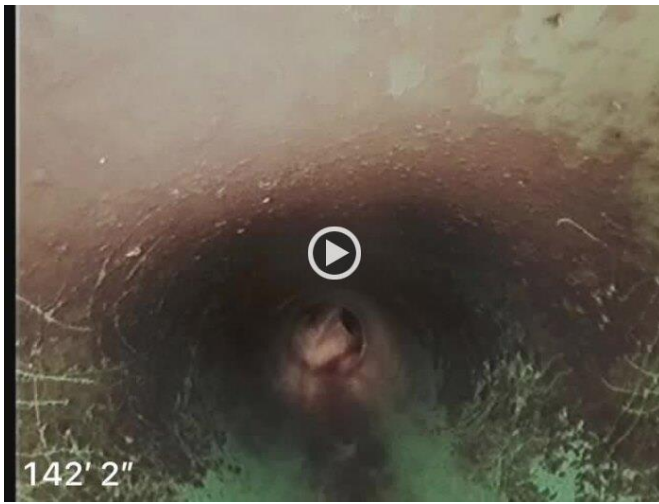
VIDEO 1

THE MAIN CAST IRON SEWER LINES APPEARED TO BE IN SERVICEABLE CONDITION AND WERE FUNCTIONAL DURING TIME OF INSPECTION. TYPICAL WEAR AND SCALE OBSERVED INSIDE THE MAIN SEWER LINE DUE TO ITS AGE.
