# Inspection Report

**Property Address:**  
1817-1819 Sunset Cliffs Blvd  
San Diego CA 92107

**Foresight Building Inspection**

| <b>Date:</b> 8/20/2026 | <b>Time:</b> 11:00 AM | <b>Report ID:</b> 3814 |

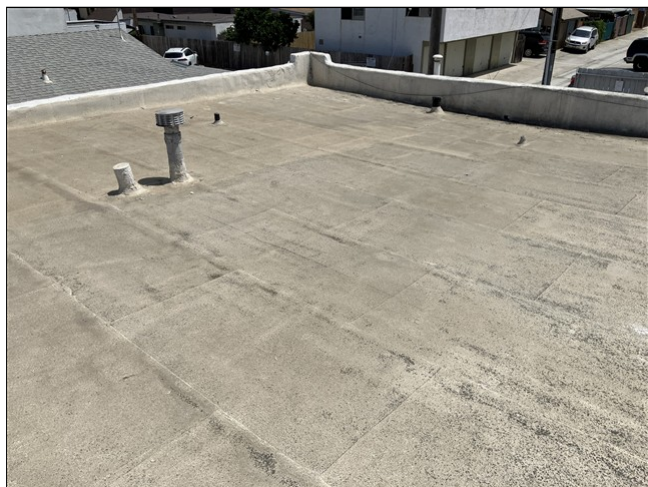
The roof covering consists of asphalt composition shingles that exhibit visible signs of wear consistent with normal aging and environmental exposure. Observed conditions include typical surface weathering and minor deterioration; however, the shingles appear to be performing their intended function at the time of inspection with no immediate indications of failure noted.

1.0 Item 1(Picture) 1819: roof covering appeared aged / recommend further evaluation

Visible defects were observed at areas of the roof covering . It is recommended to contact a licensed roofer for a complete evaluation of all roof defects and repair/replace as needed.

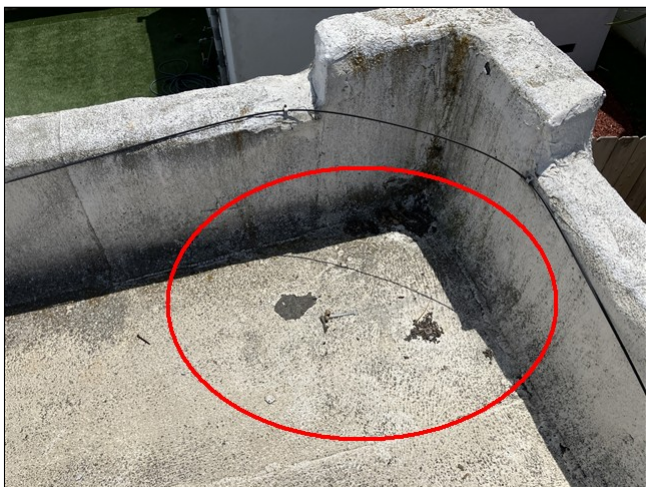
1.0 Item 2(Picture) 1819: roof covering appeared aged / recommend further evaluation

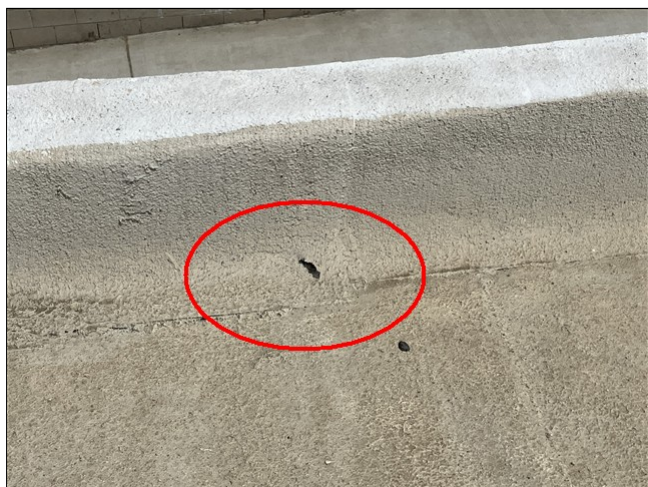
1.0 Item 3(Picture) 1819: roof covering defect/damage visible

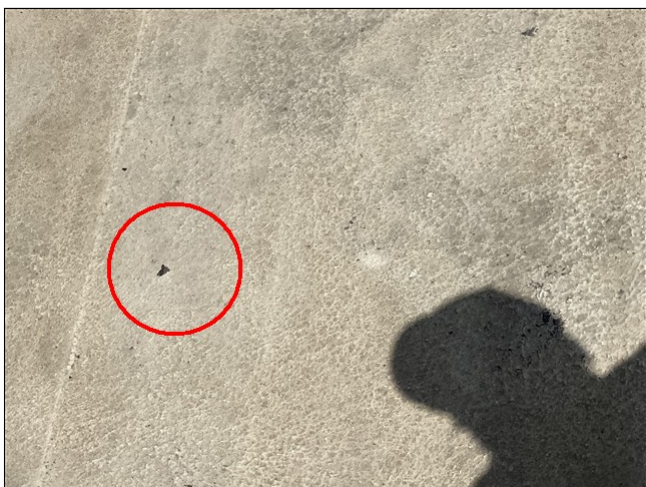
1.0 Item 4(Picture) 1819: roof covering damage/defect visible

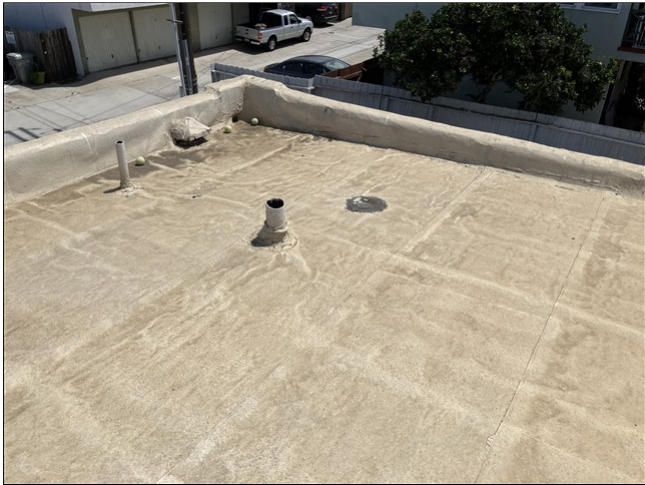
1.0 Item 5(Picture) 1817: aged roof covering / recommend further evaluation and replacement as needed

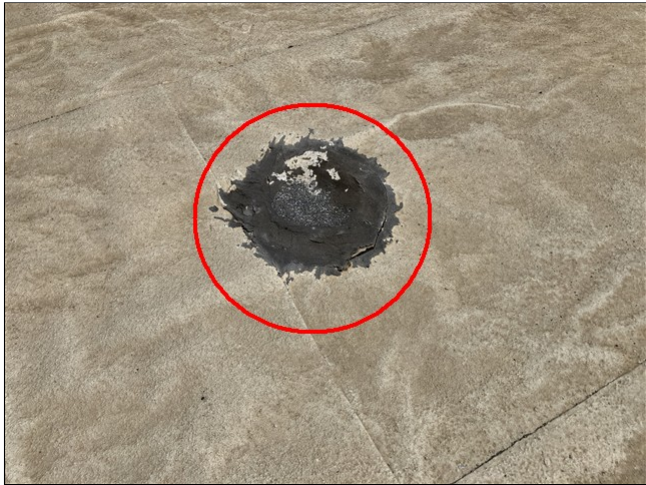
1.0 Item 6(Picture) 1817: roof covering defects visible

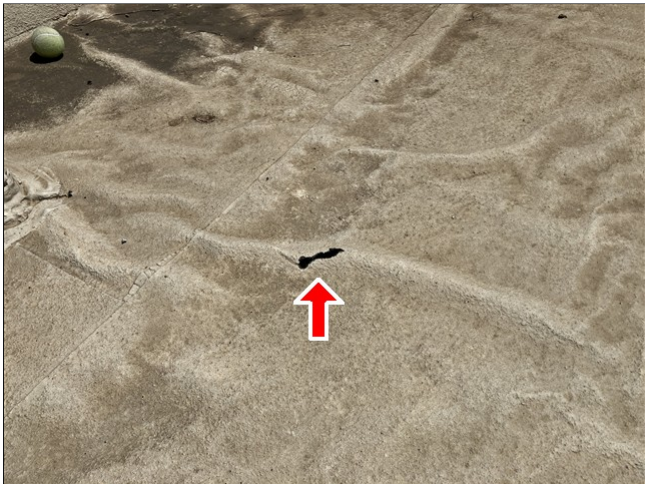
1.0 Item 7(Picture) 1817: roof covering defects visible

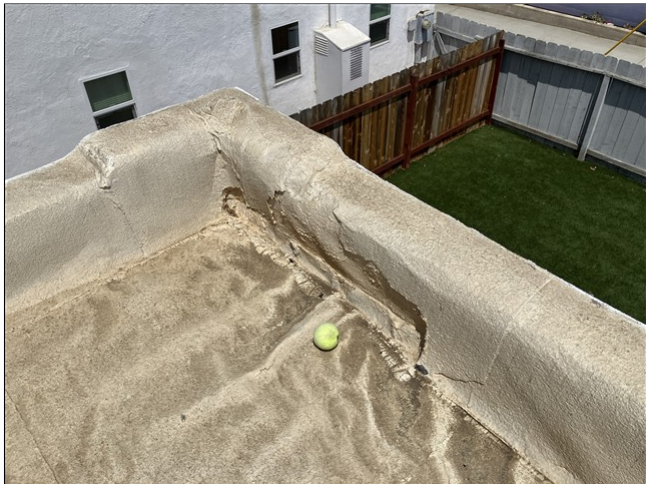
1.0 Item 8(Picture) 1817: roof covering defects visible

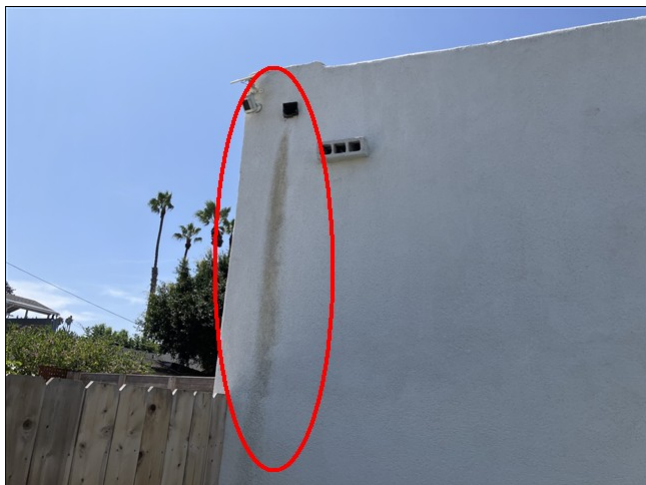
1.1 Item 1(Picture) rain gutter upgrades recommended

A properly designed and installed rain gutter system helps control water flow and keeps moisture away from the building system and its foundation. A rain gutter system or additional gutters to the existing system are a recommended upgrade.

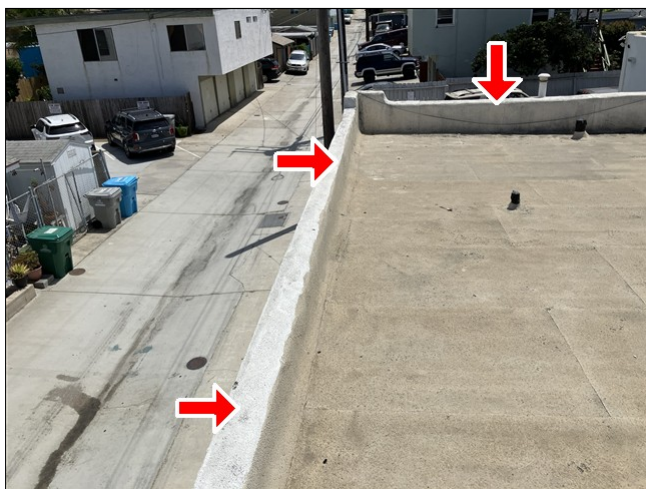
Parapet Wall Flashing/Coping: The roof membrane/roll roofing has been wrapped up and over the parapet wall rather than being terminated with a dedicated metal flashing/coping cap. Although this type of roofing termination may be an accepted installation depending on the roofing system and manufacturer's requirements, the addition of properly installed metal coping/flashing caps is recommended to provide improved protection of the parapet wall and roofing termination from weather exposure and to help reduce the potential for deterioration and water intrusion. Have a qualified roofing contractor evaluate the existing termination and install appropriate coping/flashing in accordance with the roofing manufacturer's specifications and applicable building requirements.

1.2 Item 1(Picture) 1819: parapet wall flashing caps recommended

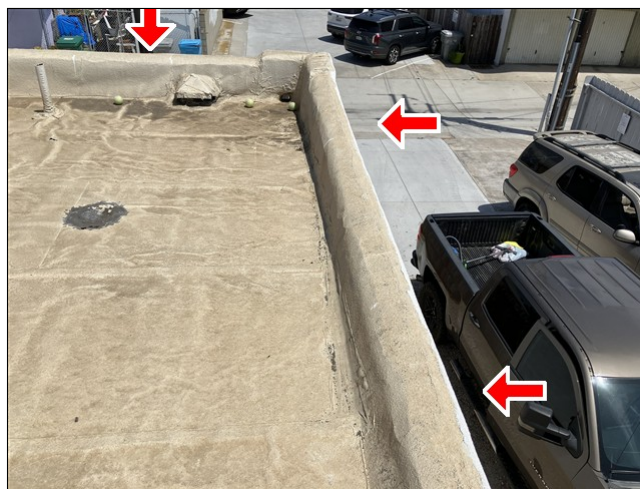
1.2 Item 2(Picture) 1819: parapet wall flashing caps recommended

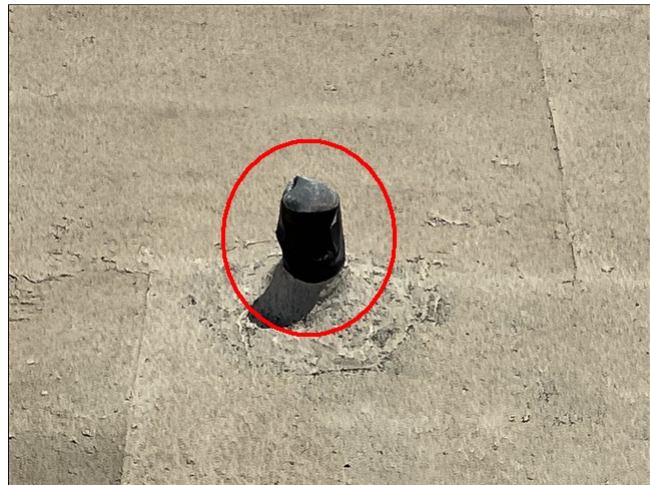
Plumbing Vent Terminations: One or more plumbing vent pipes at the roof were observed to have their openings capped/ covered with tape or other material. The reason for this condition could not be determined during the inspection. Plumbing vent terminations are intended to remain open to provide proper venting of the drainage system. Recommend evaluation by a qualified plumbing contractor to determine why the vents have been covered and to restore proper vent termination as necessary.

1.5 Item 1(Picture) 1819: vent termination was covered / recommend further evaluation

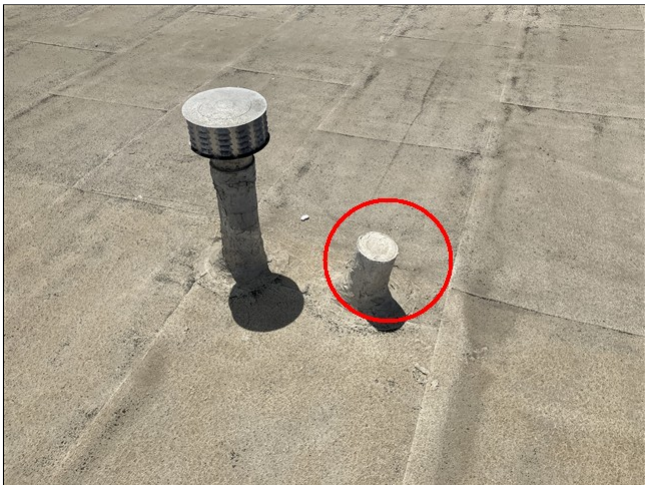
1.5 Item 2(Picture) 1819: vent termination was covered / recommend further evaluation

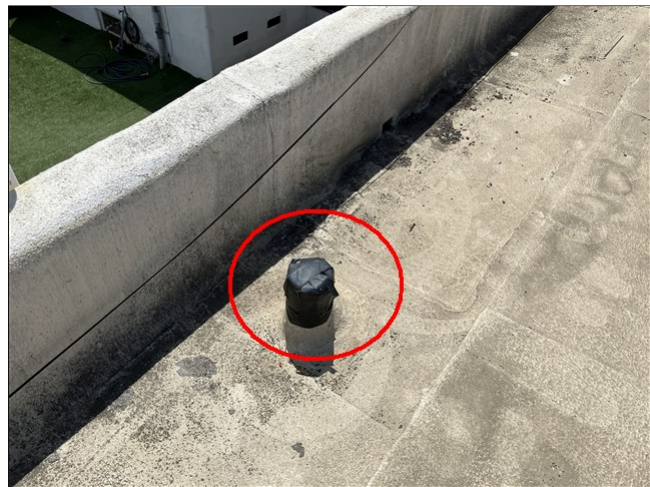
1.5 Item 3(Picture) 1819: vent termination was covered / recommend further evaluation and correction as needed

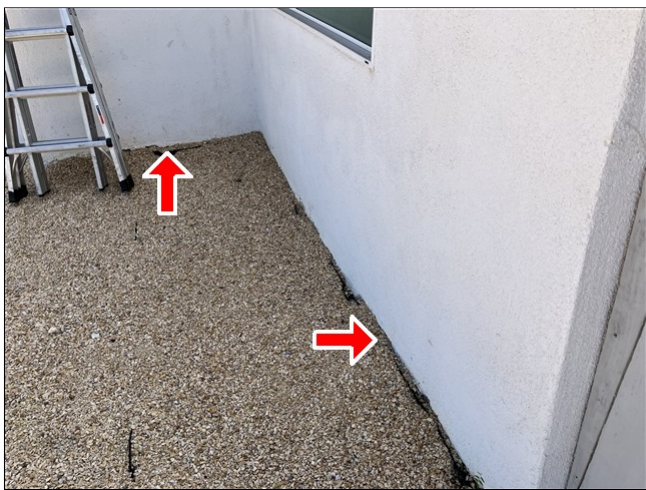
2.0 Item 2(Picture) 1819: weep screed flashing upgrades recommended

Plaster wall cladding systems (commonly referred to as stucco) have changed over the years as building materials and applications have improved. Because of the age the home, upgrading the stucco system is recommended. Consult with a stucco contractor for recommendations and upgrades.

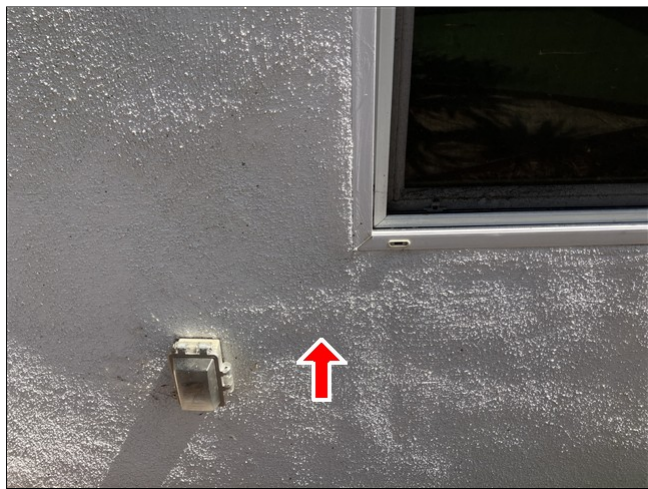
(2) Cracks were observed in the stucco wall cladding. Cracking can be caused by normal shrinkage, age, movement, settlement, moisture intrusion, installation defects, or other conditions. The cause and significance of the cracking cannot be determined through a visual inspection. This inspection is not a structural evaluation and does not determine whether concealed defects are present. Recommend further evaluation by a qualified stucco contractor and/or structural professional, as appropriate.

2.0 Item 3(Picture) 1819: crack visible at stucco

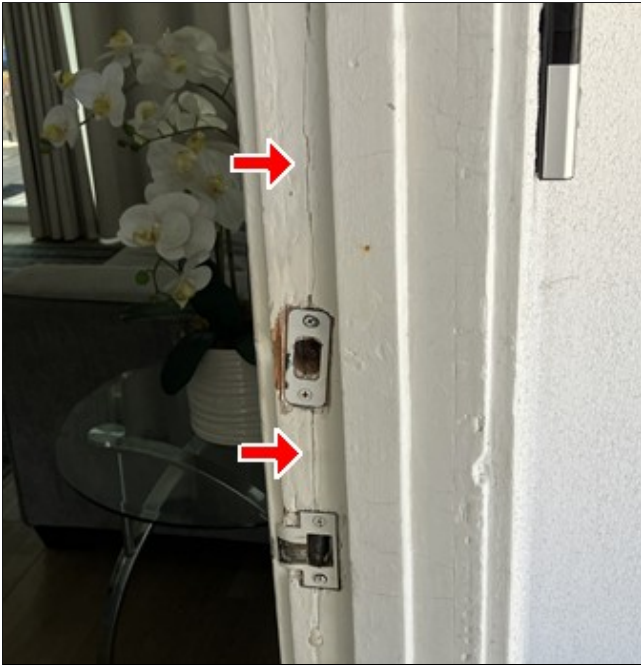
2.1 Item 1(Picture) 1819: crack visible at door jamb

One or more of the exterior door components had visible damage, did not function properly, or had other observable defect. It is recommended to have the doors evaluated by a qualified tradesman and repaired/replaced as needed.

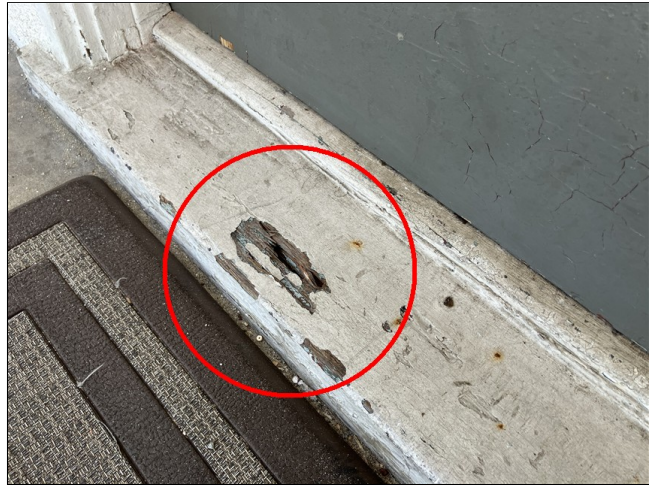
Evidence of possible wood-destroying organism (WDO) activity and/or damage was observed at the time of inspection. Conditions such as damaged wood, staining, debris, or other indicators may be consistent with current or previous WDO activity; however, this inspection is not a pest inspection and no determination is made regarding whether the activity is active or past. Concealed damage may also exist in inaccessible areas. Further evaluation by a licensed pest control or WDO specialist is recommended for identification, treatment recommendations, and determination of the extent of any damage or necessary repairs.

2.1 Item 2(Picture) 1819: possible WDO evidence or damage observed at door threshold

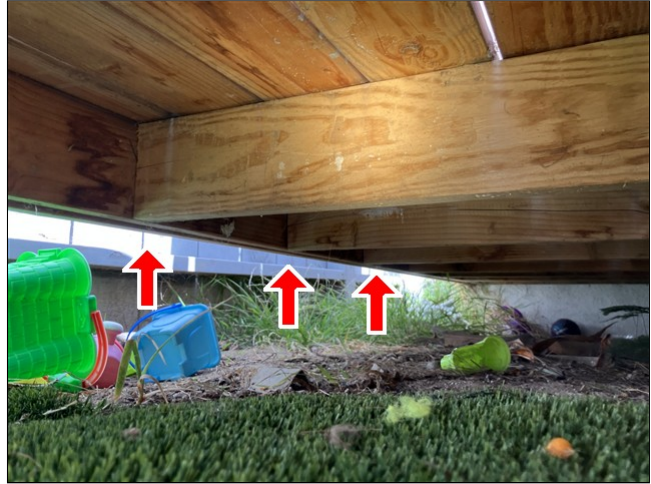
2.3 Item 2(Picture) 1819: missing deck joist hangers

One or more defects were observed at areas of the exterior deck, stairs, or attached covering systems. It is recommended to have a licensed contractor evaluate these exterior systems and repair/replace as needed.

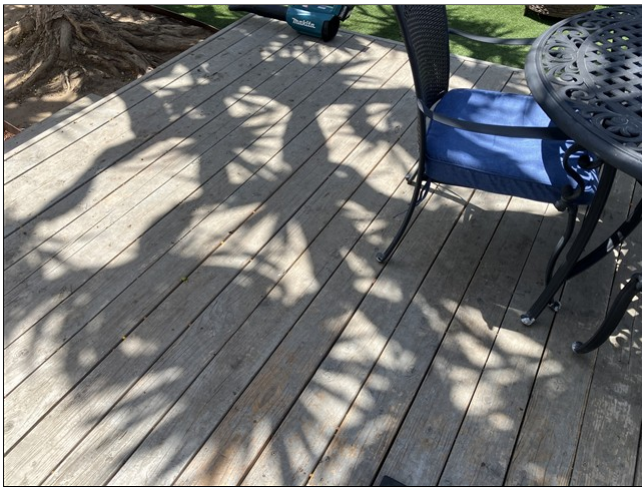
2.3 Item 3(Picture) 1819: deck boards did not appear to be protected from UV

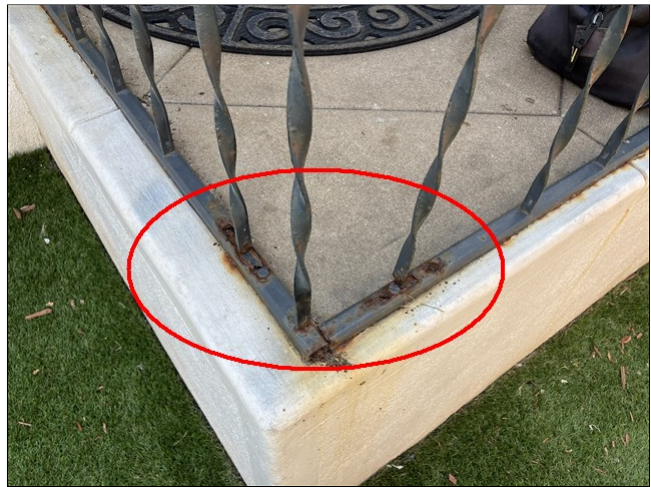
2.3 Item 4(Picture) 1817: oxidation visible at railing

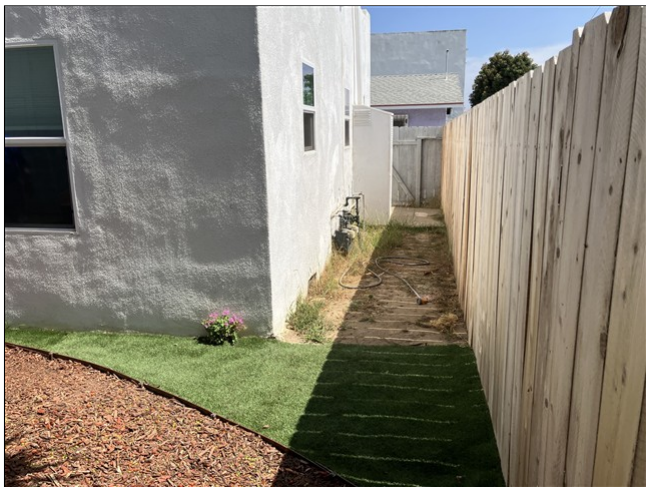
(1) Insufficient slope or potentially poor drainage was observed at areas of the driveway, walkways, or landscaping which can increase moisture related damages and defects to the structure. Drainage or landscaping corrections and improvements are recommended. It is recommended to contact a licensed landscaping contractor for evaluation and correction as needed.

2.4 Item 2(Picture) 1819: grading or drainage improvements/corrections are recommended to achieve positive slope away from the property

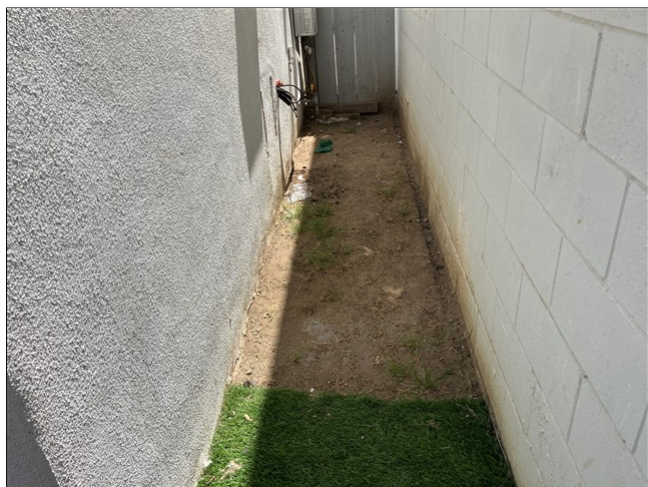
2.4 Item 3(Picture) 1817: grading or drainage improvements/corrections are recommended to achieve positive slope away from the property

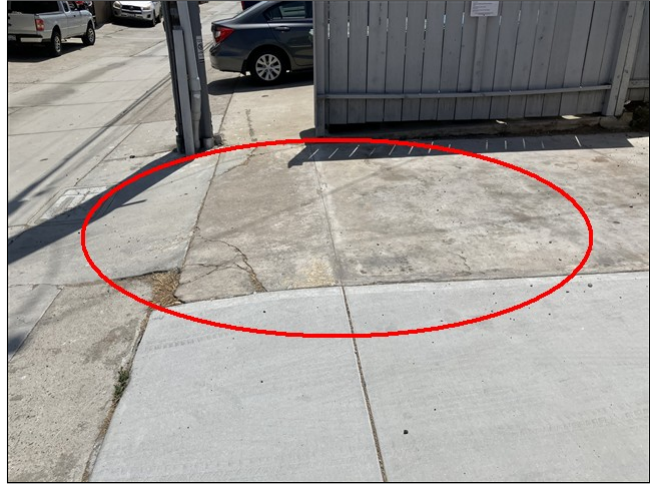
(2) Cracking, damage, or other visible defect was observed at areas of the exterior hardscape (driveway, walkway, stairs, patio, etc.). It is recommended to have these evaluated by a licensed contractor and repaired/replaced as needed.

2.4 Item 5(Picture) cracks visible at driveway

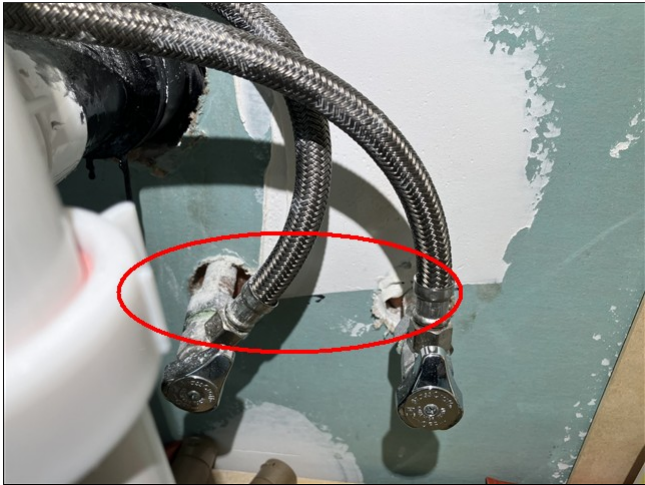
4.0 Item 3(Picture) 1819: bathroom sink wall penetrations visible

(2) Damages, missing drywall, or other defects to the walls or ceilings were observed. It is recommended to have these walls and ceilings evaluated by a qualified tradesman and repaired/replaced as needed.

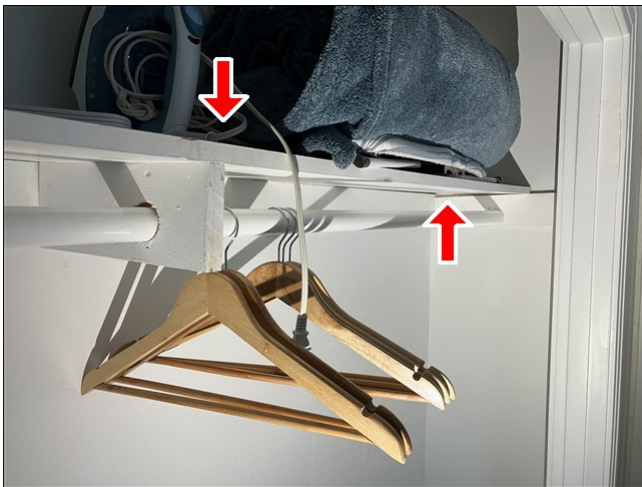
4.4 Item 1(Picture) 1819: bedroom closet shelf is leaning

One or more of the closet shelving systems were damaged, not secured properly, or had other observable defect that should be evaluated by a qualified tradesman and repaired/replaced as needed.

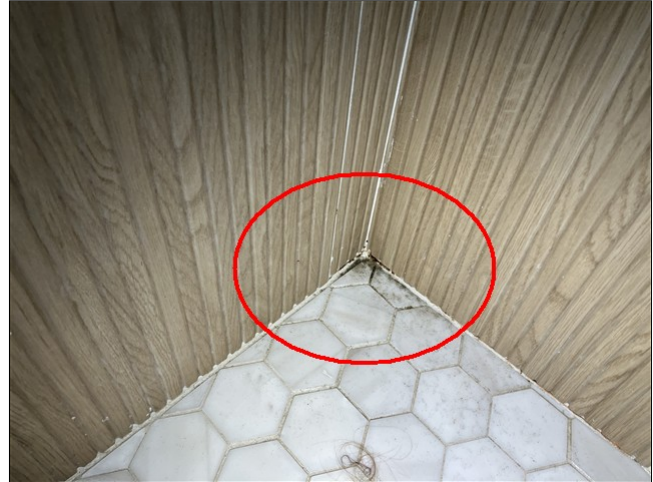
4.6 Item 2(Picture) 1819: shower surround caulking or appropriate sealant maintenance/repairs needed

(1) The caulking or grout was missing, separated, or had other observable defect at areas of one or more of the tub/shower wall or floor systems. It is recommended to have these evaluated and repaired as needed.

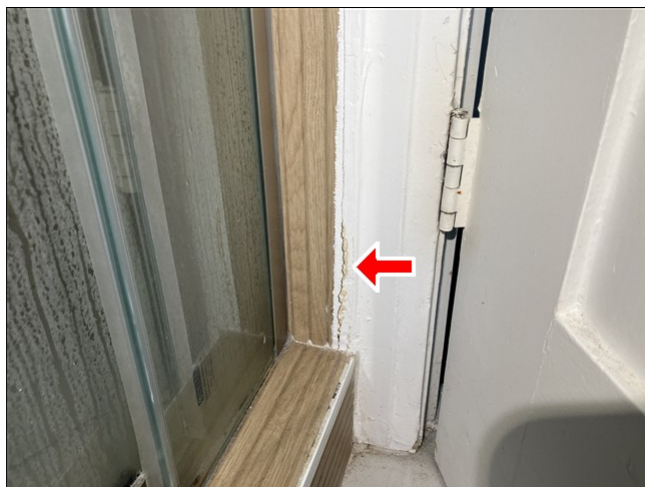
(2) Damage, stains, or other possible moisture related defects were visible around areas of the ceilings, walls, or floors. No moisture was observed at the time of the inspection. Further evaluation is recommended to determine the cause of the moisture related observations and correction as needed.

4.6 Item 4(Picture) 1819 bath: moisture stains or damage visible

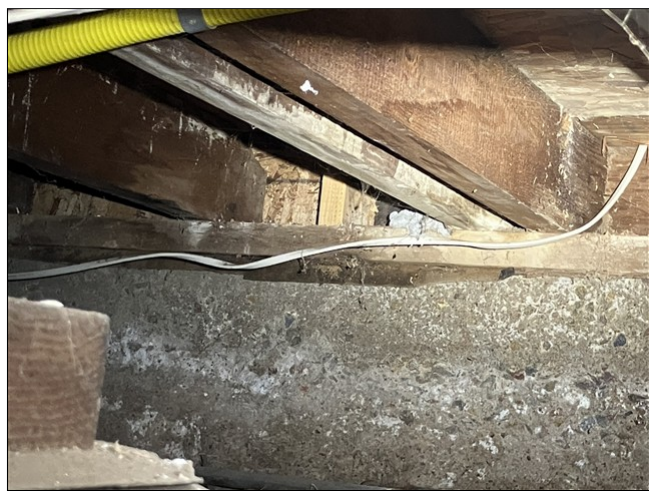
5.0 Item 2(Picture) 1817: foundation anchoring upgrades recommended

Foundation anchoring was not visible. While this may not have been required at the time of construction, foundation anchoring is an important component in preventing movement or other damages resulting from seismic activity. It is recommended to have this evaluated by a licensed contractor and upgraded as needed.

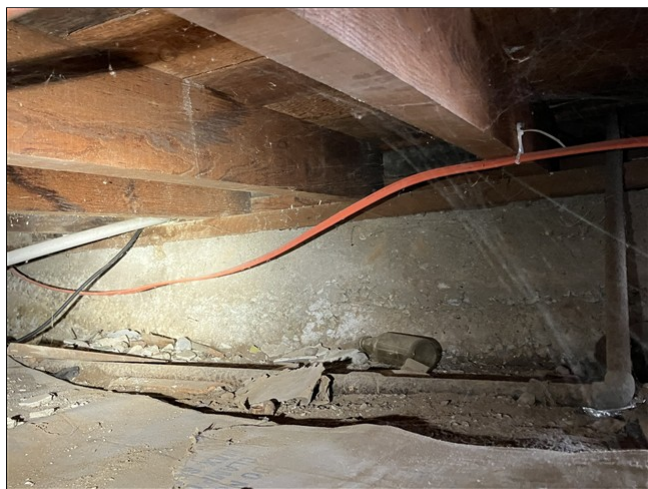
5.0 Item 3(Picture) 1819: foundation anchoring upgrades recommended

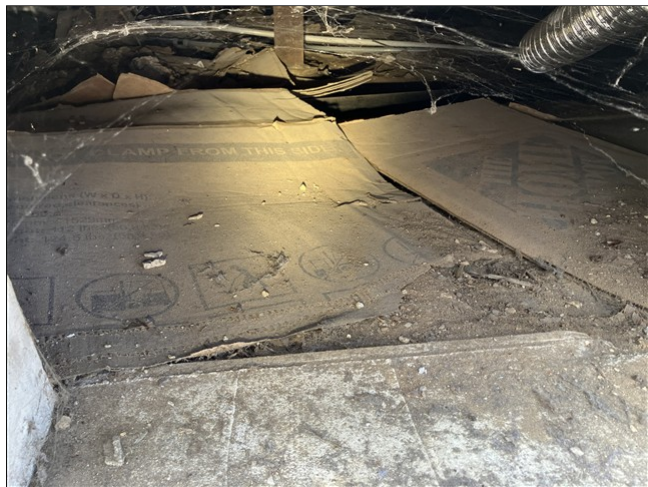
5.0 Item 4(Picture) 1819: debris visible in the subfloor area

(2) There was debris (wood, cardboard, abandoned materials, etc.) observed in the attic or subfloor area. It is recommended to have all debris removed.

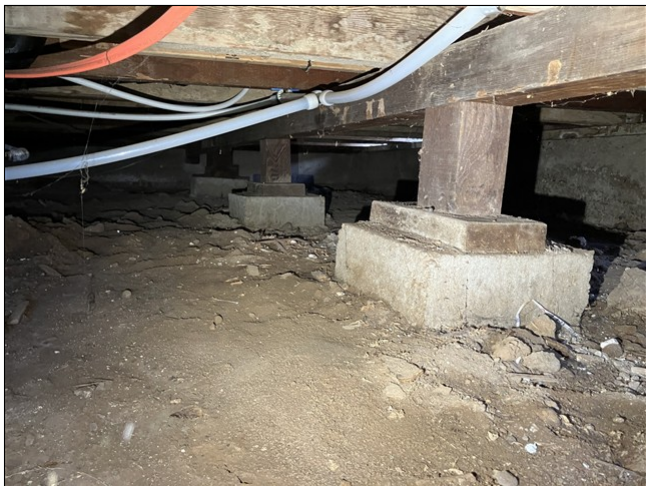
5.1 Item 2(Picture) 1817: post and pier seismic strapping/anchoring upgrades recommended

The foundation post and pier system appeared constructed conforming to the standards of the era it was built. However, these standards would not meet modern building standards, which have improved over the years to protect homes against natural and unnatural occurring stresses on the foundation such as settling, deterioration, or seismic activity. Metal strap connectors and shorter distances between posts are examples of these upgrades. It is recommended to contact and licensed contractor regarding upgrades to the foundation post and pier system.

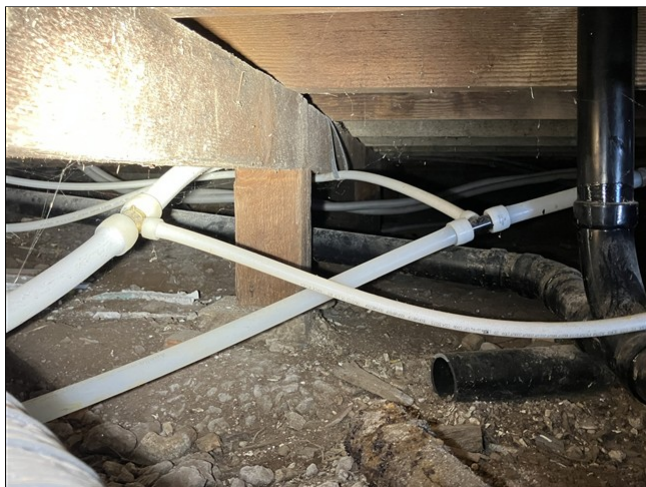
5.1 Item 3(Picture) 1819: post and pier seismic strapping/anchoring upgrades recommended

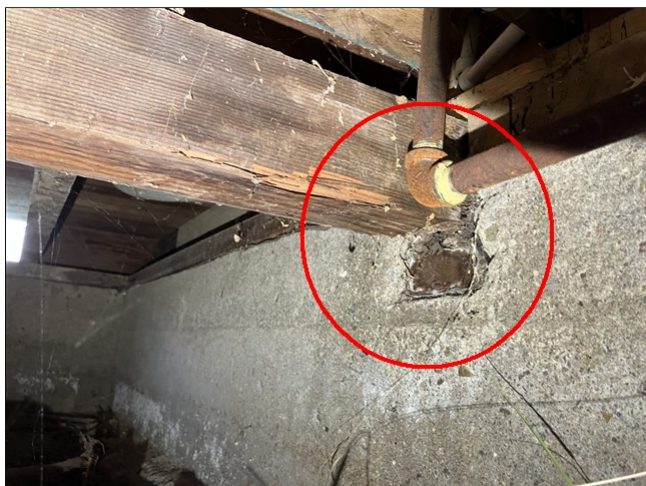
Evidence of possible wood-destroying organism (WDO) activity and/or damage was observed at the time of inspection. Conditions such as damaged wood, staining, debris, or other indicators may be consistent with current or previous WDO activity; however, this inspection is not a pest inspection and no determination is made regarding whether the activity is active or past. Concealed damage may also exist in inaccessible areas. Further evaluation by a licensed pest control or WDO specialist is recommended for identification, treatment recommendations, and determination of the extent of any damage or necessary repairs.

5.2 Item 1(Picture) 1817: possible WDO evidence or damage observed floor beam

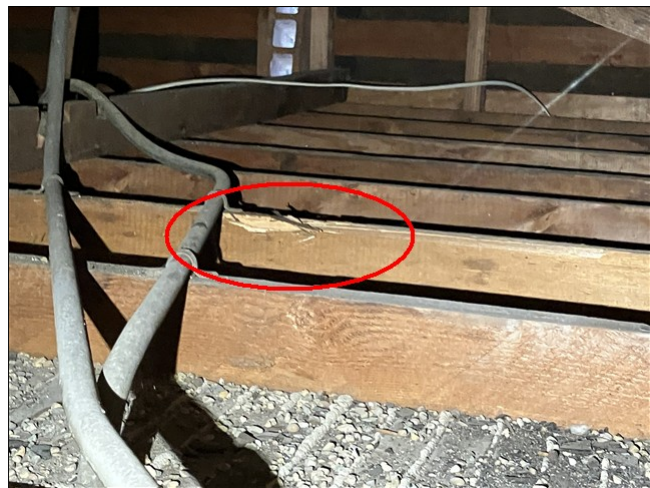
Evidence of past moisture penetration was visible in areas of the attic. No moisture was observed at the time of the inspection. Because the scope of this inspection is limited to the condition of the property at the time of the inspection and defects may not be visible, further evaluation is recommended from a licensed roofer to determine the cause of the stains and correction as needed.

5.5 Item 1(Picture) 1819 attic: possible WDO evidence or damage observed

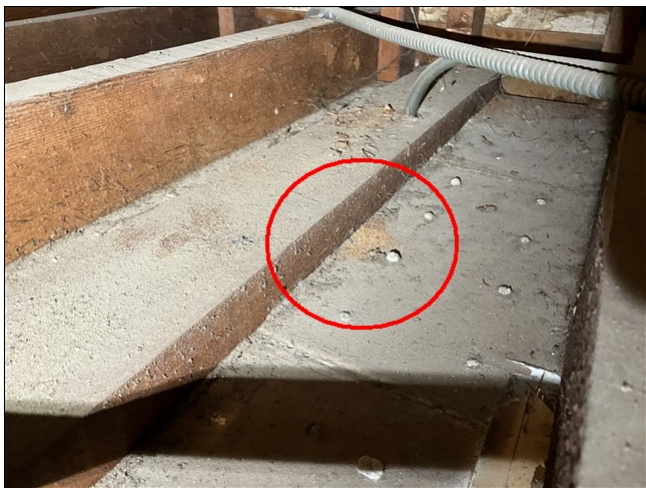
5.5 Item 2(Picture) 1817 attic: possible WDO evidence or damage observed

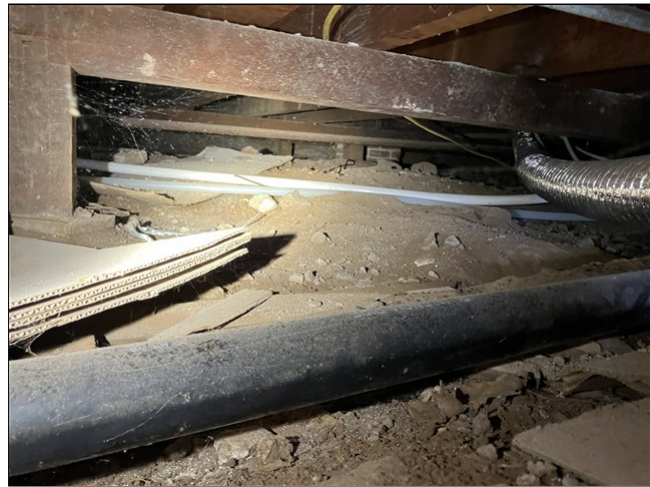
5.7 Item 1(Picture) 1819: subfloor area clearance was minimal creating limited access and/or visibility

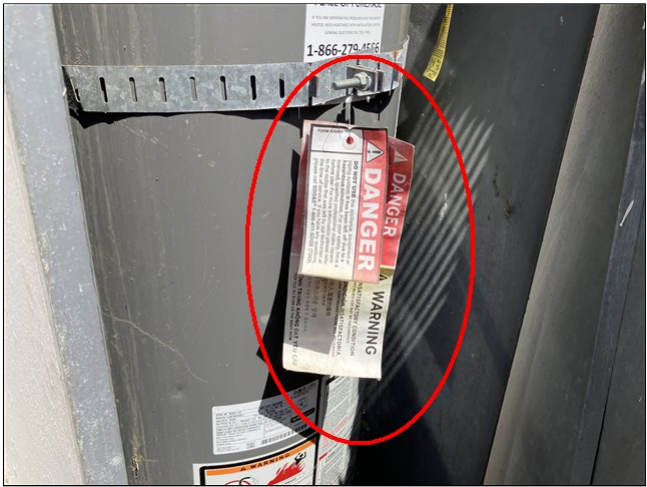
6.2 Item 2(Picture) 1819: recommend further evaluation of "danger tag"

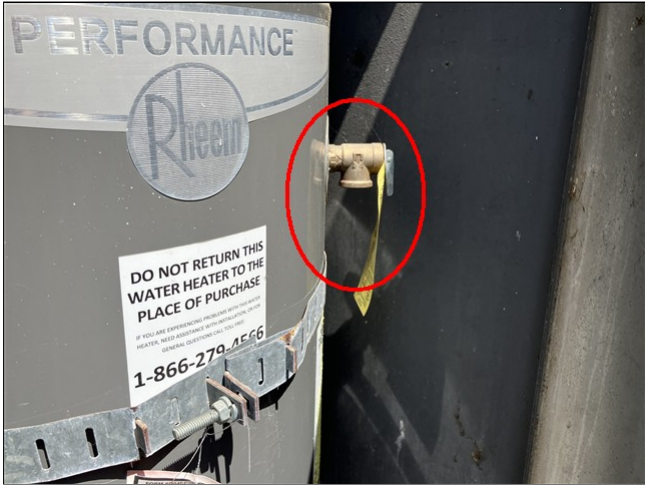
(2) The Temperature Pressure Relive Valve (TPRV) or drain system was improperly installed or had other observable defect. It is recommended to contact a licensed plumber for evaluation and correction as needed.

6.2 Item 4(Picture) 1819: missing TPRV drain

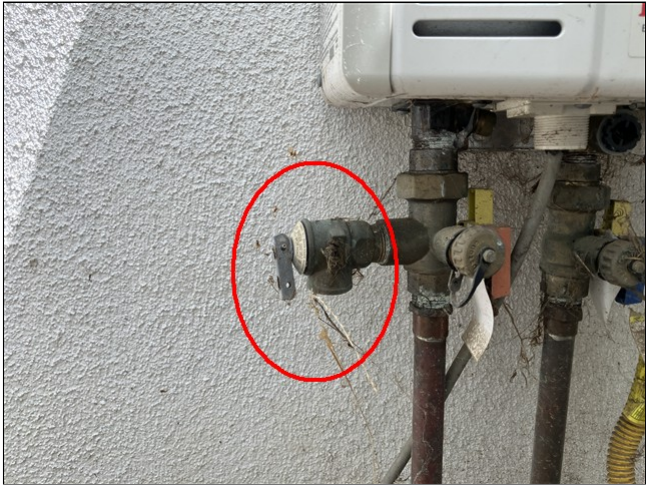
6.2 Item 5(Picture) 1817: missing TPRV drain

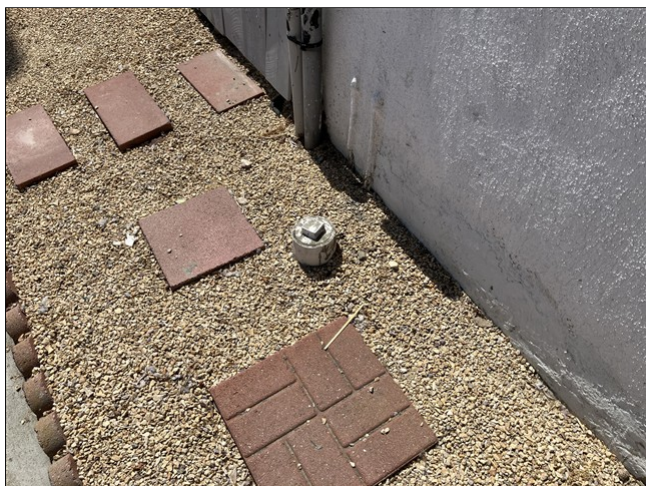
(1) Plumbing DWV (drain, waste, vent) systems may have hidden defects that can only be detected with further inspection from a qualified plumber who provides drain video/camera inspections. Because the scope of this inspection is limited to only visible and accessible systems and components, it is recommended to contact a licensed plumber for further inspection and evaluation.

6.3 Item 1(Picture) 1819: sewer camera inspection recommended

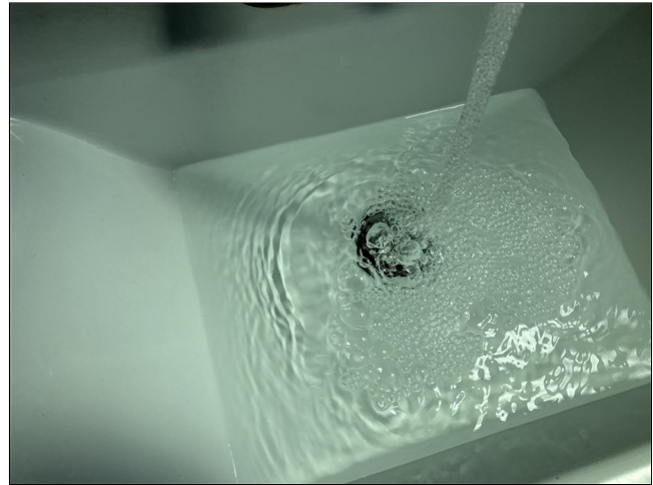
(2) The drainage at one or more of the sinks, tubs, or showers was slow or had other observable defect. It is recommended to have a licensed plumber evaluate and correct as needed.

6.3 Item 5(Picture) 1819: slow drainage observed at bathroom sink

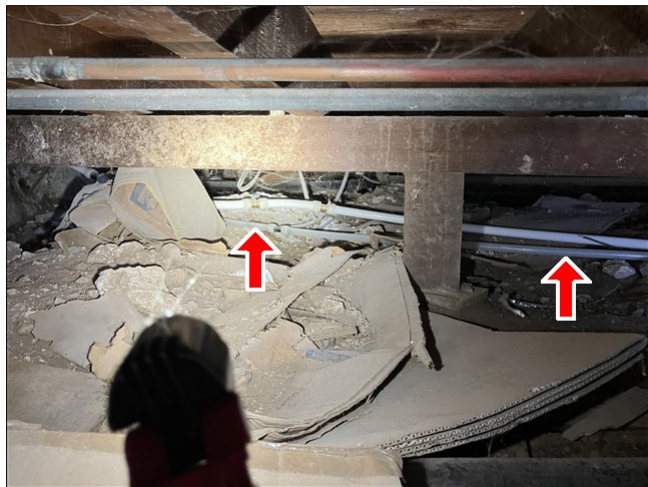
(1) Inadequate or improper water supply strapping was observed. It is recommended to have the water supply strapping evaluated by a licensed plumber and repaired/replaced as needed.

6.4 Item 1(Picture) 1819: water supply pipe was not properly strapped and supported off the ground

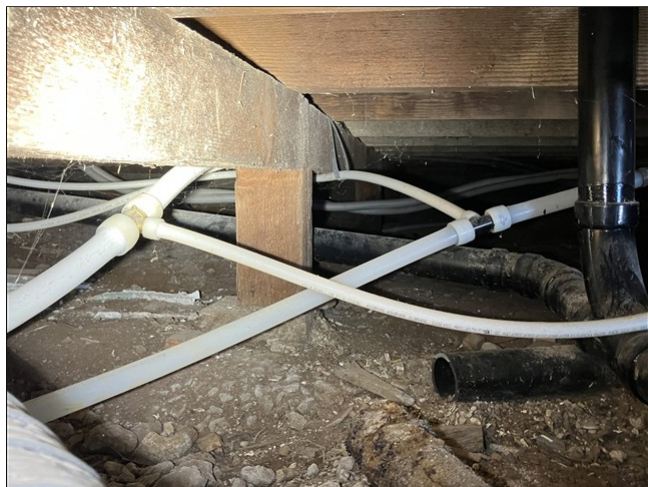
6.4 Item 3(Picture) 1819: water supply pipe was not properly strapped and supported

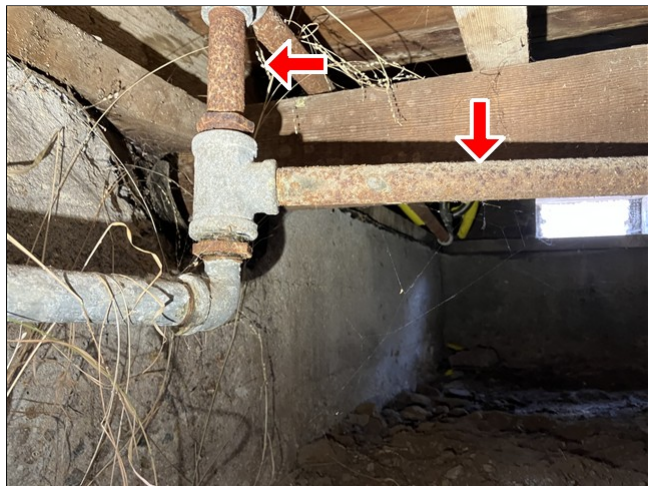
(1) The gas distribution piping appeared aged and may have exceeded or is near to exceeding its expected serviceable life. It is recommended to contact a licensed plumber to determine remaining life expectancy and replacement as needed.

6.6 Item 1(Picture) 1817: aged gas supply pipes observed

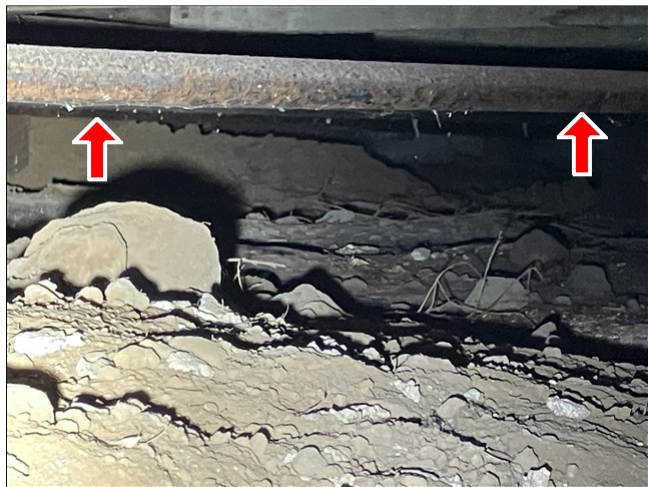
6.6 Item 3(Picture) 1819: aged gas supply pipes observed

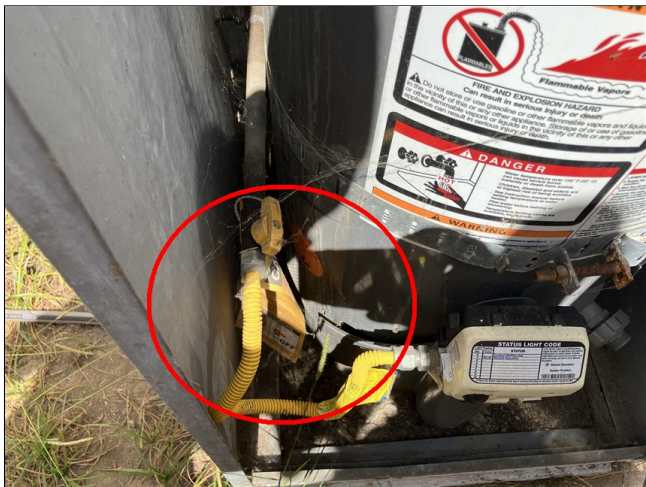
(2) There was a missing or improperly installed sediment trap after the gas supply valve to the water heater or furnace. One should be installed when a sediment trap is not incorporated as part of the appliance to prevent sediments in the gas line from entering the unit. It is recommended to have this evaluated by a licensed plumber and corrected as needed.

6.6 Item 5(Picture) 1819: missing sediment trap

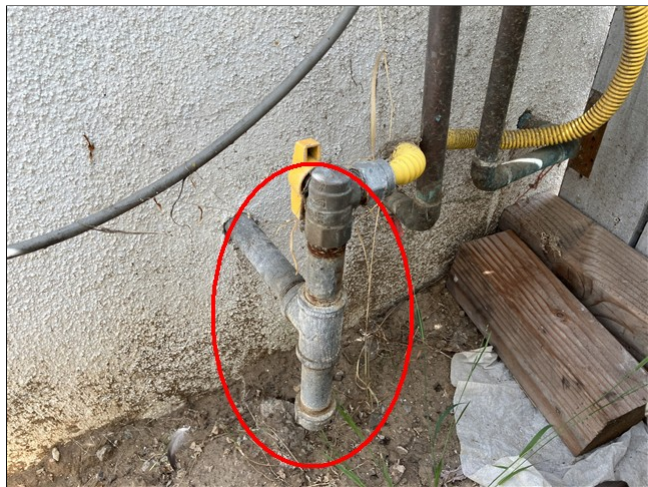
6.6 Item 6(Picture) 1817: improper sediment trap configuration

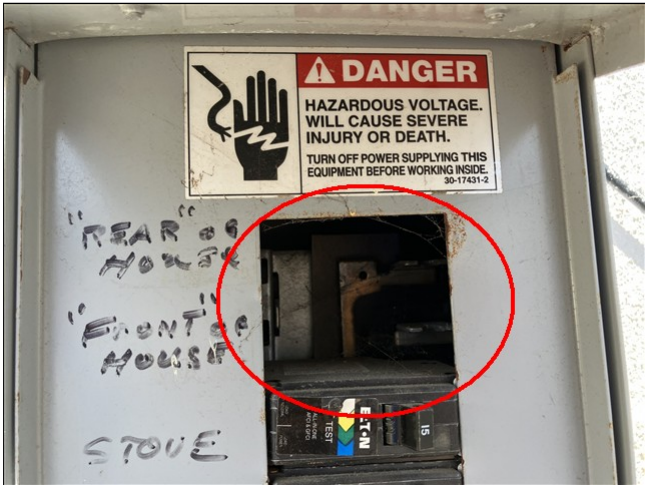
(1) There was one or more empty breaker slots in the electric panel that should be filled with an appropriate breaker blank cover.

7.3 Item 1(Picture) 1819: missing breaker blank cover

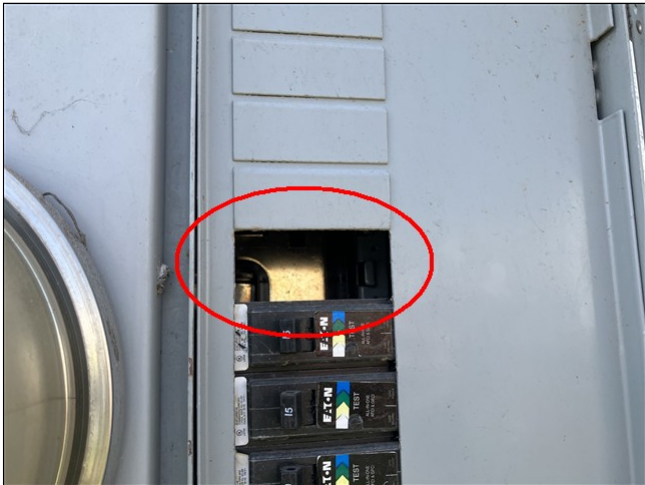
7.3 Item 2(Picture) 1817: missing breaker blank cover

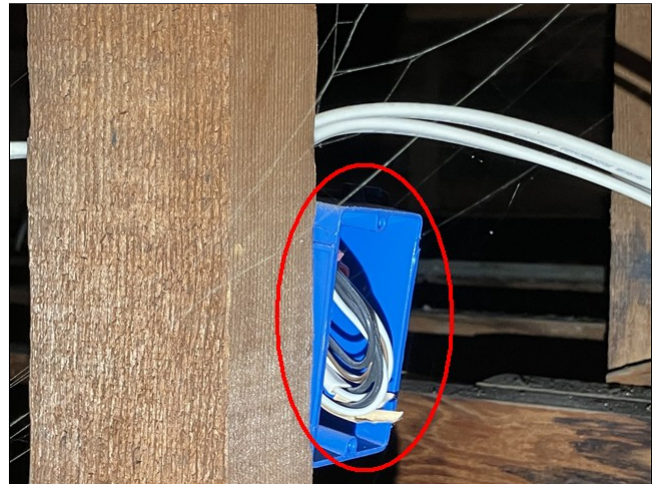
7.4 Item 2(Picture) 1819 attic: missing junction box cover

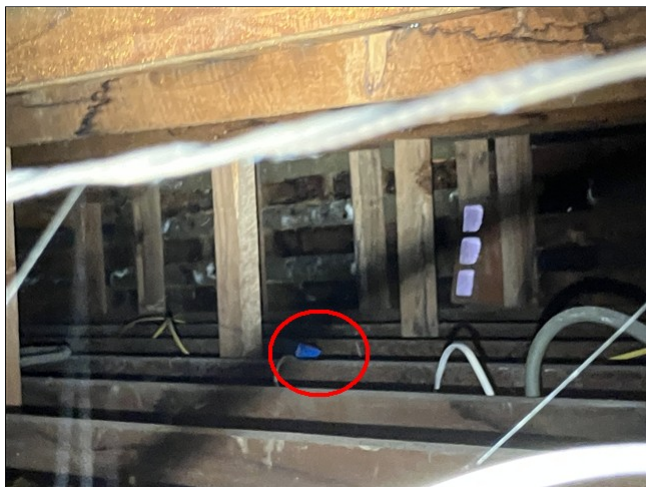
7.4 Item 3(Picture) 1819 attic: missing junction box cover

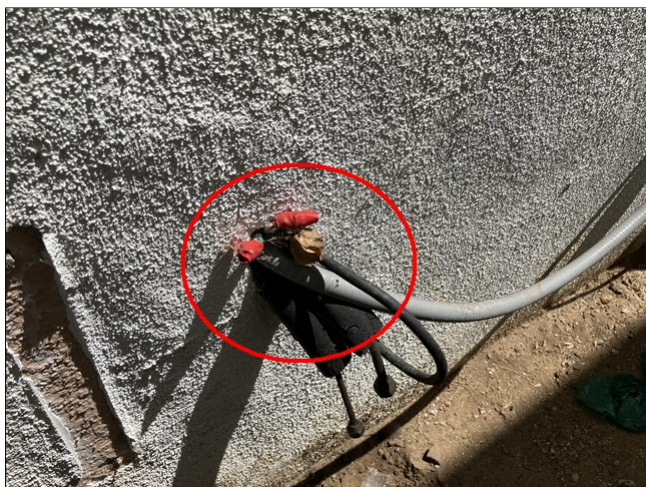
(2) Possible abandoned electrical system or components were observed. All possible abandoned electrical components should be evaluated by a licensed electrician to determine appropriate removal or corrections as needed.

7.4 Item 5(Picture) 1817: recommend further evaluation abandoned materials

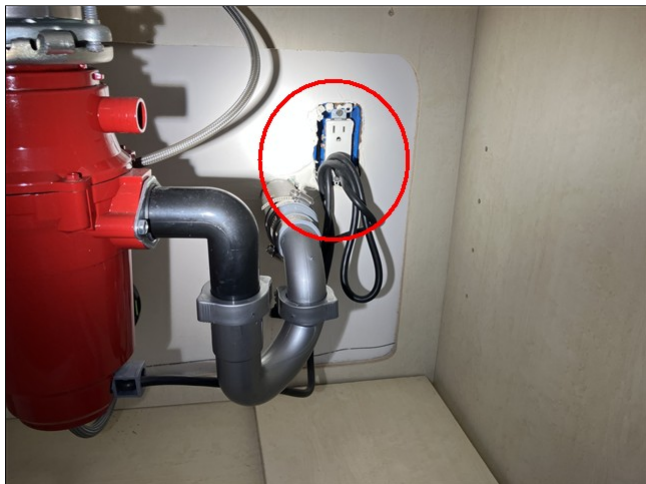
(1) Defects were observed at one or more of the outlets, switches, or fixtures. All electrical system and component defects should be considered safety hazards. It is recommended to have a licensed electrician evaluate all outlets, switches, and fixtures and repair/replace as needed.

7.5 Item 1(Picture) 1819 kitchen: missing outlet cover

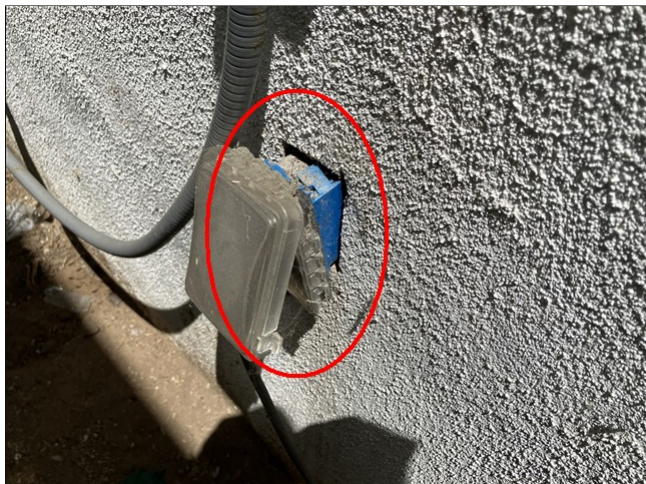
7.5 Item 3(Picture) 1817: loose exterior outlet

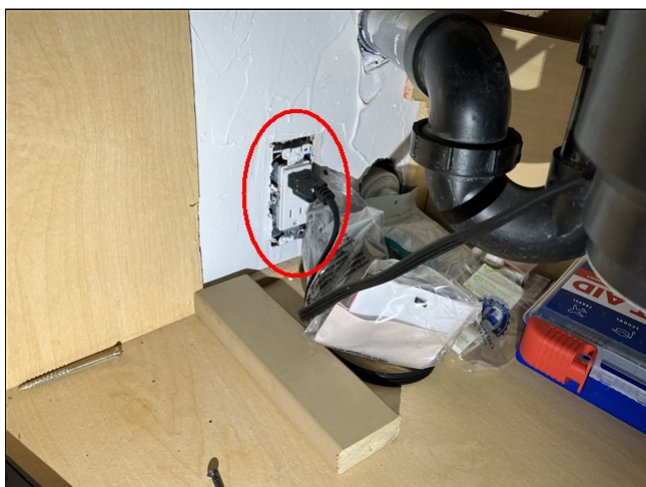
7.5 Item 5(Picture) 1817 kitchen: missing outlet cover

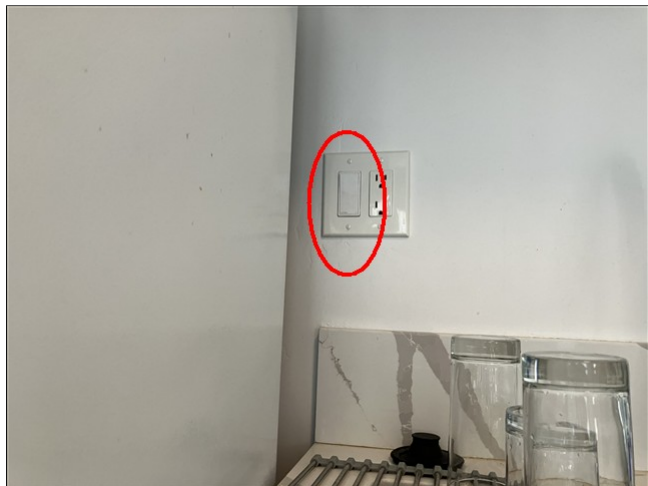
(2) While the inspector makes every effort to identify switches and their corresponding fixtures or receptacles, one or more were not identifiable. Further evaluation is recommended to identify and evaluate the corresponding fixture or outlet.

7.5 Item 6(Picture) 1819 kitchen: switch and corresponding fixture or outlet were not identified

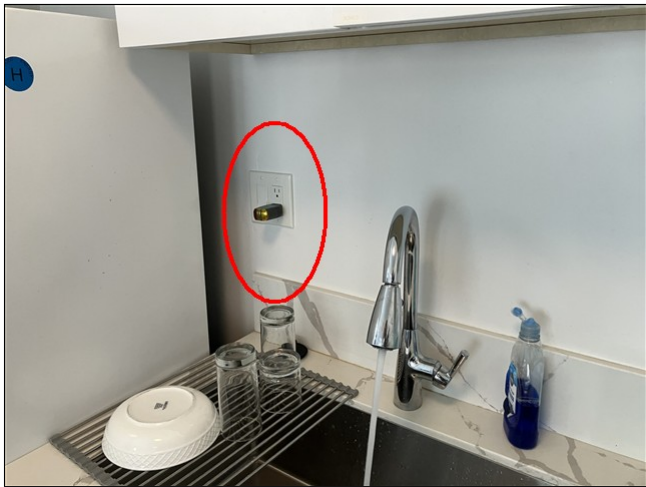
7.6 Item 2(Picture) 1819: recommend evaluation and upgrade of any non-GFCI outlets

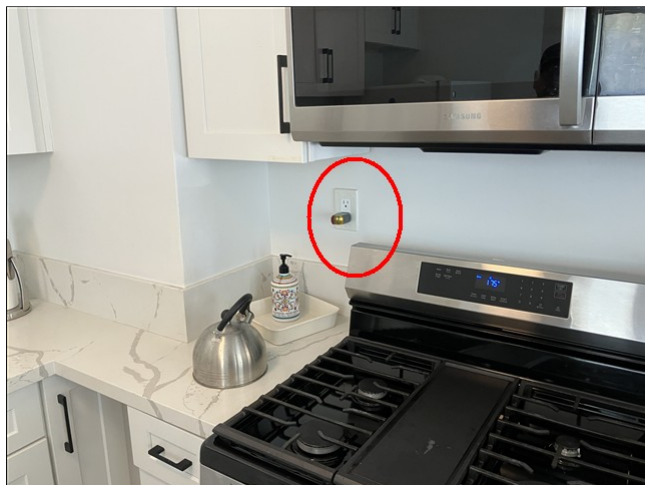
7.6 Item 3(Picture) 1819: recommend evaluation and upgrade of any non-GFCI outlets
