# Inspection Report

**Property Address:**  
1817-1819 Sunset Cliffs Blvd  
San Diego CA 92107

**Foresight Building Inspection**

| <b>Date:</b> 8/20/2026 | <b>Time:</b> 11:00 AM | <b>Report ID:</b> 3814 |

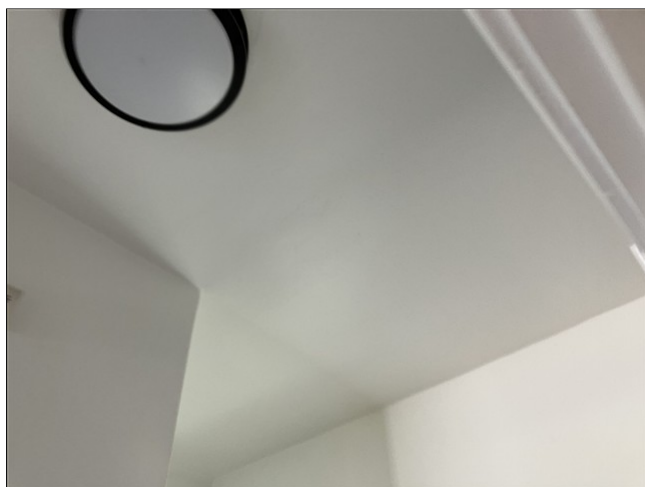
7.7 Item 1(Picture) 1819: missing hallway smoke detector

If there is no visible installation date or the age cannot be verified, it is recommended to install a new detector with a visible date to facilitate future replacement. It is recommended to test detectors according to the manufacturers specifications. Consult with the local fire department for tips and other useful information on smoke alarm installation and maintenance.

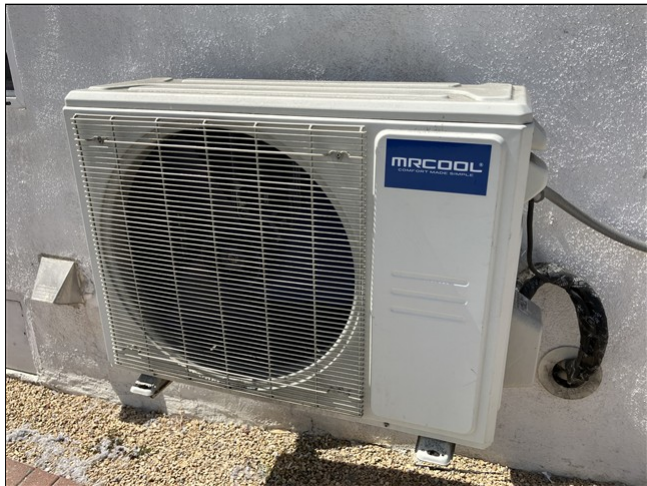
**Comments:** Further Evaluation  
Because no current visible maintenance or service record was observed, a routine maintenance inspection by a qualified HVAC technician is recommended. An annual maintenance inspection by a technician can report any defects outside the scope of this inspection and provide an estimated life expectancy for the system and components.

8.0 Item 1(Picture) 1819: no visible maintenance record observed

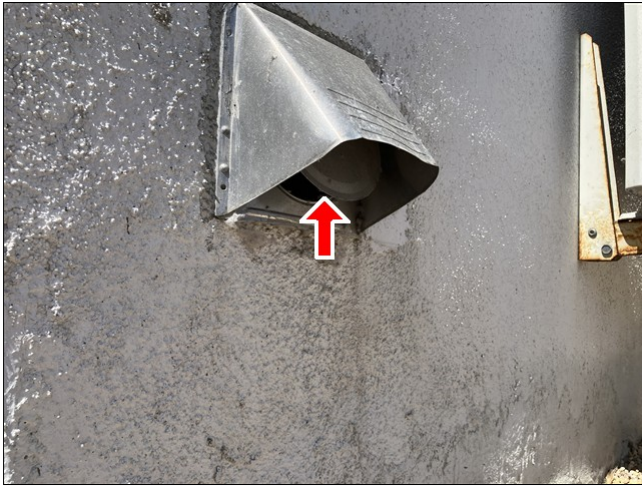
9.1 Item 1(Picture) 1819: lint debris removal for damper to fully close

Lint debris buildup in dryer ducting resulting in fires can easily be avoided by annual or semi-annual inspections and cleaning. Because the interior of dryer ducting is not visible for inspection, it is recommended to have cleaning and safety inspection performed by a qualified ducting cleaning company.

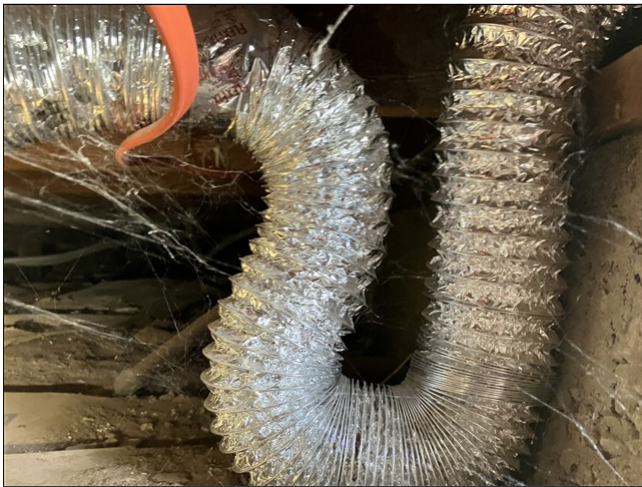
9.1 Item 2(Picture) 1819: dryer ducting material upgrade recommended

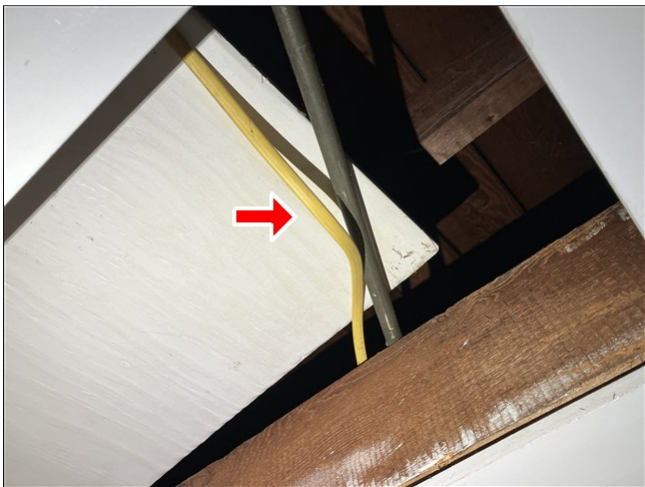
Building material was blocking the attic access which limits accessibility. It is recommended to have these rerouted.

9.3 Item 1(Picture) 1817: wiring should not cross over access to attic

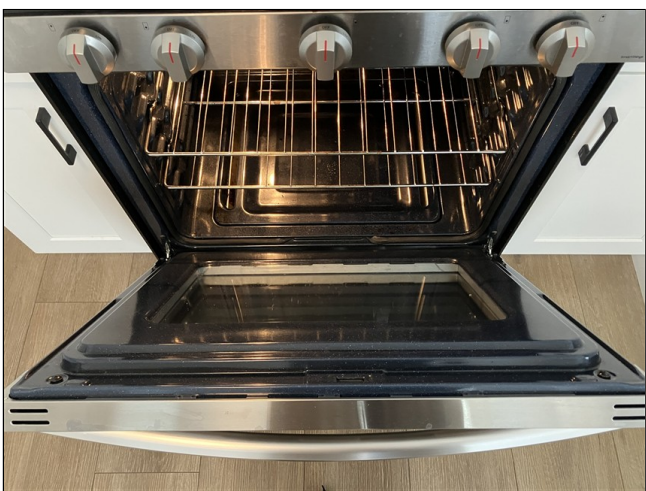
10.1 Item 2(Picture) 1819: missing anti-tip bracket
