Report # : 13913 - 1

# WOOD DESTROYING PESTS AND ORGANISMS INSPECTION REPORT

| Building No.<br>5366 | Street<br>Fall River Ct. | City<br>Oroville | ZIP<br>95966 | Date of Inspection<br>05/11/2026 | Number of Pages<br>5 |
| GENERAL DESCRIPTION:<br>Two-story duplex, slab foundation, stucco exterior, composition roofing, garage, carport with metal roofing occupied/furnished | | | | Inspection Tag Posted:<br>Water Heater<br>Other Tags Posted: | |

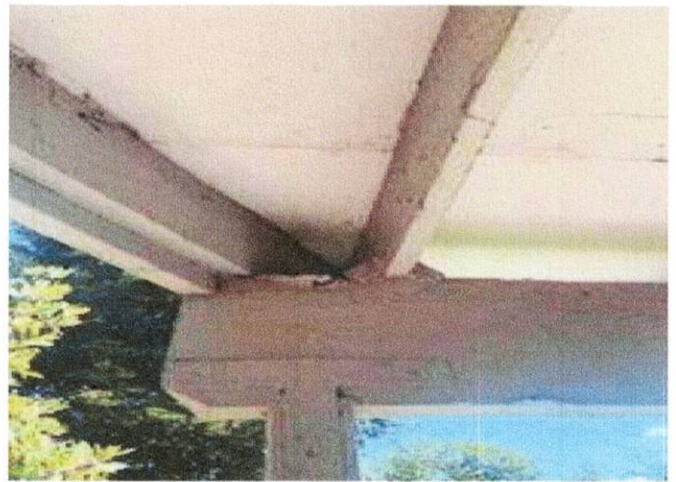
9A

FINDINGS - excessive moisture damage, fungus and/or dry rot noted to deck header beam

RECOMMENDATION -Cut out damages (fungus/dry rot) treat with fungicide and repair/replace as needed. If further damages are uncovered to areas with infections/infestations, a supplemental report will be submitted.

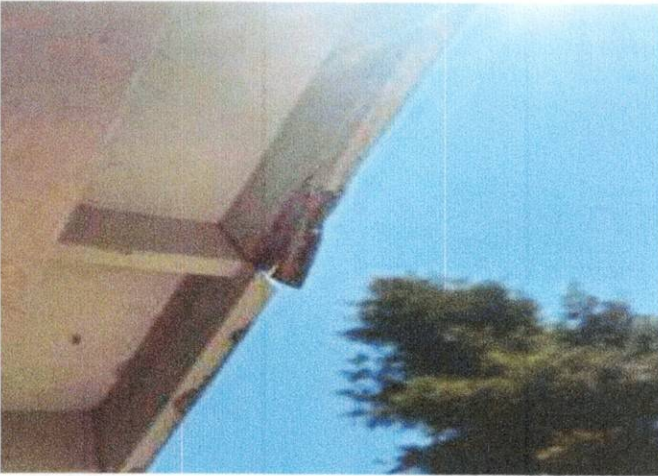
9B

FINDINGS - excessive moisture damage, fungus and/or dry rot noted to deck fascia at various locations

RECOMMENDATION - Cut back or cut out infected and or damaged wood members. Fill in, replace or repair as needed. Prime paint only

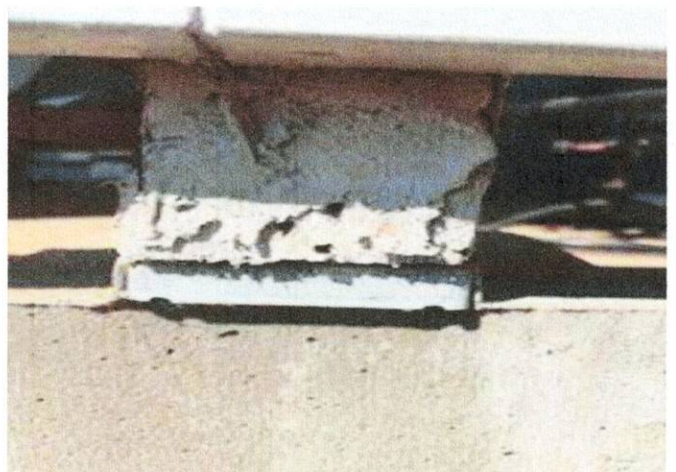
9C

FINDINGS - excessive moisture damage, fungus and/or dry rot noted to deck posts at various locations

RECOMMENDATION -Cut out damages (fungus/dry rot) treat with fungicide and repair/replace as needed. If further damages

are uncovered to areas with infections/infestations, a supplemental report will be submitted.

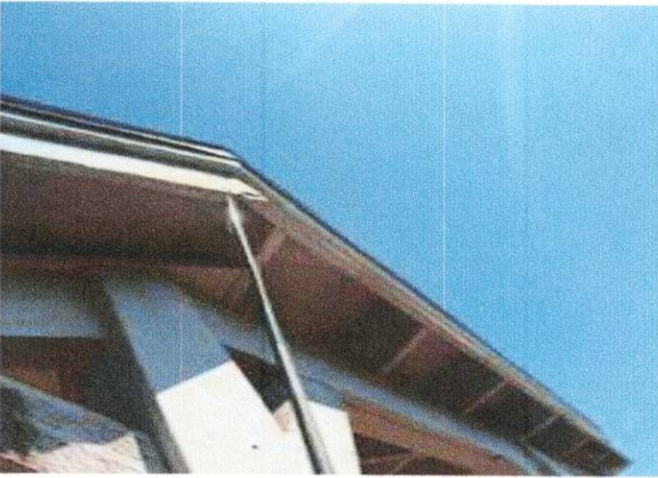
4A

FINDINGS - excessive moisture damage, fungus and/or dry rot noted to car port fascia at various locations

RECOMMENDATION - Cut back or cut out infected and or damaged wood members. Fill in, replace or repair as needed. Prime paint only

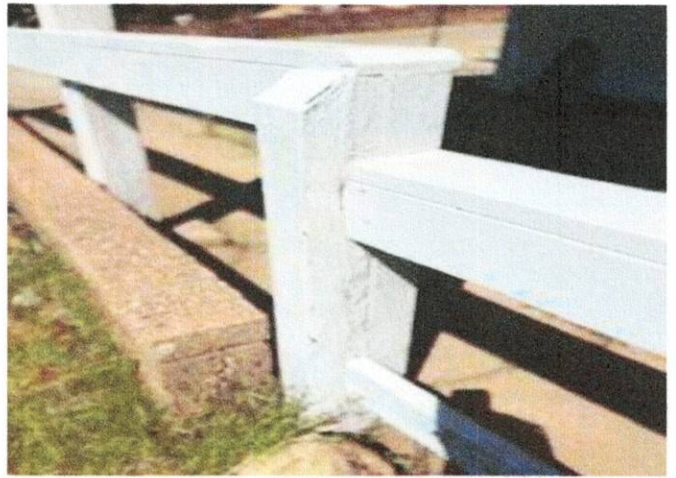
4B

FINDINGS - excessive moisture damage, fungus and/or dry rot noted to car port posts

RECOMMENDATION -Cut out damages (fungus/dry rot) treat with fungicide and repair/replace as needed. If further damages are uncovered to areas with infections/infestations, a supplemental report will be submitted.

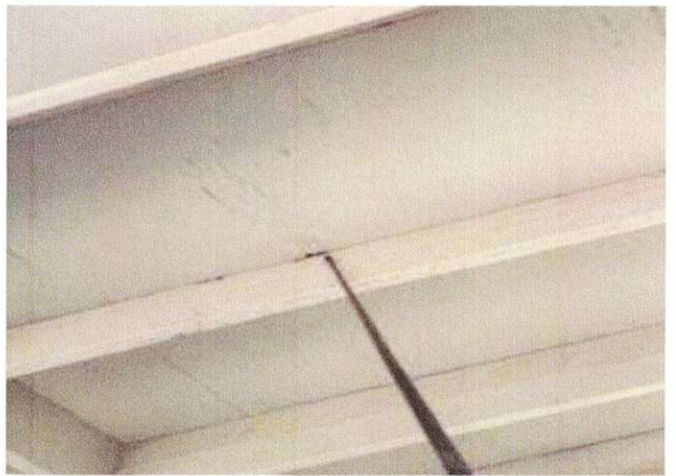
4D

FINDINGS - excessive moisture damage, fungus and/or dry rot noted to car port roof sheeting at various locations

RECOMMENDATION - Owner/agent should engage the services of a licensed roofing contractor to make any necessary repairs.

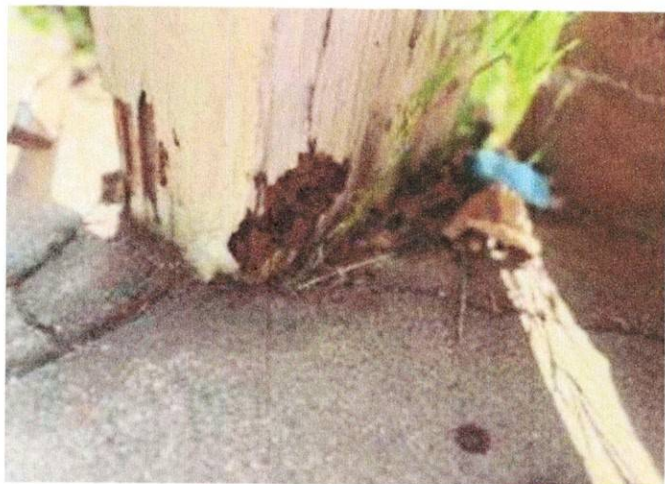
4B, 4C

FINDINGS - subterranean termite evidence noted to car port structure

RECOMMENDATION -Locally treat subsoil and/or area with evidence of infestation with an State approved chemical per State regulations and label instructions for control of subterranean termites. Hobbs Pest Solutions, Inc., will not be responsible for damage to hidden pipes, conduit, ducts or their repair.

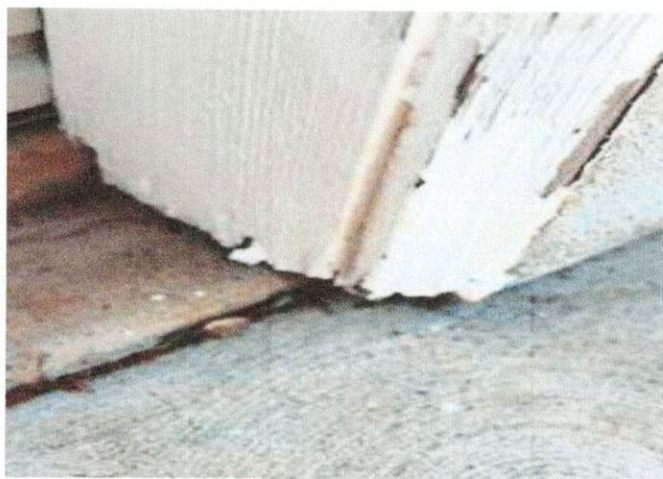
11A, 11B

FINDINGS - excessive moisture condition, chipped/peeling paint and/or bare/exposed wood noted to exterior at various locations

FINDINGS - excessive moisture damage, fungus and/or dry rot noted to door casings at various locations

RECOMMENDATION - Other trades to seal/paint/stain as needed.

RECOMMENDATION -.Cut out excessive moisture damages to wood members (dry rot and/or fungus), treat with state approved fungicide and repair as needed. (Prime Paint Only) if hidden damages are revealed during repairs, a supplemental report will be submitted

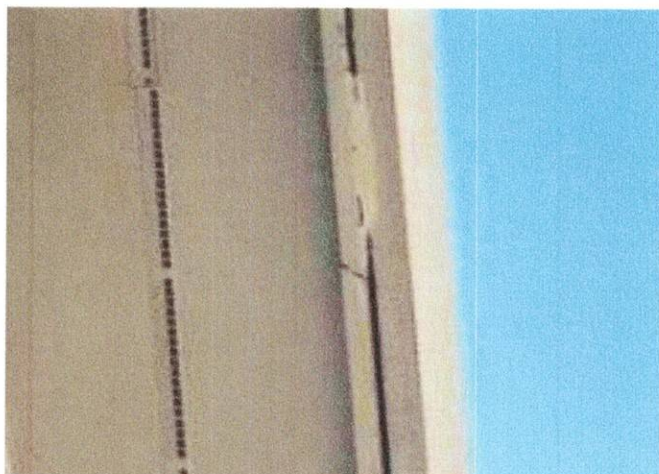
11C

FINDINGS - excessive moisture damage, fungus and/or dry rot noted to fascia and/or barge rafters at various locations

RECOMMENDATION - Cut back or cut out infected and or damaged wood members. Fill in, replace or repair as needed. Prime paint only

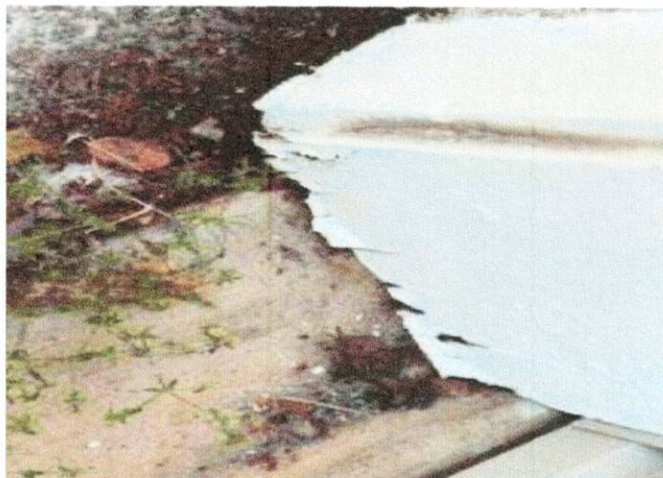
11B, 11D

FINDINGS - subterranean termite evidence noted to exterior

RECOMMENDATION -Locally treat subsoil and/or area with evidence of infestation with an State approved chemical per State regulations and label instructions for control of subterranean termites. Hobbs Pest Solutions, Inc., will not be responsible for damage to hidden pipes, conduit, ducts or their repair.

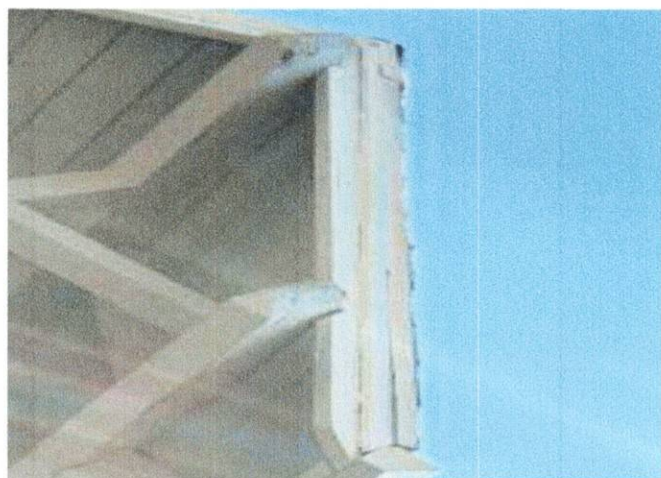
11C, 11E

FINDINGS - excessive moisture damage, fungus and/or dry rot noted to eave jacks at various locations

RECOMMENDATION - Cut back or cut out infected and or damaged wood members. Fill in, replace or repair as needed. Prime paint only

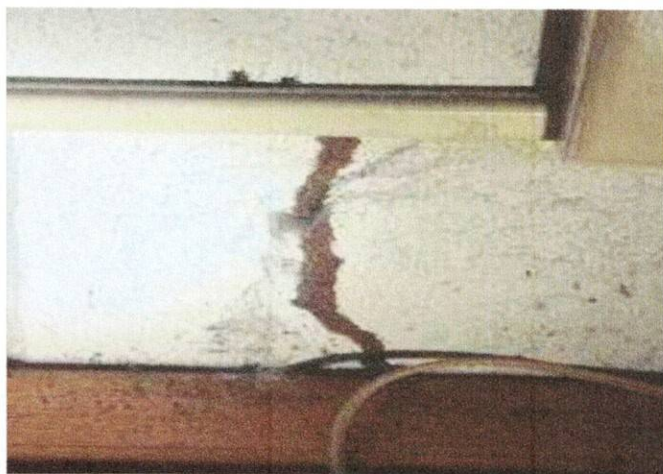
10A

FINDINGS - subterranean termite evidence noted to interior wall of lower unit (mud tube, live)

RECOMMENDATION -Full perimeter treatment, drill and treat concrete areas as well as trench and treat bare soil areas, Drill through slab foundations/patios no more than 12" apart, inject subsoil with a State approved chemical per State regulations and label instructions for control of subterranean termites. Hobbs Pest Solutions, Inc., will not be responsible for damage to hidden pipes, conduit, ducts or their repair. Trench 4"-6" into soil perimeter without concrete, apply one gallon termidor sc mixture per 10 feet. 0.6-0.8 ounces of termidor sc to be mixed per 1 gallon of water.

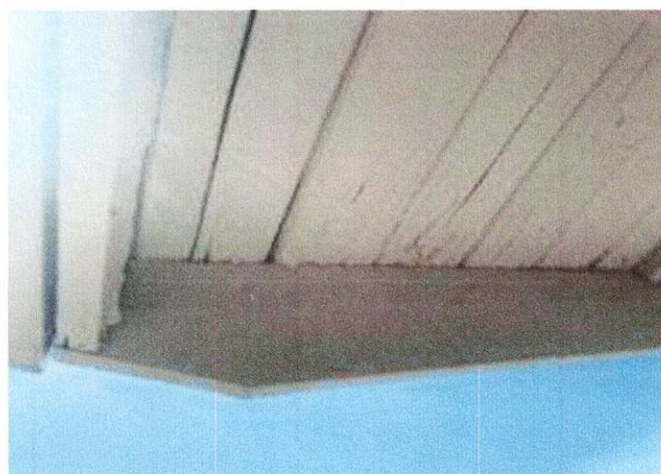
11C, 11F

FINDINGS - excessive moisture damage, fungus and/or dry rot noted to eave boards

RECOMMENDATION - Owner/agent should engage the services of a licensed roofing contractor to make any necessary repairs.
