# Property Inspection Report

**903 Sandalwood Avenue  
Arroyo Grande, CA 93420**

**Inspection Date:  
09/14/2026**

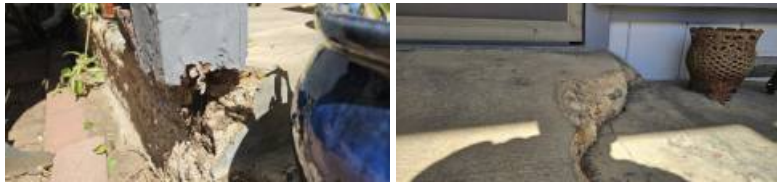
[FE] The patio cover at the left side(s) of the building was damaged/deteriorated on the support post and concrete base support material(s). Continued use in this condition without maintenance is conducive to failure of the patio cover.

[SC] Uneven surfaces were noted in the concrete patio at the left side(s) of the building. This condition is a trip/safety hazard and may be an indication of differential movement in building components.

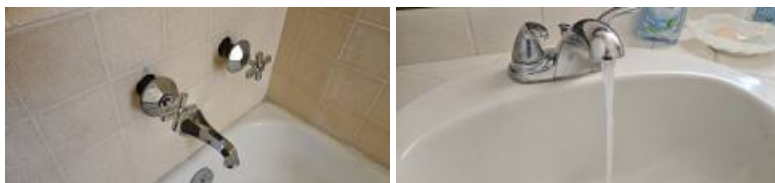
[CR] The hall bathtub faucet appears to have been disconnected from the supply piping and abandoned. It is possible that the problem is with the faucet, but the condition may involve other components.

[CR] There was low hot water flow from the sink faucet in the master bath. It is possible that the problem is with the faucet, but the condition may involve other components.

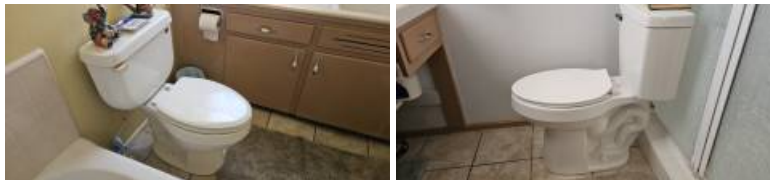
[CR] The toilet was loose on the floor in the master bath. This condition is conducive to moisture leakage into concealed spaces and damage to the building materials.

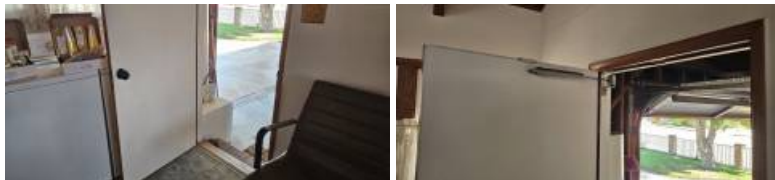
[SC] The door between the garage and living space was not a fire-resistive door. General building practices call for doors between the garage and living space to be fire-resistive, self-closing and self-latching for safety reasons.

[SC] The automatic closing-device for the fire-resistive door between the garage and living space was defective. The fire-resistive door did not self-close and self-latch. This condition is a breach in the fire-resistive wall assembly and is a safety hazard.
