# ***Cornerstone Inspection***

## **Property Inspection Report**

***1301 Los Osos Valley Rd, Los Osos, CA 93402***

***Date of Inspection: 1/30/2026 Time: 9:00 AM***

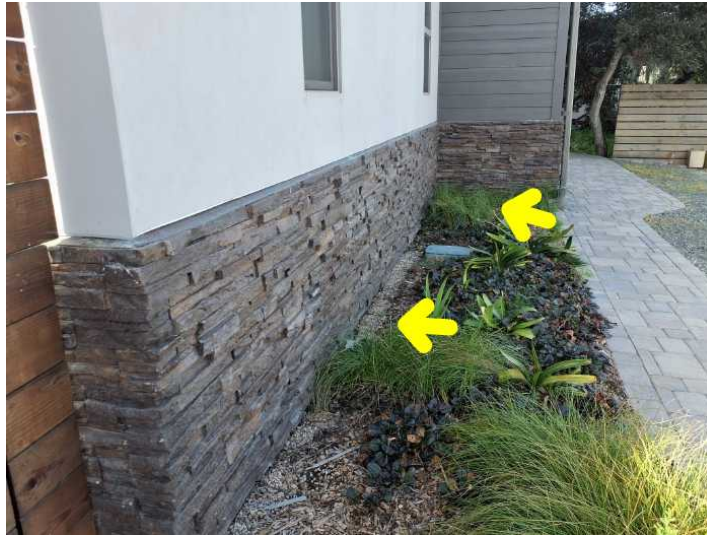
Vines, shrubs or bushes are growing on the house walls and although they are attractive they can introduce pests and rodents and accelerate deterioration. Therefore, you may wish to consider having them removed or cut back to 12 inches (30 cm) away from the home.

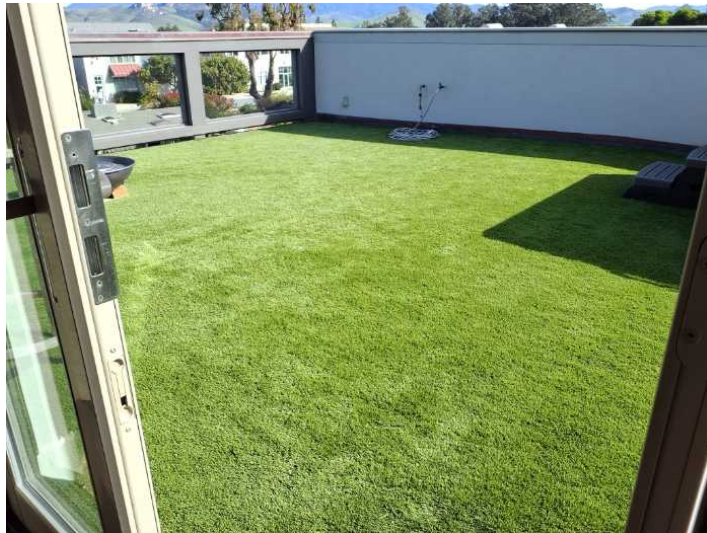
The balcony floor has been covered, which conceals any damage or deterioration that might be present.

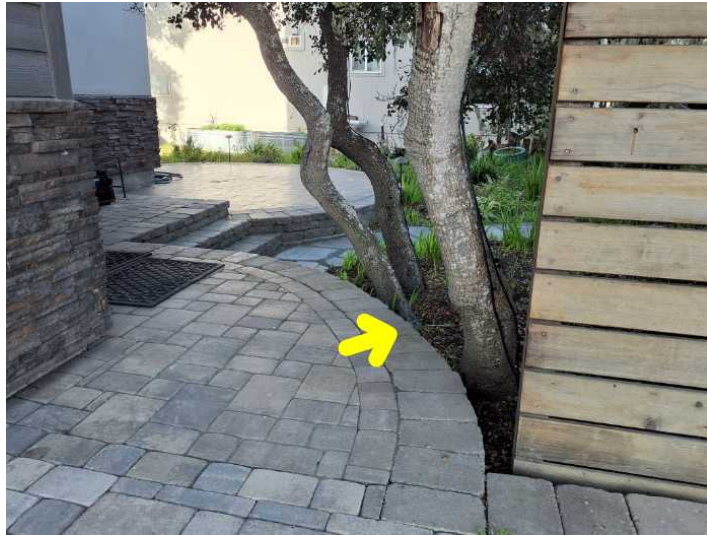
There are areas of this property that do not have guardrails, which are required for walk-offs greater than thirty inches. Where there are walk-offs less than 30 inches with no guardrail, appropriate precautions should be taken to safeguard children and the elderly.

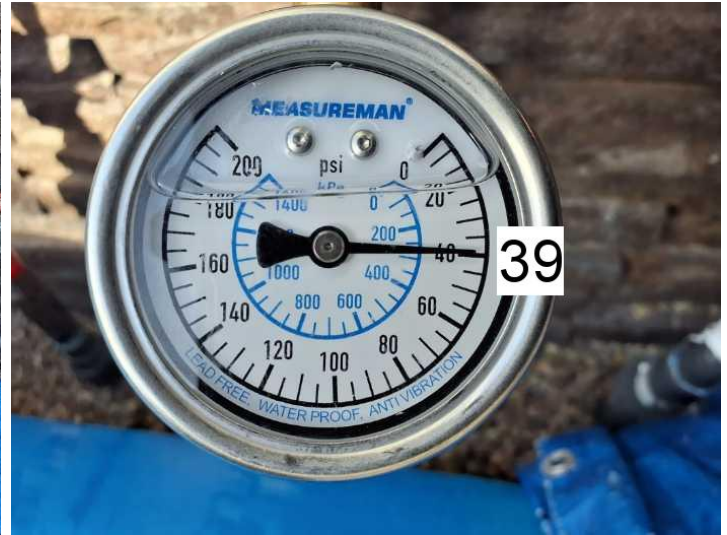
A functional pressure regulator is in place on the plumbing system.

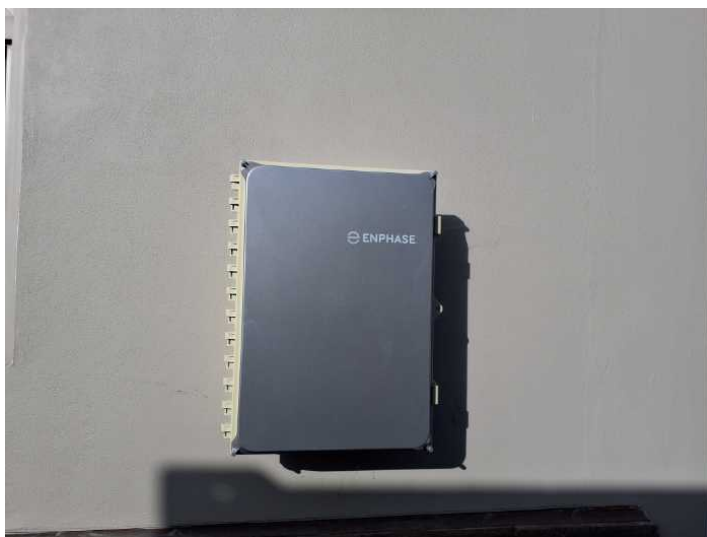
A photovoltaic solar system has been installed, which we do not have the expertise to evaluate. We recommend the sellers provide information regarding its installation, operation, and maintenance history. You may also wish to have it evaluated by a qualified specialist.

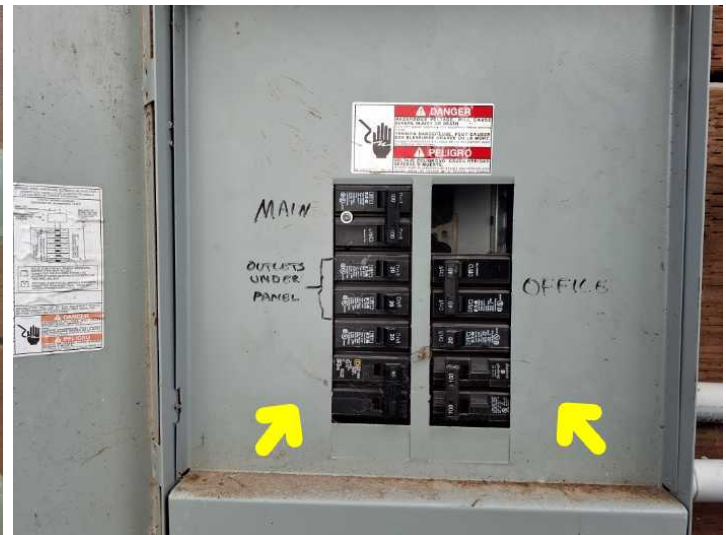
Various circuits within the sub-panel are not labeled, and this condition should be serviced by a qualified electrical contractor so that the appropriate load calculations and breaker sizes can be determined.

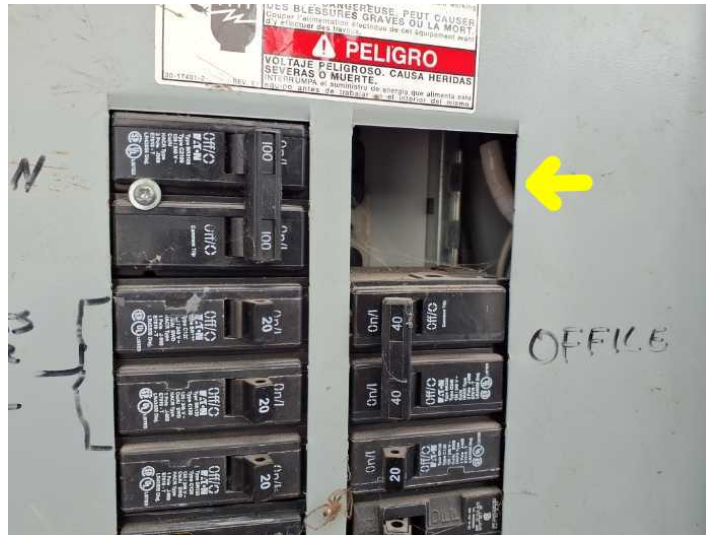
3.7. There are voids or open knockouts in the cover of the electrical sub panel that should be covered.

There are voids or open knockouts in the cover of the electrical sub panel that should be covered.

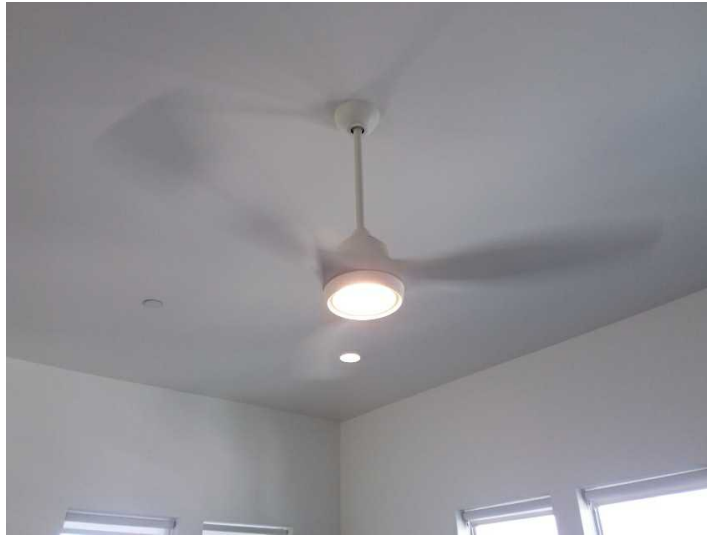
The ceiling fan is functional but slightly out of balance and should be serviced so the fan operates smoothly.

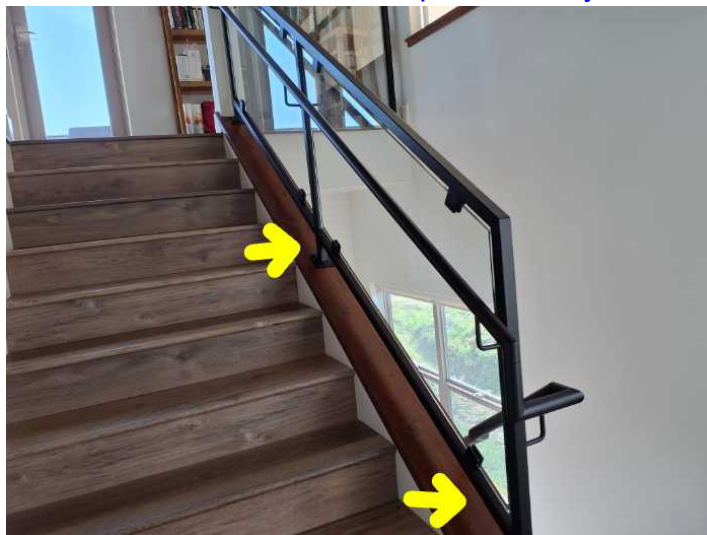
6.1. The handrail is loose and should be secured for optimal safety.

The handrail is loose and should be secured for optimal safety.

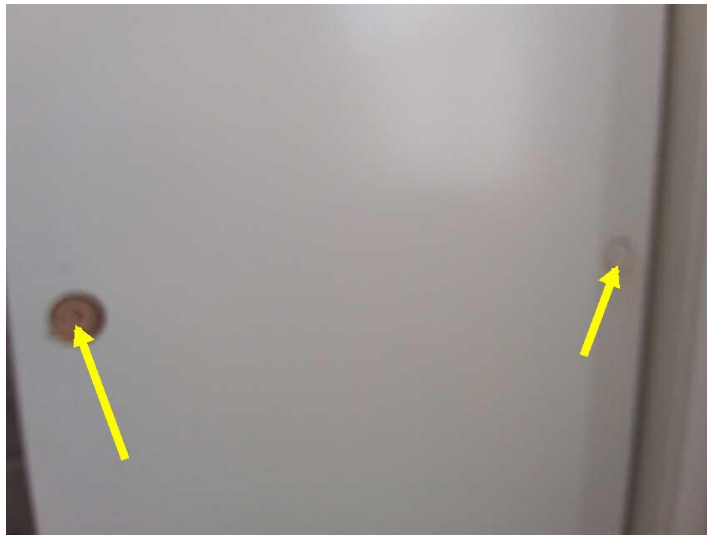
The closet door pull-hardware is missing and you may wish to have them installed.

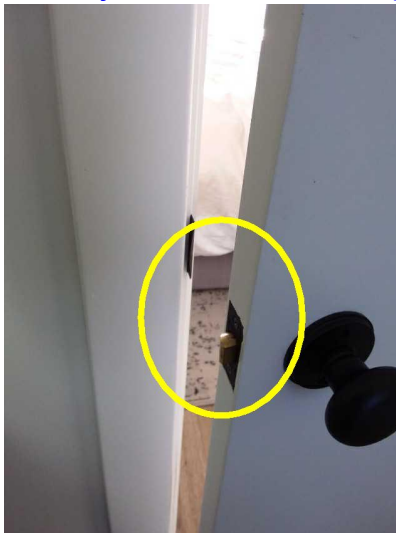
- 1.15. The door striker plate needs to be adjusted for the striker pin to engage.

The door striker plate needs to be adjusted for the striker pin to engage.

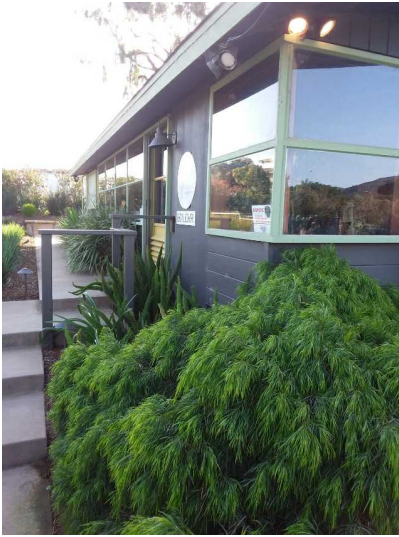
Vines, shrubs or bushes are growing on the house walls and although they are attractive they can introduce pests and rodents and accelerate deterioration. Therefore, you may wish to consider having them removed or cut back to 12 inches away from the home.

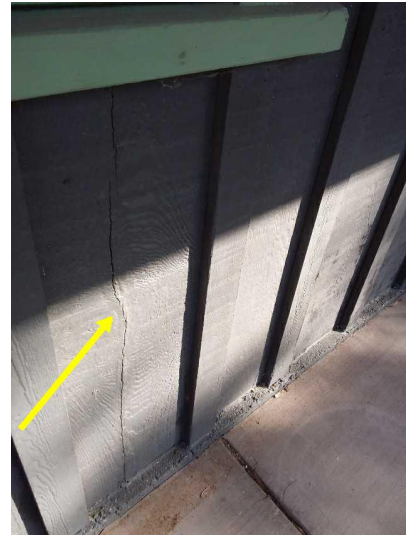
The siding needs typical maintenance such as sealing and painting.

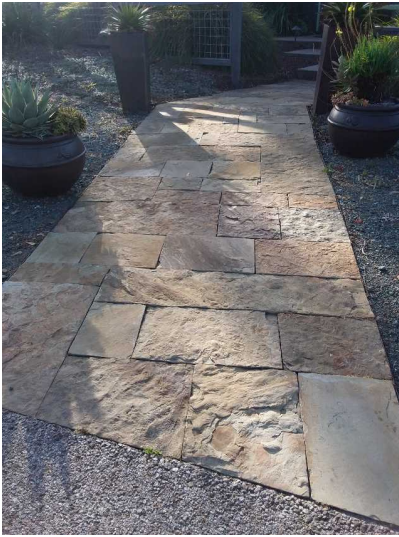
The paver patio or walkway has multiple offsets. This may be due to unsuitable soil below the pavers.

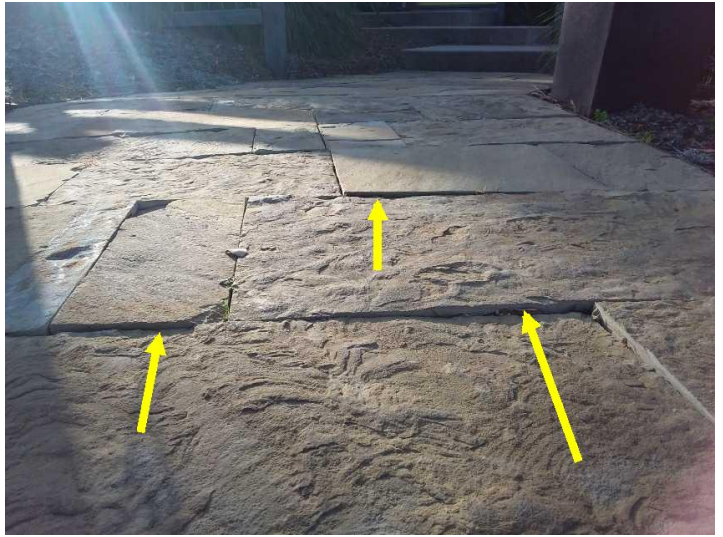
There is one or more offsets in the walkways that could prove to be trip-hazards.

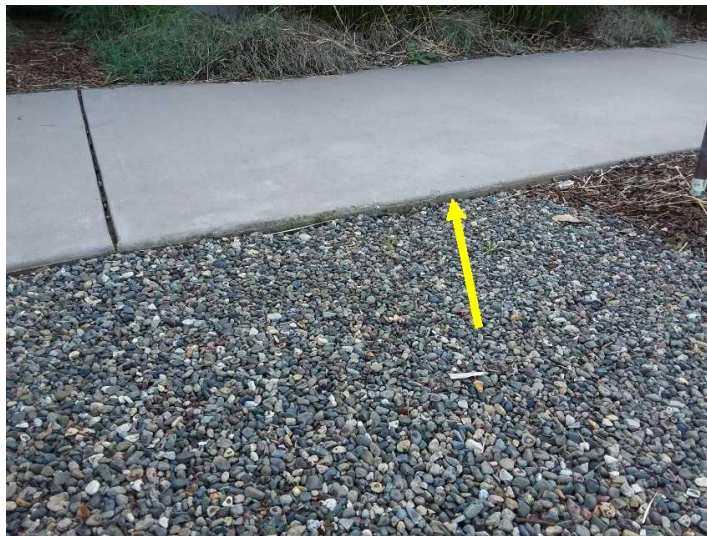
There is one or more offsets in the walkways that could prove to be trip-hazards.

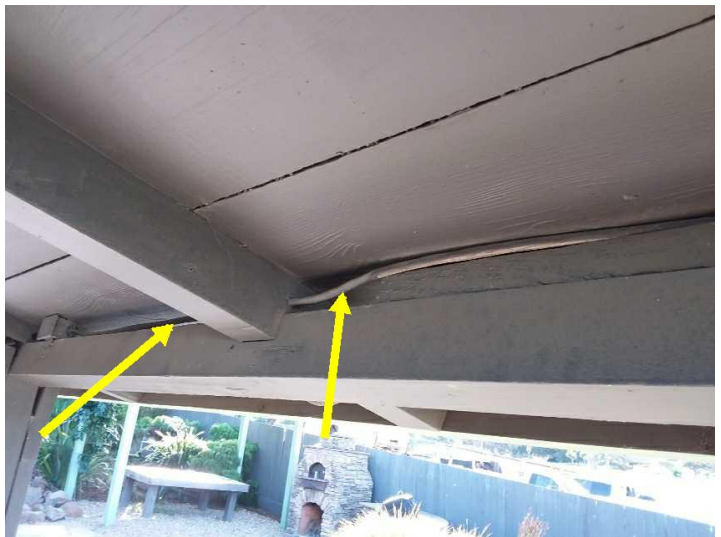
There's exposed romex electrical cable that should be protected inside conduit. A licensed electrician should evaluate and service this issue.

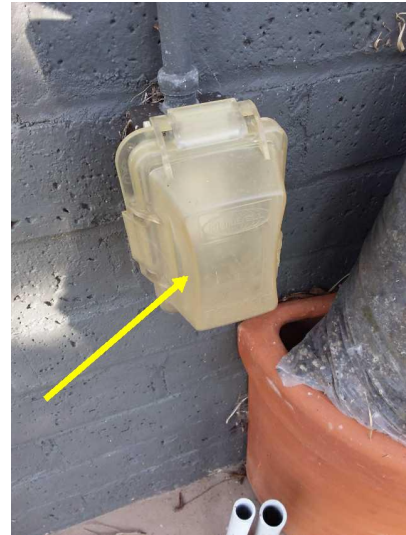
An outlet at the right side and left side has an open-ground and should be evaluated and serviced by a licensed electrical contractor.

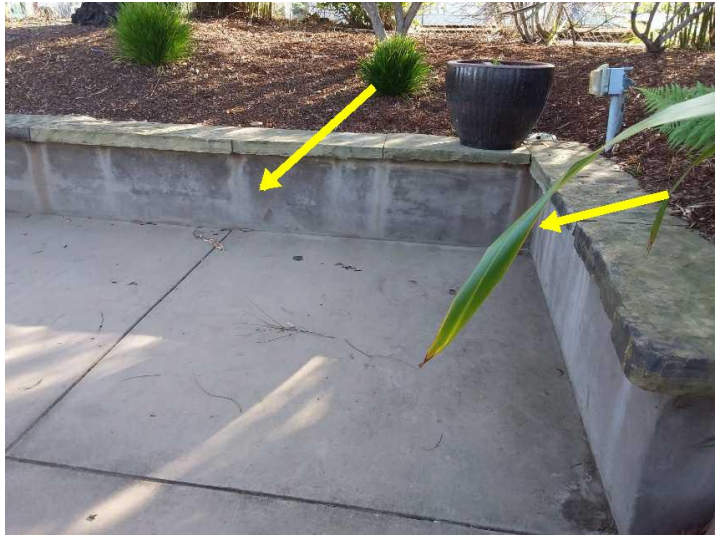
There are areas of this property that do not have guardrails, which are required for walk-offs greater than thirty inches. While there are walk offs less than 30 inches, appropriate precautions should be taken to safeguard children and the elderly.

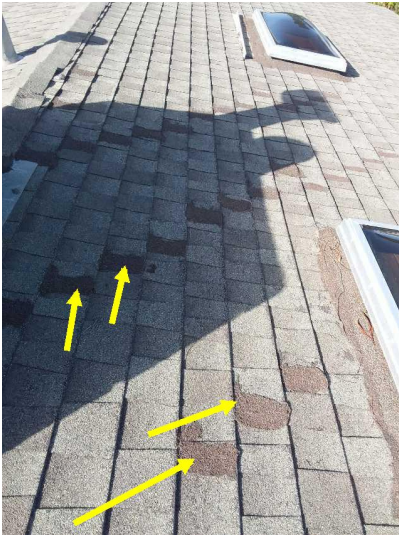
We observed repairs done to the roof that should be explained by the sellers as to why these repairs were needed.

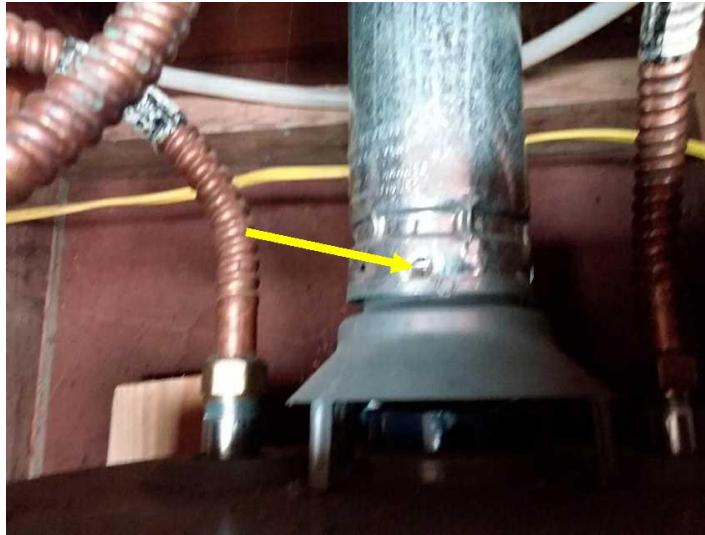
The vent pipe is not properly connected. It is required to have a minimum of 3 fasteners where the pipe connects to the draft hood or other single wall vent pipes.

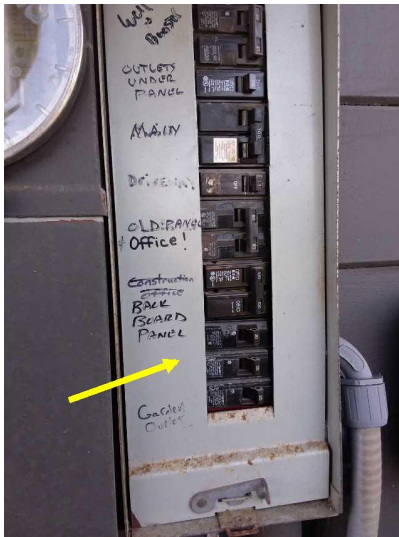
Various circuits within the sub-panel are not labeled, and should be serviced by an electrician so that the appropriate load calculations and breaker sizes could be determined.

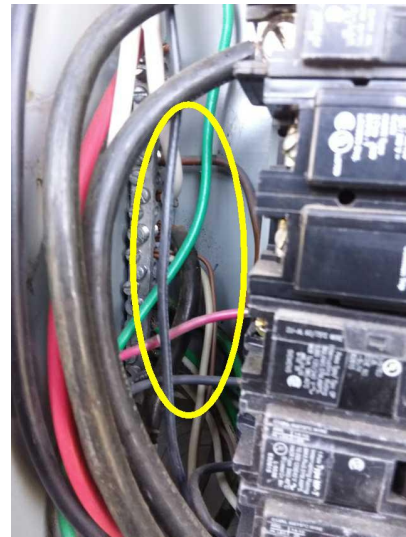
The neutral and ground wires are together on the same buss bar and should be separate. The ground wires should be bonded to the panel and the neutral wires should be separate and "floating" from the panel. We recommend that a licensed electrician evaluate and service the sub panel.

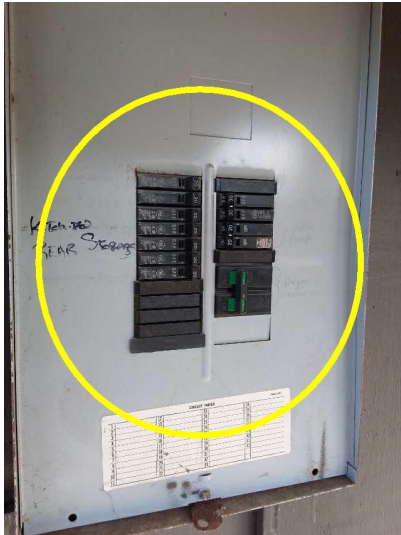
Various circuits within the sub-panel are not labeled, and should be serviced by an electrician so that the appropriate load calculations and breaker sizes could be determined.

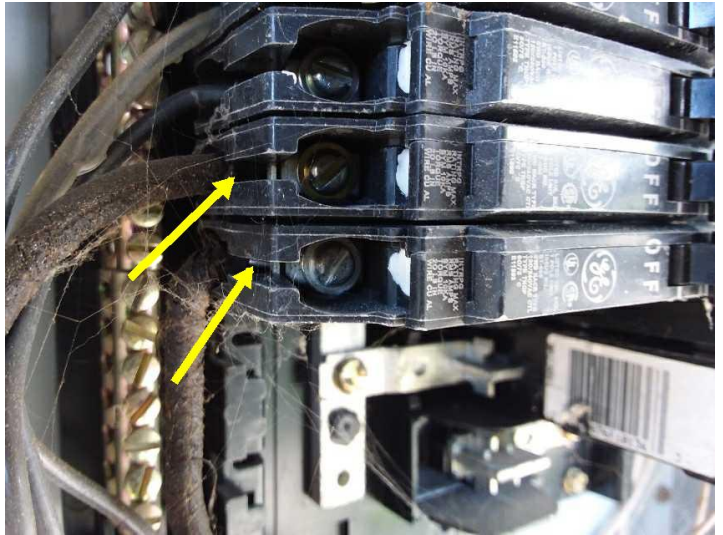
We have noted that single-strand aluminum or tin wire is present in the home, which is suspect because it does not conduct current as efficiently as copper wire, and can create a fire-hazard. Therefore, you should seek the counsel of a licensed electrician who is familiar with this issue or who performs copulum crimping.

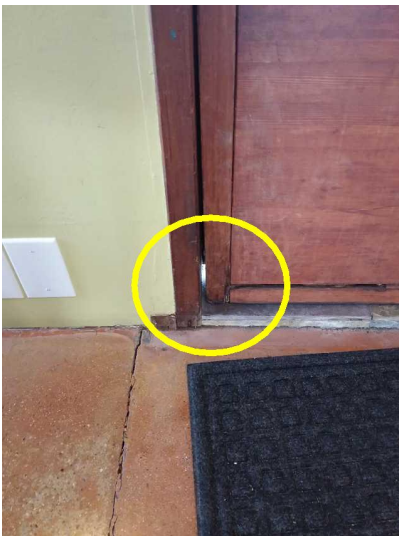
The front door is functional but not fully weather sealed.

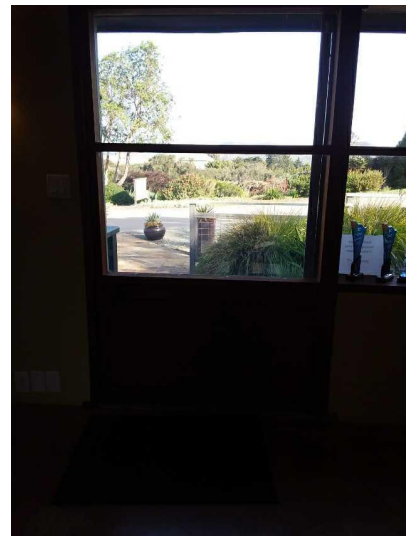
The window panes are not tempered or safety glass which is required by current standards.

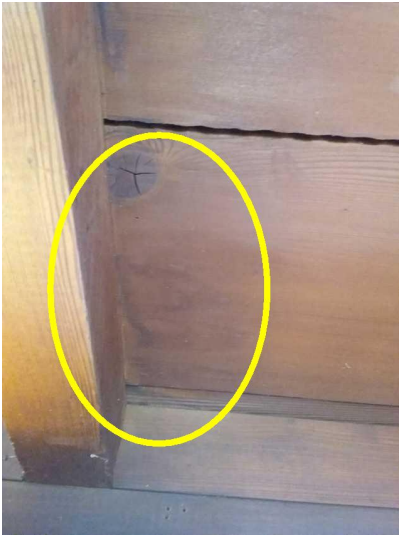
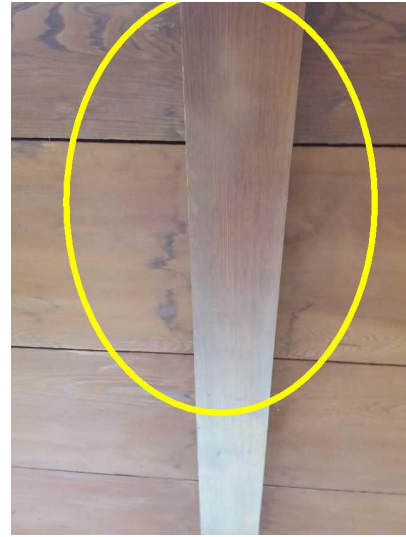
There is a moisture stain on the ceiling that should be explained or explored further.

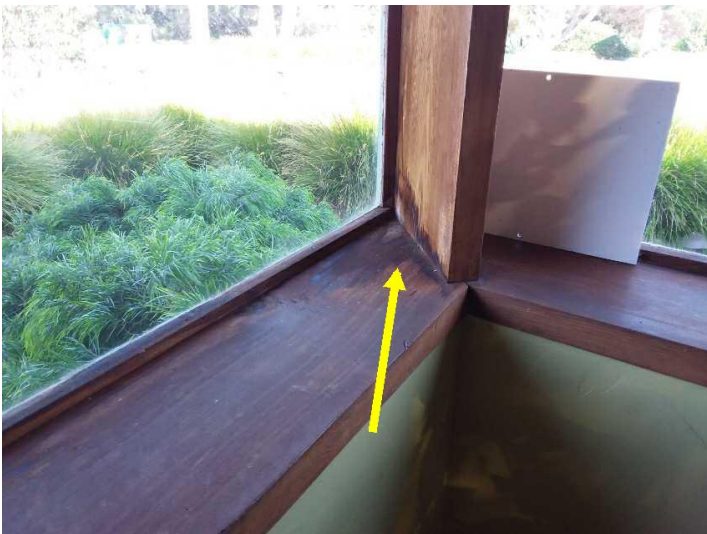
The windows sills are cosmetically damaged which you should view for yourself.

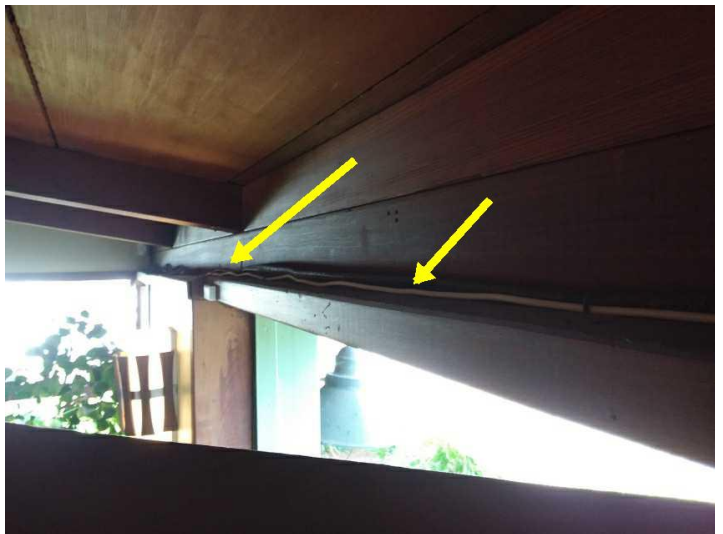
There is exposed romex that should be protected in conduit and should be repaired by a licensed electrician.

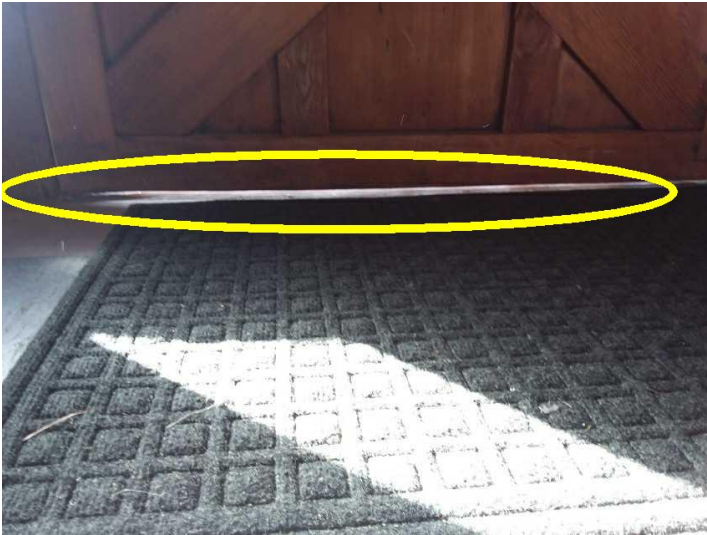
The front and rear door are functional but not fully weather sealed.

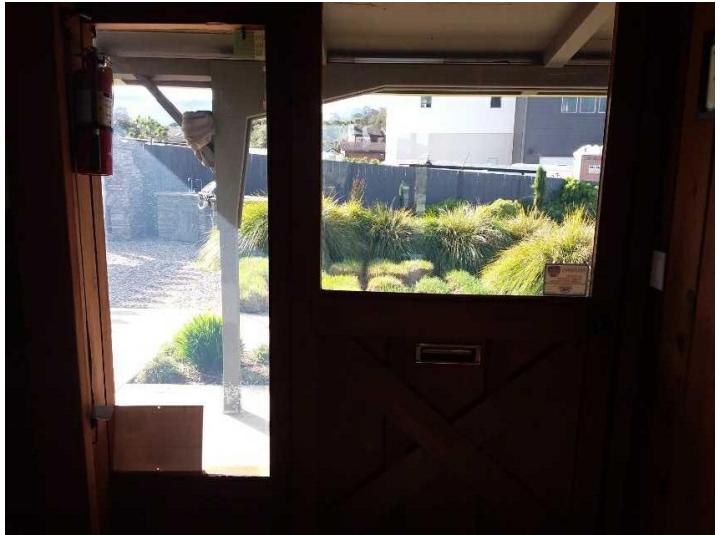
The window panes are not tempered or safety glass which is required by current standards.

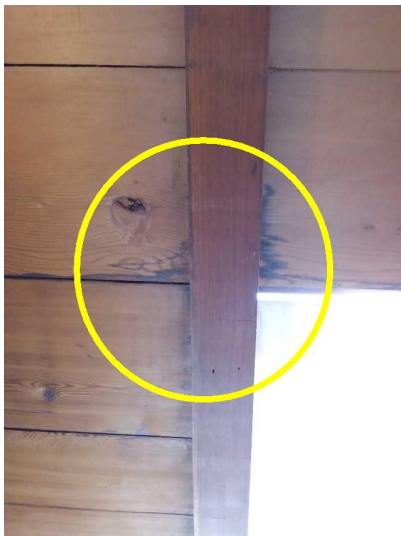
There is a moisture stain on the ceiling that should be explained or explored further.

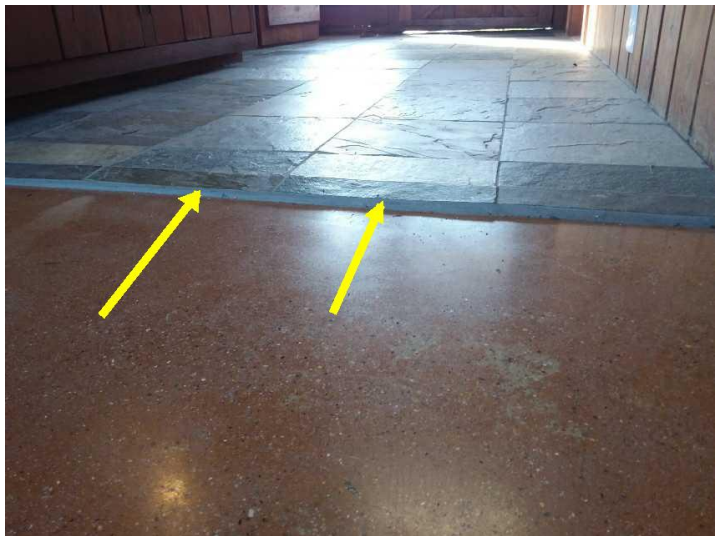
There are one or more offsets which could be a trip hazard that you may wish to have serviced.

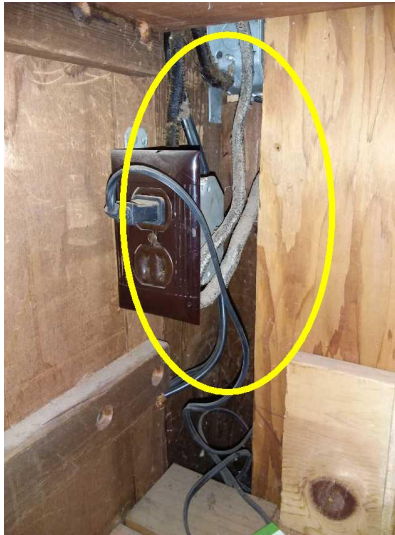
There is exposed romex that should be protected in conduit and should be repaired by a licensed electrician.

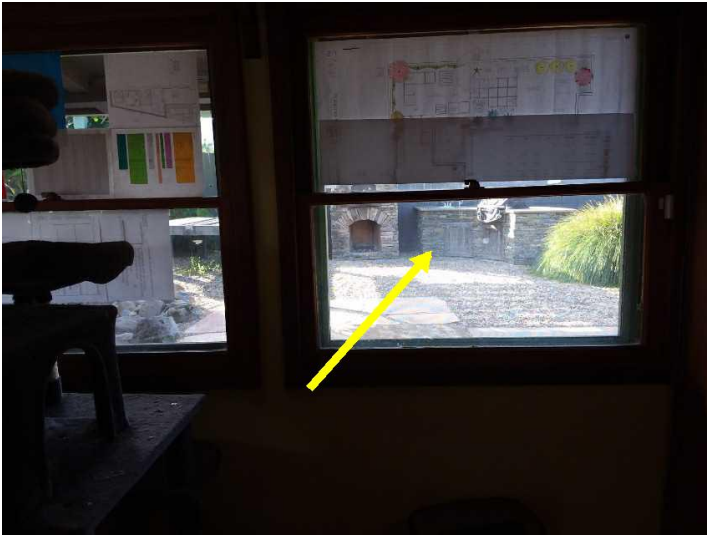
One or more of the single-hung windows will need to be serviced to function properly. Single-hung windows are typically designed so that the lower panel opens. The hardware needs to be serviced as the window will not properly stay in place when opened.

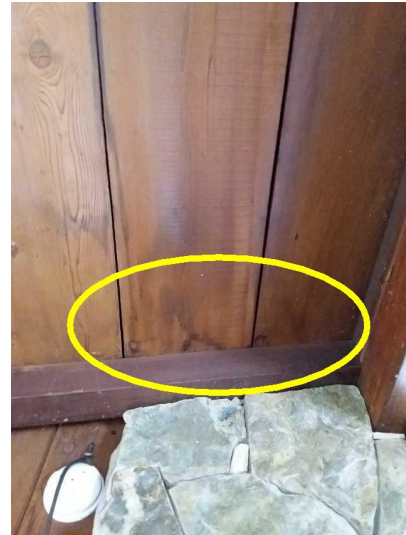
There is a moisture stain on the ceiling that should be explained or explored further.

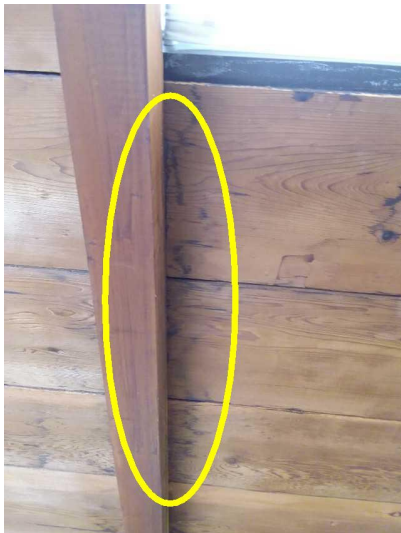
There is a moisture stain on the ceiling that should be explained or explored further.

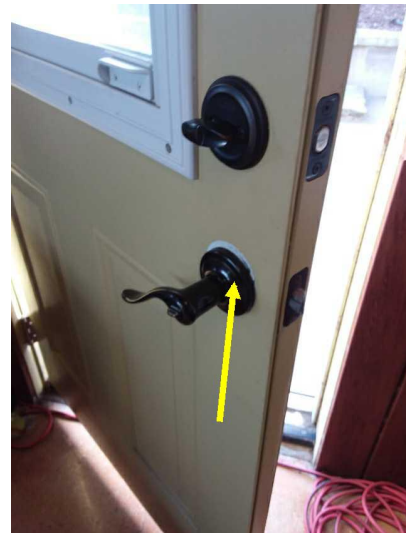
The door handle needs to be serviced to work smoothly.

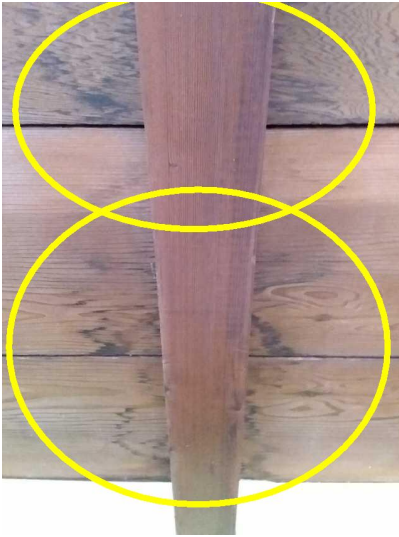
There is a moisture stain on the ceiling that should be explained or explored further.

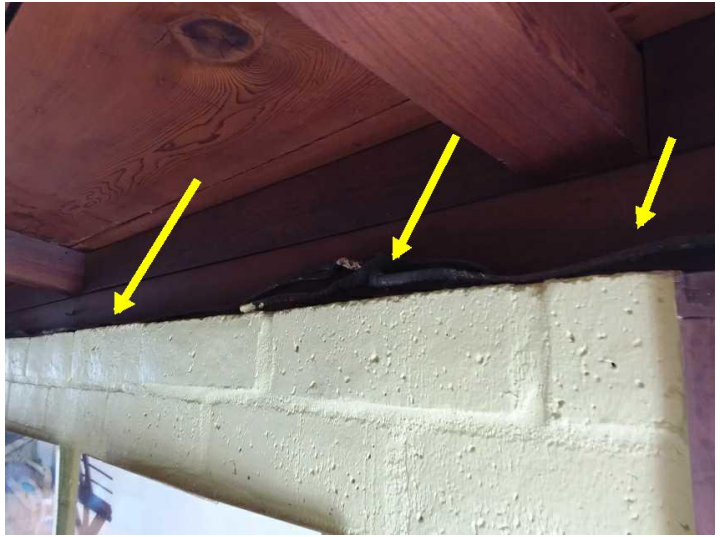
There is exposed romex or electrical wires that should be protected in conduit and should be repaired by a licensed electrician.

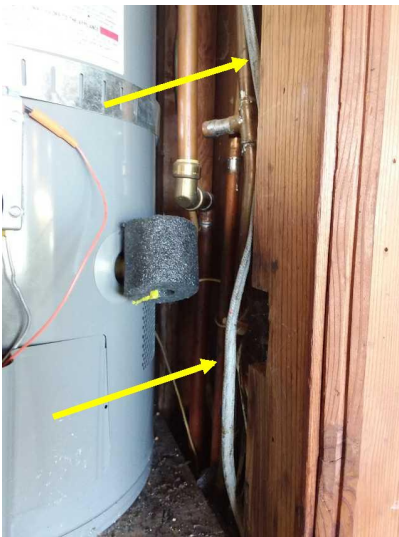
There is exposed romex or electrical wires that should be protected in conduit and should be repaired by a licensed electrician.

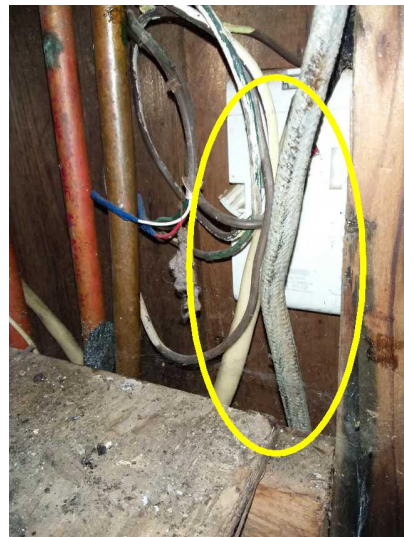
There is exposed romex or electrical wires that should be protected in conduit and should be repaired by a licensed electrician.

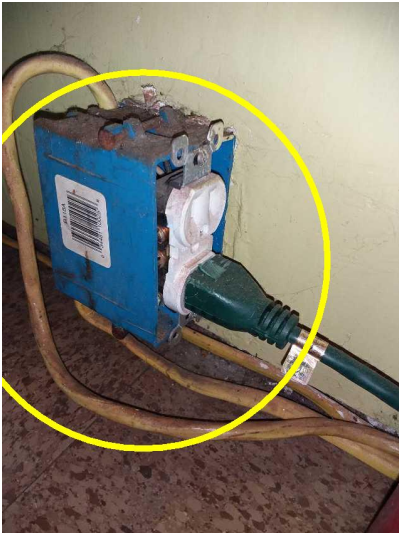
An outlet has an open ground, and should be serviced.

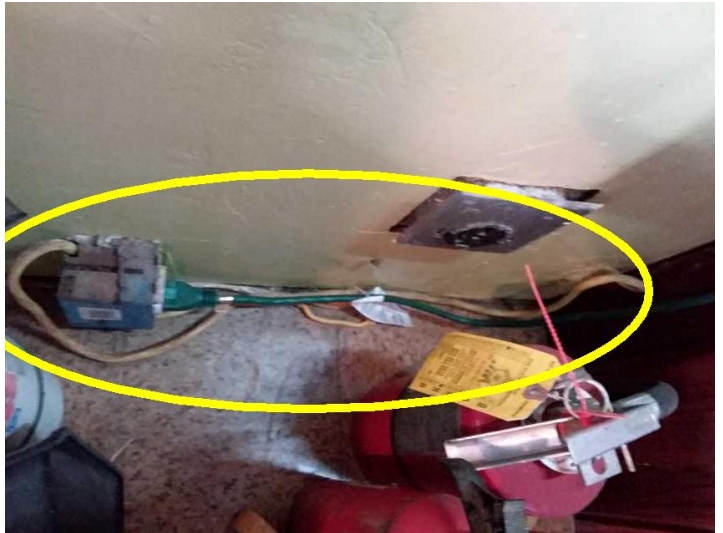
4.6. There is exposed romex that should be protected by installing the romex inside the wall cavity, or properly wired into conduit.

There is exposed romex that should be protected by installing the romex inside the wall cavity, or properly wired into conduit.

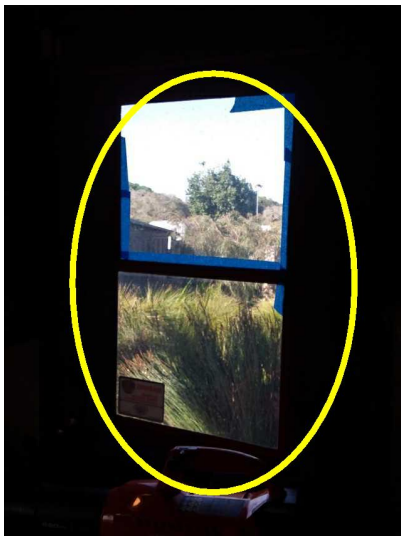
A window is stuck, taped, or painted shut, and should be serviced.

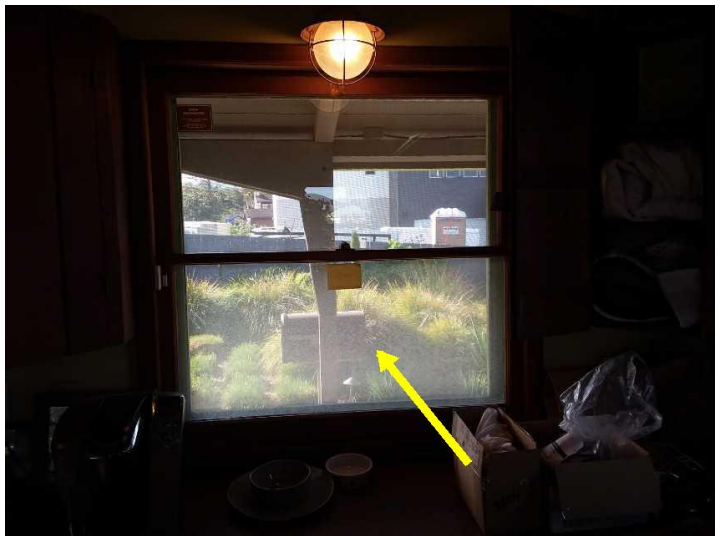
7.4. A single-hung window will need service such as adjusting or replacing the hardware to open and close smoothly and safely.

A single-hung window will need service such as adjusting or replacing the hardware to open and close smoothly and safely.

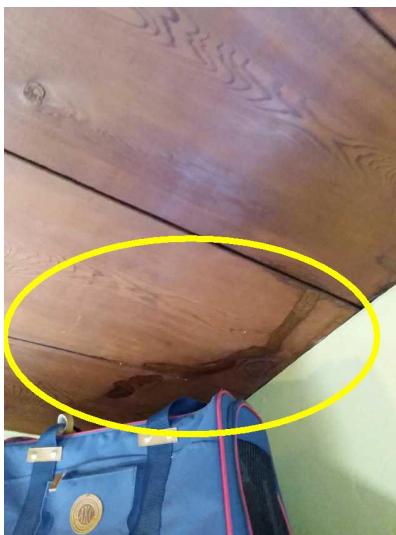
There is a moisture stain on the ceiling that should be explained or explored further.

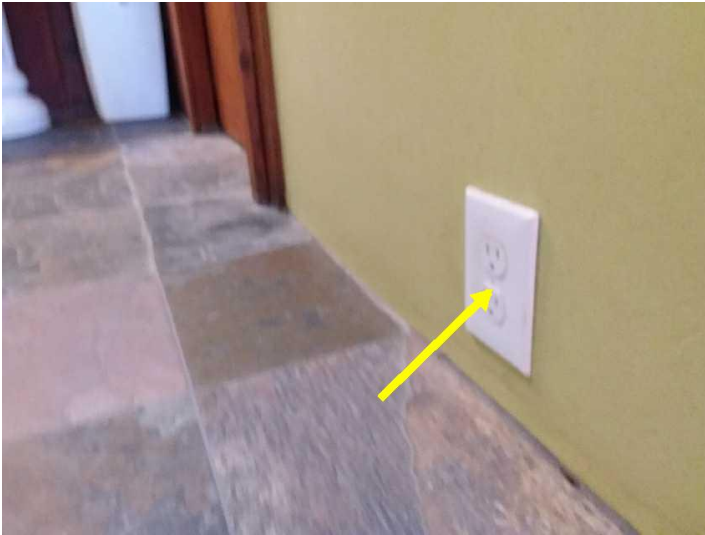
The bathroom wall outlet has an open-ground, and should be evaluated and serviced by a licensed electrical contractor.

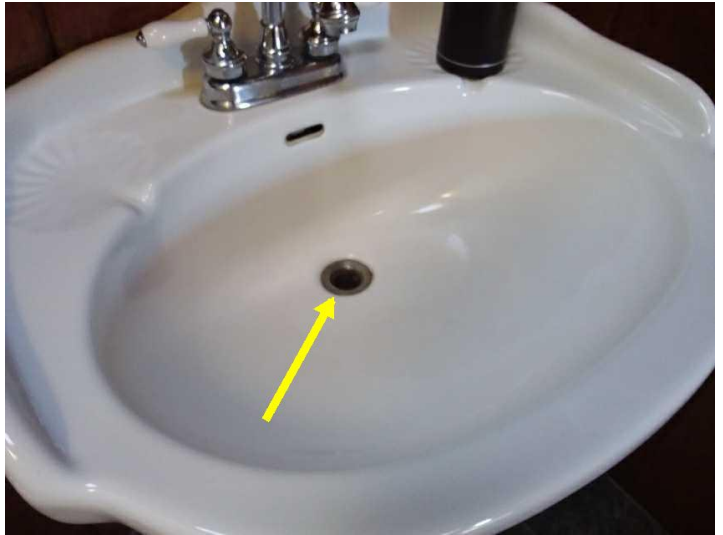
The sink drain is slow or partially blocked and should be serviced, to ensure that the blockage has not progressed beyond the trap and involved the main waste line.
