# Inspection Report

**Claire MacFarlane**  
**675 Golden Meadow Drive**  
**Paso Robles, CA 93446**

Report Date: 9/7/2026

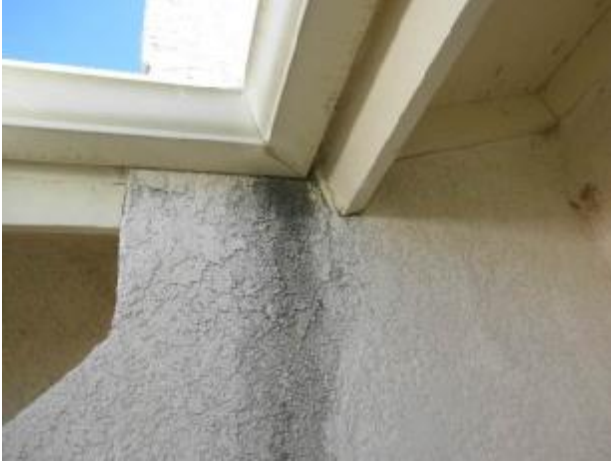
**Maintenance Note:** The gutter seams are leaking below the chimney enclosure. This can cause moisture damage to the fascia boards. Recommend sealing the gutters seams with caulking as needed.

Gutter seam is leaking.

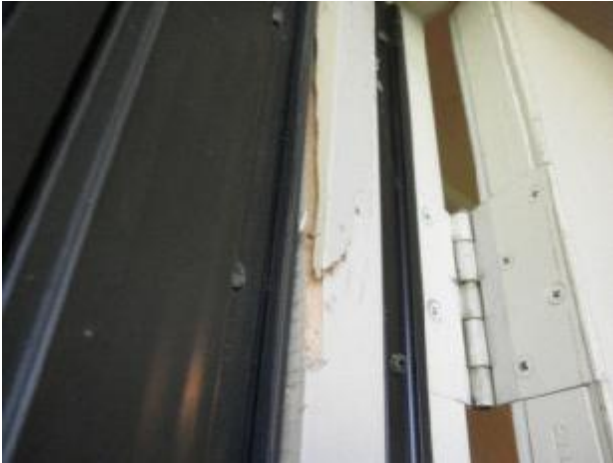
- 2.) The front entry door jamb is cracked and damaged.

Entry door jamb cracked/damaged.

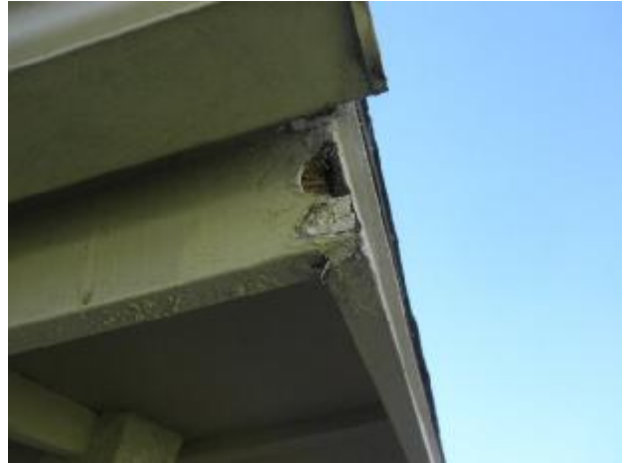
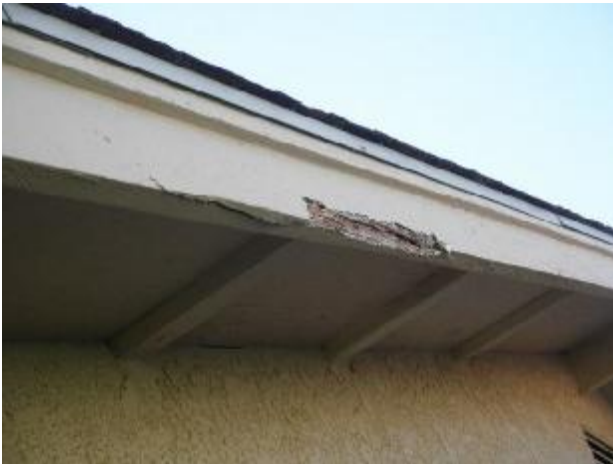
- 1.) There is moisture damage at the following locations:
- A.) Several areas at the front entry overhang fascia.
  - B.) The garage NW fascia.
  - C.) The garage NE fascia.
  - D.) The garage SE fascia.
  - E.) The base of the door spine at the garage side door.
  - F.) The SE fascia.
  - G.) The SW fascia and fascia trim.
  - H.) The NW fascia.

Moisture damage front entry fascia.

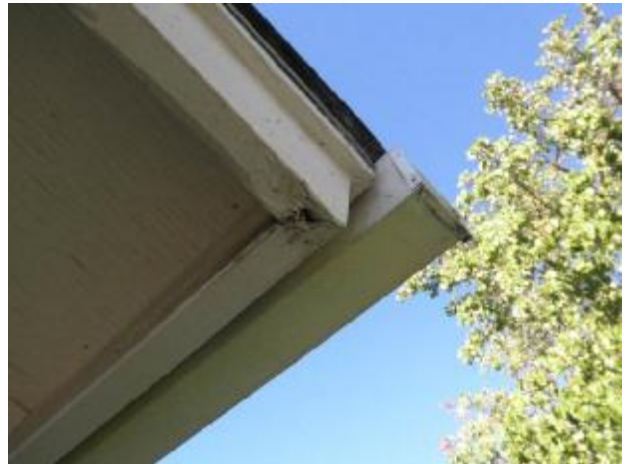
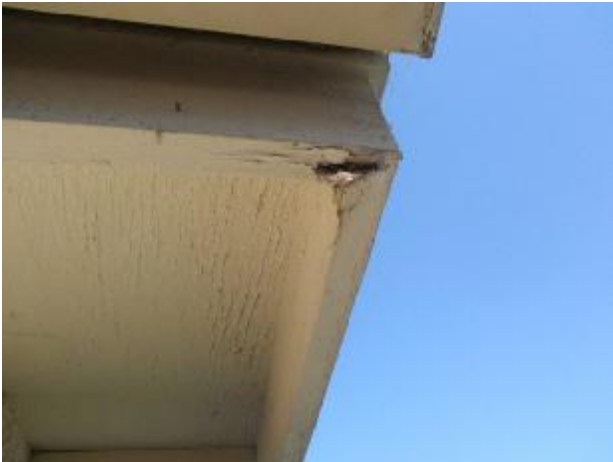
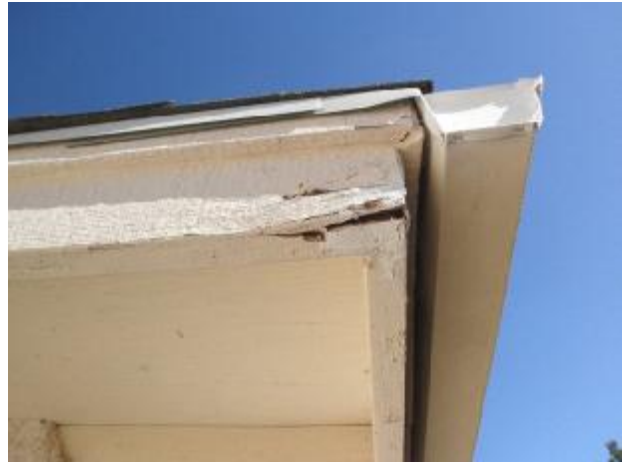
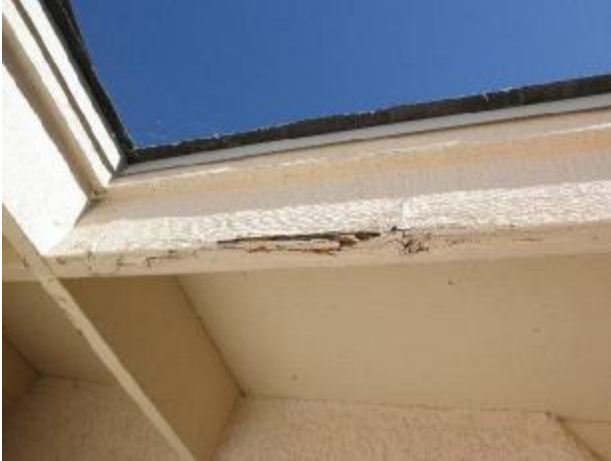
Moisture damage garage fascia.

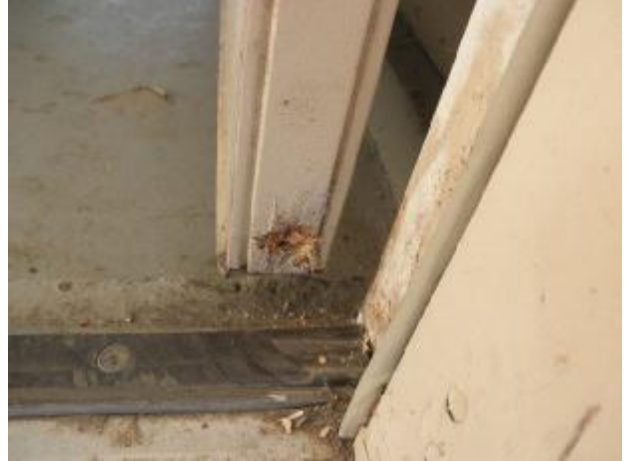
Moisture damage at the garage side door spine.

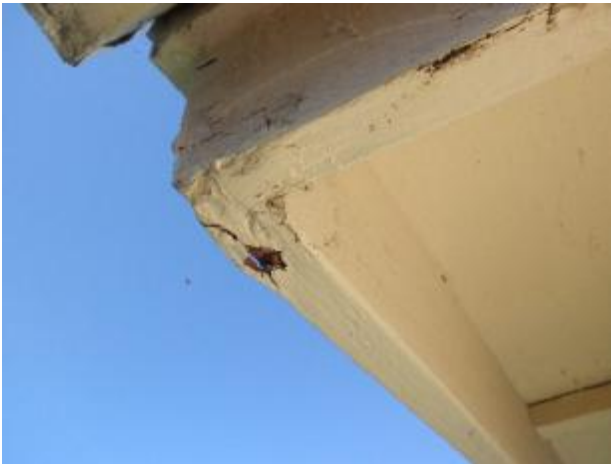
Moisture damage at the SE fascia.

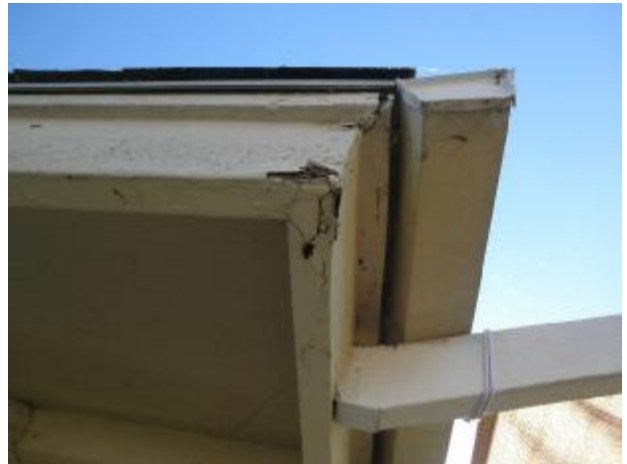
Moisture damage at the SW fascia and trim.

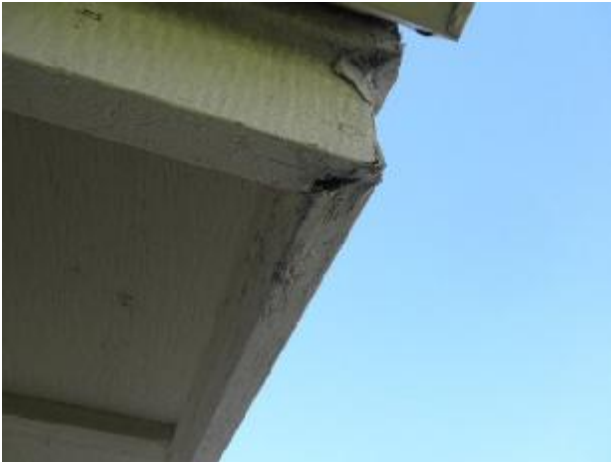
Moisture damage at the NW fascia.

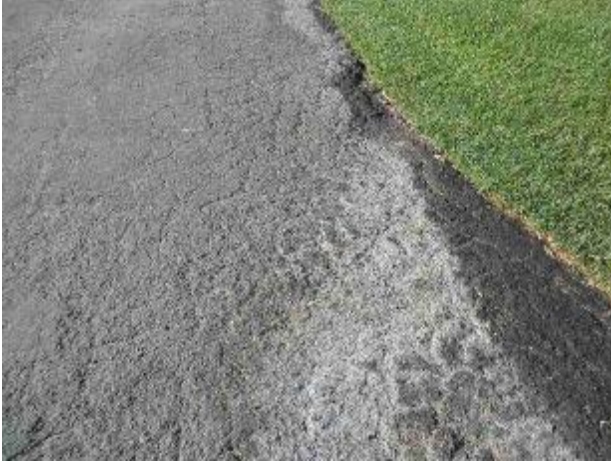
**Maintenance Note:** The asphalt driveway appears to be in reasonable condition but needs sealant. Cracks and general deterioration were observed.

The asphalt driveway needs to be sealed.

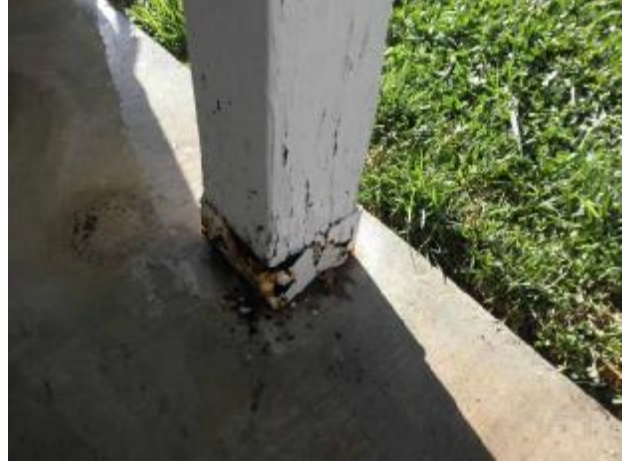
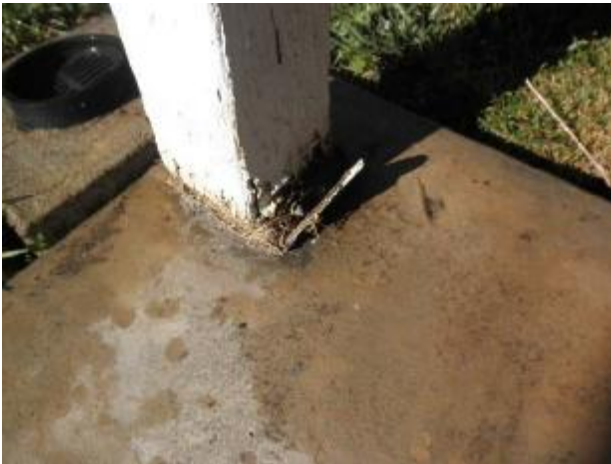
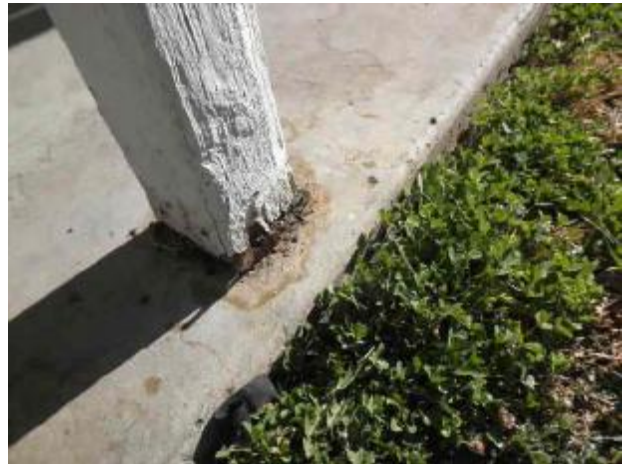
- 1.) There is moisture damage to the base of all three posts at the backyard trellis structure.

Example of moisture damage to the base of the trellis posts.

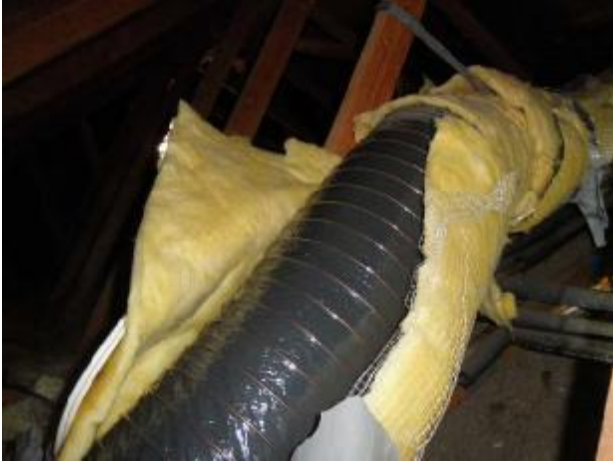
**Maintenance Note:** The insulation is loose and needs to be resecured around some of the ducts in the attic.

Insulation falling off some of the ducts in the attic.

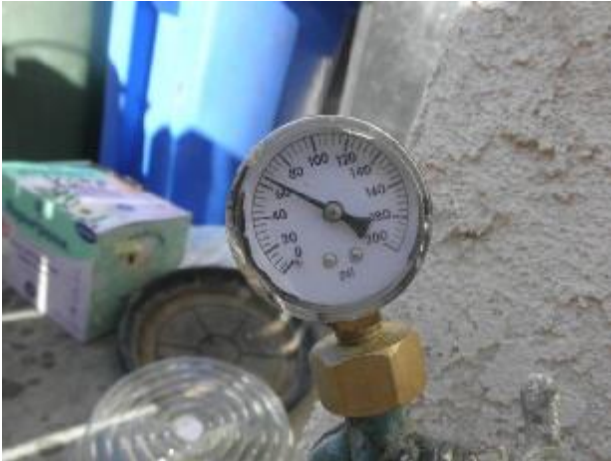
Information Note: The water pressure was measured at 60 psi. This is within a normal and acceptable range.

Water pressure is 60 psi.

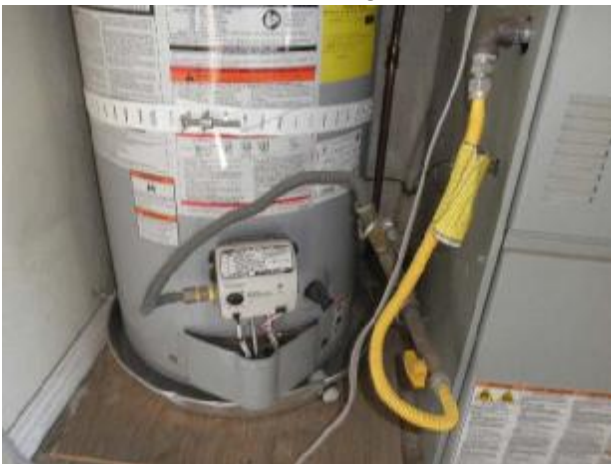
- 1.) There is no sediment trap installed at the gas line connection to the water heater as required.

Missing sediment trap at the water heater gas line.

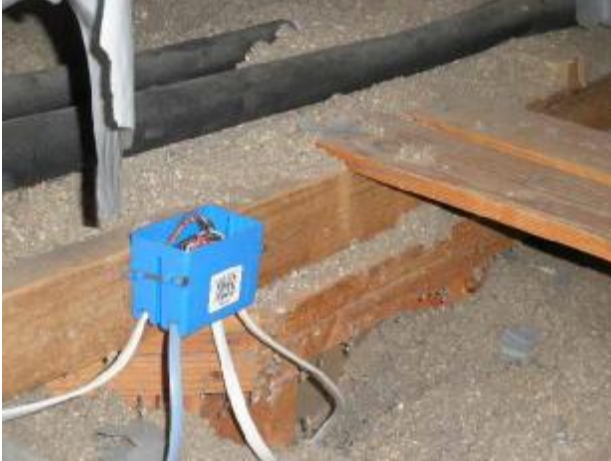
Example of open junction boxes in the attic.

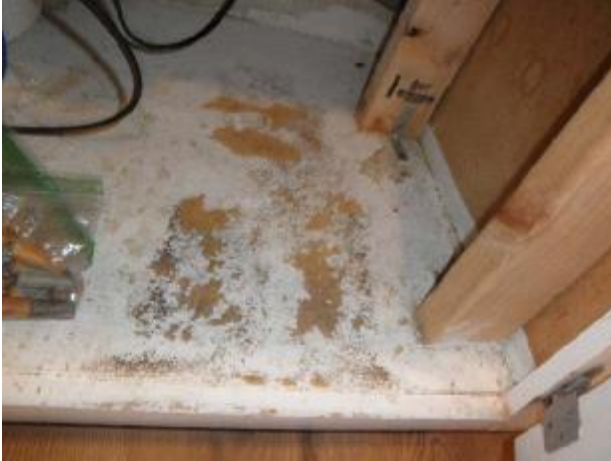
- 1.) There is minor moisture damage to the base of the kitchen sink cabinet.

Moisture damage to the base of the kitchen sink cabinet.

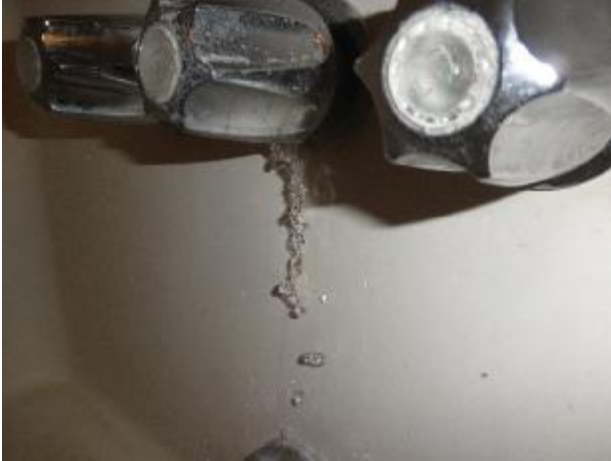
- 1.) The shower handles leak when operated in the hall bathroom.

Hall bathroom shower handles leak when operated.

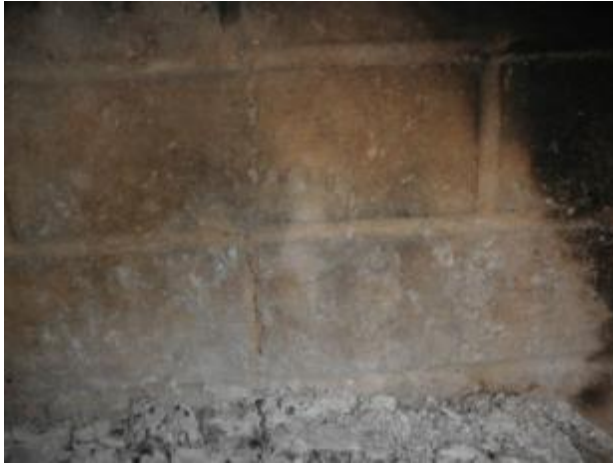
**Fire Safety Hazard Note:** The refractory plate(s) are cracked and need replacement at the prefabricated fireplace. This is recommended to be repaired by a certified and licensed fireplace contractor. (Note: The bottom plate could not be evaluated due to heavy ash inside the firebox.)

Cracks in the refractory plates inside the firebox.

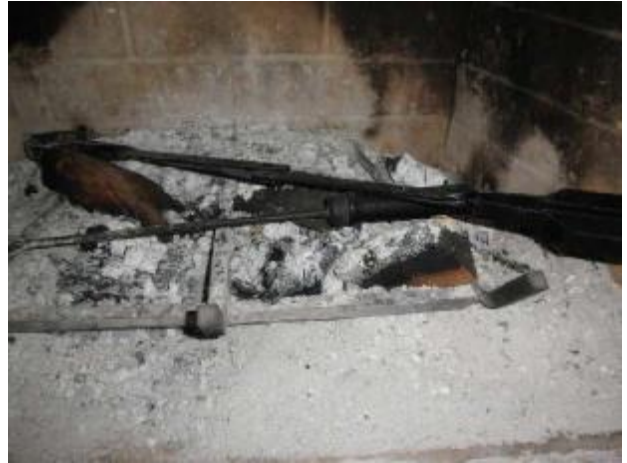
Example of heavy ash in the firebox.

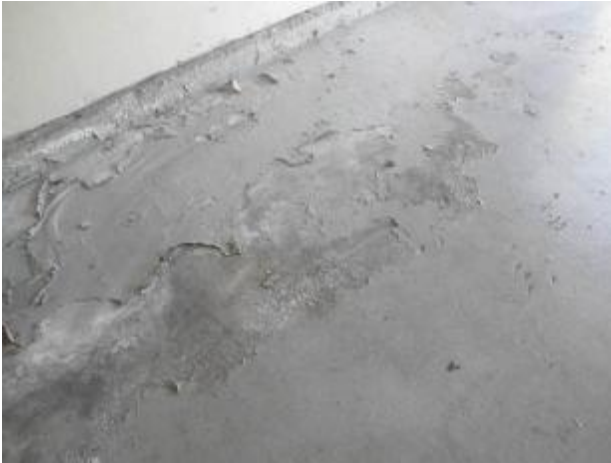
The seal at the garage slab is peeling.

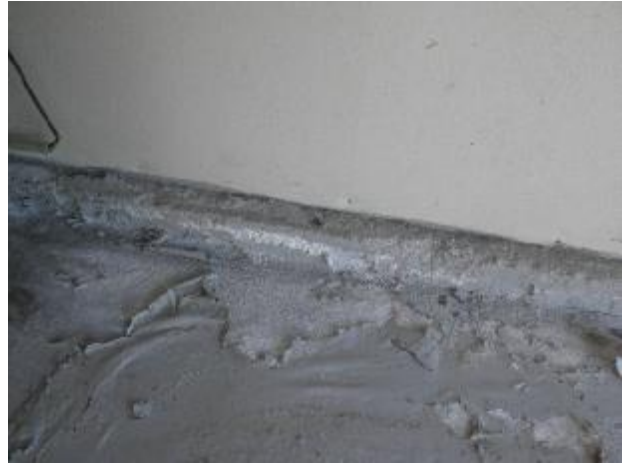
Efflorescence at the garage west wall.
