**SoCal Home Inspections**  
(909) 489-1211  
socalhomeinspections.net

## Home Inspection Report

813 Poe Court  
Lake Arrowhead, CA 92407

**Prepared For: Matt Mitchell**  
Inspected On Tue, Sep 22, 2026 at 11:00 AM

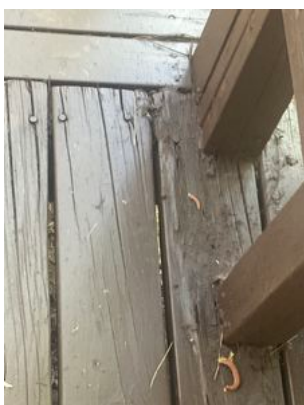
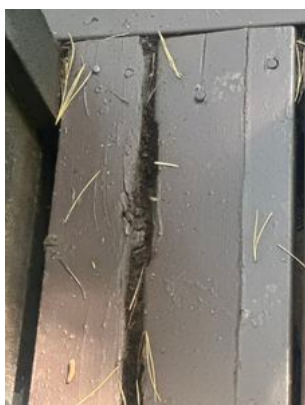
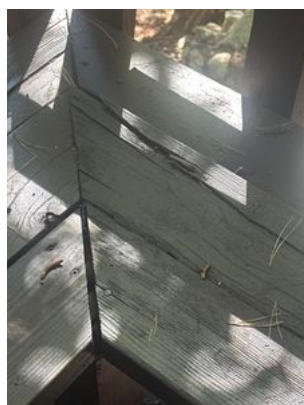
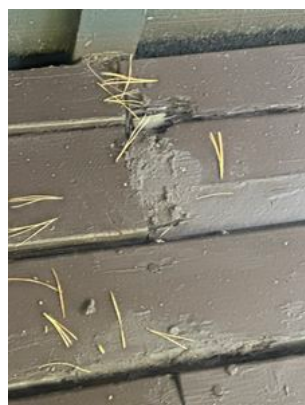
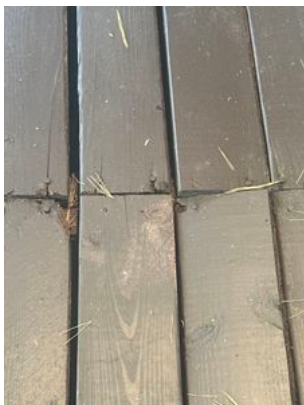
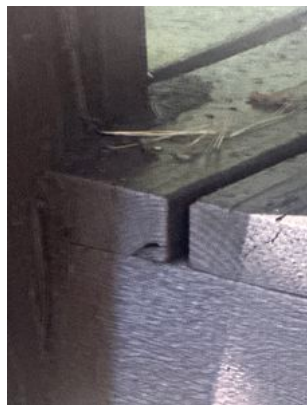
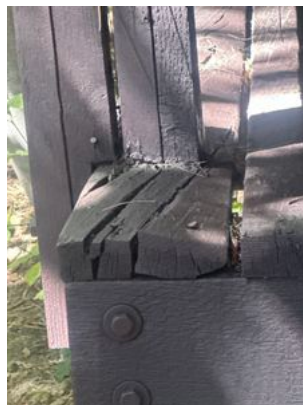
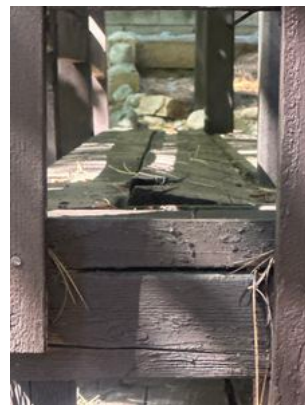
##### Site: Patios/Decks

Wood deck on South side of home has dry rot present. Floor boards are twisting/ uneven cresting a potential trip hazard.

Repair or replace

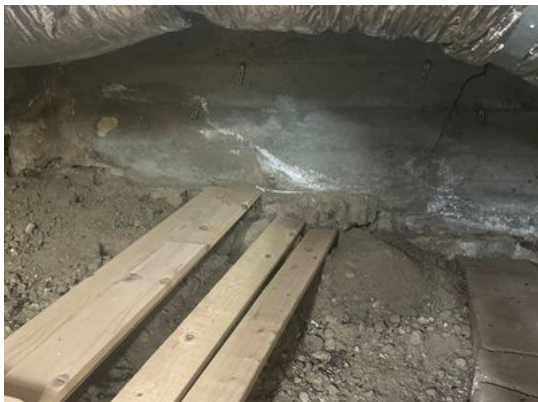
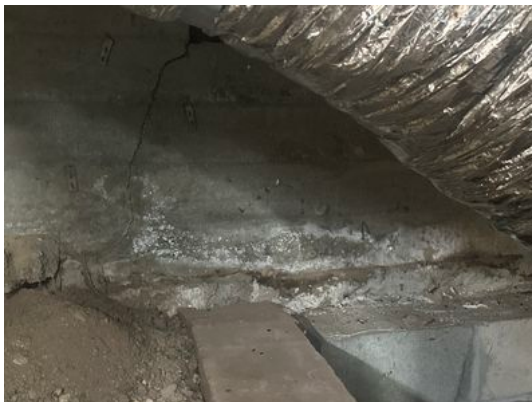
**Structure: Signs of Water Penetration**

Efflorescence staining present on north side foundation wall.

Cracking is also present on north behind furnace in build up.

Water proofing may be needed on north exterior to prevent water from soaking through foundation walls.

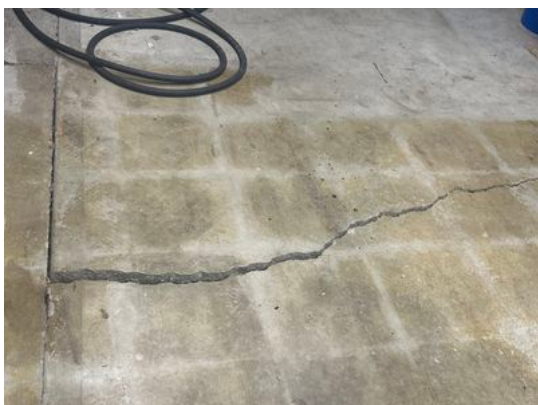
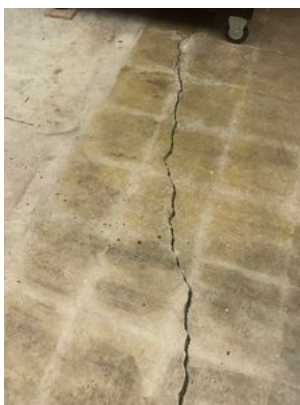
Cement floor inside build up under home has large crack present. Crack is lifted and separated.

Needs repair

Further evaluation suggested

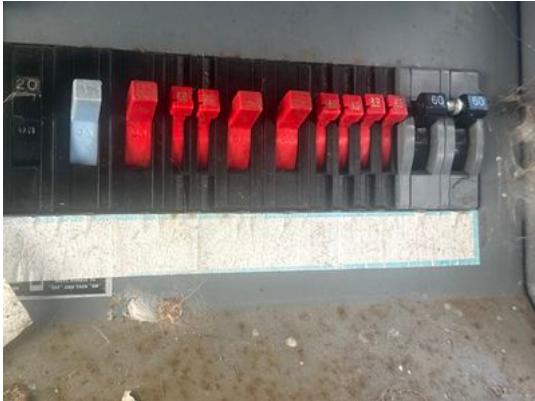
**Electrical: Panel Labeled**

Panel not labelled, all breakers should be labelled for each circuit.

Needs repair

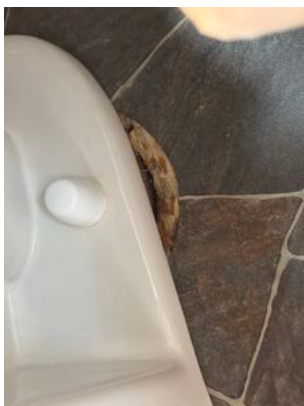
Flooring in downstairs bathroom is missing piece next to toilet.

Needs replacing

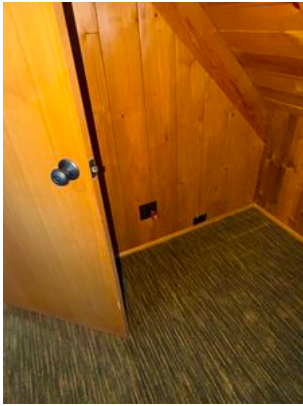
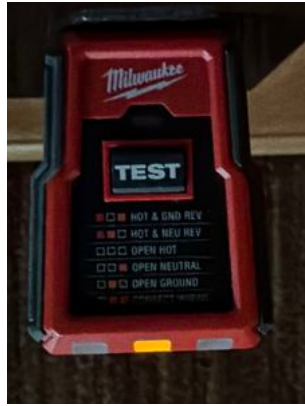
Ungrounded 3 prong outlets are a N.E.C violation in upstairs West bedroom

Needs repair

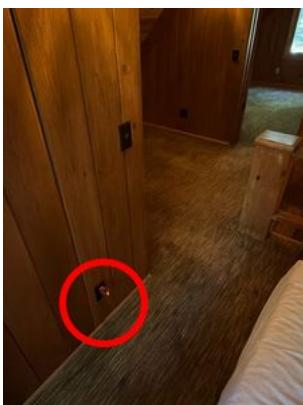
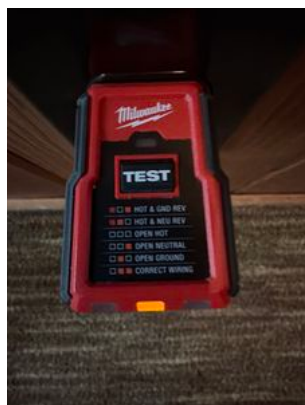
Ungrounded 3 prong outlets are a N.E.C violation on South Wall in loft and left side wall before entering West bedroom area

Needs repair

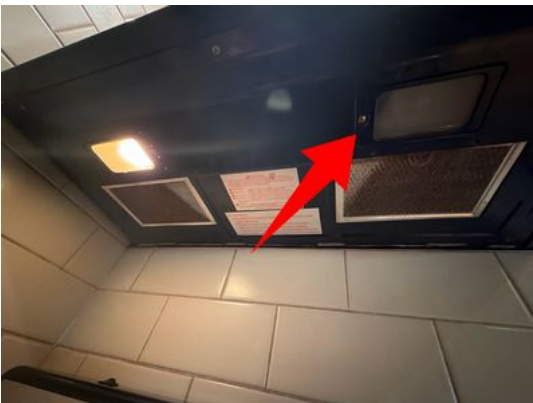
Needs light bulb replaced

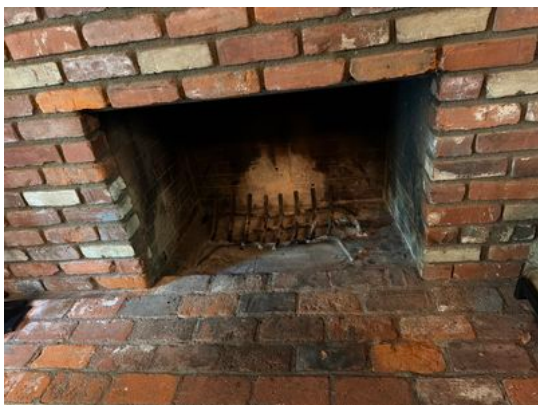
Needs a clamp on damper to prevent closing all the way. In the event of a gas leak if damper is able to fully close gas could enter home, with clamp on damper gas would be able to escape through the chimney.

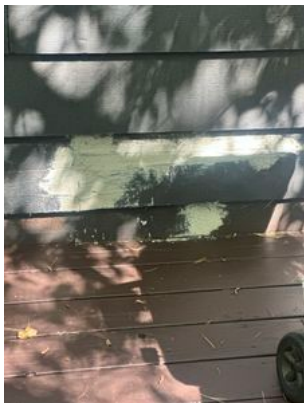
Exterior lap wood has been repaired on south bottom at wood deck.

Needs to be painted

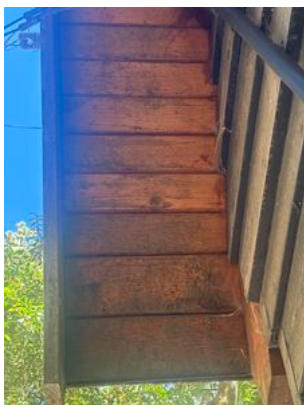
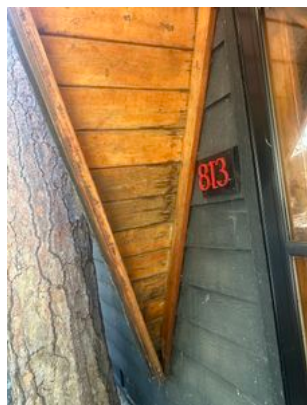
Staining present on wood eaves of home. Suggest re sealing/ painting.

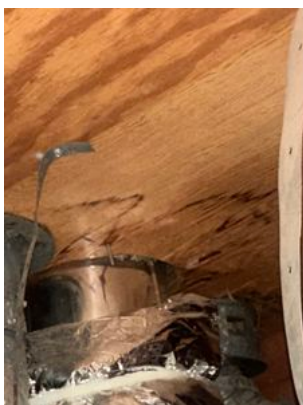
Moisture staining present on sub flooring surrounding furnace vent pipe in build up.

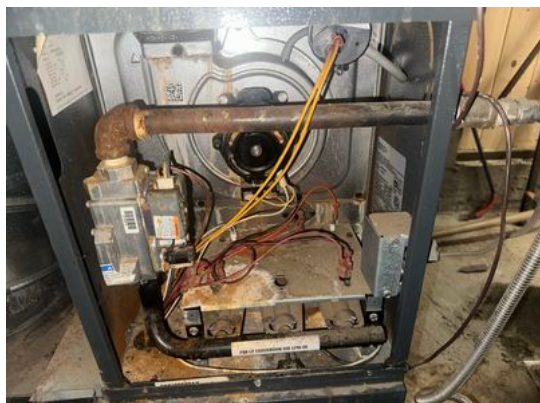
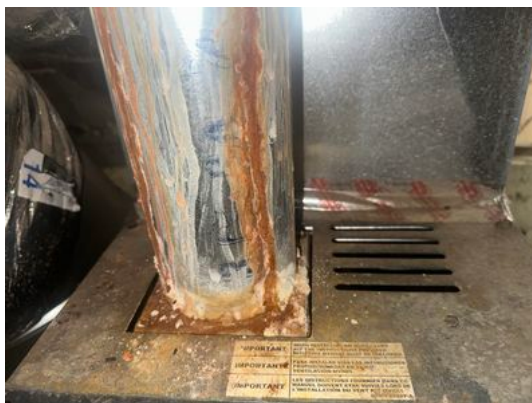
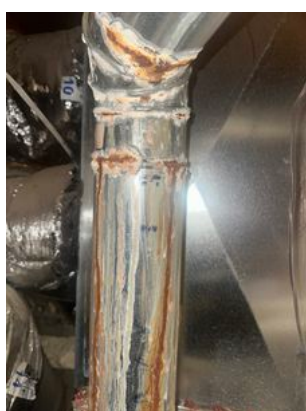
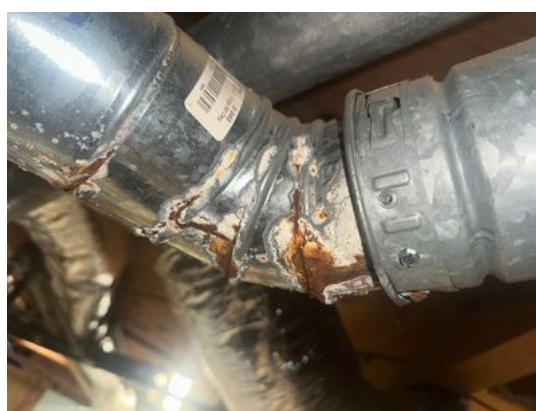
Signs of moisture intrusion on heater vent pipe in build up. Moisture has also entered furnace housing.

Further evaluation required

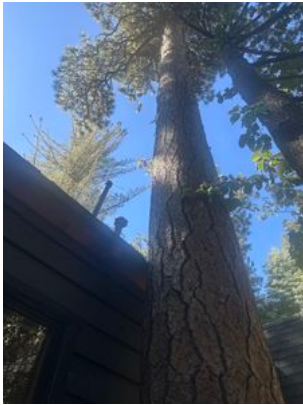
Tree growing on north side of home is almost touching home and very tall hanging over roof.

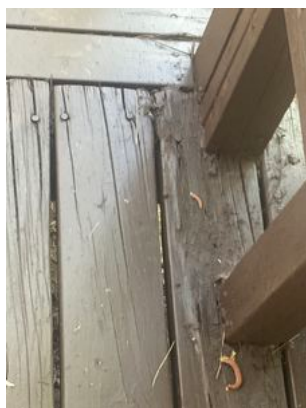
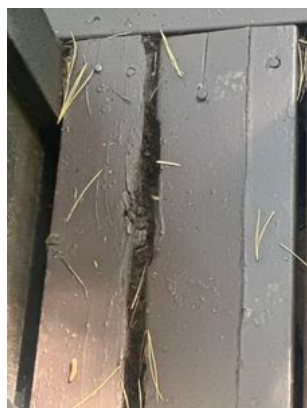
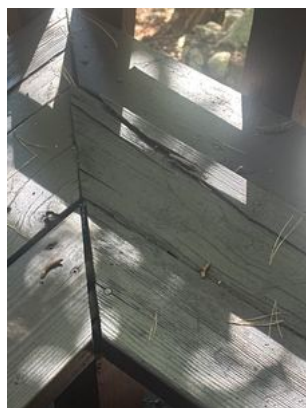
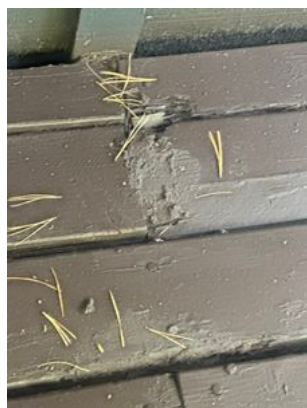
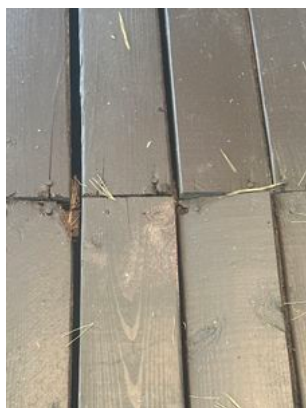
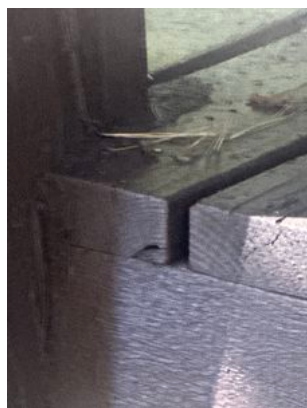
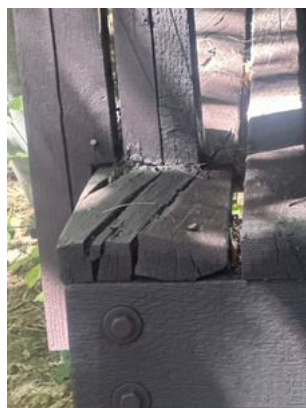
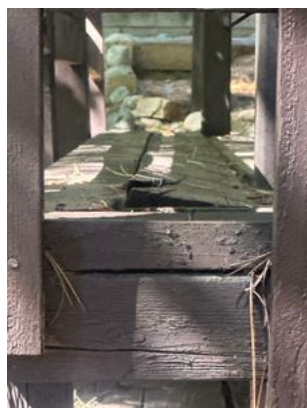
Wood deck on South side of home has dry rot present. Floor boards are twisting/ uneven cresting a potential trip hazard.

Repair or replace

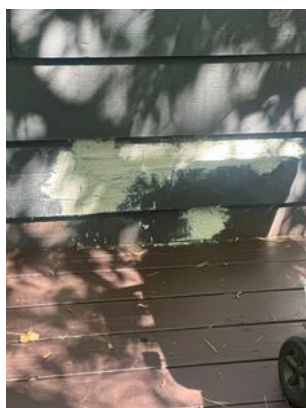
Exterior lap wood has been repaired on south bottom at wood deck.

Needs to be painted

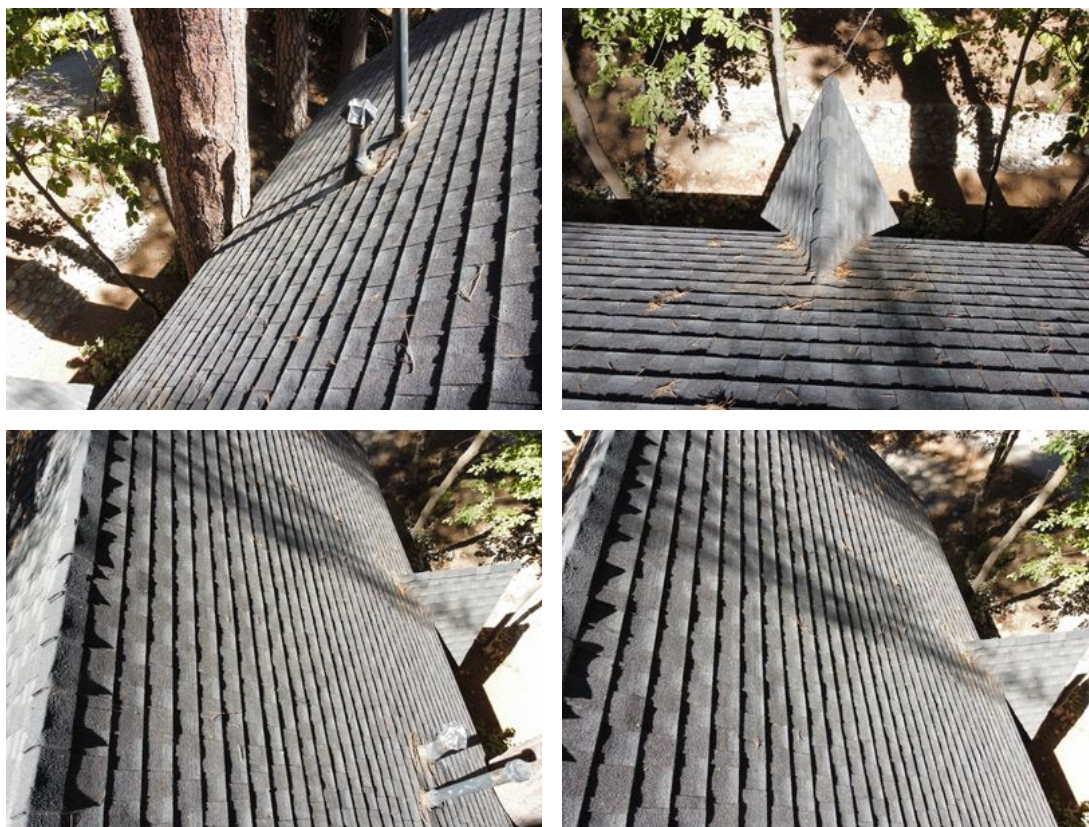
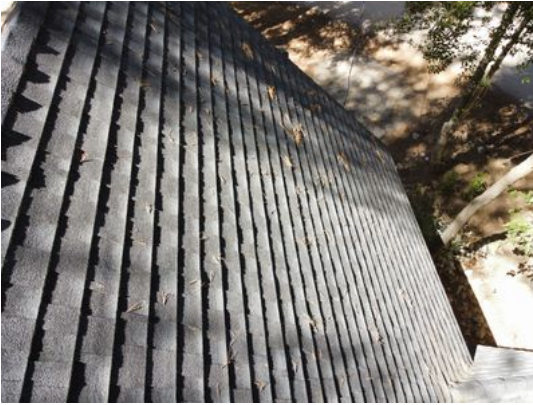
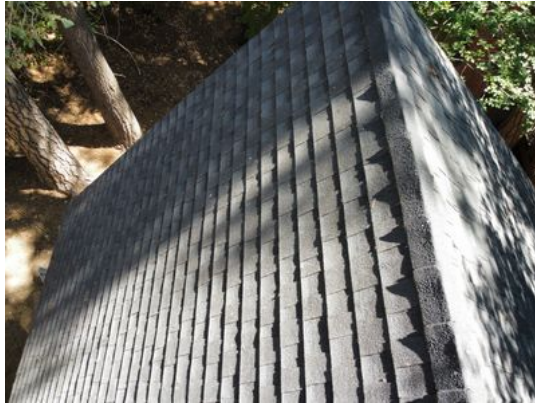
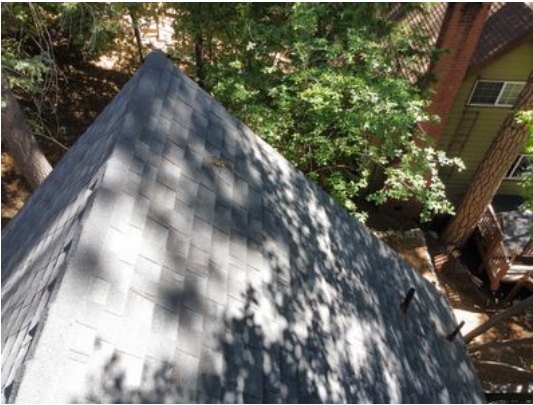
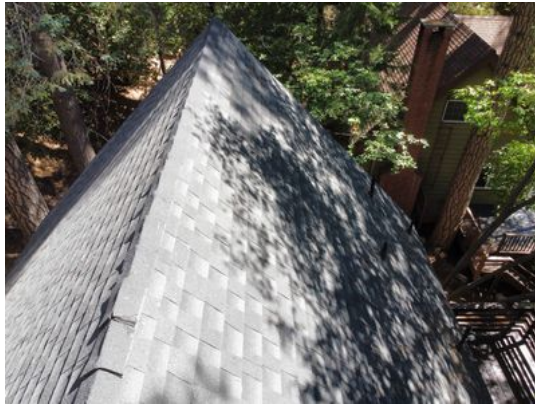
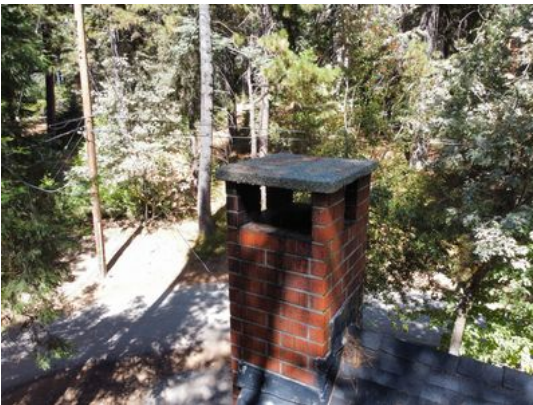
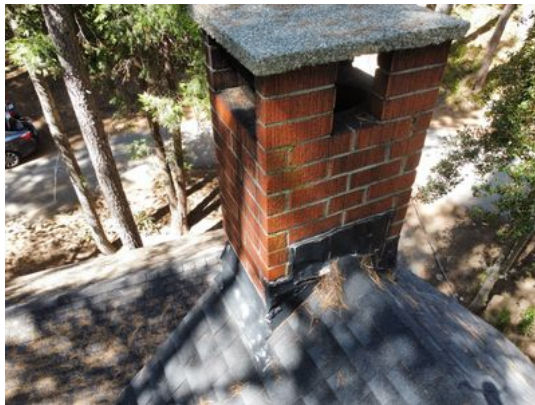
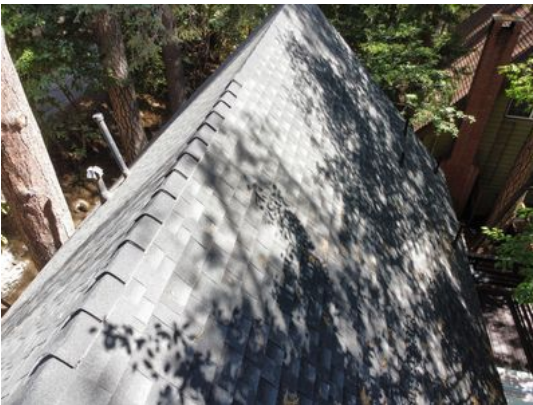
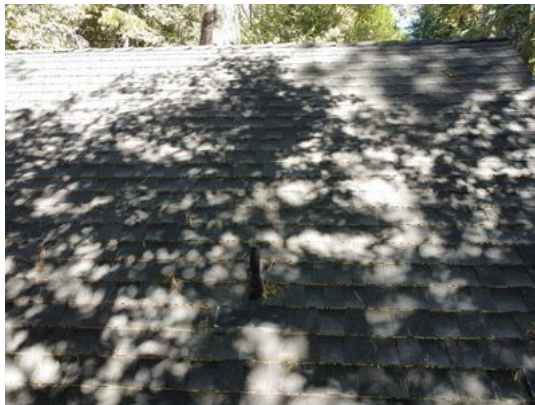
General pictures of roof ....Roof appears to be in satisfactory condition

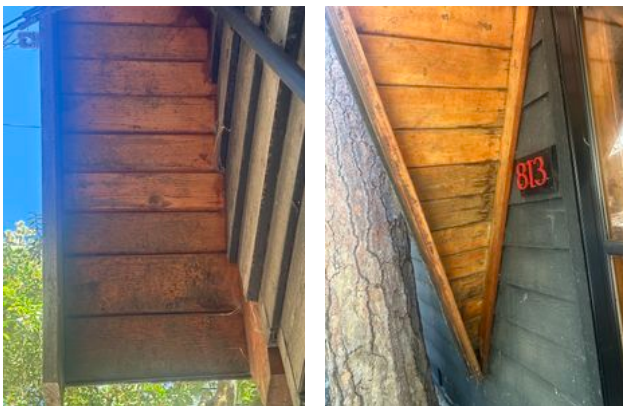
Staining present on wood eaves of home. Suggest re sealing/ painting.

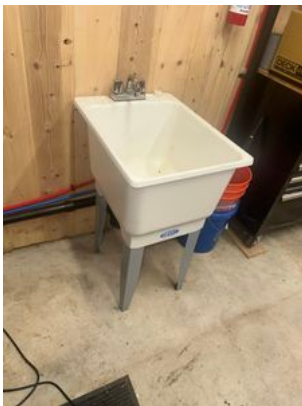
Laundry sink needs to be secured to floor or wall.

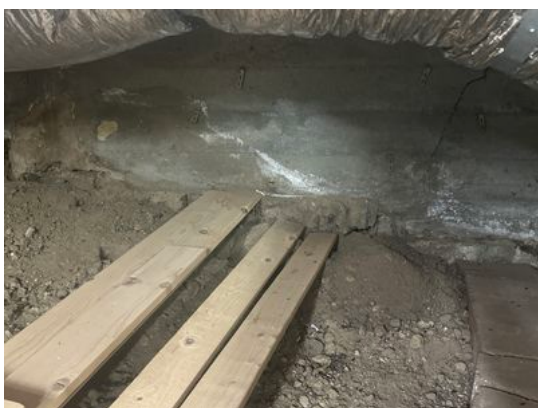
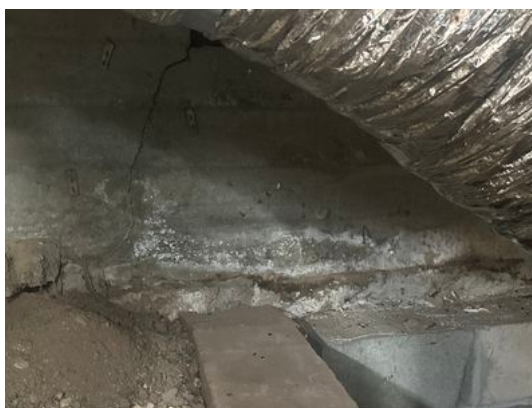
Efflorescence staining present on north side foundation wall.

Cracking is also present on north behind furnace in build up.

Water proofing may be needed on north exterior to prevent water from soaking through foundation walls.

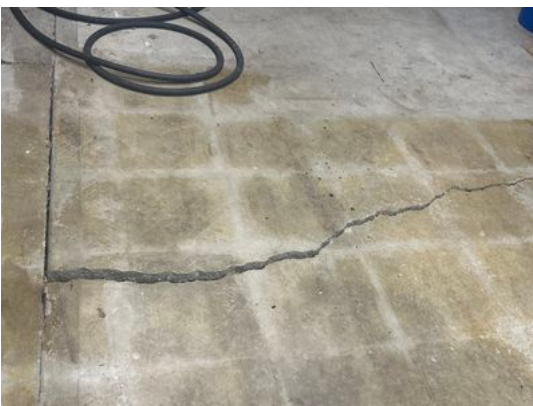
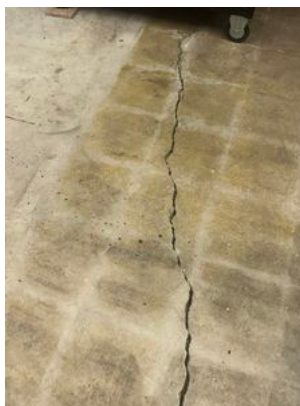
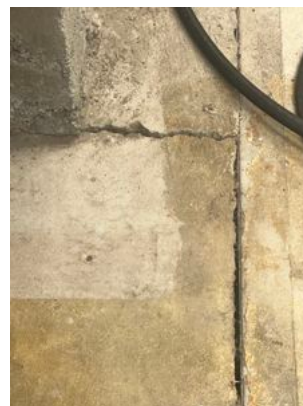
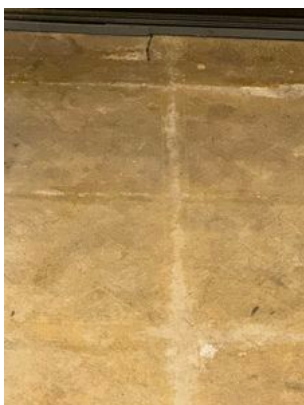
Cement floor inside build up under home has large crack present. Crack is lifted and separated.

Needs repair

Further evaluation suggested

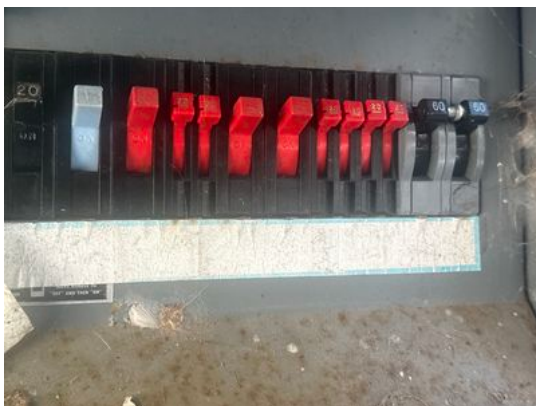
Panel not labelled, all breakers should be labelled for each circuit.

Needs repair

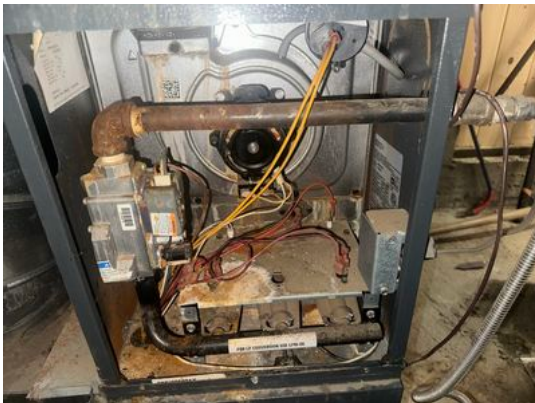
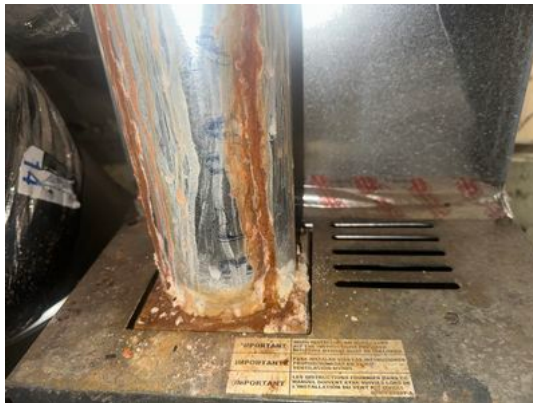
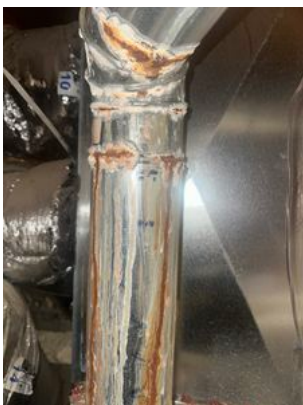
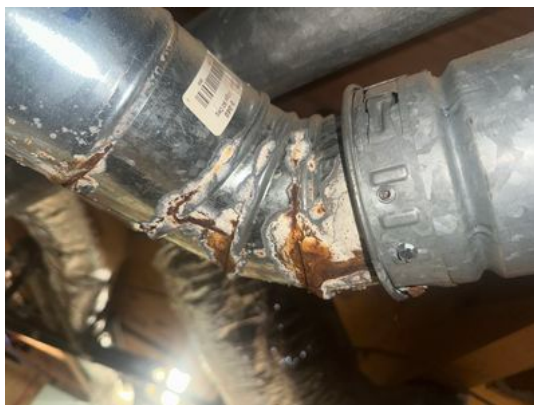
Signs of moisture intrusion on heater vent pipe in build up. Moisture has also entered furnace housing.

Further evaluation required

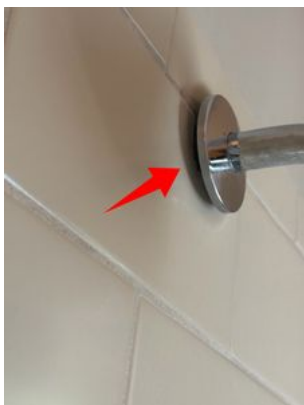
Re seal fixture cap to wall in shower and downstairs bathroom

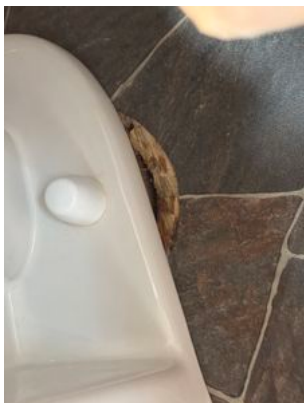
Flooring in downstairs bathroom is missing piece next to toilet.

Needs replacing

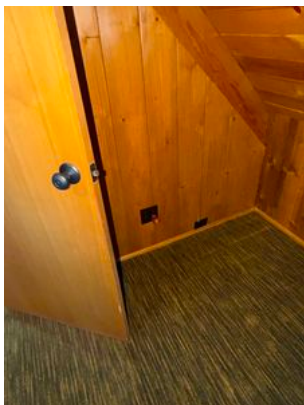
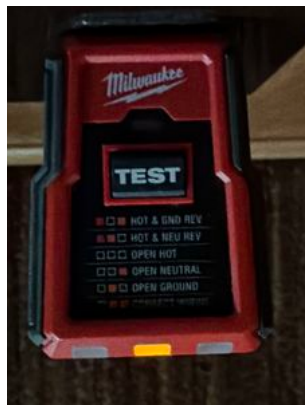
Ungrounded 3 prong outlets are a N.E.C violation in upstairs West bedroom

Needs repair

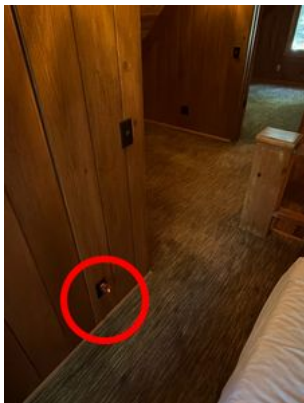
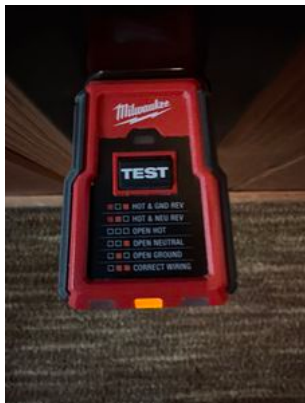
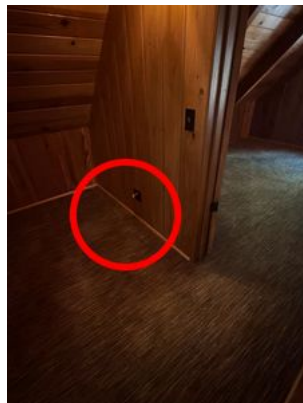
Ungrounded 3 prong outlets are a N.E.C violation on South Wall in loft and left side wall before entering West bedroom area

Needs repair

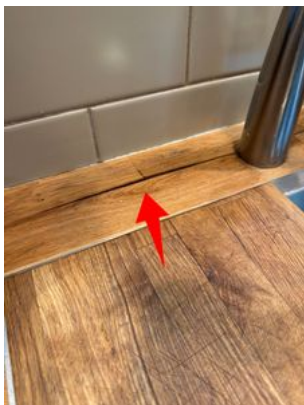
Counter wood is lifting

Needs repair

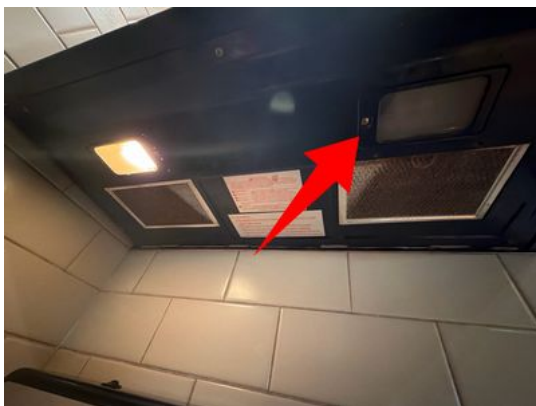
Needs light bulb replaced

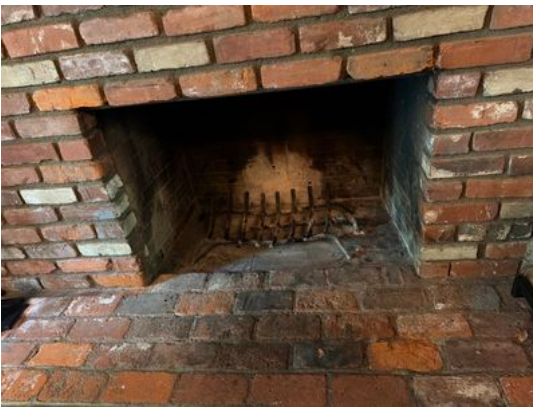
Needs a clamp on damper to prevent closing all the way. In the event of a gas leak if damper is able to fully close gas could enter home, with clamp on damper gas would be able to escape through the chimney.
