2405 Nicklaus Dr  
Santa Maria CA 93455

9/21/2026

HouseMaster  
1187 Coast Village Rd. 1-284  
Santa Barbara, CA 93108

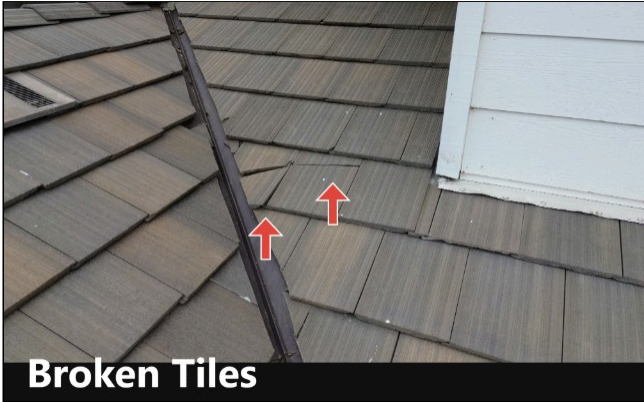
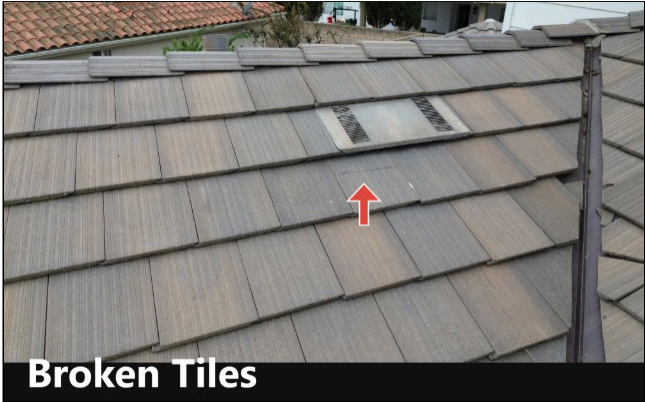
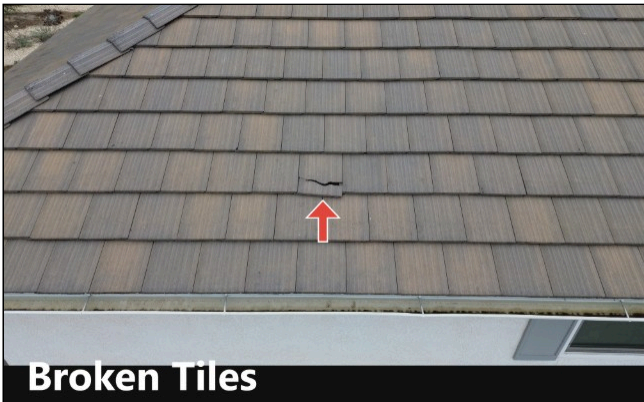
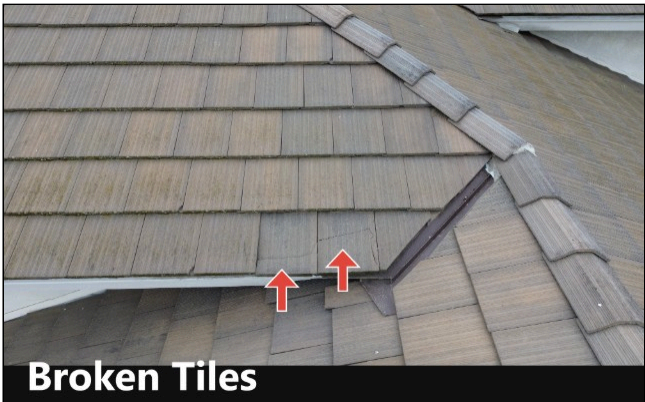
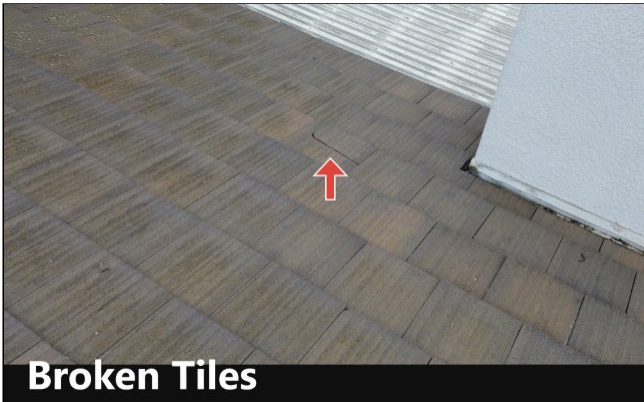
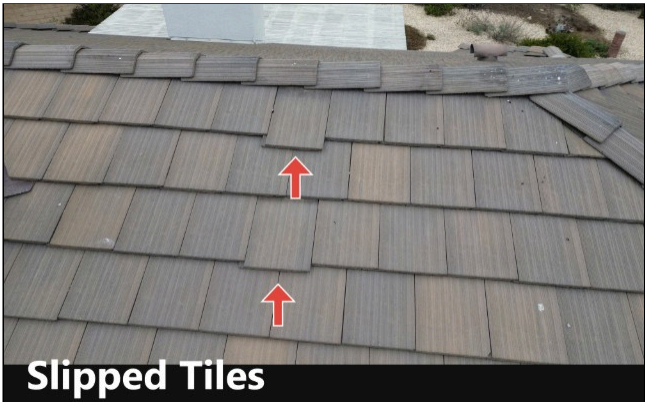
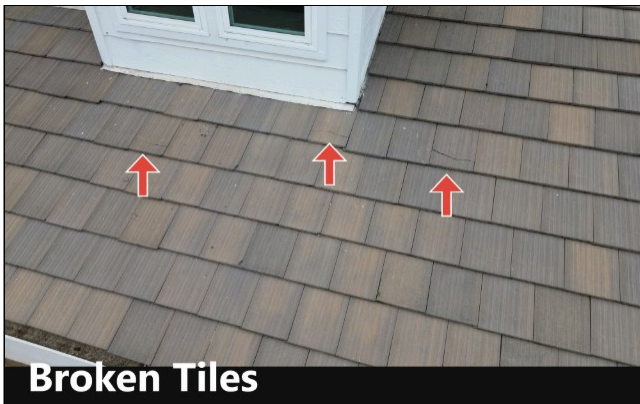
1.0 ROOFING

| ● | | | | | <b>1.0 ROOFING</b><br><p>Multiple roof tiles are broken/out of position. Consult a roofing contractor to determine cost to repair/replace broken/shifted tiles. Maintain roof tiles to aide in preventing water penetration into structure. Limit access to roof to aide in preventing damage to roof tiles.</p> <p>Roof age was not confirmed by inspectors. Contact sellers and/or building department to determine/estimate roof age.</p> <p>Roof coverings require periodic repairs and sealant, especially at exposed nailheads, flashings and around roof penetrations as part of routine maintenance. Suggest annual evaluation and sealing as needed to prevent water penetration and extend the lifespan of materials.</p> |

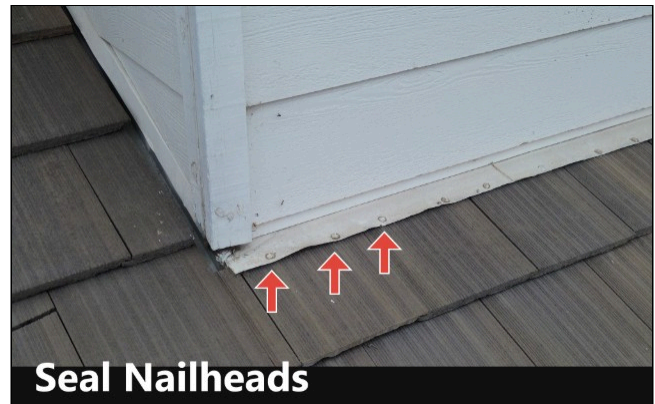
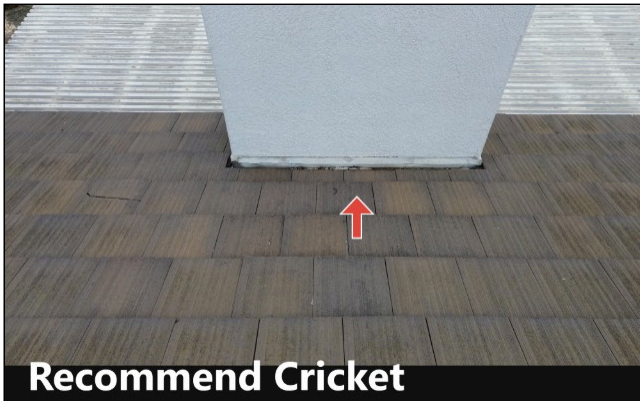
1.1 EXPOSED FLASHING

| ● | | | | | <b>1.1 EXPOSED FLASHING</b><br><p>Exposed nailheads at flashings observed on roof. Seal nailheads to prevent water penetration and extend service life.</p> <p>Recommend installing a cricket/saddle flashing at chimney when next reroofing to reduce risk of water intrusion. Crickets are recommended where the chimney width exceeds 30 inches to divert water and prevent debris buildup behind the chimney.</p> |

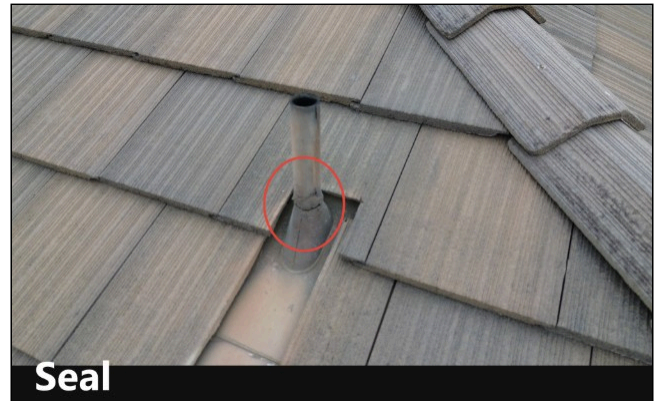
1.3 PLUMBING STACKS

| ● | | | | | <b>1.3 PLUMBING STACKS</b><br><p>Recommend sealing around all vent covers and plumbing stacks now and annually to aide in preventing water penetration.</p> |

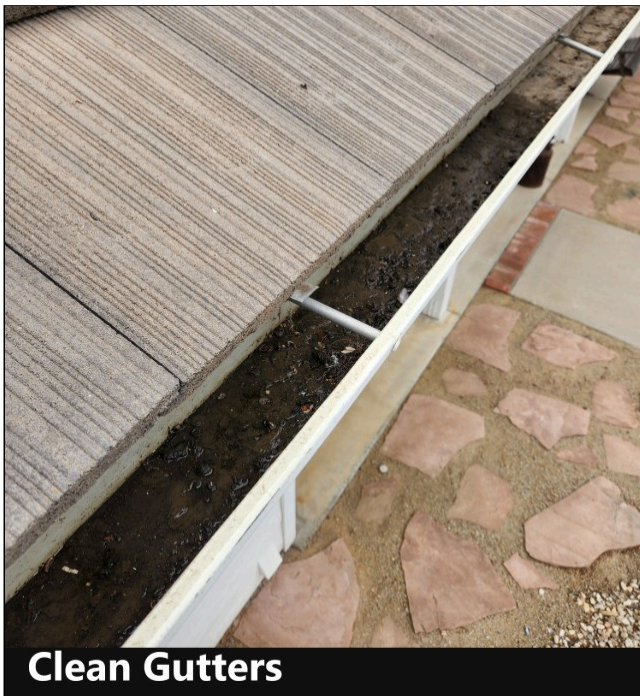
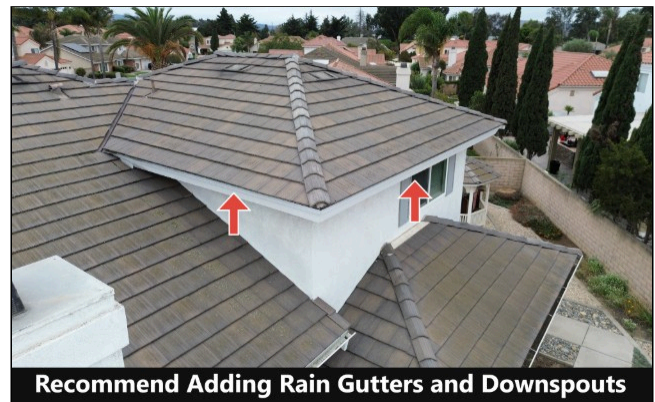
1.5 RAIN GUTTERS

| ● | | | | | <b>1.5 RAIN GUTTERS</b><br><p>Buildup in rain gutters. Suggest cleaning and flushing now and on an annual basis for proper drainage. Consider upgrade of gutter guards to prevent leaf buildup.</p> <p>Recommend installation of rain gutters and downspouts at all pitched roof edges to aide in controlling water run off away from structure and hardscaping. Gutters and downspouts help aide in reducing water runoff from splashing onto/penetrating into structure. Consider adding built-in/subsurface drains and connecting downspouts into drain system.</p> |

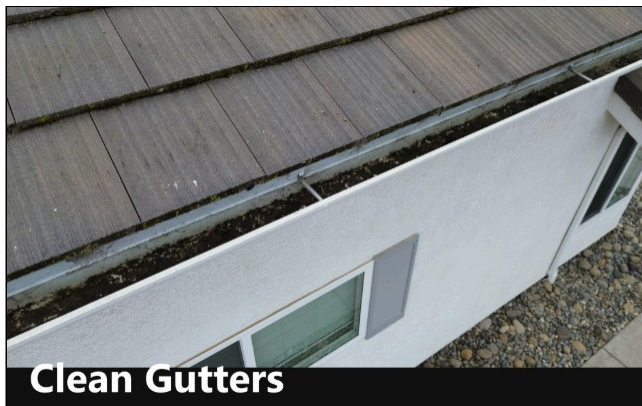
1.5 RAIN GUTTERS

**Clean Gutters**

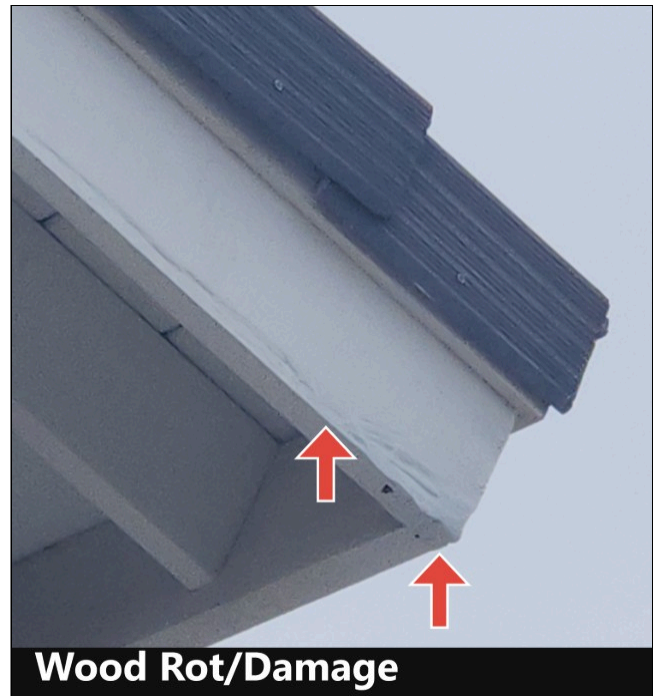
1.7 FASCIA / EAVES

| | | ● | | | <b>1.7 FASCIA / EAVES</b><br>Wood damage/rot observed at fascia/eaves/soffit members. Anticipate repairs. Consult pest control company for evaluation and repair/treatment cost estimate.<br><br>Paint is peeling in various locations. Suggest repainting on a regular basis as part of routine maintenance to enhance lifespan of materials. |

**Wood Rot/Damage**

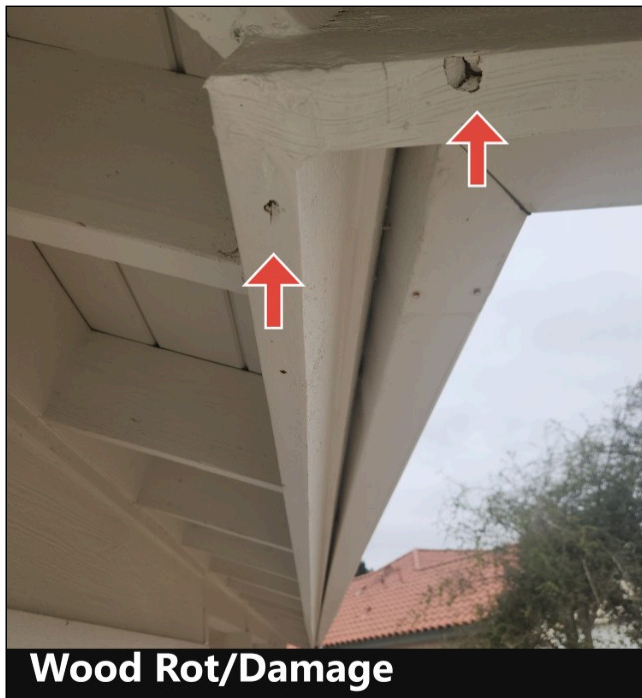
1.7 FASCIA / EAVES

**Wood Rot/Damage**

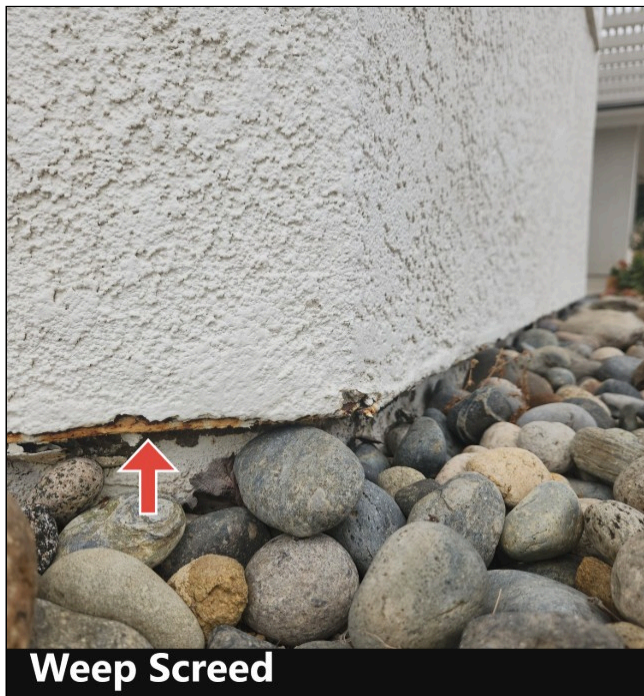
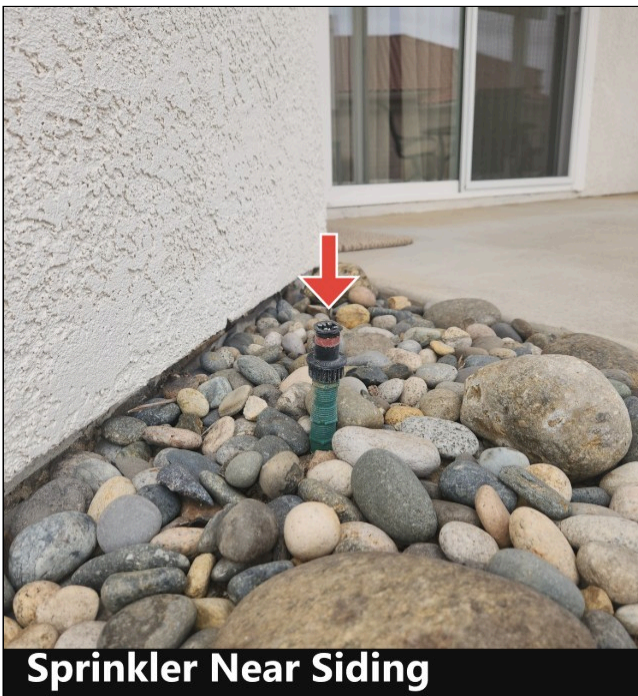
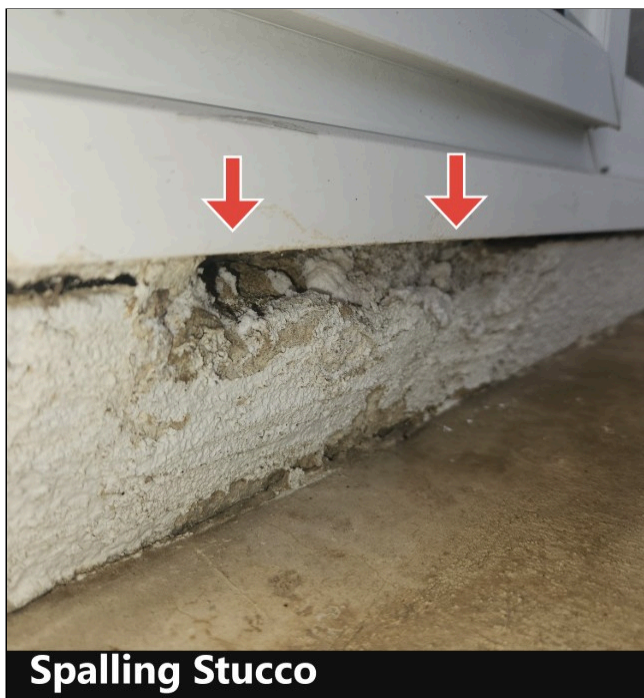
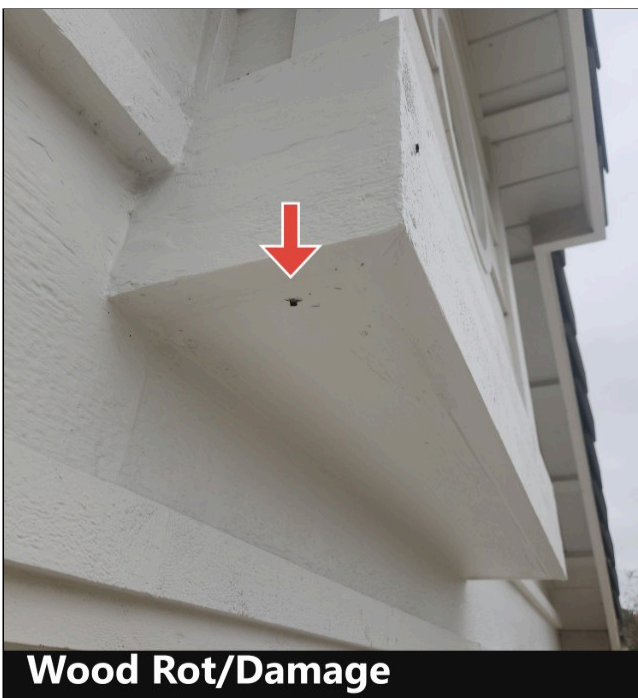
2.0 SIDING

| ● | | | | | <b>2.0 SIDING</b><br><br>Weep screed is damaged/rusted/failed at several locations. Anticipate replacing sections of weep screed and associated stucco repairs. Consult a plaster or masonry contractor to determine repair cost estimate.<br><br>Recommend replacing irrigation spray heads with drip-style irrigation near house walls to reduce water exposure to the structure. Additionally, minimize watering and ensure proper drainage away from the building to prevent moisture intrusion. Consult owner on history.<br><br>Stucco finish is spalling (chipping/flaking) beneath patio door with efflorescence (mineral deposits from moisture) observed, which may expose underlying materials to moisture intrusion and deterioration. Recommend contacting a qualified contractor for further evaluation and to repair/paint stucco to extend the lifespan of materials. Inspector was unable to determine source of moisture causing efflorescence.<br><br>Wood rot/damage observed at exterior wood siding/trim. See pest control company report for conditions related to wood siding, trim and framing members.<br><br>Gaps between lights and wall/junction box at lights at front of garage expose inside of junction box and wiring. Contact a qualified contractor to determine options and cost estimate to reconfigure/repair to limit pest and moisture access.<br><br>Suggest sealing now and annually at any holes, gaps, cracks, around light fixtures, windows, doors, trim, etc...to aide in preventing water penetration and pest intrusion. |

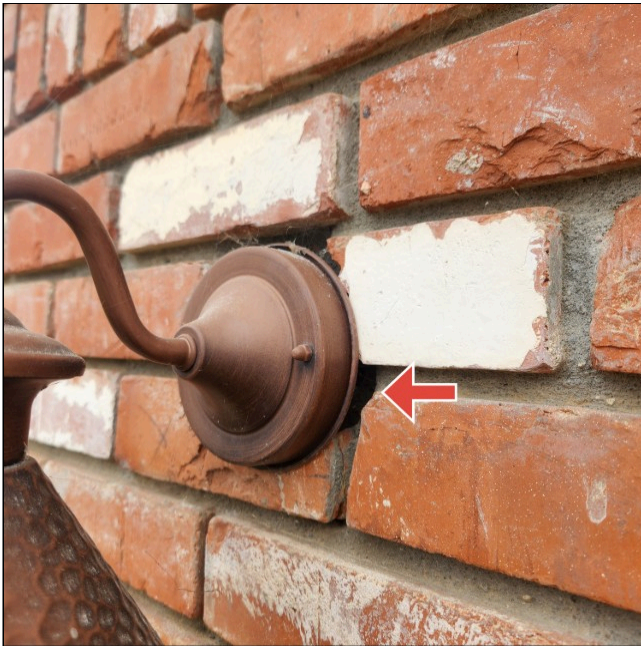
2.0 SIDING

**Gaps**

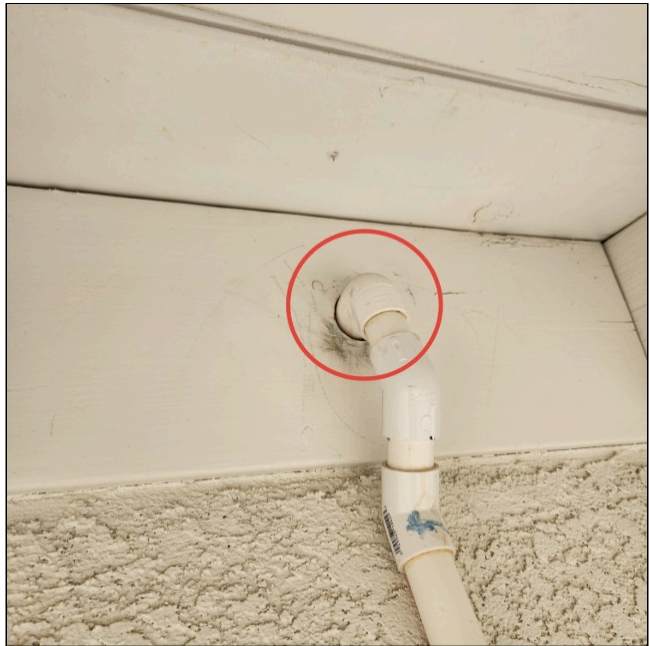
2.0 SIDING

**Seal**

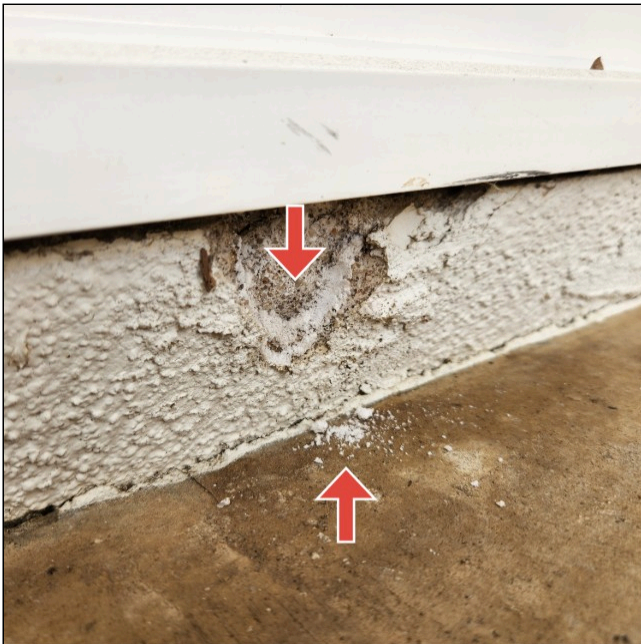
2.0 SIDING

**Efflorescence**

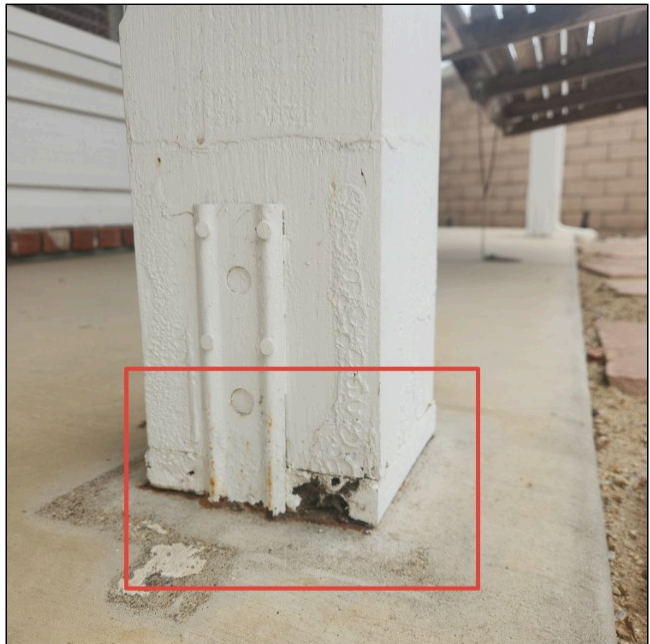
2.2 PORCH(ES) / DECK(S)

| | ● | | | | <b>2.2 PORCH(ES) / DECK(S)</b><br><br>Rusting post base brackets with missing fasteners observed at front porch. Contact a qualified contractor for evaluation/repair/replacement.<br><br>Wood rot/damage observed at porch post. Anticipate repairs. Consult pest control company for evaluation and repair/treatment cost estimate. |

**Wood Damage/Rot**

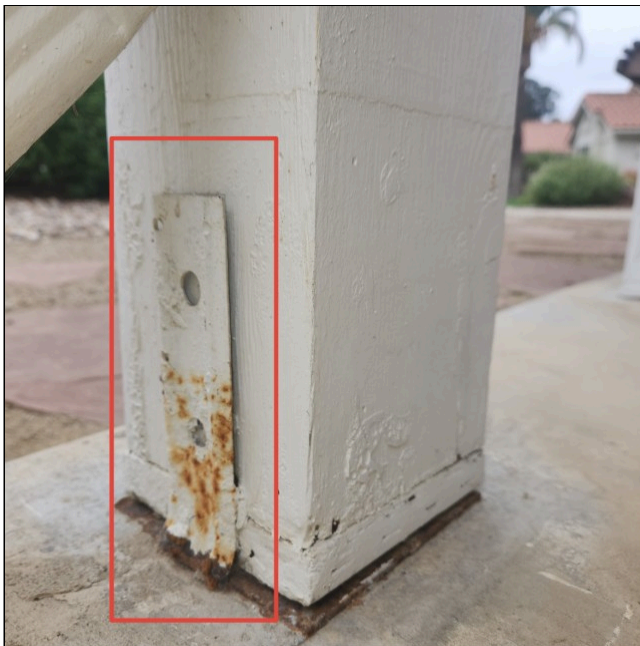
2.2 PORCH(ES) / DECK(S)

**Rusting Bracket. Missing Fasteners.**

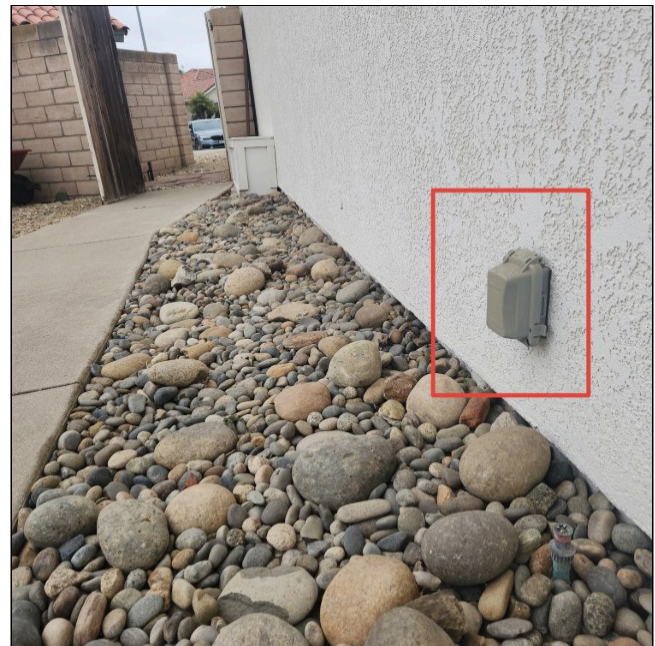
2.4 ELECTRIC / GFCI

| | | ● | | | <b>2.4 ELECTRIC / GFCI</b><br><br>GFCI at right side of house did not trip when tested and is not providing proper ground-fault protection. Recommend evaluation and correction by a licensed electrician for electrical safety. |

**Outlet Without Power**

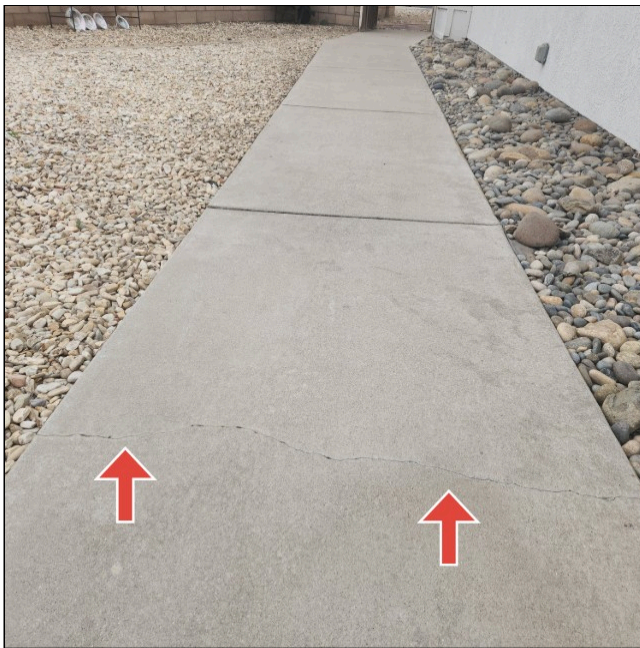
3.0 WALKWAYS

| ● | | | | | <b>3.0 WALKWAYS</b><br>Suggest sealing at any hardscaping cracks (walkways, patios & driveways) to prevent water penetration, further cracking, and to extend service life. |

**Seal Gaps/Cracks**

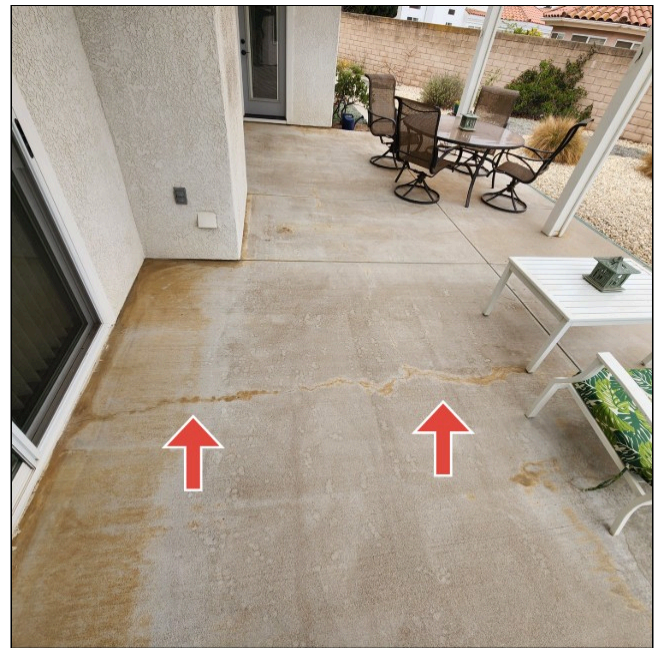
3.1 PATIO(S)

| | ● | | | | <b>3.1 PATIO(S)</b><br>See comment above.<br>Wood damage/rot observed at patio pergola. See pest control report for conditions related to decking, wood siding, trim and framing members. Anticipate repair/replacement.<br><br>Peeling paint observed at top of patio pergola. Recommend refinishing/painting pergola wood to extend the lifespan of materials. |

**Seal Cracks**

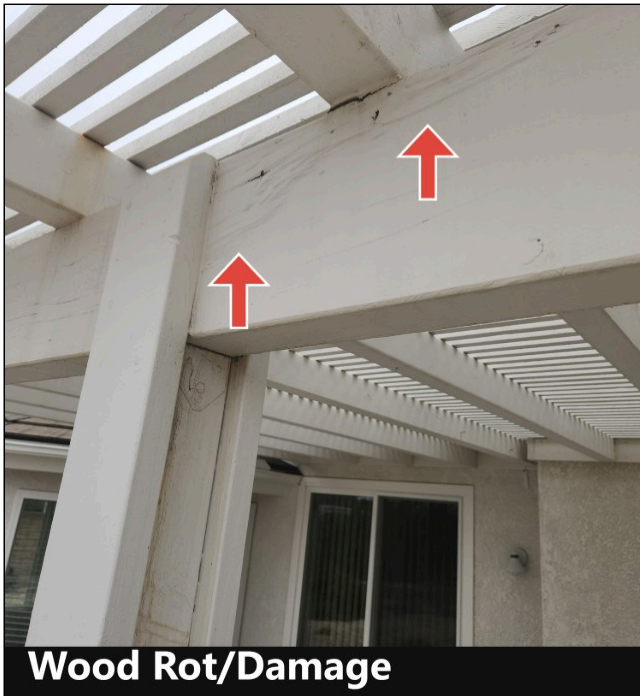
3.1 PATIO(S)

**Wood Rot/Damage**

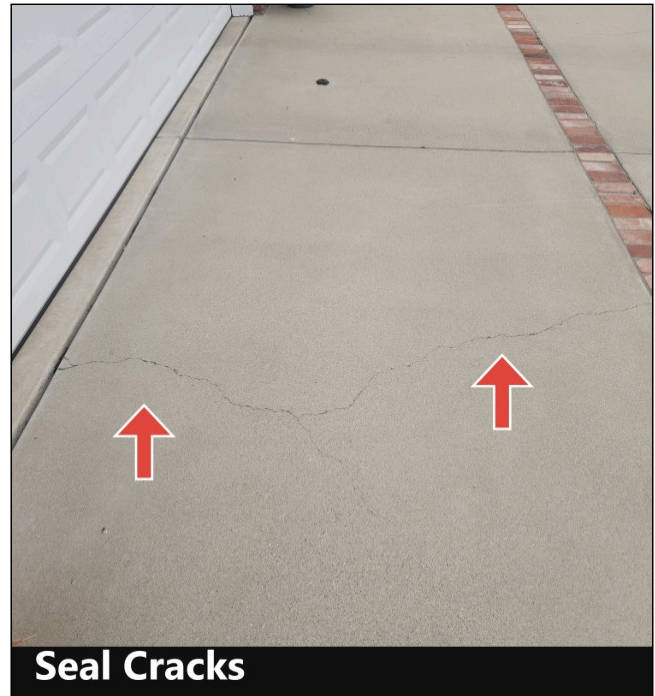
3.2 DRIVEWAY

**Seal Cracks**

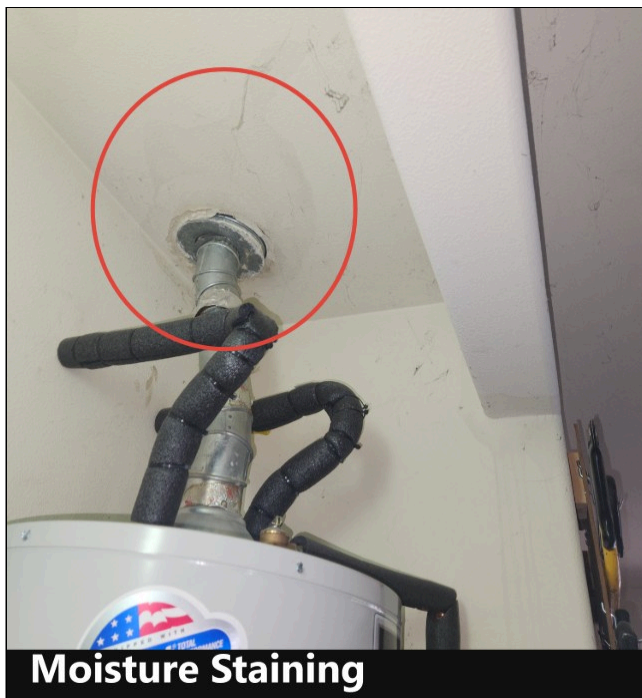
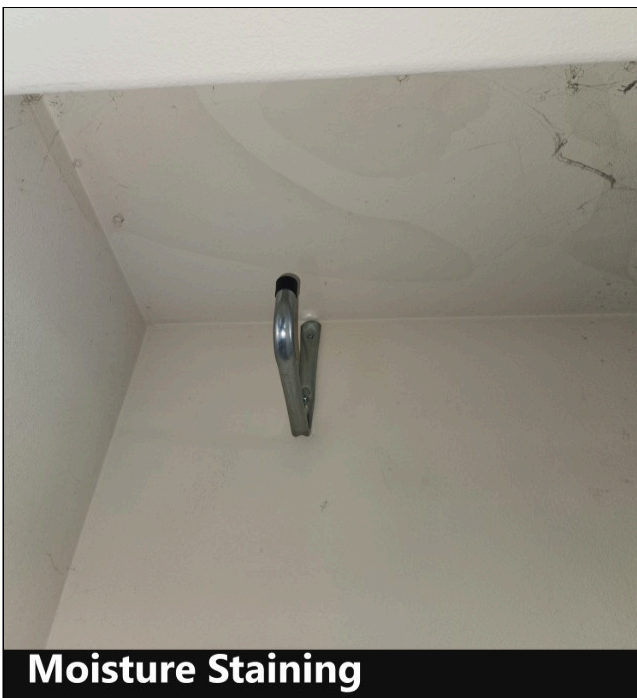
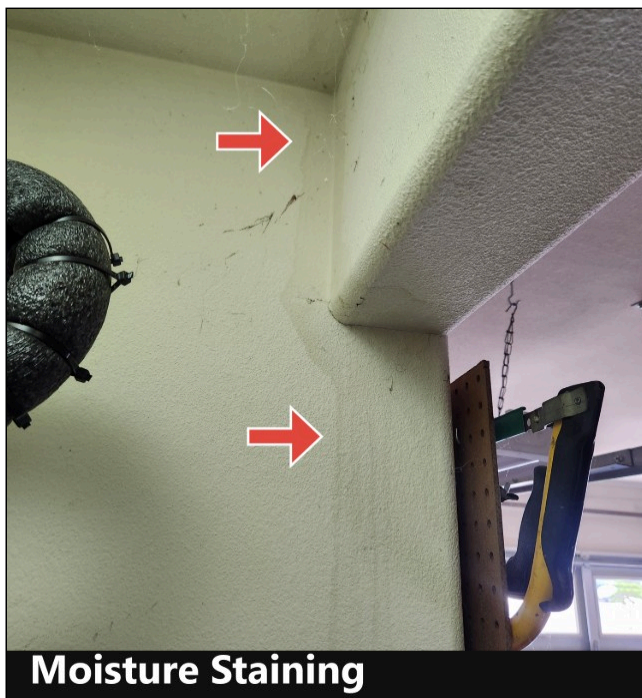
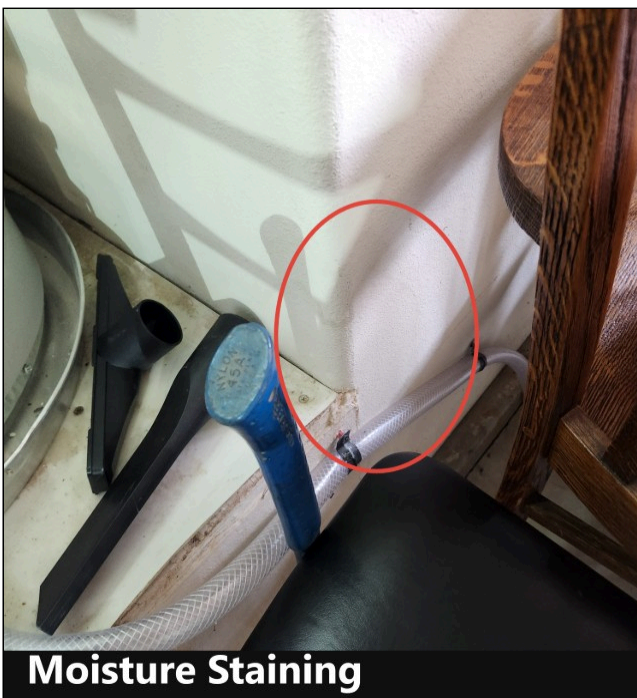
4.1 WALLS / CEILINGS

| | ● | | | | <b>4.1 WALLS / CEILINGS</b><br>Staining at ceiling and walls around water heater in garage where dry when tested with a moisture meter at time of inspection (no recent rains). Inspector is unable to determine if staining is historic or ongoing. Consult owner on history of roof replacement. Monitor conditions and make repairs as required. Inspector is unable to determine conditions behind finish materials. Look for hidden damage behind finish materials. |

**Moisture Staining**

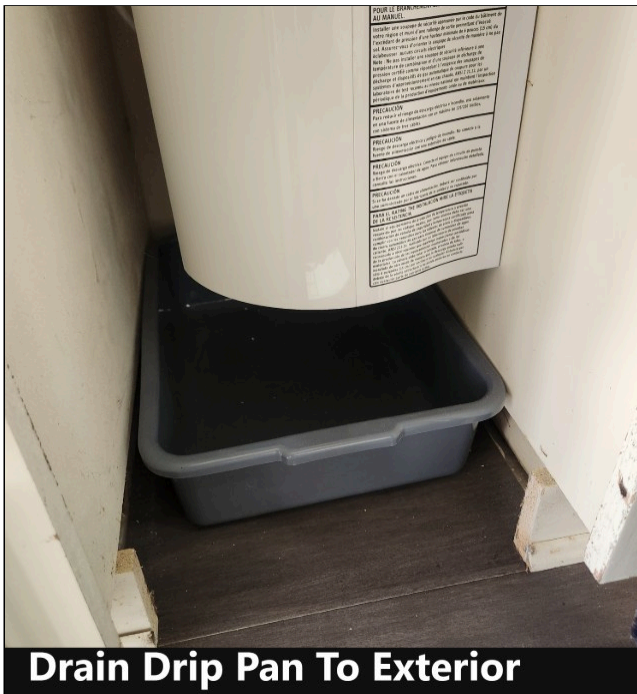
### 5.0.B WATER HEATER

| | | ● | | | <p><b>5.0.B WATER HEATER</b></p> <p>No water heater drip pan installed. Recommend drip pan installation to protect from moisture damage. Drain pipe on drip pan should be routed to exterior location. Consult a plumber for proper installation.</p> <p>Water heater operated properly at the time of inspection. It is 1 year old with a manufacturers design life of 8 - 12 years. Suggest annual flushing to remove sediment and extend service life.</p> |

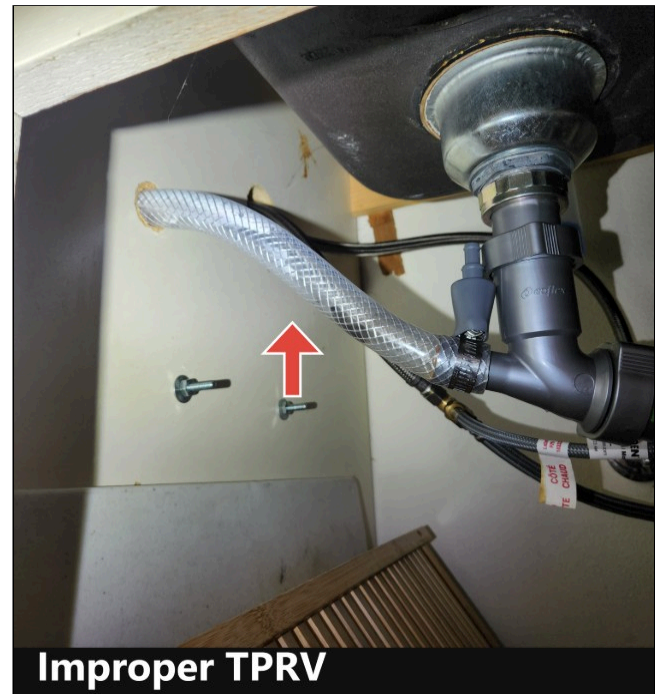
### 5.1.B SAFETY VALVE PROVISIONS

| | | ● | | | <p><b>5.1.B SAFETY VALVE PROVISIONS</b></p> <p>Temperature pressure relief valve piping is incorrectly routed to the kitchen sink drain and improper piping material has been used. Consult a plumber for installation of correct material to an approved location.</p> |

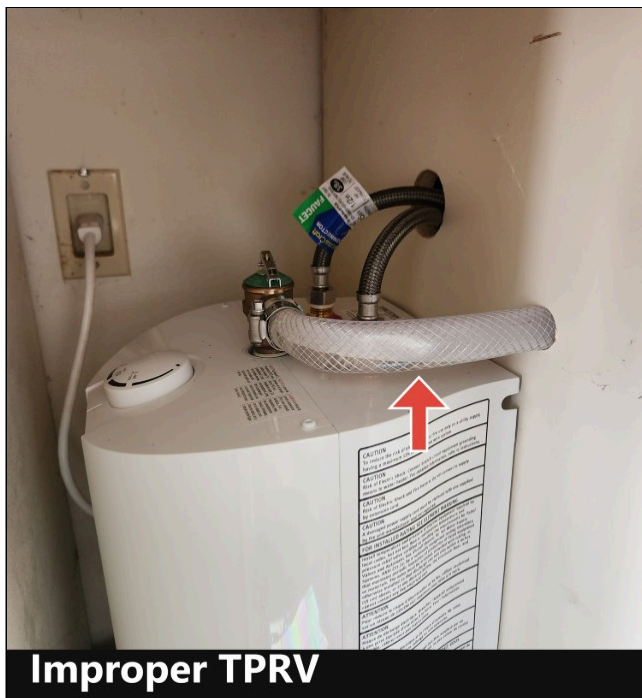
### 5.1.B SAFETY VALVE PROVISIONS

**Improper TPRV**

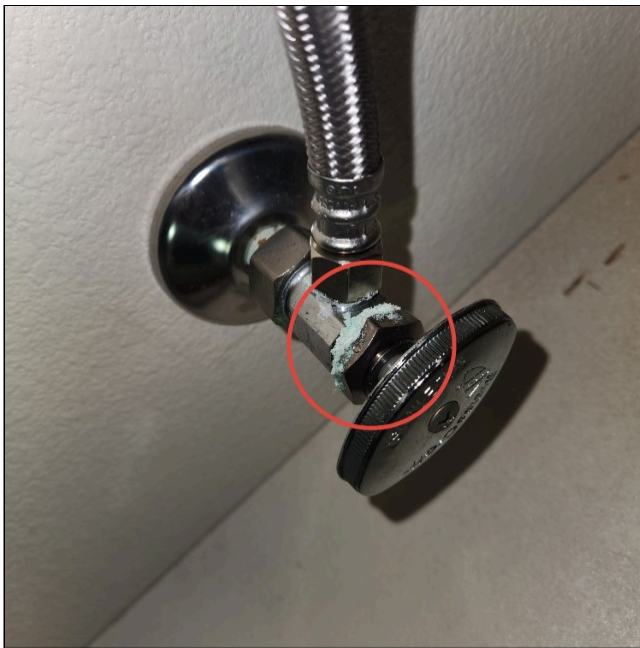
8.0 SINK(S)

**Corrosion/Mineral Deposits**

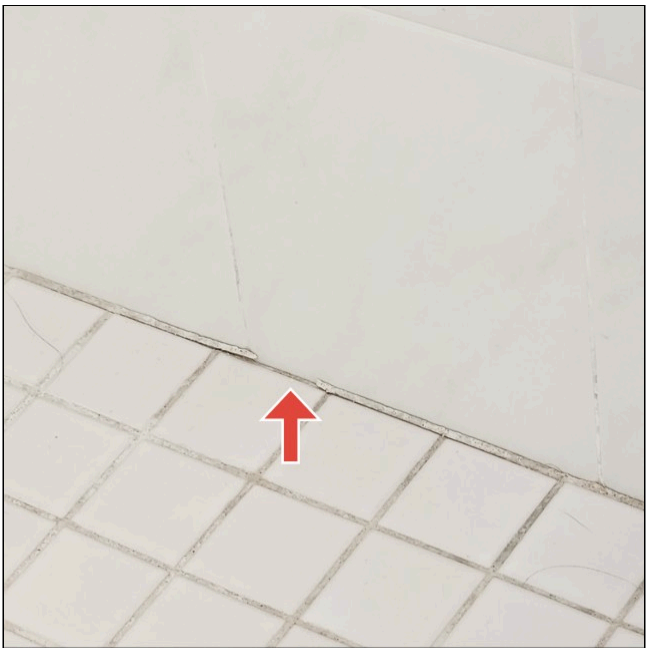
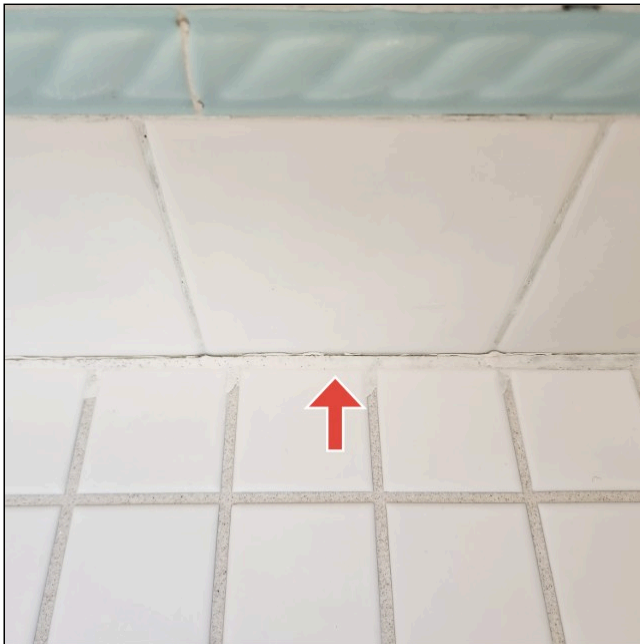
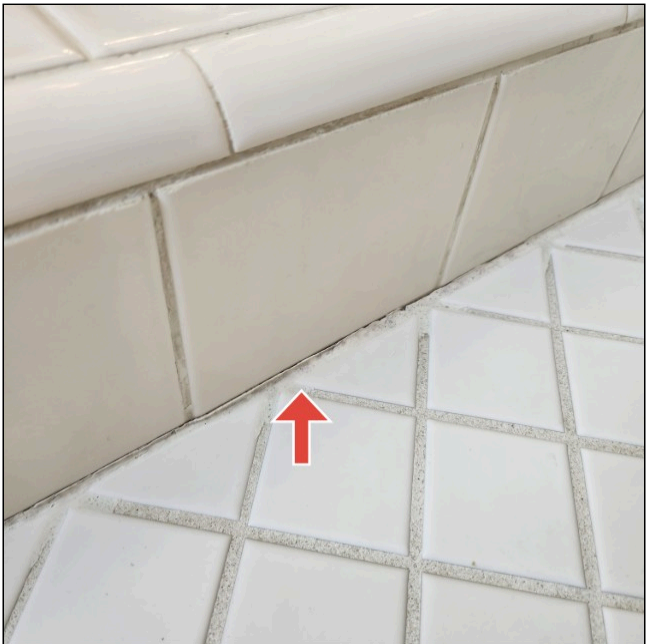
8.2 STALL SHOWER

**Seal**

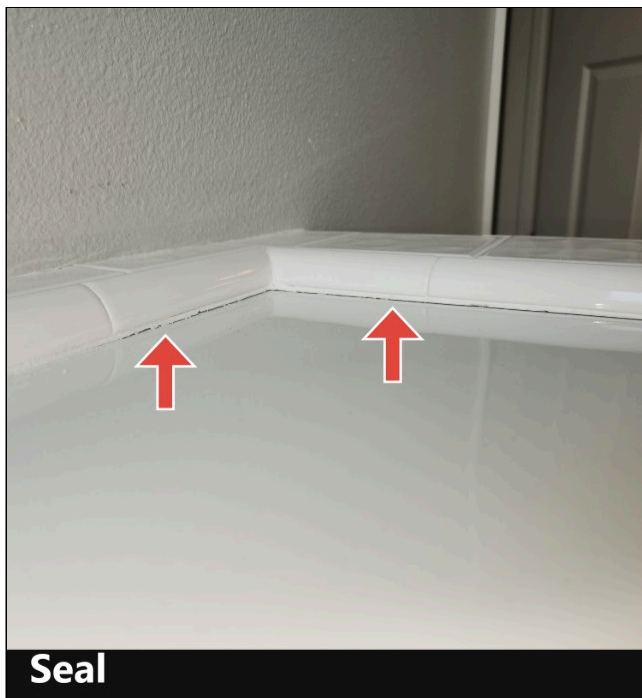
### 8.3 BATHTUB

**Seal**

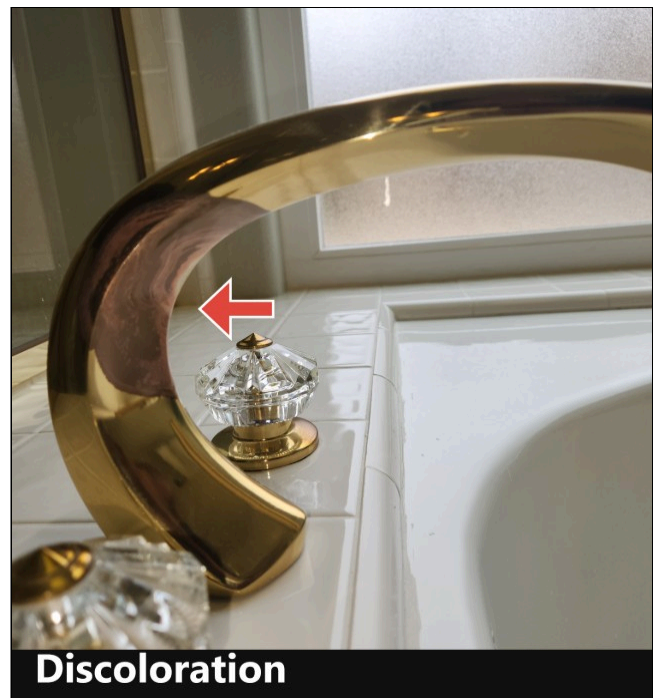
### 8.3 BATHTUB

**Discoloration**

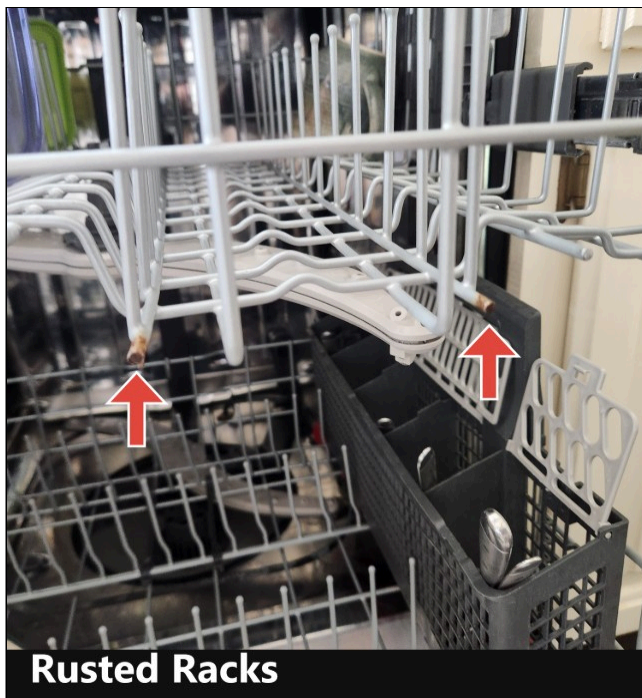
**9.2 DISHWASHER**

**Rusted Racks**

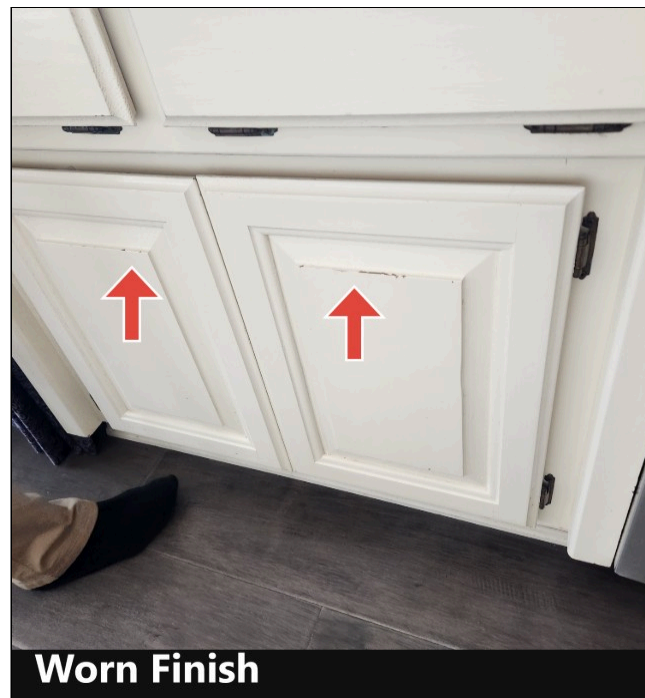
**9.8 CABINETRY**

**Worn Finish**

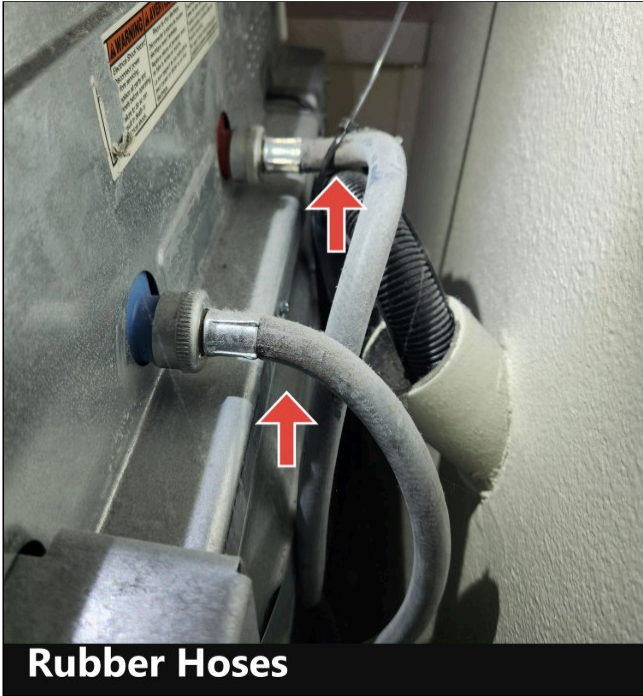
12.5 LAUNDRY

Rubber Hoses
