# PROPERTY INSPECTION REPORT

**FOUR POINT**  
HOME INSPECTION INC.

**9712 Pinal St Unit B7**  
**Inspection Prepared For: Georgia Umbertis**  
**Agent: -**

**Date of Inspection: 9/15/2026**

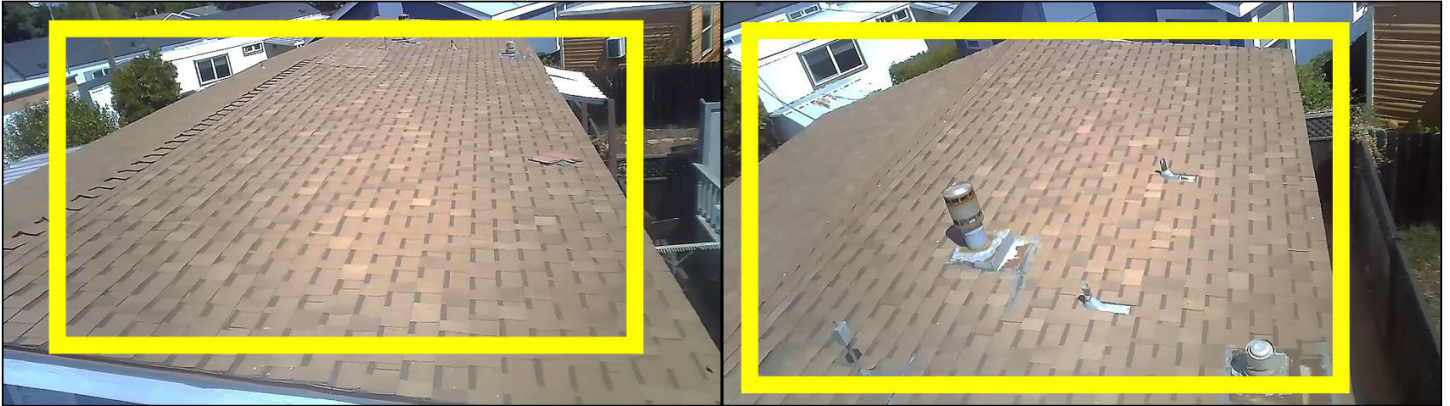
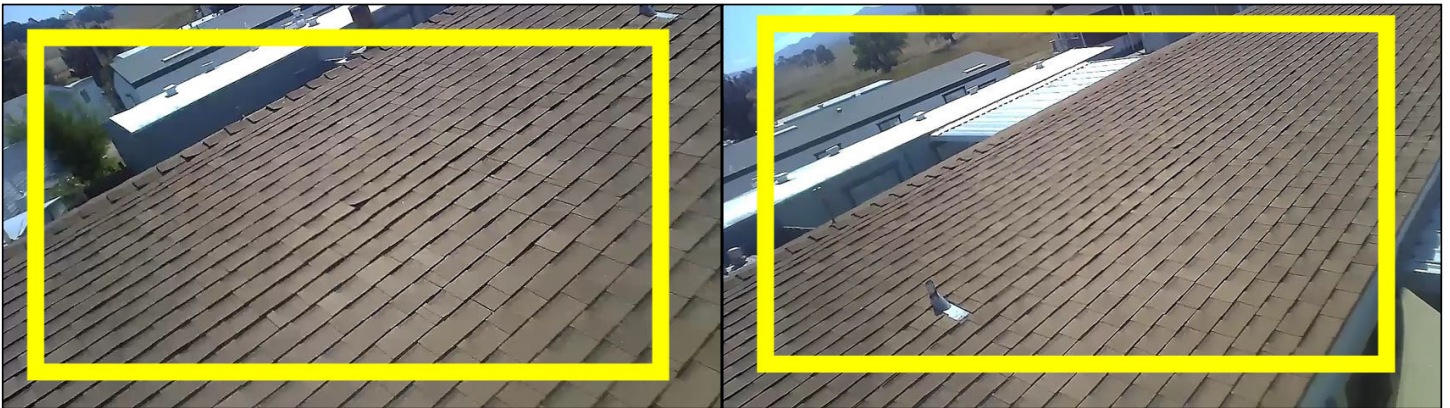
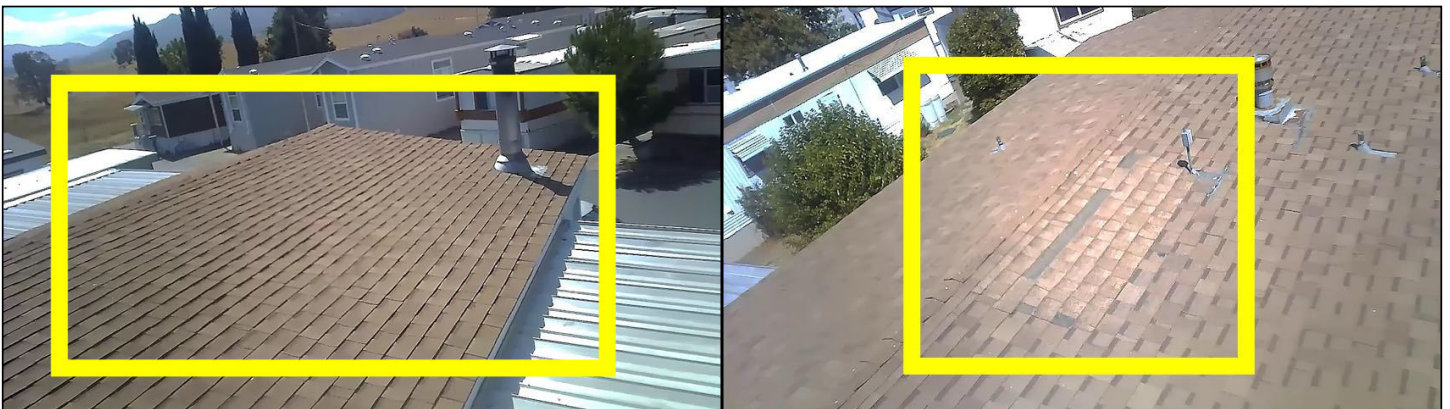
The roof had loose and/or missing shingles. The Inspector recommends replacement of any loose or missing shingles by a qualified roofing contractor to avoid damage from moisture intrusion.

The roof had loose and/or missing shingles.

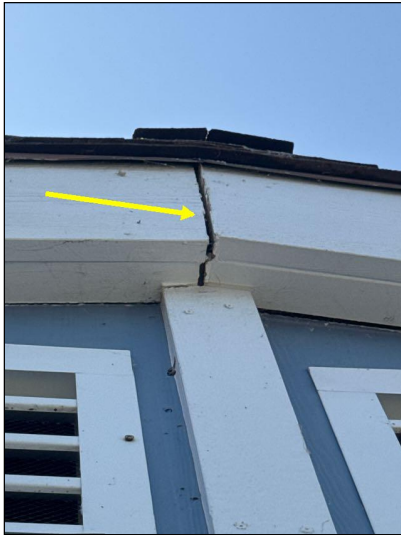
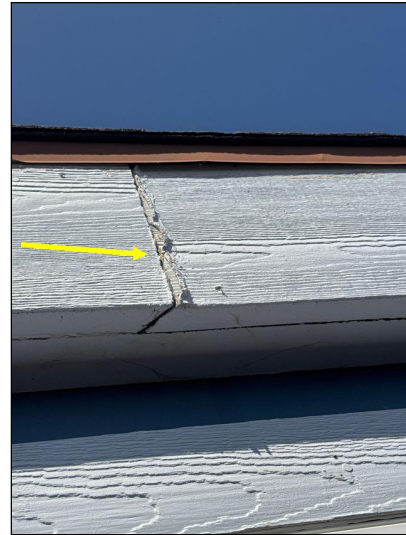
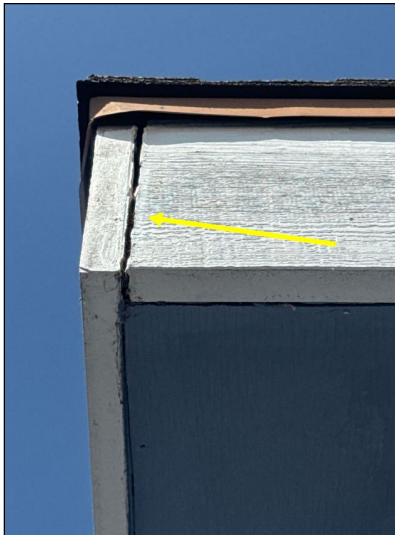
**Monitor:** Home fascia had opened at corners and splices. Recommend having these areas repaired and sealed to prevent moisture intrusion and wood decay.

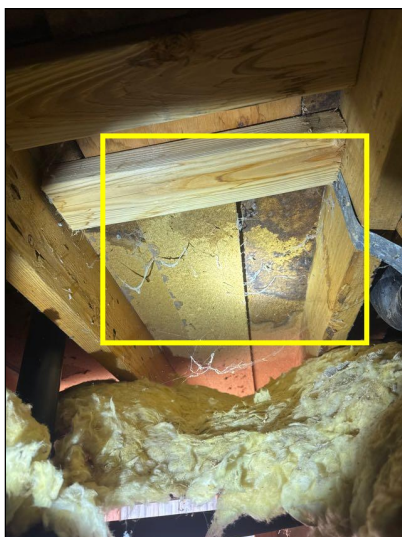
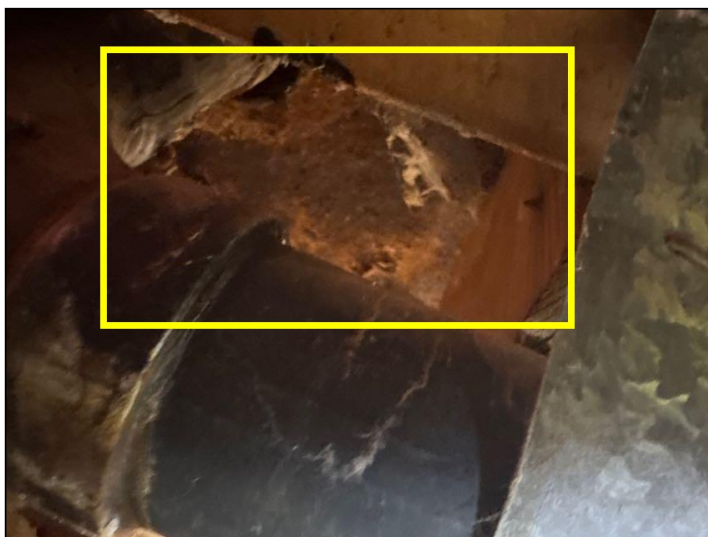
The sub floor had areas of localized advanced decay that appeared to be connected with plumbing fixture leakage. At the time of the inspection, the moisture meter showed no elevated moisture levels in framing at these areas, indicating that leaking plumbing fixtures have been repaired.

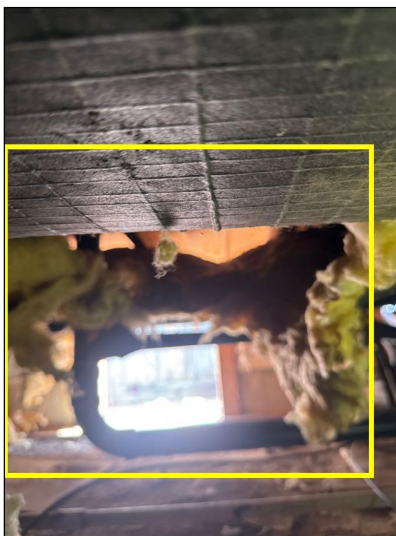
- The vapor barrier had areas of damage with loose or missing insulation. The vapor barrier (or belly wrap) is primarily used to block ground moisture from rising into the subfloor. This protective layer prevents wood rot, saturated insulation, pest infestations, and structural damage. The Inspector recommends that before the expiration of your Inspection Objection Deadline you consult with a qualified contractor to discuss options and costs for repair or replacement.

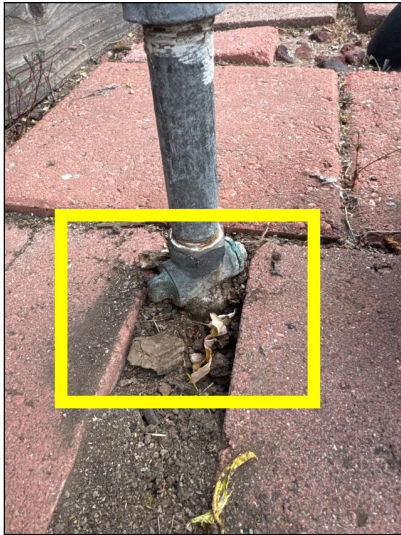
**Safety Improvement:** The main gas supply shut-off valve was difficult to access due to installed block patio.

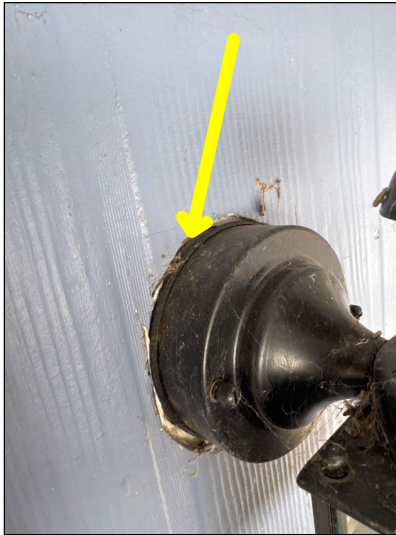
Some exterior lighting was loose to the wall and could expose electrical components to moisture intrusion. The inspector recommends all fixtures are properly fastened and sealed to the wall by a qualified electrical contractor.

Exterior lighting was loose/not flush to the wall and could expose electrical components to moisture intrusion. front door

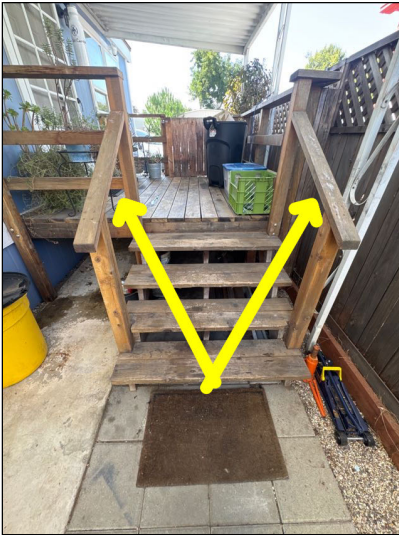
This staircase did not meet generally-accepted modern safety standards that specify the proper the size and dimensions of a grippable handrail.

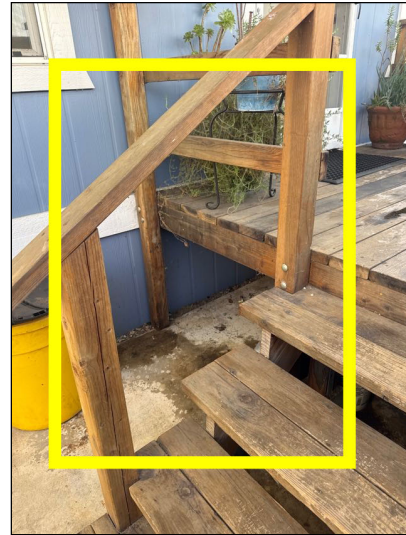
Spaces between handrail assembly balusters exceeded 4 3/8 inches at the open side of this exterior staircase.

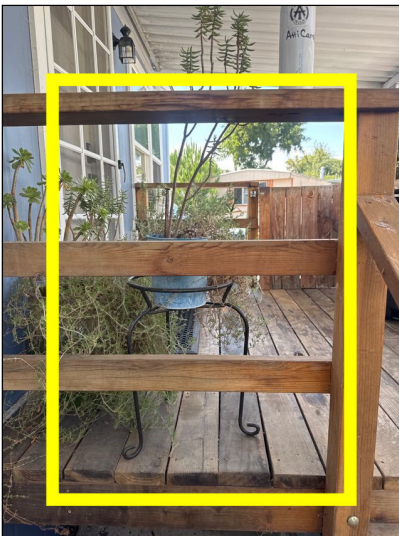
Spaces between deck guardrails balusters, beneath the guardrails or at the sides of the guardrails were too wide.

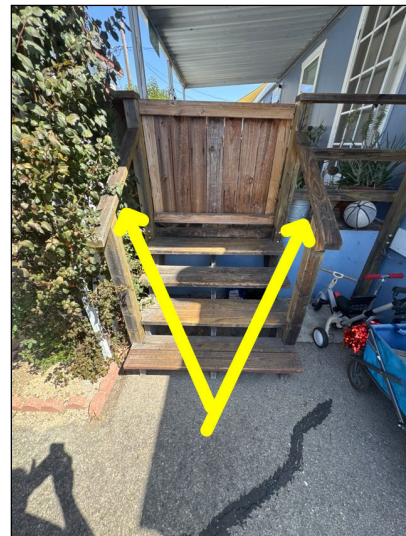
This staircase did not meet generally-accepted modern safety standards that specify the proper the size and dimensions of a grippable handrail.

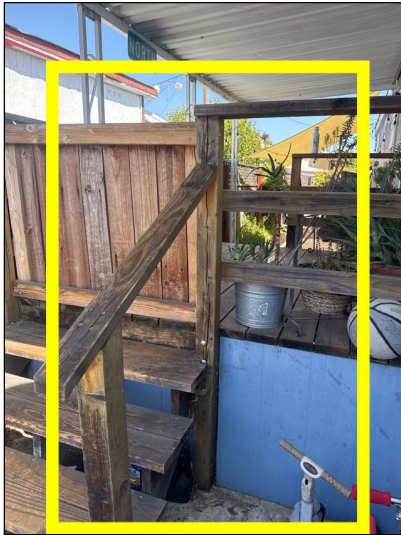
Spaces between handrail assembly balusters exceeded 4 3/8 inches at the open side of this exterior staircase.

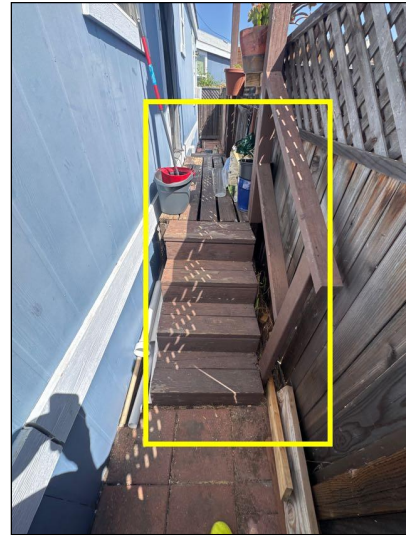
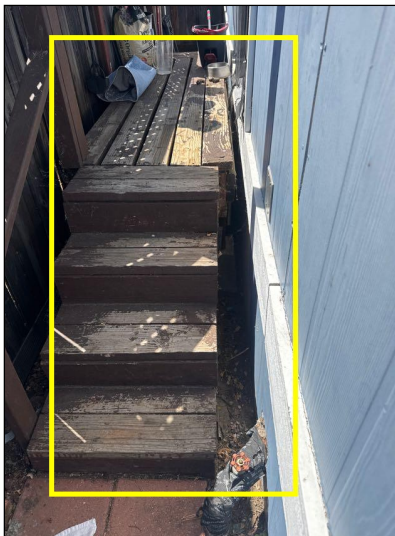
The rear stairs were old, damaged and appear unsafe. The Inspector recommends that before the expiration of your Inspection Objection Deadline you consult with a qualified contractor to discuss options and costs for replacement.

The rear stairs were old, damaged and appear unsafe.

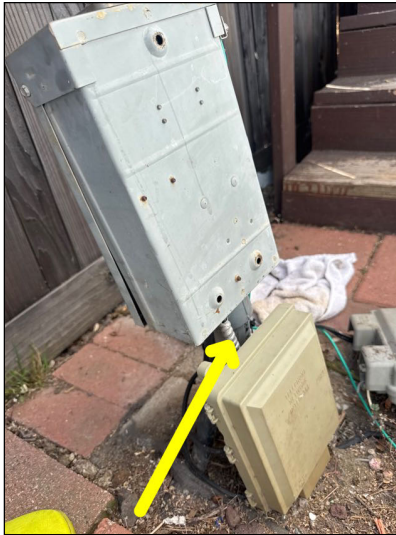
The electrical service pedestal panel cabinet was loosely mounted. It should be securely fastened to the mounting surface by a qualified electrical contractor.

The electrical service pedestal panel cabinet was loosely mounted.

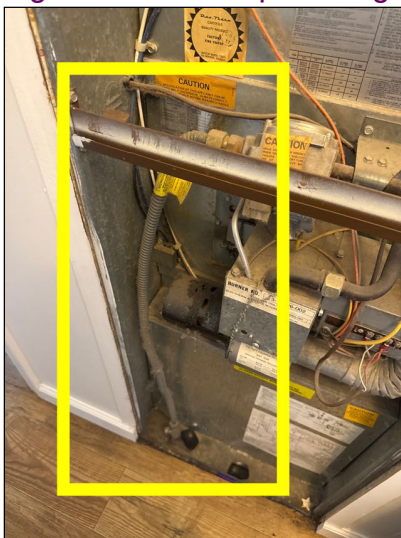
**Recommended Improvement:** The gas supply pipe contained no sediment trap. A sediment trap is generally recommended but not always required, depending on the local Authority Having Jurisdiction (AHJ). The purpose of a sediment trap is to prevent sediment or debris particulates from entering and clogging the heaters gas valve, which can cause the heater to shut down. You may wish to consult with local contractor concerning the advisability of installing a sediment trap in the gas line.

**Improvement:** The gas supply pipe contained no sediment trap.

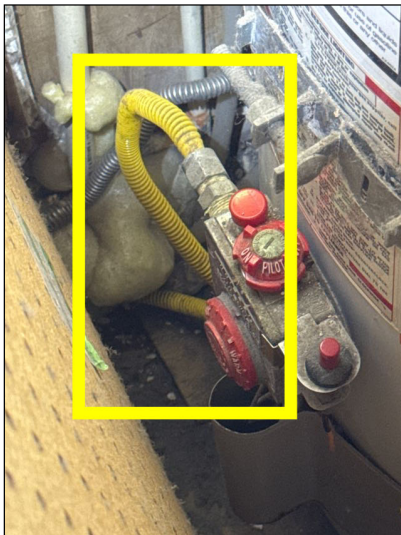
**Recommended Improvement:** The gas supply pipe contained no sediment trap. The purpose of a sediment trap is to prevent sediment or debris particulates from entering and clogging the water heater gas valve, which can cause the water heater to shut down. You may wish to consult with local contractor concerning the advisability of installing a sediment trap in the gas line.

**Improvement:** The gas supply pipe contained no sediment trap.

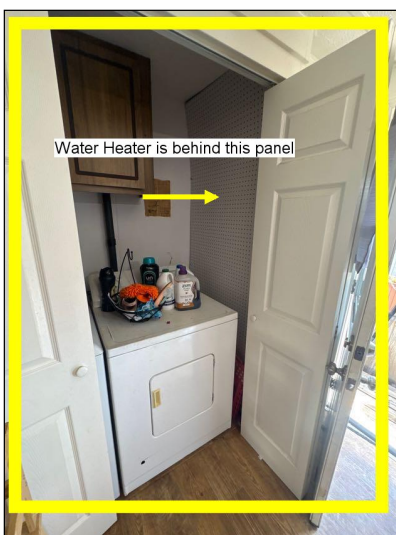
The **combustion air** supply for this water heater appeared to be insufficient when the laundry closet door are closed at the time of the inspection. Insufficient combustion air may cause incomplete combustion which can produce excessive amounts of invisible, odorless, tasteless, toxic gases like carbon monoxide. It can also cause backdrafting. "Backdrafting" is a condition in which the invisible, odorless, tasteless, toxic products of combustion from the water heater burner fail to exhaust to the home exterior, but because of lack of adequate replacement air. The inspector recommends provisions for adequate combustion air be provided, such as adding vents in the exterior door of the water heater closet. You should consult with a qualified contractor before the expiration of your Inspection Objection Deadline to discuss options and costs for correction.

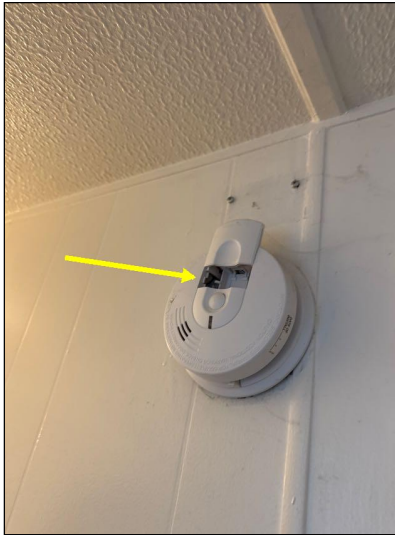
The smoke detectors did not operate during the inspection. Batteries may need to be replaced. The Inspector recommends that you have this done and test again for functionality.

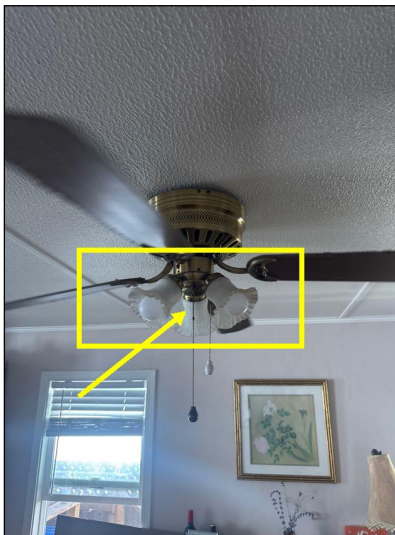
• **Monitor:** The ceiling fan light fixture in the did not respond to the switch or the pull chain. The bulb may need to be replaced or there may be a problem with the switch, wiring or light fixture. If after the bulb is replaced this light still fails to respond to the switch, this condition may be a potential fire hazard and the Inspector recommends that an evaluation and any necessary repairs be performed by a qualified electrical contractor.

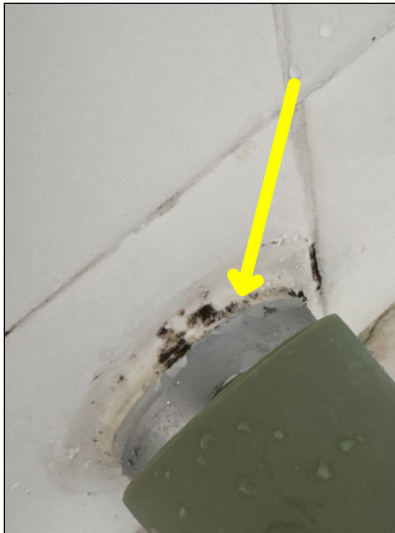
Sealant at the tub/shower was old and had visible discoloration consistent with microbial growth such as mold. The Inspector recommends that this sealant be removed and replaced to help prevent the development of unhealthy conditions.

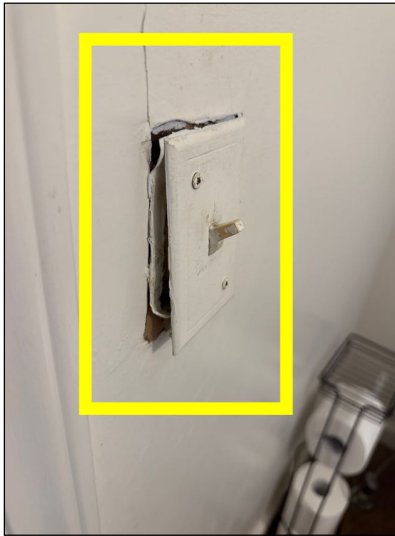
- At the time of the inspection, the Inspector observed no deficiencies in the condition or operation of the light fixture.
- **Light switch receptacle was loose. This condition should be corrected by a qualified electrical contractor.**
