## Inspection Services

### *Inspection Report*

Address: 4582 Via Santa Maria Santa Maria, CA 93455

09/16/2026

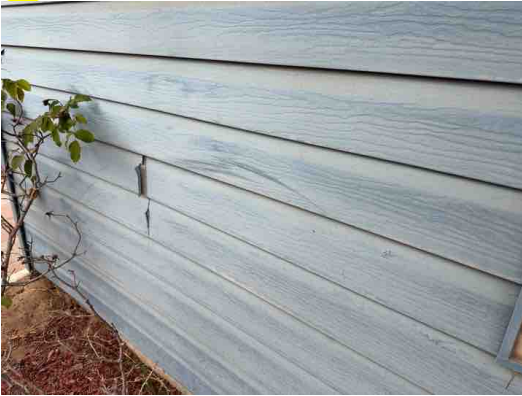
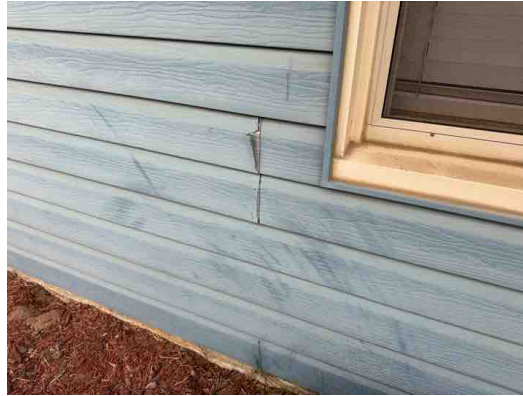
**MR 34:** Deteriorated paint at areas of the exterior.

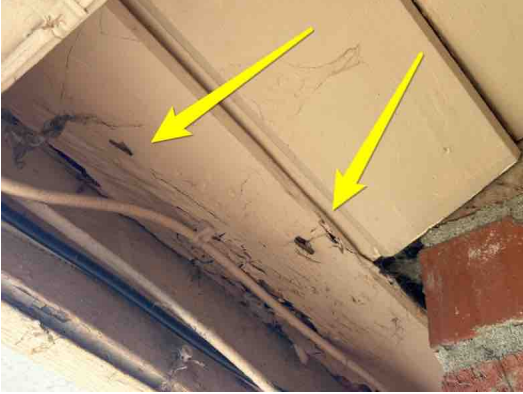
**E&C 38:** Some moisture and/or bug type damage & deterioration found at exterior areas such as eaves, fascia and/or trim. Refer to the termite report for locations and extent.

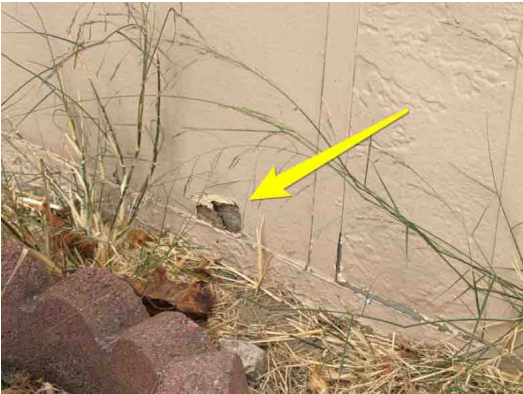
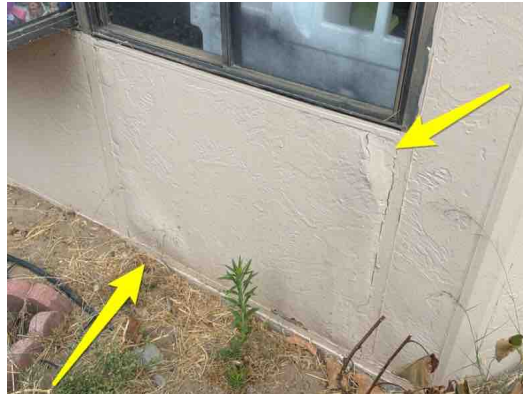
**E&C 39:** The wood fiber composite siding panels at the sun room found damaged and deteriorated. Repairs or replacement recommended.

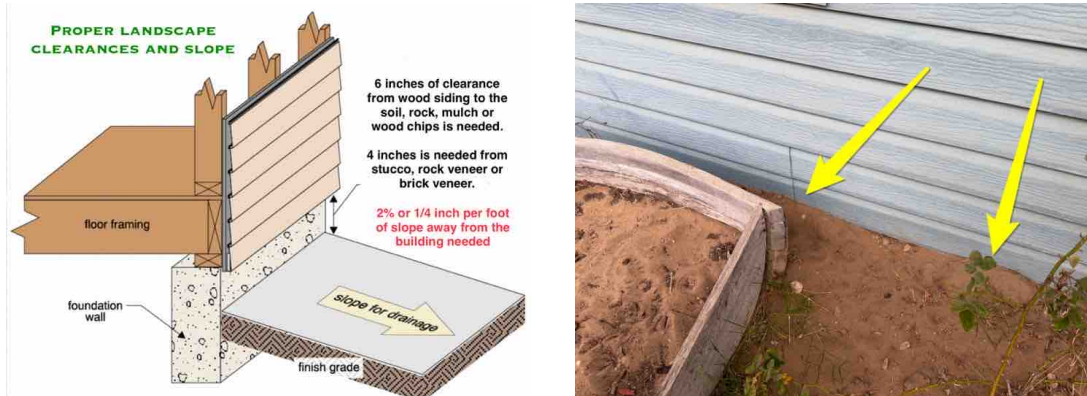
**MR 43:** Soil level found high along areas of the perimeter of the foundation and exterior siding (recommend 6 inches from the bottom of the exterior siding to dirt, rock, mulch or wood chips).

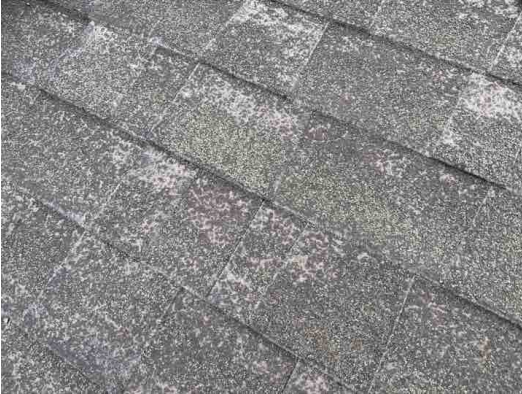
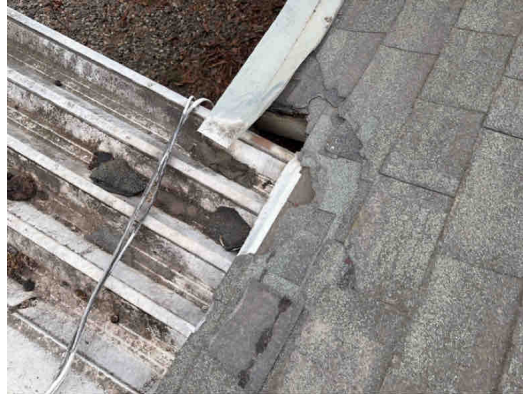
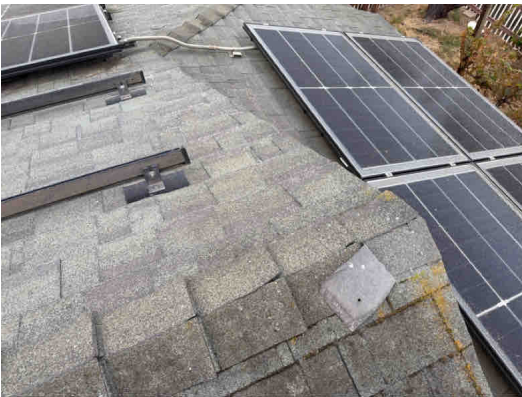
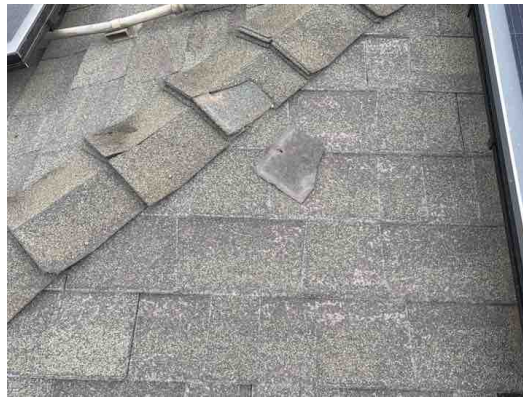
**There is Approx. 25-30 +/- years of visible wear at areas of the roof.**

**E&C DS 51:** **ROOF CONDITION:** Roof is at the end of its life expectancy. Recommend contacting a licensed roofing contractor for a price / proposal for replacement.

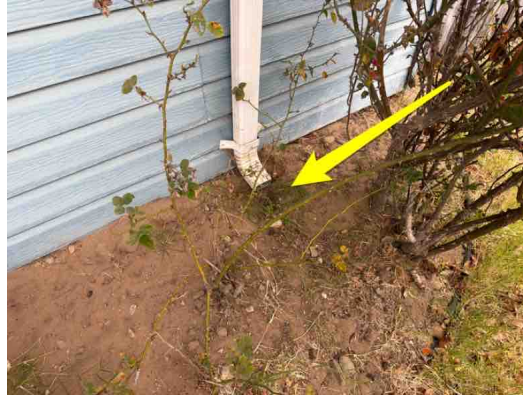
**MR 55:** Recommend splash blocks at the bottom of some rainwater downspouts to assist in proper flow of roof water away from the house and to help prevent soil erosion where not installed.

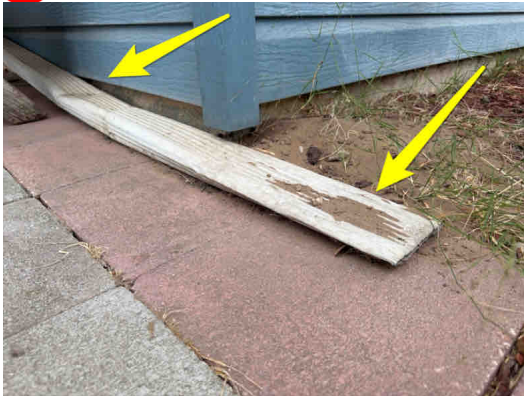
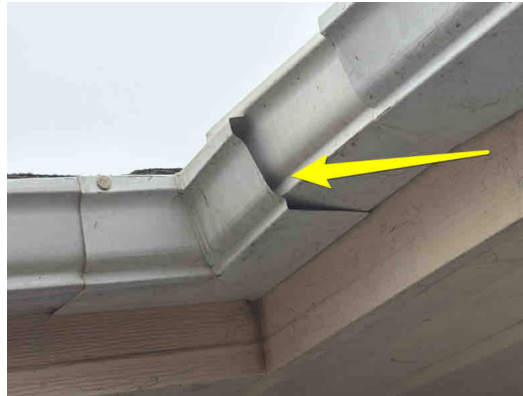
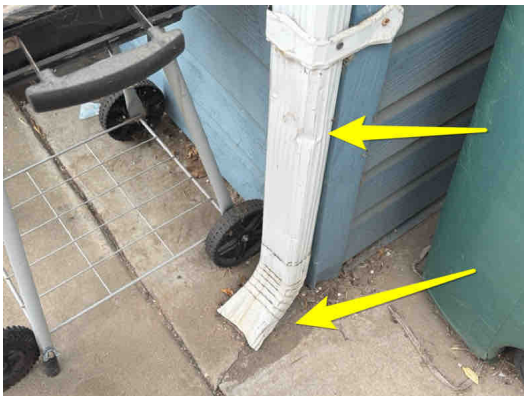
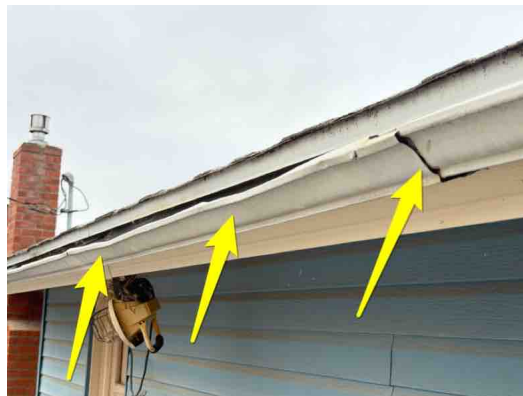
**E&C 56:** Disclosure: Areas of the rain gutters and downspouts found dented or damaged.

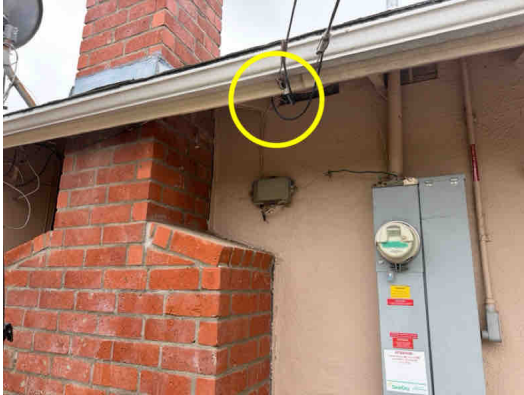
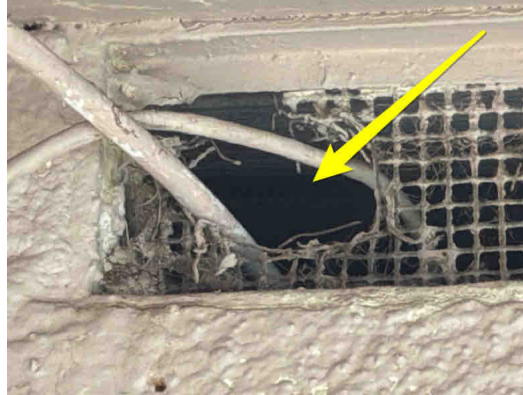
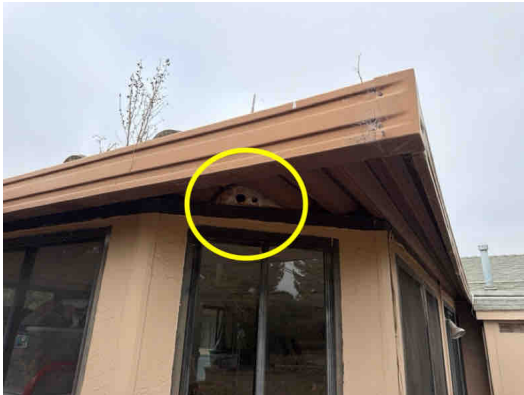
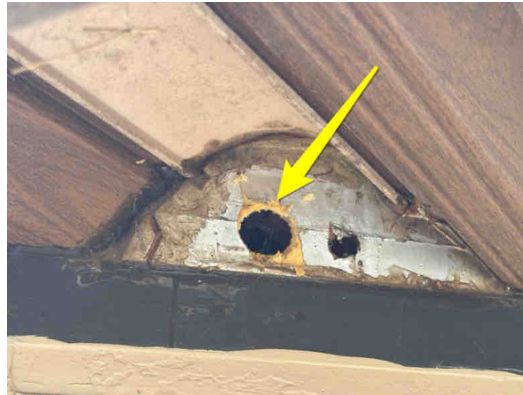
**E&C MR 65:** Some damaged or missing attic eave vent screens on areas of the exterior at the roof overhangs. Repair or replacement of the damaged or missing vent screens is recommended to help prevent critter intrusion into attic areas.

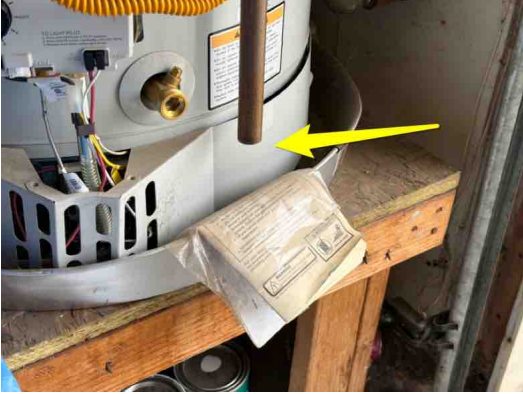
**SC 83:** The Water heater TPR (temperature pressure relief) pipe improperly terminates. Must terminate downward at the exterior at 6 to 24 inches from the ground.

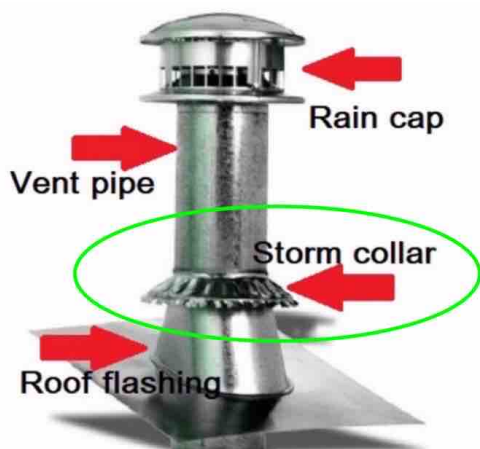
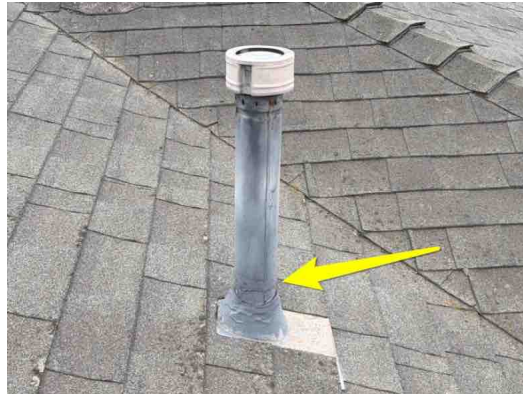
**E&C 84:** Missing / Recommend a proper storm collar per standards at the water heater vent pipe at the roof termination.

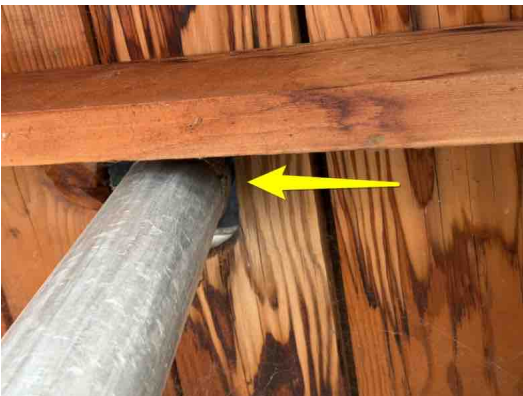
**SC 85:** Water heater vent pipe too close to combustibles through roof framing. The minimum of 1-inch clearance is required to any wood or drywall.

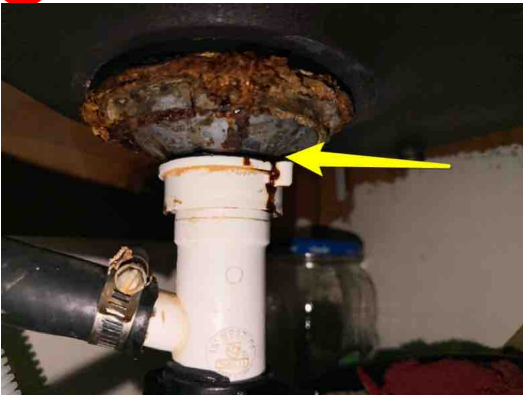
**E&C 102:** Active leak noted at the Kitchen sink drain lines.

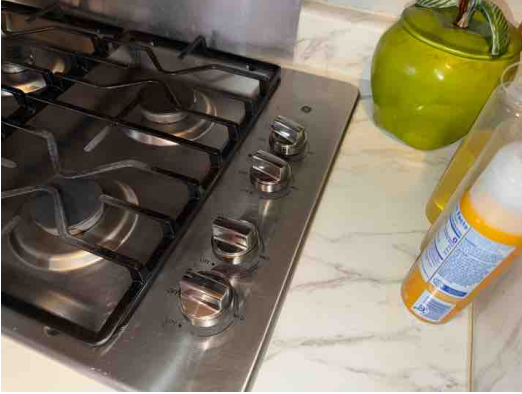
**SC** 109: Damaged / Deteriorated knobs at cook top.

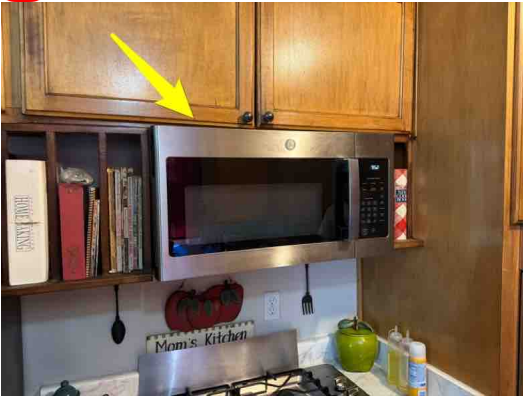
**E&C 118:** The kitchen Microwave found out of level.

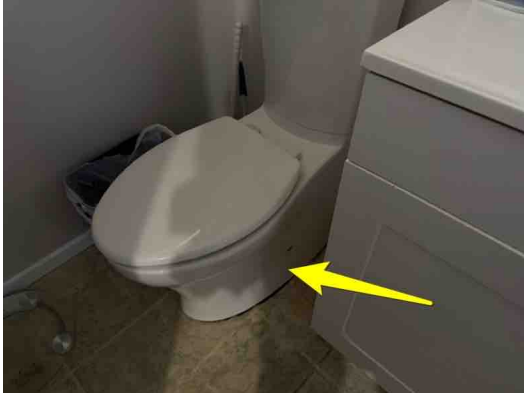
**E&C 123:** Toilet loose at floor: PRIMARY BEDROOM BATHROOM

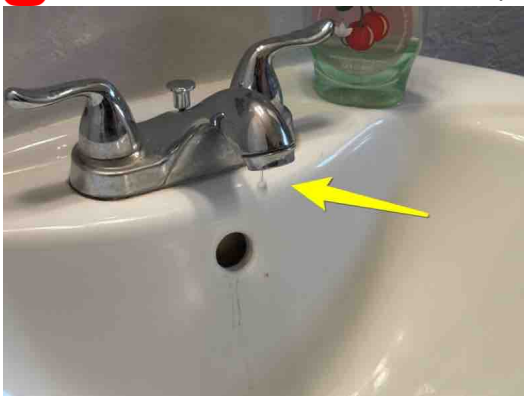
**E&C 127:** Bathroom sink faucet leaks / drips continuously: HALLWAY BATHROOM

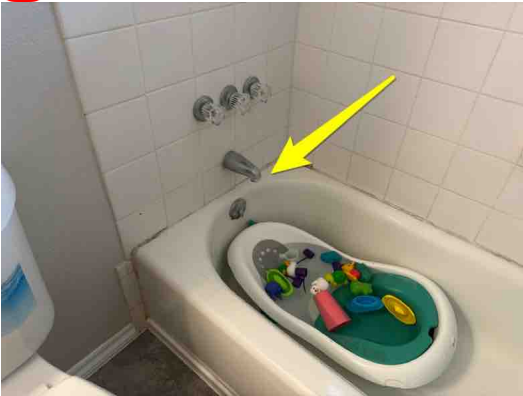
**E&C 130:** Tub faucet leaks and drips from spout continually: HALLWAY BATHROOM

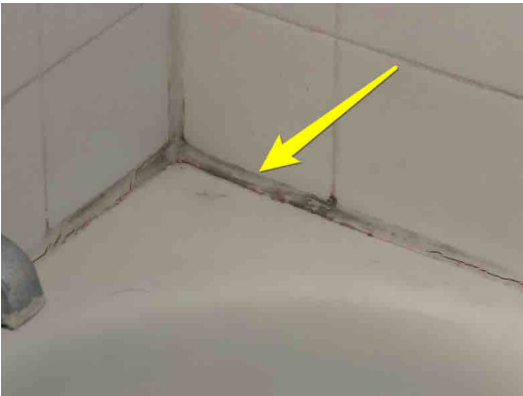
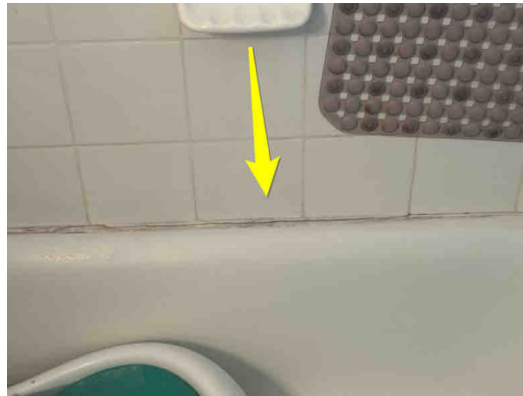
**UPG 132:** Deteriorated and or moldy grout found in the HALLWAY BATHROOM shower enclosure. Some general maintenance and/or upgrades are recommended.

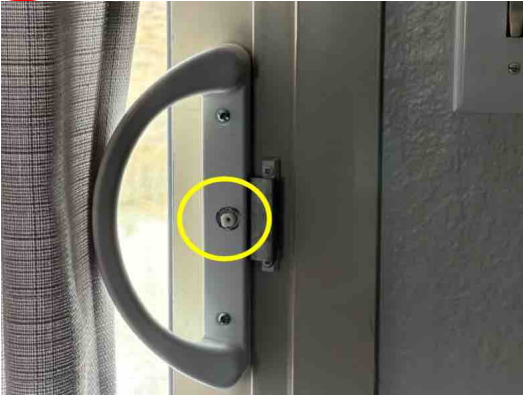
**SC** **140:** The door locking hardware found non-operational at the: LAUNDRY ROOM exterior sliding glass door.

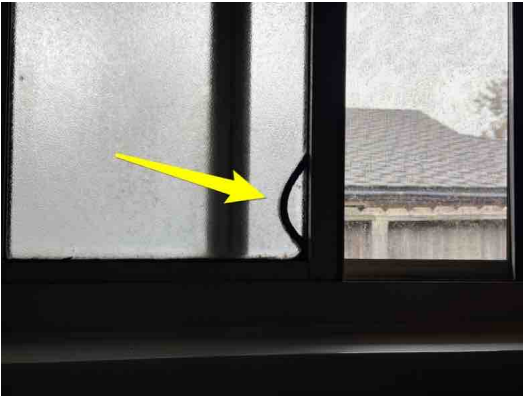
**DS 147:** Loose rubber window gasket found at some windows. Client should contact a window professional for additional comments and/or recommendation if concerned.

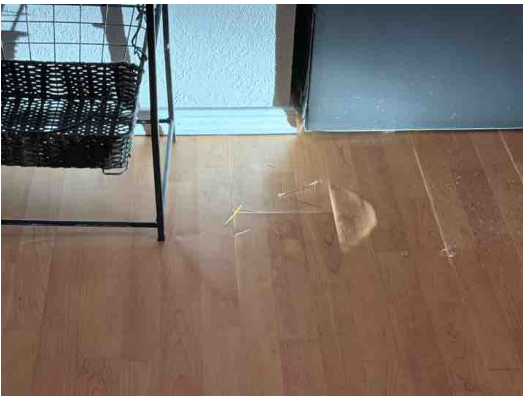
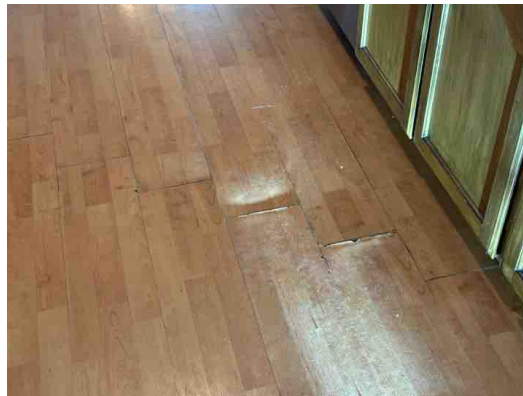
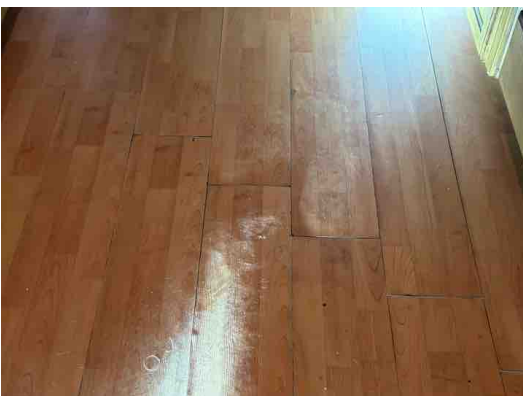
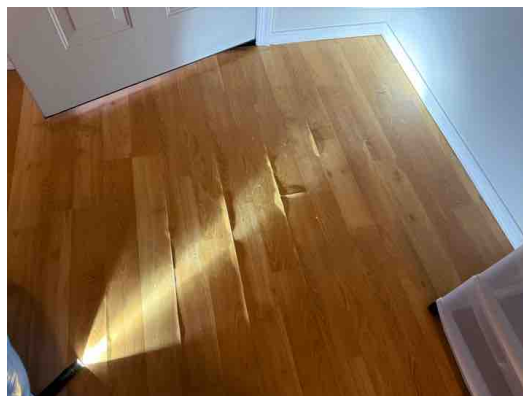
**E&C FI 151:** Evidence of past moisture stains and/ or damage at the flooring: MULTIPLE LOCATIONS THROUGHOUT. Recommend further review of the water stains to determine the cause, the current condition and if repairs are needed.

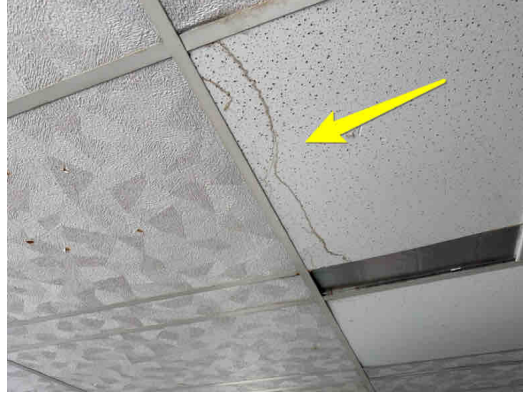
**FI 163:** Evidence of past moisture stains & damage at ceiling area in the SUNROOM. Recommend further review of the water stains to determine the cause, the current condition and if repairs are needed.

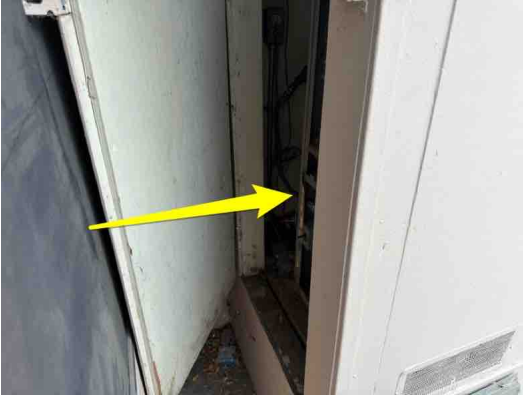
**UPG** 166: Missing the required 30" of clearances in front of the furnace per minimum installation standards. [CMC 304]

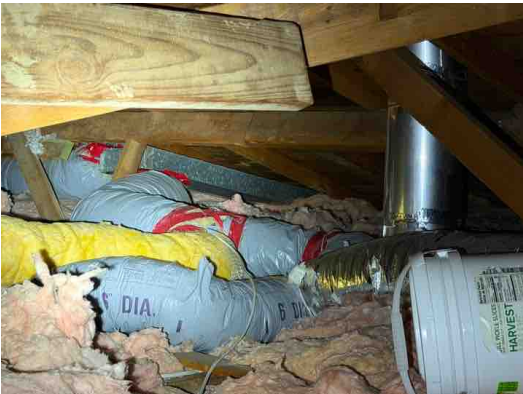
**171:** The heating/air distribution ducting in the attic appears to be improperly installed and includes numerous deficiencies, including questionable duct sizing/transitions, poor connections and support, and generally non-professional installation. The system was also observed to have poor airflow/performance. Due to the number and extent of defects, individual deficiencies are not listed. Recommend further evaluation of the entire duct system and necessary repairs or replacement by a licensed HVAC contractor.

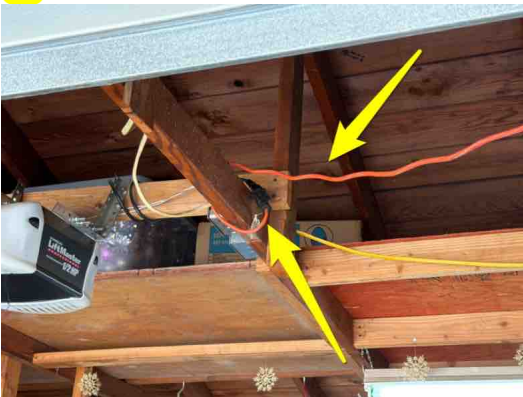
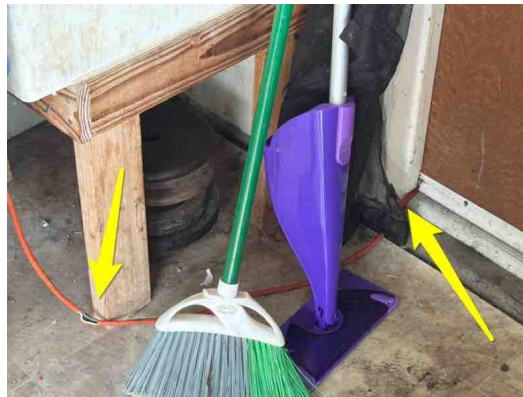
**SU 183:** Extension cord improperly used as permanent electrical wiring at the garage vehicle door opener.

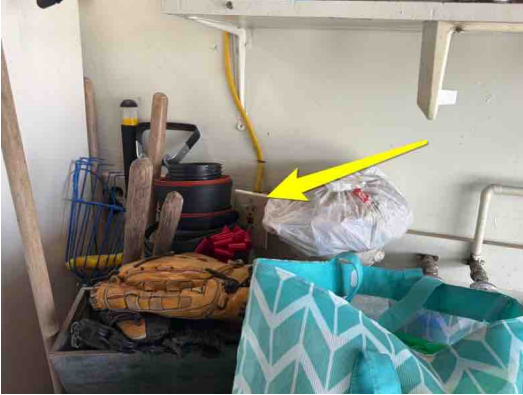
**E&C 187:** A GFCI receptacle in the garage was found tripped and would not reset when tested. Receptacles downstream of this GFCI were non-operational as a result. Recommend evaluation and repair by a qualified electrician to restore proper operation and GFCI protection.

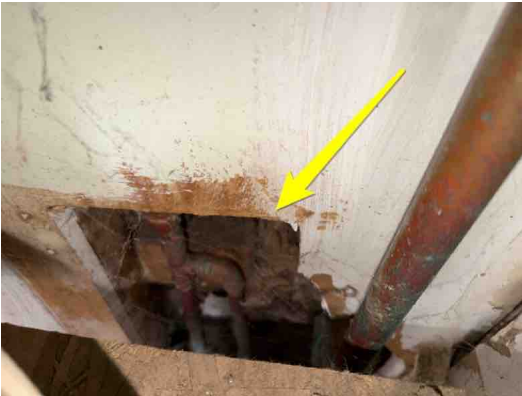
**SC FI 197:** Some holes or openings found in the garage firewall. Corrections are warranted for fire safety. Contact an appropriate contractor to review the entire garage repair as needed.

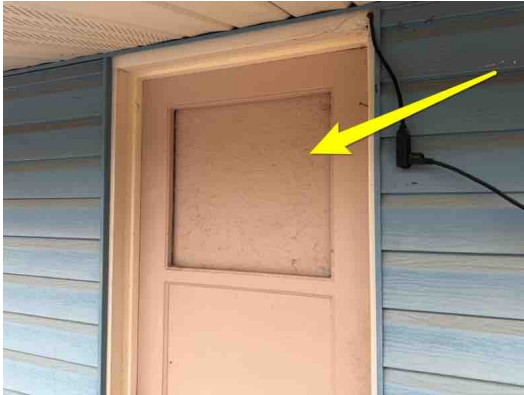
**E&C 199:** The glass at the garage exterior pedestrian door was damaged/missing and has been replaced with a piece of OSB plywood. This is not a suitable permanent replacement and may provide reduced weather resistance and security. Recommend proper repair of the door and replacement of the damaged/missing glazing by a qualified contractor.

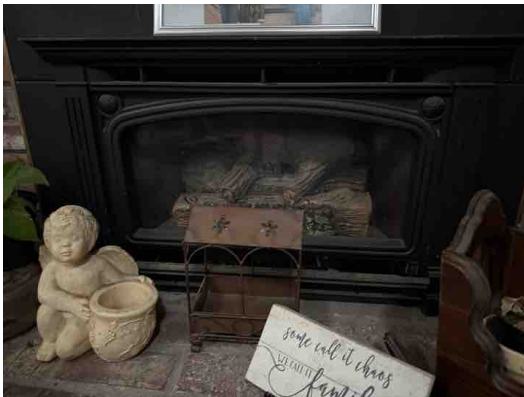
**E&C** 209: **THE FIREPLACE CONDITION:** The **LIVING ROOM GAS** Fireplace did not operate when tested and found to be in need of servicing, maintenance and/or repair. Contact the Gas Company for a free evaluation or a qualified gas fireplace service technician to evaluate and correct as needed.

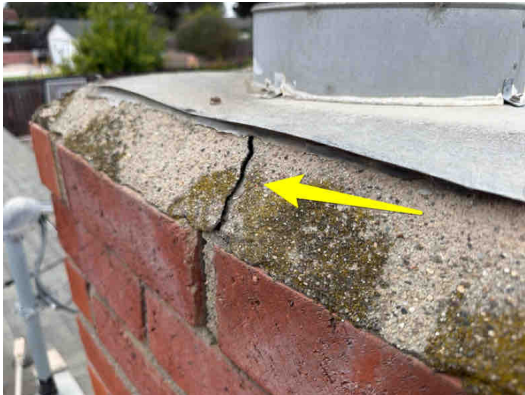
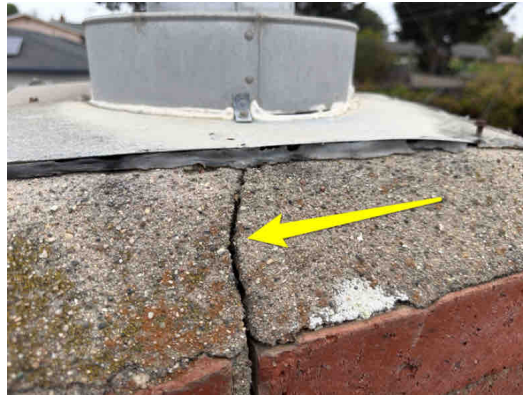
**MR 211:** Heavily deteriorated mortar crown located at the top of the LIVING ROOM fireplace chimney. Maintenance / repairs recommended to help prevent water intrusion into the confined spaces within the masonry chimney.
