# - INSPECTION REPORT -

**CHRIS RIPPY INSPECTIONS**

**1040 Trailview Ln, Corona, CA 92881, USA**  
**Inspection prepared for: Bill Williamson**  
**Real Estate Agent: Lisa Broder - Think Boutiq Real Estate**

**Date of Inspection: 8-24-2026**

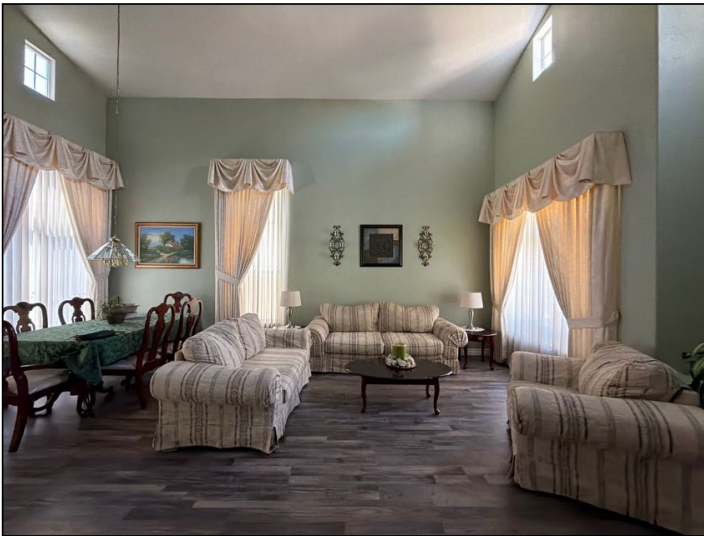
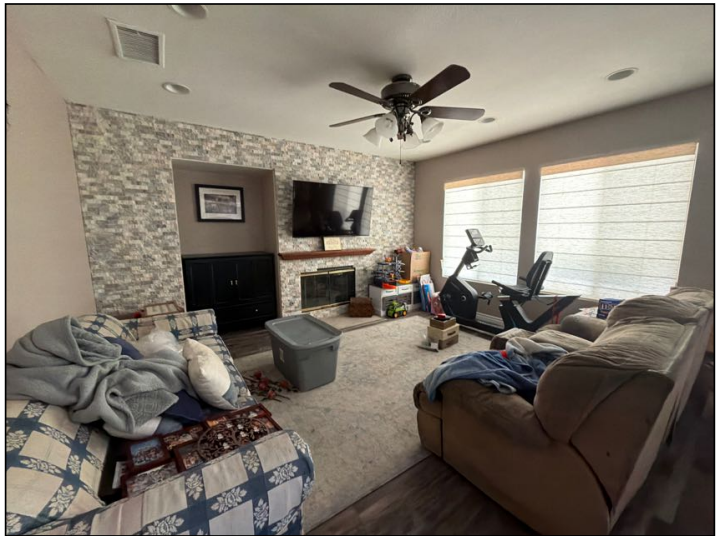
1.2. Areas appeared to have been recently painted. This may conceal underlying conditions that were not visible at the time of inspection.

1.3. Cosmetic irregularities and/or imperfections were observed. These appear to be aesthetic in nature and do not affect the functionality of the component.

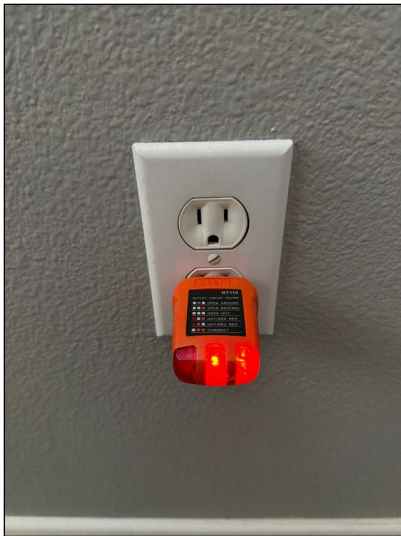
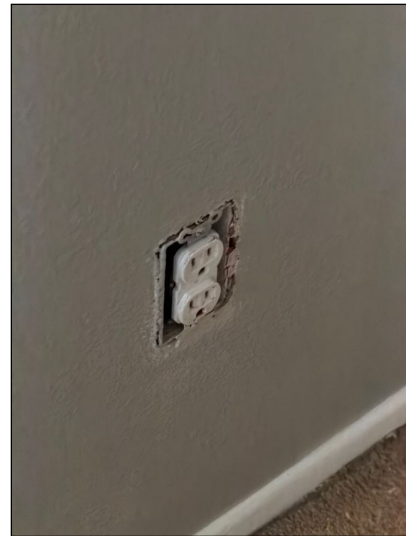
9.3. Missing cover plates observed, suggest installing for safety.

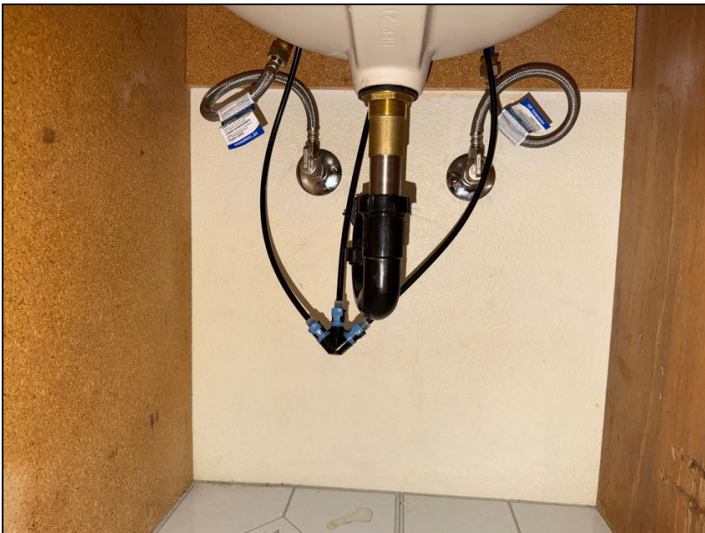
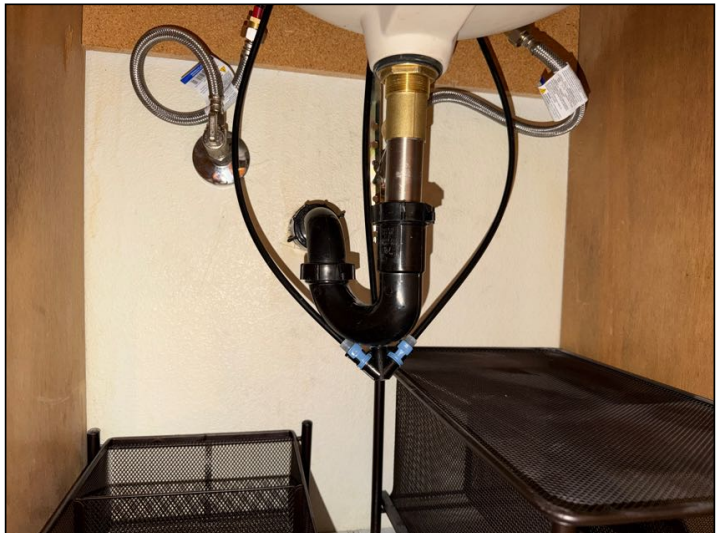
12.2. Older shutoff valves, recommend upgrading to 1/4 turn supply valves.

12.3. Flex drain observed, these are subject to frequent clogging.

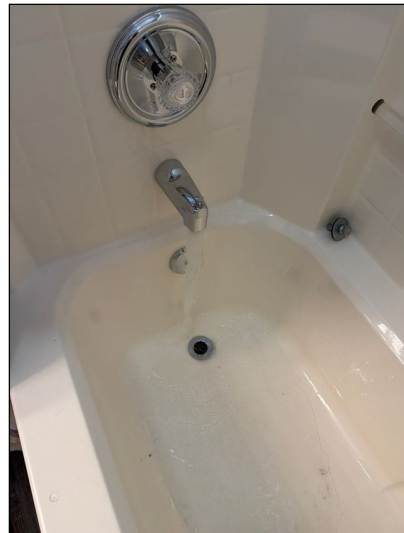
| Page 22 Item: 13 | Bath Tubs | 13.2. Bathtub: Chipping was observed along the upper edge/rim of the bathtub near the entry area. Recommend repair or refinishing as needed to prevent further deterioration. Downstairs bathroom. |

13.2. Bathtub: Chipping was observed along the upper edge/rim of the bathtub near the entry area. Recommend repair or refinishing as needed to prevent further deterioration. Downstairs bathroom.

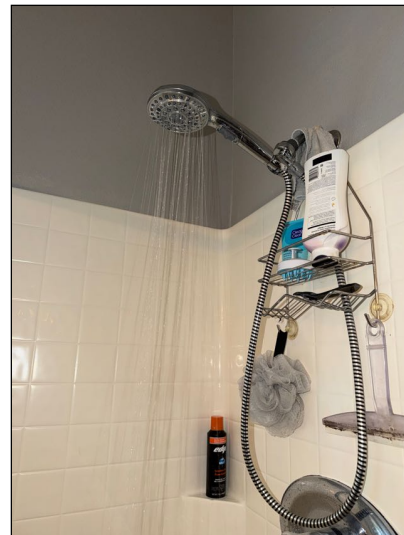
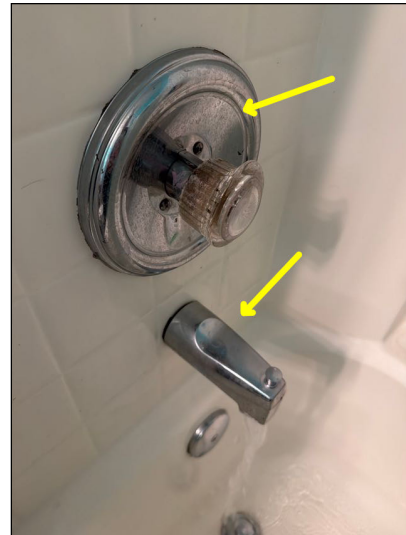
14.4. Loose escutcheon plates noted. These should be refastened and caulked to keep water from infiltrating the walls. Primary shower

14.5. Visible chipping was observed along portions of the glass shower enclosure. Recommend repair or replacement of the affected glass as needed to prevent further damage and maintain safe use. Primary

Loose

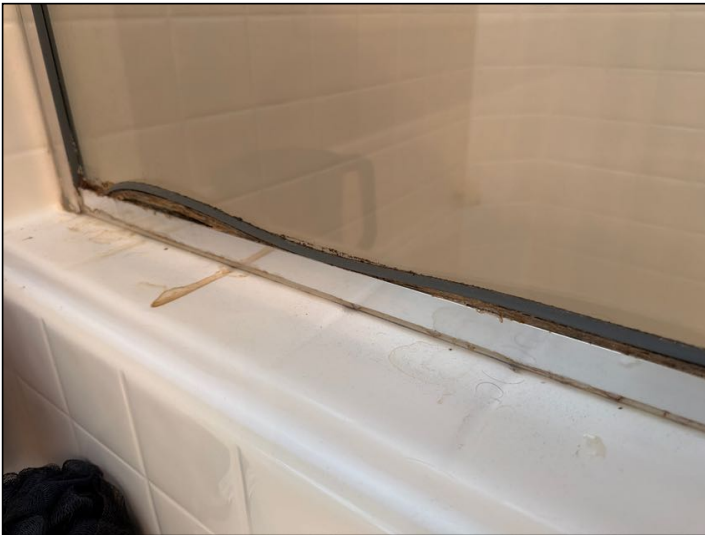
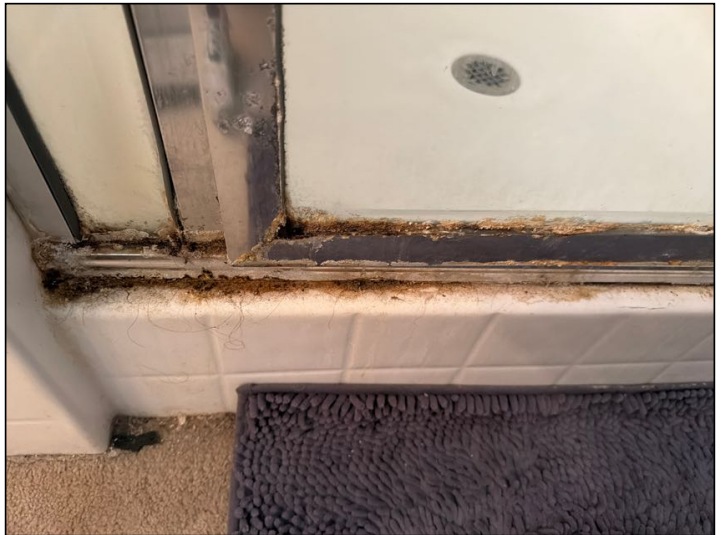
| Page 24 Item: 15 | Enclosure | 15.2. Evidence of past leaking observed. Area tested dry at the time of the inspection. |

15.2. Evidence of past leaking observed. Area tested dry at the time of the inspection.

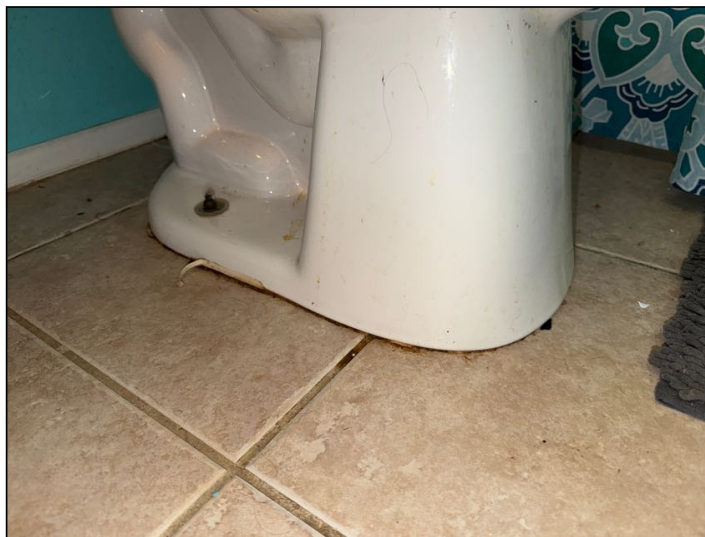
| Page 25 Item: 16 | Toilets | 16.4. Evidence of past or present leak observed. Recommend further evaluation by a licensed professional. See photo for location. Upstairs Hallway Bathroom |

16.4. Evidence of past or present leak observed. Recommend further evaluation by a licensed professional. See photo for location. Upstairs Hallway Bathroom

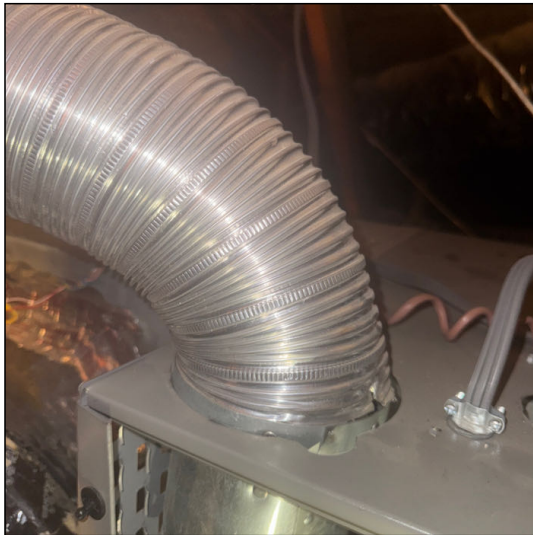
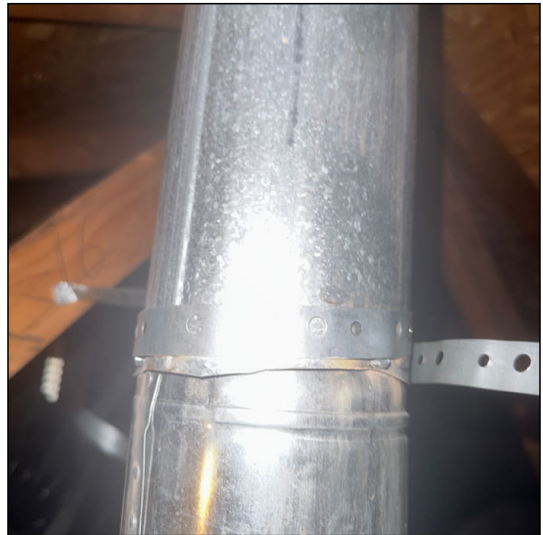
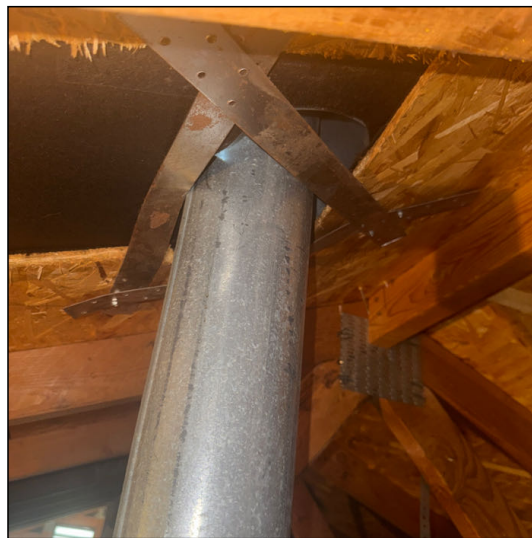
| Page 36 Item: 3 | Venting | 3.2. Recommend applying aluminum heat tape to all vent pipes. |

- 3.1. Venting materials: Metal double wall and flex tube vent pipe observed.

- 3.2. Recommend applying aluminum heat tape to all vent pipes.

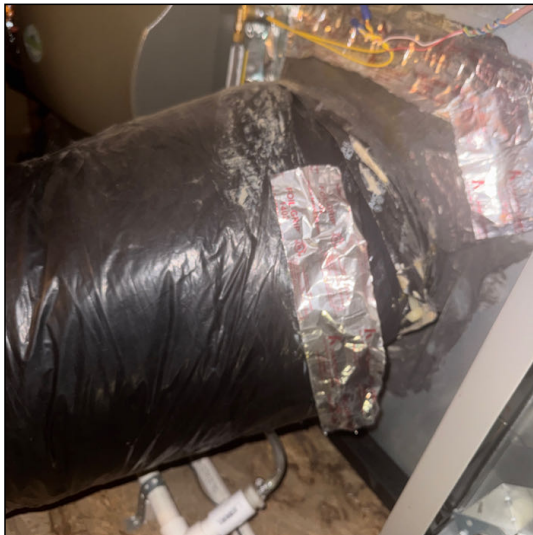
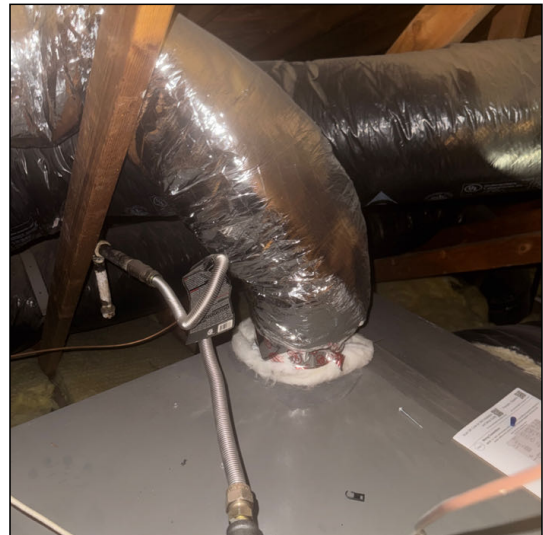
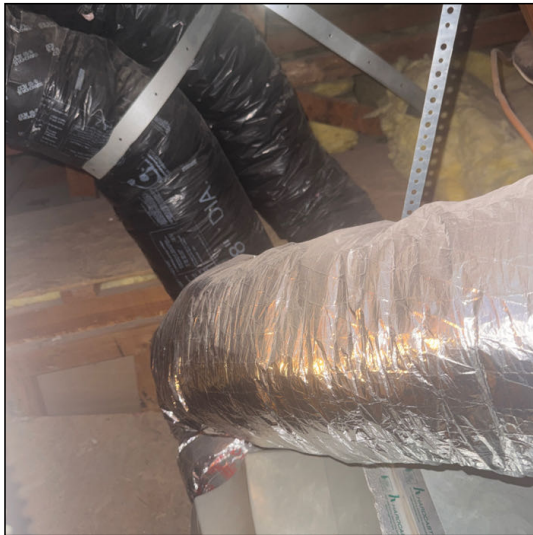
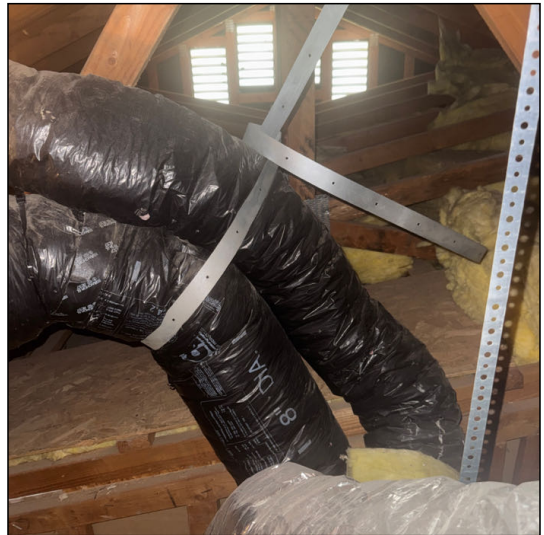
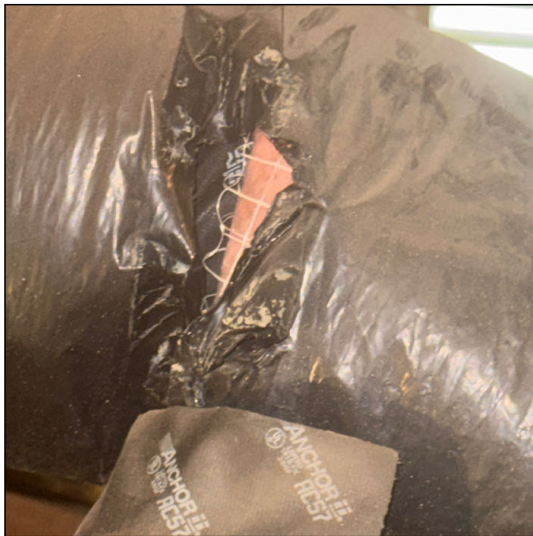
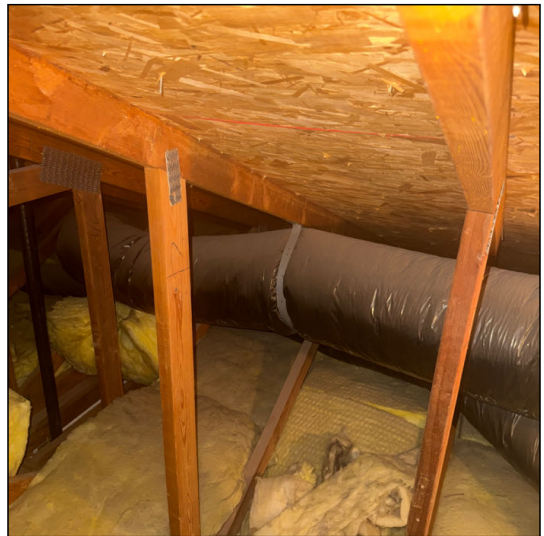
| Page 38 Item: 5 | HVAC Duct Work | 5.1. Torn outer bag insulation was observed at multiple HVAC ducts. Damaged duct insulation can reduce system efficiency and lead to condensation issues on duct surfaces. Recommend further evaluation and repair by a state licensed professional. |

5.1. Torn outer bag insulation was observed at multiple HVAC ducts. Damaged duct insulation can reduce system efficiency and lead to condensation issues on duct surfaces. Recommend further evaluation and repair by a state licensed professional.

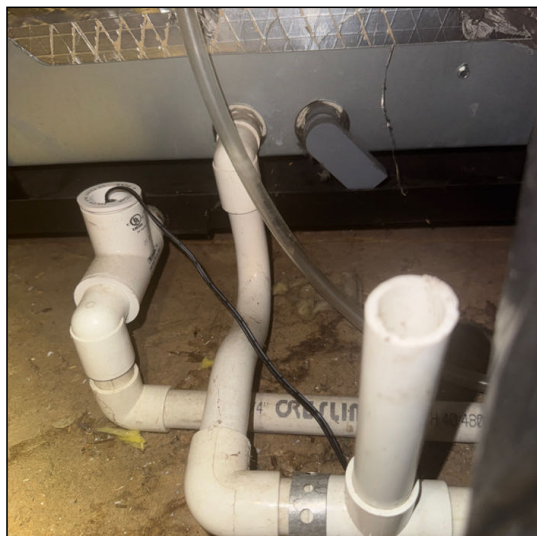
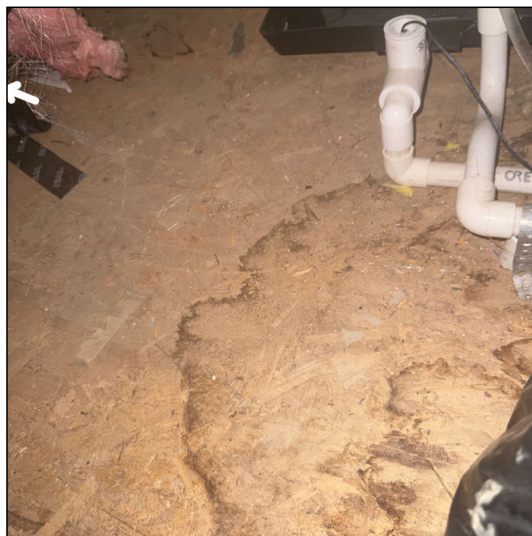
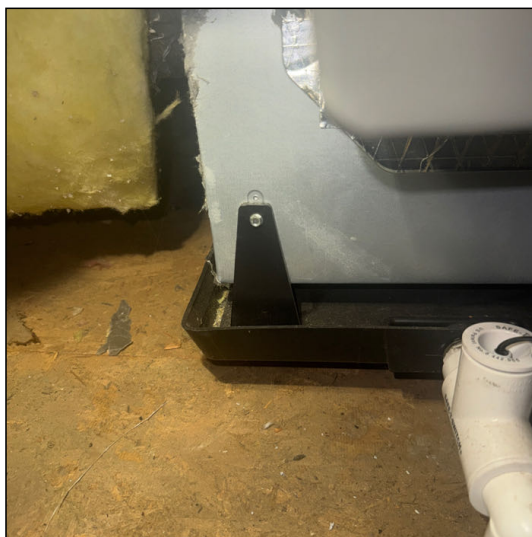
| Page 40 Item: 6 | Air Handler/EVAP Coil | 6.1. Evidence of previous leaking, likely from the condensate line or pan, was observed on the floor decking of the attic. Recommend further evaluation by a state licensed professional to confirm the source and assess for any resulting damage. |

6.1. Evidence of previous leaking, likely from the condensate line or pan, was observed on the floor decking of the attic. Recommend further evaluation by a state licensed professional to confirm the source and assess for any resulting damage.

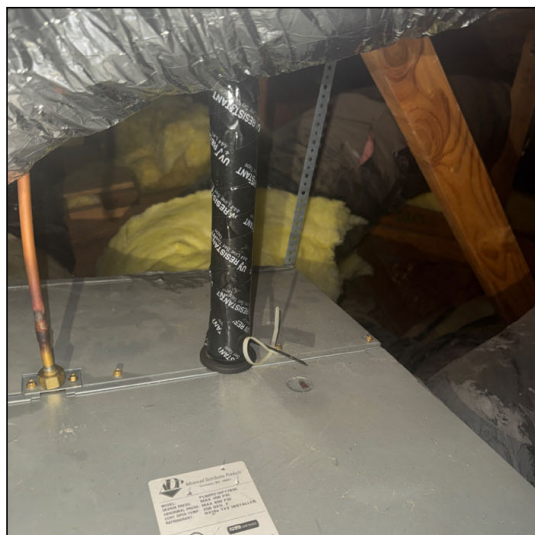
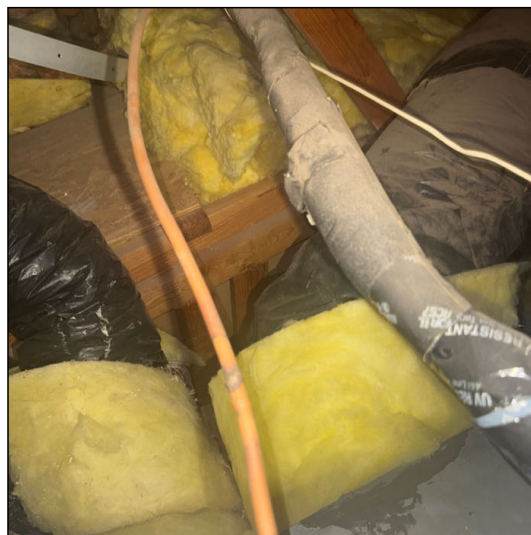
| Page 40 Item: 7 | Refrigerant Lines | 7.1. Deteriorated insulation at A/C unit. |

7.1. Deteriorated insulation at A/C unit.

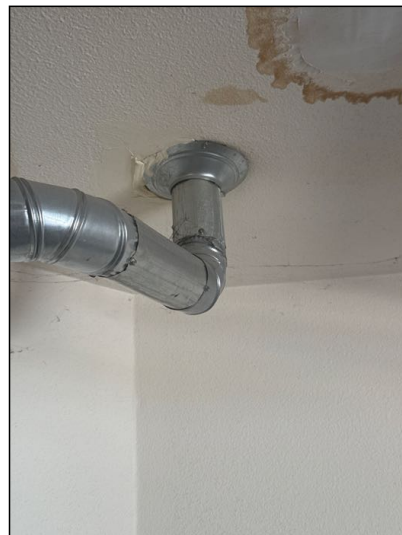
| Page 45 Item: 3 | Venting System | 3.2. Water Heater Vent Connector: Recommend sealing all accessible vent connector joints with UL-listed aluminum foil tape. Properly sealed joints help maintain the integrity of the venting system and reduce the potential for flue gas leakage. |

3.2. Water Heater Vent Connector: Recommend sealing all accessible vent connector joints with UL-listed aluminum foil tape. Properly sealed joints help maintain the integrity of the venting system and reduce the potential for flue gas leakage.

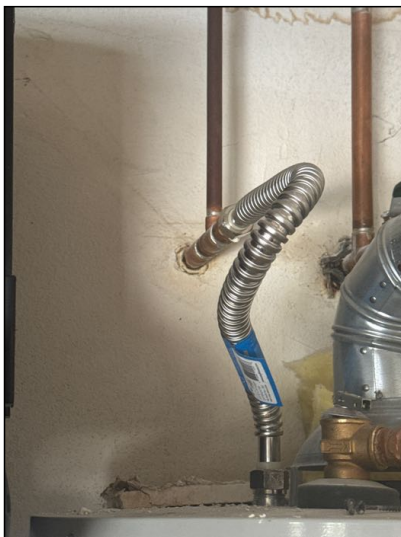
| Page 48 Item: 9 | Plumbing | 9.2. No expansion tank was observed at the time of inspection. Recommend checking local codes for requirement, and evaluation by a licensed plumber for installation as needed. |

9.2. No expansion tank was observed at the time of inspection. Recommend checking local codes for requirement, and evaluation by a licensed plumber for installation as needed.

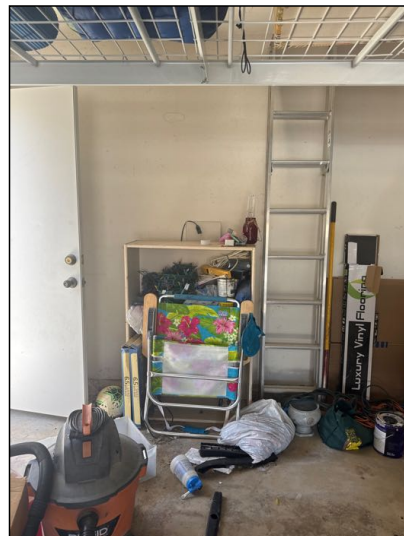
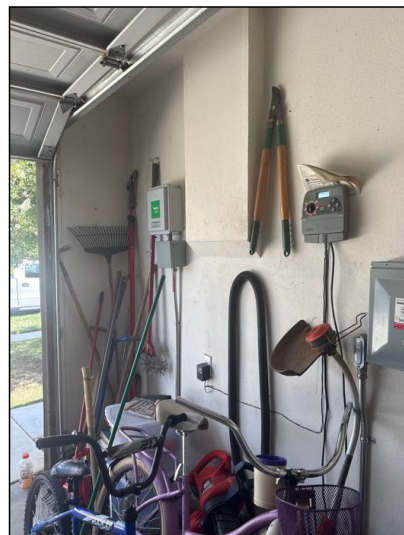
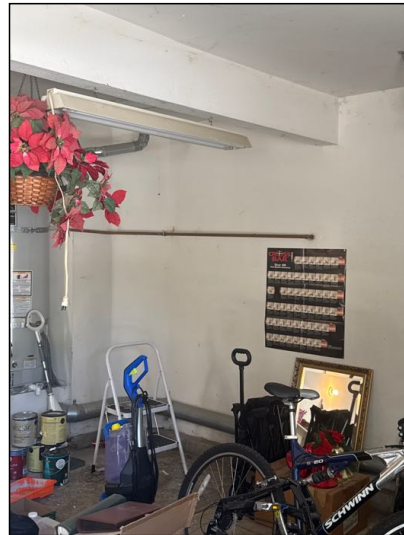
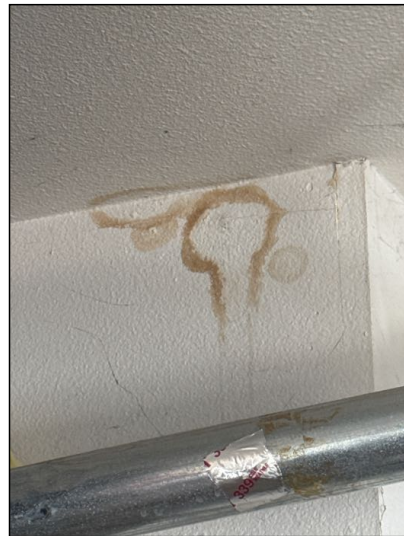
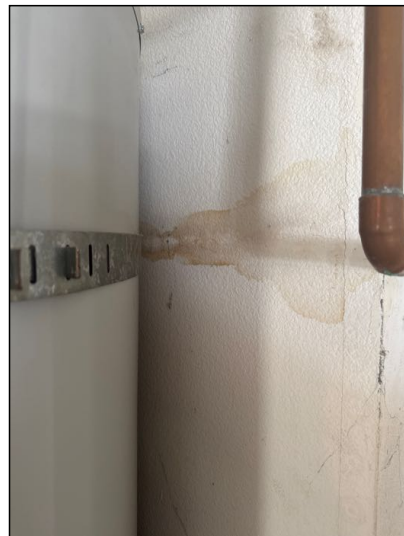
| Page 50 Item: 1 | Walls/Firewall | 1.3. Moisture staining was observed on the interior of the garage walls near the ceiling, in multiple areas, in the garage located below the second-story living space. This condition may indicate leakage from plumbing, HVAC condensate lines, or other sources within the floor assembly above. Recommend further evaluation and repair by a state licensed professional. |

**1.3. Moisture staining was observed on the interior of the garage walls near the ceiling, in multiple areas, in the garage located below the second-story living space. This condition may indicate leakage from plumbing, HVAC condensate lines, or other sources within the floor assembly above. Recommend further evaluation and repair by a state licensed professional.**

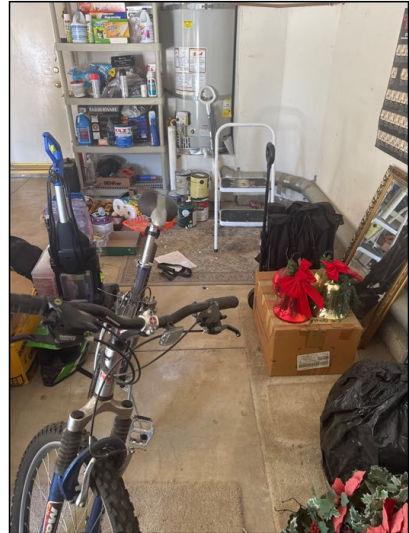
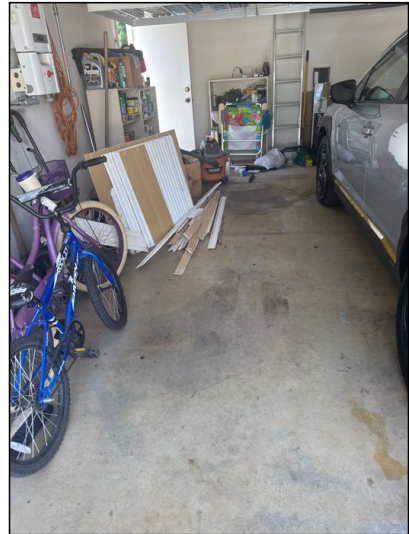
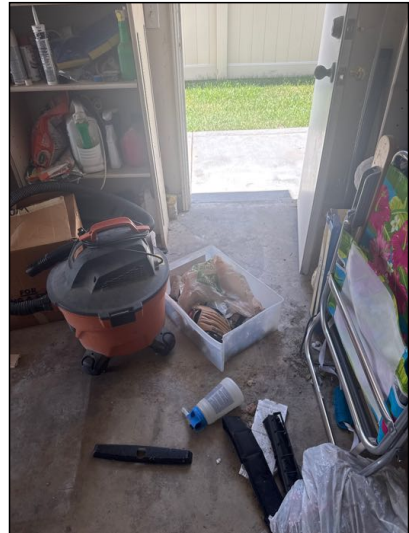
2.2. **Garage Floor:** Common cracks were observed in the garage floor. These appear consistent with normal shrinkage or settling and do not indicate a structural concern at this time. Monitoring for expansion or movement is recommended.

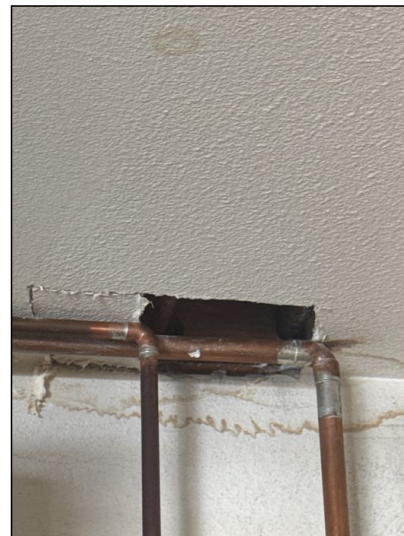
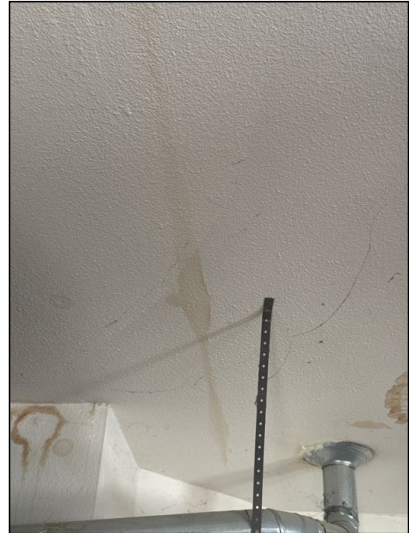
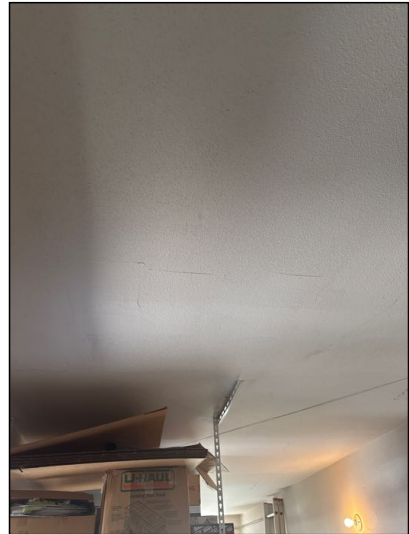
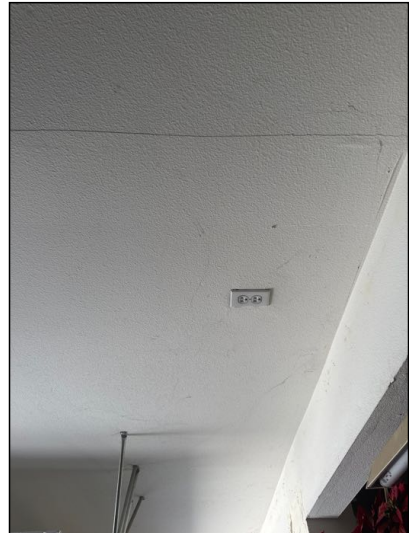
| Page 54 Item: 3 | Rafters & Ceiling | <p>3.3. <b>Fire Separation:</b> A hole was observed in the garage ceiling, compromising the required fire-resistant barrier between the garage and the living space. This condition is considered unsafe and should be repaired by a qualified contractor to restore proper fire protection and occupant safety.</p> <p>3.4. <b>Moisture Damage:</b> Staining and/or moisture-related damage was observed on the garage ceiling beneath the finished living space. The source of this condition and whether it is active or the result of a past event could not be determined during this visual inspection. Recommend further evaluation by a qualified, state-licensed professional to determine the source and perform any necessary repairs.</p> |

**3.3. Fire Separation:** A hole was observed in the garage ceiling, compromising the required fire-resistant barrier between the garage and the living space. This condition is considered unsafe and should be repaired by a qualified contractor to restore proper fire protection and occupant safety.

**3.4. Moisture Damage:** Staining and/or moisture-related damage was observed on the garage ceiling beneath the finished living space. The source of this condition and whether it is active or the result of a past event could not be determined during this visual inspection. Recommend further evaluation by a qualified, state-licensed professional to determine the source and perform any necessary repairs.

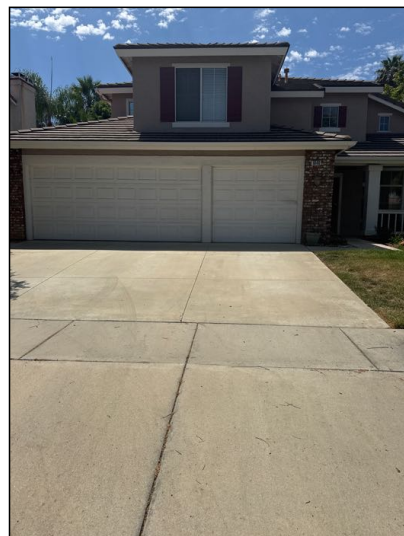
1.5. Moderate cracks in sidewalk. Repair and / or monitor for expansion and development of trip hazards.

1.6. Minor undermining of the concrete porch slab was observed at the front porch. This condition may be related to soil erosion or drainage and could worsen over time. Recommend evaluation and repair as needed by a state licensed professional.

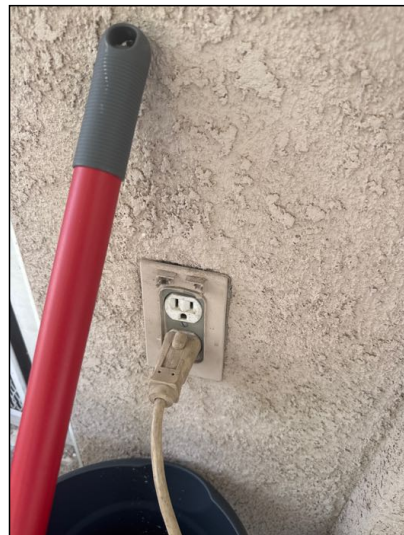
| Page 77 Item: 6 | Exterior Electrical | 6.1. Exterior outlet is missing waterproof cover. |

6.1. Exterior outlet is missing waterproof cover.

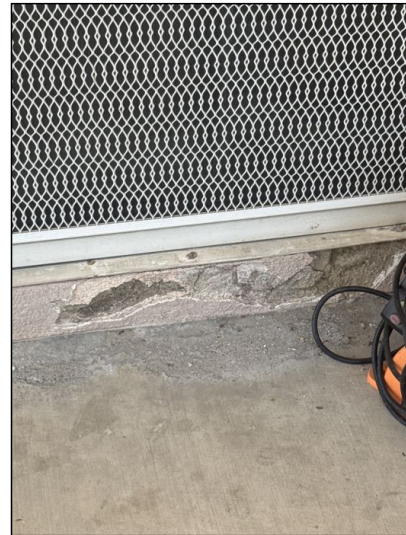
| Page 80 Item: 12 | Stucco | <p><b>12.4. Delamination or Bulging:</b> Areas of stucco appear to be bulging or separating from the wall. This may indicate hidden moisture damage and should be evaluated by a qualified stucco contractor.</p> <p><b>12.5. Impact Damage:</b> Chips, holes, or surface damage were observed on the stucco. These areas may allow moisture intrusion and should be repaired.</p> |

**12.5. Impact Damage:** Chips, holes, or surface damage were observed on the stucco. These areas may allow moisture intrusion and should be repaired.

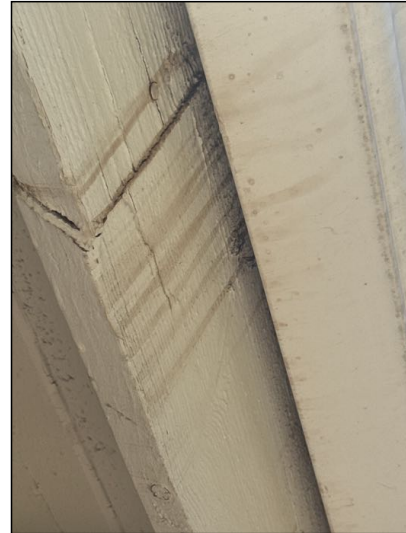
14.1. **Deteriorated or Rotted Wood:** Areas of rot or deterioration were observed at the eaves, soffits, or rafter tails. This condition is typically caused by prolonged moisture exposure and should be repaired or replaced as needed.

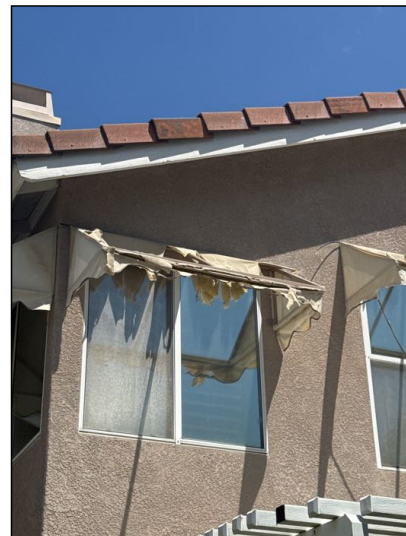
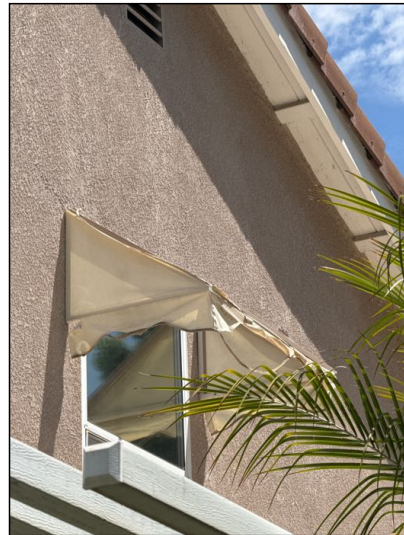
| Page 82 Item: 16 | Exterior Windows | <p><b>16.1. Failed or Missing Caulking:</b> Caulking around the exterior window frame is cracked, deteriorated, or missing. This may allow moisture intrusion and should be resealed.</p> <p><b>16.2.</b> Awnings at multiple upper-story windows were deteriorated, with some torn from their framing. Recommend further evaluation and repair by a state licensed professional.</p> |

**16.1. Failed or Missing Caulking:** Caulking around the exterior window frame is cracked, deteriorated, or missing. This may allow moisture intrusion and should be resealed.

**16.2.** Awnings at multiple upper-story windows were deteriorated, with some torn from their framing. Recommend further evaluation and repair by a state licensed professional.
