### *Inspection Report*

Address: 1050 Santa Ynez Ave Los Osos, CA 93402

08/31/2026

Inspector: Taylor Vreeken, CCI

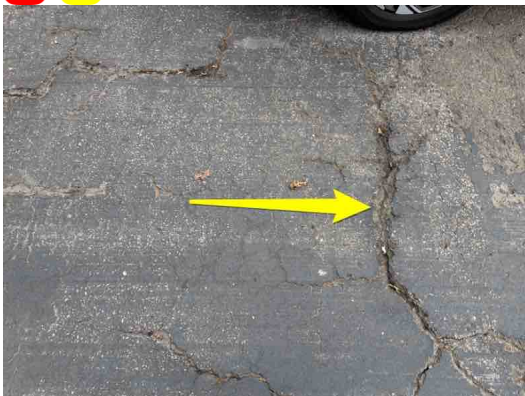
**FI** **UPG** 13: Some moderate and heavy cracks found in areas of the driveway.

**SU** 14: Areas of the driveway are uneven with potential trip hazards. Upgrades recommended.

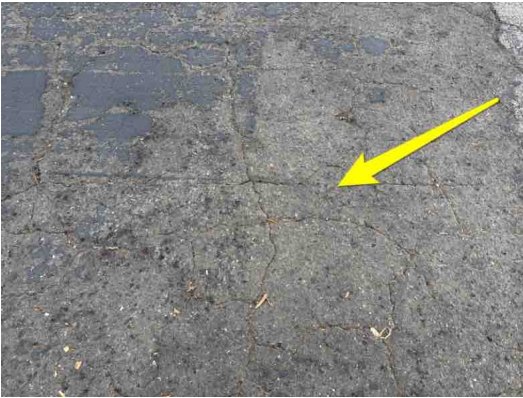
**MR 15:** Sealant and general maintenance recommended at the asphalt driveway to help to preserve the overall life.

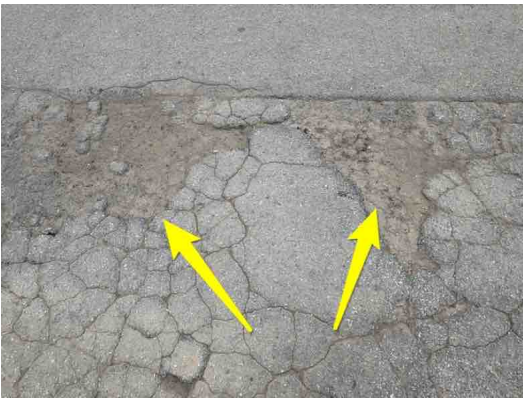
**FI MR 16:** Eroded or damaged asphalt found in some areas of the driveway. Maintenance or repairs are recommended.

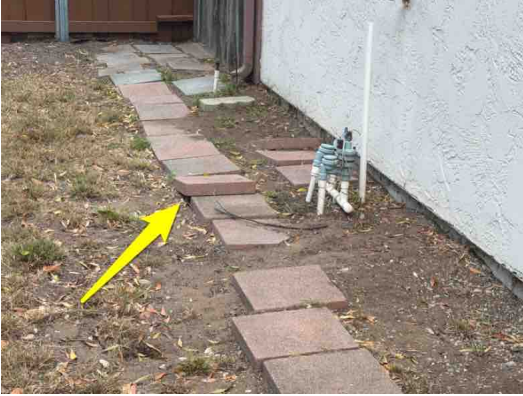
**SU** 23: Areas of the paver walkways are uneven with potential trip hazards.

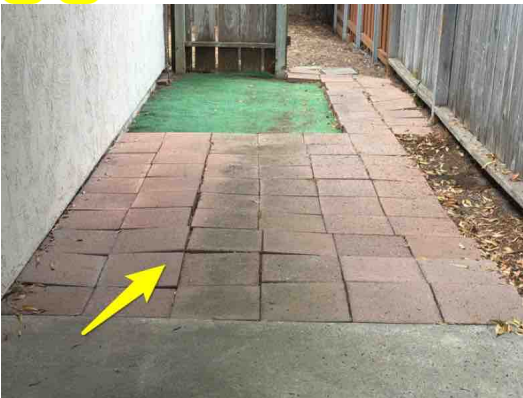
**MR SU** 29: Areas of the paver patios are uneven with potential trip hazards.

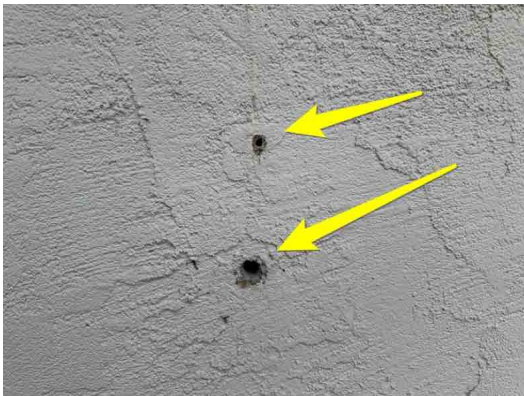
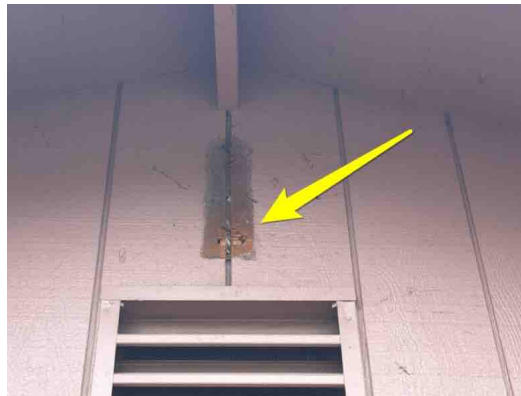
**MR 37:** Recommend sealing holes in exterior walls to prevent water intrusion around areas such as unused open holes in the exterior siding and trim, exterior light fixtures, around exterior electrical boxes and covers, and where utility pipes and/or wires pass through the exterior walls. Have a qualified painter or licensed professional evaluate the entire exterior and seal openings where needed.

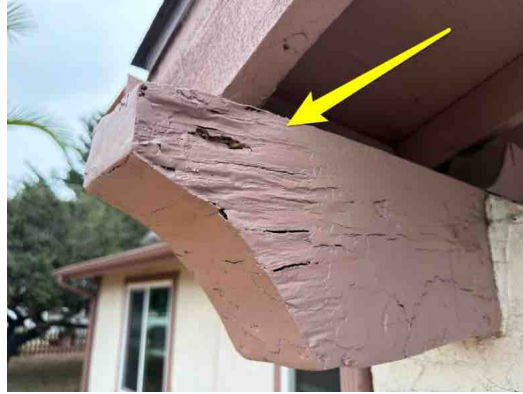
**E&C 40:** Some moisture and/or bug type damage & deterioration found at exterior areas such as eaves, fascia and/or trim. Refer to the termite report for locations and extent.

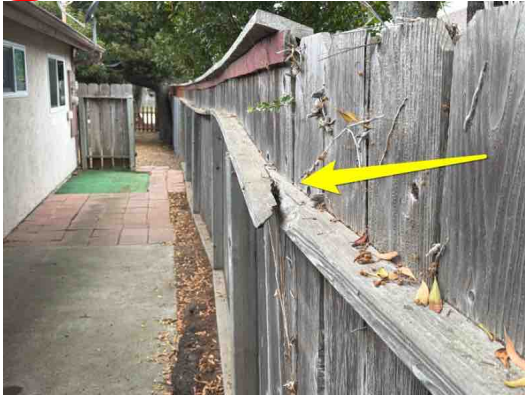
**E&C 43:** Areas of the fencing and gates are damaged. Recommend servicing and/or repair.

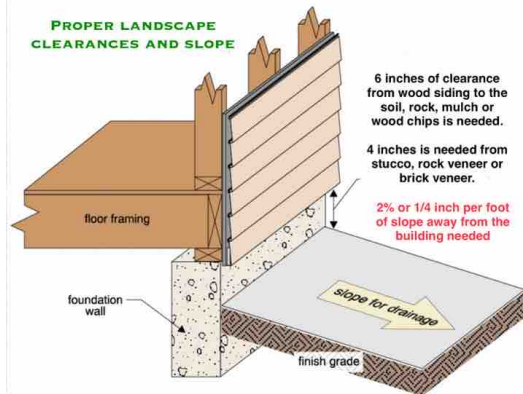
**E&C MR 47:** Soil level found high at areas of the foundation. (Recommend 4 inches from the bottom of the exterior stucco siding to dirt, rock, mulch or wood chips).

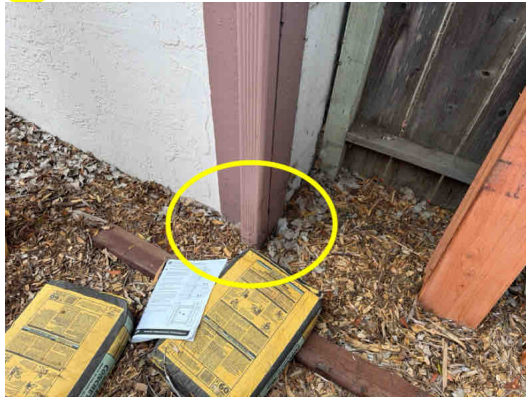
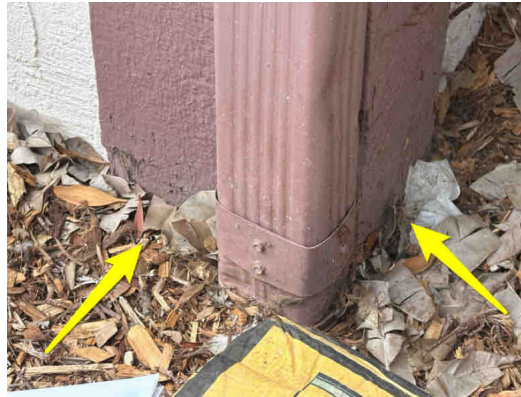
**MR 48:** Earth-to-wood contact noted at areas of the exterior trim. Proper landscape grading warranted.

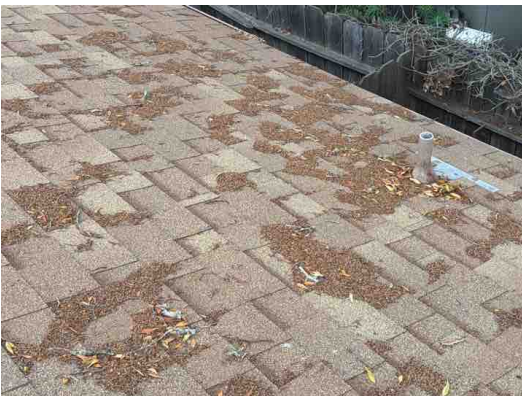
**MR 56:** Debris covers portions of the roof and/or roof flashings. This may cause deterioration and/or a roof leak. Areas of the roof are not fully visible. Clean and inspect regularly.

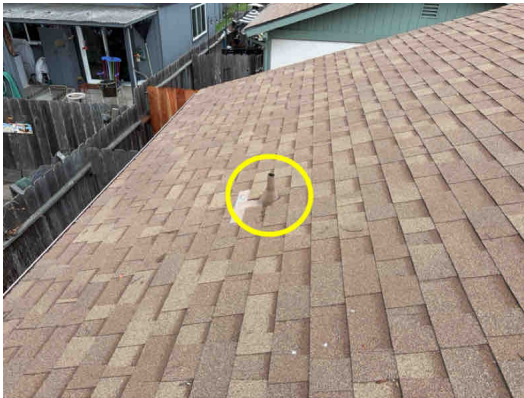
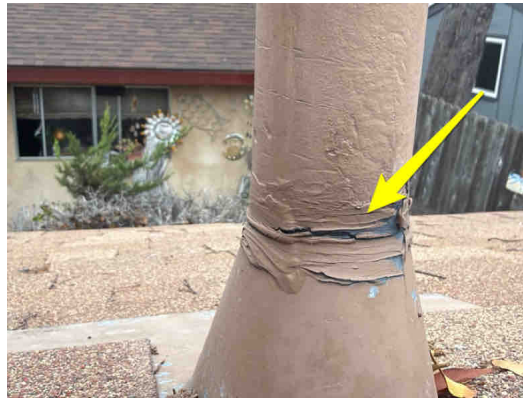
**MR 58:** Deteriorated sealant at ONE roof flashings/ roof penetration. Maintenance recommended to help prevent water intrusion into areas of the attic. Maintenance recommended.

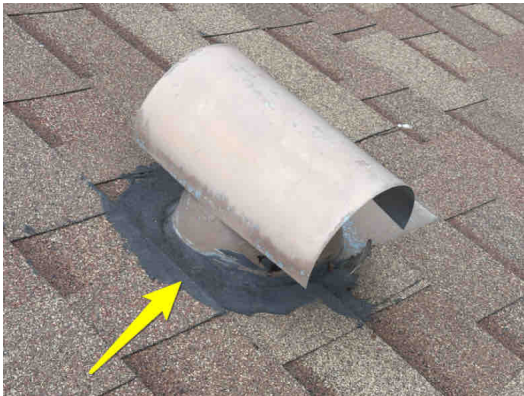
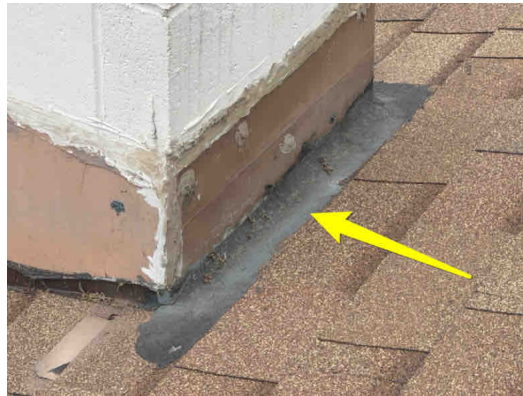
**E&C 59:** Improper installation and use of an exposed mastic or tar-type product as a past roof repairs subject to deterioration / not protected at areas of roof. Maintenance, upgrades are recommended.

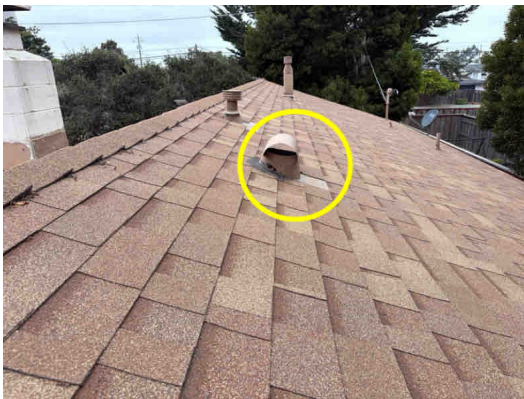
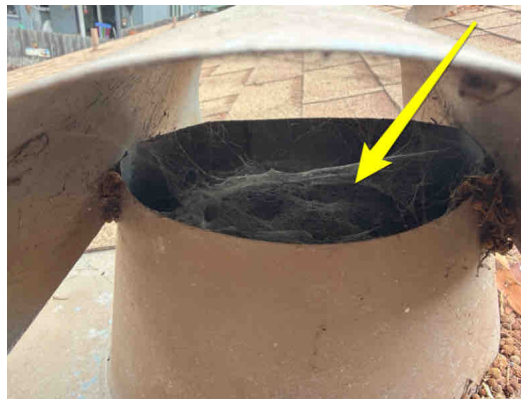
**E&C 60:** Missing the required screens on the KITCHEN exhaust vent terminations at the roof per building codes and standards to help prevent critter intrusion into the attic. **[2016 CMC 502.1]**

Exhaust openings terminating to the outdoors shall be covered with a corrosion-resistant screen having not less than  $\frac{1}{4}$  of an inch (6.4 mm) openings, and shall have not more than  $\frac{1}{2}$  of an inch (12.7 mm) openings.

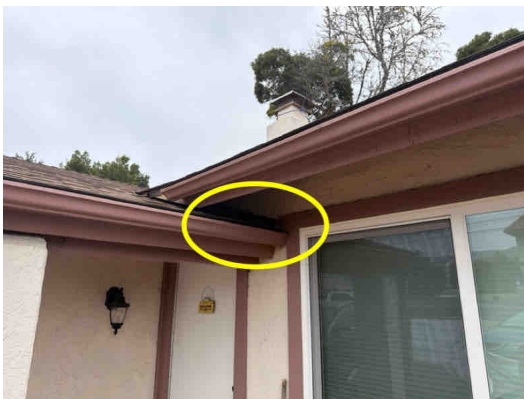
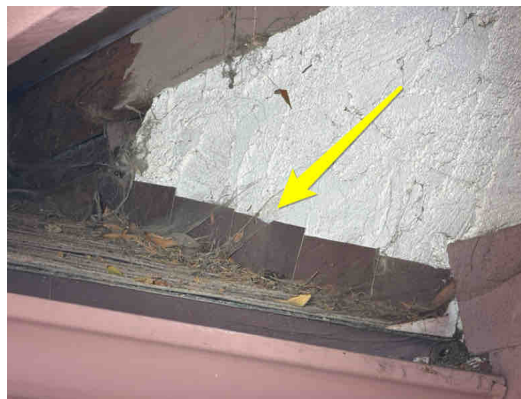
**E&C FI 61:** Missing the required primary watershed flashing at the UNIT-B entry patio cover side-wall attachment. Corrections recommended.

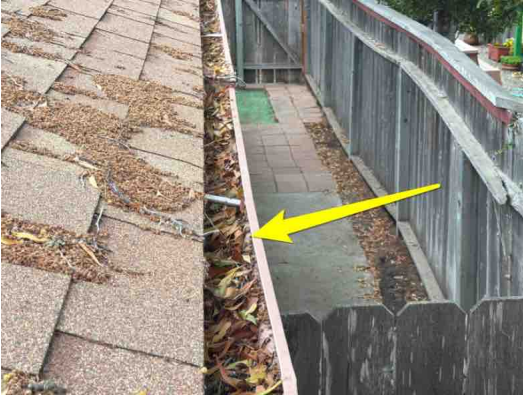
**MR 64:** Recommend some typical rain gutter maintenance. This should at minimum consist of cleaning, sealing, and re-fascinating of loose gutters and downspouts.

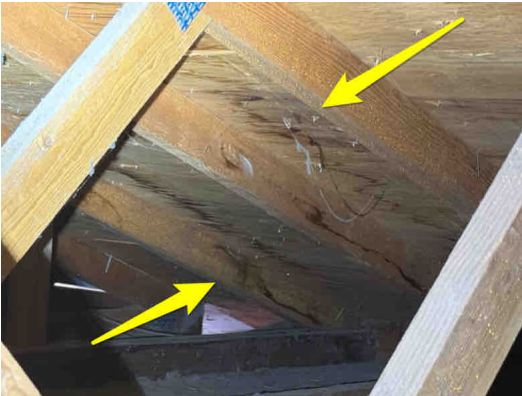
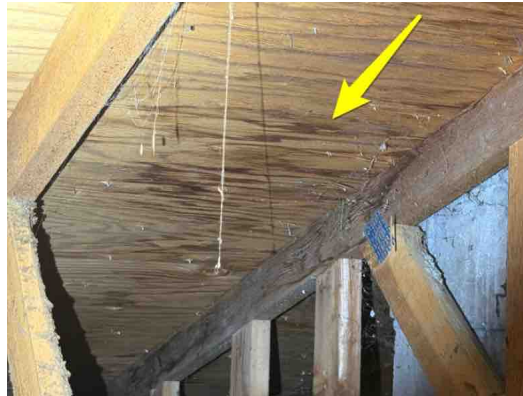
**FI DS 71:** Some minor and typical moisture stains noted in areas throughout the attic. All water stains should be investigated by a licensed roofer. Refer to termite report for additional comments and/or recommendations.

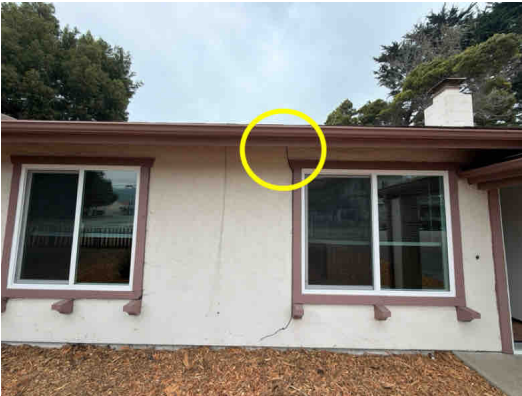
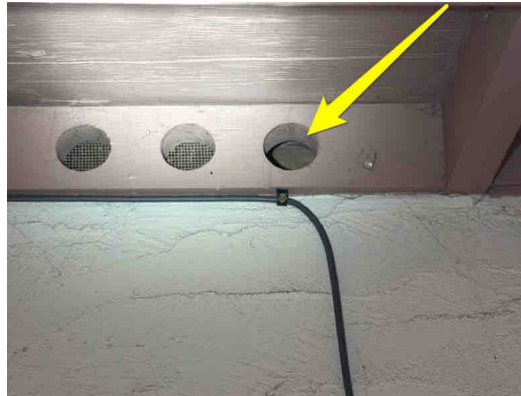
**E&C MR 72:** Some damaged or missing attic eave vent screens on areas of the exterior at the roof overhangs. Repair or replacement of the damaged or missing vent screens is recommended to help prevent critter intrusion into attic areas.

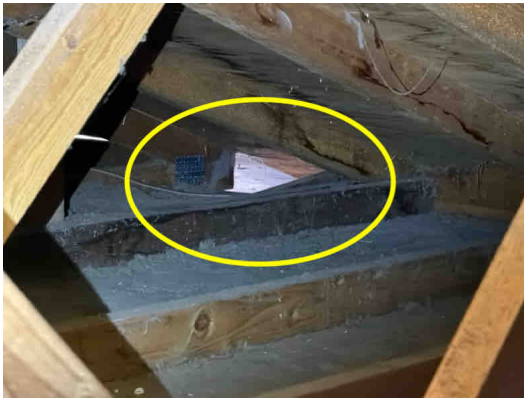
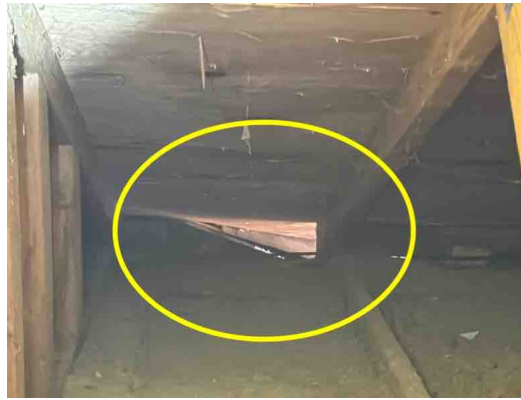
**E&C 73:** Unprotected openings into the attic or confined spaces from the exterior should be sealed or screened per standards to help keep rodents out of the attic.

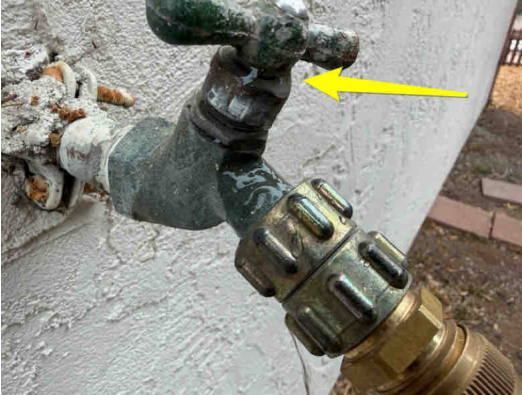
**MR 80:** Some exterior hose faucets leak at handle when on.

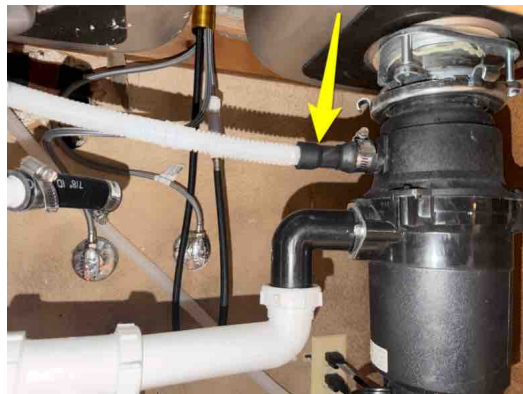
**SU** 120: Improper installation of the dishwasher drain hose. Missing the Air Gap Device at the dishwasher drain per minimum codes and standards (California does not allow for high-loop methods or direct waste connections). {CPC 801.2}

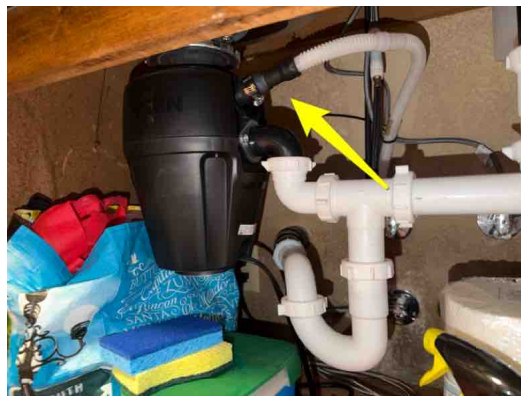
**SU 137:** Improper installation of the dishwasher drain hose. Missing the Air Gap Device at the dishwasher drain per minimum codes and standards (California does not allow for high-loop methods or direct waste connections). {CPC 801.2}

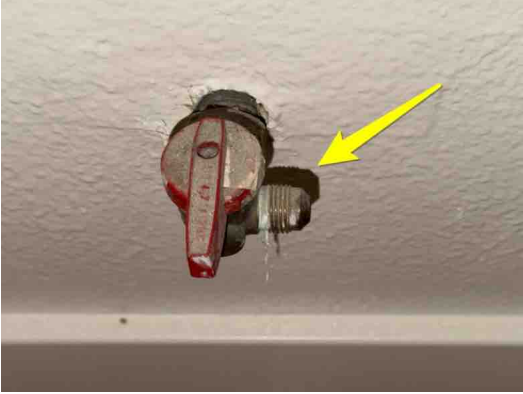
**SC 149:** A proper cap is missing at an unused gas valve per standards at the LAUNDRY. This can allow the gas valve to be accidentally turned on slightly creating a gas leak behind the laundry.

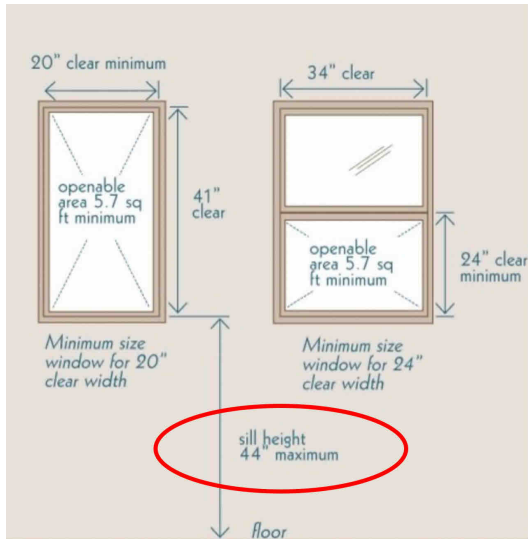
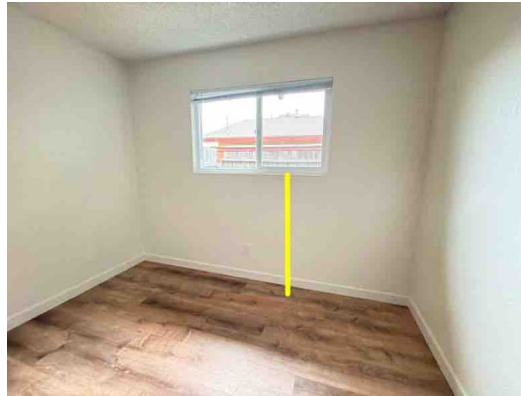
**SU 184:** Windows in BACK BEDROOMS are a too high off the floor and do not meet the current minimum fire egress standards. Standards for fire egress windows are no more than 44 inches off the floor.

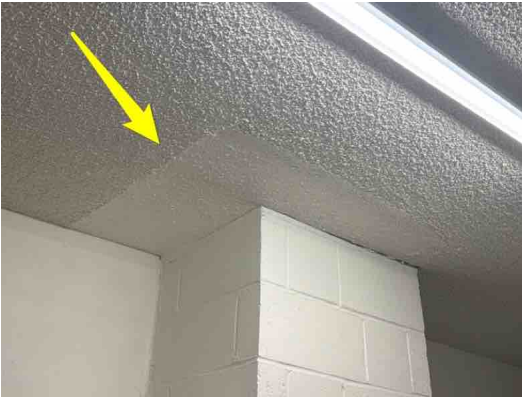
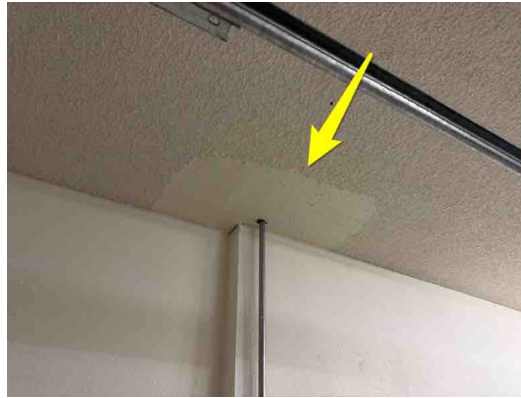
**FI DS 195:** Evidence of past ceiling and wall repairs found throughout. Client should investigate further to satisfy themselves as to the cause and current conditions.

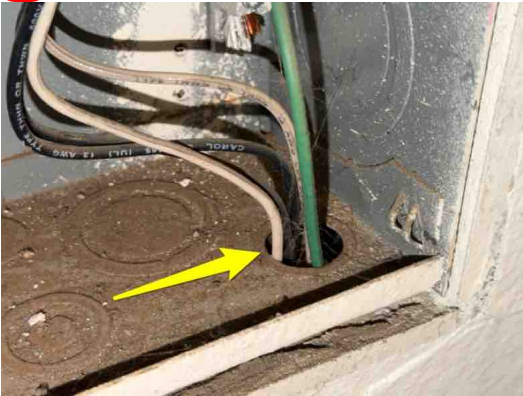
**SC 220:** Missing bushing clamp as wires are passing into the ELECTRICAL SUB PANEL.

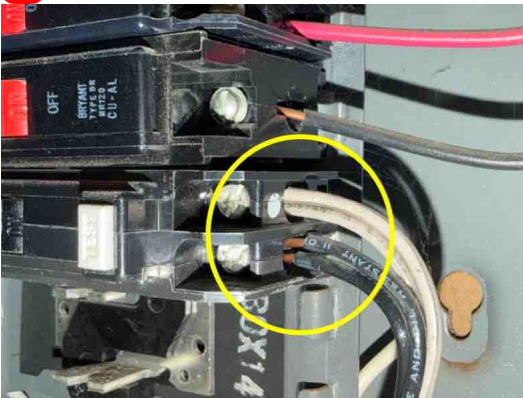
**SC 221:** Improper installation of two wires on single-wire rated circuit breaker in the ELECTRICAL SUB PANEL.

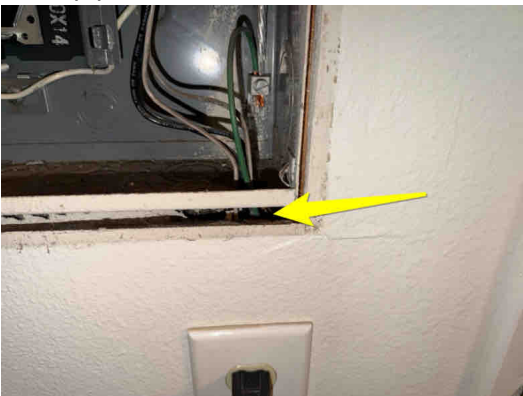
**E&C SC 222:** Improper and unsafe wiring was observed entering and passing through the metal electrical panel enclosure without approved conduit, cable connectors, bushings, or other required protection. This condition may allow conductor insulation damage from sharp metal edges and physical abrasion. Recommend evaluation and correction by a qualified licensed electrical contractor. Reference California Electrical Code (CEC) Sections 312.5(C) and 300.4.

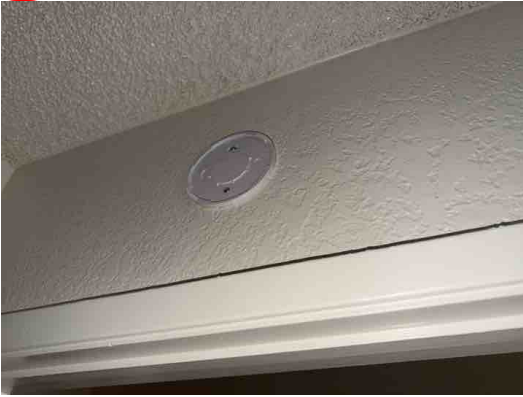
**SC 224:** Smoke detector missing at required location: UNIT-B BEDROOM HALLWAY and BEDROOM-2

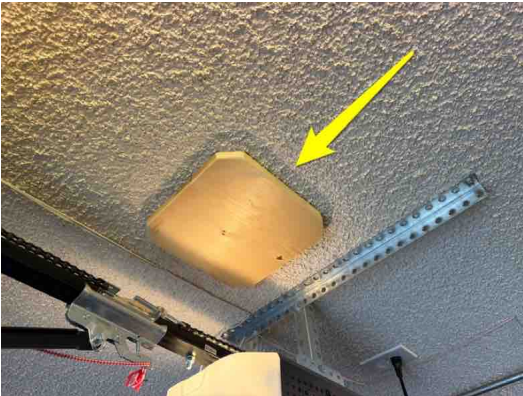
**SC FI 243:** A hole or opening found in the UNIT-B garage firewall covered with an insufficient material to retain the adequate fire assembly rating. Corrections are warranted for fire safety. Contact an appropriate contractor to review the entire garage repair as needed.

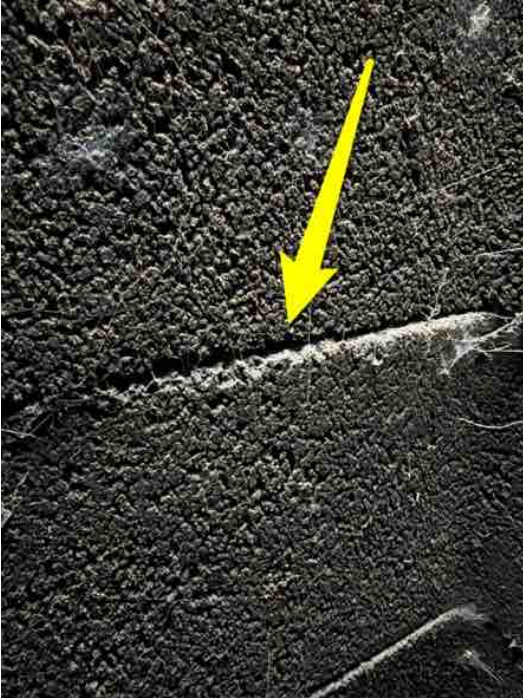
**SC FI 258:** Visible separations and missing mortar were observed at the joints between the clay flue liners within the UNIT-A masonry chimney. This condition may allow superheated gases to escape the flue and enter concealed areas of the chimney structure, potentially reducing system performance and safety. Recommend evaluation and repair by a qualified chimney contractor. Recommend a full Level II inspection with a camera and repair as needed by a licensed and certified Fireplace chimney sweep.

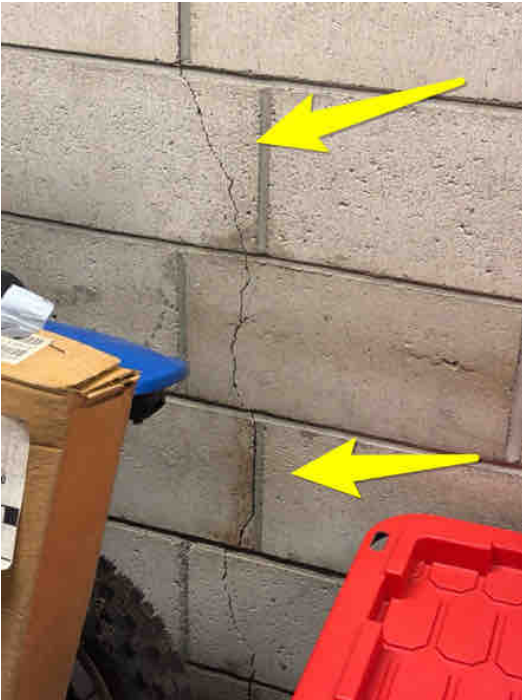
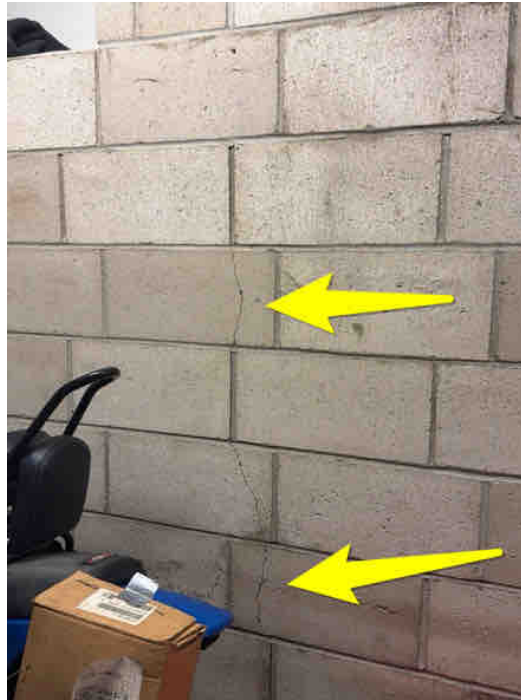
**SC FI 267:** Evidence of thermal shock cracking at the exterior of the UNIT-B fireplace masonry chimney. This is an indication that some damaged or excessive deterioration has occurred at the fireplace chimney flue liners, throat and/or firebox. Recommend scoping chimney with a camera to determine condition. (Fireplace should not use until proper corrections are performed).

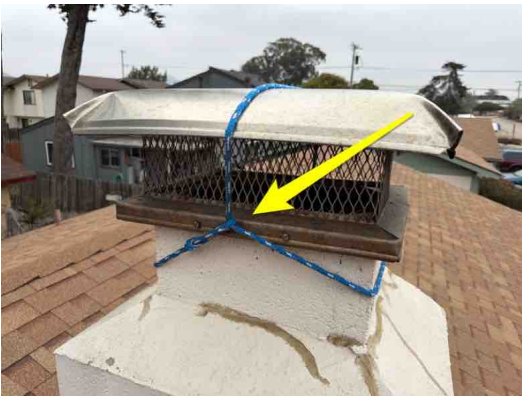
**E&C 268:** The UNIT-B chimney cap appears to be improperly secured with a rope rather than an appropriate permanent mechanical attachment. This condition may allow the cap to become loose or displaced during high winds and may permit moisture or debris entry. Recommend properly securing the chimney cap with approved corrosion-resistant mechanical fasteners or hardware.
