# Home Inspection Report

70 Shaul St., Clearlake Oaks, CA 95423

Tuesday August 4, 2026

1323

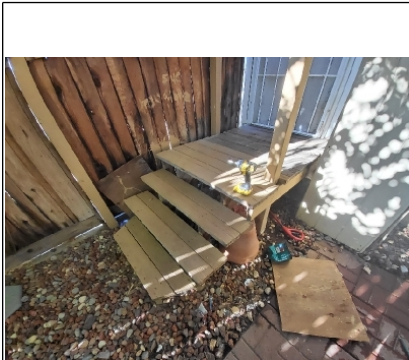
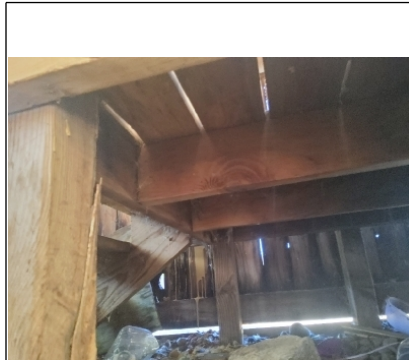
**Recommend replacing damaged tread members that are noted, structurally the steps are of no concern.**

Additional railing not required as tread to ground level is less than 30".

Recommend replacing damaged treads

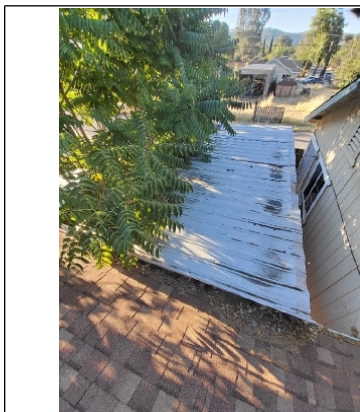
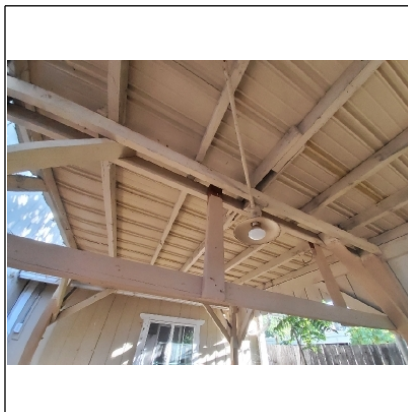
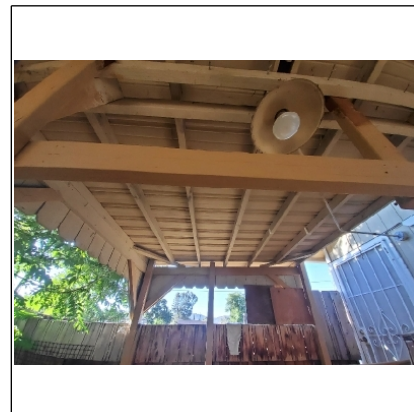
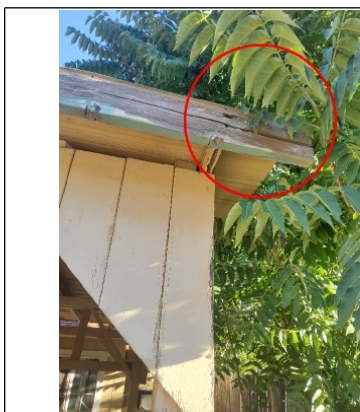
**Moisture damage was evident on fascia but structurally there are no concerns with the rear cover with regards to the structural wood members.**

Moisture damage is evident on fascia, recommend replacing

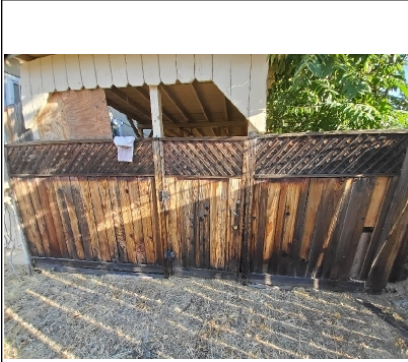
Missing and damaged planks,  
recommend repair

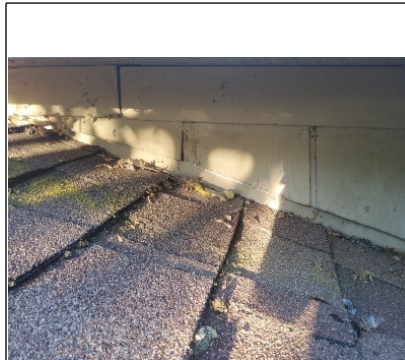
Siding should clear flashing by 1",  
flashing not visible at location.  
However, does appear to have  
galvanized flashing behind the  
siding.

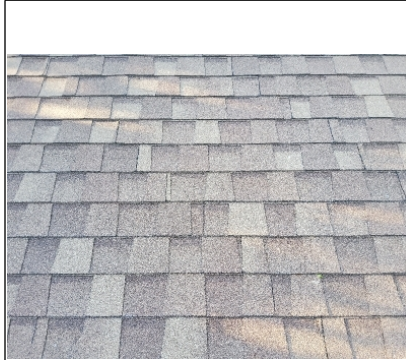
Moss is evident but shingles are not damaged during time of inspection, recommend having removed.

**Comments** **Recommend cleaning all moss "lichens" off the roof**

*With the moss build up I always recommend applying Wet & Forget this can be purchased at Home Depot, look at the forecast for about a week to make sure no rain is in site and then spray the chemical on the roof and do not use a pressure washer sprayer ever on asphalt shingles. This will kill the moss in about a month. Option 2 is on a damp morning get a dull chisel and pick the moss off then apply the Wet & Forget after.*

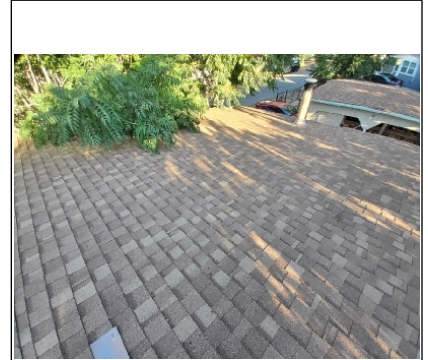
Roof is in overall satisfactory condition

Technically this section of roofing is supposed to be roll asphalt instead of asphalt shingle based on the roof pitch, but saw no serious concerns with the installed roof during the time of inspection.

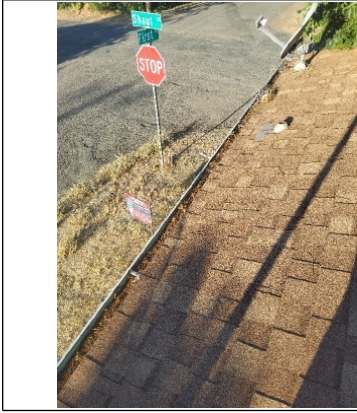
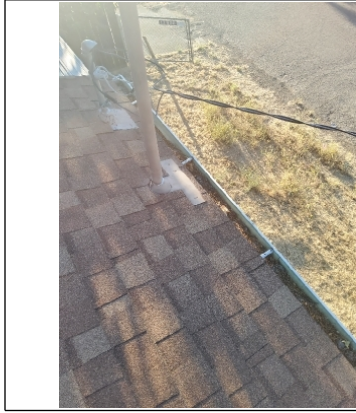
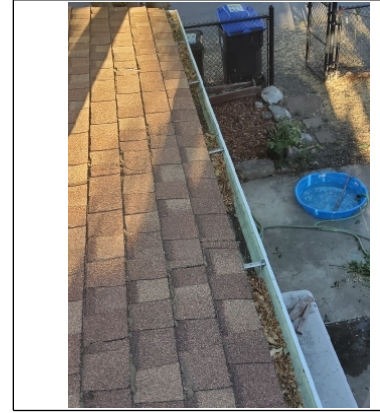
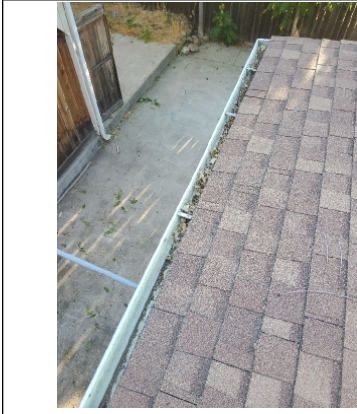
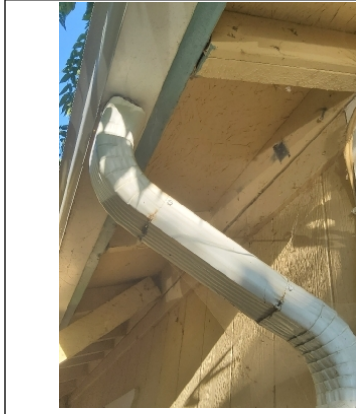
Active leak on downspout,  
recommend repair

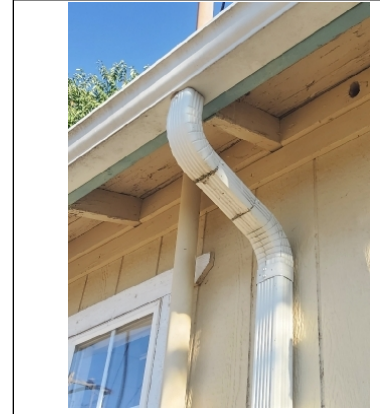
Active leak on downspout,  
recommend repair

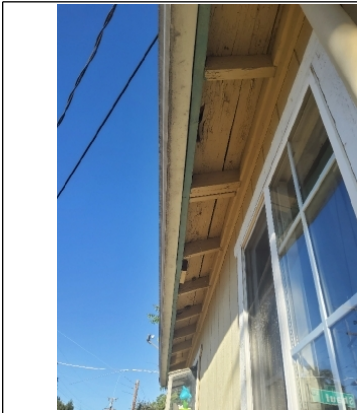
Recommend having soffit painted by a licensed painter

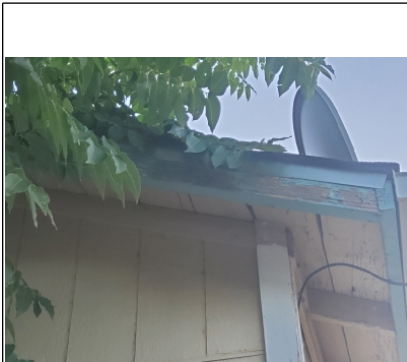
Recommend sanding and repainting section of fascia

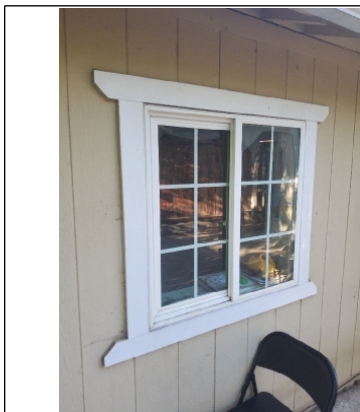
Bent screen, recommend replacing

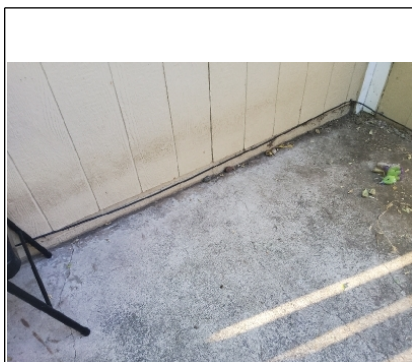
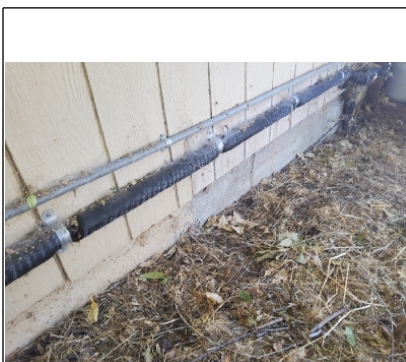
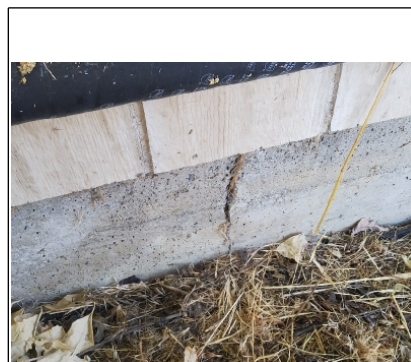
Foundation crack evident, recommend repair (Not as major of an issue as this home is built on a concrete slab). Epoxy injection can repair the crack

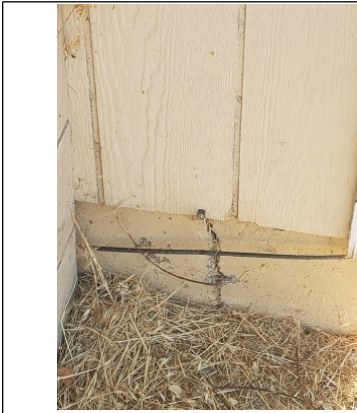
Foundation crack evident, recommend repair (Not as major of an issue as this home is built on a concrete slab). Epoxy injection can repair the crack

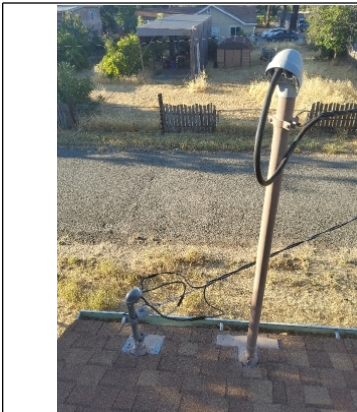
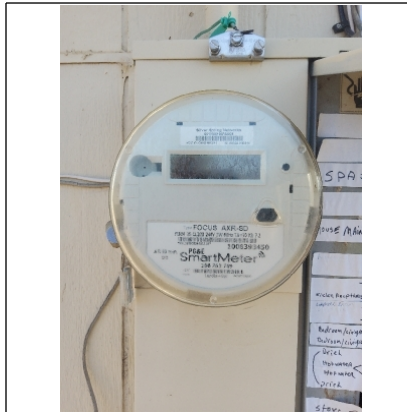
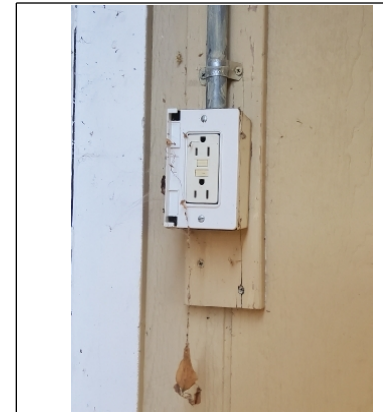
Missing exterior cover, recommend repair

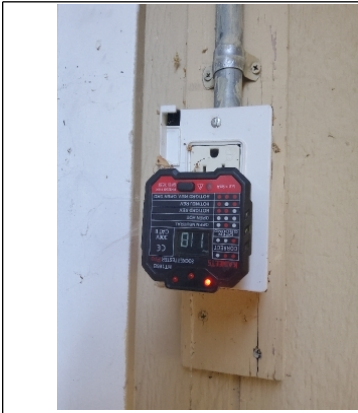
Open ground, recommend further evaluation and repair by a licensed electrician.

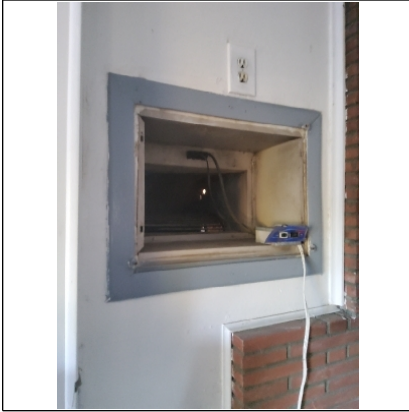
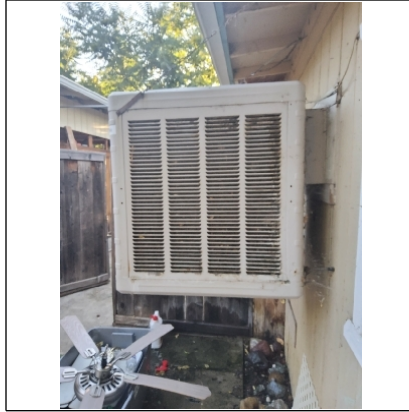
**Comments** Swamp cooler has significant rust and leaking, recommend having replaced by a licensed HVAC contractor

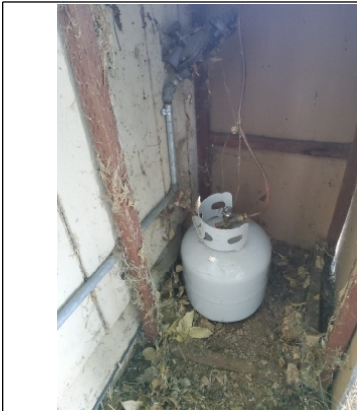
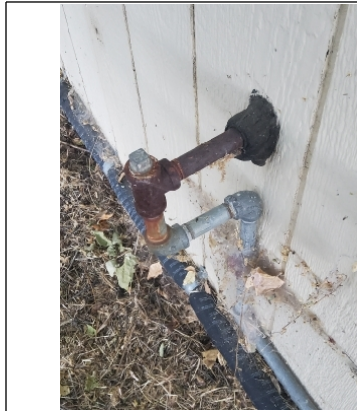
Rust is evident, however gas line is not leaking during the time of inspection.

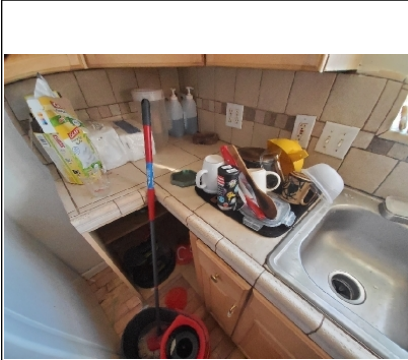
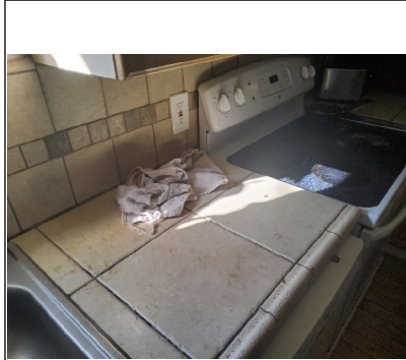
Recommend regrouting between tile and backsplash (Comes in a caulking silicone tube)

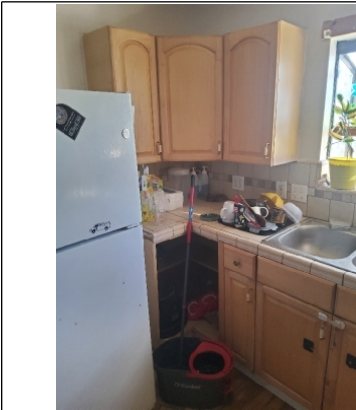
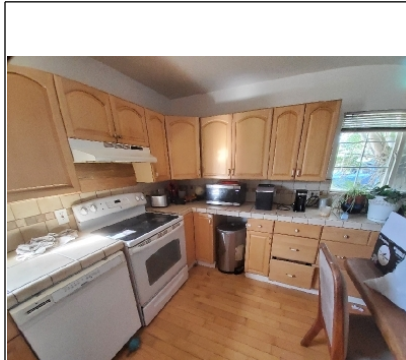
Broken door handle, recommend repair

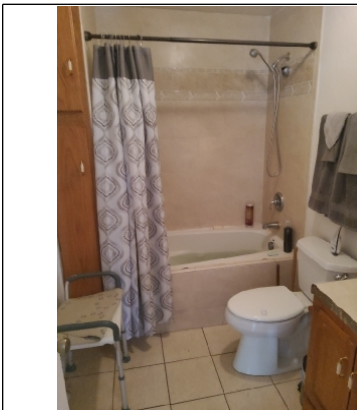
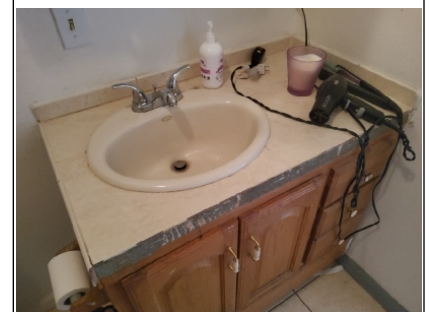
Missing corner pieces on countertop, recommend repair

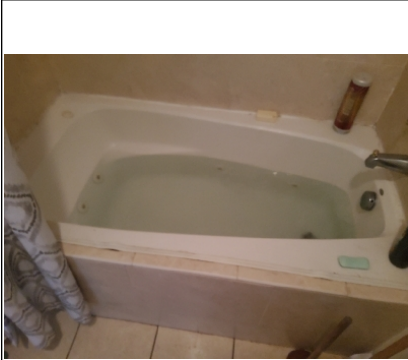
Water is entering both the shower head and the spout, I recommend having the diverter valve replaced by a licensed plumber.

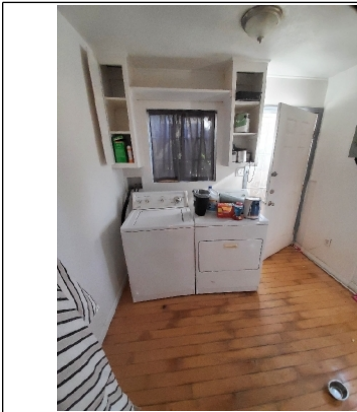
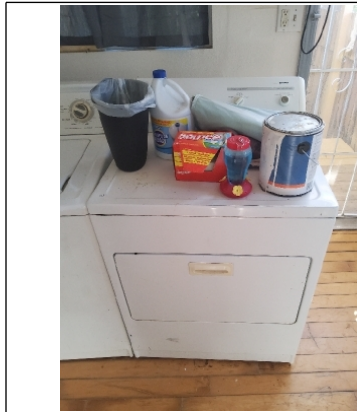
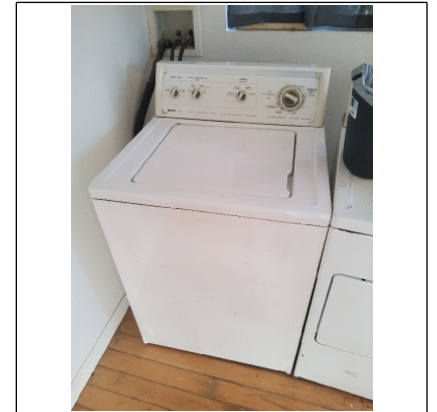
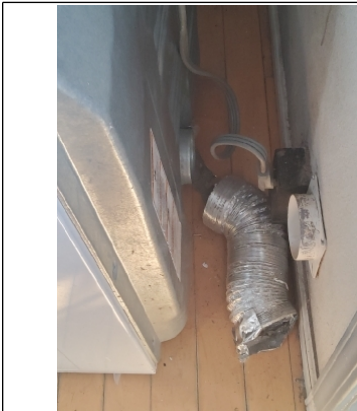
Dryer not venting to exterior, recommend repair

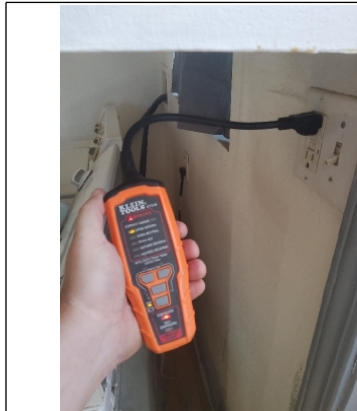
Open ground, recommend further evaluation and repair by a licensed electrician.

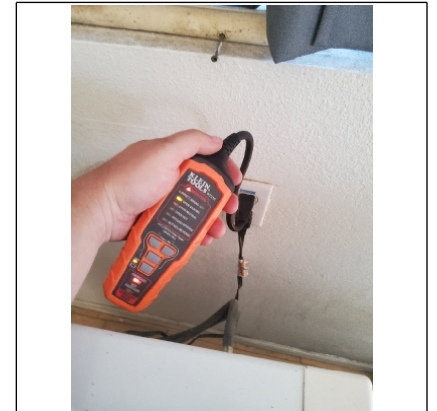
Open ground, recommend further evaluation and repair by a licensed electrician.

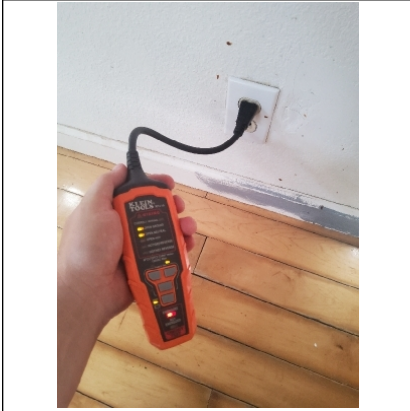
Open ground, recommend further evaluation and repair by a licensed electrician.

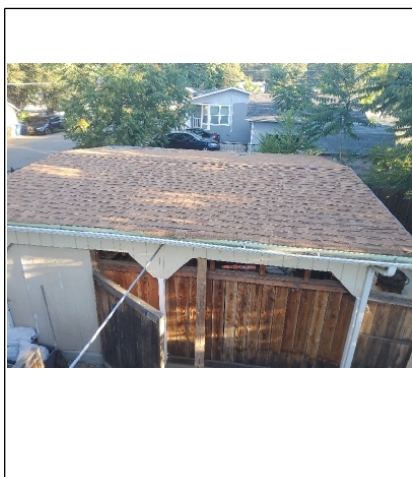
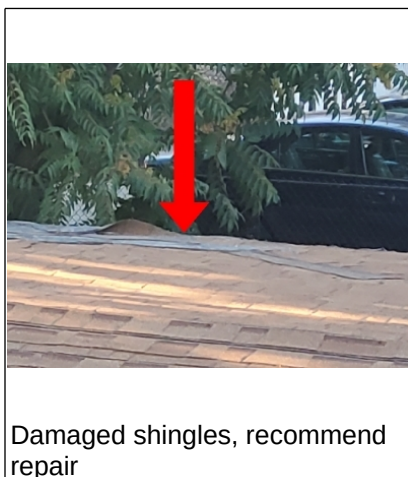
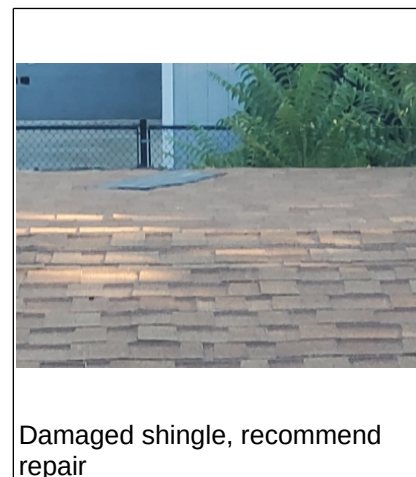
**Shingles are damaged at multiple locations, recommend repair .However best option is to have roof replaced with roll asphalt.**

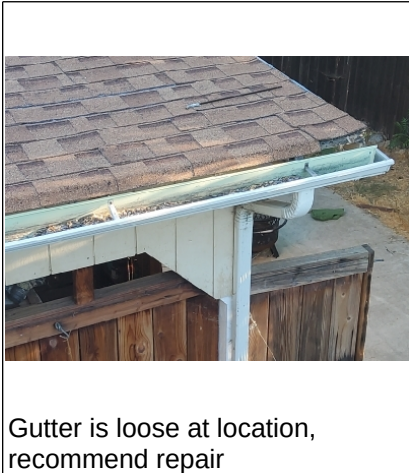
Gutter is loose at location, recommend repair

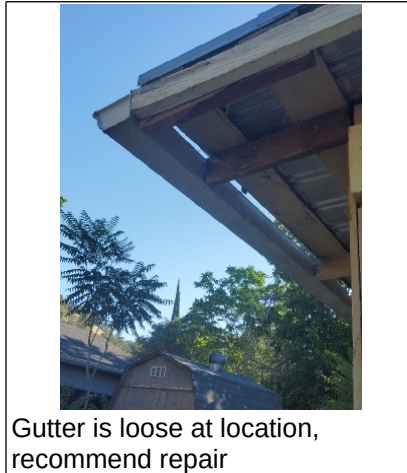
Gutter is loose at location, recommend repair

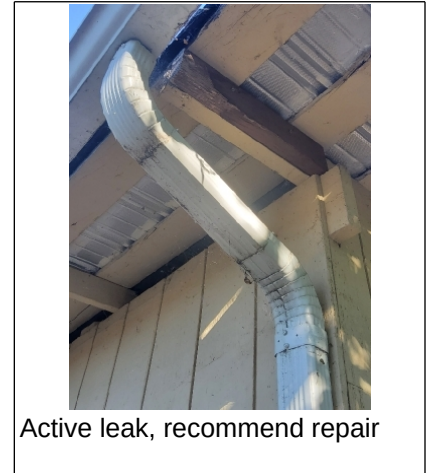
Active leak, recommend repair

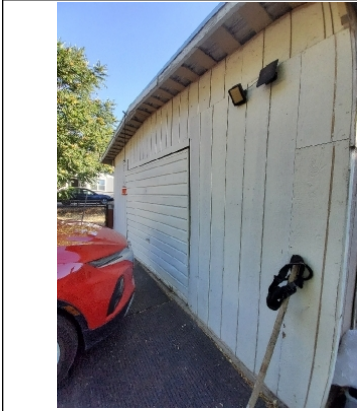
Siding not installed correctly, recommend repair by a licensed contractor.

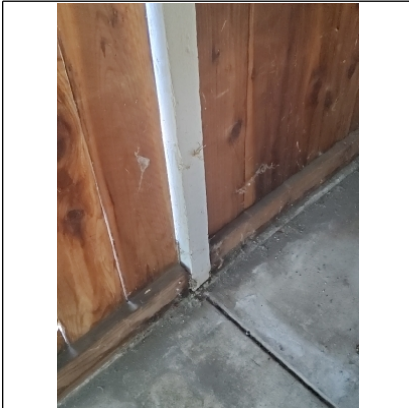
Moisture stains are evident, recommend further evaluation and repair by a licensed pest control operator.
