# WOOD DESTROYING PESTS AND ORGANISMS INSPECTION REPORT

| Building No.<br>2218 | Street<br>Hutchinson St | City<br>Chico | ZIP<br>95928 | Date of Inspection<br>09/23/2026 | Number of Pages<br>4 |
| GENERAL DESCRIPTION:<br>Single family residence; vacant, attached garage | | | | Inspection Tag Posted:<br>Garage<br>Other Tags Posted:<br>None noted | |

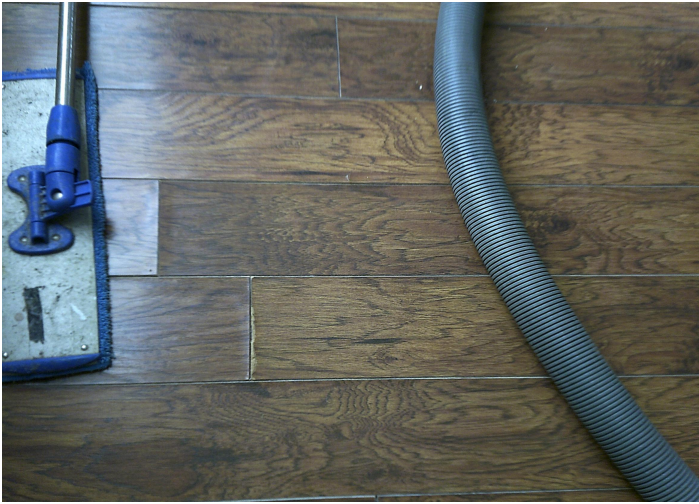
10A

**FINDING:** Stains and moisture damage noted at the living room flooring. Damage may extend into inaccessible areas.

**RECOMMENDATION:** Interested parties should engage the services of a licensed contractor to check for leaks and to perform any corrective work needed. Remove the moisture damaged portions of the flooring. Call for a reinspection of the inaccessible areas. The inaccessible areas will be inspected for a fee if made accessible by the interested parties at his/her expense. A supplemental report will be filed at such time. No opinion is rendered concerning the conditions in the area at this time. Replace with new material.

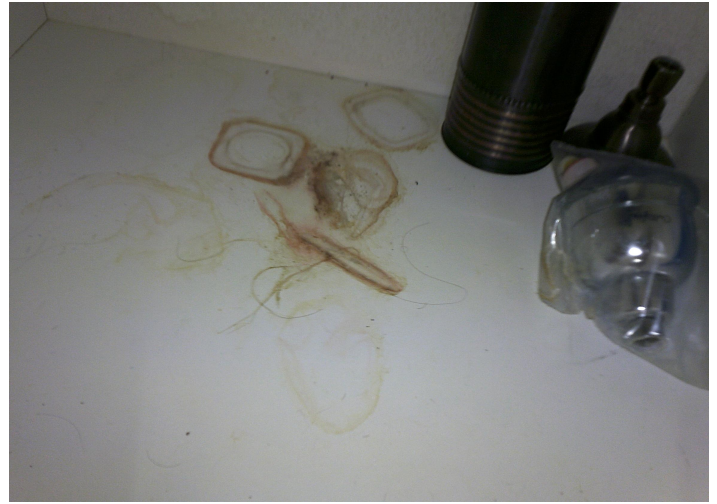
10B

**FINDING:** Stains (dry) were noted at the upstairs bathroom sink cabinet bottom.

**RECOMMENDATION:** Interested parties should engage the services of a licensed plumber to check for leaks and make repairs as needed.

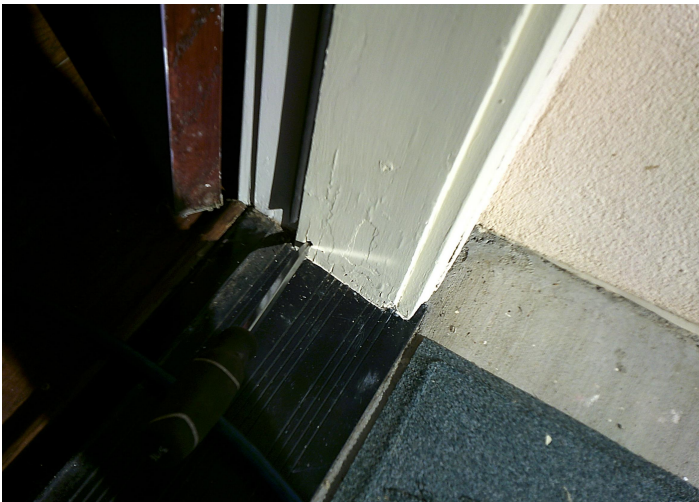
11A

**FINDING:** Stains and fungus damage noted at the door jambs. Damage may extend into inaccessible areas.

**RECOMMENDATION:** Interested parties should engage the services of a licensed contractor to check for leaks and to perform any corrective work needed. Remove the fungus damaged portions of the door jambs and replace with new material.
