# PROPERTY INSPECTION REPORT

**FOUR POINT**  
HOME INSPECTION INC.

**190 Stonebridge Ln**  
**Inspection Prepared For: Tom Bremer**  
**Agent: -**

**Date of Inspection: 9/4/2026**

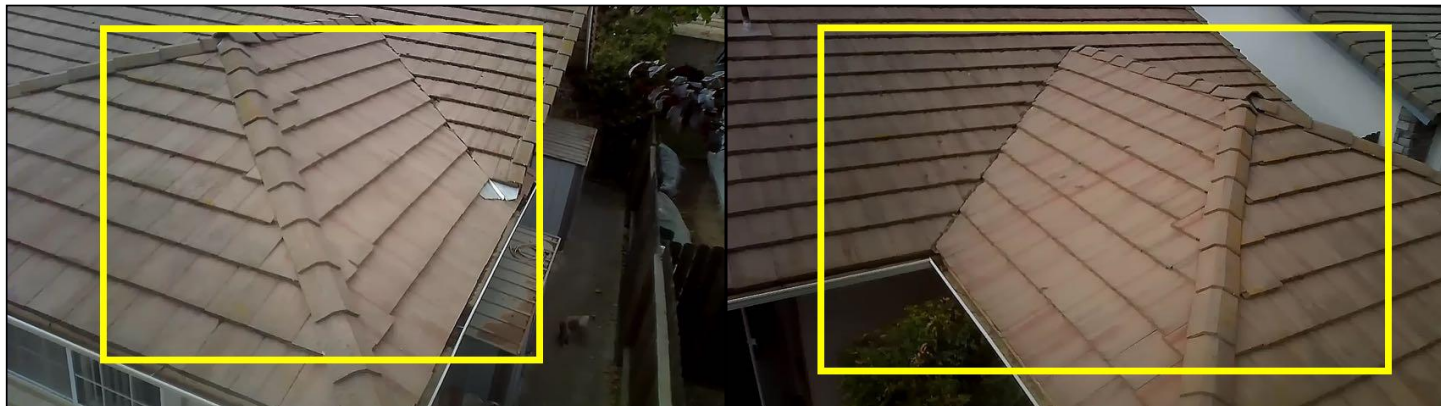
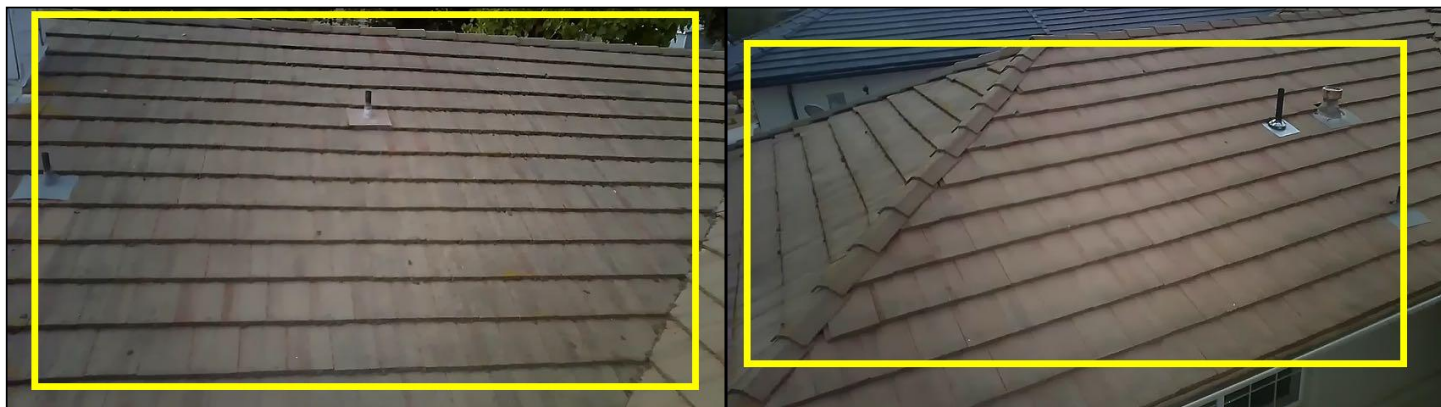
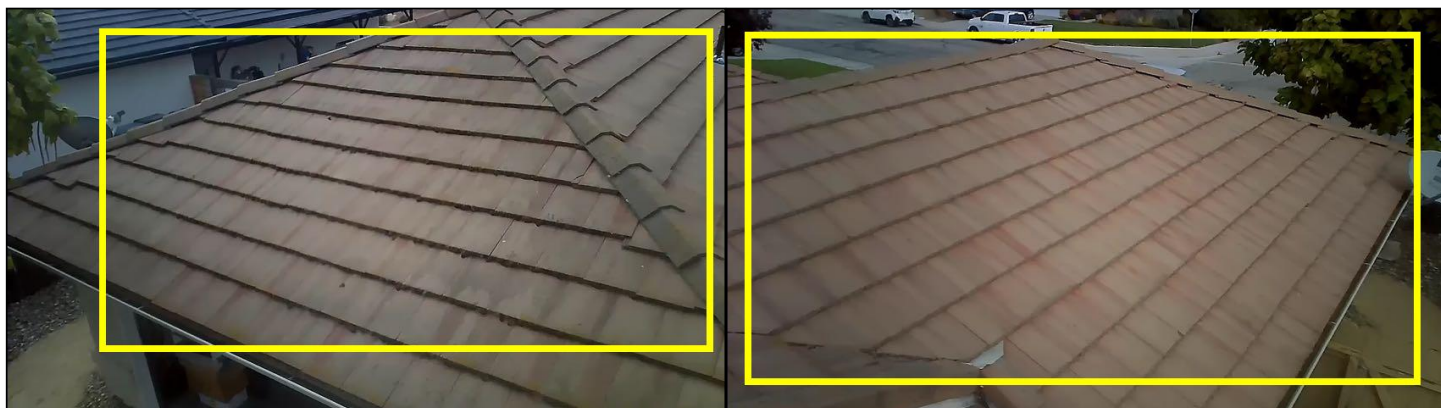
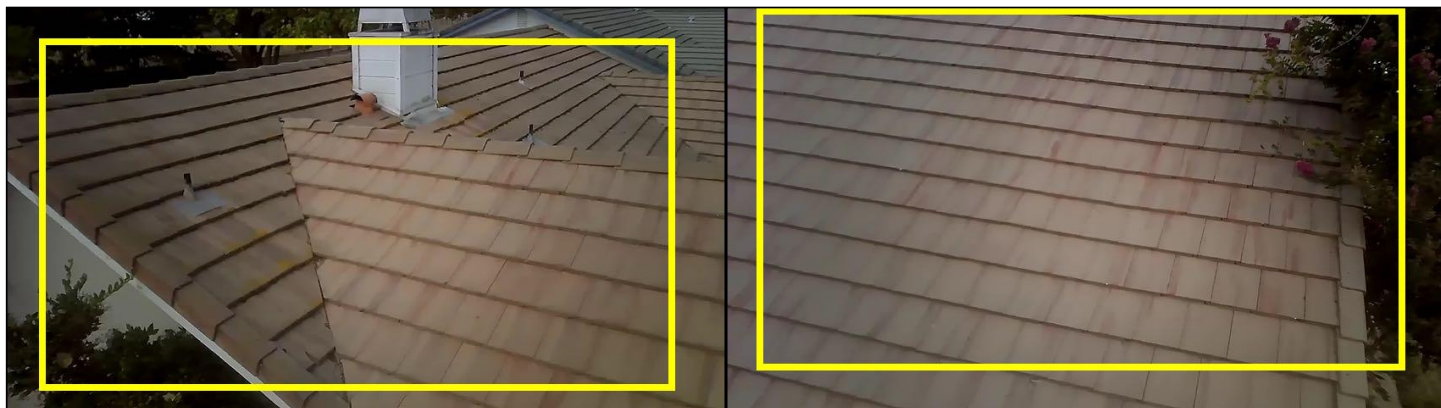
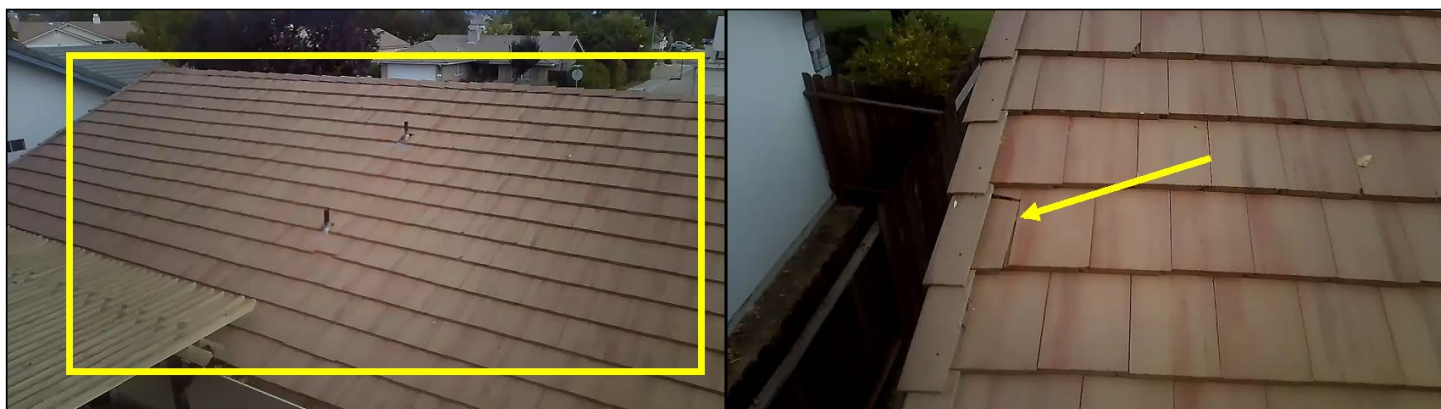
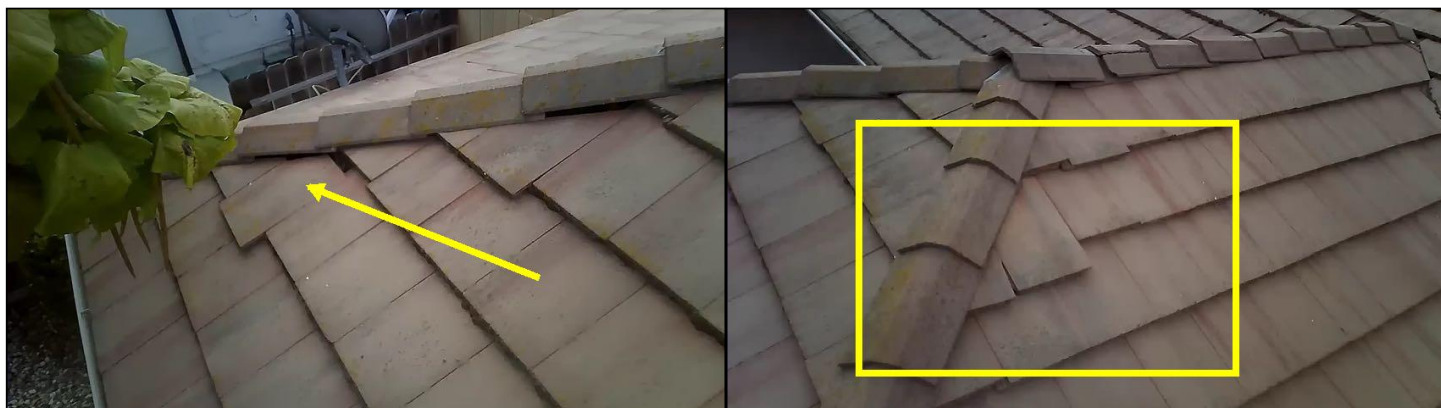
The roof had cracked and/or broken concrete roof tiles that should be replaced to help prevent damage from moisture intrusion to the home materials and the roof structure. The Inspector recommends that before the expiration of your Inspection Objection Deadline you consult with a qualified contractor to discuss options and costs for repairs.

Concrete tiles in some portions of the roof were slipping downhill. These tiles should be resecured to help prevent damage from moisture intrusion to the home materials and the roof structure. The Inspector recommends that any such tiles be replaced by a qualified roofing contractor using an appropriate adhesive.

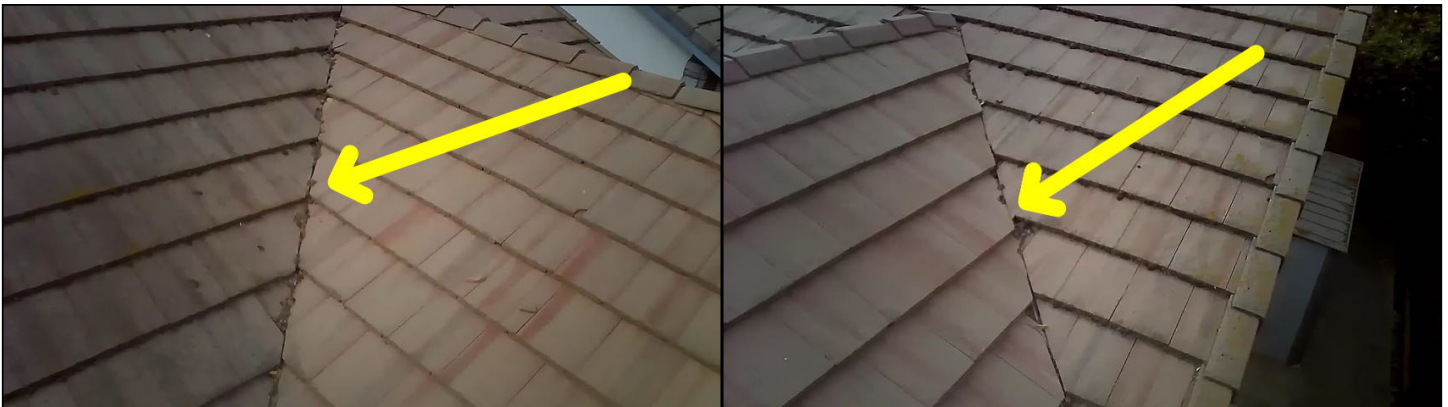
**Maintenance Needed:** Debris visible in the valley flashing at the time of the inspection should be removed to encourage proper drainage.

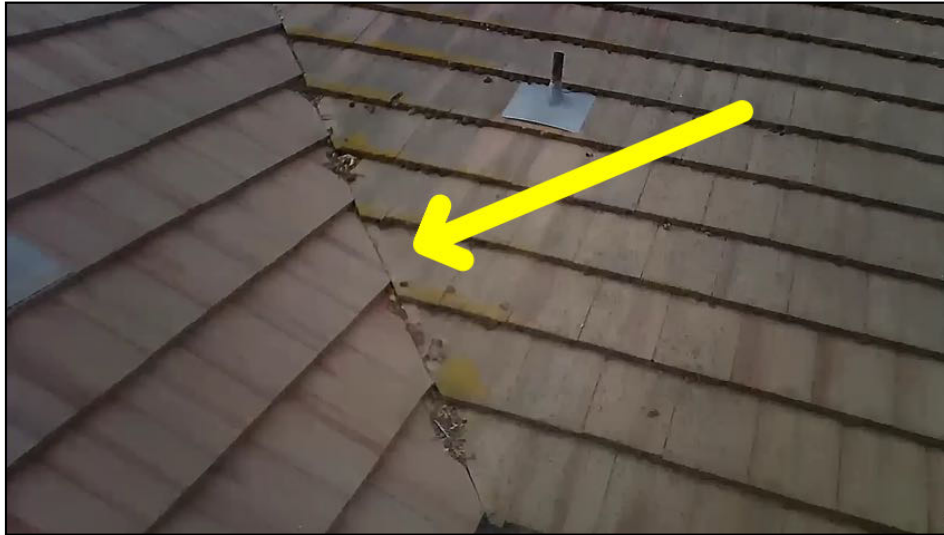
**Maintenance Needed:** Debris visible in the valley flashing at the time of the inspection should be removed to encourage proper drainage.

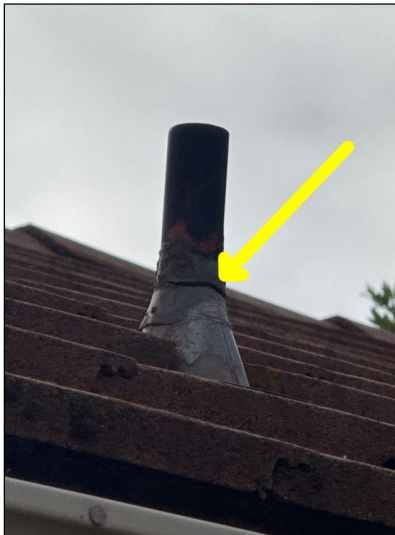
**Maintenance Needed:** Plumbing vent flashings are mastic covered and some are showing signs of cracked mastic/mastic deterioration from sun exposure. Recommend re-sealing all through the roof vents and projections as a part of routine maintenance to prevent unwanted moisture intrusion.

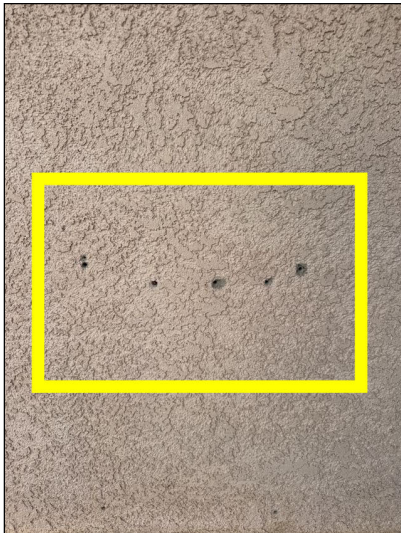
**Maintenance:** All gaps and holes in the stucco surface should be sealed to keep unwanted moisture out.

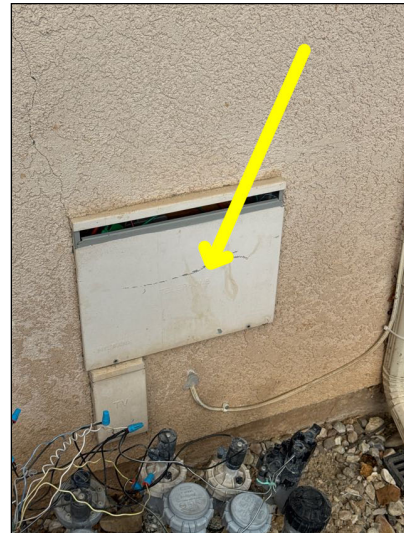
**Maintenance Needed:** Open/missing utility covers should be properly installed to keep unwanted moisture out of the exterior wall.

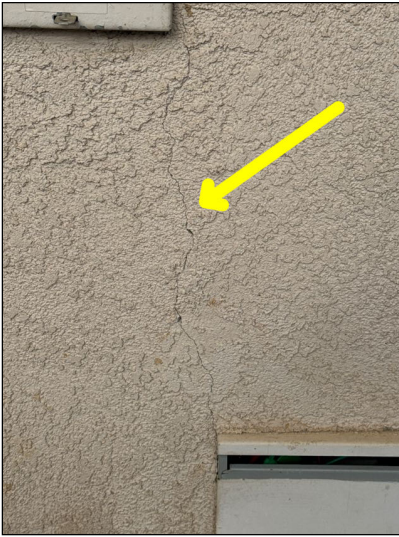
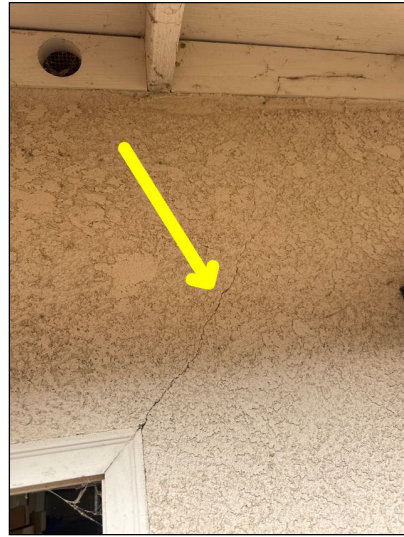
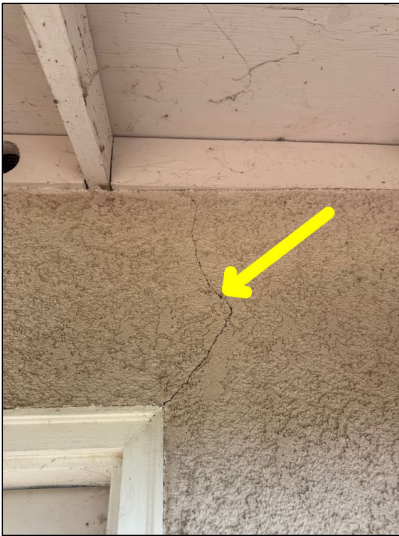
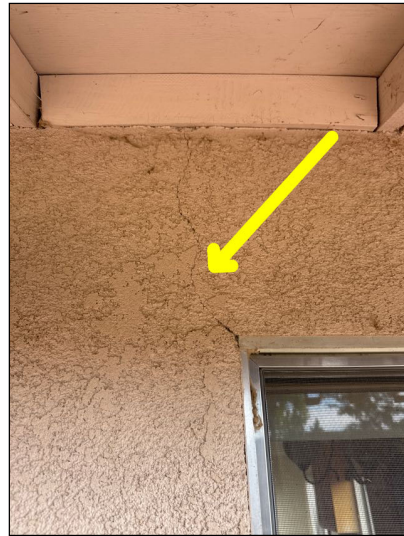
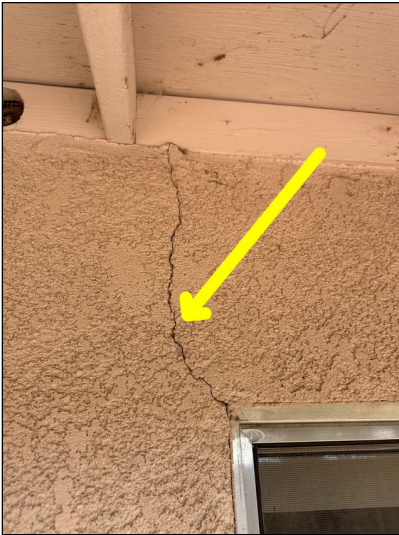
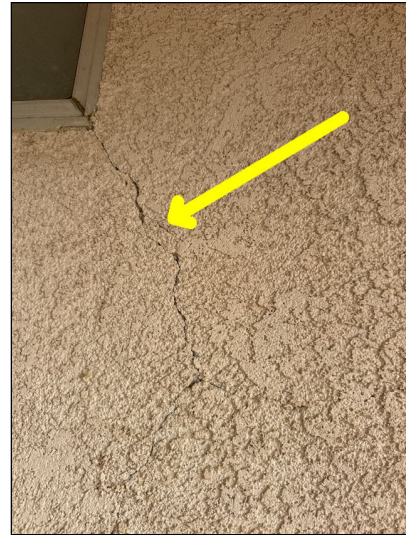
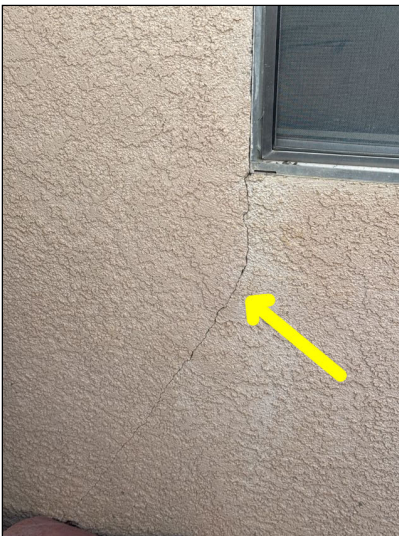
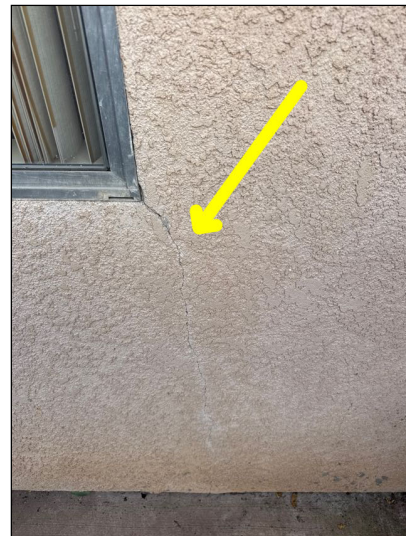
**Monitor:** Normal cracking was visible in stucco covering exterior walls of the home at the time of the inspection. This cracking appeared to be consistent with that caused by normal soil settlement. Settlement typically takes place in the first few years after original construction, and then stops. Cracks exceeding 1/16-inch (about the thickness of a penny) in width should be filled with an appropriate material to prevent future damage from moisture and monitored in the future for continued activity. Repainting with an Elastomeric paint on the stucco surface will help seal all surface cracks.

**Monitor:** Normal cracking was visible in stucco covering exterior walls of the home at the time of the inspection.

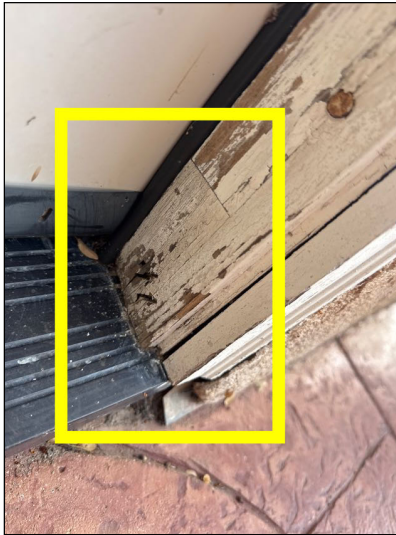
Moisture damage, wood rot, observed.

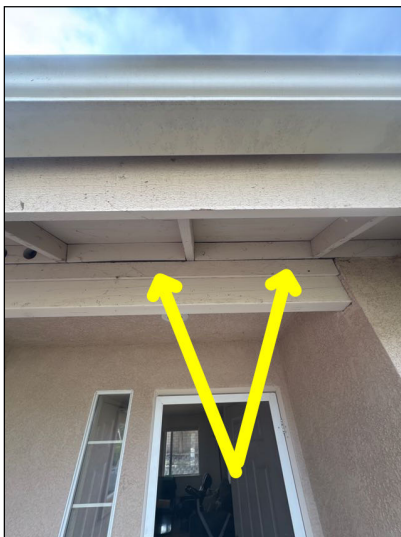
**Monitor:** The soffit was not sealed above the covered front entry at the time of the inspection. The Inspector recommends repair by a qualified contractor to prevent pests from entering the soffit space.

**Monitor:** The soffit was not sealed above the covered front entry at the time of the inspection.

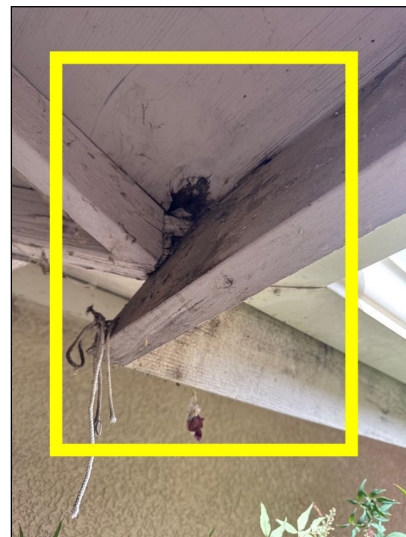
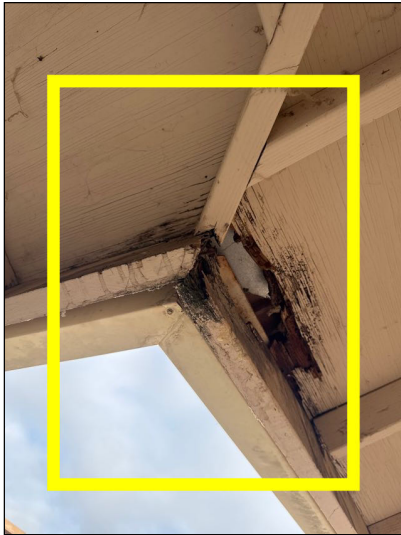
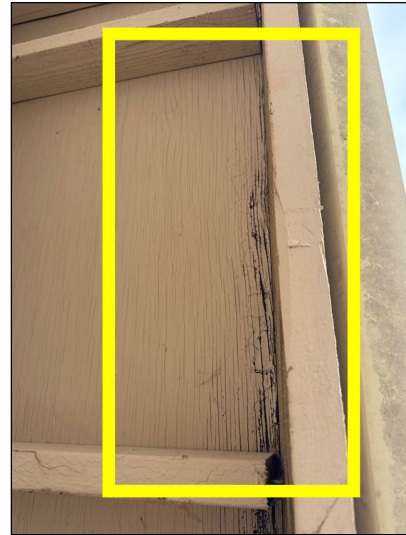
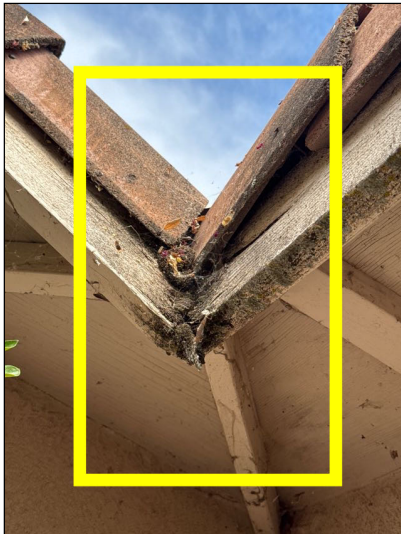
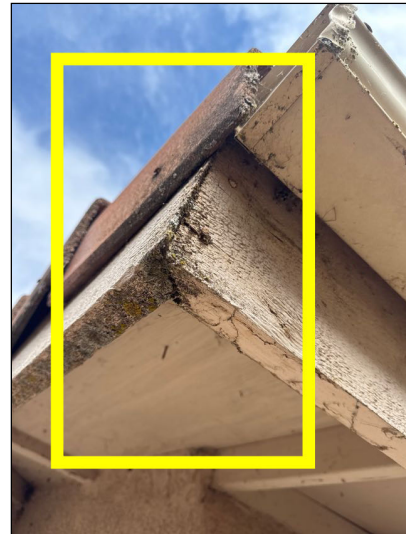
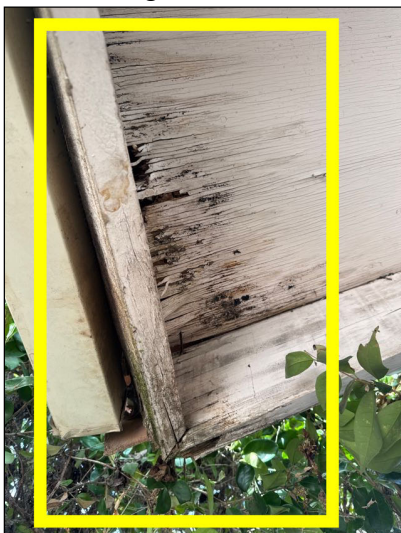
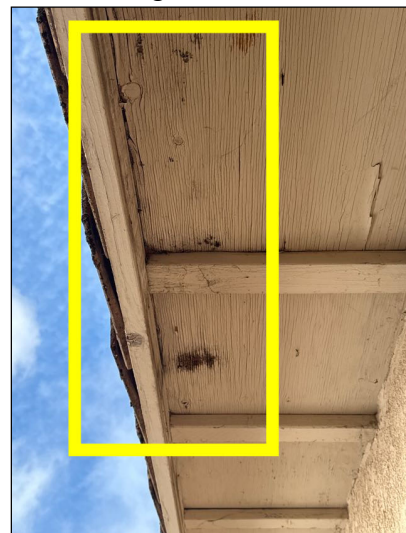
Moisture damage, wood rot, observed. Refer to pest report for further details and repair damage as needed.

Moisture damage, wood rot, observed.

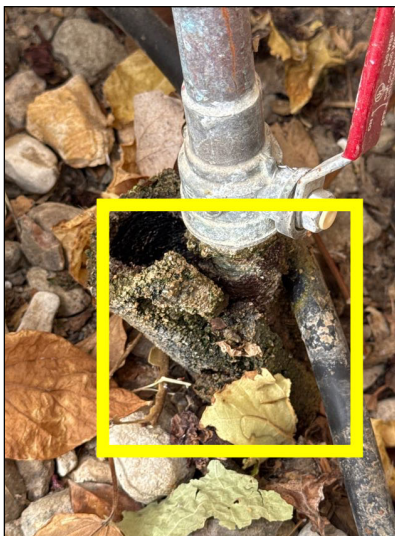
Actively leaking main water supply pipes visible at the main shut off should be repaired by a qualified plumbing contractor to avoid damage to home materials.

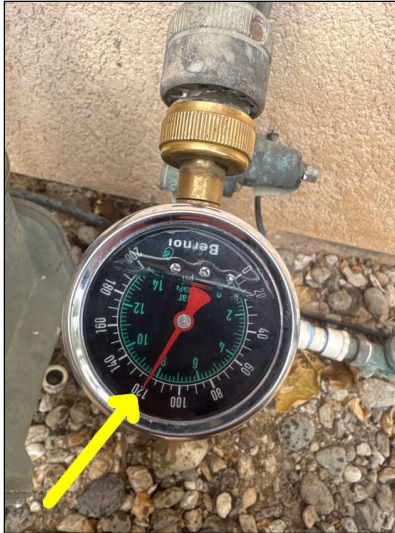
- **Monitor:** High pressure: Home water supply pressure exceeded the 80 pounds per square inch (PSI) limit considered the maximum allowable by generally-accepted current standards. Excessively high water pressure is likely to cause leaks. The Inspector recommends service by a qualified plumbing contractor.
- Recommend 40-80 PSI.
- Home water pressure measured 120 pounds per square inch (psi) at the time of the inspection.

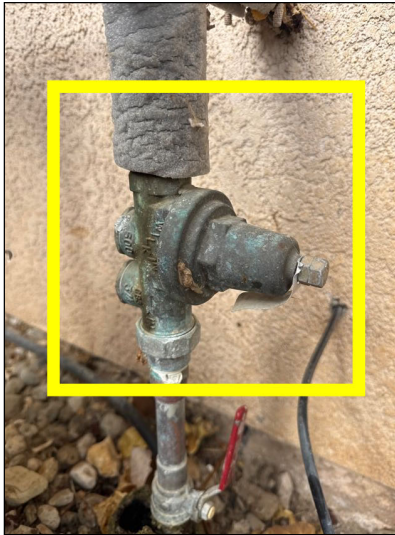
| | Page 20 Item: 5 | Pressure Regulator | <ul style="list-style-type: none"> <li>The pressure regulator appears to not be functioning due to water pressure over 75 PSI when tested. A pressure regulator is designed to regulate water pressure from the city water supply to between 25-75 PSI (they are factory set at 50 PSI). Recommend repair/replacement by licensed plumber.</li> </ul> |

The pressure regulator appears to not be functioning due to water pressure over 75 PSI when tested.

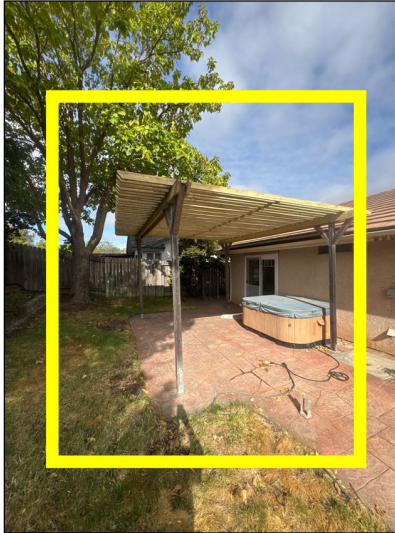
**-PATIO COVER TYPE**  
The patio was covered with an awning.
- PATIO COVER CONDITION**  
The structure covering the patio moved excessively when tested. The Inspector recommends that before the expiration of your Inspection Objection Deadline you consult with a qualified contractor to discuss options for stabilization costs.

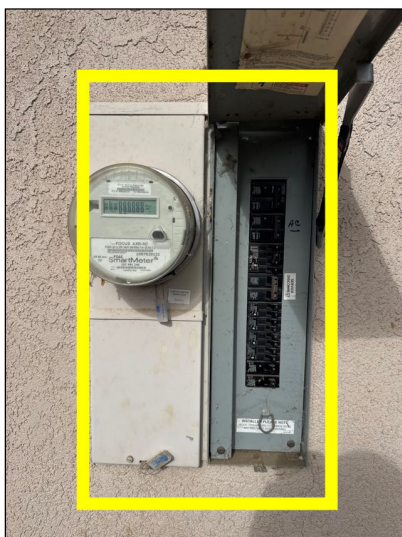
**Safety Improvement:** The Circuit Directory label identifying individual circuits at the service panel was illegible. The service panel should contain a clearly-marked label identifying individual circuits so that in an emergency, individual circuits can be quickly shut off. The Inspector recommends that a properly-marked Circuit Directory label be installed by a qualified electrical contractor.

Main electrical service panel to the home.

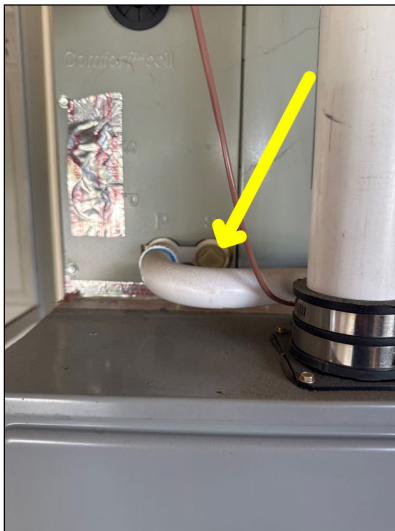
**Monitor:** No secondary condensation tube was installed. Instead, the outlet was left plugged. The secondary line is a backup line, so if the primary line gets clogged, the condensate water will then go through the secondary line. The Inspector recommends installation of a secondary condensate drain pipe by a qualified HVAC contractor.

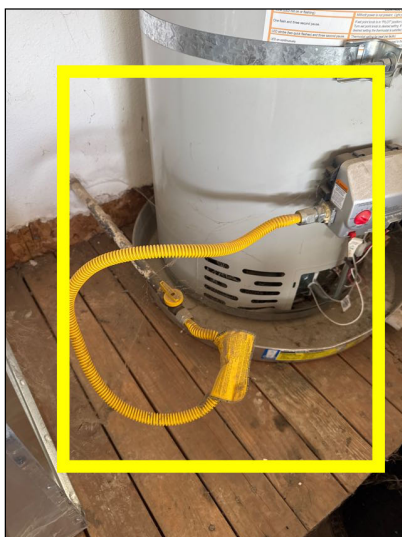
**Recommended Improvement:** The gas supply pipe contained no sediment trap. The purpose of a sediment trap is to prevent sediment or debris particulates from entering and clogging the water heater gas valve, which can cause the water heater to shut down. You may wish to consult with local contractor concerning the advisability of installing a sediment trap in the gas line.

**Improvement:** The gas supply pipe contained no sediment trap.

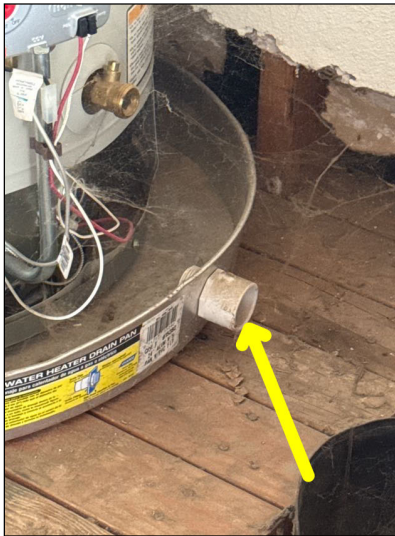
**Monitor:** The drain pipe serving this water heater drain pan had no overflow extension. To reduce the potential for damage from a leaking tank or pipe fittings, the drip pan should have an overflow pipe installed that discharges to the home exterior or just above the floor. The Inspector recommends correction by a qualified plumbing contractor.

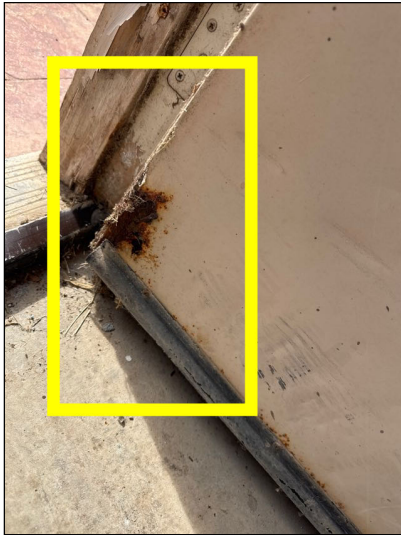
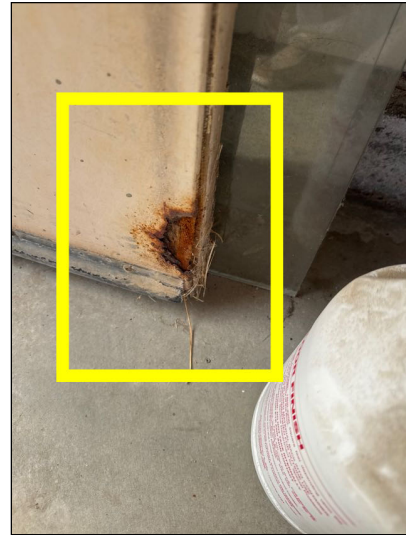
The exterior exit door in the garage had moisture damage, wood rot, observed.

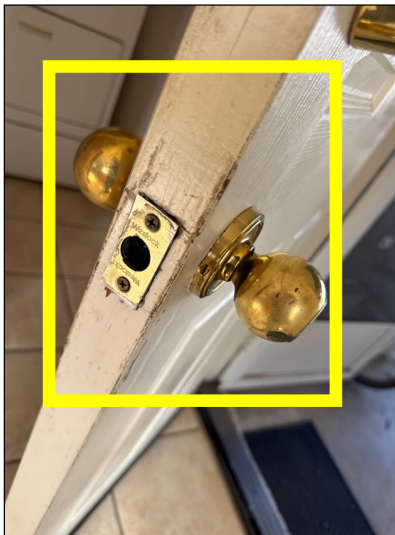
The fire door between the garage and the home had inoperable hardware at the time of the inspection. The Inspector recommends that the door hardware be brought into good operating condition by a qualified contractor.

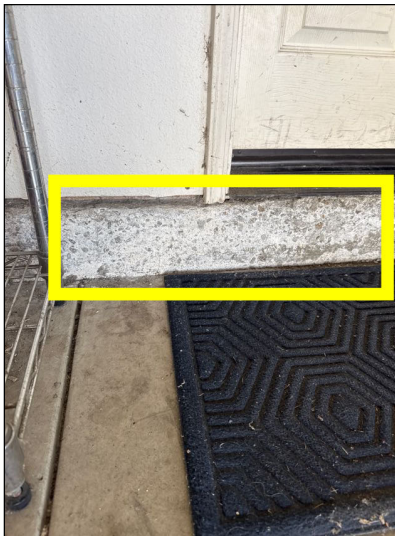
The interior of the garage concrete curb had efflorescence visible. Efflorescence is a white powdery substance left by water seepage through masonry and is typically caused by moisture intrusion, often the result of negative exterior grade. While moderate amounts of efflorescence will not damage concrete, long term moisture intrusion may result in deterioration of the concrete. The source of moisture should be identified and corrected.

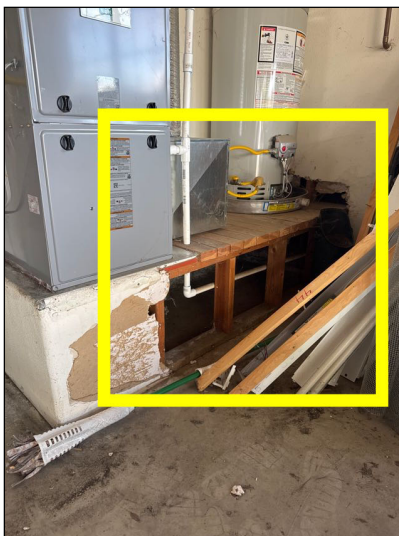
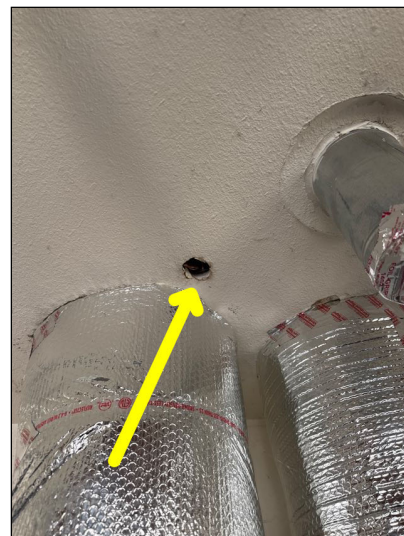
The garage wall had holes missing drywall at the time of the inspection. These areas should be repaired to provide an intact fire-resistant barrier between the garage and home living space.

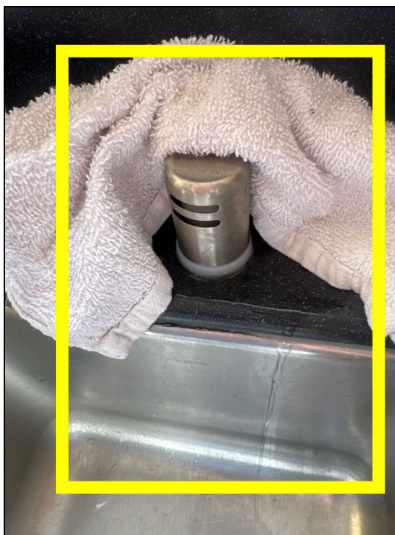
- The dishwasher drains from the **air gap**. This is normally due to a kink or blockage in the drain line from the air gap to the tail piece drain assembly below the sink. The air gap may need to be cleaned, or the drain line below the sink may be plugged.

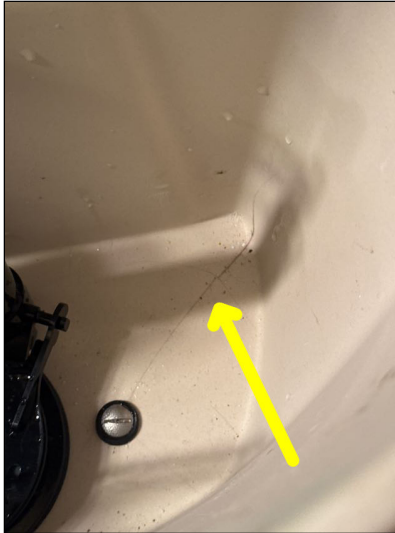
**The toilet tank was cracked and was leaking at the time of the inspection. The water supply to the toilet should be shut off and the toilet repaired or replaced to avoid damage to home materials.**

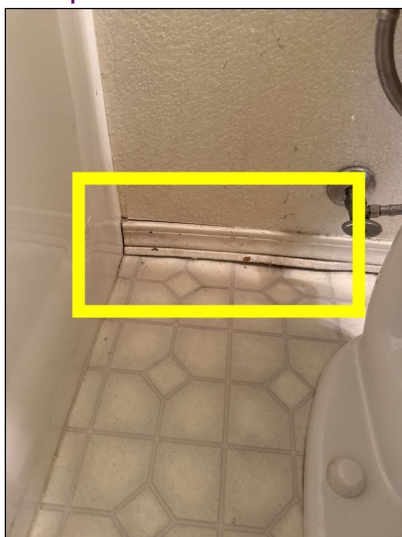
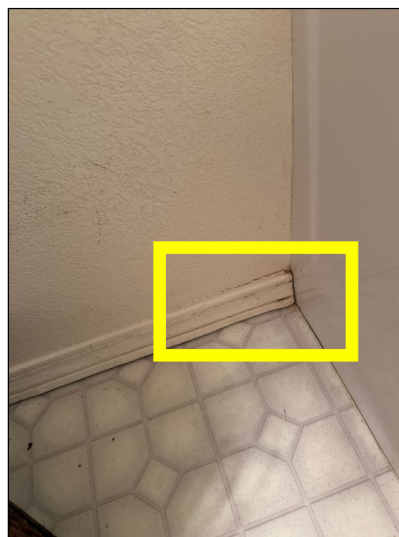
- **Monitor:** Evidence of past water intrusion on the baseboards next to the tub/shower. Probable cause from water escaping past shower curtain/door when shower is in uses. Tested dry at the time of inspection.

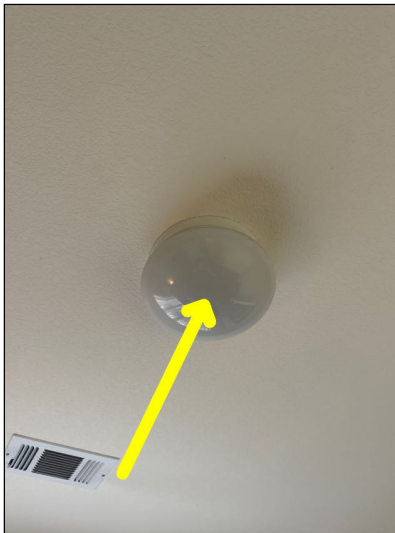
- A ceiling light fixture in the bedroom did not respond to the switch. The bulb may need to be replaced or there may be a problem with the switch, wiring or light fixture. If after the bulb is replaced this light still fails to respond to the switch, this condition may be a potential fire hazard and the Inspector recommends that an evaluation and any necessary repairs be performed by a qualified electrical contractor.

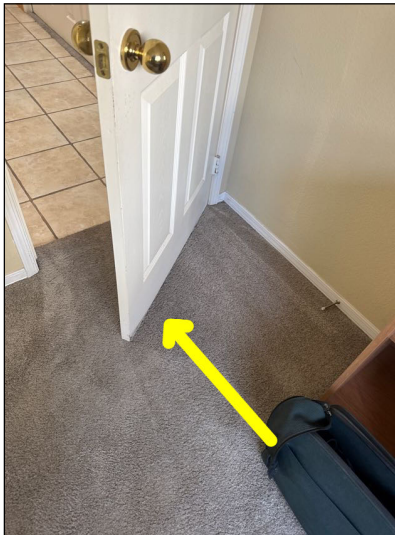
- The door to this bedroom rubbed on the carpet and needed to have the bottom cut and a sweep installed. All work should be performed by a qualified contractor.

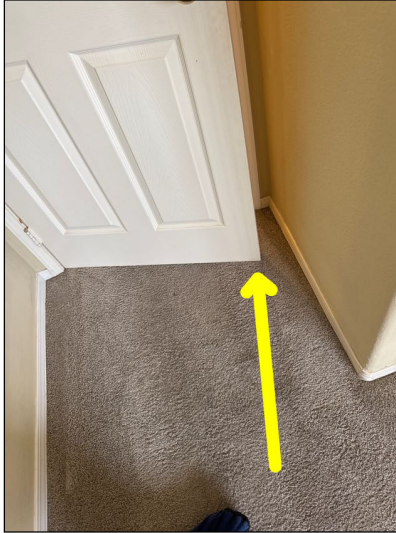
- At the time of the inspection, the Inspector observed few deficiencies in the condition of interior doors in this bedroom. Notable Exceptions are listed.
- The door to this bedroom rubbed on the carpet and needed to have the bottom cut and a sweep installed. All work should be performed by a qualified contractor.
