## Home Inspection Report

**4011 Marron St**

**San Diego, CA 92115**

Inspected On: Mon, Sep 28 2026 at 8:00AM

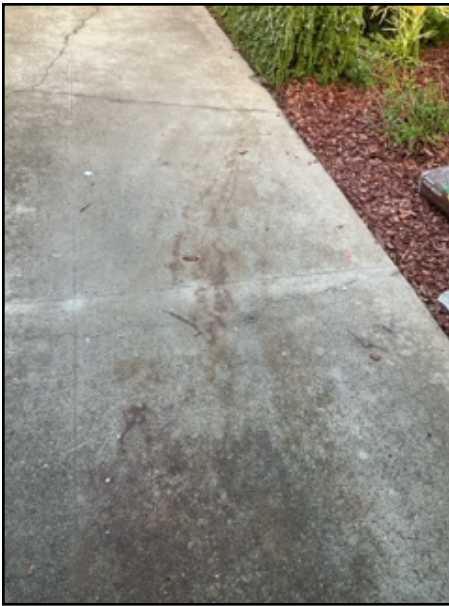
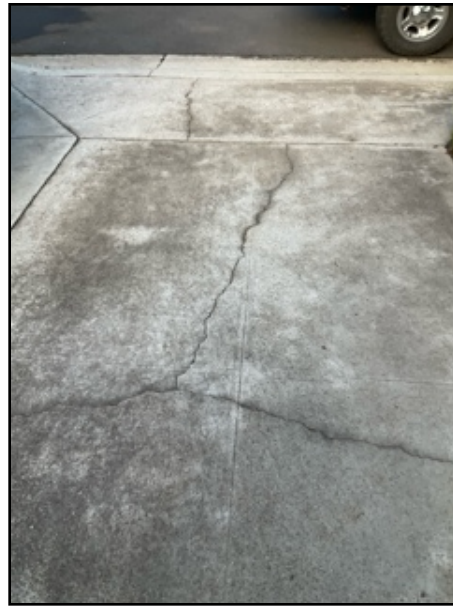
Cracks, stains and uneven surfaces noted at driveway, walkways and patio.

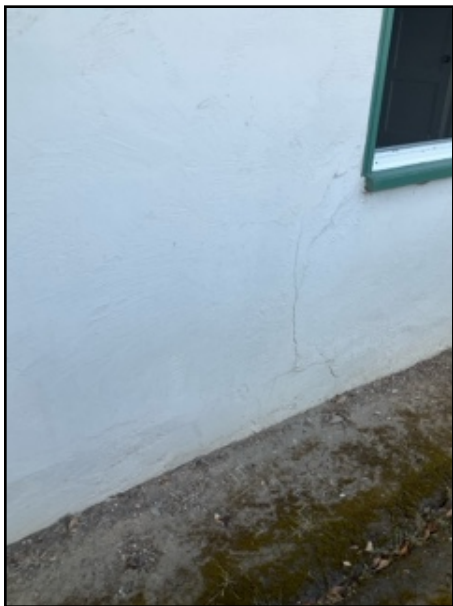
Figure 6-1

**Comment 6:**  
Defects such as peeling, holes, cracks, and patches noted at various places throughout exterior.

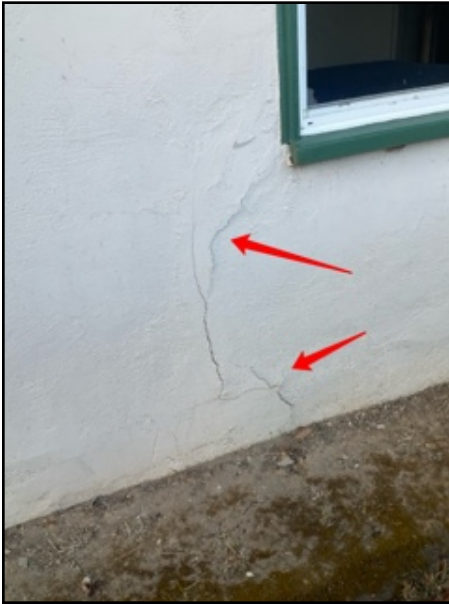
Figure 7-1

**FURTHER EVALUATION REQUIRED:** Large crack noted on north side of home. Evidence a possible movement in this corner. Have a more qualified professional to evaluate.

Possible old ficas tree on this side of yard.

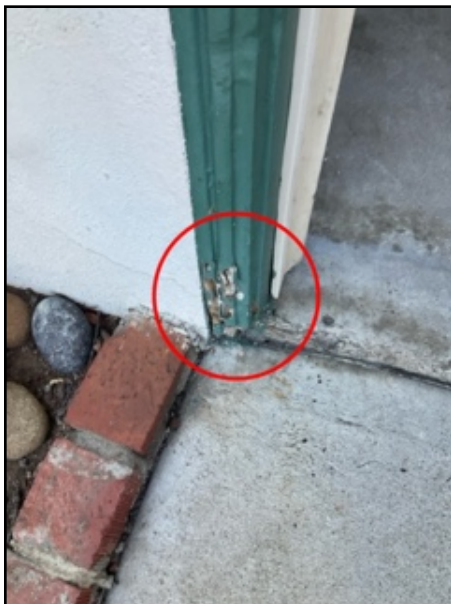
Figure 8-1

Evidence of possible wood destroying organisms / dry rot noted at the exterior wood around garage door.

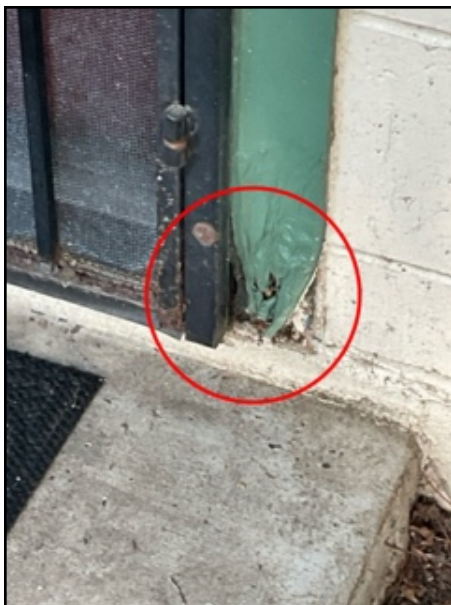
Figure 9-1

Evidence of possible wood destroying organisms / dry rot noted at the exterior.

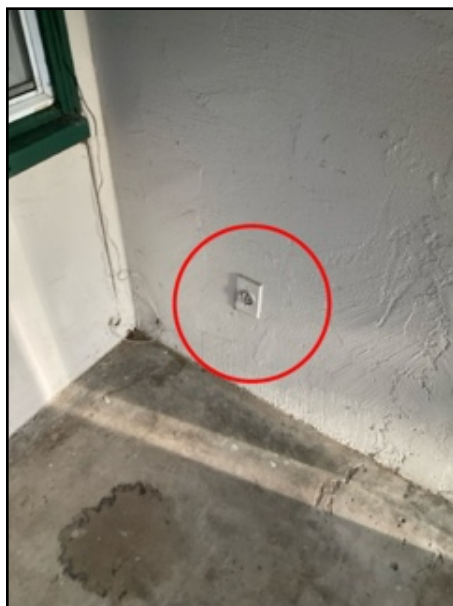
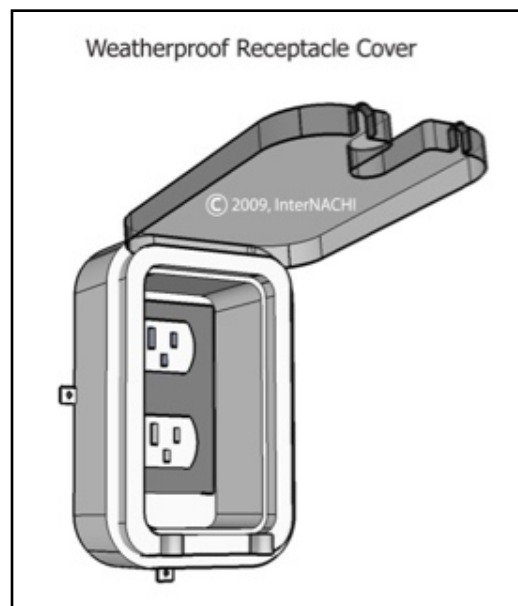
REPAIR OR REPLACE: Exterior outlet noted as missing cover.

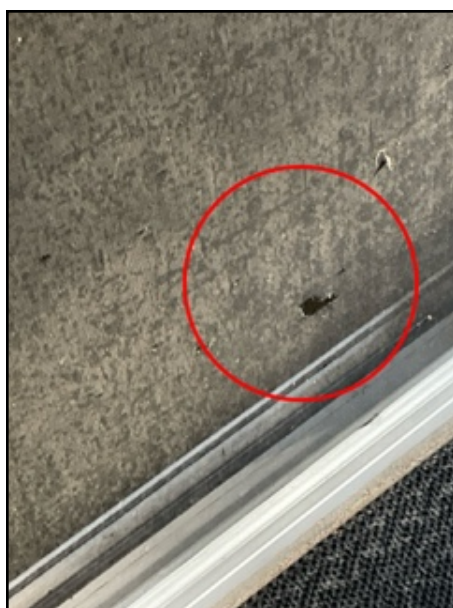
Figure 11-1

REPAIR OR REPLACE: Patio screen door noted is torn.

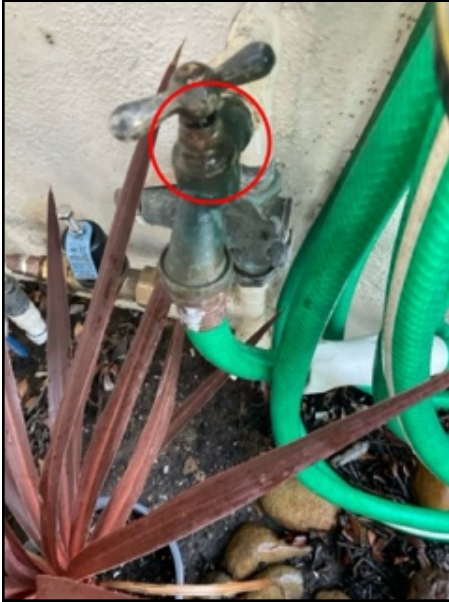
Figure 12-1

**Comment 12:**  
**REPAIR OR REPLACE:** Water noted as leaking out of water faucet handle on exterior.

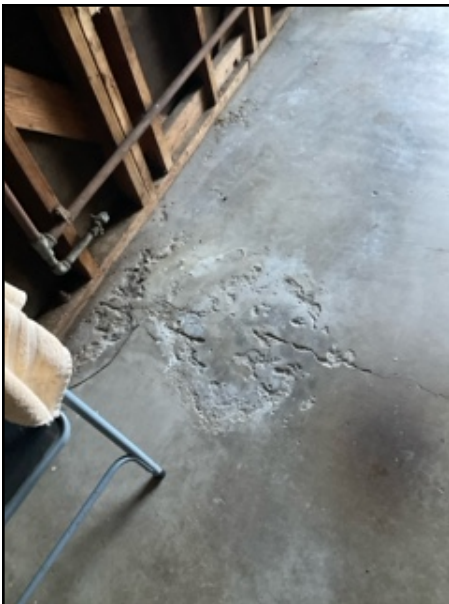
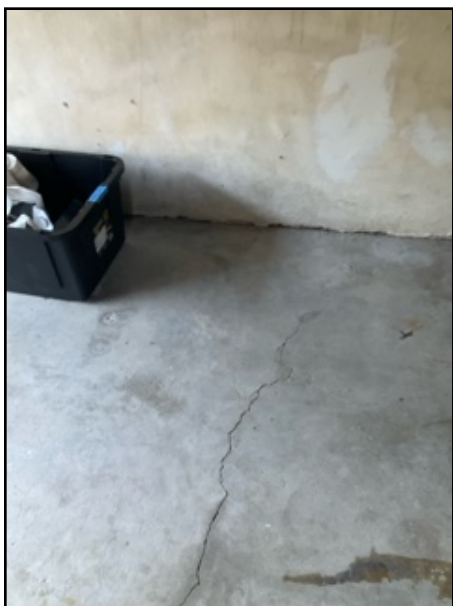
Comment 14:  
Cracks and stains noted at garage floor.

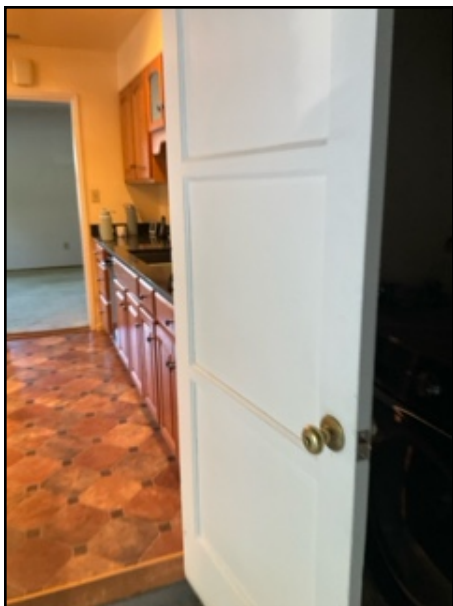
Figure 15-1

**REPAIR OR REPLACE:** Garage entry doors are required to have at least a 20-minute fire rating or be solid wood of at least 1-3/8 inches thick with a self-closing hinge that closes the door completely against weatherstripping and the door latches secure for fire safety compliance.

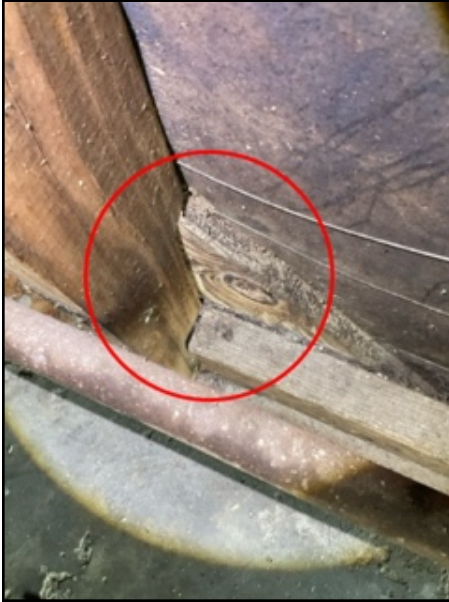
Figure 16-1

**Comment 16:**  
**FURTHER EVALUATION REQUIRED:** Evidence of possible wood destroying organisms noted at various locations on garage, wood framing.

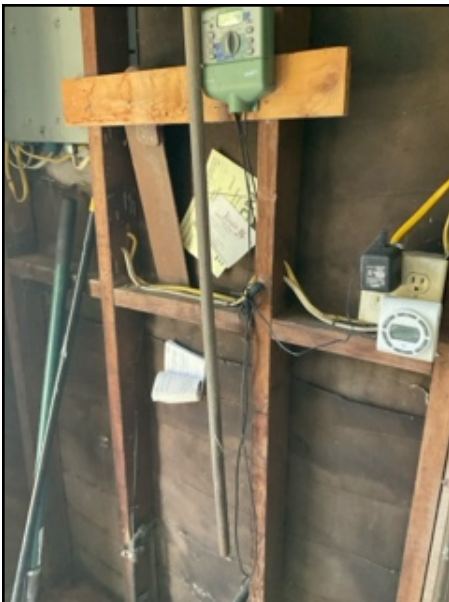
Figure 17-1

**Comment 17:**  
**FURTHER EVALUATION REQUIRED:** Exposed wires under 7 feet noted in garage.

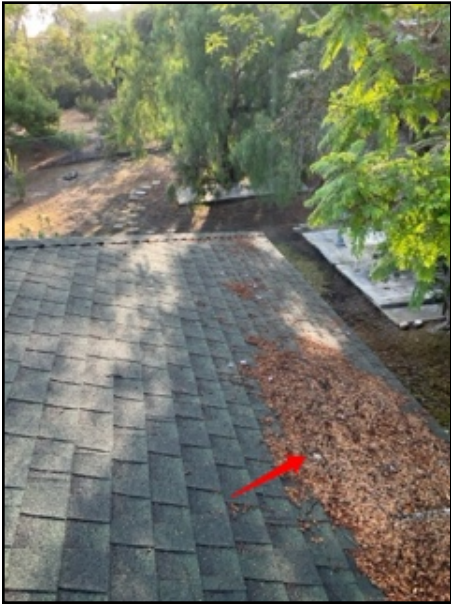
Figure 19-1

**REPAIR OR REPLACE:** Asphalt shingles noted as deteriorated at various locations. Torn shingle noted on ridge cap. Expose nails noted on ridge cap. Mastic around vent pipes noted as cracked and deteriorated. Fiberglass noted is showing around. Edges on southside. Tree debris noted on roof at various locations. As vouching goes noted as brittle. Have a more qualified professional to evaluate.

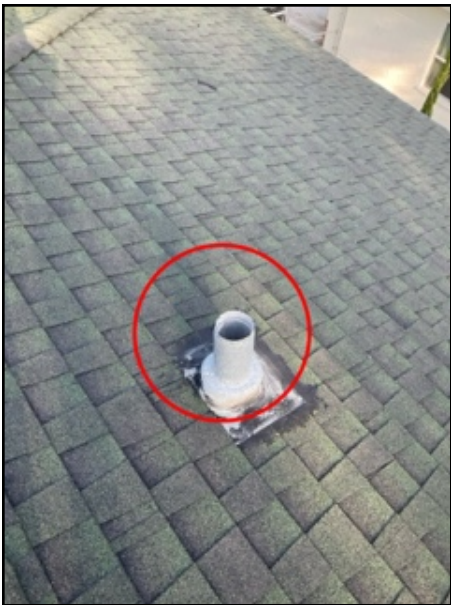
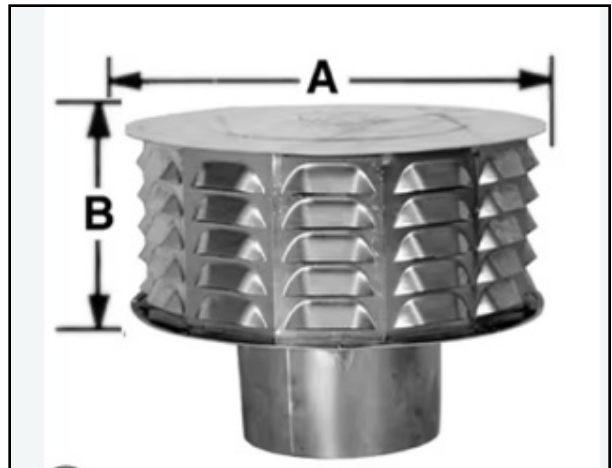
REPAIR OR REPLACE: Rain cap top over ducting for furnace noted as missing on roof.

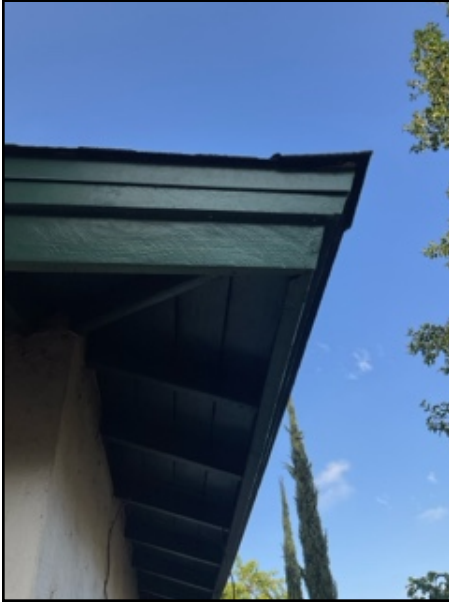
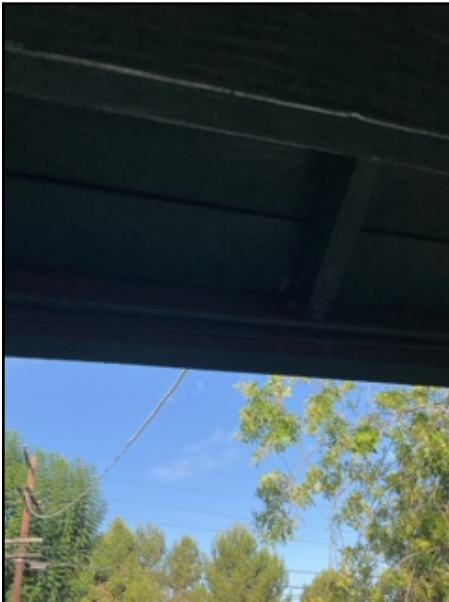
**Comment 21:**  
**FURTHER EVALUATION REQUIRED:** Evidence of possible wood destroying organisms / dry rot noted on soffit and/or fascia.

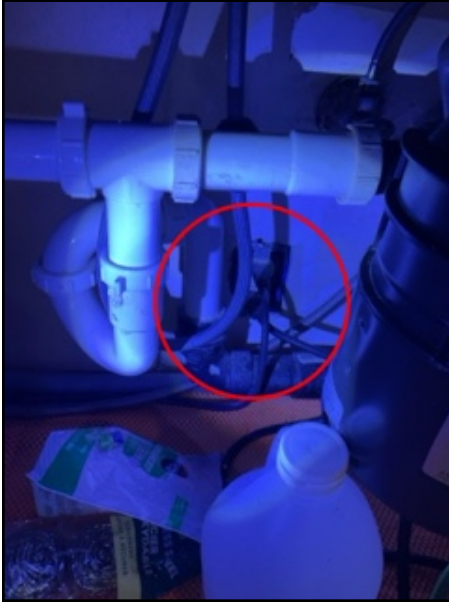
Figure 25-1

REPAIR OR REPLACE: Electrical outlet underneath kitchen sink noted as missing cover.

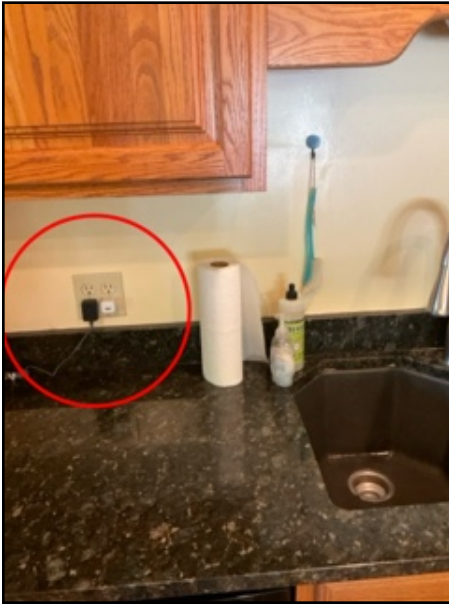
Figure 26-1

REPAIR OR REPLACE: Changes to building code in the mid-1980s requires any outlet within three feet of a water source (such as a kitchen sink) to be GFCI. No retrofit requirement is known at the time of inspection. Due to the age of the property, GFCI outlets may not have been required at the time of construction. However, when replacing outlets near a water source, compliance with modern standards is required. The kitchen sink outlets appear to have been replaced, therefore, GFCI outlets noted as not present next to kitchen sinks. These outlets will need to be replaced with properly protected outlets.

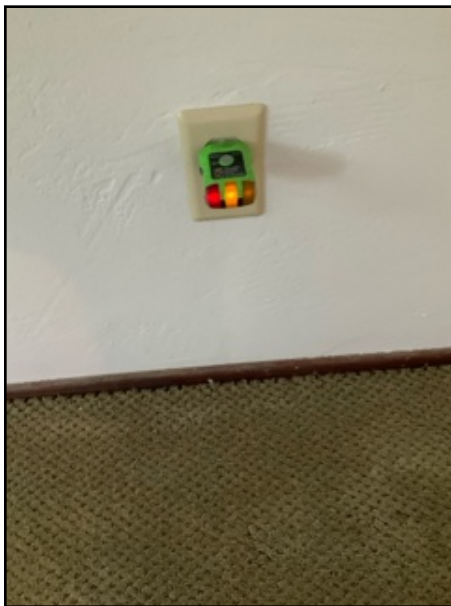
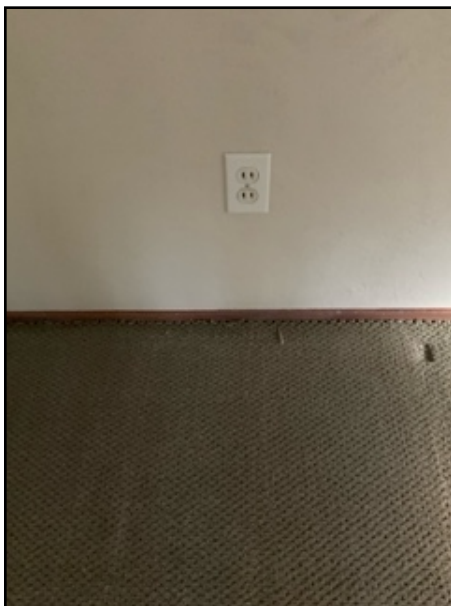
Partial outlets noted as hot and neutral wire is reversed.

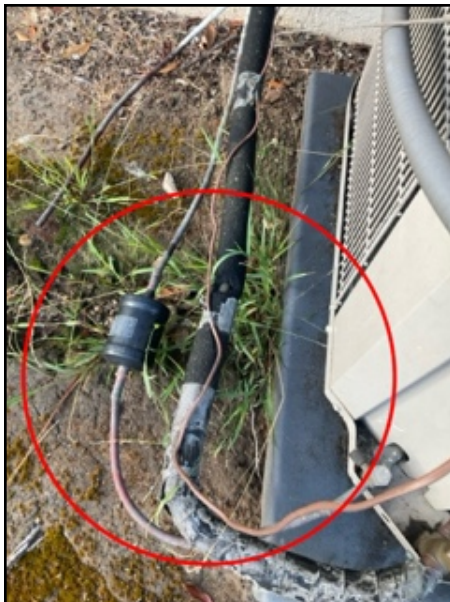
Figure 36-1

Comment 36:  
REPAIR OR REPLACE: Insulation around AC refrigerant line noted as torn and deteriorated.

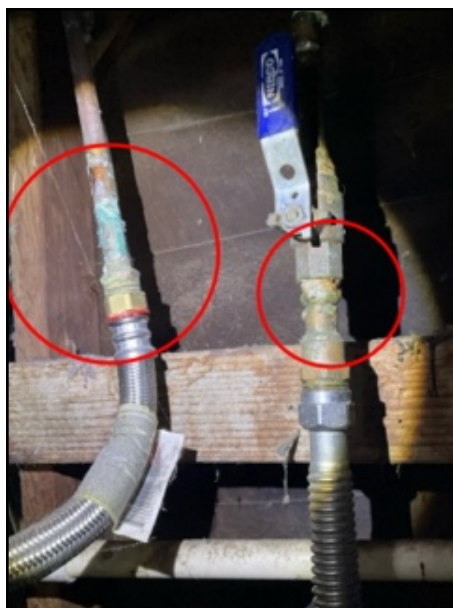
Figure 46-1

REPAIR OR REPLACE: Waterlines off water heater noted as corroded.

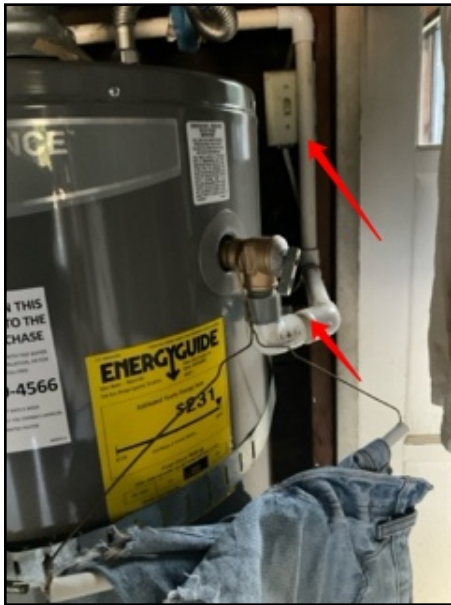
Figure 47-1

REPAIR OR REPLACE: Blow off valve drain leg/discharge pipe noted not installed or improperly installed at time of inspection. Discharge pipe needs to either go down to a drain or outside and terminate 2 to 6 inches above the floor or a waist receptor. Discharge pipe must match the valve outlet size (usually 3/4 inch) and never be plugged or capped.

TPR drain line noted as sloping upward.

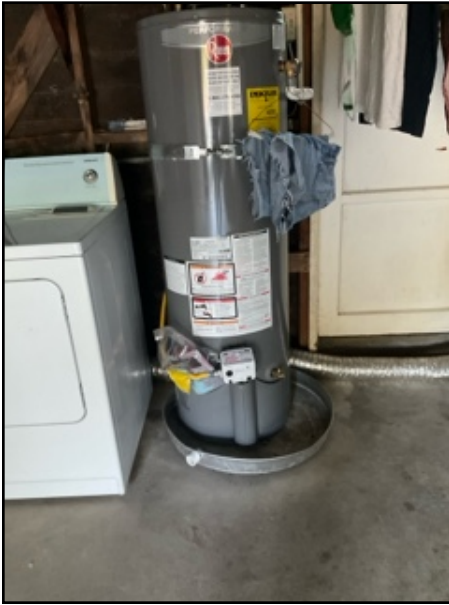
Figure 48-1

REPAIR OR REPLACE: Water heaters located in the garage are required their ignition source (pilot light, burner or heating element) elevated at at least 18 inches above the floor. The safety requirement prevents the ignition of flame vapors such as gasoline or paint fumes that tend to accumulate near the ground.

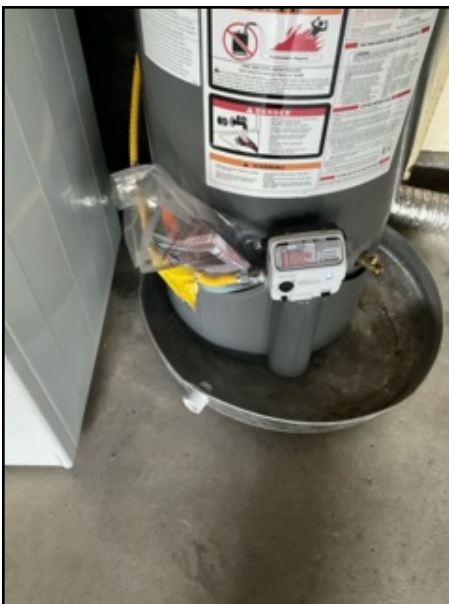
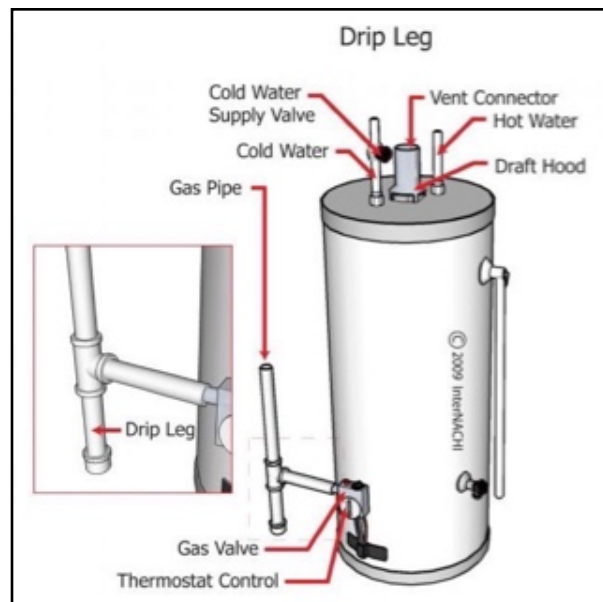
**REPAIR OR REPLACE:** Gas sediment trap noted not present or installed improperly at time of inspection. Sediment trap is designed to catch debris, rust, and moisture and gas line to help prevent clogging and/or damage to appliance burners and valves. Sediment trap should be installed as close as possible to the appliance inlet as possible.

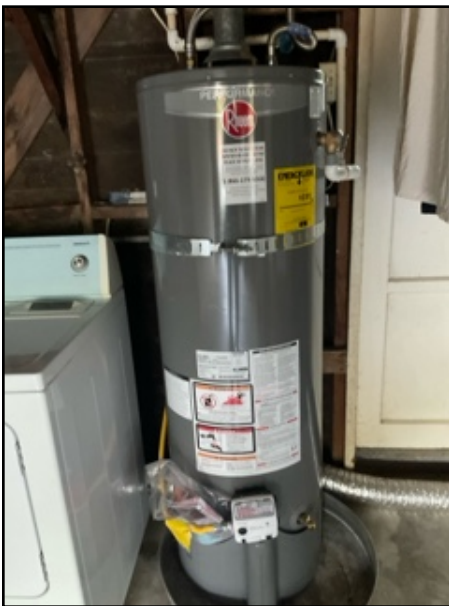
Figure 50-1

**REPAIR OR REPLACE:** Insufficient seismic strapping noted not installed or loose. Seismic straps are essential to prevent water heaters from tipping over during an earthquake, which can cause severe and costly damage including ruptured gas lines (leading to fire or explosion), water leaks and broken pipes. Seismic straps should be properly anchored and placed in the upper third and lower third of the tank.

Only one size mixed strap noted as installed.

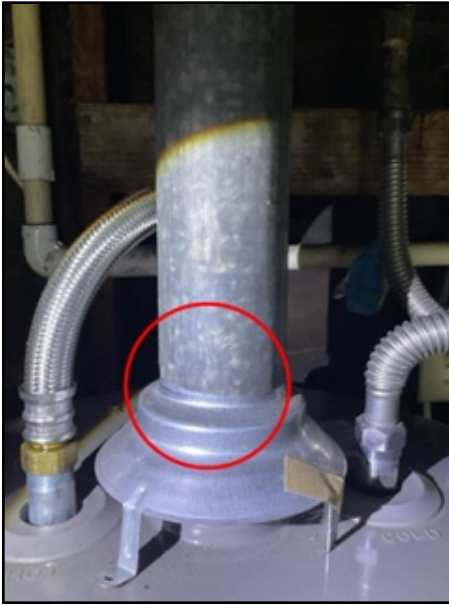
Figure 51-1

**REPAIR OR REPLACE:** Water heater flue noted as not securely fastened with sheet metal screws.

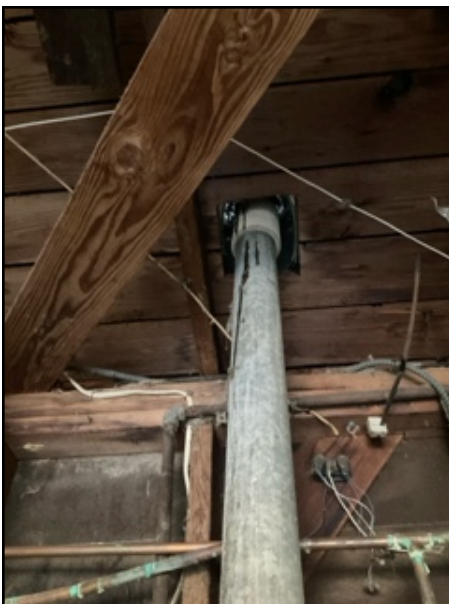
Figure 52-1

**FURTHER EVALUATION REQUIRED:** Apparent Transite exhaust ducting noted at water heater. This type of pipe is common in older homes and when intact and undisturbed generally does not pose an immediate health risk. Recommend leaving the material undisturbed and monitoring for damage. If removal, repair or invasive work is planned, engage in more qualified professional for further evaluation.

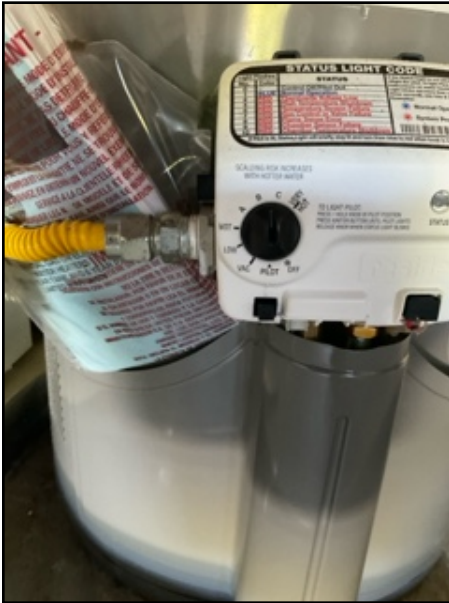
Figure 53-1

Water temperature was 141°F. Most appliance manufacturers recommend a temperature of around 120°F. Generally temperatures above 130°F are considered unsafe.

**FURTHER EVALUATION REQUIRED:** Thermostat on water heater noted as set to second high setting at time of inspection. Water temperature reach 141°F. Inspector recommends turning down thermostat to recommended manufactured setting.

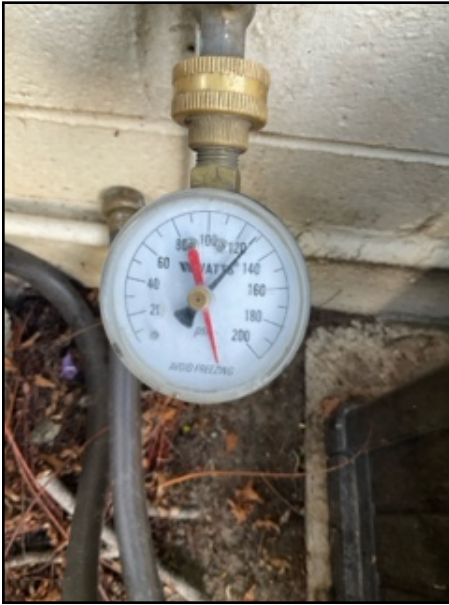
Figure 54-1

**REPAIR OR REPLACE:** Water pressure is 130 psi. Most appliance manufacturers recommend pressure to be set between 40 and 80 psi.

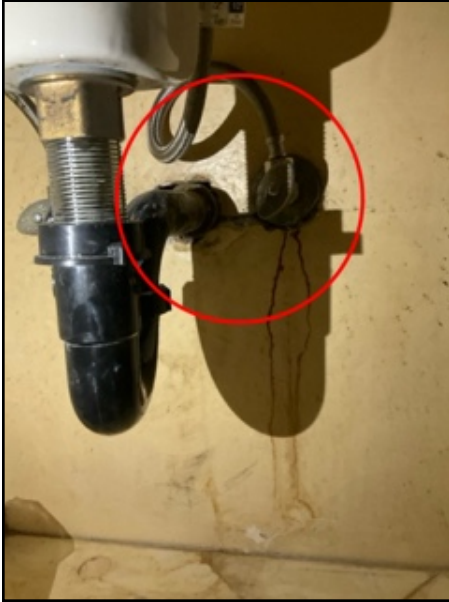
Figure 55-1

REPAIR OR REPLACE: Plumbing penetrations underneath sink noted is not sealed to wall. Evidence of possible previous plumbing leak noted.

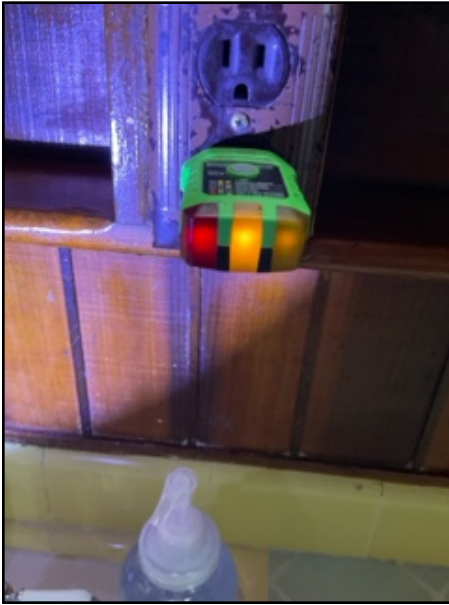
Figure 56-1

Electrical outlet noted as hot and ventral wires reversed.

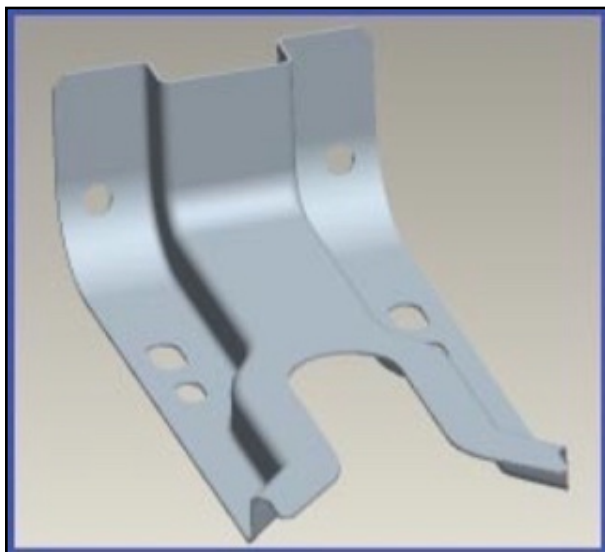
Figure 58-1

As of 2012 anti-tip devices are required to be installed on all new range installations. Age of range is unknown. Anti tip device not installed at range.

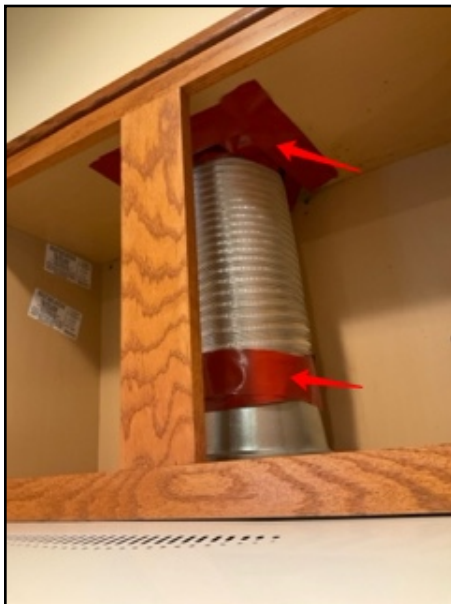
Figure 59-1

REPAIR OR REPLACE: Ducting for range hood noted as sealed with duct tape. HVAC metal tape should be used.

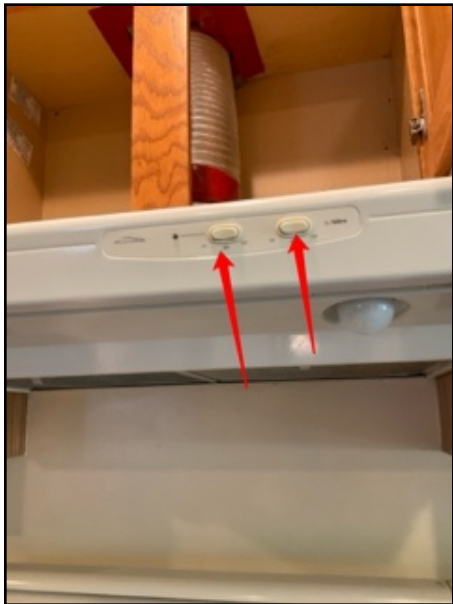
Figure 60-1

**Comment 60:**  
REPAIR OR REPLACE: Range hood buttons noted as not working at time of inspection.

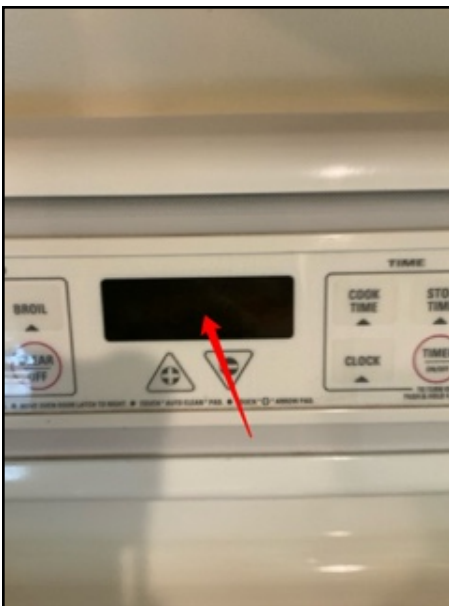
Figure 63-1

Comment 63:  
REPAIR OR REPLACE: Display on range not as difficult to read.

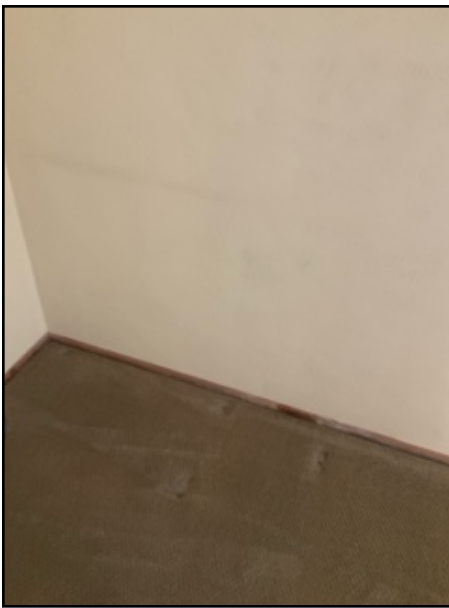
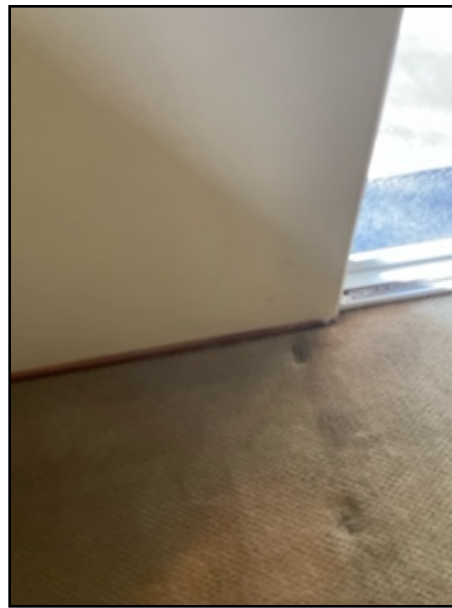
Minor paint, drywall damage, burned out bulbs, broken/missing covers and other minor cosmetic defects noted at various locations throughout the home.

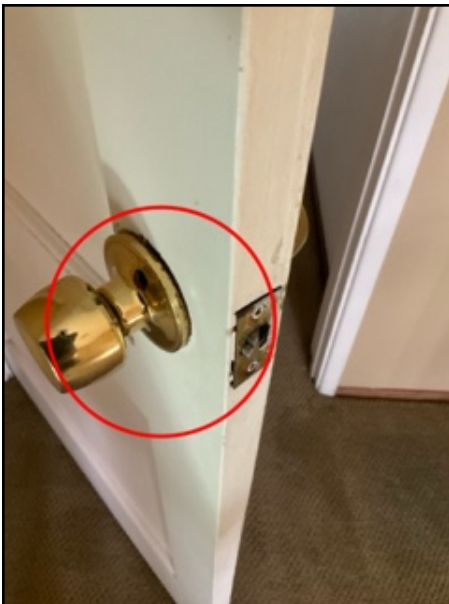
Figure 70-1

REPAIR OR REPLACE: Door handle to back bedroom noted as broken.

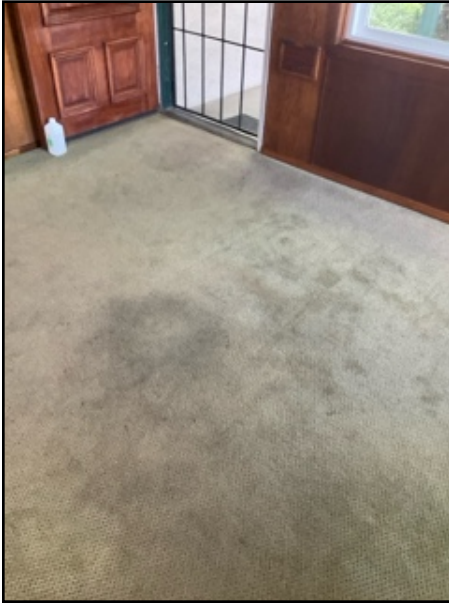
Figure 71-1

REPAIR OR REPLACE: Carpet noted as stained at various locations.

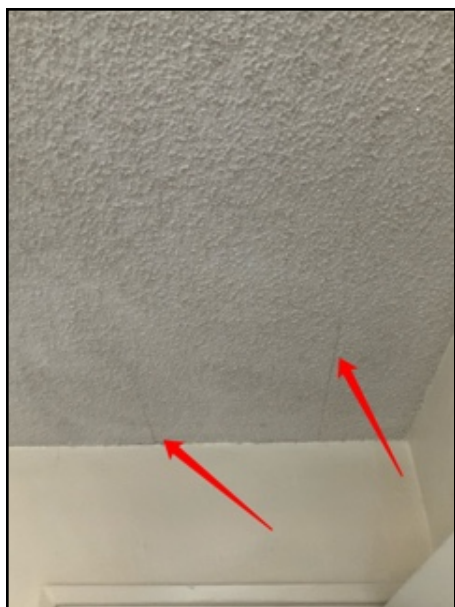
Figure 74-1

REPAIR OR REPLACE: Ceiling drywall noted as cracked in small bedroom. This is approximate area where furnace was installed in attic.

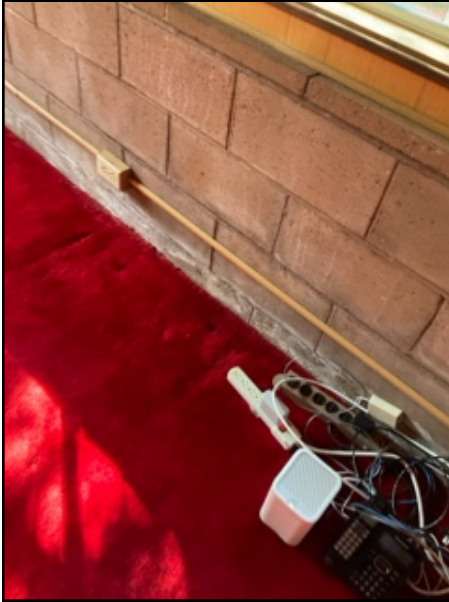
Figure 75-1

FURTHER EVALUATION REQUIRED: Effluorescence noted on cinderblock wall in converted patio. Floor flooring noted as uneven under carpet.
