# PROPERTY INSPECTION REPORT

**FOUR POINT**  
HOME INSPECTION INC.

**904 Salida del Sol Dr**  
**Inspection Prepared For: Don Ellis**  
**Agent: -**

**Date of Inspection: 9/21/2026**  
**Year Built: 2005 Size: 3029**  
**Weather: Mild/Light rain**

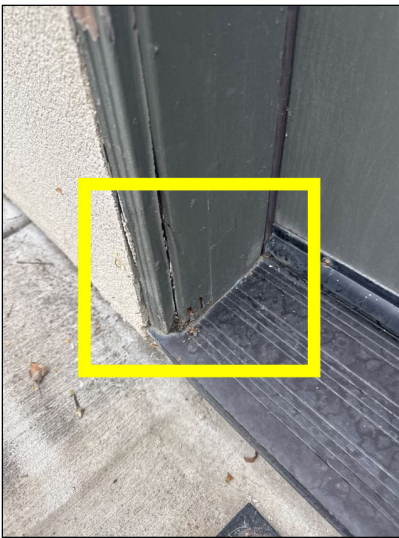
| | Page 14 Item: 2 | Trim Condition | • Moisture damage, wood rot, observed. Refer to pest report for further details and repair damage as needed. |

- Moisture damage, wood rot, observed. Refer to pest report for further details and repair damage as needed.

Moisture damage, wood rot, observed.

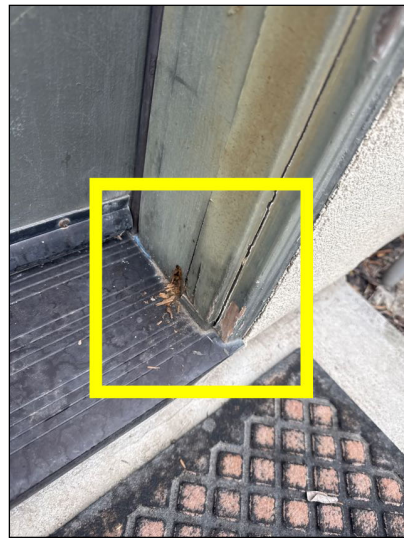
Moisture damage, wood rot, observed.

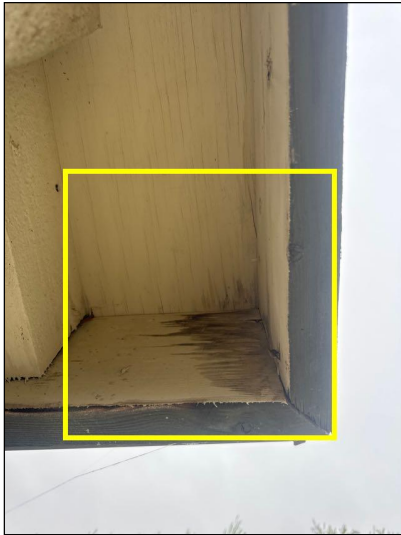
**Monitor:** Home soffits had stained areas visible at the time of the inspection indicating past roof leakage. The Inspector observed no deficiencies in the condition of the roof-covering material above these areas, indicating that the source of leakage has been corrected.

**Monitor:** Home soffits had stained areas visible at the time of the inspection indicating past roof leakage.

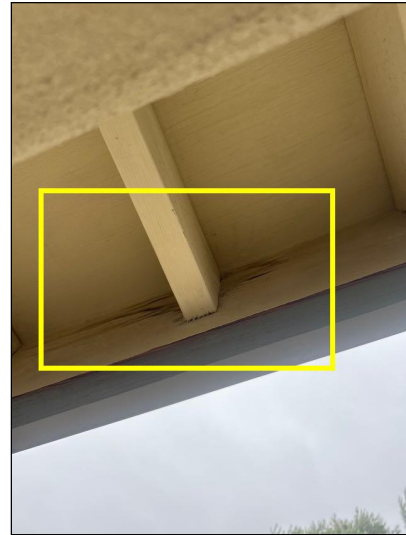
**Monitor:** Home soffits had stained areas visible at the time of the inspection indicating past roof leakage.

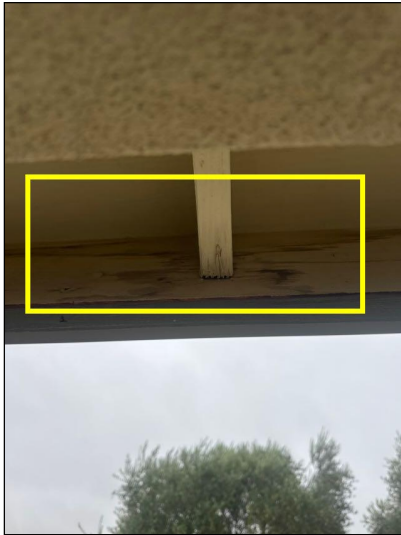
**Monitor:** Home soffits had stained areas visible at the time of the inspection indicating past roof leakage.

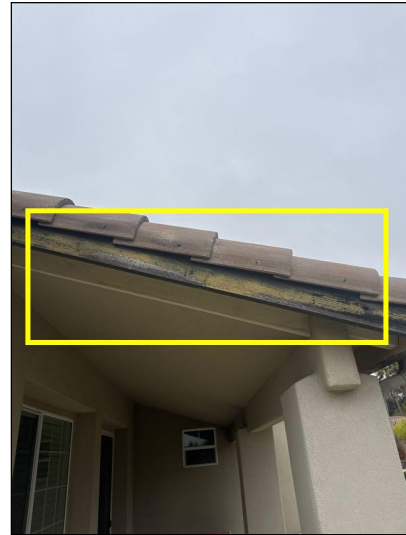
**Maintenance Needed:** Fascia had peeling paint and needed maintenance. All work should be performed by a qualified contractor.

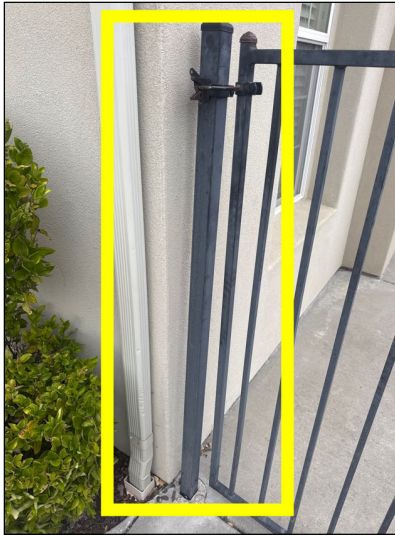
Gate post was loose and needed to be resecured.

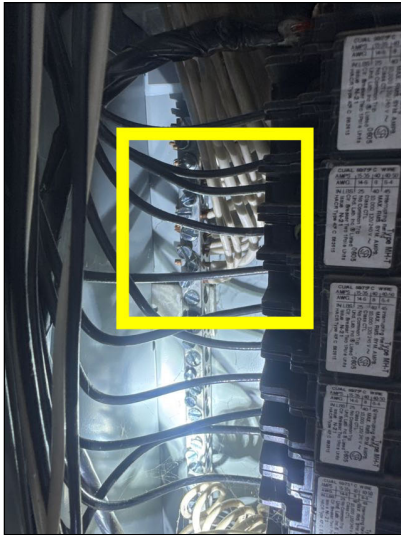
Multiple neutral conductors (white wire) from separate branch or separate feeder circuits cannot be installed in the same neutral terminal (lug screw). The Inspector recommends correction by a qualified electrical contractor.

Multiple neutral conductors (white wire) from separate branch or separate feeder circuits cannot be installed in the same neutral terminal (lug screw)

| | Page 24 Item: 4 | Panel Wiring | Multiple neutral conductors (white wire) from separate branch or separate feeder circuits cannot be installed in the same neutral terminal (lug screw). The Inspector recommends correction by a qualified electrical contractor. |

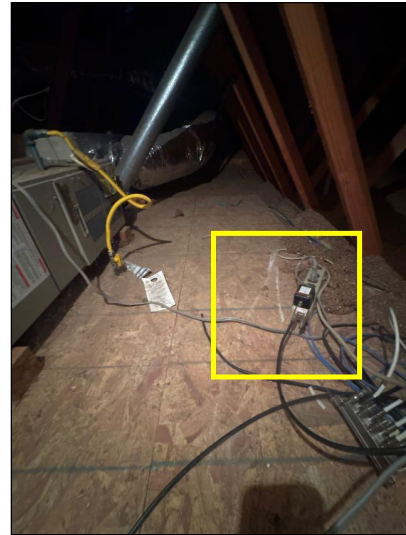
The furnace was plugged into an extension cord/power strip. Extension cords should not be used as permanent wiring. To provide power for this opener, the Inspector recommends that a dedicated electrical receptacle be installed at an appropriate location by a qualified electrical contractor.

The furnace was plugged into an extension cord/power strip.

| | Page 27 Item: 2 | Heater Condition | The furnace was plugged into an extension cord/power strip. Extension cords should not be used as permanent wiring. To provide power for this opener, the Inspector recommends that a dedicated electrical receptacle be installed at an appropriate location by a qualified electrical contractor. |

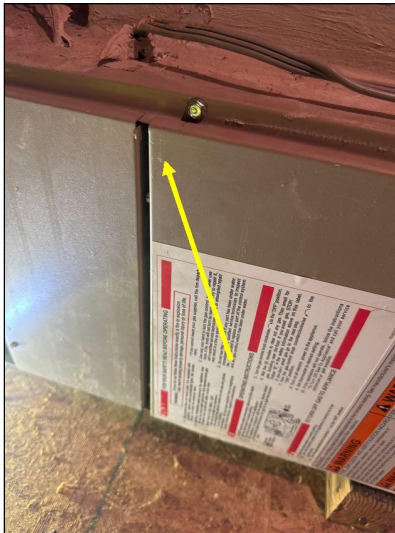
The safety switch in the blower compartment would not stay closed due to the faulty blower door. The Inspector recommends an evaluation and any necessary repairs be performed by a qualified HVAC technician.

| | Page 28 Item: 3 | Blower | The safety switch in the blower compartment would not stay closed due to the faulty blower door. The Inspector recommends an evaluation and any necessary repairs be performed by a qualified HVAC technician. |

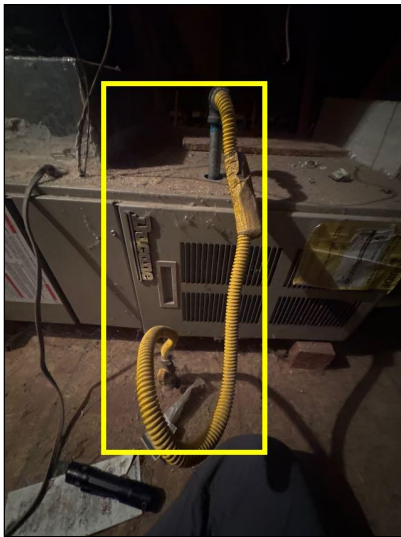
**Improvement:** The gas supply pipe contained no sediment trap.

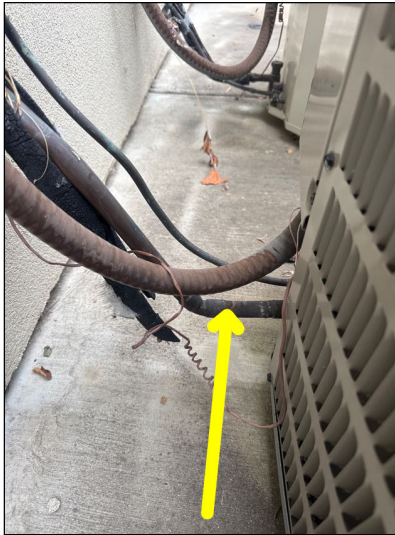
**Maintenance:** Insulation on the air-conditioning suction (large, insulated) line was damaged or missing at the A/C unit.

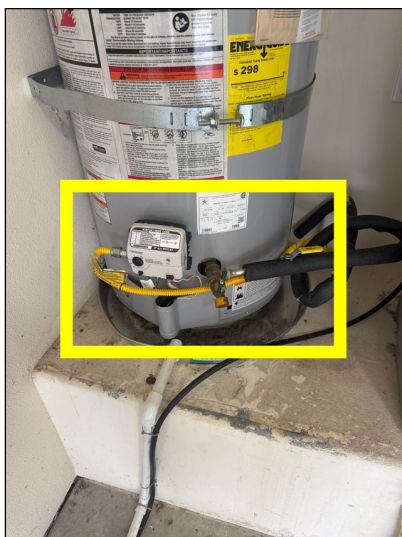
**Improvement:** The gas supply pipe contained no sediment trap.

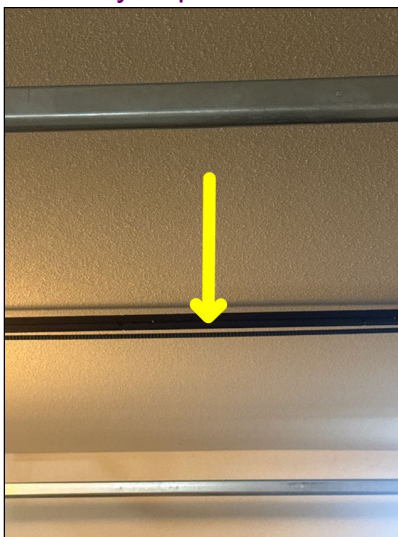
The belt tension on the overhead opener needs to be adjusted. When the belt is properly adjusted the belt will be 1/2" (for T-Rail) or 1/4 " (for Square Rail) above the base of the rail at its midpoint. Recommend adjustment by a qualified contractor.

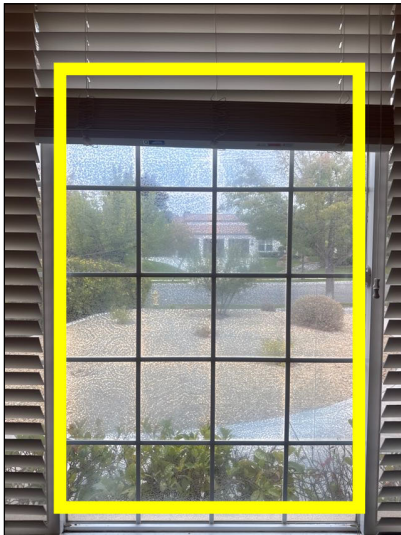
Staining and etching of the glass at the window indicated a loss of thermal integrity.

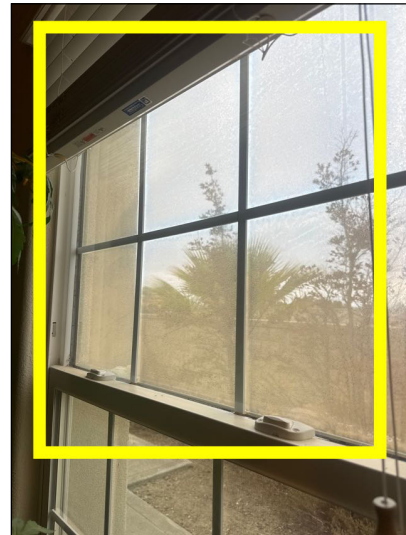
Staining and etching of the glass at the window indicated a loss of thermal integrity.

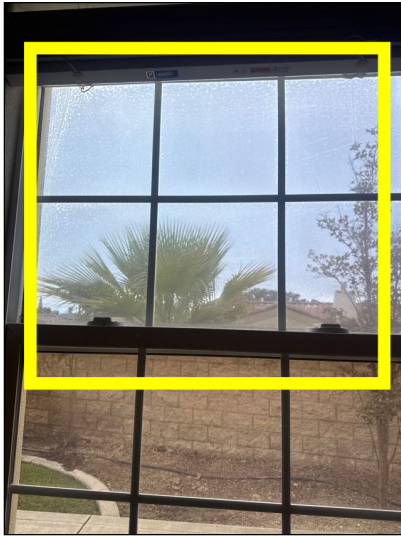
Staining and etching of the glass at the window indicated a loss of thermal integrity.

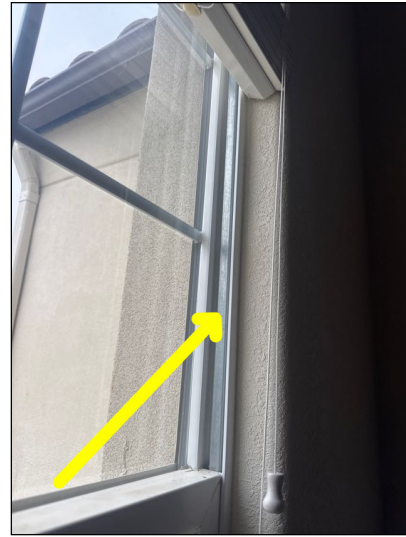
The sash bar has dropped out of place on a single-hung window in the family room. This could affect the ability for the window stay up when lifted and released and or make the window non-functioning. The Inspector recommends repair or replacement by a qualified contractor.

The sash bar has dropped out of place on a single-hung window

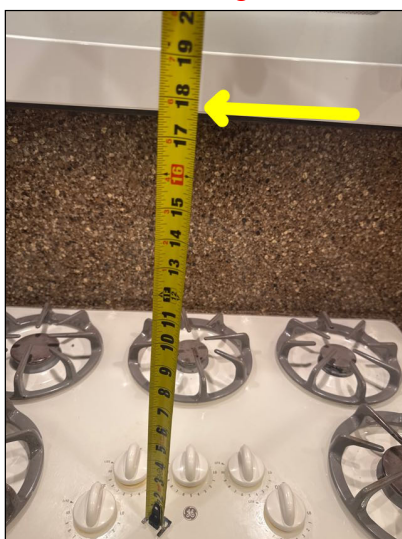
**Safety:** Any range hood, including microwaves, installed above the stove must be a minimum of 24 inches

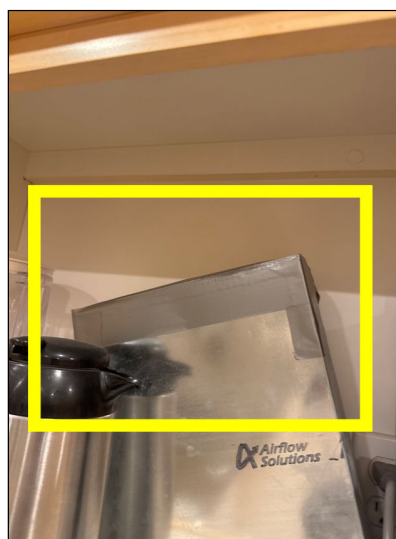
**Safety:** Improper cloth backed duct tape utilized on the vent duct connections.

| | Page 50 Item: 10 | Vent Condition | <p>• <b>Safety:</b> Improper cloth backed duct tape utilized on the vent duct connections in the cabinet above the vent hood is considered a fire hazard. Recommend proper metallic foil tape utilized to re-attach the ducting.</p> |

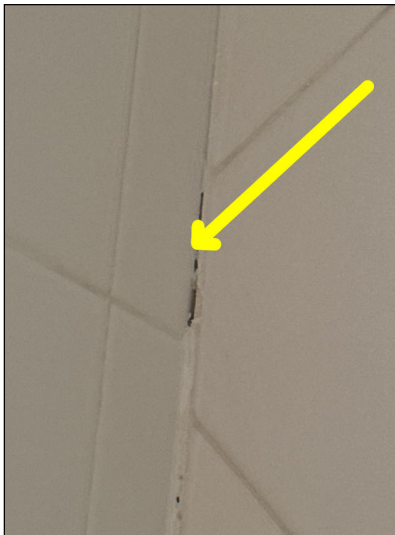
- **Maintenance:** The shower tiles had areas of missing grout that may allow moisture to penetrate the walls. Recommend re grouting as needed to prevent any moisture intrusion to the walls.

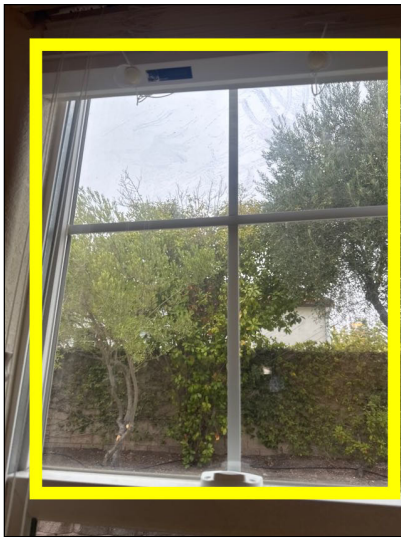
Staining and etching of the glass at the window indicated a loss of thermal integrity.

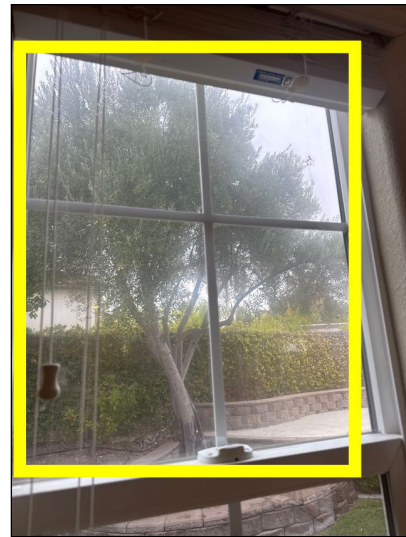
Staining and etching of the glass at the window indicated a loss of thermal integrity.

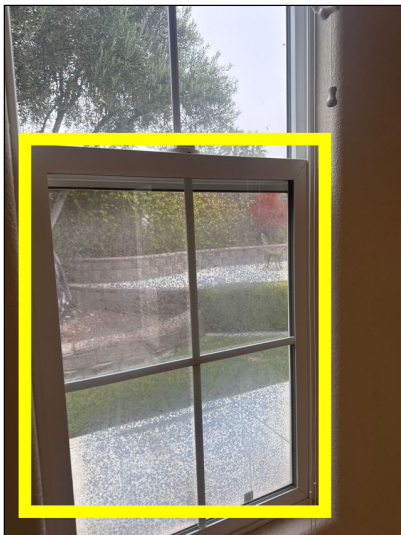
Staining and etching of the glass at the window indicated a loss of thermal integrity.

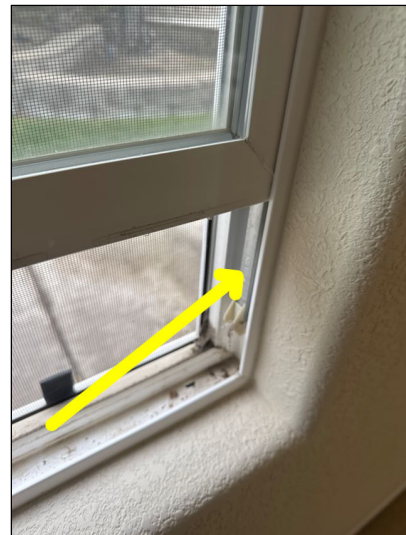
The sash bar has dropped out of place on a single-hung window

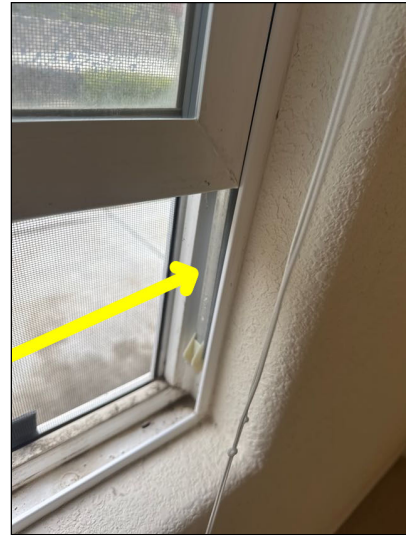
The sash bar has dropped out of place on a single-hung window
